# The Road Inventory of Wilson's Creek National Battlefield WICR - 6370

Prepared By:  
Federal Highway Administration  
Eastern Federal Lands Highway Division  
Cycle 3

# Wilson's Creek National Battlefield in Missouri

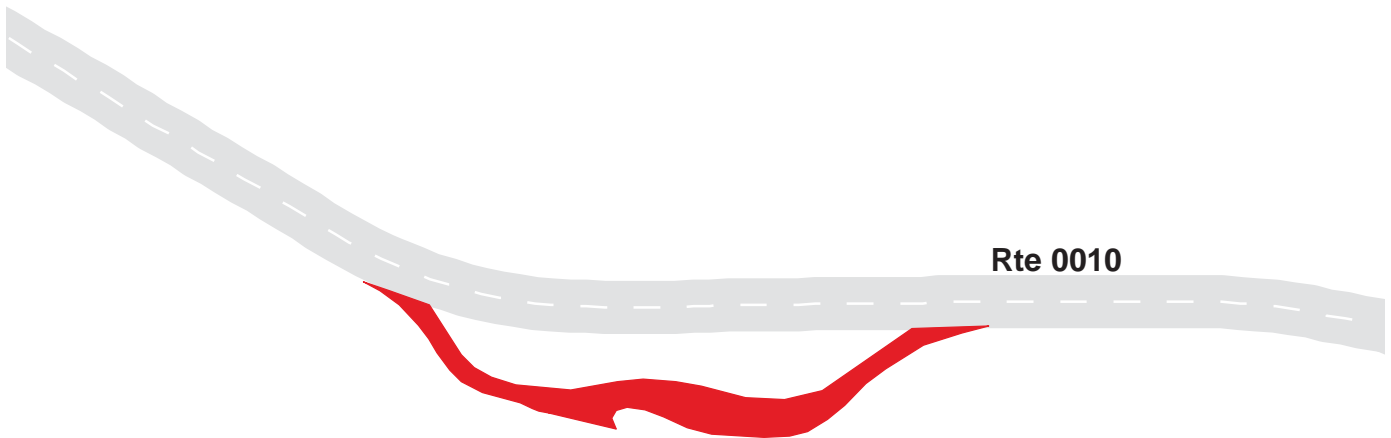
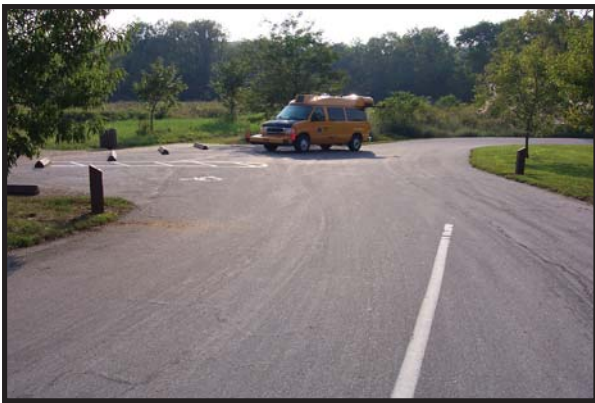
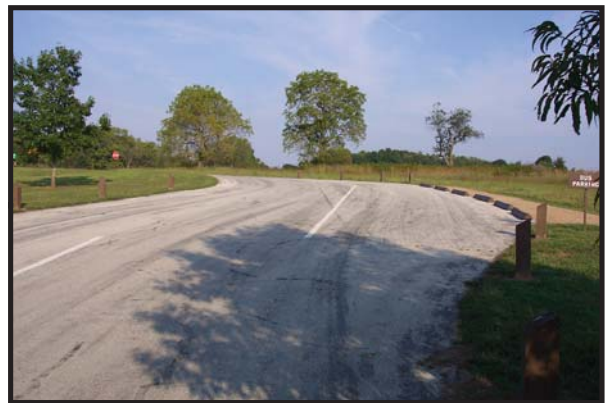
## Route 0902

Route	Public / NonPublic	Date Visited	Area (sq ft)	Lane Miles *	Surface Type	Condition / PCR
0902	Public	9/9/2003	21500	0.37	AS	GOOD / 90

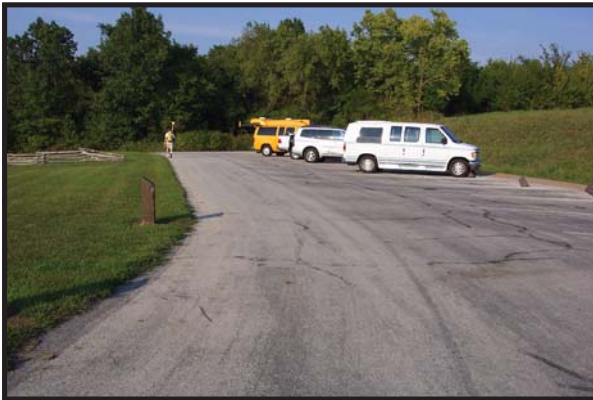
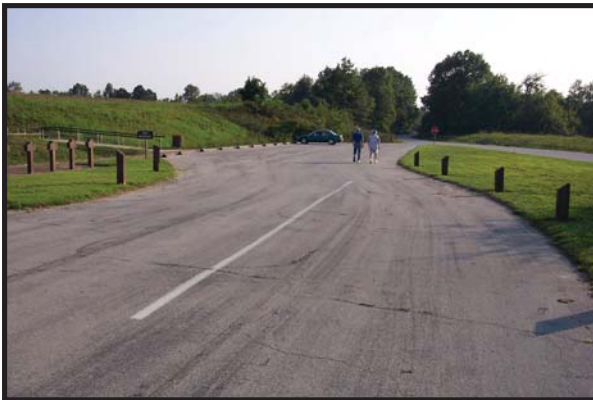
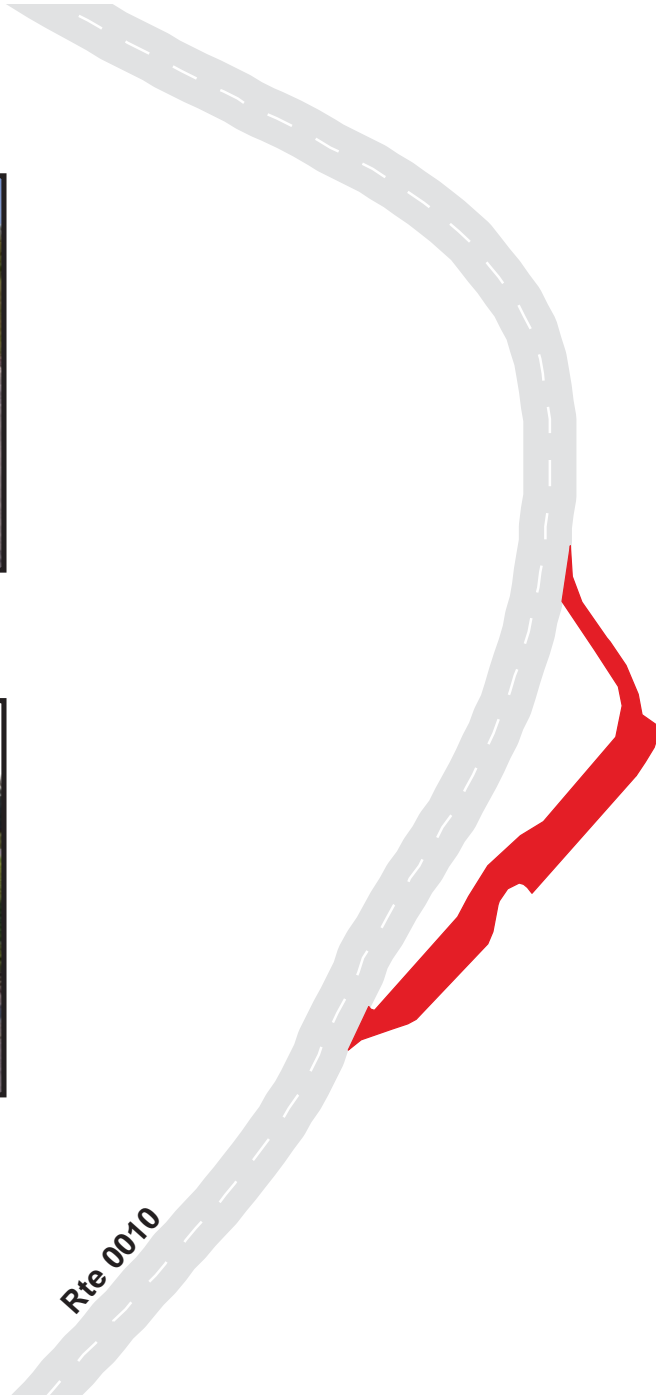
## Route 0903

Route	Public / NonPublic	Date Visited	Area (sq ft)	Lane Miles *	Surface Type	Condition / PCR
0903	Public	9/9/2003	22075	0.38	AS	FAIR / 73

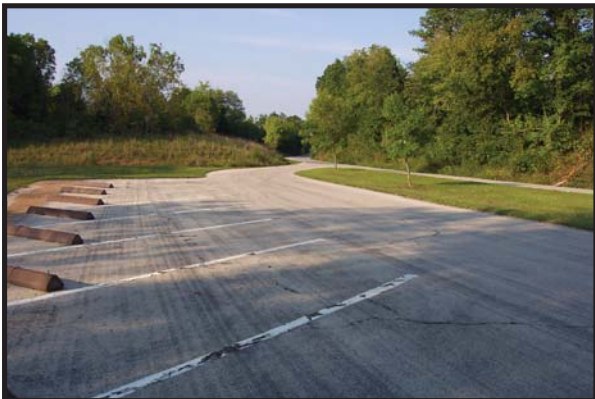
## Route 0904

Route	Public / NonPublic	Date Visited	Area (sq ft)	Lane Miles *	Surface Type	Condition / PCR
0904	Public	9/9/2003	15632	0.27	AS	GOOD / 90

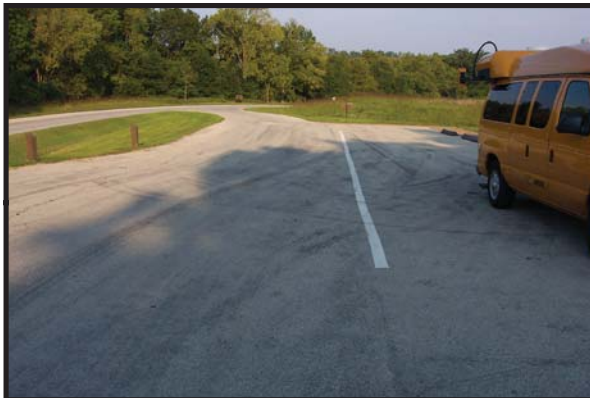
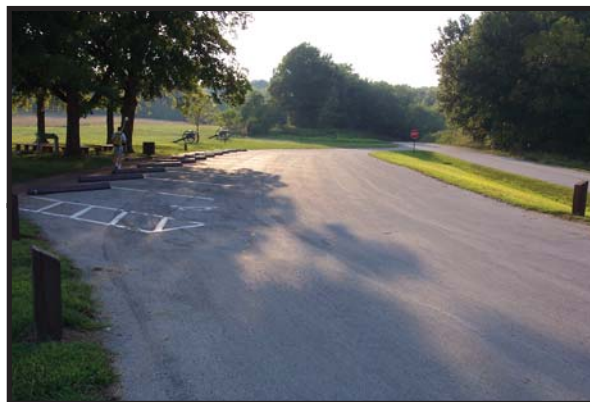
## Route 0905

Route	Public / NonPublic	Date Visited	Area (sq ft)	Lane Miles *	Surface Type	Condition / PCR
0905	Public	9/9/2003	21755	0.37	AS	GOOD / 90

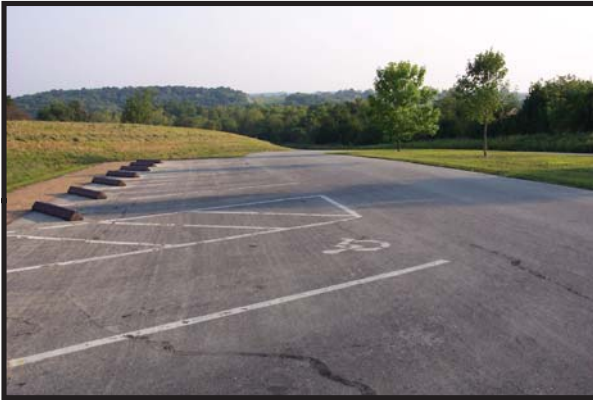
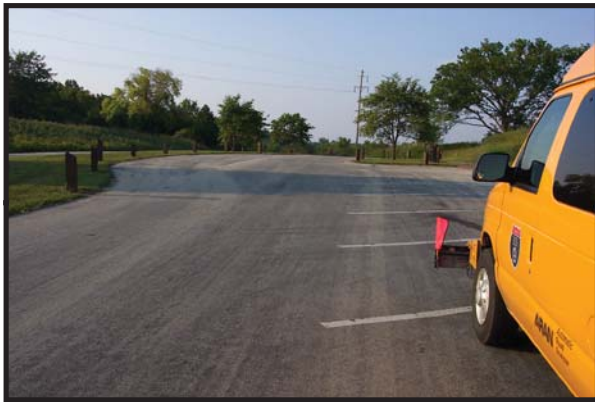
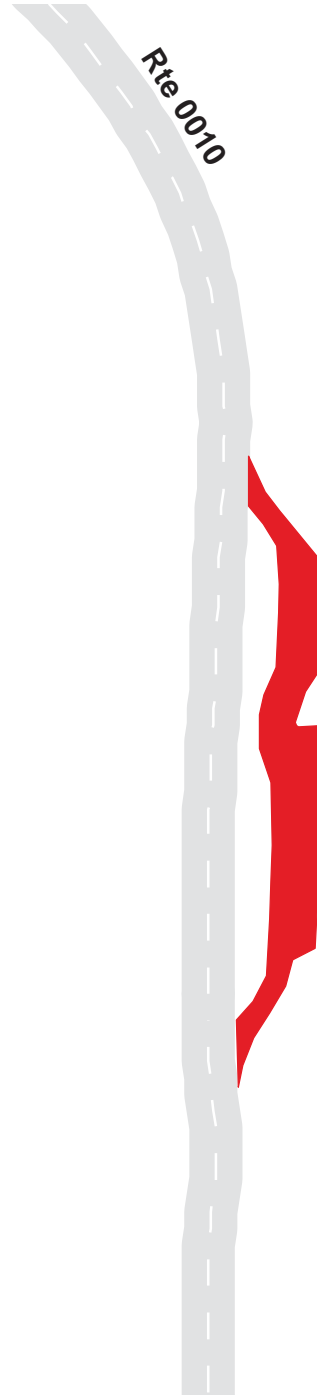
## Route 0906

Route	Public / NonPublic	Date Visited	Area (sq ft)	Lane Miles *	Surface Type	Condition / PCR
0906	NonPublic	9/9/2003	9148	0.16	AS	POOR / 45

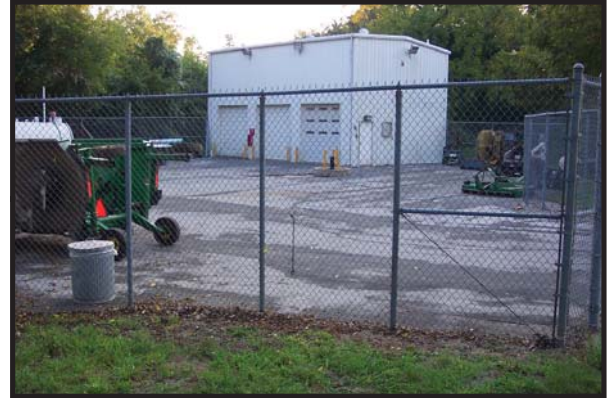
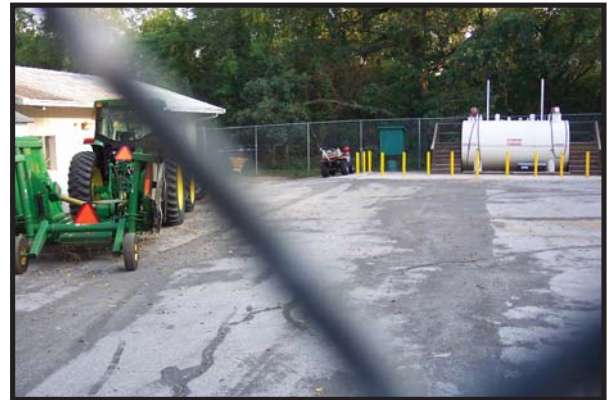
## Route 0907

Route	Public / NonPublic	Date Visited	Area (sq ft)	Lane Miles *	Surface Type	Condition / PCR
0907	NonPublic	9/9/2003	7522	0.13	AS	FAIR / 73
