**The Road Inventory  
of  
William Howard Taft National  
Historic Site  
WIHO – 6518**

Prepared By:  
Federal Highway Administration  
Eastern Federal Lands Highway Division  
Cycle 3

# William Howard Taft National Historic Site in Ohio

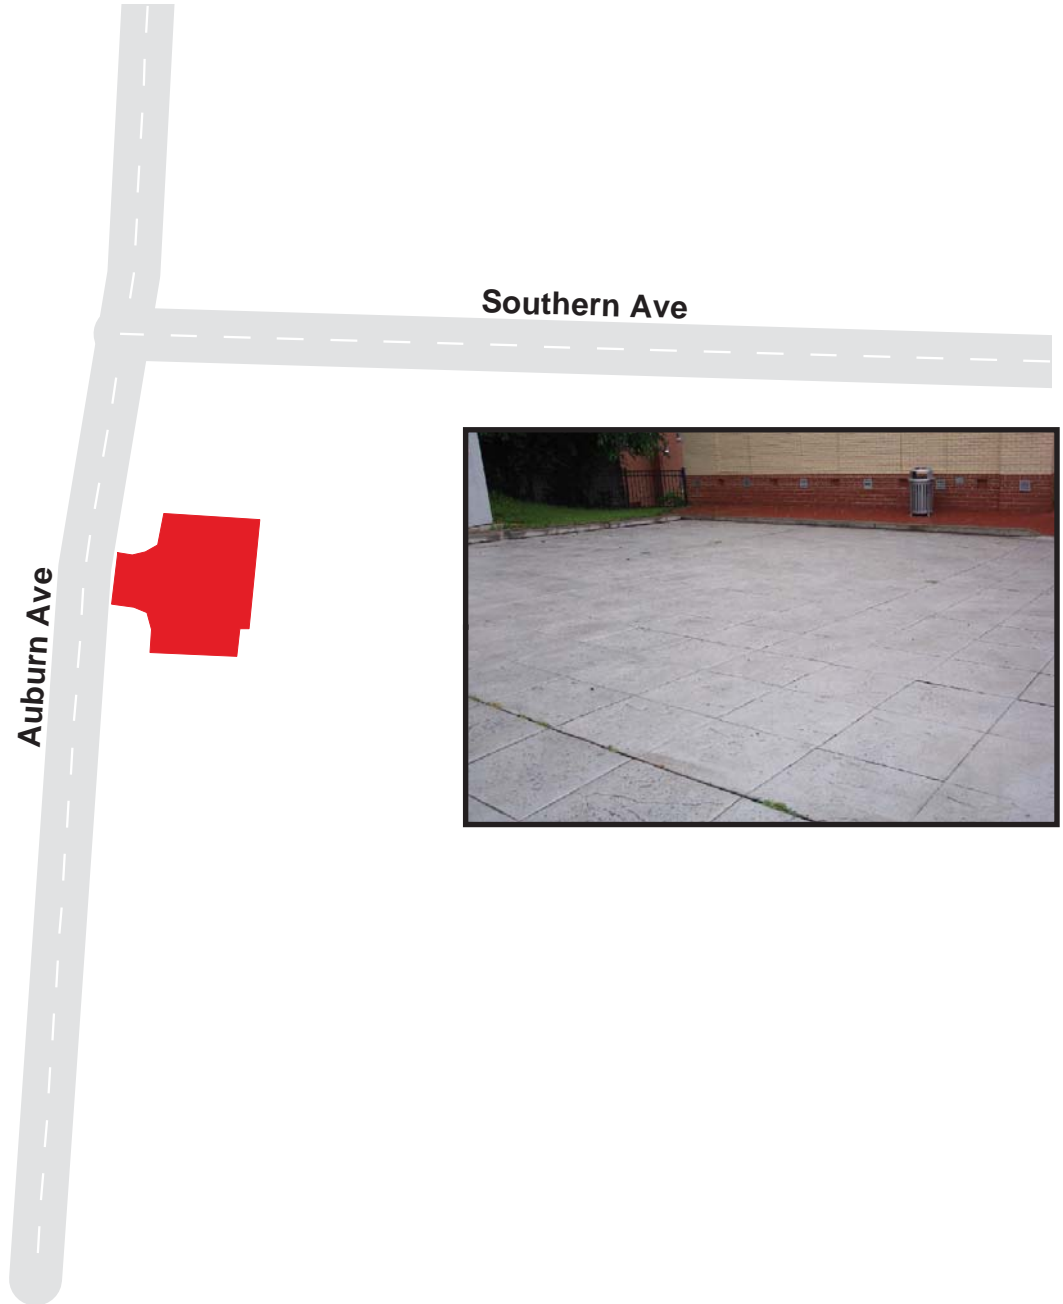
## Route 0900

### VISITOR CENTER PARKING FROM AUBURN AVE

Route	Public / NonPublic	Date Visited	Area (sq ft)	Lane Miles *	Surface Type	Condition / PCR
0900	Public	7/28/2003	2532	0.04	CO	GOOD / 90

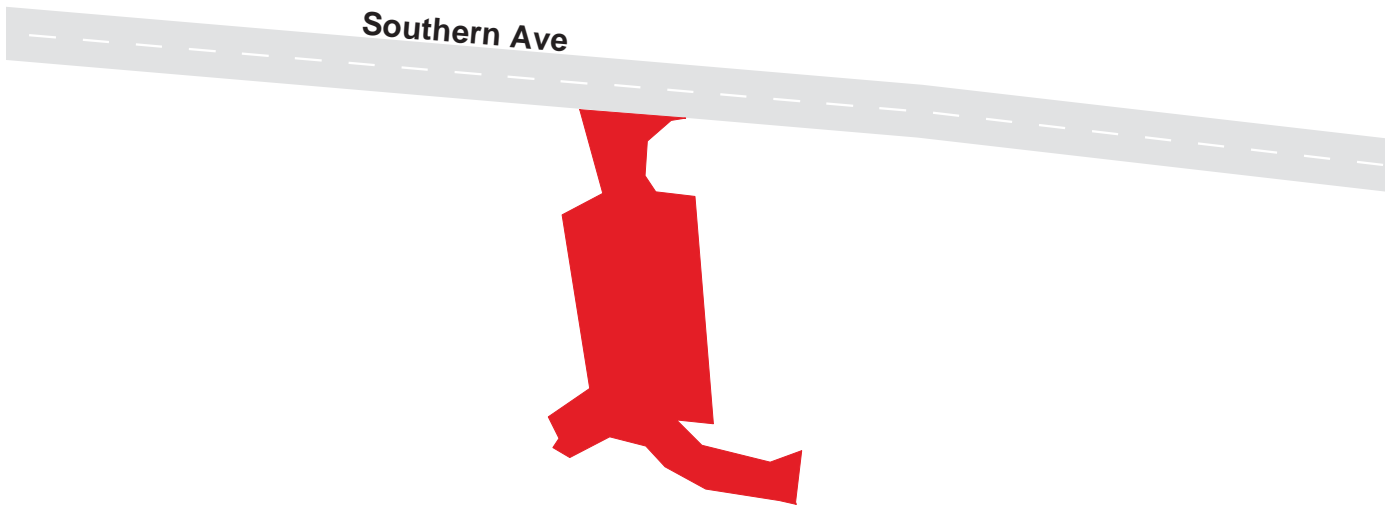
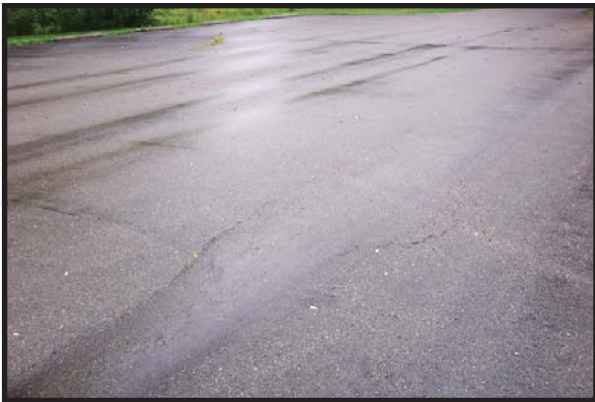
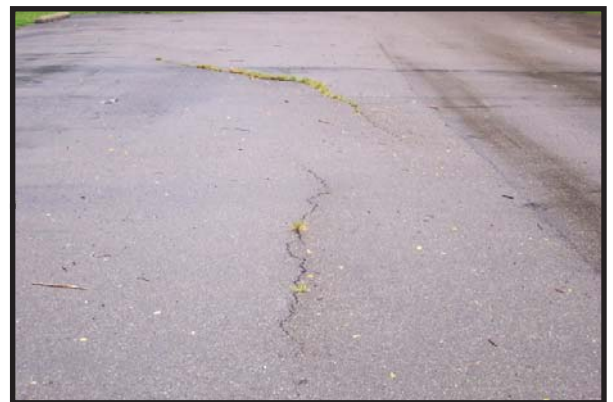
## Route 0901

### OVERFLOW PARKING FROM SOUTHERN AVE

Route	Public / NonPublic	Date Visited	Area (sq ft)	Lane Miles *	Surface Type	Condition / PCR
0901	Public	7/28/2003	10011	0.17	AS	FAIR / 73
