The Road Inventory of Women's Rights National Historical Park WORI - 1955

Road Inventory Program

Prepared By:
Federal Highway Administration
Eastern Federal Lands Highway Division
Cycle 3

Women's Rights National Historical Park in New York

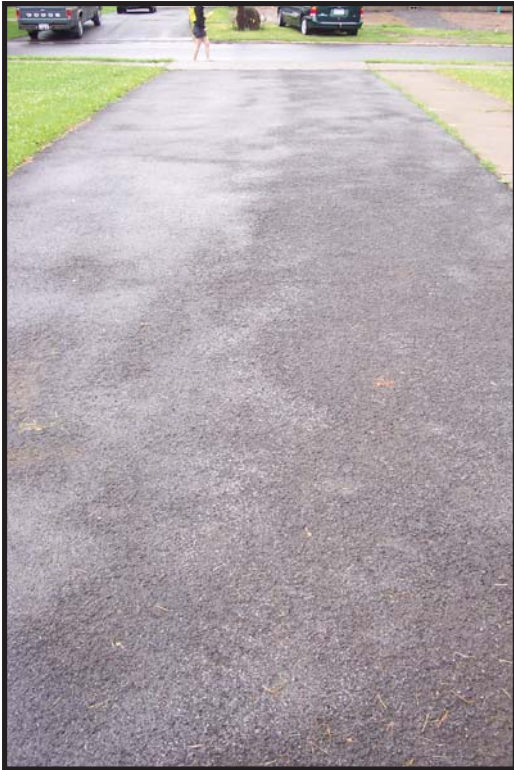
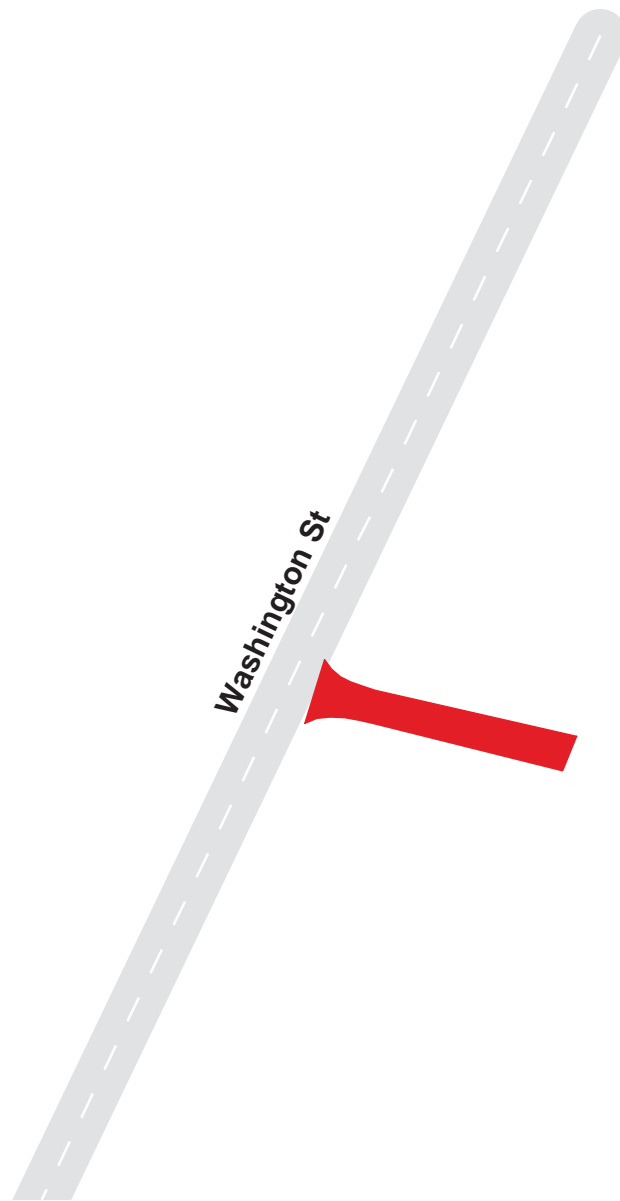
Route 0902

RANGER STATION PARKING

From Washington Street

Route	Public / NonPublic	Date Visited	Area (sq ft)	Lane Miles *	Surface Type	Condition / PCR
0902	NonPublic	7/12/2004	904	0.02	AS	GOOD / 90

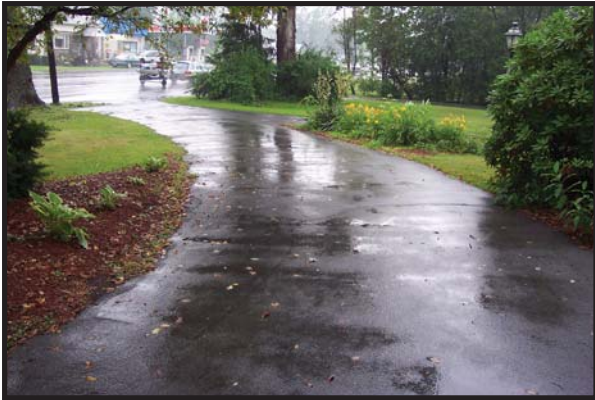
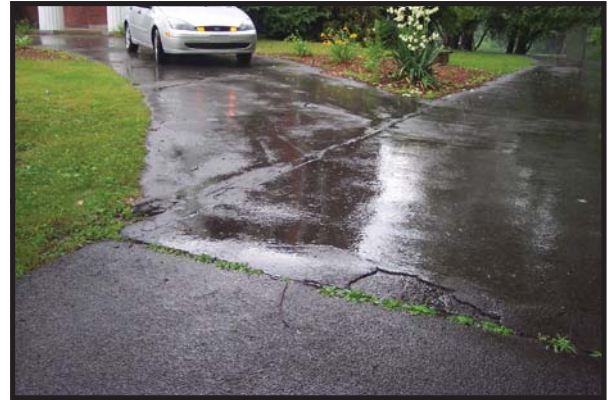
Route 0903

HUNT HOUSE PARKING

From East Main Street

Route	Public / NonPublic	Date Visited	Area (sq ft)	Lane Miles *	Surface Type	Condition / PCR
0903	Public	7/12/2004	6031	0.10	AS	FAIR / 73
