The Road Inventory of Wright Brothers National Memorial WRBR - 5187

Road Inventory Program

Prepared By:
Federal Highway Administration
Eastern Federal Lands Highway Division
Cycle 3

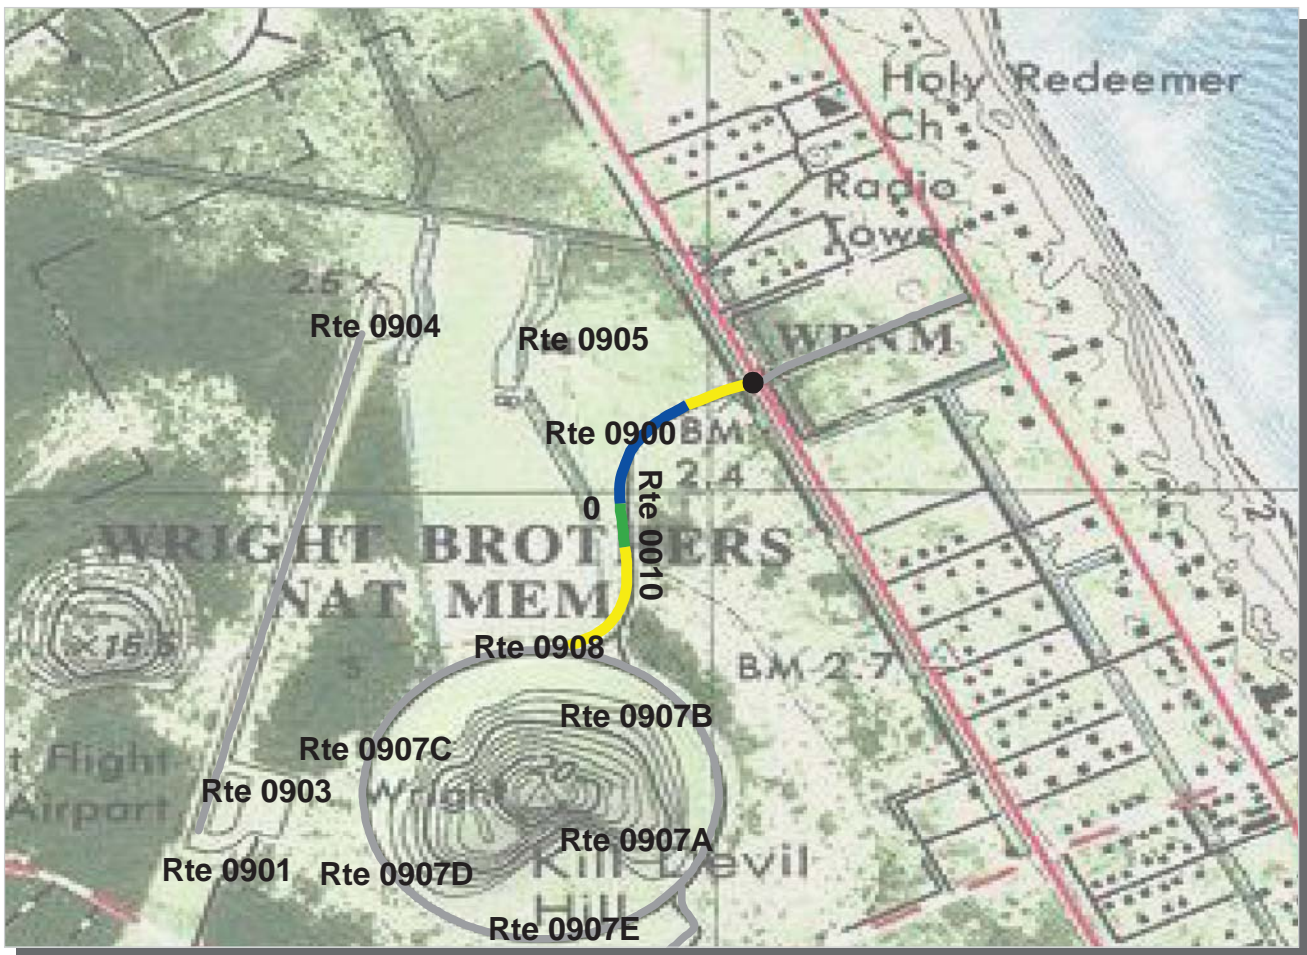
ROUTE: 0010 Entrance Road **TOTAL LENGTH: 0.35 Miles**

Section Number	0				
Section Length (mi)	0.35				
AADT	**				
SADT	**				
ADT Date	**				
Cross Section Information					
Number of Lanes	2				
Paved Width (ft)	21				
Lane Width (ft)	9				
Shoulder Width (ft)	0				
Roadway Condition Information					
PCR (Pavement Condition Rating)	82				
RCI (Roughness Condition Index)	91				
SCR (Surface Condition Rating)	78				
Alligator Cracking Index	100				
Rutting Index	81				
Patching Index	99				
Transverse Cracking Index	97				
Longitudinal Cracking Index	99				
Shoulder Condition Rating	N/A				
Drainage Condition Rating	GOOD

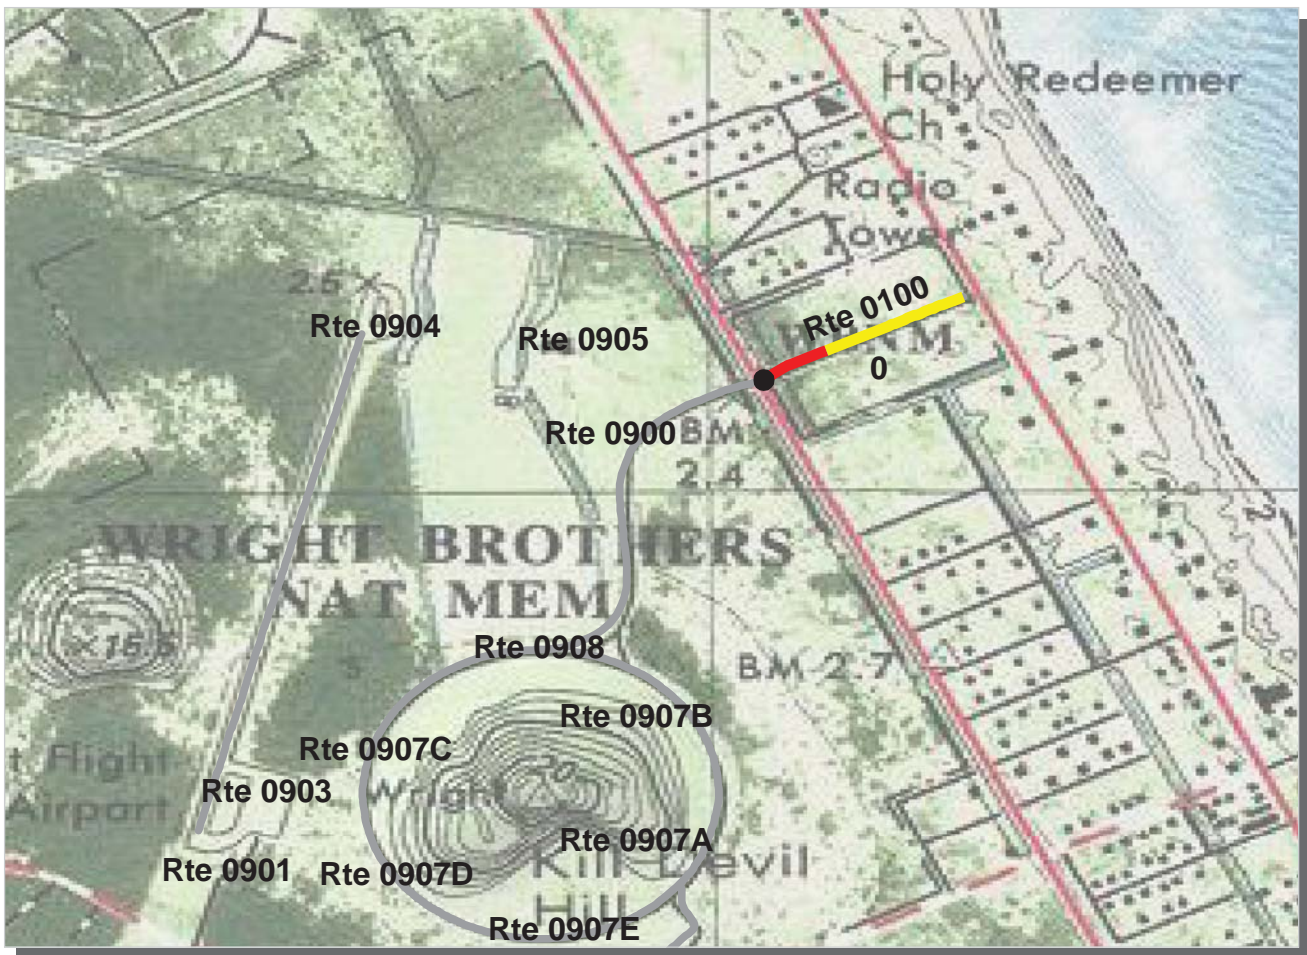
ROUTE: 0100 Prospect Avenue

Section Number	0				
Section Length (mi)	0.20				
AADT	**				
SADT	**				
ADT Date	**				
Cross Section Information					
Number of Lanes	2				
Paved Width (ft)	26				
Lane Width (ft)	9				
Shoulder Width (ft)	7				
Roadway Condition Information					
PCR (Pavement Condition Rating)	60				
RCI (Roughness Condition Index)	77				
SCR (Surface Condition Rating)	57				
Alligator Cracking Index	100				
Rutting Index	64				
Patching Index	99				
Transverse Cracking Index	94				
Longitudinal Cracking Index	98				
Shoulder Condition Rating	GOOD				
Drainage Condition Rating	GOOD

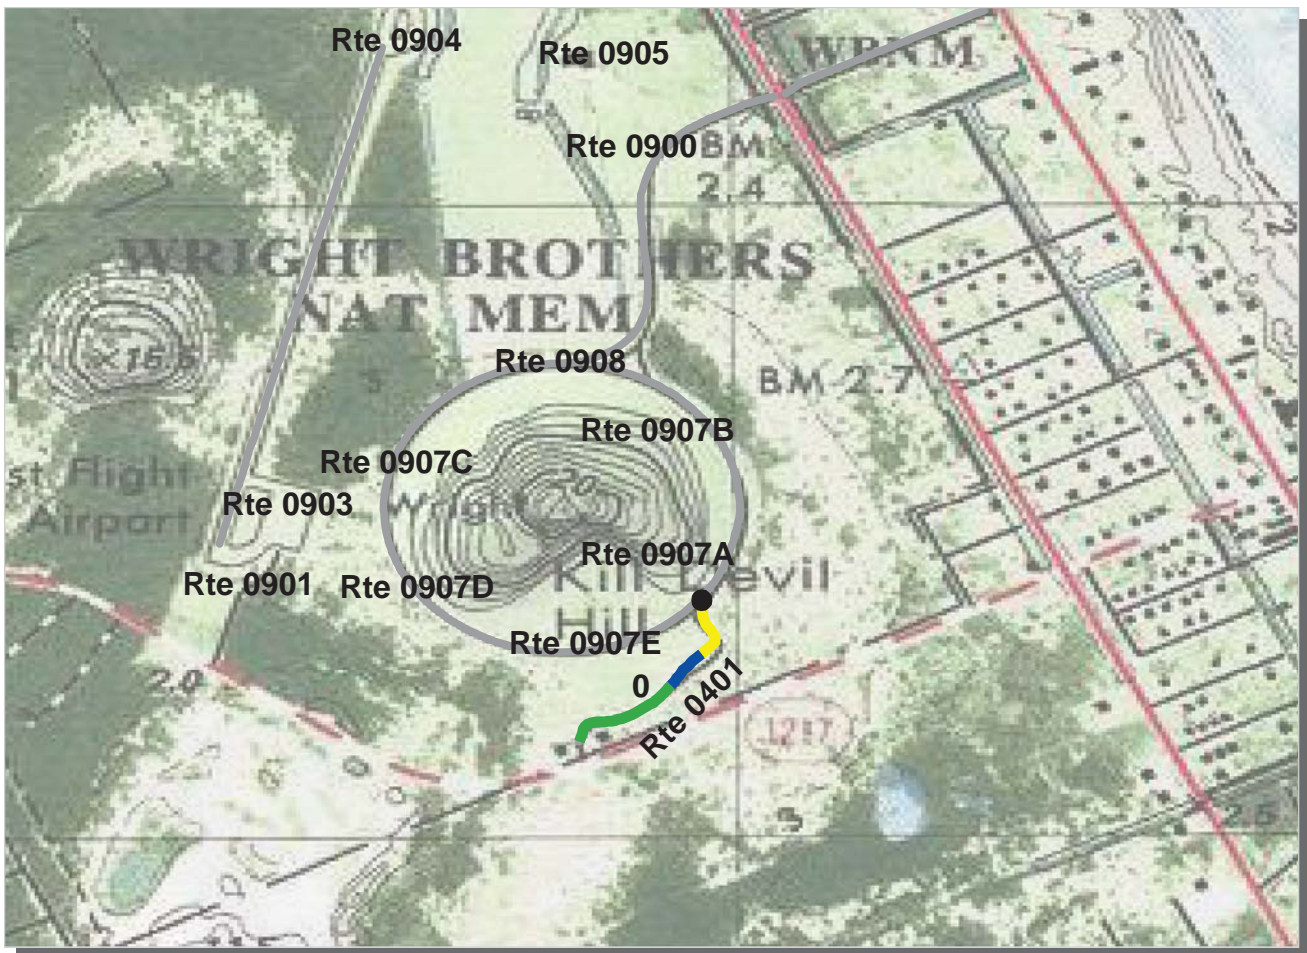
ROUTE: 0401 Maintenance Access Road

Section Number	0				
Section Length (mi)	0.22				
AADT	**				
SADT	**				
ADT Date	**				
Cross Section Information					
Number of Lanes	1				
Paved Width (ft)	15				
Lane Width (ft)	15				
Shoulder Width (ft)	5				
Roadway Condition Information					
PCR (Pavement Condition Rating)	77				
RCI (Roughness Condition Index)	90				
SCR (Surface Condition Rating)	77				
Alligator Cracking Index	100				
Rutting Index	82				
Patching Index	100				
Transverse Cracking Index	96				
Longitudinal Cracking Index	98				
Shoulder Condition Rating	GOOD				
Drainage Condition Rating	GOOD

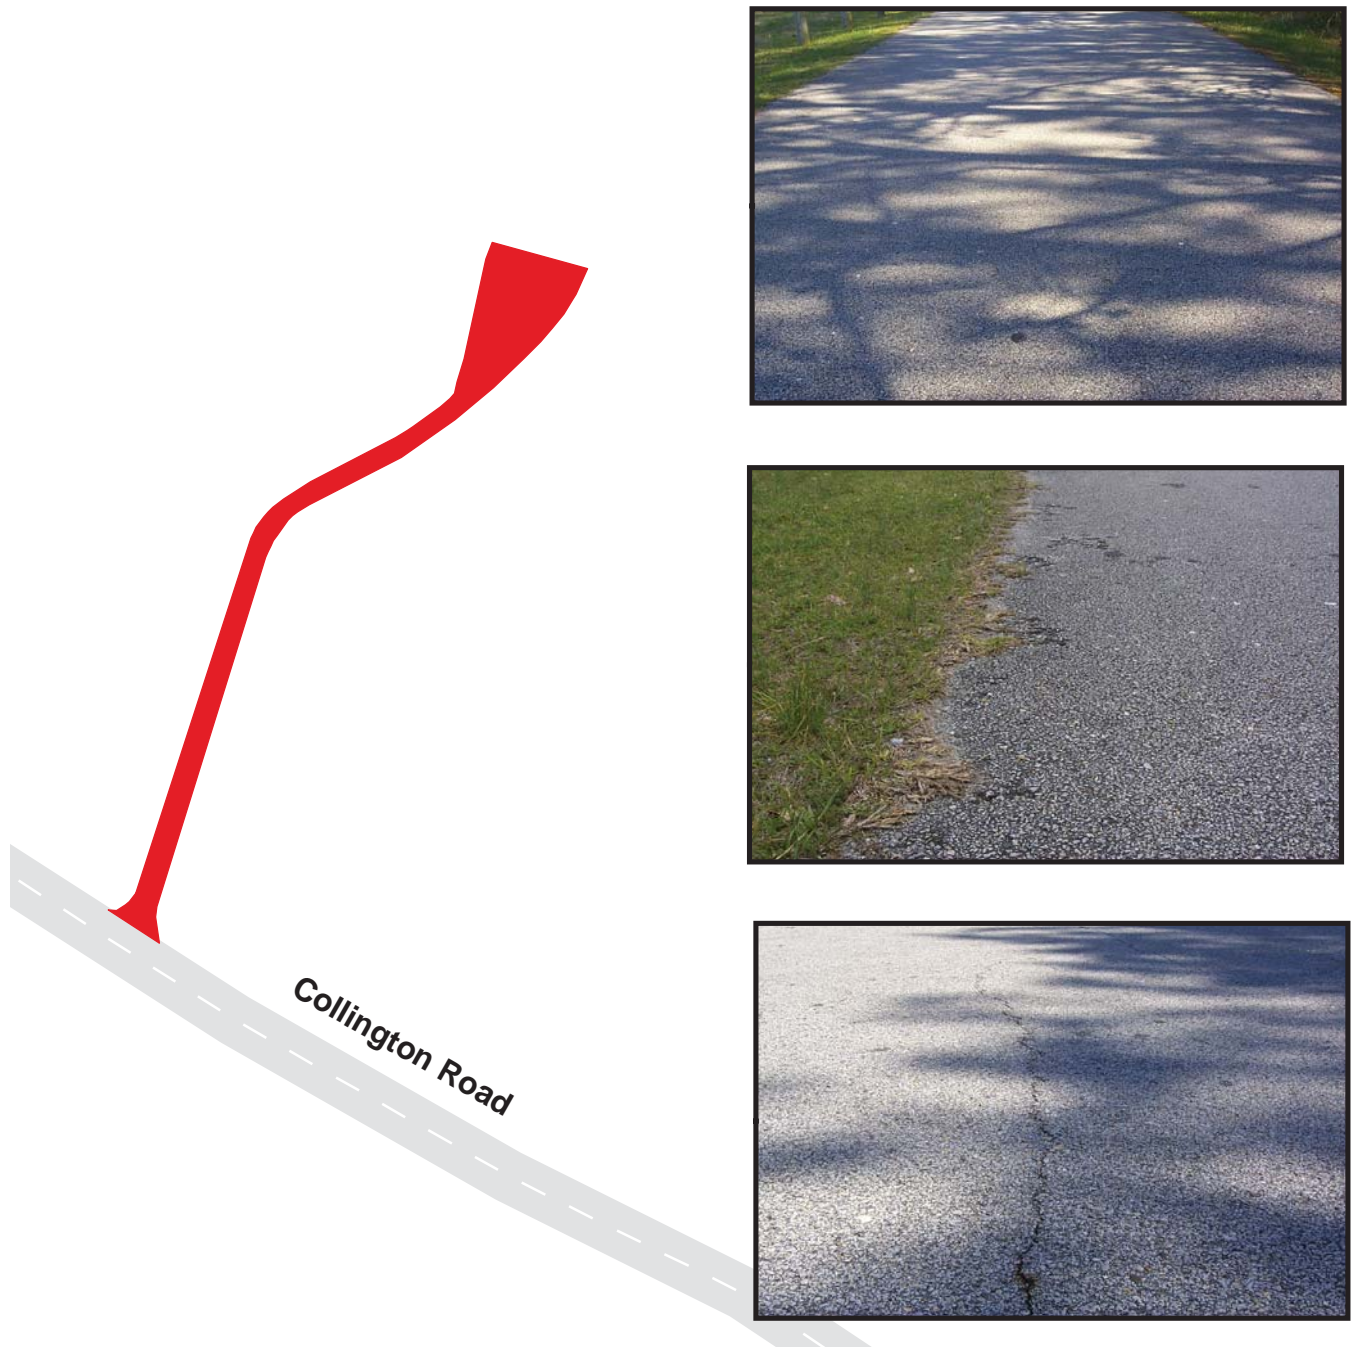
Route 0901

Route	Public / NonPublic	Date Visited	Area (sq ft)	Lane Miles *	Surface Type	Condition / PCR
0901	Public	4/9/2002	15541	0.27	AS	GOOD / 90
