The Road Inventory of Wupatki National Monument WUPA – 7470

Road Inventory Program

Prepared By:
Federal Highway Administration
Eastern Federal Lands Highway Division
Cycle 3

Wupatki National Monument in Arizona

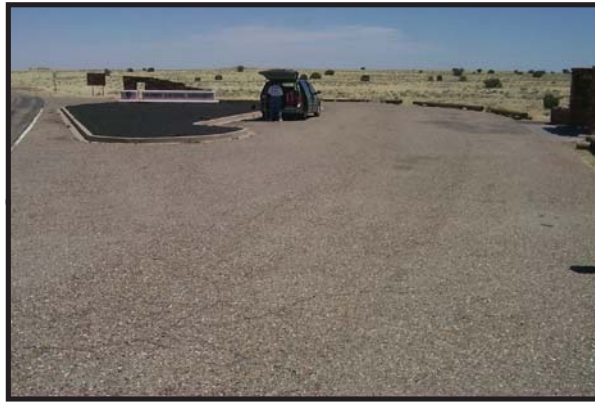
Route	Public / NonPublic	Date Visited	Area (sq ft)	Lane Miles *	Surface Type	Condition / PCR
0900	Public	5/9/2002	9149	0.16	AS	FAIR / 73

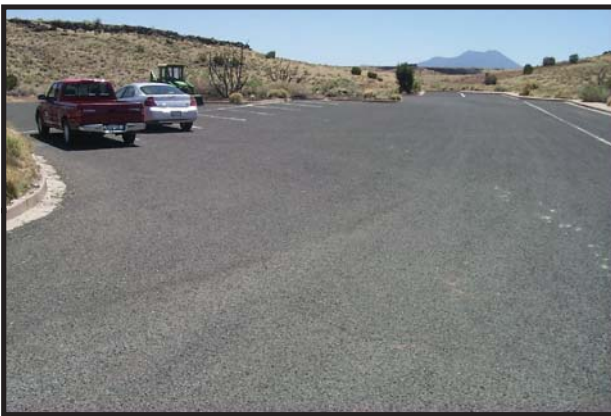
Route 0901

Route	Public / NonPublic	Date Visited	Area (sq ft)	Lane Miles *	Surface Type	Condition / PCR
0901	Public	5/9/2002	31179	0.54	OC	EXCELLENT / 97

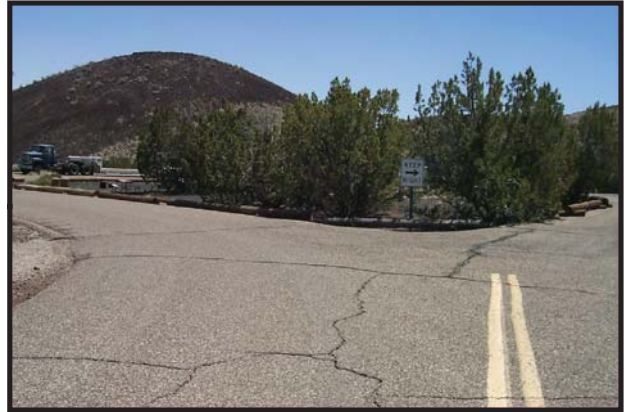
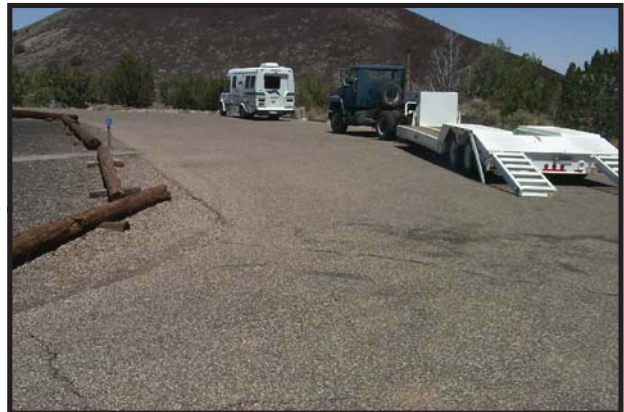
Route 0903

Route	Public / NonPublic	Date Visited	Area (sq ft)	Lane Miles *	Surface Type	Condition / PCR
0903	Public	5/9/2002	13180	0.23	AS	FAIR / 73

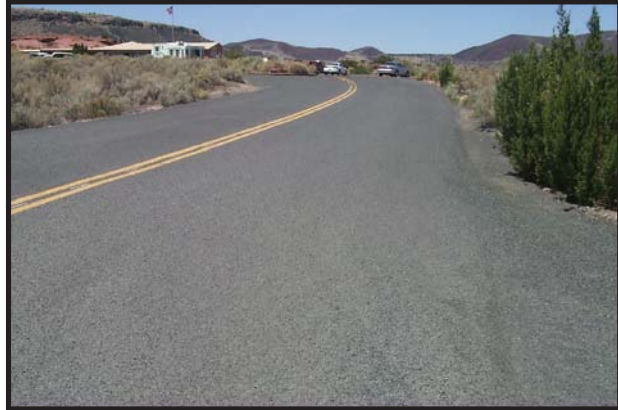
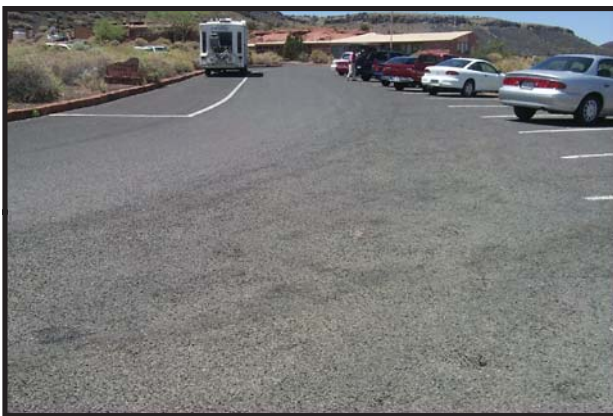
Route 0904

Route	Public / NonPublic	Date Visited	Area (sq ft)	Lane Miles *	Surface Type	Condition / PCR
0904	Public	5/9/2002	32109	0.55	AS	GOOD / 90

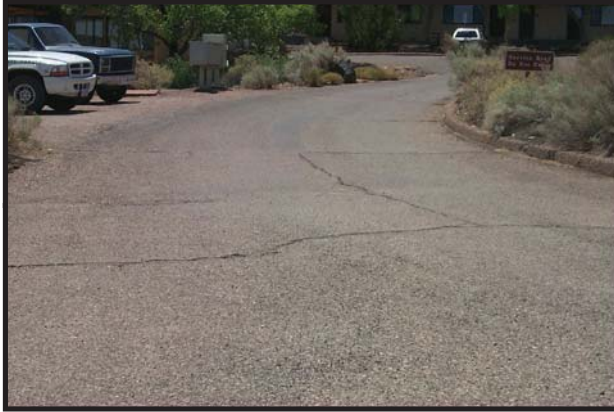
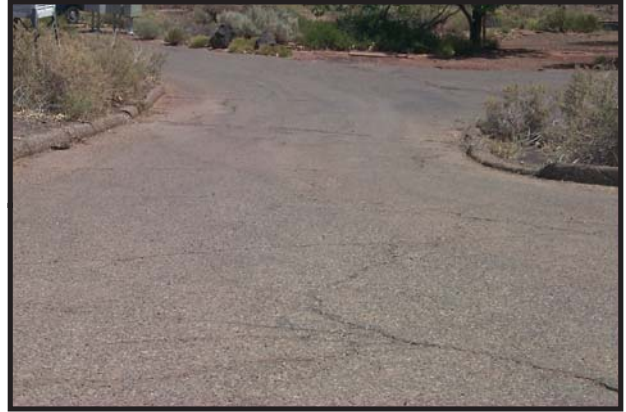
Route	Public / NonPublic	Date Visited	Area (sq ft)	Lane Miles *	Surface Type	Condition / PCR
0905	NonPublic	5/9/2002	13757	0.24	AS	FAIR / 73

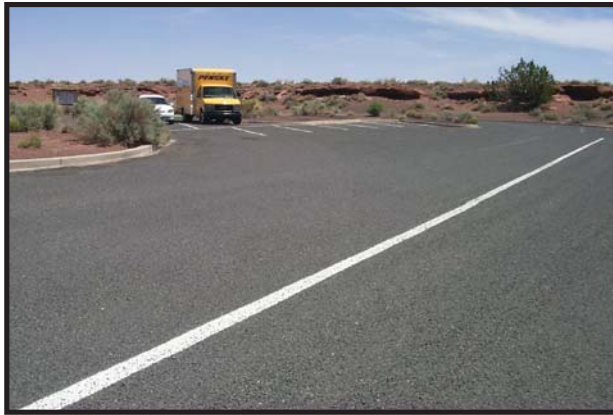
Route 0906

Route	Public / NonPublic	Date Visited	Area (sq ft)	Lane Miles *	Surface Type	Condition / PCR
0906	Public	5/9/2002	21486	0.37	OC	EXCELLENT / 97

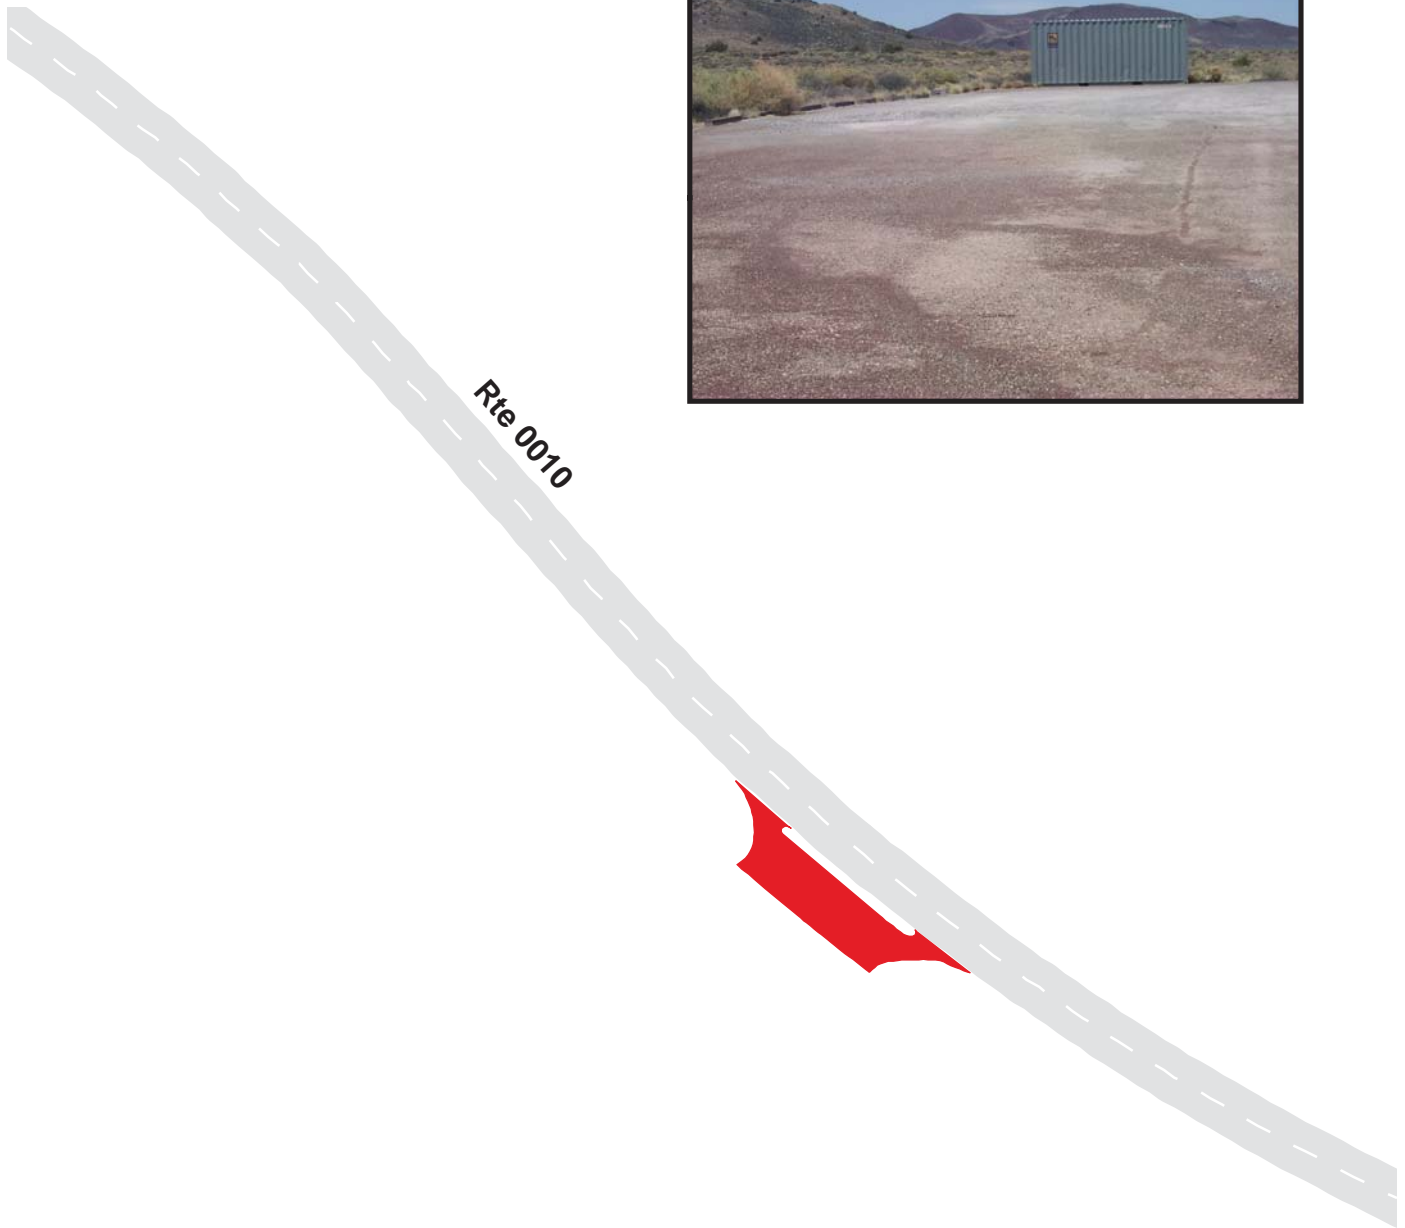
Route 0907

Route	Public / NonPublic	Date Visited	Area (sq ft)	Lane Miles *	Surface Type	Condition / PCR
0907	Public	5/9/2002	16078	0.28	AS	POOR / 45

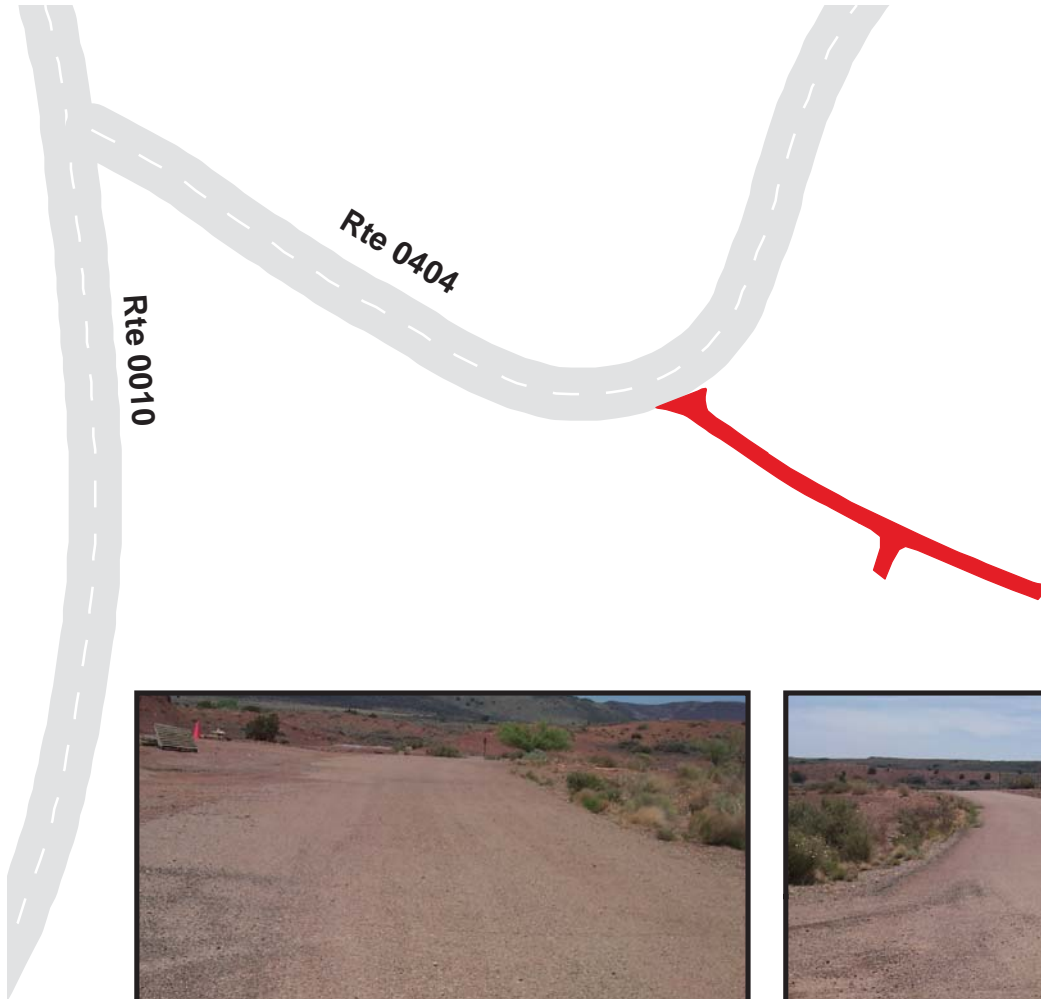
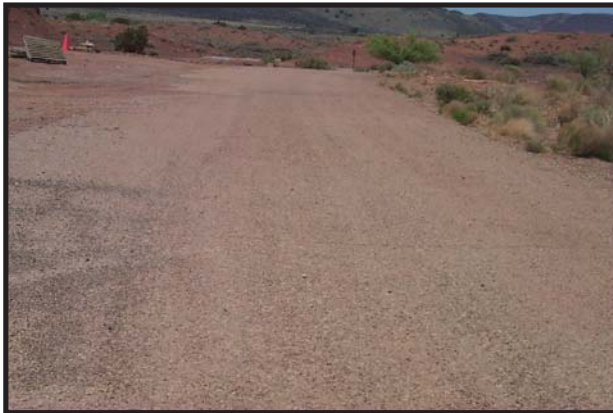
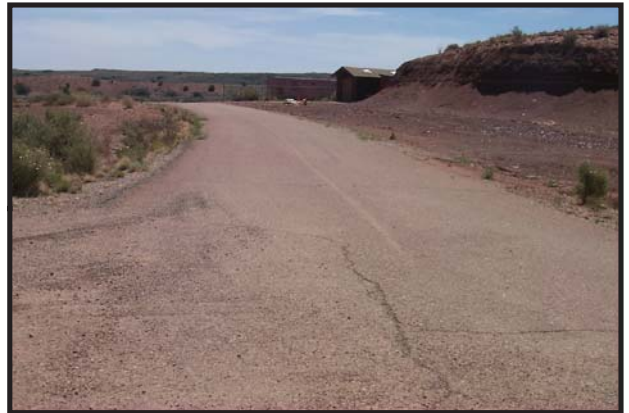
Route 0908

Route	Public / NonPublic	Date Visited	Area (sq ft)	Lane Miles *	Surface Type	Condition / PCR
0908	NonPublic	5/9/2002	10965	0.19	AS	FAIR / 73
