The Road Inventory of Zion National Park ZION – 1590

Road Inventory Program

Prepared By:
Federal Highway Administration
Eastern Federal Lands Highway Division
Cycle 3

Zion National Park in Utah

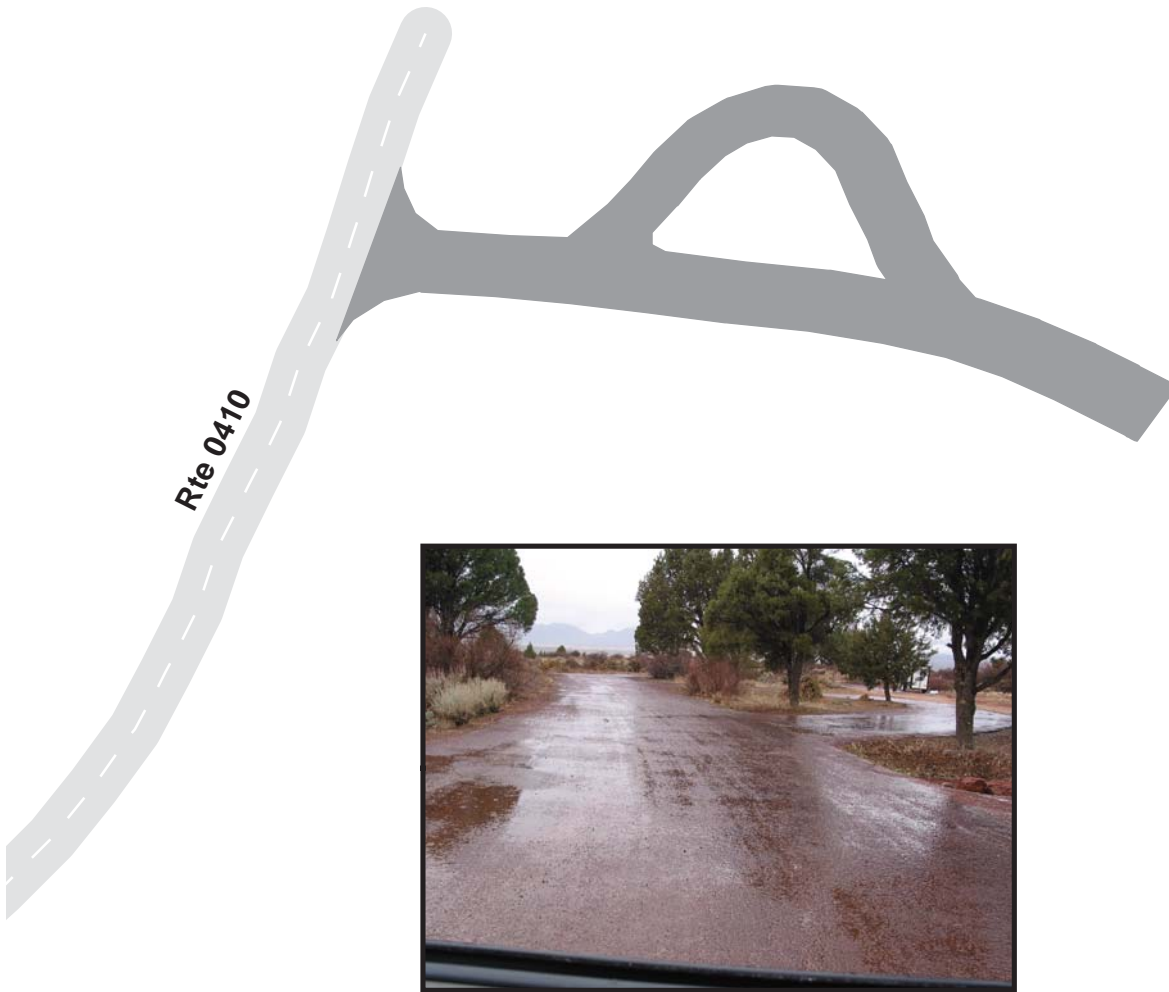
Route 0900

Route	Public / NonPublic	Date Visited	Area (sq ft)	Lane Miles *	Surface Type	Condition / PCR
0900	Public	2/11/2003	12501	0.22	OC	FAIR / 73

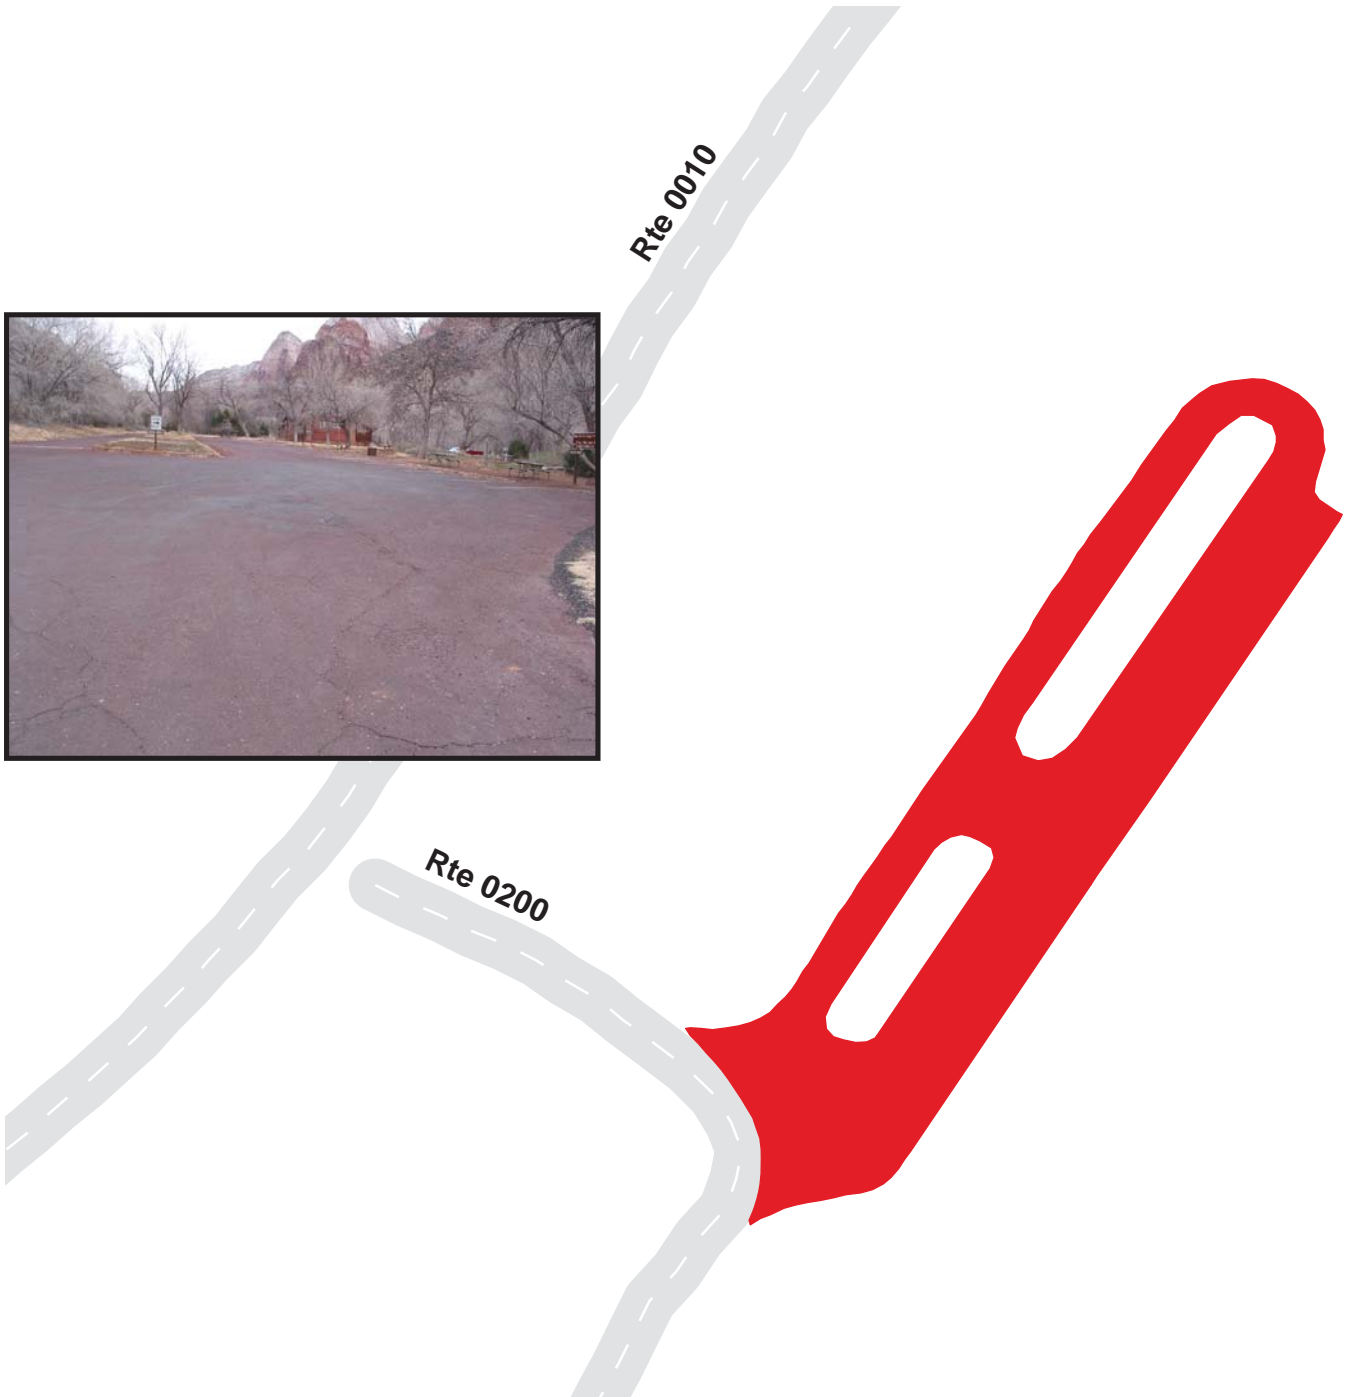
Zion National Park
Route 0907
 South Amphitheater Parking
 Adjacent to Route 0906

Route	Public / NonPublic	Date Visited	Area (sq ft)	Lane Miles *	Surface Type	Condition / PCR
0907	Public	2/11/2003	24767	0.43	AS	FAIR / 73

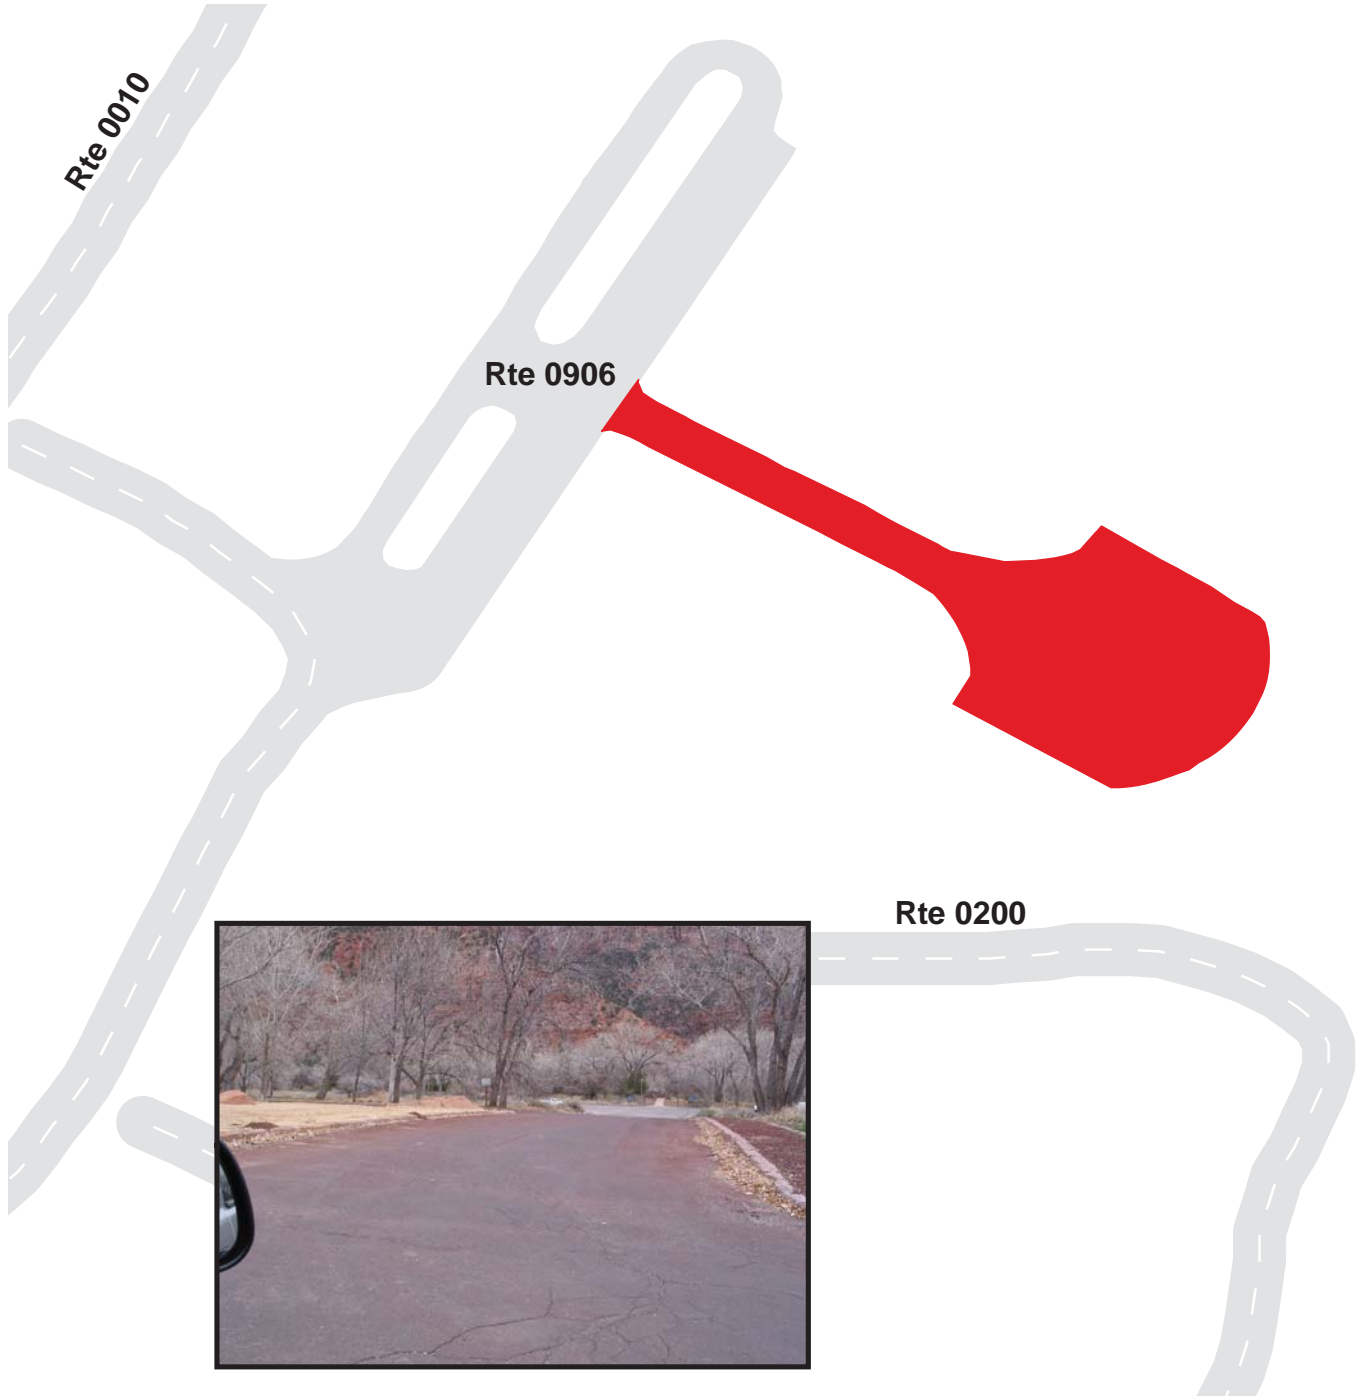
Route 0908

Route	Public / NonPublic	Date Visited	Area (sq ft)	Lane Miles *	Surface Type	Condition / PCR
0908	NonPublic	2/11/2003	21062	0.36	OC	FAIR / 73

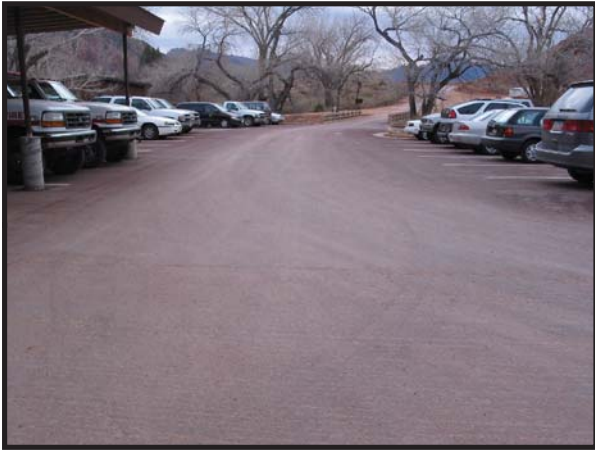
Route 0909A

Route	Public / NonPublic	Date Visited	Area (sq ft)	Lane Miles *	Surface Type	Condition / PCR
0909A	NonPublic	2/11/2003	2022	0.03	AS	POOR / 45

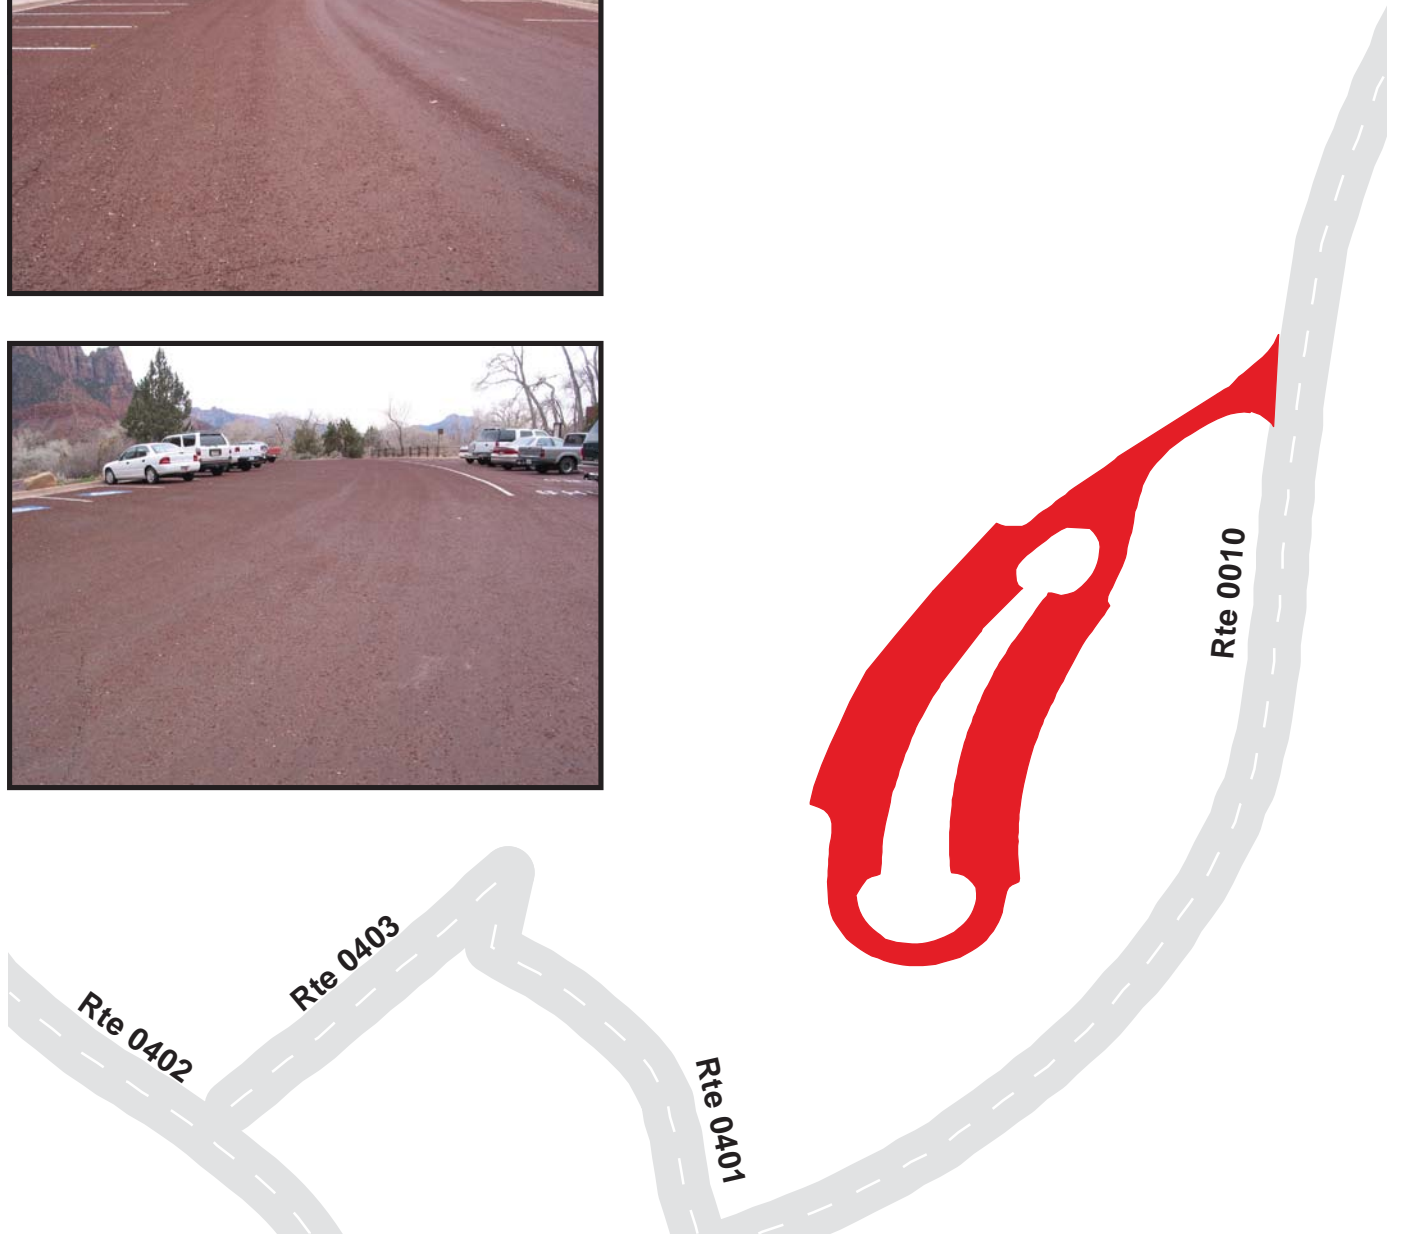
Route 0912

Route	Public / NonPublic	Date Visited	Area (sq ft)	Lane Miles *	Surface Type	Condition / PCR
0912	Public	2/11/2003	5301	0.09	AS	POOR / 45

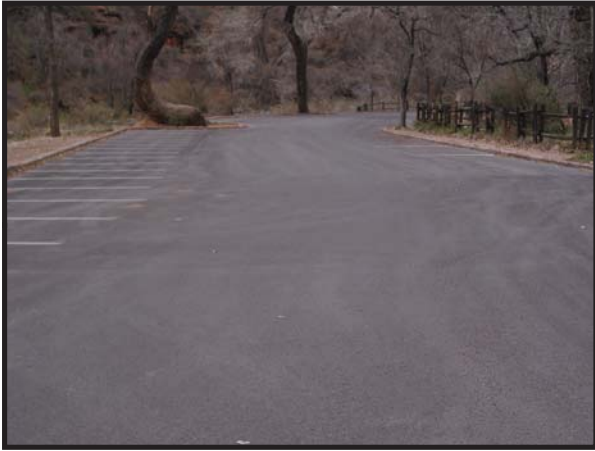
Zion National Park
Route 0924
 Emerald Pools Horse Corral
 Adjacent to Route 0011

Route	Public / NonPublic	Date Visited	Area (sq ft)	Lane Miles *	Surface Type	Condition / PCR
0924	Public	2/11/2003	17020	0.29	OC	FAIR / 73

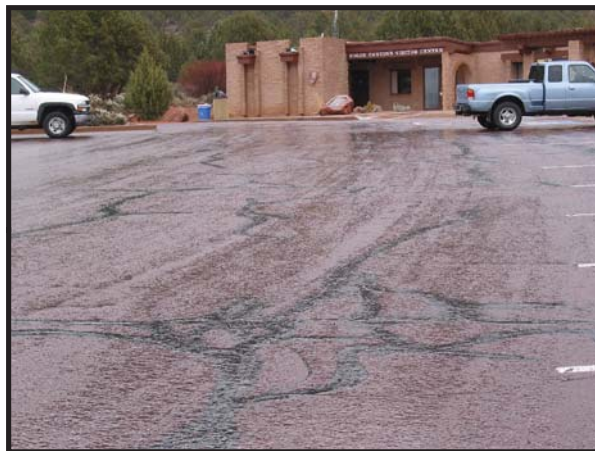
Route 0927

Route	Public / NonPublic	Date Visited	Area (sq ft)	Lane Miles *	Surface Type	Condition / PCR
0927	Public	2/11/2003	15763	0.27	OC	FAIR / 73

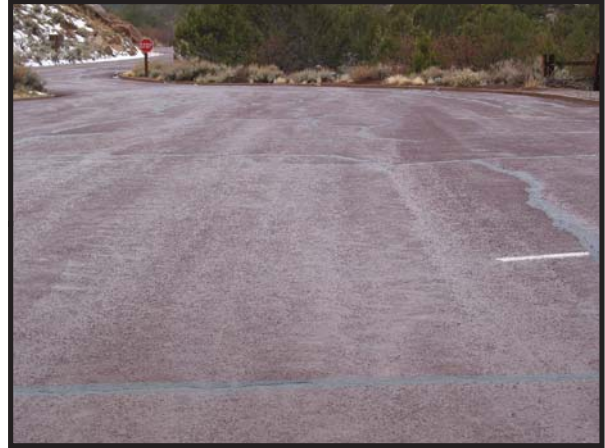
Route 0928

Route	Public / NonPublic	Date Visited	Area (sq ft)	Lane Miles *	Surface Type	Condition / PCR
0928	Public	2/11/2003	15746	0.27	OC	FAIR / 73

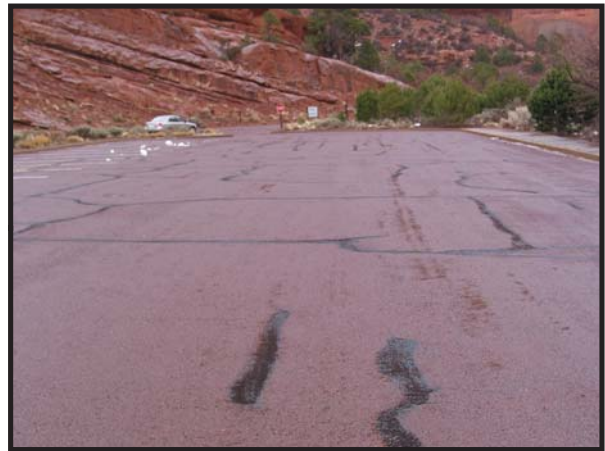
Route 0929

Route	Public / NonPublic	Date Visited	Area (sq ft)	Lane Miles *	Surface Type	Condition / PCR
0929	Public	2/11/2003	4882	0.08	OC	FAIR / 73

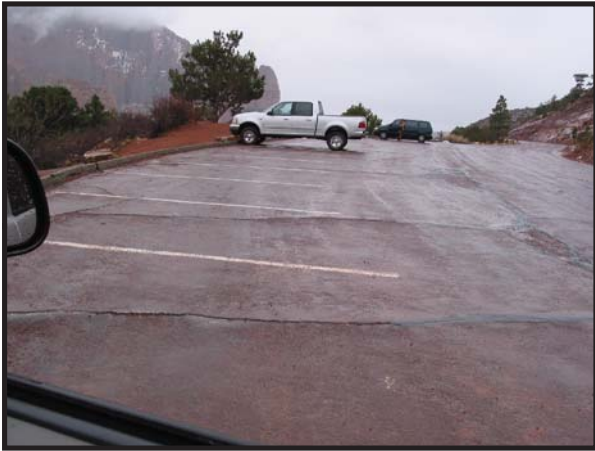
Route 0930

Route	Public / NonPublic	Date Visited	Area (sq ft)	Lane Miles *	Surface Type	Condition / PCR
0930	Public	2/11/2003	30194	0.52	OC	FAIR / 73

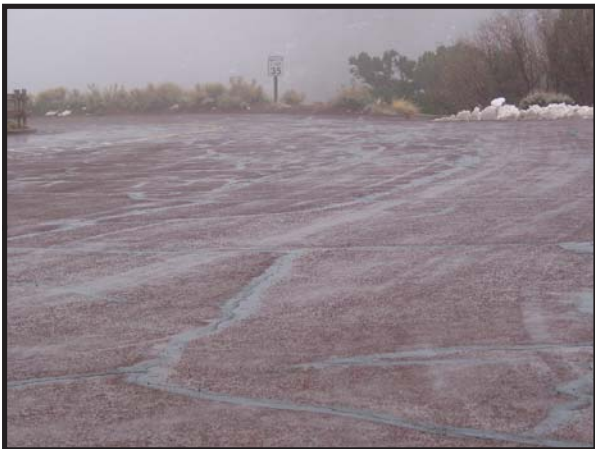
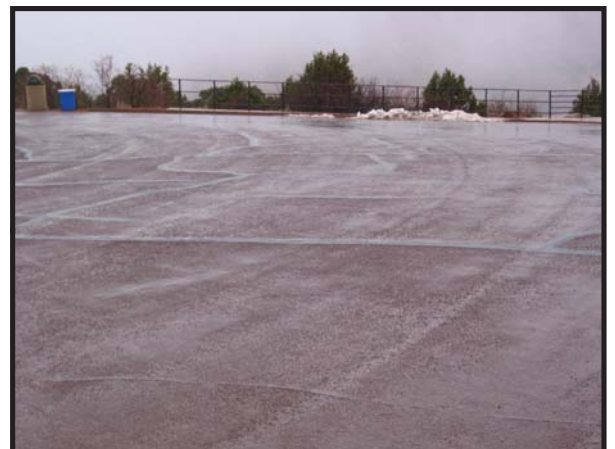
Route 0931A

Route	Public / NonPublic	Date Visited	Area (sq ft)	Lane Miles *	Surface Type	Condition / PCR
0931A	NonPublic	2/11/2003	1358	0.02	AS	GOOD / 90

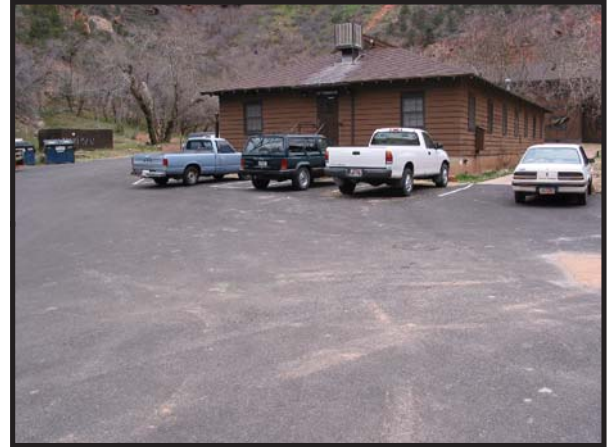
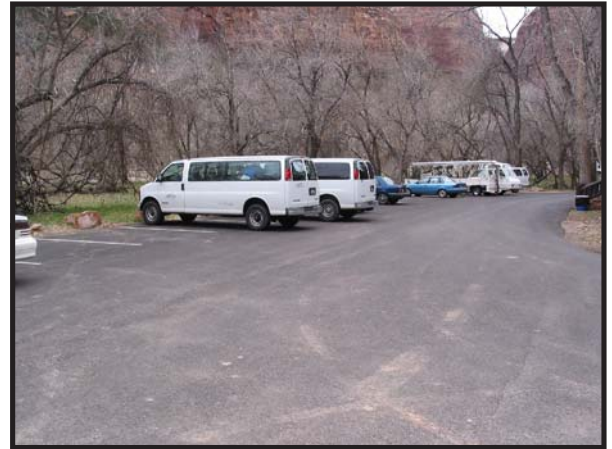
Route 0931C

Route	Public / NonPublic	Date Visited	Area (sq ft)	Lane Miles *	Surface Type	Condition / PCR
0931C	NonPublic	2/11/2003	1760	0.03	AS	GOOD / 90

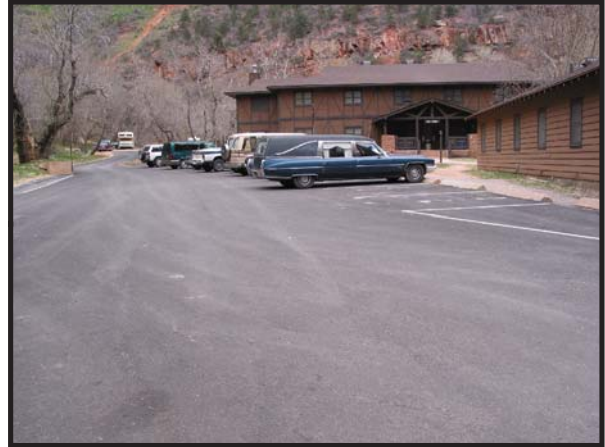
Route 0932

Route	Public / NonPublic	Date Visited	Area (sq ft)	Lane Miles *	Surface Type	Condition / PCR
0932	Public	2/11/2003	2662	0.05	OC	POOR / 45

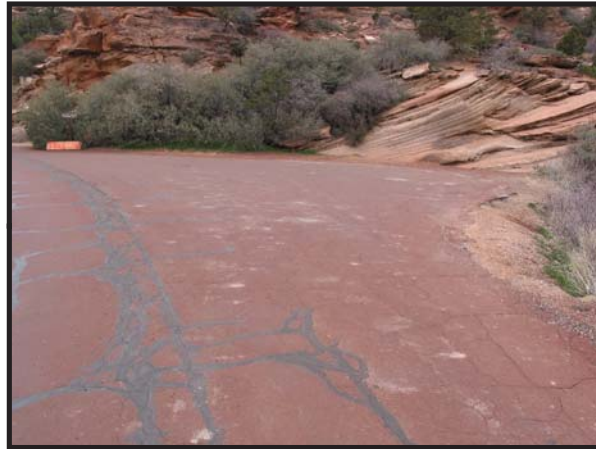
Route 0933A

Route	Public / NonPublic	Date Visited	Area (sq ft)	Lane Miles *	Surface Type	Condition / PCR
0933A	Public	2/11/2003	1245	0.02	OC	FAIR / 73

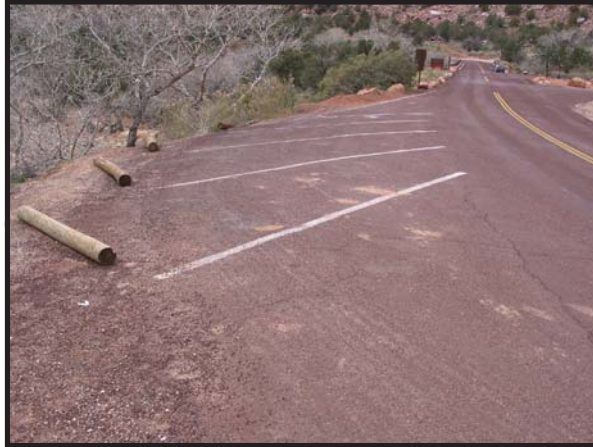
Route 0933B

Route	Public / NonPublic	Date Visited	Area (sq ft)	Lane Miles *	Surface Type	Condition / PCR
0933B	Public	2/11/2003	3065	0.05	OC	FAIR / 73

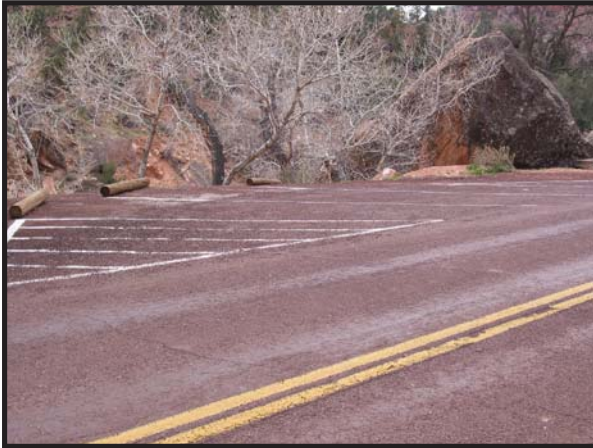
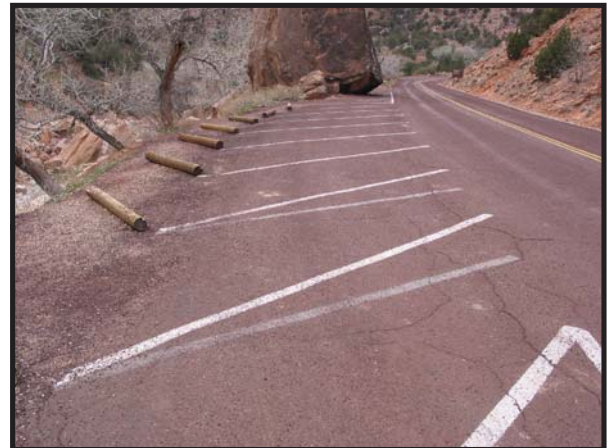
Route 0934

Route	Public / NonPublic	Date Visited	Area (sq ft)	Lane Miles *	Surface Type	Condition / PCR
0934	NonPublic	2/11/2003	112513	1.94	AS	GOOD / 90

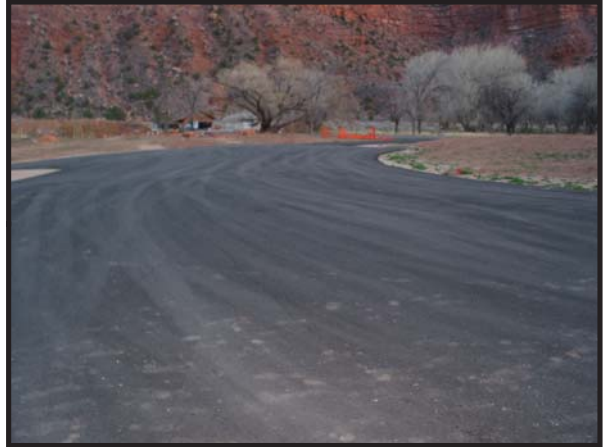
Zion National Park
Route 0936
 Zion Nature Center Parking
 Adjacent to Route 0907

Route	Public / NonPublic	Date Visited	Area (sq ft)	Lane Miles *	Surface Type	Condition / PCR
0936	Public	2/11/2003	8066	0.14	OC	POOR / 45

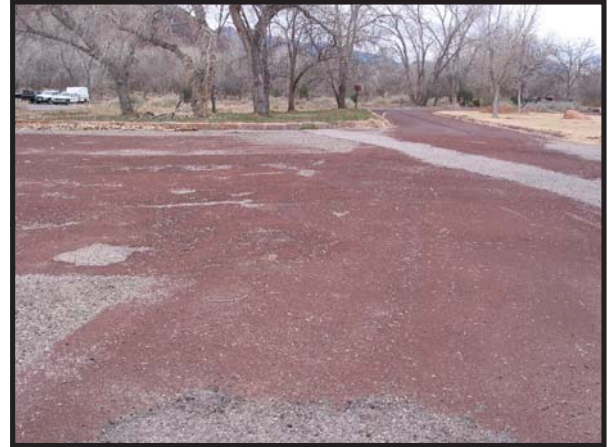
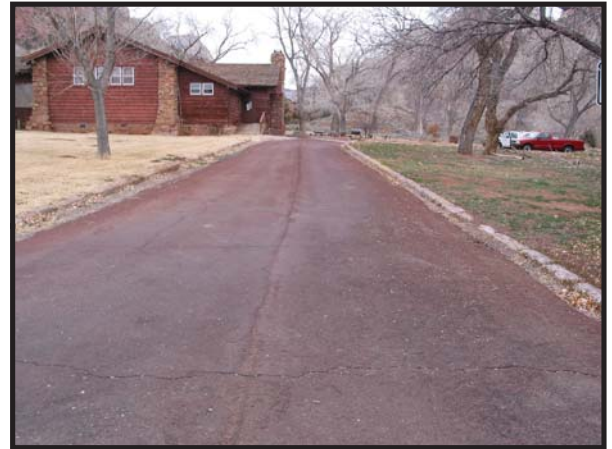
Route 0937

Route	Public / NonPublic	Date Visited	Area (sq ft)	Lane Miles *	Surface Type	Condition / PCR
0937	Public	2/11/2003	12352	0.21	OC	FAIR / 73

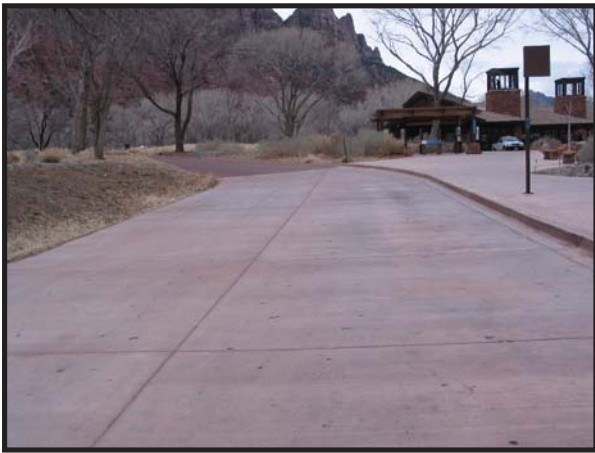
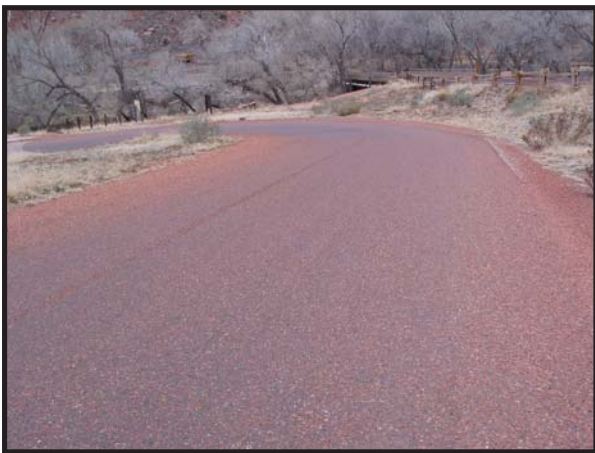
Route 0938

Route	Public / NonPublic	Date Visited	Area (sq ft)	Lane Miles *	Surface Type	Condition / PCR
0938	NonPublic	2/11/2003	10884	0.19	AS	GOOD / 90
