**The Road Inventory
of
Arches National Park
ARCH – 1348
Cycle 4**

**Prepared By:
Federal Highway Administration
Road Inventory Program
Cycle 4**

Arches National Park in Utah

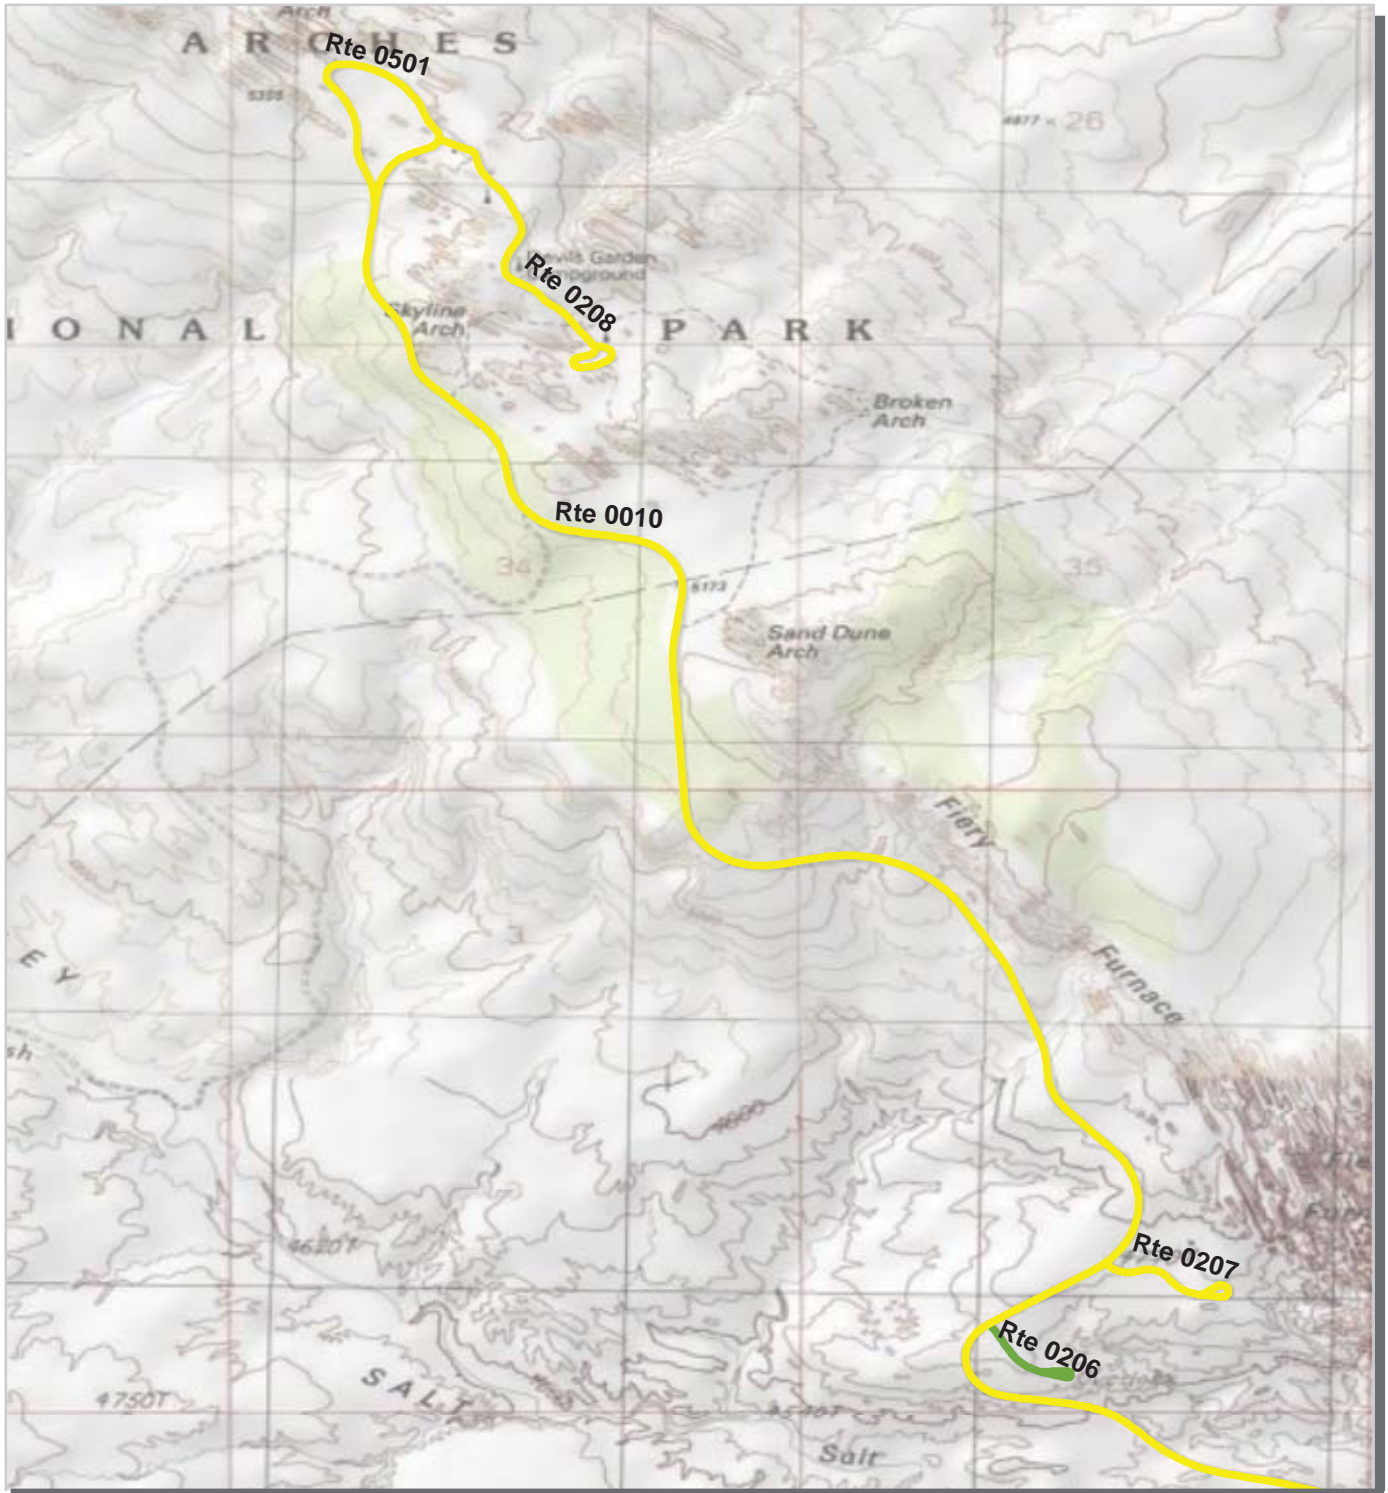
Arches National Park Route Condition Map PCR - Mile by Mile Area 1

PCR	Poor	Fair	Good	Excellent	No Data
	(≤ 60)	(61 - 84)	(85 - 94)	(95 - 100)

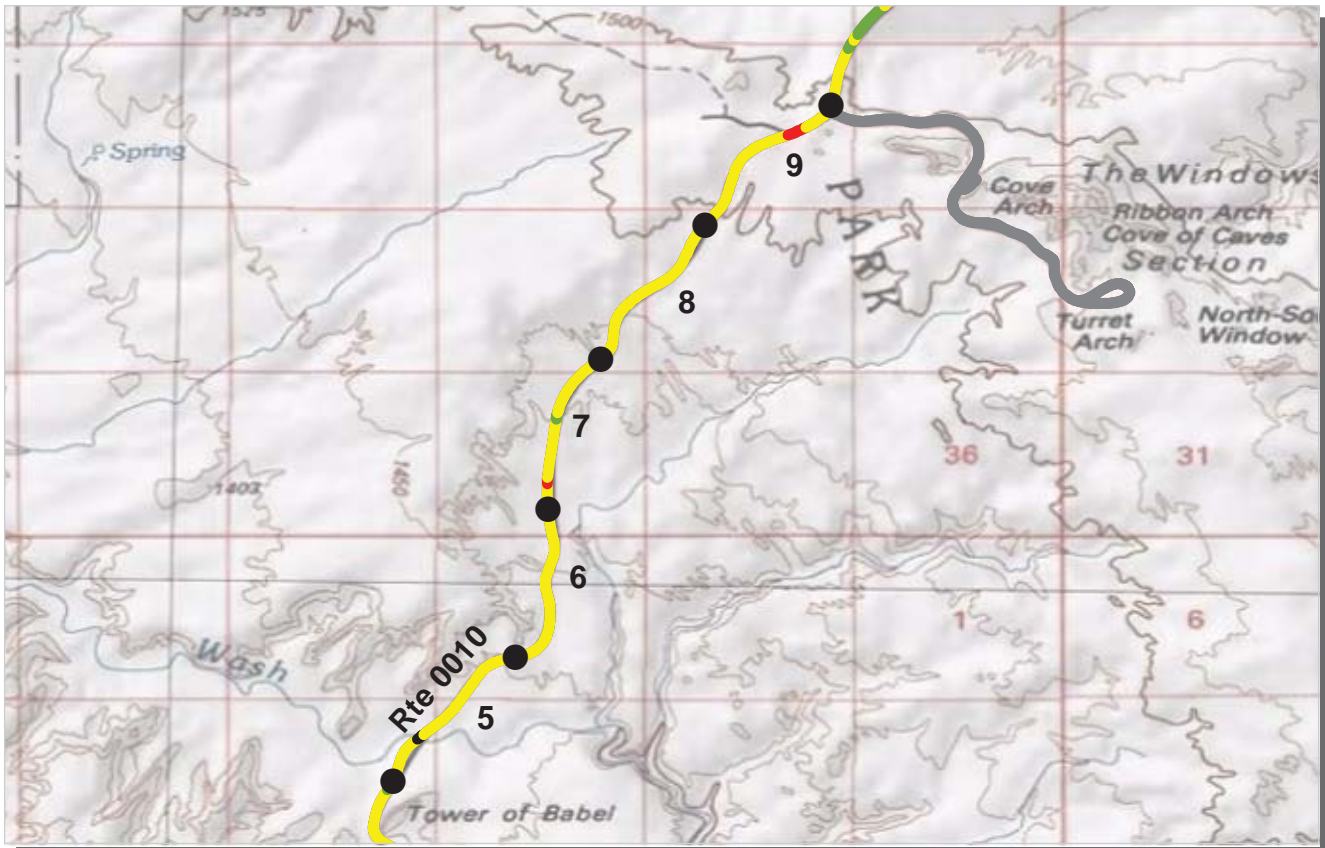
ROUTE: 0010 MAIN PARK ROAD

Section Number	5	6	7	8	9
Section Length (mi)	1.00	1.00	1.00	1.00	1.00
Traffic	Traffic data may be found at www.efl.fhwa.dot.gov Click on PROGRAMS / NPS Traffic Data (Note: Not all parks have traffic data)				
Cross Section Information					
Number of Lanes	2	2	2	2	2
Paved Width (ft)	26	24	23	26	21
Lane Width (ft)	10	9	9	9	9
Shoulder Width Right (ft)	NC	NC	NC	NC	NC
Shoulder Width Left (ft)	NC	NC	NC	NC	NC
Roadway Condition Information					
SCR (Surface Condition Rating)	66	64	63	63	61
PCR (Pavement Condition Rating)	75	75	75	73	72
Distress Index Values					
Alligator Cracking Index	100	100	100	100	100
Longitudinal Cracking Index	96	95	96	96	96
Transverse Cracking Index	92	91	91	92	88
Patching Index	100	100	100	100	100
Rutting Index	79	79	76	76	76
Roughness Condition Index (RCI)	88	91	92	89	89

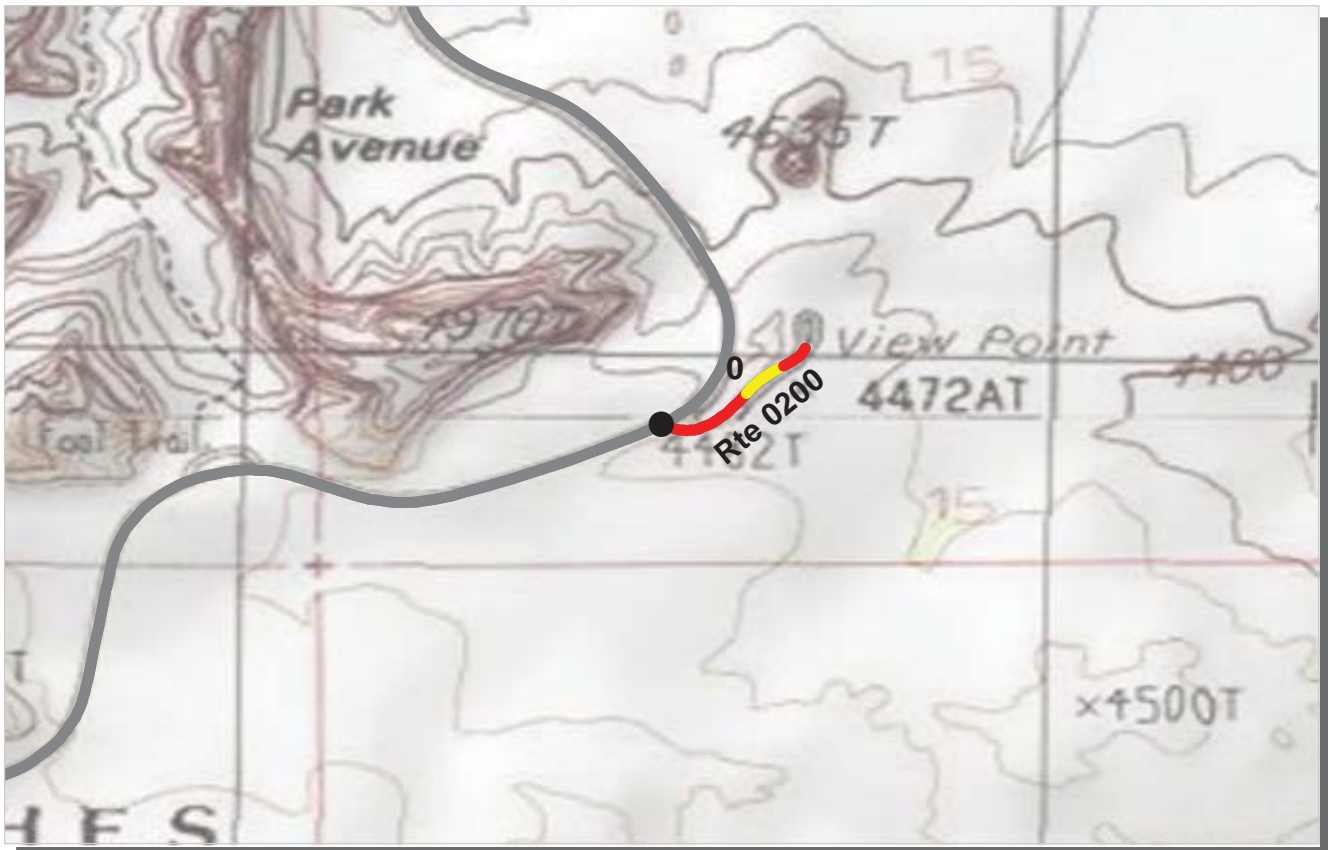
ROUTE: 0200 LA SAL MOUNTAIN VIEW ROAD

Section Number	0				
Section Length (mi)	0.15				
Traffic	Traffic data may be found at www.efl.fhwa.dot.gov Click on PROGRAMS / NPS Traffic Data (Note: Not all parks have traffic data)				
Cross Section Information					
Number of Lanes	2				
Paved Width (ft)	21				
Lane Width (ft)	10				
Shoulder Width Right (ft)	NC				
Shoulder Width Left (ft)	NC				
Roadway Condition Information					
SCR (Surface Condition Rating)	53				
PCR (Pavement Condition Rating)	54				
Distress Index Values					
Alligator Cracking Index	100				
Longitudinal Cracking Index	96				
Transverse Cracking Index	92				
Patching Index	100				
Rutting Index	65				
Roughness Condition Index (RCI)	59

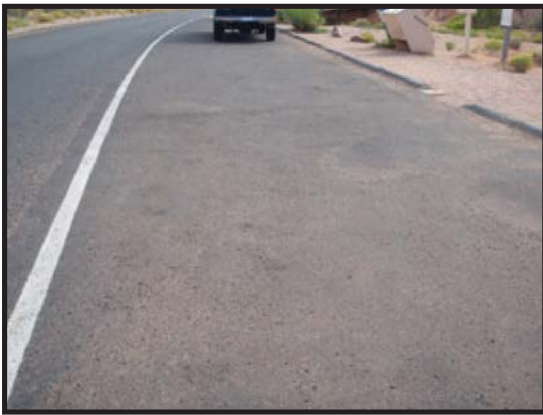
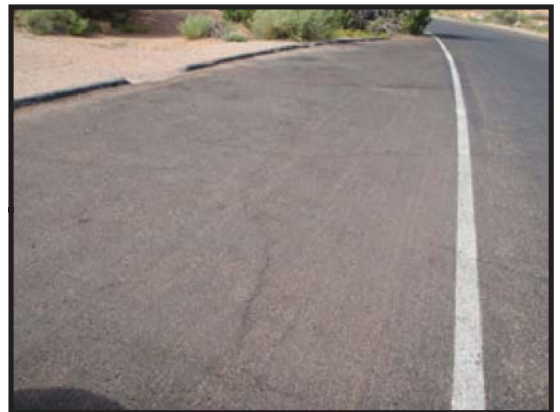
Route Number	Public / NonPublic	Date Visited		Area (sq ft)	Lane Miles *	Surface Type
0900B	PUBLIC	8/25/2009		2,403	0.04	AS
Culverts	Drop Inlets	Gates	Fire Hydrants	Curb & Gutter	Curb	PCR
0	0	0	0	NO CURB AND GUTTER	ASPHALT CURB	GOOD/90

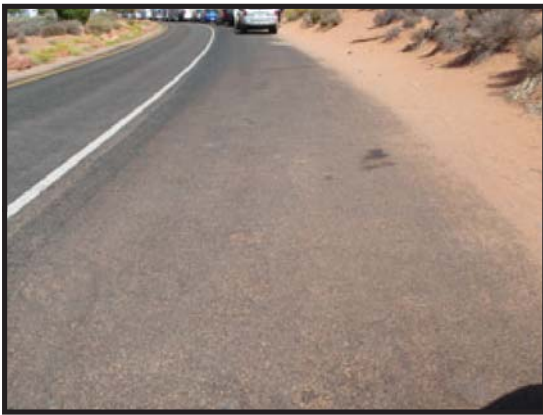
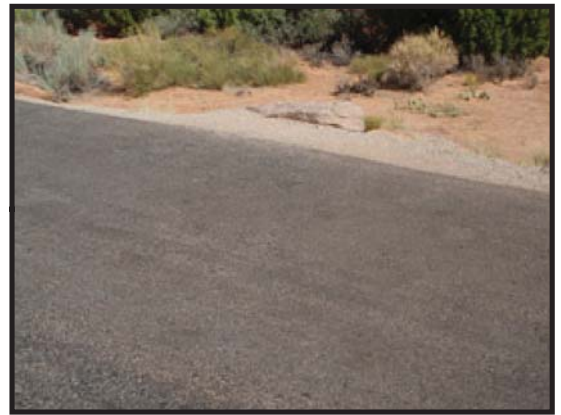
Route 0901A

Route Number	Public / NonPublic	Date Visited		Area (sq ft)	Lane Miles *	Surface Type
0901A	PUBLIC	8/25/2009		13,619	0.23	AS
Culverts	Drop Inlets	Gates	Fire Hydrants	Curb & Gutter	Curb	PCR
0	0	0	0	NO CURB AND GUTTER	NO CURB	GOOD/90

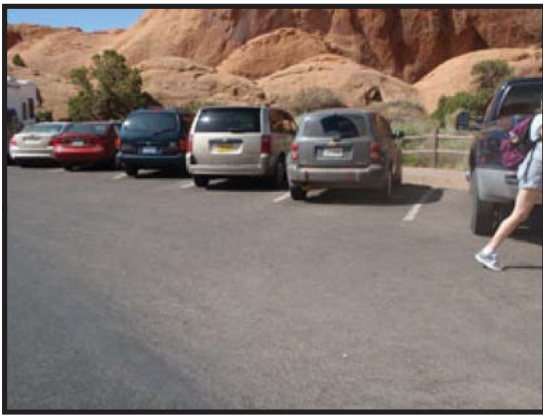
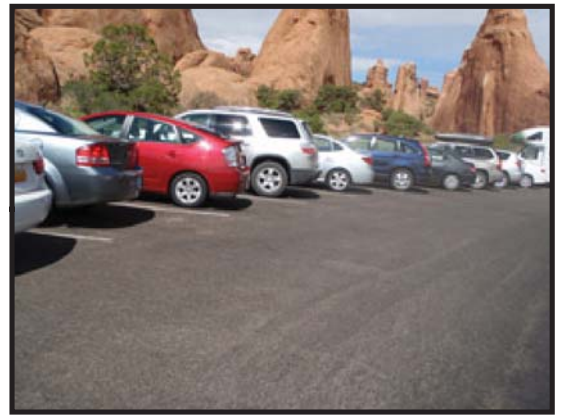
Route 0901B

Route Number	Public / NonPublic	Date Visited		Area (sq ft)	Lane Miles *	Surface Type
0901B	PUBLIC	8/25/2009		4,194	0.07	AS
Culverts	Drop Inlets	Gates	Fire Hydrants	Curb & Gutter	Curb	PCR
0	0	0	0	CONCRETE CURB AND GUTTER	NO CURB	GOOD/90

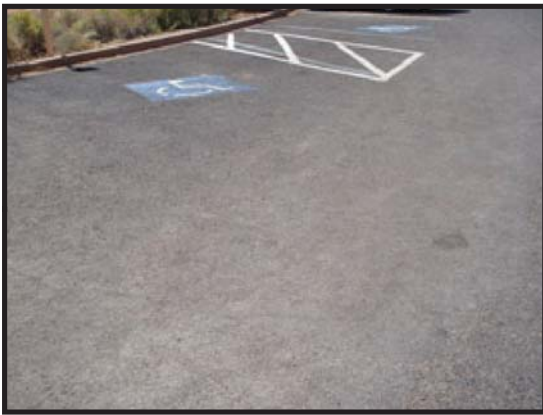
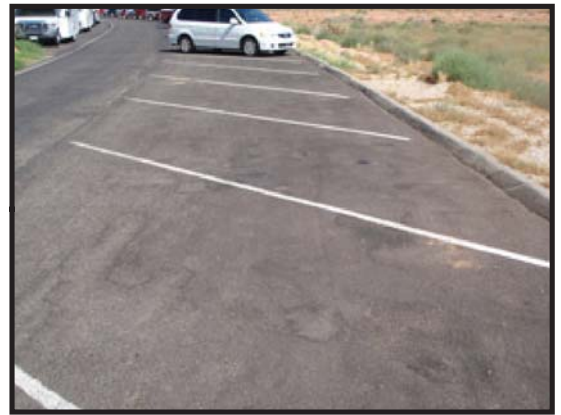
Route 0901C

Route Number	Public / NonPublic	Date Visited		Area (sq ft)	Lane Miles *	Surface Type
0901C	PUBLIC	8/25/2009		11,604	0.20	AS
Culverts	Drop Inlets	Gates	Fire Hydrants	Curb & Gutter	Curb	PCR
0	0	0	0	CONCRETE CURB AND GUTTER	ASPHALT CURB	GOOD/90

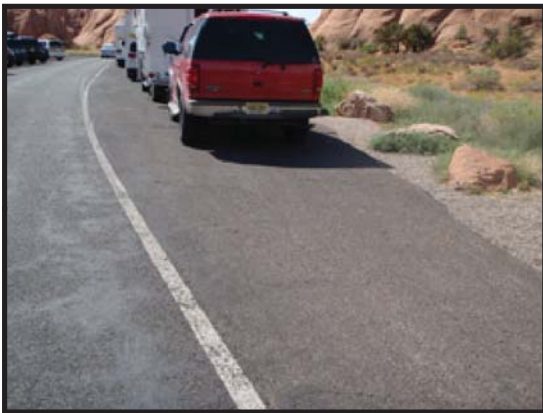
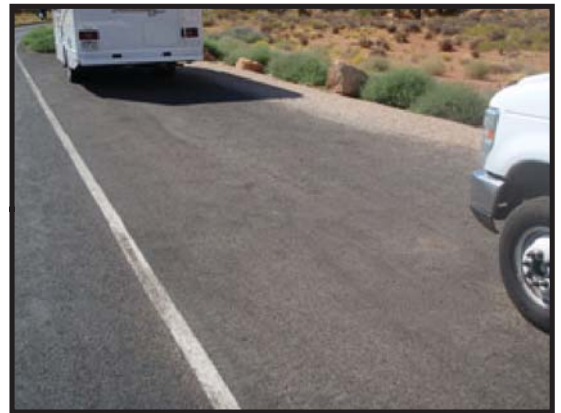
Route 0901D

Route Number	Public / NonPublic	Date Visited		Area (sq ft)	Lane Miles *	Surface Type
0901D	PUBLIC	8/25/2009		2,892	0.05	AS
Culverts	Drop Inlets	Gates	Fire Hydrants	Curb & Gutter	Curb	PCR
0	0	0	0	NO CURB AND GUTTER	NO CURB	GOOD/90

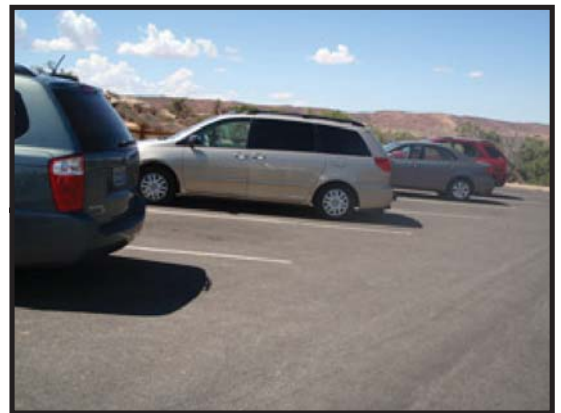
Route 0902A

Route Number	Public / NonPublic	Date Visited		Area (sq ft)	Lane Miles *	Surface Type
0902A	PUBLIC	8/25/2009		3,452	0.06	AS
Culverts	Drop Inlets	Gates	Fire Hydrants	Curb & Gutter	Curb	PCR
0	0	0	0	CONCRETE CURB AND GUTTER	NO CURB	FAIR/73

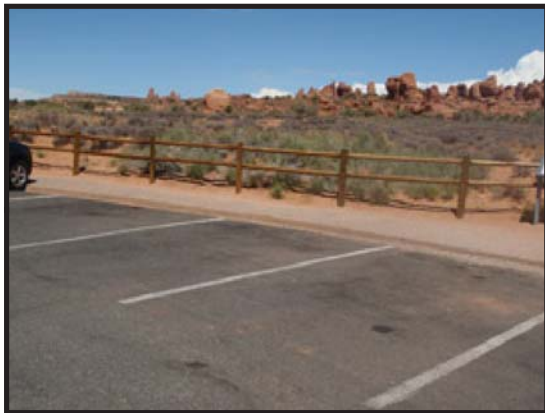
Route 0902B

Route Number	Public / NonPublic	Date Visited		Area (sq ft)	Lane Miles *	Surface Type
0902B	PUBLIC	8/25/2009		3,088	0.05	AS
Culverts	Drop Inlets	Gates	Fire Hydrants	Curb & Gutter	Curb	PCR
0	0	0	0	CONCRETE CURB AND GUTTER	NO CURB	FAIR/73

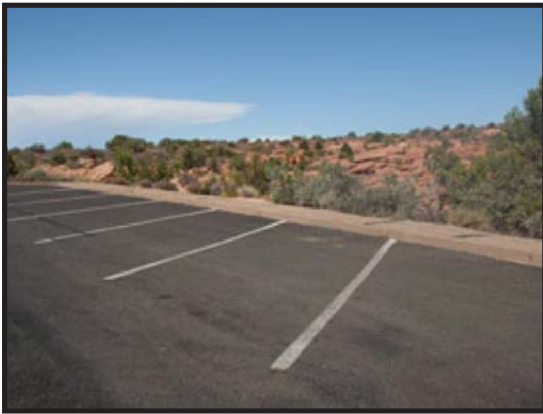
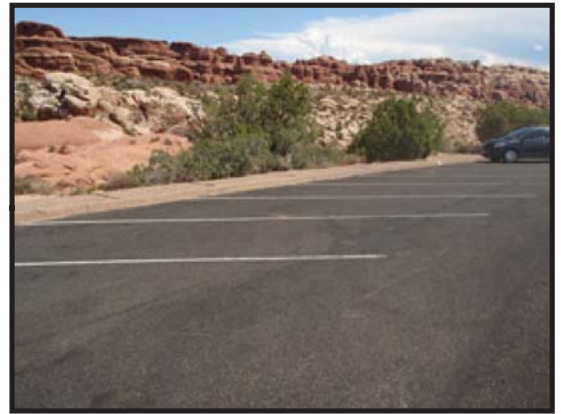
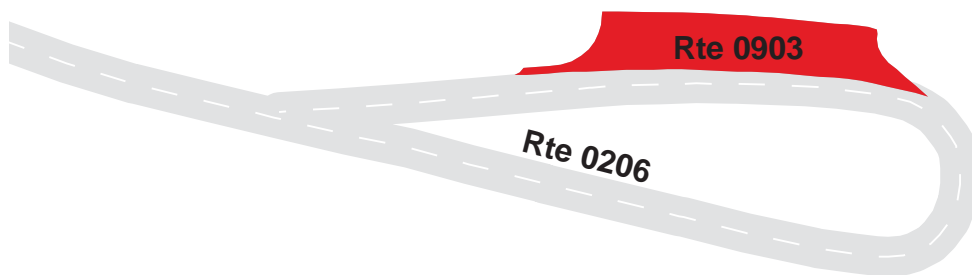
Route 0903

Route Number	Public / NonPublic	Date Visited		Area (sq ft)	Lane Miles *	Surface Type
0903	PUBLIC	8/25/2009		3,054	0.05	AS
Culverts	Drop Inlets	Gates	Fire Hydrants	Curb & Gutter	Curb	PCR
0	0	0	0	CONCRETE CURB AND GUTTER	NO CURB	GOOD/90

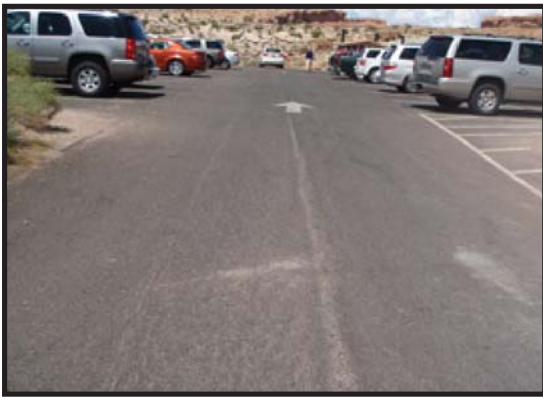
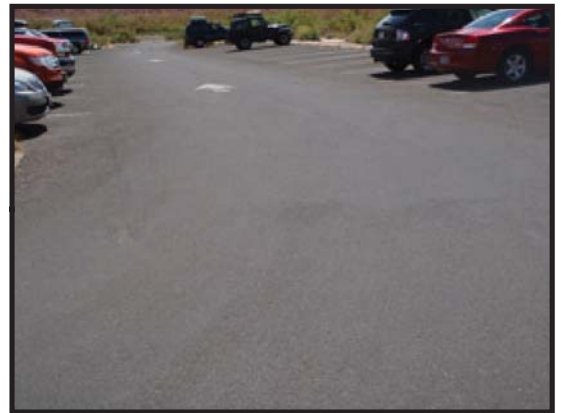
Route 0904A

Route Number	Public / NonPublic	Date Visited		Area (sq ft)	Lane Miles *	Surface Type
0904A	PUBLIC	8/25/2009		24,573	0.42	AS
Culverts	Drop Inlets	Gates	Fire Hydrants	Curb & Gutter	Curb	PCR
0	0	0	0	NO CURB AND GUTTER	NO CURB	GOOD/90

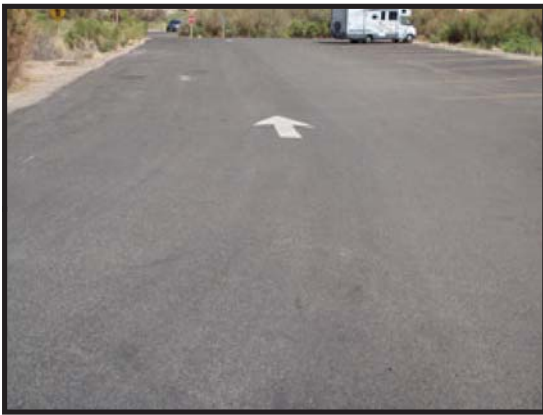
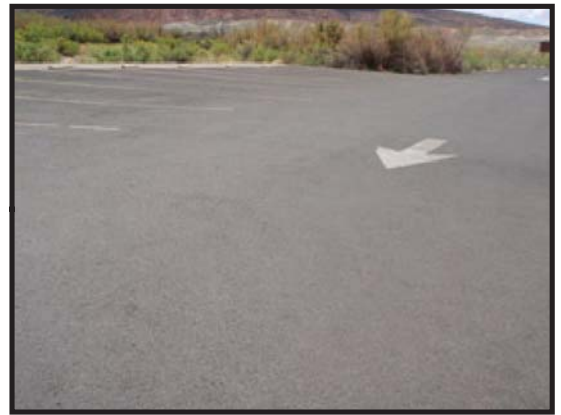
Route 0904B

Route Number	Public / NonPublic	Date Visited		Area (sq ft)	Lane Miles *	Surface Type
0904B	PUBLIC	8/25/2009		14,857	0.26	AS
Culverts	Drop Inlets	Gates	Fire Hydrants	Curb & Gutter	Curb	PCR
2	0	0	0	NO CURB AND GUTTER	NO CURB	GOOD/90

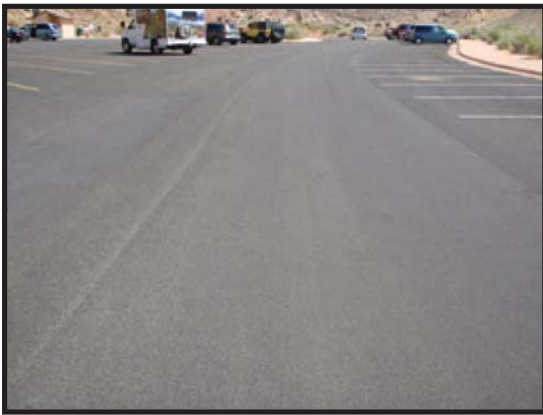
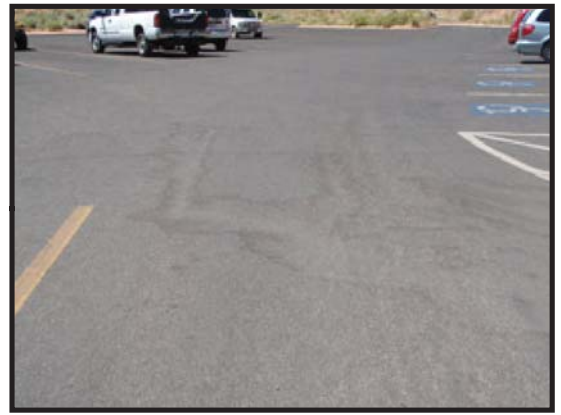
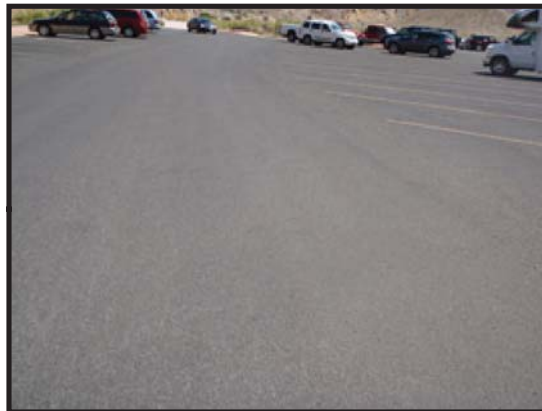
Route 0905

Route Number	Public / NonPublic	Date Visited		Area (sq ft)	Lane Miles *	Surface Type
0905	PUBLIC	8/25/2009		56,768	0.98	AS
Culverts	Drop Inlets	Gates	Fire Hydrants	Curb & Gutter	Curb	PCR
0	0	0	0	CONCRETE CURB AND GUTTER	NO CURB	EXCELLENT/97

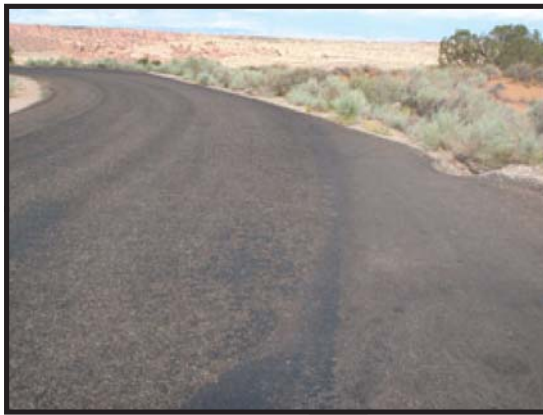
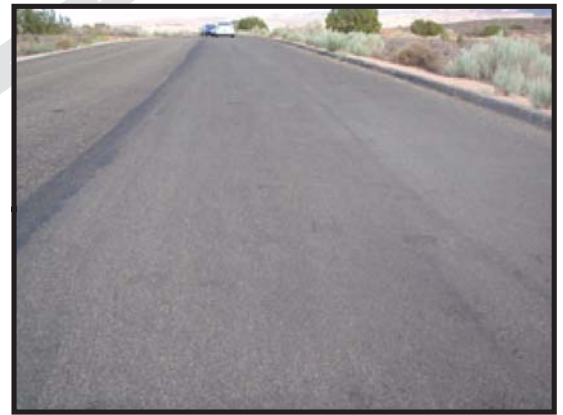
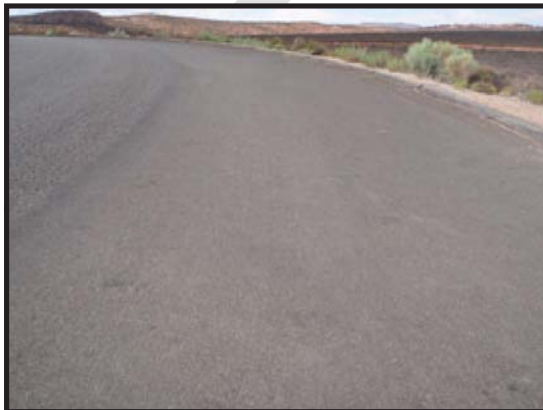
Route 0906

Route Number	Public / NonPublic	Date Visited		Area (sq ft)	Lane Miles *	Surface Type
0906	PUBLIC	8/25/2009		10,745	0.19	AS
Culverts	Drop Inlets	Gates	Fire Hydrants	Curb & Gutter	Curb	PCR
0	0	0	0	NO CURB AND GUTTER	ASPHALT CURB	GOOD/90

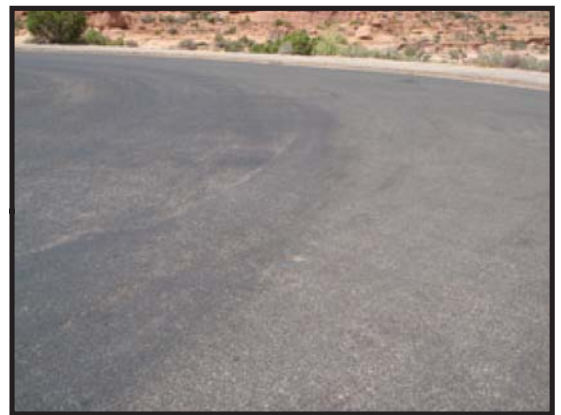
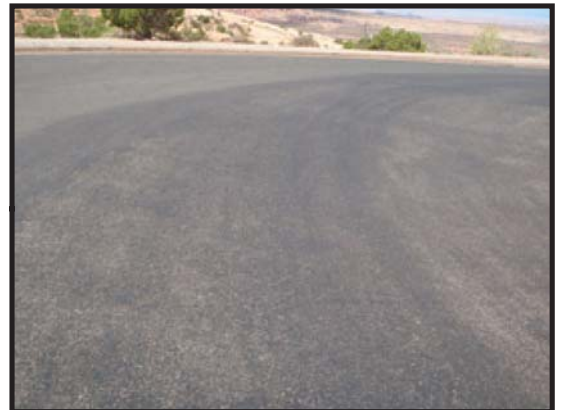
Route Number	Public / NonPublic	Date Visited		Area (sq ft)	Lane Miles *	Surface Type
0907	PUBLIC	8/25/2009		10,329	0.18	AS
Culverts	Drop Inlets	Gates	Fire Hydrants	Curb & Gutter	Curb	PCR
0	1	0	0	CONCRETE CURB AND GUTTER	NO CURB	GOOD/90

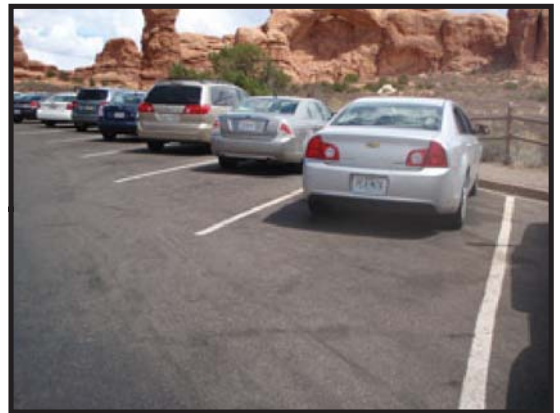
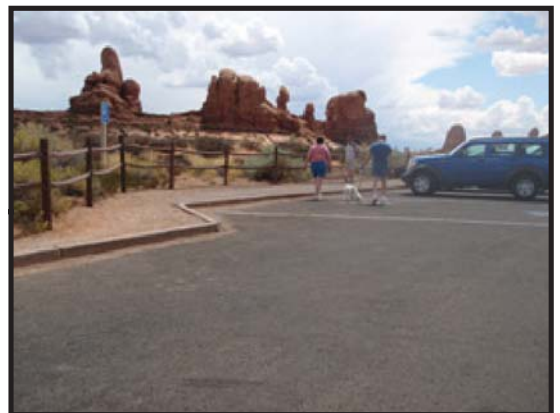
Route 0908A

Route Number	Public / NonPublic	Date Visited		Area (sq ft)	Lane Miles *	Surface Type
0908A	PUBLIC	8/25/2009		6,783	0.12	AS
Culverts	Drop Inlets	Gates	Fire Hydrants	Curb & Gutter	Curb	PCR
0	0	0	0	CONCRETE CURB AND GUTTER	NO CURB	GOOD/90

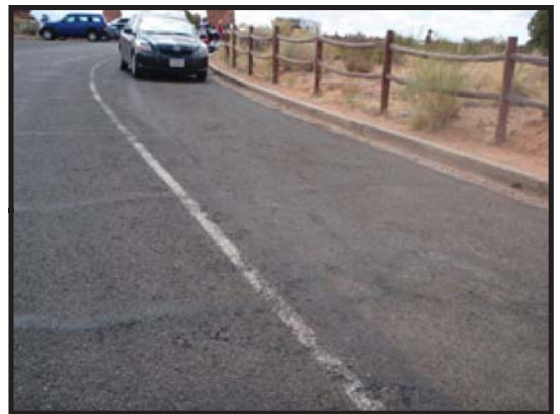
Route 0908B

Route Number	Public / NonPublic	Date Visited		Area (sq ft)	Lane Miles *	Surface Type
0908B	PUBLIC	8/25/2009		4,007	0.07	AS
Culverts	Drop Inlets	Gates	Fire Hydrants	Curb & Gutter	Curb	PCR
0	0	0	0	CONCRETE CURB AND GUTTER	NO CURB	GOOD/90

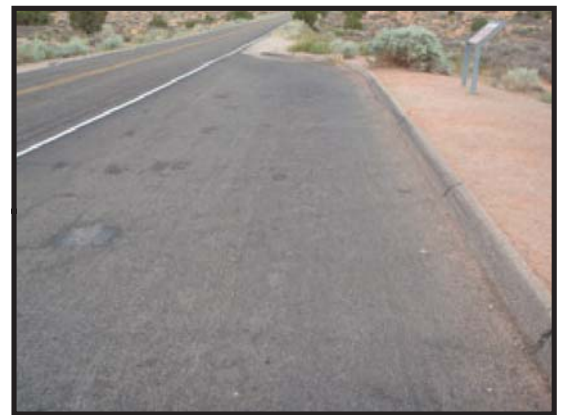
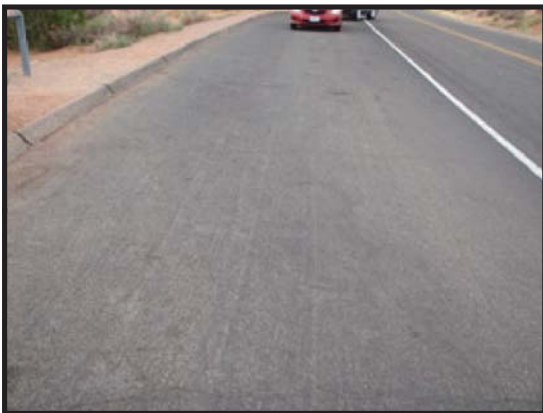
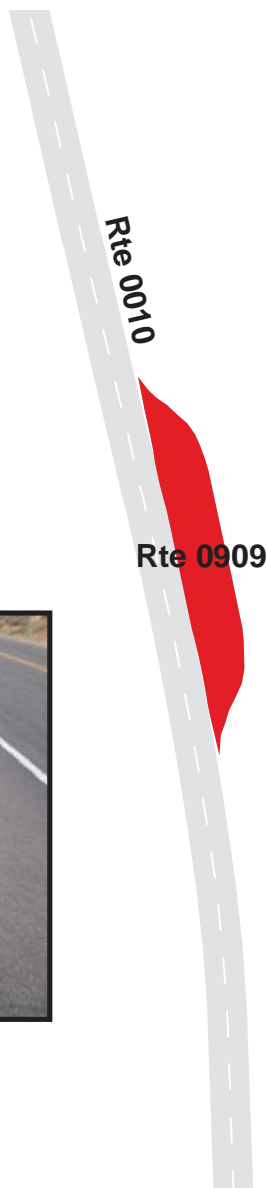
Route Number	Public / NonPublic	Date Visited		Area (sq ft)	Lane Miles *	Surface Type
0909	PUBLIC	8/25/2009		1,901	0.03	AS
Culverts	Drop Inlets	Gates	Fire Hydrants	Curb & Gutter	Curb	PCR
0	0	0	0	NO CURB AND GUTTER	ASPHALT CURB	FAIR/73

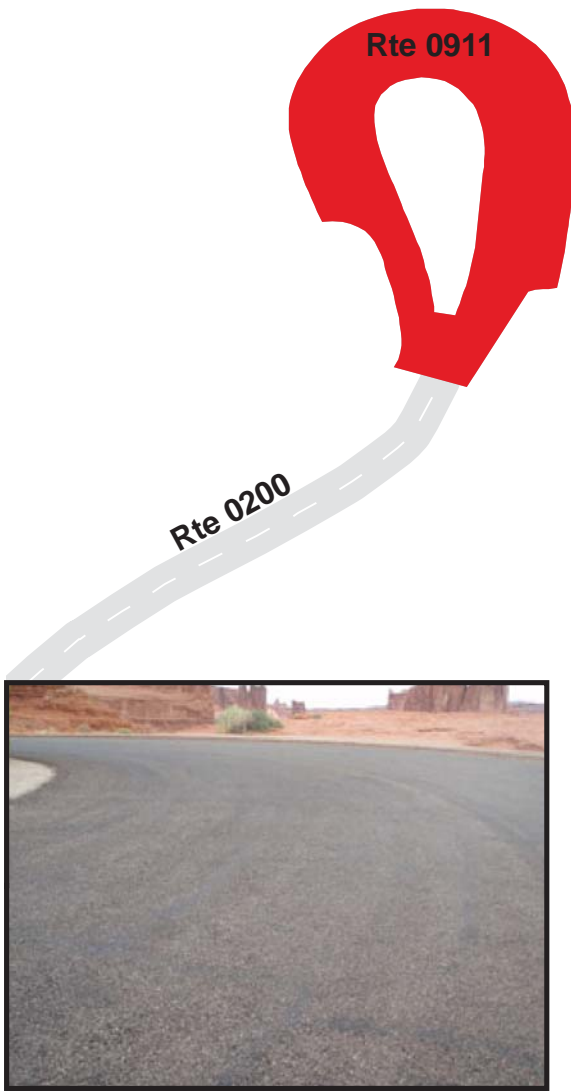
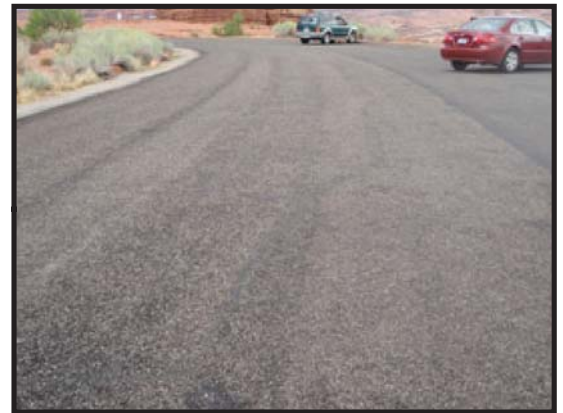
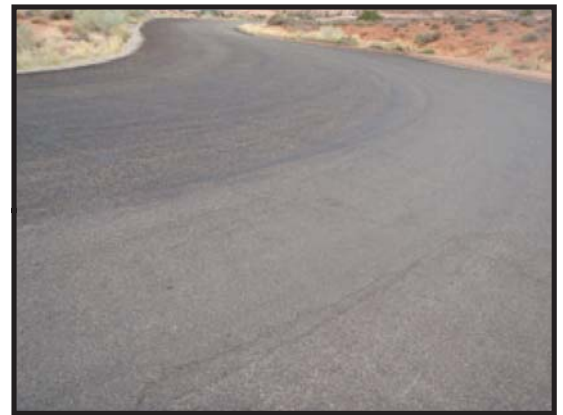
Route Number	Public / NonPublic	Date Visited		Area (sq ft)	Lane Miles *	Surface Type
0911	PUBLIC	8/25/2009		16,555	0.29	AS
Culverts	Drop Inlets	Gates	Fire Hydrants	Curb & Gutter	Curb	PCR
0	0	0	0	CONCRETE CURB AND GUTTER	NO CURB	GOOD/90

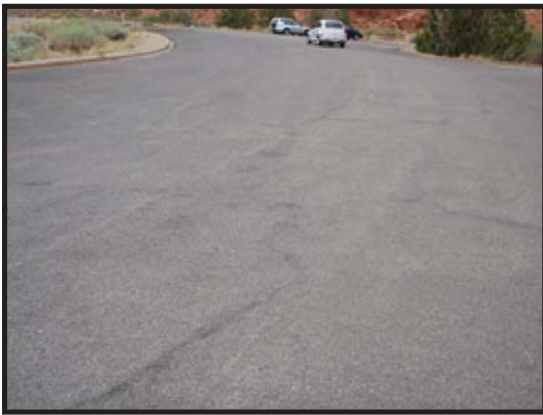
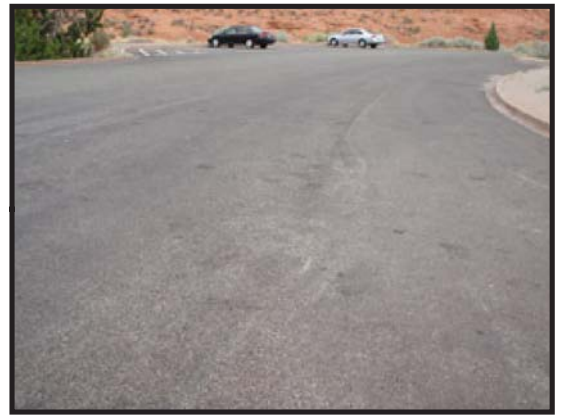
Route 0912

Route Number	Public / NonPublic	Date Visited		Area (sq ft)	Lane Miles *	Surface Type
0912	PUBLIC	8/25/2009		16,960	0.29	AS
Culverts	Drop Inlets	Gates	Fire Hydrants	Curb & Gutter	Curb	PCR
0	0	0	0	CONCRETE CURB AND GUTTER	NO CURB	GOOD/90

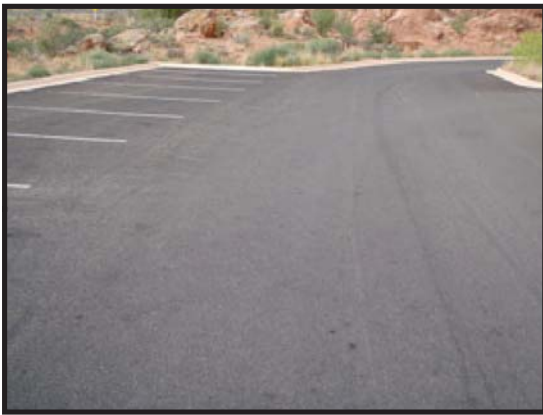
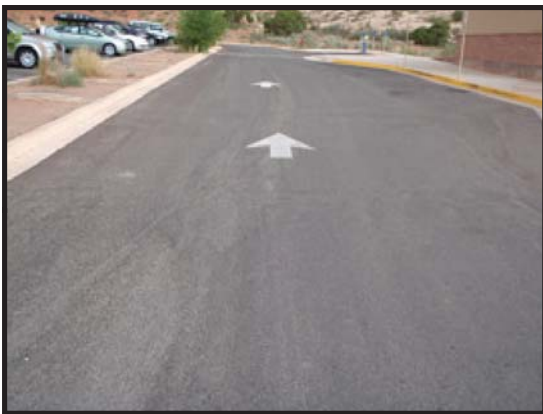
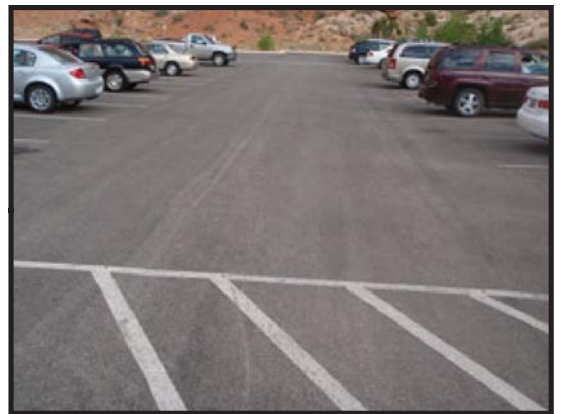
Route 0913

Route Number	Public / NonPublic	Date Visited		Area (sq ft)	Lane Miles *	Surface Type
0913	PUBLIC	8/25/2009		73,846	1.27	AS
Culverts	Drop Inlets	Gates	Fire Hydrants	Curb & Gutter	Curb	PCR
0	6	0	1	CONCRETE CURB AND GUTTER	NO CURB	GOOD/90

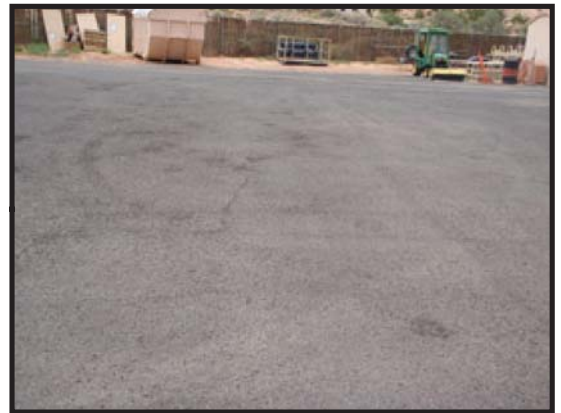
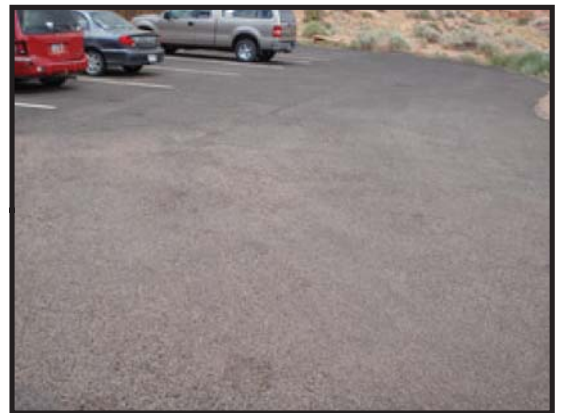
Route 0914

Route Number	Public / NonPublic	Date Visited		Area (sq ft)	Lane Miles *	Surface Type
0914	PUBLIC	8/25/2009		18,586	0.32	AS
Culverts	Drop Inlets	Gates	Fire Hydrants	Curb & Gutter	Curb	PCR
0	0	1	0	NO CURB AND GUTTER	NO CURB	GOOD/90

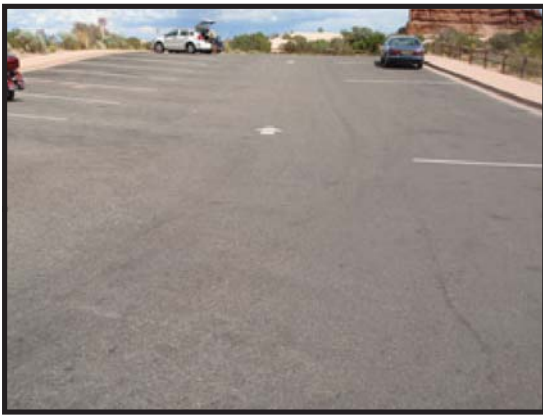
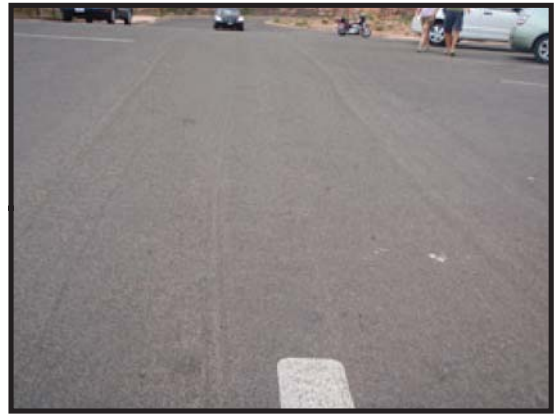
Route 0915

Route Number	Public / NonPublic	Date Visited		Area (sq ft)	Lane Miles *	Surface Type
0915	PUBLIC	8/25/2009		13,406	0.23	AS
Culverts	Drop Inlets	Gates	Fire Hydrants	Curb & Gutter	Curb	PCR
0	1	0	0	CONCRETE CURB AND GUTTER	NO CURB	GOOD/90

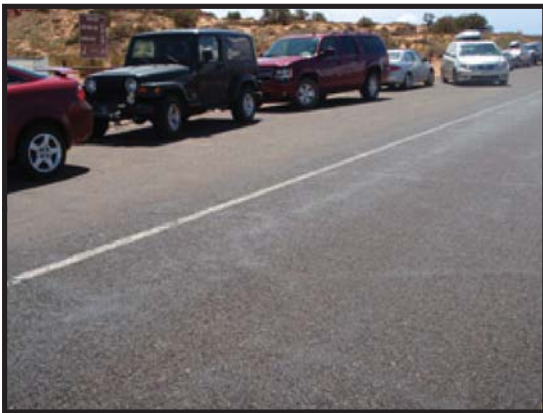
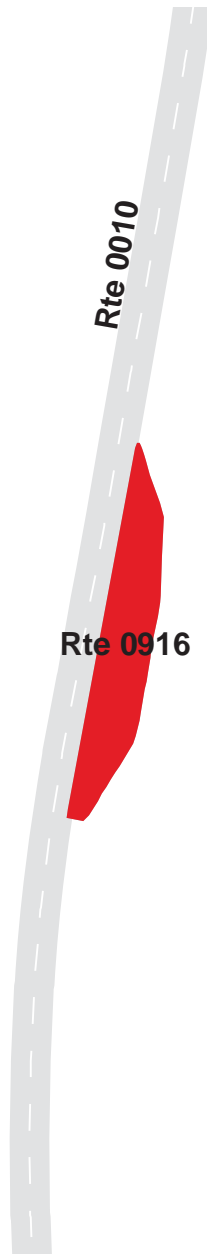
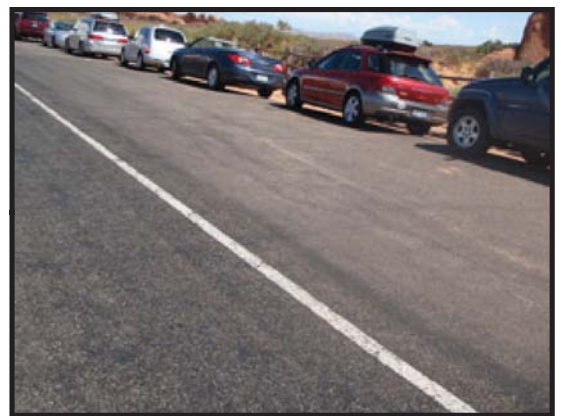
Route 0916

Route Number	Public / NonPublic	Date Visited		Area (sq ft)	Lane Miles *	Surface Type
0916	PUBLIC	8/25/2009		5,894	0.10	AS
Culverts	Drop Inlets	Gates	Fire Hydrants	Curb & Gutter	Curb	PCR
0	0	0	0	NO CURB AND GUTTER	ASPHALT CURB	GOOD/90

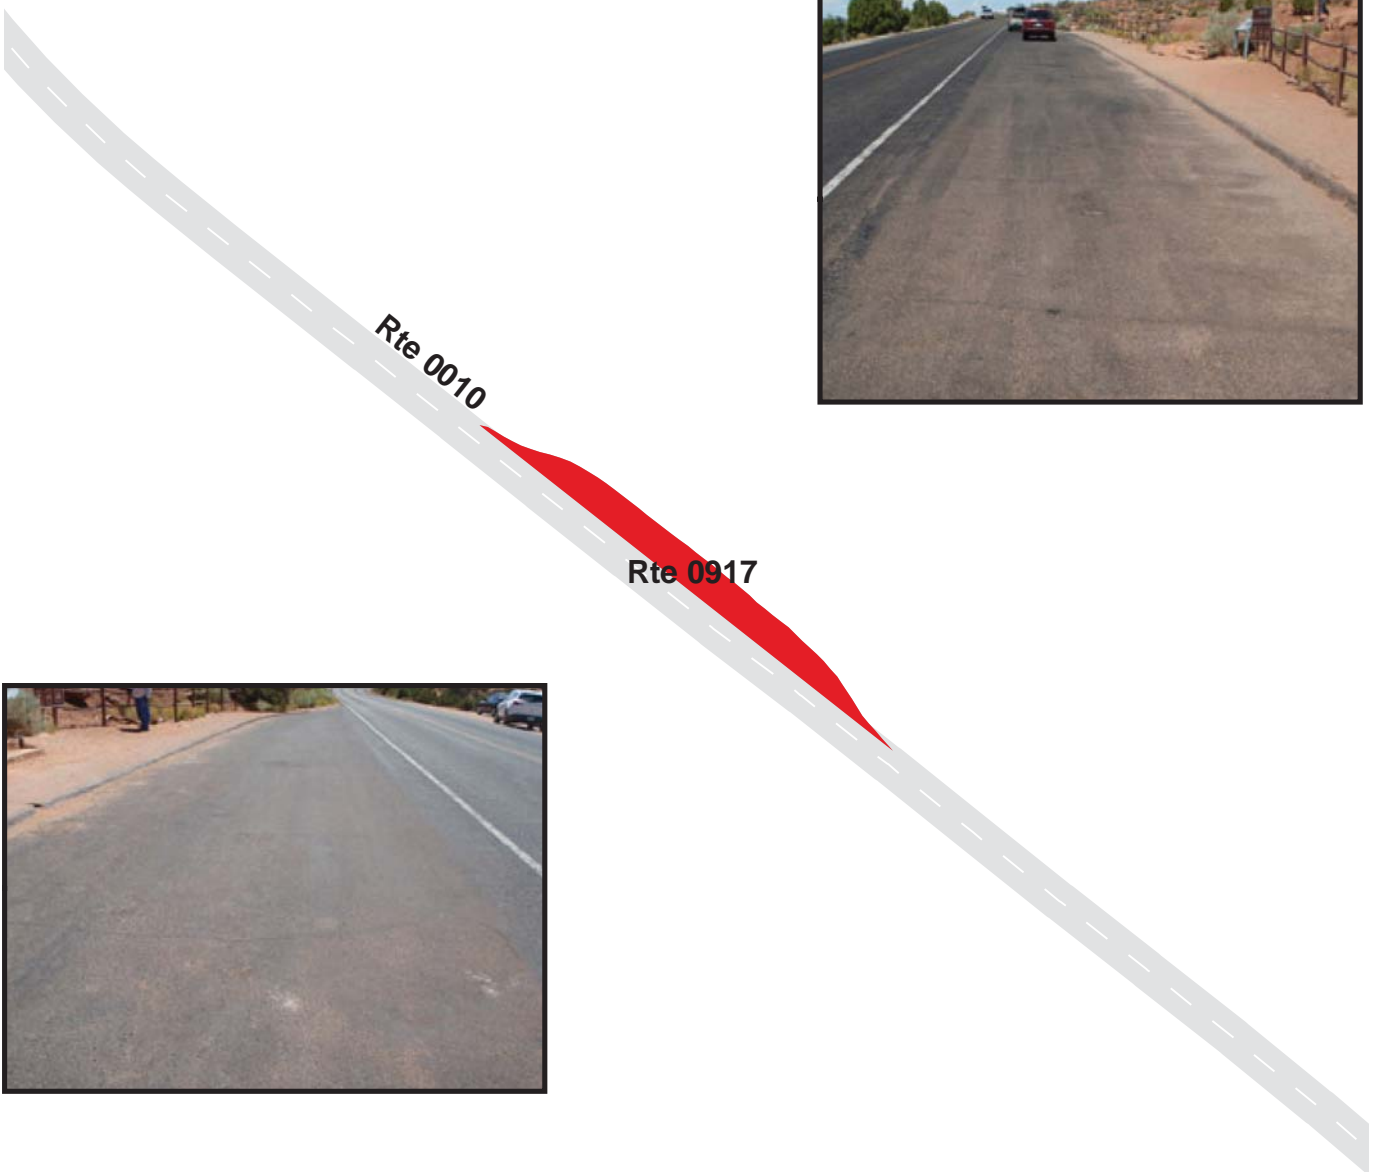
Route 0917

Route Number	Public / NonPublic	Date Visited		Area (sq ft)	Lane Miles *	Surface Type
0917	PUBLIC	8/25/2009		3,040	0.05	AS
Culverts	Drop Inlets	Gates	Fire Hydrants	Curb & Gutter	Curb	PCR
0	0	0	0	NO CURB AND GUTTER	ASPHALT CURB	FAIR/73

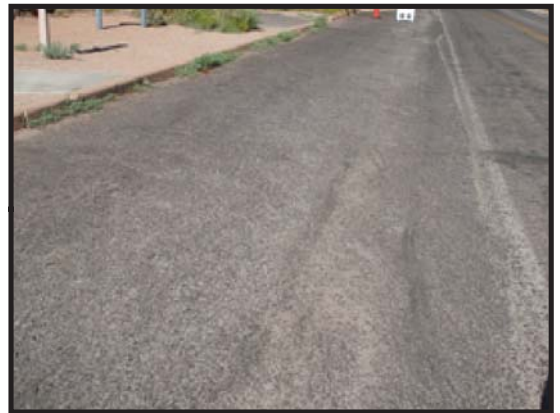
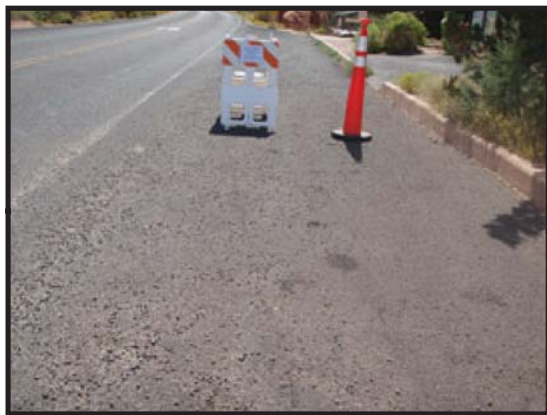
Route 0918

Route Number	Public / NonPublic	Date Visited		Area (sq ft)	Lane Miles *	Surface Type
0918	PUBLIC	8/25/2009		1,122	0.02	AS
Culverts	Drop Inlets	Gates	Fire Hydrants	Curb & Gutter	Curb	PCR
0	0	0	0	NO CURB AND GUTTER	CONCRETE CURB	GOOD/90

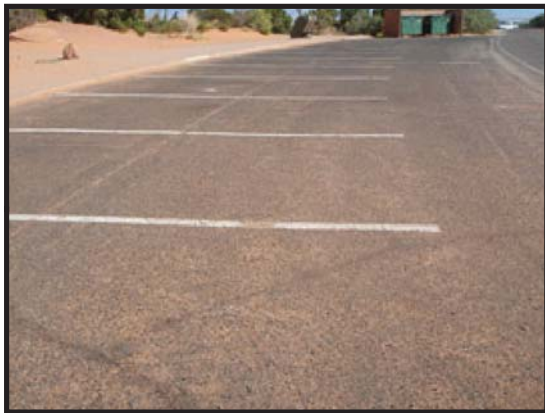
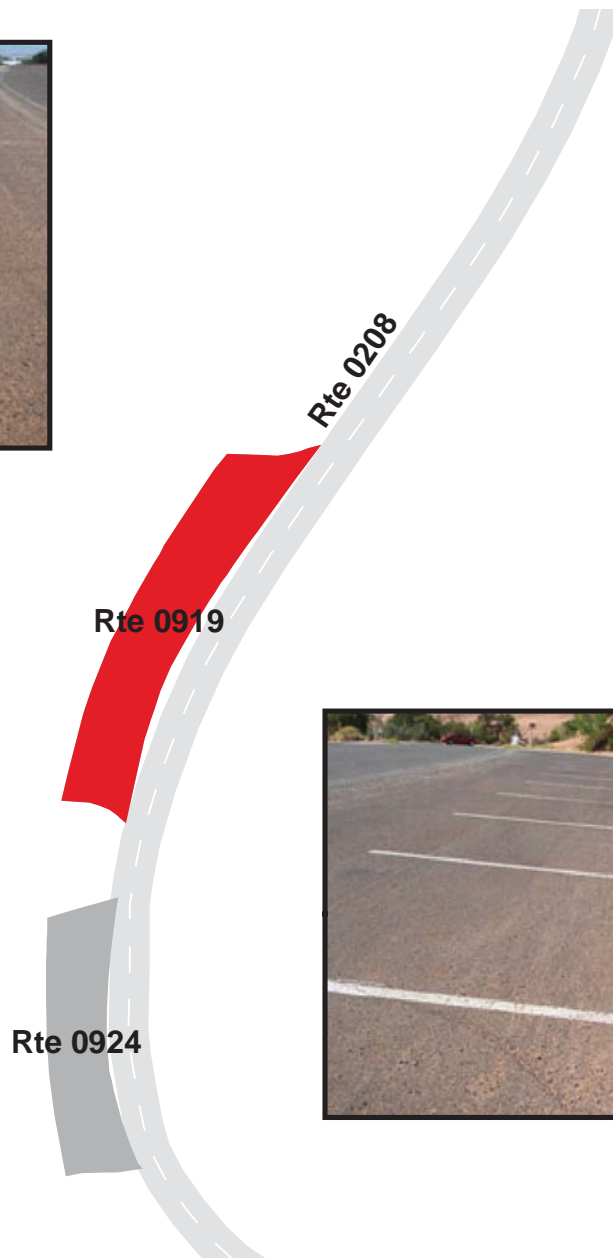
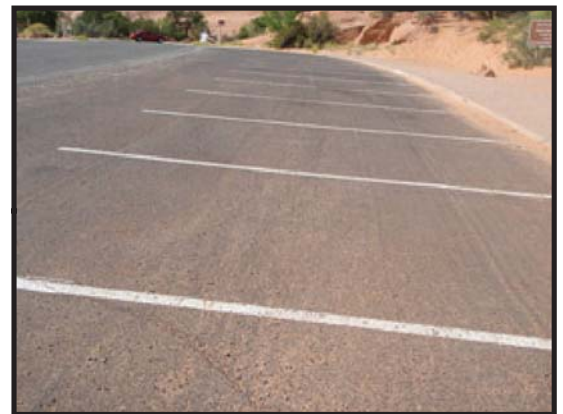
Route 0919

Route Number	Public / NonPublic	Date Visited		Area (sq ft)	Lane Miles *	Surface Type
0919	PUBLIC	8/25/2009		3,867	0.07	AS
Culverts	Drop Inlets	Gates	Fire Hydrants	Curb & Gutter	Curb	PCR
0	0	0	0	NO CURB AND GUTTER	CONCRETE CURB	GOOD/90

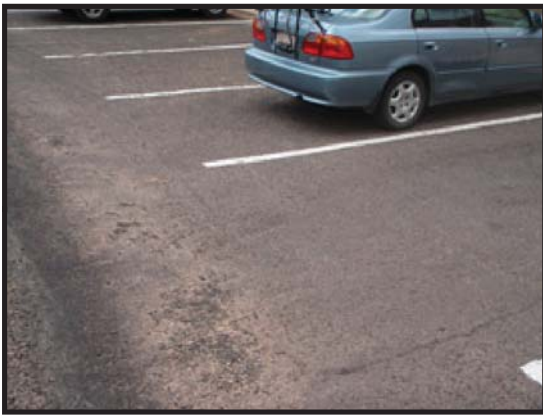
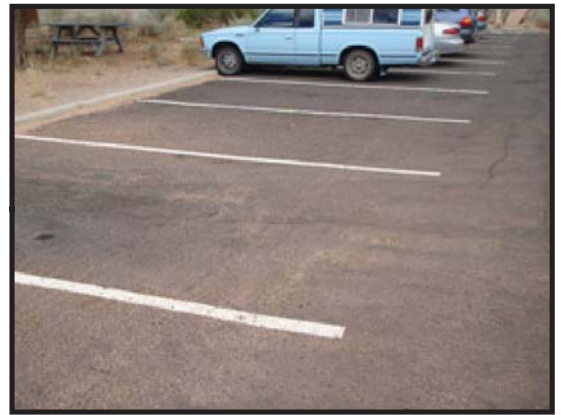
Route 0920

Route Number	Public / NonPublic	Date Visited		Area (sq ft)	Lane Miles *	Surface Type
0920	NONPUBLIC	8/25/2009		2,361	0.04	AS
Culverts	Drop Inlets	Gates	Fire Hydrants	Curb & Gutter	Curb	PCR
0	0	0	0	CONCRETE CURB AND GUTTER	NO CURB	GOOD/90

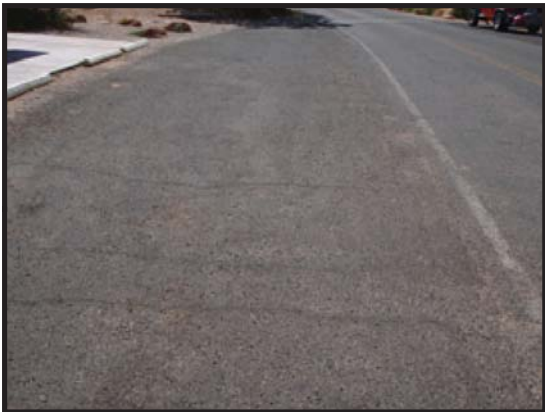
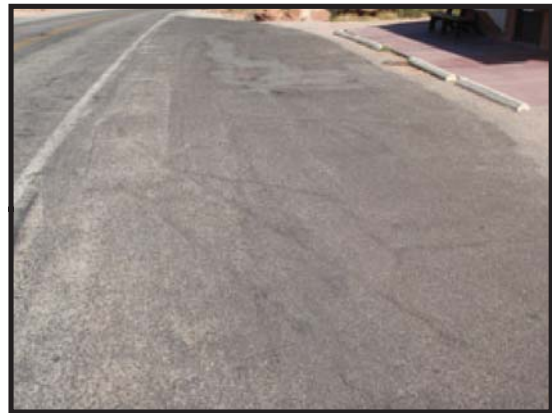
Route 0921

Route Number	Public / NonPublic	Date Visited		Area (sq ft)	Lane Miles *	Surface Type
0921	PUBLIC	8/25/2009		849	0.02	AS
Culverts	Drop Inlets	Gates	Fire Hydrants	Curb & Gutter	Curb	PCR
0	0	0	0	NO CURB AND GUTTER	NO CURB	POOR/45

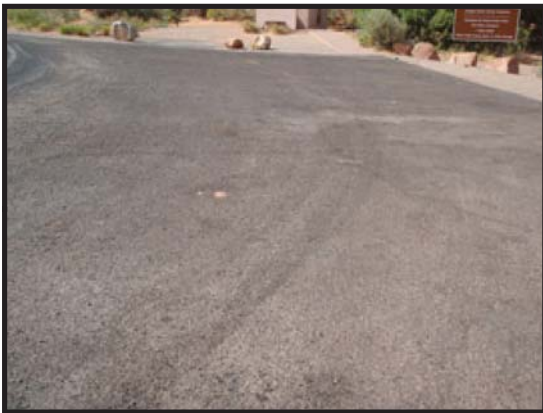
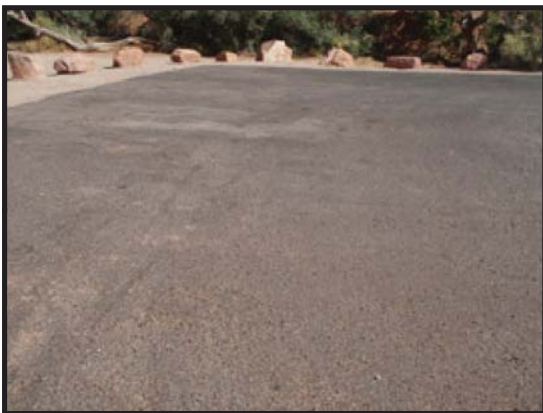
Route 0922

Route Number	Public / NonPublic	Date Visited		Area (sq ft)	Lane Miles *	Surface Type
0922	PUBLIC	8/25/2009		2,109	0.04	AS
Culverts	Drop Inlets	Gates	Fire Hydrants	Curb & Gutter	Curb	PCR
0	0	0	0	NO CURB AND GUTTER	NO CURB	GOOD/90
