**The Road Inventory
of
Arches National Park
ARCH – 1348
Cycle 4**

**Prepared By:
Federal Highway Administration
Road Inventory Program
Cycle 4**

Arches National Park in Utah

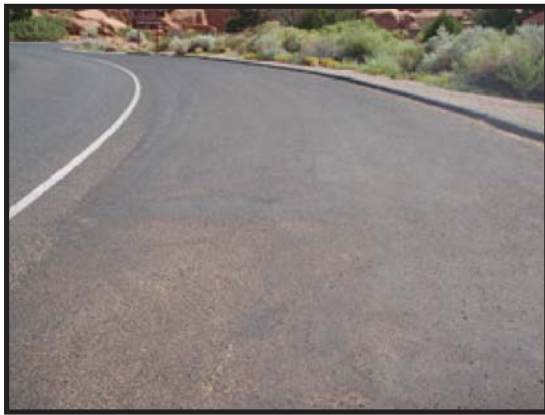
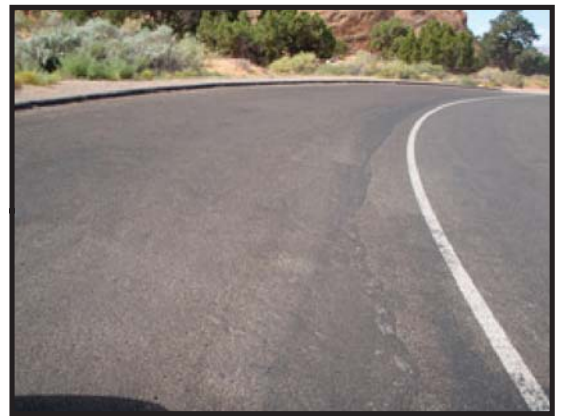
Route 0923

Route Number	Public / NonPublic	Date Visited		Area (sq ft)	Lane Miles *	Surface Type
0923	PUBLIC	8/25/2009		1,999	0.03	AS
Culverts	Drop Inlets	Gates	Fire Hydrants	Curb & Gutter	Curb	PCR
0	0	0	0	NO CURB AND GUTTER	ASPHALT CURB	GOOD/90

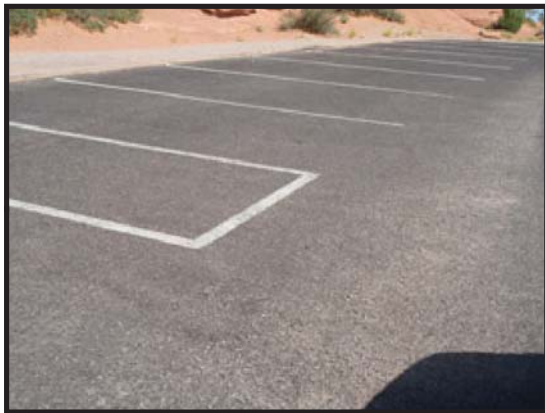
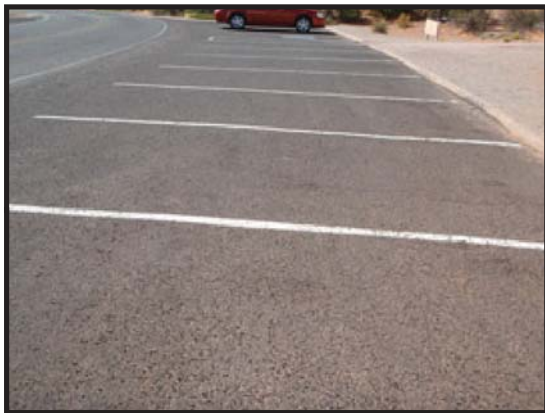
Route 0924

Route Number	Public / NonPublic	Date Visited		Area (sq ft)	Lane Miles *	Surface Type
0924	PUBLIC	8/25/2009		2,449	0.04	AS
Culverts	Drop Inlets	Gates	Fire Hydrants	Curb & Gutter	Curb	PCR
0	0	0	0	NO CURB AND GUTTER	CONCRETE CURB	GOOD/90

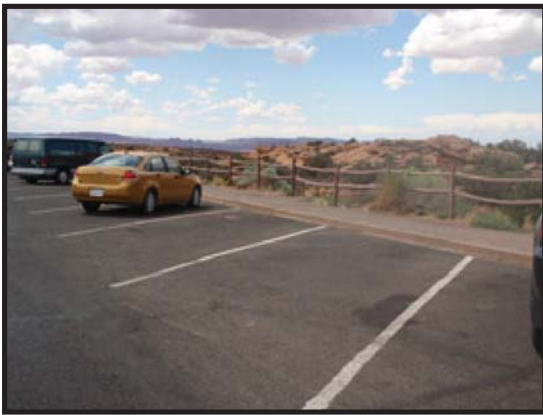
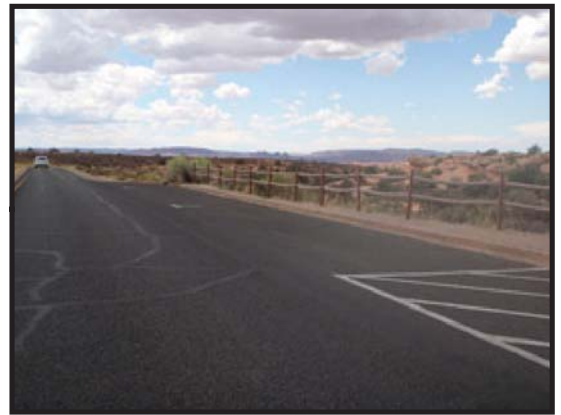
Route 0925A

Route Number	Public / NonPublic	Date Visited		Area (sq ft)	Lane Miles *	Surface Type
0925A	PUBLIC	8/25/2009		6,307	0.11	AS
Culverts	Drop Inlets	Gates	Fire Hydrants	Curb & Gutter	Curb	PCR
0	1	0	0	CONCRETE CURB AND GUTTER	NO CURB	GOOD/90

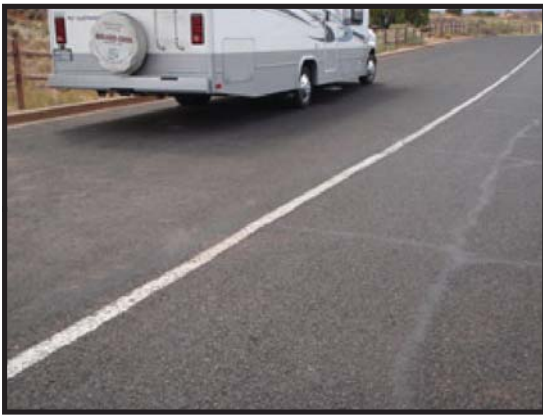
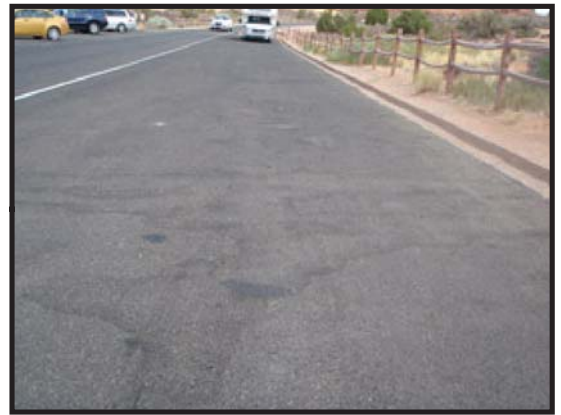
Route 0925B

Route Number	Public / NonPublic	Date Visited		Area (sq ft)	Lane Miles *	Surface Type
0925B	PUBLIC	8/25/2009		4,747	0.08	AS
Culverts	Drop Inlets	Gates	Fire Hydrants	Curb & Gutter	Curb	PCR
0	0	0	0	CONCRETE CURB AND GUTTER	NO CURB	GOOD/90

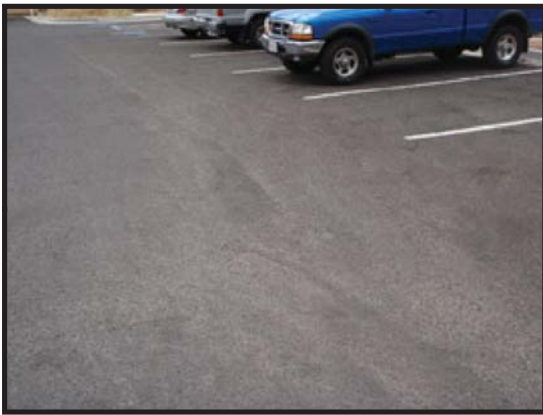
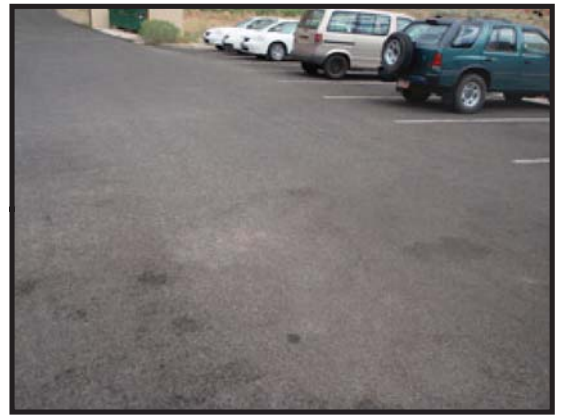
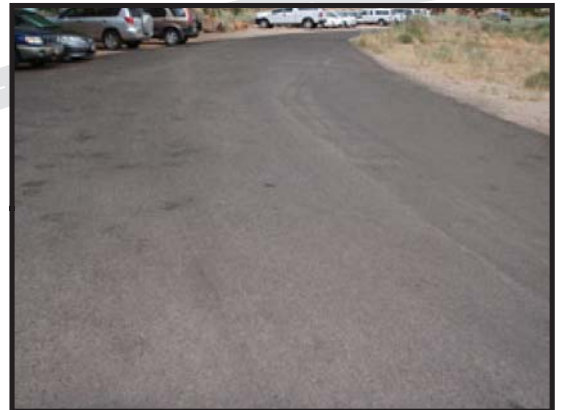
Route Number	Public / NonPublic	Date Visited		Area (sq ft)	Lane Miles *	Surface Type
0926	NONPUBLIC	8/25/2009		9,000	0.16	AS
Culverts	Drop Inlets	Gates	Fire Hydrants	Curb & Gutter	Curb	PCR
0	0	0	0	CONCRETE CURB AND GUTTER	NO CURB	FAIR/73

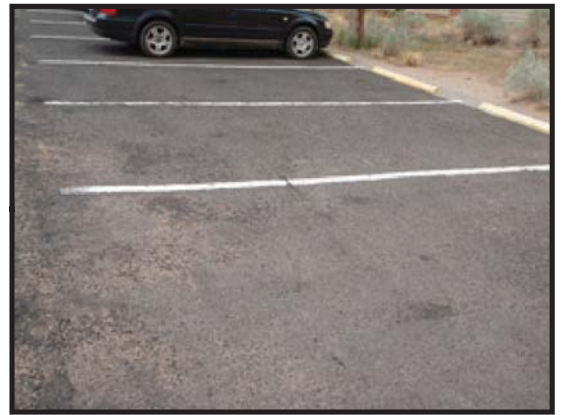
Route 0927

Route Number	Public / NonPublic	Date Visited		Area (sq ft)	Lane Miles *	Surface Type
0927	NONPUBLIC	8/25/2009		1,354	0.02	AS
Culverts	Drop Inlets	Gates	Fire Hydrants	Curb & Gutter	Curb	PCR
0	0	0	1	NO CURB AND GUTTER	NO CURB	FAIR/73

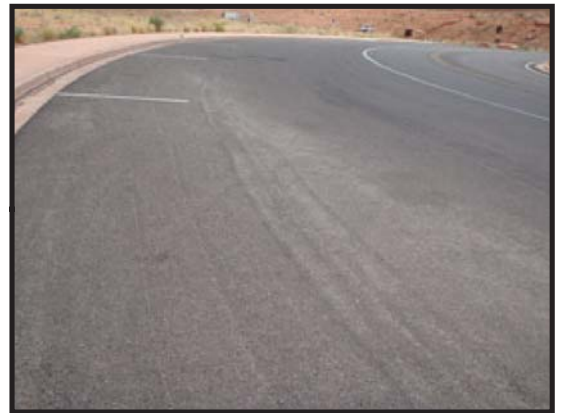
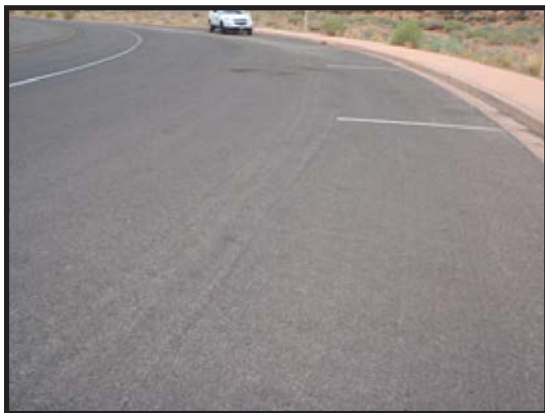
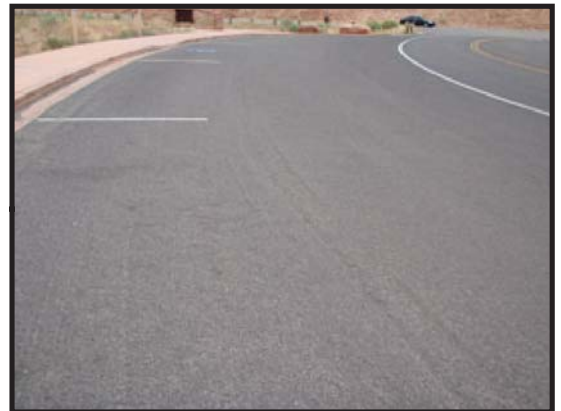
Route Number	Public / NonPublic	Date Visited		Area (sq ft)	Lane Miles *	Surface Type
0928	NONPUBLIC	8/25/2009		9,545	0.16	AS
Culverts	Drop Inlets	Gates	Fire Hydrants	Curb & Gutter	Curb	PCR
0	1	0	0	CONCRETE CURB AND GUTTER	NO CURB	GOOD/90
