**The Road Inventory  
of  
Badlands National Park  
BADL – 1300  
Cycle 4**

**Prepared By:  
Federal Highway Administration  
Road Inventory Program  
Cycle 4**

# Badlands National Park in South Dakota

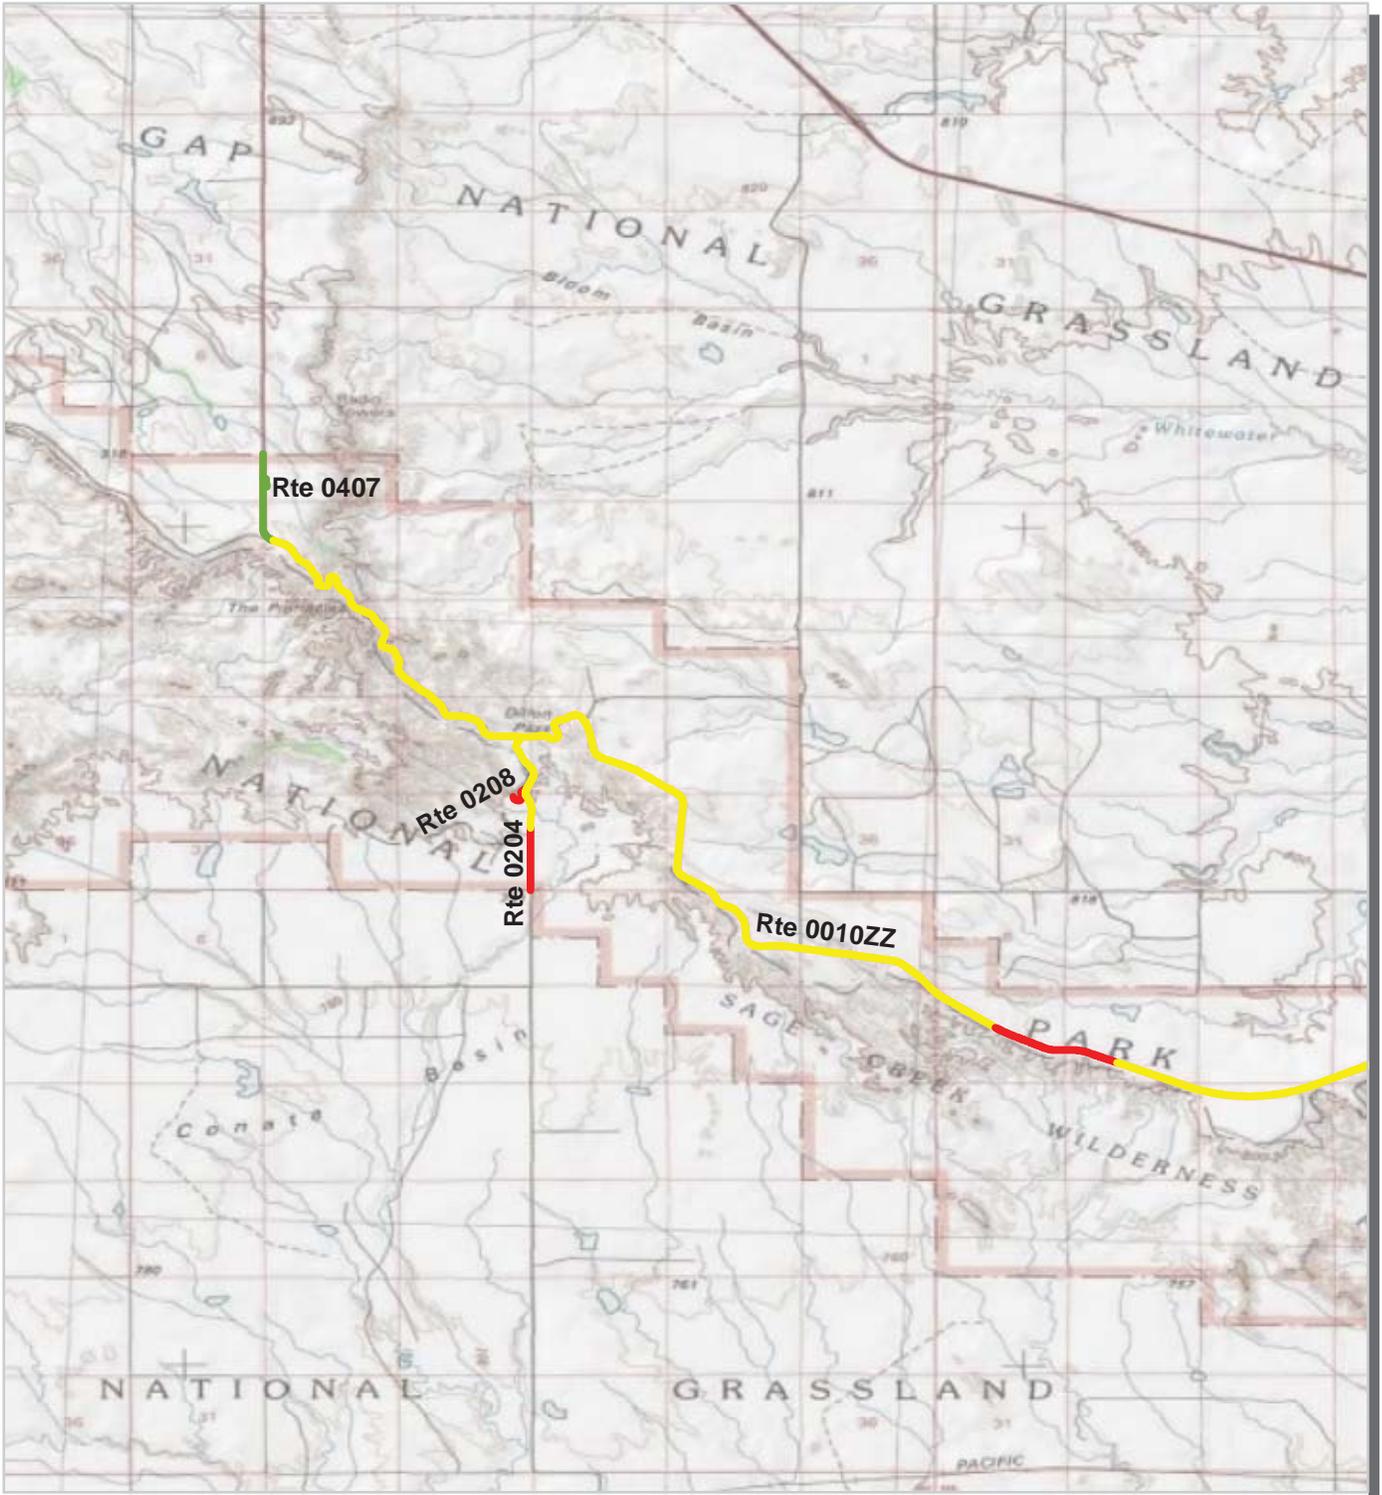
**Badlands National Park  
Route Condition Map  
PCR - Mile by Mile  
Area 1**

PCR	Poor (≤60)	Fair (61 - 84)	Good (85 - 94)	Excellent (95 - 100)	No Data

\* If the PCR rating is not available for a section, the SCR rating will be displayed. See appendix for definitions and formulas.

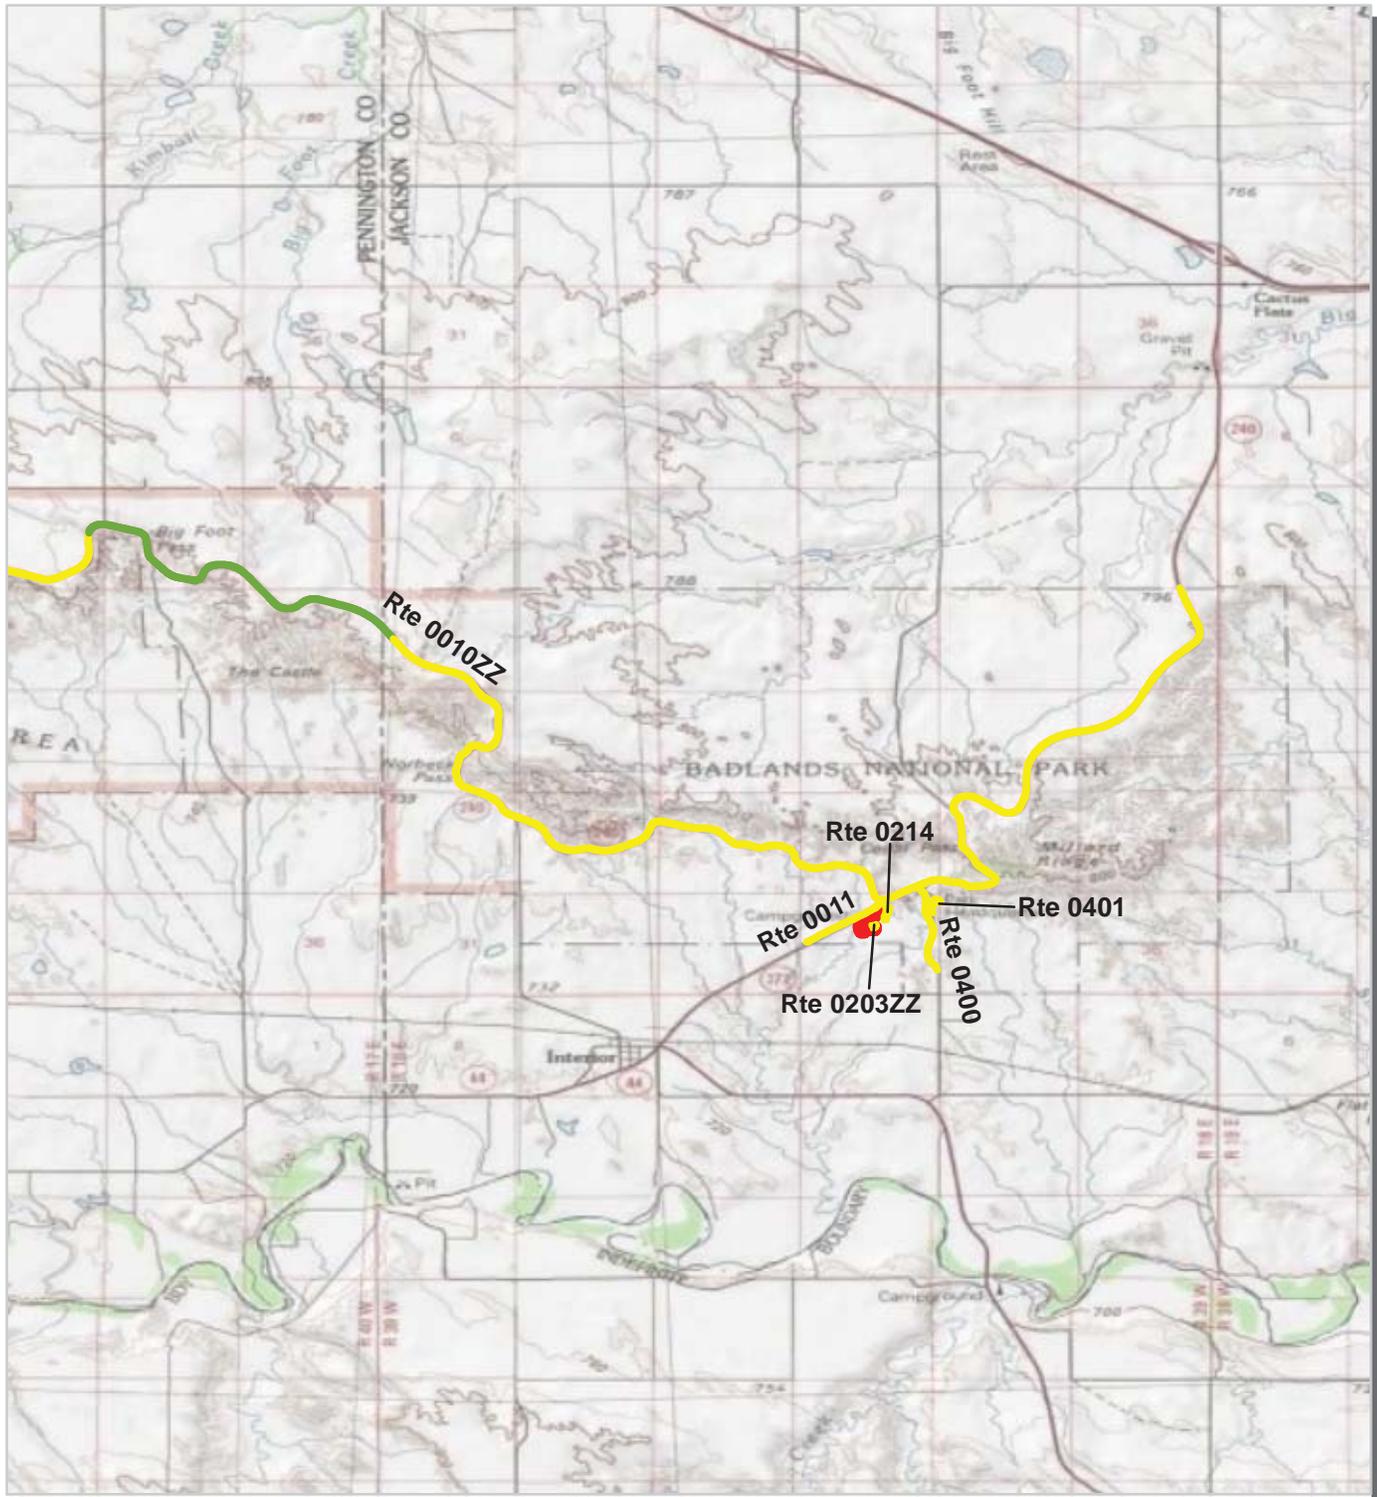
# Badlands National Park Route Condition Map PCR - Mile by Mile Area 2

PCR	Poor	<span style="display: inline-block; width: 15px; height: 15px; background-color: red; border: 1px solid black;"></span>	Fair	<span style="display: inline-block; width: 15px; height: 15px; background-color: yellow; border: 1px solid black;"></span>	Good	<span style="display: inline-block; width: 15px; height: 15px; background-color: green; border: 1px solid black;"></span>	Excellent	<span style="display: inline-block; width: 15px; height: 15px; background-color: blue; border: 1px solid black;"></span>	No Data	<span style="display: inline-block; width: 15px; height: 15px; background-color: black; border: 1px solid black;"></span>
	(<=60)		(61 - 84)	(85 - 94)	(95 - 100)

\* If the PCR rating is not available for a section, the SCR rating will be displayed. See appendix for definitions and formulas.

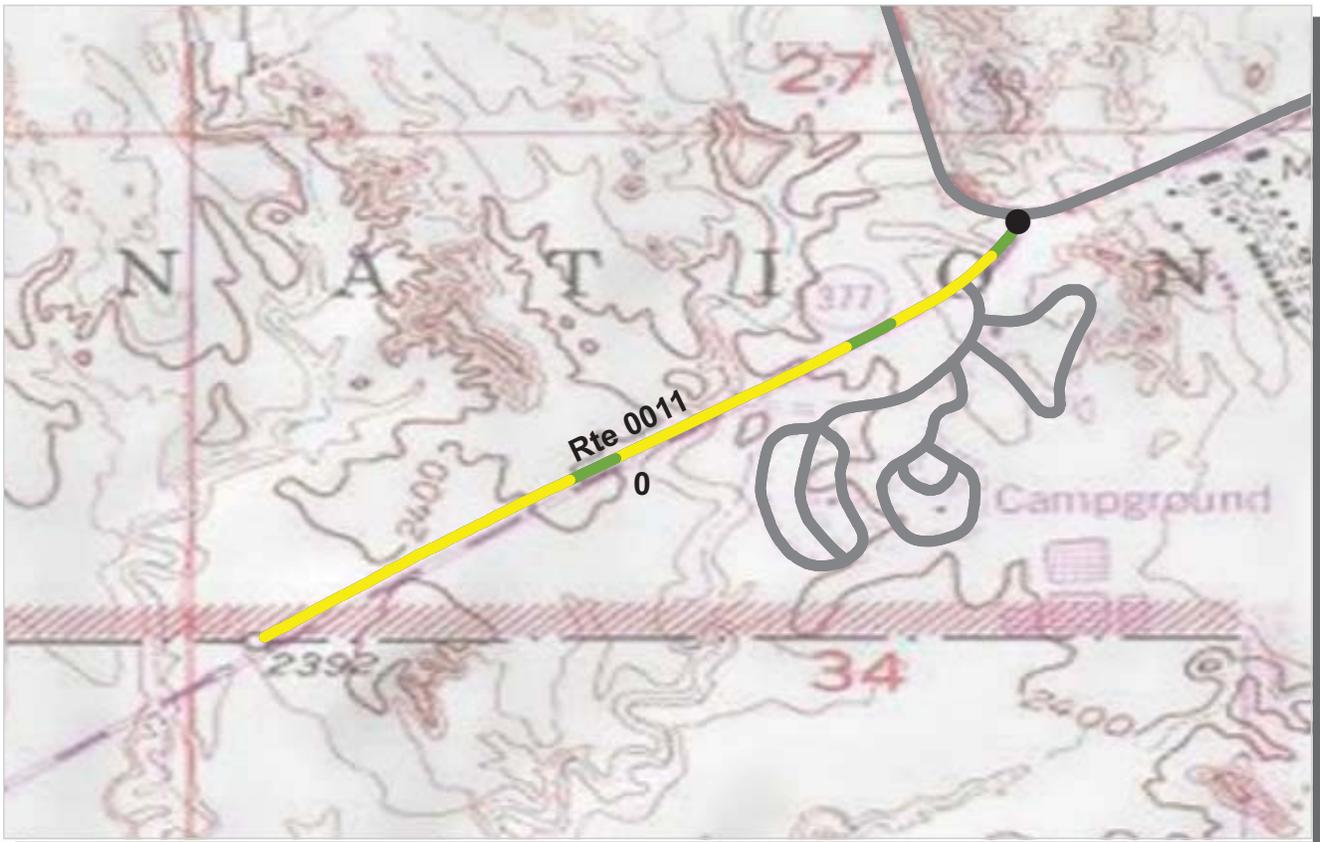
**ROUTE: 0011 ENTRANCE ROAD (HIGHWAY 377)**

<b>Section Number</b>	0				
<b>Section Length (mi)</b>	0.69				
<b>Traffic</b>	Traffic data may be found at <a href="http://www.efl.fhwa.dot.gov">www.efl.fhwa.dot.gov</a> Click on PROGRAMS / NPS Traffic Data (Note: Not all parks have traffic data)				
<b>Cross Section Information</b>					
Number of Lanes	2				
Paved Width (ft)	28				
Lane Width (ft)	11				
Shoulder Width Right (ft)	NC				
Shoulder Width Left (ft)	NC				
<b>Roadway Condition Information</b>					
SCR (Surface Condition Rating)	84				
PCR (Pavement Condition Rating)	78				
<b>Distress Index Values</b>					
Alligator Cracking Index	100				
Longitudinal Cracking Index	99				
Transverse Cracking Index	97				
Patching Index	100				
Rutting Index	88				
Roughness Condition Index (RCI)	69

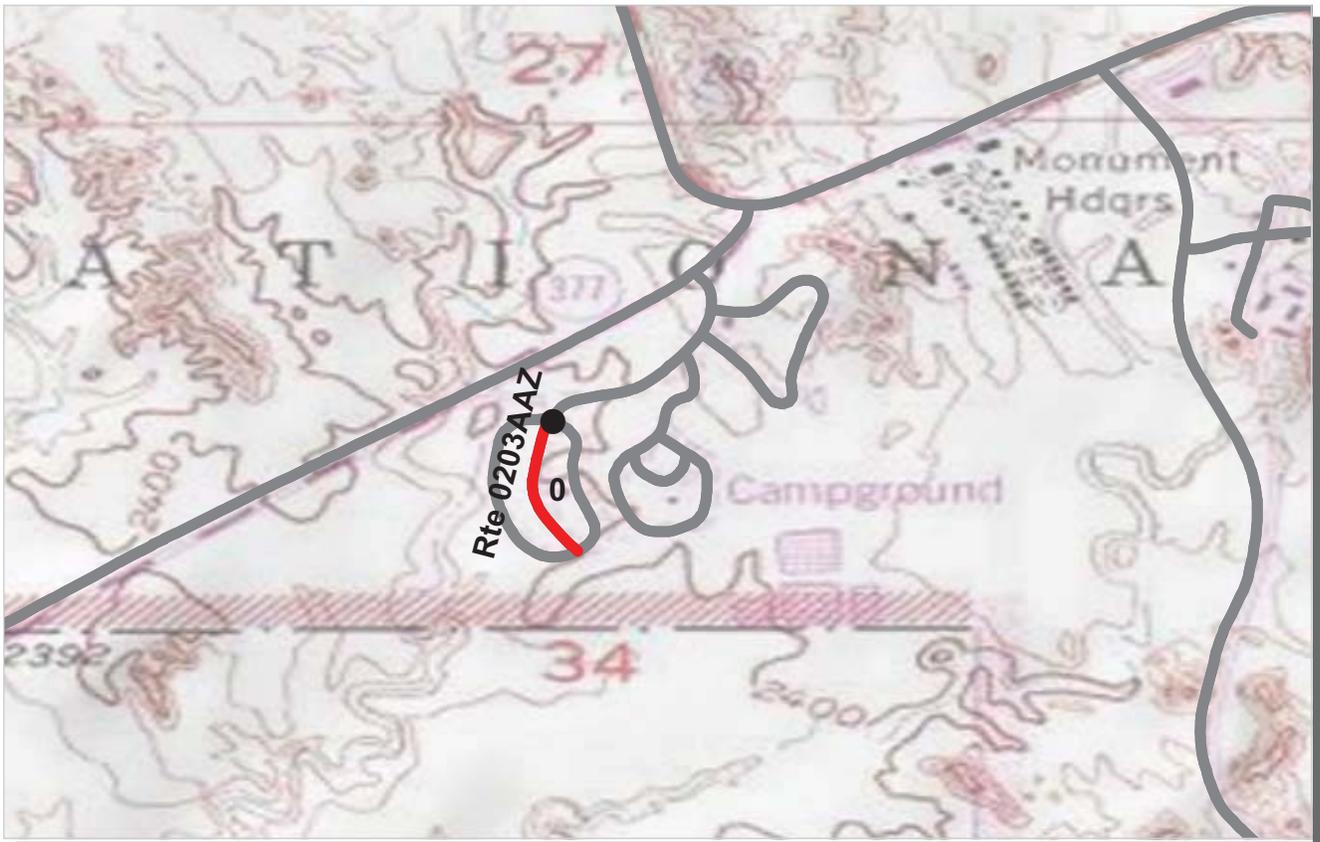
**ROUTE: 0203AAZ CEDAR PASS CAMPGROUND ROAD AA**

<b>Section Number</b>	0				
<b>Section Length (mi)</b>	0.13				
<b>Traffic</b>	Traffic data may be found at <a href="http://www.efl.fhwa.dot.gov">www.efl.fhwa.dot.gov</a> Click on PROGRAMS / NPS Traffic Data (Note: Not all parks have traffic data)				
<b>Cross Section Information</b>					
Number of Lanes	2				
Paved Width (ft)	28				
Lane Width (ft)	14				
Shoulder Width Right (ft)	NC				
Shoulder Width Left (ft)	NC				
<b>Roadway Condition Information</b>					
SCR (Surface Condition Rating)	64				
PCR (Pavement Condition Rating)	56				
<b>Distress Index Values</b>					
Alligator Cracking Index	100				
Longitudinal Cracking Index	100				
Transverse Cracking Index	100				
Patching Index	100				
Rutting Index	64				
Roughness Condition Index (RCI)	44

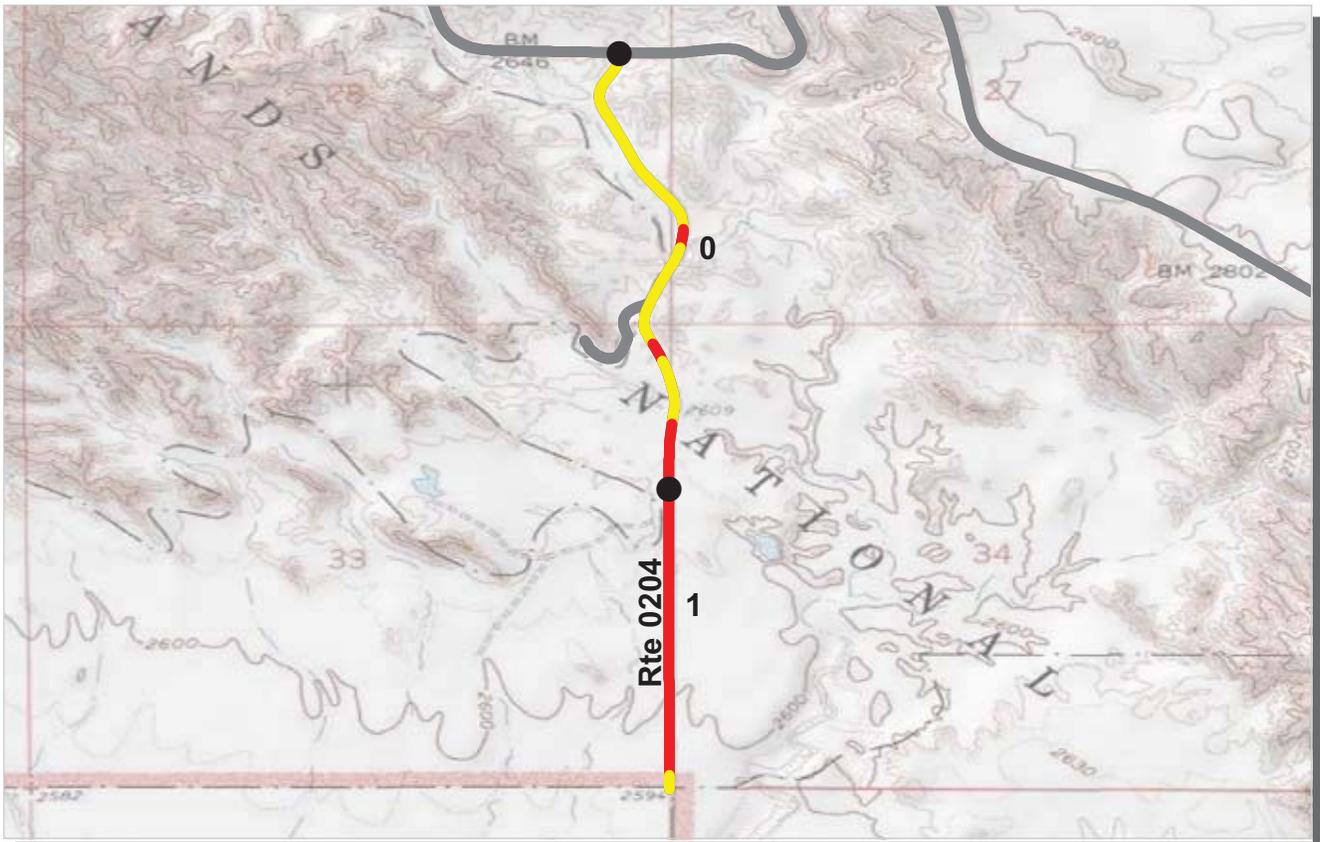
**ROUTE: 0204 CONATA ROAD**

Section Number	0	1			
Section Length (mi)	1.00	0.65			
<b>Traffic</b>	Traffic data may be found at <a href="http://www.efl.fhwa.dot.gov">www.efl.fhwa.dot.gov</a> Click on PROGRAMS / NPS Traffic Data (Note: Not all parks have traffic data)				
<b>Cross Section Information</b>					
Number of Lanes	2	2			
Paved Width (ft)	25	24			
Lane Width (ft)	10	10			
Shoulder Width Right (ft)	NC	NC			
Shoulder Width Left (ft)	NC	NC			
<b>Roadway Condition Information</b>					
SCR (Surface Condition Rating)	72	46			
PCR (Pavement Condition Rating)	69	47			
<b>Distress Index Values</b>					
Alligator Cracking Index	100	99			
Longitudinal Cracking Index	100	98			
Transverse Cracking Index	100	99			
Patching Index	100	99			
Rutting Index	72	50			
Roughness Condition Index (RCI)	64	49

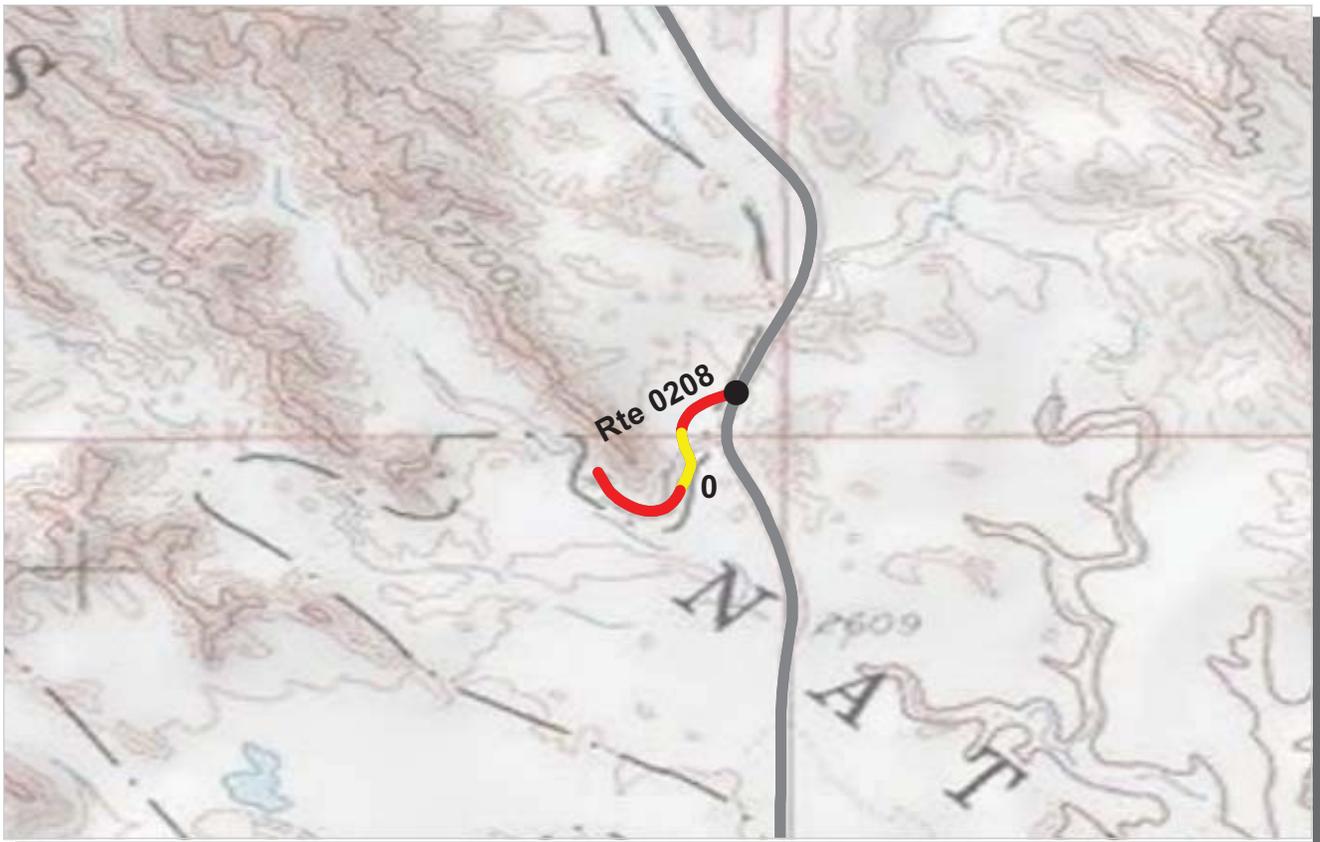
**ROUTE: 0208 CONATA PICNIC AREA ROAD**

<b>Section Number</b>	0				
<b>Section Length (mi)</b>	0.21				
<b>Traffic</b>	Traffic data may be found at <a href="http://www.efl.fhwa.dot.gov">www.efl.fhwa.dot.gov</a> Click on PROGRAMS / NPS Traffic Data (Note: Not all parks have traffic data)				
<b>Cross Section Information</b>					
Number of Lanes	2				
Paved Width (ft)	22				
Lane Width (ft)	11				
Shoulder Width Right (ft)	NC				
Shoulder Width Left (ft)	NC				
<b>Roadway Condition Information</b>					
SCR (Surface Condition Rating)	71				
PCR (Pavement Condition Rating)	58				
<b>Distress Index Values</b>					
Alligator Cracking Index	100				
Longitudinal Cracking Index	100				
Transverse Cracking Index	100				
Patching Index	100				
Rutting Index	71				
Roughness Condition Index (RCI)	36

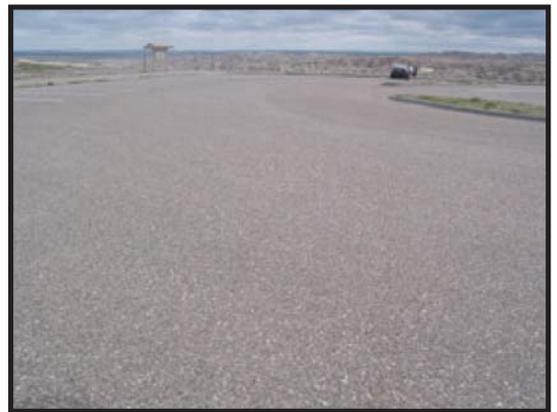
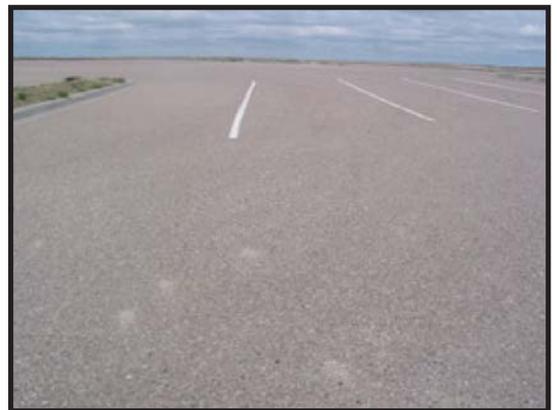
## Route 0902

Route Number	Public / NonPublic	Date Visited		Area (sq ft)	Lane Miles *	Surface Type
0902	PUBLIC	5/12/2008		121,894	2.10	AS
Culverts	Drop Inlets	Gates	Fire Hydrants	Curb & Gutter	Curb	PCR
0	5	0	0	NO CURB AND GUTTER	WOOD CURB	FAIR/73

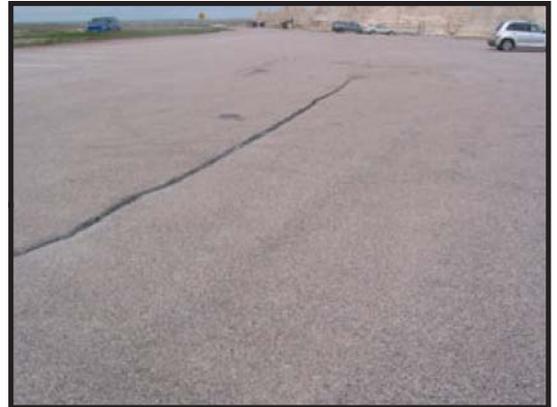
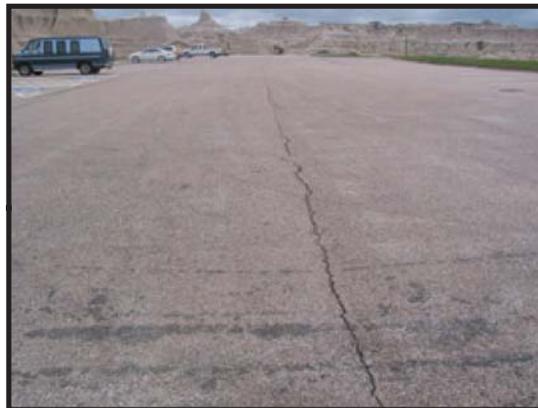
## Route 0903

Route Number	Public / NonPublic	Date Visited		Area (sq ft)	Lane Miles *	Surface Type
0903	PUBLIC	5/12/2008		21,038	0.36	AS
Culverts	Drop Inlets	Gates	Fire Hydrants	Curb & Gutter	Curb	PCR
0	1	0	0	NO CURB AND GUTTER	WOOD CURB	FAIR/73

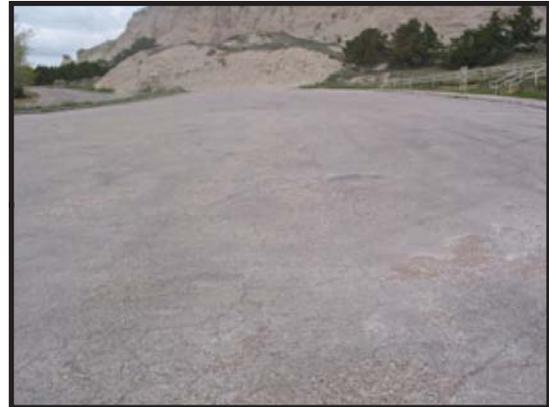
## Route 0904

Route Number	Public / NonPublic	Date Visited		Area (sq ft)	Lane Miles *	Surface Type
0904	PUBLIC	5/12/2008		23,003	0.40	AS
Culverts	Drop Inlets	Gates	Fire Hydrants	Curb & Gutter	Curb	PCR
0	1	0	0	CONCRETE CURB AND GUTTER	CONCRETE CURB	POOR/45

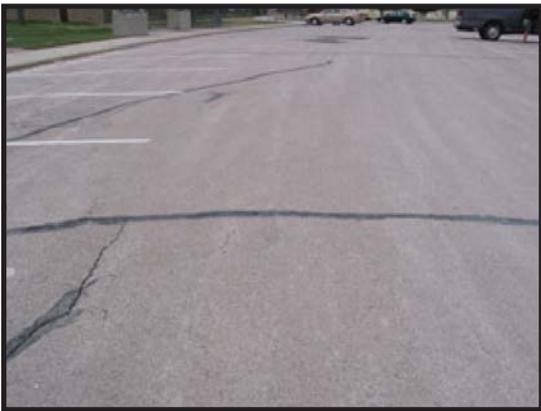
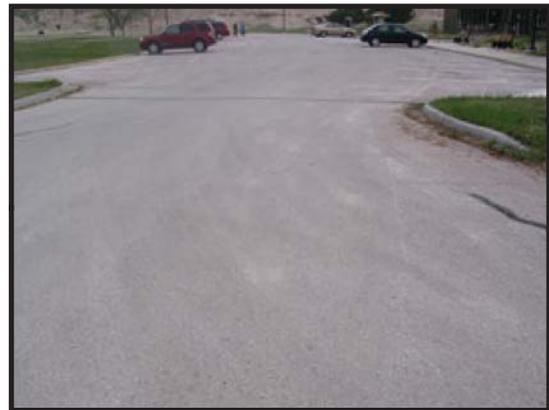
## Route 0905ZZ

Route Number	Public / NonPublic	Date Visited		Area (sq ft)	Lane Miles *	Surface Type
0905ZZ	PUBLIC	5/12/2008		66,499	1.15	AS
Culverts	Drop Inlets	Gates	Fire Hydrants	Curb & Gutter	Curb	PCR
1	0	0	0	NO CURB AND GUTTER	NO CURB	SUMMARY/75.44

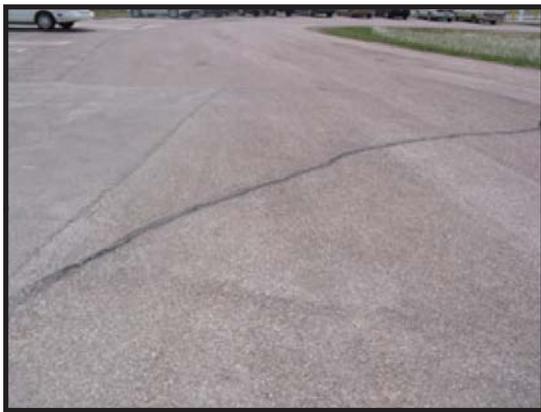
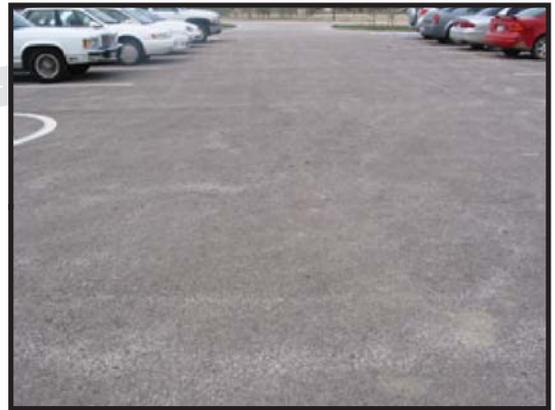
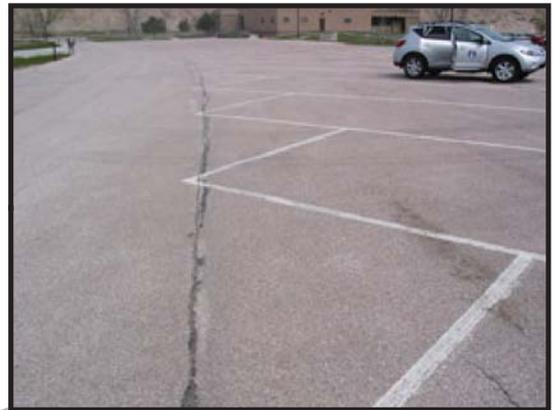
## Route 0906

Route Number	Public / NonPublic	Date Visited		Area (sq ft)	Lane Miles *	Surface Type
0906	NONPUBLIC	5/12/2008		32,495	0.56	AS
Culverts	Drop Inlets	Gates	Fire Hydrants	Curb & Gutter	Curb	PCR
0	0	0	1	NO CURB AND GUTTER	NO CURB	FAIR/73

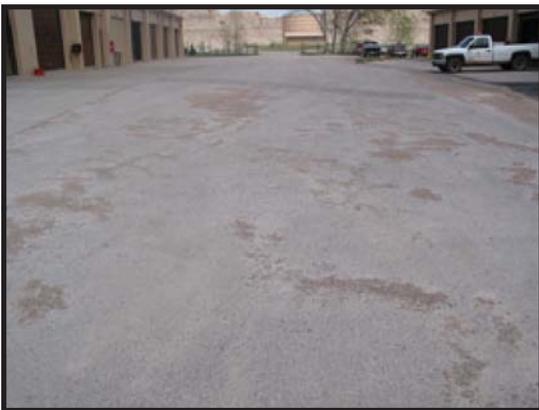
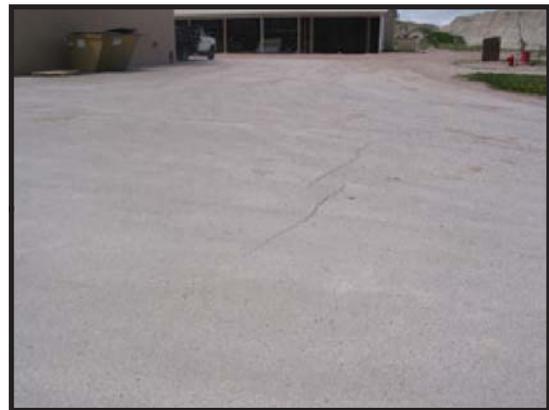
## Route 0908

Route Number	Public / NonPublic	Date Visited		Area (sq ft)	Lane Miles *	Surface Type
0908	PUBLIC	5/12/2008		57,828	1.00	AS
Culverts	Drop Inlets	Gates	Fire Hydrants	Curb & Gutter	Curb	PCR
0	2	0	1	CONCRETE CURB AND GUTTER	CONCRETE CURB	FAIR/73

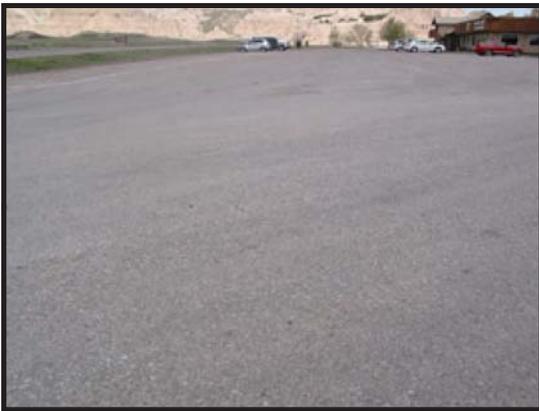
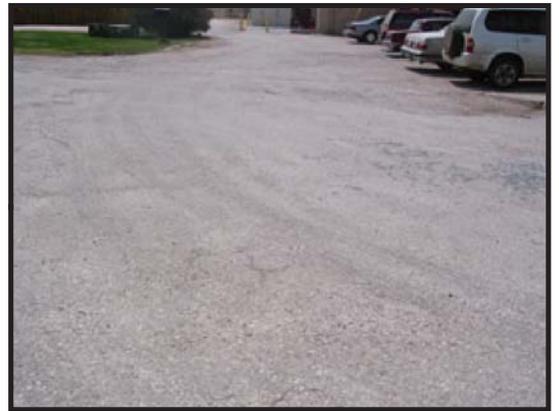
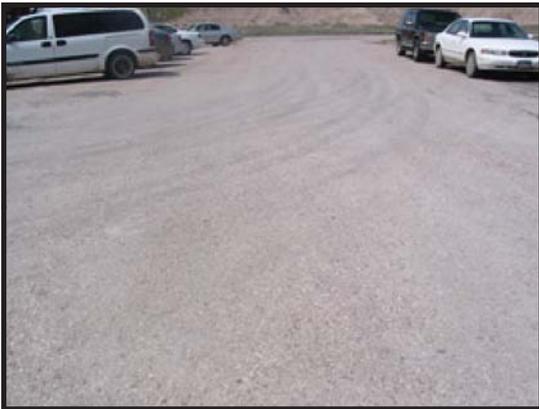
## Route 0909

Route Number	Public / NonPublic	Date Visited		Area (sq ft)	Lane Miles *	Surface Type
0909	PUBLIC	5/12/2008		18,023	0.31	AS
Culverts	Drop Inlets	Gates	Fire Hydrants	Curb & Gutter	Curb	PCR
0	0	0	0	NO CURB AND GUTTER	WOOD CURB	GOOD/90

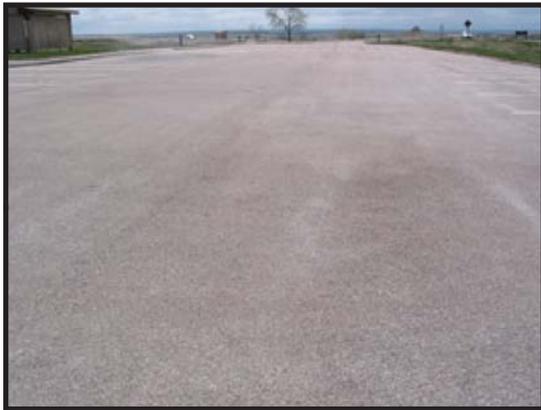
## Route 0910

Route Number	Public / NonPublic	Date Visited		Area (sq ft)	Lane Miles *	Surface Type
0910	PUBLIC	5/12/2008		9,027	0.16	AS
Culverts	Drop Inlets	Gates	Fire Hydrants	Curb & Gutter	Curb	PCR
0	0	0	0	NO CURB AND GUTTER	NO CURB	GOOD/90

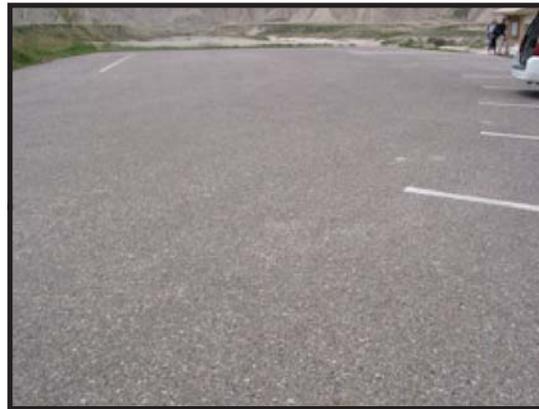
## Route 0912

Route Number	Public / NonPublic	Date Visited		Area (sq ft)	Lane Miles *	Surface Type
0912	PUBLIC	5/12/2008		58,744	1.01	AS
Culverts	Drop Inlets	Gates	Fire Hydrants	Curb & Gutter	Curb	PCR
0	2	0	0	CONCRETE CURB AND GUTTER	CONCRETE & WOOD CURB	GOOD/90

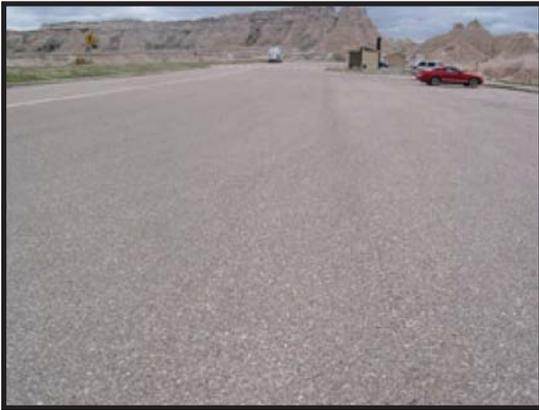
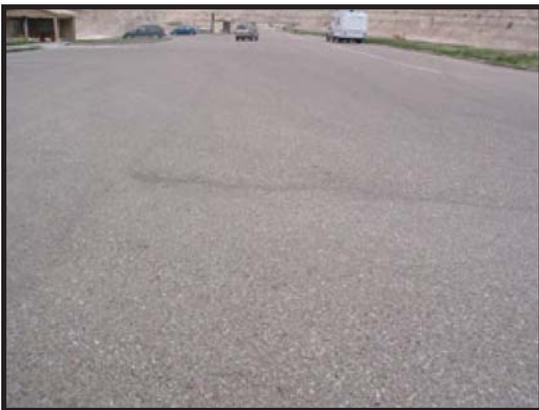
## Route 0913

Route Number	Public / NonPublic	Date Visited		Area (sq ft)	Lane Miles *	Surface Type
0913	PUBLIC	5/12/2008		25,868	0.45	AS
Culverts	Drop Inlets	Gates	Fire Hydrants	Curb & Gutter	Curb	PCR
0	0	0	0	NO CURB AND GUTTER	WOOD CURB	GOOD/90

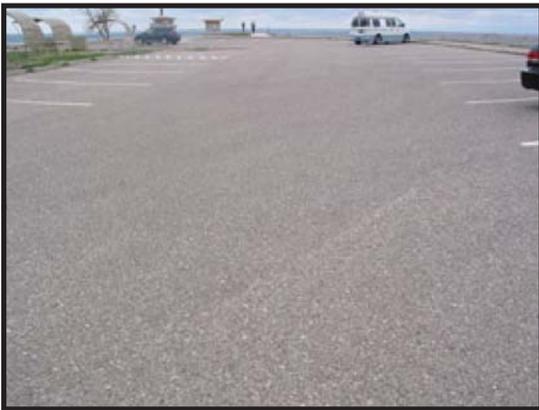
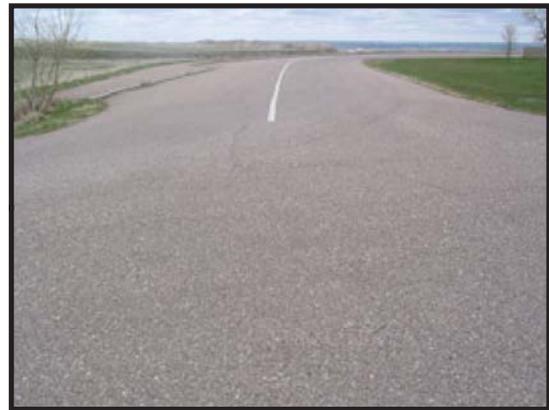
Route Number	Public / NonPublic	Date Visited		Area (sq ft)	Lane Miles *	Surface Type
0914	PUBLIC	5/12/2008		33,077	0.57	AS
Culverts	Drop Inlets	Gates	Fire Hydrants	Curb & Gutter	Curb	PCR
1	0	0	0	NO CURB AND GUTTER	WOOD CURB	GOOD/90

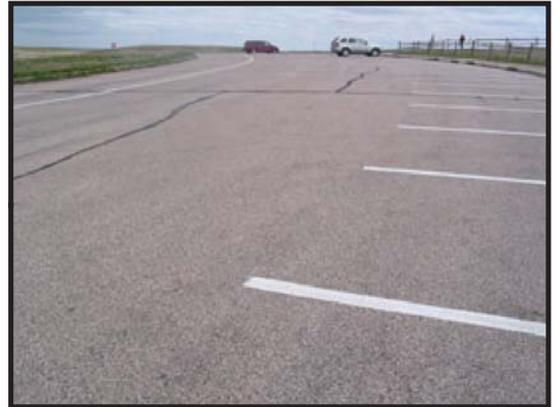
## Route 0915

Route Number	Public / NonPublic	Date Visited		Area (sq ft)	Lane Miles *	Surface Type
0915	PUBLIC	5/12/2008		26,237	0.45	AS
Culverts	Drop Inlets	Gates	Fire Hydrants	Curb & Gutter	Curb	PCR
0	0	0	0	NO CURB AND GUTTER	WOOD CURB	FAIR/73

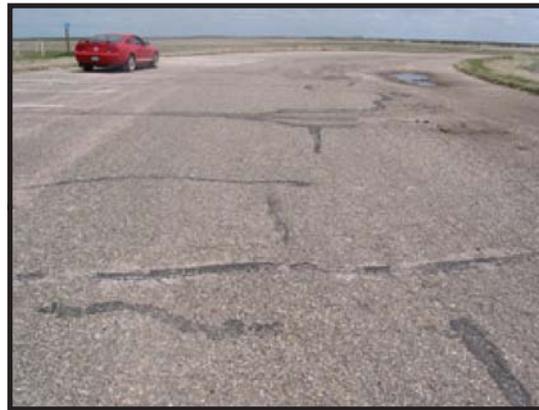
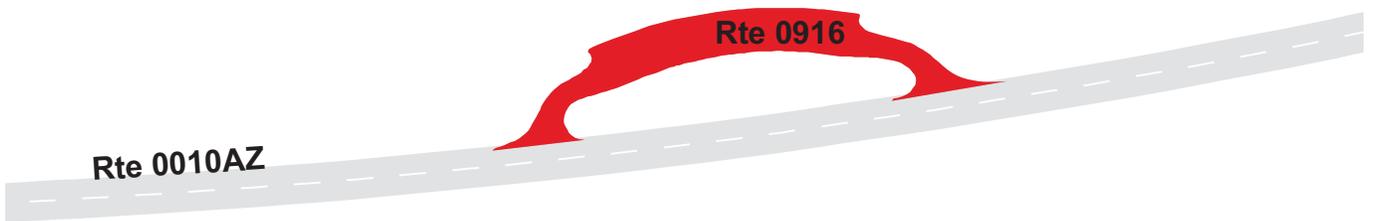
## Route 0916

Route Number	Public / NonPublic	Date Visited		Area (sq ft)	Lane Miles *	Surface Type
0916	PUBLIC	5/12/2008		19,535	0.34	AS
Culverts	Drop Inlets	Gates	Fire Hydrants	Curb & Gutter	Curb	PCR
0	0	0	0	NO CURB AND GUTTER	WOOD CURB	POOR/45

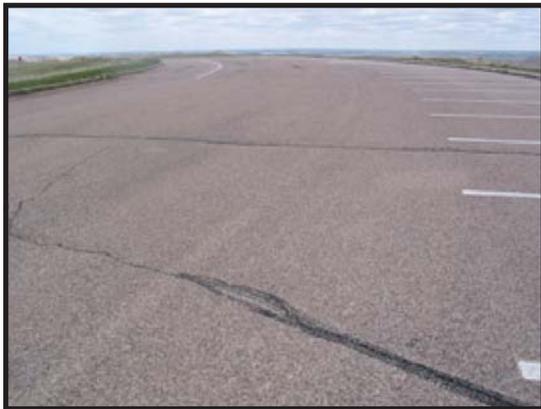
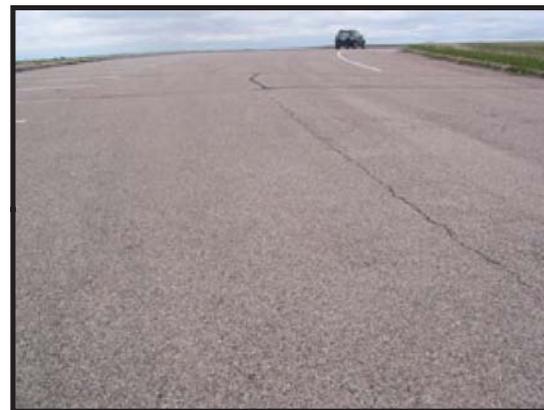
## Route 0917

BURNS BASIN OVERLOOK PARKING  
 ADJACENT TO ROUTE 0010AZ AT MP 18.39 ON LEFT

Route Number	Public / NonPublic	Date Visited		Area (sq ft)	Lane Miles *	Surface Type
0917	PUBLIC	5/12/2008		25,537	0.44	AS
Culverts	Drop Inlets	Gates	Fire Hydrants	Curb & Gutter	Curb	PCR
0	0	0	0	NO CURB AND GUTTER	WOOD CURB	FAIR/73

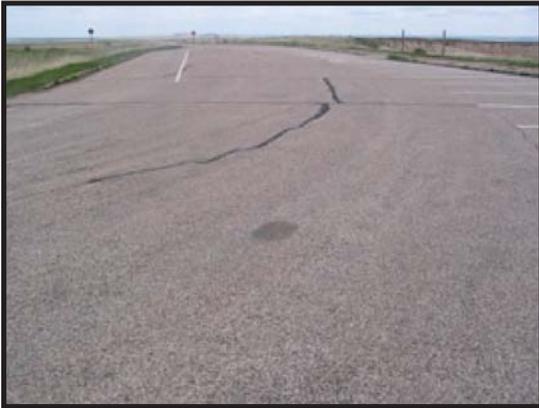
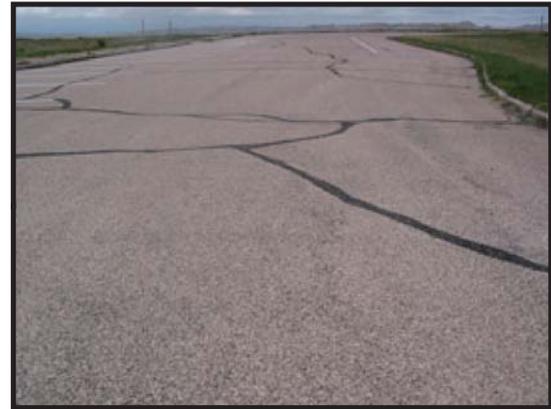
## Route 0918

Route Number	Public / NonPublic	Date Visited		Area (sq ft)	Lane Miles *	Surface Type
0918	PUBLIC	5/12/2008		20,290	0.35	AS
Culverts	Drop Inlets	Gates	Fire Hydrants	Curb & Gutter	Curb	PCR
0	1	0	0	NO CURB AND GUTTER	WOOD CURB	FAIR/73

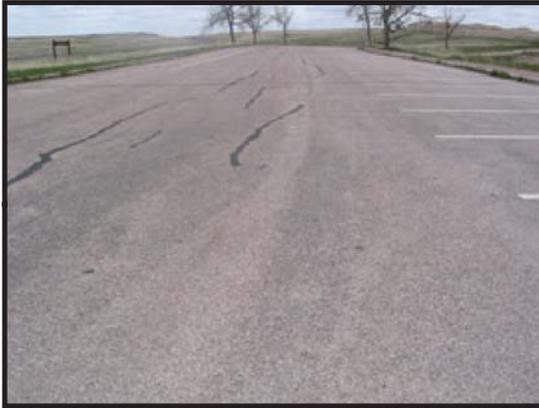
## Route 0919

Route Number	Public / NonPublic	Date Visited		Area (sq ft)	Lane Miles *	Surface Type
0919	PUBLIC	5/12/2008		22,029	0.38	AS
Culverts	Drop Inlets	Gates	Fire Hydrants	Curb & Gutter	Curb	PCR
0	0	0	0	NO CURB AND GUTTER	WOOD CURB	FAIR/73

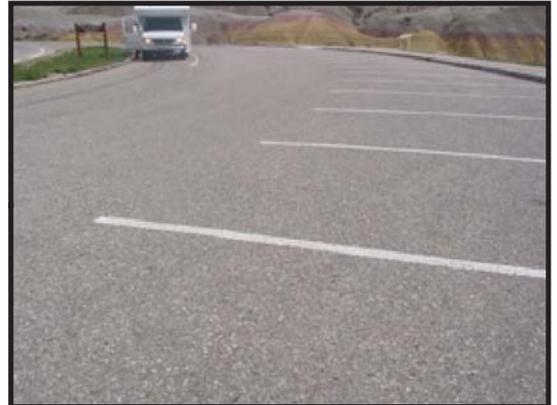
## Route 0920

Route Number	Public / NonPublic	Date Visited		Area (sq ft)	Lane Miles *	Surface Type
0920	PUBLIC	5/12/2008		11,592	0.20	AS
Culverts	Drop Inlets	Gates	Fire Hydrants	Curb & Gutter	Curb	PCR
0	1	0	0	NO CURB AND GUTTER	WOOD CURB	GOOD/90

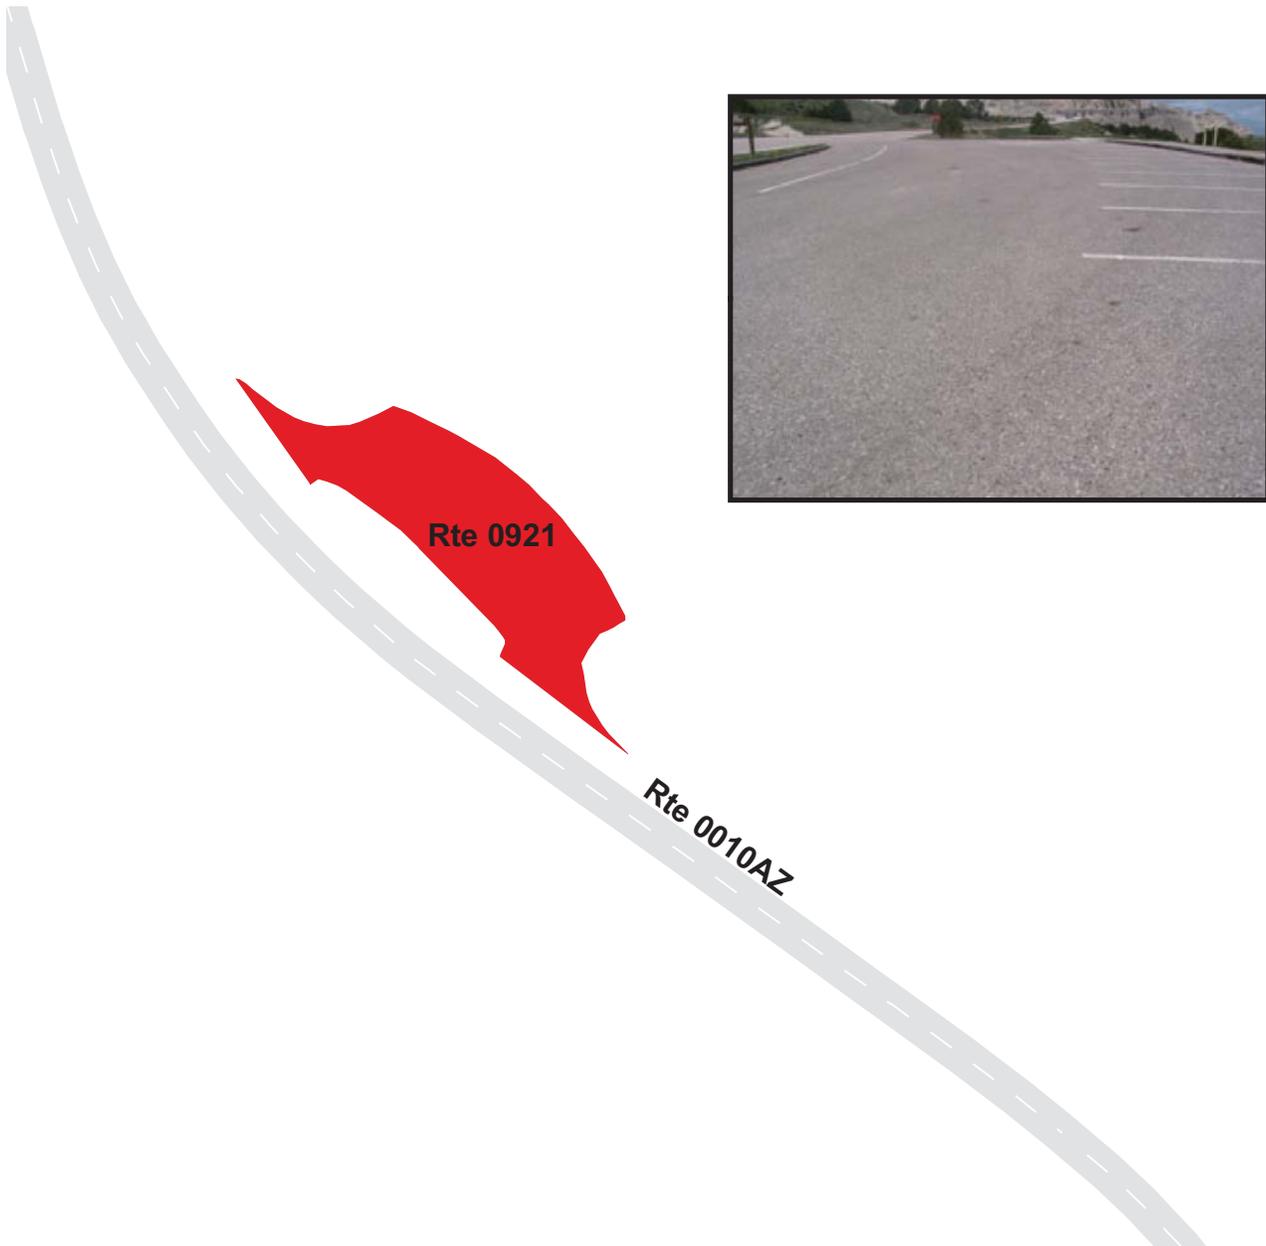
## Route 0921

Route Number	Public / NonPublic	Date Visited		Area (sq ft)	Lane Miles *	Surface Type
0921	PUBLIC	5/12/2008		8,843	0.15	AS
Culverts	Drop Inlets	Gates	Fire Hydrants	Curb & Gutter	Curb	PCR
1	1	0	0	NO CURB AND GUTTER	WOOD CURB	GOOD/90

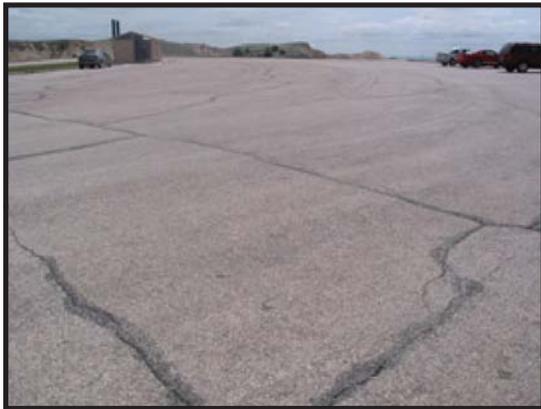
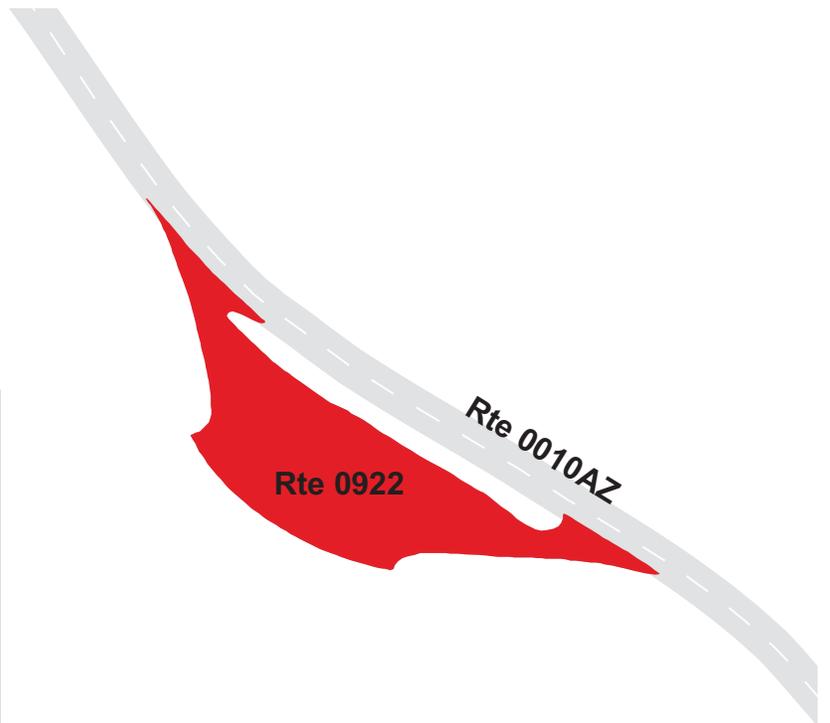
## Route 0922

Route Number	Public / NonPublic	Date Visited		Area (sq ft)	Lane Miles *	Surface Type
0922	PUBLIC	5/12/2008		33,396	0.58	AS
Culverts	Drop Inlets	Gates	Fire Hydrants	Curb & Gutter	Curb	PCR
0	0	0	0	NO CURB AND GUTTER	WOOD CURB	FAIR/73

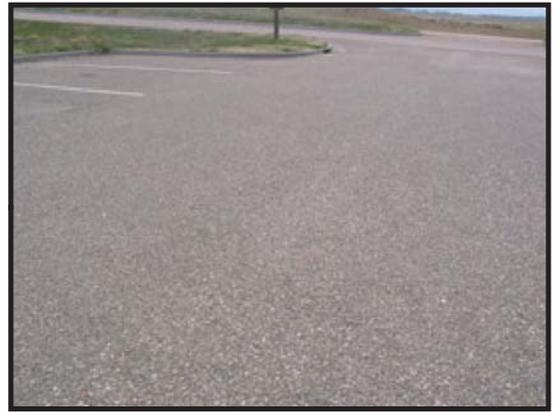
## Route 0930

Route Number	Public / NonPublic	Date Visited		Area (sq ft)	Lane Miles *	Surface Type
0930	NONPUBLIC	5/12/2008		4,220	0.07	AS
Culverts	Drop Inlets	Gates	Fire Hydrants	Curb & Gutter	Curb	PCR
1	1	0	0	CONCRETE CURB AND GUTTER	CONCRETE CURB	GOOD/90

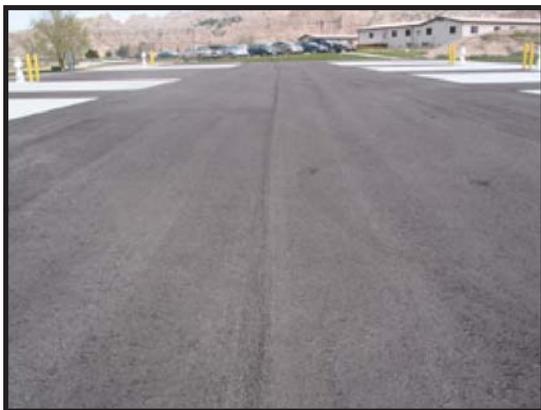
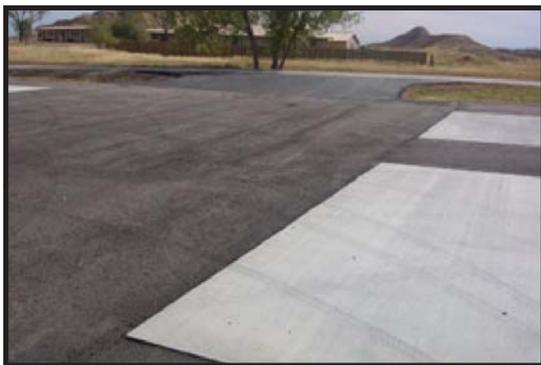
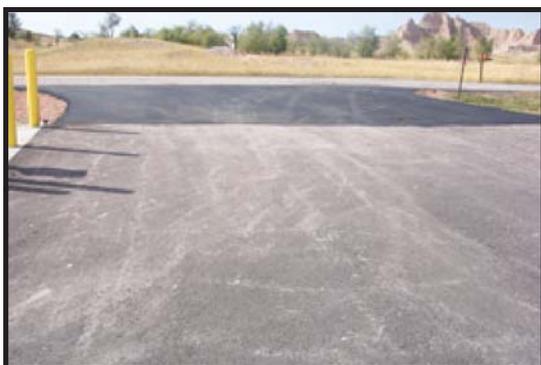
## Route 0931

Route Number	Public / NonPublic	Date Visited		Area (sq ft)	Lane Miles *	Surface Type
0931	PUBLIC	5/12/2008		21,963	0.38	AS
Culverts	Drop Inlets	Gates	Fire Hydrants	Curb & Gutter	Curb	PCR
0	0	0	0	NO CURB AND GUTTER	NO CURB	EXCELLENT/97

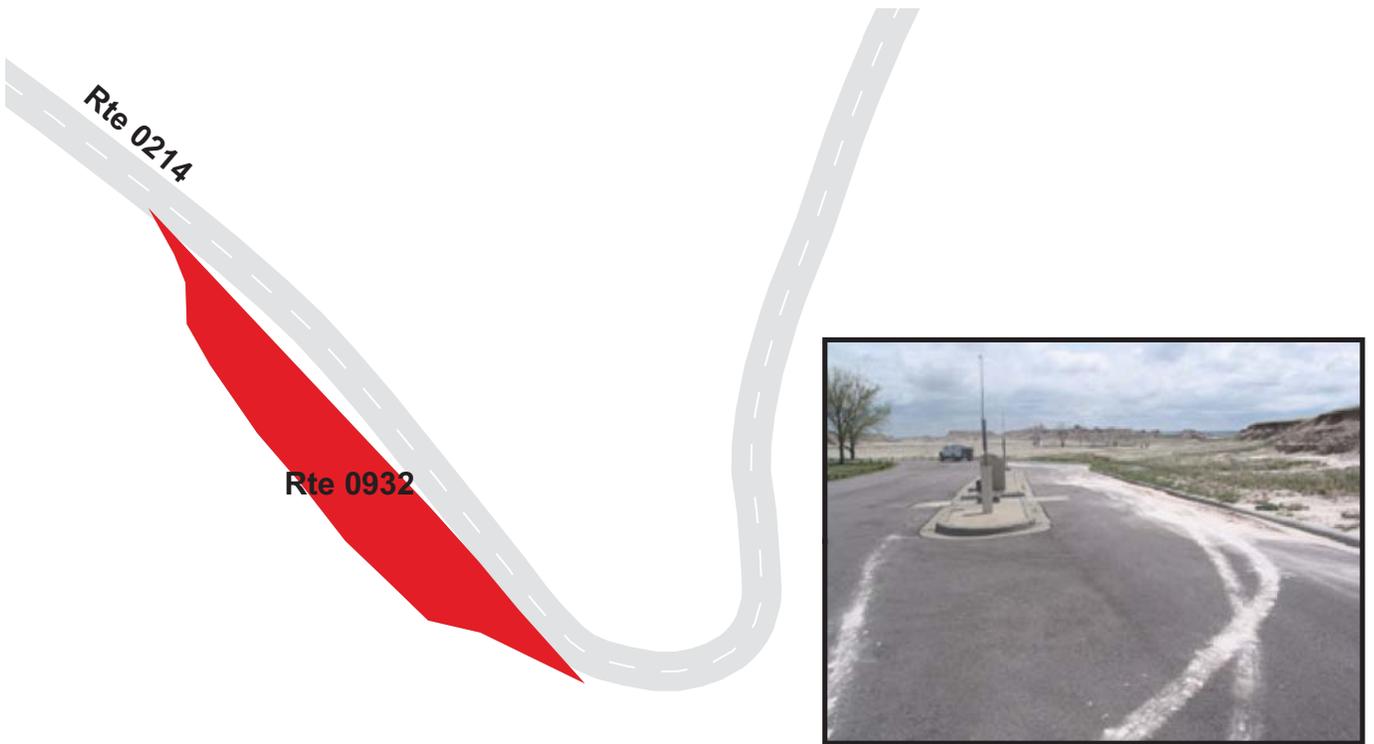
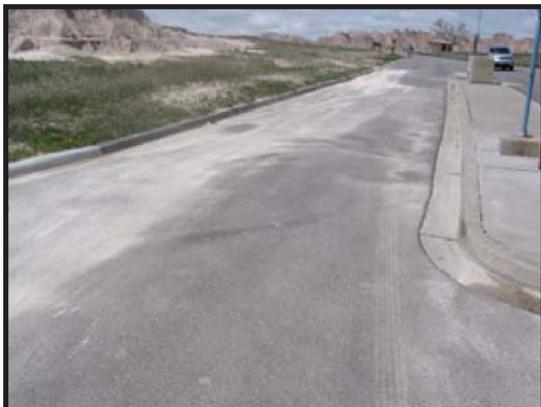
## Route 0932

Route Number	Public / NonPublic	Date Visited		Area (sq ft)	Lane Miles *	Surface Type
0932	PUBLIC	5/12/2008		8,077	0.14	AS
Culverts	Drop Inlets	Gates	Fire Hydrants	Curb & Gutter	Curb	PCR
0	0	0	0	CONCRETE CURB AND GUTTER	NO CURB	EXCELLENT/97
