**The Road Inventory  
of  
Badlands National Park  
BADL – 1300  
Cycle 4**

**Prepared By:  
Federal Highway Administration  
Road Inventory Program  
Cycle 4**

# Badlands National Park in South Dakota

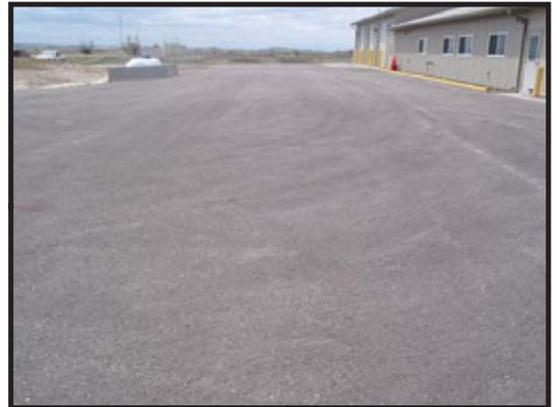
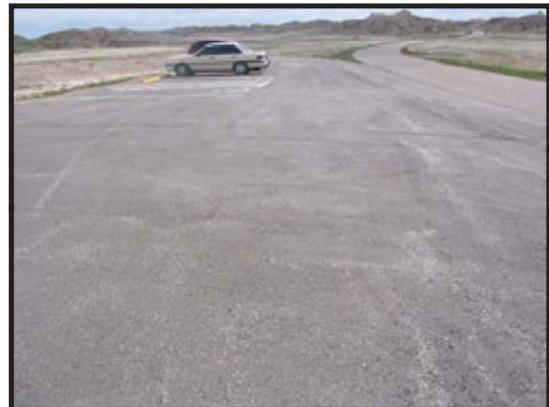
## Route 0933

Route Number	Public / NonPublic	Date Visited		Area (sq ft)	Lane Miles *	Surface Type
0933	PUBLIC	5/12/2008		24,565	0.42	AS
Culverts	Drop Inlets	Gates	Fire Hydrants	Curb & Gutter	Curb	PCR
1	0	0	1	NO CURB AND GUTTER	NO CURB	EXCELLENT/97

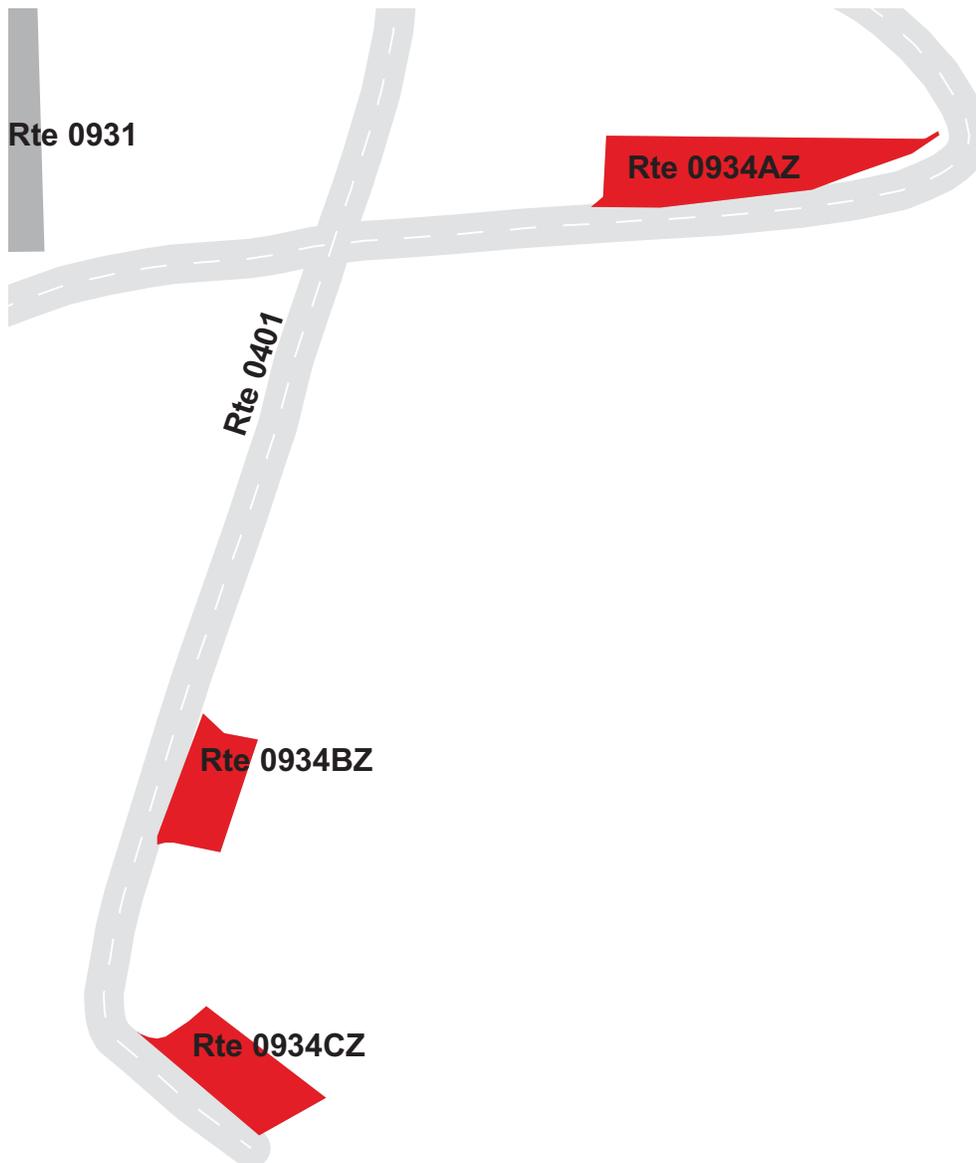
## Route 0934ZZ

Route Number	Public / NonPublic	Date Visited		Area (sq ft)	Lane Miles *	Surface Type
0934ZZ	PUBLIC	5/12/2008		8,106	0.14	AS
Culverts	Drop Inlets	Gates	Fire Hydrants	Curb & Gutter	Curb	PCR
0	0	0	0	NO CURB AND GUTTER	NO CURB	SUMMARY/73

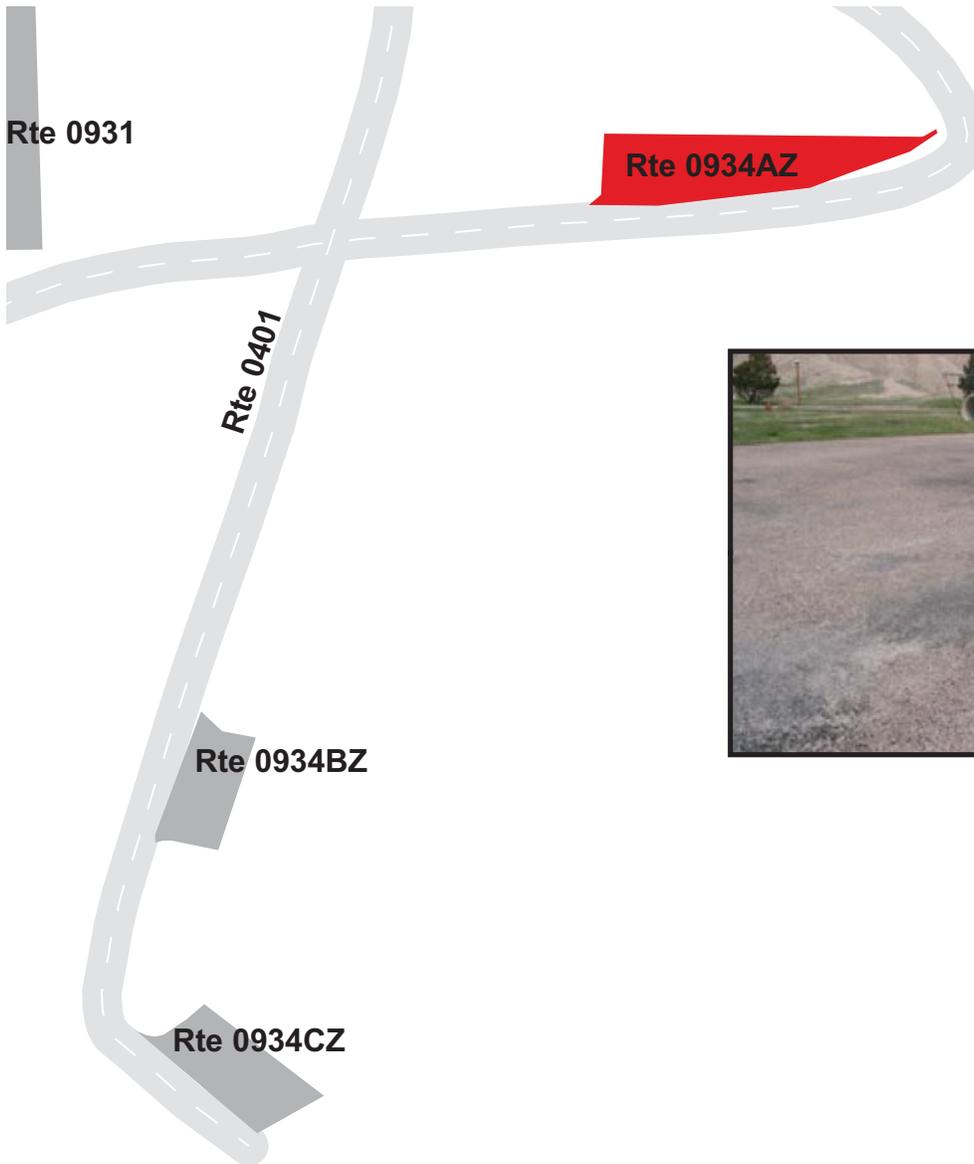
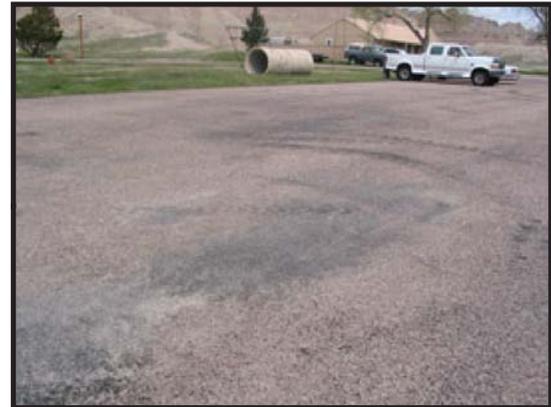
## Route 0934AZ

Route Number	Public / NonPublic	Date Visited		Area (sq ft)	Lane Miles *	Surface Type
0934AZ	PUBLIC	5/12/2008		3,985	0.07	AS
Culverts	Drop Inlets	Gates	Fire Hydrants	Curb & Gutter	Curb	PCR
0	0	0	0	NO CURB AND GUTTER	NO CURB	FAIR/73

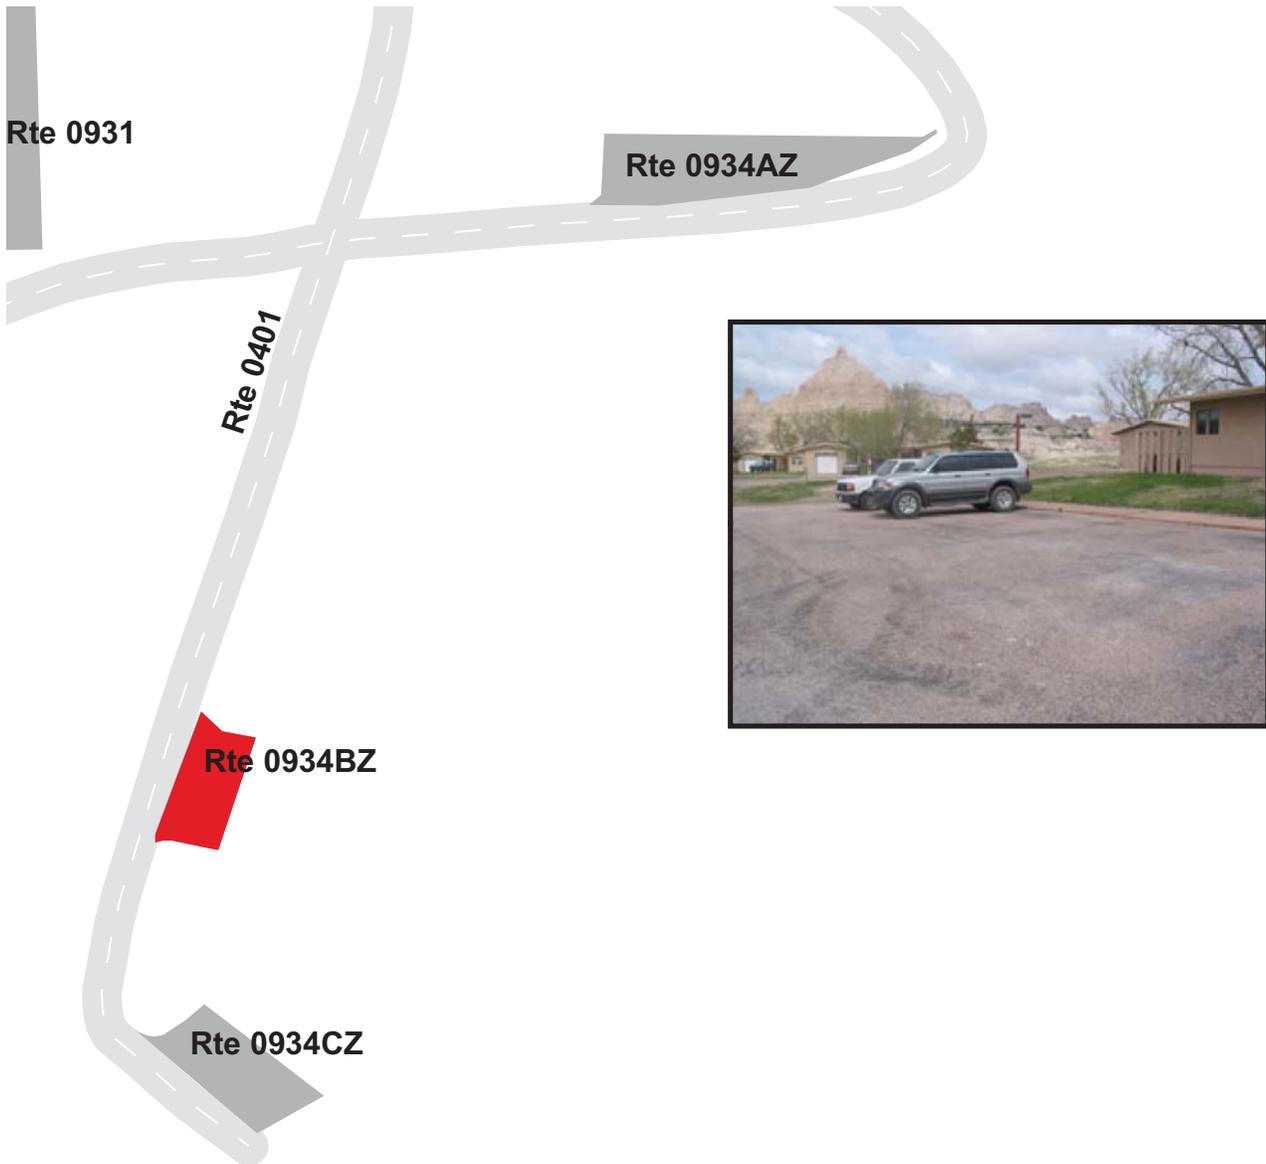
## Route 0934BZ

Route Number	Public / NonPublic	Date Visited		Area (sq ft)	Lane Miles *	Surface Type
0934BZ	PUBLIC	5/12/2008		1,810	0.03	AS
Culverts	Drop Inlets	Gates	Fire Hydrants	Curb & Gutter	Curb	PCR
0	0	0	0	NO CURB AND GUTTER	NO CURB	FAIR/73

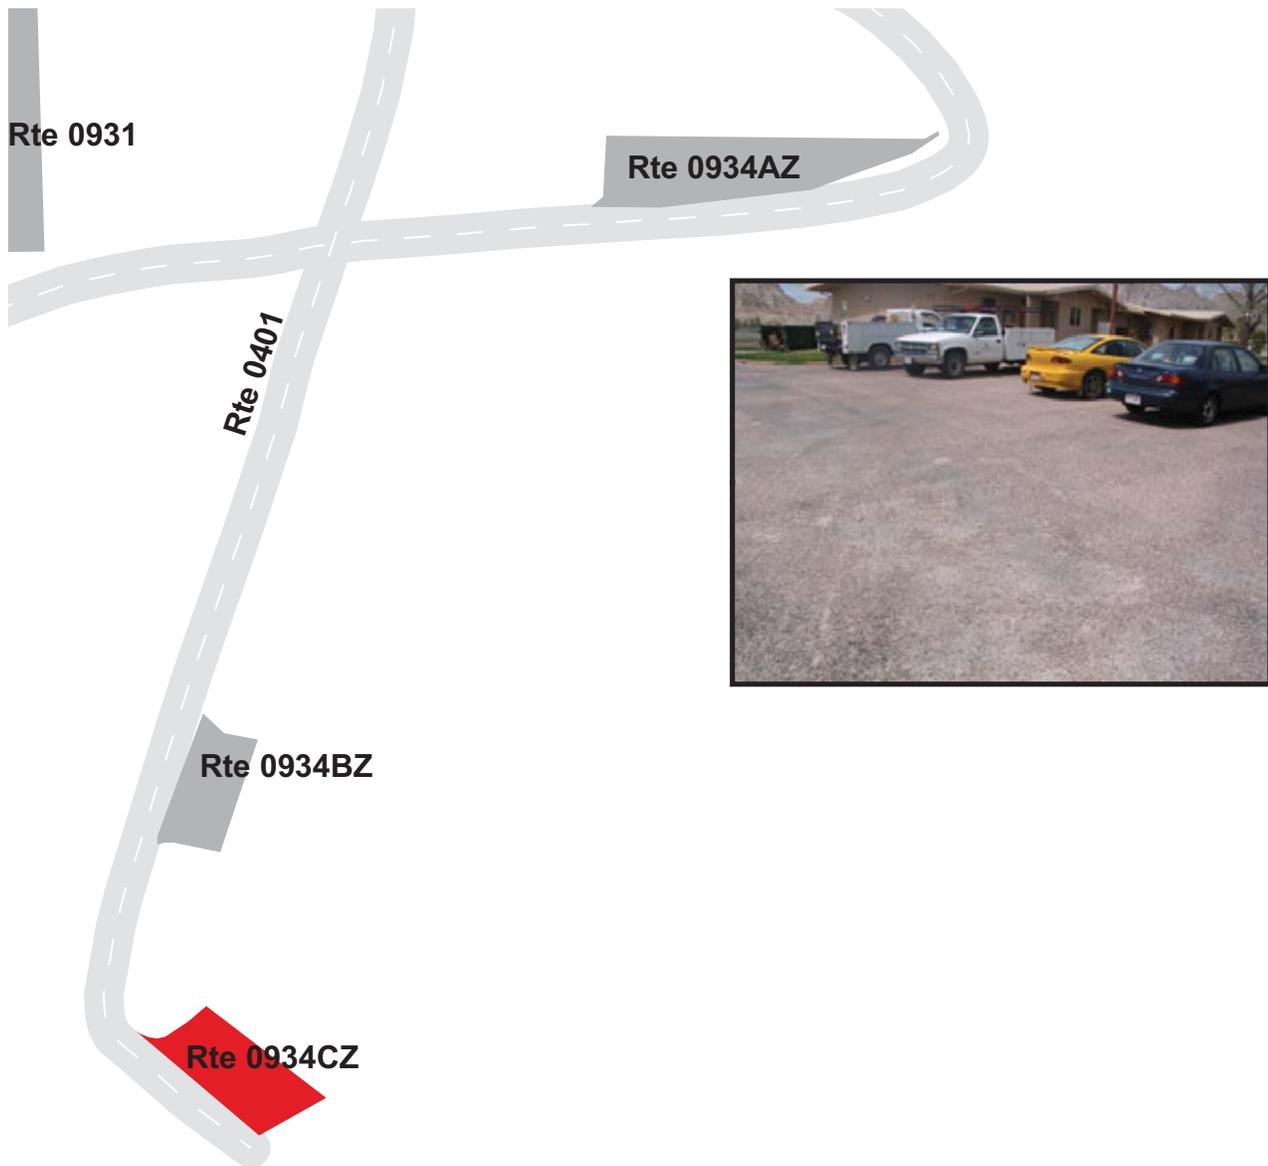
## Route 0934CZ

Route Number	Public / NonPublic	Date Visited		Area (sq ft)	Lane Miles *	Surface Type
0934CZ	PUBLIC	5/12/2008		2,311	0.04	AS
Culverts	Drop Inlets	Gates	Fire Hydrants	Curb & Gutter	Curb	PCR
0	0	0	0	NO CURB AND GUTTER	NO CURB	FAIR/73

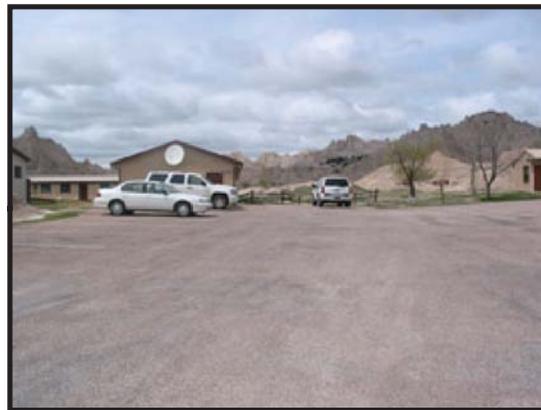
## Route 0935

Route Number	Public / NonPublic	Date Visited		Area (sq ft)	Lane Miles *	Surface Type
0935	NONPUBLIC	5/12/2008		6,265	0.11	AS
Culverts	Drop Inlets	Gates	Fire Hydrants	Curb & Gutter	Curb	PCR
0	0	0	0	NO CURB AND GUTTER	NO CURB	FAIR/73

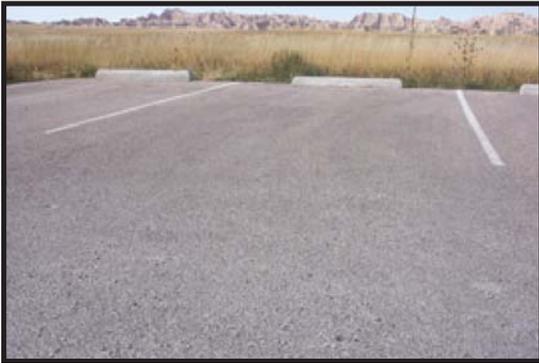
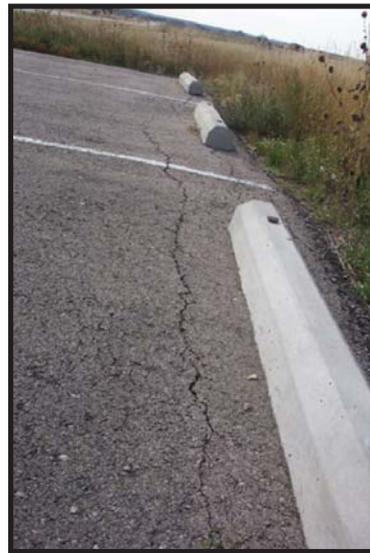
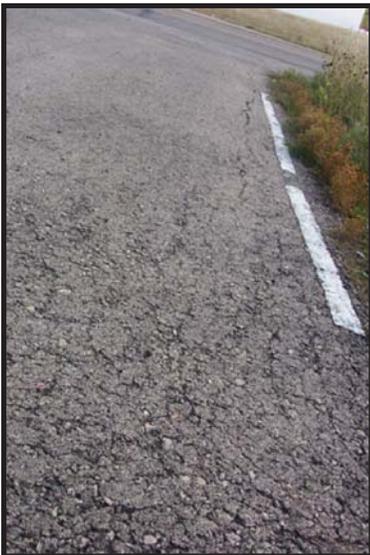
## Route 0936

Route Number	Public / NonPublic	Date Visited		Area (sq ft)	Lane Miles *	Surface Type
0936	PUBLIC	10/14/2008		1,112	0.02	AS
Culverts	Drop Inlets	Gates	Fire Hydrants	Curb & Gutter	Curb	PCR
0	0	0	0	NO CURB AND GUTTER	NO CURB	GOOD/90

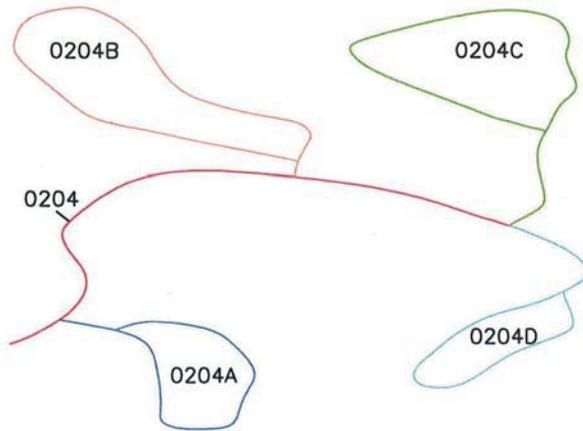
**Figure 1: Campground with five routes and five assets**

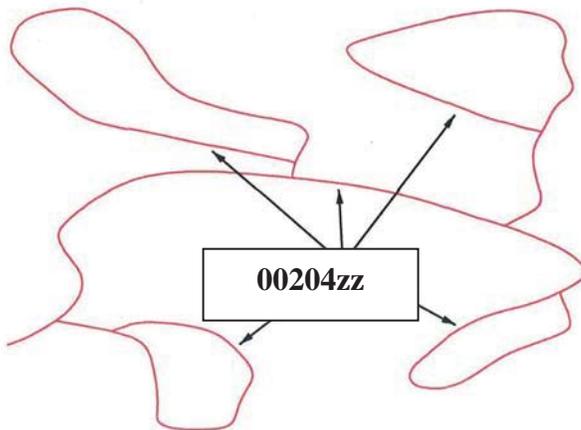
**Figure 2: Campground with all loops combined into one route and one asset. This has eliminated four assets.**

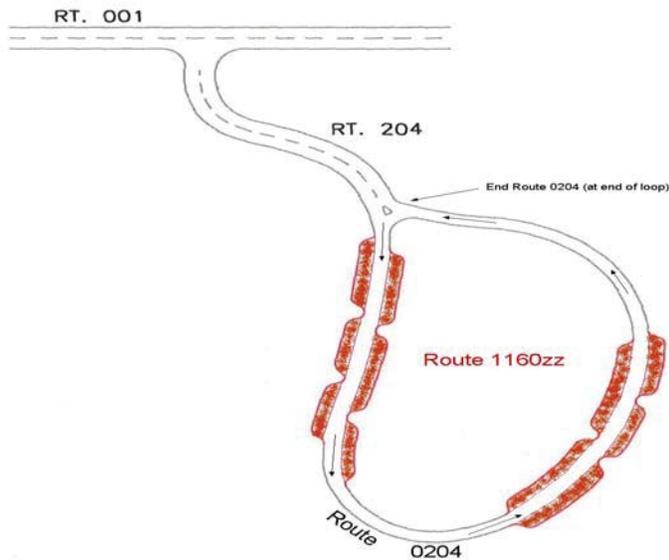
Figure 4: Parking with access route 204 and one parking area 1160zz. Route 204 is assumed longer than 0.25 miles. There are now 2 assets (one 1100 asset, one 1300 asset) instead of 12.

Discrete parking areas may be combined into a single asset where they service the same facility or resource and are within walking distance of each other. These combined areas should be maintained as one asset. There are many instances where small (5-10 space), discrete parking areas have been separated into individual assets even though they provide parking for the same area or facility. These may be combined into a single asset. Figures 3 and 4 shows examples of combining parking areas.

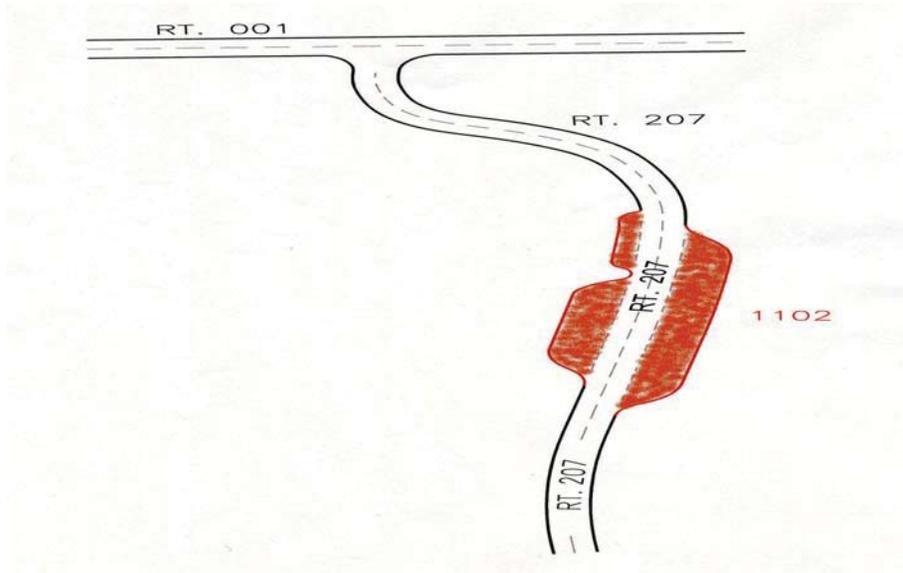
**Figure 5: Parking with access route 207 running through and continuing beyond parking 1102. This access route cannot be considered a part of the parking area and two routes and two assets continue to exist.**

Parking areas and roads may not be combined. Parking areas and roads are tracked as separate asset types (1300 vs. 1100) in FMSS and as such should not be combined except in situations described by 5g. In Figure 5, Route 207 is a spur road from the main route running through parking area 1102. Since the spur road continues through and beyond the parking area, it will remain a separate route.

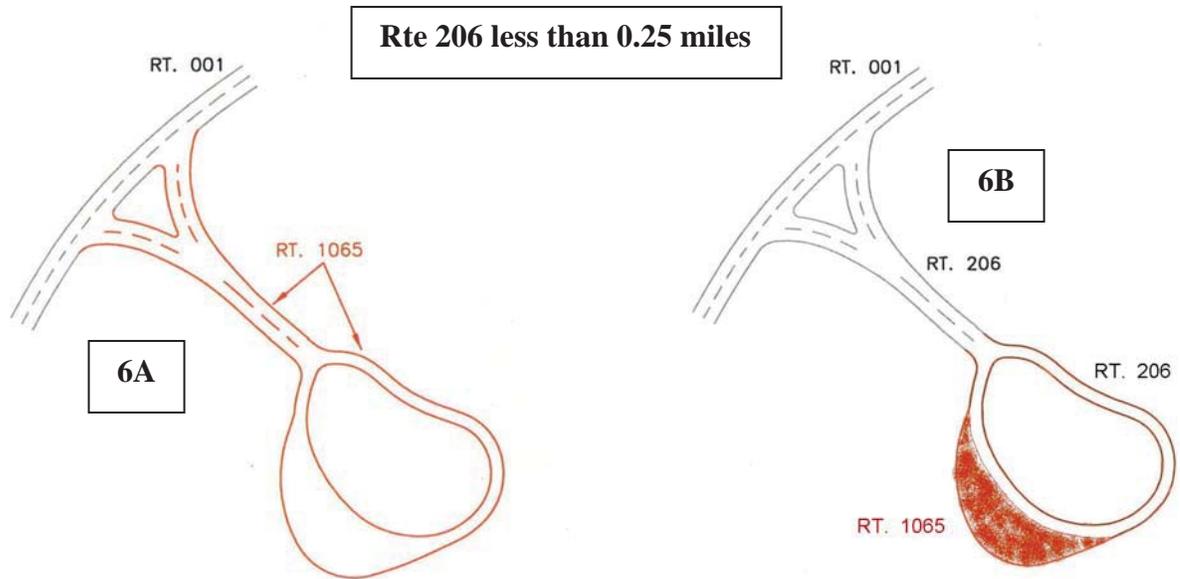
**Figure 6:** Since the access route is less than .25 miles in length and the only use of the access is to the parking, one route for both the access and the parking area can be established.

Where the primary purpose of a road is to provide access to a parking area, and that road segment is less than 0.25 miles in length, the access road should be considered part of the parking area. See Figures 8. Where a road continues on past a parking area to another facility or destination, even if it is less than 0.25 miles to the initial parking area, the road and parking area may not be combined.

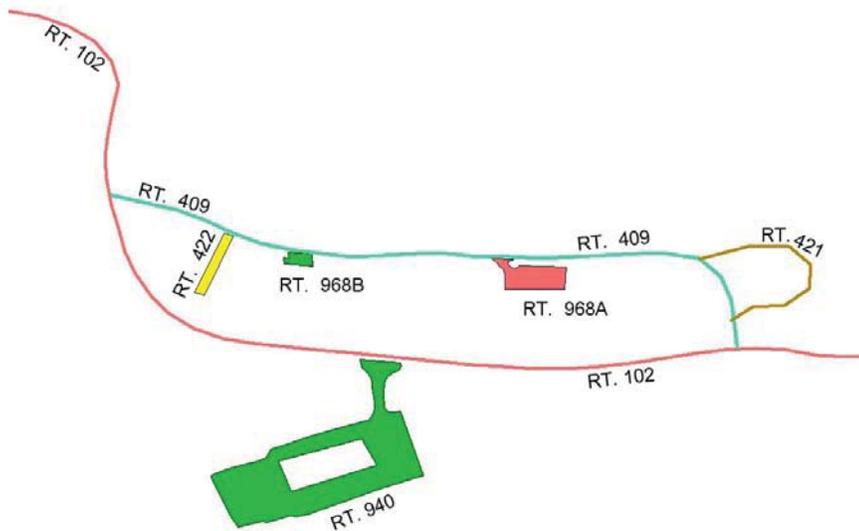
**Figure 7 – Current Housing area access configuration. Route 409 is less than 0.25 miles long.**

The area serviced by Routes 409, 421, 422, 968A, and 968B is all employee housing. Route 940 provides access to visitor services and not to the housing area. Routes may be combined to create assets that reflect local management. Routes 409, 421, and 422 are all the same functional class, provide access to one type of activity (housing) and are all posted as non-public. These routes may be combined. They should not be combined with any parking areas even though they are all less than 0.25 miles long. This is because their main function is not to provide access to parking. Routes 968A and B provide parking for access to the same facility (housing). Even though these discrete areas may provide parking to different housing units, it's reasonable to manage them as a single asset. They may also be combined.

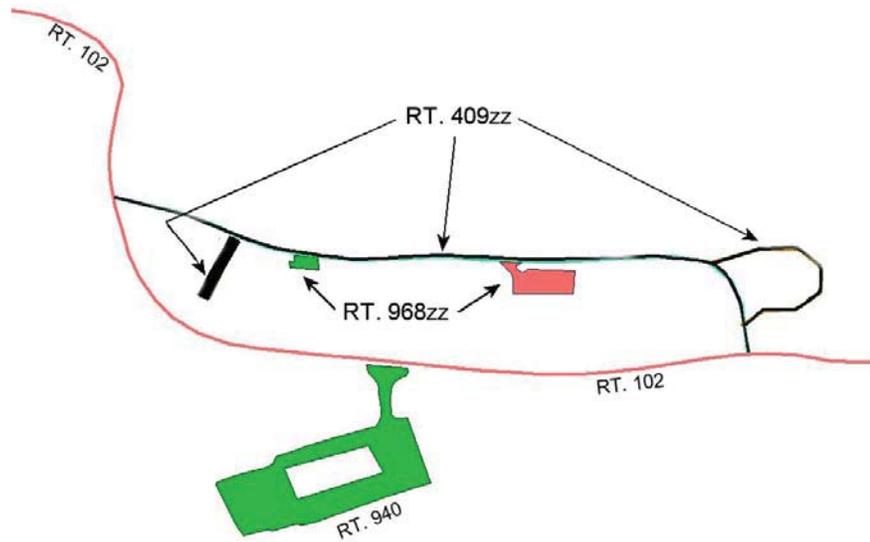
**Figure 8 – Combined housing area access configuration – Parking and road assets combined to eliminate 3 assets.**
