**The Road Inventory
of
Big Bend National Park
BIBE – 7130
Cycle 4**

**Prepared By:
Federal Highway Administration
Road Inventory Program
Cycle 4**

Big Bend National Park in Texas

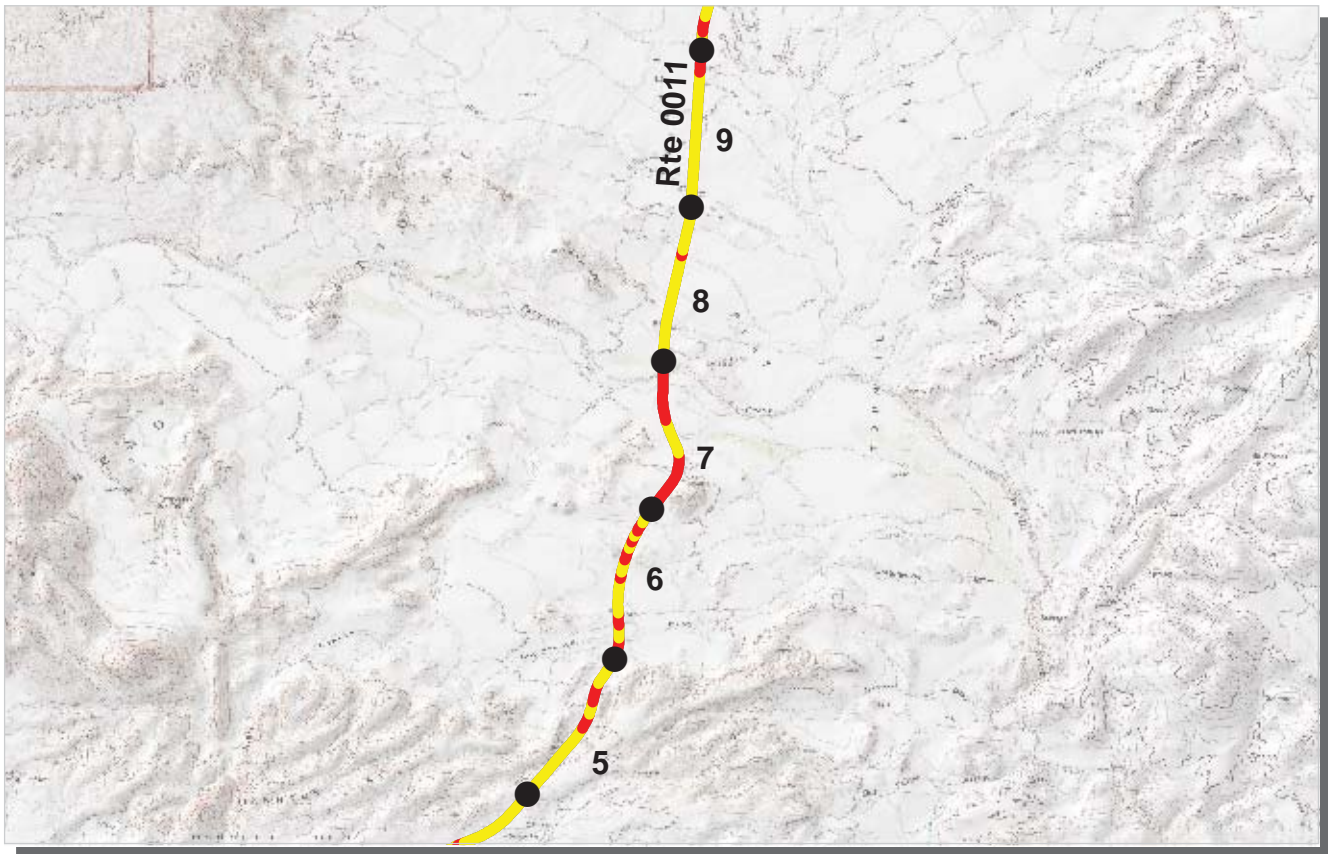
ROUTE: 0011 NORTH ENTRANCE ROAD

Section Number	0	1	2	3	4
Section Length (mi)	1.00	1.00	1.00	1.00	1.00
Traffic	Traffic data may be found at www.efl.fhwa.dot.gov Click on PROGRAMS / NPS Traffic Data (Note: Not all parks have traffic data)				
Cross Section Information					
Number of Lanes	2	2	2	2	2
Paved Width (ft)	29	26	25	24	24
Lane Width (ft)	12	11	10	10	10
Shoulder Width Right (ft)**	7	8	8	9	7
Shoulder Width Left (ft)**	11	7	6	9	8
Roadway Condition Information					
SCR (Surface Condition Rating)	60	61	56	56	57
PCR (Pavement Condition Rating)	69	70	66	68	69
Distress Index Values					
Alligator Cracking Index	100	100	100	100	100
Longitudinal Cracking Index	100	100	100	100	100
Transverse Cracking Index	100	100	100	100	100
Patching Index	100	100	100	100	100
Rutting Index	60	61	56	56	57
Roughness Condition Index (RCI)	83	83	80	85	87

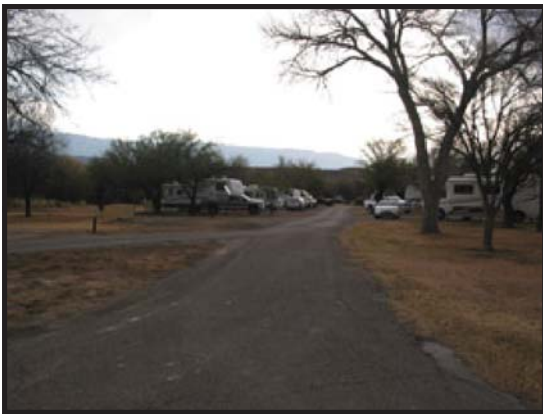
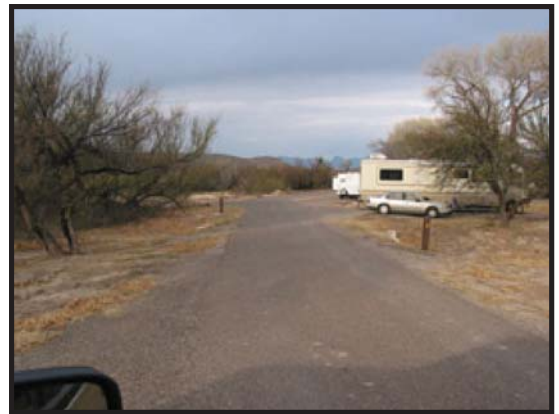
Route 0203

Route Number	Public / NonPublic	Date Visited		Area (sq ft)	Lane Miles *	Surface Type
0203	PUBLIC	1/11/2007		122,075	2.10	AS
Culverts	Drop Inlets	Gates	Fire Hydrants	Curb & Gutter	Curb	PCR
9	0	0	2	NO CURB AND GUTTER	NO CURB	POOR/45

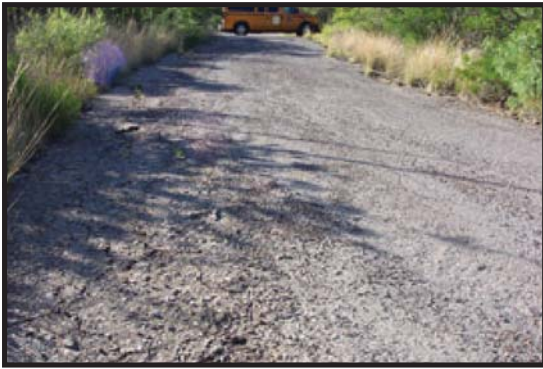
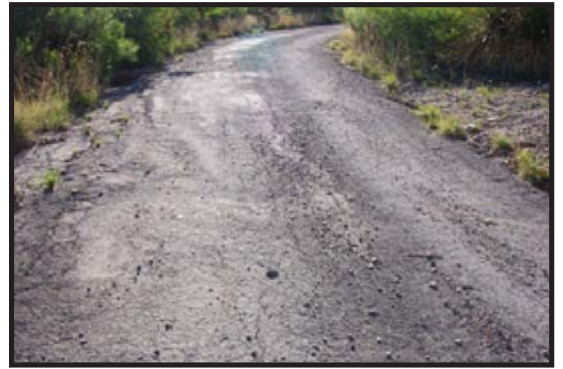
Route 0416

Route Number	Public / NonPublic	Date Visited		Area (sq ft)	Lane Miles *	Surface Type
0416	PUBLIC	1/9/2007		8,137	0.14	AS
Culverts	Drop Inlets	Gates	Fire Hydrants	Curb & Gutter	Curb	PCR
0	0	0	6	CONCRETE CURB AND GUTTER	CONCRETE CURB	POOR/45

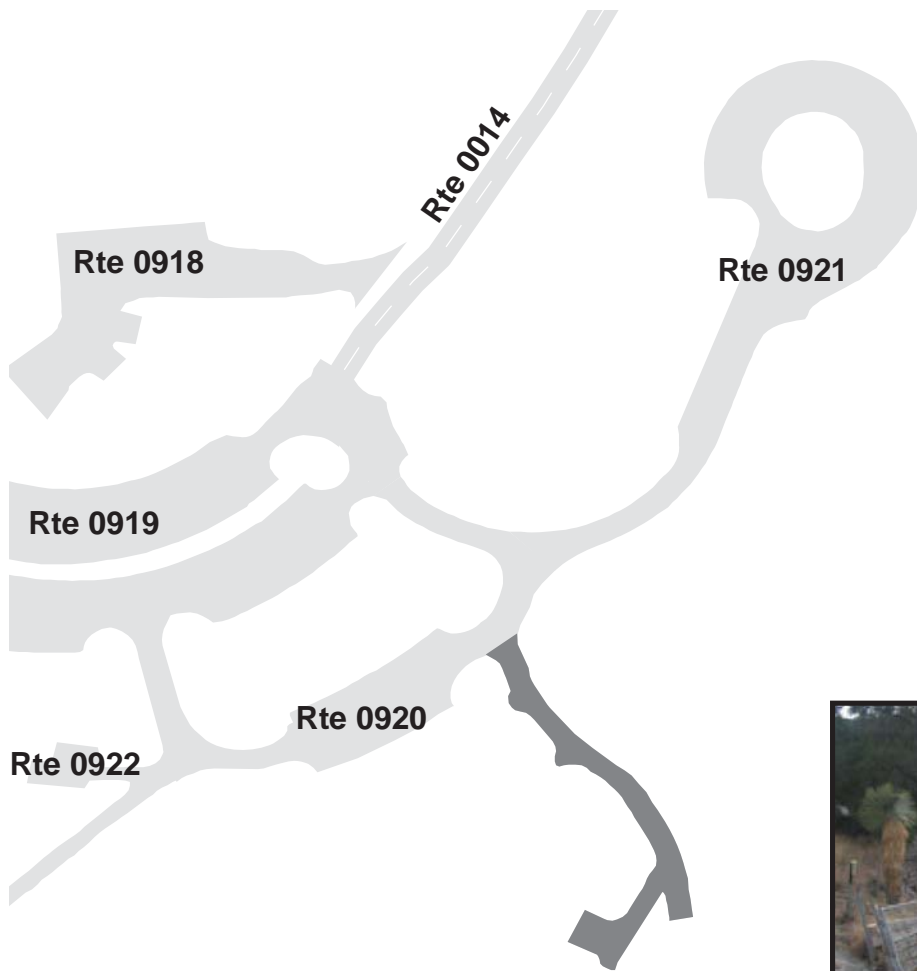
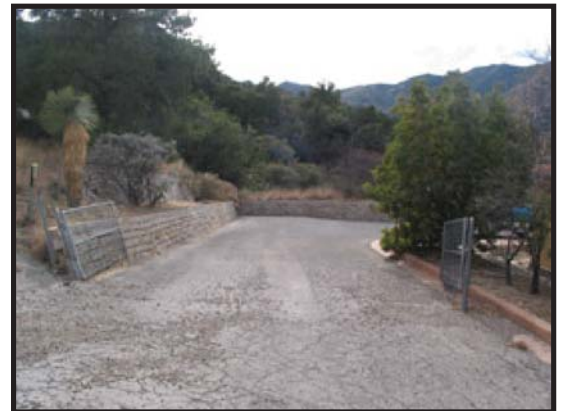
Route 0418

Route Number	Public / NonPublic	Date Visited		Area (sq ft)	Lane Miles *	Surface Type
0418	NONPUBLIC	1/9/2007		7,370	0.13	AS
Culverts	Drop Inlets	Gates	Fire Hydrants	Curb & Gutter	Curb	PCR
0	0	1	1	CONCRETE CURB AND GUTTER	CONCRETE CURB	POOR/45

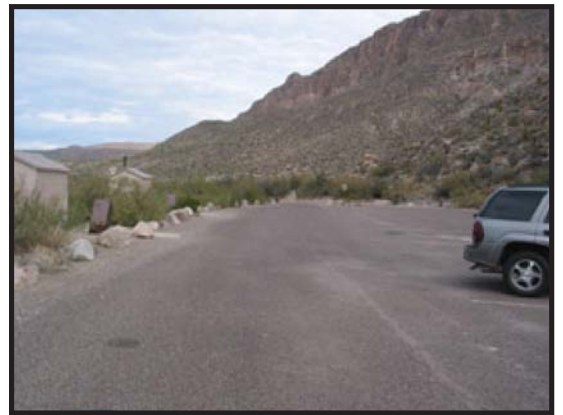
BIG BEND NATIONAL PARK
Route 0905
BOQUILLAS CANYON TRAIL PARKING
 AT END OF ROUTE 0109

Route Number	Public / NonPublic	Date Visited		Area (sq ft)	Lane Miles *	Surface Type
0905	PUBLIC	1/11/2007		15,008	0.26	AS
Culverts	Drop Inlets	Gates	Fire Hydrants	Curb & Gutter	Curb	PCR
0	0	0	0	NO CURB AND GUTTER	NO CURB	FAIR/73

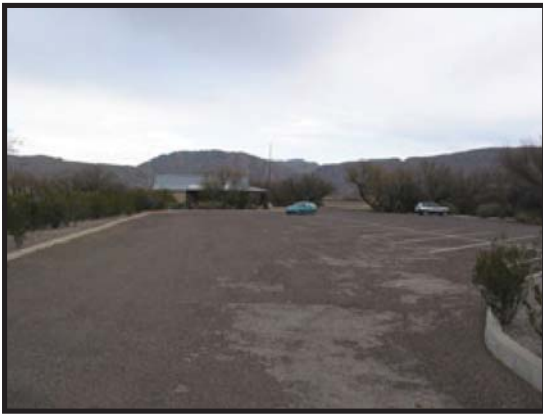
Route 0907

Route Number	Public / NonPublic	Date Visited		Area (sq ft)	Lane Miles *	Surface Type
0907	PUBLIC	1/11/2007		5,996	0.10	AS
Culverts	Drop Inlets	Gates	Fire Hydrants	Curb & Gutter	Curb	PCR
0	0	0	0	NO CURB AND GUTTER	NO CURB	FAIR/73

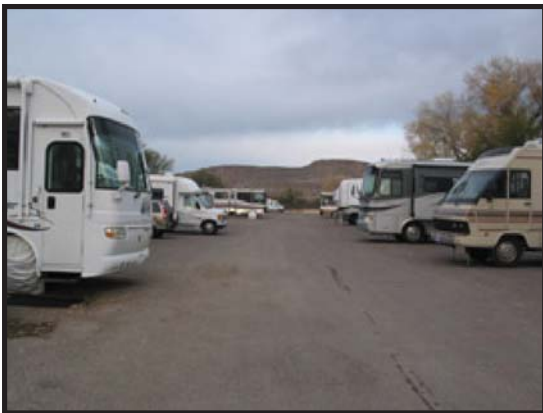
Route 0908

Route Number	Public / NonPublic	Date Visited		Area (sq ft)	Lane Miles *	Surface Type
0908	PUBLIC	1/11/2007		37,041	0.64	AS
Culverts	Drop Inlets	Gates	Fire Hydrants	Curb & Gutter	Curb	PCR
2	0	0	2	CONCRETE CURB AND GUTTER	NO CURB	FAIR/73

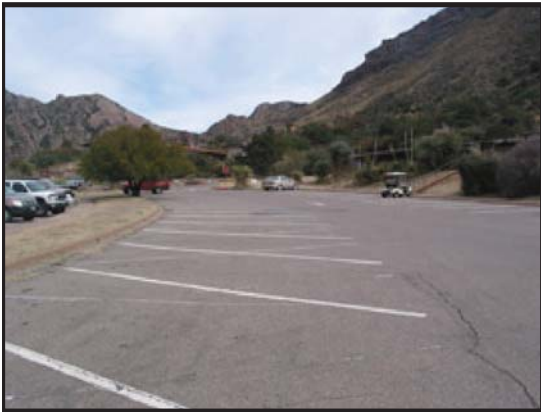
BIG BEND NATIONAL PARK
Route 0919
 BASIN VISITORS CENTER PARKING
 AT END OF ROUTE 0014

Route Number	Public / NonPublic	Date Visited		Area (sq ft)	Lane Miles *	Surface Type
0919	PUBLIC	1/9/2007		45,477	0.78	AS
Culverts	Drop Inlets	Gates	Fire Hydrants	Curb & Gutter	Curb	PCR
0	1	0	3	CONCRETE CURB AND GUTTER	NO CURB	FAIR/73

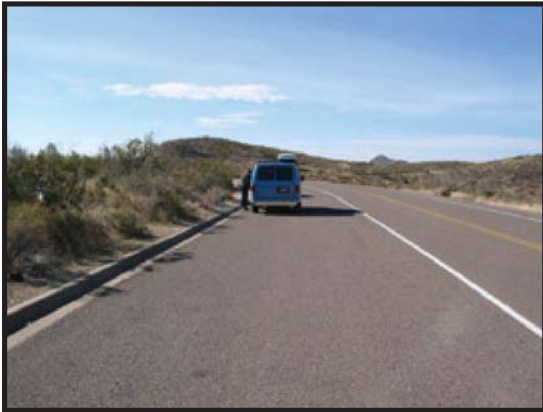
BIG BEND NATIONAL PARK
Route 0925
BLUE CREEK OVERLOOK PARKING
 ADJACENT TO ROUTE 0015 AT MP 8.11

Route Number	Public / NonPublic	Date Visited		Area (sq ft)	Lane Miles *	Surface Type
0925	PUBLIC	1/10/2007		5,851	0.10	AS
Culverts	Drop Inlets	Gates	Fire Hydrants	Curb & Gutter	Curb	PCR
0	0	0	0	CONCRETE CURB AND GUTTER	NO CURB	GOOD/90

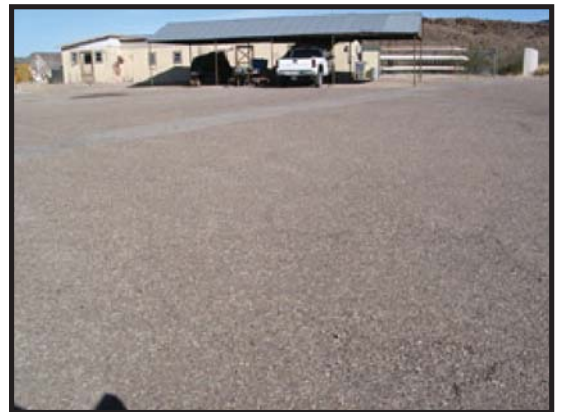
BIG BEND NATIONAL PARK
Route 0932
CASTOLON MAINTENANCE PARKING
AT END OF ROUTE 0426

Route Number	Public / NonPublic	Date Visited		Area (sq ft)	Lane Miles *	Surface Type
0932	NONPUBLIC	1/10/2007		15,561	0.27	AS
Culverts	Drop Inlets	Gates	Fire Hydrants	Curb & Gutter	Curb	PCR
0	0	2	0	NO CURB AND GUTTER	NO CURB	FAIR/73

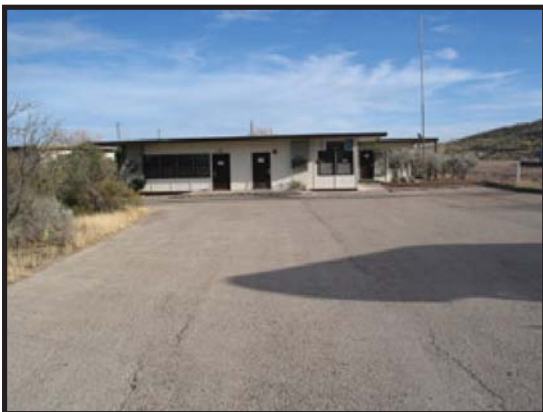
BIG BEND NATIONAL PARK
Route 0937
PANTHER JUNCTION SCHOOL PARKING
AT END OF ROUTE 0443

Route Number	Public / NonPublic	Date Visited		Area (sq ft)	Lane Miles *	Surface Type
0937	PUBLIC	1/9/2007		5,132	0.09	AS
Culverts	Drop Inlets	Gates	Fire Hydrants	Curb & Gutter	Curb	PCR
0	0	0	2	NO CURB AND GUTTER	WOOD CURB	FAIR/73

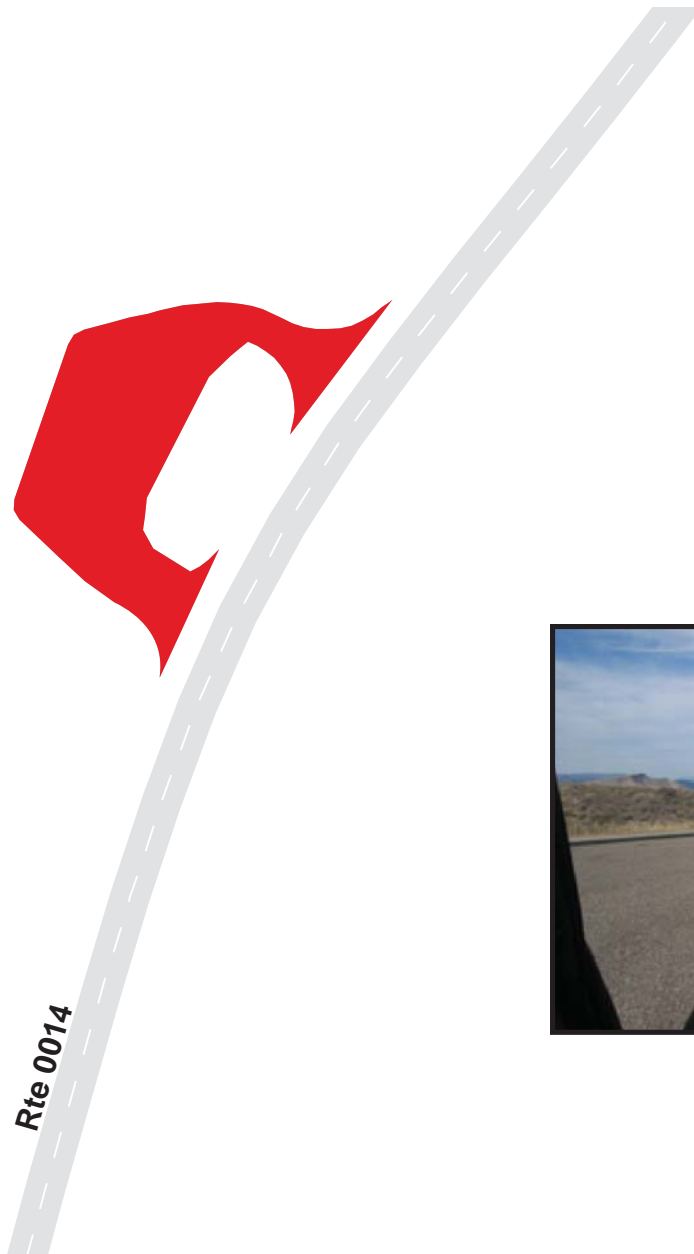
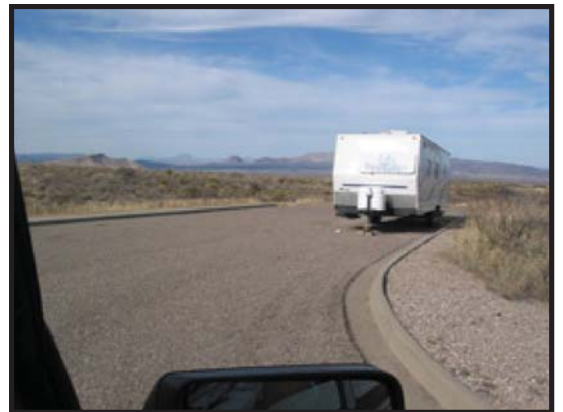
Route Number	Public / NonPublic	Date Visited		Area (sq ft)	Lane Miles *	Surface Type
1000	PUBLIC	1/9/2007		8,662	0.15	AS
Culverts	Drop Inlets	Gates	Fire Hydrants	Curb & Gutter	Curb	PCR
0	0	0	0	CONCRETE CURB AND GUTTER	NO CURB	FAIR/73

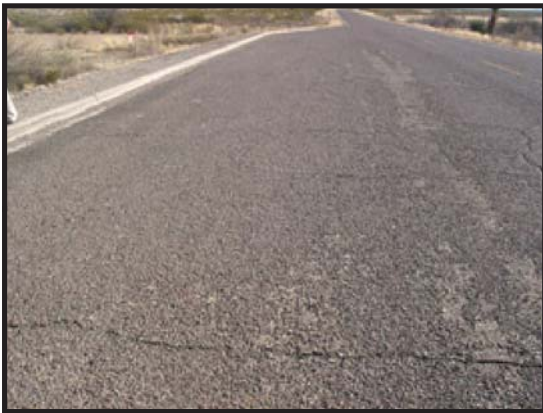
Route 1004

Route Number	Public / NonPublic	Date Visited		Area (sq ft)	Lane Miles *	Surface Type
1004	PUBLIC	1/10/2007		3,431	0.06	AS
Culverts	Drop Inlets	Gates	Fire Hydrants	Curb & Gutter	Curb	PCR
0	0	0	0	CONCRETE CURB AND GUTTER	NO CURB	FAIR/73

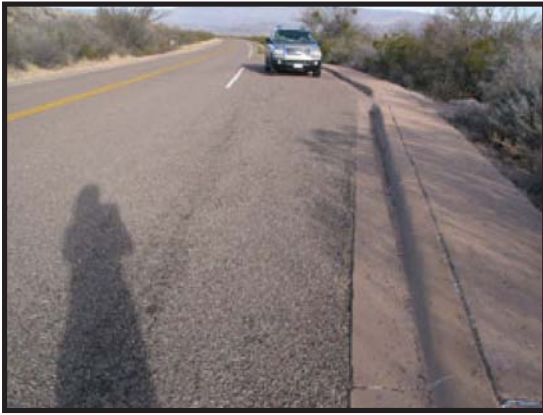
Route 1008

Route Number	Public / NonPublic	Date Visited		Area (sq ft)	Lane Miles *	Surface Type
1008	PUBLIC	1/10/2007		1,285	0.02	AS
Culverts	Drop Inlets	Gates	Fire Hydrants	Curb & Gutter	Curb	PCR
0	0	0	0	CONCRETE CURB AND GUTTER	NO CURB	GOOD/90

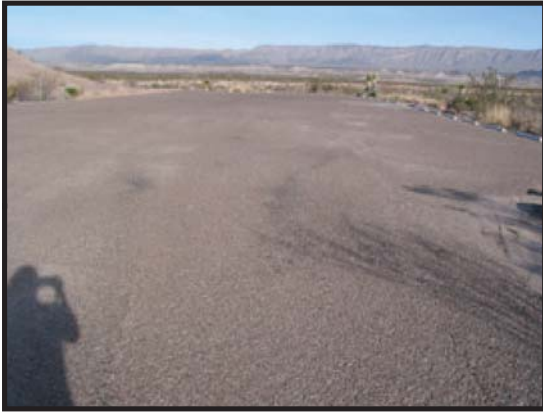
Route 1015

Route Number	Public / NonPublic	Date Visited		Area (sq ft)	Lane Miles *	Surface Type
1015	PUBLIC	1/10/2007		8,650	0.15	AS
Culverts	Drop Inlets	Gates	Fire Hydrants	Curb & Gutter	Curb	PCR
0	0	0	0	CONCRETE CURB AND GUTTER	NO CURB	FAIR/73
