**The Road Inventory
of
Bighorn Canyon National Recreation Area
BICA – 1320
Cycle 4**

**Prepared By:
Federal Highway Administration
Road Inventory Program
Cycle 4**

Bighorn Canyon National Recreation Area in Montana & Wyoming

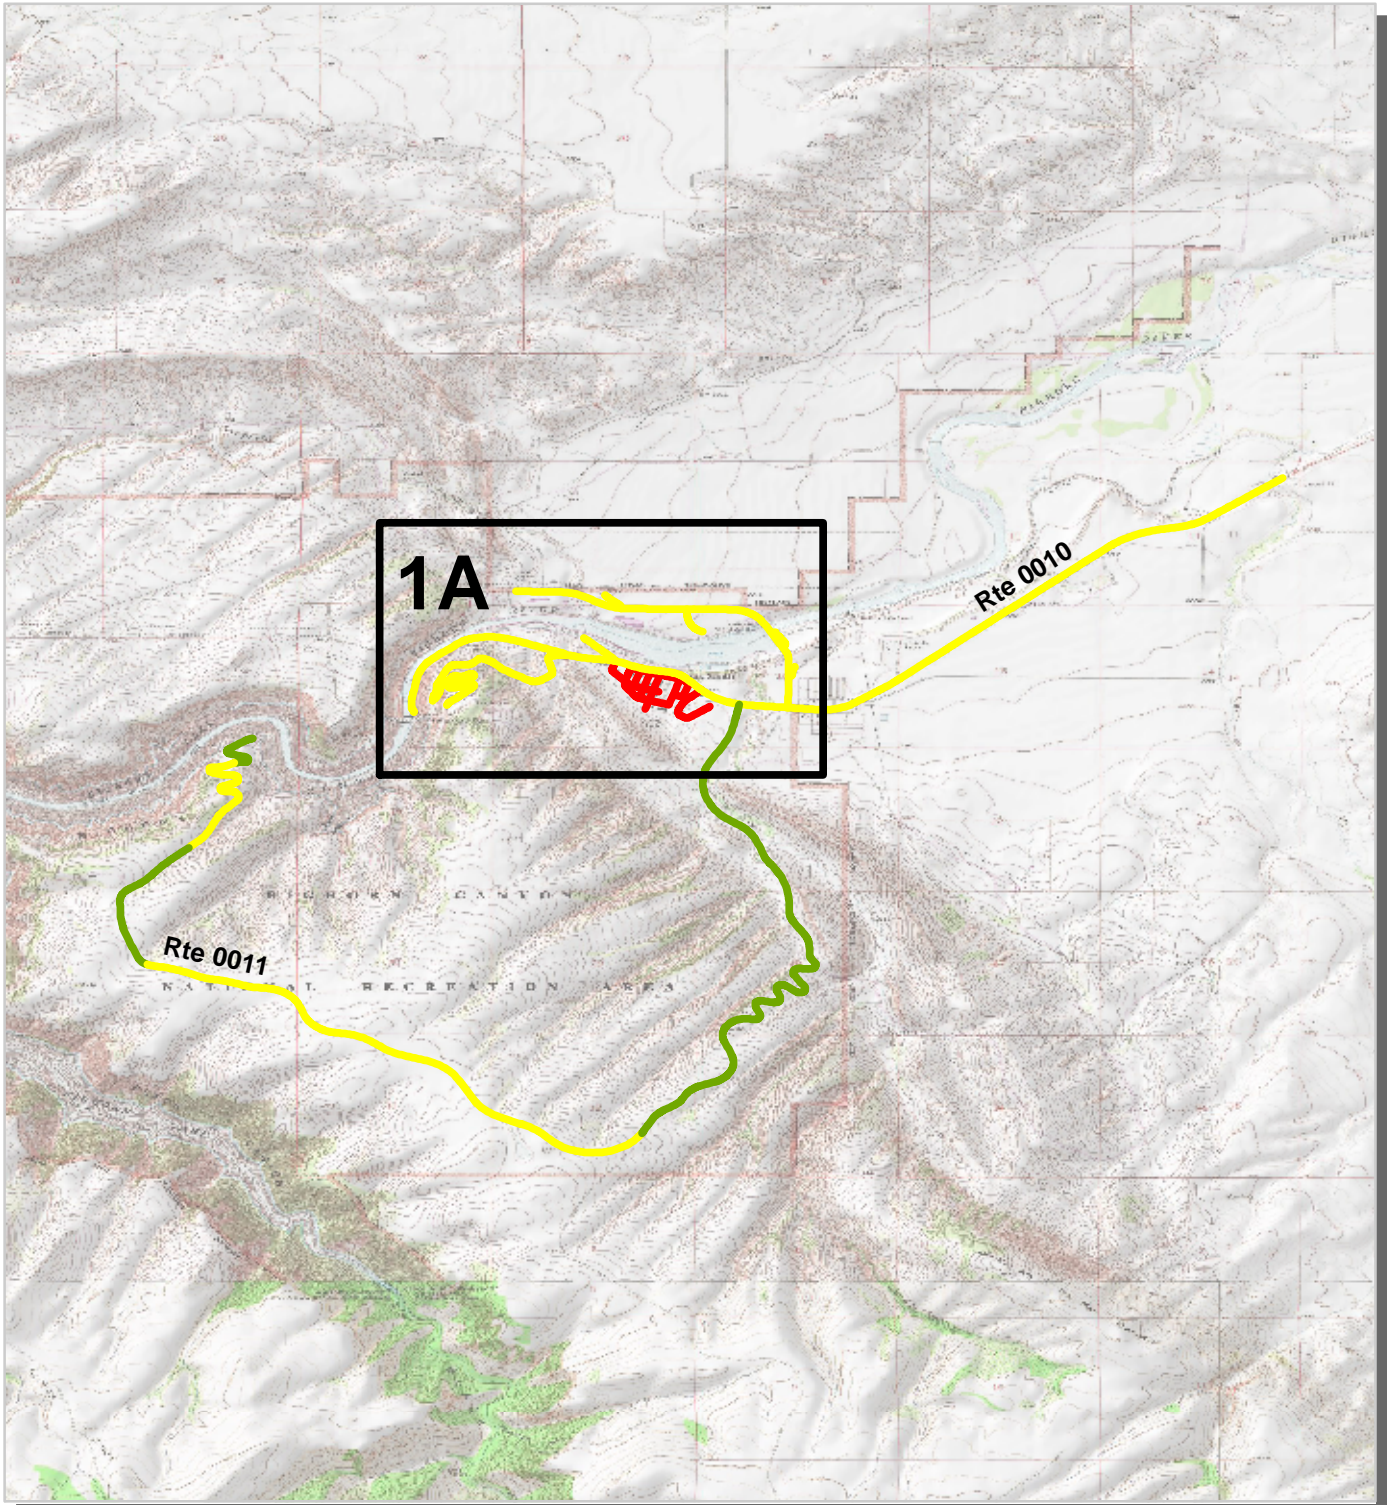
**Bighorn Canyon National Recreation Area
Route Condition Map
PCR - Mile by Mile
Area 1**

PCR	Poor	Fair	Good	Excellent	No Data
	(≤60)	(61 - 84)	(85 - 94)	(95 - 100)

* If the PCR rating is not available for a section, the SCR rating will be displayed. See appendix for definitions and formulas.

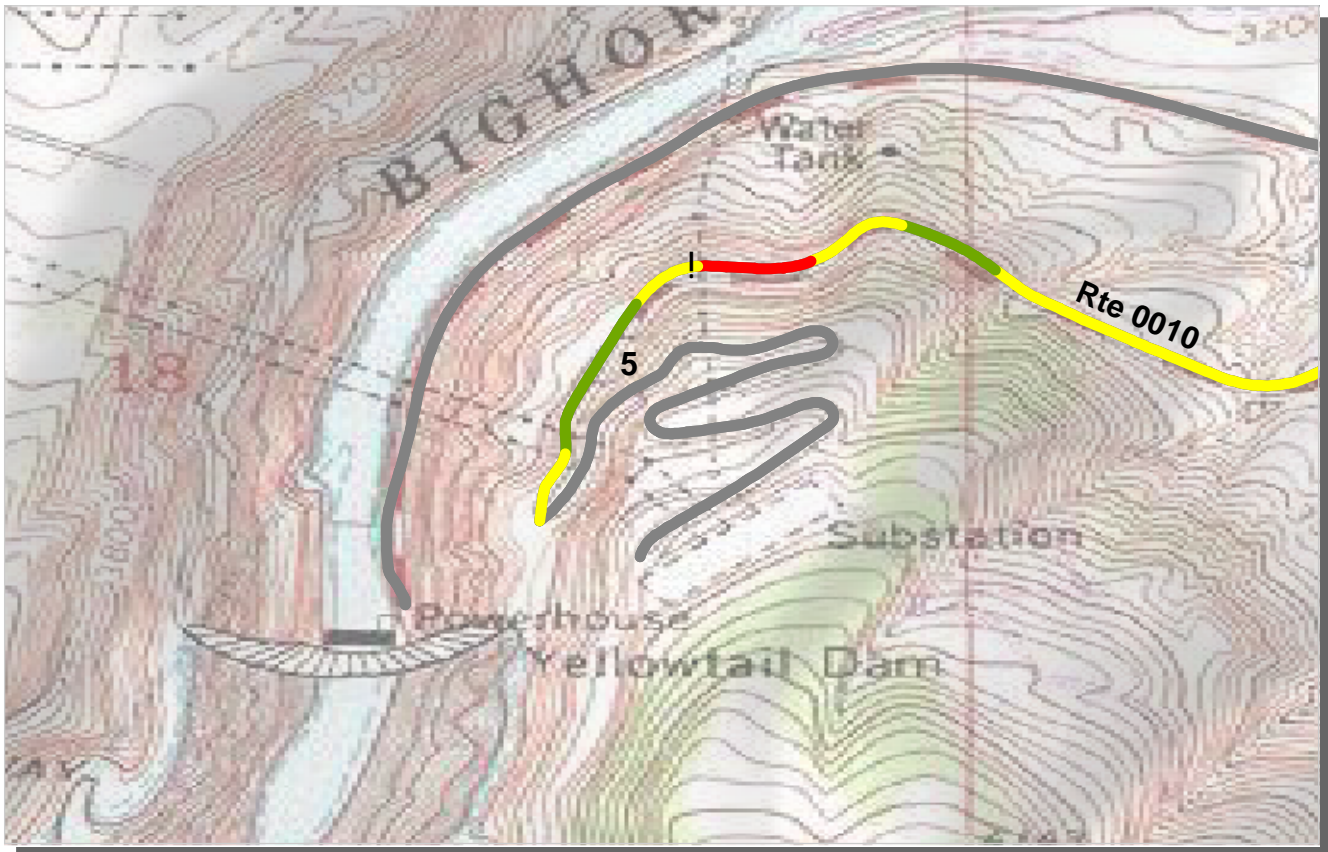
ROUTE: 0010 FORT SMITH ACCESS ROAD

Section Number	5				
Section Length (mi)	0.29				
Traffic	Traffic data may be found at www.efl.fhwa.dot.gov Click on PROGRAMS / NPS Traffic Data (Note: Not all parks have traffic data)				
Cross Section Information					
Number of Lanes	2				
Paved Width (ft)	32				
Lane Width (ft)	9				
Shoulder Width Right (ft)	NC				
Shoulder Width Left (ft)	NC				
Roadway Condition Information					
SCR (Surface Condition Rating)	81				
PCR (Pavement Condition Rating)	80				
Distress Index Values					
Alligator Cracking Index	100				
Longitudinal Cracking Index	99				
Transverse Cracking Index	98				
Patching Index	100				
Rutting Index	84				
Roughness Condition Index (RCI)	79

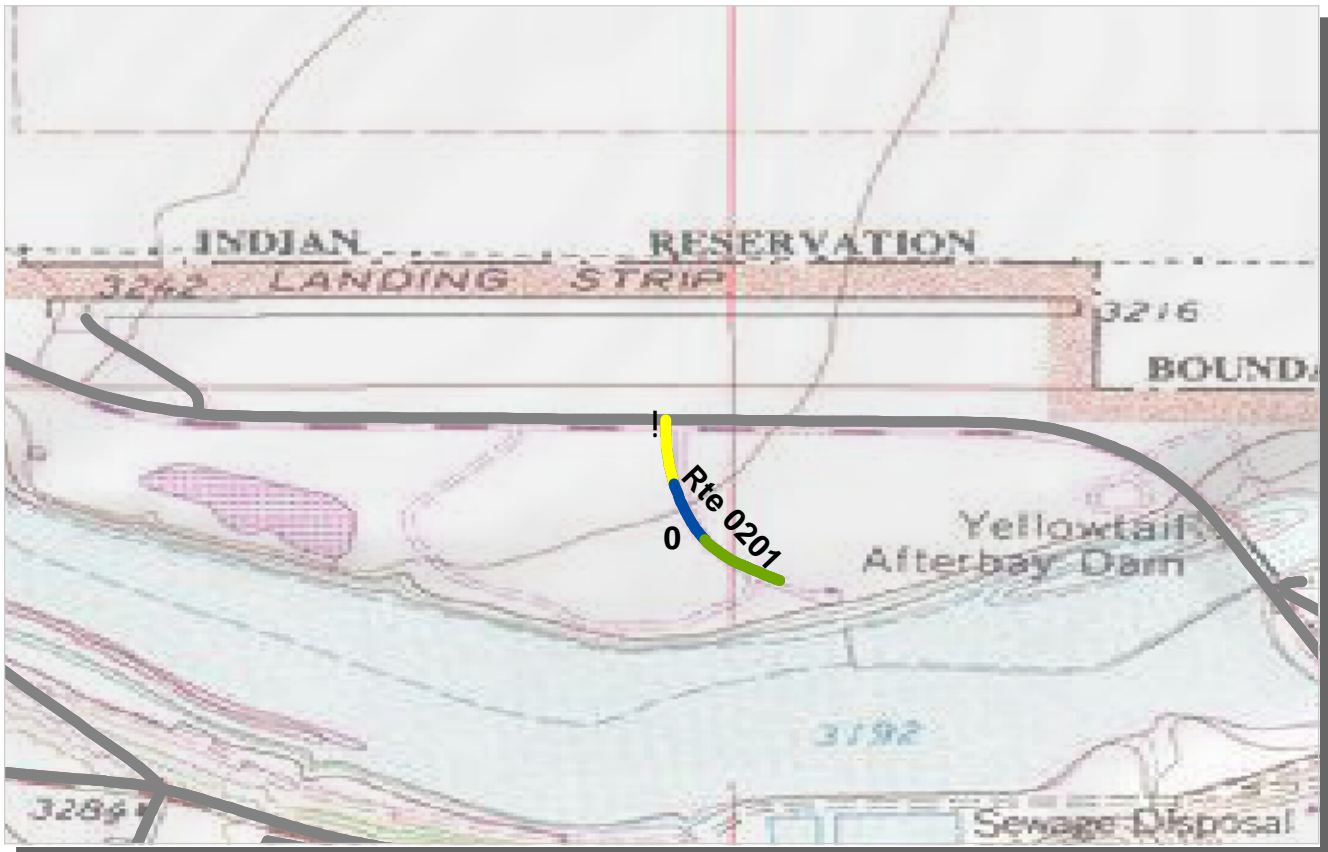
ROUTE: 0200 AFTER BAY CAMPGROUND ROAD

Section Number	0				
Section Length (mi)	0.19				
Traffic	Traffic data may be found at www.efl.fhwa.dot.gov Click on PROGRAMS / NPS Traffic Data (Note: Not all parks have traffic data)				
Cross Section Information					
Number of Lanes	2				
Paved Width (ft)	26				
Lane Width (ft)	12				
Shoulder Width Right (ft)	NC				
Shoulder Width Left (ft)	NC				
Roadway Condition Information					
SCR (Surface Condition Rating)	83				
PCR (Pavement Condition Rating)	84				
Distress Index Values					
Alligator Cracking Index	100				
Longitudinal Cracking Index	98				
Transverse Cracking Index	99				
Patching Index	100				
Rutting Index	85				
Roughness Condition Index (RCI)	88

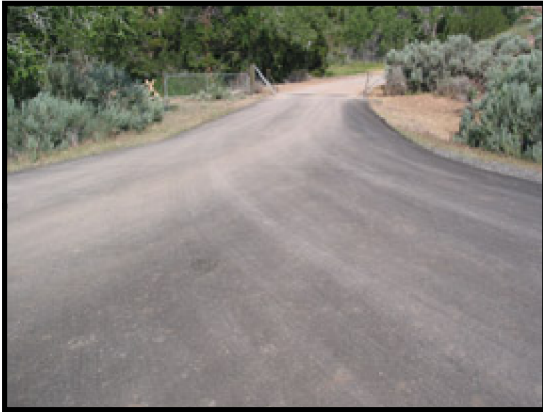
Route Number	Public / NonPublic	Date Visited		Area (sq ft)	Lane Miles *	Surface Type
0205	PUBLIC	6/27/2007		1,563	0.03	AS
Culverts	Drop Inlets	Gates	Fire Hydrants	Curb & Gutter	Curb	PCR
0	0	0	0	NO CURB AND GUTTER	NO CURB	EXCELLENT/97

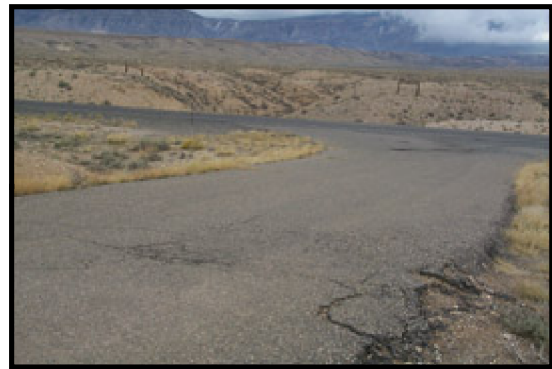
The condition data being displayed for Route 0209 is from RIP Cycle-3, no data was collected in RIP Cycle-4.

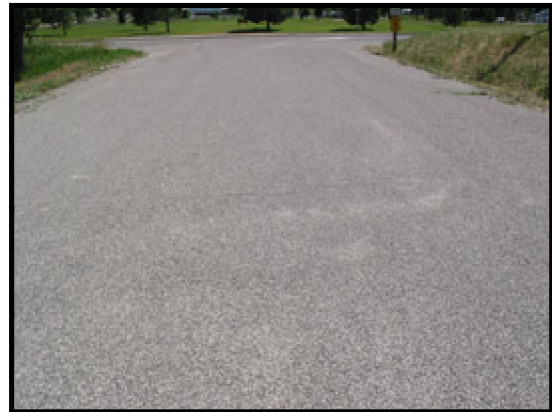
Route Number	Public / NonPublic	Date Visited		Area (sq ft)	Lane Miles *	Surface Type
0419	PUBLIC	6/26/2007		5,400	0.09	AS
Culverts	Drop Inlets	Gates	Fire Hydrants	Curb & Gutter	Curb	PCR
1	0	0	0	NO CURB AND GUTTER	NO CURB	GOOD/90

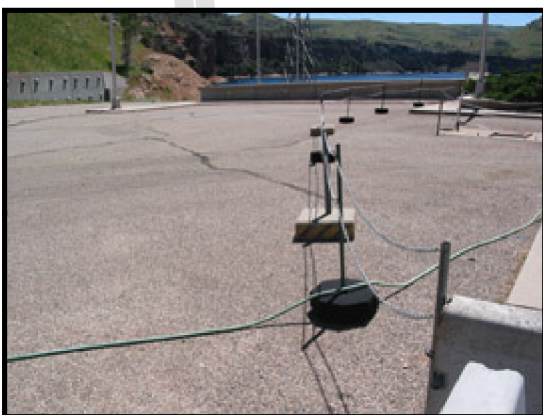
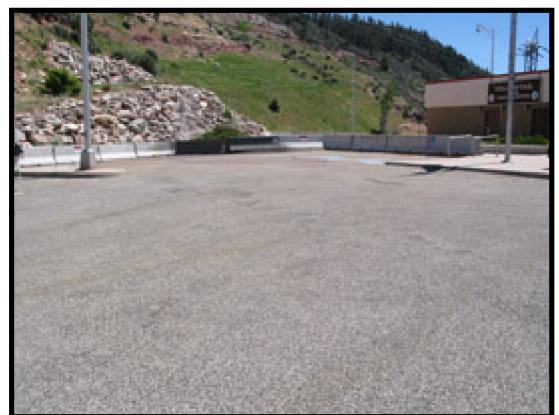
Route Number	Public / NonPublic	Date Visited		Area (sq ft)	Lane Miles *	Surface Type
0900	PUBLIC	6/26/2007		27,689	0.48	AS
Culverts	Drop Inlets	Gates	Fire Hydrants	Curb & Gutter	Curb	PCR
0	1	0	0	NO CURB AND GUTTER	CONCRETE CURB	FAIR/73

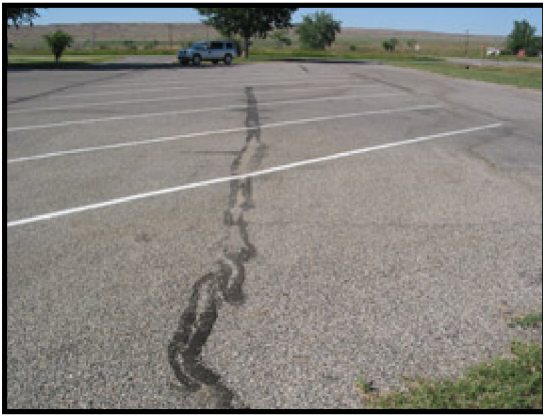
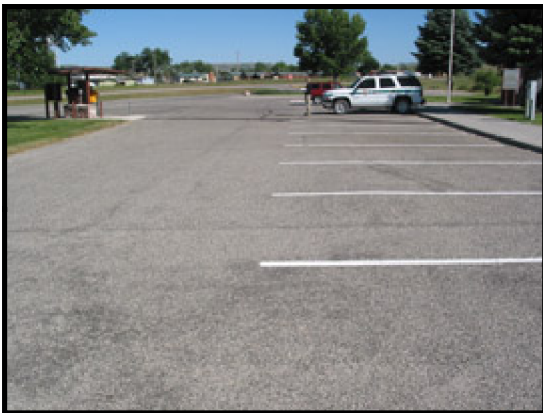
Route Number	Public / NonPublic	Date Visited		Area (sq ft)	Lane Miles *	Surface Type
0901	PUBLIC	6/26/2007		36,477	0.63	AS
Culverts	Drop Inlets	Gates	Fire Hydrants	Curb & Gutter	Curb	PCR
2	0	0	0	NO CURB AND GUTTER	CONCRETE CURB	GOOD/90

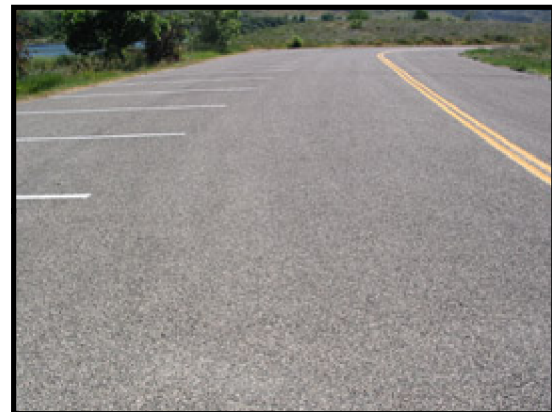
Route Number	Public / NonPublic	Date Visited		Area (sq ft)	Lane Miles *	Surface Type
0902	PUBLIC	6/26/2007		26,086	0.45	AS
Culverts	Drop Inlets	Gates	Fire Hydrants	Curb & Gutter	Curb	PCR
0	0	0	0	NO CURB AND GUTTER	NO CURB	GOOD/90

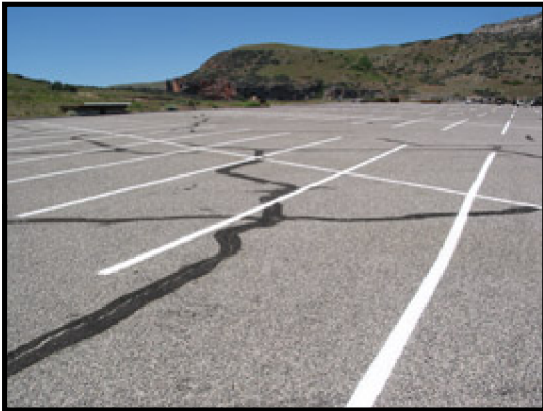
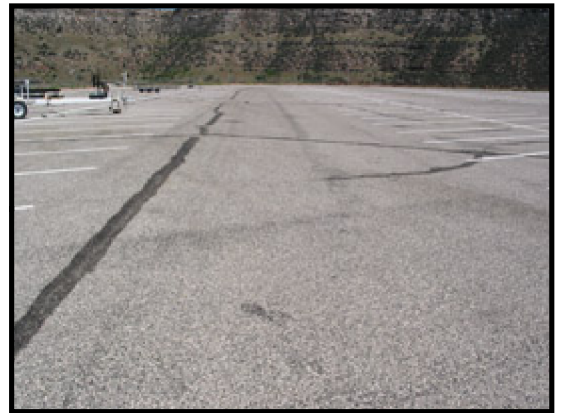
Route 0903

Route Number	Public / NonPublic	Date Visited		Area (sq ft)	Lane Miles *	Surface Type
0903	PUBLIC	6/26/2007		120,811	2.08	AS
Culverts	Drop Inlets	Gates	Fire Hydrants	Curb & Gutter	Curb	PCR
0	4	0	0	CONCRETE CURB AND GUTTER	ASPHALT CURB	FAIR/73

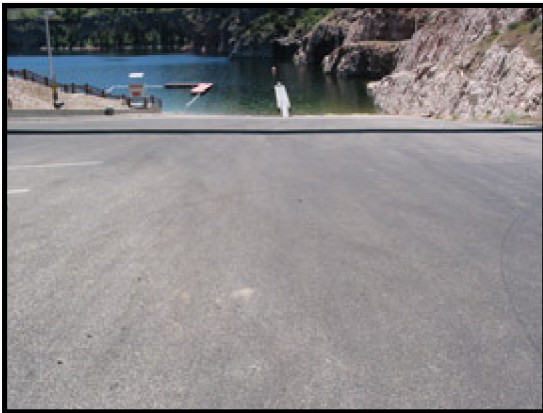
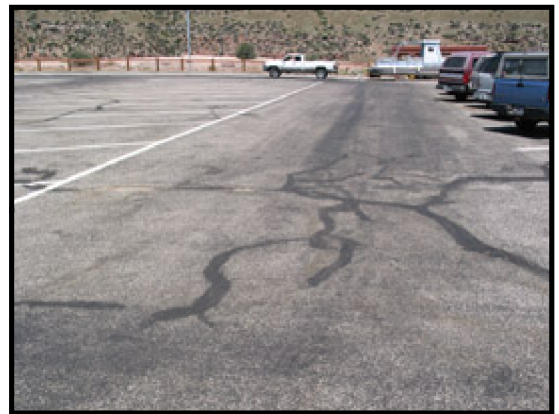
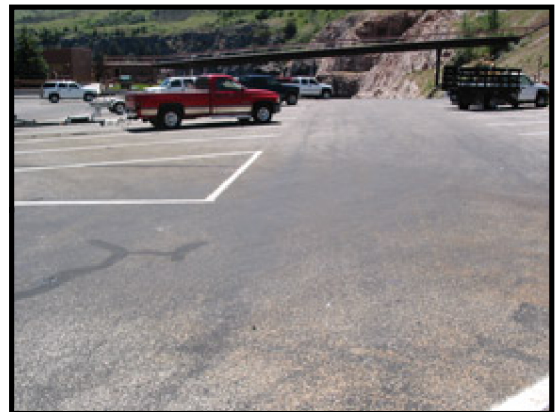
Route Number	Public / NonPublic	Date Visited		Area (sq ft)	Lane Miles *	Surface Type
0904	PUBLIC	6/26/2007		53,615	0.92	AS
Culverts	Drop Inlets	Gates	Fire Hydrants	Curb & Gutter	Curb	PCR
0	1	0	0	CONCRETE CURB AND GUTTER	ASPHALT CURB	FAIR/73

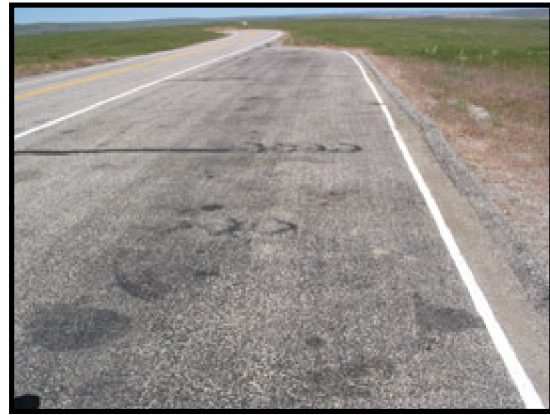
Route 0906

Route Number	Public / NonPublic	Date Visited		Area (sq ft)	Lane Miles *	Surface Type
0906	PUBLIC	6/26/2007		2,086	0.04	AS
Culverts	Drop Inlets	Gates	Fire Hydrants	Curb & Gutter	Curb	PCR
0	0	0	0	NO CURB AND GUTTER	ASPHALT CURB	FAIR/73

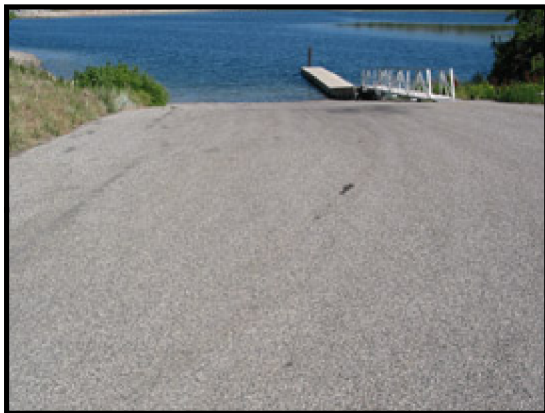
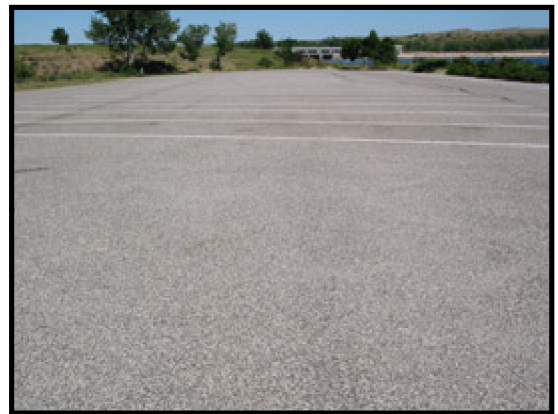
Route 0909

Route Number	Public / NonPublic	Date Visited		Area (sq ft)	Lane Miles *	Surface Type
0909	PUBLIC	6/26/2007		57,702	0.99	AS
Culverts	Drop Inlets	Gates	Fire Hydrants	Curb & Gutter	Curb	PCR
0	0	0	0	NO CURB AND GUTTER	NO CURB	GOOD/90

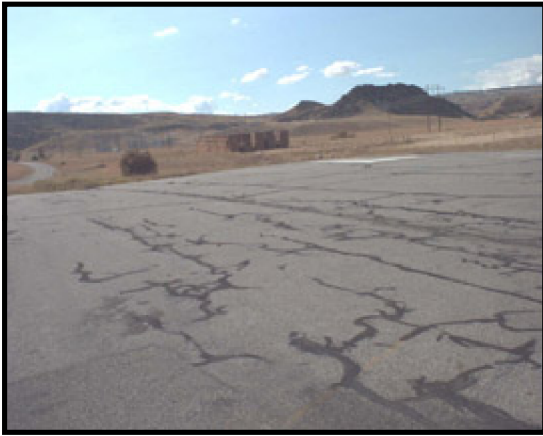
Route Number	Public / NonPublic	Date Visited		Area (sq ft)	Lane Miles *	Surface Type
0911	PUBLIC	8/15/2008		15,815	0.27	AS
Culverts	Drop Inlets	Gates	Fire Hydrants	Curb & Gutter	Curb	PCR
0	0	0	0	NO CURB AND GUTTER	NO CURB	FAIR/73

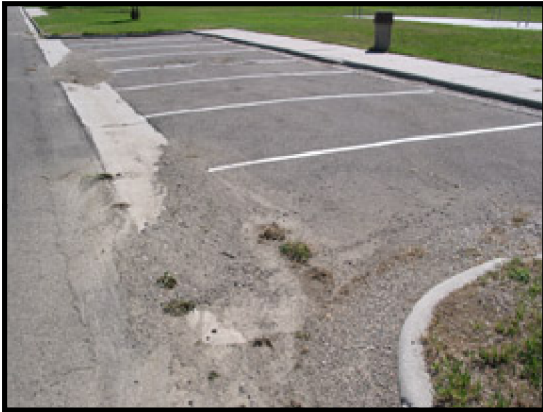
Route Number	Public / NonPublic	Date Visited		Area (sq ft)	Lane Miles *	Surface Type
0917	PUBLIC	6/26/2007		1,552	0.03	AS
Culverts	Drop Inlets	Gates	Fire Hydrants	Curb & Gutter	Curb	PCR
0	0	0	0	CONCRETE CURB AND GUTTER	NO CURB	POOR/45

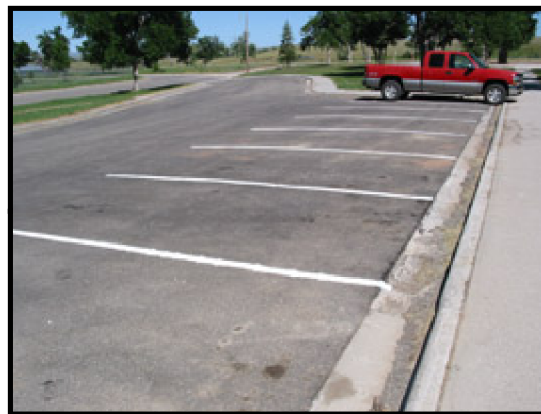
Route 0918

Route Number	Public / NonPublic	Date Visited		Area (sq ft)	Lane Miles *	Surface Type
0918	PUBLIC	6/26/2007		10,616	0.18	AS
Culverts	Drop Inlets	Gates	Fire Hydrants	Curb & Gutter	Curb	PCR
0	0	0	0	CONCRETE CURB AND GUTTER	NO CURB	FAIR/73

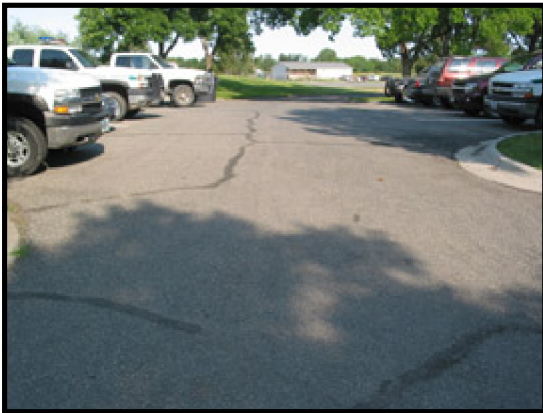
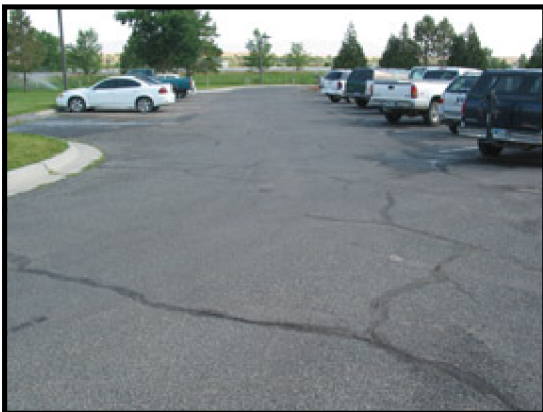
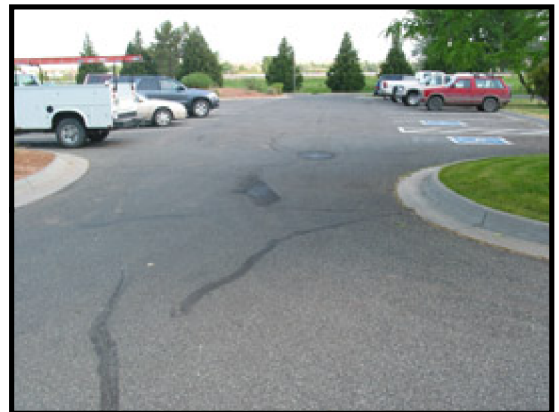
Route Number	Public / NonPublic	Date Visited		Area (sq ft)	Lane Miles *	Surface Type
0919	PUBLIC	6/27/2007		56,083	0.97	AS
Culverts	Drop Inlets	Gates	Fire Hydrants	Curb & Gutter	Curb	PCR
1	2	0	1	CONCRETE CURB AND GUTTER	NO CURB	FAIR/73

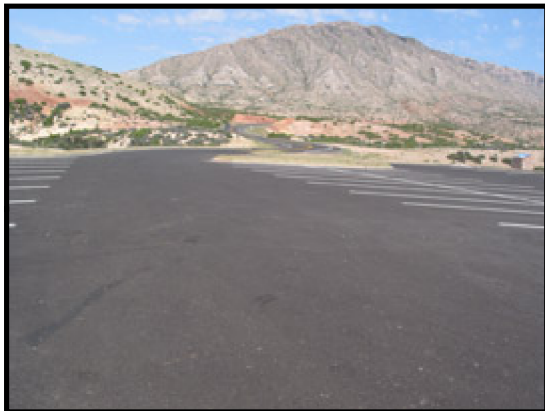
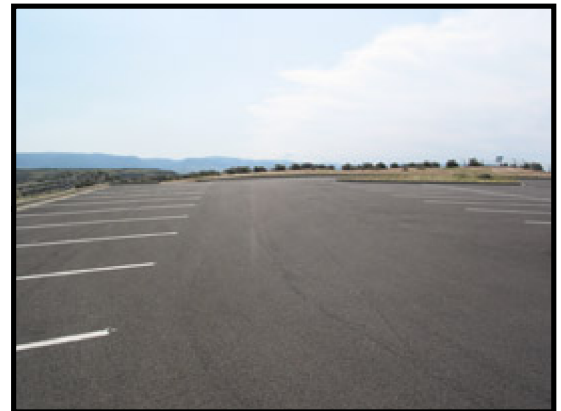
Route Number	Public / NonPublic	Date Visited		Area (sq ft)	Lane Miles *	Surface Type
0921	PUBLIC	6/27/2007		17,598	0.30	AS
Culverts	Drop Inlets	Gates	Fire Hydrants	Curb & Gutter	Curb	PCR
0	1	0	0	CONCRETE CURB AND GUTTER	NO CURB	EXCELLENT/97

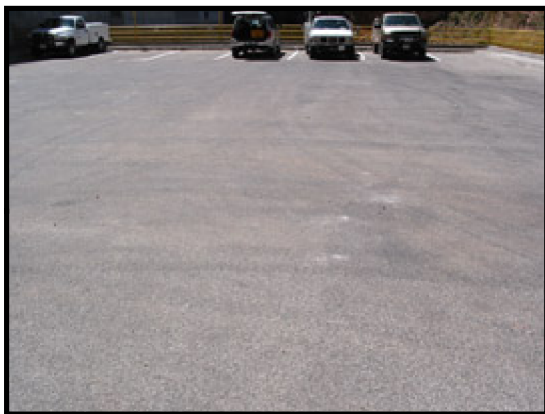
Route Number	Public / NonPublic	Date Visited		Area (sq ft)	Lane Miles *	Surface Type
0923	NONPUBLIC	6/26/2007		16,008	0.28	AS
Culverts	Drop Inlets	Gates	Fire Hydrants	Curb & Gutter	Curb	PCR
0	2	0	0	NO CURB AND GUTTER	CONCRETE CURB	FAIR/73

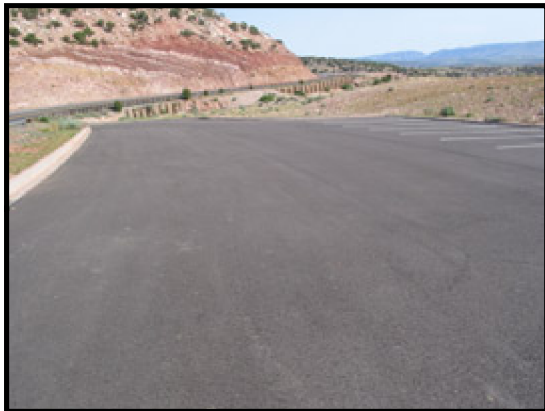
Route Number	Public / NonPublic	Date Visited		Area (sq ft)	Lane Miles *	Surface Type
0925	PUBLIC	6/27/2007		11,771	0.20	AS
Culverts	Drop Inlets	Gates	Fire Hydrants	Curb & Gutter	Curb	PCR
0	0	0	0	NO CURB AND GUTTER	CONCRETE CURB	EXCELLENT/97

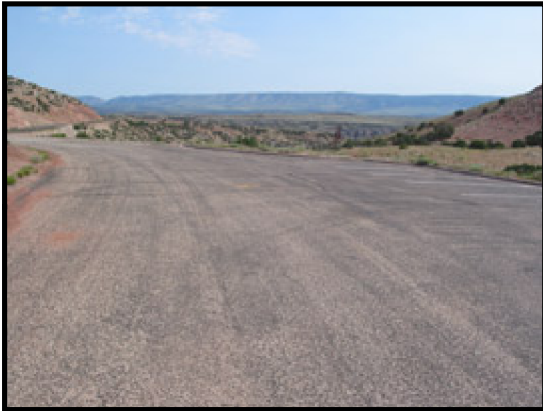
Route Number	Public / NonPublic	Date Visited		Area (sq ft)	Lane Miles *	Surface Type
0926	PUBLIC	6/27/2007		15,540	0.27	AS
Culverts	Drop Inlets	Gates	Fire Hydrants	Curb & Gutter	Curb	PCR
0	1	0	0	NO CURB AND GUTTER	CONCRETE CURB	FAIR/73

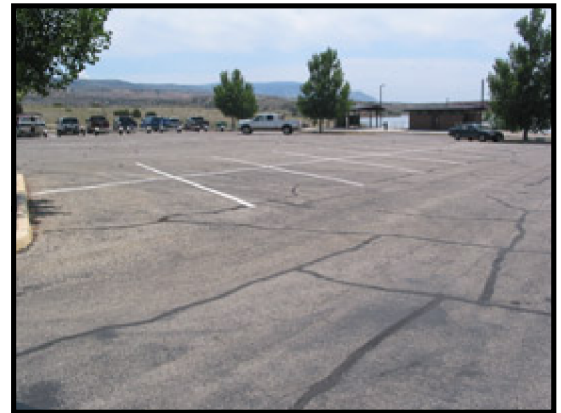
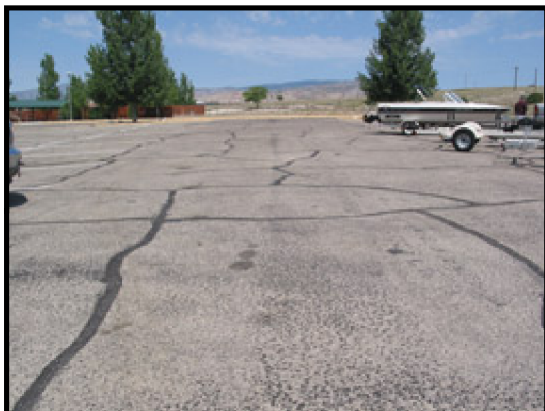
Route Number	Public / NonPublic	Date Visited		Area (sq ft)	Lane Miles *	Surface Type
0927	PUBLIC	6/27/2007		46,182	0.80	AS
Culverts	Drop Inlets	Gates	Fire Hydrants	Curb & Gutter	Curb	PCR
0	0	0	0	CONCRETE CURB AND GUTTER	CONCRETE CURB	POOR/45

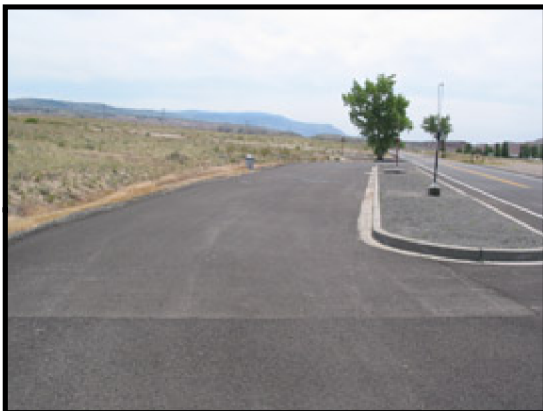
Route Number	Public / NonPublic	Date Visited		Area (sq ft)	Lane Miles *	Surface Type
0930	PUBLIC	6/27/2007		4,076	0.07	AS
Culverts	Drop Inlets	Gates	Fire Hydrants	Curb & Gutter	Curb	PCR
0	0	0	0	CONCRETE CURB AND GUTTER	NO CURB	EXCELLENT/97

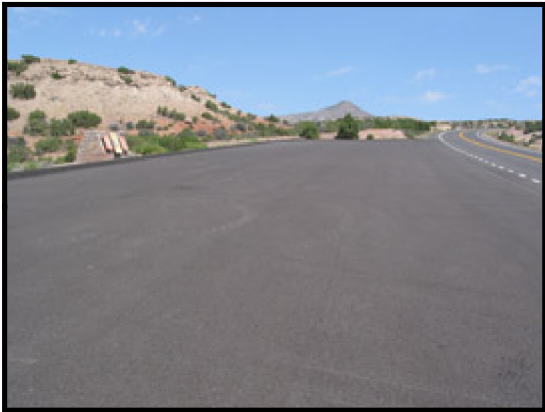
Route Number	Public / NonPublic	Date Visited		Area (sq ft)	Lane Miles *	Surface Type
0931	PUBLIC	6/27/2007		11,483	0.20	AS
Culverts	Drop Inlets	Gates	Fire Hydrants	Curb & Gutter	Curb	PCR
0	0	0	0	NO CURB AND GUTTER	ASPHALT CURB	EXCELLENT/97

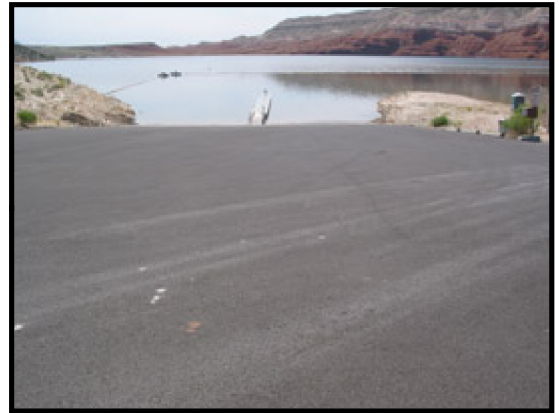
Route Number	Public / NonPublic	Date Visited		Area (sq ft)	Lane Miles *	Surface Type
0932	PUBLIC	6/27/2007		13,377	0.23	AS
Culverts	Drop Inlets	Gates	Fire Hydrants	Curb & Gutter	Curb	PCR
0	1	0	0	CONCRETE CURB AND GUTTER	NO CURB	EXCELLENT/97

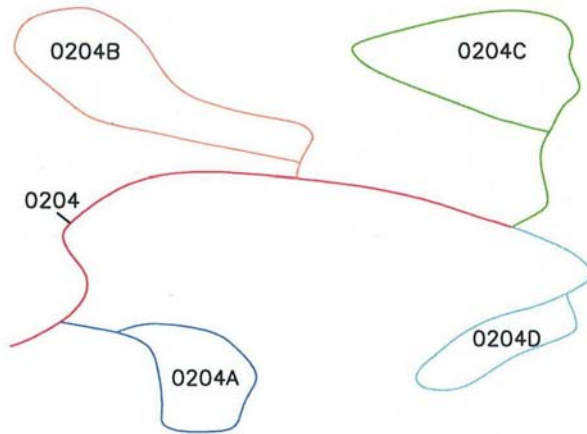
Figure 1: Campground with five routes and five assets

Individual road segments (asset subcomponents) may be combined into a single asset. Where previous route ID practices have generated more assets (routes) than are practical from an asset management standpoint, small, discrete road lengths may be designated as asset subcomponents and then combined into a larger single asset. A subcomponent is NOT an FMSS term. Subcomponents will be used in RIP to indicate which routes are small, drivable individual road segments and which routes may include these segments. Once a piece of road is designated a subcomponent of another route, it will no longer have any individual identity in FMSS. Only those routes listed on the RIP Route ID report will have asset numbers in FMSS. As stated in business rule 2 above, subcomponents will not be listed on the route ID. The quantity information (length, area) will be included into the larger route of which they are a part. See Figures 1 and 2 for an example of how existing assets may be combined using subcomponents. Note that

subcomponents will have an identity in the RIP database and, if driven by RIP team, may be referenced in RIP reports, Visidata, or other RIP documentation.

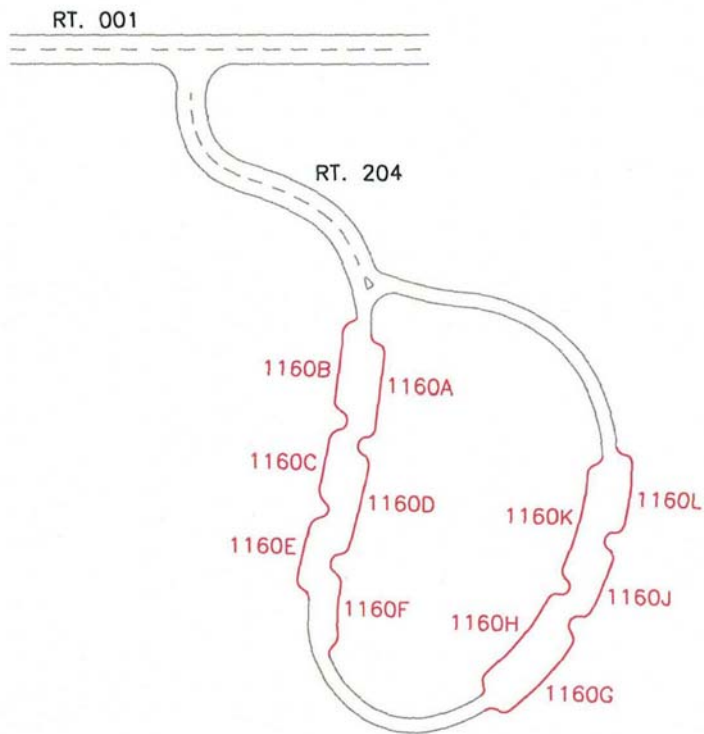
Discrete parking areas may be combined into a single asset where they service the same facility or resource and are within walking distance of each other. These combined areas should be maintained as one asset. There are many instances where small (5-10 space), discrete parking areas have been separated into individual assets even though they provide parking for the same area or facility. These may be combined into a single asset. Figures 3 and 4 shows examples of combining parking areas.

Figure 3: Parking with access route 204 and multiple parking areas (1160 A-L). Currently, this parking area is 12 routes and 12 assets (one 1100 asset and 11 1300 assets).
