**The Road Inventory
of
Big South Fork National River
and Recreation Area
BISO – 5130
Cycle 4**

**Prepared By:
Federal Highway Administration
Road Inventory Program
Cycle 4**

Big South Fork National River and Recreation Area in Tennessee / Kentucky

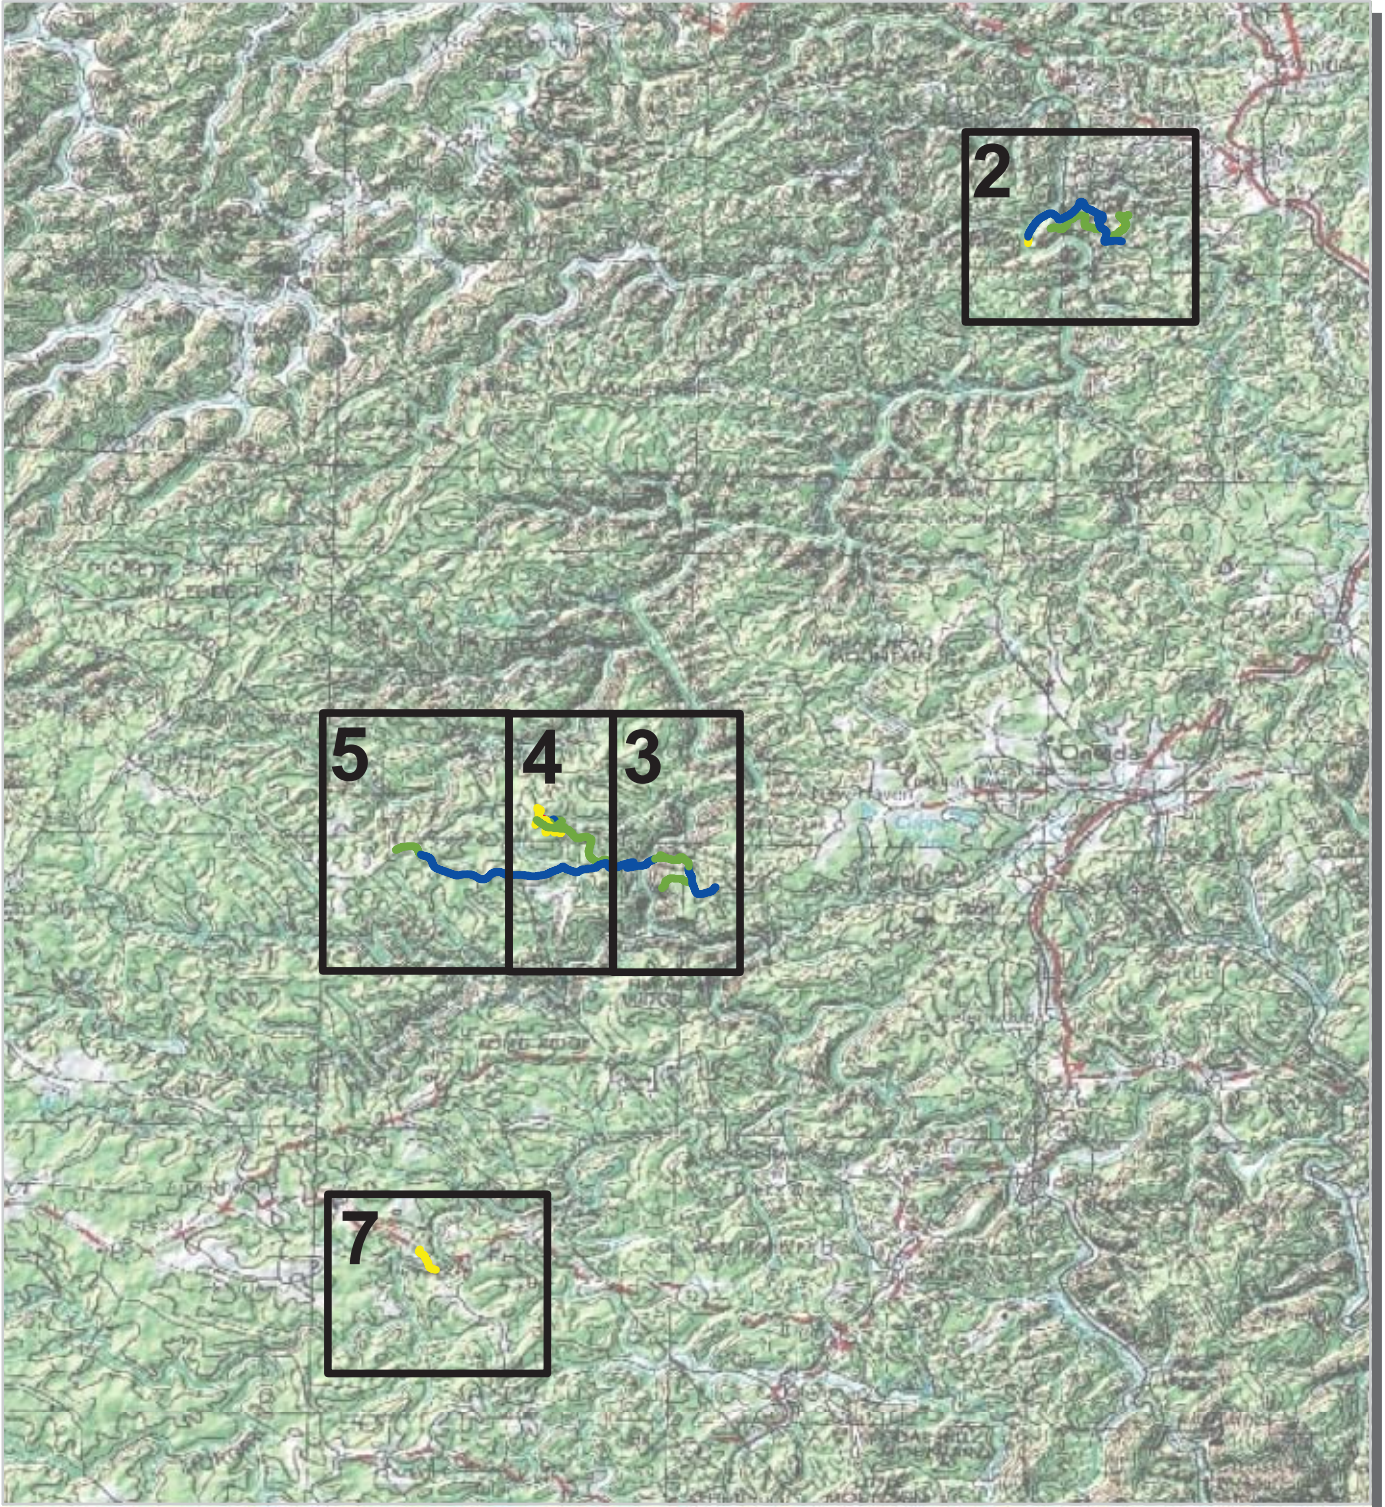
**Big South Fork National River and Recreation Area
Route Condition Map
PCR - Mile by Mile
Key Map**

PCR	Poor	Fair	Good	Excellent	No Data
	(≤60)	(61 - 84)	(85 - 94)	(95 - 100)

* If the PCR rating is not available for a section, the SCR rating will be displayed. See appendix for definitions and formulas.

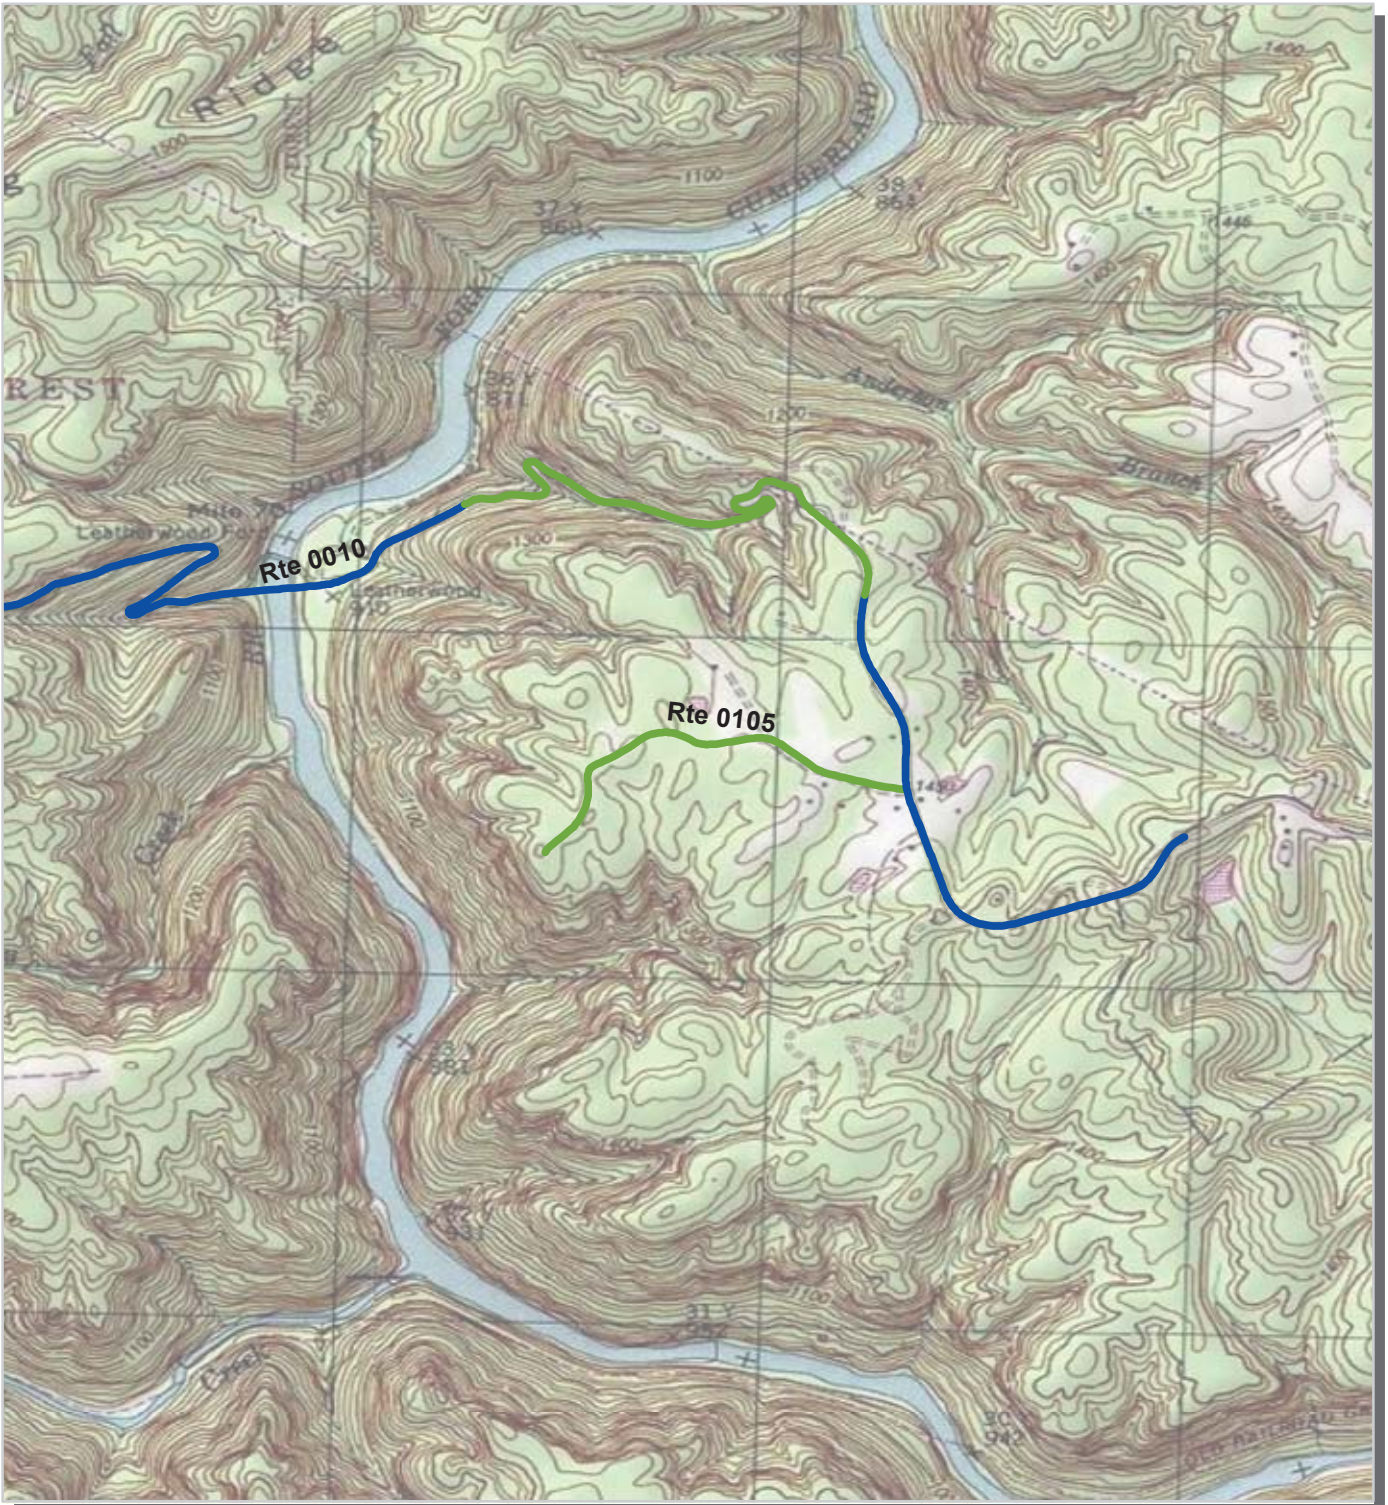
Area 3

PCR	Poor		Fair		Good		Excellent		No Data	
	(<=60)		(61 - 84)		(85 - 94)		(95 - 100)

* If the PCR rating is not available for a section, the SCR rating will be displayed. See appendix for definitions and formulas.

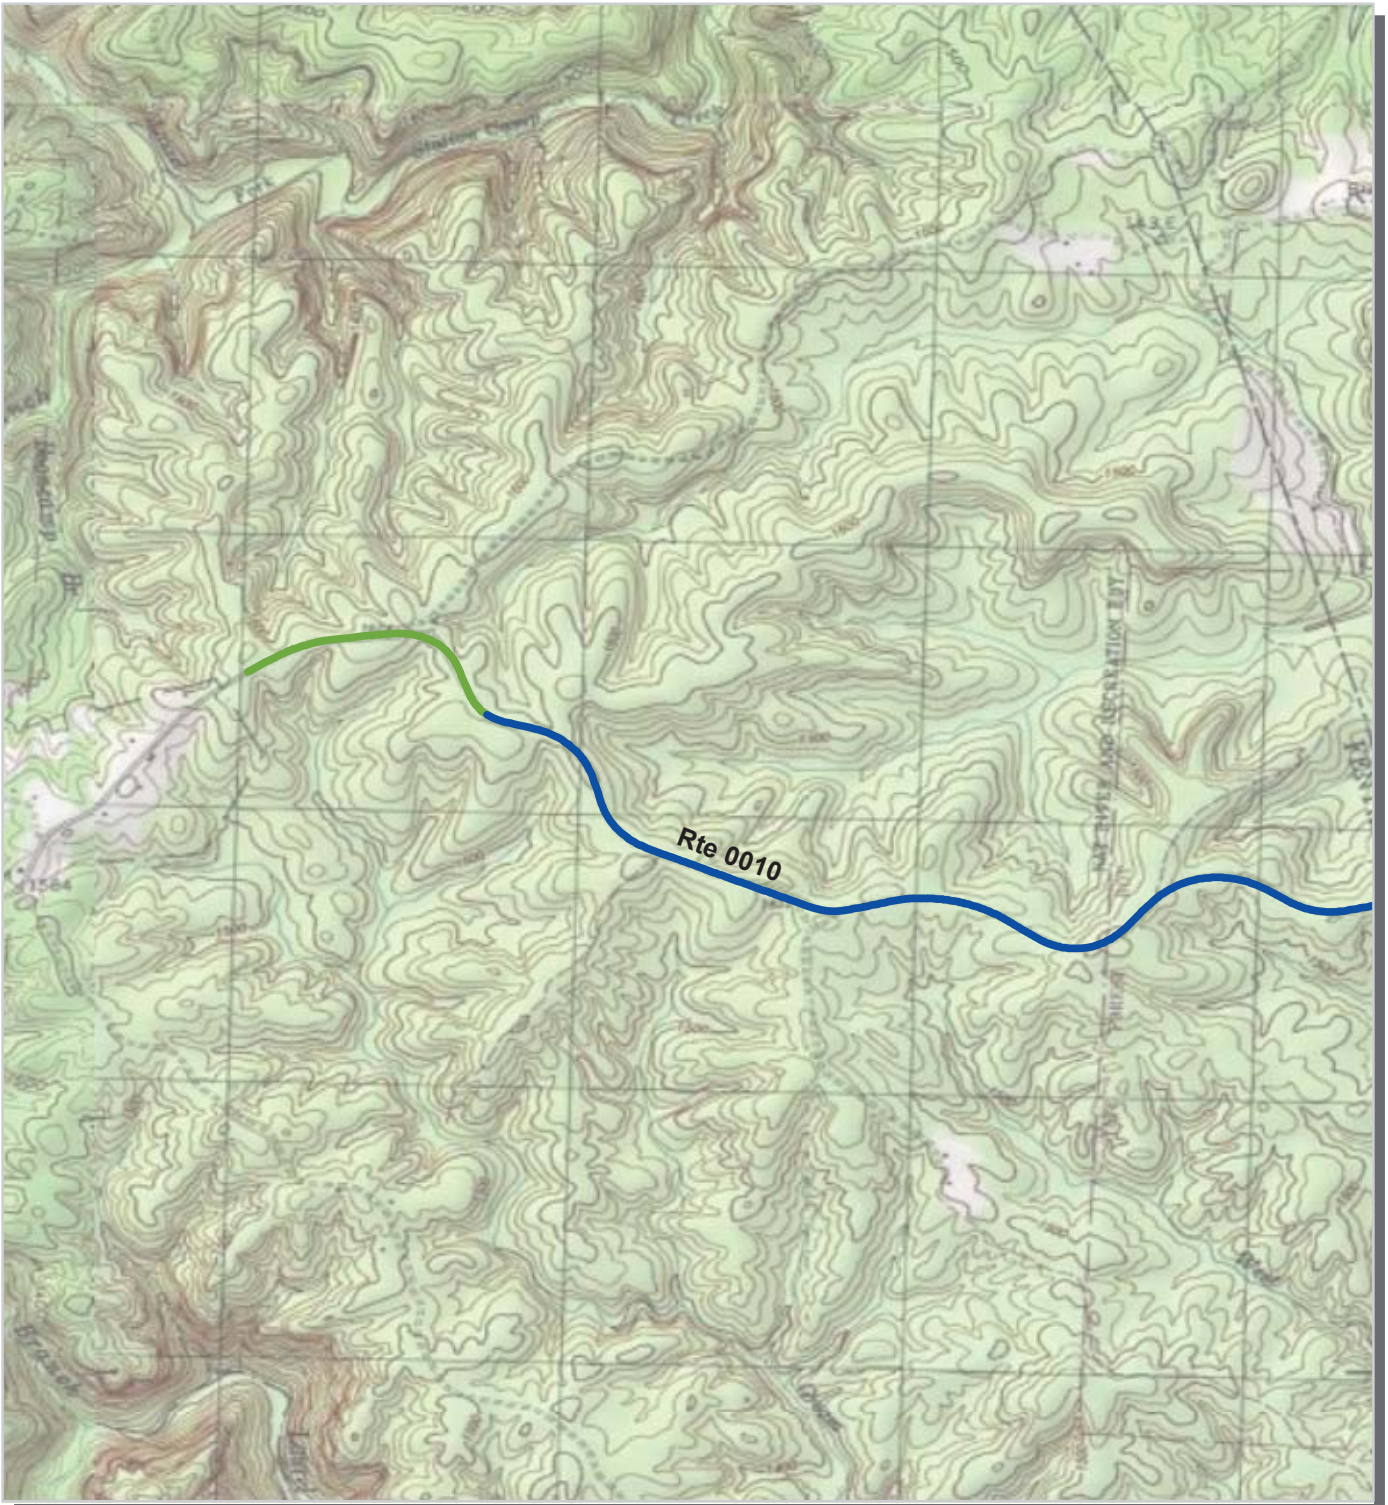
**Big South Fork National River and Recreation Area
Route Condition Map
PCR - Mile by Mile
Area 5**

PCR	Poor	Fair	Good	Excellent	No Data
	(≤60)	(61 - 84)	(85 - 94)	(95 - 100)

* If the PCR rating is not available for a section, the SCR rating will be displayed. See appendix for definitions and formulas.
