**The Road Inventory  
of  
Canaveral National Seashore  
CANA – 5180  
Cycle 4**

**Prepared By:  
Federal Highway Administration  
Road Inventory Program  
Cycle 4**

# Canaveral National Seashore in Florida

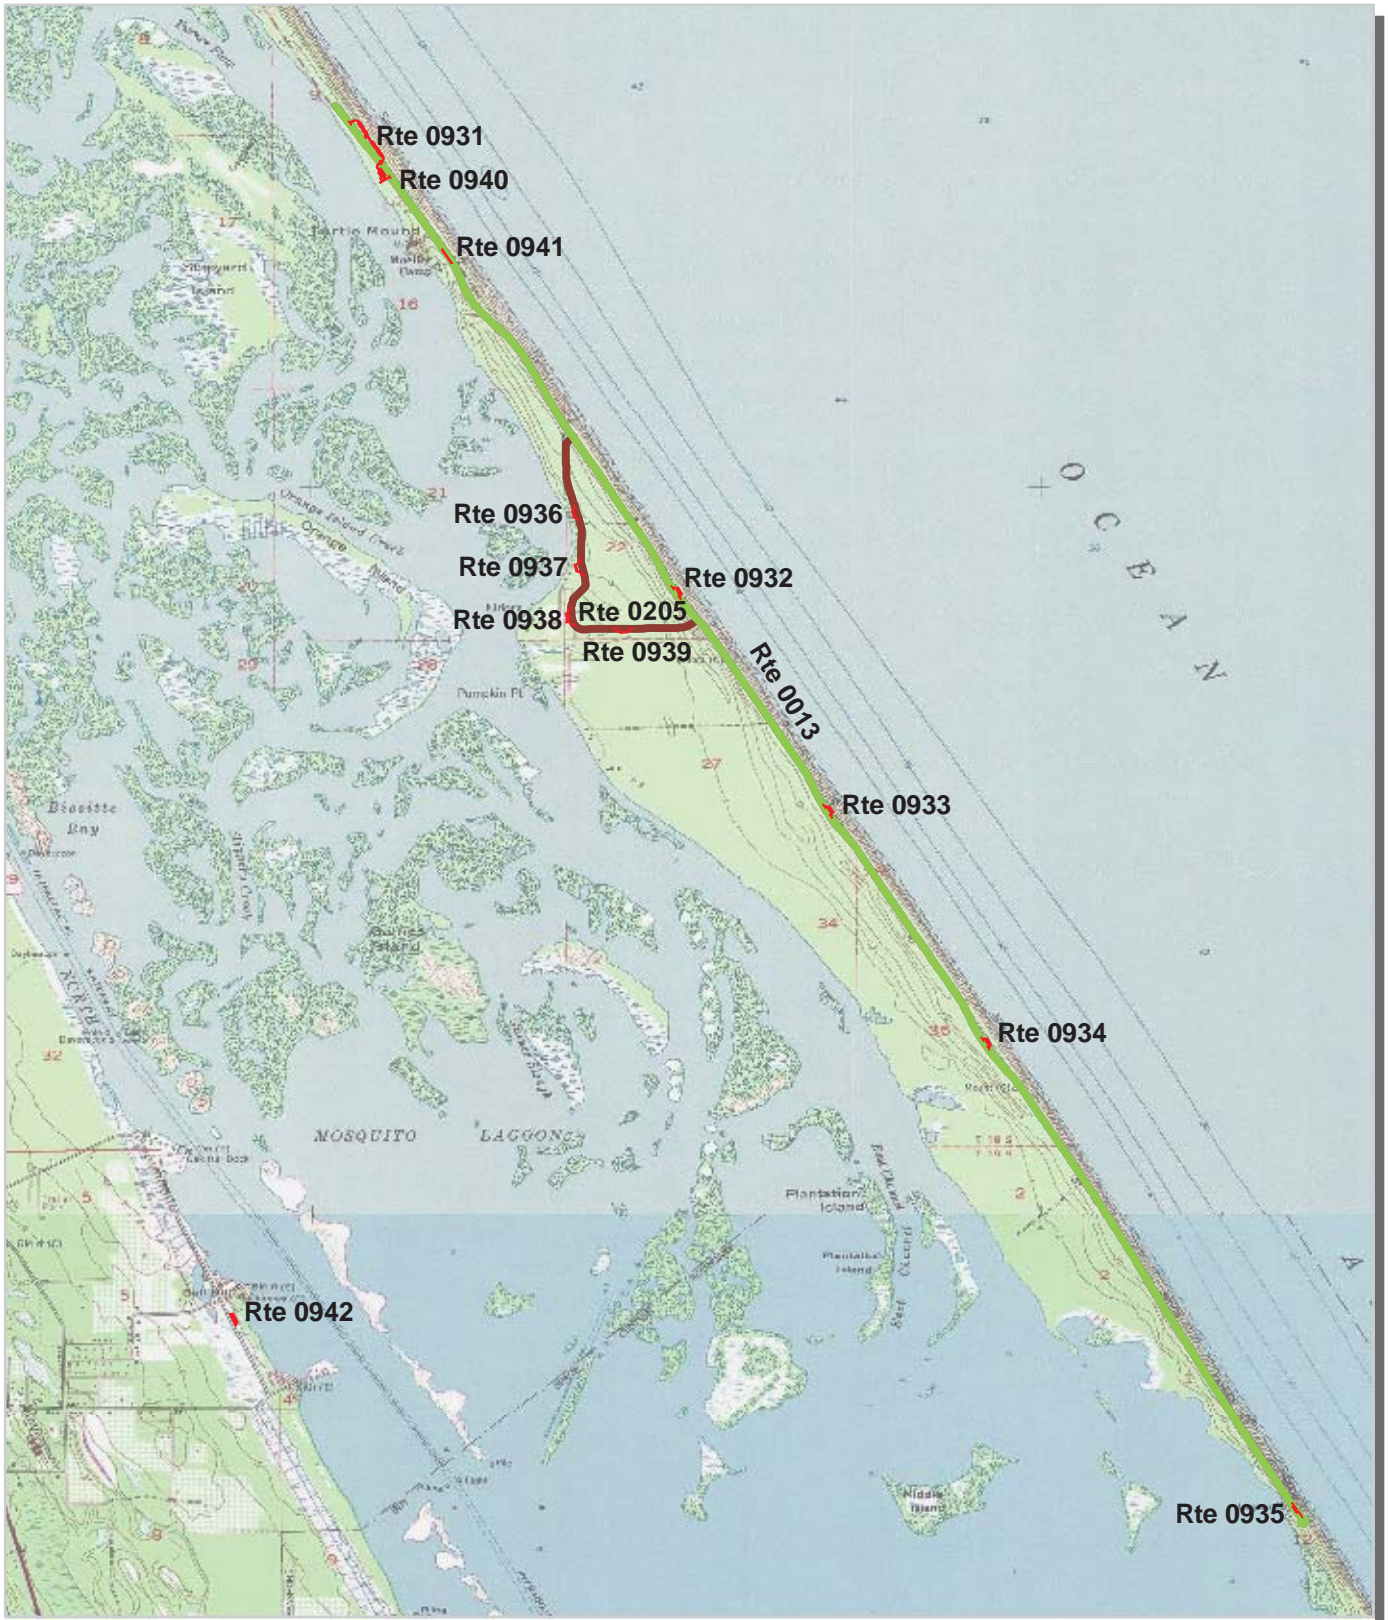
# Canaveral National Seashore Route Location Map Area 1

Unique colors used to differentiate routes

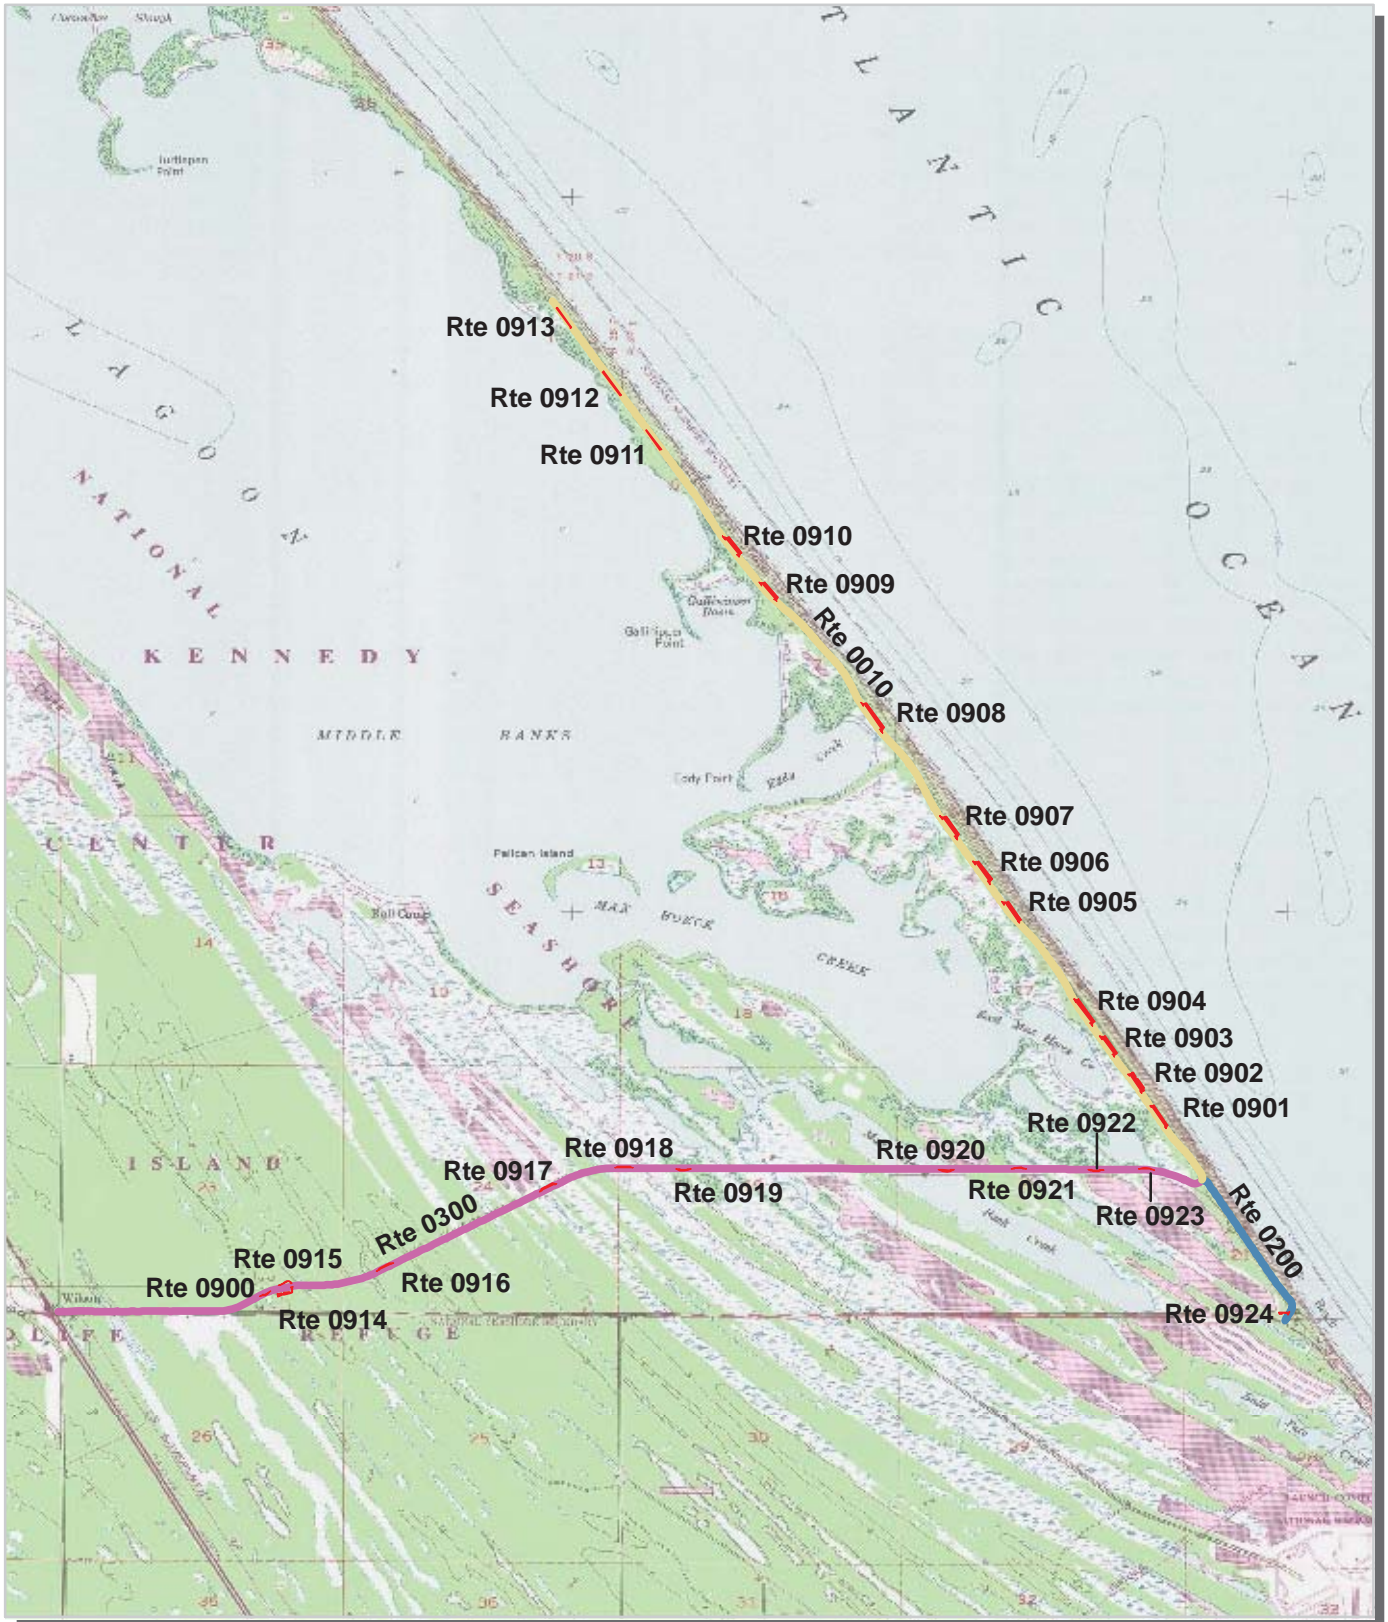
# Canaveral National Seashore Route Location Map Area 2

Unique colors used to differentiate routes

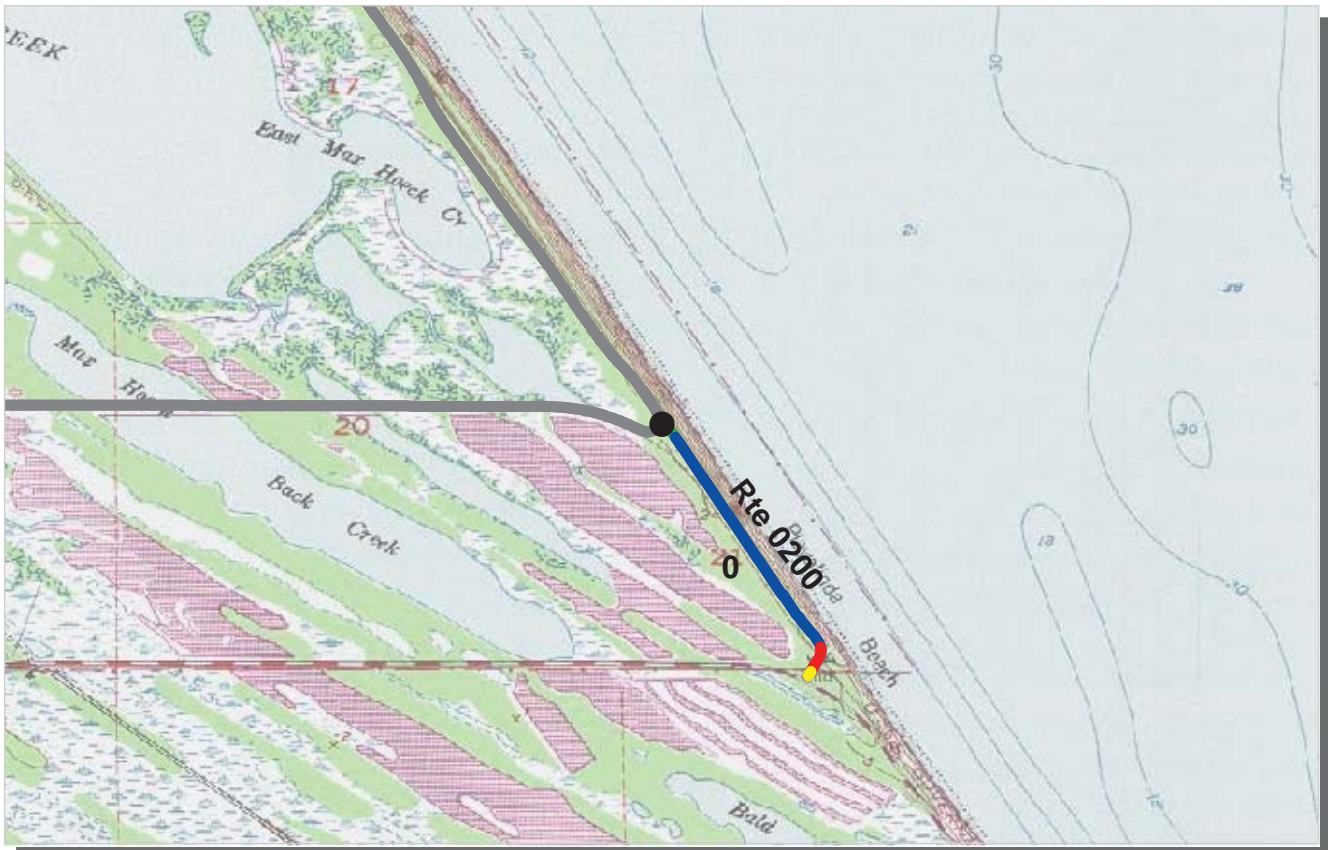
**ROUTE: 0200 BEACH OFFICE COMPLEX**

PCR	Poor	<span style="display:inline-block; width:15px; height:15px; background-color:red;"></span>	Fair	<span style="display:inline-block; width:15px; height:15px; background-color:yellow;"></span>	Good	<span style="display:inline-block; width:15px; height:15px; background-color:green;"></span>	Excellent	<span style="display:inline-block; width:15px; height:15px; background-color:blue;"></span>
		(<=60)		(61 - 84)		(85 - 94)		(95 - 100)

\* If the PCR rating is not available for a section, the SCR rating will be displayed. See appendix for definitions and formulas.

<b>Section Number</b>	0				
<b>Section Length (mi)</b>	0.67				
<b>Traffic</b>	Traffic data may be found at <a href="http://www.epl.fhwa.dot.gov">www.epl.fhwa.dot.gov</a> Click on PROGRAMS / NPS Traffic Data (Note: Not all parks have traffic data)				
<b>Cross Section Information</b>					
Number of Lanes	2				
Paved Width (ft)	22				
Lane Width (ft)	11				
Shoulder Width Right (ft)**	9				
Shoulder Width Left (ft)**	3				
<b>Roadway Condition Information</b>					
SCR (Surface Condition Rating)	95				
PCR (Pavement Condition Rating)	94				
<b>Distress Index Values</b>					
Alligator Cracking Index	100				
Longitudinal Cracking Index	99				
Transverse Cracking Index	99				
Patching Index	100				
Rutting Index	97				
Roughness Condition Index (RCI)	94

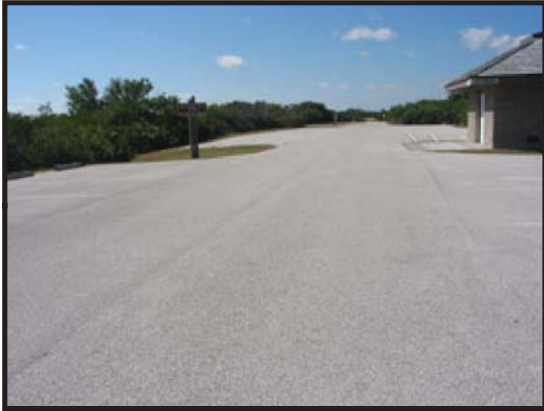
Route Number	Public / NonPublic	Date Visited		Area (sq ft)	Lane Miles *	Surface Type
0201	PUBLIC	11/8/2006		28,924	0.50	AS
Culverts	Drop Inlets	Gates	Fire Hydrants	Curb & Gutter	Curb	PCR
0	0	0	0	NO CURB AND GUTTER	NO CURB	FAIR/73

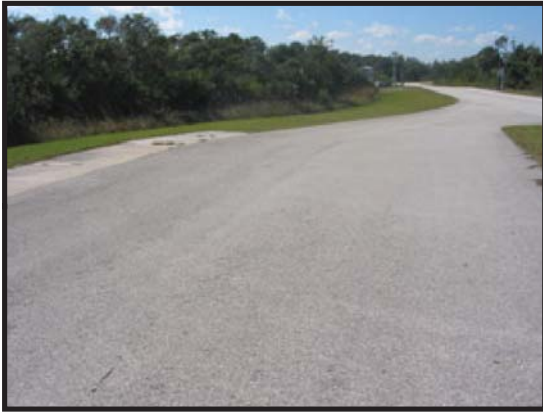
Route Number	Public / NonPublic	Date Visited		Area (sq ft)	Lane Miles *	Surface Type
0900	PUBLIC	11/8/2006		3,808	0.07	AS
Culverts	Drop Inlets	Gates	Fire Hydrants	Curb & Gutter	Curb	PCR
0	0	0	0	NO CURB AND GUTTER	NO CURB	GOOD/90

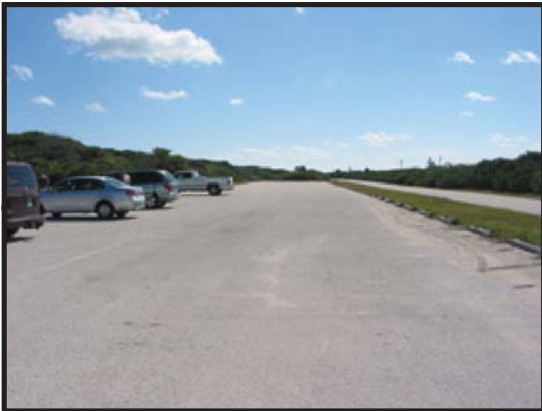
Route Number	Public / NonPublic	Date Visited		Area (sq ft)	Lane Miles *	Surface Type
0901	PUBLIC	11/8/2006		28,731	0.50	AS
Culverts	Drop Inlets	Gates	Fire Hydrants	Curb & Gutter	Curb	PCR
0	0	0	0	NO CURB AND GUTTER	NO CURB	FAIR/73

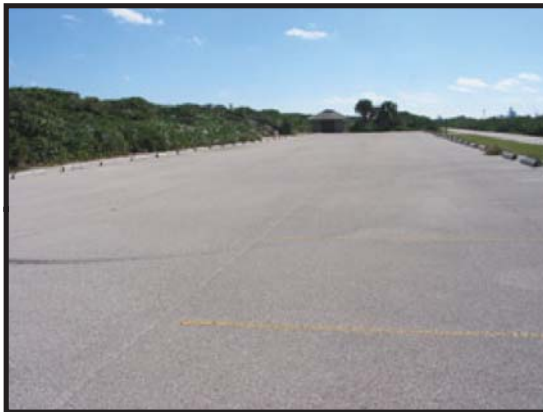
Route Number	Public / NonPublic	Date Visited		Area (sq ft)	Lane Miles *	Surface Type
0903	PUBLIC	11/8/2006		31,052	0.54	AS
Culverts	Drop Inlets	Gates	Fire Hydrants	Curb & Gutter	Curb	PCR
0	0	0	0	NO CURB AND GUTTER	NO CURB	FAIR/73

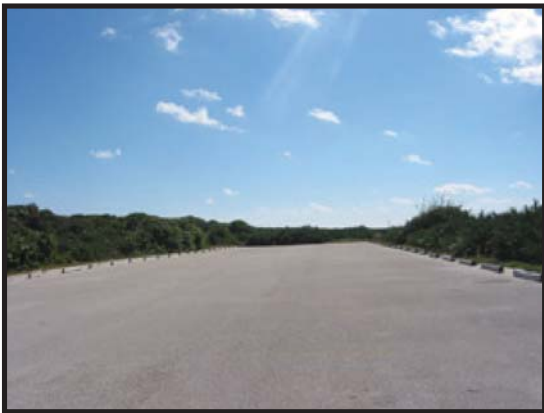
Route Number	Public / NonPublic	Date Visited		Area (sq ft)	Lane Miles *	Surface Type
0906	PUBLIC	11/8/2006		42,120	0.73	AS
Culverts	Drop Inlets	Gates	Fire Hydrants	Curb & Gutter	Curb	PCR
0	0	0	0	NO CURB AND GUTTER	NO CURB	GOOD/90

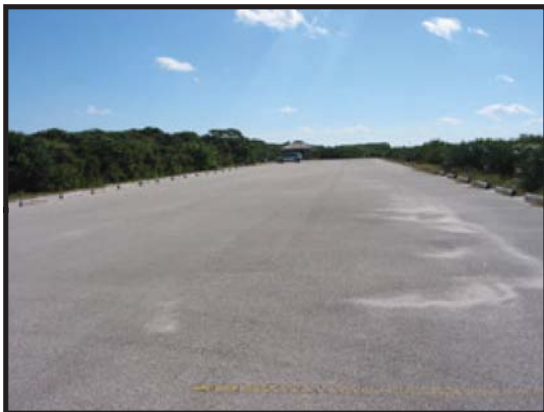
Route Number	Public / NonPublic	Date Visited		Area (sq ft)	Lane Miles *	Surface Type
0907	PUBLIC	11/8/2006		34,663	0.60	AS
Culverts	Drop Inlets	Gates	Fire Hydrants	Curb & Gutter	Curb	PCR
0	0	0	0	NO CURB AND GUTTER	NO CURB	GOOD/90

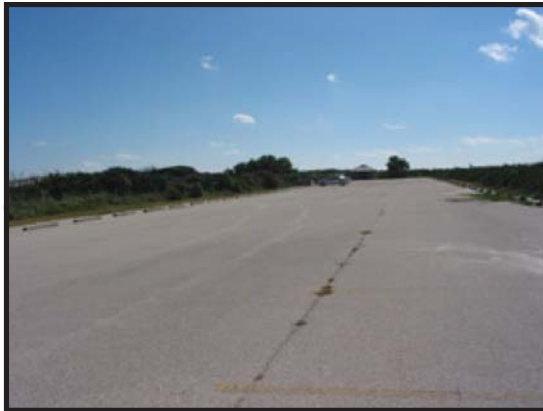
Route Number	Public / NonPublic	Date Visited		Area (sq ft)	Lane Miles *	Surface Type
0908	PUBLIC	11/8/2006		41,613	0.72	AS
Culverts	Drop Inlets	Gates	Fire Hydrants	Curb & Gutter	Curb	PCR
0	0	0	0	NO CURB AND GUTTER	NO CURB	FAIR/73

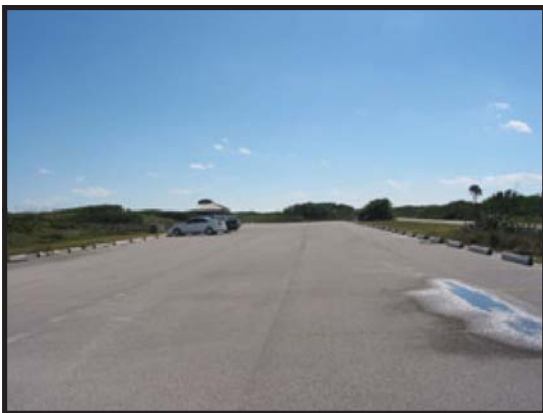
Route Number	Public / NonPublic	Date Visited		Area (sq ft)	Lane Miles *	Surface Type
0910	PUBLIC	11/8/2006		30,036	0.52	AS
Culverts	Drop Inlets	Gates	Fire Hydrants	Curb & Gutter	Curb	PCR
0	0	0	0	NO CURB AND GUTTER	NO CURB	GOOD/90

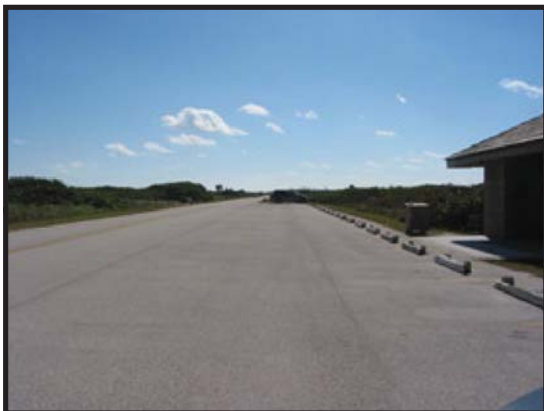
Route Number	Public / NonPublic	Date Visited		Area (sq ft)	Lane Miles *	Surface Type
0911	PUBLIC	11/8/2006		14,399	0.25	AS
Culverts	Drop Inlets	Gates	Fire Hydrants	Curb & Gutter	Curb	PCR
0	0	0	0	NO CURB AND GUTTER	NO CURB	FAIR/73

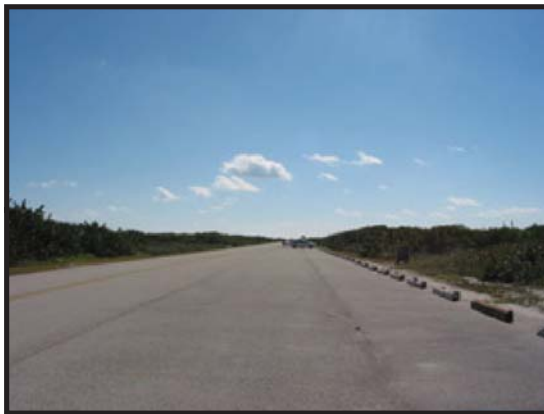
Route Number	Public / NonPublic	Date Visited		Area (sq ft)	Lane Miles *	Surface Type
0912	PUBLIC	11/8/2006		14,727	0.25	AS
Culverts	Drop Inlets	Gates	Fire Hydrants	Curb & Gutter	Curb	PCR
0	0	0	0	NO CURB AND GUTTER	NO CURB	FAIR/73

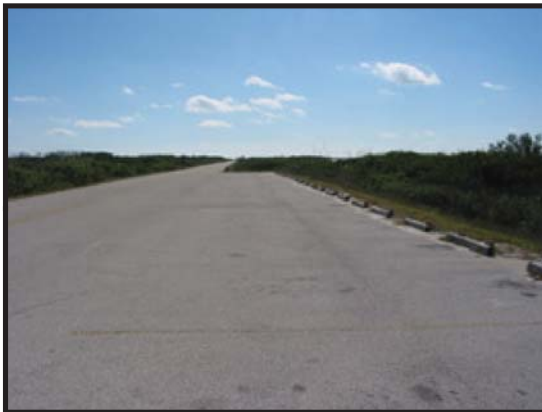
Route Number	Public / NonPublic	Date Visited		Area (sq ft)	Lane Miles *	Surface Type
0913	PUBLIC	11/8/2006		12,735	0.22	AS
Culverts	Drop Inlets	Gates	Fire Hydrants	Curb & Gutter	Curb	PCR
0	0	0	0	NO CURB AND GUTTER	NO CURB	GOOD/90

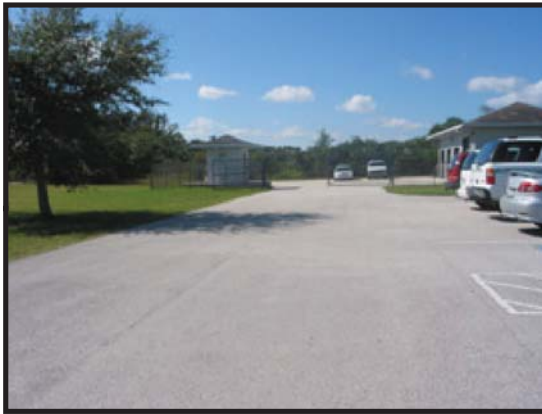
Route Number	Public / NonPublic	Date Visited		Area (sq ft)	Lane Miles *	Surface Type
0914	PUBLIC	11/8/2006		12,926	0.22	AS
Culverts	Drop Inlets	Gates	Fire Hydrants	Curb & Gutter	Curb	PCR
0	0	2	0	NO CURB AND GUTTER	CONCRETE CURB	FAIR/73

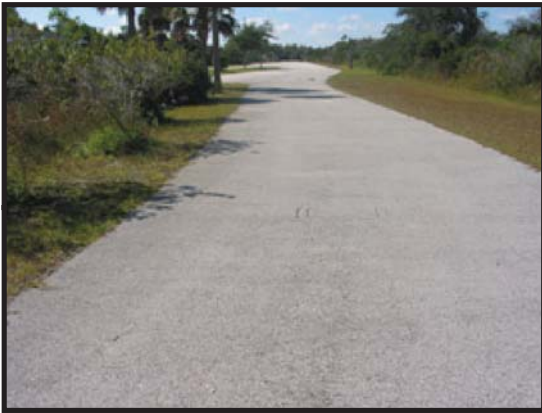
Route Number	Public / NonPublic	Date Visited		Area (sq ft)	Lane Miles *	Surface Type
0915	PUBLIC	11/8/2006		2,794	0.05	AS
Culverts	Drop Inlets	Gates	Fire Hydrants	Curb & Gutter	Curb	PCR
0	0	0	0	NO CURB AND GUTTER	NO CURB	GOOD/90

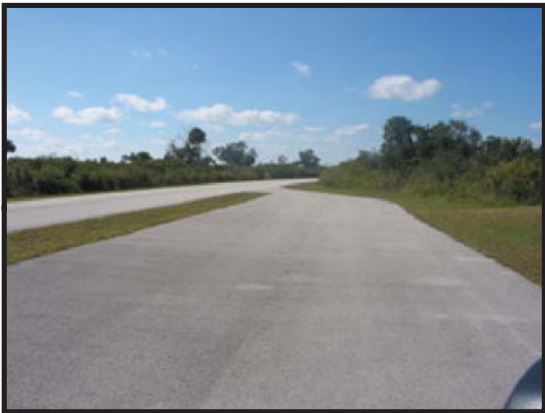
Route Number	Public / NonPublic	Date Visited		Area (sq ft)	Lane Miles *	Surface Type
0916	PUBLIC	11/8/2006		7,408	0.13	AS
Culverts	Drop Inlets	Gates	Fire Hydrants	Curb & Gutter	Curb	PCR
0	0	0	0	NO CURB AND GUTTER	NO CURB	GOOD/90

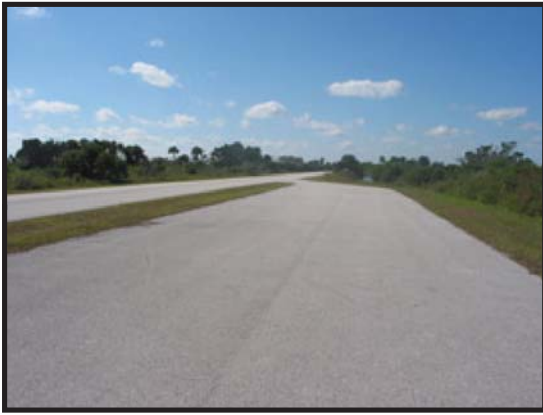
Route Number	Public / NonPublic	Date Visited		Area (sq ft)	Lane Miles *	Surface Type
0917	PUBLIC	11/8/2006		12,272	0.21	AS
Culverts	Drop Inlets	Gates	Fire Hydrants	Curb & Gutter	Curb	PCR
0	0	0	0	NO CURB AND GUTTER	NO CURB	GOOD/90

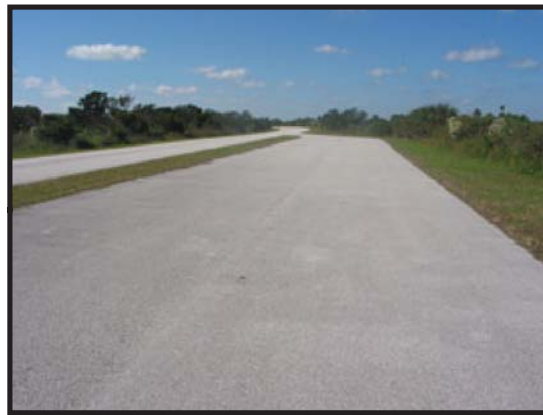
Route Number	Public / NonPublic	Date Visited		Area (sq ft)	Lane Miles *	Surface Type
0918	PUBLIC	11/8/2006		7,849	0.14	AS
Culverts	Drop Inlets	Gates	Fire Hydrants	Curb & Gutter	Curb	PCR
0	0	0	0	NO CURB AND GUTTER	NO CURB	GOOD/90

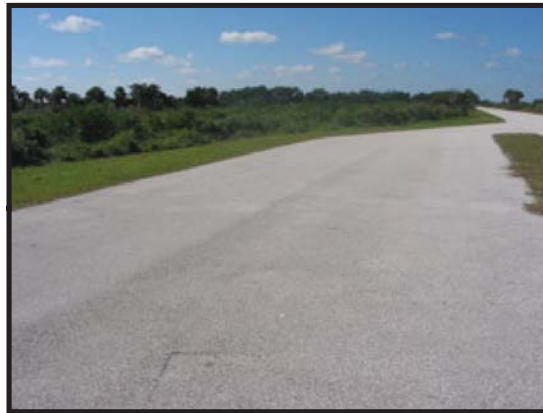
Route Number	Public / NonPublic	Date Visited		Area (sq ft)	Lane Miles *	Surface Type
0919	PUBLIC	11/8/2006		6,359	0.11	AS
Culverts	Drop Inlets	Gates	Fire Hydrants	Curb & Gutter	Curb	PCR
0	0	0	0	NO CURB AND GUTTER	NO CURB	GOOD/90

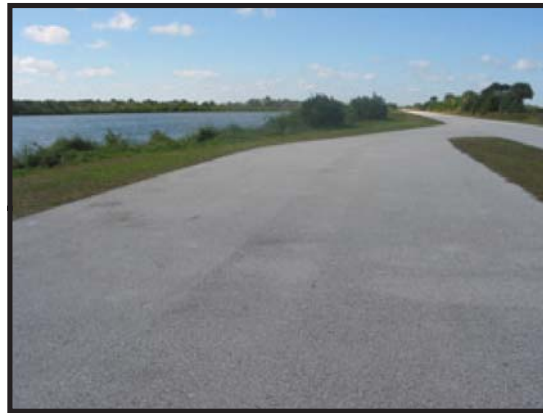
Route Number	Public / NonPublic	Date Visited		Area (sq ft)	Lane Miles *	Surface Type
0920	PUBLIC	11/8/2006		9,642	0.17	AS
Culverts	Drop Inlets	Gates	Fire Hydrants	Curb & Gutter	Curb	PCR
0	0	0	0	NO CURB AND GUTTER	NO CURB	GOOD/90

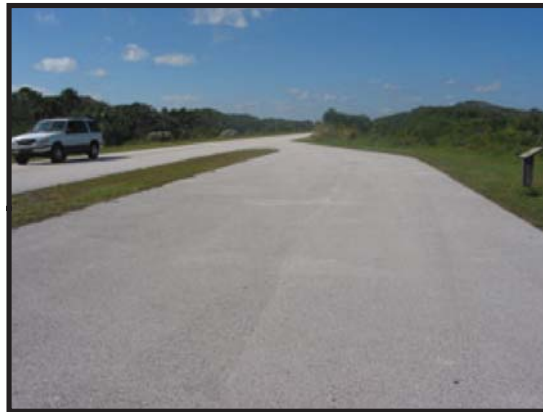
Route Number	Public / NonPublic	Date Visited		Area (sq ft)	Lane Miles *	Surface Type
0921	PUBLIC	11/8/2006		6,298	0.11	AS
Culverts	Drop Inlets	Gates	Fire Hydrants	Curb & Gutter	Curb	PCR
0	0	0	0	NO CURB AND GUTTER	NO CURB	GOOD/90

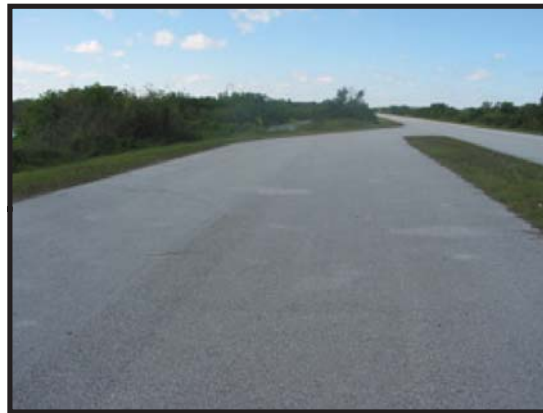
Route Number	Public / NonPublic	Date Visited		Area (sq ft)	Lane Miles *	Surface Type
0922	PUBLIC	11/8/2006		7,931	0.14	AS
Culverts	Drop Inlets	Gates	Fire Hydrants	Curb & Gutter	Curb	PCR
0	0	0	0	NO CURB AND GUTTER	NO CURB	GOOD/90

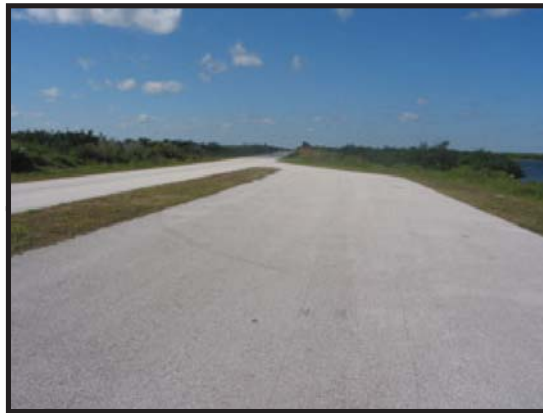
Route Number	Public / NonPublic	Date Visited		Area (sq ft)	Lane Miles *	Surface Type
0923	PUBLIC	11/8/2006		5,901	0.10	AS
Culverts	Drop Inlets	Gates	Fire Hydrants	Curb & Gutter	Curb	PCR
0	0	0	0	NO CURB AND GUTTER	NO CURB	GOOD/90

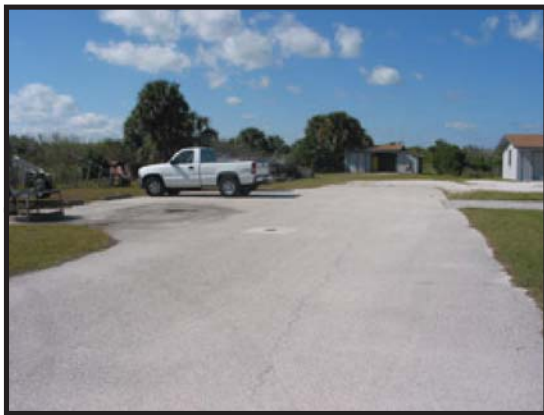
Route Number	Public / NonPublic	Date Visited		Area (sq ft)	Lane Miles *	Surface Type
0924	PUBLIC	11/8/2006		5,438	0.09	AS
Culverts	Drop Inlets	Gates	Fire Hydrants	Curb & Gutter	Curb	PCR
0	0	0	0	NO CURB AND GUTTER	NO CURB	POOR/45

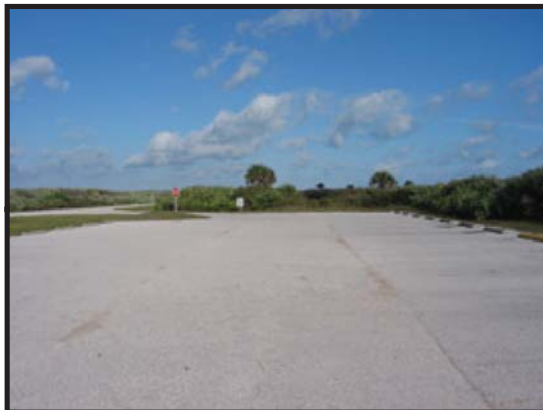
Route Number	Public / NonPublic	Date Visited		Area (sq ft)	Lane Miles *	Surface Type
0932	PUBLIC	11/8/2006		12,833	0.22	AS
Culverts	Drop Inlets	Gates	Fire Hydrants	Curb & Gutter	Curb	PCR
0	0	0	0	NO CURB AND GUTTER	NO CURB	FAIR/73

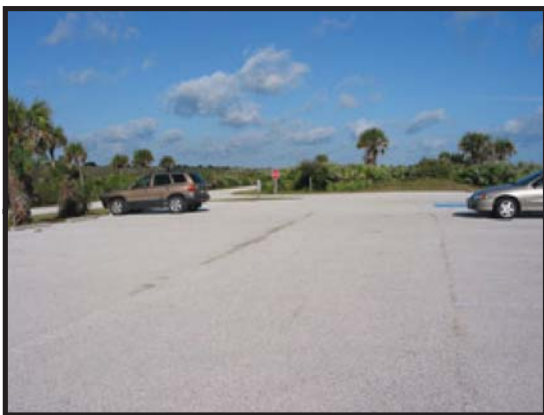
Route Number	Public / NonPublic	Date Visited		Area (sq ft)	Lane Miles *	Surface Type
0933	PUBLIC	11/8/2006		12,977	0.22	AS
Culverts	Drop Inlets	Gates	Fire Hydrants	Curb & Gutter	Curb	PCR
0	0	0	0	NO CURB AND GUTTER	NO CURB	FAIR/73

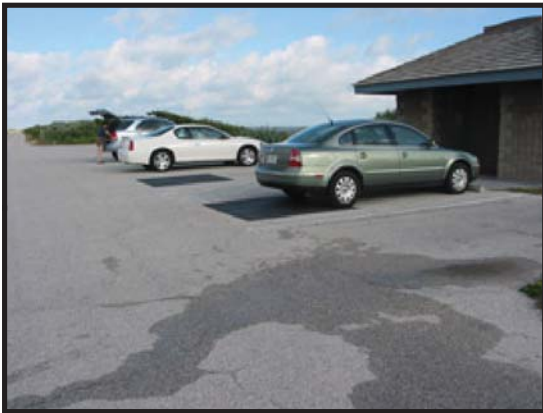
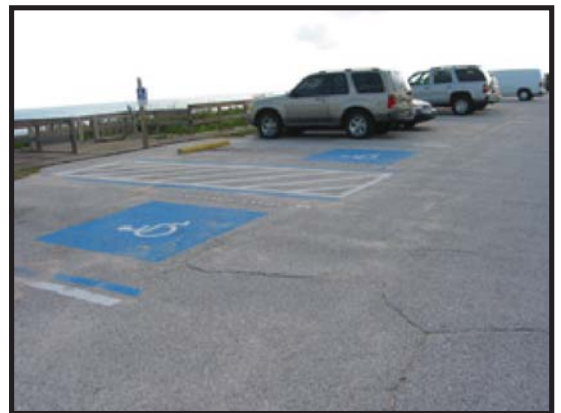
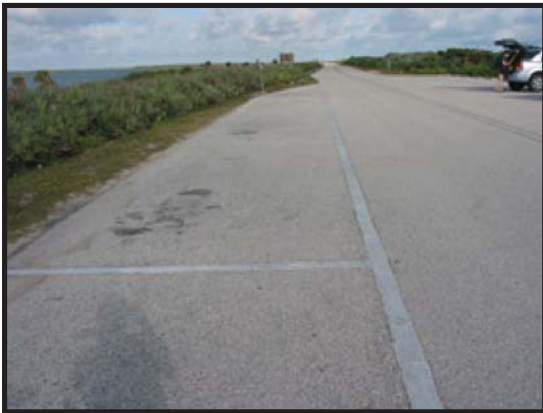
Route Number	Public / NonPublic	Date Visited		Area (sq ft)	Lane Miles *	Surface Type
0935	PUBLIC	11/8/2006		7,425	0.13	AS
Culverts	Drop Inlets	Gates	Fire Hydrants	Curb & Gutter	Curb	PCR
0	0	0	0	NO CURB AND GUTTER	NO CURB	FAIR/73

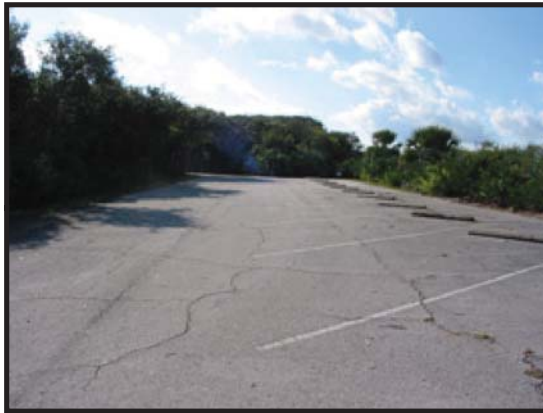
## Route 0936

Route Number	Public / NonPublic	Date Visited		Area (sq ft)	Lane Miles *	Surface Type
0936	PUBLIC	11/8/2006		9,332	0.16	AS
Culverts	Drop Inlets	Gates	Fire Hydrants	Curb & Gutter	Curb	PCR
0	0	0	0	NO CURB AND GUTTER	NO CURB	POOR/45

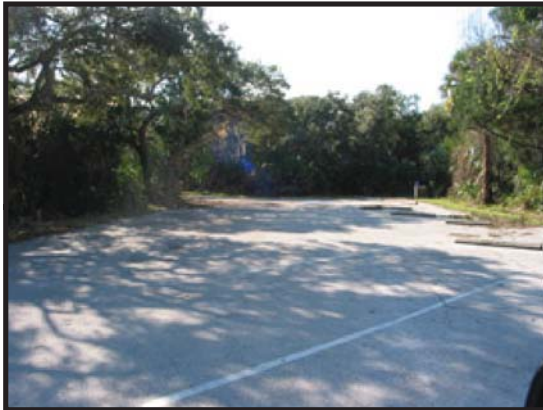
## Route 0937

Route Number	Public / NonPublic	Date Visited		Area (sq ft)	Lane Miles *	Surface Type
0937	PUBLIC	11/8/2006		10,654	0.18	AS
Culverts	Drop Inlets	Gates	Fire Hydrants	Curb & Gutter	Curb	PCR
0	0	0	0	NO CURB AND GUTTER	NO CURB	POOR/45

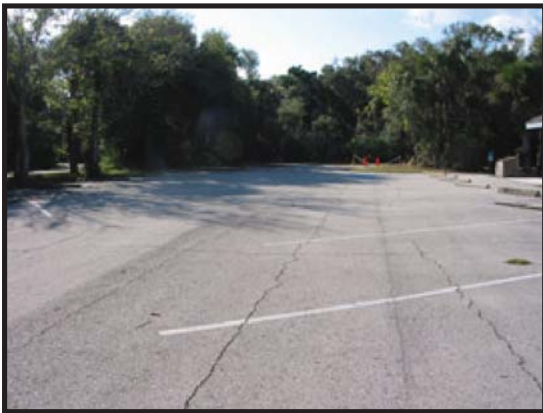
## Route 0938

Route Number	Public / NonPublic	Date Visited		Area (sq ft)	Lane Miles *	Surface Type
0938	PUBLIC	11/8/2006		13,550	0.23	AS
Culverts	Drop Inlets	Gates	Fire Hydrants	Curb & Gutter	Curb	PCR
0	0	1	0	NO CURB AND GUTTER	NO CURB	POOR/45

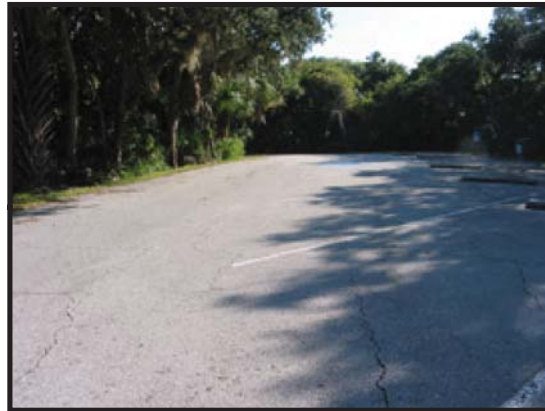
## Route 0939

Route Number	Public / NonPublic	Date Visited		Area (sq ft)	Lane Miles *	Surface Type
0939	PUBLIC	11/8/2006		8,870	0.15	AS
Culverts	Drop Inlets	Gates	Fire Hydrants	Curb & Gutter	Curb	PCR
0	0	0	0	NO CURB AND GUTTER	NO CURB	POOR/45

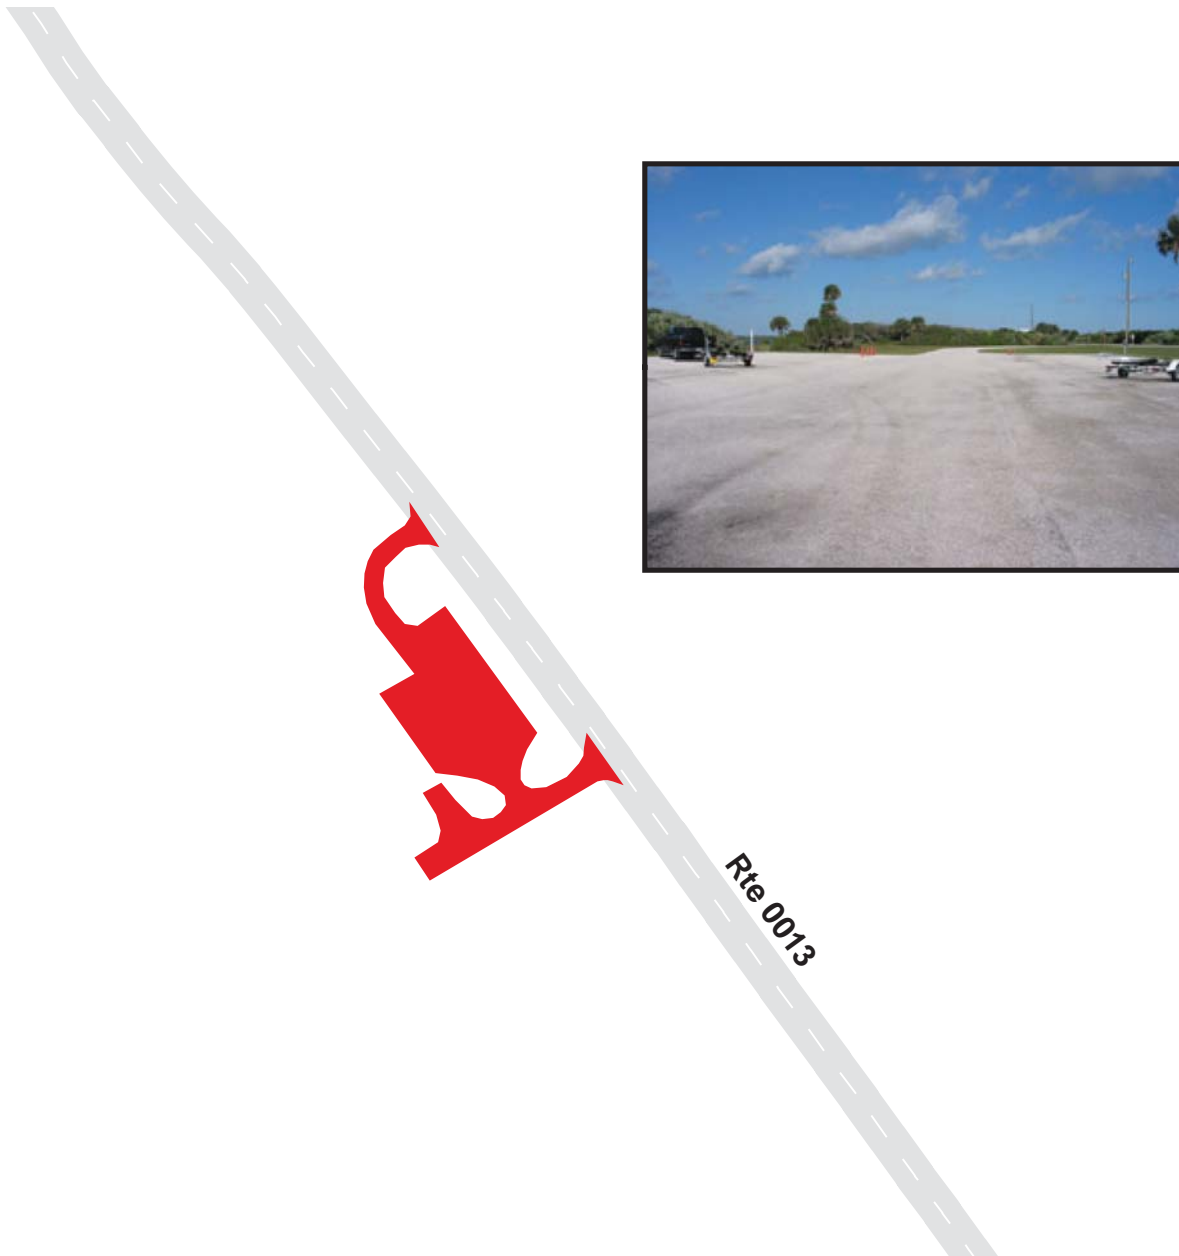
Route Number	Public / NonPublic	Date Visited		Area (sq ft)	Lane Miles *	Surface Type
0940	PUBLIC	11/8/2006		55,100	0.95	AS
Culverts	Drop Inlets	Gates	Fire Hydrants	Curb & Gutter	Curb	PCR
0	0	0	0	NO CURB AND GUTTER	NO CURB	FAIR/73

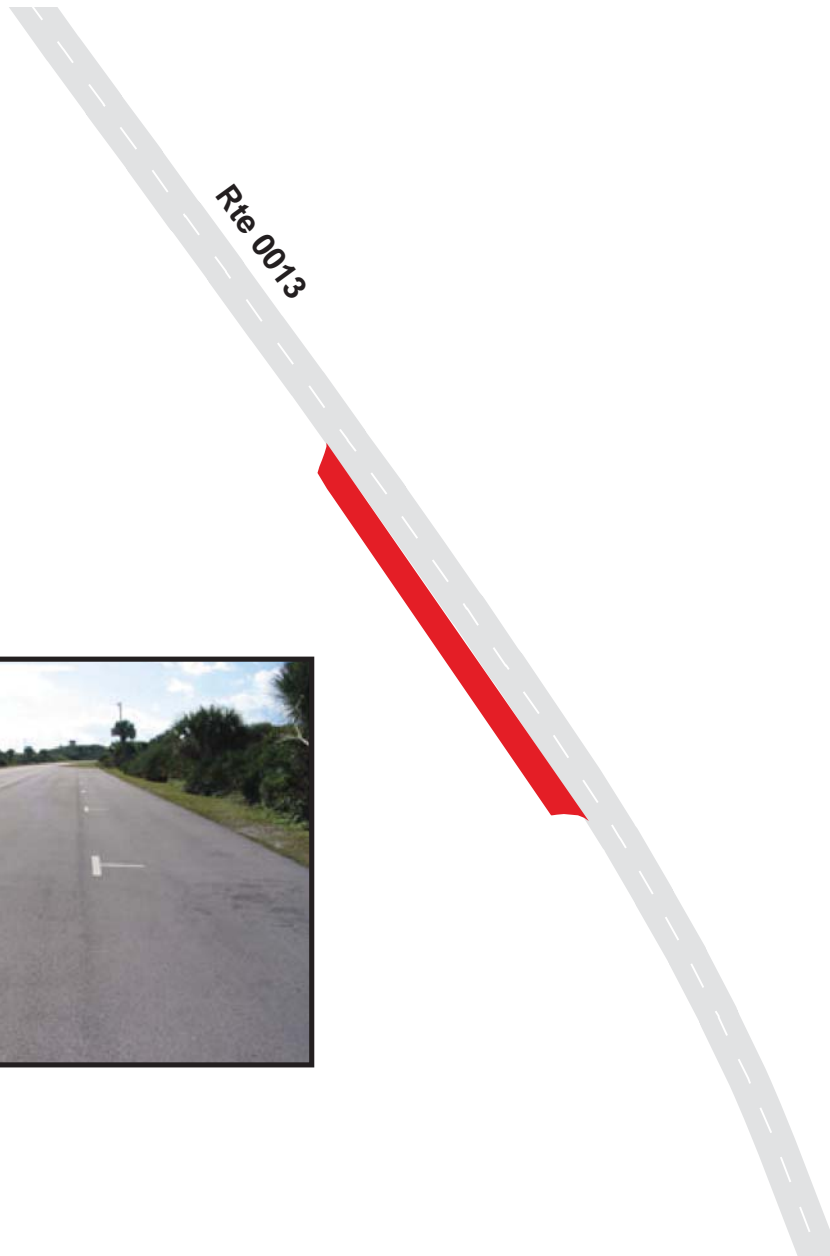
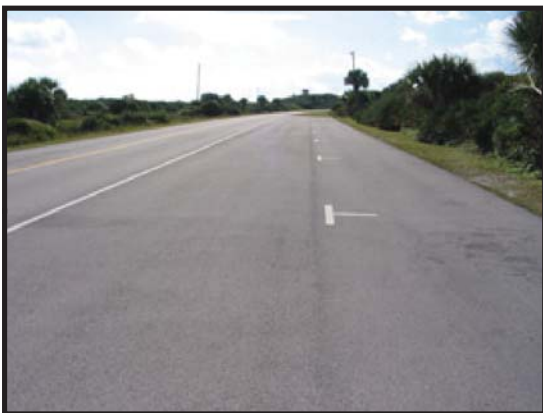
## Route 0941

Route Number	Public / NonPublic	Date Visited		Area (sq ft)	Lane Miles *	Surface Type
0941	PUBLIC	11/8/2006		6,356	0.11	AS
Culverts	Drop Inlets	Gates	Fire Hydrants	Curb & Gutter	Curb	PCR
0	0	0	0	NO CURB AND GUTTER	NO CURB	GOOD/90

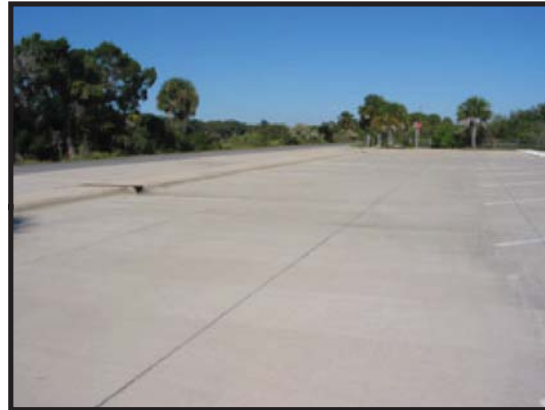
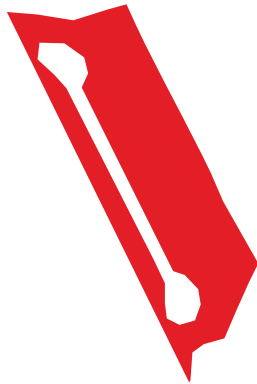
## Route 0942

Route Number	Public / NonPublic	Date Visited		Area (sq ft)	Lane Miles *	Surface Type
0942	PUBLIC	11/8/2006		15,082	0.26	CO
Culverts	Drop Inlets	Gates	Fire Hydrants	Curb & Gutter	Curb	PCR
0	2	2	0	CONCRETE CURB AND GUTTER	NO CURB	GOOD/90
