**The Road Inventory  
of  
Colorado National Monument  
COLM – 1378  
Cycle 4**

**Prepared By:  
Federal Highway Administration  
Road Inventory Program  
Cycle 4**

# Colorado National Monument in Colorado

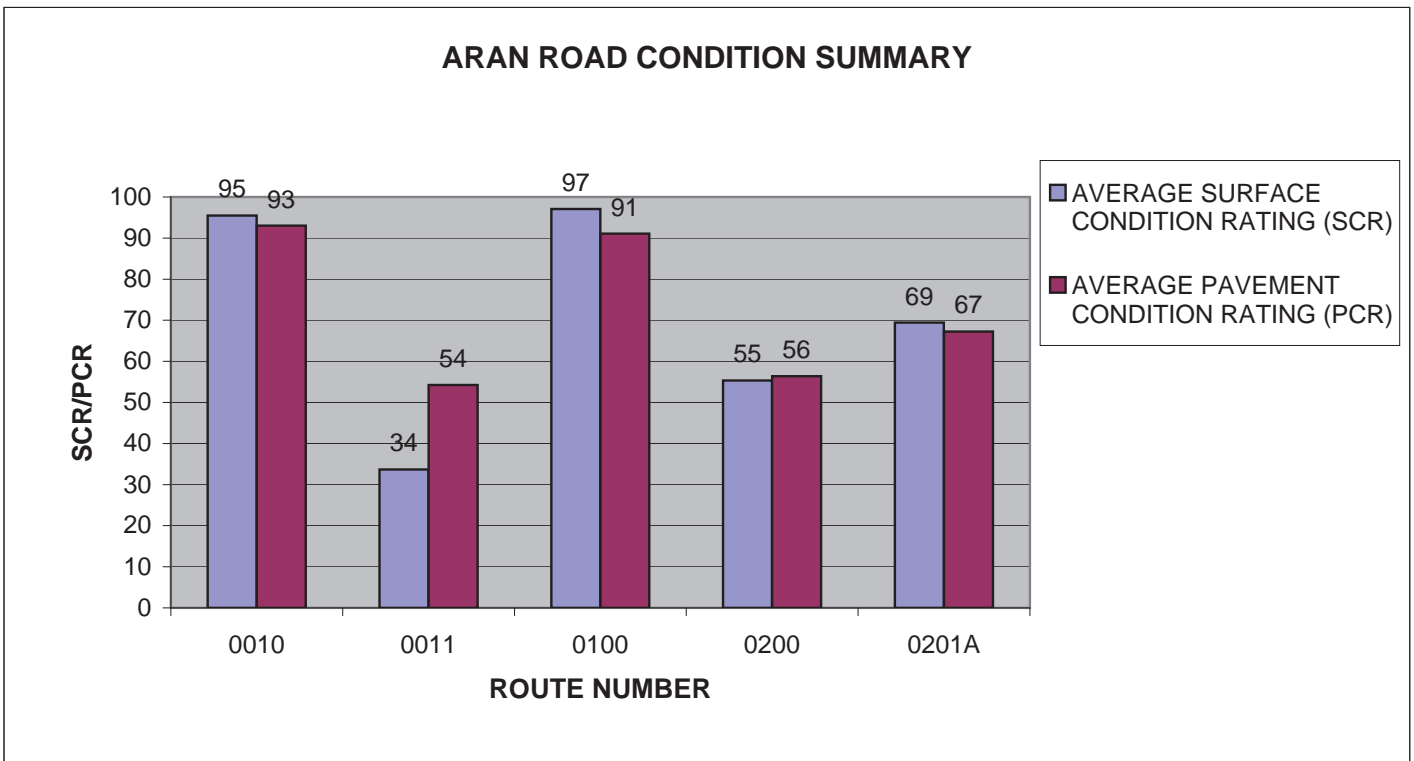
ROUTE NUMBER	ROUTE NAME	FUNCT CLASS	ROUTE LENGTH	SURFACE TYPE	AVERAGE SURFACE CONDITION RATING (SCR)	AVERAGE PAVEMENT CONDITION RATING (PCR)
0010	RIMROCK DRIVE	1	22.48	ASPHALT	95	93
0011	EAST GLADE PARK ROAD	1	0.71	ASPHALT	34	54
0100	WEST GLADE PARK ROAD	2	0.13	ASPHALT	97	91
0200	SADDLEHORN LOOP ROAD	3	0.94	ASPHALT	55	56
0201A	SADDLEHORN CAMPGROUND LOOP A	3	0.22	ASPHALT	69	67

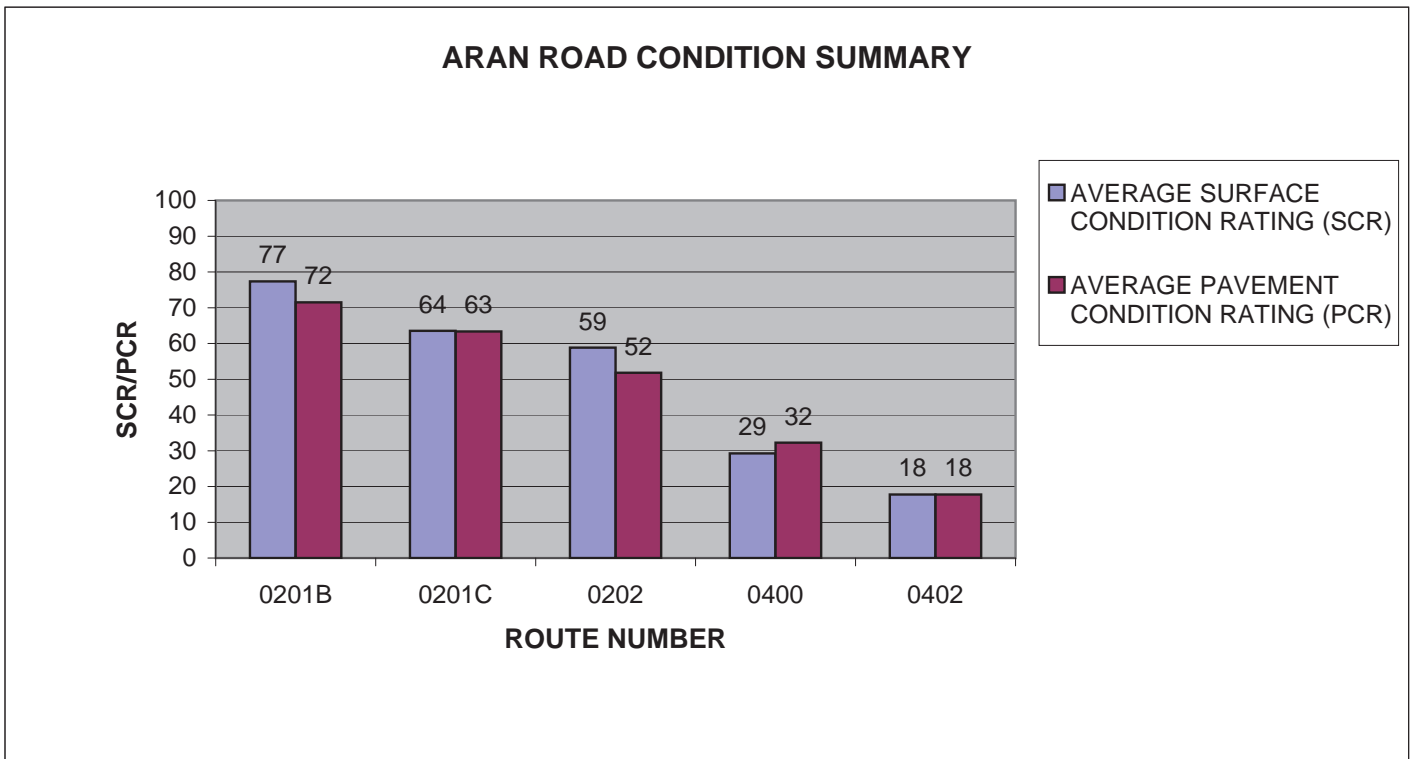
ROUTE NUMBER	ROUTE NAME	FUNCT CLASS	ROUTE LENGTH	SURFACE TYPE	AVERAGE SURFACE CONDITION RATING (SCR)	AVERAGE PAVEMENT CONDITION RATING (PCR)
0201B	SADDLEHORN CAMPGROUND LOOP B	3	0.28	ASPHALT	77	72
0201C	SADDLEHORN CAMPGROUND LOOP C	3	0.26	ASPHALT	64	63
0202	DEVIL'S KITCHEN PICNIC AREA ROAD	3	0.11	ASPHALT	59	52
0400	SADDLEHORN MAINTENANCE/RESIDENCE ROAD	6	0.33	ASPHALT	29	32
0402	EAST SHOP ROAD	6	0.11	ASPHALT	18	18

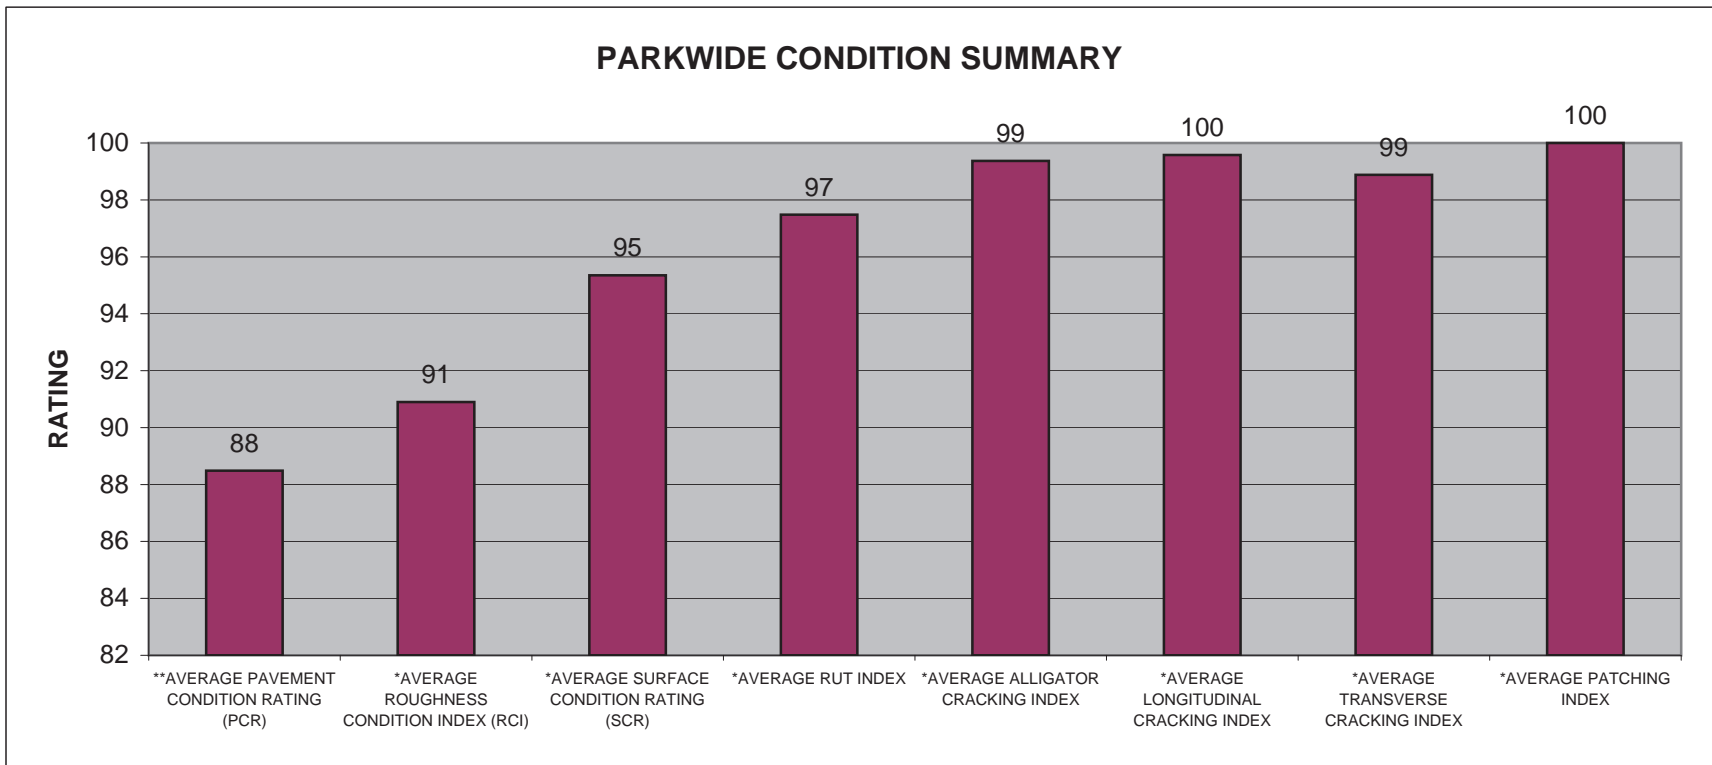
# COLM: PARKWIDE CONDITION SUMMARY

**AVERAGE PAVEMENT CONDITION RATING (PCR)	*AVERAGE ROUGHNESS CONDITION INDEX (RCI)	*AVERAGE SURFACE CONDITION RATING (SCR)	*AVERAGE RUT INDEX	*AVERAGE ALLIGATOR CRACKING INDEX	*AVERAGE LONGITUDINAL CRACKING INDEX	*AVERAGE TRANSVERSE CRACKING INDEX	*AVERAGE PATCHING INDEX
88	91	95	97	99	100	99	100

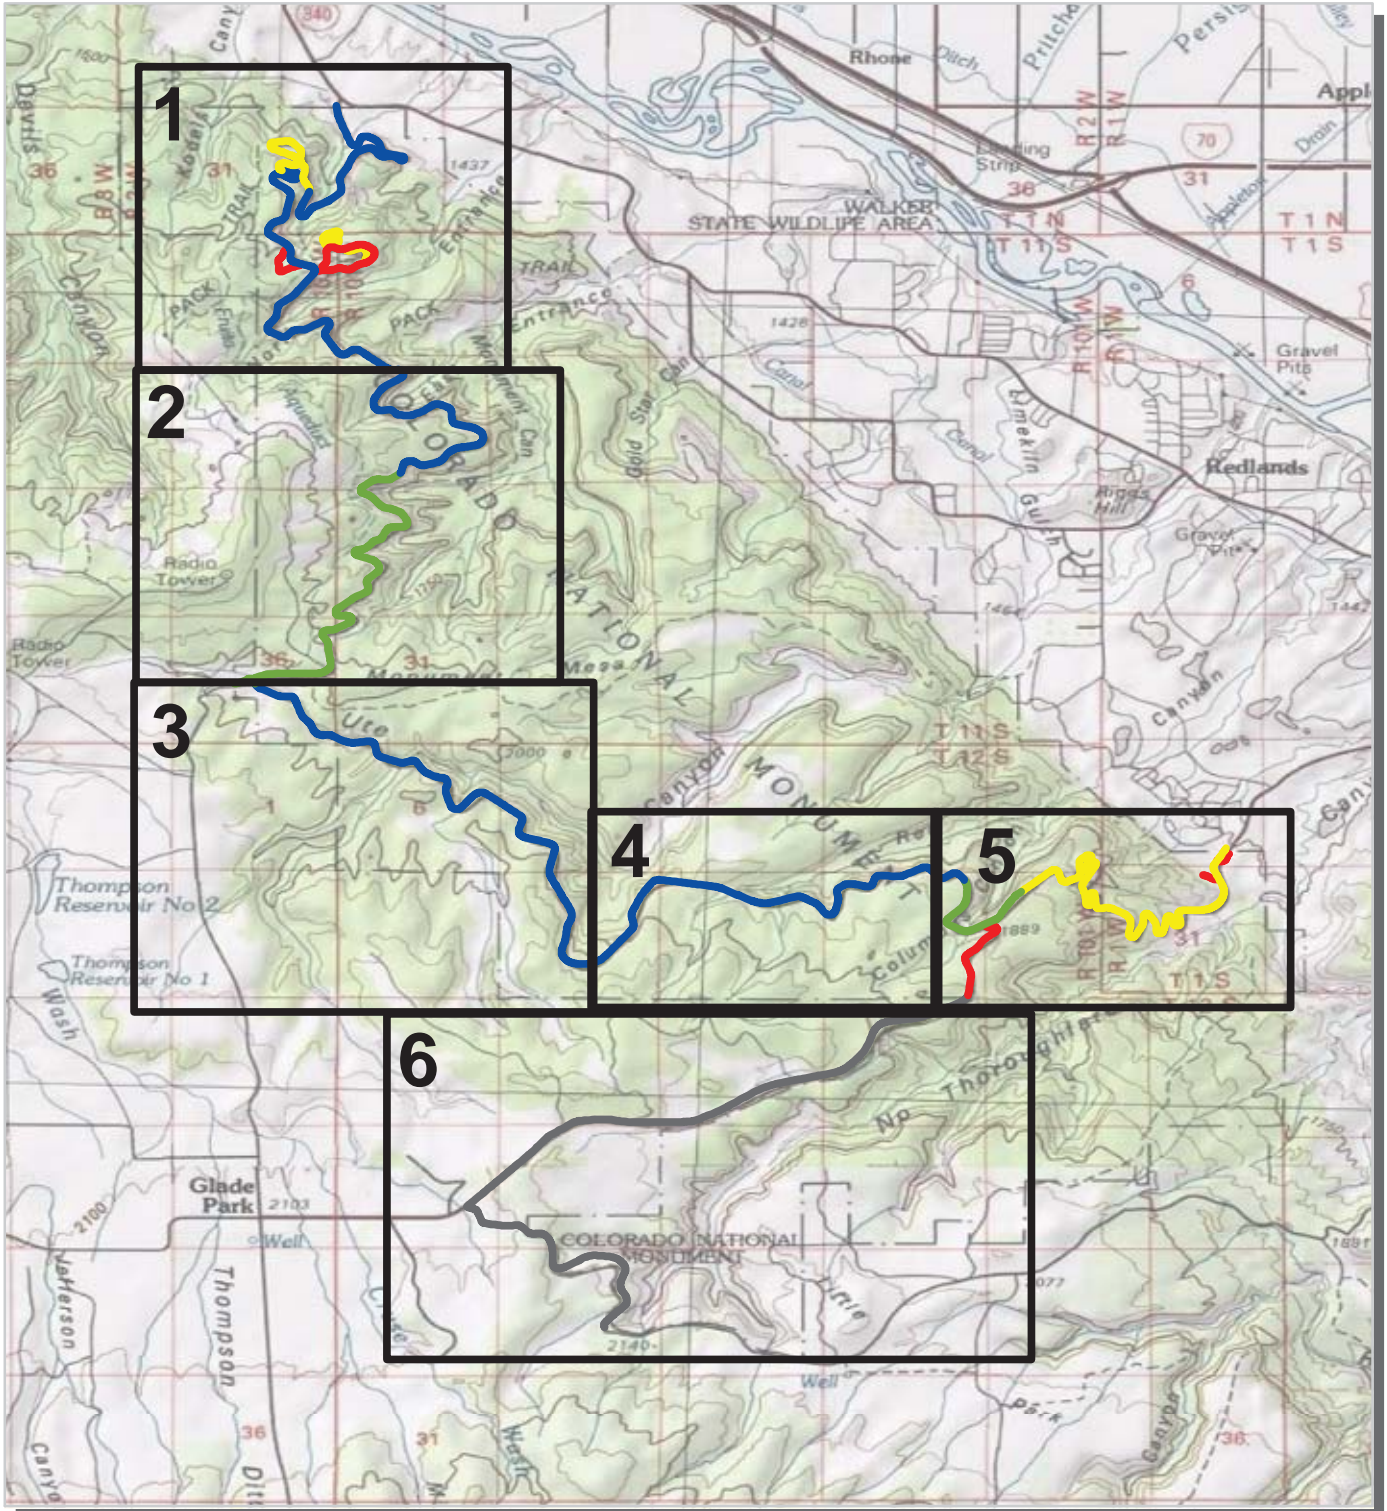
### Key Map

PCR	Poor	Fair	Good	Excellent	No Data
	(≤60)	(61 - 84)	(85 - 94)	(95 - 100)

\* If the PCR rating is not available for a section, the SCR rating will be displayed. See appendix for definitions and formulas.

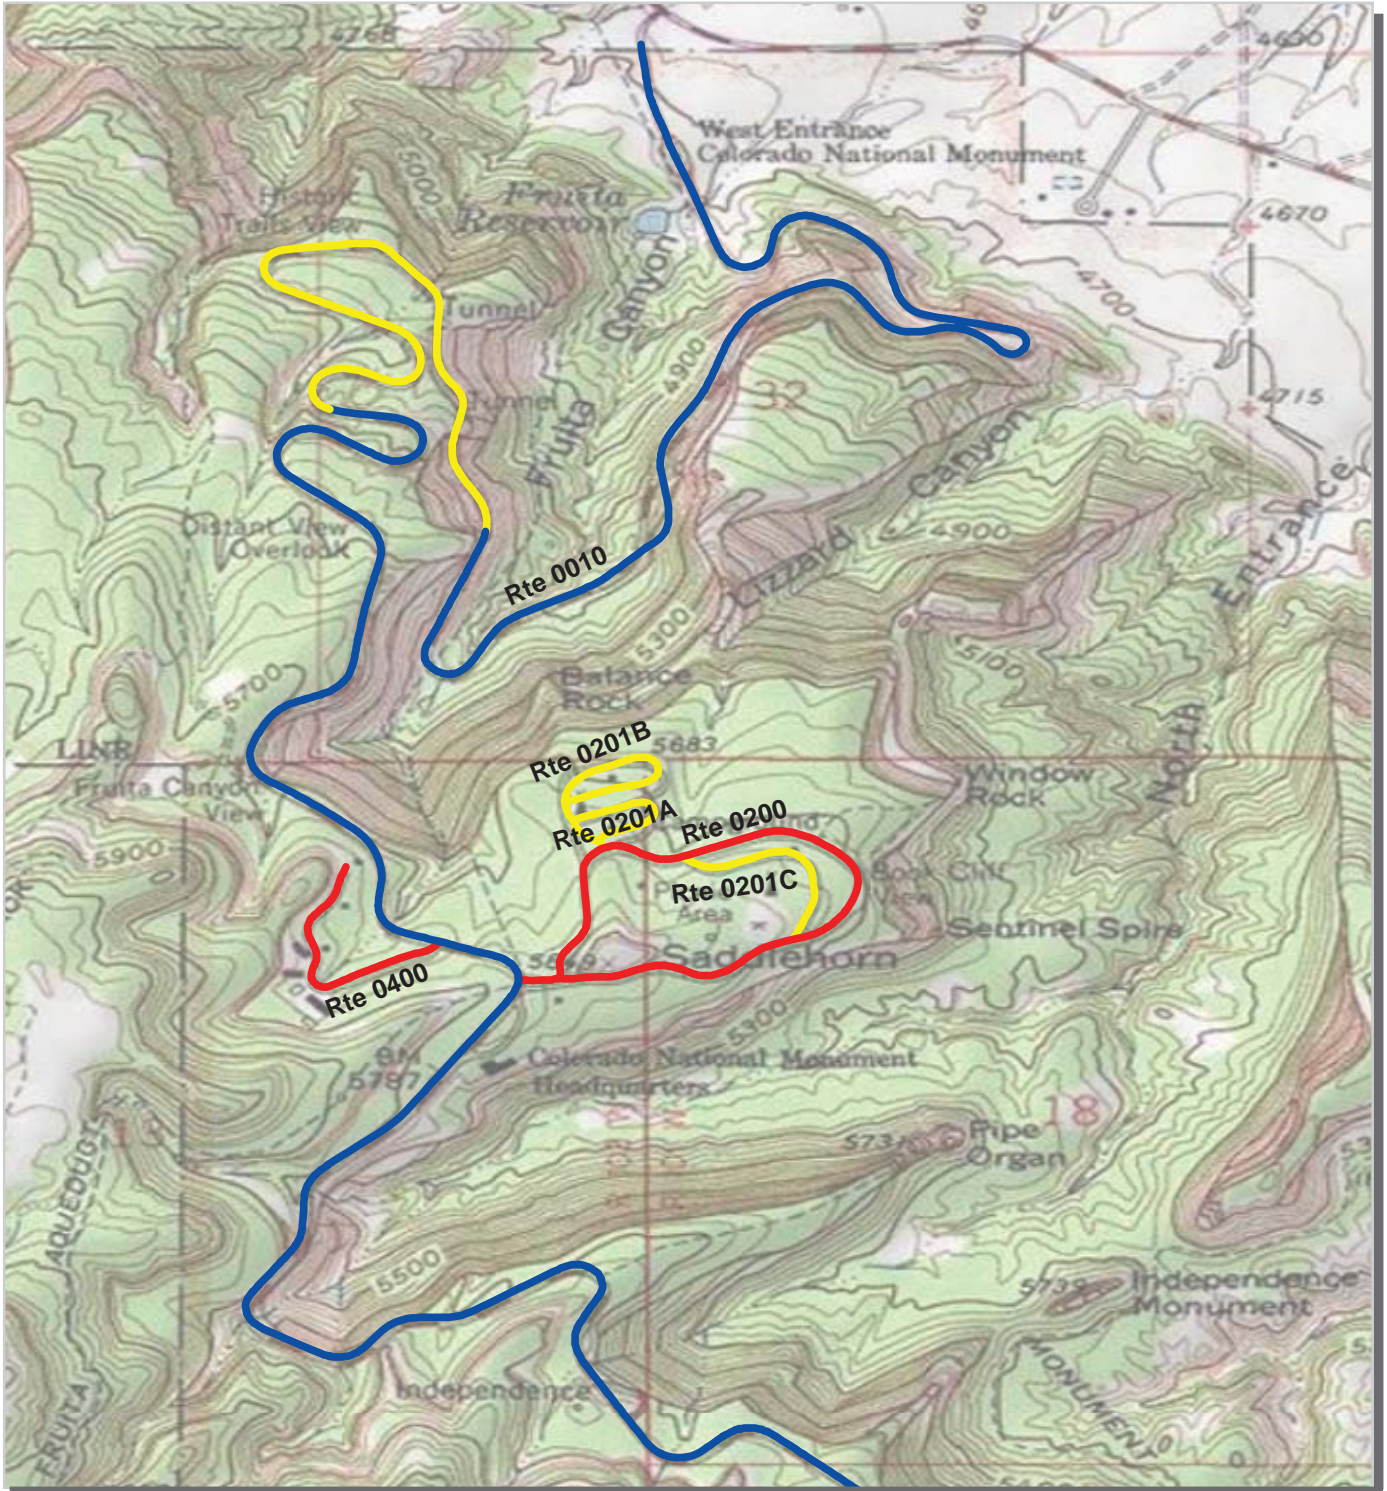
# Colorado National Monument Route Condition Map PCR - Mile by Mile Area 1

PCR	Poor	Fair	Good	Excellent	No Data
	<span style="color: red;">■</span>	<span style="color: yellow;">■</span>	<span style="color: green;">■</span>	<span style="color: blue;">■</span>	<span style="color: black;">■</span>
	(<=60)	(61 - 84)	(85 - 94)	(95 - 100)

\* If the PCR rating is not available for a section, the SCR rating will be displayed. See appendix for definitions and formulas.

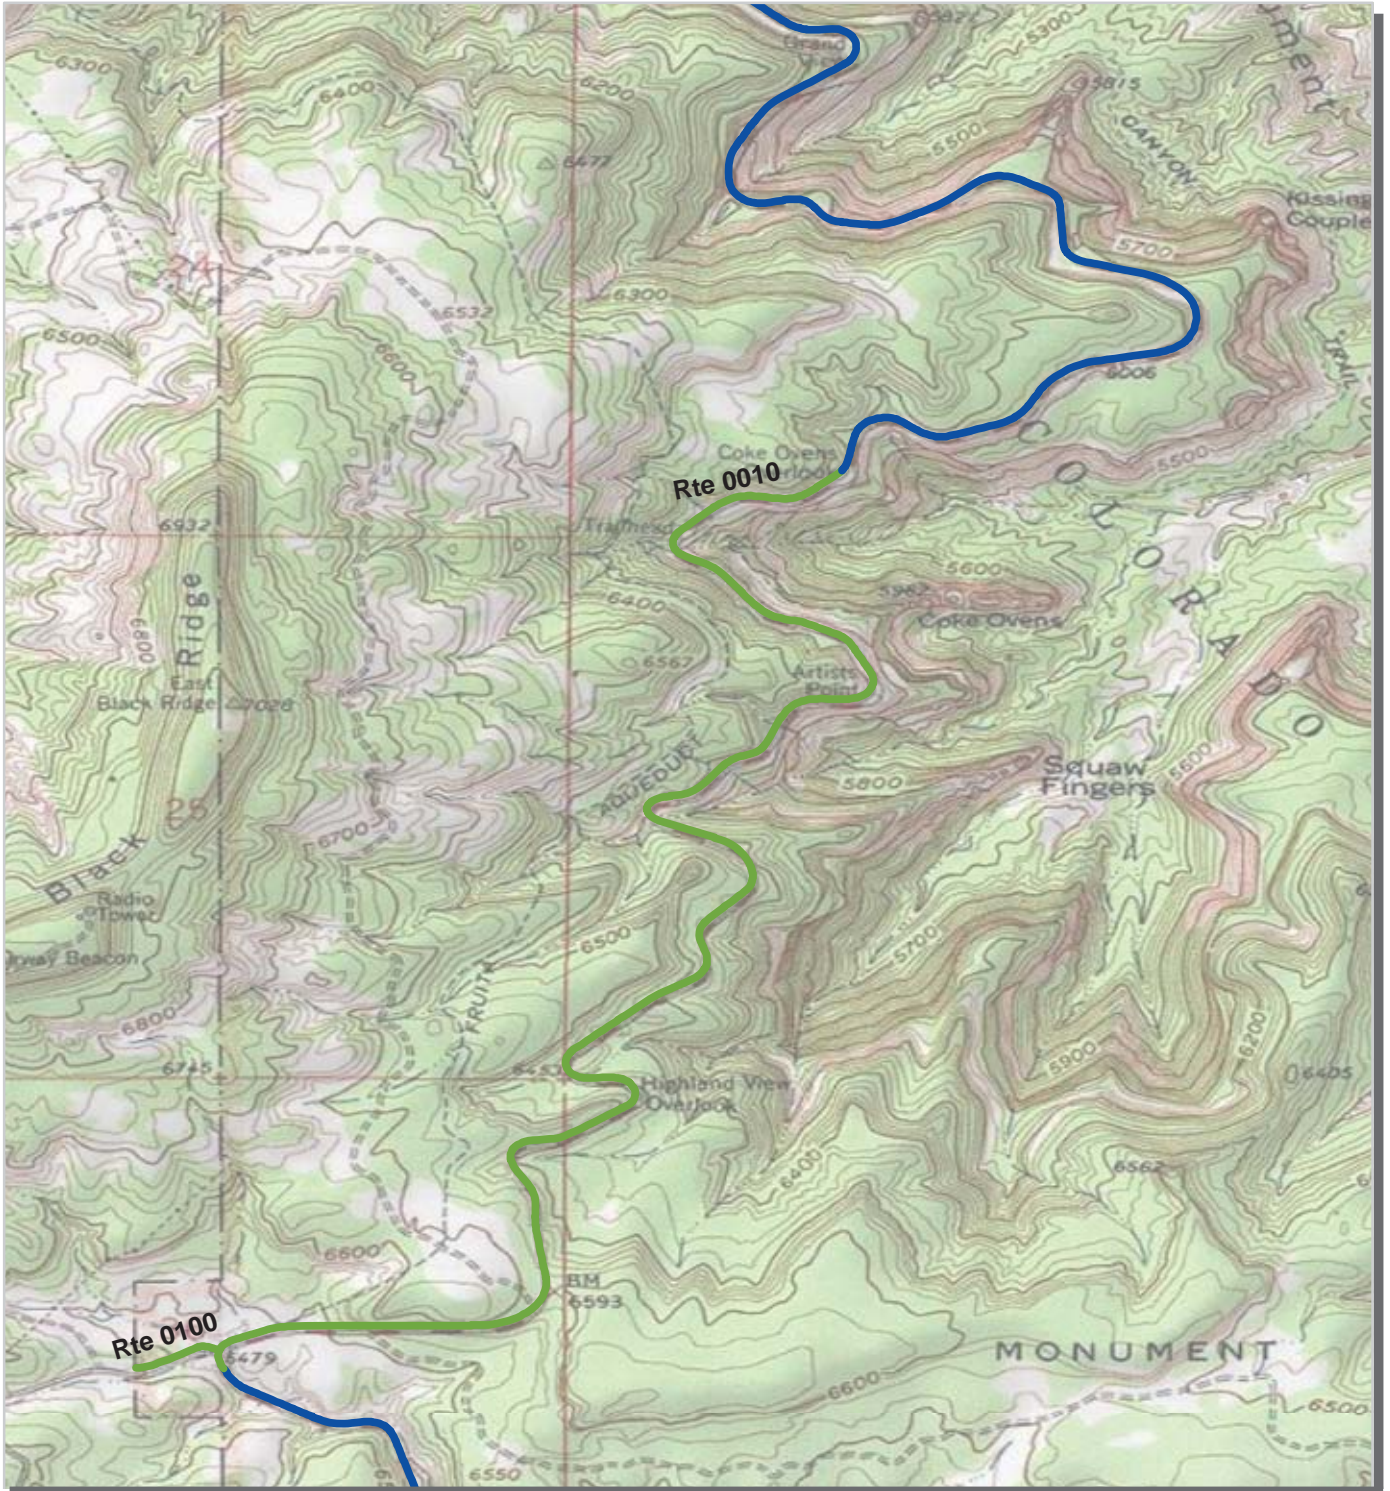
#### Area 2

PCR	Poor	<span style="display: inline-block; width: 20px; height: 10px; background-color: red; border: 1px solid black;"></span>	Fair	<span style="display: inline-block; width: 20px; height: 10px; background-color: yellow; border: 1px solid black;"></span>	Good	<span style="display: inline-block; width: 20px; height: 10px; background-color: green; border: 1px solid black;"></span>	Excellent	<span style="display: inline-block; width: 20px; height: 10px; background-color: blue; border: 1px solid black;"></span>	No Data	<span style="display: inline-block; width: 20px; height: 10px; background-color: black; border: 1px solid black;"></span>
	(<=60)		(61 - 84)		(85 - 94)		(95 - 100)

\* If the PCR rating is not available for a section, the SCR rating will be displayed. See appendix for definitions and formulas.

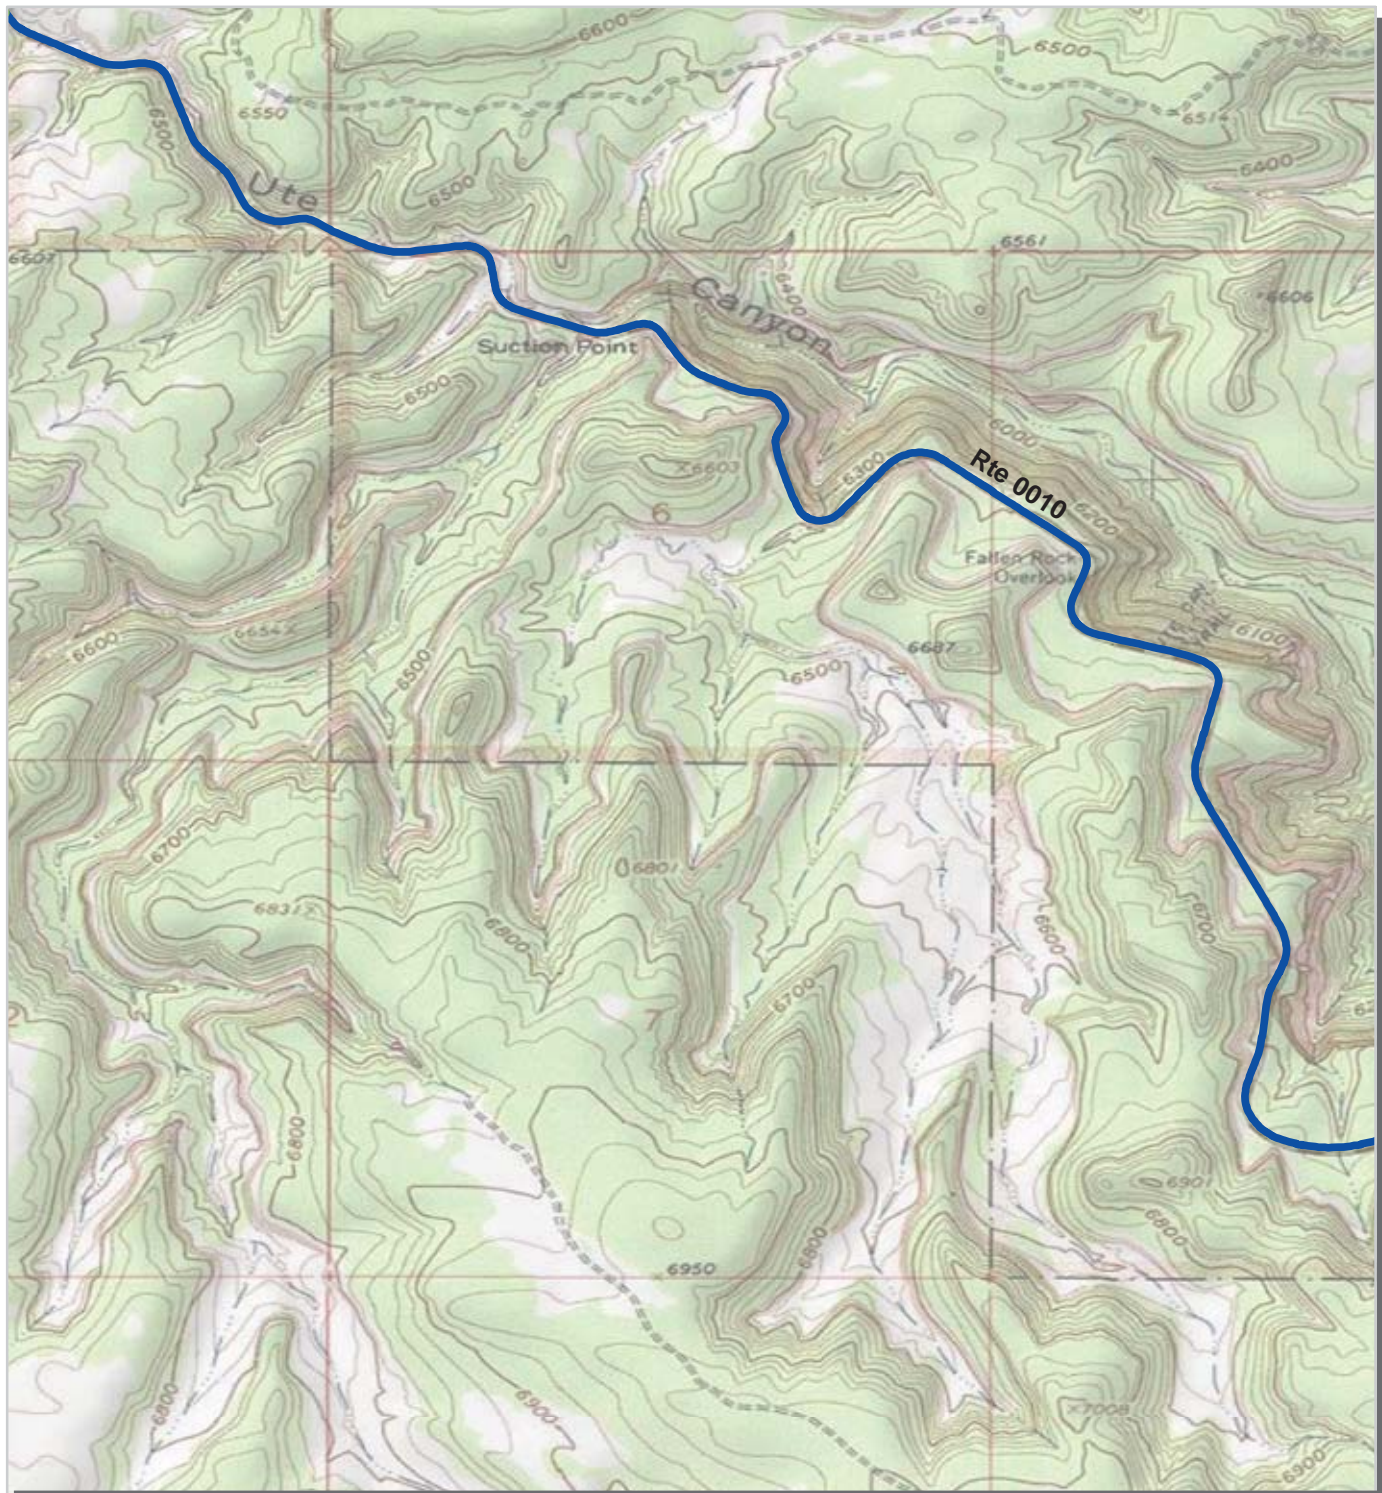
#### Area 3

PCR	Poor	<span style="display: inline-block; width: 20px; height: 10px; background-color: red; border: 1px solid black;"></span>	Fair	<span style="display: inline-block; width: 20px; height: 10px; background-color: yellow; border: 1px solid black;"></span>	Good	<span style="display: inline-block; width: 20px; height: 10px; background-color: green; border: 1px solid black;"></span>	Excellent	<span style="display: inline-block; width: 20px; height: 10px; background-color: blue; border: 1px solid black;"></span>	No Data	<span style="display: inline-block; width: 20px; height: 10px; background-color: black; border: 1px solid black;"></span>
	(<=60)		(61 - 84)	(85 - 94)	(95 - 100)

\* If the PCR rating is not available for a section, the SCR rating will be displayed. See appendix for definitions and formulas.

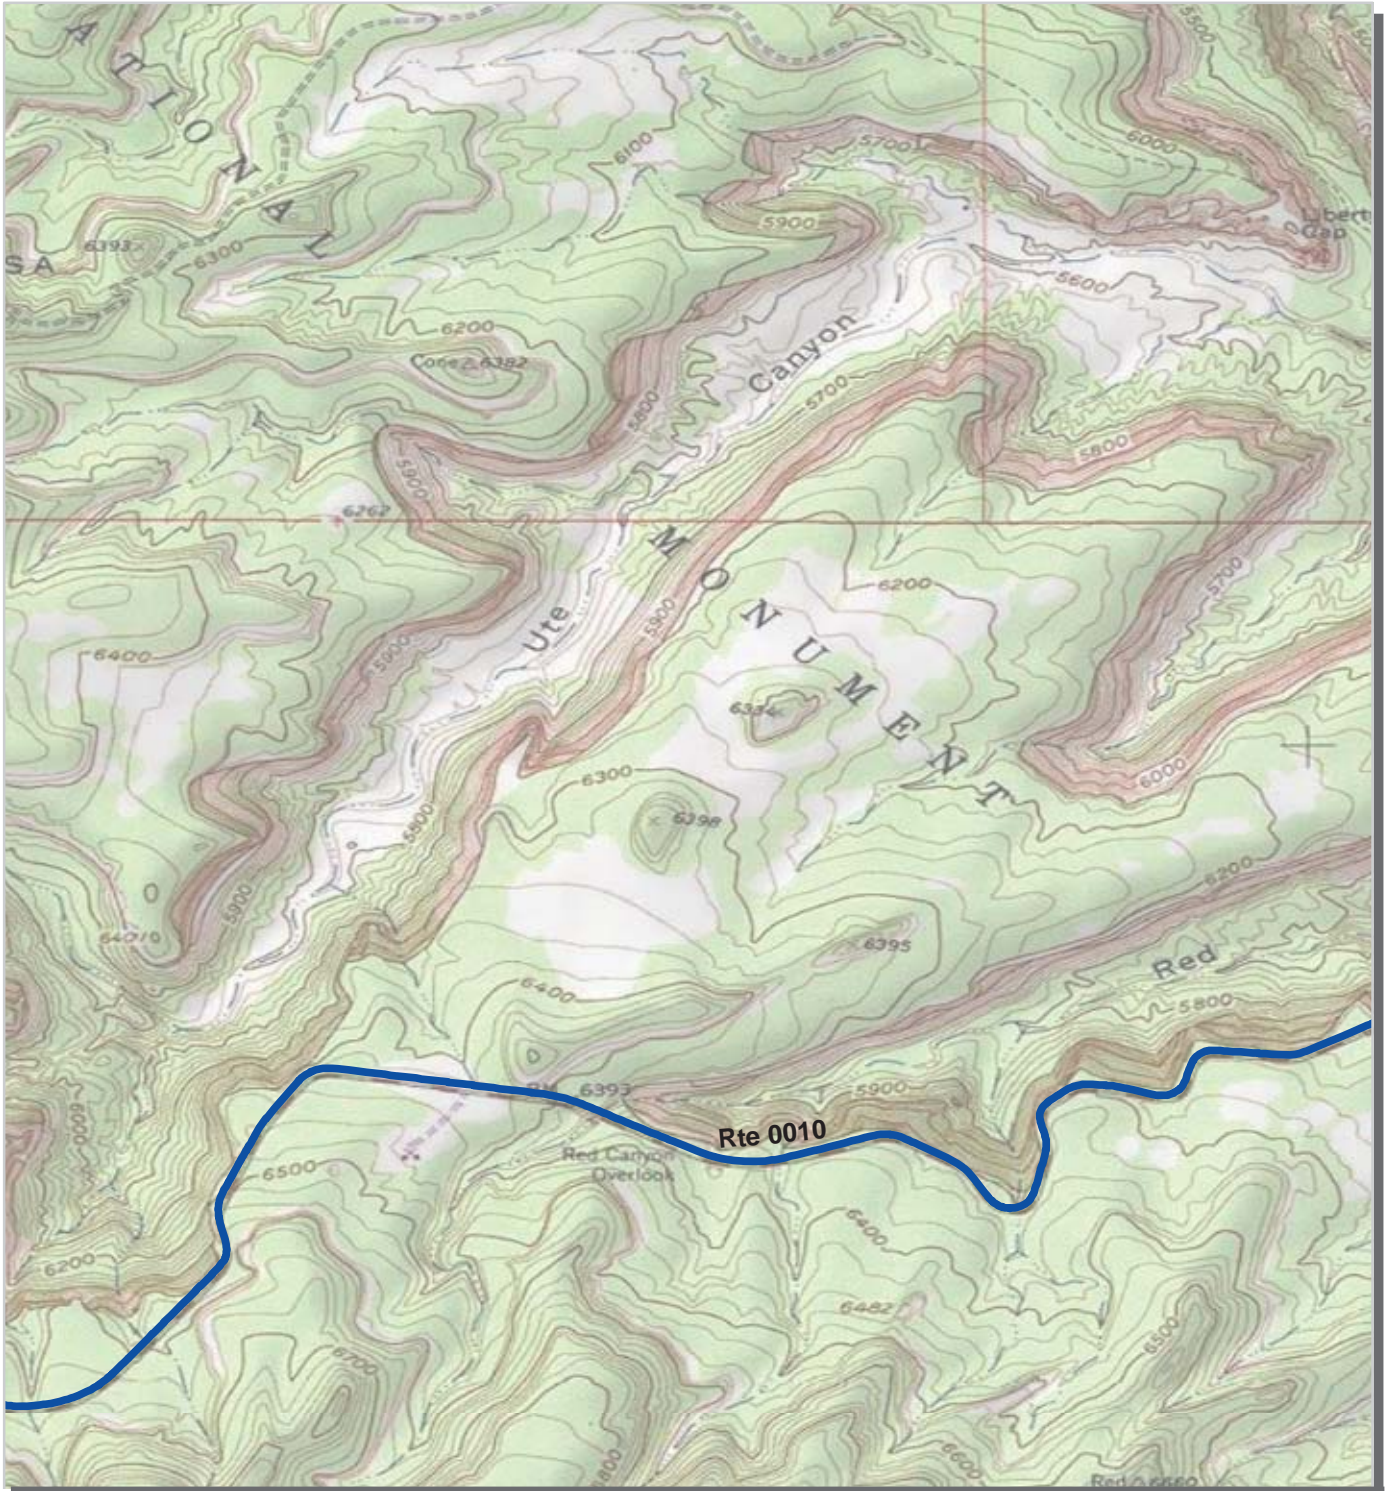
#### Area 4

PCR	Poor	Fair	Good	Excellent	No Data
	<span style="color: red;">■</span>	<span style="color: yellow;">■</span>	<span style="color: green;">■</span>	<span style="color: blue;">■</span>	<span style="color: black;">■</span>
	(<=60)	(61 - 84)	(85 - 94)	(95 - 100)

\* If the PCR rating is not available for a section, the SCR rating will be displayed. See appendix for definitions and formulas.

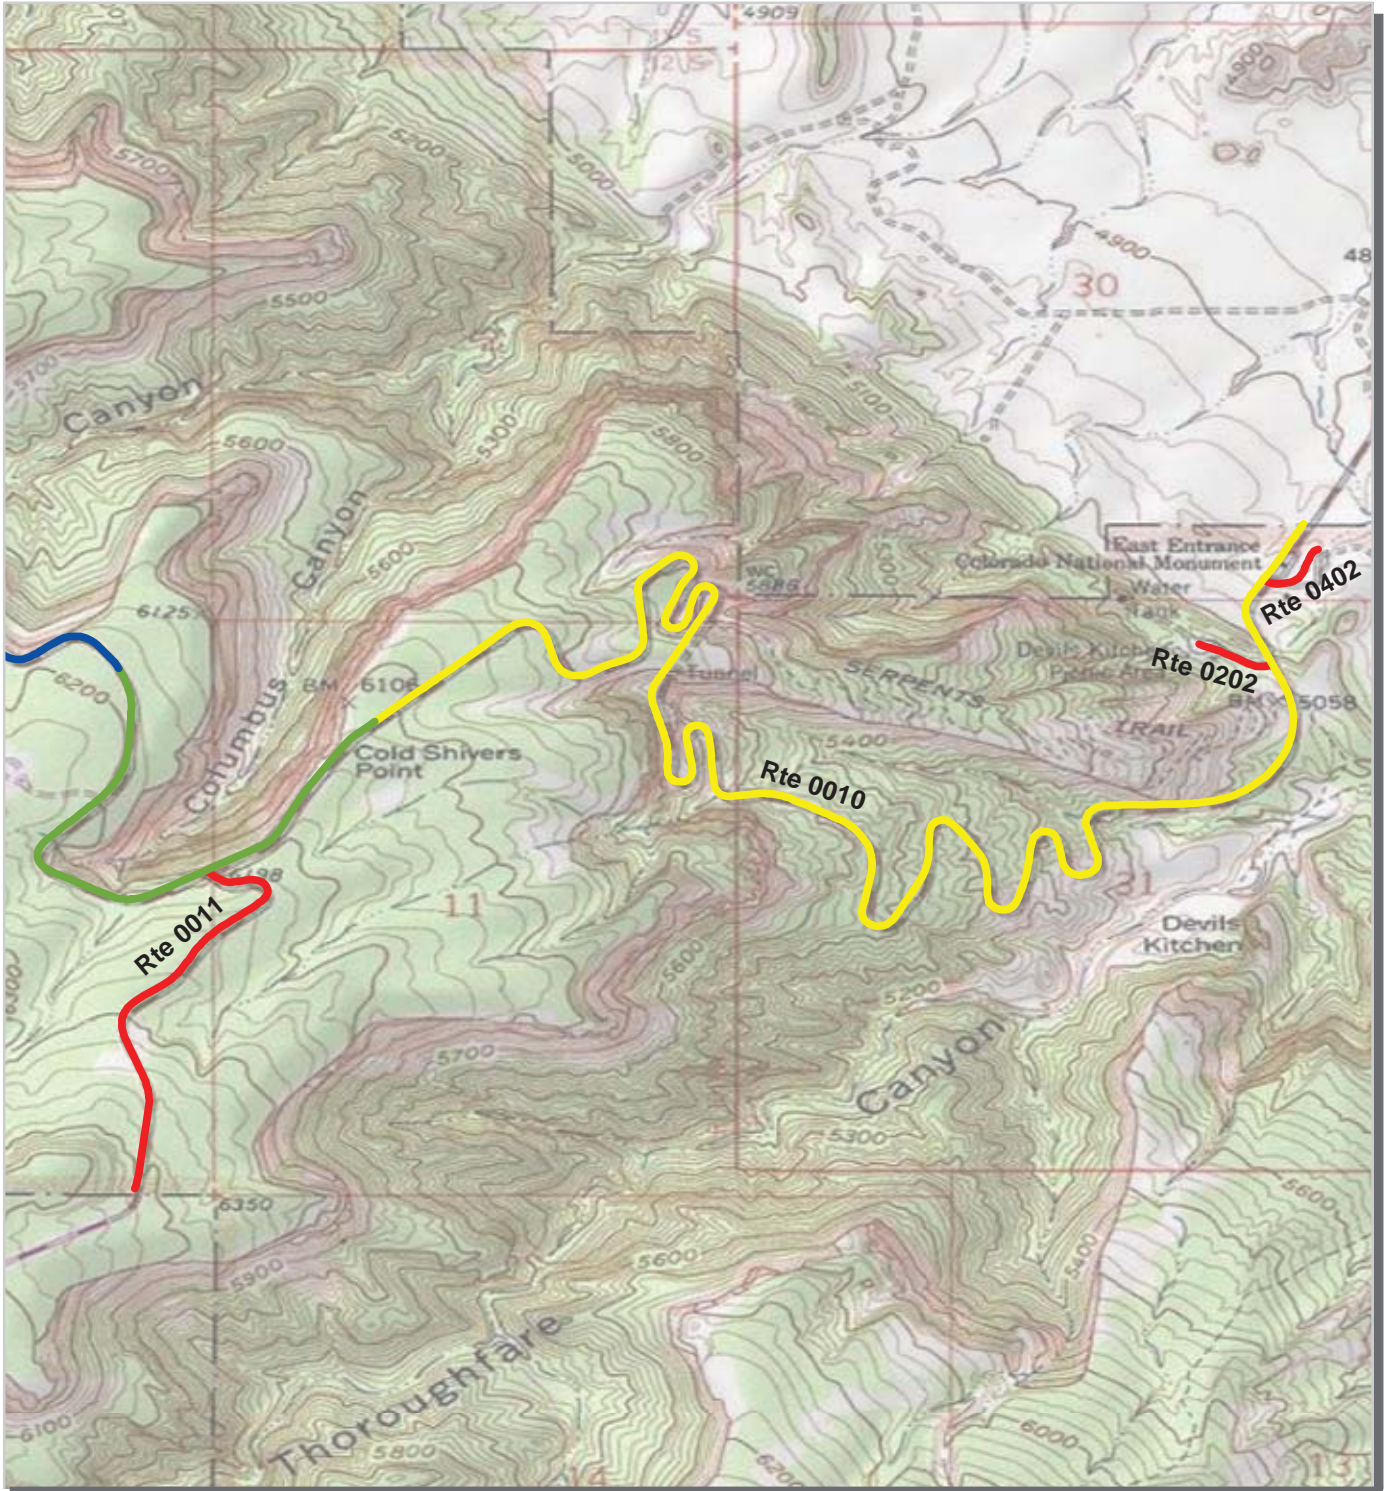
#### Area 5

PCR	Poor	<span style="display: inline-block; width: 20px; height: 10px; background-color: red; border: 1px solid black;"></span>	Fair	<span style="display: inline-block; width: 20px; height: 10px; background-color: yellow; border: 1px solid black;"></span>	Good	<span style="display: inline-block; width: 20px; height: 10px; background-color: green; border: 1px solid black;"></span>	Excellent	<span style="display: inline-block; width: 20px; height: 10px; background-color: blue; border: 1px solid black;"></span>	No Data	<span style="display: inline-block; width: 20px; height: 10px; background-color: black; border: 1px solid black;"></span>
	(<=60)		(61 - 84)	(85 - 94)	(95 - 100)

\* If the PCR rating is not available for a section, the SCR rating will be displayed. See appendix for definitions and formulas.

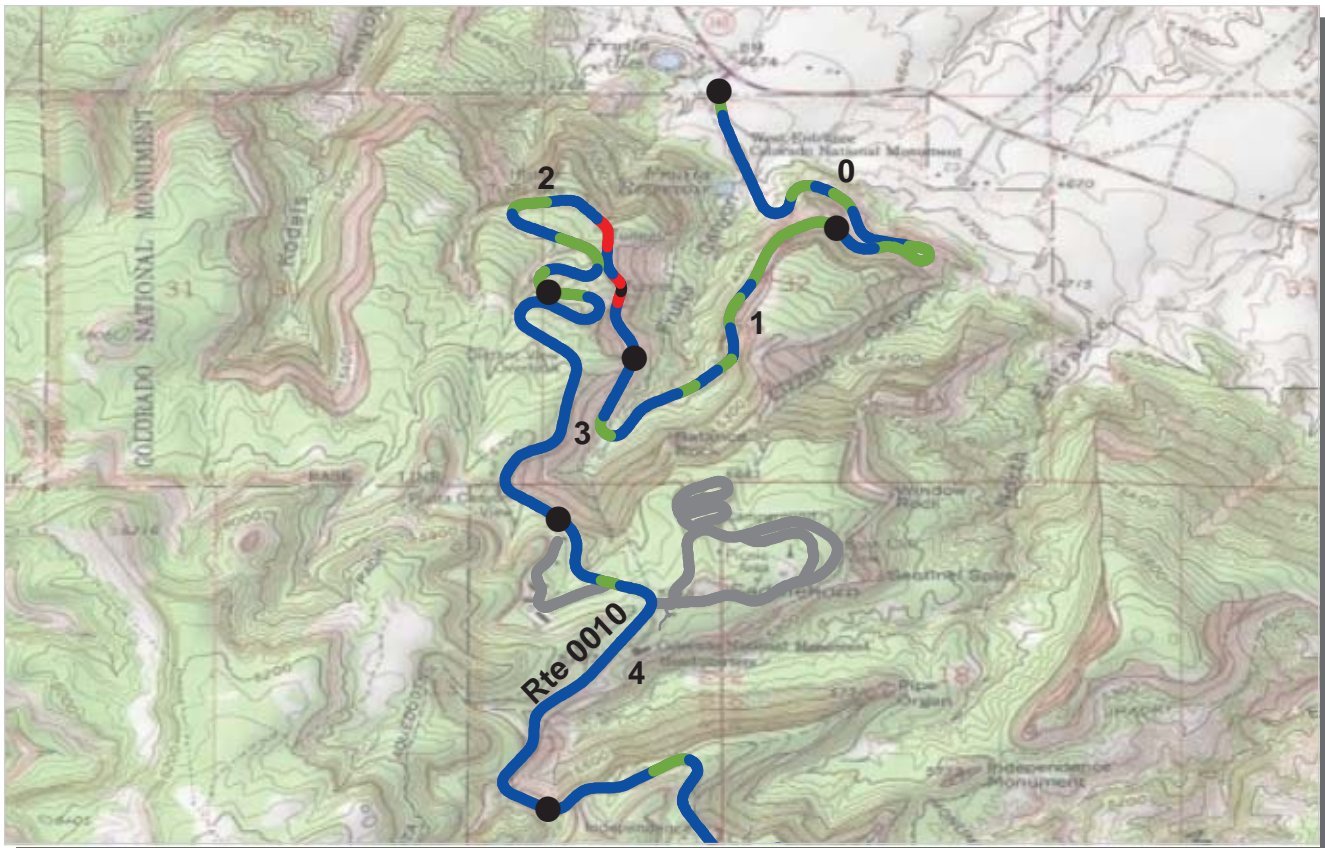
**ROUTE: 0010 RIMROCK DRIVE**

<i>Section Number</i>	0	1	2	3	4
<i>Section Length (mi)</i>	1.00	1.00	1.00	1.00	1.00
<i>Traffic</i>	Traffic data may be found at <a href="http://www.efl.fhwa.dot.gov">www.efl.fhwa.dot.gov</a> Click on PROGRAMS / NPS Traffic Data (Note: Not all parks have traffic data)				
<i>Cross Section Information</i>					
Number of Lanes	2	2	2	2	2
Paved Width (ft)	24	23	23	24	25
Lane Width (ft)	10	10	10	10	10
Shoulder Width Right (ft)	NC	NC	NC	NC	NC
Shoulder Width Left (ft)	NC	NC	NC	NC	NC
<i>Roadway Condition Information</i>					
SCR (Surface Condition Rating)	100	100	100	100	100
PCR (Pavement Condition Rating)	95	95	81	98	98
<i>Distress Index Values</i>					
Alligator Cracking Index	100	100	100	100	100
Longitudinal Cracking Index	100	100	100	100	100
Transverse Cracking Index	100	100	100	100	100
Patching Index	100	100	100	100	100
Rutting Index	100	100	100	100	100
Roughness Condition Index (RCI)	87	87	76	96	95

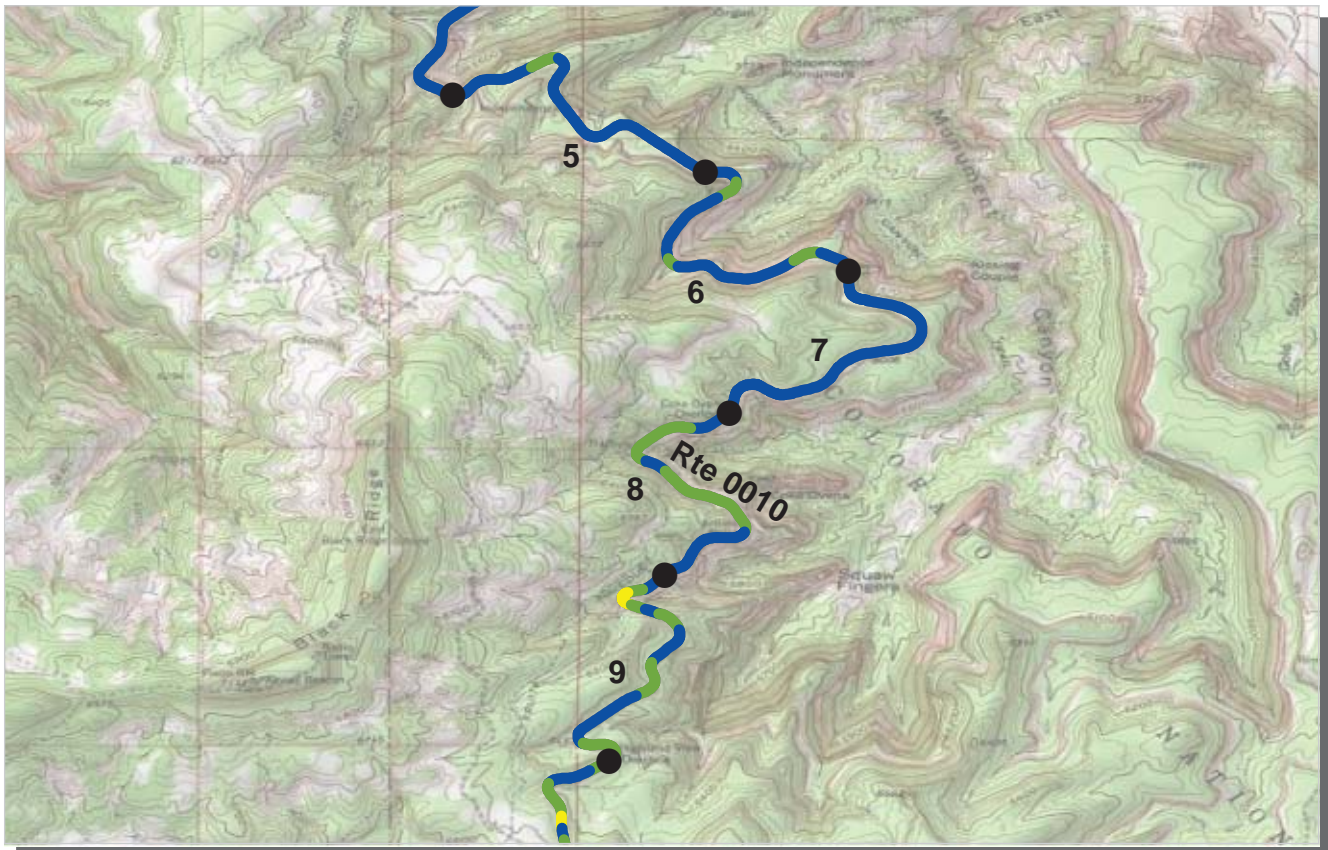
Section Number	5	6	7	8	9
Section Length (mi)	1.00	1.00	1.00	1.00	1.00
<b>Traffic</b>	Traffic data may be found at <a href="http://www.efl.fhwa.dot.gov">www.efl.fhwa.dot.gov</a> Click on PROGRAMS / NPS Traffic Data (Note: Not all parks have traffic data)				
<b>Cross Section Information</b>					
Number of Lanes	2	2	2	2	2
Paved Width (ft)	22	23	22	22	23
Lane Width (ft)	10	10	10	10	10
Shoulder Width Right (ft)	NC	NC	NC	NC	NC
Shoulder Width Left (ft)	NC	NC	NC	NC	NC
<b>Roadway Condition Information</b>					
SCR (Surface Condition Rating)	100	100	100	99	99
PCR (Pavement Condition Rating)	97	97	99	94	93
<b>Distress Index Values</b>					
Alligator Cracking Index	100	100	100	100	100
Longitudinal Cracking Index	100	100	100	99	99
Transverse Cracking Index	100	100	100	100	100
Patching Index	100	100	100	100	100
Rutting Index	100	100	100	100	100
Roughness Condition Index (RCI)	92	93	97	86	84

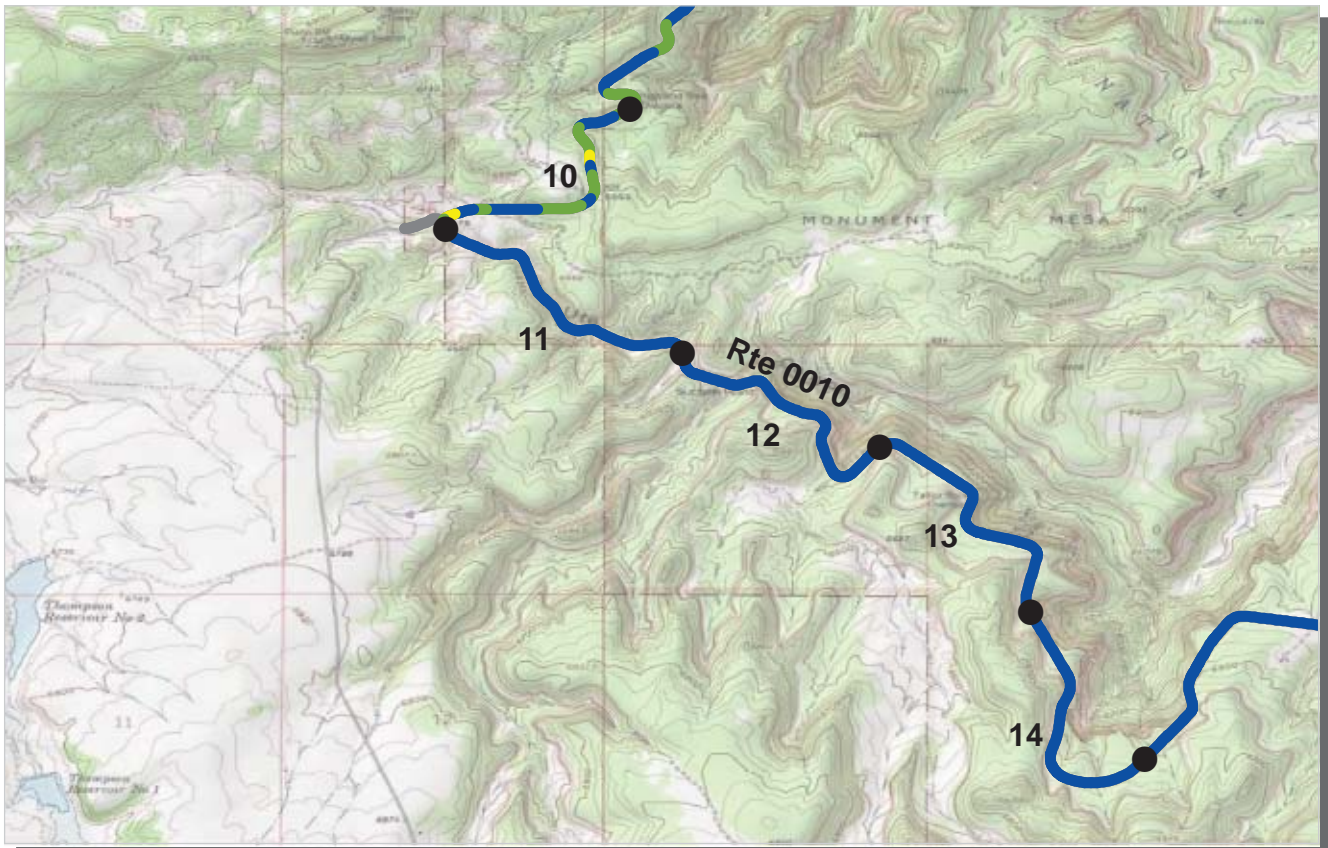
**ROUTE: 0010 RIMROCK DRIVE**

Section Number	10	11	12	13	14
Section Length (mi)	1.00	1.00	1.00	1.00	1.00
<b>Traffic</b>	Traffic data may be found at <a href="http://www.efl.fhwa.dot.gov">www.efl.fhwa.dot.gov</a> Click on PROGRAMS / NPS Traffic Data (Note: Not all parks have traffic data)				
<b>Cross Section Information</b>					
Number of Lanes	2	2	2	2	2
Paved Width (ft)	23	22	22	22	22
Lane Width (ft)	10	10	10	10	10
Shoulder Width Right (ft)	NC	NC	NC	NC	NC
Shoulder Width Left (ft)	NC	NC	NC	NC	NC
<b>Roadway Condition Information</b>					
SCR (Surface Condition Rating)	98	100	100	100	100
PCR (Pavement Condition Rating)	92	99	99	100	100
<b>Distress Index Values</b>					
Alligator Cracking Index	100	100	100	100	100
Longitudinal Cracking Index	99	100	100	100	100
Transverse Cracking Index	100	100	100	100	100
Patching Index	100	100	100	100	100
Rutting Index	100	100	100	100	100
Roughness Condition Index (RCI)	82	97	98	99	100

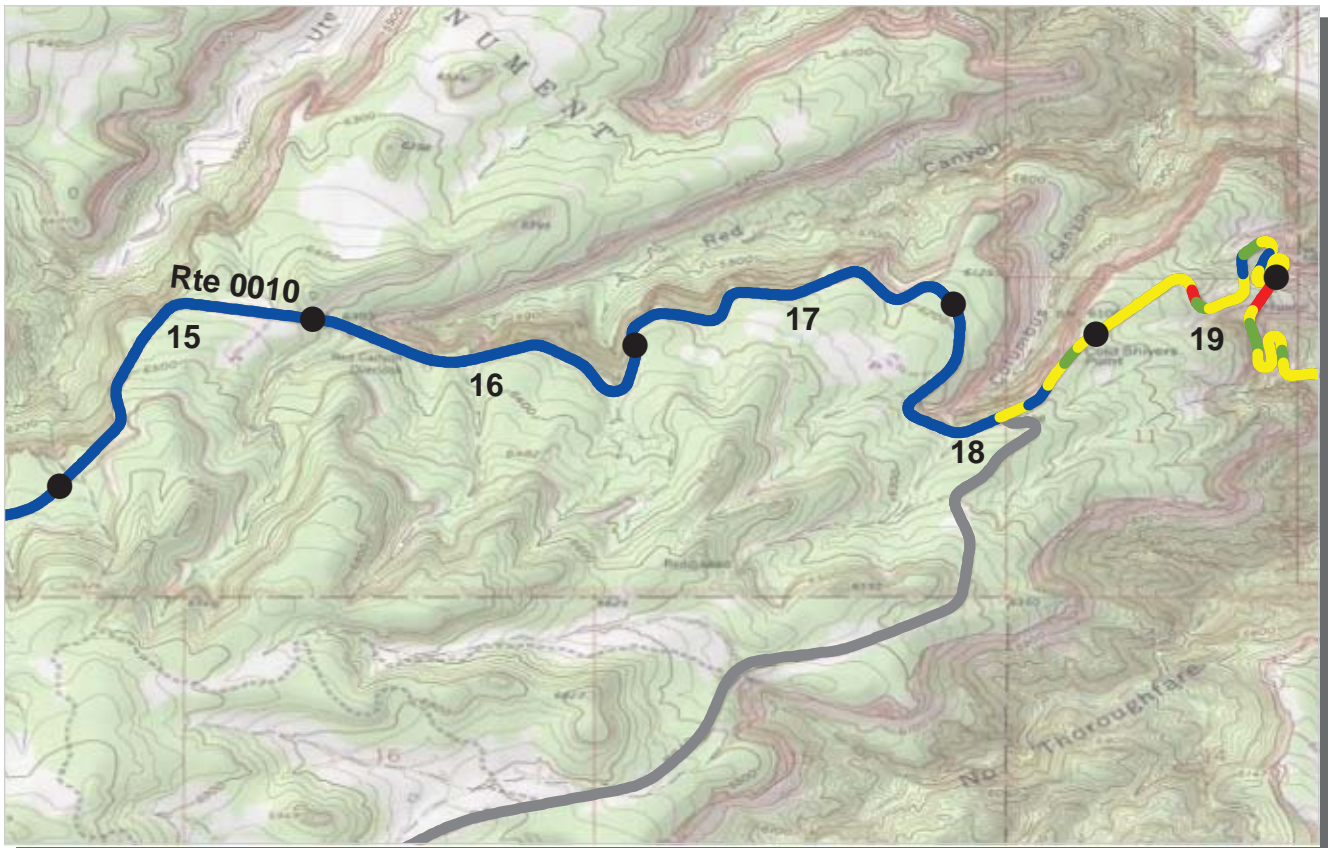
Section Number	15	16	17	18	19
Section Length (mi)	1.00	1.00	1.00	1.00	1.00
<b>Traffic</b>	Traffic data may be found at <a href="http://www.efl.fhwa.dot.gov">www.efl.fhwa.dot.gov</a> Click on PROGRAMS / NPS Traffic Data (Note: Not all parks have traffic data)				
<b>Cross Section Information</b>					
Number of Lanes	2	2	2	2	2
Paved Width (ft)	23	22	23	23	25
Lane Width (ft)	10	10	10	10	11
Shoulder Width Right (ft)	NC	NC	NC	NC	NC
Shoulder Width Left (ft)	NC	NC	NC	NC	NC
<b>Roadway Condition Information</b>					
SCR (Surface Condition Rating)	100	100	100	87	68
PCR (Pavement Condition Rating)	100	100	99	91	72
<b>Distress Index Values</b>					
Alligator Cracking Index	100	100	100	94	96
Longitudinal Cracking Index	100	100	100	99	99
Transverse Cracking Index	100	100	100	98	85
Patching Index	100	100	100	100	100
Rutting Index	100	100	100	95	88
Roughness Condition Index (RCI)	100	100	99	97	80
