**The Road Inventory  
of  
Colorado National Monument  
COLM – 1378  
Cycle 4**

**Prepared By:  
Federal Highway Administration  
Road Inventory Program  
Cycle 4**

# Colorado National Monument in Colorado

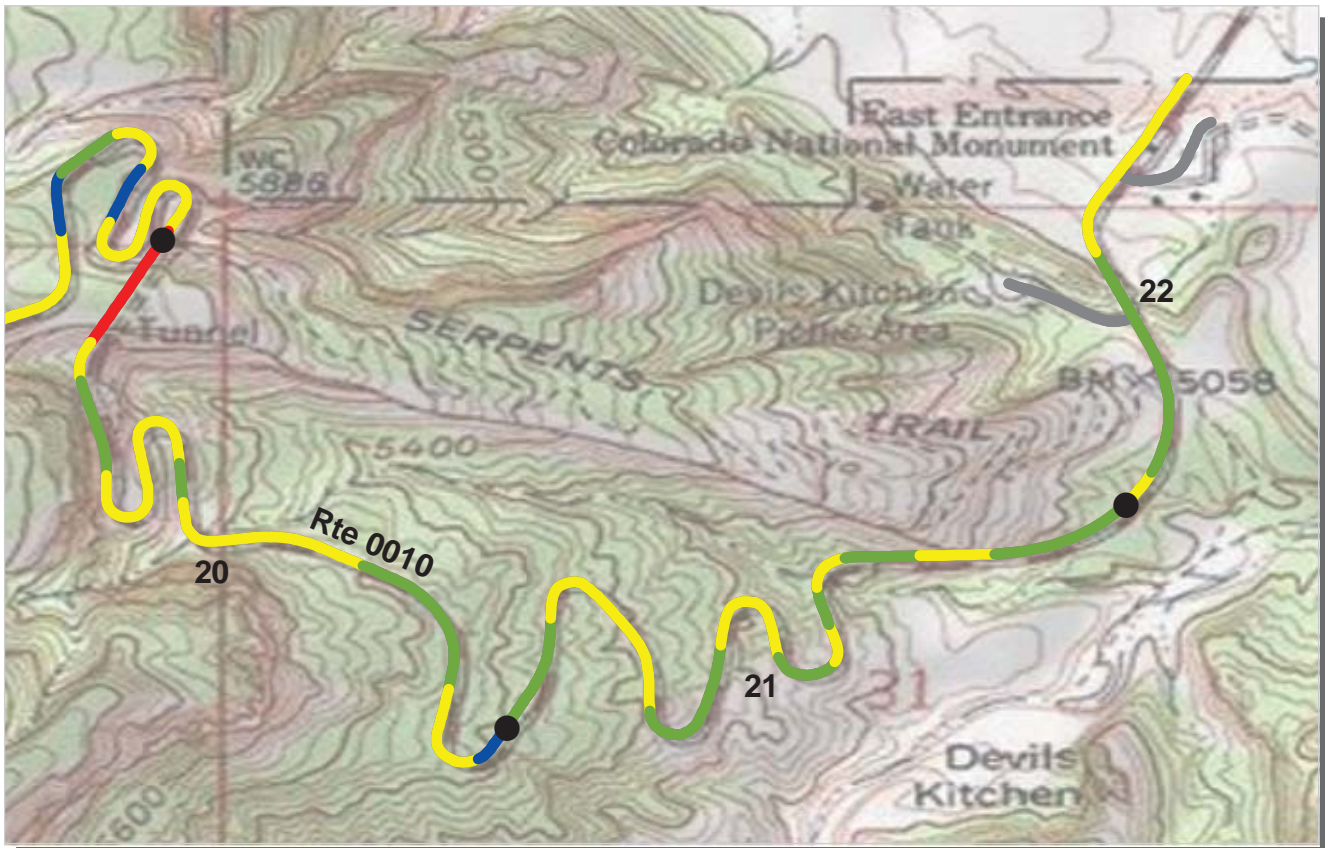
**ROUTE: 0010 RIMROCK DRIVE**

Section Number	20	21	22		
Section Length (mi)	1.00	1.00	0.48		
<b>Traffic</b>	Traffic data may be found at <a href="http://www.efl.fhwa.dot.gov">www.efl.fhwa.dot.gov</a> Click on PROGRAMS / NPS Traffic Data (Note: Not all parks have traffic data)				
<b>Cross Section Information</b>					
Number of Lanes	2	2	2		
Paved Width (ft)	25	25	23		
Lane Width (ft)	11	11	10		
Shoulder Width Right (ft)	NC	NC	NC		
Shoulder Width Left (ft)	NC	NC	NC		
<b>Roadway Condition Information</b>					
SCR (Surface Condition Rating)	82	79	77		
PCR (Pavement Condition Rating)	72	81	81		
<b>Distress Index Values</b>					
Alligator Cracking Index	99	98	96		
Longitudinal Cracking Index	99	99	99		
Transverse Cracking Index	98	98	96		
Patching Index	100	100	100		
Rutting Index	85	83	85		
Roughness Condition Index (RCI)	72	85	92

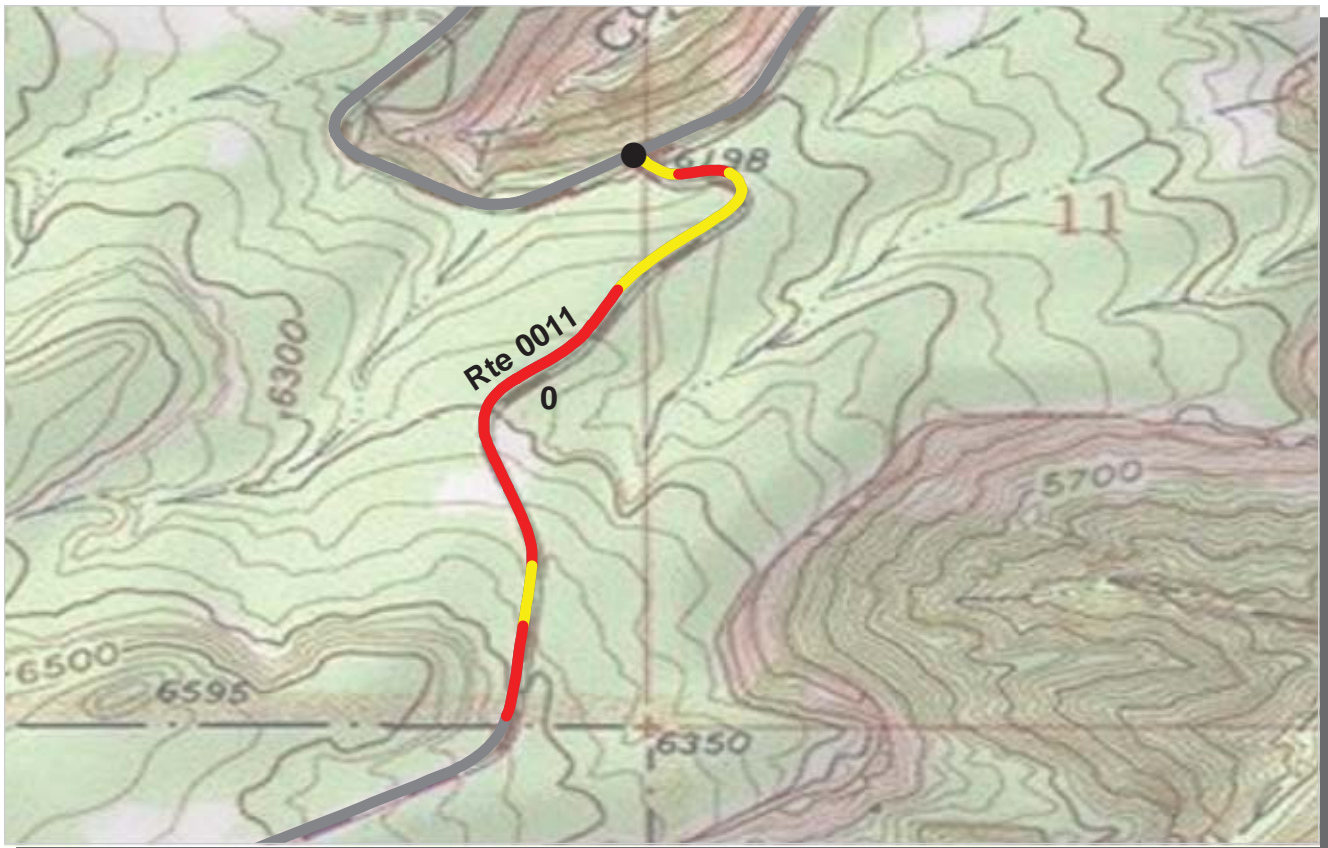
**ROUTE: 0011 EAST GLADE PARK ROAD**

<b>Section Number</b>	0				
<b>Section Length (mi)</b>	0.71				
<b>Traffic</b>	Traffic data may be found at <a href="http://www.efl.fhwa.dot.gov">www.efl.fhwa.dot.gov</a> Click on PROGRAMS / NPS Traffic Data (Note: Not all parks have traffic data)				
<b>Cross Section Information</b>					
Number of Lanes	2				
Paved Width (ft)	23				
Lane Width (ft)	10				
Shoulder Width Right (ft)	NC				
Shoulder Width Left (ft)	NC				
<b>Roadway Condition Information</b>					
SCR (Surface Condition Rating)	34				
PCR (Pavement Condition Rating)	54				
<b>Distress Index Values</b>					
Alligator Cracking Index	91				
Longitudinal Cracking Index	80				
Transverse Cracking Index	72				
Patching Index	100				
Rutting Index	88				
Roughness Condition Index (RCI)	88

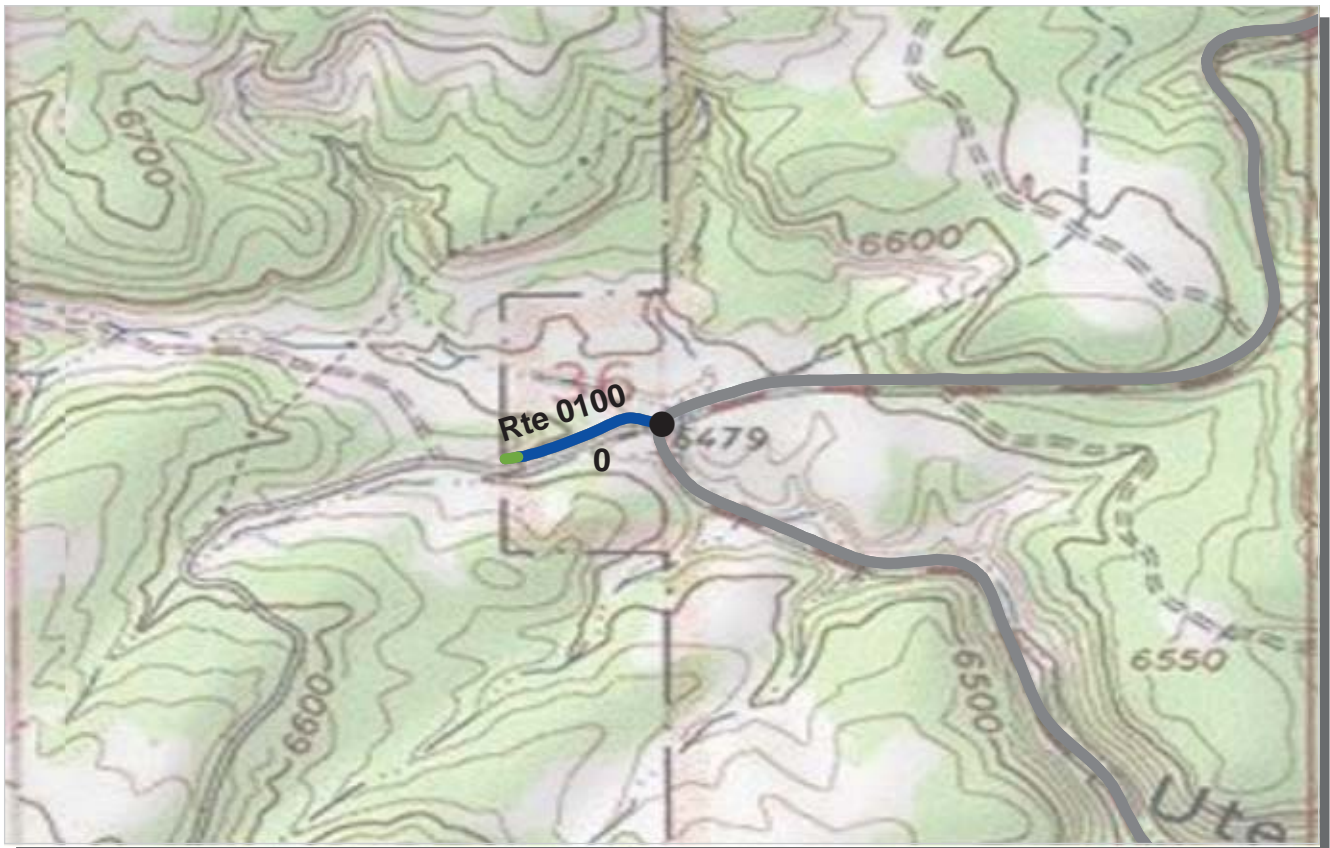
**ROUTE: 0100 WEST GLADE PARK ROAD**

<b>Section Number</b>	0				
<b>Section Length (mi)</b>	0.13				
<b>Traffic</b>	Traffic data may be found at <a href="http://www.efl.fhwa.dot.gov">www.efl.fhwa.dot.gov</a> Click on PROGRAMS / NPS Traffic Data (Note: Not all parks have traffic data)				
<b>Cross Section Information</b>					
Number of Lanes	2				
Paved Width (ft)	23				
Lane Width (ft)	11				
Shoulder Width Right (ft)	NC				
Shoulder Width Left (ft)	NC				
<b>Roadway Condition Information</b>					
SCR (Surface Condition Rating)	97				
PCR (Pavement Condition Rating)	89				
<b>Distress Index Values</b>					
Alligator Cracking Index	100				
Longitudinal Cracking Index	99				
Transverse Cracking Index	100				
Patching Index	100				
Rutting Index	98				
Roughness Condition Index (RCI)	64

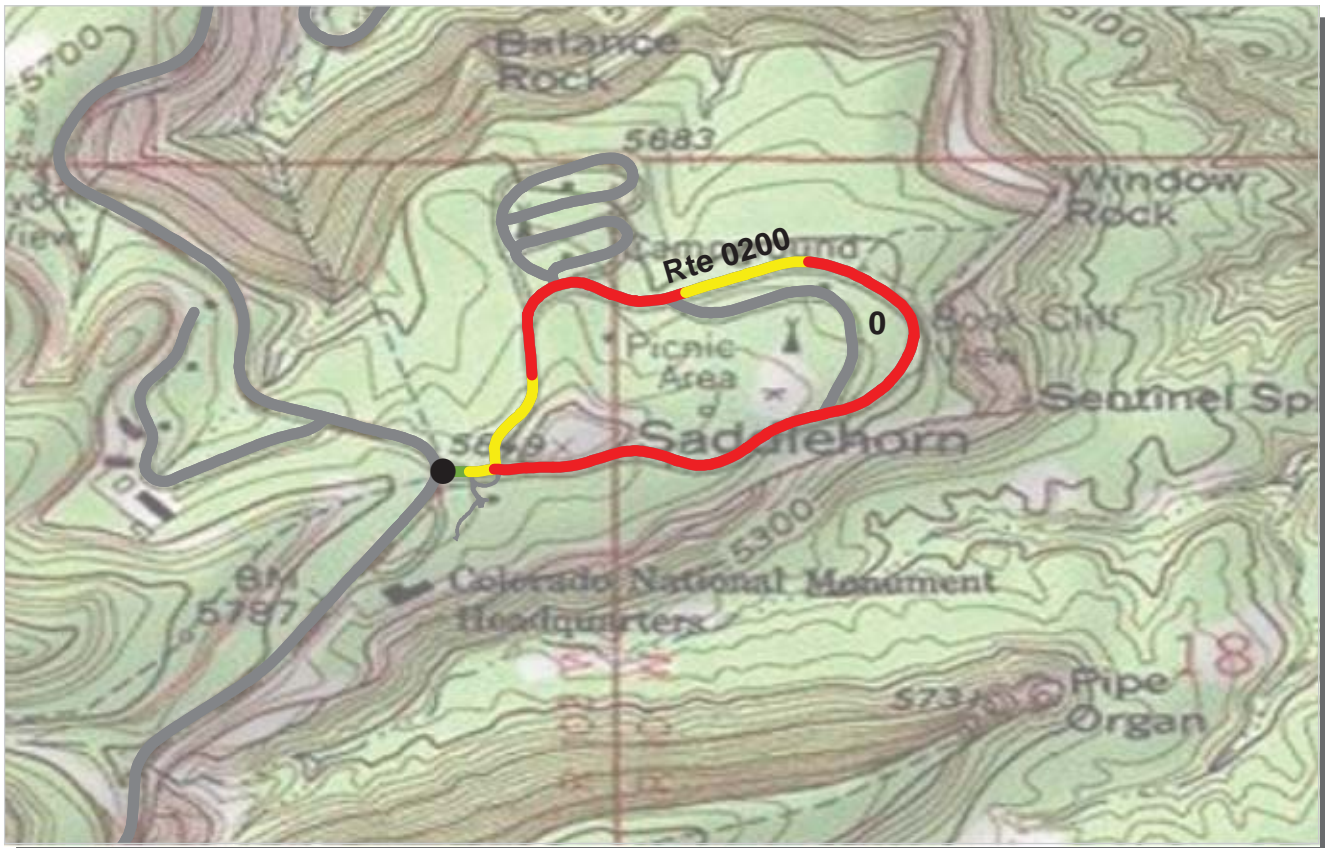
**ROUTE: 0200 SADDLEHORN LOOP ROAD**

<b>Section Number</b>	0				
<b>Section Length (mi)</b>	0.94				
<b>Traffic</b>	Traffic data may be found at <a href="http://www.efl.fhwa.dot.gov">www.efl.fhwa.dot.gov</a> Click on PROGRAMS / NPS Traffic Data (Note: Not all parks have traffic data)				
<b>Cross Section Information</b>					
Number of Lanes	1				
Paved Width (ft)	17				
Lane Width (ft)	14				
Shoulder Width Right (ft)	NC				
Shoulder Width Left (ft)	NC				
<b>Roadway Condition Information</b>					
SCR (Surface Condition Rating)	55				
PCR (Pavement Condition Rating)	56				
<b>Distress Index Values</b>					
Alligator Cracking Index	100				
Longitudinal Cracking Index	90				
Transverse Cracking Index	88				
Patching Index	100				
Rutting Index	77				
Roughness Condition Index (RCI)	57

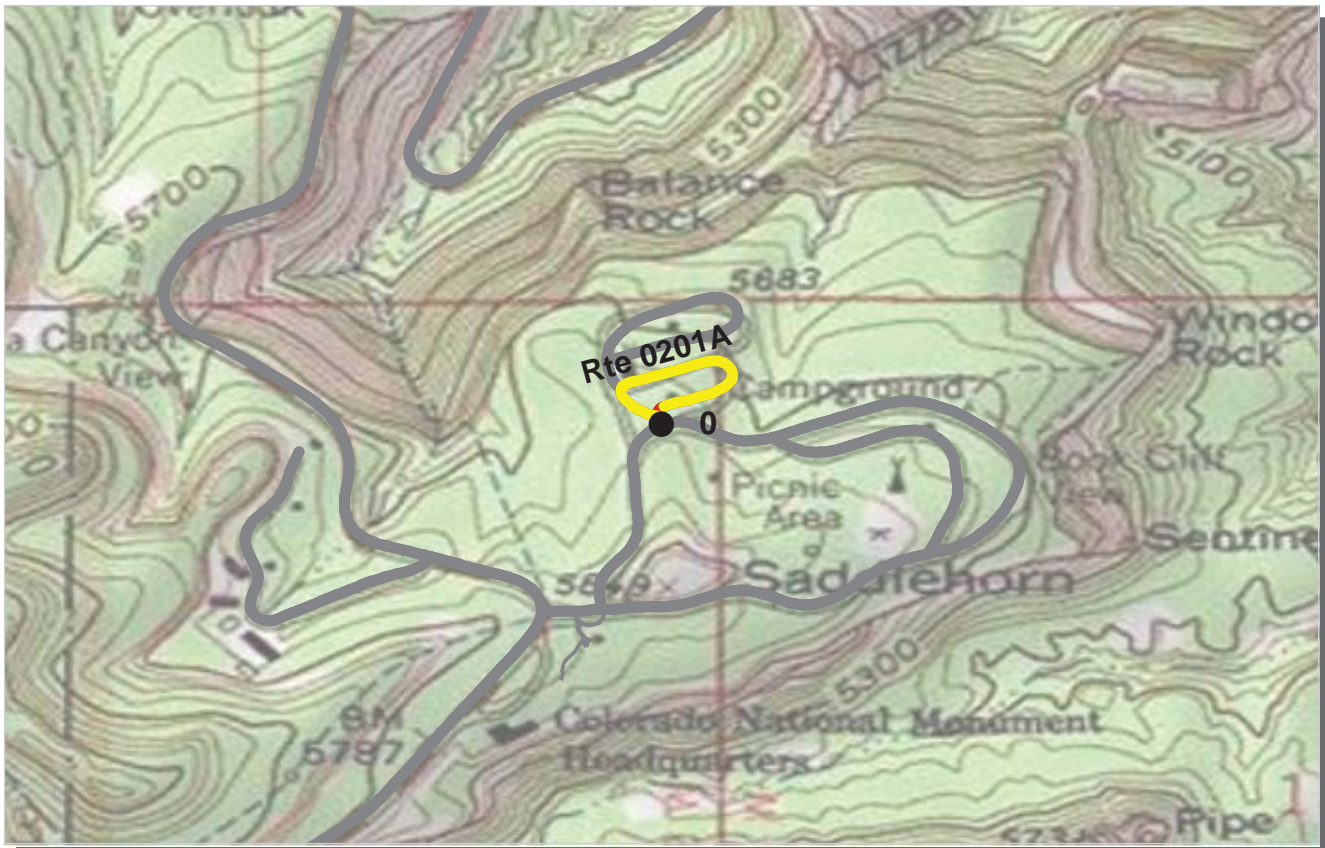
**ROUTE: 0201A SADDLEHORN CAMPGROUND LOOP A**

<b>Section Number</b>	0				
<b>Section Length (mi)</b>	0.22				
<b>Traffic</b>	Traffic data may be found at <a href="http://www.efl.fhwa.dot.gov">www.efl.fhwa.dot.gov</a> Click on PROGRAMS / NPS Traffic Data (Note: Not all parks have traffic data)				
<b>Cross Section Information</b>					
Number of Lanes	1				
Paved Width (ft)	14				
Lane Width (ft)	12				
Shoulder Width Right (ft)	NC				
Shoulder Width Left (ft)	NC				
<b>Roadway Condition Information</b>					
SCR (Surface Condition Rating)	69				
PCR (Pavement Condition Rating)	67				
<b>Distress Index Values</b>					
Alligator Cracking Index	100				
Longitudinal Cracking Index	98				
Transverse Cracking Index	90				
Patching Index	100				
Rutting Index	81				
Roughness Condition Index (RCI)	57

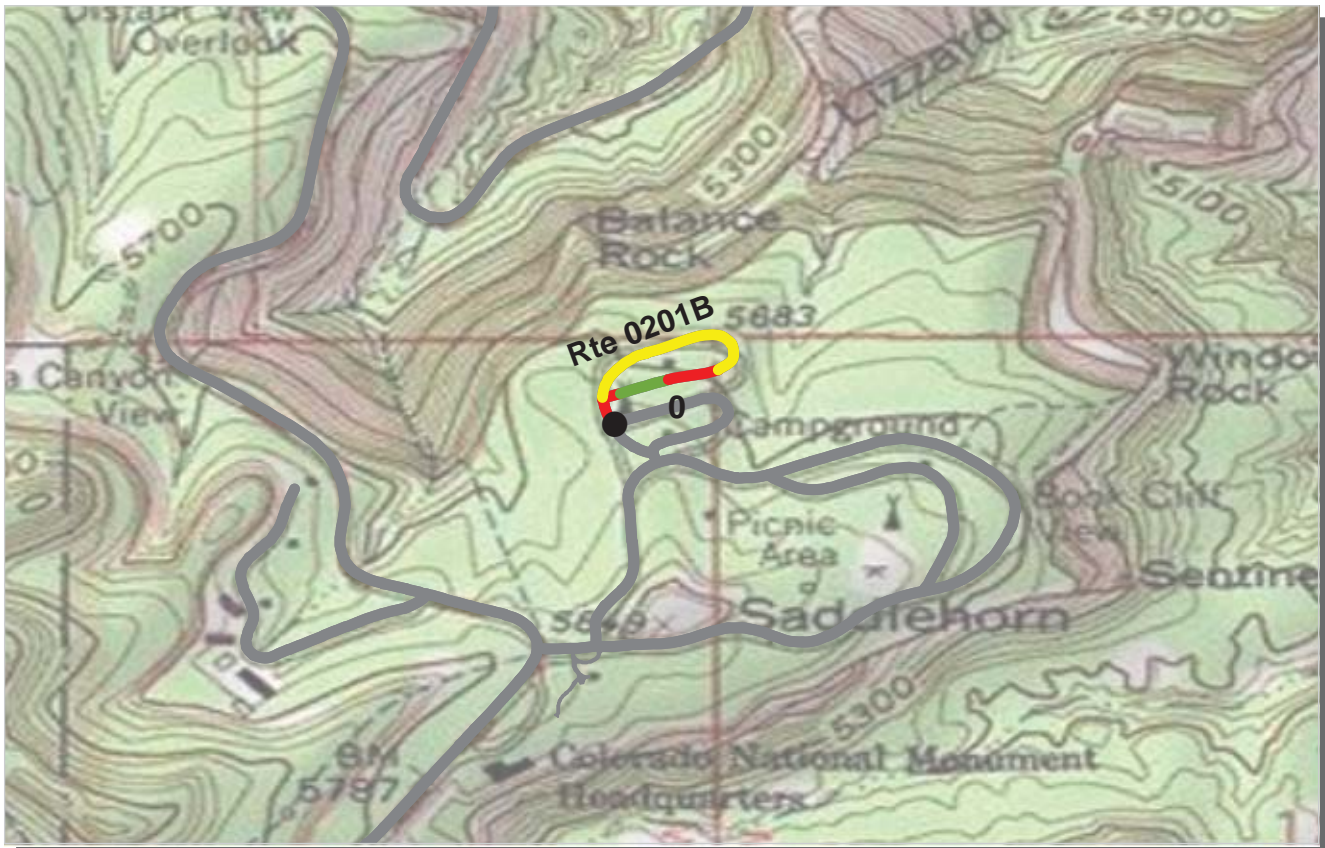
**ROUTE: 0201B SADDLEHORN CAMPGROUND LOOP B**

<b>Section Number</b>	0				
<b>Section Length (mi)</b>	0.28				
<b>Traffic</b>	Traffic data may be found at <a href="http://www.efl.fhwa.dot.gov">www.efl.fhwa.dot.gov</a> Click on PROGRAMS / NPS Traffic Data (Note: Not all parks have traffic data)				
<b>Cross Section Information</b>					
Number of Lanes	1				
Paved Width (ft)	12				
Lane Width (ft)	11				
Shoulder Width Right (ft)	NC				
Shoulder Width Left (ft)	NC				
<b>Roadway Condition Information</b>					
SCR (Surface Condition Rating)	77				
PCR (Pavement Condition Rating)	72				
<b>Distress Index Values</b>					
Alligator Cracking Index	100				
Longitudinal Cracking Index	98				
Transverse Cracking Index	92				
Patching Index	100				
Rutting Index	87				
Roughness Condition Index (RCI)	51

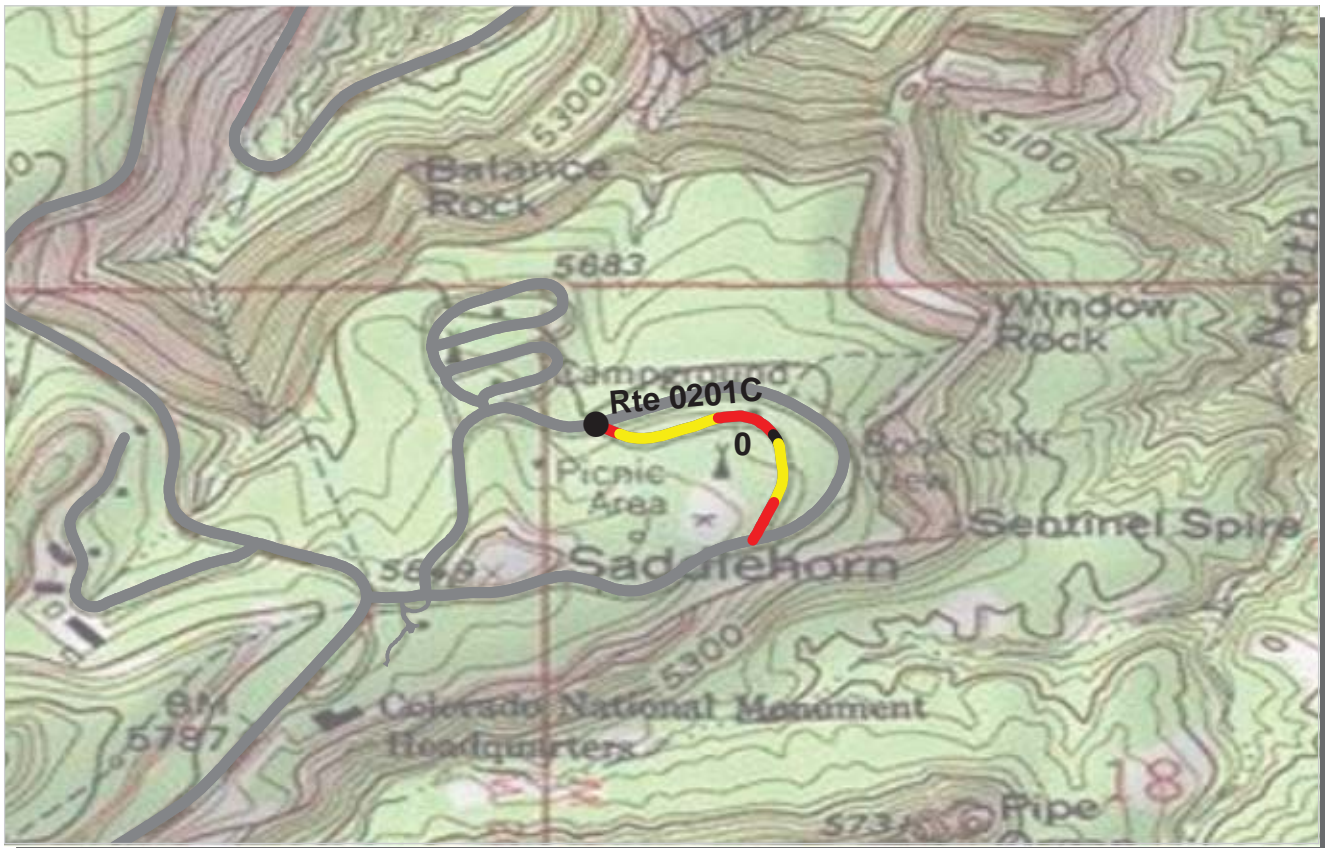
**ROUTE: 0201C SADDLEHORN CAMPGROUND LOOP C**

<b>Section Number</b>	0				
<b>Section Length (mi)</b>	0.26				
<b>Traffic</b>	Traffic data may be found at <a href="http://www.efl.fhwa.dot.gov">www.efl.fhwa.dot.gov</a> Click on PROGRAMS / NPS Traffic Data (Note: Not all parks have traffic data)				
<b>Cross Section Information</b>					
Number of Lanes	1				
Paved Width (ft)	10				
Lane Width (ft)	10				
Shoulder Width Right (ft)	NC				
Shoulder Width Left (ft)	NC				
<b>Roadway Condition Information</b>					
SCR (Surface Condition Rating)	64				
PCR (Pavement Condition Rating)	64				
<b>Distress Index Values</b>					
Alligator Cracking Index	100				
Longitudinal Cracking Index	98				
Transverse Cracking Index	92				
Patching Index	100				
Rutting Index	74				
Roughness Condition Index (RCI)	49

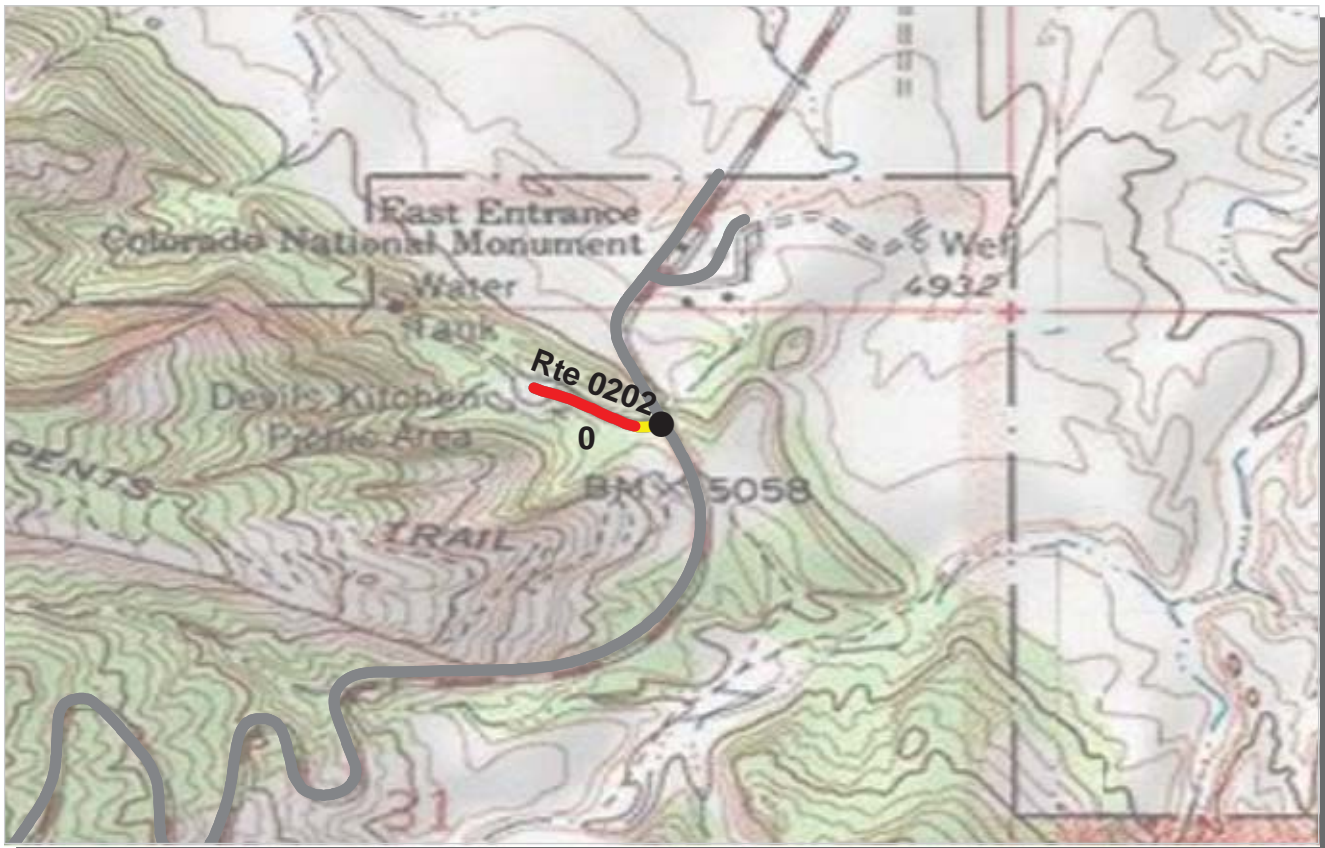
**ROUTE: 0202 DEVIL'S KITCHEN PICNIC AREA ROAD**

<b>Section Number</b>	0				
<b>Section Length (mi)</b>	0.11				
<b>Traffic</b>	Traffic data may be found at <a href="http://www.efl.fhwa.dot.gov">www.efl.fhwa.dot.gov</a> Click on PROGRAMS / NPS Traffic Data (Note: Not all parks have traffic data)				
<b>Cross Section Information</b>					
Number of Lanes	2				
Paved Width (ft)	20				
Lane Width (ft)	9				
Shoulder Width Right (ft)	NC				
Shoulder Width Left (ft)	NC				
<b>Roadway Condition Information</b>					
SCR (Surface Condition Rating)	61				
PCR (Pavement Condition Rating)	52				
<b>Distress Index Values</b>					
Alligator Cracking Index	100				
Longitudinal Cracking Index	94				
Transverse Cracking Index	88				
Patching Index	100				
Rutting Index	79				
Roughness Condition Index (RCI)	26

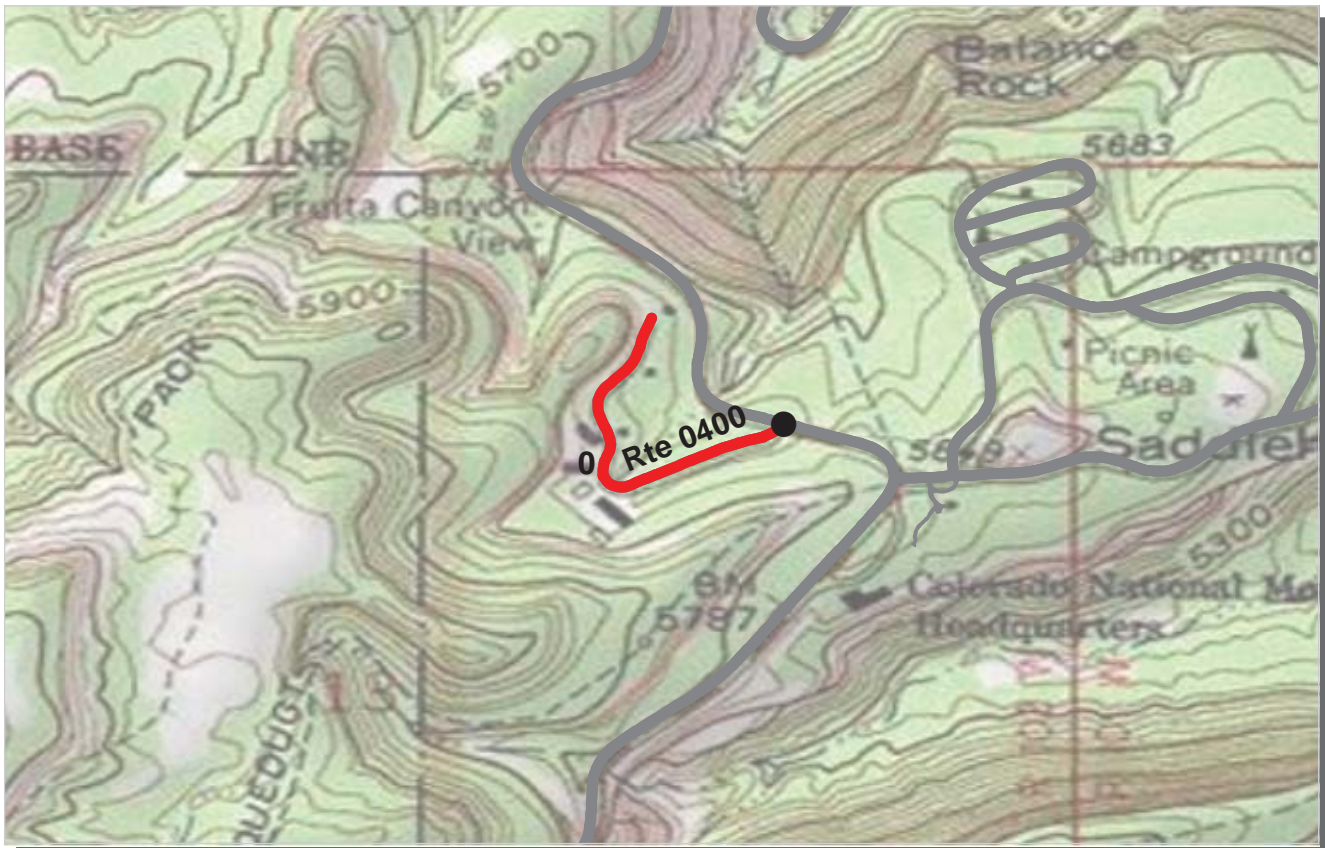
PCR    Poor ■    Fair ■    Good ■    Excellent ■    No Data ■  
 (<=60)    (61 - 84)    (85 - 94)    (95 - 100)

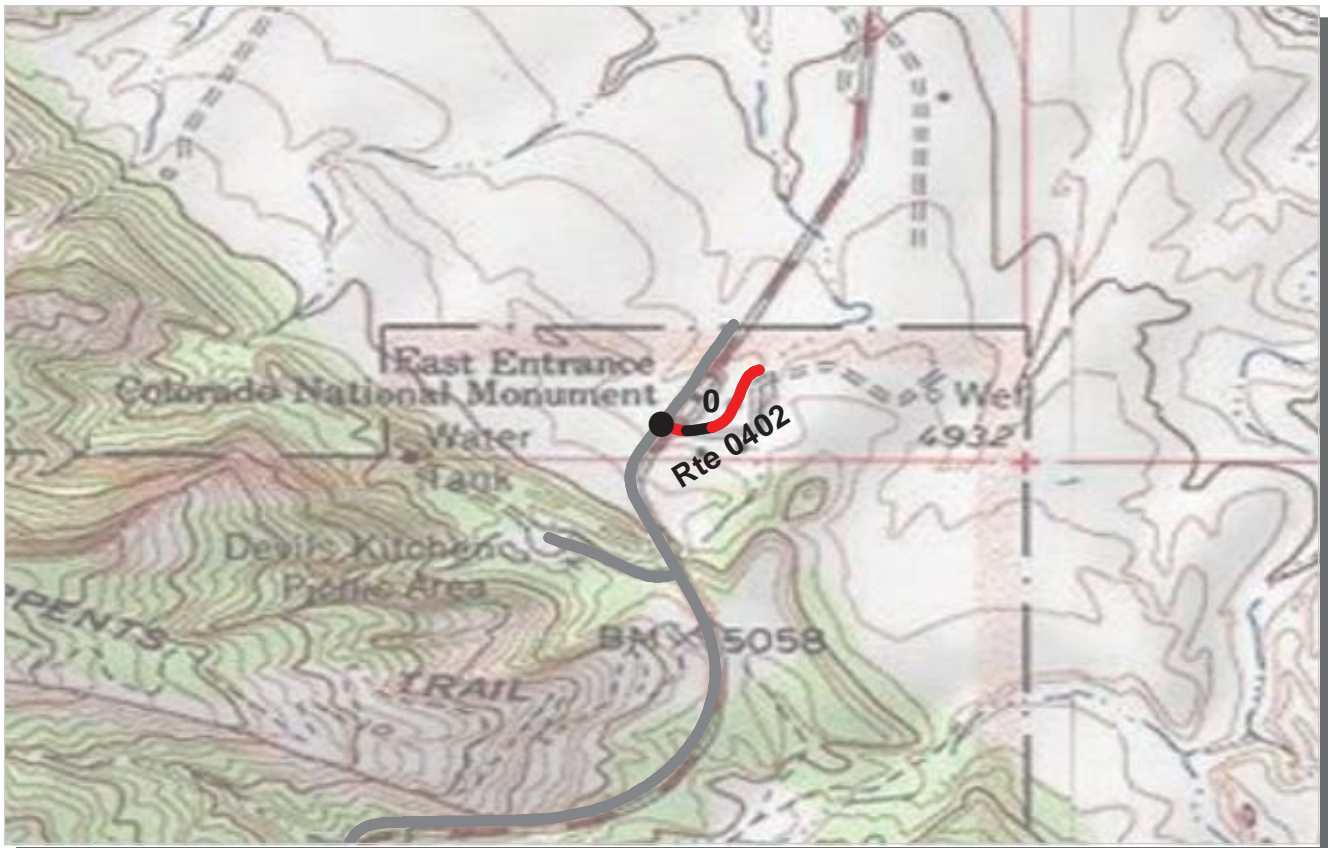
<b>Section Number</b>	0				
<b>Section Length (mi)</b>	0.33				
<b>Traffic</b>	Traffic data may be found at <a href="http://www.efl.fhwa.dot.gov">www.efl.fhwa.dot.gov</a> Click on PROGRAMS / NPS Traffic Data (Note: Not all parks have traffic data)				
<b>Cross Section Information</b>					
Number of Lanes	2				
Paved Width (ft)	18				
Lane Width (ft)	8				
Shoulder Width Right (ft)	NC				
Shoulder Width Left (ft)	NC				
<b>Roadway Condition Information</b>					
SCR (Surface Condition Rating)	30				
PCR (Pavement Condition Rating)	33				
<b>Distress Index Values</b>					
Alligator Cracking Index	86				
Longitudinal Cracking Index	83				
Transverse Cracking Index	84				
Patching Index	100				
Rutting Index	73				
Roughness Condition Index (RCI)	42

PCR	Poor	Fair	Good	Excellent	No Data
	(≤60)	(61 - 84)	(85 - 94)	(95 - 100)

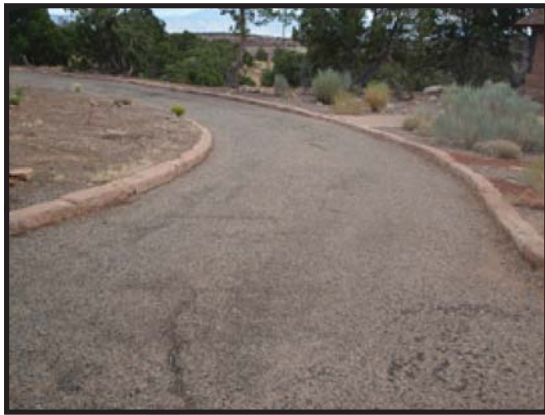
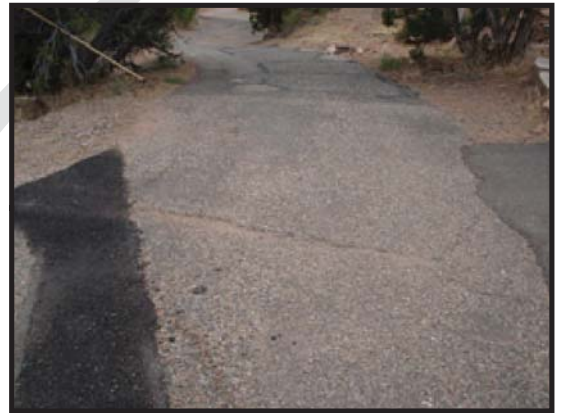
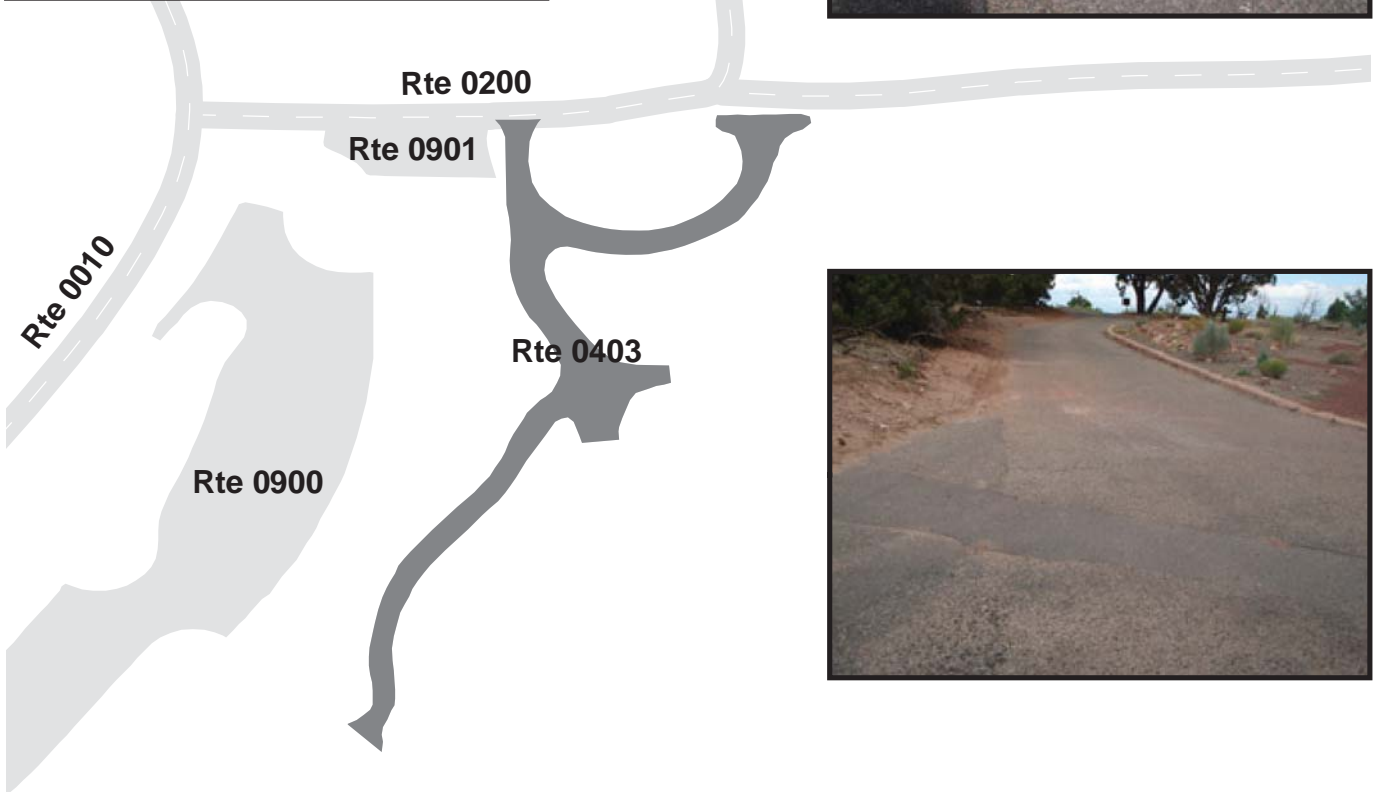
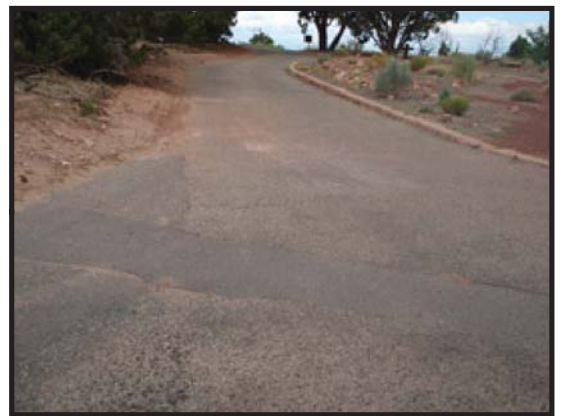
Route Number	Public / NonPublic	Date Visited		Area (sq ft)	Lane Miles *	Surface Type
0403	NONPUBLIC	8/24/2009		8,264	0.14	AS
Culverts	Drop Inlets	Gates	Fire Hydrants	Curb & Gutter	Curb	PCR
0	3	0	1	NO CURB AND GUTTER	STONE CURB	POOR/45

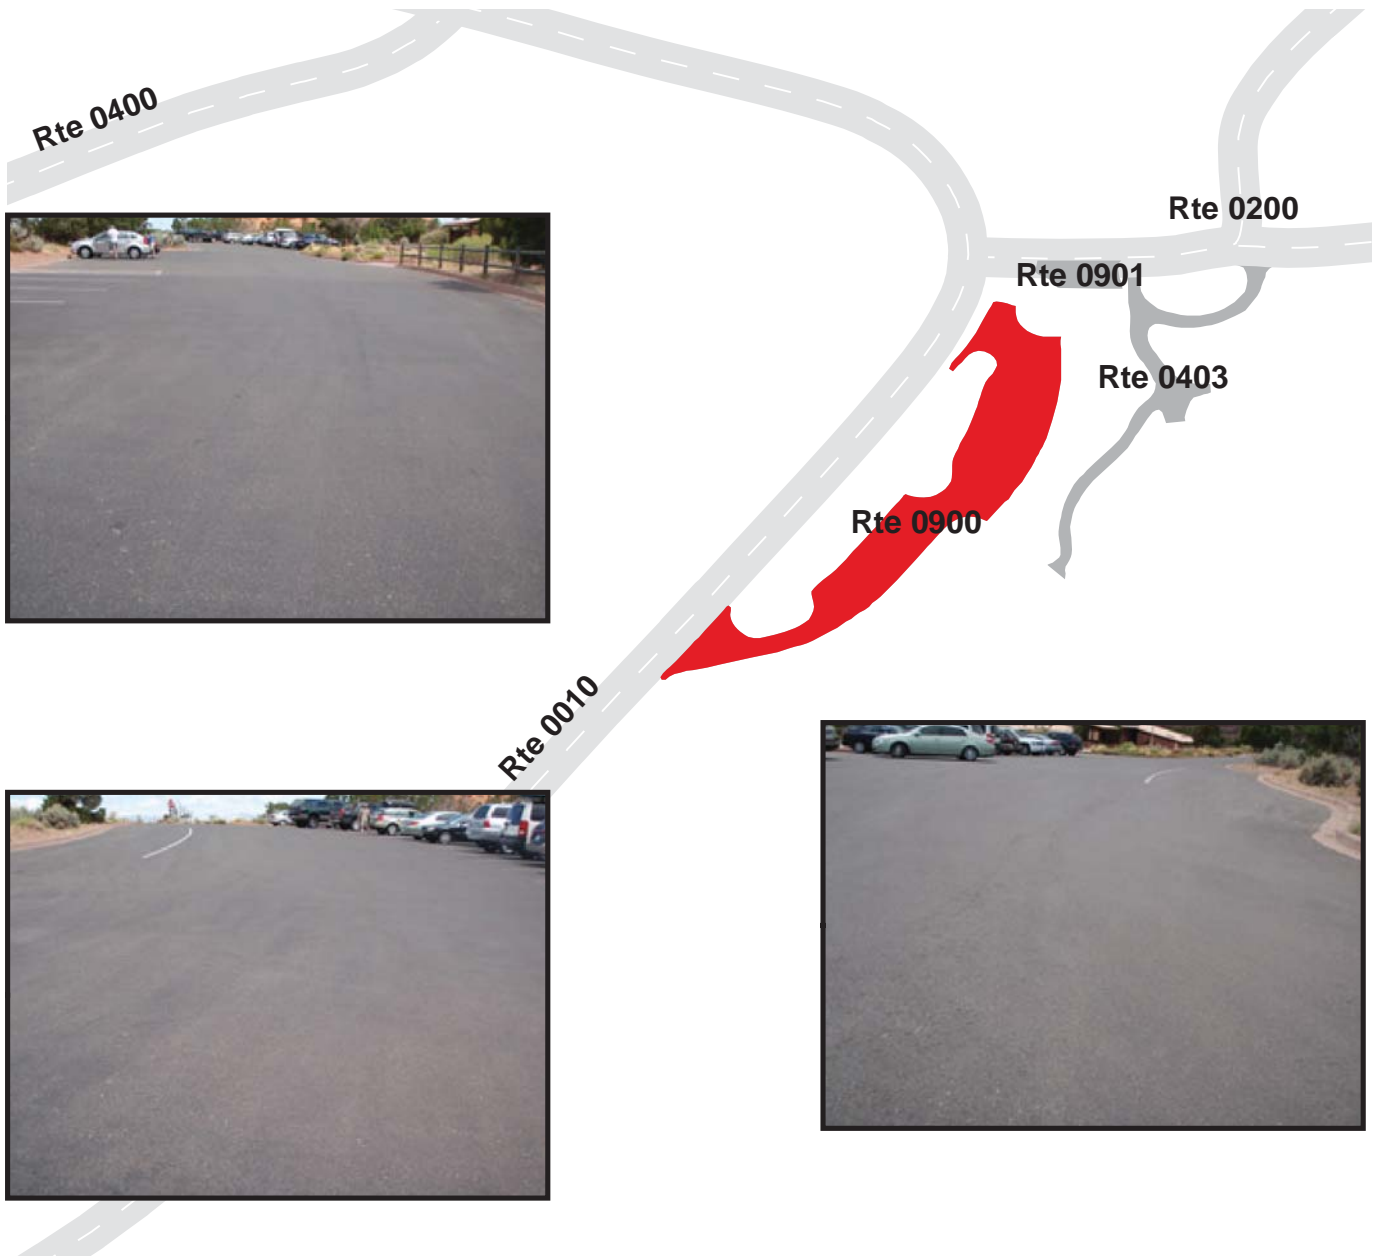
Route Number	Public / NonPublic	Date Visited		Area (sq ft)	Lane Miles *	Surface Type
0900	PUBLIC	8/24/2009		26,539	0.46	AS
Culverts	Drop Inlets	Gates	Fire Hydrants	Curb & Gutter	Curb	PCR
0	1	0	1	CONCRETE CURB AND GUTTER	NO CURB	EXCELLENT/97

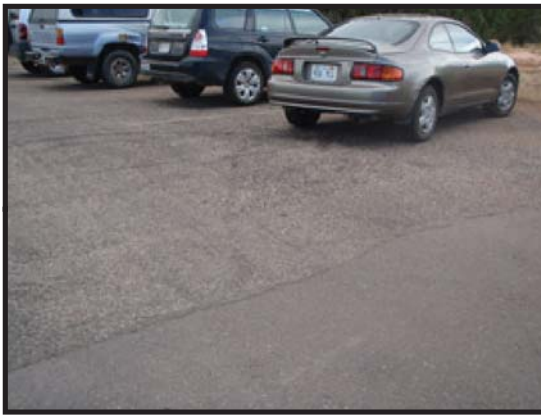
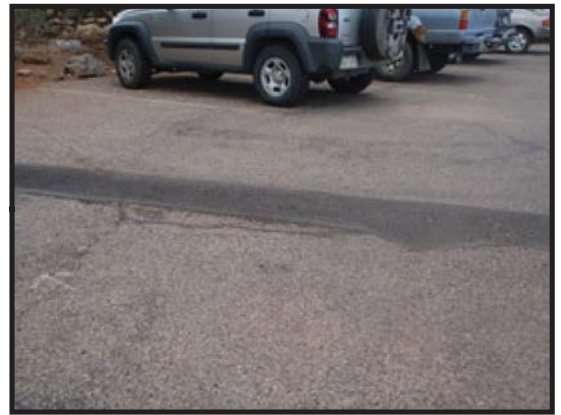
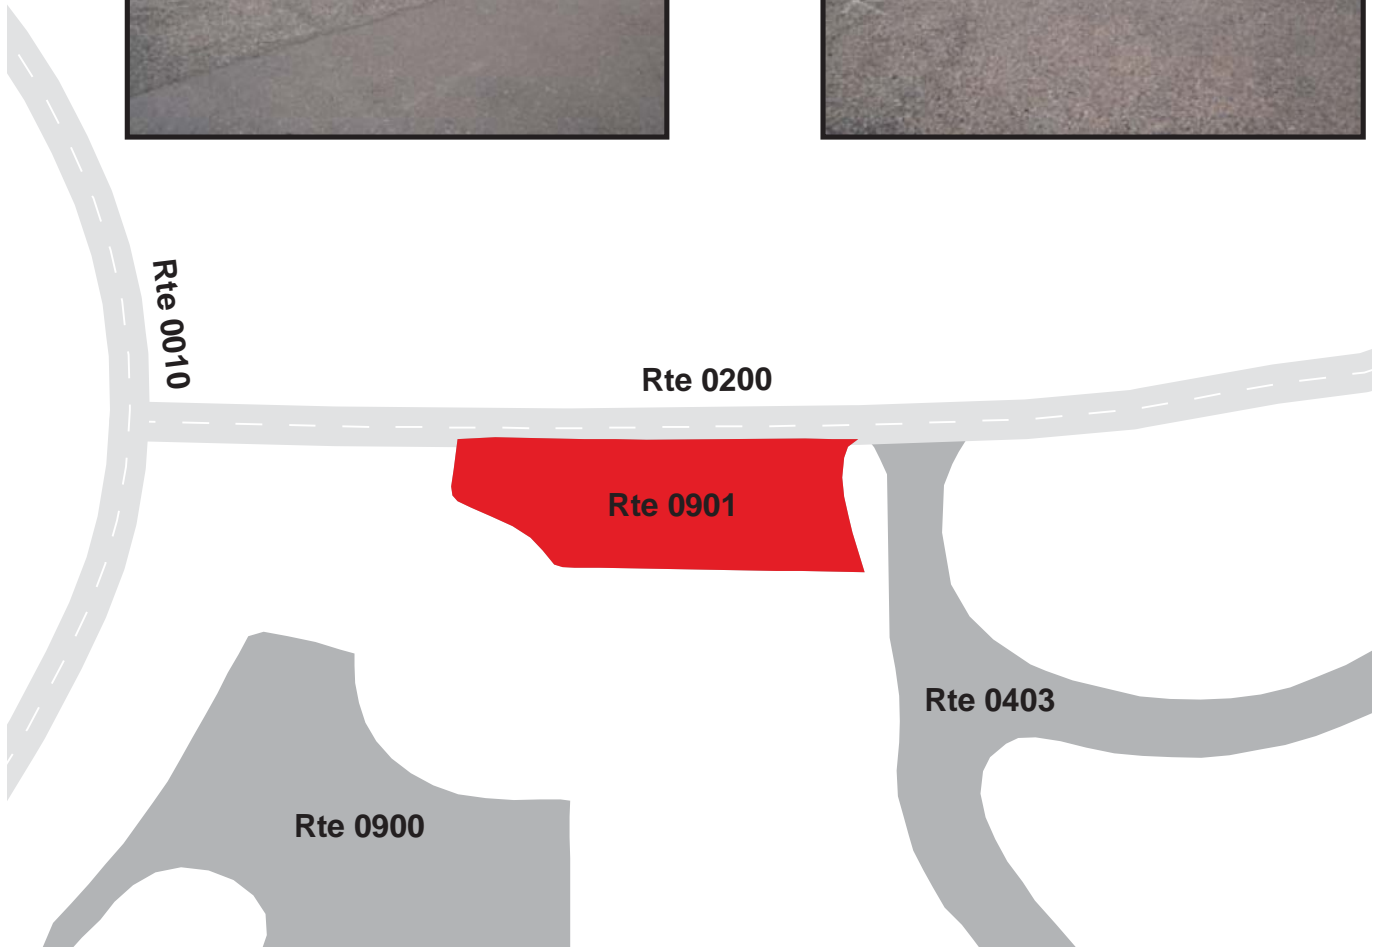
**COLORADO NATIONAL MONUMENT**  
**Route 0901**  
**STONE HOUSE PARKING**  
 ADJACENT TO ROUTE 0200 (SADDLEHORN LOOP ROAD)

Route Number	Public / NonPublic	Date Visited		Area (sq ft)	Lane Miles *	Surface Type
0901	PUBLIC	8/24/2009		2,047	0.04	AS
Culverts	Drop Inlets	Gates	Fire Hydrants	Curb & Gutter	Curb	PCR
0	0	0	0	NO CURB AND GUTTER	NO CURB	FAIR/73

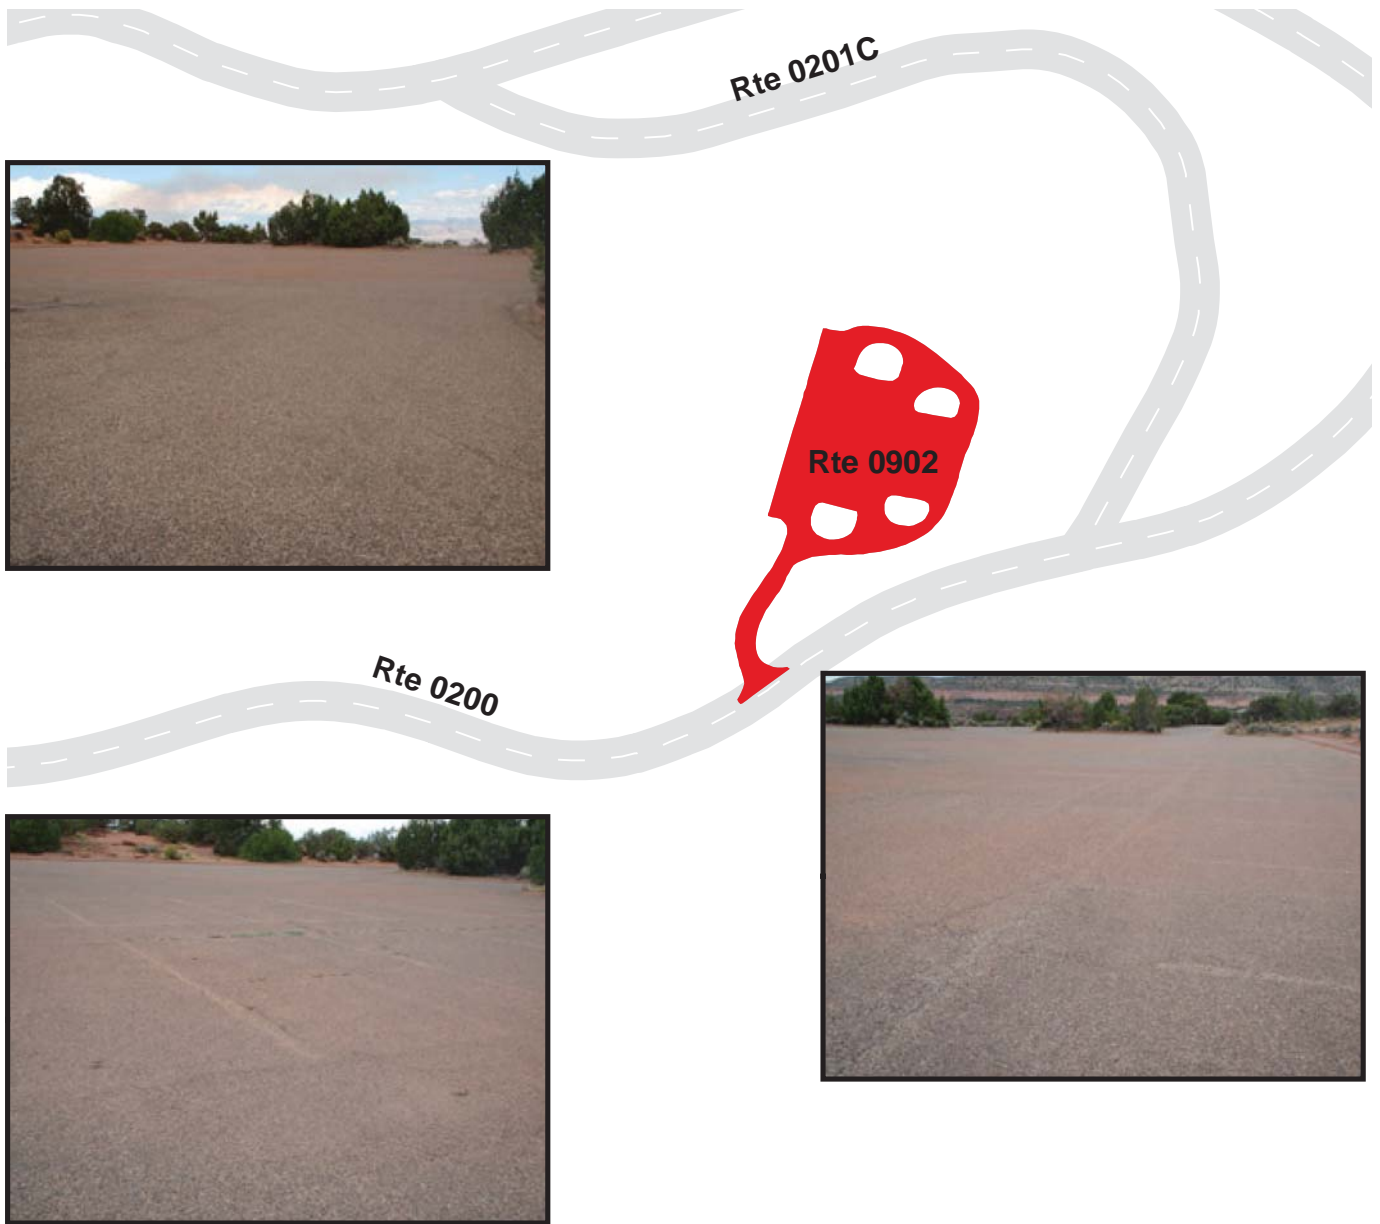
## Route 0902

Route Number	Public / NonPublic	Date Visited		Area (sq ft)	Lane Miles *	Surface Type
0902	PUBLIC	8/24/2009		43,406	0.75	AS
Culverts	Drop Inlets	Gates	Fire Hydrants	Curb & Gutter	Curb	PCR
0	0	0	0	CONCRETE CURB AND GUTTER	NO CURB	FAIR/73

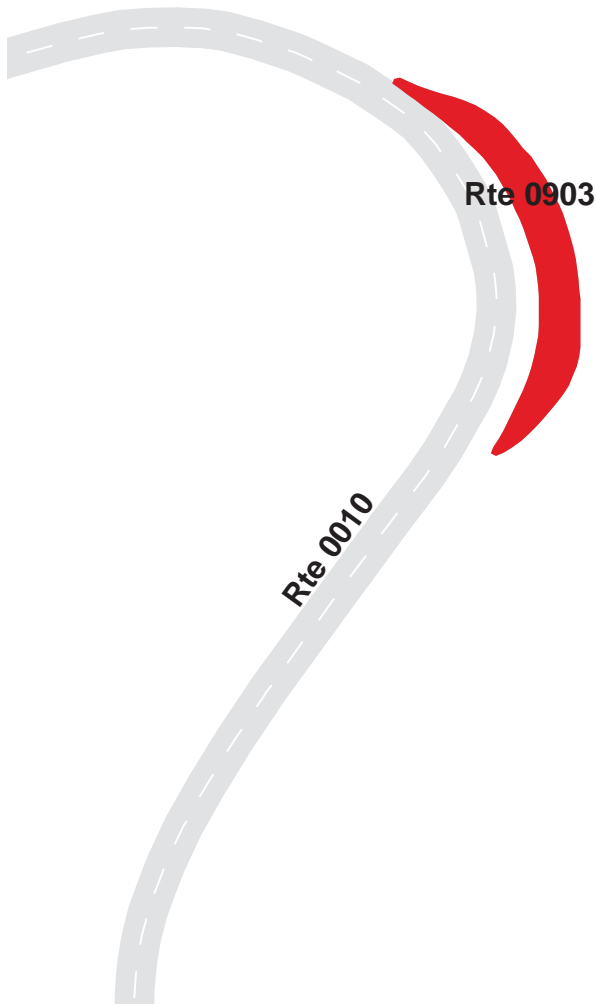
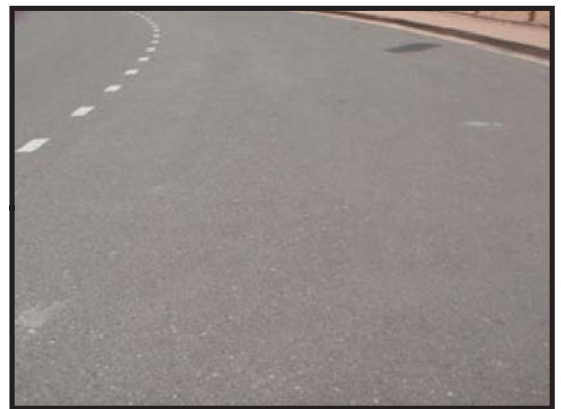
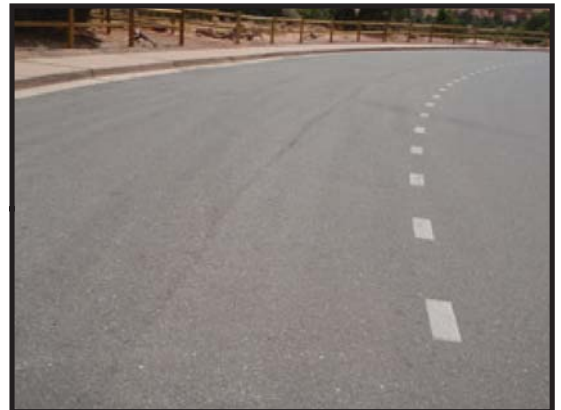
Route Number	Public / NonPublic	Date Visited		Area (sq ft)	Lane Miles *	Surface Type
0903	PUBLIC	8/24/2009		3,881	0.07	AS
Culverts	Drop Inlets	Gates	Fire Hydrants	Curb & Gutter	Curb	PCR
0	0	0	0	CONCRETE CURB AND GUTTER	NO CURB	EXCELLENT/97
