**The Road Inventory  
of  
Colorado National Monument  
COLM – 1378  
Cycle 4**

**Prepared By:  
Federal Highway Administration  
Road Inventory Program  
Cycle 4**

# Colorado National Monument in Colorado

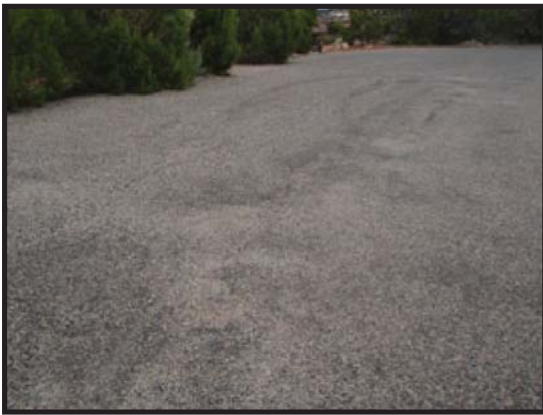
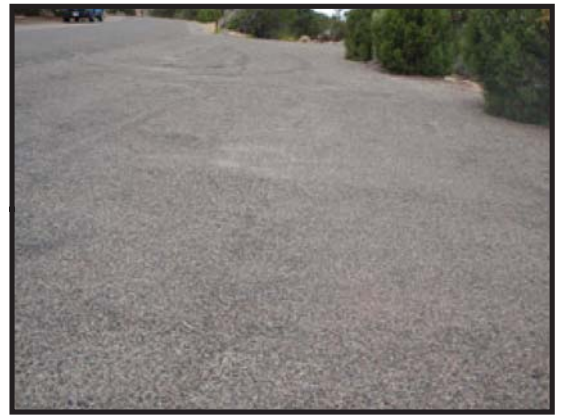
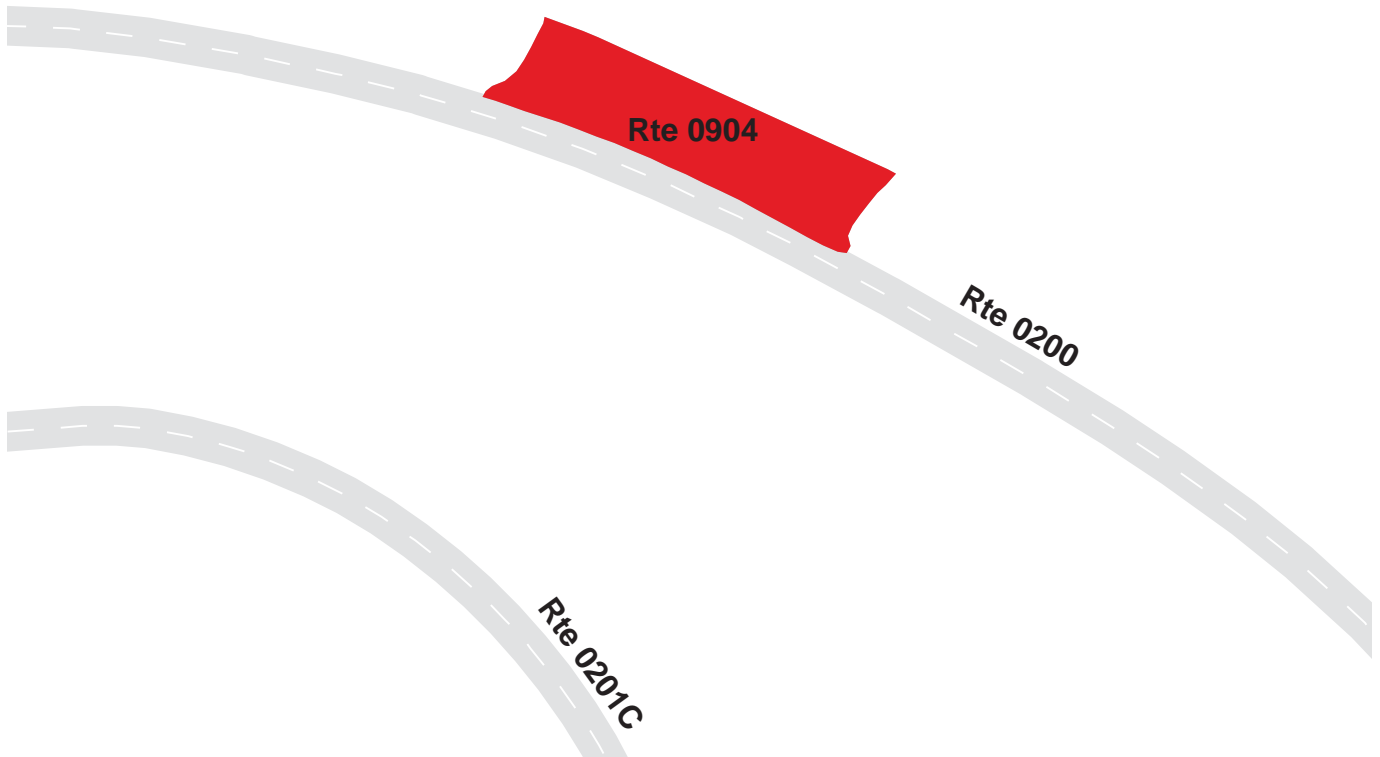
## Route 0904

Route Number	Public / NonPublic	Date Visited		Area (sq ft)	Lane Miles *	Surface Type
0904	PUBLIC	8/24/2009		3,821	0.07	AS
Culverts	Drop Inlets	Gates	Fire Hydrants	Curb & Gutter	Curb	PCR
0	0	0	0	NO CURB AND GUTTER	NO CURB	FAIR/73

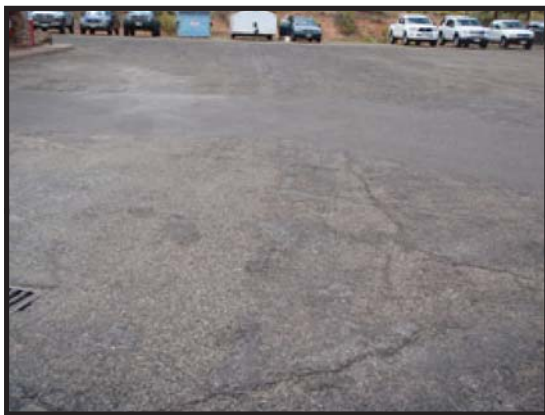
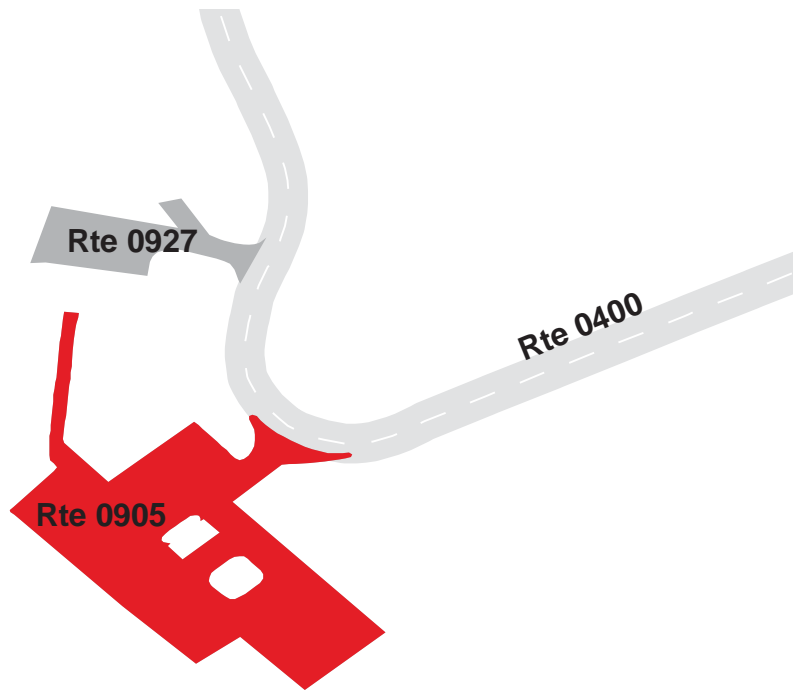
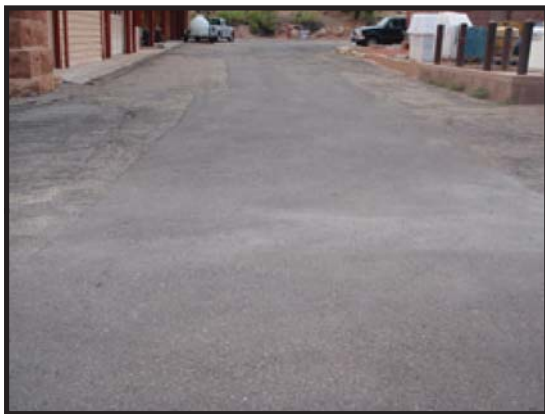
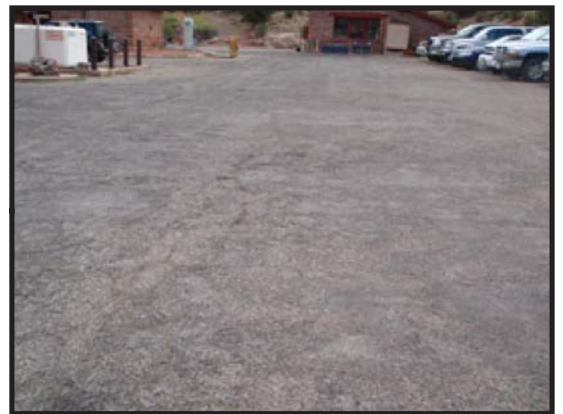
## Route 0905

Route Number	Public / NonPublic	Date Visited		Area (sq ft)	Lane Miles *	Surface Type
0905	NONPUBLIC	8/24/2009		30,689	0.53	AS
Culverts	Drop Inlets	Gates	Fire Hydrants	Curb & Gutter	Curb	PCR
0	1	1	2	NO CURB AND GUTTER	CONCRETE & STONE CURB	POOR/45

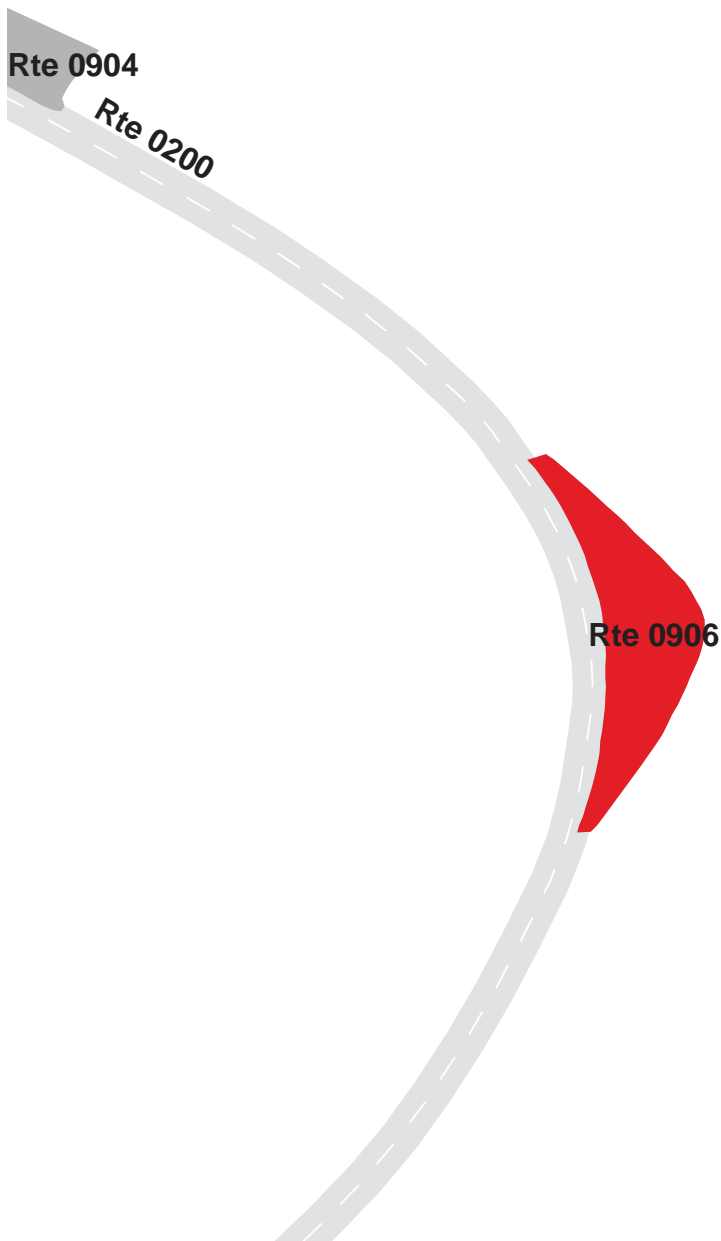
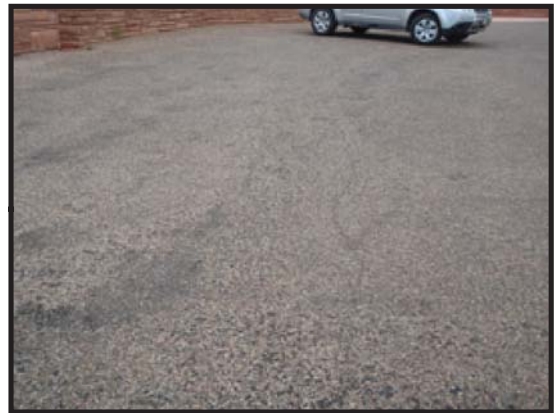
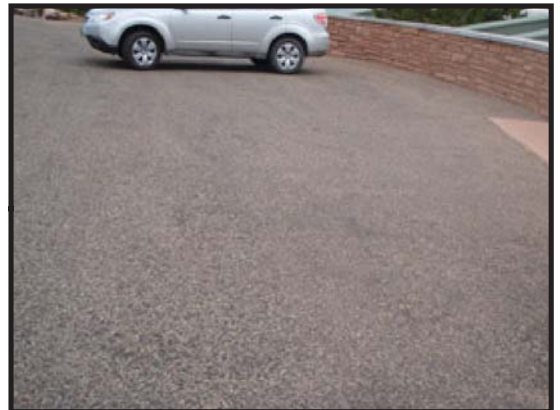
## Route 0906

Route Number	Public / NonPublic	Date Visited		Area (sq ft)	Lane Miles *	Surface Type
0906	PUBLIC	8/24/2009		4,409	0.08	AS
Culverts	Drop Inlets	Gates	Fire Hydrants	Curb & Gutter	Curb	PCR
0	0	0	0	NO CURB AND GUTTER	NO CURB	GOOD/90

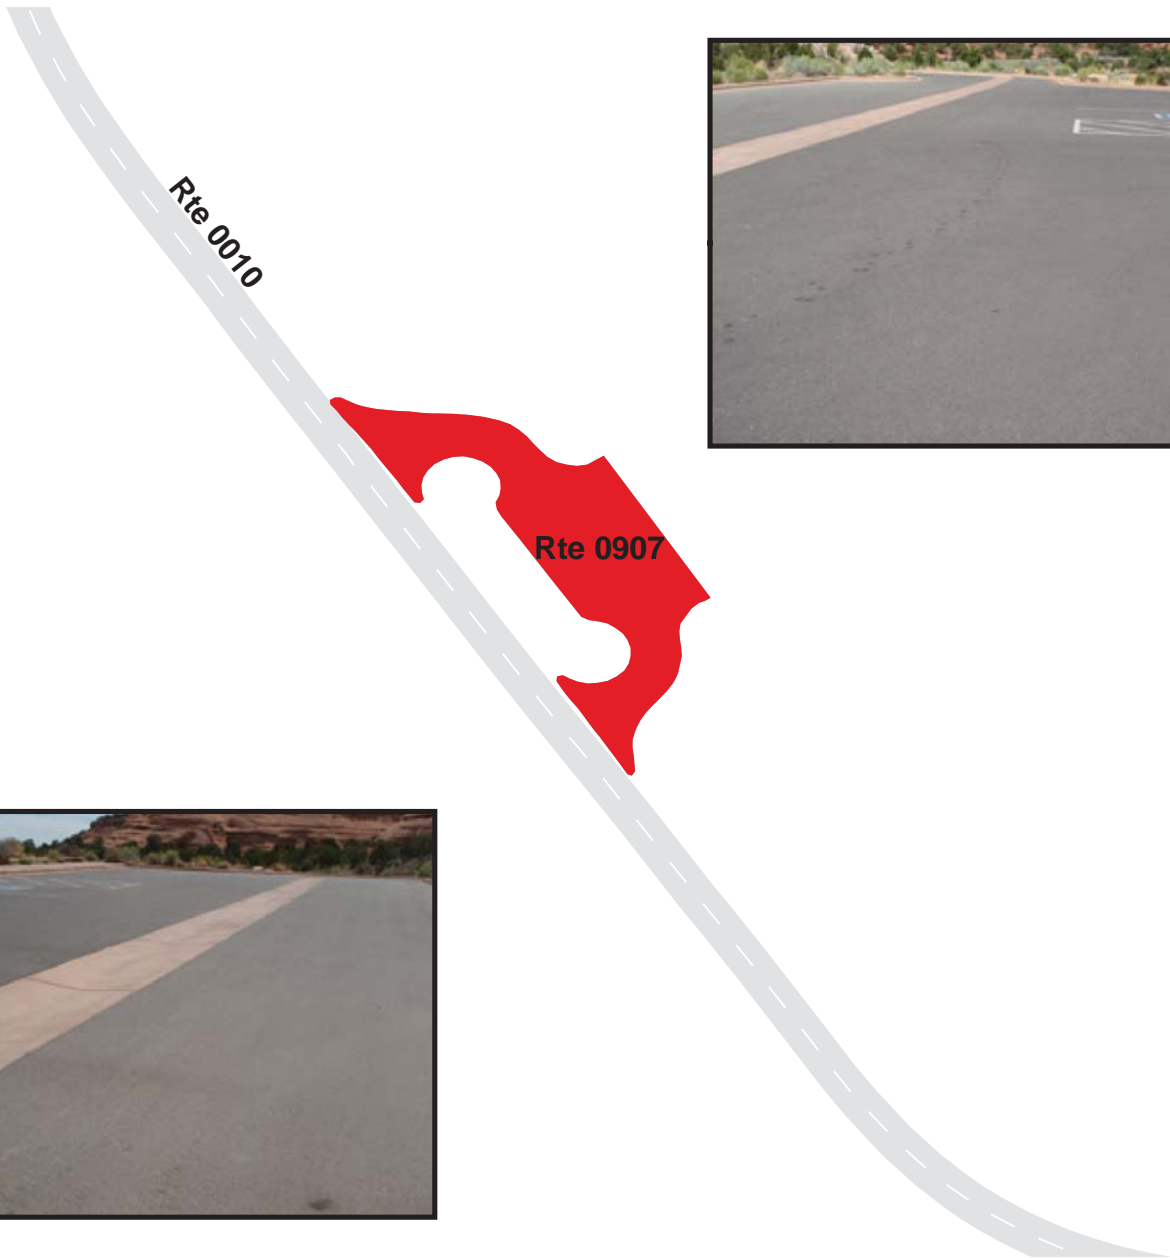
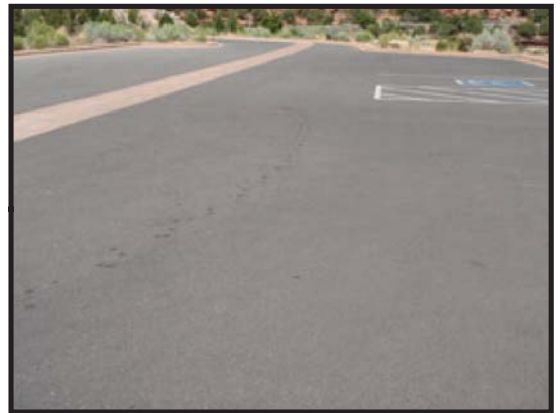
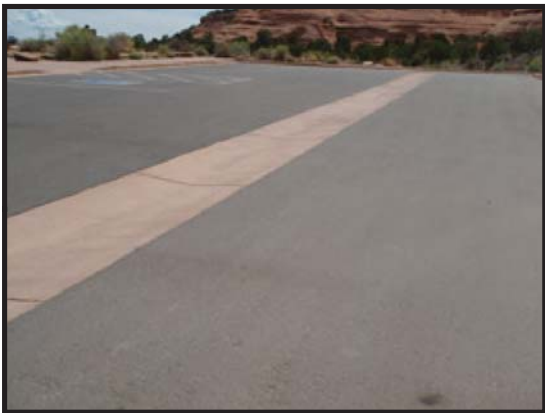
## Route 0907

Route Number	Public / NonPublic	Date Visited		Area (sq ft)	Lane Miles *	Surface Type
0907	PUBLIC	8/24/2009		11,437	0.20	AS
Culverts	Drop Inlets	Gates	Fire Hydrants	Curb & Gutter	Curb	PCR
0	1	0	0	CONCRETE CURB AND GUTTER	NO CURB	EXCELLENT/97

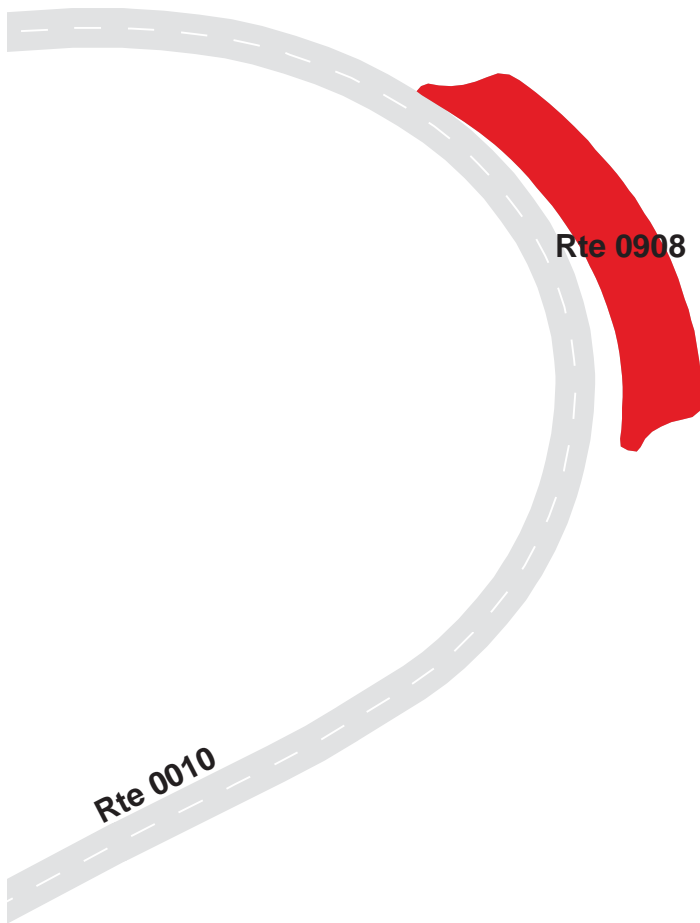
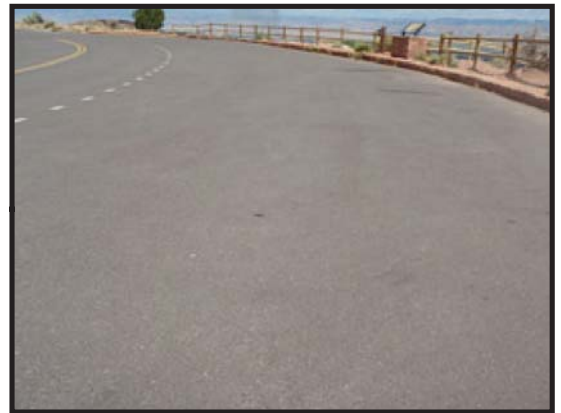
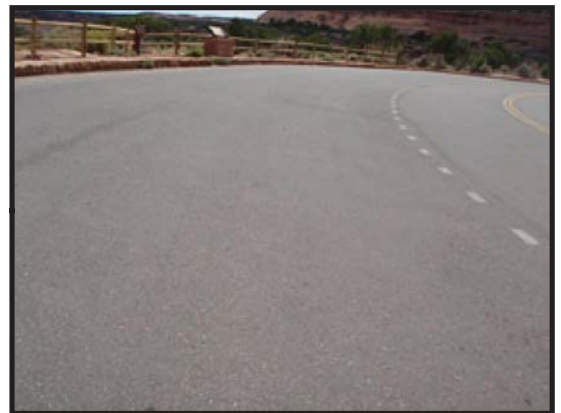
## Route 0908

Route Number	Public / NonPublic	Date Visited		Area (sq ft)	Lane Miles *	Surface Type
0908	PUBLIC	8/24/2009		5,768	0.10	AS
Culverts	Drop Inlets	Gates	Fire Hydrants	Curb & Gutter	Curb	PCR
0	0	0	0	NO CURB AND GUTTER	NO CURB	EXCELLENT/97

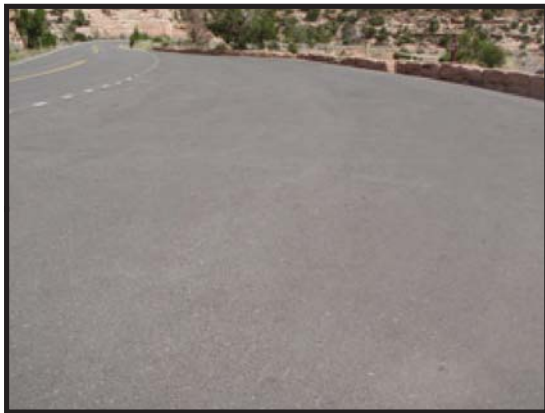
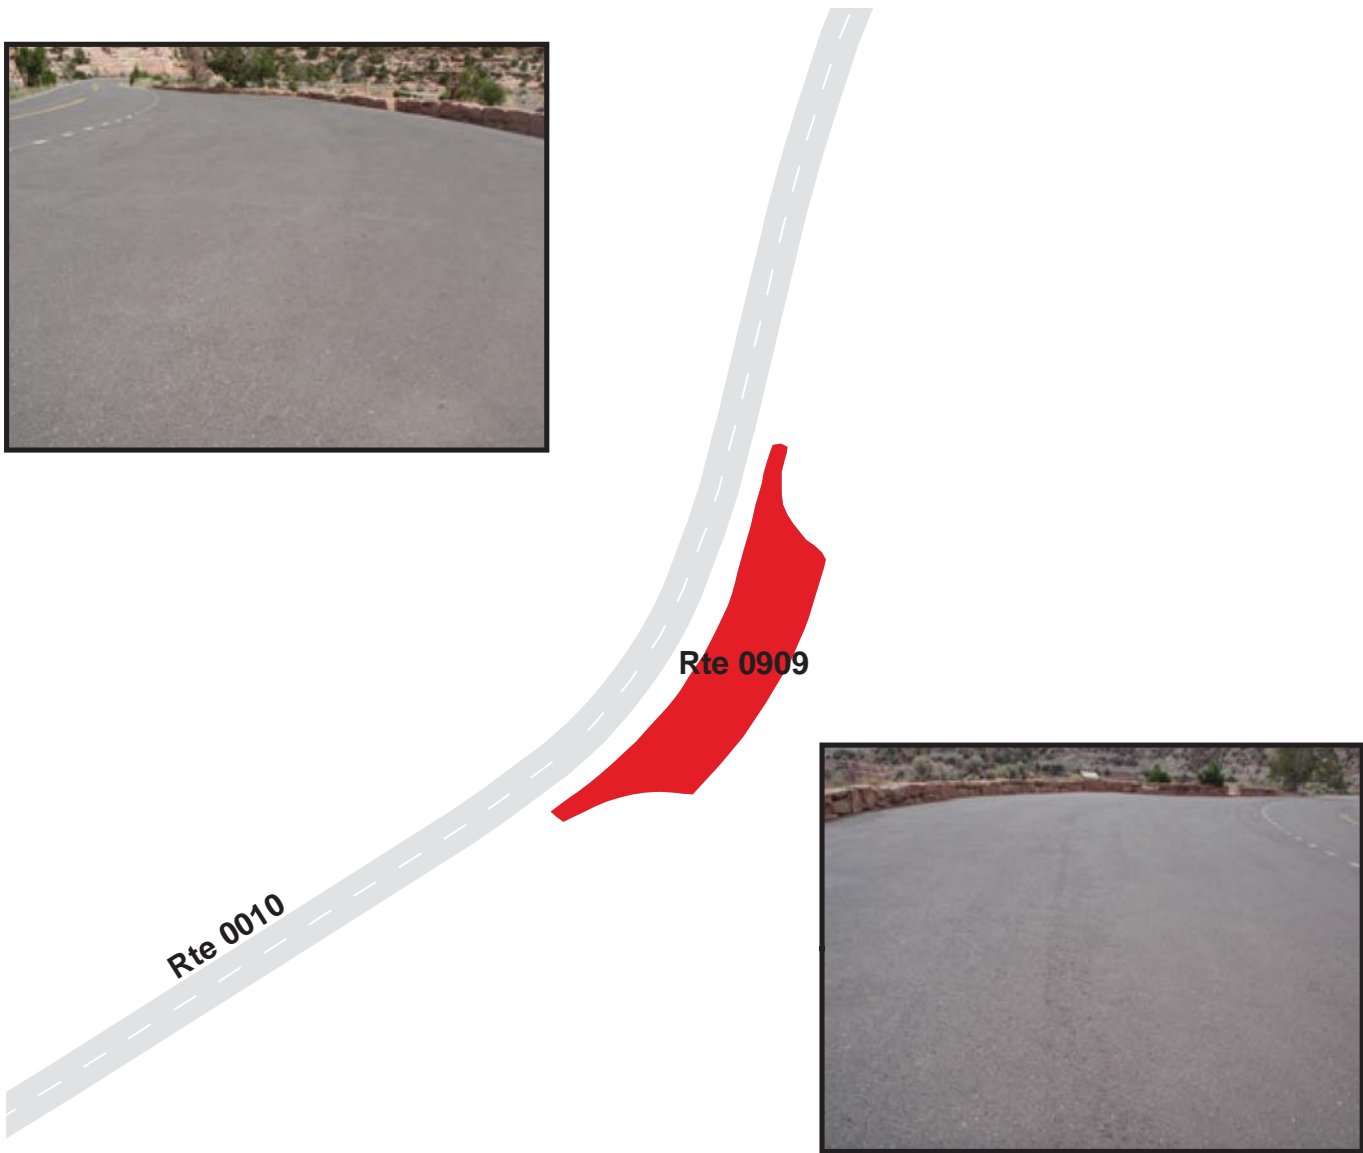
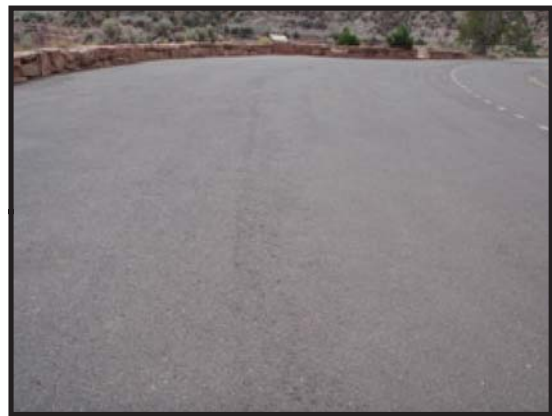
## Route 0909

Route Number	Public / NonPublic	Date Visited		Area (sq ft)	Lane Miles *	Surface Type
0909	PUBLIC	8/24/2009		4,894	0.08	AS
Culverts	Drop Inlets	Gates	Fire Hydrants	Curb & Gutter	Curb	PCR
0	0	0	0	NO CURB AND GUTTER	NO CURB	EXCELLENT/97

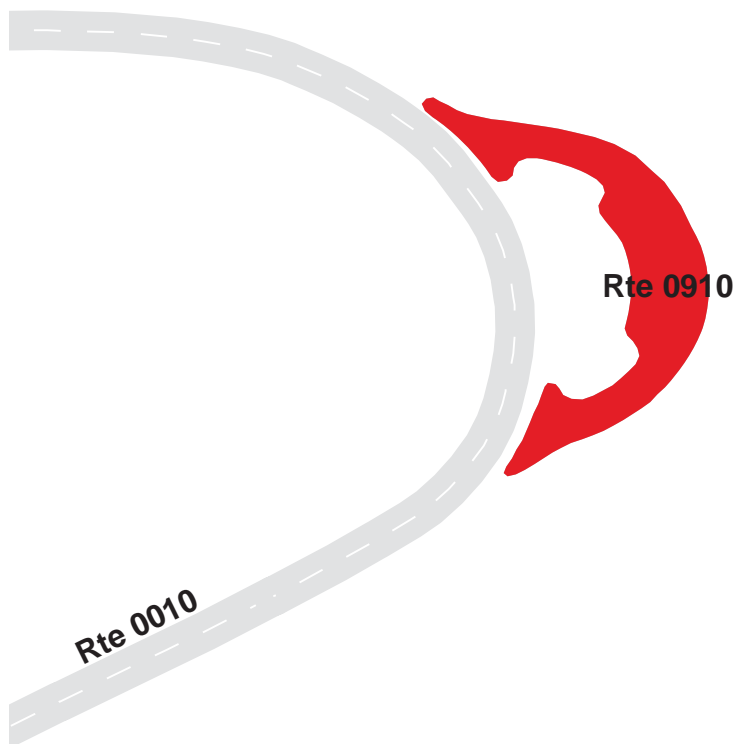
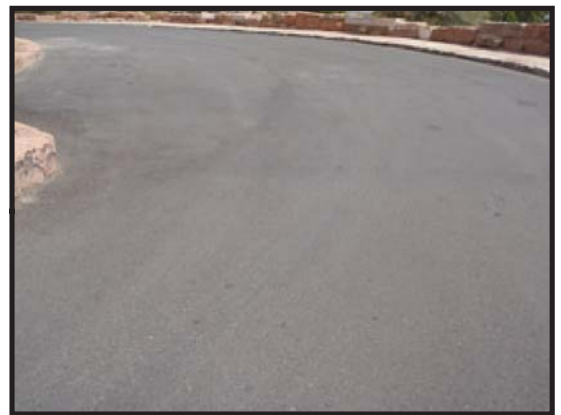
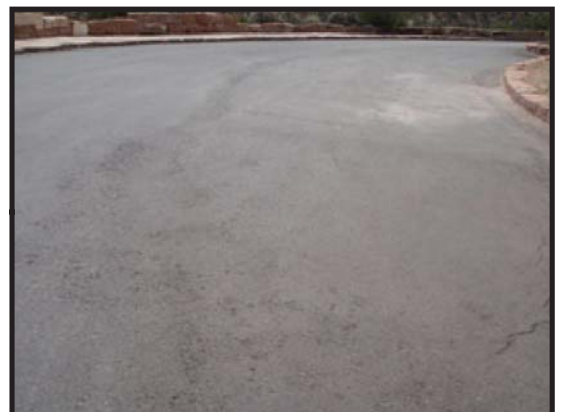
## Route 0910

Route Number	Public / NonPublic	Date Visited		Area (sq ft)	Lane Miles *	Surface Type
0910	PUBLIC	8/24/2009		6,316	0.11	AS
Culverts	Drop Inlets	Gates	Fire Hydrants	Curb & Gutter	Curb	PCR
0	0	0	0	NO CURB AND GUTTER	STONE CURB	EXCELLENT/97

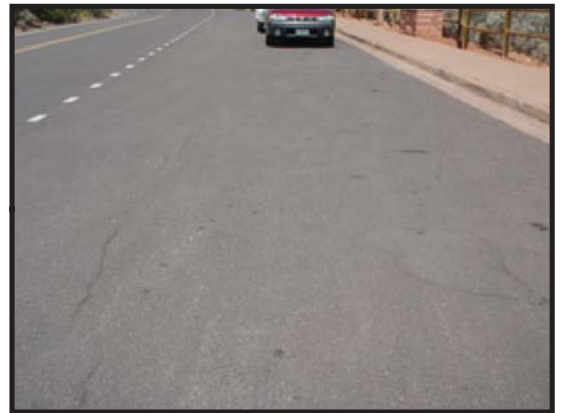
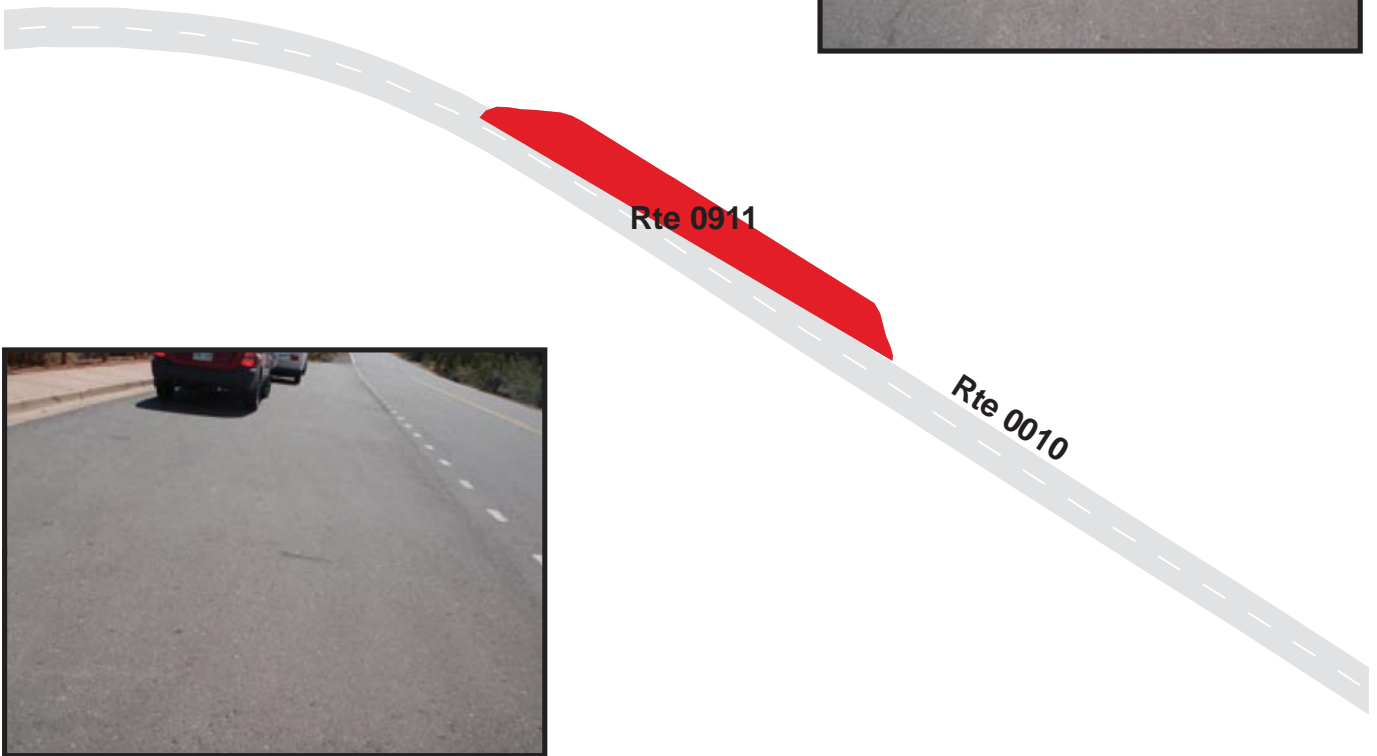
## Route 0911

Route Number	Public / NonPublic	Date Visited		Area (sq ft)	Lane Miles *	Surface Type
0911	PUBLIC	8/24/2009		3,315	0.06	AS
Culverts	Drop Inlets	Gates	Fire Hydrants	Curb & Gutter	Curb	PCR
0	0	0	0	CONCRETE CURB AND GUTTER	NO CURB	GOOD/90

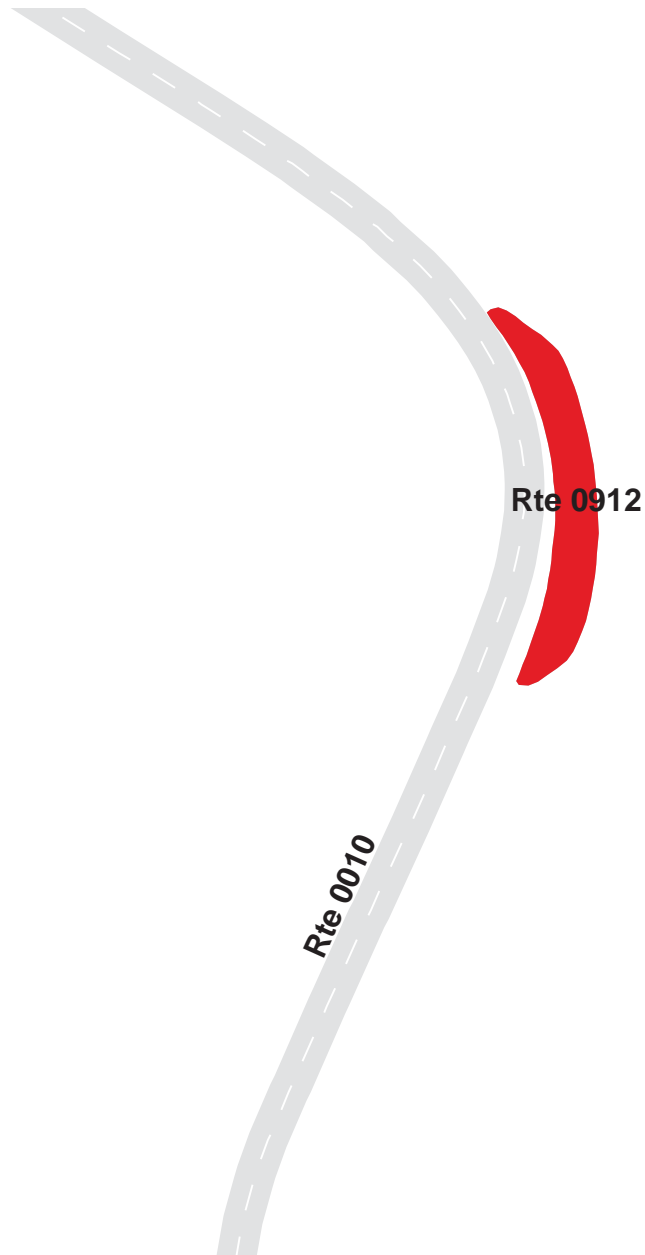
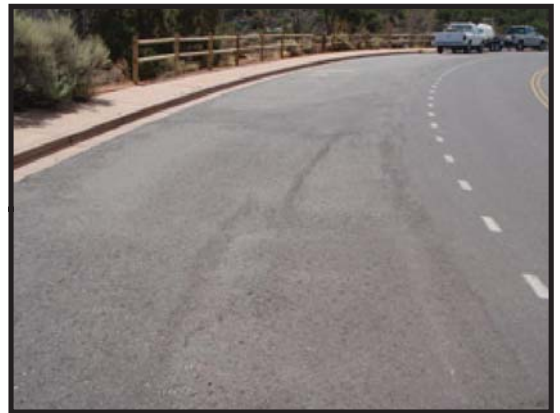
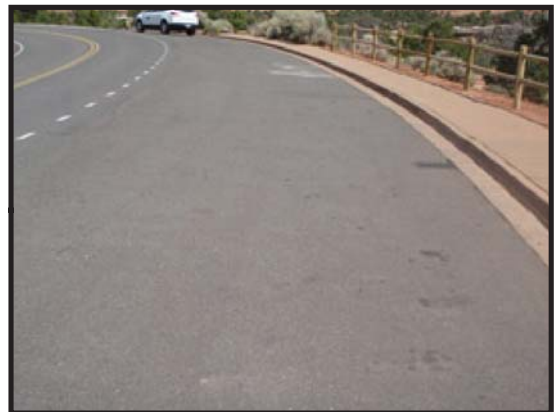
## Route 0912

Route Number	Public / NonPublic	Date Visited		Area (sq ft)	Lane Miles *	Surface Type
0912	PUBLIC	8/24/2009		4,008	0.07	AS
Culverts	Drop Inlets	Gates	Fire Hydrants	Curb & Gutter	Curb	PCR
1	0	0	0	CONCRETE CURB AND GUTTER	NO CURB	GOOD/90

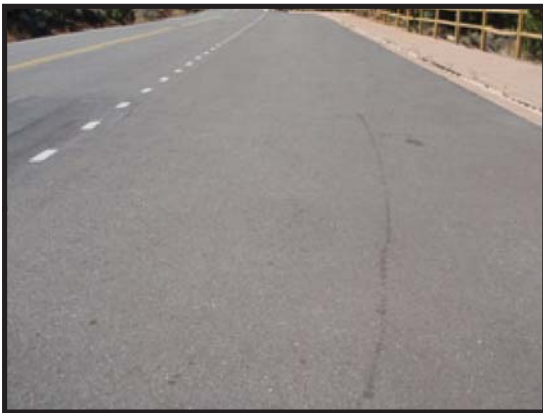
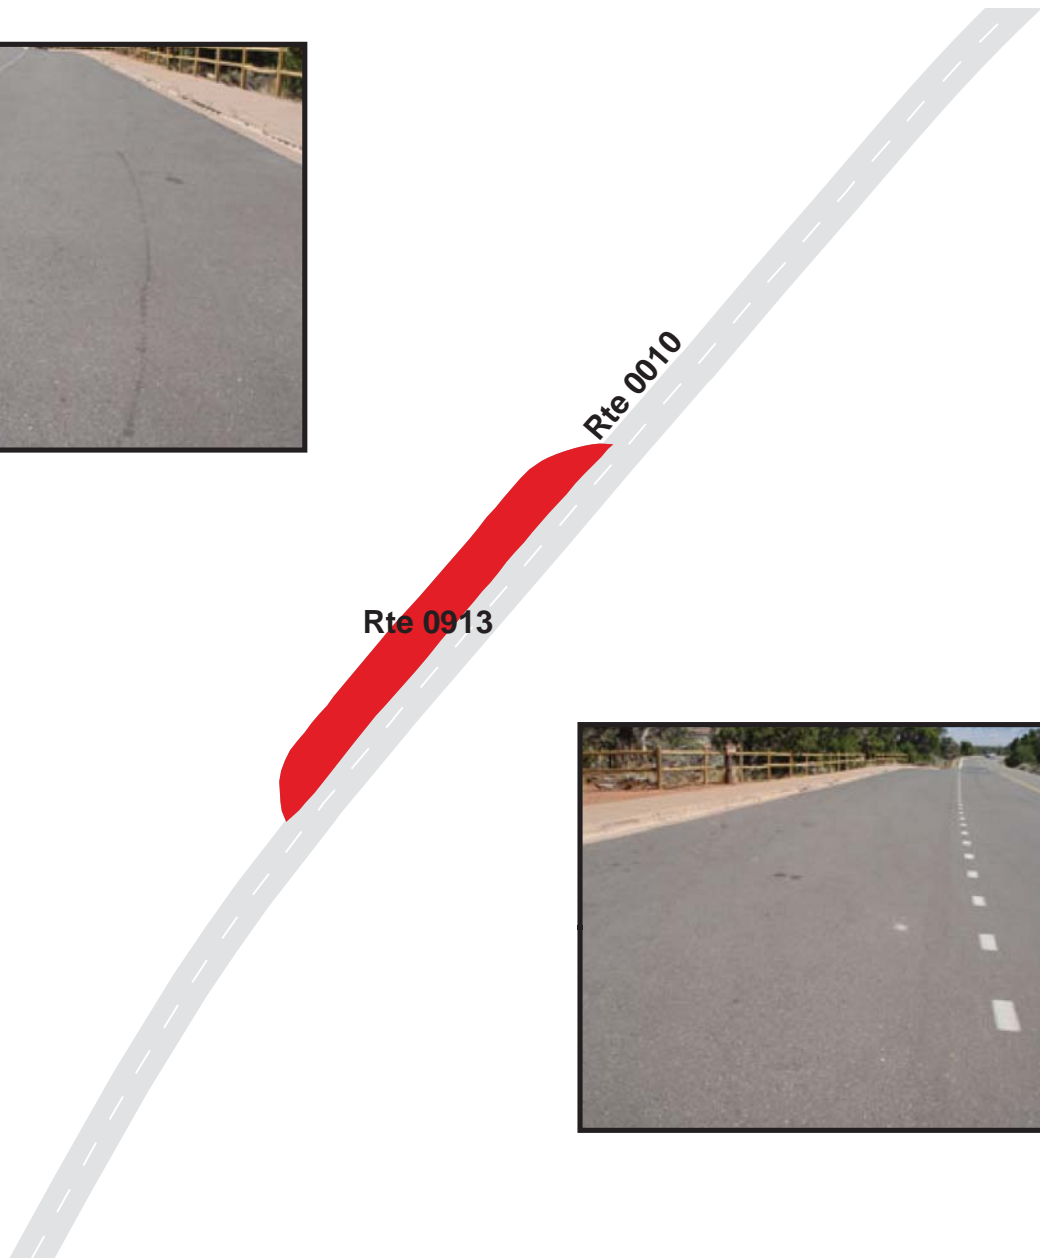
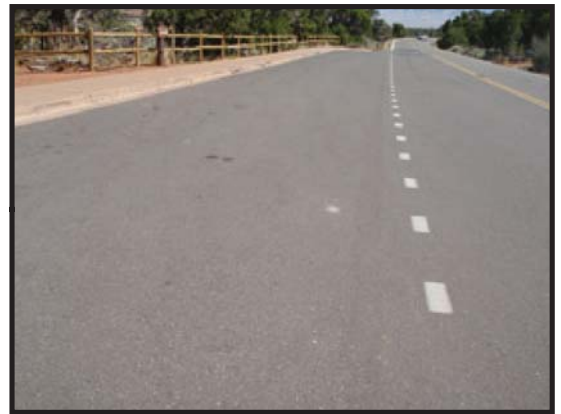
## Route 0913

Route Number	Public / NonPublic	Date Visited		Area (sq ft)	Lane Miles *	Surface Type
0913	PUBLIC	8/24/2009		3,987	0.07	AS
Culverts	Drop Inlets	Gates	Fire Hydrants	Curb & Gutter	Curb	PCR
0	0	0	0	CONCRETE CURB AND GUTTER	NO CURB	GOOD/90

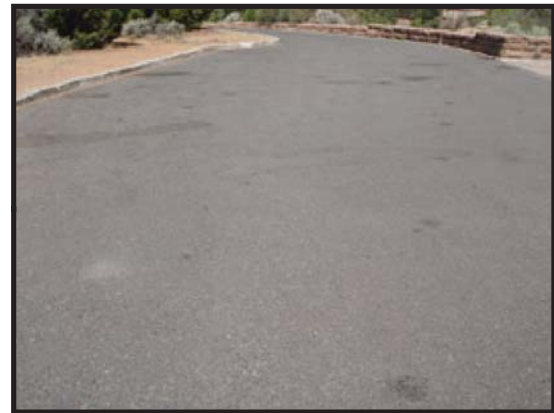
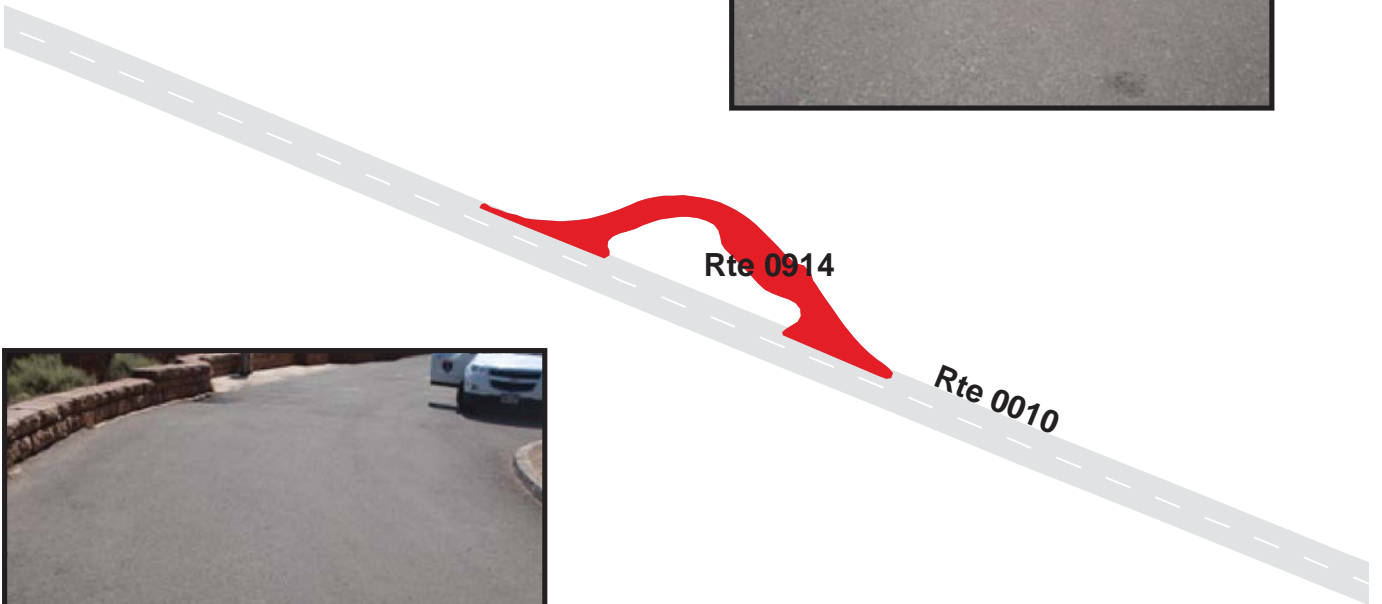
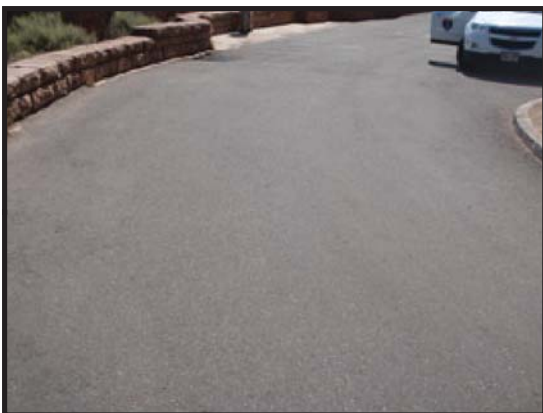
## Route 0914

Route Number	Public / NonPublic	Date Visited		Area (sq ft)	Lane Miles *	Surface Type
0914	PUBLIC	8/24/2009		5,546	0.10	AS
Culverts	Drop Inlets	Gates	Fire Hydrants	Curb & Gutter	Curb	PCR
0	1	0	0	NO CURB AND GUTTER	STONE CURB	GOOD/90

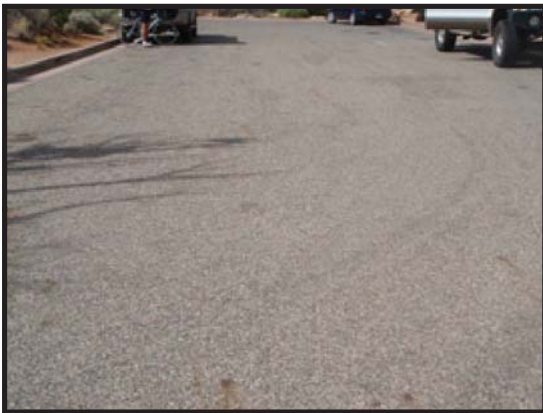
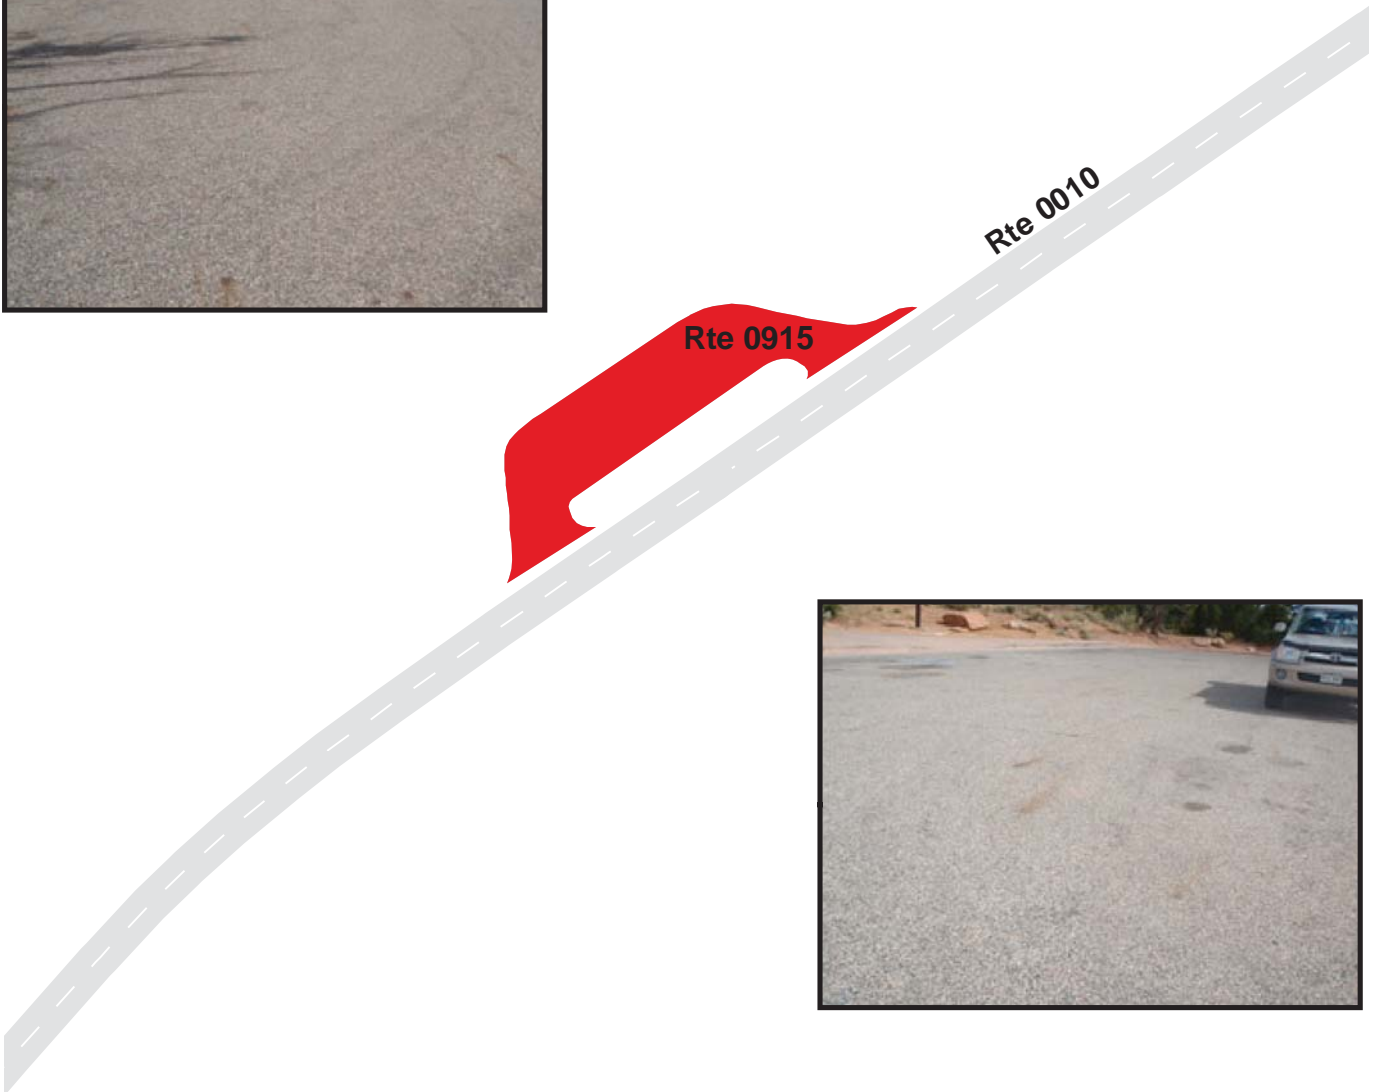
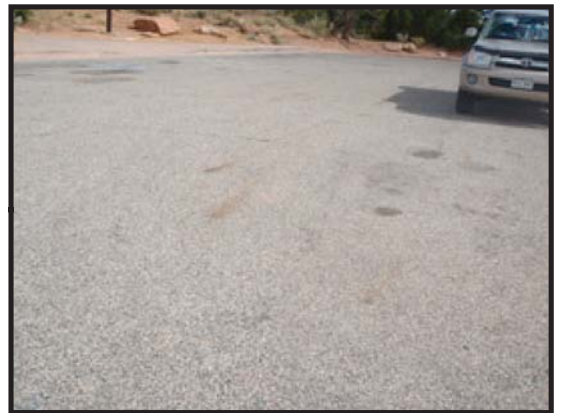
## Route 0915

Route Number	Public / NonPublic	Date Visited		Area (sq ft)	Lane Miles *	Surface Type
0915	PUBLIC	8/24/2009		5,549	0.10	AS
Culverts	Drop Inlets	Gates	Fire Hydrants	Curb & Gutter	Curb	PCR
0	0	0	0	CONCRETE CURB AND GUTTER	NO CURB	FAIR/73

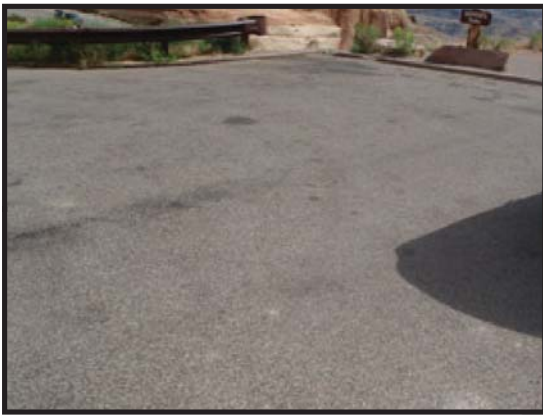
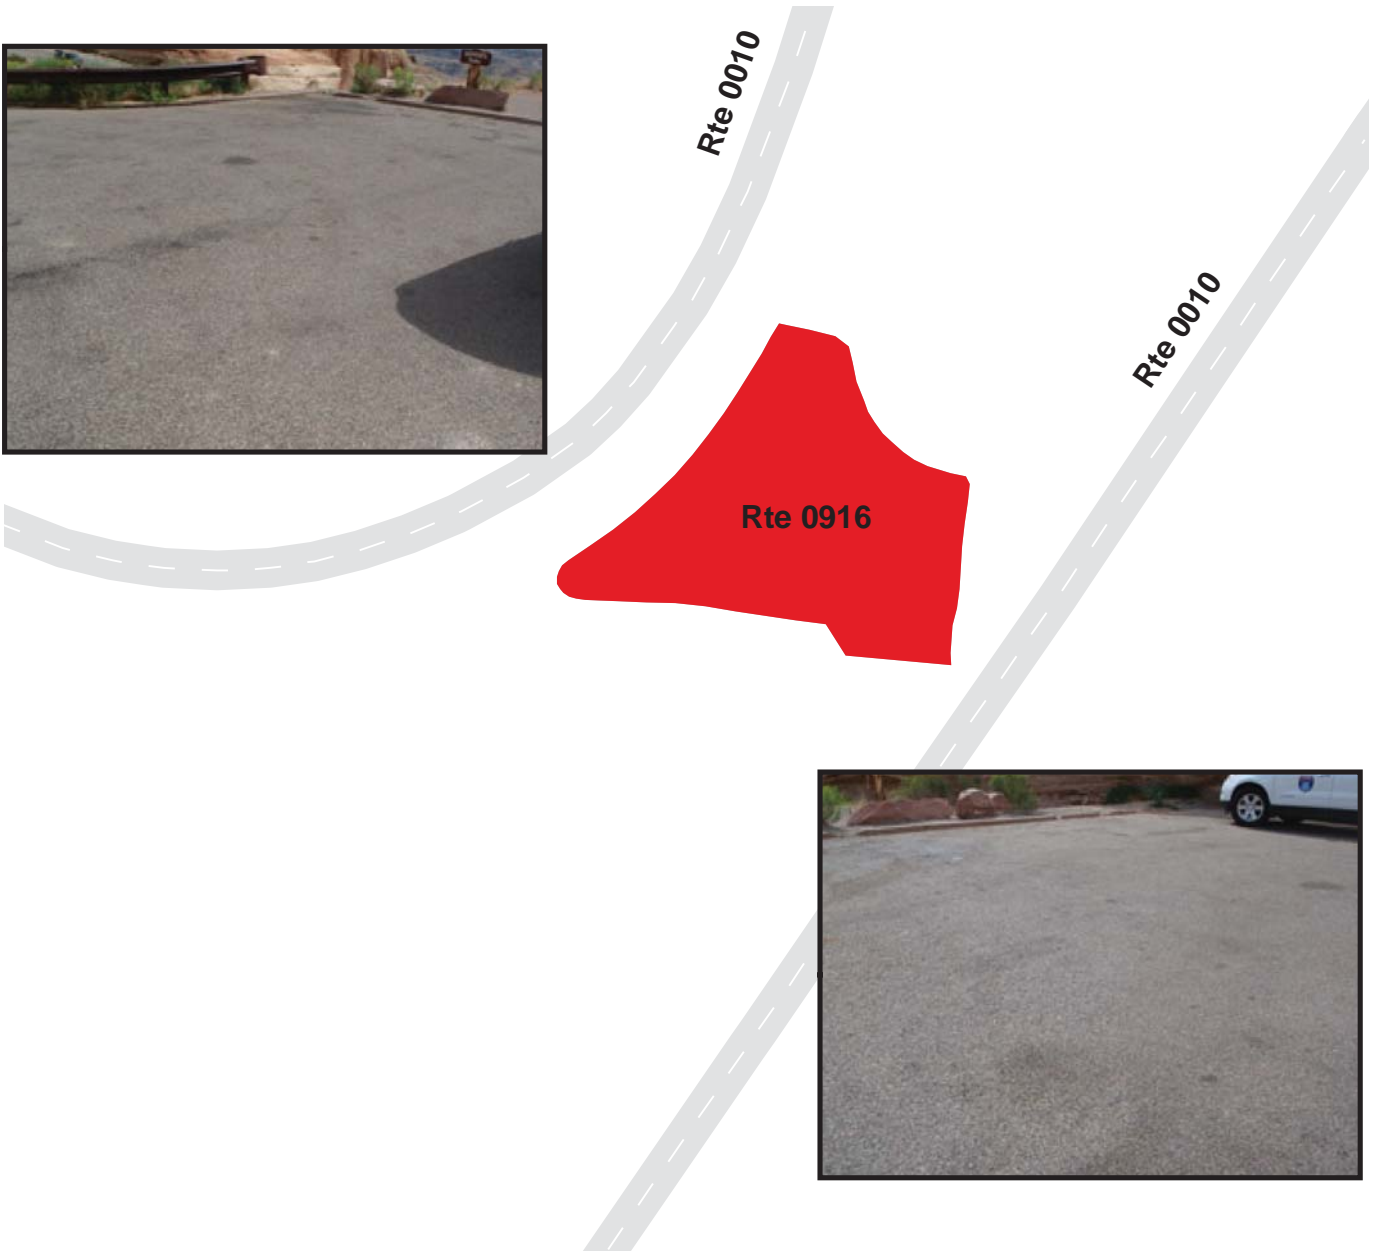
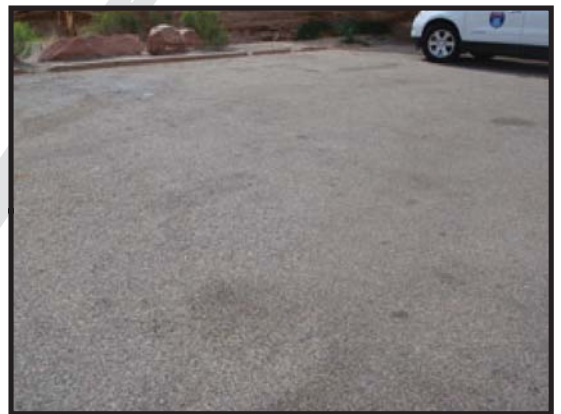
Route Number	Public / NonPublic	Date Visited		Area (sq ft)	Lane Miles *	Surface Type
0916	PUBLIC	8/24/2009		2,482	0.04	AS
Culverts	Drop Inlets	Gates	Fire Hydrants	Curb & Gutter	Curb	PCR
0	0	0	0	NO CURB AND GUTTER	CONCRETE CURB	FAIR/73

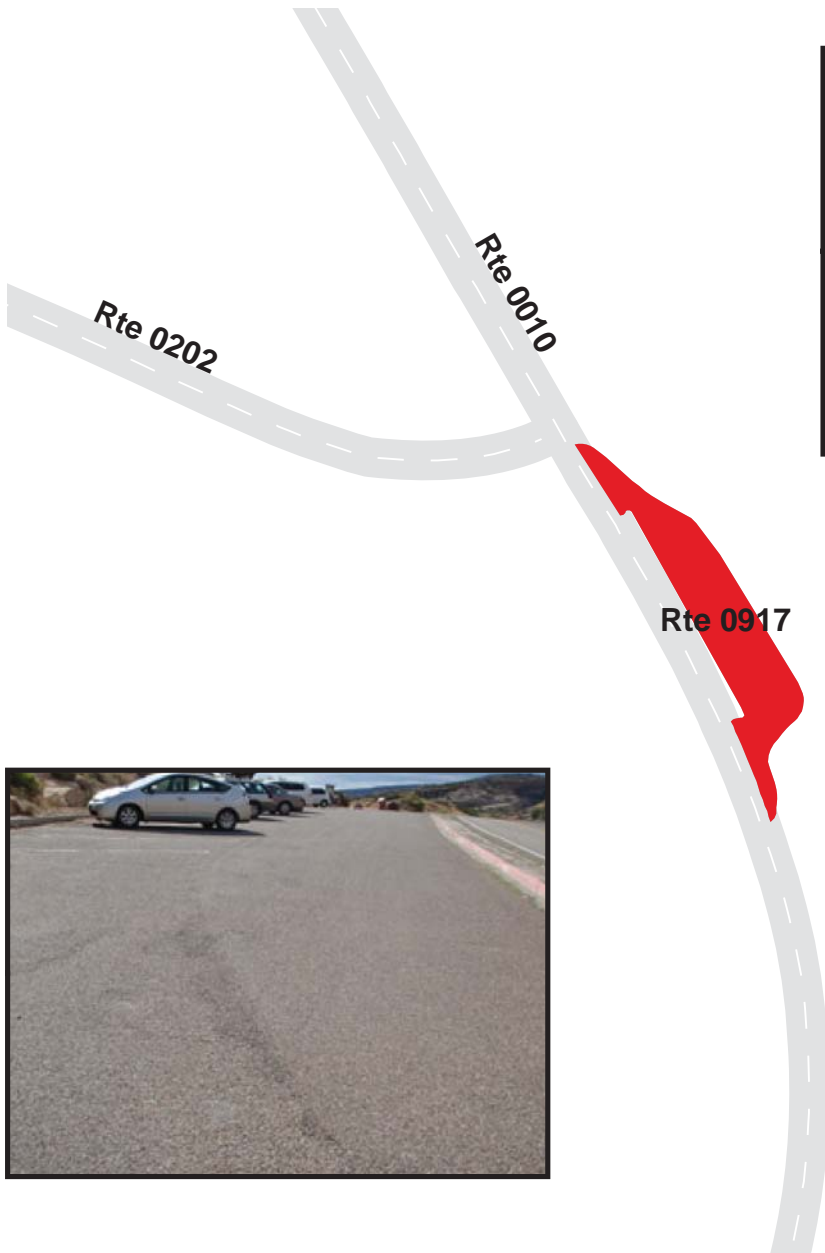
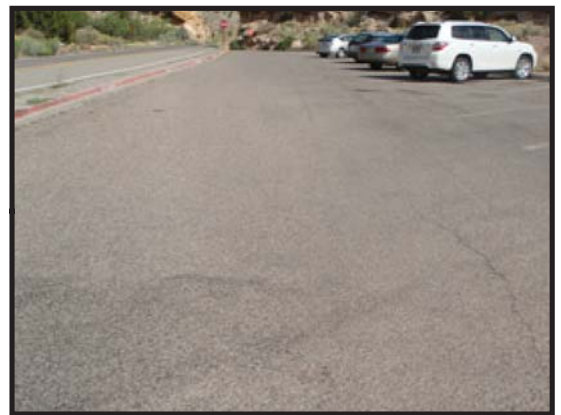
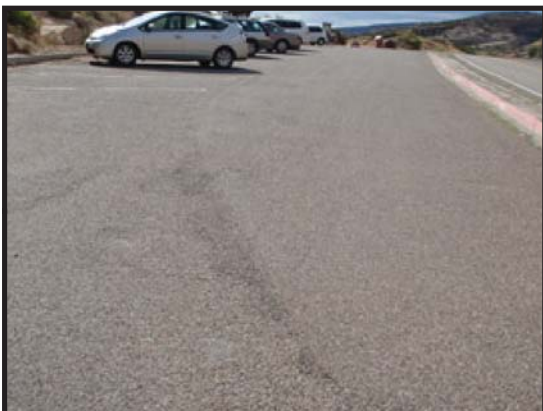
## Route 0917

Route Number	Public / NonPublic	Date Visited		Area (sq ft)	Lane Miles *	Surface Type
0917	PUBLIC	8/24/2009		8,647	0.15	AS
Culverts	Drop Inlets	Gates	Fire Hydrants	Curb & Gutter	Curb	PCR
0	0	0	0	CONCRETE CURB AND GUTTER	CONCRETE CURB	FAIR/73

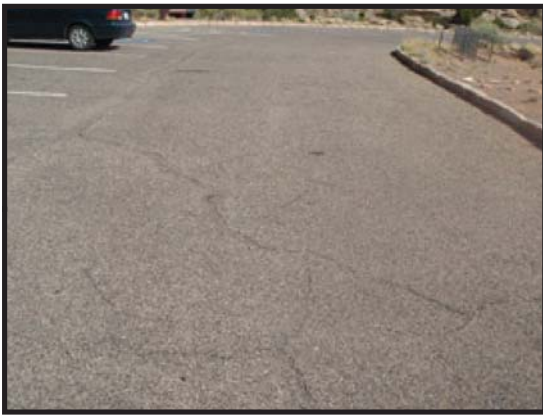
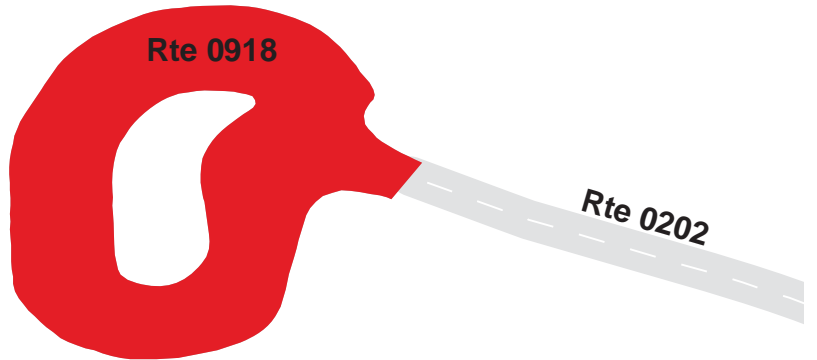
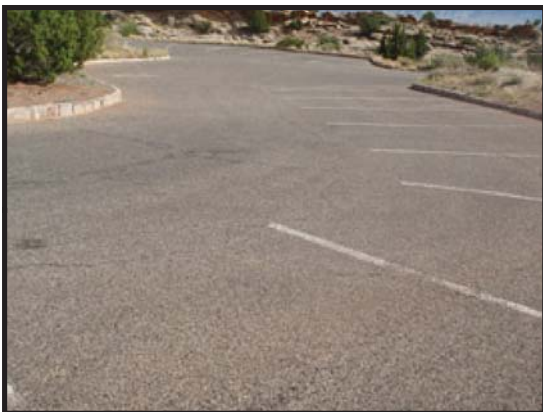
## Route 0918

Route Number	Public / NonPublic	Date Visited		Area (sq ft)	Lane Miles *	Surface Type
0918	PUBLIC	8/24/2009		15,140	0.26	AS
Culverts	Drop Inlets	Gates	Fire Hydrants	Curb & Gutter	Curb	PCR
0	0	0	0	NO CURB AND GUTTER	STONE CURB	FAIR/73
