**The Road Inventory  
of  
Colorado National Monument  
COLM – 1378  
Cycle 4**

**Prepared By:  
Federal Highway Administration  
Road Inventory Program  
Cycle 4**

# Colorado National Monument in Colorado

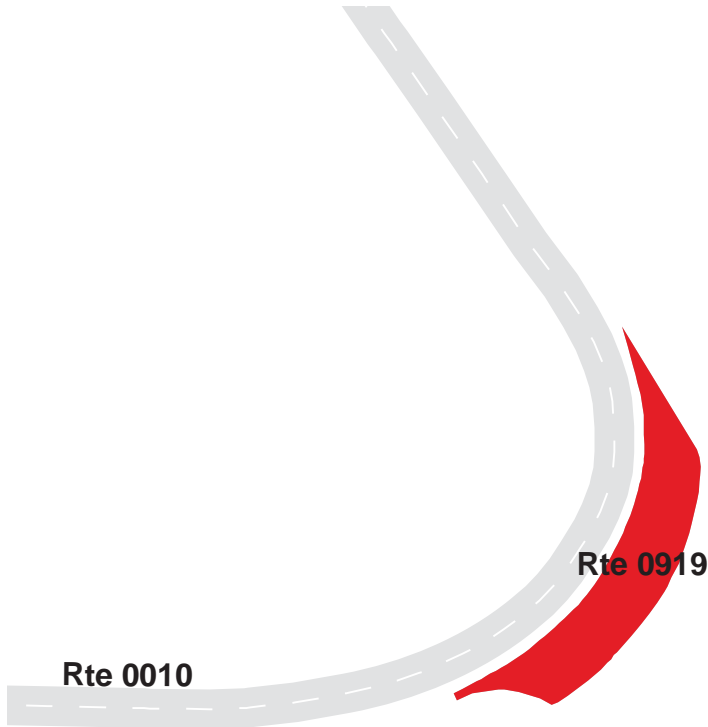
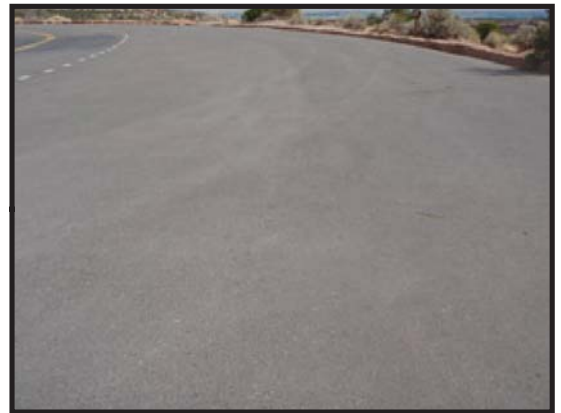
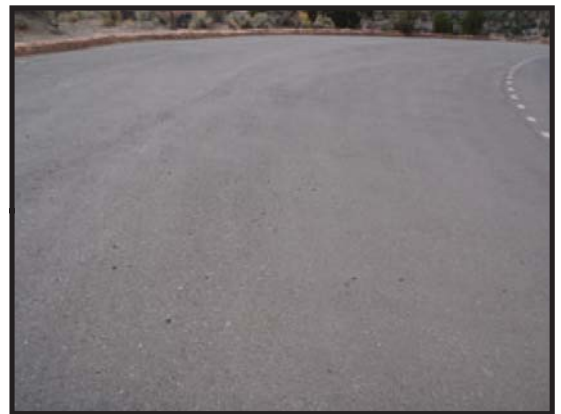
## Route 0919

Route Number	Public / NonPublic	Date Visited		Area (sq ft)	Lane Miles *	Surface Type
0919	PUBLIC	8/24/2009		7,230	0.12	AS
Culverts	Drop Inlets	Gates	Fire Hydrants	Curb & Gutter	Curb	PCR
0	0	0	0	NO CURB AND GUTTER	STONE CURB	EXCELLENT/97

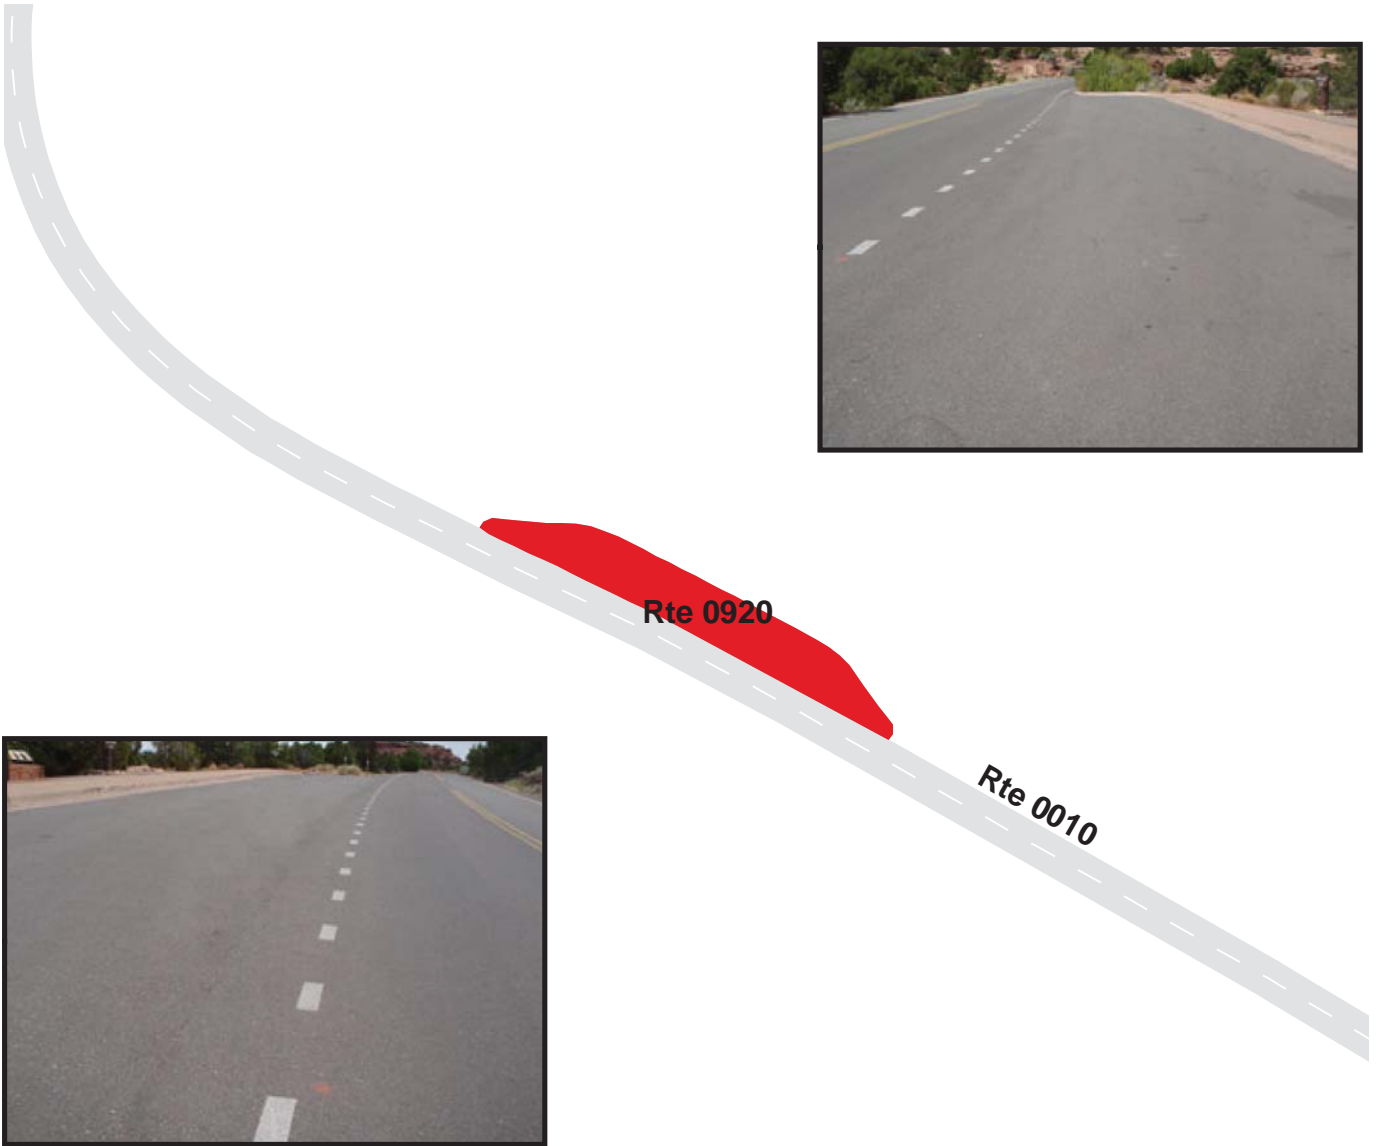
## Route 0920

Route Number	Public / NonPublic	Date Visited		Area (sq ft)	Lane Miles *	Surface Type
0920	PUBLIC	8/24/2009		3,139	0.05	AS
Culverts	Drop Inlets	Gates	Fire Hydrants	Curb & Gutter	Curb	PCR
0	1	0	0	CONCRETE CURB AND GUTTER	NO CURB	GOOD/90

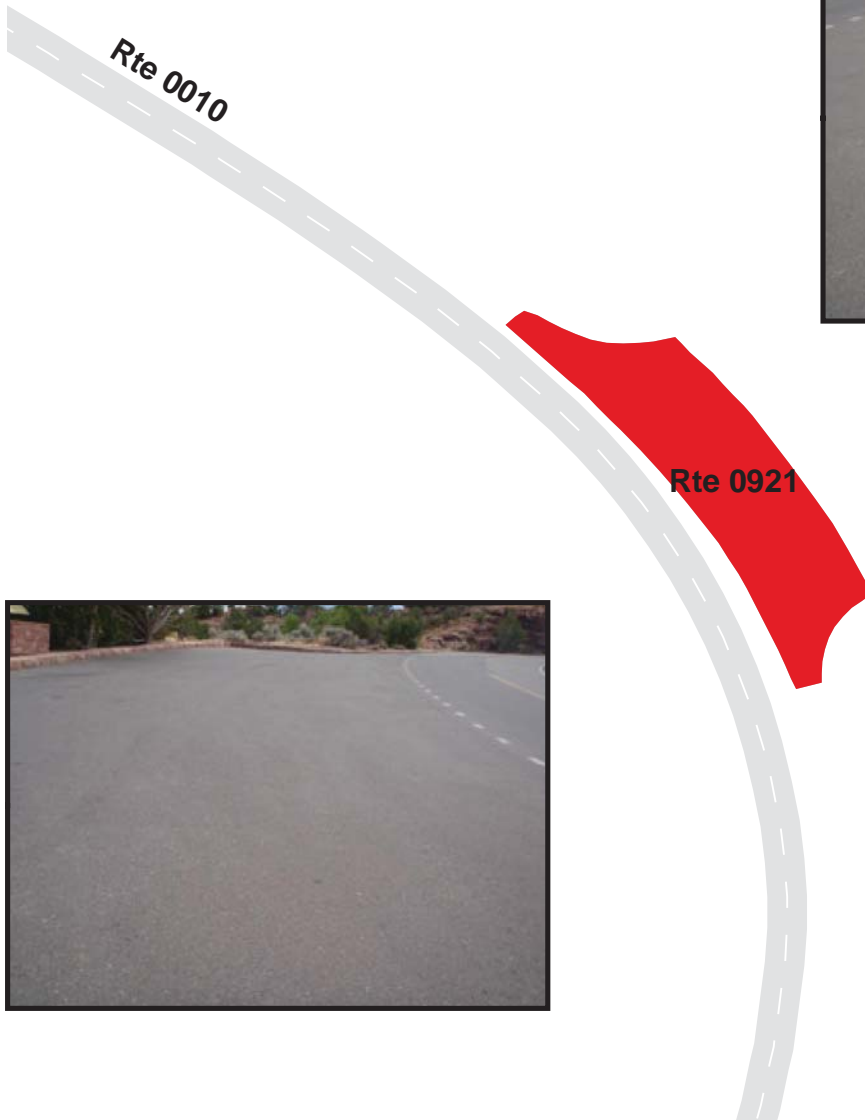
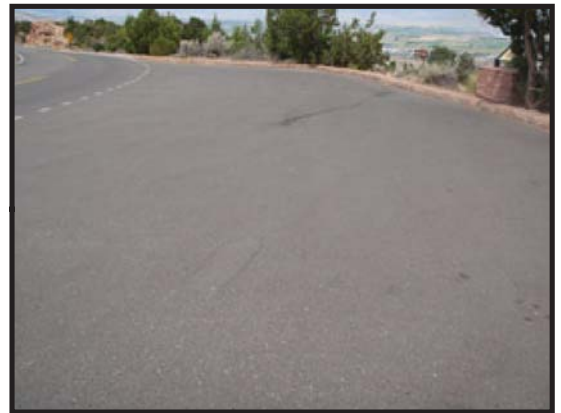
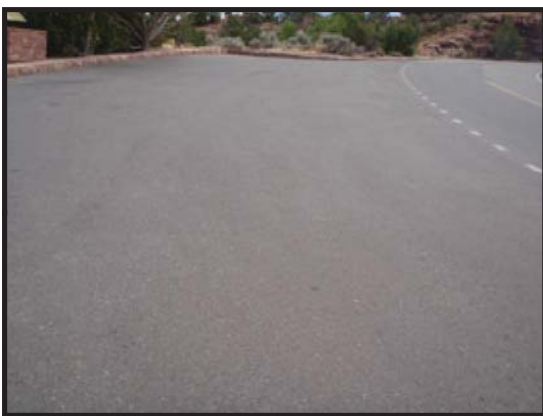
## Route 0921

Route Number	Public / NonPublic	Date Visited		Area (sq ft)	Lane Miles *	Surface Type
0921	PUBLIC	8/24/2009		3,852	0.07	AS
Culverts	Drop Inlets	Gates	Fire Hydrants	Curb & Gutter	Curb	PCR
0	0	0	0	NO CURB AND GUTTER	STONE CURB	GOOD/90

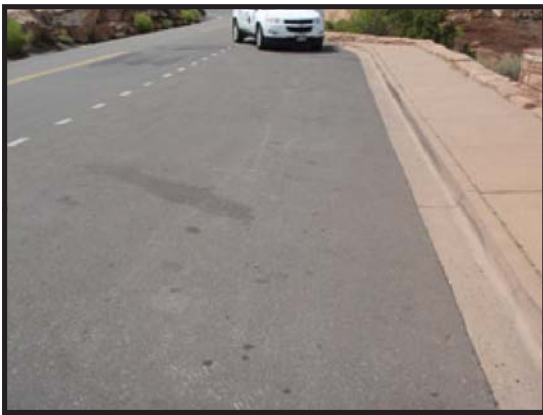
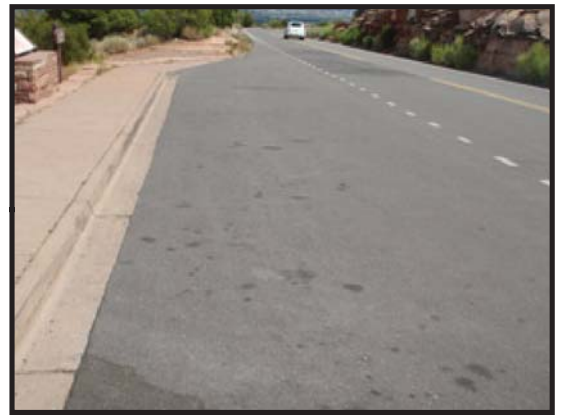
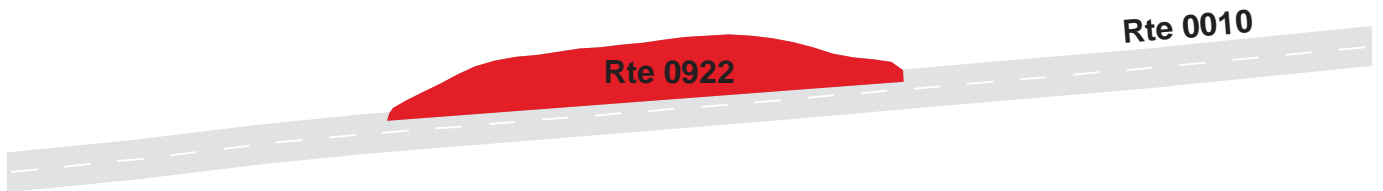
## Route 0922

Route Number	Public / NonPublic	Date Visited		Area (sq ft)	Lane Miles *	Surface Type
0922	PUBLIC	8/24/2009		1,995	0.03	AS
Culverts	Drop Inlets	Gates	Fire Hydrants	Curb & Gutter	Curb	PCR
0	0	0	0	CONCRETE CURB AND GUTTER	NO CURB	GOOD/90

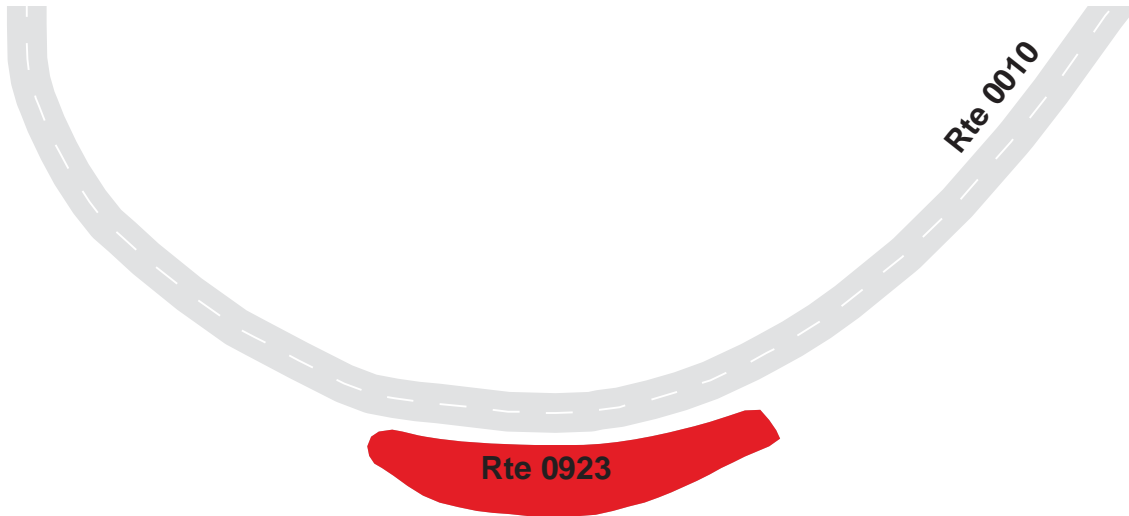
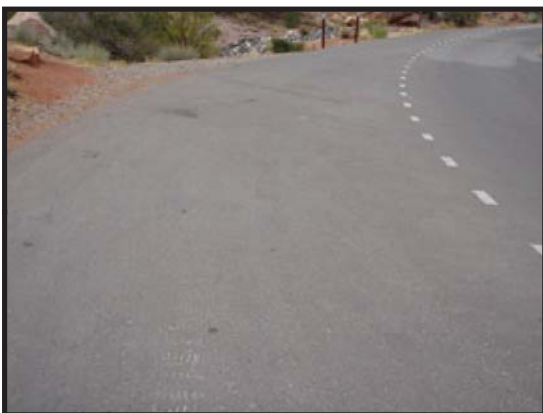
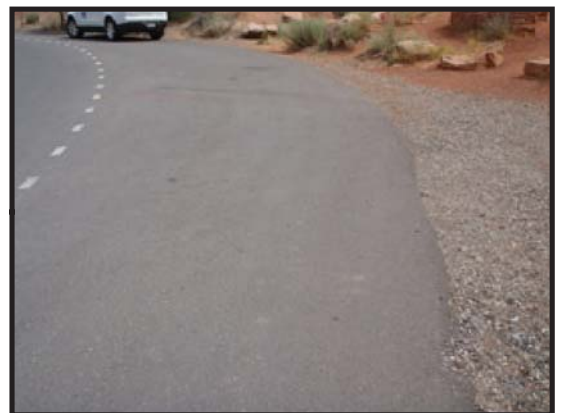
## Route 0923

Route Number	Public / NonPublic	Date Visited		Area (sq ft)	Lane Miles *	Surface Type
0923	PUBLIC	8/24/2009		2,395	0.04	AS
Culverts	Drop Inlets	Gates	Fire Hydrants	Curb & Gutter	Curb	PCR
0	0	0	0	NO CURB AND GUTTER	NO CURB	GOOD/90

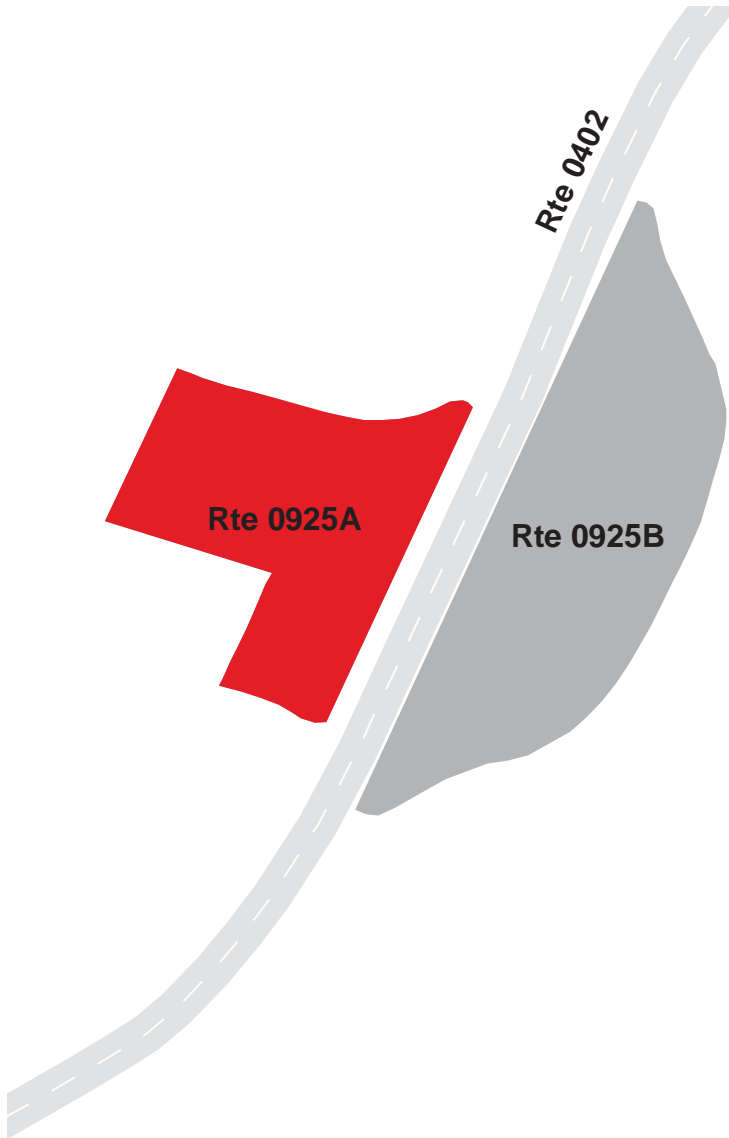
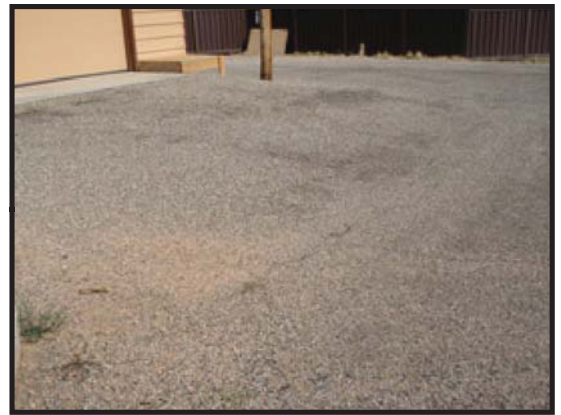
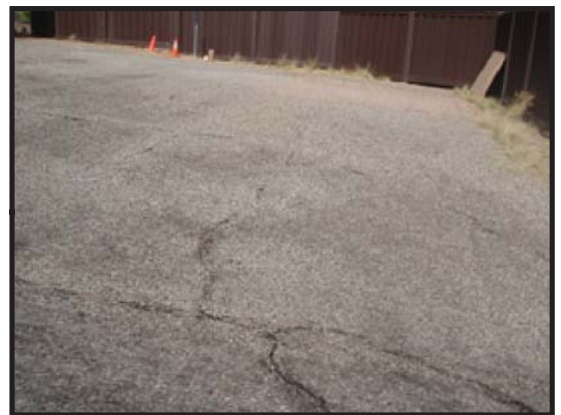
## Route 0925A

Route Number	Public / NonPublic	Date Visited		Area (sq ft)	Lane Miles *	Surface Type
0925A	NONPUBLIC	8/24/2009		2,591	0.05	AS
Culverts	Drop Inlets	Gates	Fire Hydrants	Curb & Gutter	Curb	PCR
0	0	0	0	NO CURB AND GUTTER	CONCRETE CURB	FAIR/73

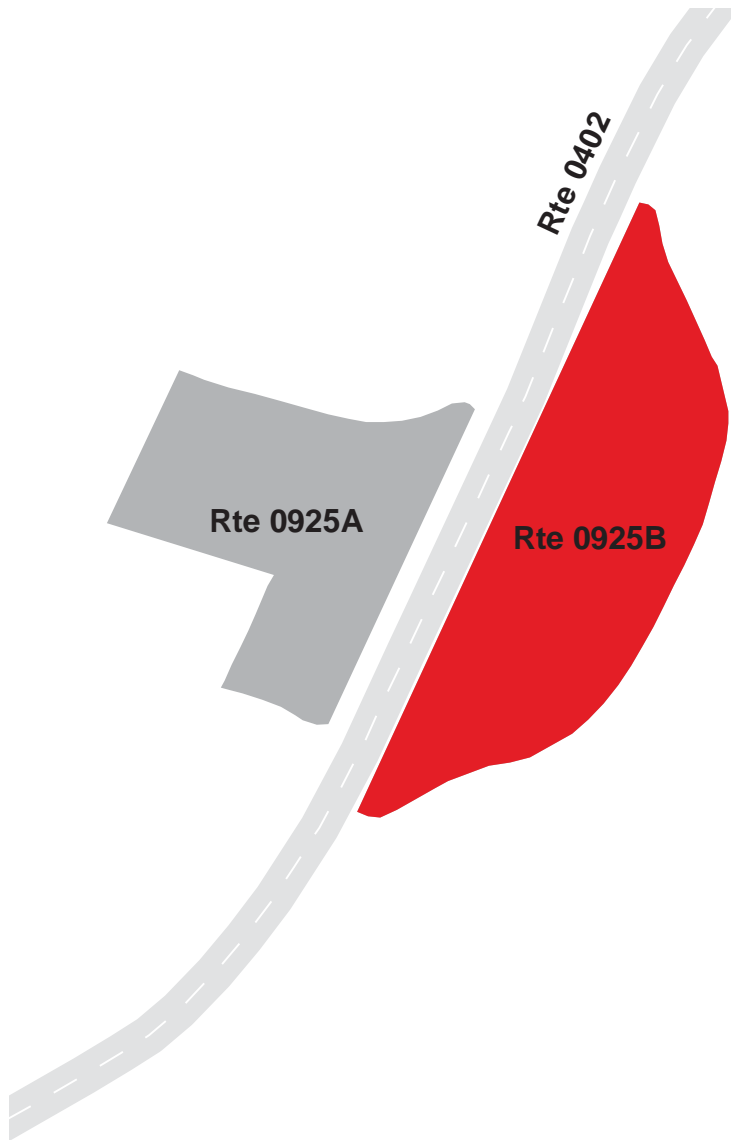
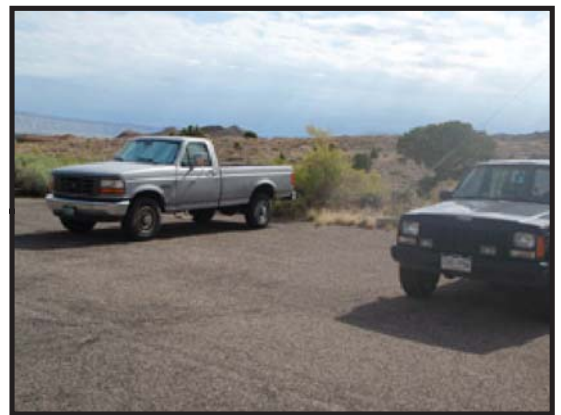
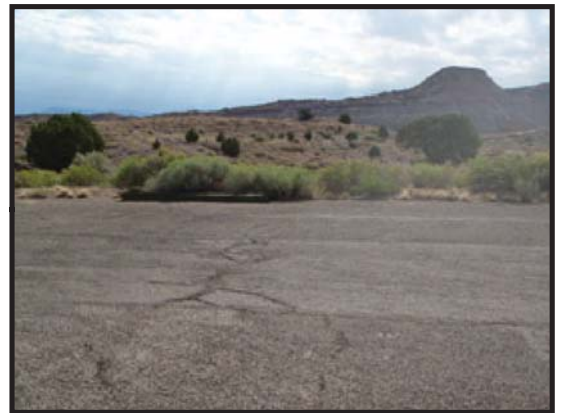
## Route 0925B

Route Number	Public / NonPublic	Date Visited		Area (sq ft)	Lane Miles *	Surface Type
0925B	NONPUBLIC	8/24/2009		3,765	0.07	AS
Culverts	Drop Inlets	Gates	Fire Hydrants	Curb & Gutter	Curb	PCR
0	0	0	0	NO CURB AND GUTTER	NO CURB	POOR/45

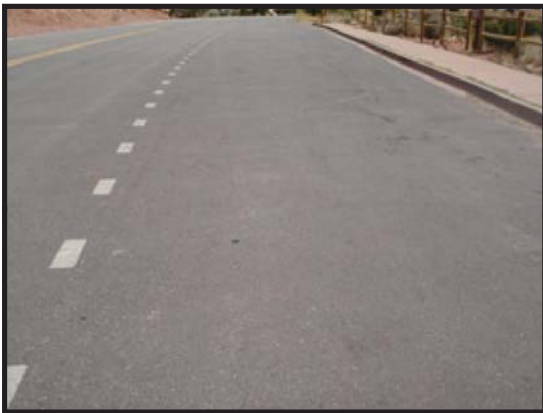
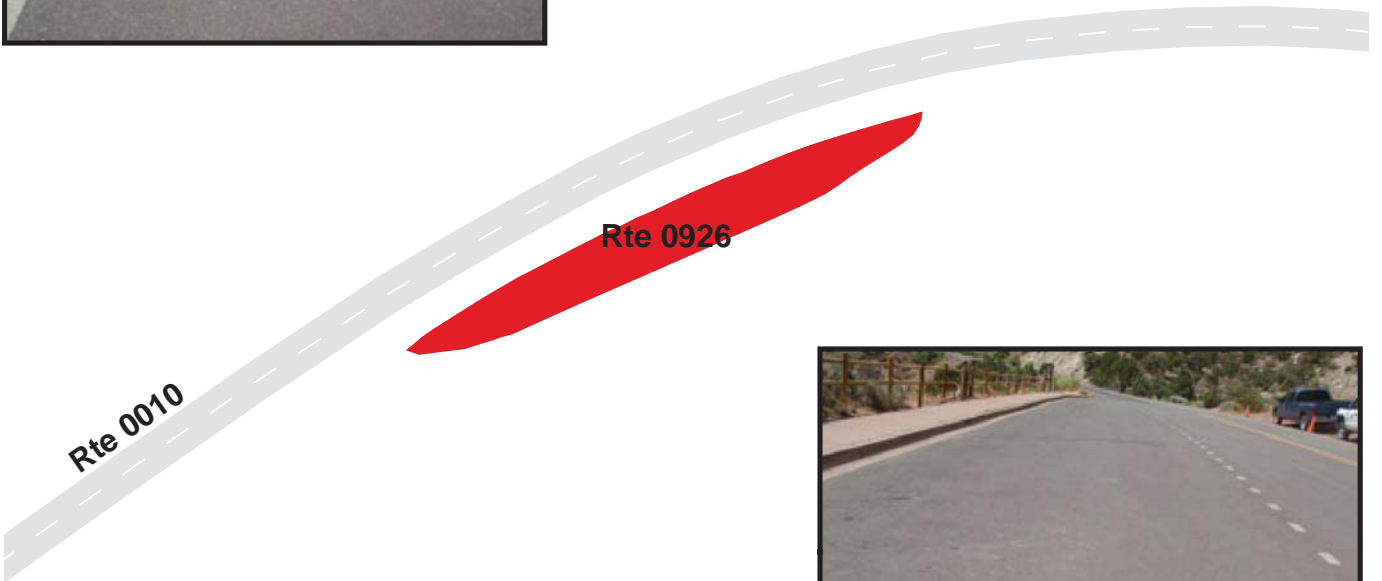
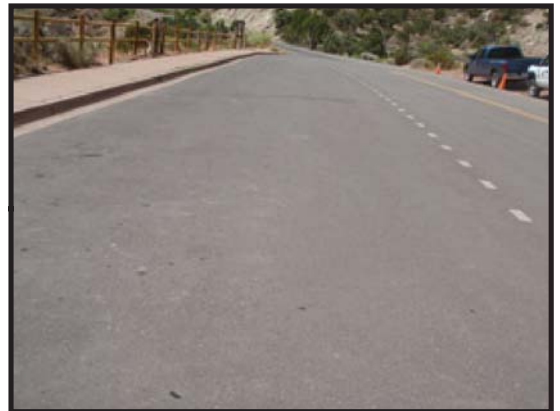
## Route 0926

Route Number	Public / NonPublic	Date Visited		Area (sq ft)	Lane Miles *	Surface Type
0926	PUBLIC	8/24/2009		3,522	0.06	AS
Culverts	Drop Inlets	Gates	Fire Hydrants	Curb & Gutter	Curb	PCR
0	0	0	0	CONCRETE CURB AND GUTTER	NO CURB	EXCELLENT/97

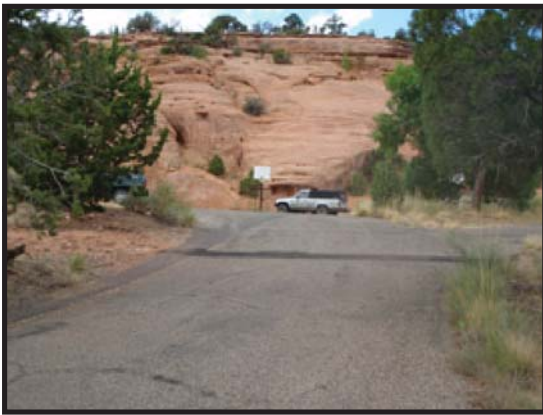
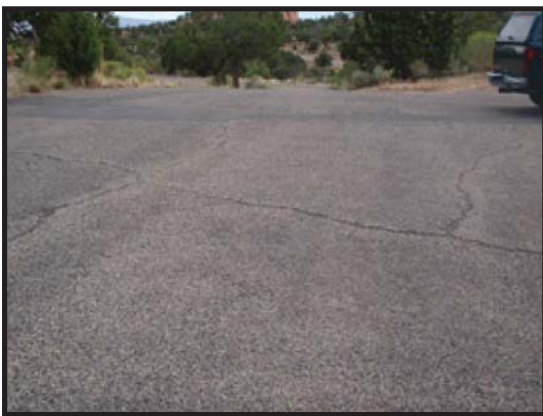
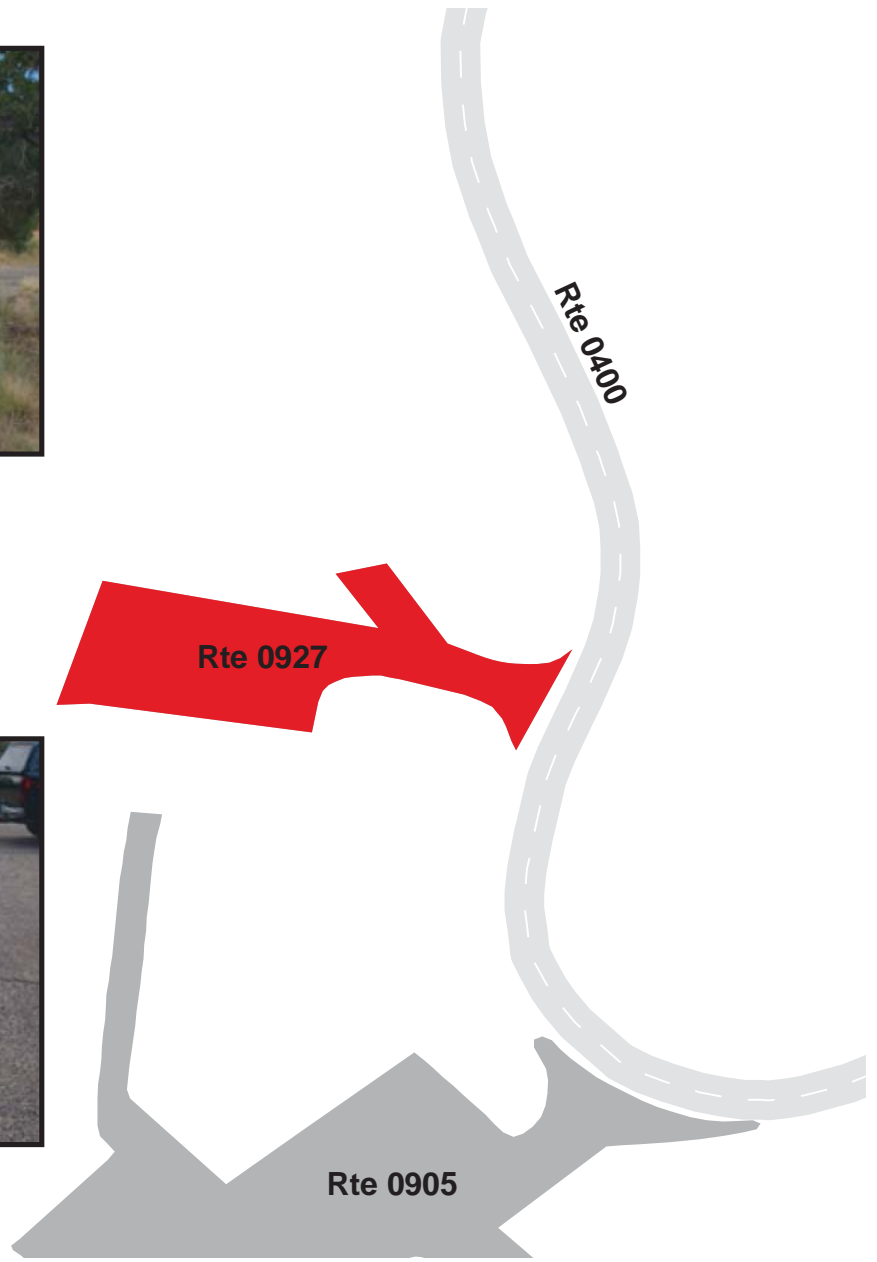
## Route 0927

Route Number	Public / NonPublic	Date Visited		Area (sq ft)	Lane Miles *	Surface Type
0927	NONPUBLIC	8/24/2009		6,032	0.10	AS
Culverts	Drop Inlets	Gates	Fire Hydrants	Curb & Gutter	Curb	PCR
1	1	0	0	CONCRETE CURB AND GUTTER	NO CURB	POOR/45

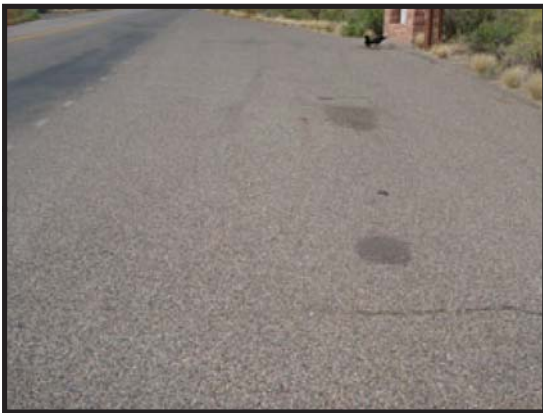
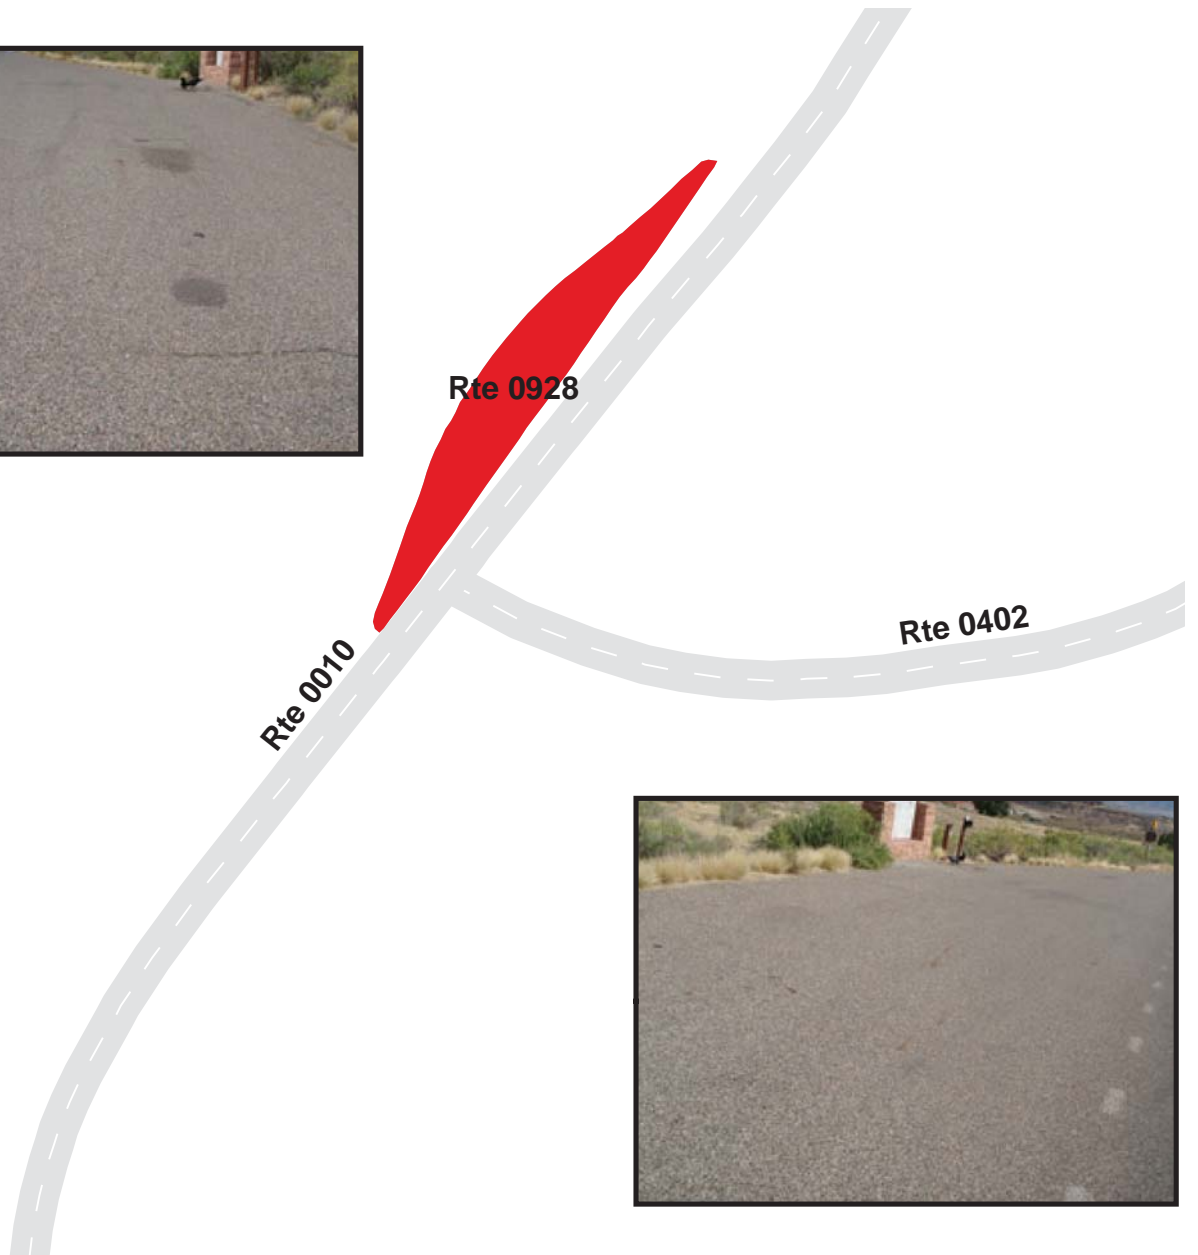
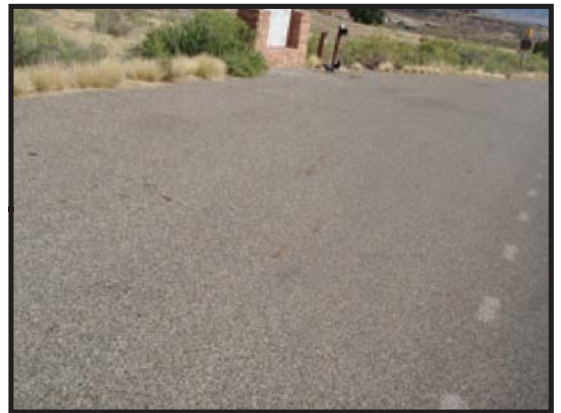
## Route 0928

Route Number	Public / NonPublic	Date Visited		Area (sq ft)	Lane Miles *	Surface Type
0928	PUBLIC	8/24/2009		3,278	0.06	AS
Culverts	Drop Inlets	Gates	Fire Hydrants	Curb & Gutter	Curb	PCR
0	0	0	0	NO CURB AND GUTTER	NO CURB	FAIR/73

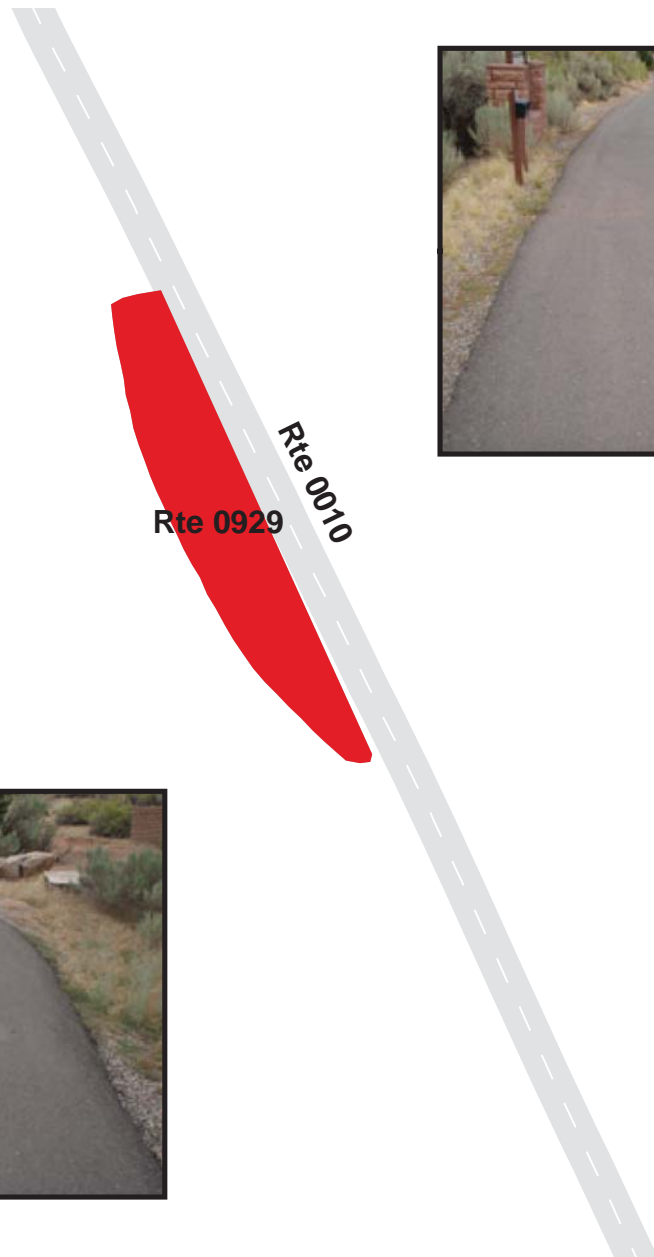
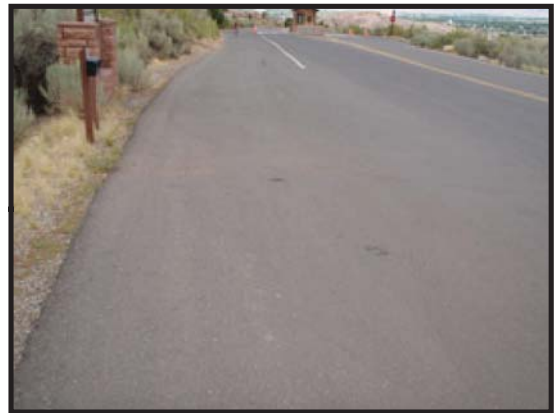
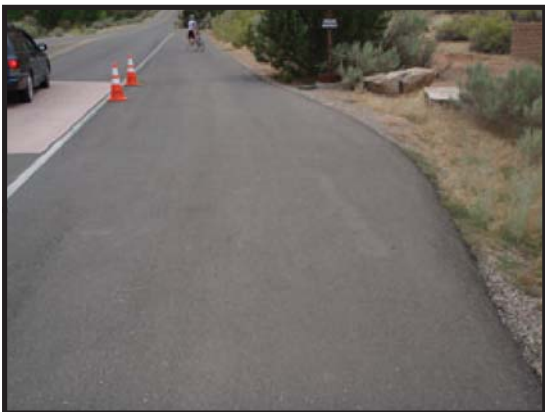
## Route 0929

Route Number	Public / NonPublic	Date Visited		Area (sq ft)	Lane Miles *	Surface Type
0929	PUBLIC	8/24/2009		2,752	0.05	AS
Culverts	Drop Inlets	Gates	Fire Hydrants	Curb & Gutter	Curb	PCR
0	0	0	0	NO CURB AND GUTTER	NO CURB	GOOD/90

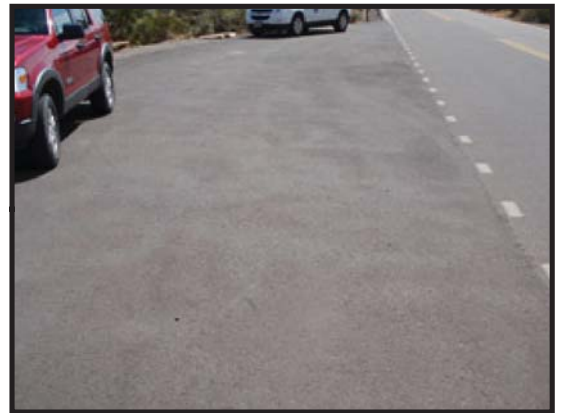
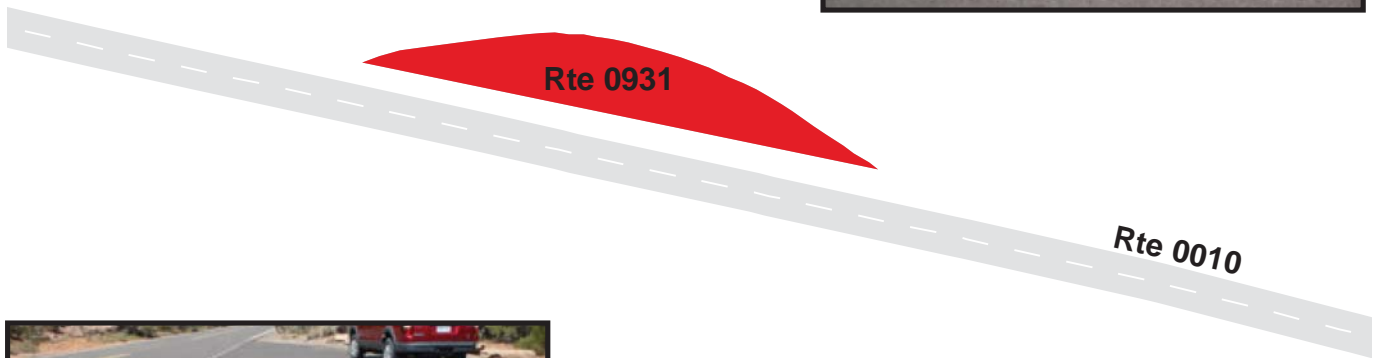
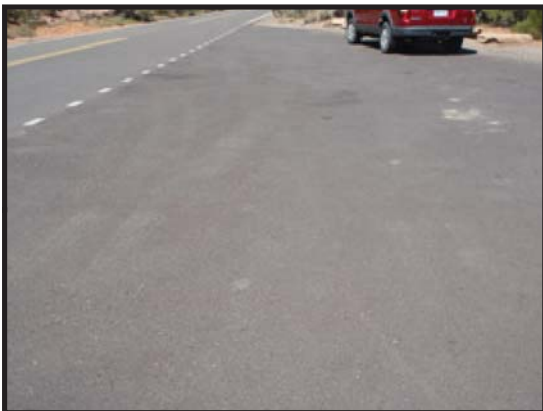
Route Number	Public / NonPublic	Date Visited		Area (sq ft)	Lane Miles *	Surface Type
0931	PUBLIC	8/24/2009		2,142	0.04	AS
Culverts	Drop Inlets	Gates	Fire Hydrants	Curb & Gutter	Curb	PCR
0	0	0	0	NO CURB AND GUTTER	NO CURB	GOOD/90

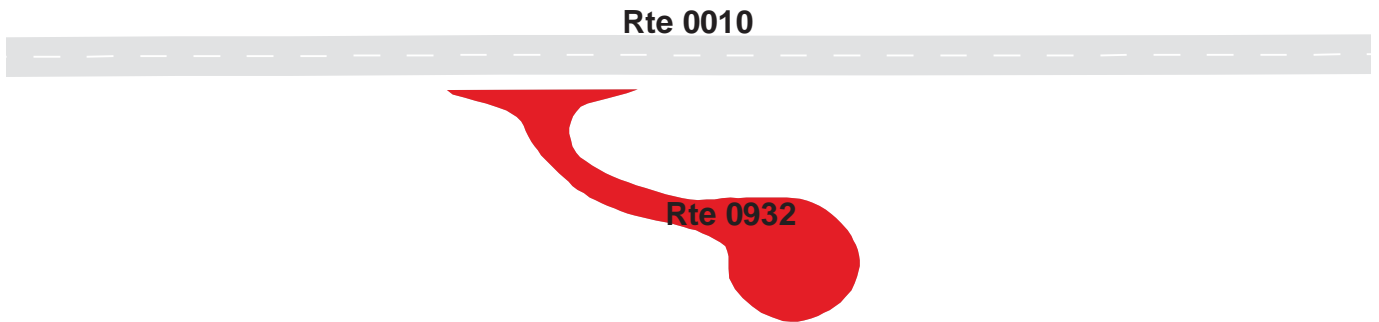
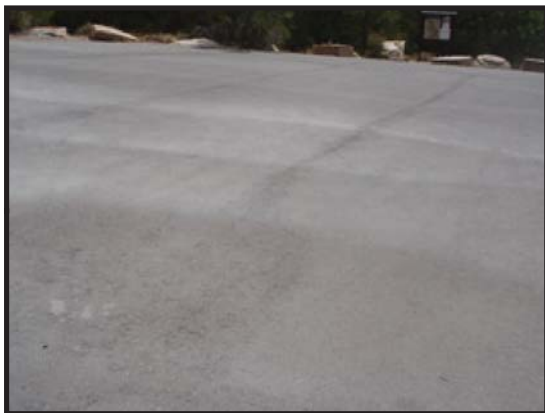
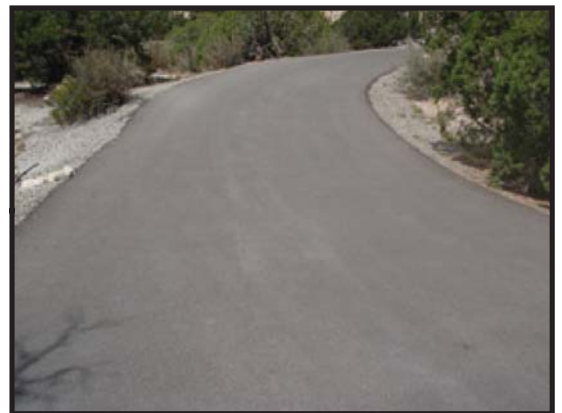
## Route 0932

Route Number	Public / NonPublic	Date Visited		Area (sq ft)	Lane Miles *	Surface Type
0932	PUBLIC	8/24/2009		7,184	0.12	AS
Culverts	Drop Inlets	Gates	Fire Hydrants	Curb & Gutter	Curb	PCR
0	0	0	0	NO CURB AND GUTTER	NO CURB	GOOD/90

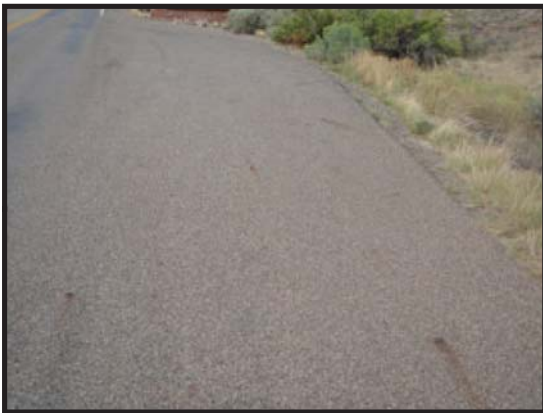
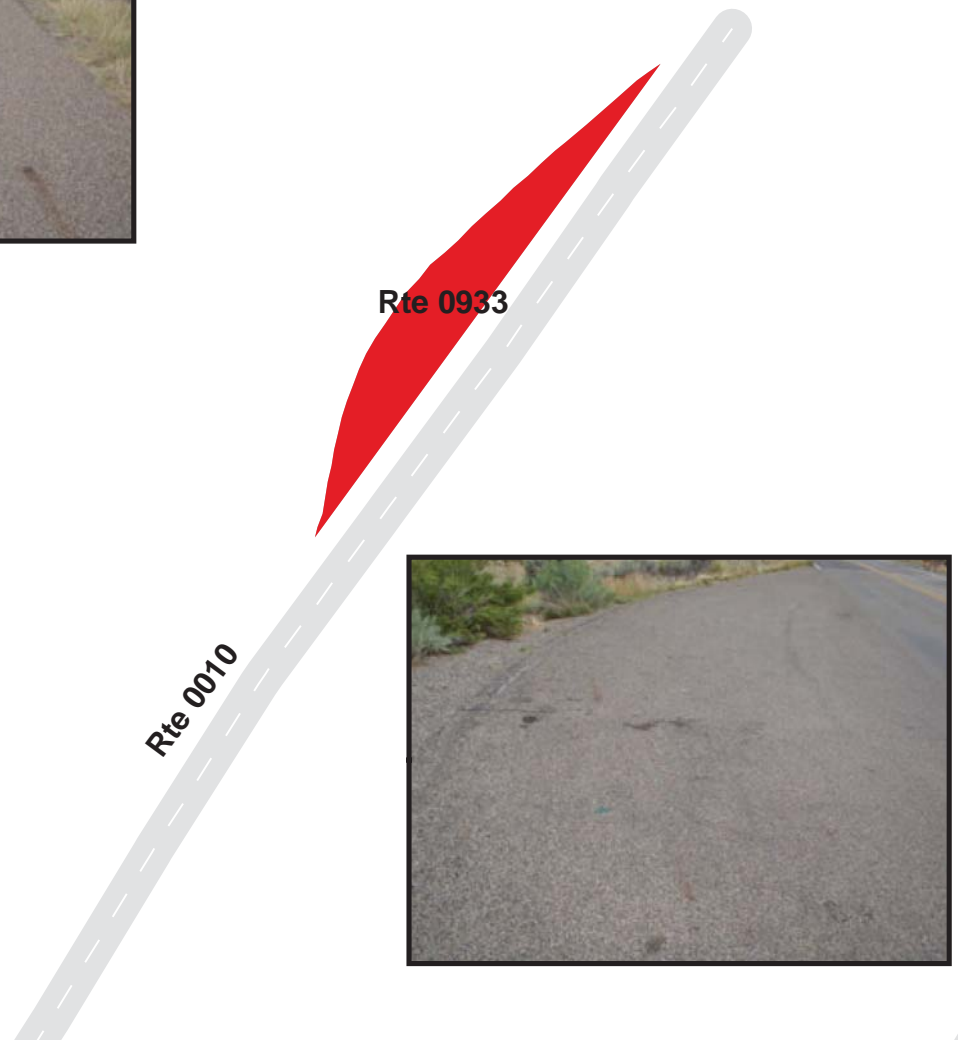
## Route 0933

Route Number	Public / NonPublic	Date Visited		Area (sq ft)	Lane Miles *	Surface Type
0933	PUBLIC	8/24/2009		1,533	0.03	AS
Culverts	Drop Inlets	Gates	Fire Hydrants	Curb & Gutter	Curb	PCR
0	0	0	0	NO CURB AND GUTTER	NO CURB	FAIR/73
