**The Road Inventory
of
Crater Lake National Park
CRLA – 9320
Cycle 4**

**Prepared By:
Federal Highway Administration
Road Inventory Program
Cycle 4**

Crater Lake National Park in Oregon

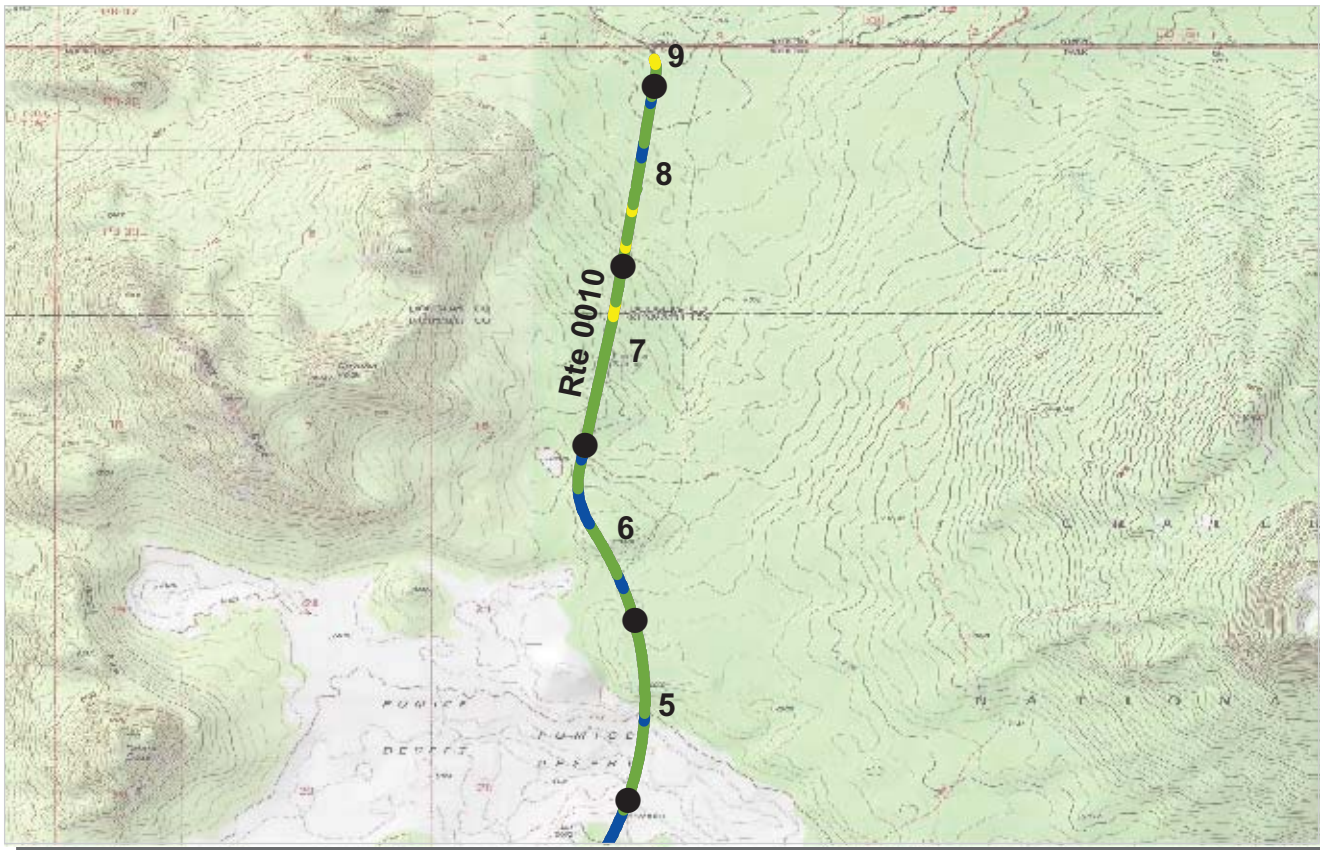
ROUTE: 0010 NORTH ENTRANCE ROAD

<i>Section Number</i>	0	1	2	3	4
<i>Section Length (mi)</i>	1.00	1.00	1.00	1.00	1.00
<i>Traffic</i>	Traffic data may be found at www.efl.fhwa.dot.gov Click on PROGRAMS / NPS Traffic Data (Note: Not all parks have traffic data)				
<i>Cross Section Information</i>					
Number of Lanes	3	2	2	2	2
Paved Width (ft)	26	25	25	25	25
Lane Width (ft)	11	11	11	11	11
Shoulder Width Right (ft)	NC	NC	NC	NC	NC
Shoulder Width Left (ft)	NC	NC	NC	NC	NC
<i>Roadway Condition Information</i>					
SCR (Surface Condition Rating)	93	94	92	91	91
PCR (Pavement Condition Rating)	95	96	95	95	94
<i>Distress Index Values</i>					
Alligator Cracking Index	100	100	100	100	100
Longitudinal Cracking Index	99	99	97	98	100
Transverse Cracking Index	100	100	100	100	100
Patching Index	100	100	100	100	100
Rutting Index	94	95	95	93	91
Roughness Condition Index (RCI)	98	98	99	99	100

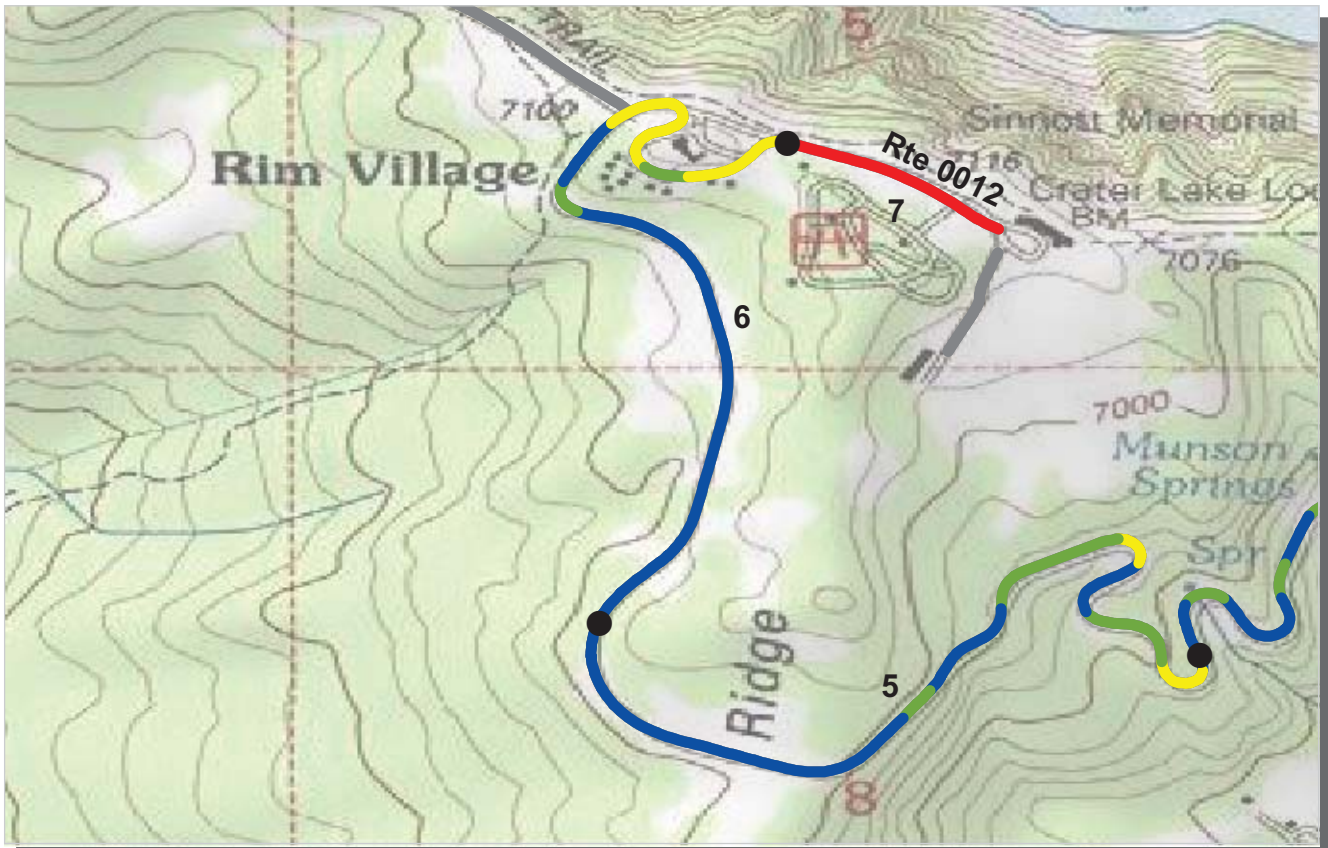
ROUTE: 0012 MUNSON VALLEY ROAD

<i>Section Number</i>	0	1	2	3	4
<i>Section Length (mi)</i>	1.00	1.00	1.00	1.00	1.00
<i>Traffic</i>	Traffic data may be found at www.efl.fhwa.dot.gov Click on PROGRAMS / NPS Traffic Data (Note: Not all parks have traffic data)				
<i>Cross Section Information</i>					
Number of Lanes	3	2	2	2	2
Paved Width (ft)	32	28	26	27	27
Lane Width (ft)	13	11	10	10	10
Shoulder Width Right (ft)	NC	NC	NC	NC	NC
Shoulder Width Left (ft)	NC	NC	NC	NC	NC
<i>Roadway Condition Information</i>					
SCR (Surface Condition Rating)	93	92	94	94	95
PCR (Pavement Condition Rating)	92	94	96	94	95
<i>Distress Index Values</i>					
Alligator Cracking Index	100	100	100	100	100
Longitudinal Cracking Index	100	100	100	100	99
Transverse Cracking Index	100	100	100	100	100
Patching Index	100	100	100	100	100
Rutting Index	93	93	94	94	96
Roughness Condition Index (RCI)	90	97	98	95	96

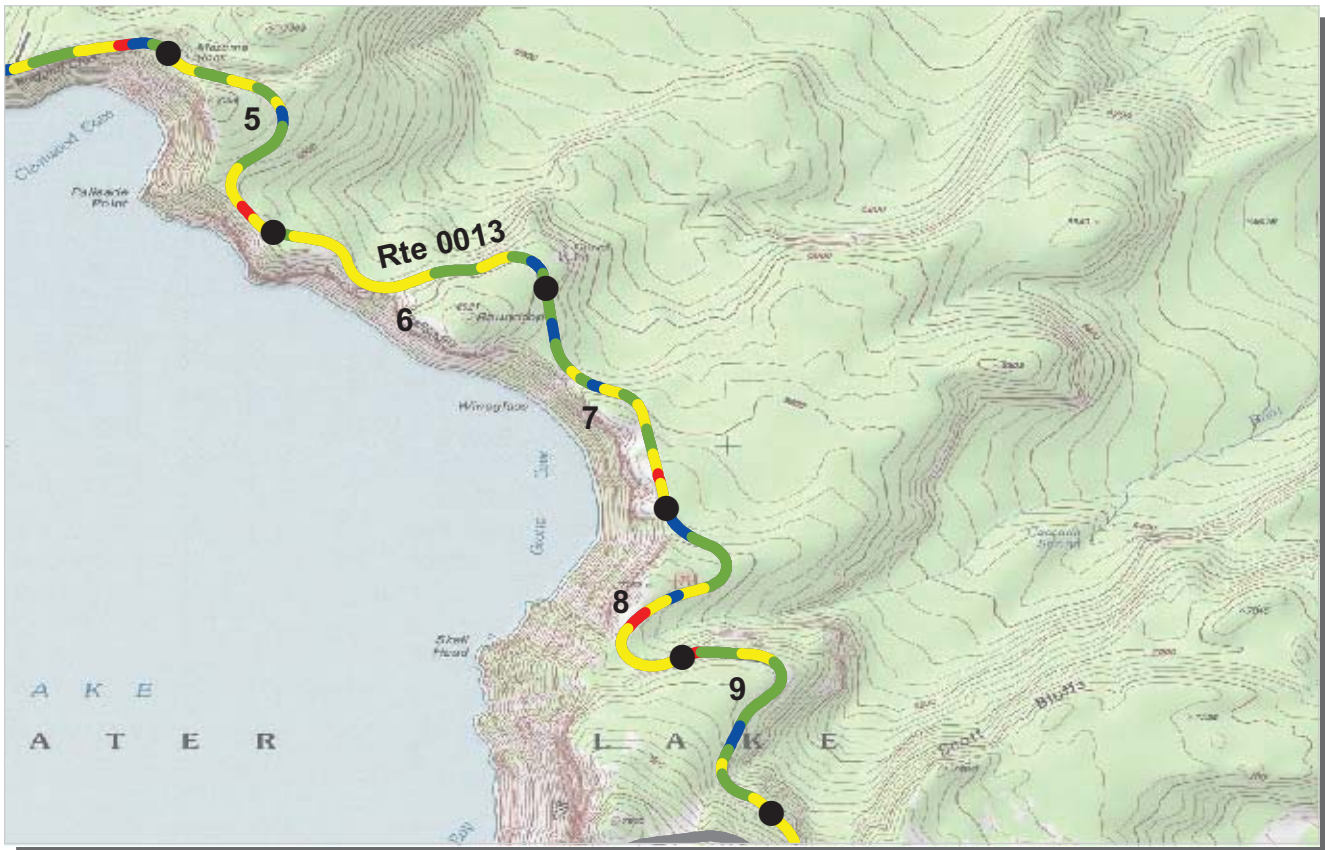
ROUTE: 0013 EAST RIM DRIVE

Section Number	0	1	2	3	4
Section Length (mi)	1.00	1.00	1.00	1.00	1.00
Traffic	Traffic data may be found at www.efl.fhwa.dot.gov Click on PROGRAMS / NPS Traffic Data (Note: Not all parks have traffic data)				
Cross Section Information					
Number of Lanes	2	2	2	2	2
Paved Width (ft)	22	21	21	21	21
Lane Width (ft)	10	10	10	9	9
Shoulder Width Right (ft)	NC	NC	NC	NC	NC
Shoulder Width Left (ft)	NC	NC	NC	NC	NC
Roadway Condition Information					
SCR (Surface Condition Rating)	86	82	77	78	77
PCR (Pavement Condition Rating)	85	83	78	81	81
Distress Index Values					
Alligator Cracking Index	99	100	100	100	99
Longitudinal Cracking Index	99	100	100	100	99
Transverse Cracking Index	99	100	100	100	99
Patching Index	99	100	97	100	98
Rutting Index	89	83	80	79	82
Roughness Condition Index (RCI)	83	84	80	84	87

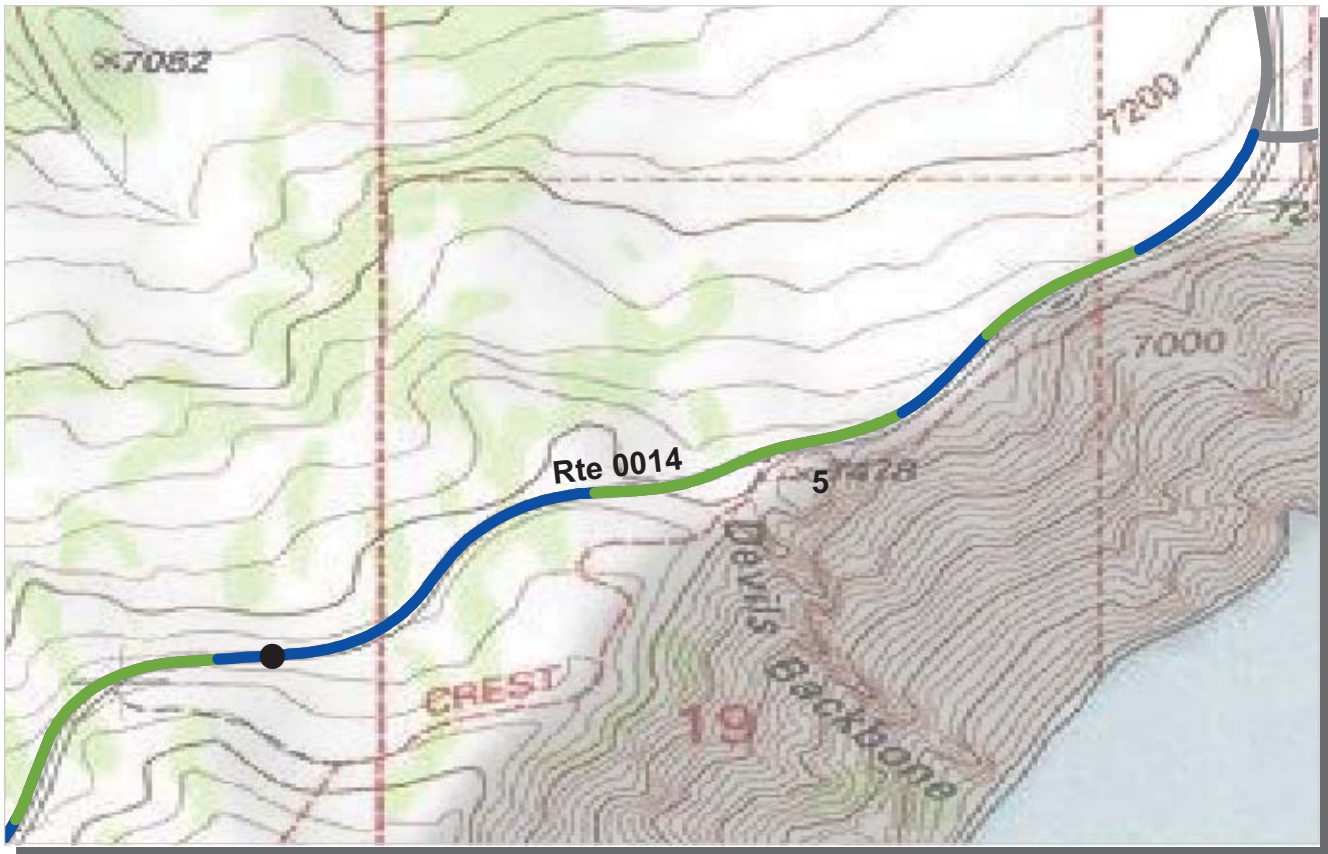
ROUTE: 0014 WEST RIM DRIVE

Section Number	0	1	2	3	4
Section Length (mi)	1.00	1.00	1.00	1.00	1.00
Traffic	Traffic data may be found at www.efl.fhwa.dot.gov Click on PROGRAMS / NPS Traffic Data (Note: Not all parks have traffic data)				
Cross Section Information					
Number of Lanes	2	2	2	2	2
Paved Width (ft)	26	25	25	24	25
Lane Width (ft)	10	10	10	10	10
Shoulder Width Right (ft)	NC	NC	NC	NC	NC
Shoulder Width Left (ft)	NC	NC	NC	NC	NC
Roadway Condition Information					
SCR (Surface Condition Rating)	86	79	87	83	90
PCR (Pavement Condition Rating)	86	79	87	84	92
Distress Index Values					
Alligator Cracking Index	100	98	100	99	100
Longitudinal Cracking Index	99	97	97	96	96
Transverse Cracking Index	99	95	99	98	100
Patching Index	100	100	100	100	100
Rutting Index	88	90	91	90	94
Roughness Condition Index (RCI)	87	79	88	85	96

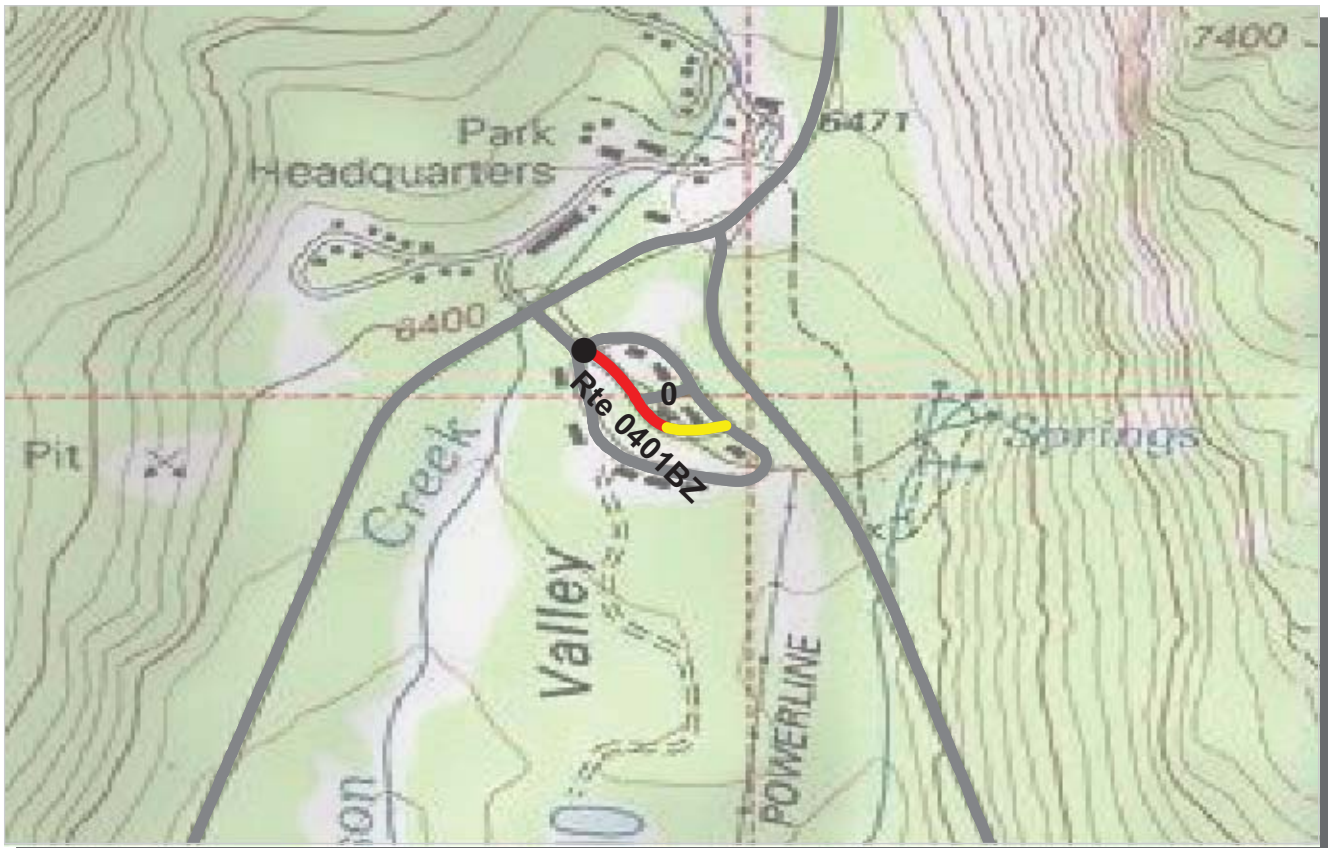
ROUTE: 0401AZ HEADQUARTERS RESIDENCE AREA OUTER LOOP ROAD

Section Number	0				
Section Length (mi)	0.48				
Traffic	Traffic data may be found at www.efl.fhwa.dot.gov Click on PROGRAMS / NPS Traffic Data (Note: Not all parks have traffic data)				
Cross Section Information					
Number of Lanes	2				
Paved Width (ft)	22				
Lane Width (ft)	11				
Shoulder Width Right (ft)	NC				
Shoulder Width Left (ft)	NC				
Roadway Condition Information					
SCR (Surface Condition Rating)	62				
PCR (Pavement Condition Rating)	55				
Distress Index Values					
Alligator Cracking Index	92				
Longitudinal Cracking Index	89				
Transverse Cracking Index	93				
Patching Index	100				
Rutting Index	86				
Roughness Condition Index (RCI)	44

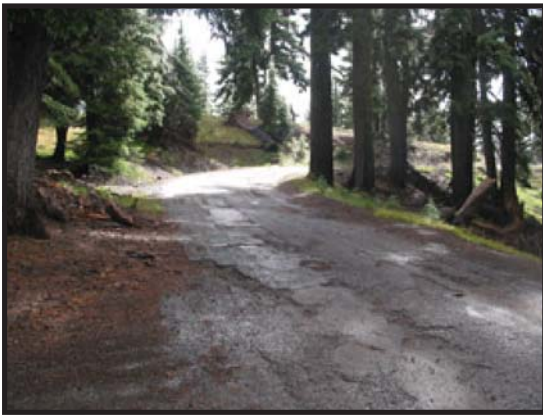
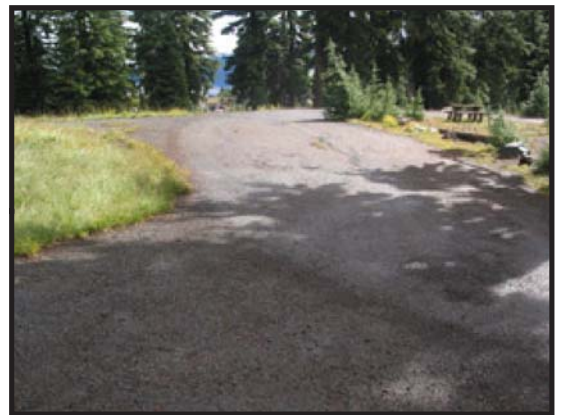
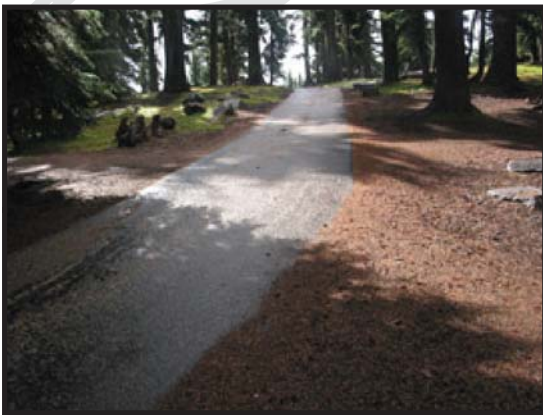
Route Number	Public / NonPublic	Date Visited		Area (sq ft)	Lane Miles *	Surface Type
0207	PUBLIC	8/21/2007		55,228	0.95	AS
Culverts	Drop Inlets	Gates	Fire Hydrants	Curb & Gutter	Curb	PCR
0	0	0	0	NO CURB AND GUTTER	ASPHALT CURB	POOR/45

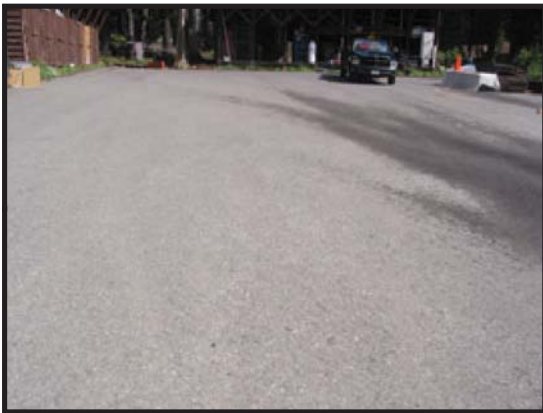
Route Number	Public / NonPublic	Date Visited		Area (sq ft)	Lane Miles *	Surface Type
0402AZ	PUBLIC	8/21/2007		90,585	1.56	AS
Culverts	Drop Inlets	Gates	Fire Hydrants	Curb & Gutter	Curb	PCR
0	5	1	3	NO CURB AND GUTTER	NO CURB	GOOD/90

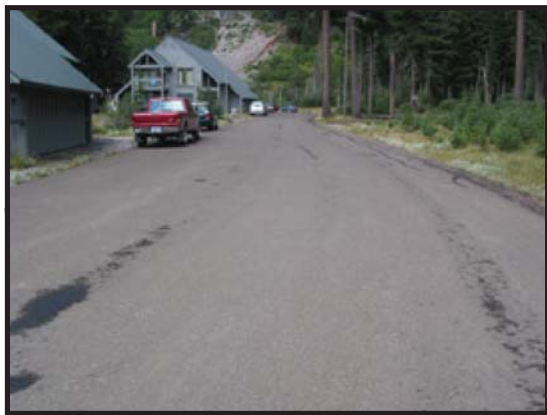
Route Number	Public / NonPublic	Date Visited		Area (sq ft)	Lane Miles *	Surface Type
0402BZ	PUBLIC	8/21/2007		41,502	0.72	AS
Culverts	Drop Inlets	Gates	Fire Hydrants	Curb & Gutter	Curb	PCR
0	0	0	3	NO CURB AND GUTTER	NO CURB	GOOD/90

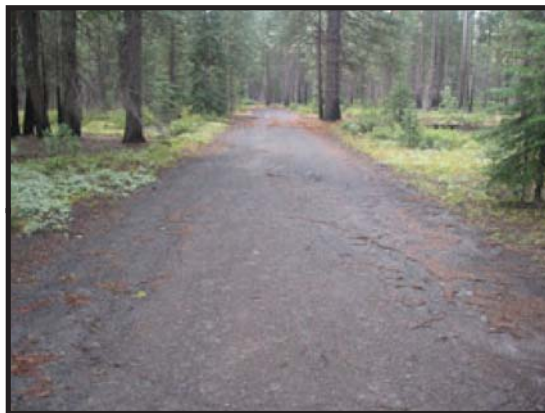
Route Number	Public / NonPublic	Date Visited		Area (sq ft)	Lane Miles *	Surface Type
0405	NONPUBLIC	8/21/2007		7,920	0.14	AS
Culverts	Drop Inlets	Gates	Fire Hydrants	Curb & Gutter	Curb	PCR
0	0	1	0	NO CURB AND GUTTER	NO CURB	POOR/45

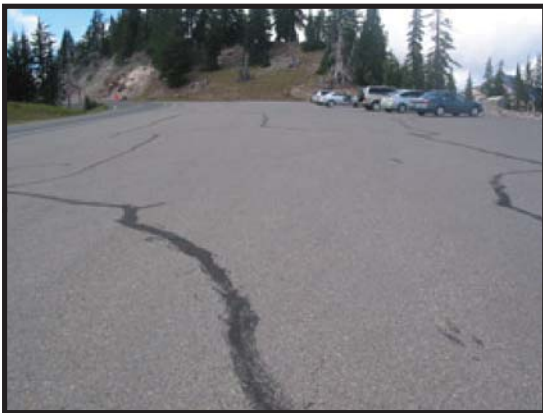
Route Number	Public / NonPublic	Date Visited		Area (sq ft)	Lane Miles *	Surface Type
0900	PUBLIC	8/21/2007		32,511	0.56	AS
Culverts	Drop Inlets	Gates	Fire Hydrants	Curb & Gutter	Curb	PCR
0	0	0	0	NO CURB AND GUTTER	NO CURB	FAIR/73

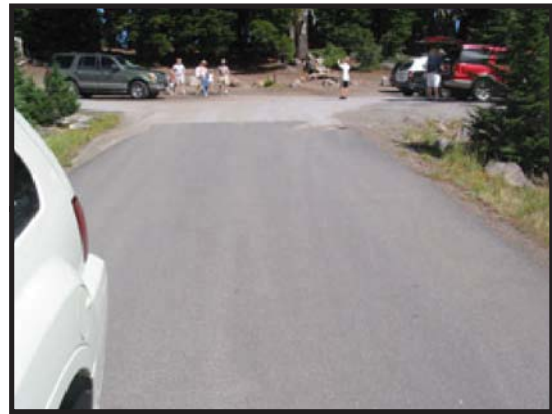
Route Number	Public / NonPublic	Date Visited		Area (sq ft)	Lane Miles *	Surface Type
0902	PUBLIC	8/21/2007		5,176	0.09	AS
Culverts	Drop Inlets	Gates	Fire Hydrants	Curb & Gutter	Curb	PCR
0	0	0	0	NO CURB AND GUTTER	NO CURB	POOR/45

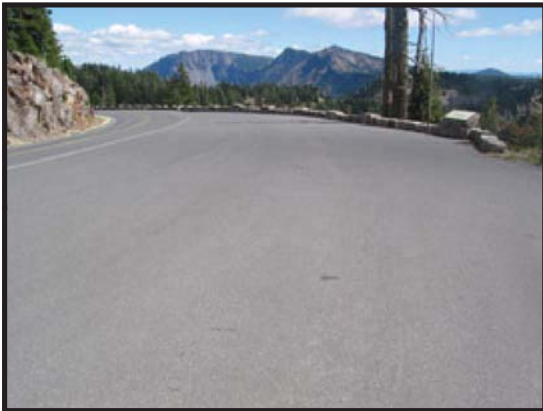
Route Number	Public / NonPublic	Date Visited		Area (sq ft)	Lane Miles *	Surface Type
0903	PUBLIC	8/21/2007		5,304	0.09	AS
Culverts	Drop Inlets	Gates	Fire Hydrants	Curb & Gutter	Curb	PCR
0	0	0	0	NO CURB AND GUTTER	NO CURB	GOOD/90

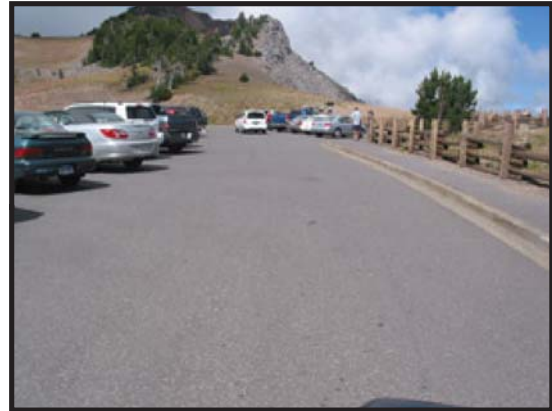
Route Number	Public / NonPublic	Date Visited		Area (sq ft)	Lane Miles *	Surface Type
0904	PUBLIC	8/21/2007		13,566	0.23	AS
Culverts	Drop Inlets	Gates	Fire Hydrants	Curb & Gutter	Curb	PCR
0	1	0	0	CONCRETE CURB AND GUTTER	CONCRETE CURB	FAIR/73

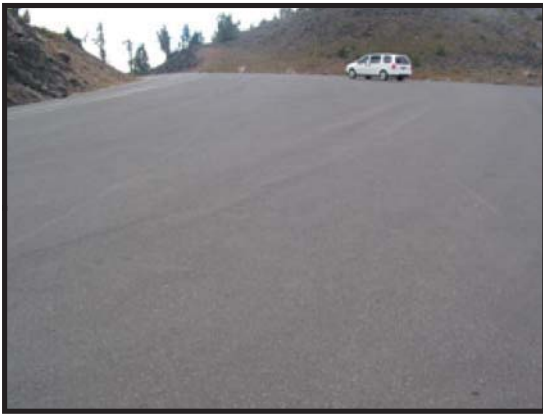
Route Number	Public / NonPublic	Date Visited		Area (sq ft)	Lane Miles *	Surface Type
0905	PUBLIC	8/21/2007		12,545	0.22	AS
Culverts	Drop Inlets	Gates	Fire Hydrants	Curb & Gutter	Curb	PCR
0	0	0	0	NO CURB AND GUTTER	NO CURB	GOOD/90

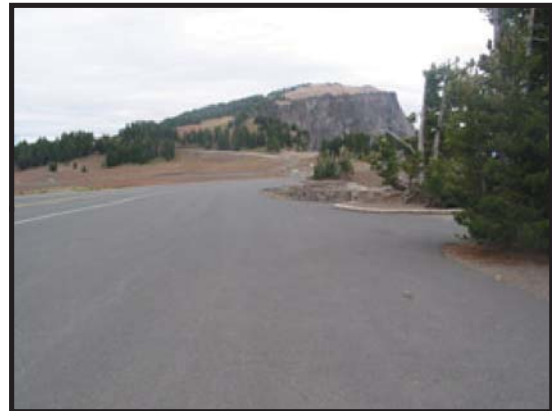
Route Number	Public / NonPublic	Date Visited		Area (sq ft)	Lane Miles *	Surface Type
0906	PUBLIC	8/21/2007		20,571	0.35	AS
Culverts	Drop Inlets	Gates	Fire Hydrants	Curb & Gutter	Curb	PCR
0	0	0	0	NO CURB AND GUTTER	STONE CURB	GOOD/90

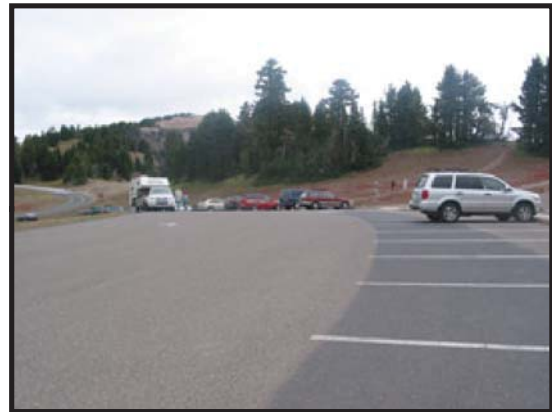
Route Number	Public / NonPublic	Date Visited		Area (sq ft)	Lane Miles *	Surface Type
0907	PUBLIC	8/21/2007		23,921	0.41	AS
Culverts	Drop Inlets	Gates	Fire Hydrants	Curb & Gutter	Curb	PCR
1	0	0	0	NO CURB AND GUTTER	CONCRETE CURB	GOOD/90

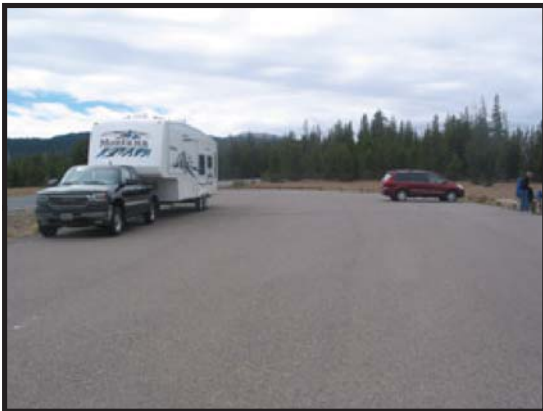
Route Number	Public / NonPublic	Date Visited		Area (sq ft)	Lane Miles *	Surface Type
0909	PUBLIC	8/21/2007		11,960	0.21	AS
Culverts	Drop Inlets	Gates	Fire Hydrants	Curb & Gutter	Curb	PCR
2	0	0	0	NO CURB AND GUTTER	NO CURB	GOOD/90

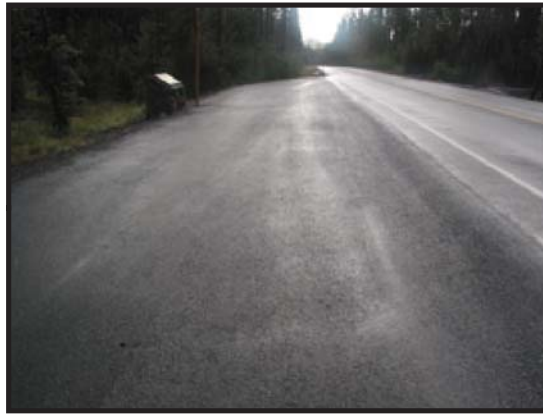
Route Number	Public / NonPublic	Date Visited		Area (sq ft)	Lane Miles *	Surface Type
0910	PUBLIC	8/21/2007		2,338	0.04	AS
Culverts	Drop Inlets	Gates	Fire Hydrants	Curb & Gutter	Curb	PCR
0	0	0	0	NO CURB AND GUTTER	NO CURB	GOOD/90

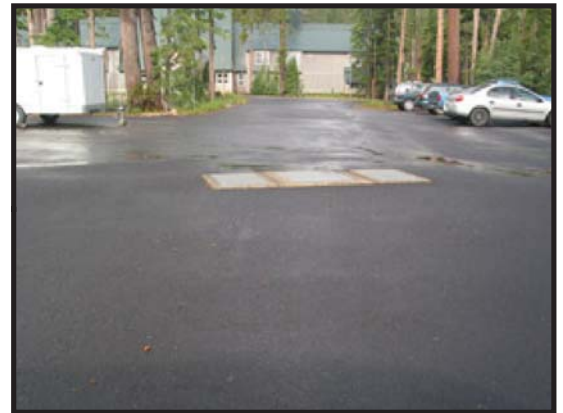
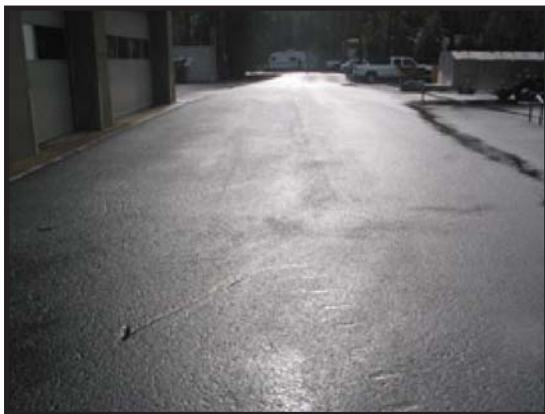
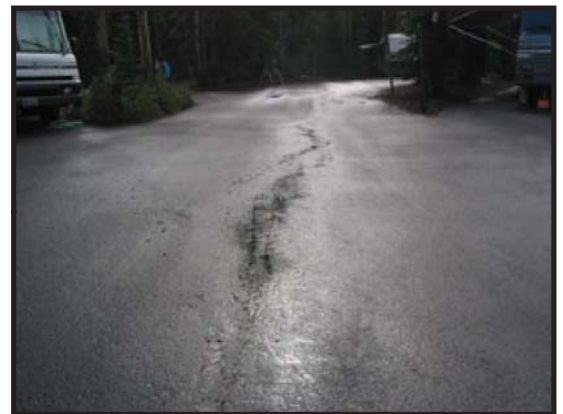
Route 0913

Route Number	Public / NonPublic	Date Visited		Area (sq ft)	Lane Miles *	Surface Type
0913	NONPUBLIC	8/21/2007		40,353	0.70	AS
Culverts	Drop Inlets	Gates	Fire Hydrants	Curb & Gutter	Curb	PCR
0	0	0	0	NO CURB AND GUTTER	NO CURB	GOOD/90

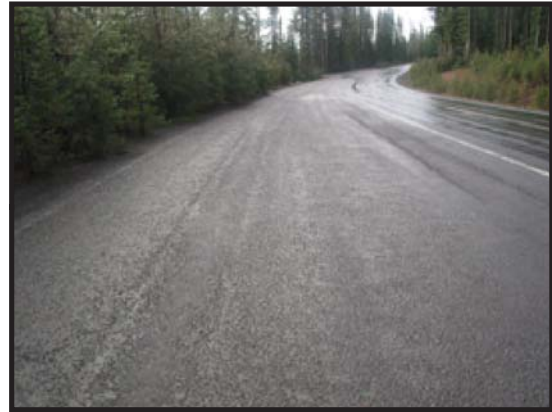
Route 0914

Route Number	Public / NonPublic	Date Visited		Area (sq ft)	Lane Miles *	Surface Type
0914	PUBLIC	8/21/2007		15,672	0.27	AS
Culverts	Drop Inlets	Gates	Fire Hydrants	Curb & Gutter	Curb	PCR
0	0	0	0	NO CURB AND GUTTER	NO CURB	GOOD/90

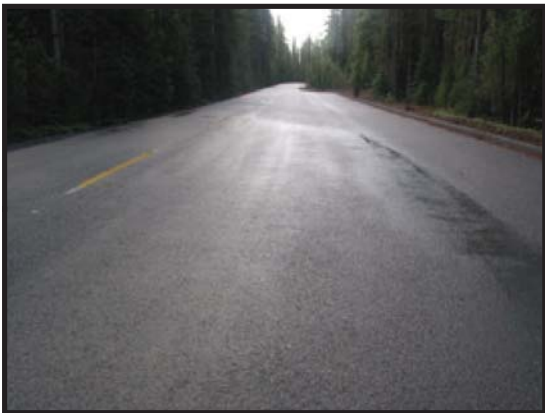
Route 0915

Route Number	Public / NonPublic	Date Visited		Area (sq ft)	Lane Miles *	Surface Type
0915	PUBLIC	8/21/2007		42,041	0.72	AS
Culverts	Drop Inlets	Gates	Fire Hydrants	Curb & Gutter	Curb	PCR
1	0	0	0	NO CURB AND GUTTER	ASPHALT CURB	FAIR/73

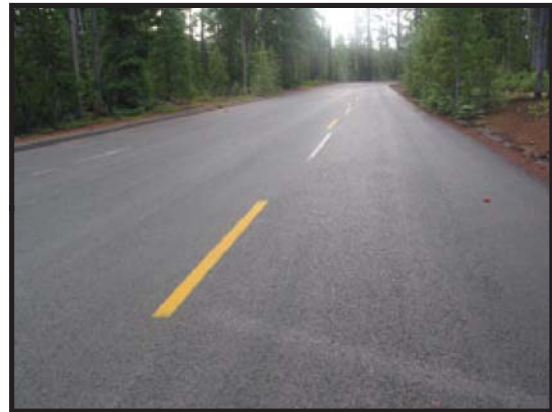
Route 0916

Route Number	Public / NonPublic	Date Visited		Area (sq ft)	Lane Miles *	Surface Type
0916	PUBLIC	8/21/2007		37,011	0.64	AS
Culverts	Drop Inlets	Gates	Fire Hydrants	Curb & Gutter	Curb	PCR
1	0	0	0	NO CURB AND GUTTER	ASPHALT CURB	FAIR/73

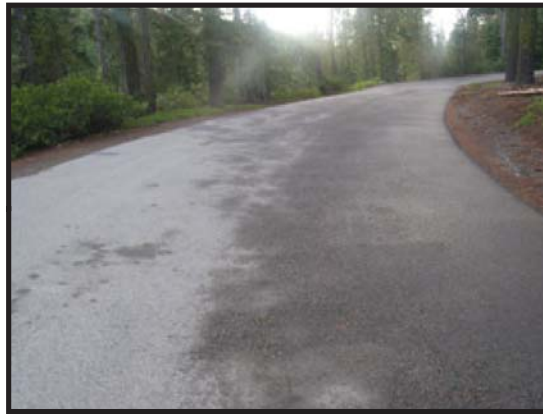
Route 0917

Route Number	Public / NonPublic	Date Visited		Area (sq ft)	Lane Miles *	Surface Type
0917	PUBLIC	8/21/2007		9,738	0.17	AS
Culverts	Drop Inlets	Gates	Fire Hydrants	Curb & Gutter	Curb	PCR
1	0	0	0	NO CURB AND GUTTER	NO CURB	GOOD/90

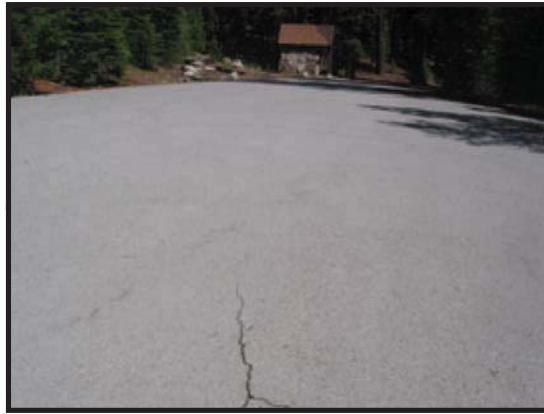
Route 0919

Route Number	Public / NonPublic	Date Visited		Area (sq ft)	Lane Miles *	Surface Type
0919	PUBLIC	8/21/2007		9,178	0.16	AS
Culverts	Drop Inlets	Gates	Fire Hydrants	Curb & Gutter	Curb	PCR
0	0	0	0	NO CURB AND GUTTER	ASPHALT CURB	FAIR/73

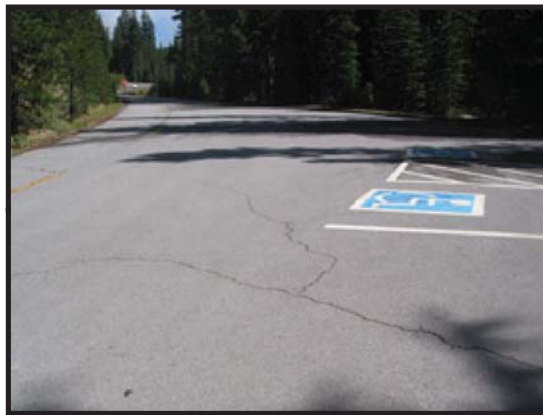
Route 0920

Route Number	Public / NonPublic	Date Visited		Area (sq ft)	Lane Miles *	Surface Type
0920	PUBLIC	8/21/2007		22,196	0.38	AS
Culverts	Drop Inlets	Gates	Fire Hydrants	Curb & Gutter	Curb	PCR
1	0	0	0	NO CURB AND GUTTER	ASPHALT CURB	FAIR/73

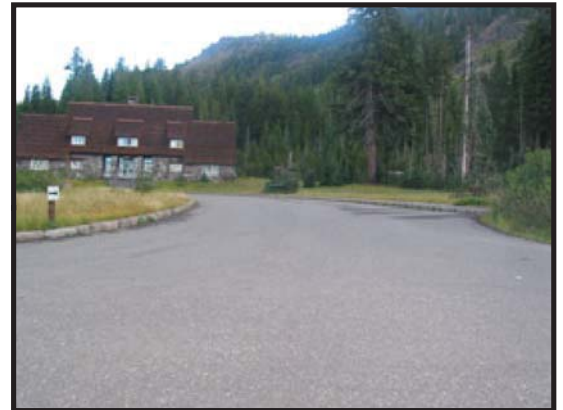
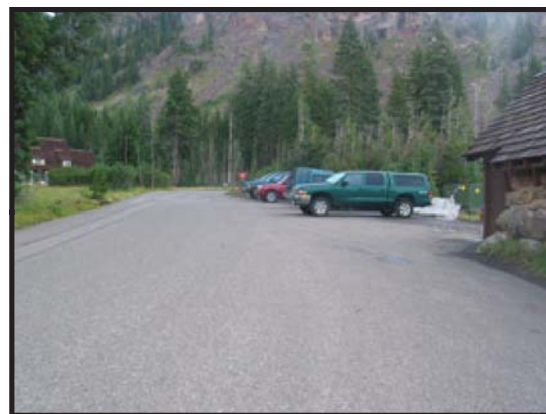
Route 0921

Route Number	Public / NonPublic	Date Visited		Area (sq ft)	Lane Miles *	Surface Type
0921	PUBLIC	8/21/2007		34,297	0.59	AS
Culverts	Drop Inlets	Gates	Fire Hydrants	Curb & Gutter	Curb	PCR
1	2	0	1	NO CURB AND GUTTER	STONE CURB	FAIR/73

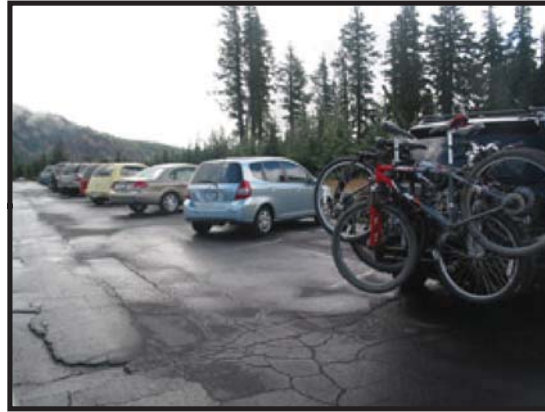
Route Number	Public / NonPublic	Date Visited		Area (sq ft)	Lane Miles *	Surface Type
0923AZ	PUBLIC	8/21/2007		4,661	0.08	AS
Culverts	Drop Inlets	Gates	Fire Hydrants	Curb & Gutter	Curb	PCR
0	1	0	0	NO CURB AND GUTTER	STONE CURB	FAIR/73

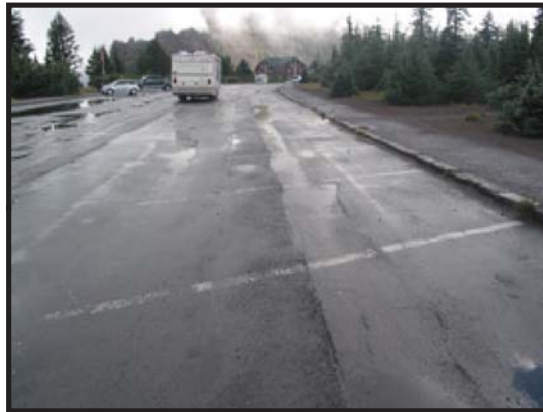
Route 0923BZ

Route Number	Public / NonPublic	Date Visited		Area (sq ft)	Lane Miles *	Surface Type
0923BZ	PUBLIC	8/21/2007		15,374	0.27	AS
Culverts	Drop Inlets	Gates	Fire Hydrants	Curb & Gutter	Curb	PCR
0	0	0	0	NO CURB AND GUTTER	STONE CURB	FAIR/73

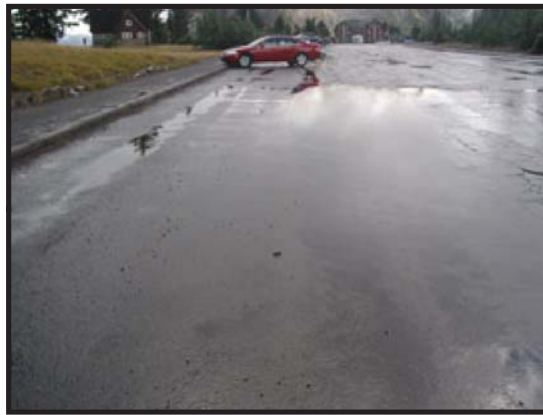
Route 0923CZ

Route Number	Public / NonPublic	Date Visited		Area (sq ft)	Lane Miles *	Surface Type
0923CZ	PUBLIC	8/21/2007		18,825	0.32	AS
Culverts	Drop Inlets	Gates	Fire Hydrants	Curb & Gutter	Curb	PCR
0	0	0	1	NO CURB AND GUTTER	STONE CURB	FAIR/73

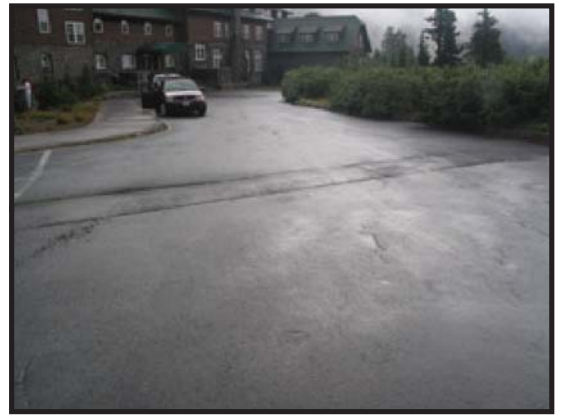
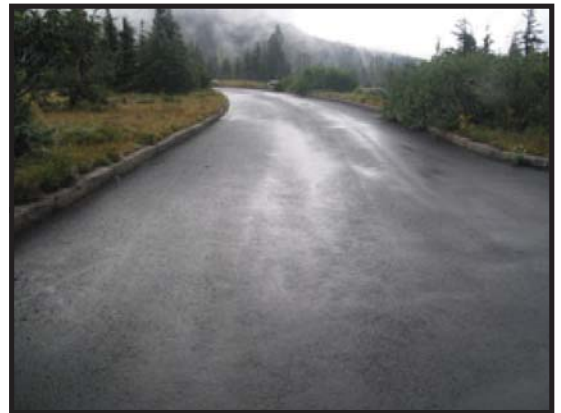
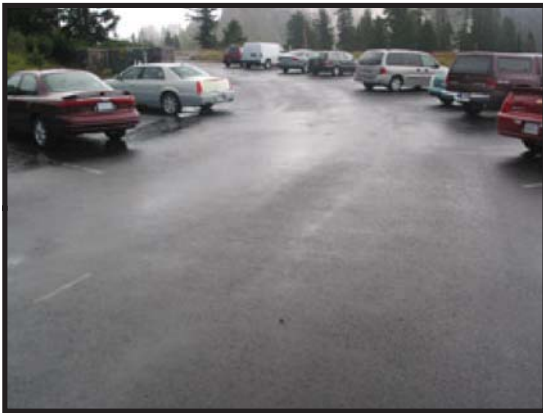
Route 0924

Route Number	Public / NonPublic	Date Visited		Area (sq ft)	Lane Miles *	Surface Type
0924	PUBLIC	8/21/2007		31,320	0.54	AS
Culverts	Drop Inlets	Gates	Fire Hydrants	Curb & Gutter	Curb	PCR
0	0	0	0	NO CURB AND GUTTER	STONE CURB	GOOD/90

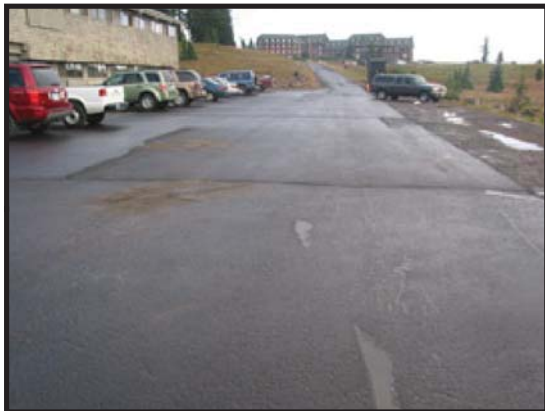
Route 0925

Route Number	Public / NonPublic	Date Visited		Area (sq ft)	Lane Miles *	Surface Type
0925	NONPUBLIC	8/21/2007		8,352	0.14	AS
Culverts	Drop Inlets	Gates	Fire Hydrants	Curb & Gutter	Curb	PCR
0	0	0	0	NO CURB AND GUTTER	CONCRETE CURB	FAIR/73

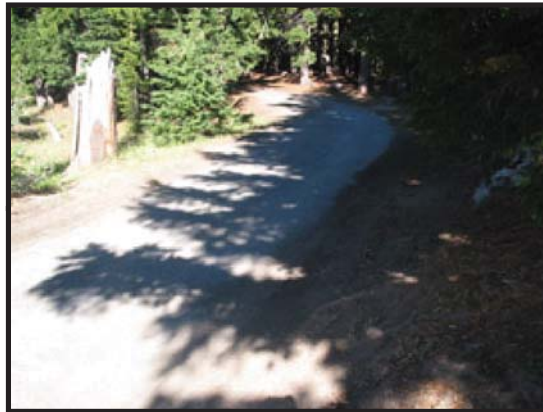
Route 0926

Route Number	Public / NonPublic	Date Visited		Area (sq ft)	Lane Miles *	Surface Type
0926	PUBLIC	8/21/2007		6,112	0.11	AS
Culverts	Drop Inlets	Gates	Fire Hydrants	Curb & Gutter	Curb	PCR
0	0	0	0	NO CURB AND GUTTER	NO CURB	POOR/45

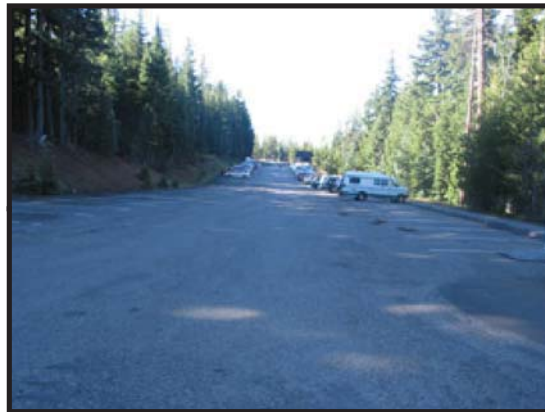
Route 0927

Route Number	Public / NonPublic	Date Visited		Area (sq ft)	Lane Miles *	Surface Type
0927	PUBLIC	8/21/2007		40,760	0.70	AS
Culverts	Drop Inlets	Gates	Fire Hydrants	Curb & Gutter	Curb	PCR
0	1	0	0	NO CURB AND GUTTER	ASPHALT CURB	POOR/45

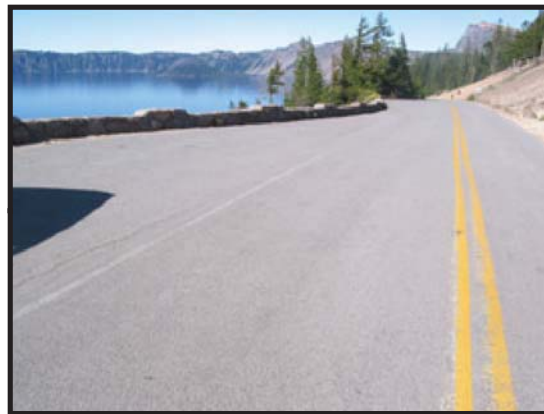
Route 0928

Route Number	Public / NonPublic	Date Visited		Area (sq ft)	Lane Miles *	Surface Type
0928	PUBLIC	8/21/2007		4,208	0.07	AS
Culverts	Drop Inlets	Gates	Fire Hydrants	Curb & Gutter	Curb	PCR
0	0	0	0	NO CURB AND GUTTER	NO CURB	FAIR/73

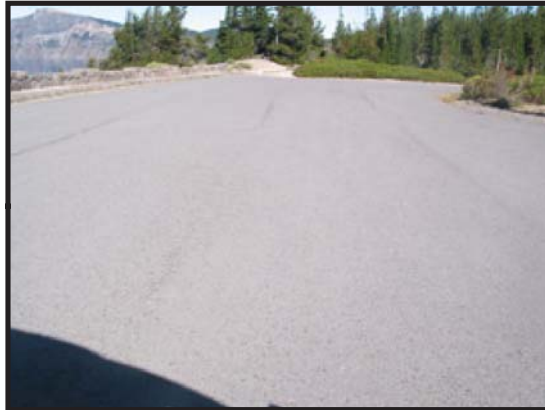
Route 0929

Route Number	Public / NonPublic	Date Visited		Area (sq ft)	Lane Miles *	Surface Type
0929	PUBLIC	8/21/2007		14,221	0.25	AS
Culverts	Drop Inlets	Gates	Fire Hydrants	Curb & Gutter	Curb	PCR
0	0	0	0	NO CURB AND GUTTER	STONE CURB	FAIR/73

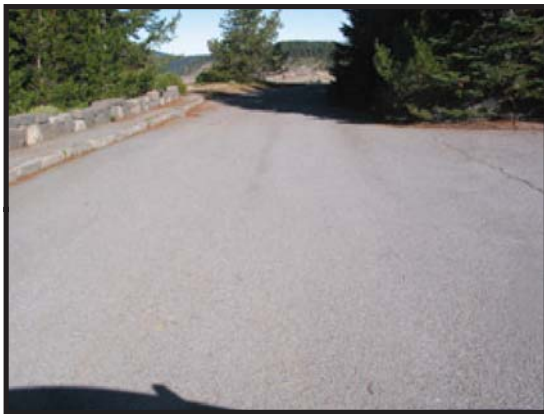
Route 0930

Route Number	Public / NonPublic	Date Visited		Area (sq ft)	Lane Miles *	Surface Type
0930	PUBLIC	8/21/2007		5,853	0.10	AS
Culverts	Drop Inlets	Gates	Fire Hydrants	Curb & Gutter	Curb	PCR
0	0	0	0	NO CURB AND GUTTER	STONE CURB	FAIR/73

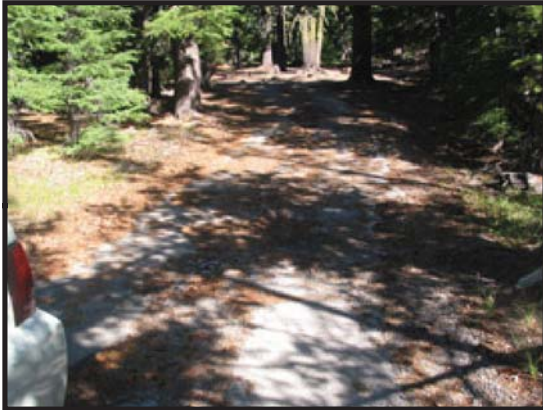
Route 0931

Route Number	Public / NonPublic	Date Visited		Area (sq ft)	Lane Miles *	Surface Type
0931	PUBLIC	8/21/2007		3,479	0.06	AS
Culverts	Drop Inlets	Gates	Fire Hydrants	Curb & Gutter	Curb	PCR
0	0	0	0	NO CURB AND GUTTER	NO CURB	POOR/45

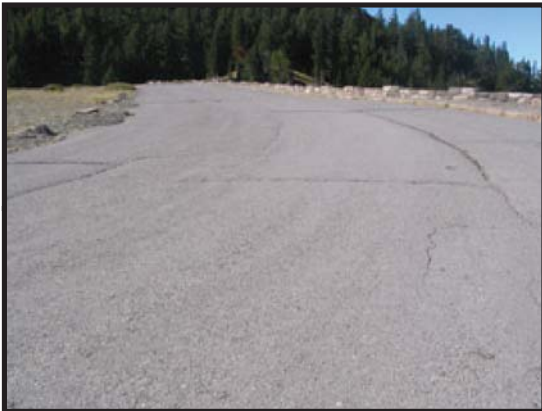
Route 0932

Route Number	Public / NonPublic	Date Visited		Area (sq ft)	Lane Miles *	Surface Type
0932	PUBLIC	8/21/2007		28,600	0.49	AS
Culverts	Drop Inlets	Gates	Fire Hydrants	Curb & Gutter	Curb	PCR
0	0	0	0	NO CURB AND GUTTER	STONE CURB	FAIR/73

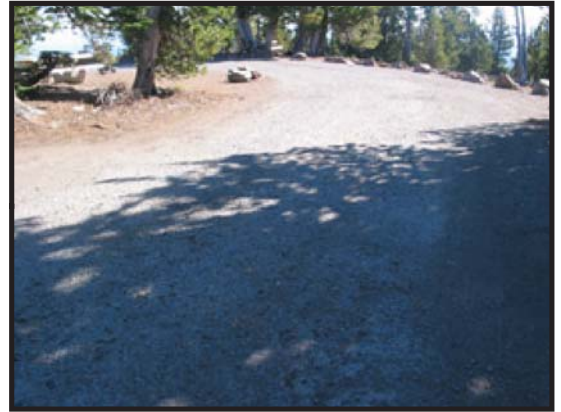
Route 0933

Route Number	Public / NonPublic	Date Visited		Area (sq ft)	Lane Miles *	Surface Type
0933	PUBLIC	8/21/2007		5,857	0.10	AS
Culverts	Drop Inlets	Gates	Fire Hydrants	Curb & Gutter	Curb	PCR
0	0	0	0	NO CURB AND GUTTER	NO CURB	POOR/45

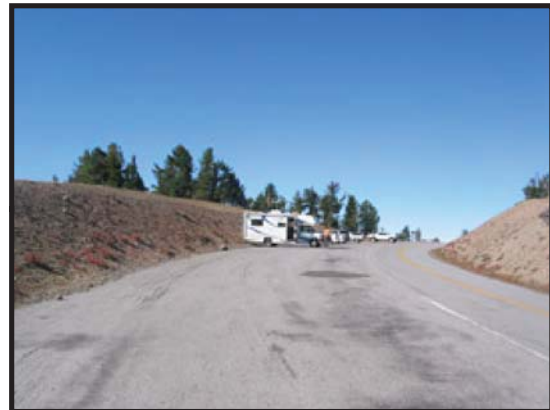
Route 0934

Route Number	Public / NonPublic	Date Visited		Area (sq ft)	Lane Miles *	Surface Type
0934	PUBLIC	8/21/2007		10,352	0.18	AS
Culverts	Drop Inlets	Gates	Fire Hydrants	Curb & Gutter	Curb	PCR
0	0	0	0	NO CURB AND GUTTER	NO CURB	FAIR/73

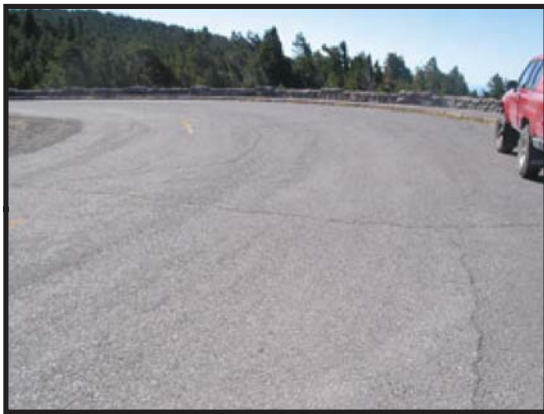
Route 0935

Route Number	Public / NonPublic	Date Visited		Area (sq ft)	Lane Miles *	Surface Type
0935	PUBLIC	8/21/2007		4,031	0.07	AS
Culverts	Drop Inlets	Gates	Fire Hydrants	Curb & Gutter	Curb	PCR
0	0	0	0	NO CURB AND GUTTER	STONE CURB	FAIR/73

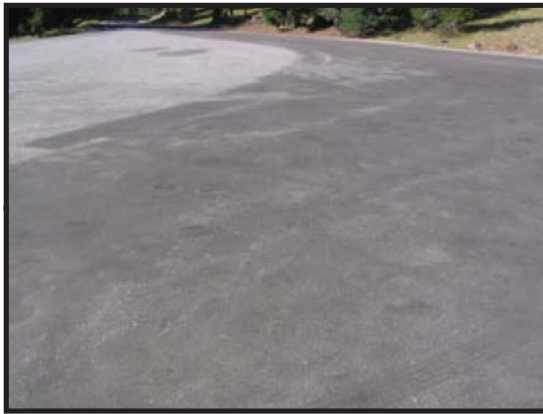
Route 0936

Route Number	Public / NonPublic	Date Visited		Area (sq ft)	Lane Miles *	Surface Type
0936	PUBLIC	8/21/2007		15,834	0.27	AS
Culverts	Drop Inlets	Gates	Fire Hydrants	Curb & Gutter	Curb	PCR
0	1	0	0	NO CURB AND GUTTER	STONE CURB	GOOD/90

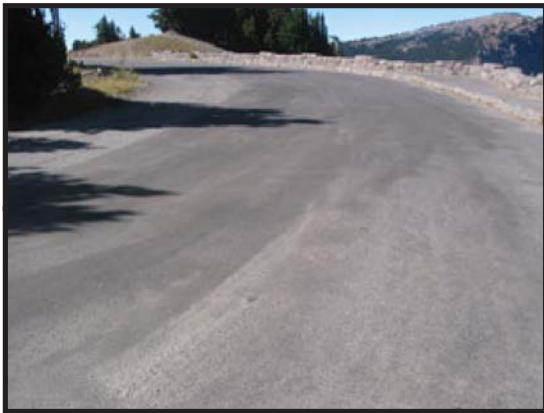
Route 0937

Route Number	Public / NonPublic	Date Visited		Area (sq ft)	Lane Miles *	Surface Type
0937	PUBLIC	8/21/2007		11,850	0.20	AS
Culverts	Drop Inlets	Gates	Fire Hydrants	Curb & Gutter	Curb	PCR
0	0	0	0	NO CURB AND GUTTER	STONE CURB	FAIR/73

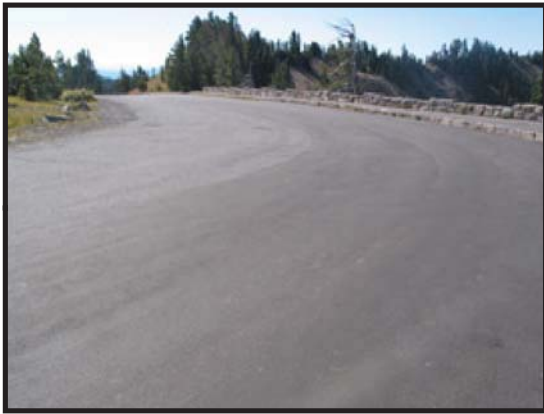
Route 0938

Route Number	Public / NonPublic	Date Visited		Area (sq ft)	Lane Miles *	Surface Type
0938	PUBLIC	8/21/2007		12,520	0.22	AS
Culverts	Drop Inlets	Gates	Fire Hydrants	Curb & Gutter	Curb	PCR
0	0	0	0	NO CURB AND GUTTER	STONE CURB	POOR/45

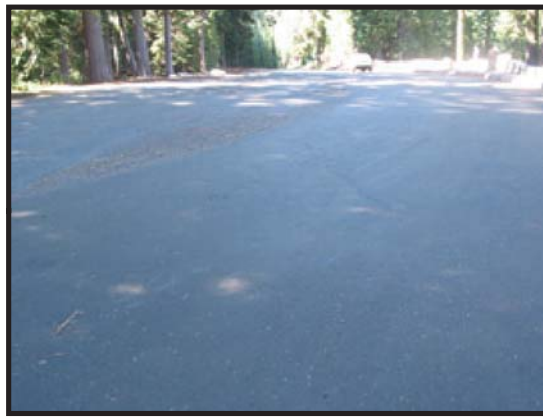
Route 0939

Route Number	Public / NonPublic	Date Visited		Area (sq ft)	Lane Miles *	Surface Type
0939	PUBLIC	8/21/2007		36,772	0.63	AS
Culverts	Drop Inlets	Gates	Fire Hydrants	Curb & Gutter	Curb	PCR
0	0	0	0	NO CURB AND GUTTER	STONE CURB	FAIR/73

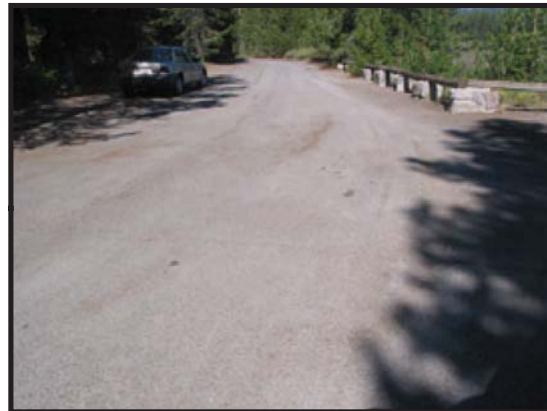
Route 0940

Route Number	Public / NonPublic	Date Visited		Area (sq ft)	Lane Miles *	Surface Type
0940	PUBLIC	8/21/2007		13,662	0.24	AS
Culverts	Drop Inlets	Gates	Fire Hydrants	Curb & Gutter	Curb	PCR
0	0	0	0	NO CURB AND GUTTER	NO CURB	POOR/45

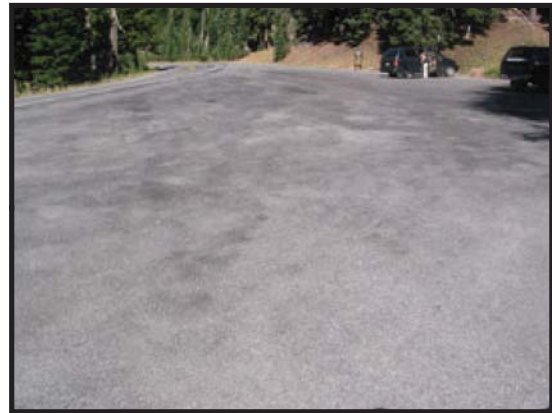
Route 0941

Route Number	Public / NonPublic	Date Visited		Area (sq ft)	Lane Miles *	Surface Type
0941	PUBLIC	8/21/2007		10,942	0.19	AS
Culverts	Drop Inlets	Gates	Fire Hydrants	Curb & Gutter	Curb	PCR
0	0	0	0	NO CURB AND GUTTER	NO CURB	GOOD/90

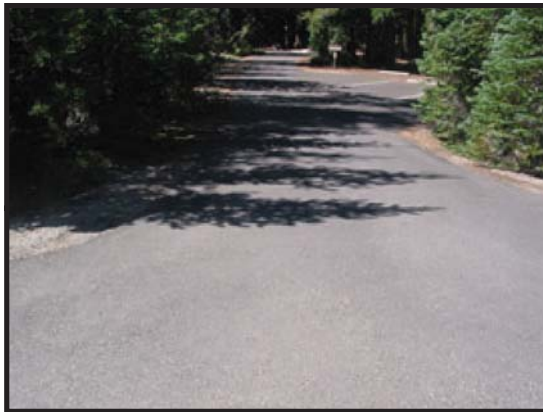
Route 0943

Route Number	Public / NonPublic	Date Visited		Area (sq ft)	Lane Miles *	Surface Type
0943	PUBLIC	8/21/2007		10,852	0.19	AS
Culverts	Drop Inlets	Gates	Fire Hydrants	Curb & Gutter	Curb	PCR
0	0	0	0	NO CURB AND GUTTER	NO CURB	EXCELLENT/97

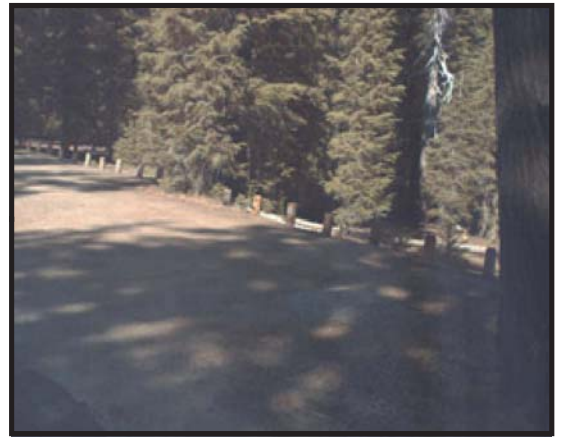
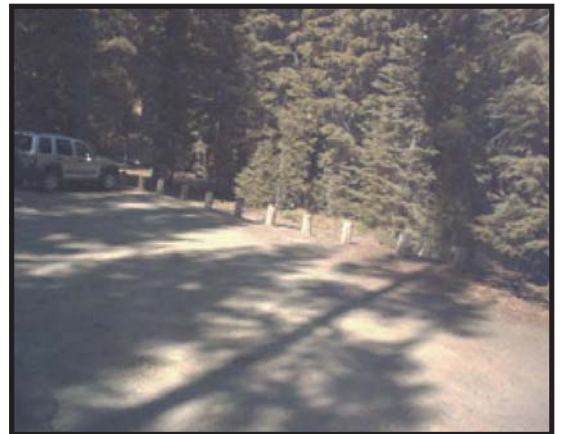
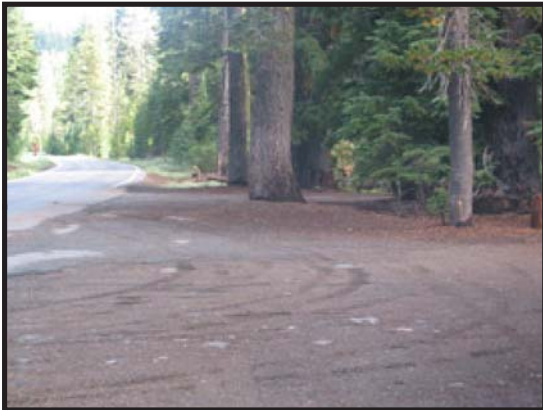
Route 0944

Route Number	Public / NonPublic	Date Visited		Area (sq ft)	Lane Miles *	Surface Type
0944	PUBLIC	8/21/2007		1,095	0.02	AS
Culverts	Drop Inlets	Gates	Fire Hydrants	Curb & Gutter	Curb	PCR
0	0	0	0	NO CURB AND GUTTER	NO CURB	POOR/45

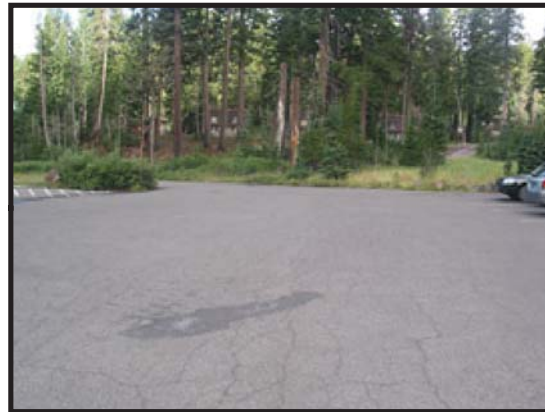
Route 0946

Route Number	Public / NonPublic	Date Visited		Area (sq ft)	Lane Miles *	Surface Type
0946	NONPUBLIC	8/21/2007		10,795	0.19	AS
Culverts	Drop Inlets	Gates	Fire Hydrants	Curb & Gutter	Curb	PCR
0	0	0	1	NO CURB AND GUTTER	STONE CURB	POOR/45

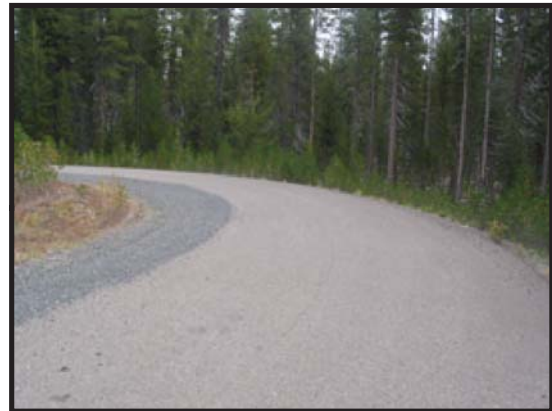
Route 0950

Route Number	Public / NonPublic	Date Visited		Area (sq ft)	Lane Miles *	Surface Type
0950	PUBLIC	8/21/2007		3,373	0.06	AS
Culverts	Drop Inlets	Gates	Fire Hydrants	Curb & Gutter	Curb	PCR
0	0	0	0	NO CURB AND GUTTER	NO CURB	GOOD/90

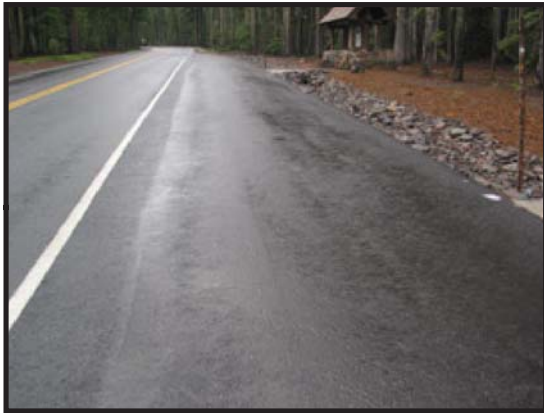
Route 0951

Route Number	Public / NonPublic	Date Visited		Area (sq ft)	Lane Miles *	Surface Type
0951	PUBLIC	8/21/2007		3,621	0.06	AS
Culverts	Drop Inlets	Gates	Fire Hydrants	Curb & Gutter	Curb	PCR
2	0	0	0	NO CURB AND GUTTER	NO CURB	GOOD/90
