**The Road Inventory
of
Crater Lake National Park
CRLA – 9320
Cycle 4**

**Prepared By:
Federal Highway Administration
Road Inventory Program
Cycle 4**

Crater Lake National Park in Oregon

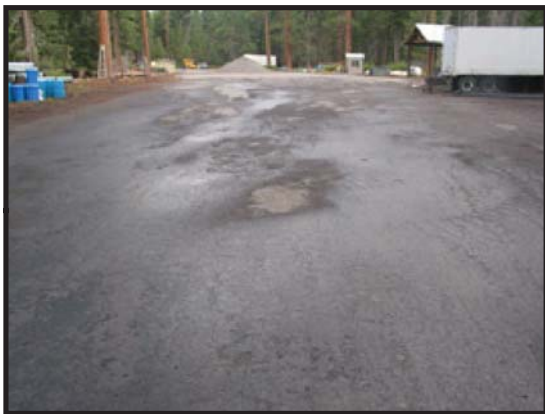
Route 0952

Route Number	Public / NonPublic	Date Visited		Area (sq ft)	Lane Miles *	Surface Type
0952	NONPUBLIC	8/21/2007		39,216	0.68	AS
Culverts	Drop Inlets	Gates	Fire Hydrants	Curb & Gutter	Curb	PCR
0	0	0	0	NO CURB AND GUTTER	NO CURB	POOR/45
