**The Road Inventory
Of
Cumberland Gap National Historical Park
CUGA- 5230
Cycle 4**

**Prepared By:
Federal Highway Administration
Road Inventory Program
Cycle 4**

Cumberland Gap National Historical Park in Kentucky / Virginia / Tennessee

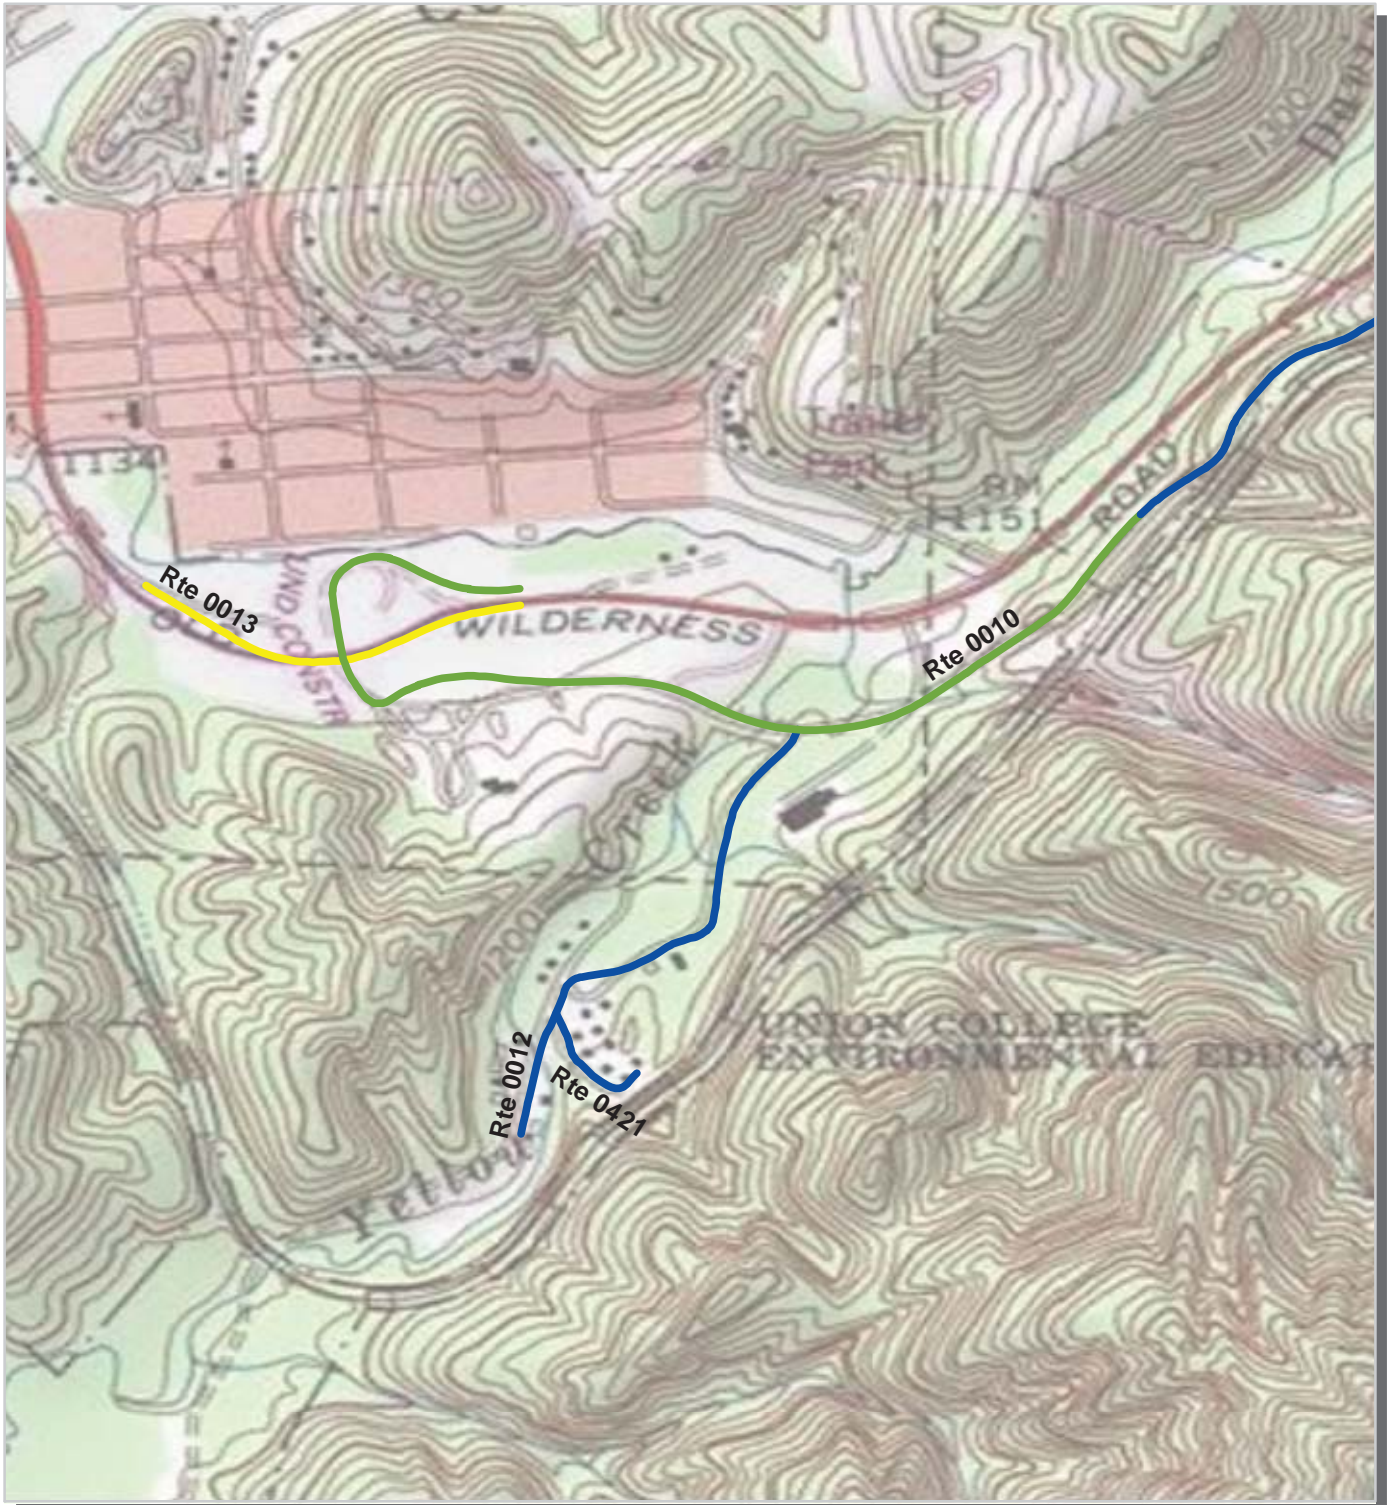
**Cumberland Gap National Historic Park
Route Condition Map
PCR - Mile by Mile
Area 1**

PCR	Poor	Fair	Good	Excellent	No Data
	(≤60)	(61 - 84)	(85 - 94)	(95 - 100)

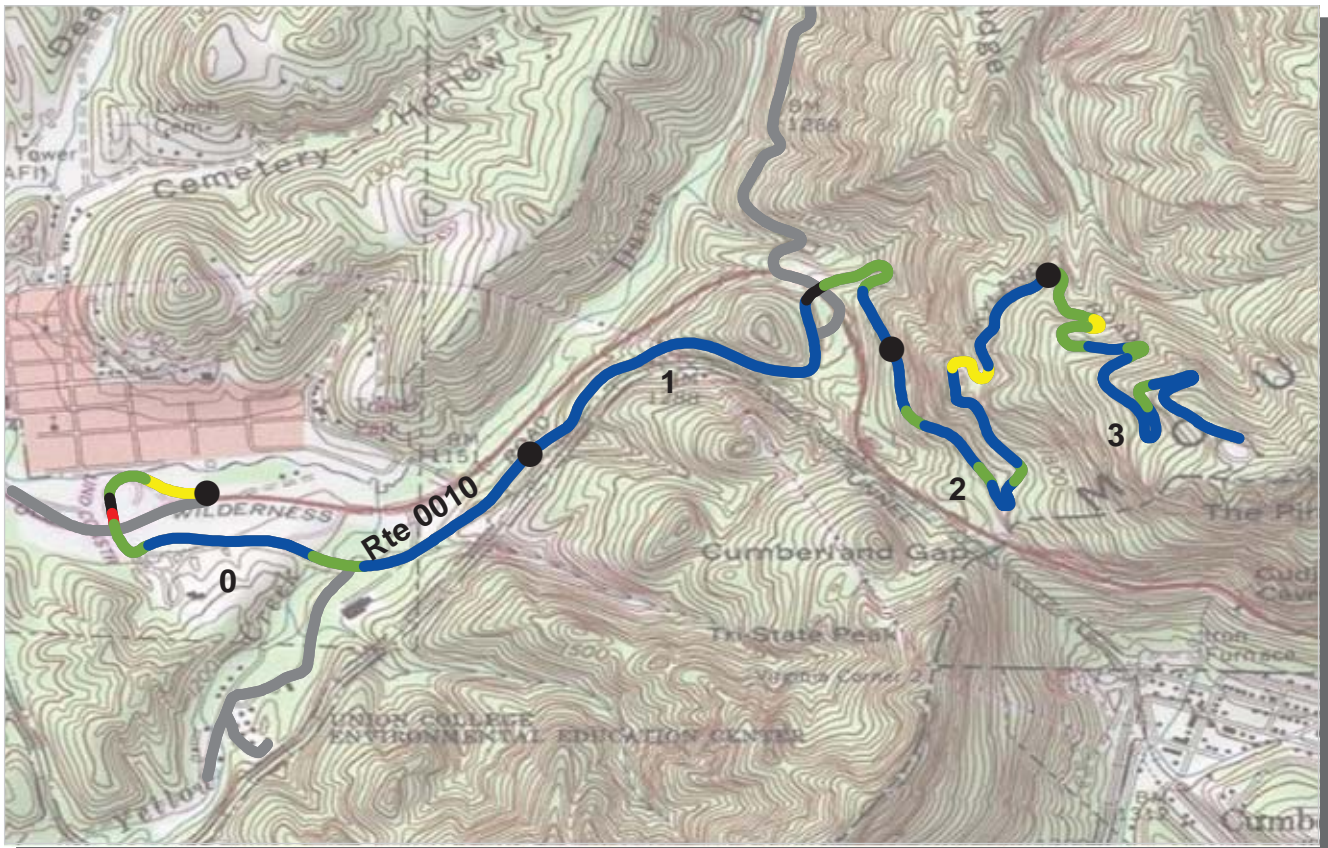
ROUTE: 0010 PINNACLE ROAD

Section Number	0	1	2	3	
Section Length (mi)	1.00	1.00	1.00	0.99	
Traffic	Traffic data may be found at www.efl.fhwa.dot.gov Click on PROGRAMS / NPS Traffic Data (Note: Not all parks have traffic data)				
Cross Section Information					
Number of Lanes	1	2	2	2	
Paved Width (ft)	27	24	21	21	
Lane Width (ft)	11	10	9	9	
Shoulder Width Right (ft)	NC	NC	NC	NC	
Shoulder Width Left (ft)	NC	NC	NC	NC	
Roadway Condition Information					
SCR (Surface Condition Rating)	96	100	99	98	
PCR (Pavement Condition Rating)	91	97	95	93	
Distress Index Values					
Alligator Cracking Index	100	100	100	100	
Longitudinal Cracking Index	100	100	100	100	
Transverse Cracking Index	100	100	100	100	
Patching Index	100	100	100	100	
Rutting Index	96	100	99	98	
Roughness Condition Index (RCI)	90	93	86	82

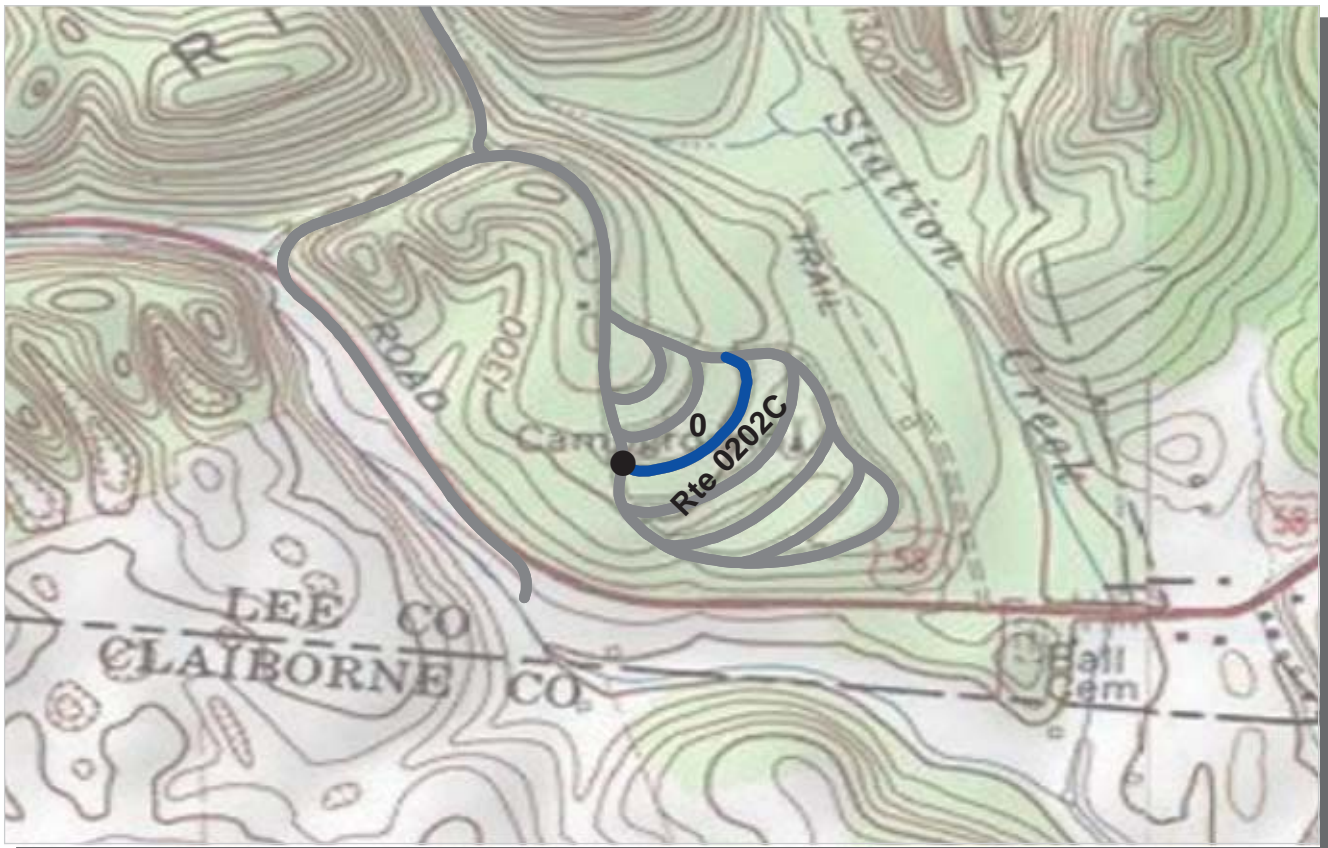
ROUTE: 0202B WILDERNESS ROAD CAMPGROUND B

Section Number	0				
Section Length (mi)	0.12				
Traffic	Traffic data may be found at www.efl.fhwa.dot.gov Click on PROGRAMS / NPS Traffic Data (Note: Not all parks have traffic data)				
Cross Section Information					
Number of Lanes	1				
Paved Width (ft)	15				
Lane Width (ft)	15				
Shoulder Width Right (ft)	NC				
Shoulder Width Left (ft)	NC				
Roadway Condition Information					
SCR (Surface Condition Rating)	98				
PCR (Pavement Condition Rating)	98				
Distress Index Values					
Alligator Cracking Index	100				
Longitudinal Cracking Index	100				
Transverse Cracking Index	100				
Patching Index	100				
Rutting Index	98				
Roughness Condition Index (RCI)	NC

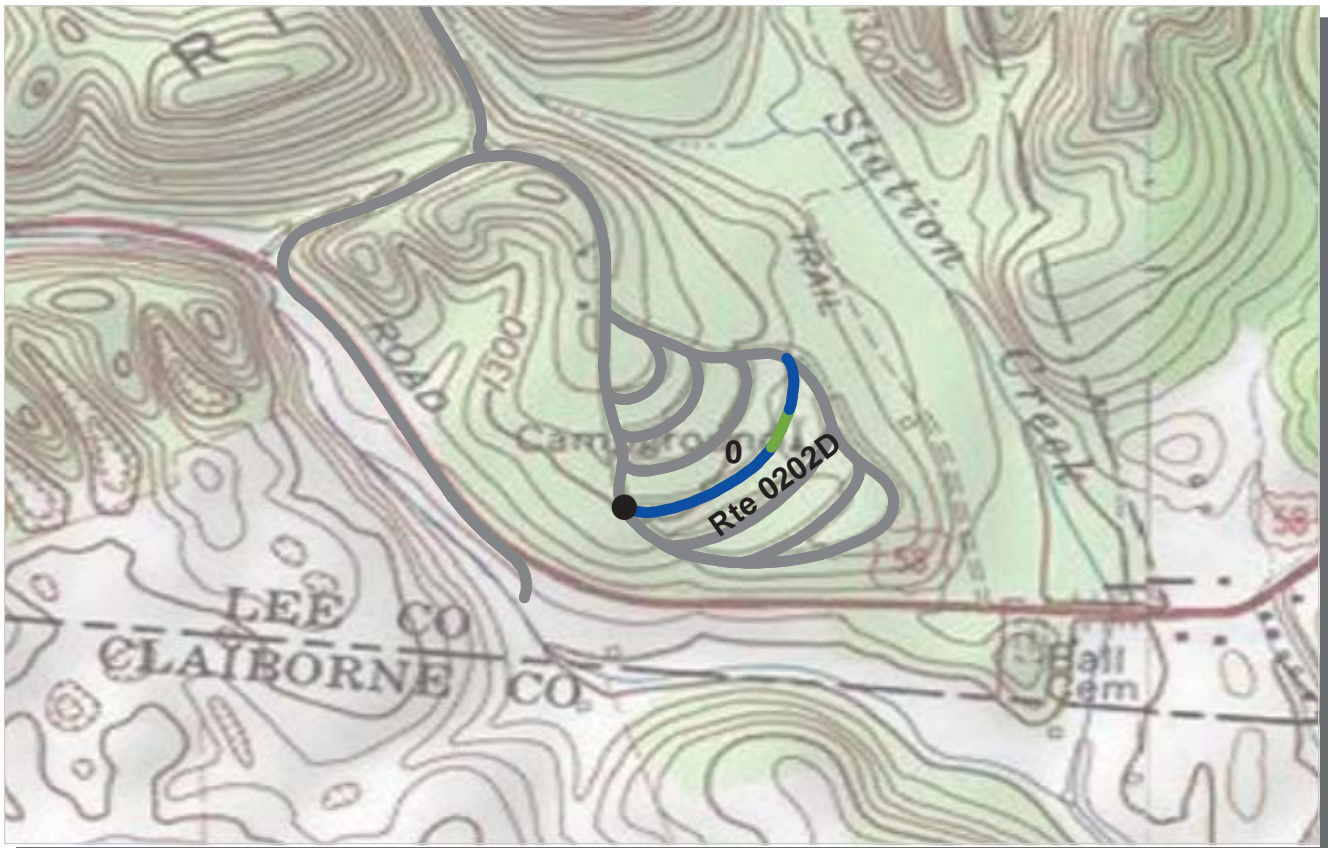
ROUTE: 0202C WILDERNESS ROAD CAMPGROUND C

Section Number	0				
Section Length (mi)	0.18				
Traffic	Traffic data may be found at www.efl.fhwa.dot.gov Click on PROGRAMS / NPS Traffic Data (Note: Not all parks have traffic data)				
Cross Section Information					
Number of Lanes	1				
Paved Width (ft)	18				
Lane Width (ft)	18				
Shoulder Width Right (ft)	NC				
Shoulder Width Left (ft)	NC				
Roadway Condition Information					
SCR (Surface Condition Rating)	98				
PCR (Pavement Condition Rating)	98				
Distress Index Values					
Alligator Cracking Index	100				
Longitudinal Cracking Index	100				
Transverse Cracking Index	100				
Patching Index	100				
Rutting Index	98				
Roughness Condition Index (RCI)	97

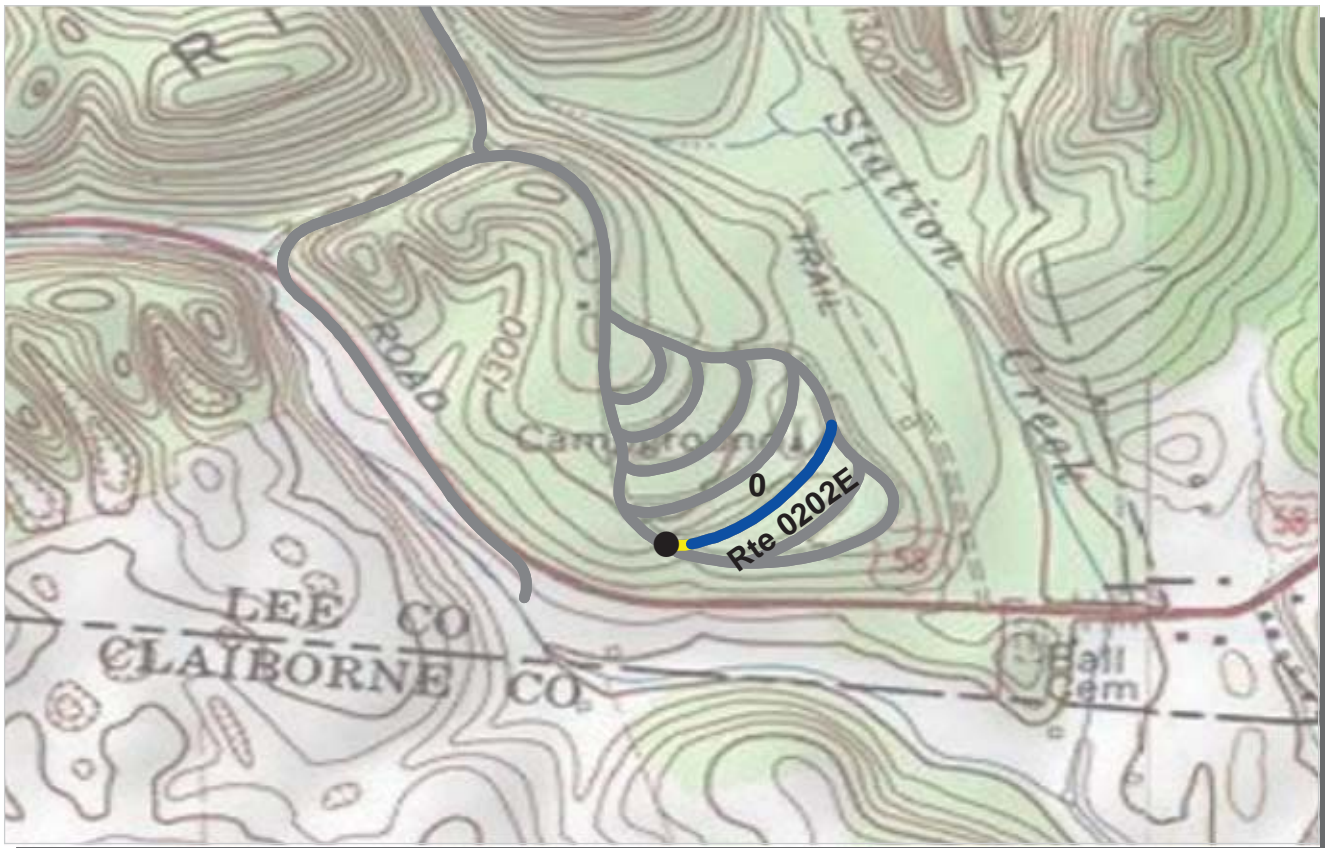
ROUTE: 0202D WILDERNESS ROAD CAMPGROUND D

Section Number	0				
Section Length (mi)	0.23				
Traffic	Traffic data may be found at www.efl.fhwa.dot.gov Click on PROGRAMS / NPS Traffic Data (Note: Not all parks have traffic data)				
Cross Section Information					
Number of Lanes	1				
Paved Width (ft)	16				
Lane Width (ft)	16				
Shoulder Width Right (ft)	NC				
Shoulder Width Left (ft)	NC				
Roadway Condition Information					
SCR (Surface Condition Rating)	99				
PCR (Pavement Condition Rating)	97				
Distress Index Values					
Alligator Cracking Index	100				
Longitudinal Cracking Index	100				
Transverse Cracking Index	100				
Patching Index	100				
Rutting Index	99				
Roughness Condition Index (RCI)	93

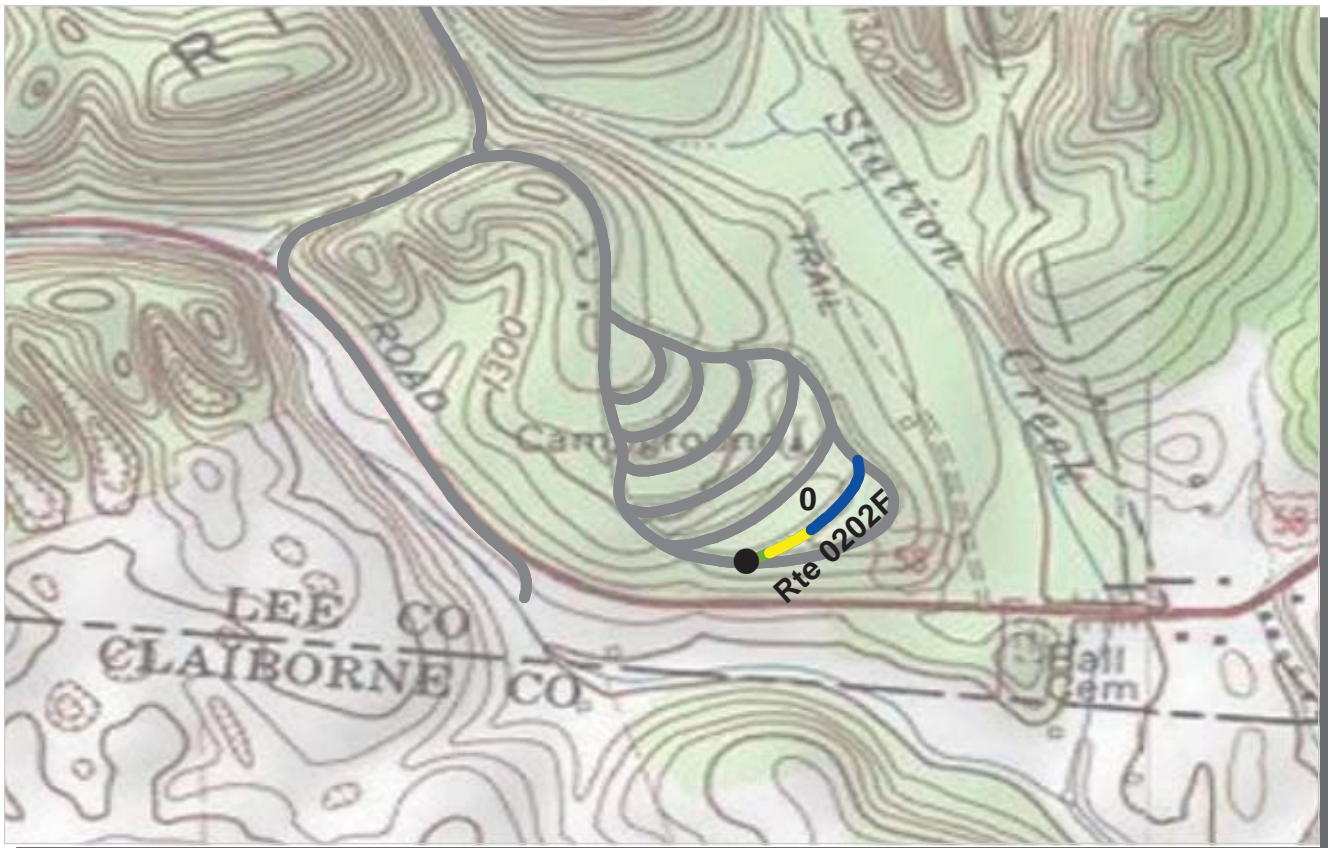
ROUTE: 0202E WILDERNESS ROAD CAMPGROUND E

Section Number	0				
Section Length (mi)	0.19				
Traffic	Traffic data may be found at www.efl.fhwa.dot.gov Click on PROGRAMS / NPS Traffic Data (Note: Not all parks have traffic data)				
Cross Section Information					
Number of Lanes	1				
Paved Width (ft)	16				
Lane Width (ft)	16				
Shoulder Width Right (ft)	NC				
Shoulder Width Left (ft)	NC				
Roadway Condition Information					
SCR (Surface Condition Rating)	98				
PCR (Pavement Condition Rating)	95				
Distress Index Values					
Alligator Cracking Index	100				
Longitudinal Cracking Index	100				
Transverse Cracking Index	100				
Patching Index	100				
Rutting Index	98				
Roughness Condition Index (RCI)	83

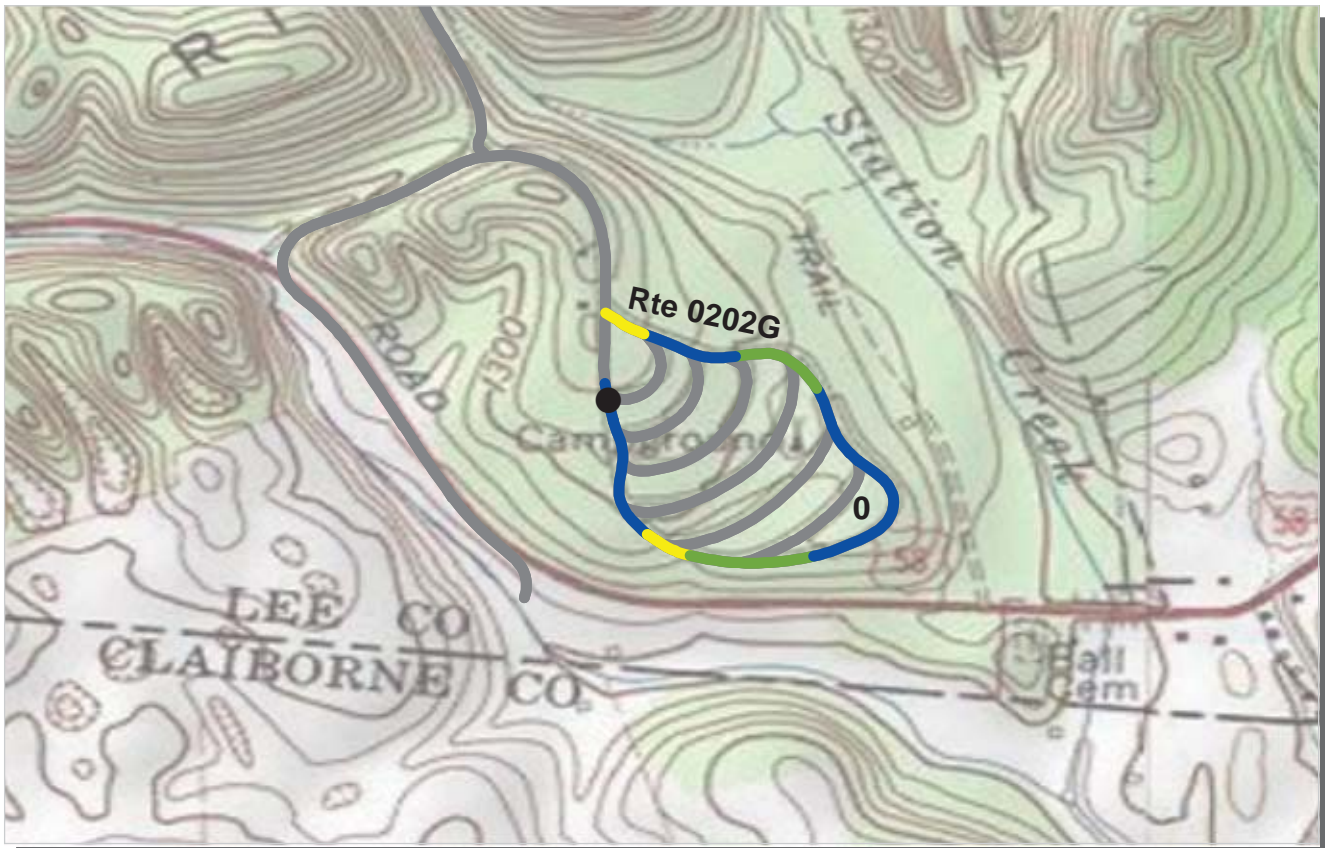
ROUTE: 0202F WILDERNESS ROAD CAMPGROUND F

Section Number	0				
Section Length (mi)	0.14				
Traffic	Traffic data may be found at www.efl.fhwa.dot.gov Click on PROGRAMS / NPS Traffic Data (Note: Not all parks have traffic data)				
Cross Section Information					
Number of Lanes	1				
Paved Width (ft)	15				
Lane Width (ft)	15				
Shoulder Width Right (ft)	NC				
Shoulder Width Left (ft)	NC				
Roadway Condition Information					
SCR (Surface Condition Rating)	97				
PCR (Pavement Condition Rating)	92				
Distress Index Values					
Alligator Cracking Index	100				
Longitudinal Cracking Index	100				
Transverse Cracking Index	100				
Patching Index	100				
Rutting Index	97				
Roughness Condition Index (RCI)	71

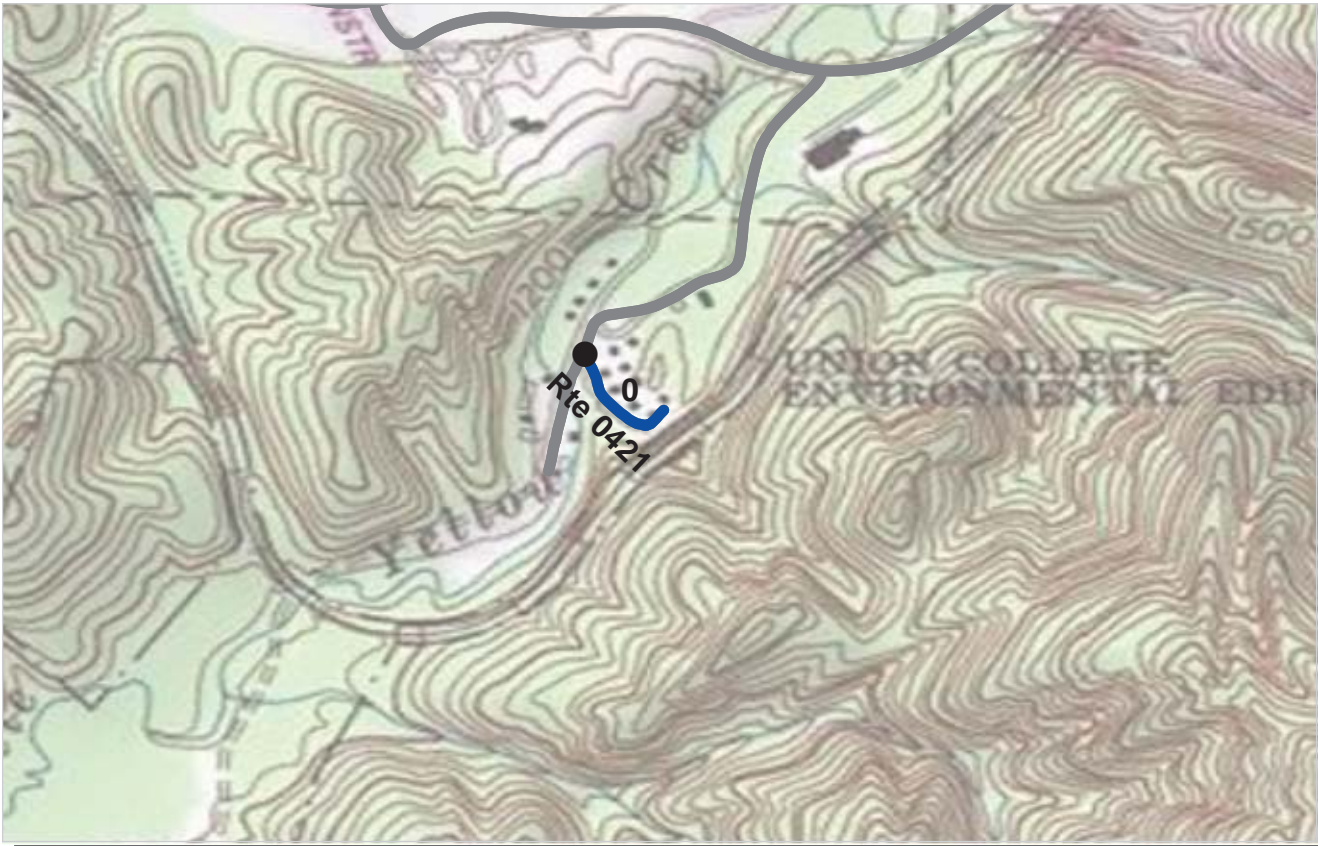
ROUTE: 0202G WILDERNESS ROAD CAMPGROUND G

Section Number	0				
Section Length (mi)	0.69				
Traffic	Traffic data may be found at www.efl.fhwa.dot.gov Click on PROGRAMS / NPS Traffic Data (Note: Not all parks have traffic data)				
Cross Section Information					
Number of Lanes	1				
Paved Width (ft)	15				
Lane Width (ft)	13				
Shoulder Width Right (ft)	NC				
Shoulder Width Left (ft)	NC				
Roadway Condition Information					
SCR (Surface Condition Rating)	99				
PCR (Pavement Condition Rating)	93				
Distress Index Values					
Alligator Cracking Index	100				
Longitudinal Cracking Index	100				
Transverse Cracking Index	100				
Patching Index	100				
Rutting Index	99				
Roughness Condition Index (RCI)	83

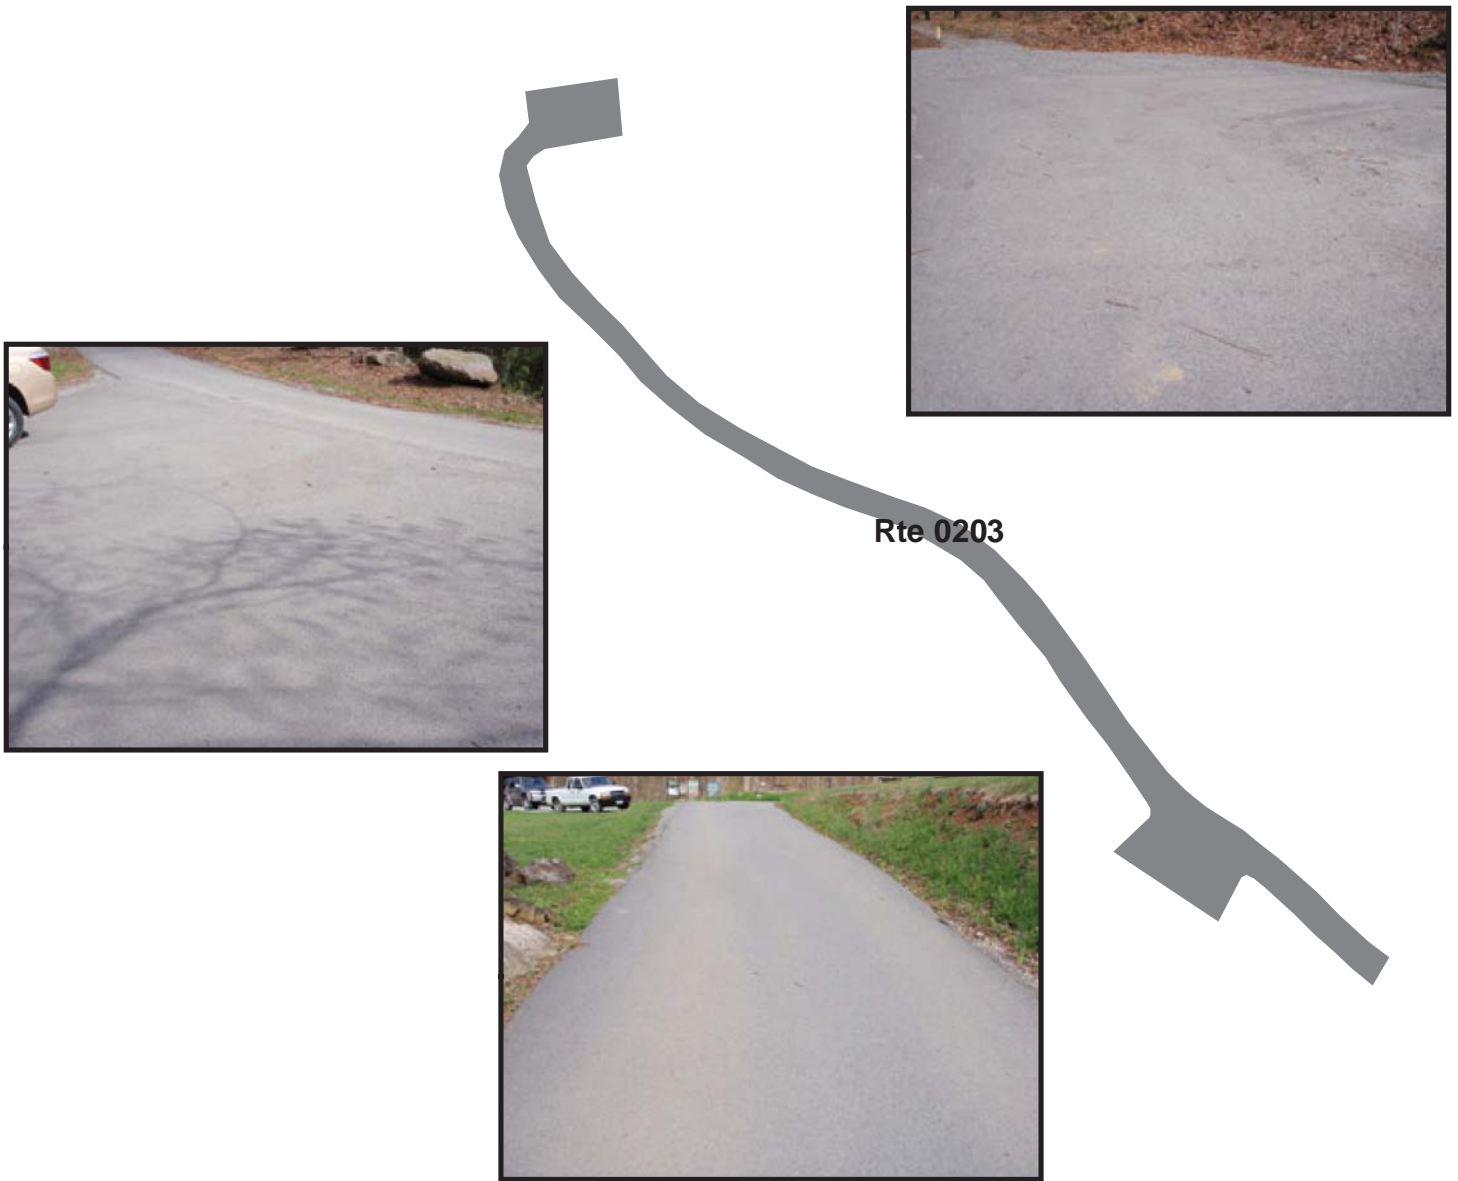
Route 0203

Route Number	Public / NonPublic	Date Visited		Area (sq ft)	Lane Miles *	Surface Type
0203	PUBLIC	4/16/2009		20,839	0.36	AS
Culverts	Drop Inlets	Gates	Fire Hydrants	Curb & Gutter	Curb	PCR
0	1	1	0	NO CURB AND GUTTER	NO CURB	GOOD/90

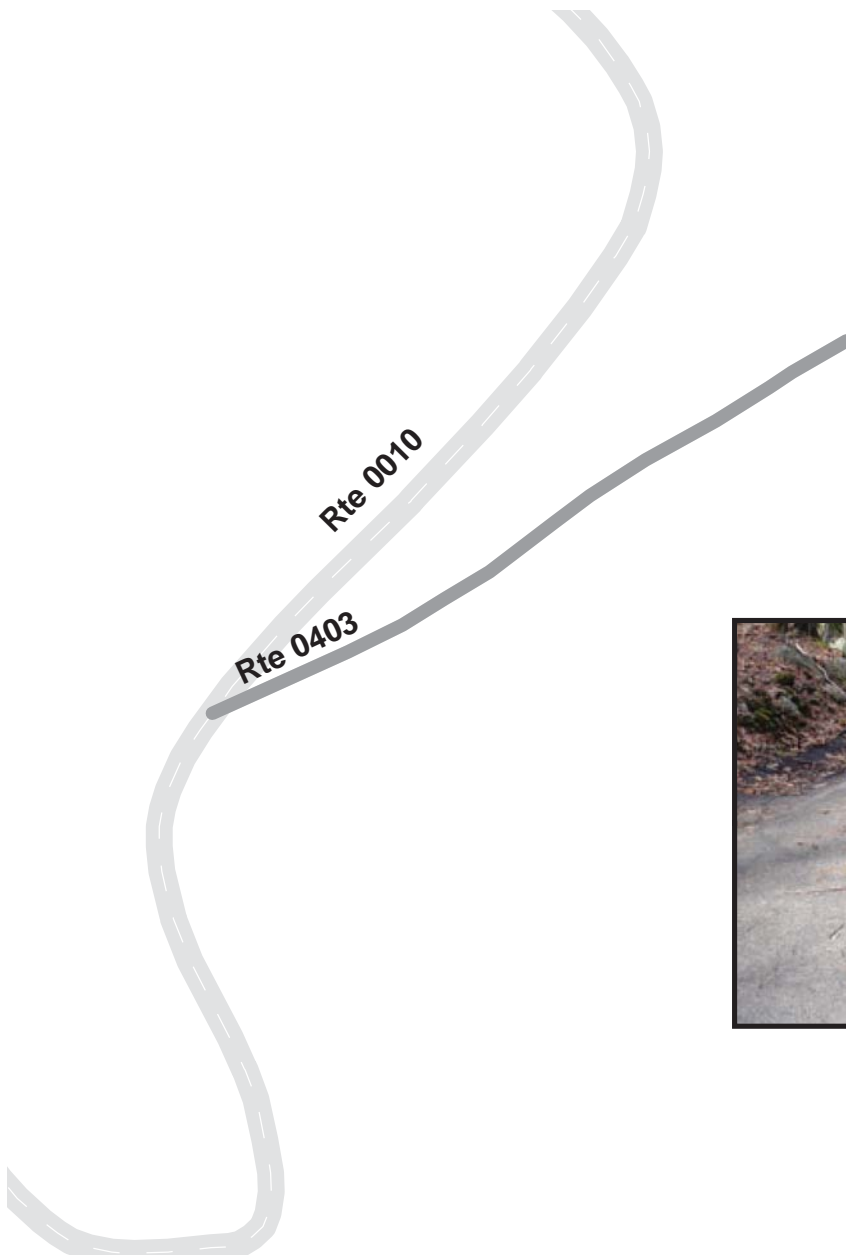
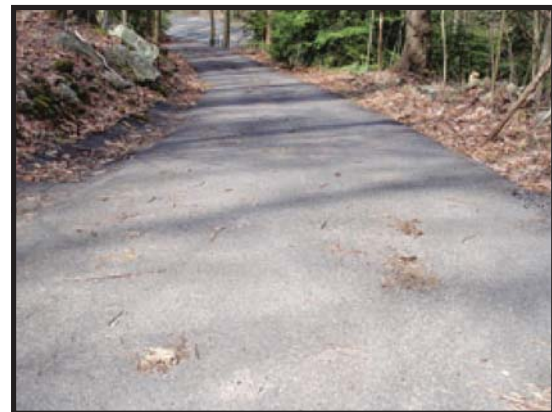
Route 0403

Route Number	Public / NonPublic	Date Visited		Area (sq ft)	Lane Miles *	Surface Type
0403	NONPUBLIC	4/16/2009		1,901	0.03	AS
Culverts	Drop Inlets	Gates	Fire Hydrants	Curb & Gutter	Curb	PCR
0	0	0	0	NO CURB AND GUTTER	NO CURB	FAIR/73

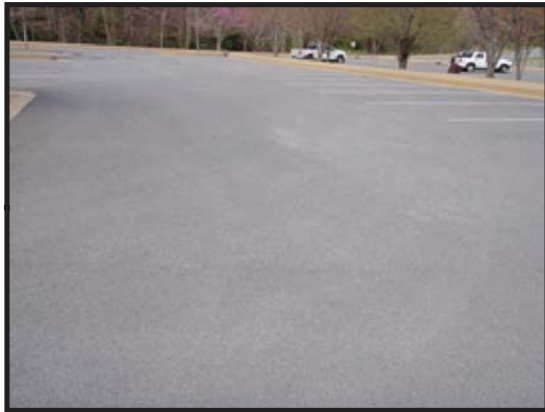
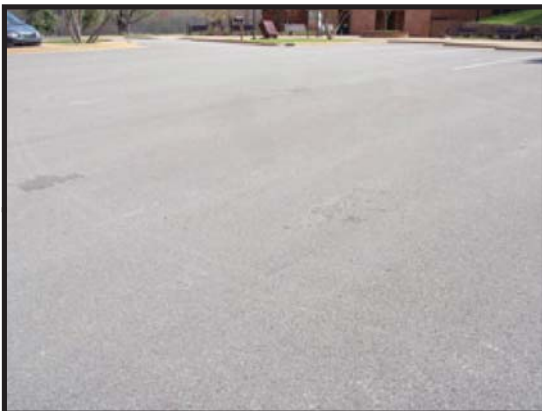
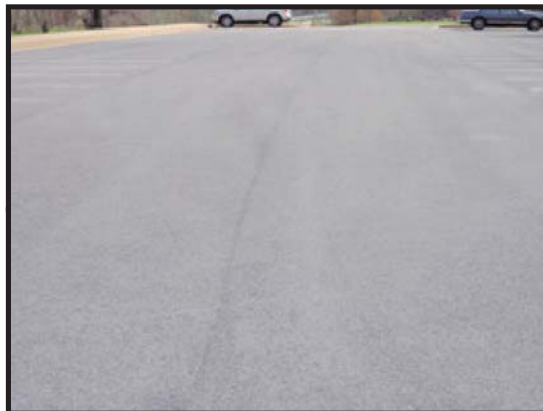
Route Number	Public / NonPublic	Date Visited		Area (sq ft)	Lane Miles *	Surface Type
0900	PUBLIC	4/16/2009		86,083	1.48	AS
Culverts	Drop Inlets	Gates	Fire Hydrants	Curb & Gutter	Curb	PCR
0	18	0	0	CONCRETE CURB AND GUTTER	NO CURB	GOOD/90

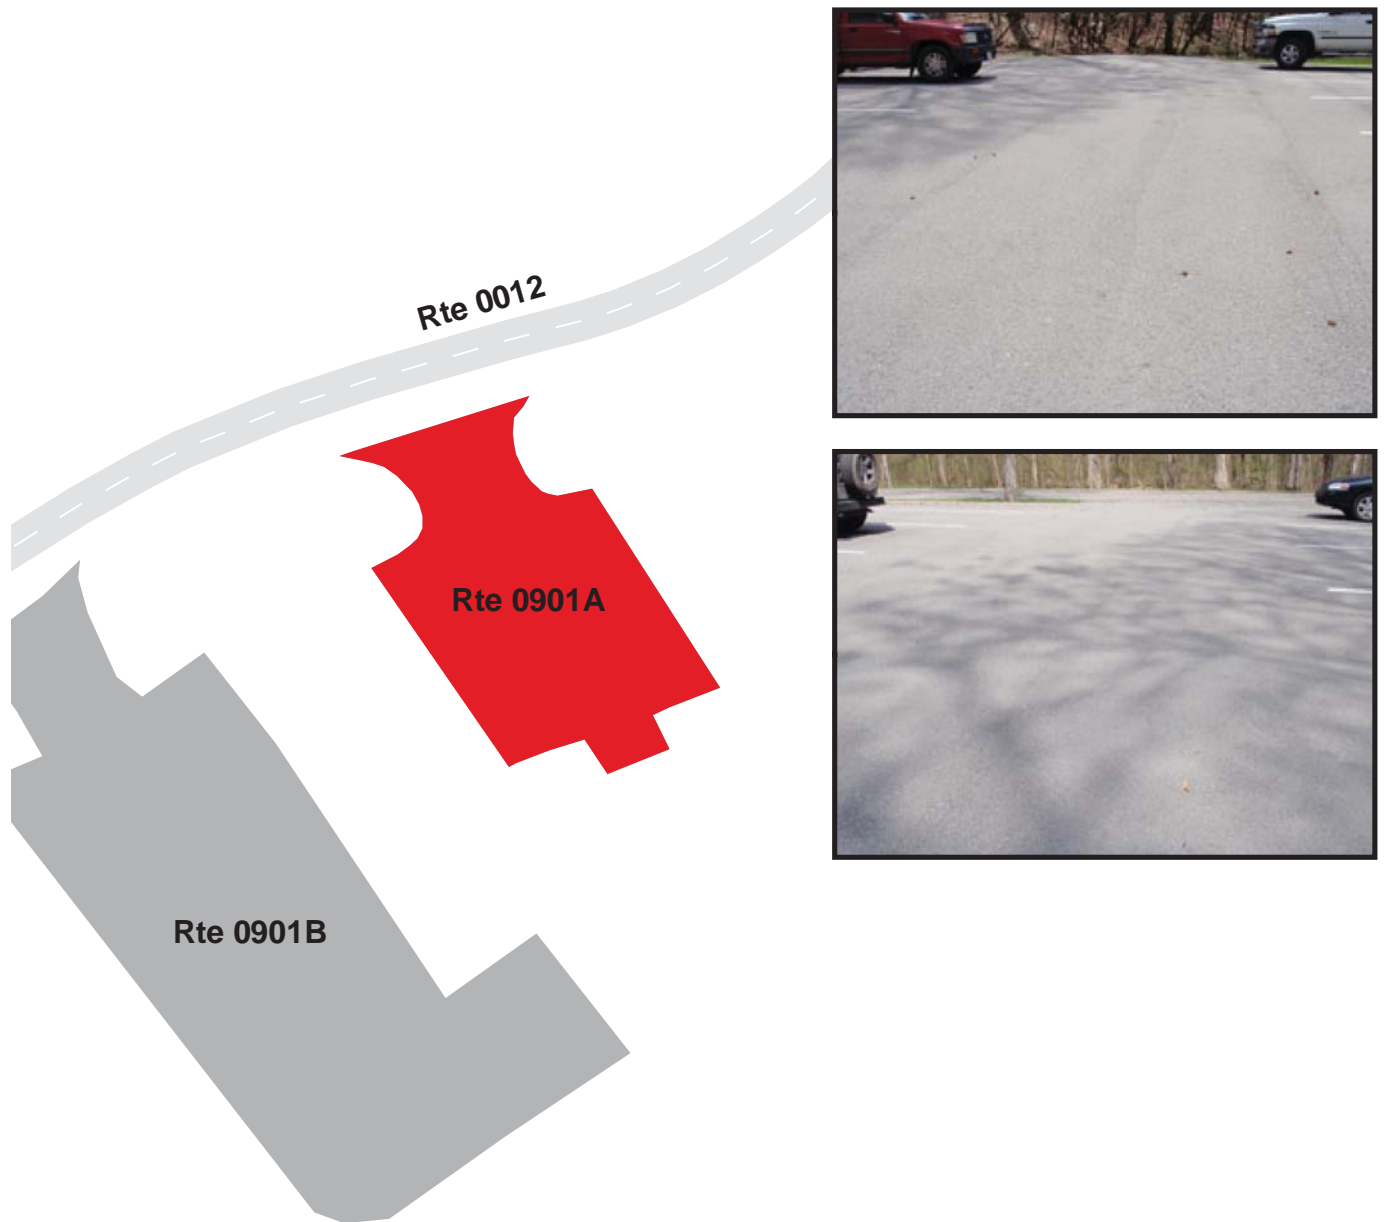
Route 0901A

Route Number	Public / NonPublic	Date Visited		Area (sq ft)	Lane Miles *	Surface Type
0901A	NONPUBLIC	4/16/2009		4,410	0.08	AS
Culverts	Drop Inlets	Gates	Fire Hydrants	Curb & Gutter	Curb	PCR
1	0	0	0	NO CURB AND GUTTER	NO CURB	GOOD/90

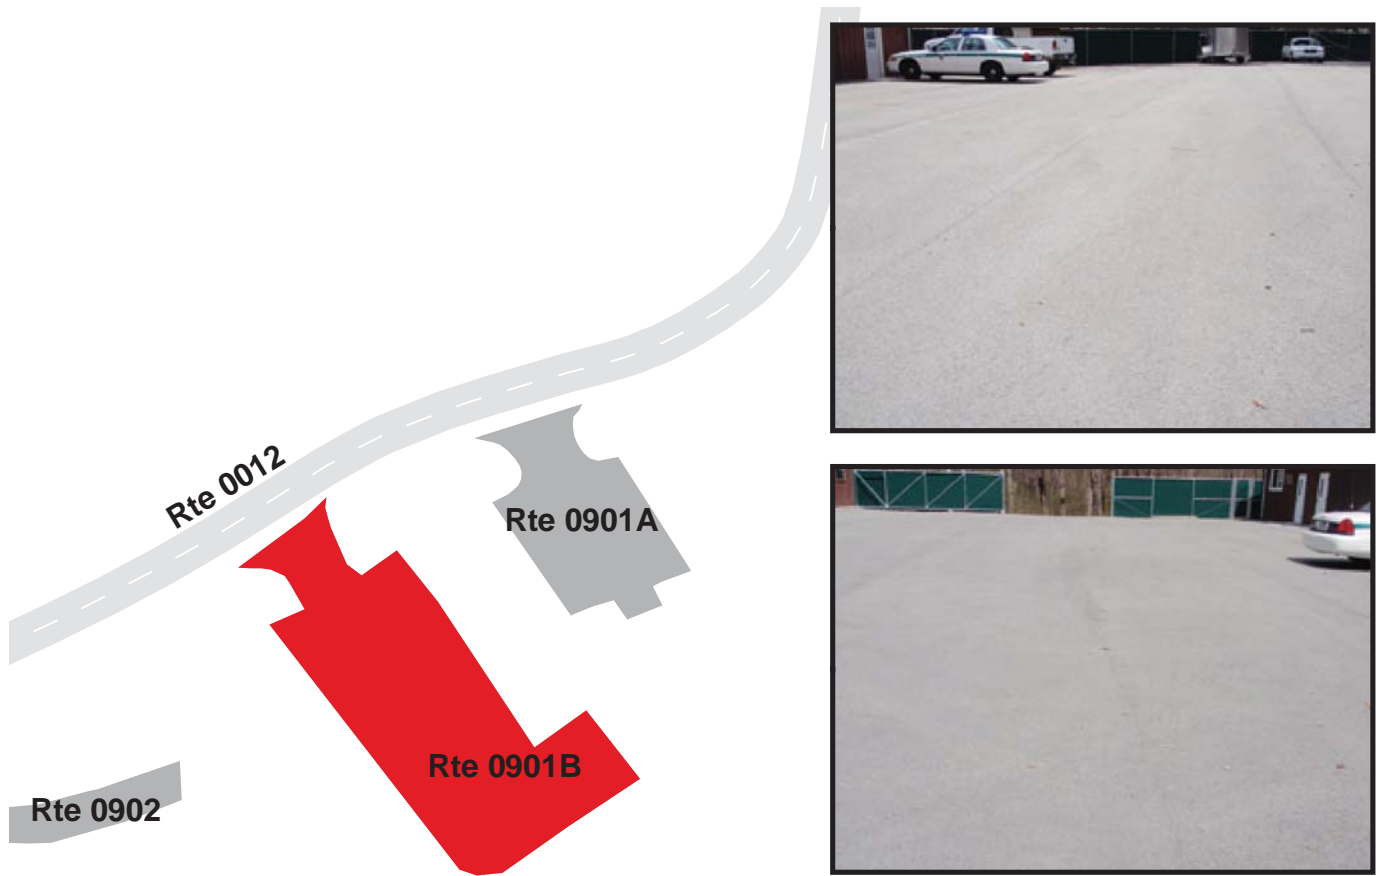
Route 0901B

Route Number	Public / NonPublic	Date Visited		Area (sq ft)	Lane Miles *	Surface Type
0901B	NONPUBLIC	4/16/2009		10,664	0.18	AS
Culverts	Drop Inlets	Gates	Fire Hydrants	Curb & Gutter	Curb	PCR
0	0	1	0	NO CURB AND GUTTER	NO CURB	GOOD/90

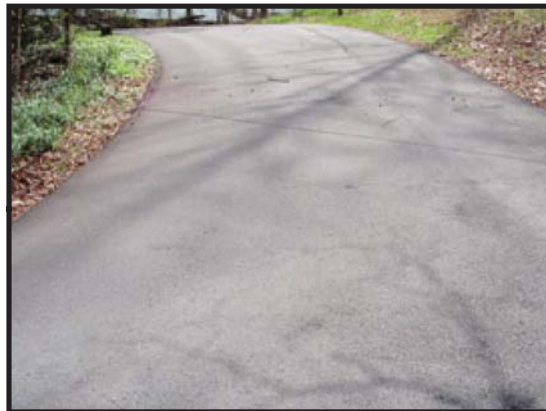
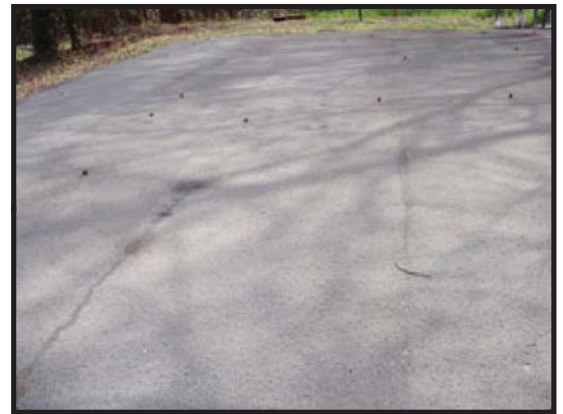
Route 0902

Route Number	Public / NonPublic	Date Visited		Area (sq ft)	Lane Miles *	Surface Type
0902	PUBLIC	4/16/2009		1,796	0.03	AS
Culverts	Drop Inlets	Gates	Fire Hydrants	Curb & Gutter	Curb	PCR
0	0	0	0	NO CURB AND GUTTER	NO CURB	GOOD/90

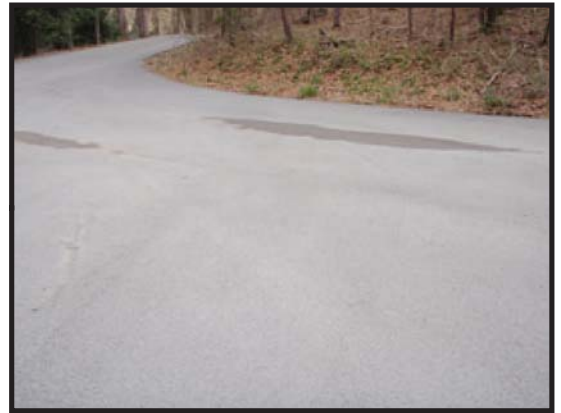
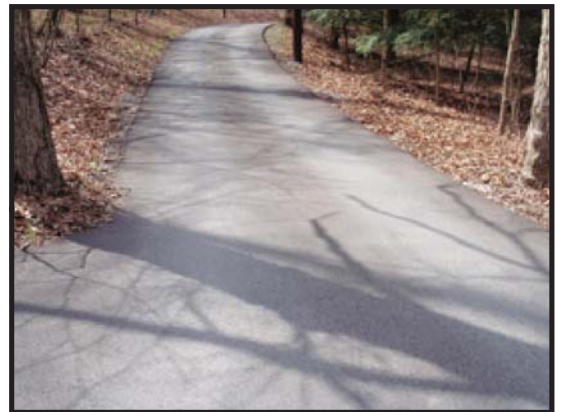
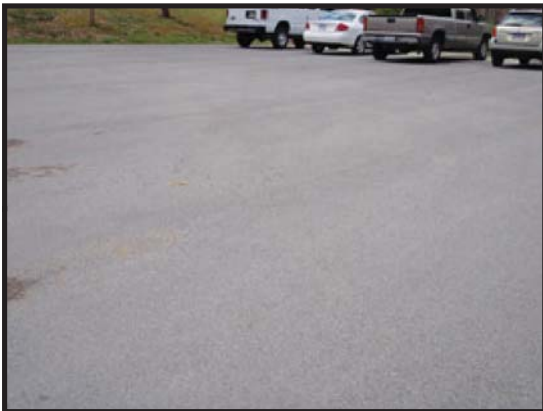
Route 0903

Route Number	Public / NonPublic	Date Visited		Area (sq ft)	Lane Miles *	Surface Type
0903	PUBLIC	4/16/2009		11,501	0.20	AS
Culverts	Drop Inlets	Gates	Fire Hydrants	Curb & Gutter	Curb	PCR
0	1	0	0	NO CURB AND GUTTER	NO CURB	GOOD/90

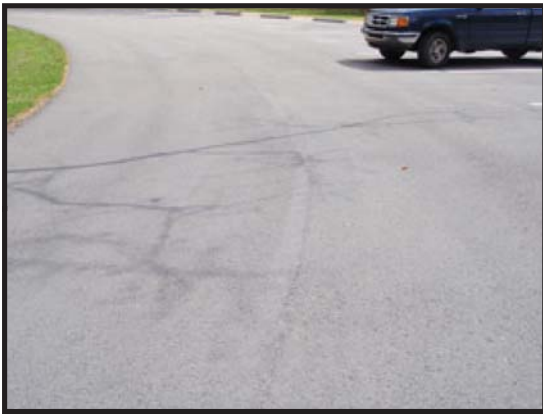
Route 0904

Route Number	Public / NonPublic	Date Visited		Area (sq ft)	Lane Miles *	Surface Type
0904	NONPUBLIC	4/16/2009		10,535	0.18	AS
Culverts	Drop Inlets	Gates	Fire Hydrants	Curb & Gutter	Curb	PCR
0	0	0	0	NO CURB AND GUTTER	NO CURB	GOOD/90

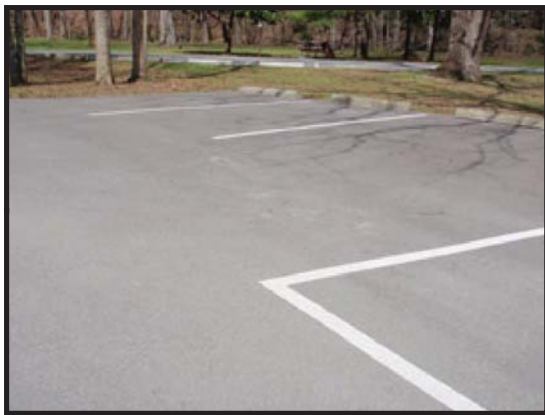
Rte 0905B

Route Number	Public / NonPublic	Date Visited		Area (sq ft)	Lane Miles *	Surface Type
0905B	PUBLIC	4/16/2009		9,680	0.17	AS
Culverts	Drop Inlets	Gates	Fire Hydrants	Curb & Gutter	Curb	PCR
0	0	0	0	NO CURB AND GUTTER	NO CURB	GOOD/90

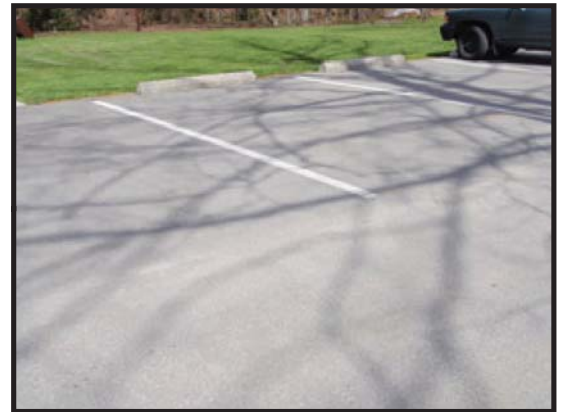
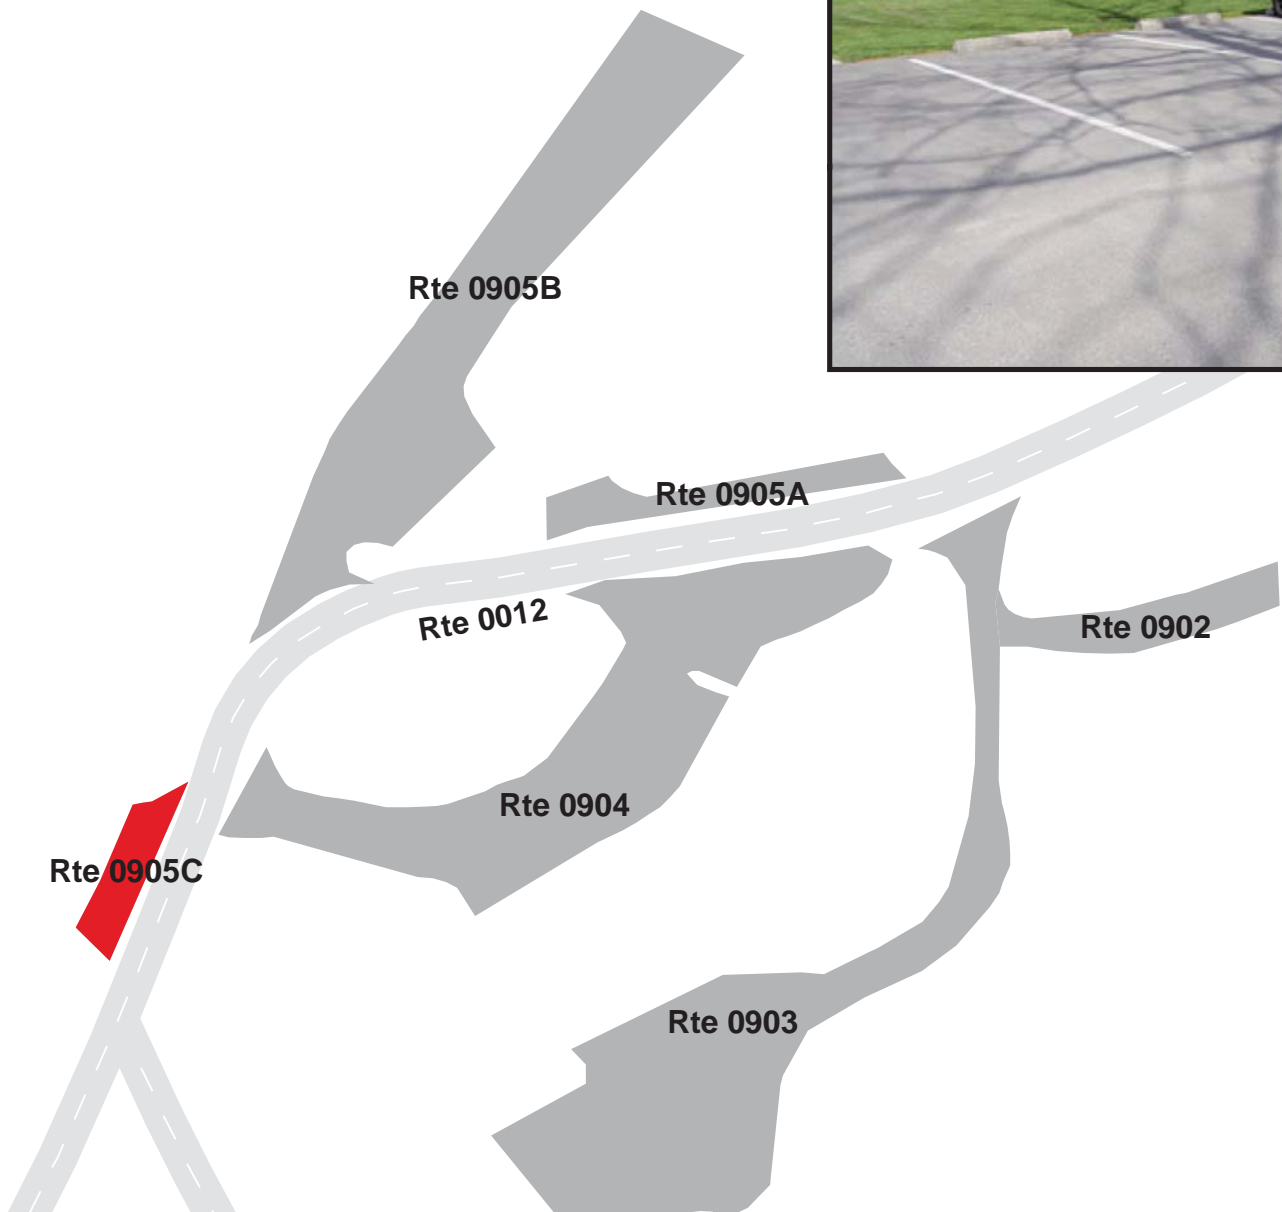
Route Number	Public / NonPublic	Date Visited		Area (sq ft)	Lane Miles *	Surface Type
0905C	PUBLIC	4/16/2009		1,031	0.02	AS
Culverts	Drop Inlets	Gates	Fire Hydrants	Curb & Gutter	Curb	PCR
0	0	0	0	NO CURB AND GUTTER	NO CURB	GOOD/90

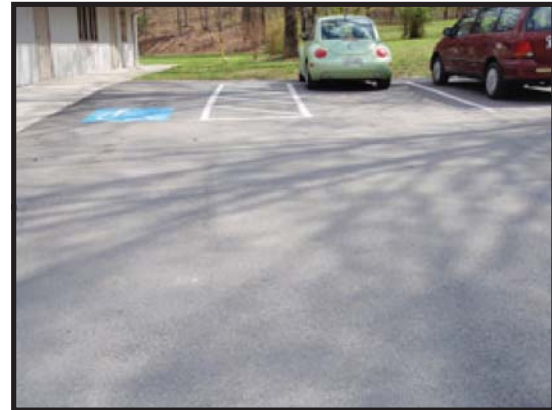
Route 0906

Route Number	Public / NonPublic	Date Visited		Area (sq ft)	Lane Miles *	Surface Type
0906	PUBLIC	4/16/2009		974	0.02	AS
Culverts	Drop Inlets	Gates	Fire Hydrants	Curb & Gutter	Curb	PCR
0	0	0	0	NO CURB AND GUTTER	NO CURB	GOOD/90

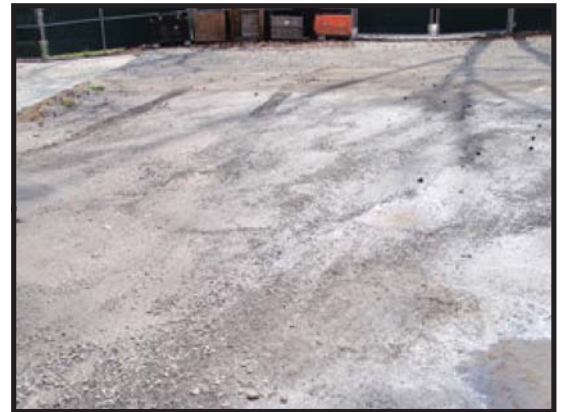
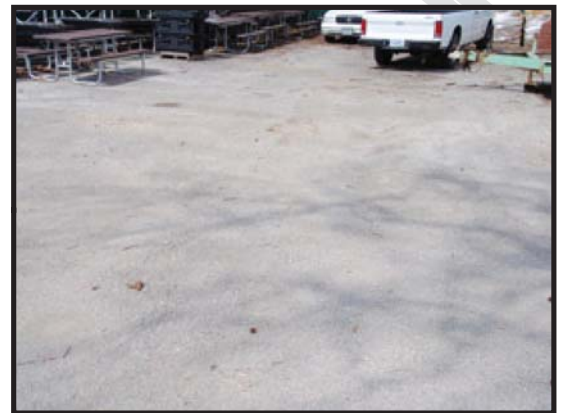
Route Number	Public / NonPublic	Date Visited		Area (sq ft)	Lane Miles *	Surface Type
0907B	NONPUBLIC	4/16/2009		11,910	0.21	AS
Culverts	Drop Inlets	Gates	Fire Hydrants	Curb & Gutter	Curb	PCR
0	0	2	0	NO CURB AND GUTTER	NO CURB	POOR/45
