**The Road Inventory
Of
Cumberland Gap National Historical Park
CUGA- 5230
Cycle 4**

**Prepared By:
Federal Highway Administration
Road Inventory Program
Cycle 4**

Cumberland Gap National Historical Park in Kentucky / Virginia / Tennessee

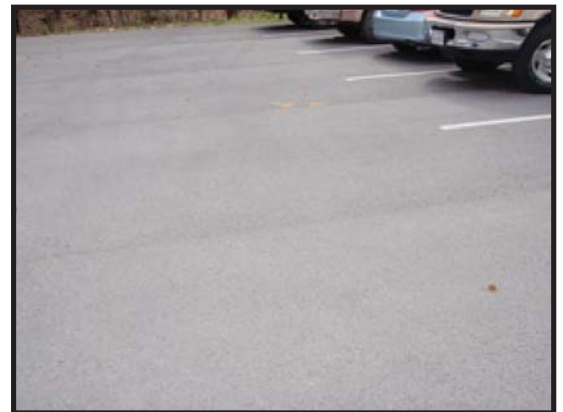
Route 0908A

Route Number	Public / NonPublic	Date Visited		Area (sq ft)	Lane Miles *	Surface Type
0908A	NONPUBLIC	4/16/2009		3,537	0.06	AS
Culverts	Drop Inlets	Gates	Fire Hydrants	Curb & Gutter	Curb	PCR
0	0	0	0	NO CURB AND GUTTER	NO CURB	GOOD/90

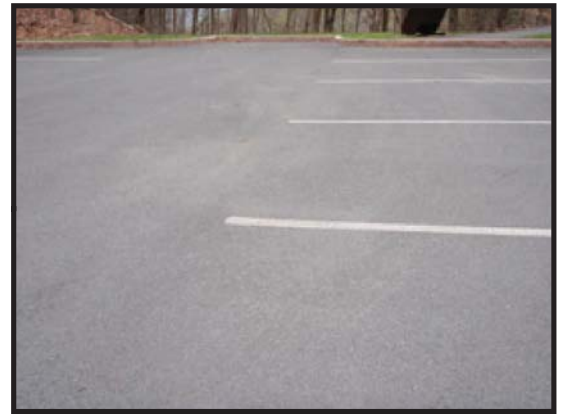
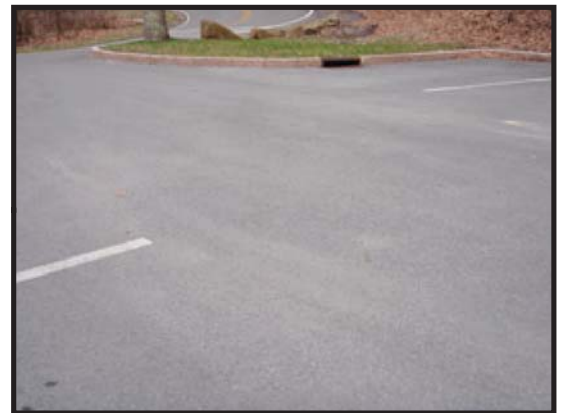
Route Number	Public / NonPublic	Date Visited		Area (sq ft)	Lane Miles *	Surface Type
0911	PUBLIC	4/15/2009		3,874	0.07	AS
Culverts	Drop Inlets	Gates	Fire Hydrants	Curb & Gutter	Curb	PCR
0	1	0	0	NO CURB AND GUTTER	STONE CURB	GOOD/90

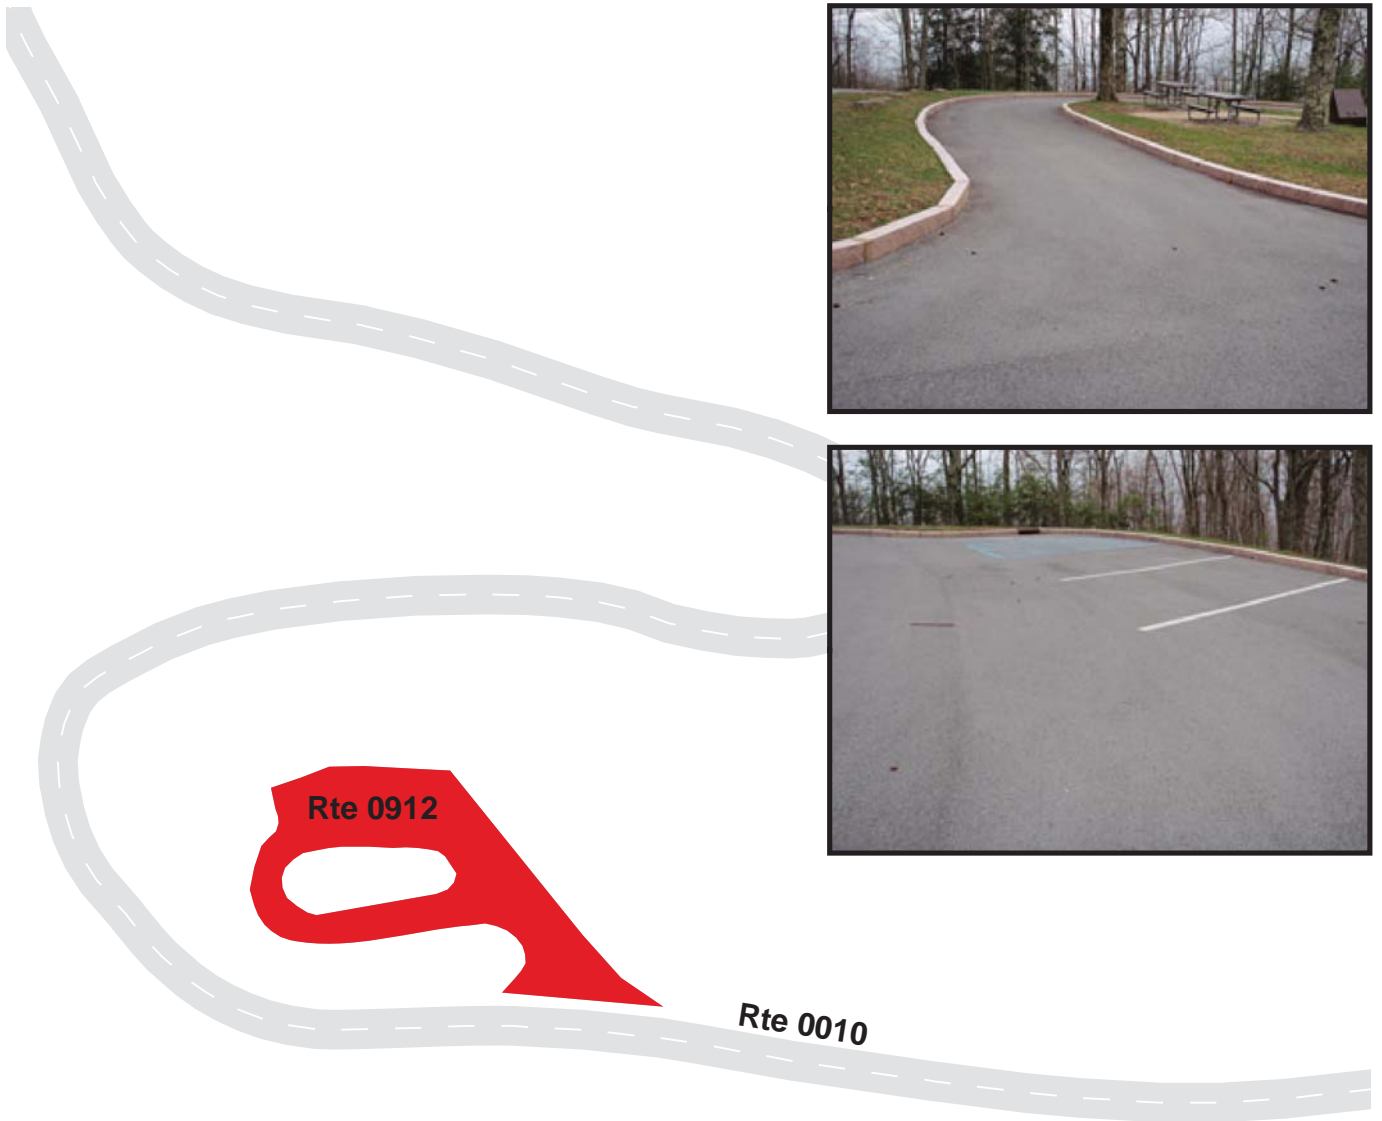
Route 0912

Route Number	Public / NonPublic	Date Visited		Area (sq ft)	Lane Miles *	Surface Type
0912	PUBLIC	4/15/2009		6,219	0.11	AS
Culverts	Drop Inlets	Gates	Fire Hydrants	Curb & Gutter	Curb	PCR
0	1	0	0	NO CURB AND GUTTER	CONCRETE CURB	GOOD/90

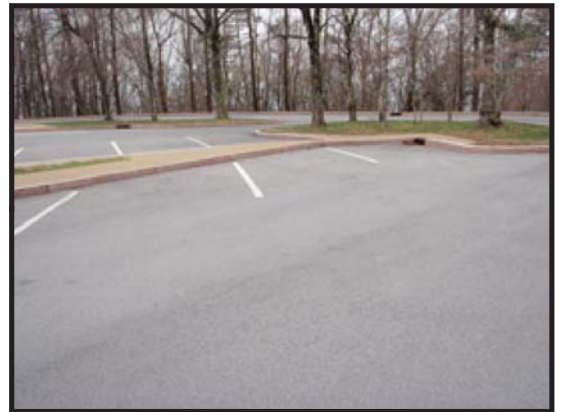
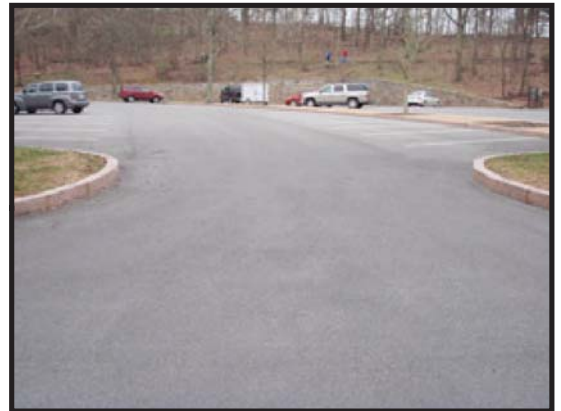
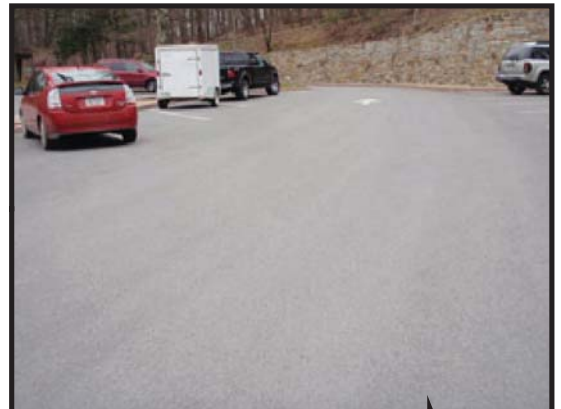
Route 0913

Route Number	Public / NonPublic	Date Visited		Area (sq ft)	Lane Miles *	Surface Type
0913	PUBLIC	4/15/2009		40,943	0.71	AS
Culverts	Drop Inlets	Gates	Fire Hydrants	Curb & Gutter	Curb	PCR
0	9	0	0	NO CURB AND GUTTER	STONE CURB	GOOD/90

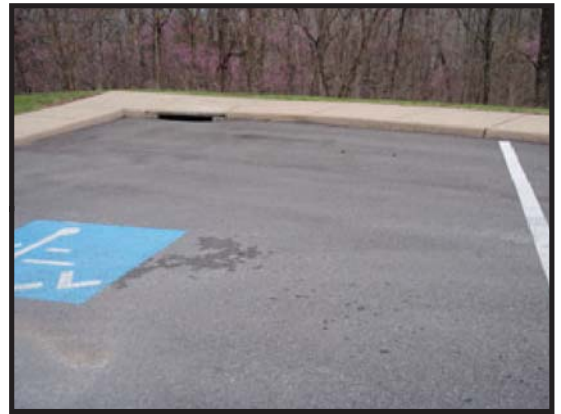
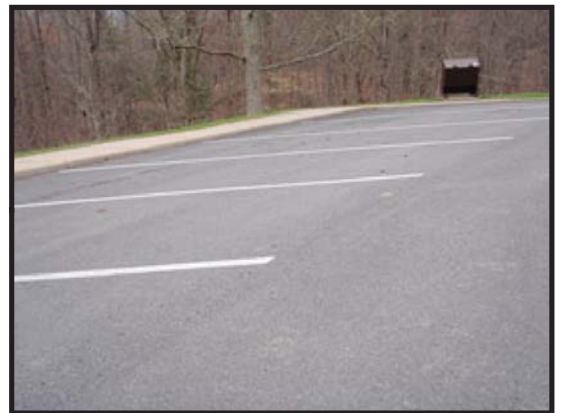
Route Number	Public / NonPublic	Date Visited		Area (sq ft)	Lane Miles *	Surface Type
0915	PUBLIC	4/15/2009		4,634	0.08	AS
Culverts	Drop Inlets	Gates	Fire Hydrants	Curb & Gutter	Curb	PCR
0	1	0	0	NO CURB AND GUTTER	CONCRETE CURB	GOOD/90

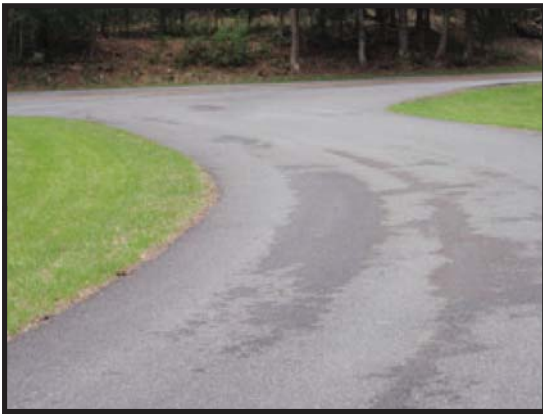
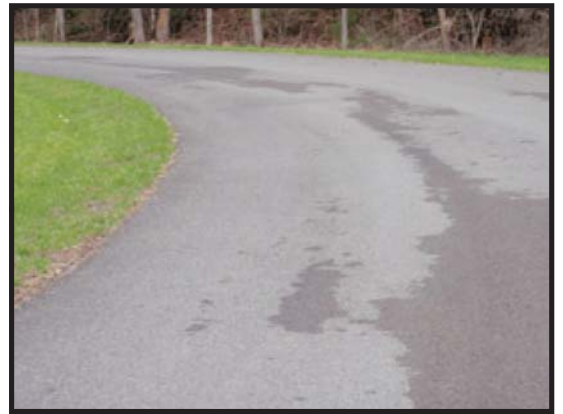
Route Number	Public / NonPublic	Date Visited		Area (sq ft)	Lane Miles *	Surface Type
0916	PUBLIC	4/15/2009		5,284	0.09	AS
Culverts	Drop Inlets	Gates	Fire Hydrants	Curb & Gutter	Curb	PCR
1	0	0	0	NO CURB AND GUTTER	NO CURB	GOOD/90

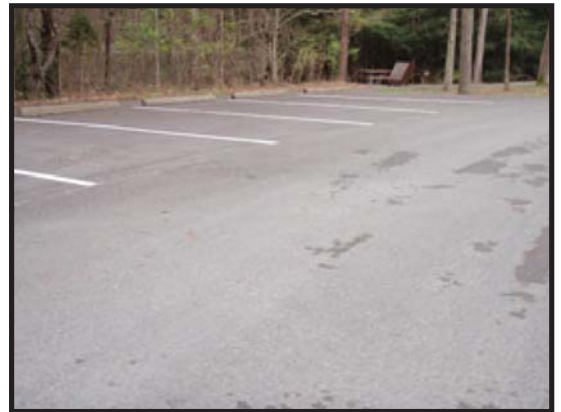
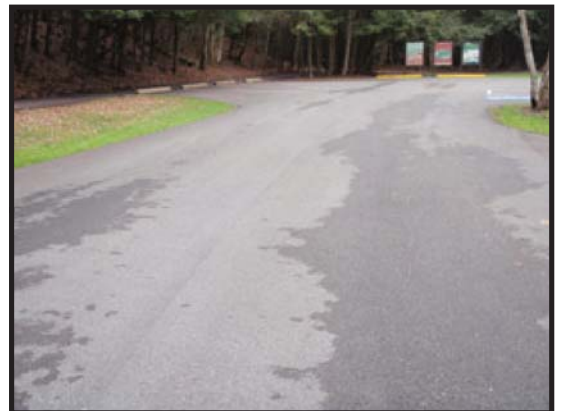
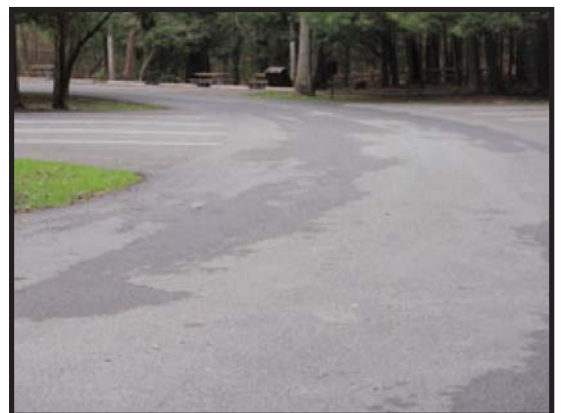
Route 0917

Route Number	Public / NonPublic	Date Visited		Area (sq ft)	Lane Miles *	Surface Type
0917	PUBLIC	4/15/2009		16,182	0.28	AS
Culverts	Drop Inlets	Gates	Fire Hydrants	Curb & Gutter	Curb	PCR
1	0	1	0	NO CURB AND GUTTER	NO CURB	GOOD/90

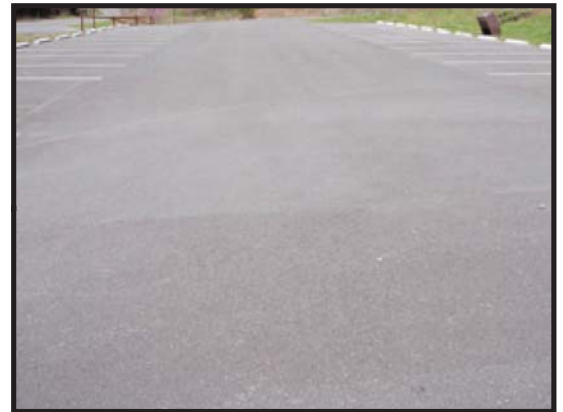
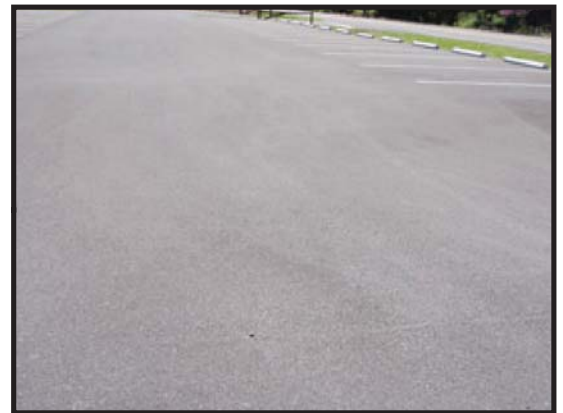
Route 0918A

Route Number	Public / NonPublic	Date Visited		Area (sq ft)	Lane Miles *	Surface Type
0918A	PUBLIC	4/16/2009		15,354	0.26	AS
Culverts	Drop Inlets	Gates	Fire Hydrants	Curb & Gutter	Curb	PCR
2	0	2	0	NO CURB AND GUTTER	NO CURB	EXCELLENT/97

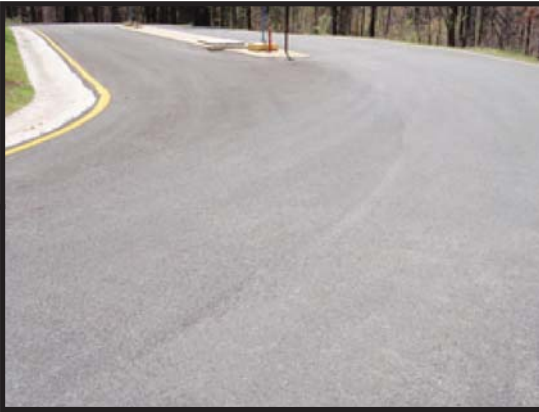
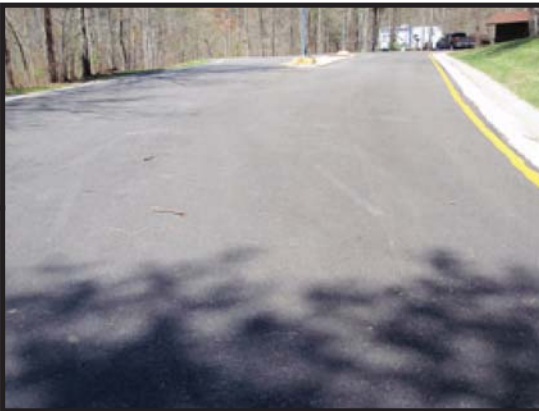
Route Number	Public / NonPublic	Date Visited		Area (sq ft)	Lane Miles *	Surface Type
0919	PUBLIC	4/16/2009		8,301	0.14	AS
Culverts	Drop Inlets	Gates	Fire Hydrants	Curb & Gutter	Curb	PCR
0	0	0	0	NO CURB AND GUTTER	NO CURB	GOOD/90

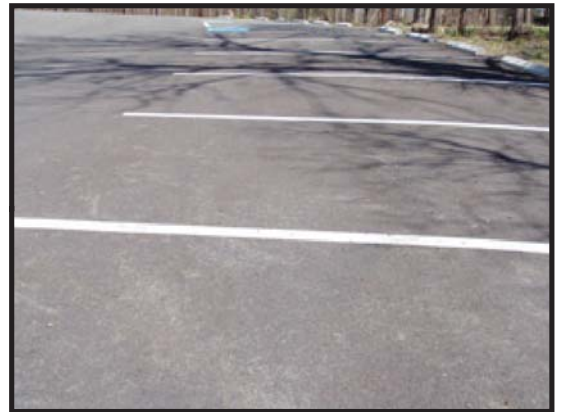
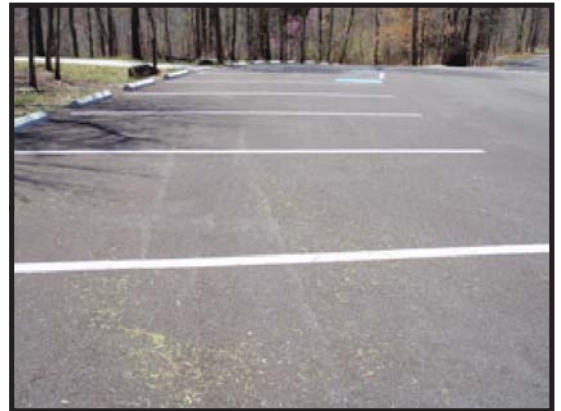
Route 0920

Route Number	Public / NonPublic	Date Visited		Area (sq ft)	Lane Miles *	Surface Type
0920	PUBLIC	4/16/2009		4,950	0.09	AS
Culverts	Drop Inlets	Gates	Fire Hydrants	Curb & Gutter	Curb	PCR
0	0	0	0	NO CURB AND GUTTER	NO CURB	EXCELLENT/97

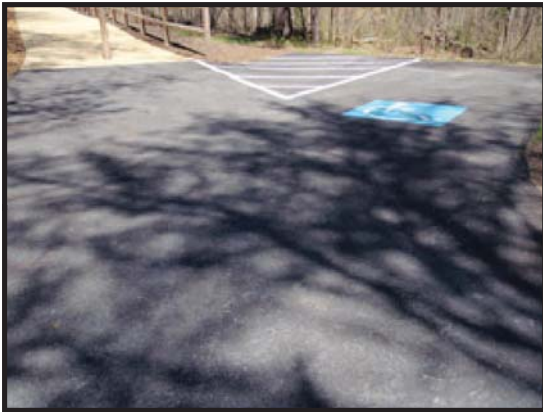
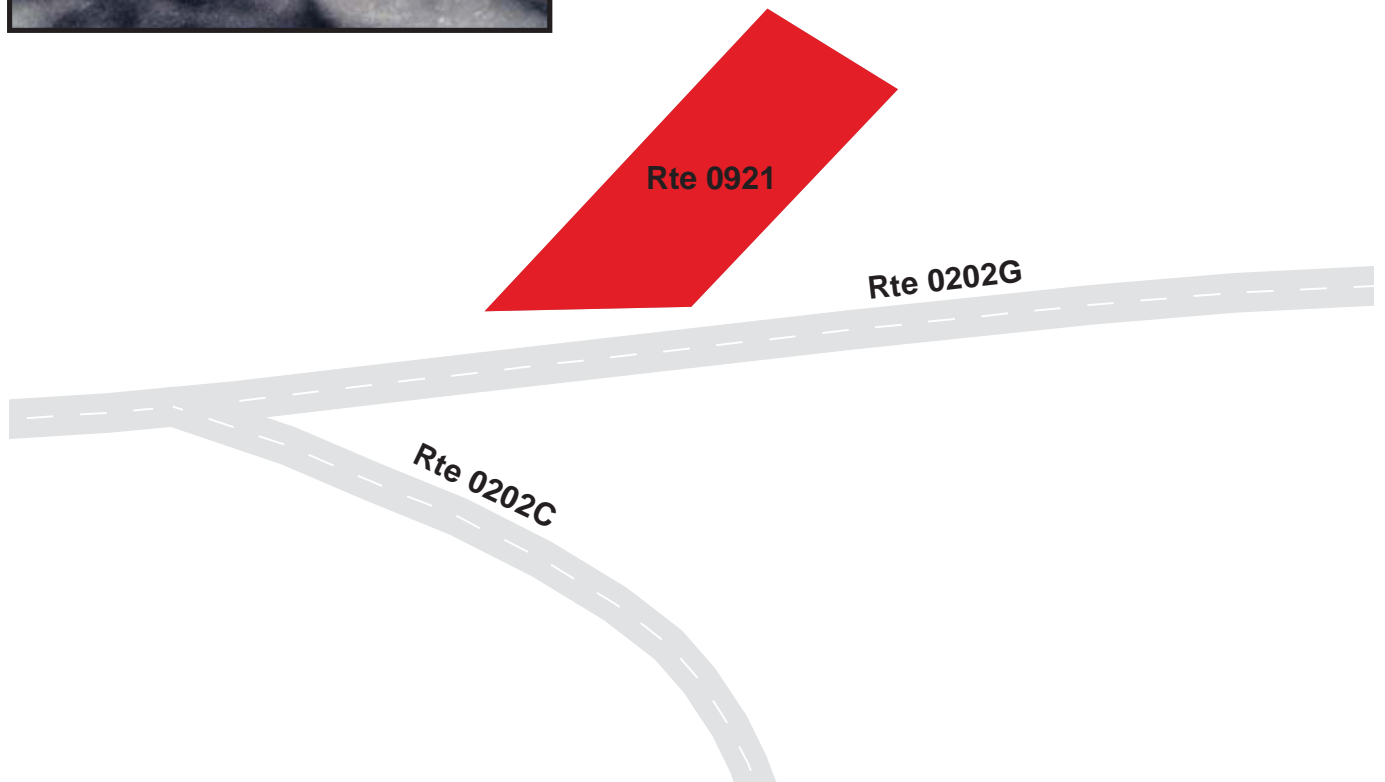
Route 0921

Route Number	Public / NonPublic	Date Visited		Area (sq ft)	Lane Miles *	Surface Type
0921	PUBLIC	4/16/2009		1,237	0.02	AS
Culverts	Drop Inlets	Gates	Fire Hydrants	Curb & Gutter	Curb	PCR
0	0	0	0	NO CURB AND GUTTER	NO CURB	EXCELLENT/97

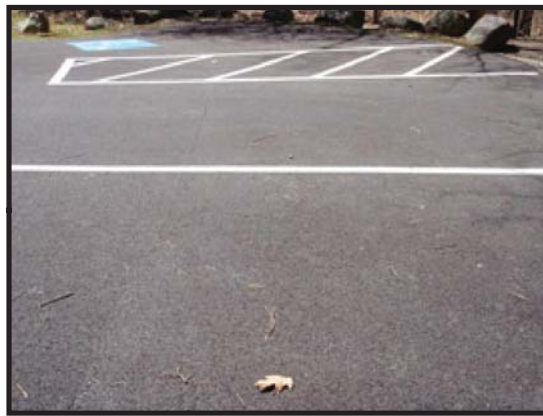
Route Number	Public / NonPublic	Date Visited		Area (sq ft)	Lane Miles *	Surface Type
0922B	PUBLIC	4/16/2009		2,113	0.04	AS
Culverts	Drop Inlets	Gates	Fire Hydrants	Curb & Gutter	Curb	PCR
1	0	0	0	NO CURB AND GUTTER	NO CURB	EXCELLENT/97

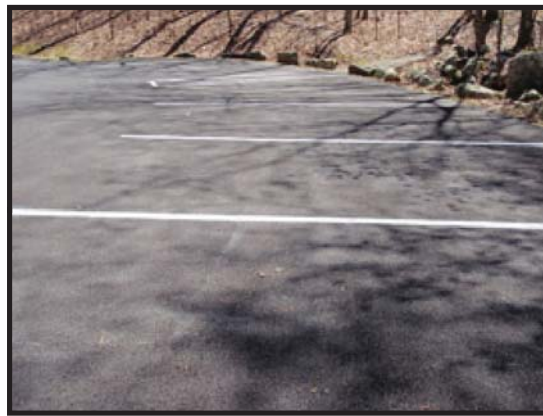
Route 0922C

Route Number	Public / NonPublic	Date Visited		Area (sq ft)	Lane Miles *	Surface Type
0922C	PUBLIC	4/16/2009		1,804	0.03	AS
Culverts	Drop Inlets	Gates	Fire Hydrants	Curb & Gutter	Curb	PCR
0	0	0	0	NO CURB AND GUTTER	NO CURB	EXCELLENT/97

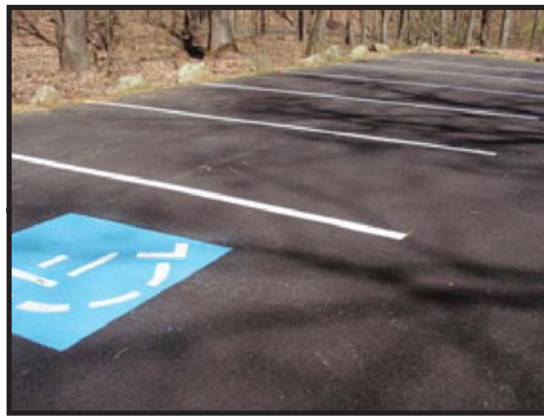
Route 0922D

Route Number	Public / NonPublic	Date Visited		Area (sq ft)	Lane Miles *	Surface Type
0922D	PUBLIC	4/16/2009		2,583	0.04	AS
Culverts	Drop Inlets	Gates	Fire Hydrants	Curb & Gutter	Curb	PCR
0	0	0	0	NO CURB AND GUTTER	NO CURB	EXCELLENT/97

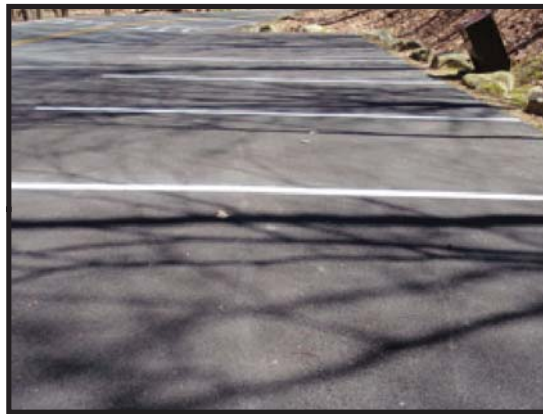
Route 0922E

Route Number	Public / NonPublic	Date Visited		Area (sq ft)	Lane Miles *	Surface Type
0922E	PUBLIC	4/16/2009		2,076	0.04	AS
Culverts	Drop Inlets	Gates	Fire Hydrants	Curb & Gutter	Curb	PCR
0	0	0	0	NO CURB AND GUTTER	NO CURB	EXCELLENT/97

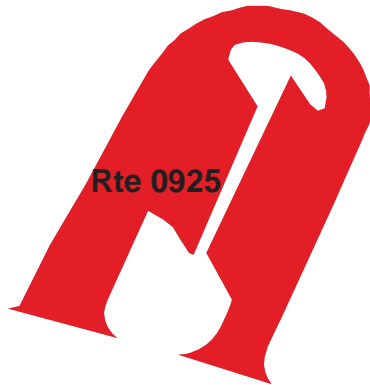
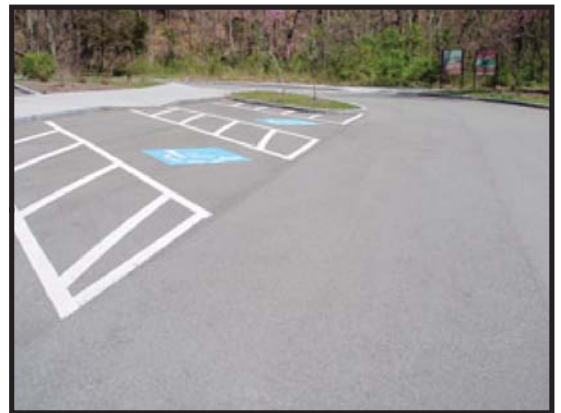
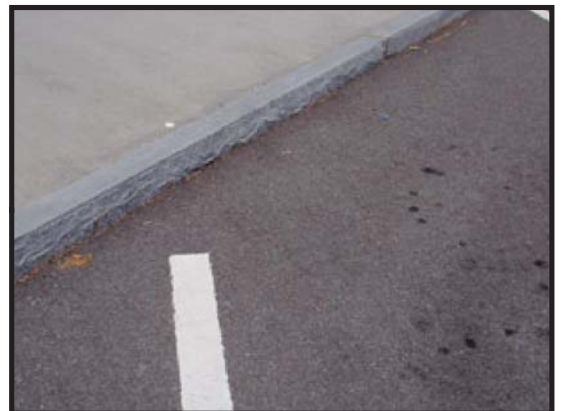
Route Number	Public / NonPublic	Date Visited		Area (sq ft)	Lane Miles *	Surface Type
0925	PUBLIC	4/16/2009		15,344	0.26	AS
Culverts	Drop Inlets	Gates	Fire Hydrants	Curb & Gutter	Curb	PCR
0	2	2	0	NO CURB AND GUTTER	STONE CURB	GOOD/90

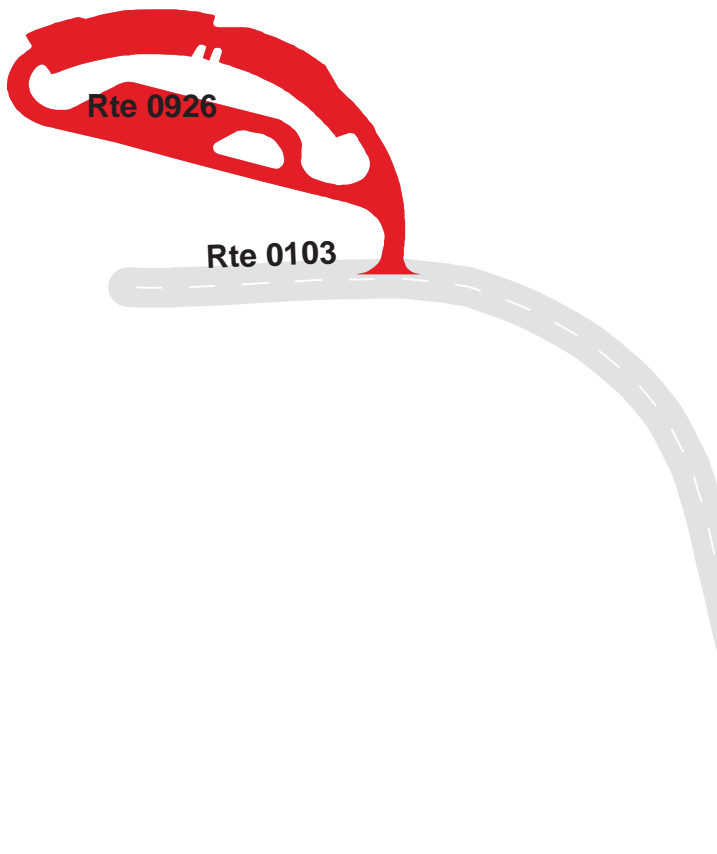
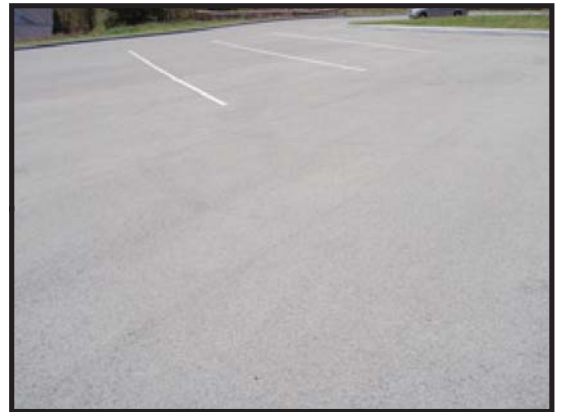
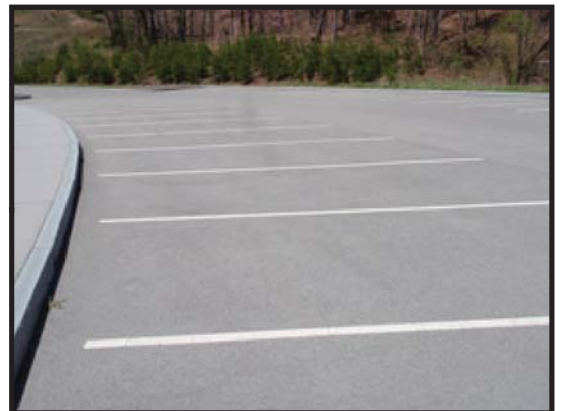
Route 0926

Route Number	Public / NonPublic	Date Visited		Area (sq ft)	Lane Miles *	Surface Type
0926	PUBLIC	4/16/2009		54,724	0.94	AS
Culverts	Drop Inlets	Gates	Fire Hydrants	Curb & Gutter	Curb	PCR
0	3	1	0	NO CURB AND GUTTER	STONE CURB	GOOD/90
