**The Road Inventory  
of  
Death Valley National Park  
DEVA – 8130  
Cycle 4**

**Prepared By:  
Federal Highway Administration  
Road Inventory Program  
Cycle 4**

# Death Valley National Park in California

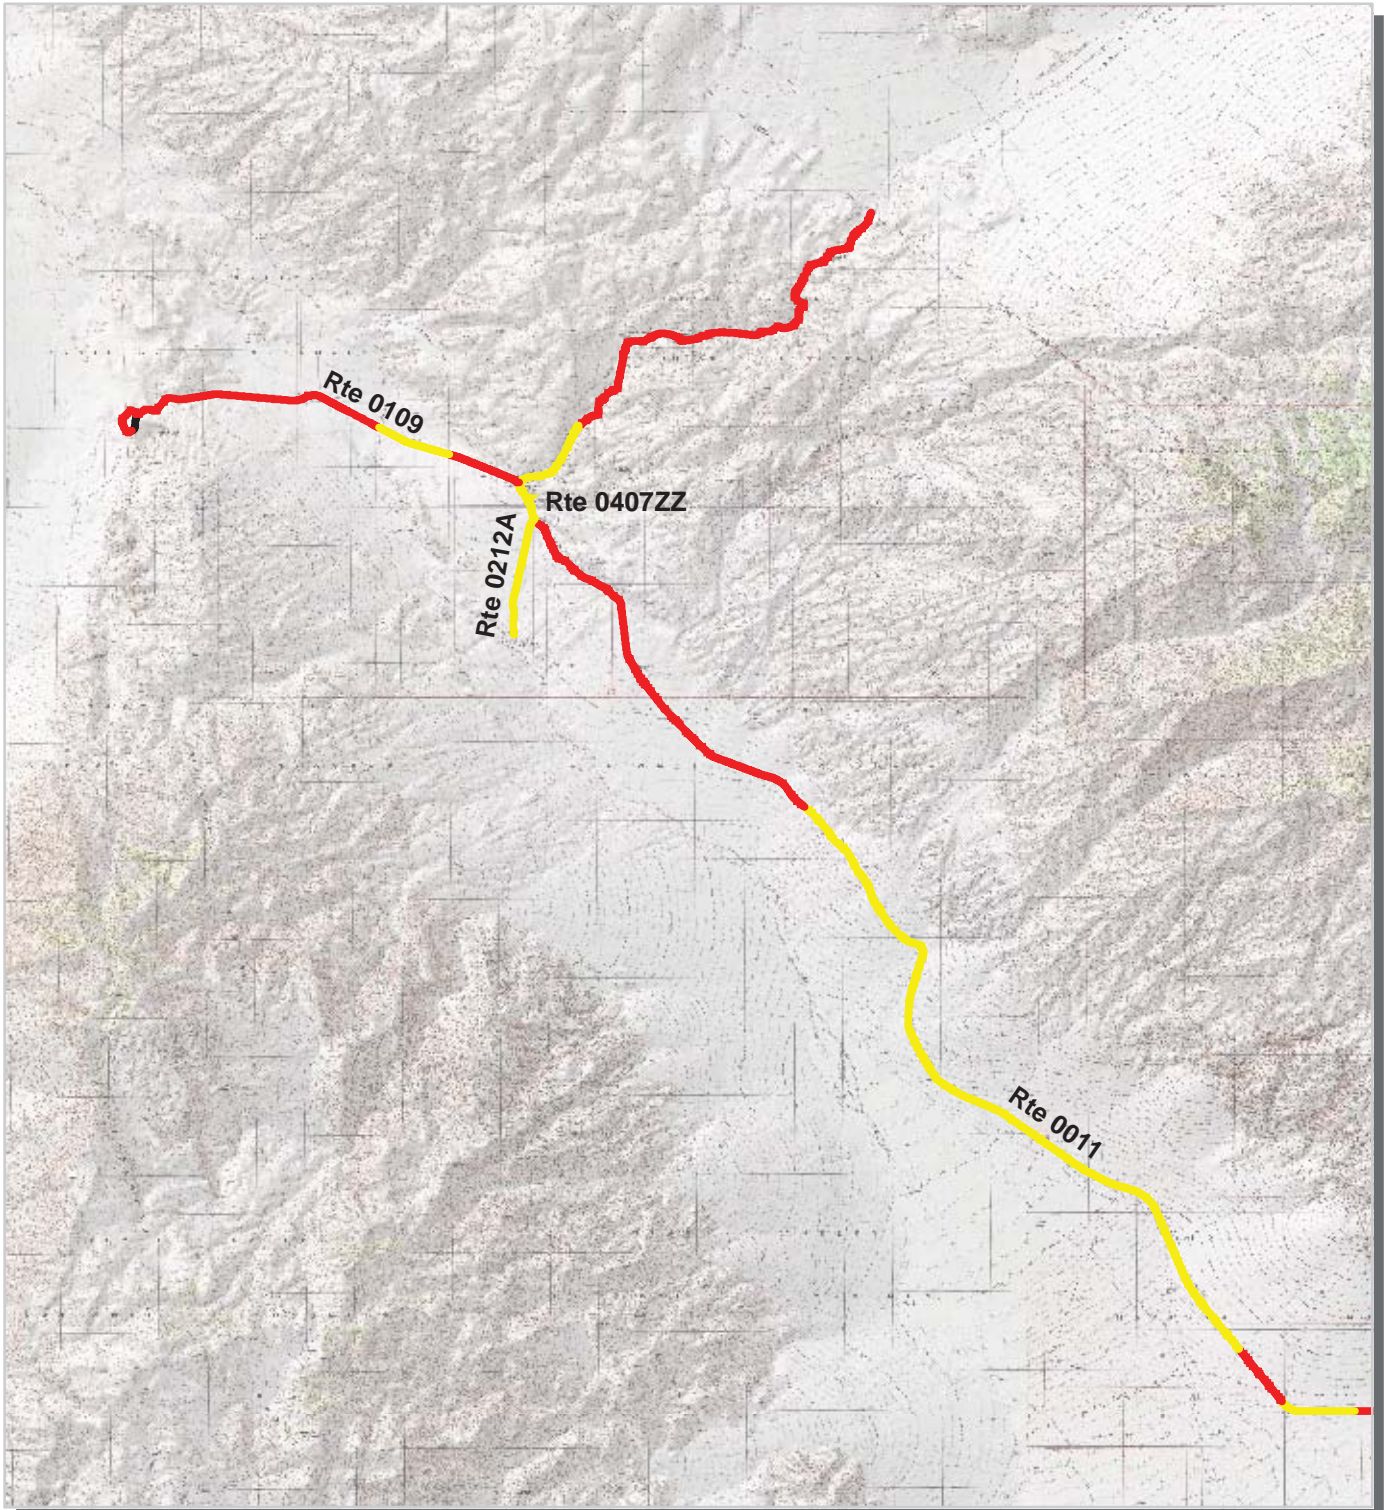
**Death Valley National Park  
Route Condition Map  
PCR - Mile by Mile  
Area 1**

PCR	Poor	Fair	Good	Excellent	No Data
	( $\leq 60$ )	(61 - 84)	(85 - 94)	(95 - 100)

\* If the PCR rating is not available for a section, the SCR rating will be displayed. See appendix for definitions and formulas.

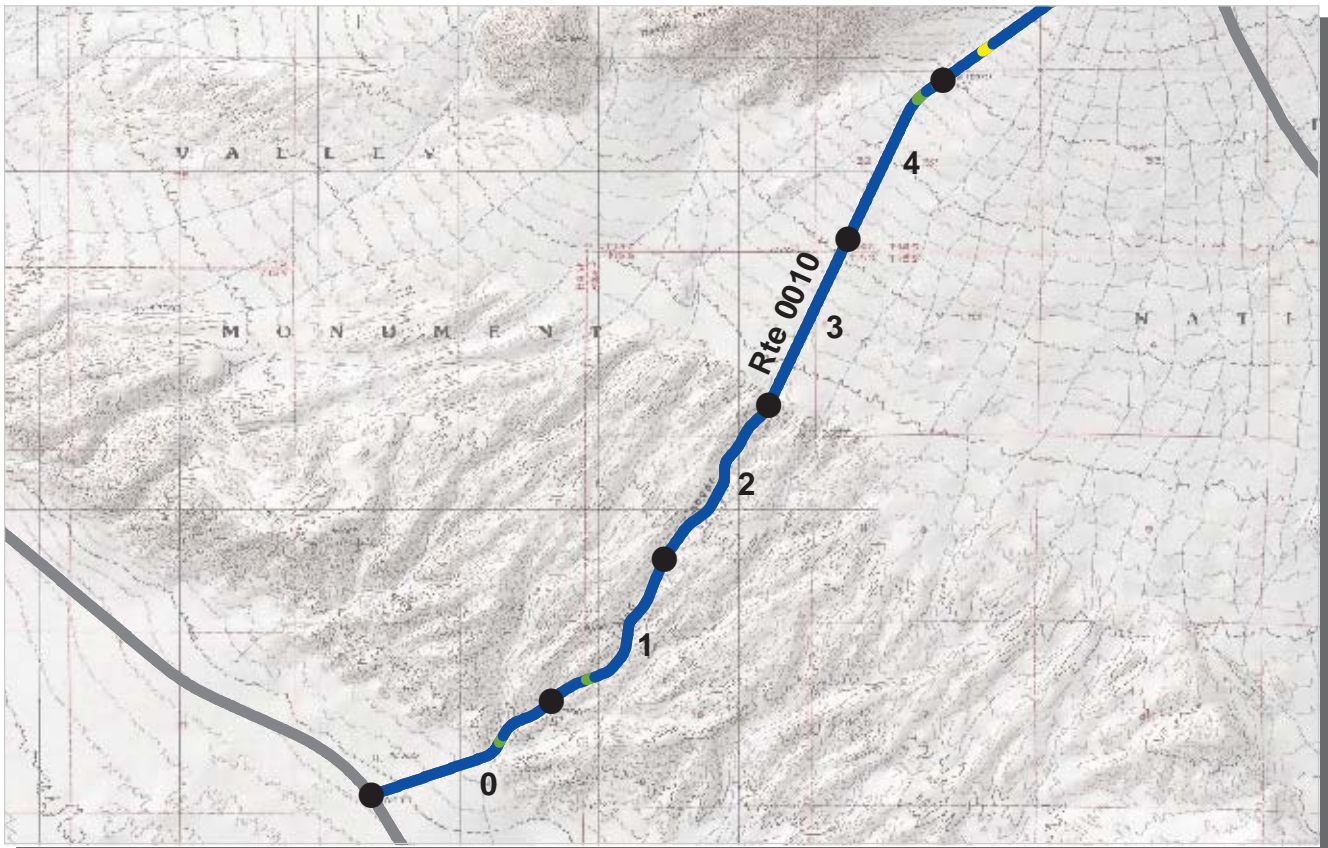
**ROUTE: 0010 DAYLIGHT PASS (MUD CANYON) ROAD**

<i>Section Number</i>	0	1	2	3	4
<i>Section Length (mi)</i>	1.00	1.00	1.00	1.00	1.00
<i>Traffic</i>	Traffic data may be found at <a href="http://www.efl.fhwa.dot.gov">www.efl.fhwa.dot.gov</a> Click on PROGRAMS / NPS Traffic Data (Note: Not all parks have traffic data)				
<i>Cross Section Information</i>					
Number of Lanes	1	2	2	2	2
Paved Width (ft)	13	25	28	26	25
Lane Width (ft)	10	10	10	10	10
Shoulder Width Right (ft)**	0	0	0	0	0
Shoulder Width Left (ft)**	0	0	0	0	0
<i>Roadway Condition Information</i>					
SCR (Surface Condition Rating)	96	96	98	98	96
PCR (Pavement Condition Rating)	97	98	99	99	97
<i>Distress Index Values</i>					
Alligator Cracking Index	100	100	100	100	100
Longitudinal Cracking Index	100	100	100	100	100
Transverse Cracking Index	100	100	100	100	100
Patching Index	100	100	100	100	100
Rutting Index	96	96	98	98	96
Roughness Condition Index (RCI)	100	100	100	100	100

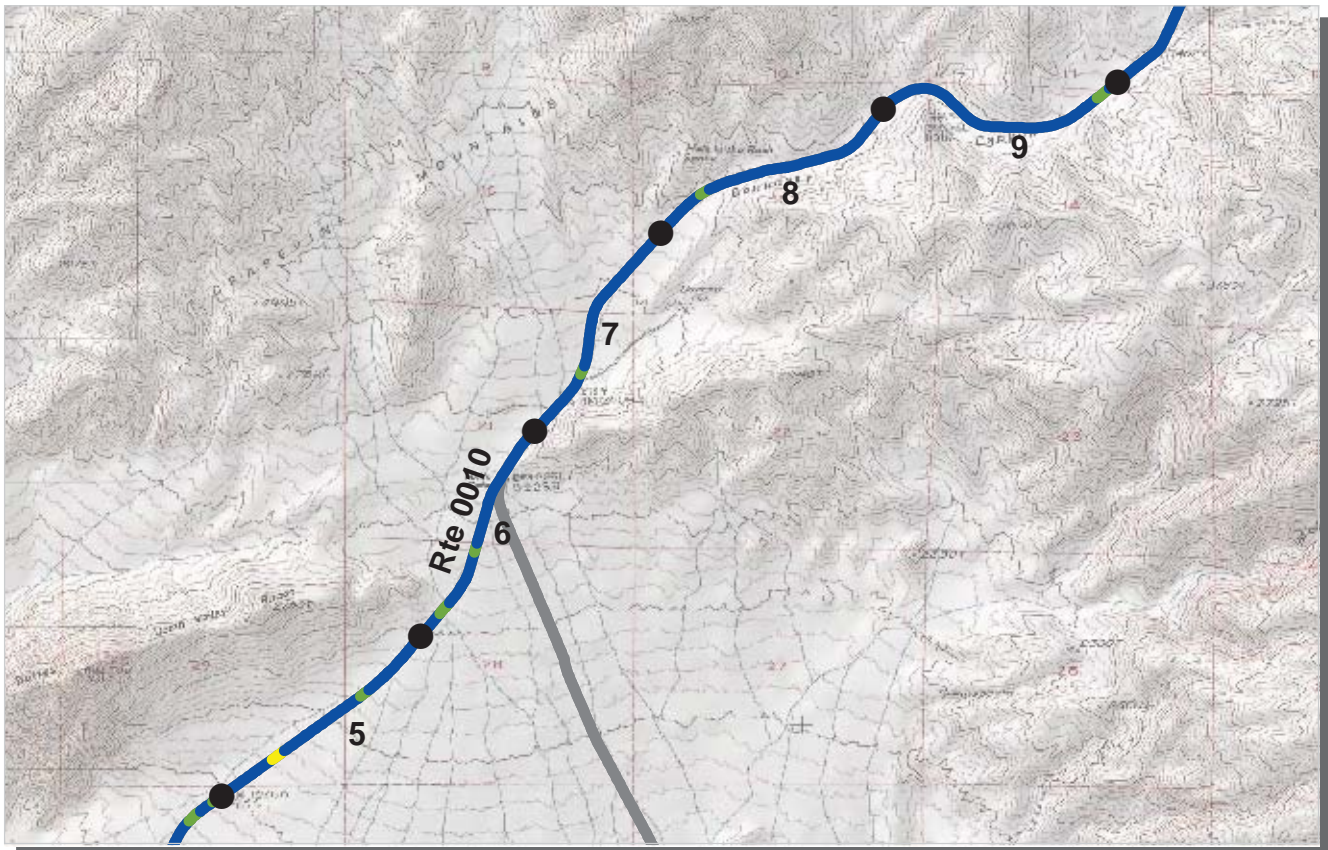
**ROUTE: 0010 DAYLIGHT PASS (MUD CANYON) ROAD**

Section Number	5	6	7	8	9
Section Length (mi)	1.00	1.00	1.00	1.00	1.00
<b>Traffic</b>	Traffic data may be found at <a href="http://www.efl.fhwa.dot.gov">www.efl.fhwa.dot.gov</a> Click on PROGRAMS / NPS Traffic Data (Note: Not all parks have traffic data)				
<b>Cross Section Information</b>					
Number of Lanes	2	2	2	2	2
Paved Width (ft)	24	24	25	24	26
Lane Width (ft)	10	11	11	10	10
Shoulder Width Right (ft)**	0	0	0	0	0
Shoulder Width Left (ft)**	0	0	0	0	0
<b>Roadway Condition Information</b>					
SCR (Surface Condition Rating)	96	95	96	97	96
PCR (Pavement Condition Rating)	97	97	97	98	97
<b>Distress Index Values</b>					
Alligator Cracking Index	100	100	100	100	100
Longitudinal Cracking Index	100	100	100	100	100
Transverse Cracking Index	100	100	100	100	100
Patching Index	100	100	100	100	100
Rutting Index	96	95	96	97	97
Roughness Condition Index (RCI)	100	99	100	100	100

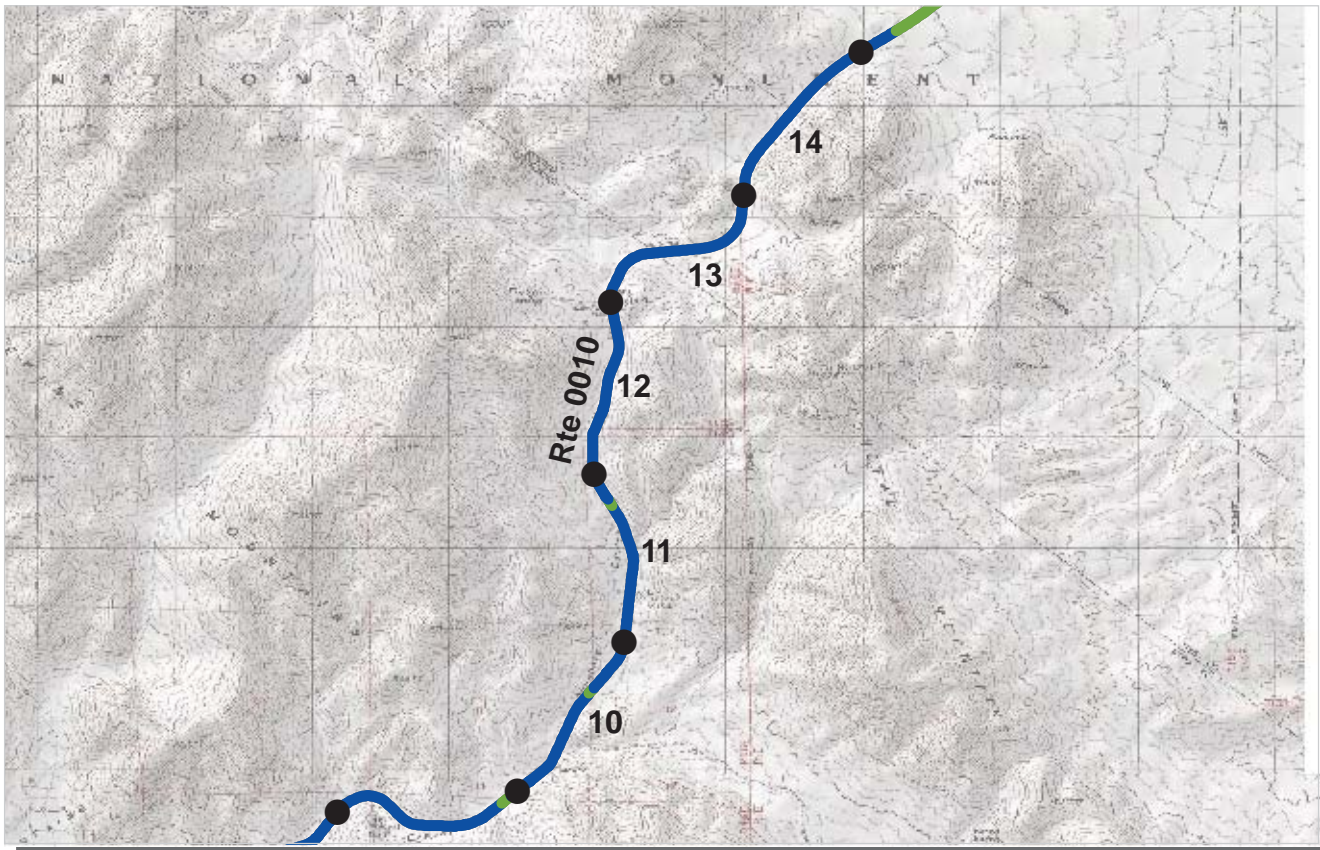
**ROUTE: 0010 DAYLIGHT PASS (MUD CANYON) ROAD**

<i>Section Number</i>	10	11	12	13	14
<i>Section Length (mi)</i>	1.00	1.00	1.00	1.00	1.00
<i>Traffic</i>	Traffic data may be found at <a href="http://www.efl.fhwa.dot.gov">www.efl.fhwa.dot.gov</a> Click on PROGRAMS / NPS Traffic Data (Note: Not all parks have traffic data)				
<i>Cross Section Information</i>					
Number of Lanes	2	2	2	2	2
Paved Width (ft)	25	24	24	28	24
Lane Width (ft)	10	10	10	10	10
Shoulder Width Right (ft)**	0	0	0	0	0
Shoulder Width Left (ft)**	0	0	0	0	0
<i>Roadway Condition Information</i>					
SCR (Surface Condition Rating)	99	99	99	99	100
PCR (Pavement Condition Rating)	99	99	99	99	100
<i>Distress Index Values</i>					
Alligator Cracking Index	100	100	100	100	100
Longitudinal Cracking Index	100	100	100	100	100
Transverse Cracking Index	100	100	100	100	100
Patching Index	100	100	100	100	100
Rutting Index	99	99	99	99	100
Roughness Condition Index (RCI)	100	100	100	99	100

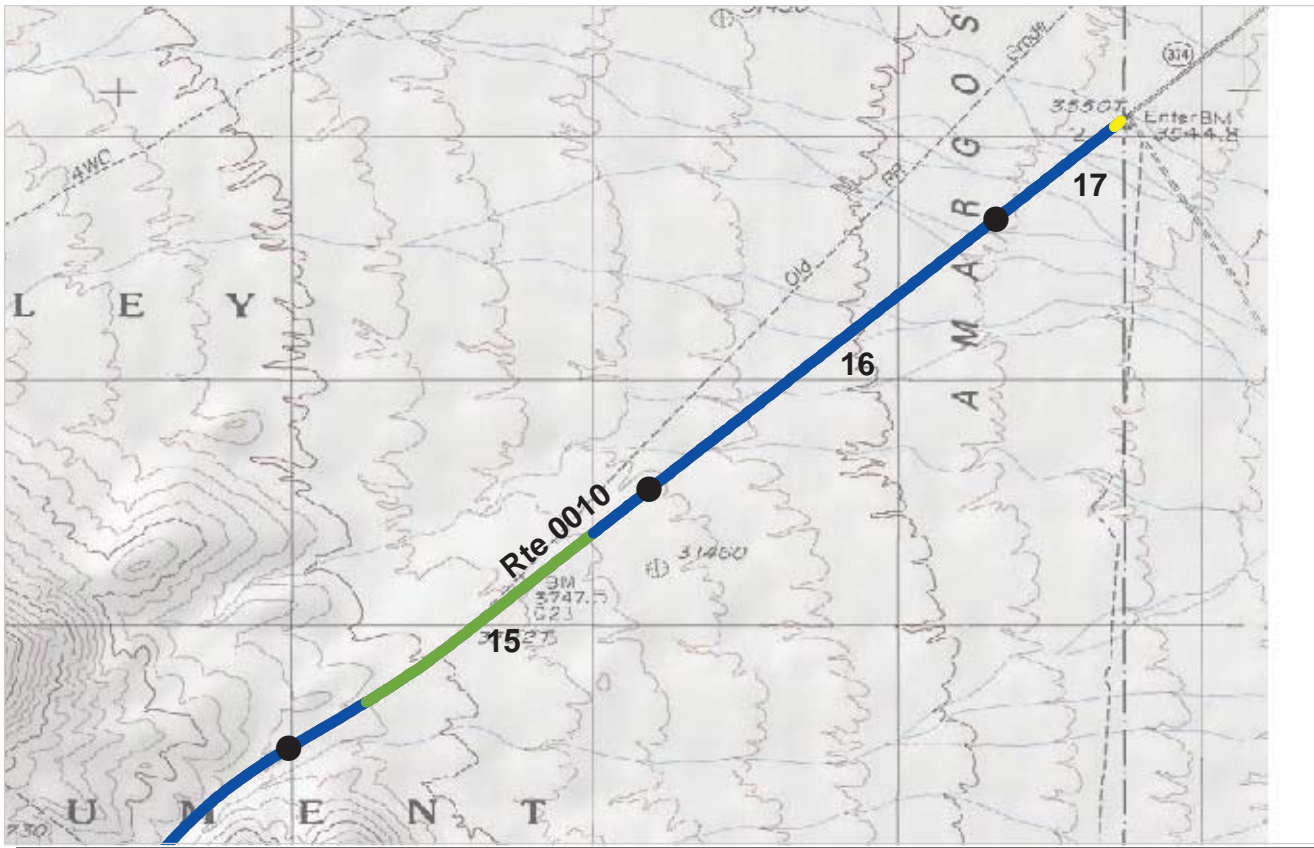
**ROUTE: 0010 DAYLIGHT PASS (MUD CANYON) ROAD**

Section Number	15	16	17		
Section Length (mi)	1.00	1.00	0.36		
<b>Traffic</b>	Traffic data may be found at <a href="http://www.efl.fhwa.dot.gov">www.efl.fhwa.dot.gov</a> Click on PROGRAMS / NPS Traffic Data (Note: Not all parks have traffic data)				
<b>Cross Section Information</b>					
Number of Lanes	2	2	2		
Paved Width (ft)	24	24	25		
Lane Width (ft)	10	10	10		
Shoulder Width Right (ft)**	0	0	0		
Shoulder Width Left (ft)**	0	0	0		
<b>Roadway Condition Information</b>					
SCR (Surface Condition Rating)	91	99	98		
PCR (Pavement Condition Rating)	94	99	97		
<b>Distress Index Values</b>					
Alligator Cracking Index	100	100	100		
Longitudinal Cracking Index	93	100	100		
Transverse Cracking Index	100	100	100		
Patching Index	100	100	100		
Rutting Index	98	99	98		
Roughness Condition Index (RCI)	100	99	96

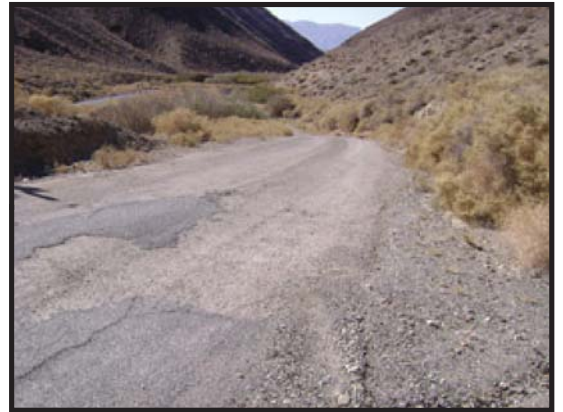
Route Number	Public / NonPublic	Date Visited		Area (sq ft)	Lane Miles *	Surface Type
0116	PUBLIC	11/3/2007		5,551	0.10	AS
Culverts	Drop Inlets	Gates	Fire Hydrants	Curb & Gutter	Curb	PCR
0	0	0	0	NO CURB AND GUTTER	NO CURB	POOR/45

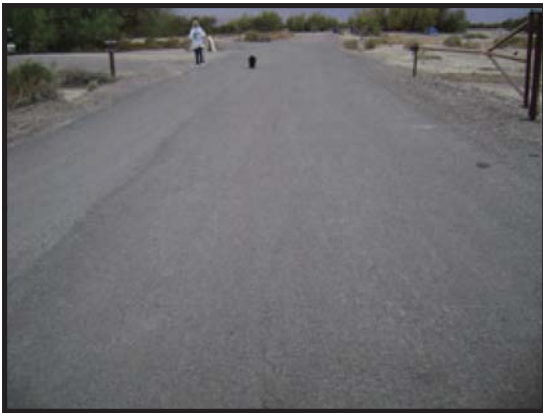
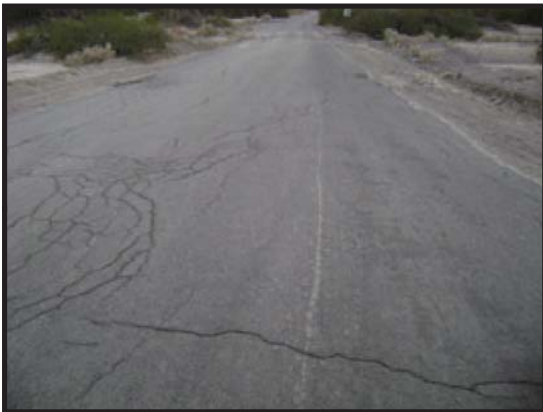
## Route 0201

Route Number	Public / NonPublic	Date Visited		Area (sq ft)	Lane Miles *	Surface Type
0201	PUBLIC	11/4/2007		153,629	2.65	AS
Culverts	Drop Inlets	Gates	Fire Hydrants	Curb & Gutter	Curb	PCR
0	0	1	1	NO CURB AND GUTTER	NO CURB	POOR/45

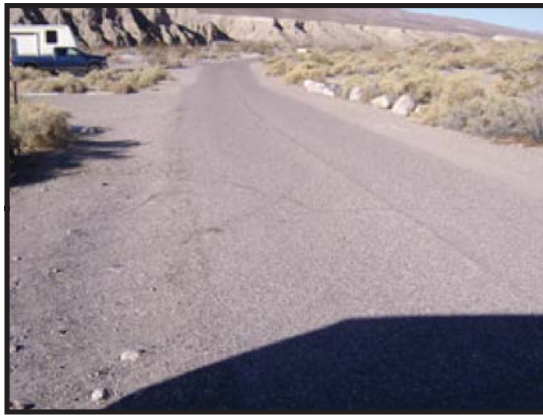
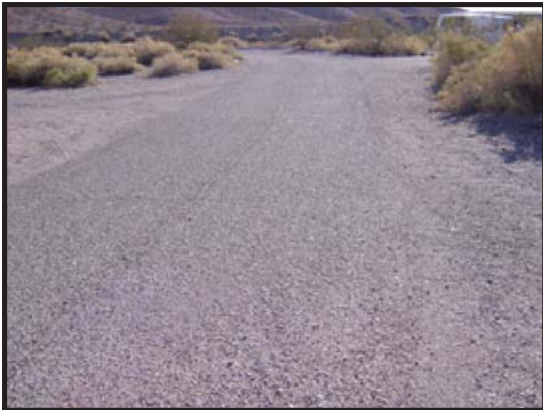
## Route 0212B

Route Number	Public / NonPublic	Date Visited		Area (sq ft)	Lane Miles *	Surface Type
0212B	PUBLIC	11/3/2007		74,351	1.28	AS
Culverts	Drop Inlets	Gates	Fire Hydrants	Curb & Gutter	Curb	PCR
0	0	0	0	NO CURB AND GUTTER	NO CURB	FAIR/73

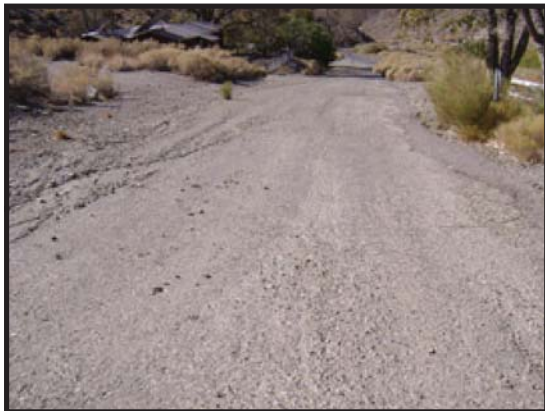
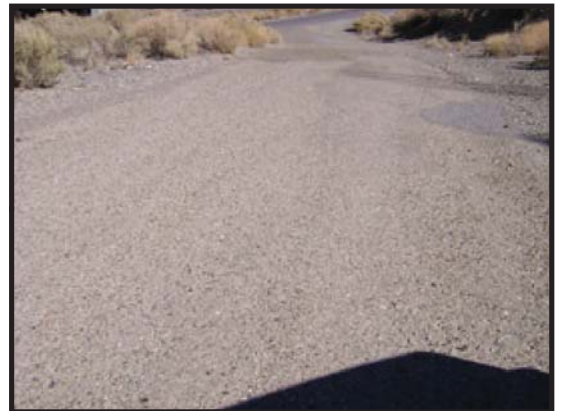
## Route 0412

Route Number	Public / NonPublic	Date Visited		Area (sq ft)	Lane Miles *	Surface Type
0412	NONPUBLIC	11/3/2007		9,132	0.16	AS
Culverts	Drop Inlets	Gates	Fire Hydrants	Curb & Gutter	Curb	PCR
0	0	0	2	NO CURB AND GUTTER	NO CURB	POOR/45

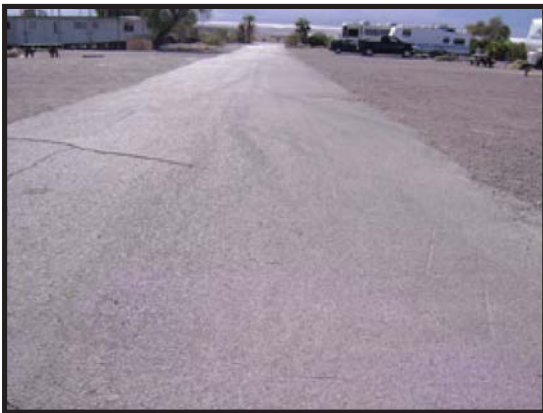
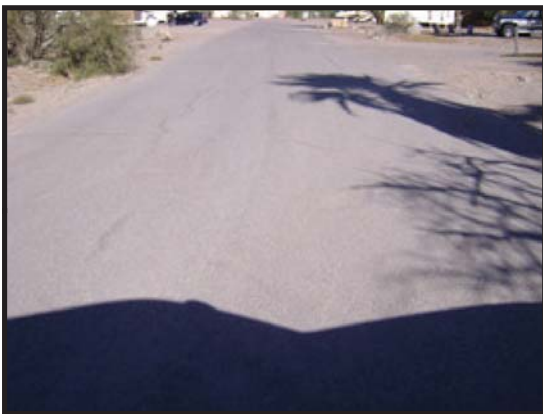
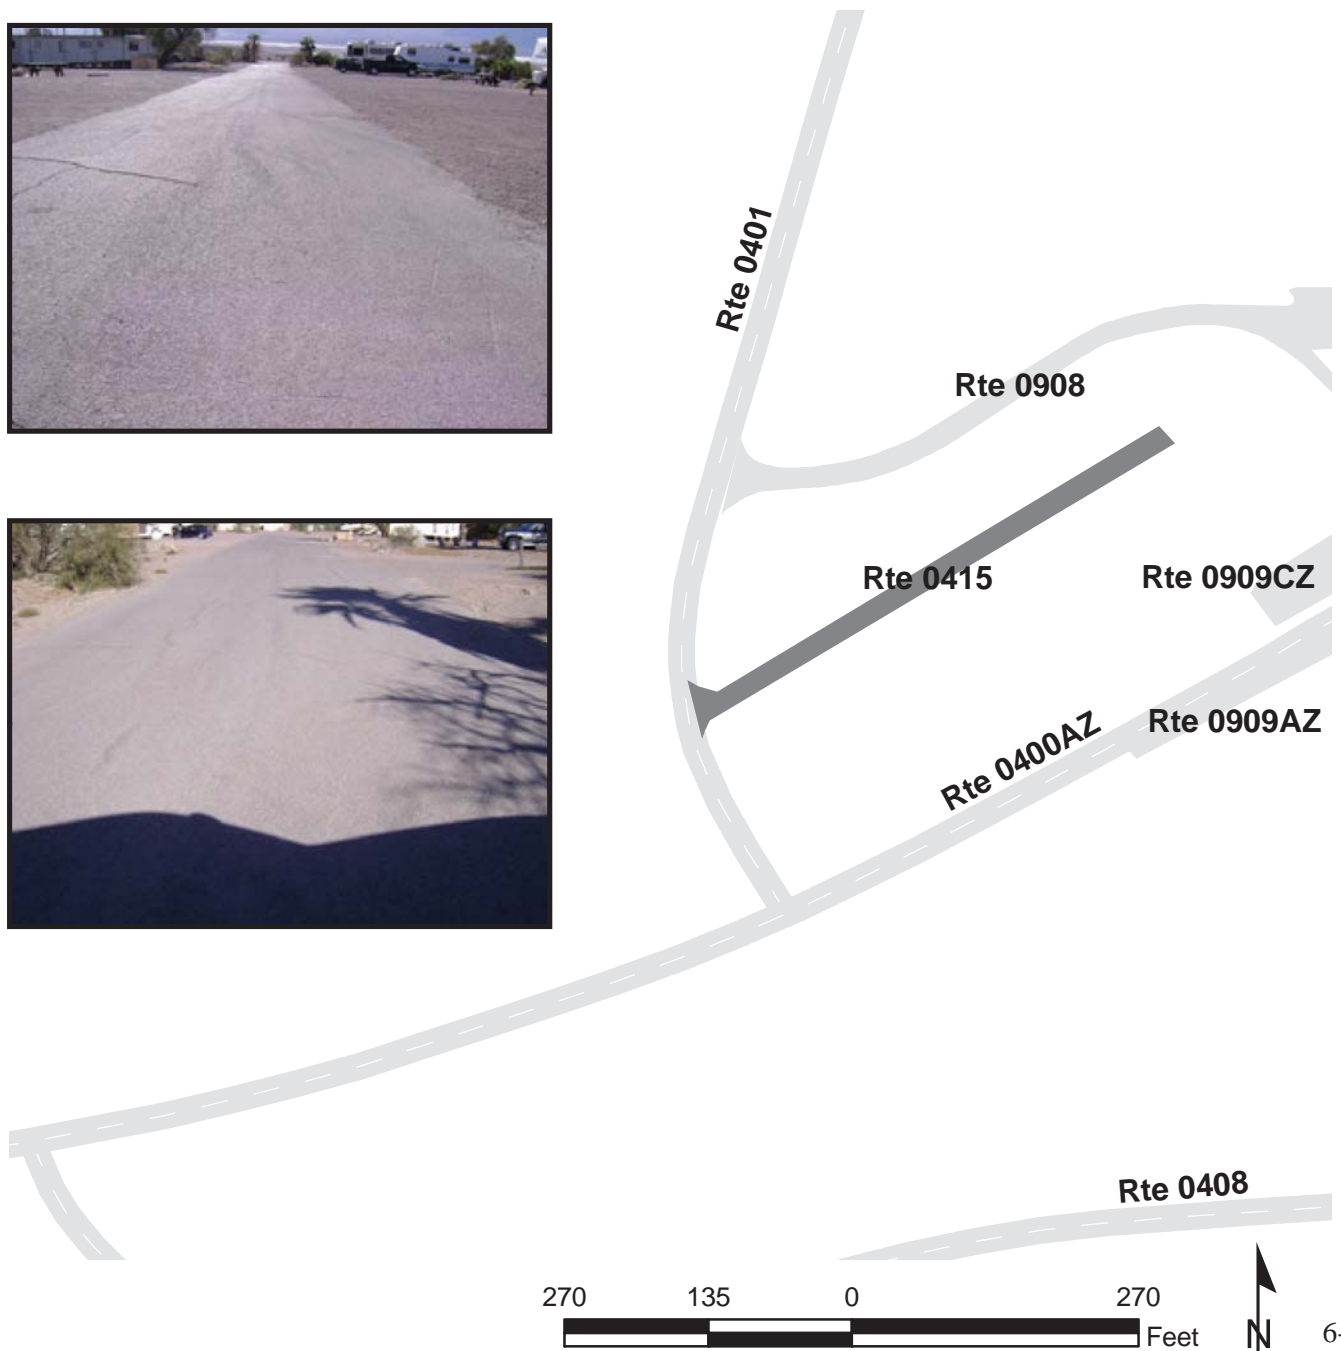
Route Number	Public / NonPublic	Date Visited		Area (sq ft)	Lane Miles *	Surface Type
0415	NONPUBLIC	11/5/2007		8,758	0.15	AS
Culverts	Drop Inlets	Gates	Fire Hydrants	Curb & Gutter	Curb	PCR
0	0	0	0	NO CURB AND GUTTER	NO CURB	FAIR/73

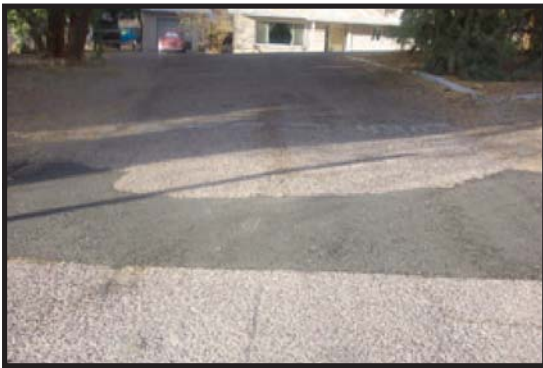
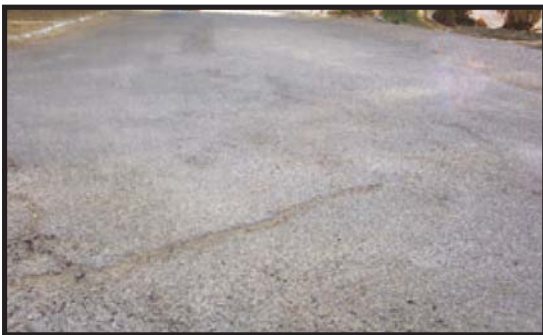
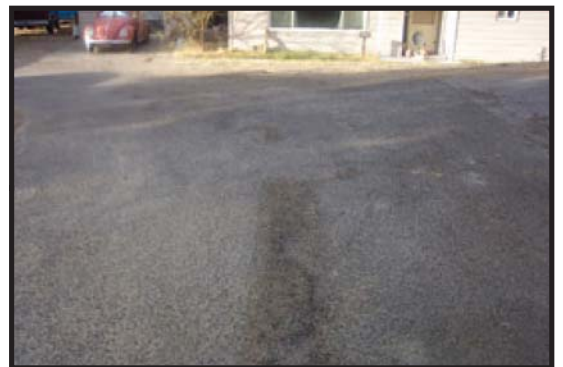
## Route 0506

Route Number	Public / NonPublic	Date Visited		Area (sq ft)	Lane Miles *	Surface Type
0506	PUBLIC	1/24/2008		1,200	0.02	AS
Culverts	Drop Inlets	Gates	Fire Hydrants	Curb & Gutter	Curb	PCR
1	0	0	0	NO CURB AND GUTTER	NO CURB	FAIR/73

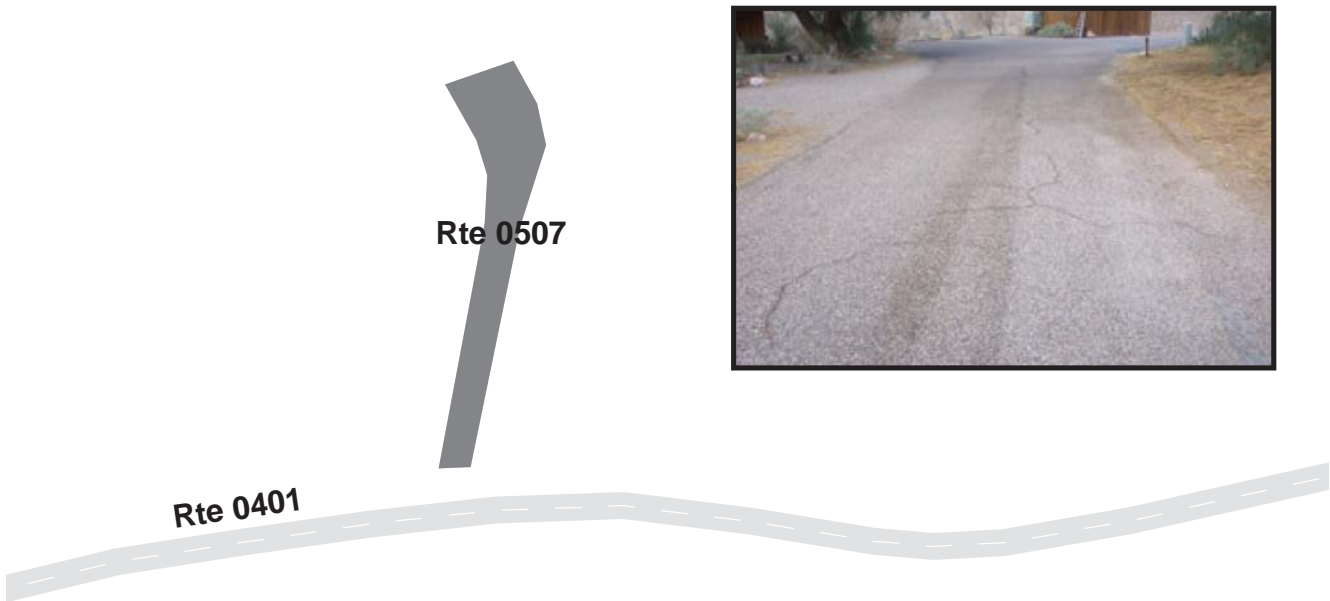
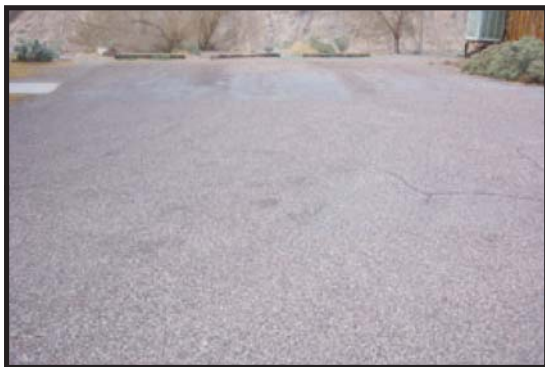
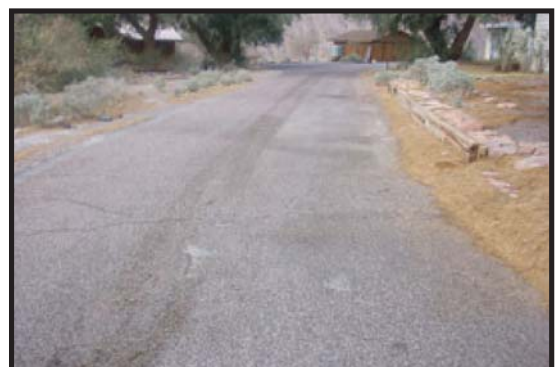
## Route 0507

Route Number	Public / NonPublic	Date Visited		Area (sq ft)	Lane Miles *	Surface Type
0507	PUBLIC	1/24/2008		3,578	0.06	AS
Culverts	Drop Inlets	Gates	Fire Hydrants	Curb & Gutter	Curb	PCR
0	0	0	0	NO CURB AND GUTTER	NO CURB	FAIR/73

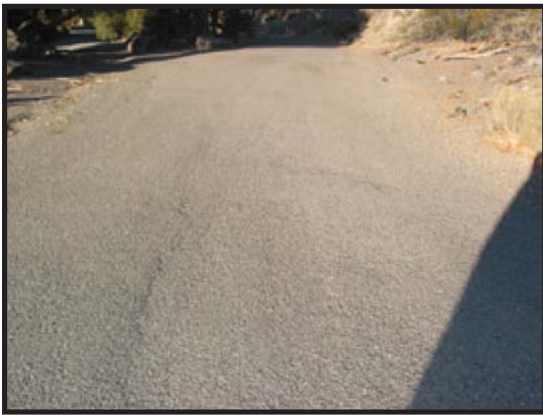
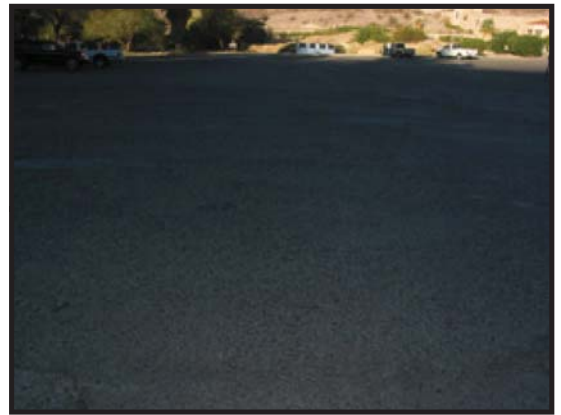
Route Number	Public / NonPublic	Date Visited		Area (sq ft)	Lane Miles *	Surface Type
0900	PUBLIC	11/3/2007		92,440	1.59	AS
Culverts	Drop Inlets	Gates	Fire Hydrants	Curb & Gutter	Curb	PCR
0	0	2	5	NO CURB AND GUTTER	NO CURB	FAIR/73

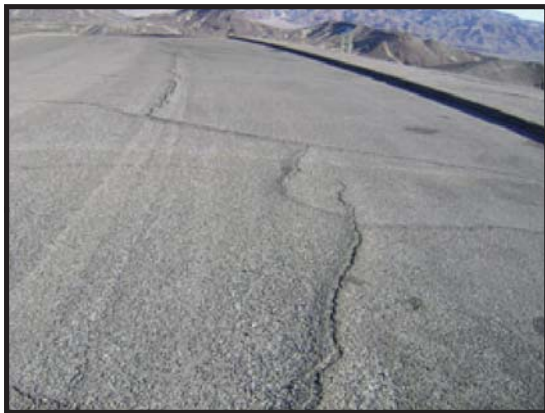
Route Number	Public / NonPublic	Date Visited		Area (sq ft)	Lane Miles *	Surface Type
0901AZ	PUBLIC	11/3/2007		6,026	0.10	AS
Culverts	Drop Inlets	Gates	Fire Hydrants	Curb & Gutter	Curb	PCR
0	0	0	0	NO CURB AND GUTTER	ASPHALT CURB	FAIR/73

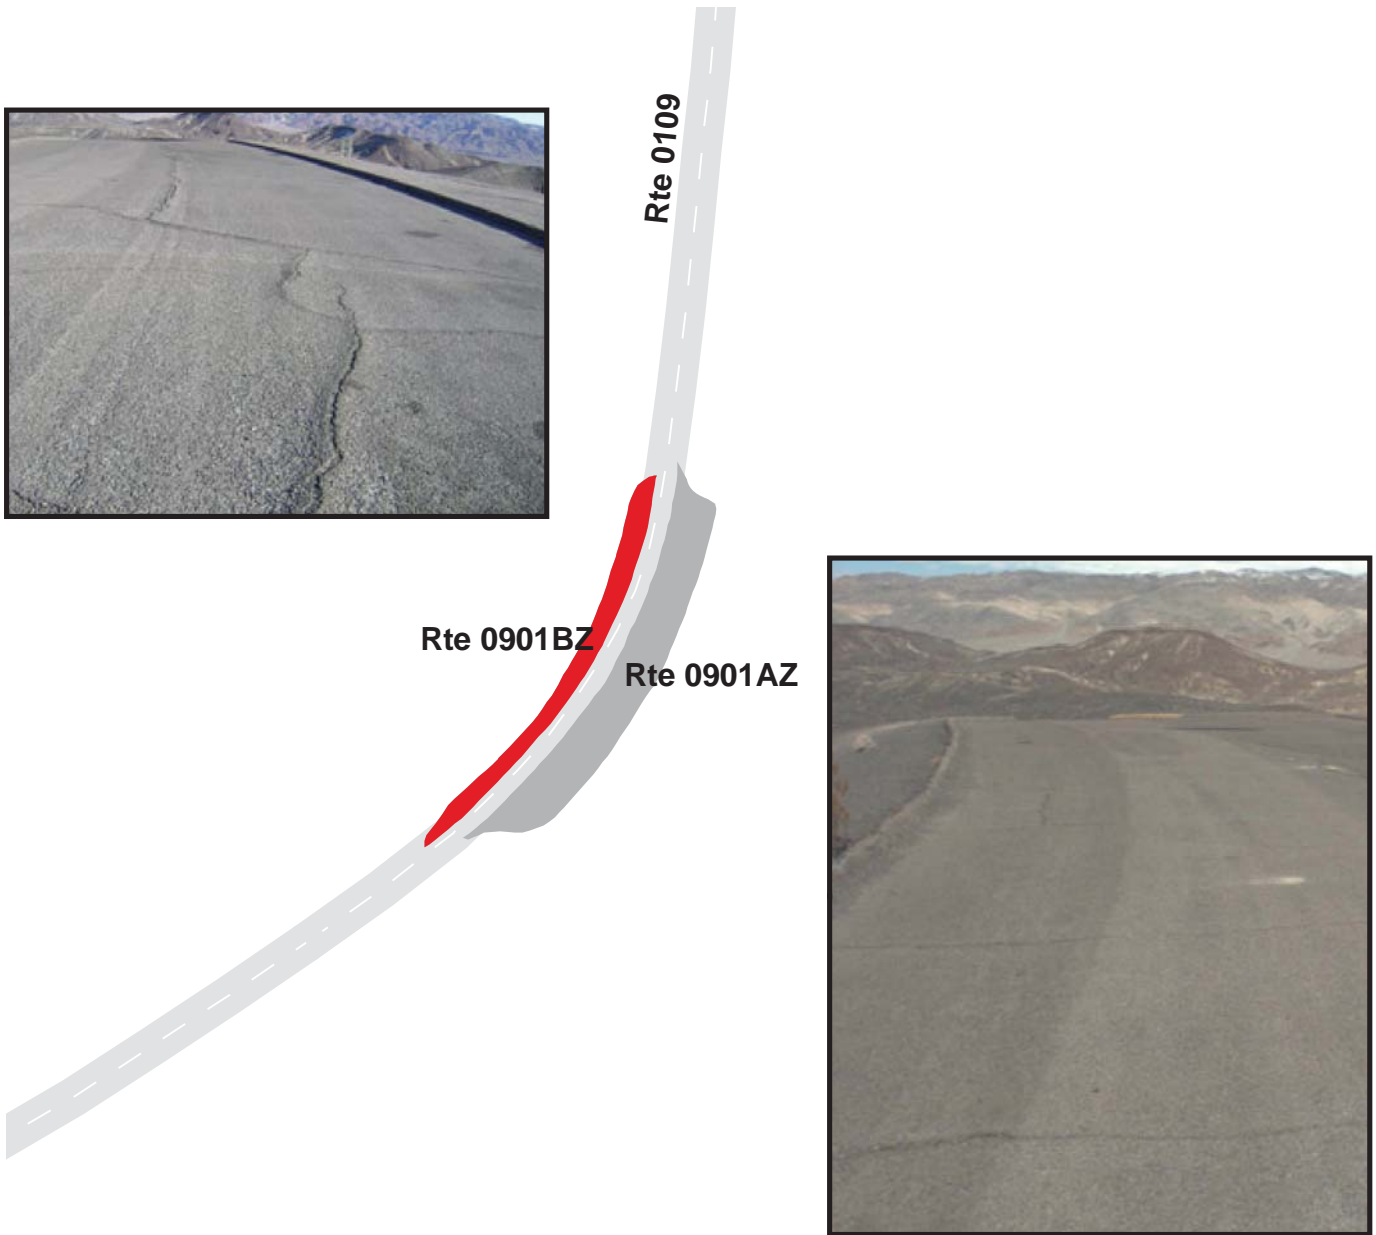
## Route 0901BZ

Route Number	Public / NonPublic	Date Visited		Area (sq ft)	Lane Miles *	Surface Type
0901BZ	PUBLIC	11/3/2007		2,634	0.05	AS
Culverts	Drop Inlets	Gates	Fire Hydrants	Curb & Gutter	Curb	PCR
0	0	0	0	NO CURB AND GUTTER	ASPHALT CURB	FAIR/73

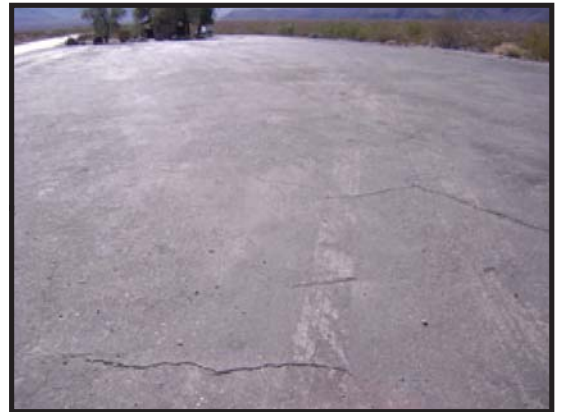
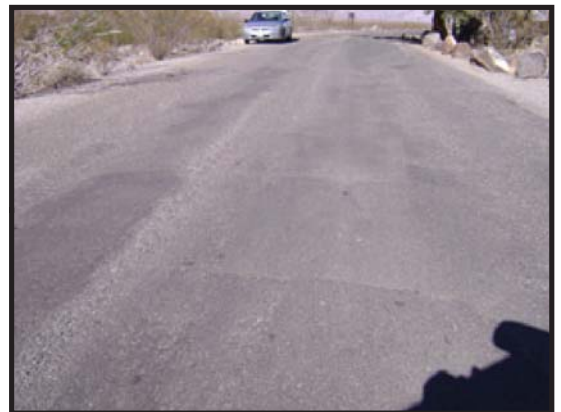
## Route 0903

Route Number	Public / NonPublic	Date Visited		Area (sq ft)	Lane Miles *	Surface Type
0903	PUBLIC	11/3/2007		23,511	0.41	AS
Culverts	Drop Inlets	Gates	Fire Hydrants	Curb & Gutter	Curb	PCR
0	0	0	0	NO CURB AND GUTTER	NO CURB	POOR/45

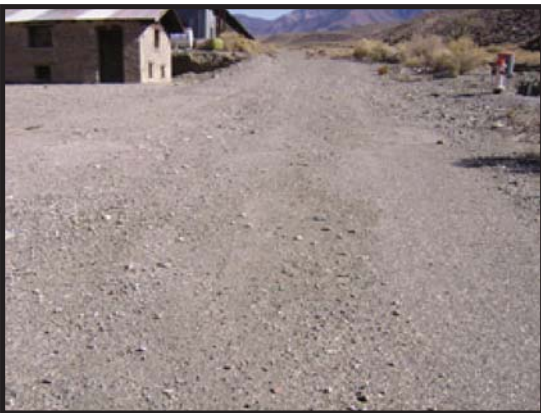
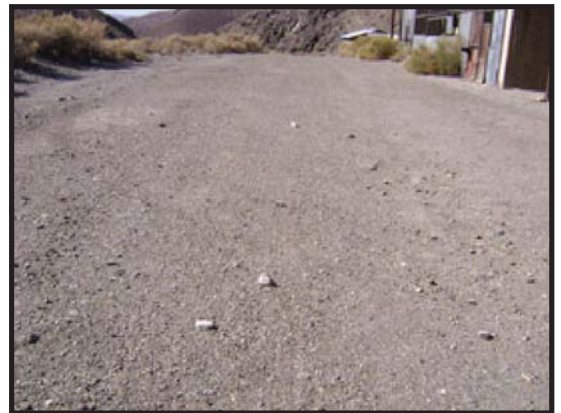
## Route 0906

Route Number	Public / NonPublic	Date Visited		Area (sq ft)	Lane Miles *	Surface Type
0906	NONPUBLIC	11/3/2007		7,888	0.14	AS
Culverts	Drop Inlets	Gates	Fire Hydrants	Curb & Gutter	Curb	PCR
0	0	0	1	NO CURB AND GUTTER	NO CURB	POOR/45

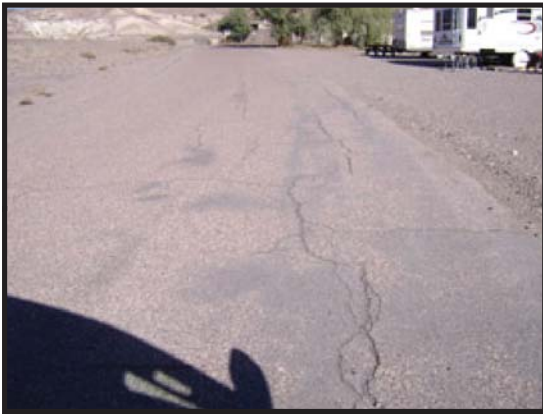
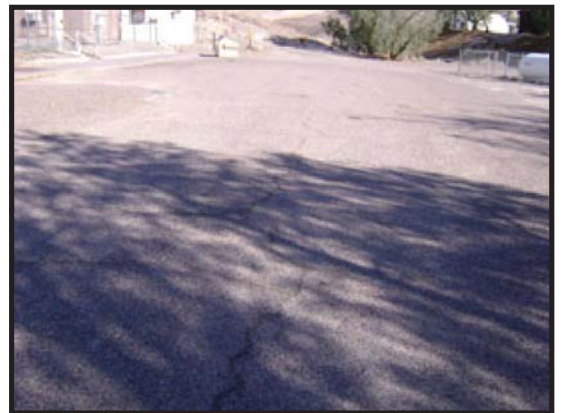
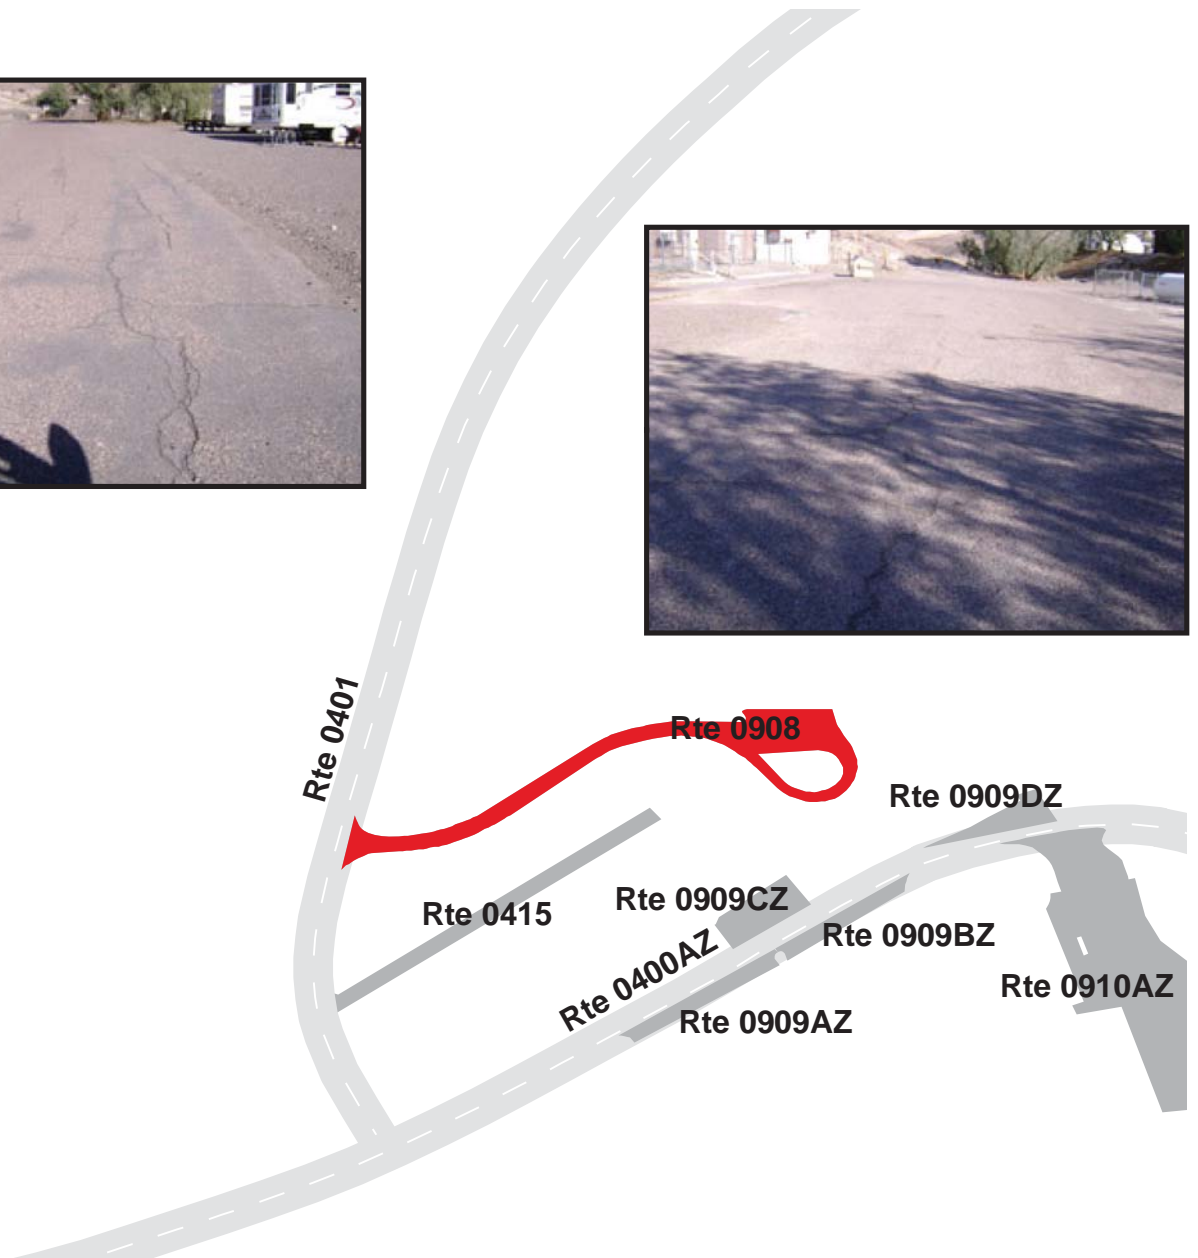
## Route 0908

Route Number	Public / NonPublic	Date Visited		Area (sq ft)	Lane Miles *	Surface Type
0908	PUBLIC	11/5/2007		18,605	0.32	AS
Culverts	Drop Inlets	Gates	Fire Hydrants	Curb & Gutter	Curb	PCR
0	0	0	1	CONCRETE CURB AND GUTTER	CONCRETE CURB	FAIR/73

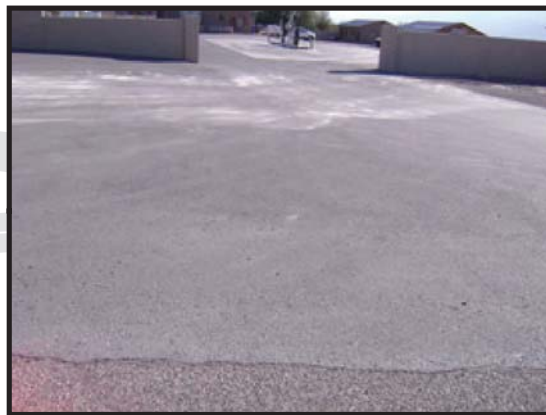
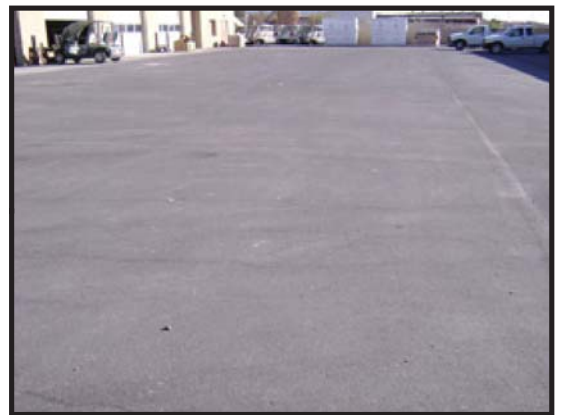
Route Number	Public / NonPublic	Date Visited		Area (sq ft)	Lane Miles *	Surface Type
0910AZ	NONPUBLIC	11/3/2007		55,702	0.96	AS
Culverts	Drop Inlets	Gates	Fire Hydrants	Curb & Gutter	Curb	PCR
0	1	0	1	CONCRETE CURB AND GUTTER	STONE CURB	FAIR/73

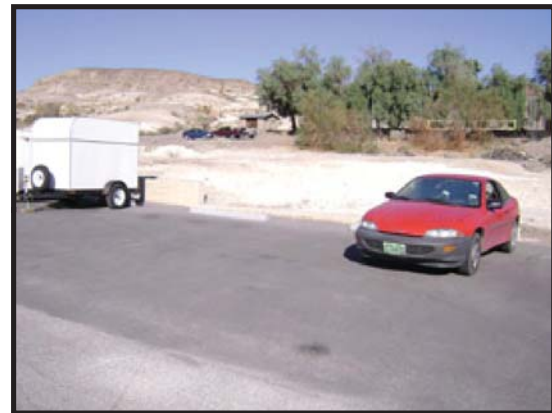
## Route 0910BZ

Route Number	Public / NonPublic	Date Visited		Area (sq ft)	Lane Miles *	Surface Type
0910BZ	NONPUBLIC	11/5/2007		2,680	0.05	AS
Culverts	Drop Inlets	Gates	Fire Hydrants	Curb & Gutter	Curb	PCR
0	0	0	0	NO CURB AND GUTTER	NO CURB	EXCELLENT/97

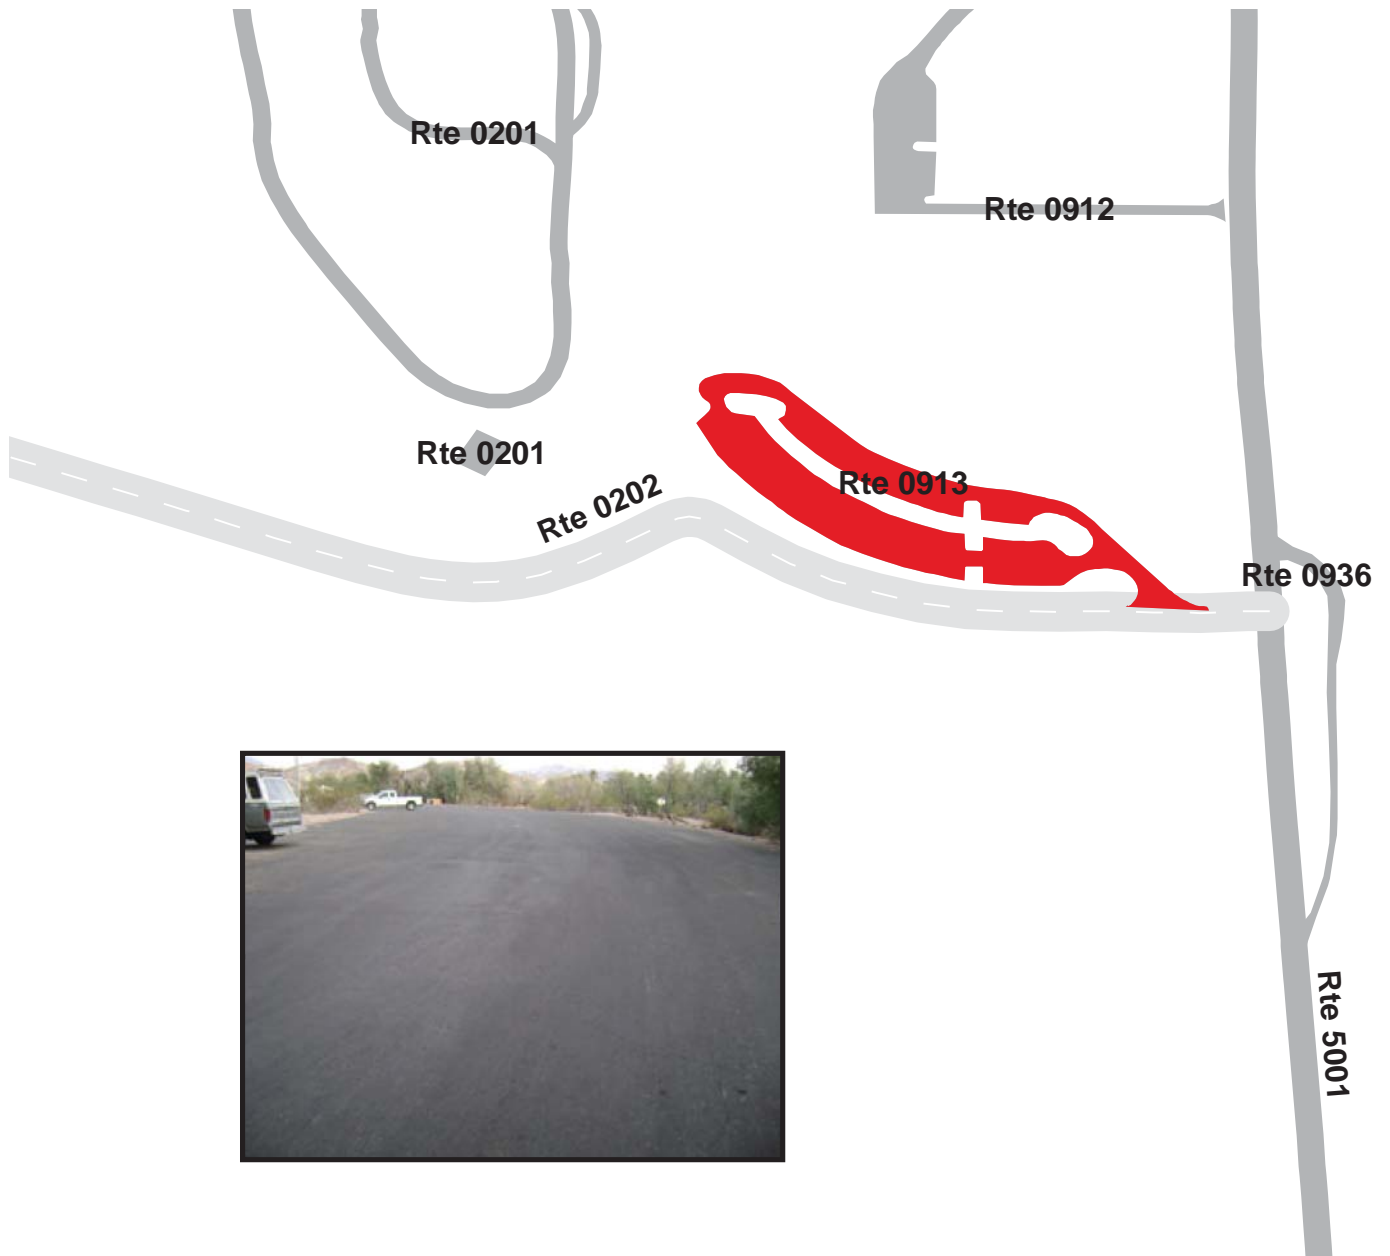
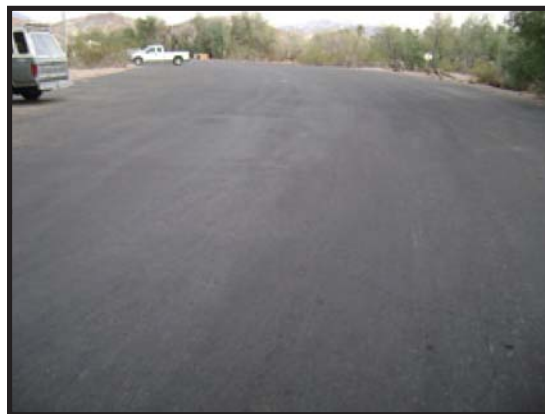
Route Number	Public / NonPublic	Date Visited		Area (sq ft)	Lane Miles *	Surface Type
0913	PUBLIC	11/4/2007		50,799	0.88	AS
Culverts	Drop Inlets	Gates	Fire Hydrants	Curb & Gutter	Curb	PCR
0	0	0	0	CONCRETE CURB AND GUTTER	CONCRETE CURB	EXCELLENT/97

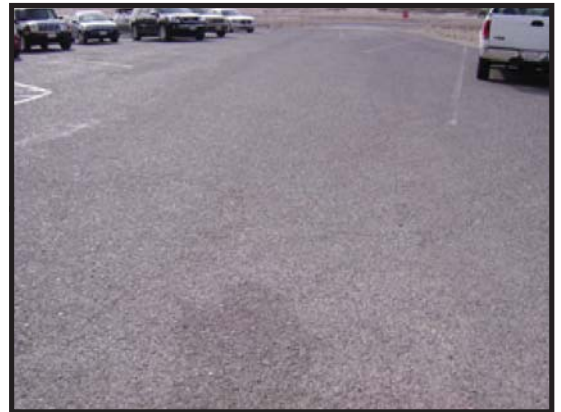
## Route 0915

Route Number	Public / NonPublic	Date Visited		Area (sq ft)	Lane Miles *	Surface Type
0915	PUBLIC	11/4/2007		19,549	0.34	AS
Culverts	Drop Inlets	Gates	Fire Hydrants	Curb & Gutter	Curb	PCR
0	0	0	0	NO CURB AND GUTTER	NO CURB	GOOD/90
