**The Road Inventory  
of  
Death Valley National Park  
DEVA – 8130  
Cycle 4**

**Prepared By:  
Federal Highway Administration  
Road Inventory Program  
Cycle 4**

# Death Valley National Park in California

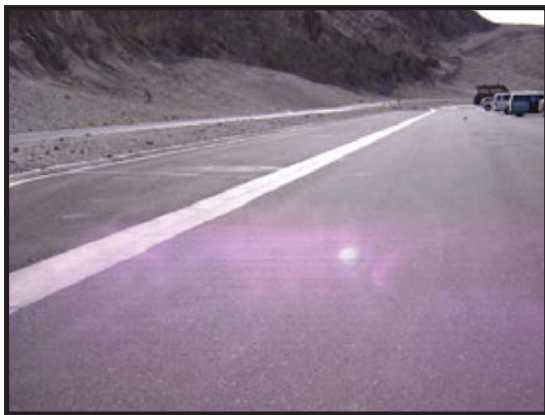
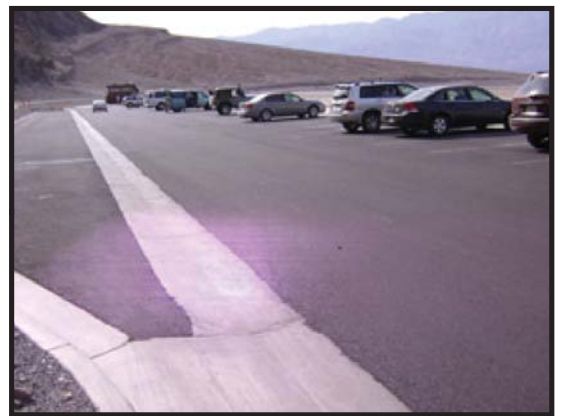
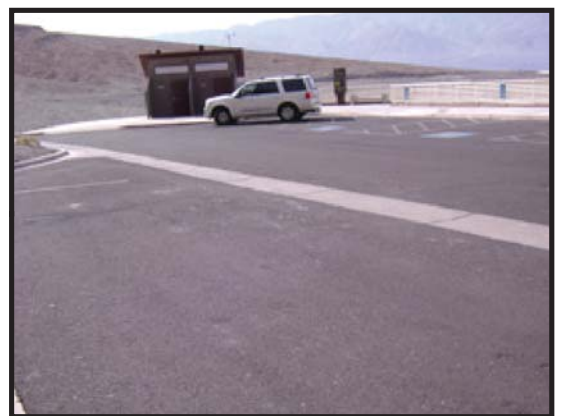
## Route 0917

Route Number	Public / NonPublic	Date Visited		Area (sq ft)	Lane Miles *	Surface Type
0917	PUBLIC	11/3/2007		31,101	0.54	AS
Culverts	Drop Inlets	Gates	Fire Hydrants	Curb & Gutter	Curb	PCR
0	0	0	0	CONCRETE CURB AND GUTTER	CONCRETE CURB	EXCELLENT/97

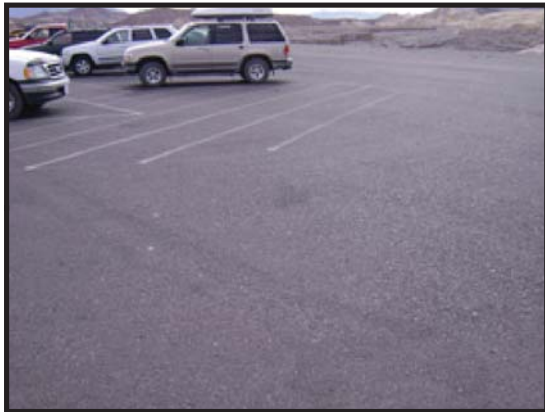
## Route 0918

Route Number	Public / NonPublic	Date Visited		Area (sq ft)	Lane Miles *	Surface Type
0918	PUBLIC	11/3/2007		29,261	0.50	AS
Culverts	Drop Inlets	Gates	Fire Hydrants	Curb & Gutter	Curb	PCR
0	0	0	0	NO CURB AND GUTTER	NO CURB	GOOD/90

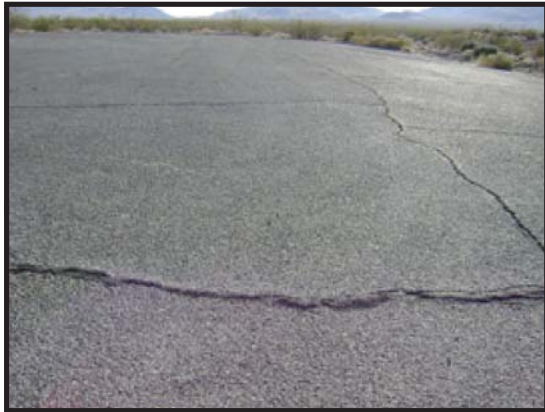
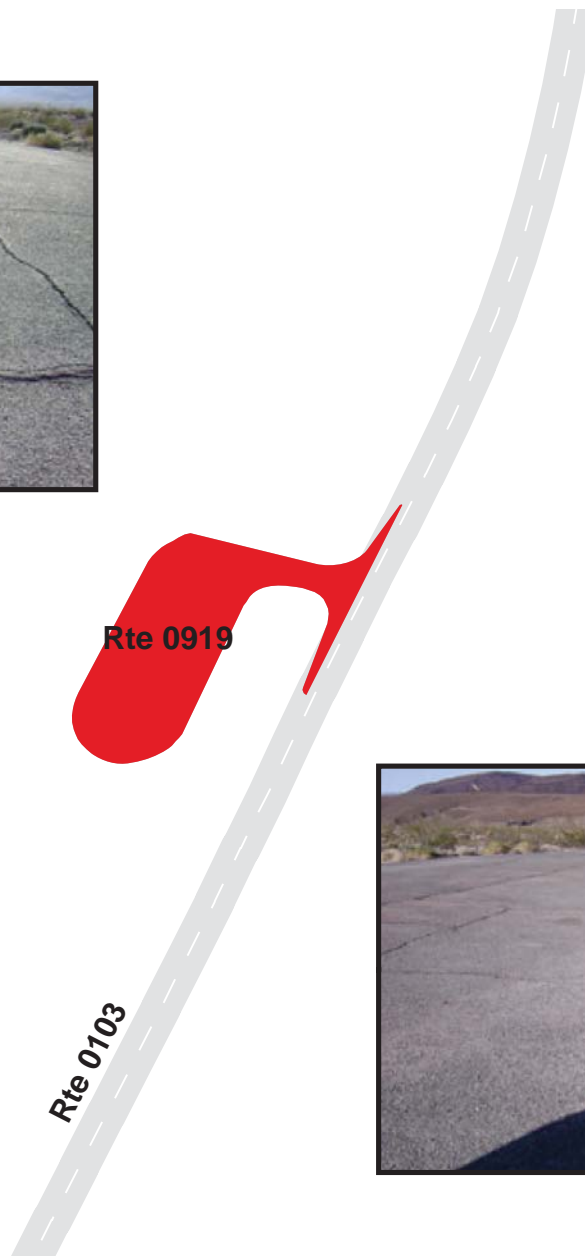
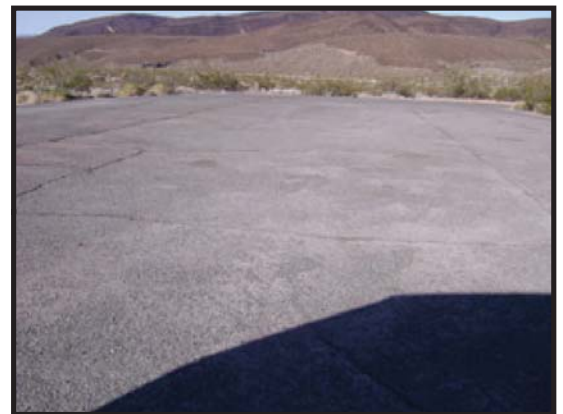
## Route 0919

Route Number	Public / NonPublic	Date Visited		Area (sq ft)	Lane Miles *	Surface Type
0919	PUBLIC	11/3/2007		20,193	0.35	AS
Culverts	Drop Inlets	Gates	Fire Hydrants	Curb & Gutter	Curb	PCR
0	0	0	0	NO CURB AND GUTTER	NO CURB	POOR/45

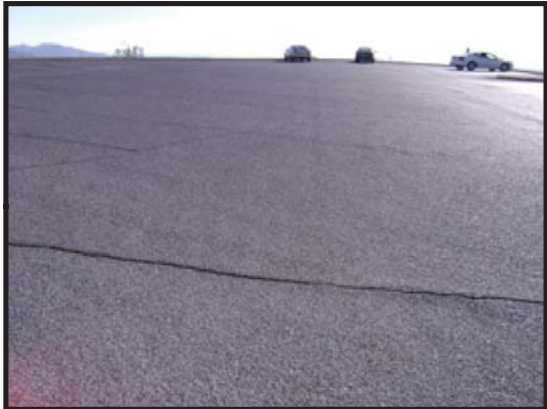
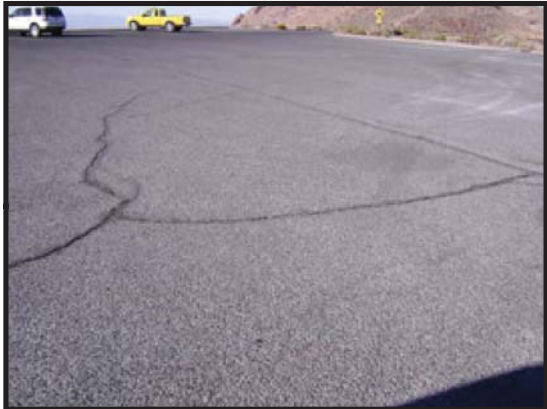
## Route 0920

Route Number	Public / NonPublic	Date Visited		Area (sq ft)	Lane Miles *	Surface Type
0920	PUBLIC	11/3/2007		25,117	0.43	AS
Culverts	Drop Inlets	Gates	Fire Hydrants	Curb & Gutter	Curb	PCR
0	0	0	0	CONCRETE CURB AND GUTTER	CONCRETE CURB	FAIR/73

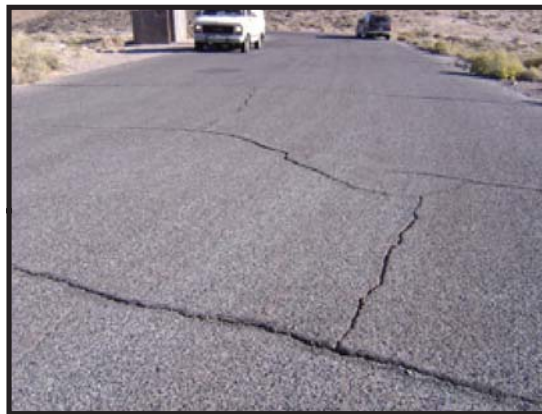
## Route 0926

Route Number	Public / NonPublic	Date Visited		Area (sq ft)	Lane Miles *	Surface Type
0926	PUBLIC	11/3/2007		8,823	0.15	AS
Culverts	Drop Inlets	Gates	Fire Hydrants	Curb & Gutter	Curb	PCR
0	0	0	0	NO CURB AND GUTTER	NO CURB	FAIR/73

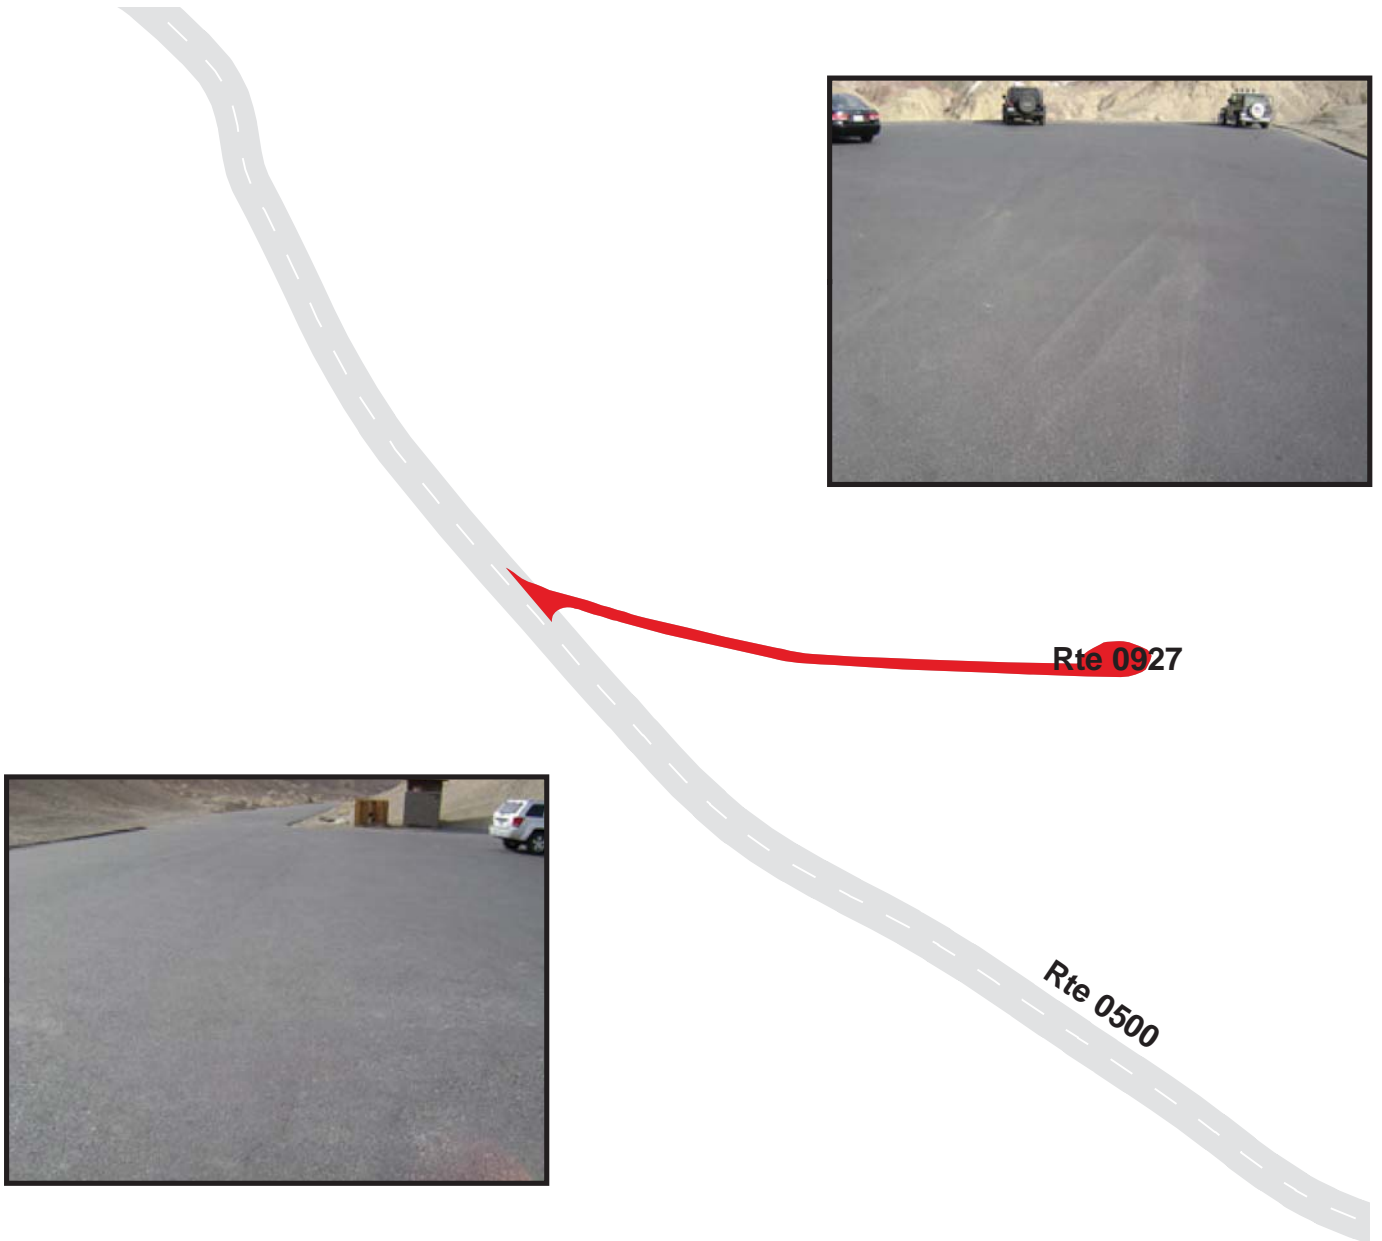
## Route 0927

Route Number	Public / NonPublic	Date Visited		Area (sq ft)	Lane Miles *	Surface Type
0927	PUBLIC	11/4/2007		22,453	0.39	AS
Culverts	Drop Inlets	Gates	Fire Hydrants	Curb & Gutter	Curb	PCR
0	0	0	0	NO CURB AND GUTTER	ASPHALT CURB	EXCELLENT/97

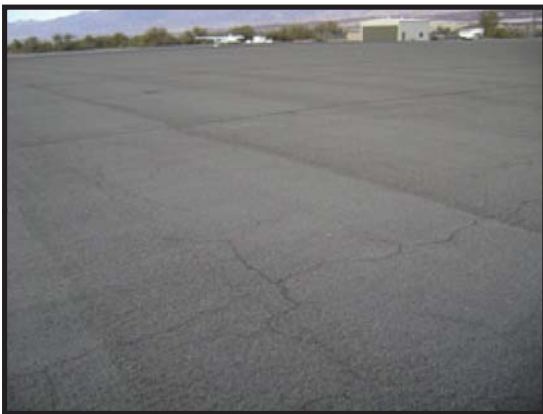
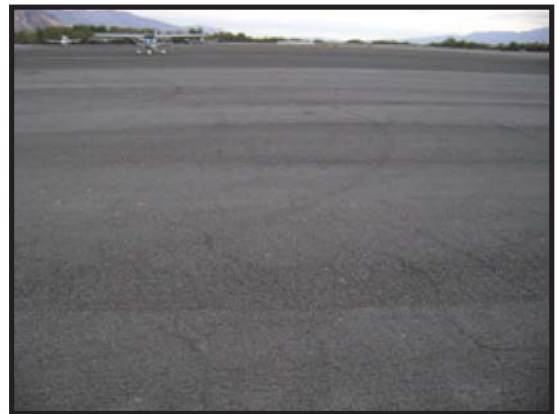
Route Number	Public / NonPublic	Date Visited		Area (sq ft)	Lane Miles *	Surface Type
0930	PUBLIC	11/3/2007		237,799	4.09	AS
Culverts	Drop Inlets	Gates	Fire Hydrants	Curb & Gutter	Curb	PCR
0	0	0	0	NO CURB AND GUTTER	NO CURB	FAIR/73

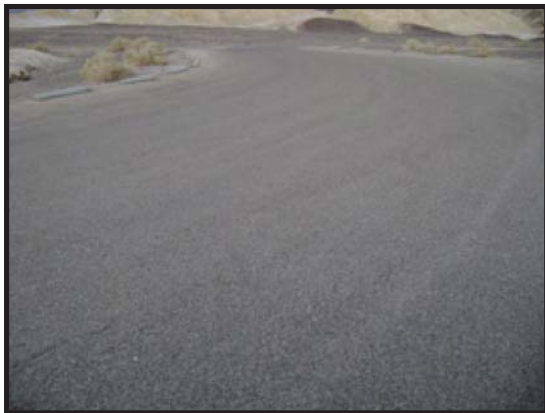
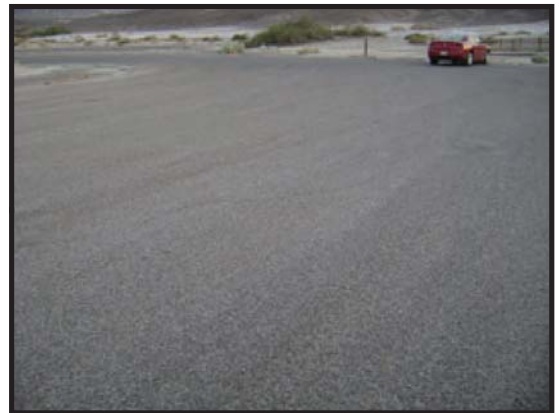
## Route 0931

Route Number	Public / NonPublic	Date Visited		Area (sq ft)	Lane Miles *	Surface Type
0931	PUBLIC	11/3/2007		20,818	0.36	AS
Culverts	Drop Inlets	Gates	Fire Hydrants	Curb & Gutter	Curb	PCR
0	0	0	0	NO CURB AND GUTTER	NO CURB	POOR/45

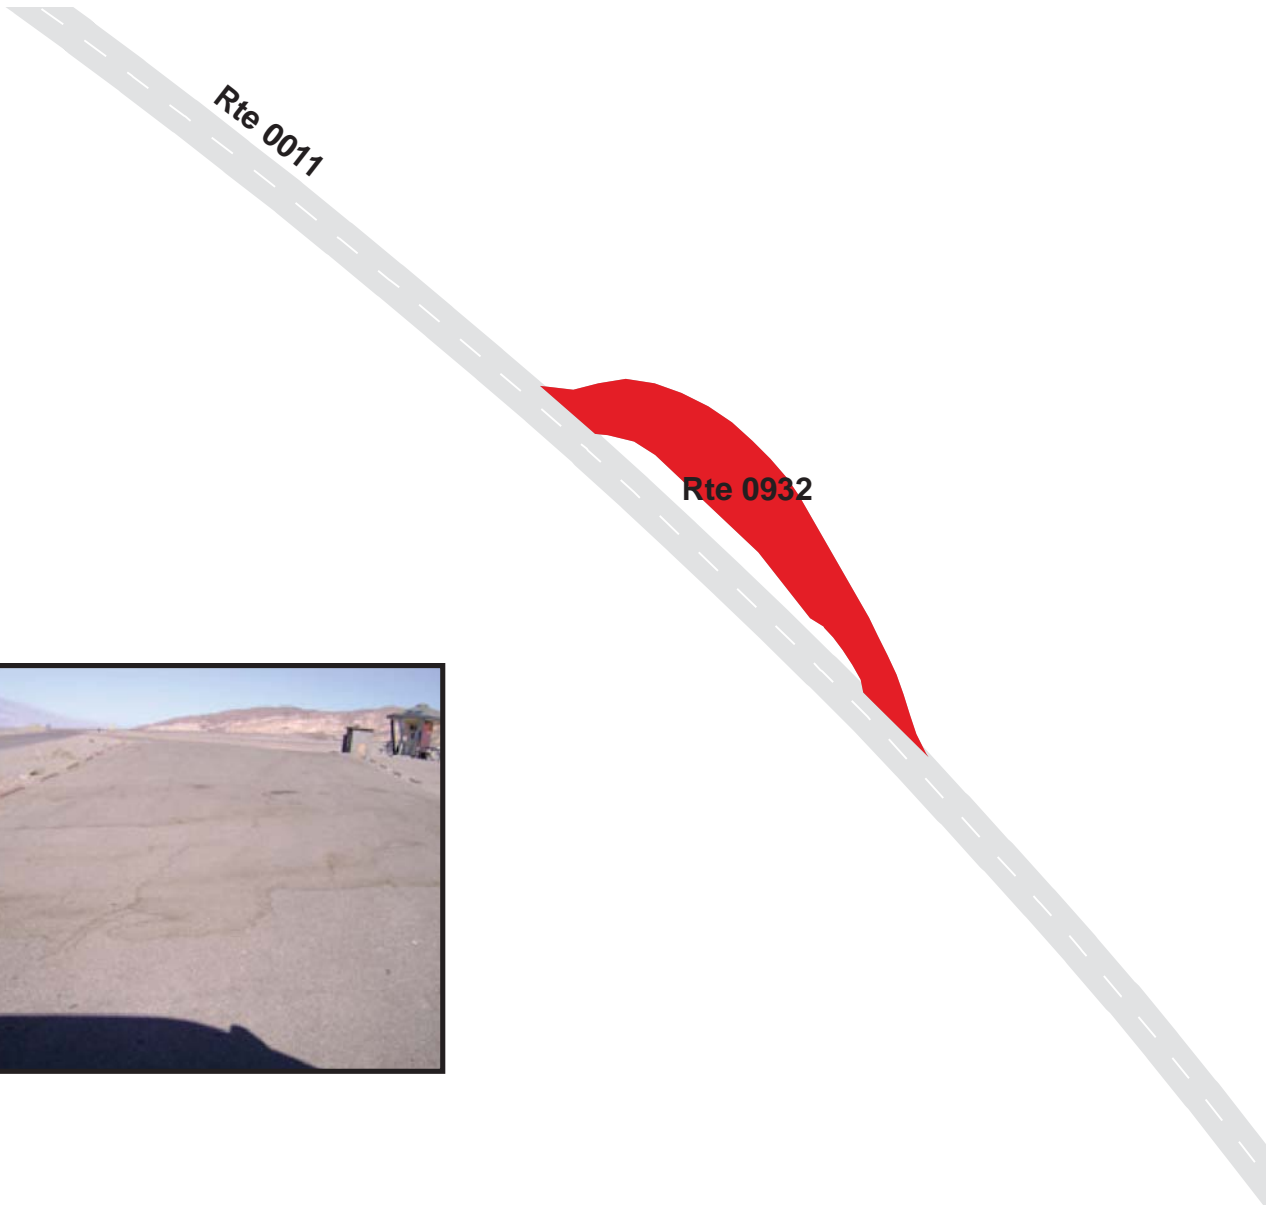
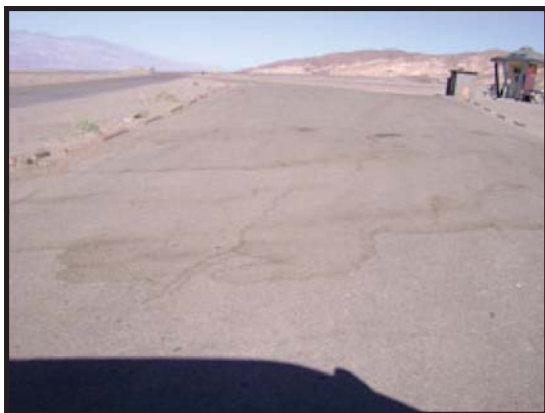
## Route 0932

Route Number	Public / NonPublic	Date Visited		Area (sq ft)	Lane Miles *	Surface Type
0932	PUBLIC	11/3/2007		18,050	0.31	AS
Culverts	Drop Inlets	Gates	Fire Hydrants	Curb & Gutter	Curb	PCR
0	0	0	0	NO CURB AND GUTTER	NO CURB	POOR/45

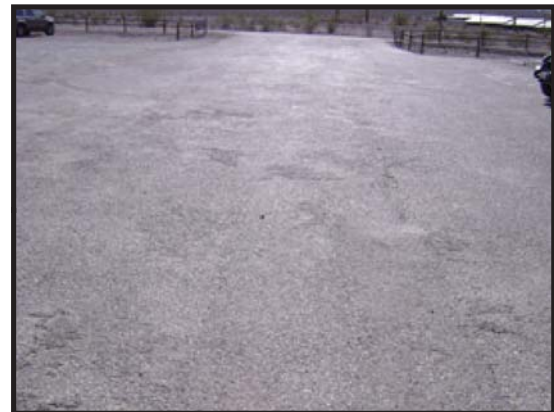
## Route 0933

Route Number	Public / NonPublic	Date Visited		Area (sq ft)	Lane Miles *	Surface Type
0933	PUBLIC	11/3/2007		7,092	0.12	AS
Culverts	Drop Inlets	Gates	Fire Hydrants	Curb & Gutter	Curb	PCR
0	0	0	0	NO CURB AND GUTTER	NO CURB	FAIR/73

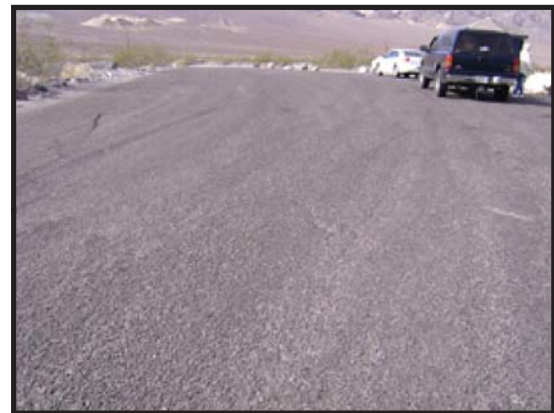
## Route 0934

Route Number	Public / NonPublic	Date Visited		Area (sq ft)	Lane Miles *	Surface Type
0934	PUBLIC	11/3/2007		12,141	0.21	AS
Culverts	Drop Inlets	Gates	Fire Hydrants	Curb & Gutter	Curb	PCR
0	0	0	0	NO CURB AND GUTTER	NO CURB	FAIR/73

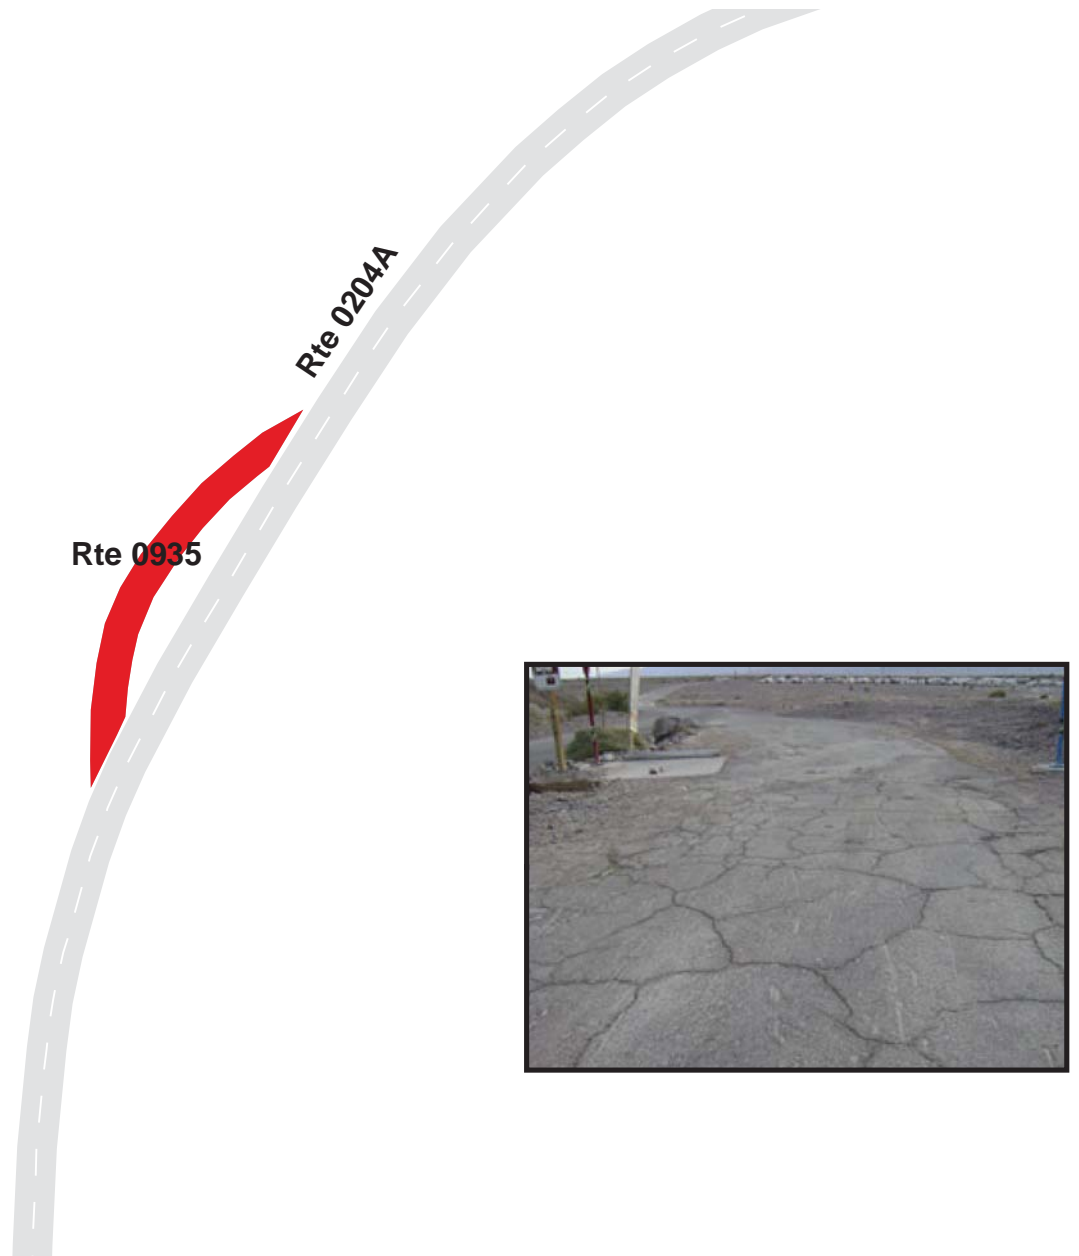
## Route 0935

Route Number	Public / NonPublic	Date Visited		Area (sq ft)	Lane Miles *	Surface Type
0935	PUBLIC	11/3/2007		2,884	0.05	AS
Culverts	Drop Inlets	Gates	Fire Hydrants	Curb & Gutter	Curb	PCR
0	0	0	0	NO CURB AND GUTTER	NO CURB	POOR/45

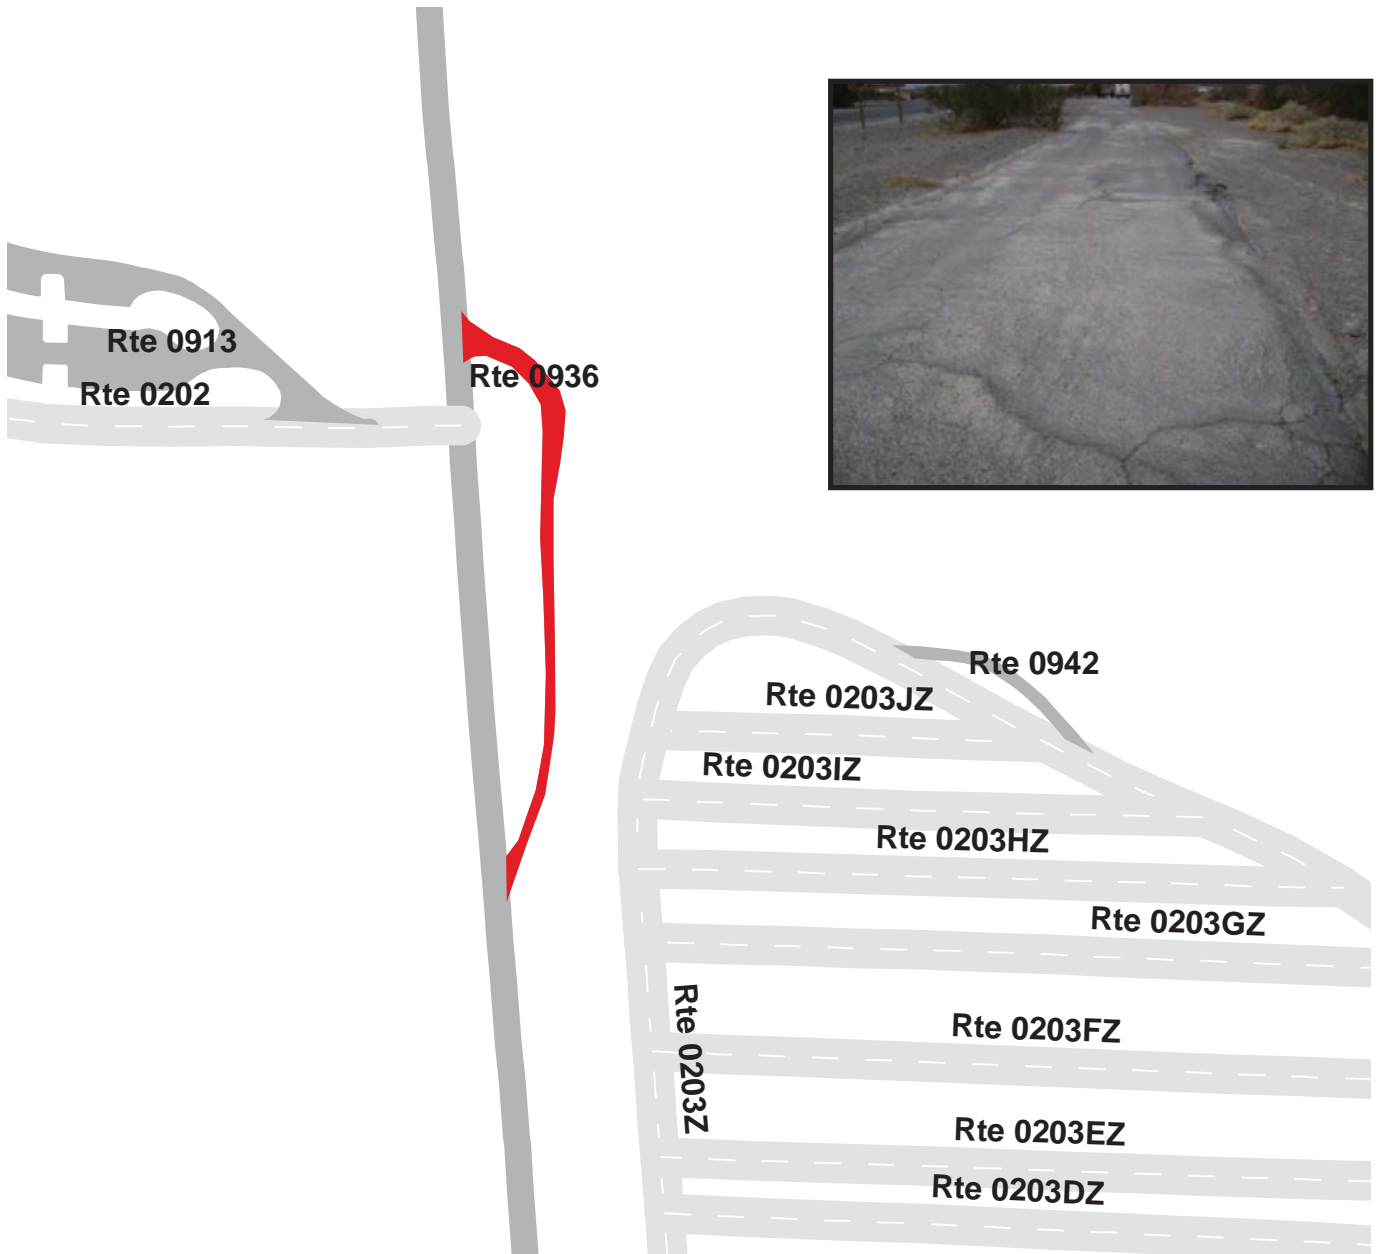
## Route 0936

Route Number	Public / NonPublic	Date Visited		Area (sq ft)	Lane Miles *	Surface Type
0936	PUBLIC	11/4/2007		7,211	0.12	AS
Culverts	Drop Inlets	Gates	Fire Hydrants	Curb & Gutter	Curb	PCR
0	0	0	0	NO CURB AND GUTTER	NO CURB	POOR/45

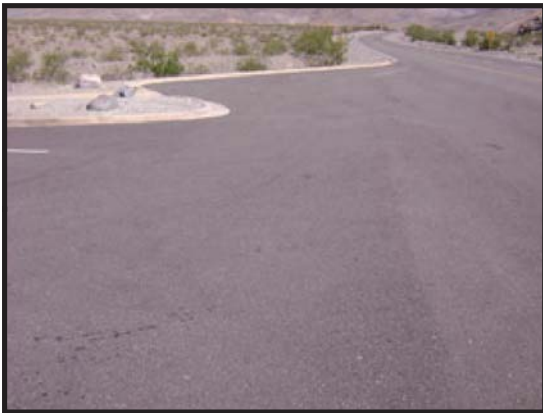
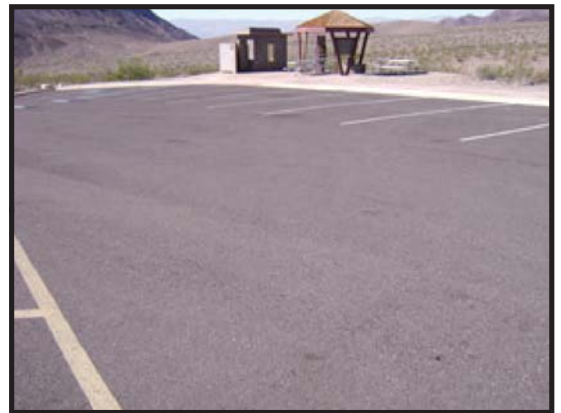
Route Number	Public / NonPublic	Date Visited		Area (sq ft)	Lane Miles *	Surface Type
0938	PUBLIC	11/3/2007		11,738	0.20	AS
Culverts	Drop Inlets	Gates	Fire Hydrants	Curb & Gutter	Curb	PCR
0	0	0	0	CONCRETE CURB AND GUTTER	CONCRETE CURB	EXCELLENT/97

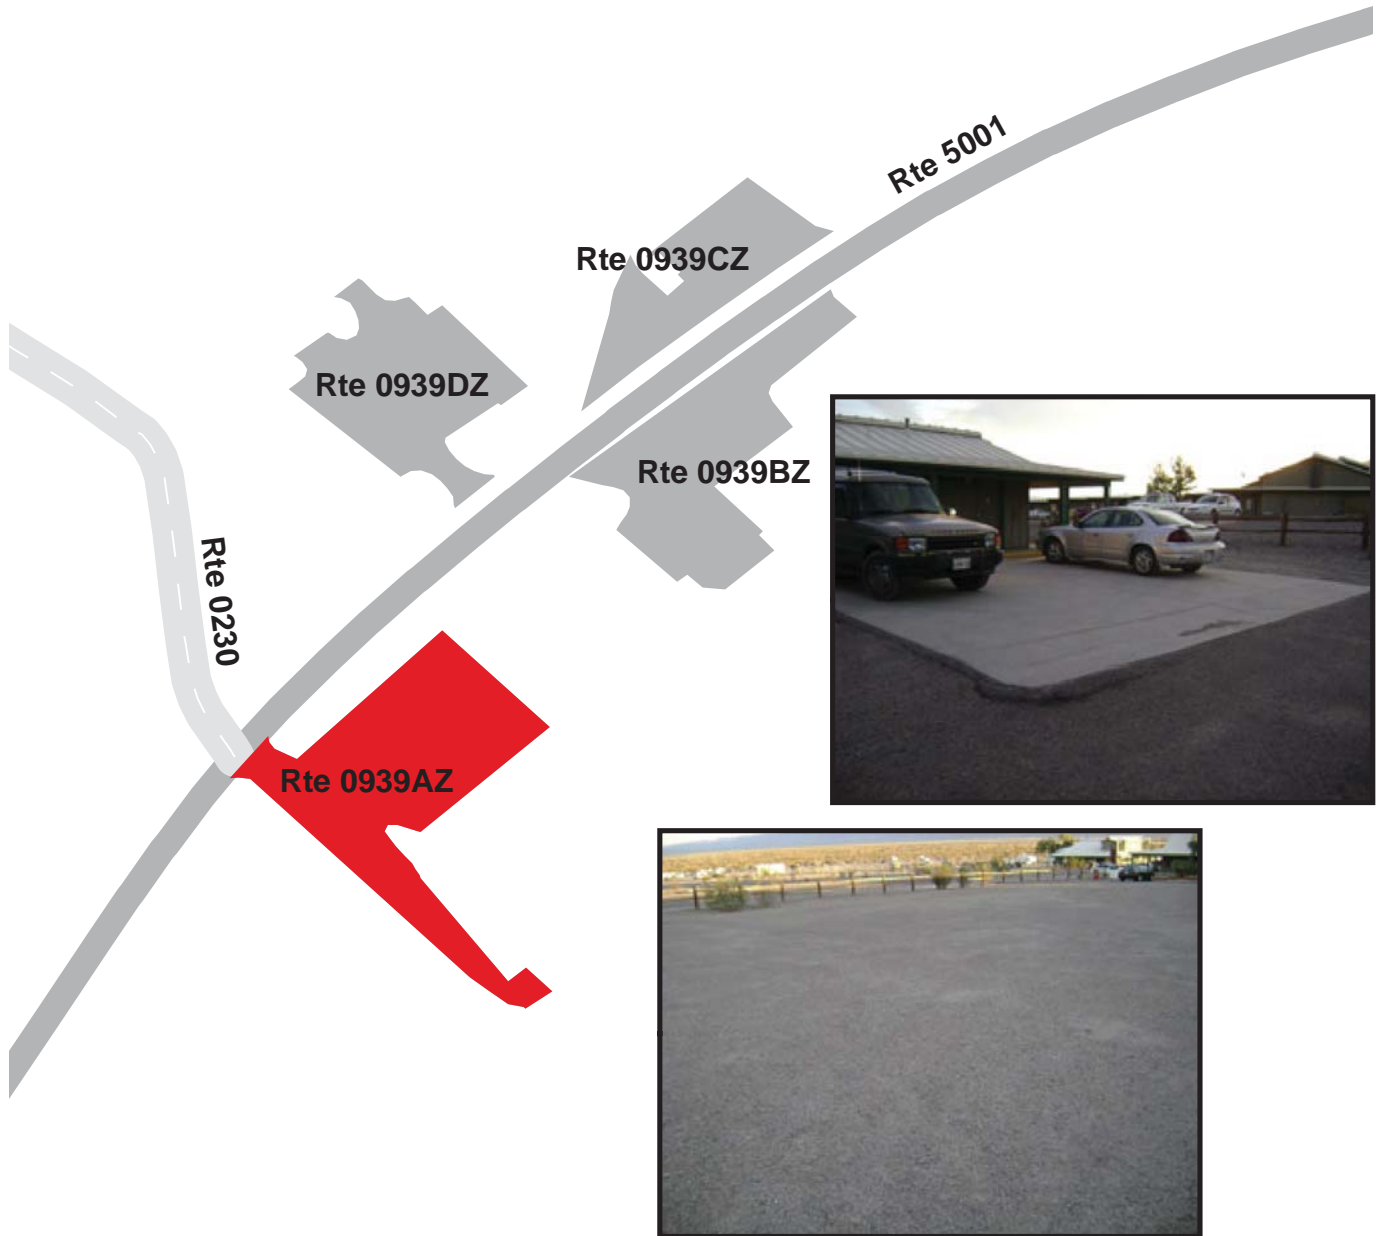
Route Number	Public / NonPublic	Date Visited		Area (sq ft)	Lane Miles *	Surface Type
0939AZ	PUBLIC	11/4/2007		28,990	0.50	AS
Culverts	Drop Inlets	Gates	Fire Hydrants	Curb & Gutter	Curb	PCR
0	0	0	2	NO CURB AND GUTTER	NO CURB	POOR/45

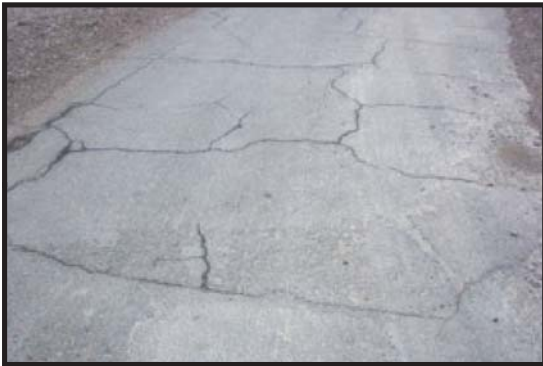
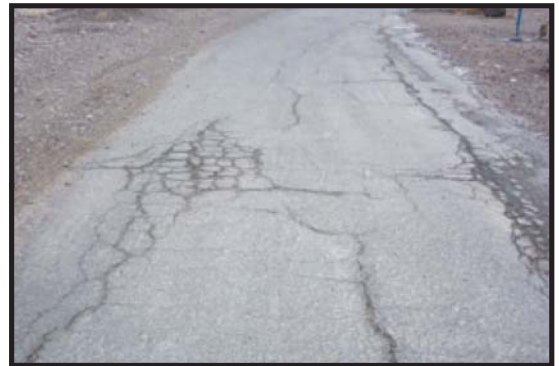
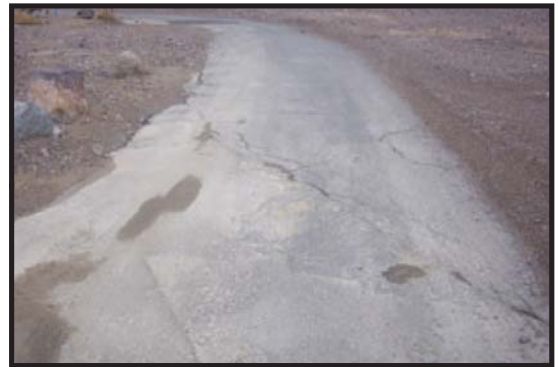
Route Number	Public / NonPublic	Date Visited		Area (sq ft)	Lane Miles *	Surface Type
0942	PUBLIC	1/27/2008		2,177	0.04	AS
Culverts	Drop Inlets	Gates	Fire Hydrants	Curb & Gutter	Curb	PCR
0	0	0	0	N/A	N/A	POOR/45
