**The Road Inventory
of
Delaware Water Gap National Recreation Area
DEWA – 4320
Cycle 4**

**Prepared By:
Federal Highway Administration
Road Inventory Program
Cycle 4**

Delaware Water Gap National Recreation Area in Pennsylvania and New Jersey

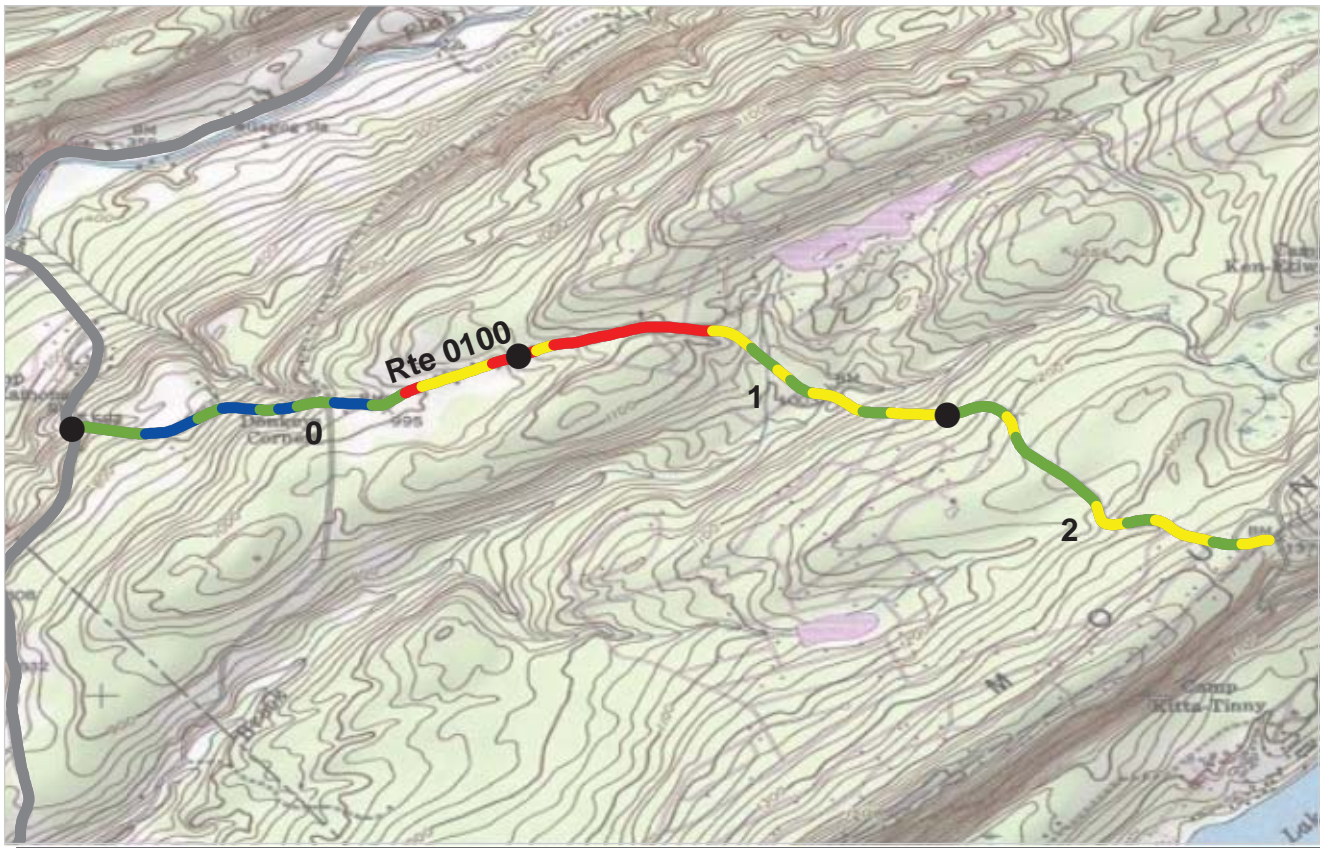
ROUTE: 0015 OLD MINE ROAD (NORTH SECTION)

<i>Section Number</i>	5	6	7		
<i>Section Length (mi)</i>	1.00	1.00	0.58		
<i>Traffic</i>	Traffic data may be found at www.efl.fhwa.dot.gov Click on PROGRAMS / NPS Traffic Data (Note: Not all parks have traffic data)				
<i>Cross Section Information</i>					
Number of Lanes	2	2	2		
Paved Width (ft)	19	21	20		
Lane Width (ft)	9	9	9		
Shoulder Width Right (ft)	NC	NC	NC		
Shoulder Width Left (ft)	NC	NC	NC		
<i>Roadway Condition Information</i>					
SCR (Surface Condition Rating)	34	17	30		
PCR (Pavement Condition Rating)	44	35	39		
<i>Distress Index Values</i>					
Alligator Cracking Index	71	58	76		
Longitudinal Cracking Index	91	92	92		
Transverse Cracking Index	94	95	94		
Patching Index	100	100	100		
Rutting Index	78	70	66		
Roughness Condition Index (RCI)	59	64	57

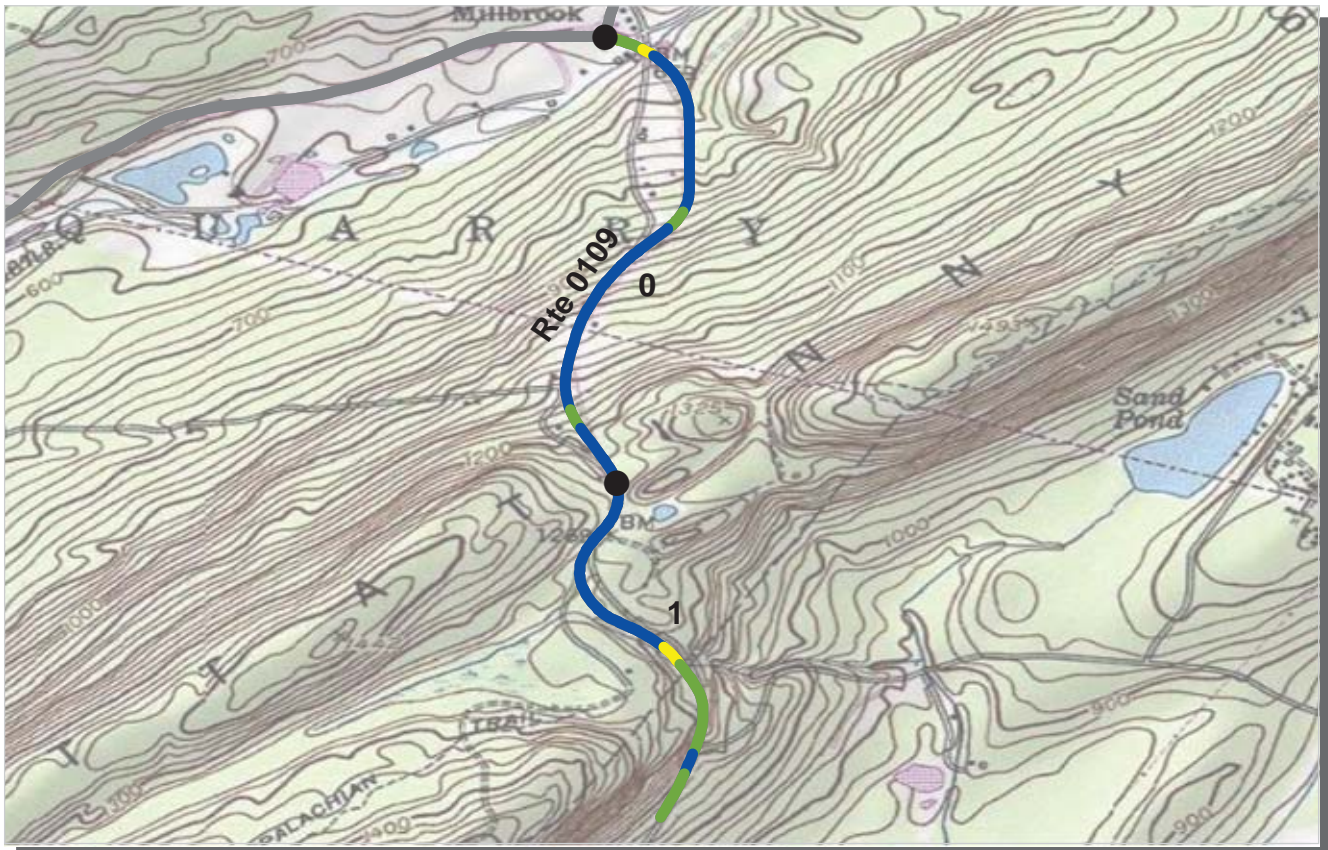
ROUTE: 0106 JAGER ROAD

Section Number	0				
Section Length (mi)	0.68				
Traffic	Traffic data may be found at www.efl.fhwa.dot.gov Click on PROGRAMS / NPS Traffic Data (Note: Not all parks have traffic data)				
Cross Section Information					
Number of Lanes	2				
Paved Width (ft)	22				
Lane Width (ft)	10				
Shoulder Width Right (ft)	NC				
Shoulder Width Left (ft)	NC				
Roadway Condition Information					
SCR (Surface Condition Rating)	91				
PCR (Pavement Condition Rating)	87				
Distress Index Values					
Alligator Cracking Index	100				
Longitudinal Cracking Index	100				
Transverse Cracking Index	100				
Patching Index	100				
Rutting Index	91				
Roughness Condition Index (RCI)	80

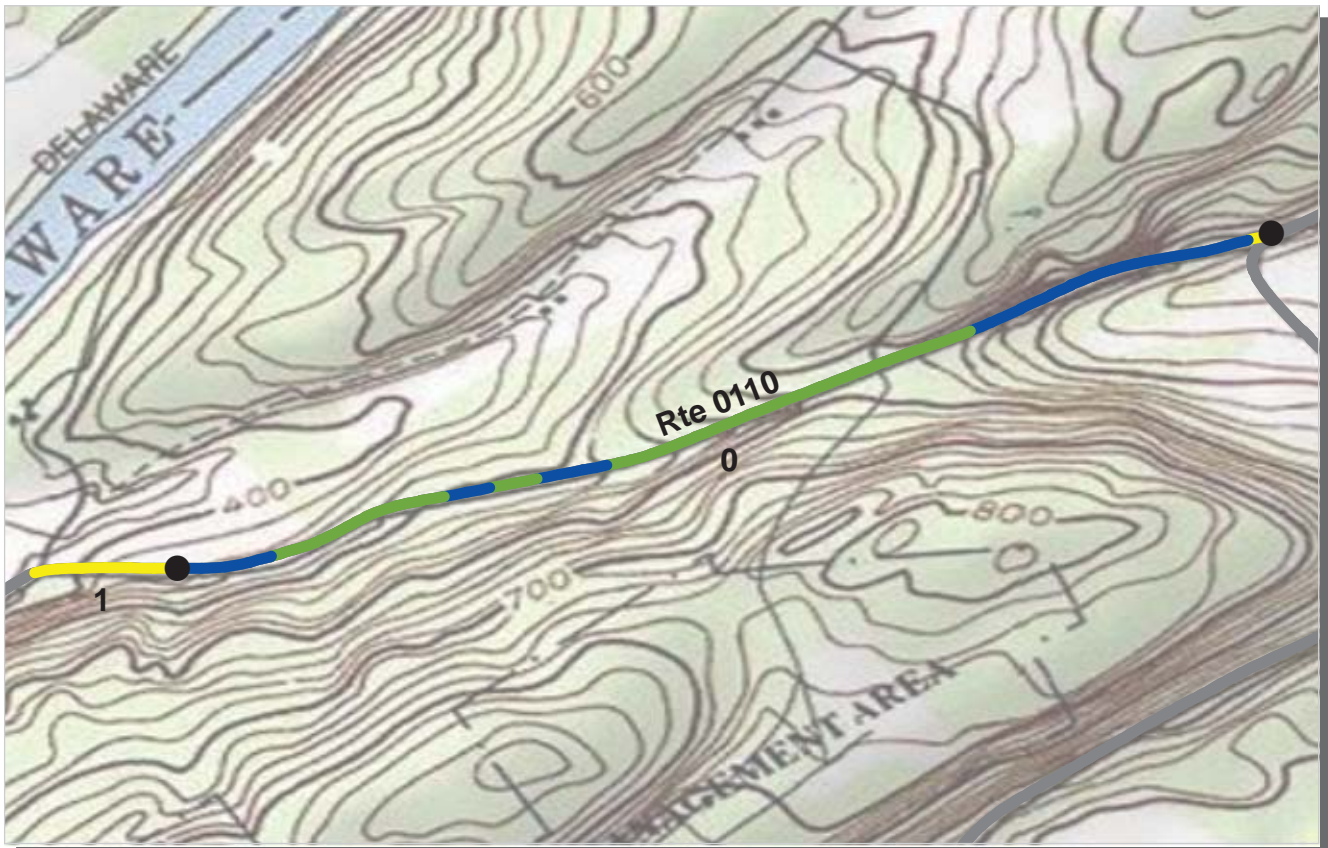
ROUTE: 0109 NPS 602

Section Number	0	1			
Section Length (mi)	1.00	0.73			
Traffic	Traffic data may be found at www.efl.fhwa.dot.gov Click on PROGRAMS / NPS Traffic Data (Note: Not all parks have traffic data)				
Cross Section Information					
Number of Lanes	2	2			
Paved Width (ft)	25	24			
Lane Width (ft)	10	10			
Shoulder Width Right (ft)	NC	NC			
Shoulder Width Left (ft)	NC	NC			
Roadway Condition Information					
SCR (Surface Condition Rating)	99	99			
PCR (Pavement Condition Rating)	97	95			
Distress Index Values					
Alligator Cracking Index	100	100			
Longitudinal Cracking Index	100	100			
Transverse Cracking Index	100	100			
Patching Index	100	100			
Rutting Index	100	100			
Roughness Condition Index (RCI)	93	87

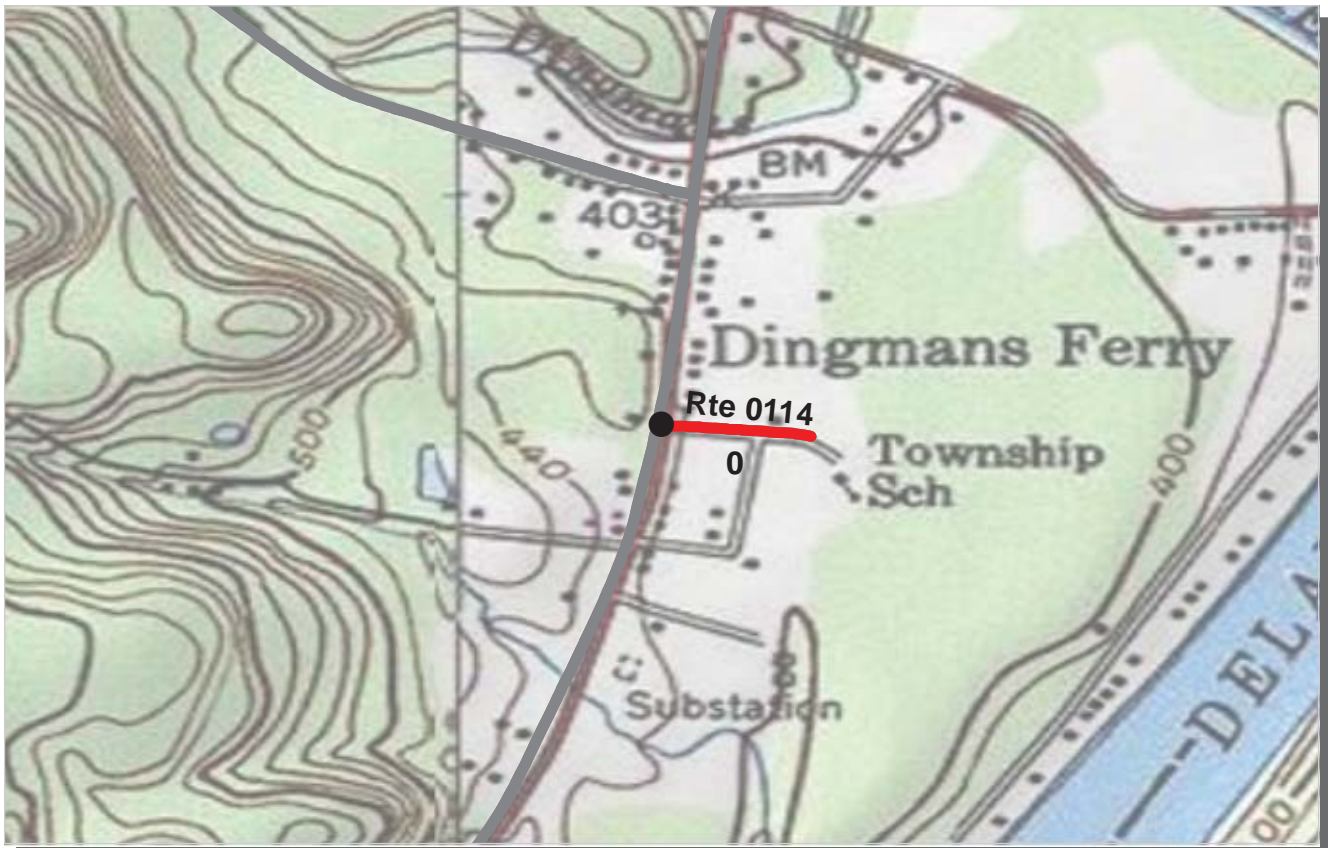
ROUTE: 0113 NPS 615

<i>Section Number</i>	5	6	7	8	9
<i>Section Length (mi)</i>	1.00	1.00	1.00	1.00	0.72
<i>Traffic</i>	Traffic data may be found at www.efl.fhwa.dot.gov Click on PROGRAMS / NPS Traffic Data (Note: Not all parks have traffic data)				
<i>Cross Section Information</i>					
Number of Lanes	2	2	2	2	2
Paved Width (ft)	22	22	22	24	24
Lane Width (ft)	10	10	10	11	10
Shoulder Width Right (ft)	NC	NC	NC	NC	NC
Shoulder Width Left (ft)	NC	NC	NC	NC	NC
<i>Roadway Condition Information</i>					
SCR (Surface Condition Rating)	100	99	99	98	98
PCR (Pavement Condition Rating)	92	92	93	91	92
<i>Distress Index Values</i>					
Alligator Cracking Index	100	100	100	100	100
Longitudinal Cracking Index	100	100	100	100	99
Transverse Cracking Index	100	100	100	100	100
Patching Index	100	100	100	100	100
Rutting Index	100	99	99	99	99
Roughness Condition Index (RCI)	79	81	84	81	82

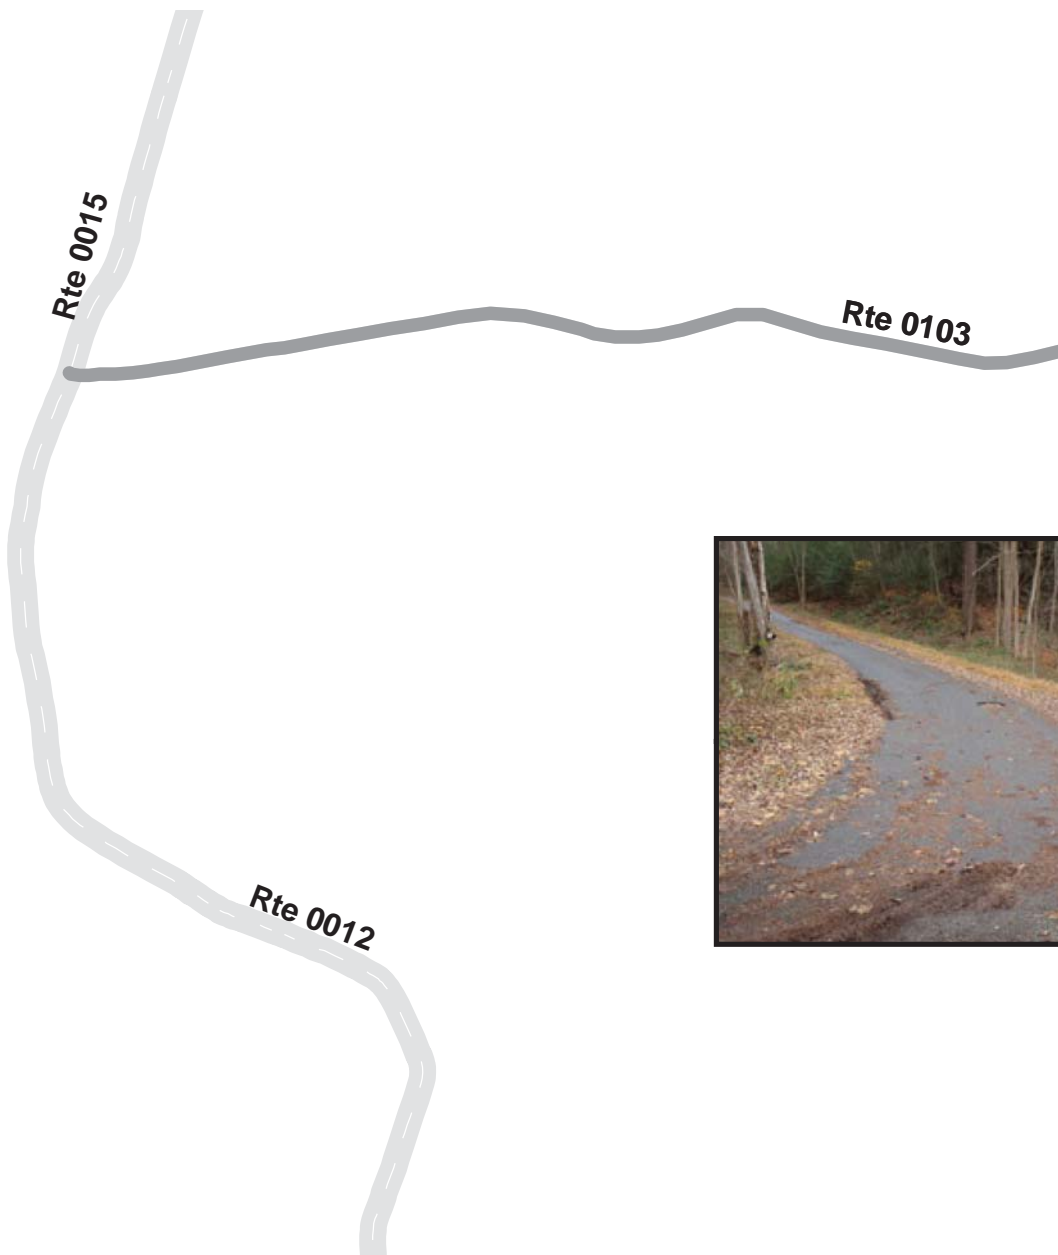
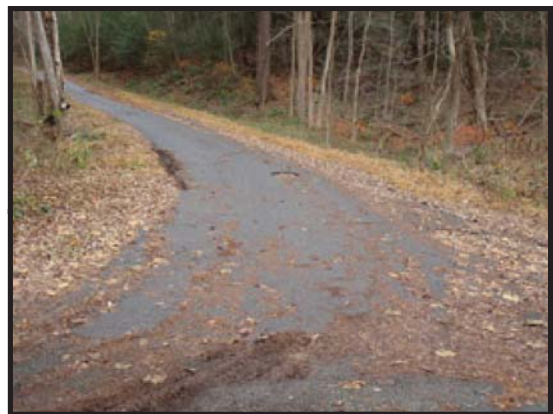
Route Number	Public / NonPublic	Date Visited		Area (sq ft)	Lane Miles *	Surface Type
0103	PUBLIC	11/7/2008		68,825	1.19	AS
Culverts	Drop Inlets	Gates	Fire Hydrants	Curb & Gutter	Curb	PCR
0	0	0	0	NO CURB AND GUTTER	NO CURB	POOR/45

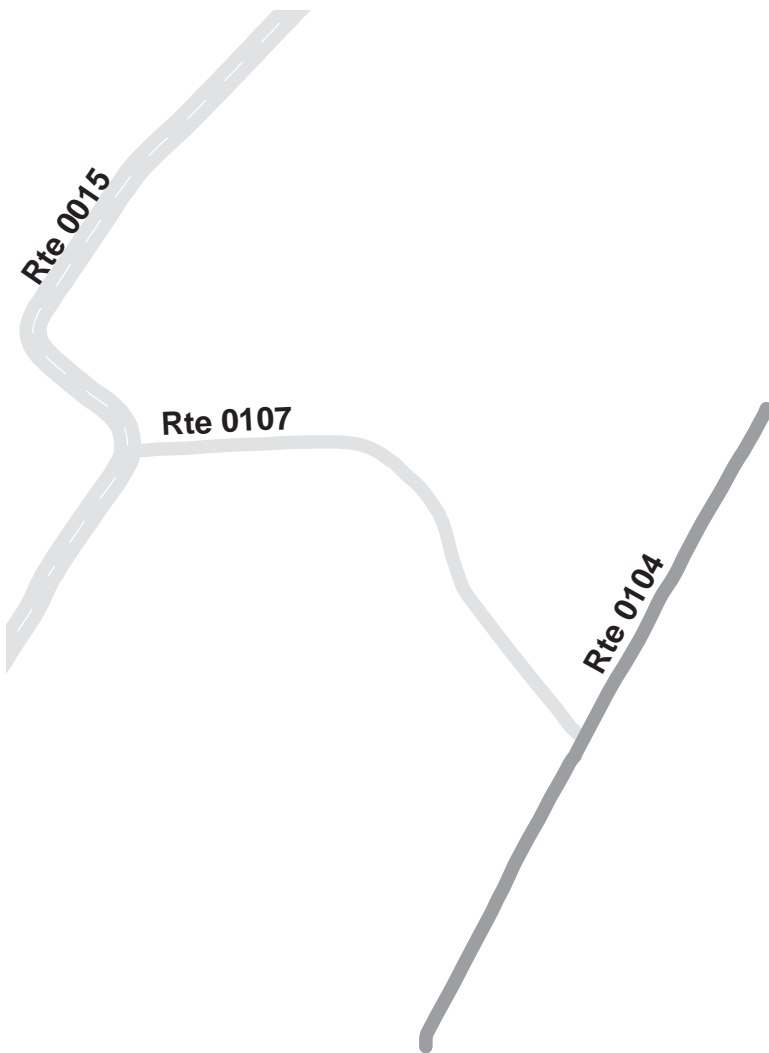
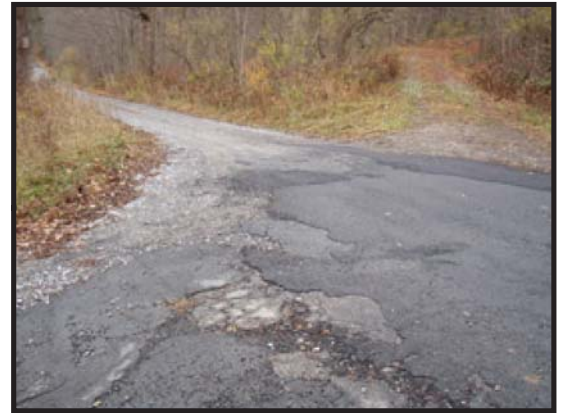
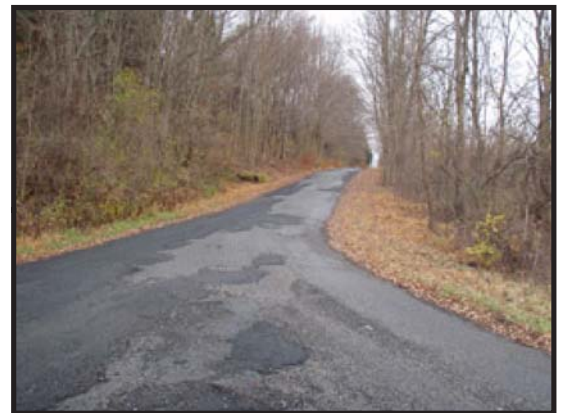
Route 0104

Route Number	Public / NonPublic	Date Visited		Area (sq ft)	Lane Miles *	Surface Type
0104	PUBLIC	11/7/2008		68,239	1.18	AS
Culverts	Drop Inlets	Gates	Fire Hydrants	Curb & Gutter	Curb	PCR
0	0	0	0	NO CURB AND GUTTER	NO CURB	POOR/45

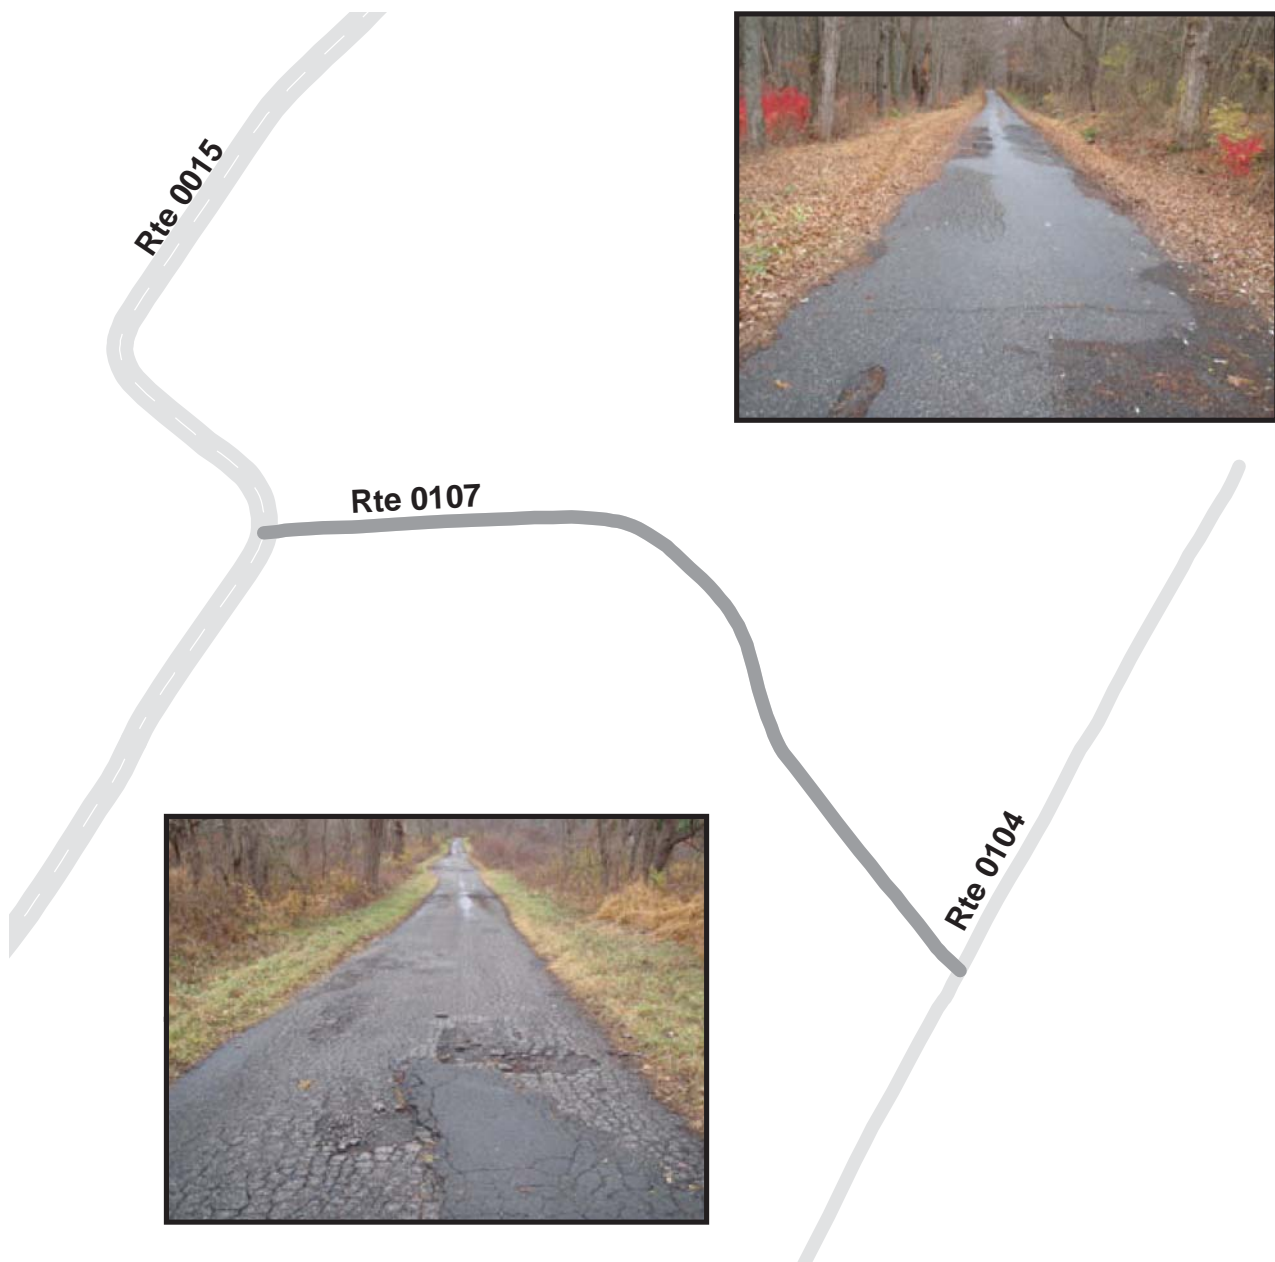
Route 0107

Route Number	Public / NonPublic	Date Visited		Area (sq ft)	Lane Miles *	Surface Type
0107	PUBLIC	11/7/2008		34,024	0.59	AS
Culverts	Drop Inlets	Gates	Fire Hydrants	Curb & Gutter	Curb	PCR
0	0	0	0	NO CURB AND GUTTER	NO CURB	POOR/45

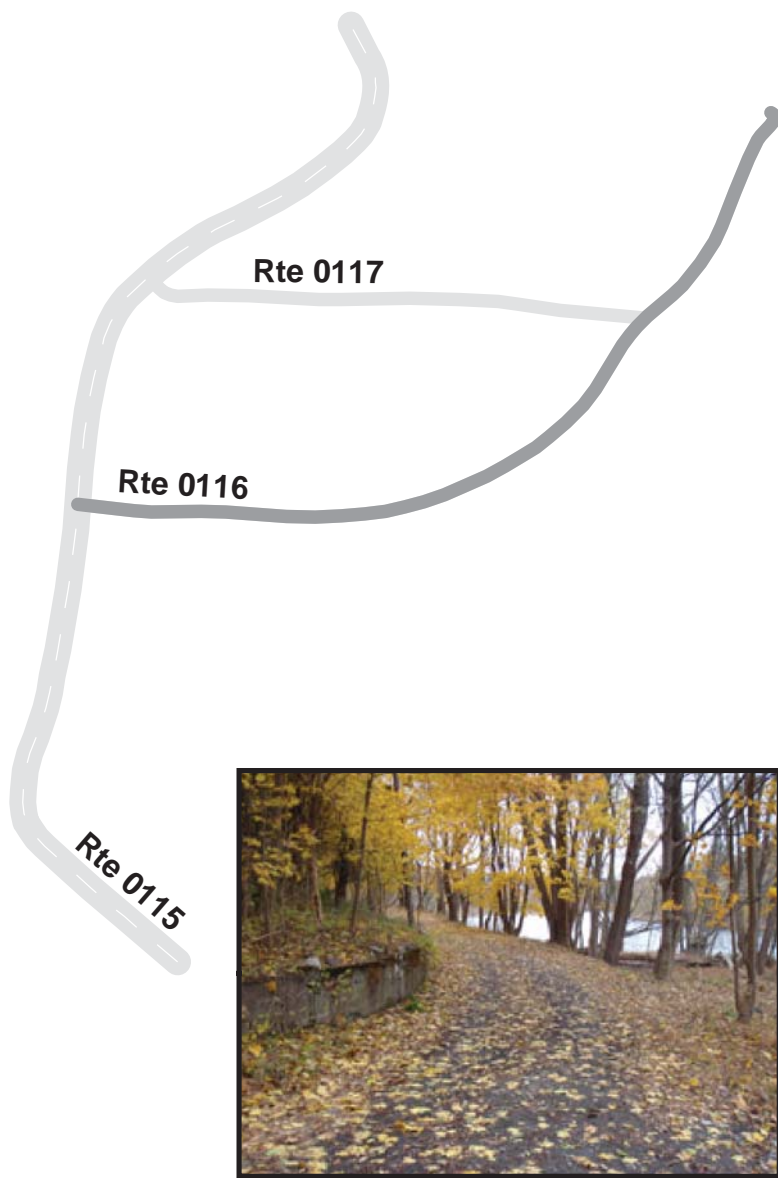
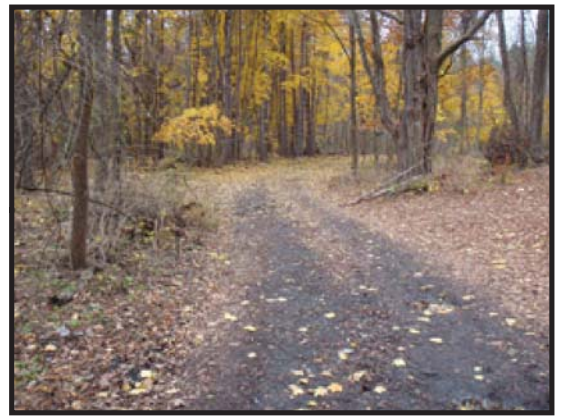
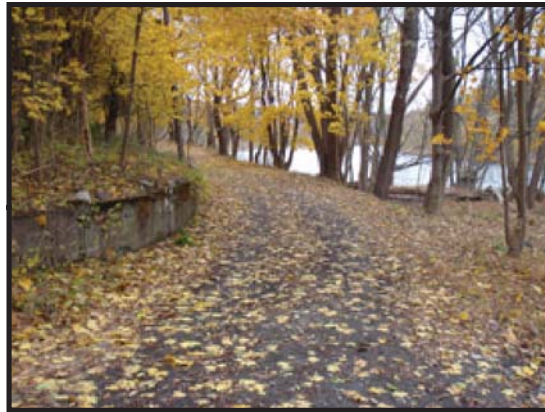
Route 0116

Route Number	Public / NonPublic	Date Visited		Area (sq ft)	Lane Miles *	Surface Type
0116	PUBLIC	11/6/2008		7,202	0.12	AS
Culverts	Drop Inlets	Gates	Fire Hydrants	Curb & Gutter	Curb	PCR
0	0	0	0	NO CURB AND GUTTER	NO CURB	POOR/45

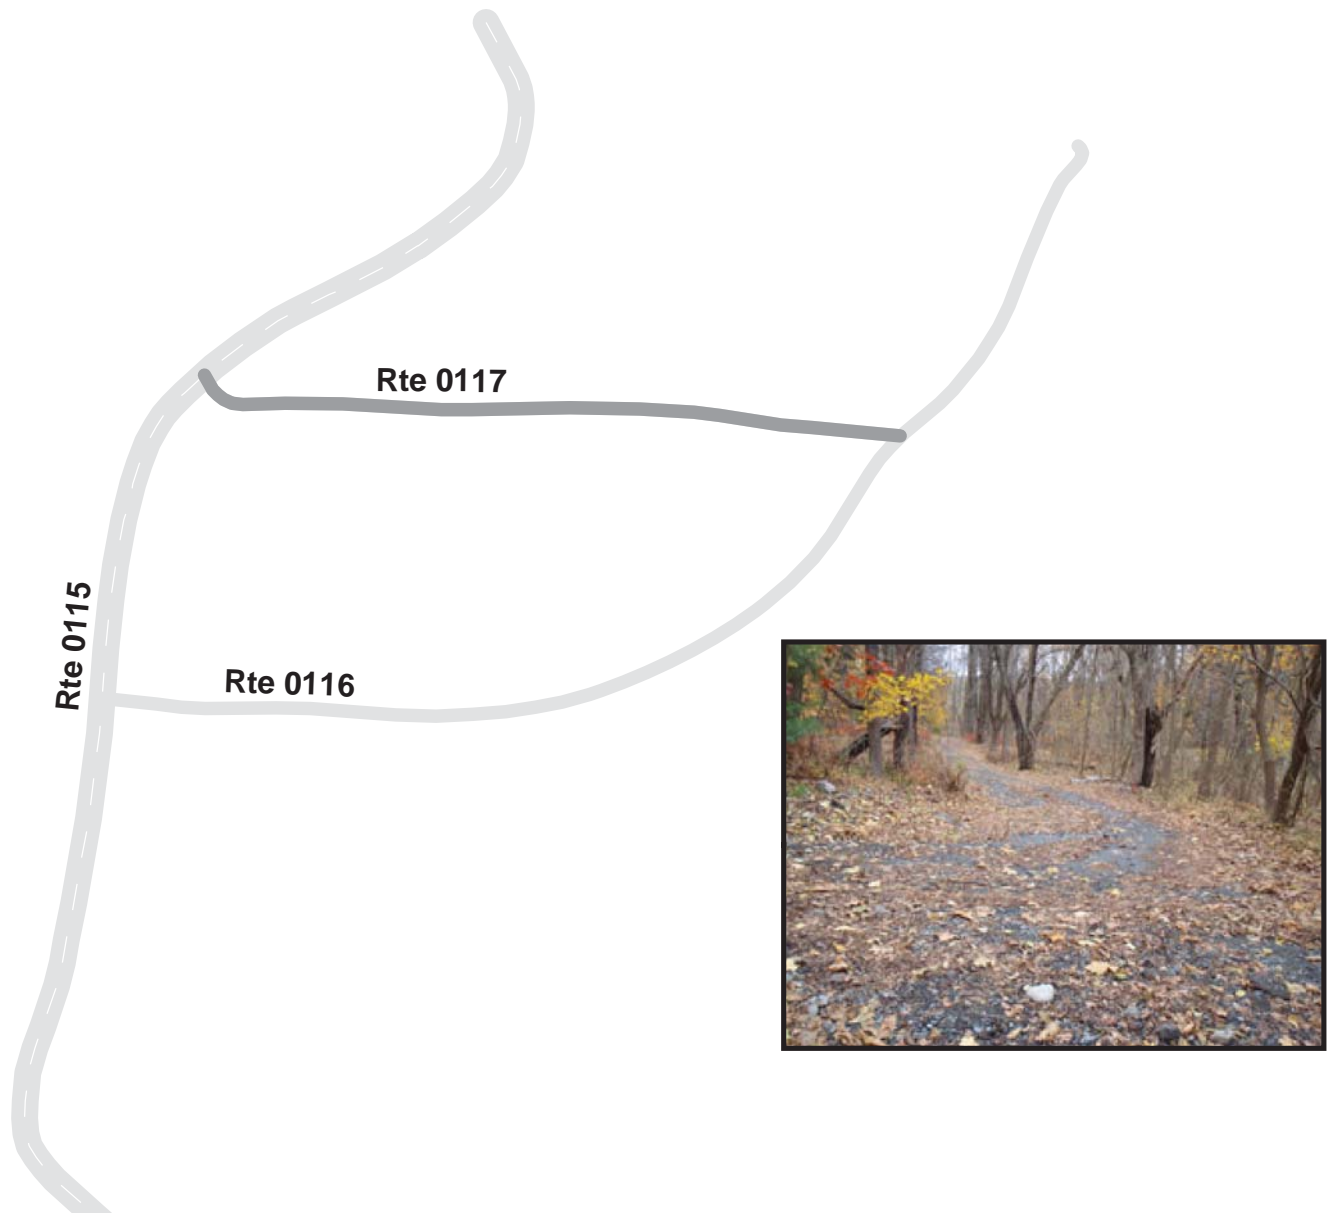
Route 0117

Route Number	Public / NonPublic	Date Visited		Area (sq ft)	Lane Miles *	Surface Type
0117	PUBLIC	11/6/2008		2,756	0.05	AS
Culverts	Drop Inlets	Gates	Fire Hydrants	Curb & Gutter	Curb	PCR
0	0	0	0	NO CURB AND GUTTER	NO CURB	POOR/45

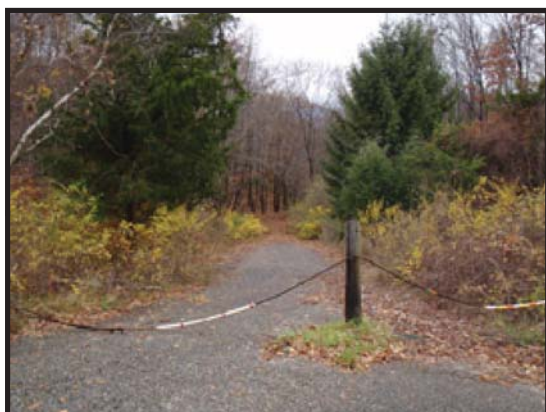
Route 0211

NOTE: No data was collected in Cycle 4 because the park has abandoned this road.

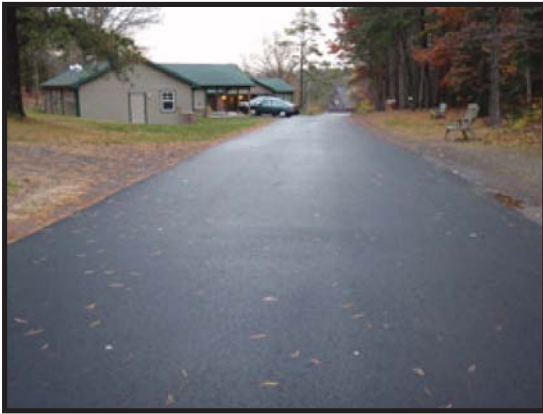
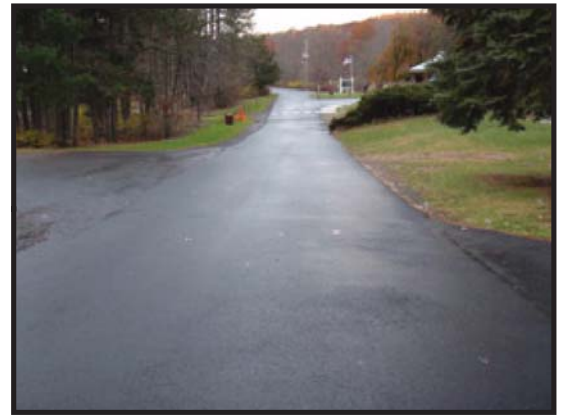
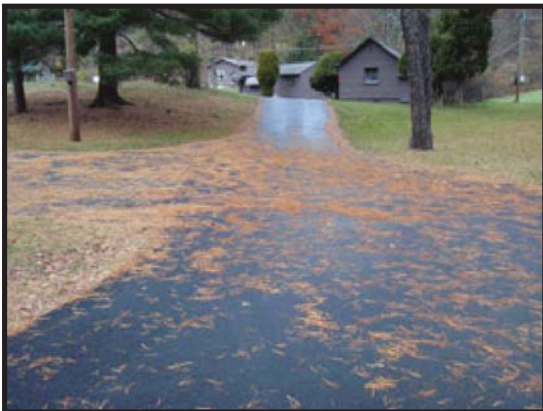
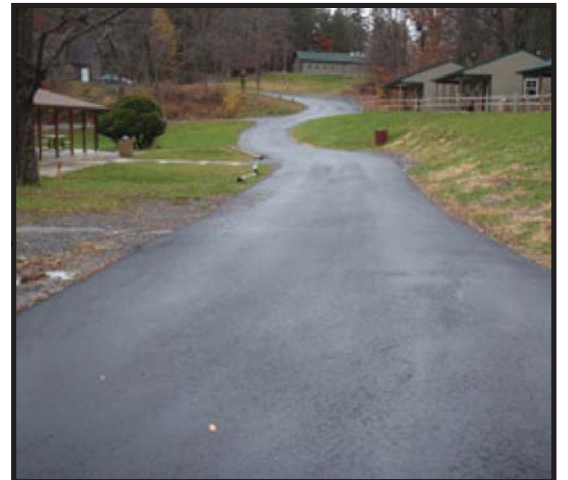
Route 0235

Route Number	Public / NonPublic	Date Visited		Area (sq ft)	Lane Miles *	Surface Type
0235	PUBLIC	11/7/2008		4,277	0.07	AS
Culverts	Drop Inlets	Gates	Fire Hydrants	Curb & Gutter	Curb	PCR
0	0	1	0	NO CURB AND GUTTER	NO CURB	POOR/45

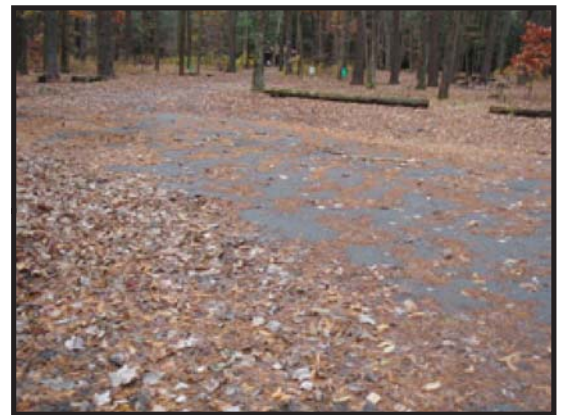
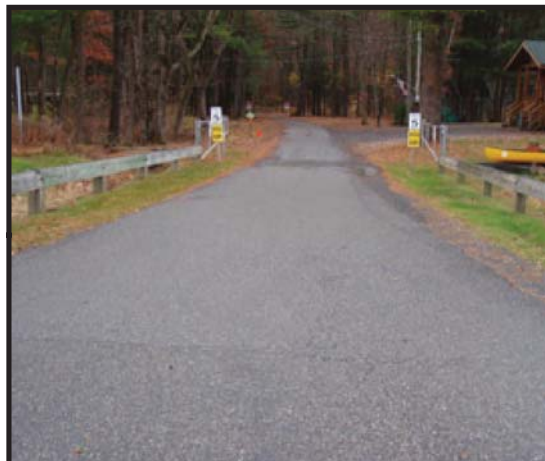
Route 0422

Route Number	Public / NonPublic	Date Visited		Area (sq ft)	Lane Miles *	Surface Type
0422	NONPUBLIC	11/6/2008		24,288	0.42	AS
Culverts	Drop Inlets	Gates	Fire Hydrants	Curb & Gutter	Curb	PCR
0	0	0	0	NO CURB AND GUTTER	NO CURB	EXCELLENT/97

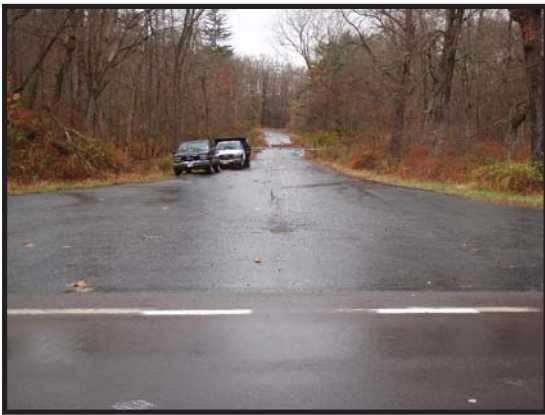
Route 0423

Route Number	Public / NonPublic	Date Visited		Area (sq ft)	Lane Miles *	Surface Type
0423	NONPUBLIC	11/7/2008		3,854	0.07	AS
Culverts	Drop Inlets	Gates	Fire Hydrants	Curb & Gutter	Curb	PCR
0	0	0	0	NO CURB AND GUTTER	NO CURB	EXCELLENT/97

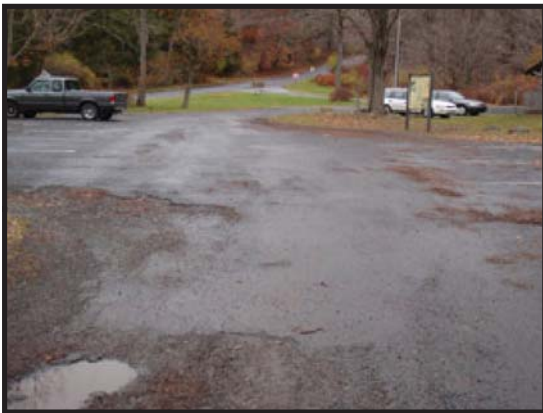
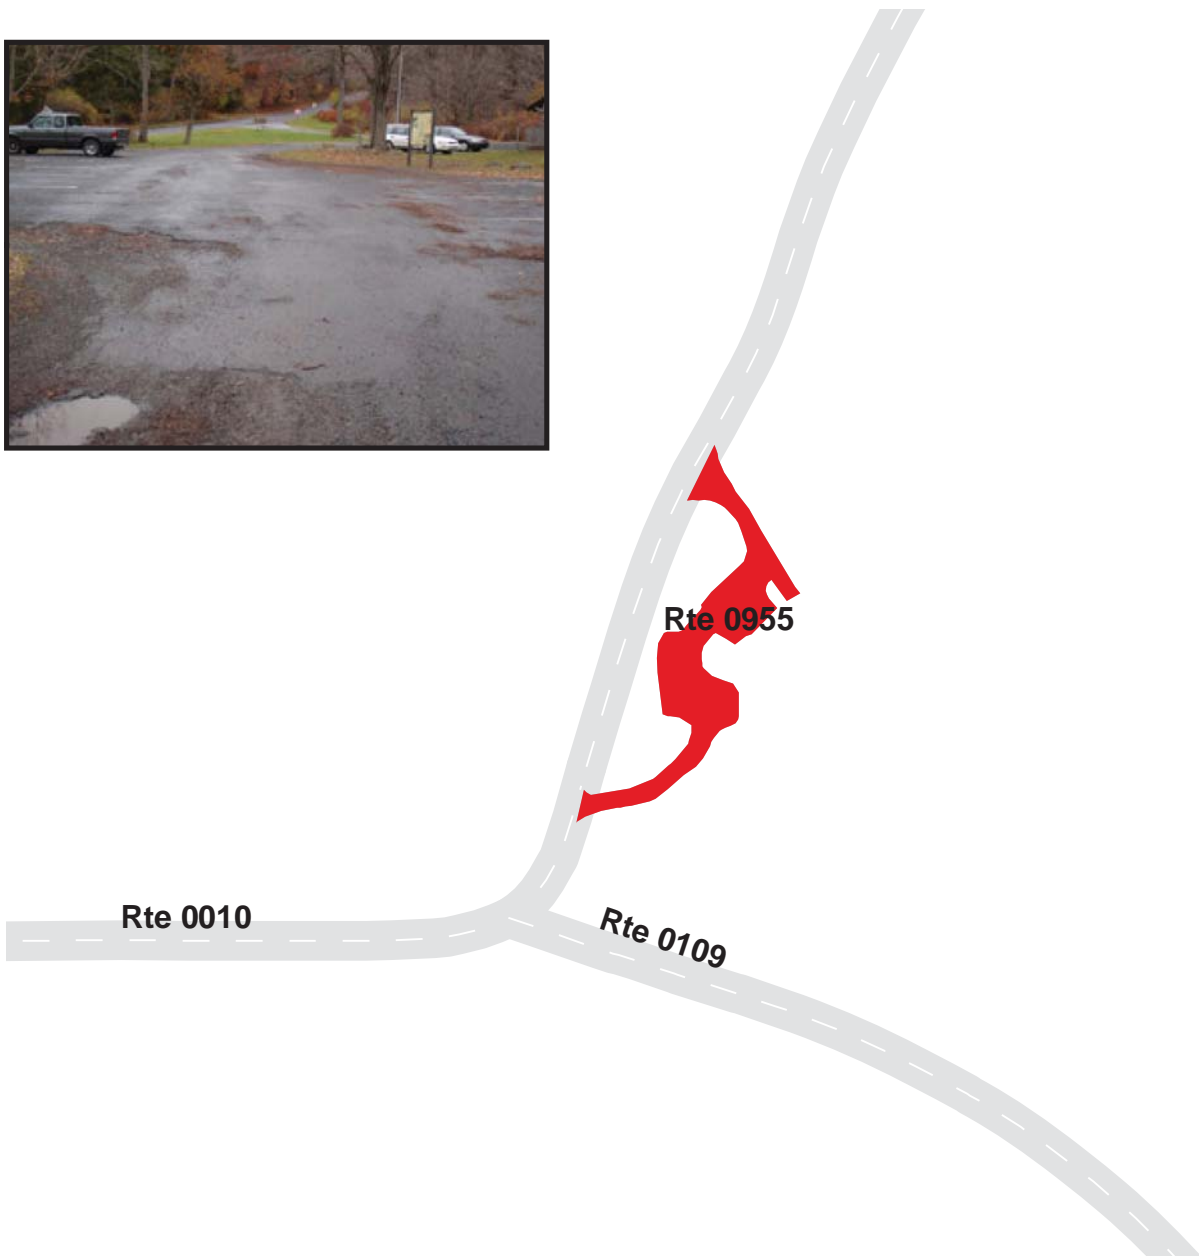
Route Number	Public / NonPublic	Date Visited		Area (sq ft)	Lane Miles *	Surface Type
0955	PUBLIC	11/7/2008		13,177	0.23	AS
Culverts	Drop Inlets	Gates	Fire Hydrants	Curb & Gutter	Curb	PCR
0	0	0	0	NO CURB AND GUTTER	NO CURB	POOR/45

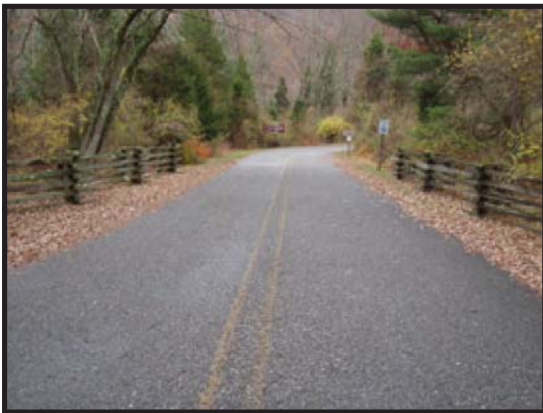
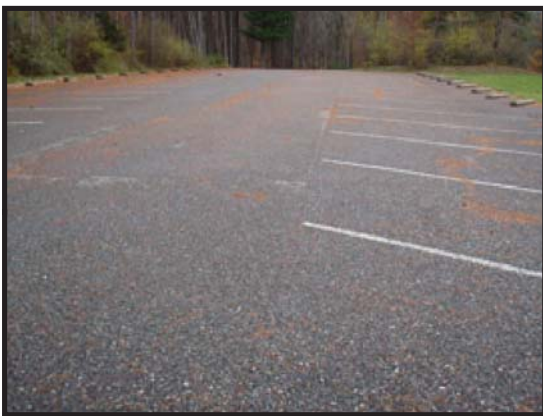
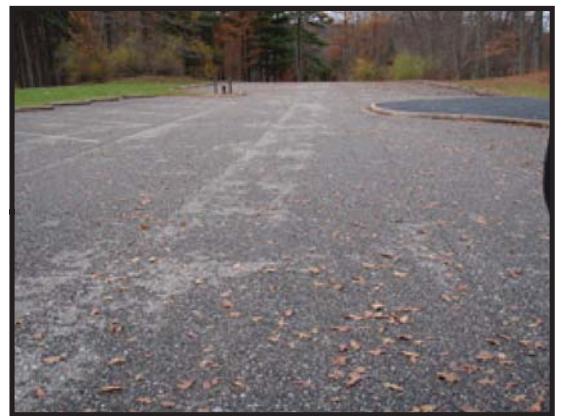
Route 0956

Route Number	Public / NonPublic	Date Visited		Area (sq ft)	Lane Miles *	Surface Type
0956	PUBLIC	11/7/2008		54,363	0.94	AS
Culverts	Drop Inlets	Gates	Fire Hydrants	Curb & Gutter	Curb	PCR
0	1	0	0	CONCRETE CURB AND GUTTER	CONCRETE CURB	GOOD/90

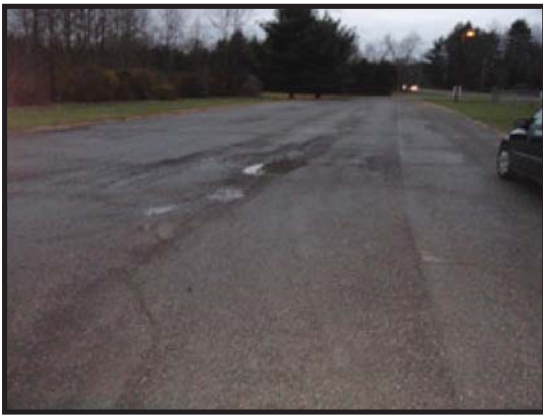
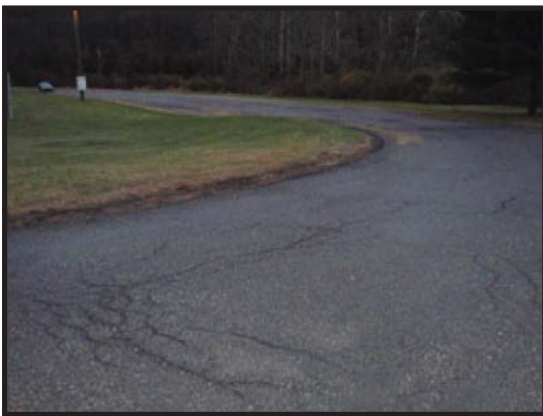
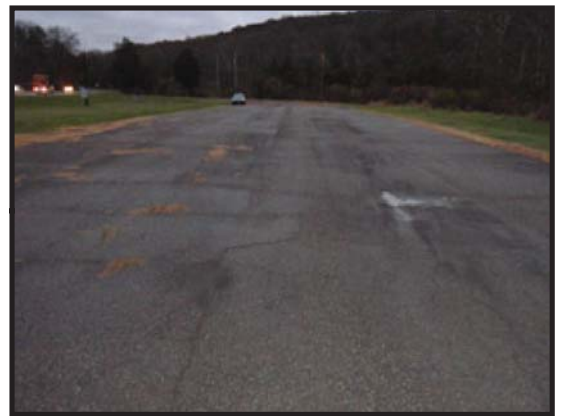
Route 0957

Route Number	Public / NonPublic	Date Visited		Area (sq ft)	Lane Miles *	Surface Type
0957	PUBLIC	11/6/2008		23,297	0.40	AS
Culverts	Drop Inlets	Gates	Fire Hydrants	Curb & Gutter	Curb	PCR
1	0	0	0	NO CURB AND GUTTER	NO CURB	POOR/45

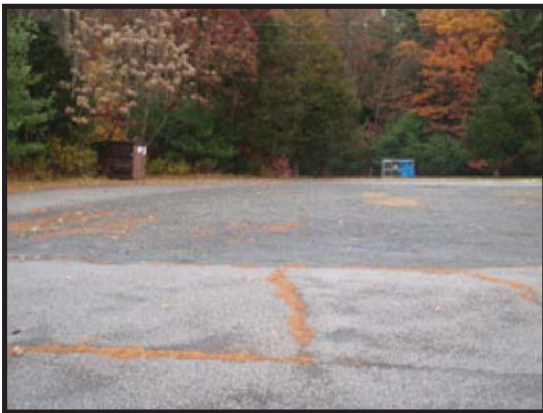
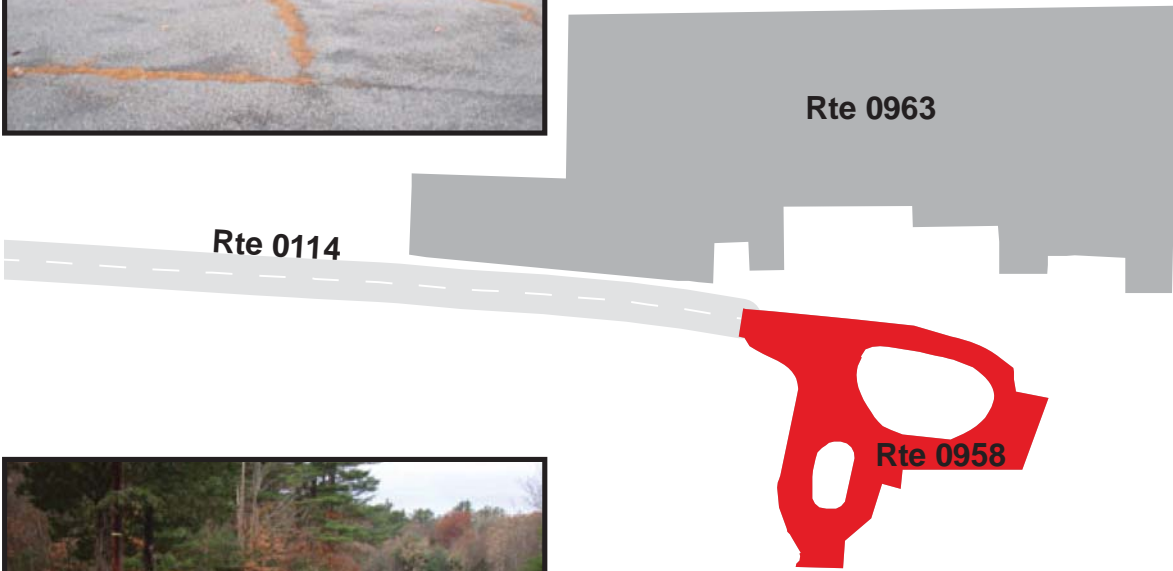
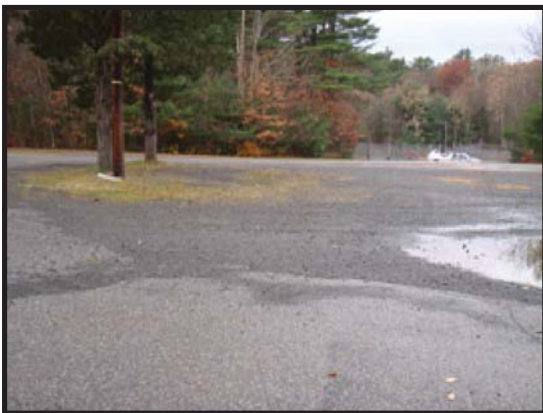
Route 0958

Route Number	Public / NonPublic	Date Visited		Area (sq ft)	Lane Miles *	Surface Type
0958	PUBLIC	11/6/2008		16,273	0.28	AS
Culverts	Drop Inlets	Gates	Fire Hydrants	Curb & Gutter	Curb	PCR
0	0	0	0	NO CURB AND GUTTER	NO CURB	POOR/45

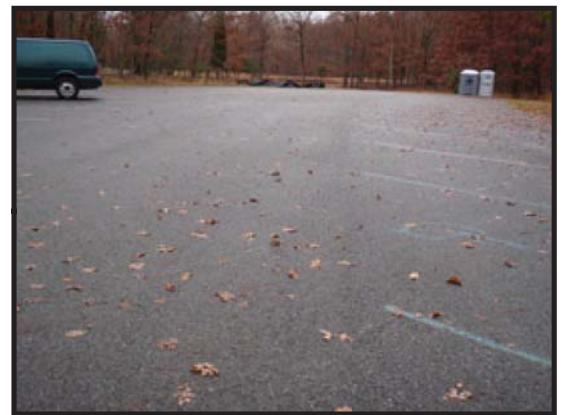
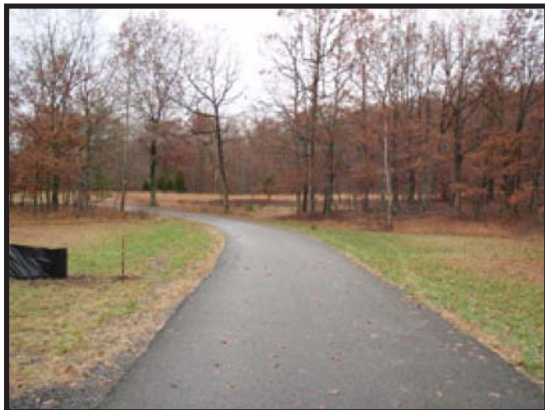
Route 0961

Route Number	Public / NonPublic	Date Visited		Area (sq ft)	Lane Miles *	Surface Type
0961	PUBLIC	11/7/2008		16,791	0.29	AS
Culverts	Drop Inlets	Gates	Fire Hydrants	Curb & Gutter	Curb	PCR
0	0	0	0	NO CURB AND GUTTER	NO CURB	GOOD/90

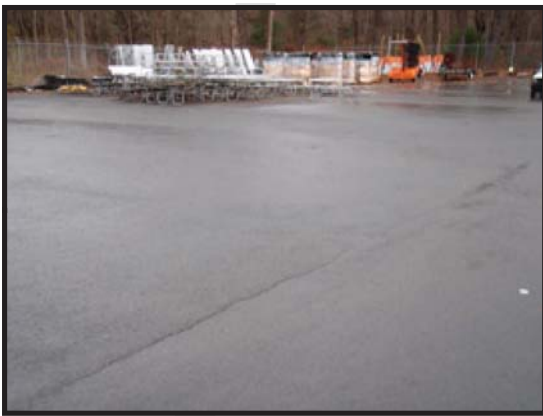
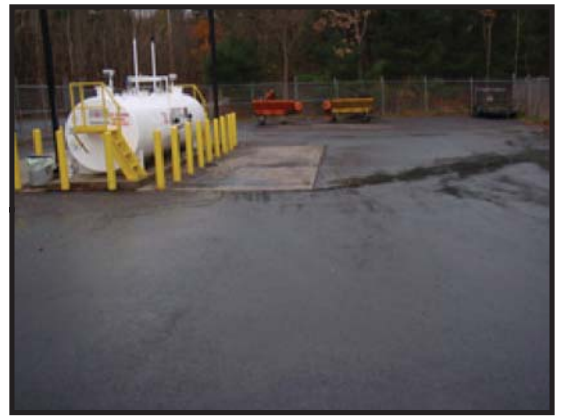
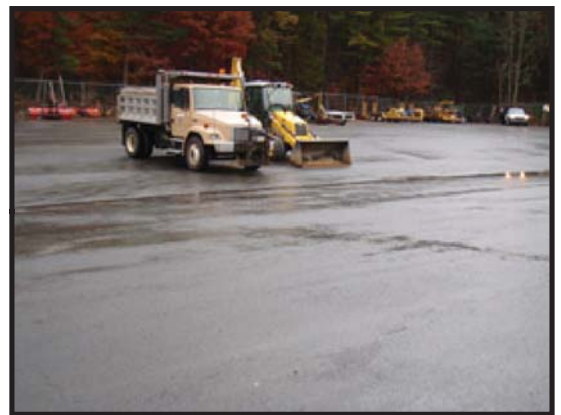
Route 0963

Route Number	Public / NonPublic	Date Visited		Area (sq ft)	Lane Miles *	Surface Type
0963	NONPUBLIC	11/7/2008		83,783	1.44	AS
Culverts	Drop Inlets	Gates	Fire Hydrants	Curb & Gutter	Curb	PCR
0	1	2	0	NO CURB AND GUTTER	NO CURB	GOOD/90
