**The Road Inventory
of
Eisenhower National Historic Site
EISE – 4410
Cycle 4**

**Prepared By:
Federal Highway Administration
Road Inventory Program
Cycle 4**

Eisenhower National Historic Site in Pennsylvania

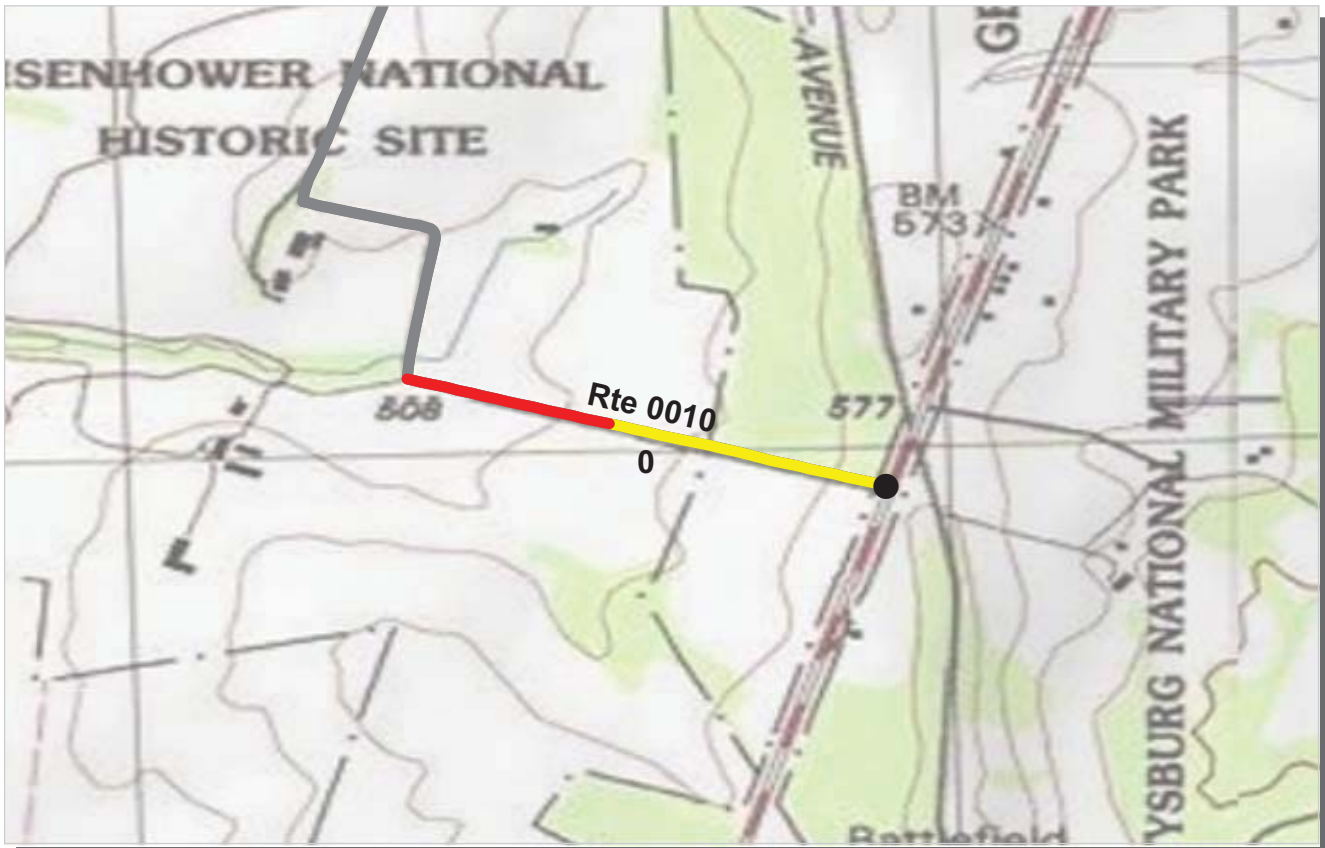
ROUTE: 0010 EISENHOWER BACK LANE

Section Number	0				
Section Length (mi)	0.38				
Traffic	Traffic data may be found at www.efl.fhwa.dot.gov Click on PROGRAMS / NPS Traffic Data (Note: Not all parks have traffic data)				
Cross Section Information					
Number of Lanes	2				
Paved Width (ft)	17				
Lane Width (ft)	9				
Shoulder Width Right (ft)	NC				
Shoulder Width Left (ft)	NC				
Roadway Condition Information					
SCR (Surface Condition Rating)	50				
PCR (Pavement Condition Rating)	58				
Distress Index Values					
Alligator Cracking Index	96				
Longitudinal Cracking Index	91				
Transverse Cracking Index	96				
Patching Index	100				
Rutting Index	68				
Roughness Condition Index (RCI)	72

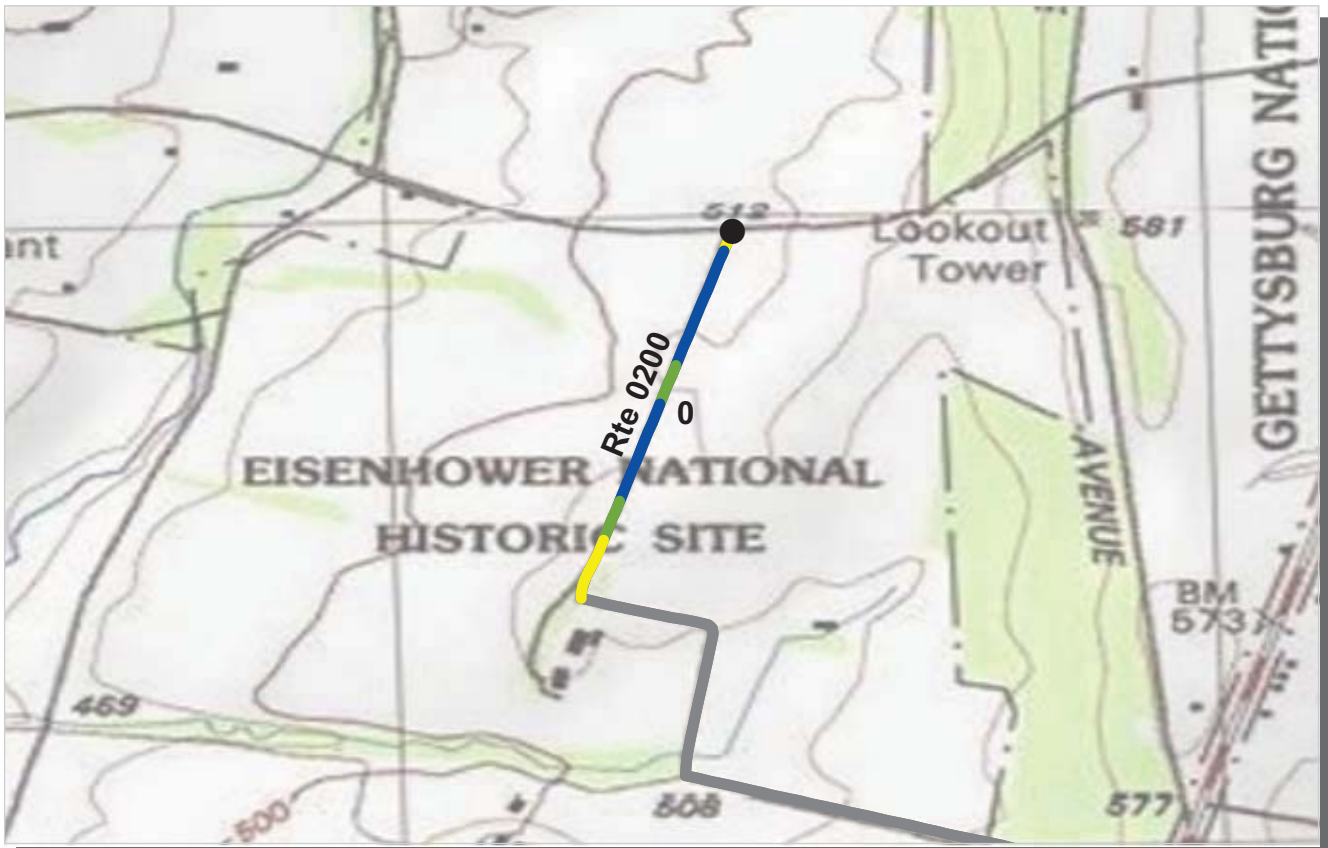
ROUTE: 0200 EISENHOWER DRIVE FARM 1

Section Number	0				
Section Length (mi)	0.38				
Traffic	Traffic data may be found at www.efl.fhwa.dot.gov Click on PROGRAMS / NPS Traffic Data (Note: Not all parks have traffic data)				
Cross Section Information					
Number of Lanes	1				
Paved Width (ft)	11				
Lane Width (ft)	11				
Shoulder Width Right (ft)	NC				
Shoulder Width Left (ft)	NC				
Roadway Condition Information					
SCR (Surface Condition Rating)	97				
PCR (Pavement Condition Rating)	92				
Distress Index Values					
Alligator Cracking Index	100				
Longitudinal Cracking Index	99				
Transverse Cracking Index	100				
Patching Index	100				
Rutting Index	99				
Roughness Condition Index (RCI)	83
