**The Road Inventory
of
Fort Washington Park
FOWA – 3551
Cycle 4**

**Prepared By:
Federal Highway Administration
Road Inventory Program
Cycle 4**

Fort Washington Park in Maryland

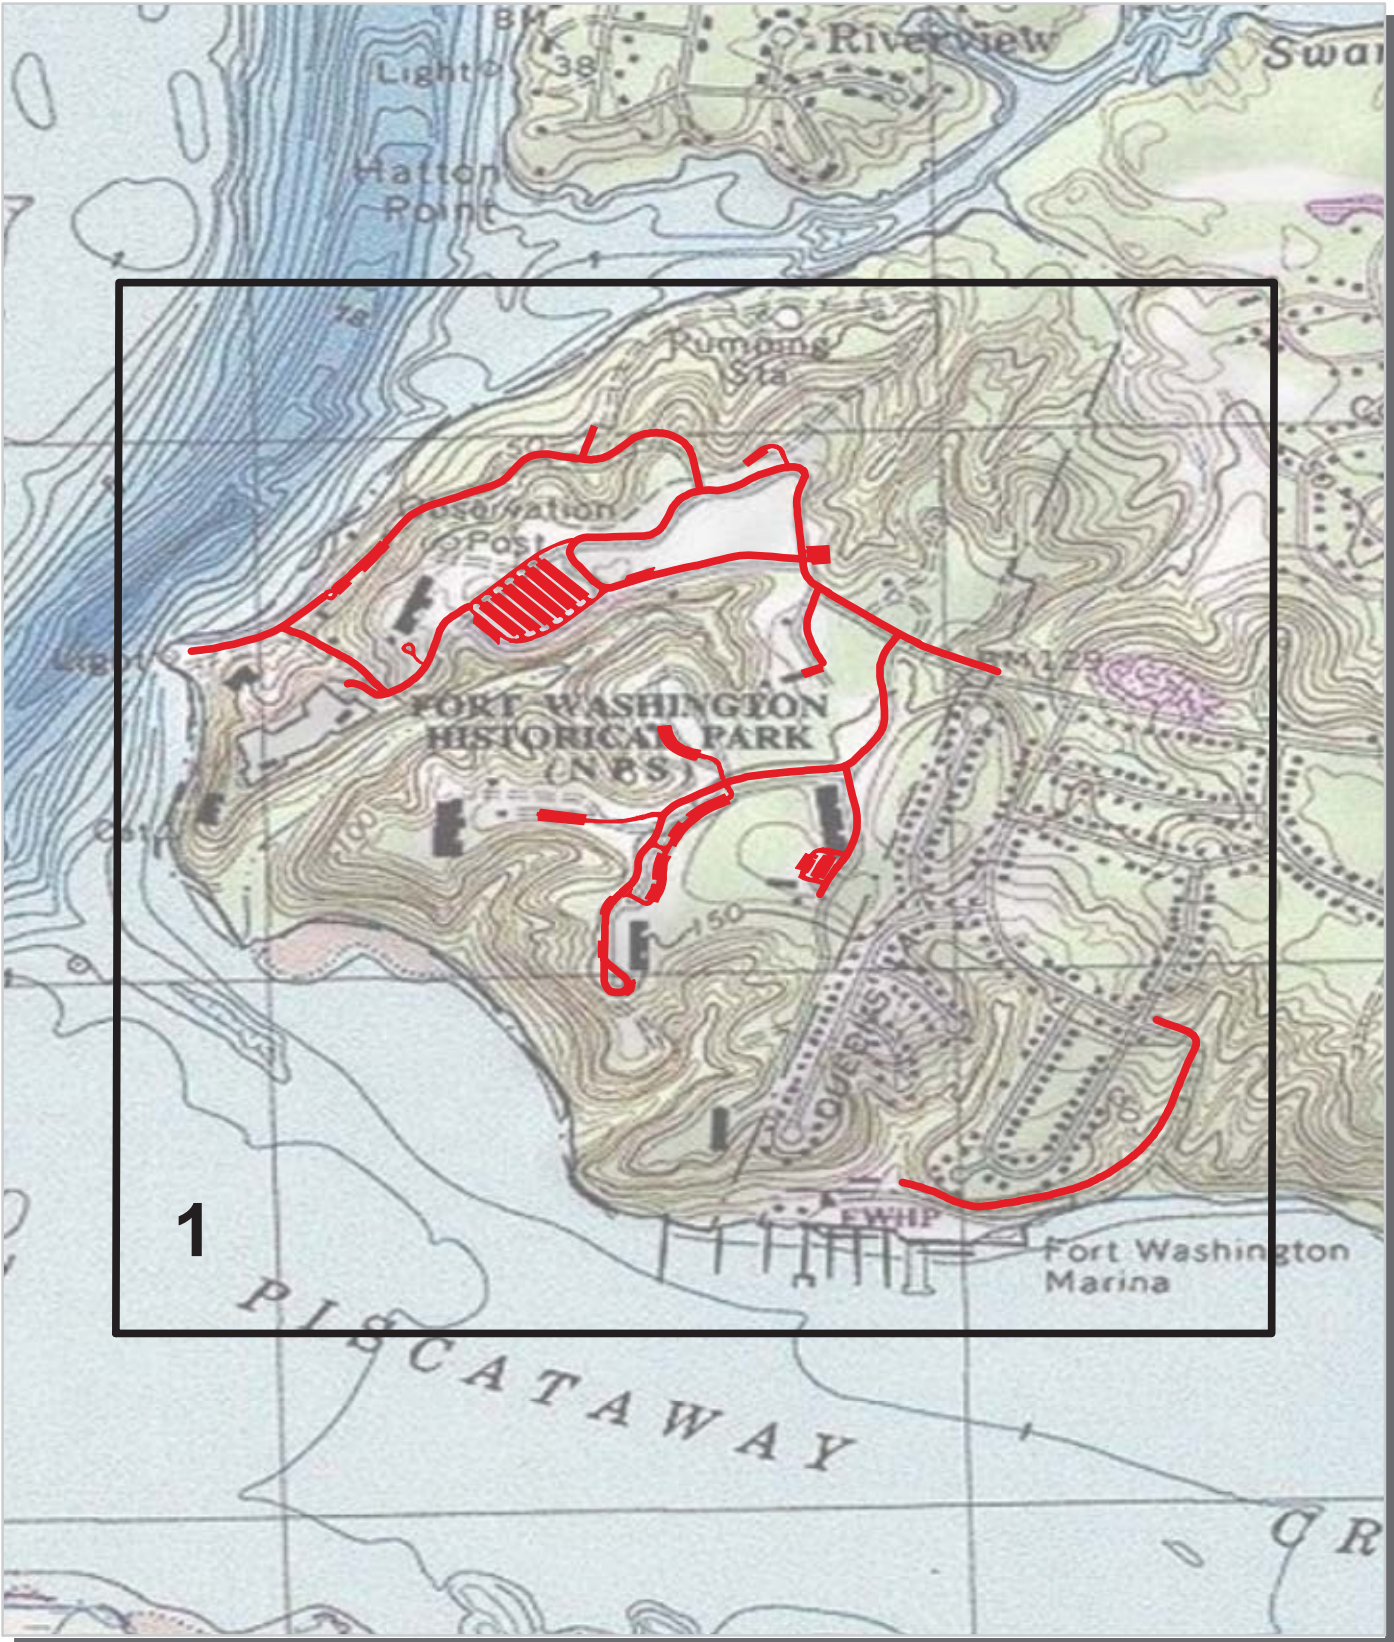
**Fort Washington Park
Route Location Map
Key Map**

— Park Owned Routes
