**The Road Inventory
of
Fredericksburg and Spotsylvania
National Military Park
FRSP – 4370
Cycle 4**

**Prepared By:
Federal Highway Administration
Road Inventory Program
Cycle 4**

Fredericksburg and Spotsylvania National Military Park in Virginia

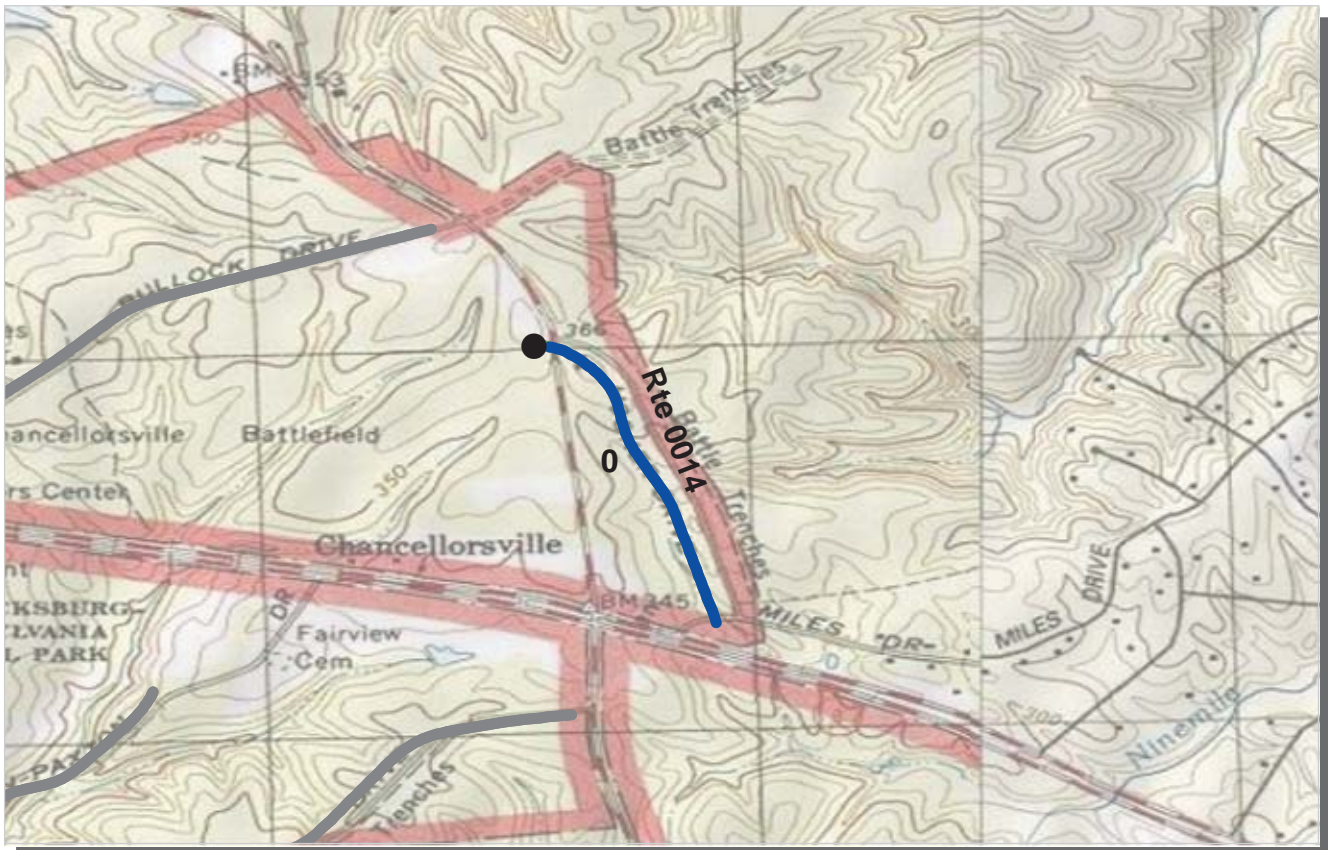
ROUTE: 0013 MCLAWS-FURNACE-SICKLES-STUART-BULLOCK DRIVE

Section Number	0	1	2	3	4
Section Length (mi)	1.00	1.00	1.00	1.00	0.69
Traffic	Traffic data may be found at www.efl.fhwa.dot.gov Click on PROGRAMS / NPS Traffic Data (Note: Not all parks have traffic data)				
Cross Section Information					
Number of Lanes	2	2	2	2	2
Paved Width (ft)	20	20	21	21	16
Lane Width (ft)	10	10	11	10	14
Shoulder Width Right (ft)	NC	NC	NC	NC	NC
Shoulder Width Left (ft)	NC	NC	NC	NC	NC
Roadway Condition Information					
SCR (Surface Condition Rating)	67	100	98	97	100
PCR (Pavement Condition Rating)	74	98	95	95	99
Distress Index Values					
Alligator Cracking Index	90	100	100	100	100
Longitudinal Cracking Index	90	100	98	98	100
Transverse Cracking Index	93	100	100	99	100
Patching Index	100	100	100	100	100
Rutting Index	95	100	100	100	100
Roughness Condition Index (RCI)	85	96	91	93	97

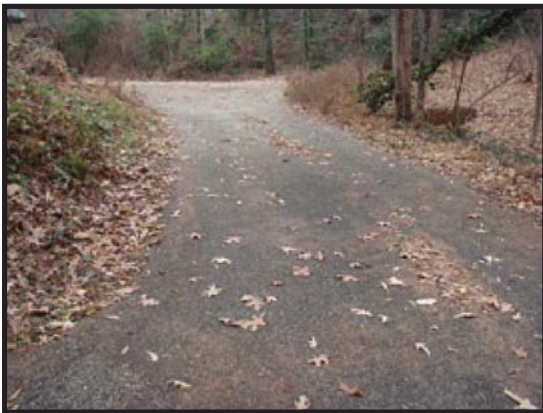
Route Number	Public / NonPublic	Date Visited		Area (sq ft)	Lane Miles *	Surface Type
0402B	PUBLIC	12/8/2008		755	0.01	AS
Culverts	Drop Inlets	Gates	Fire Hydrants	Curb & Gutter	Curb	PCR
0	0	0	0	NO CURB AND GUTTER	NO CURB	POOR/45

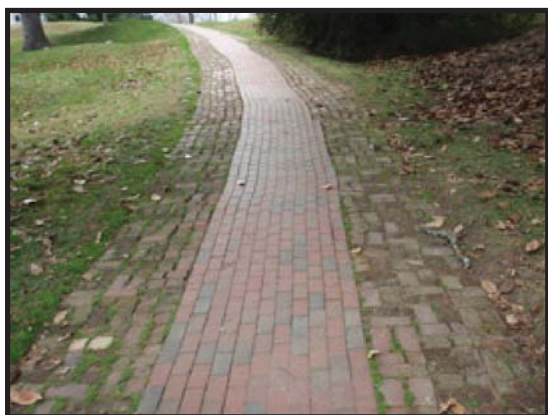
Route 0408

Route Number	Public / NonPublic	Date Visited		Area (sq ft)	Lane Miles *	Surface Type
0408	PUBLIC	12/9/2008		3,089	0.05	BR
Culverts	Drop Inlets	Gates	Fire Hydrants	Curb & Gutter	Curb	PCR
0	0	0	0	NO CURB AND GUTTER	NO CURB	GOOD/90

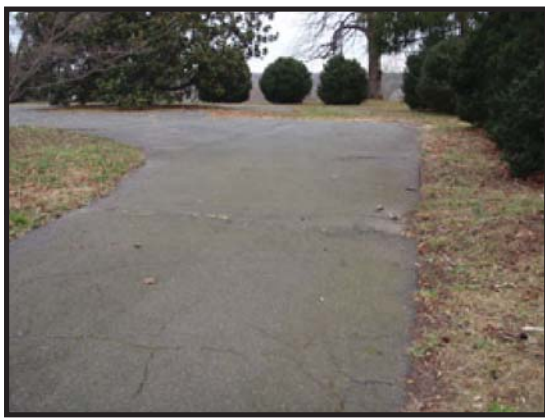
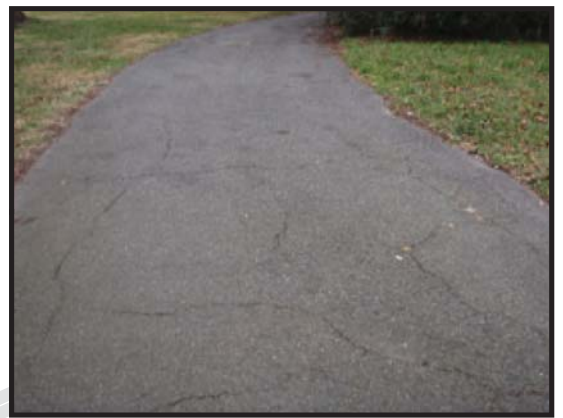
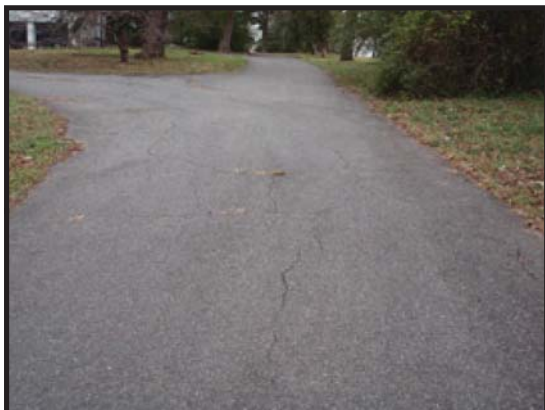
Route 0503B

Route Number	Public / NonPublic	Date Visited		Area (sq ft)	Lane Miles *	Surface Type
0503B	PUBLIC	12/9/2008		4,594	0.08	AS
Culverts	Drop Inlets	Gates	Fire Hydrants	Curb & Gutter	Curb	PCR
0	0	0	0	NO CURB AND GUTTER	NO CURB	POOR/45

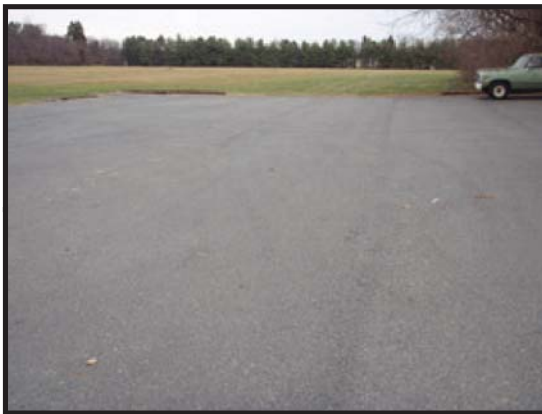
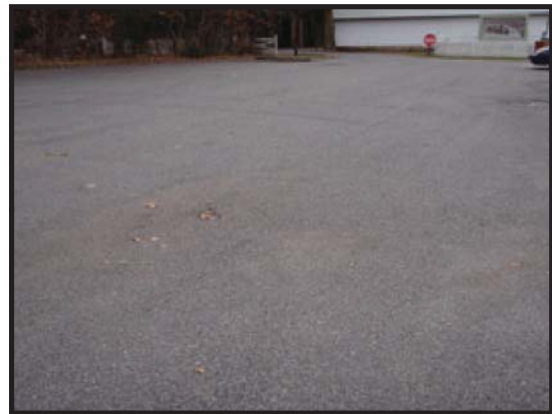
Route Number	Public / NonPublic	Date Visited		Area (sq ft)	Lane Miles *	Surface Type
0902	PUBLIC	12/9/2008		7,126	0.12	AS
Culverts	Drop Inlets	Gates	Fire Hydrants	Curb & Gutter	Curb	PCR
0	1	0	0	NO CURB AND GUTTER	NO CURB	FAIR/73

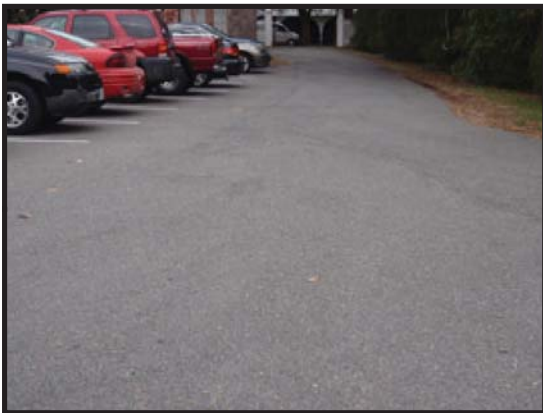
Route 0903

Route Number	Public / NonPublic	Date Visited		Area (sq ft)	Lane Miles *	Surface Type
0903	PUBLIC	12/9/2008		10,568	0.18	AS
Culverts	Drop Inlets	Gates	Fire Hydrants	Curb & Gutter	Curb	PCR
0	0	0	0	NO CURB AND GUTTER	NO CURB	FAIR/73

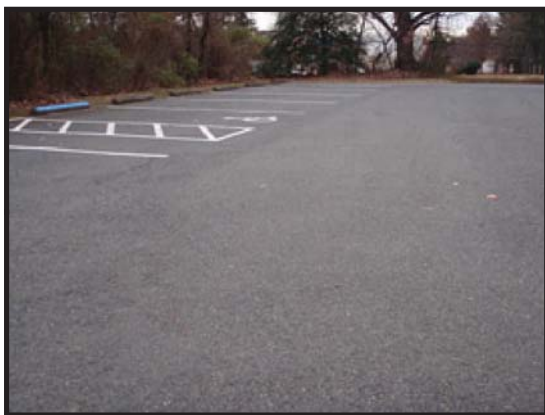
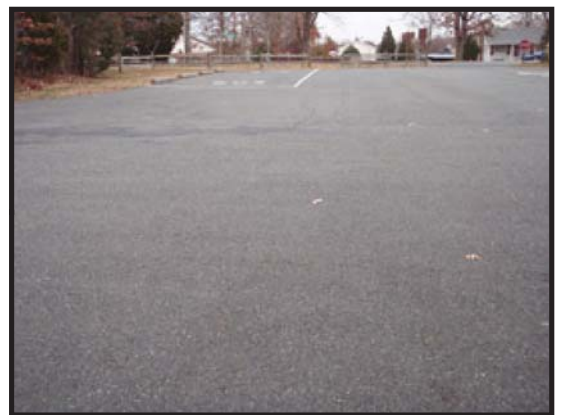
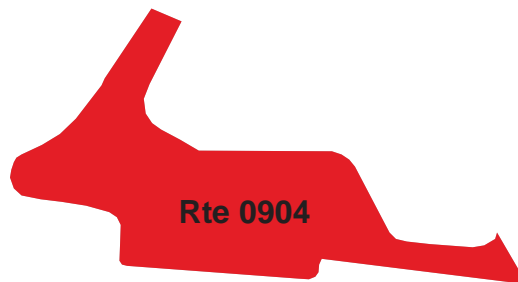
Route 0904

Route Number	Public / NonPublic	Date Visited		Area (sq ft)	Lane Miles *	Surface Type
0904	PUBLIC	12/9/2008		9,098	0.16	AS
Culverts	Drop Inlets	Gates	Fire Hydrants	Curb & Gutter	Curb	PCR
0	0	0	0	NO CURB AND GUTTER	NO CURB	FAIR/73

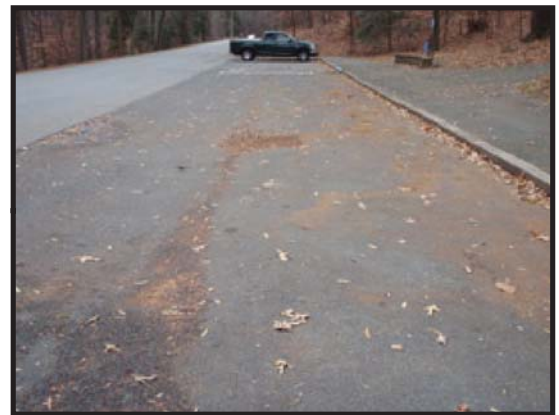
Route 0905

Route Number	Public / NonPublic	Date Visited		Area (sq ft)	Lane Miles *	Surface Type
0905	PUBLIC	12/9/2008		2,547	0.04	AS
Culverts	Drop Inlets	Gates	Fire Hydrants	Curb & Gutter	Curb	PCR
0	1	0	0	NO CURB AND GUTTER	CONCRETE CURB	GOOD/90

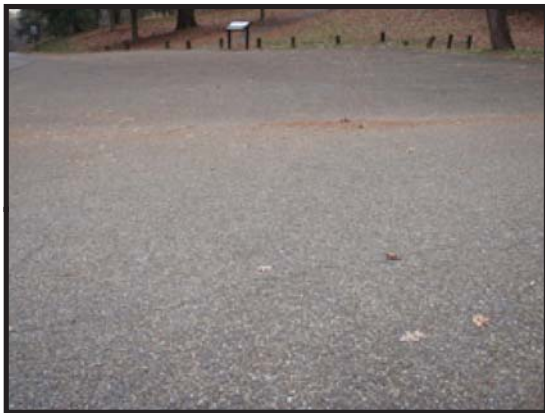
Route 0906

Route Number	Public / NonPublic	Date Visited		Area (sq ft)	Lane Miles *	Surface Type
0906	PUBLIC	12/9/2008		4,430	0.08	AS
Culverts	Drop Inlets	Gates	Fire Hydrants	Curb & Gutter	Curb	PCR
0	0	0	0	NO CURB AND GUTTER	NO CURB	FAIR/73

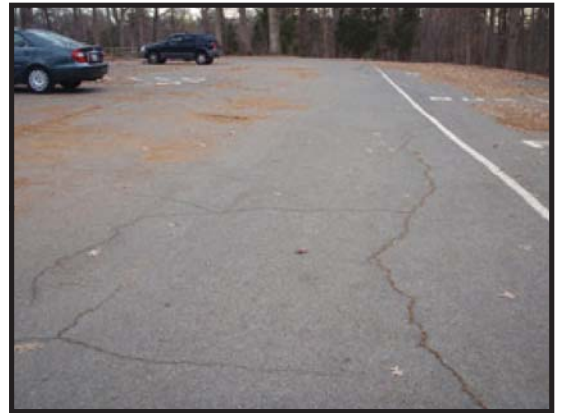
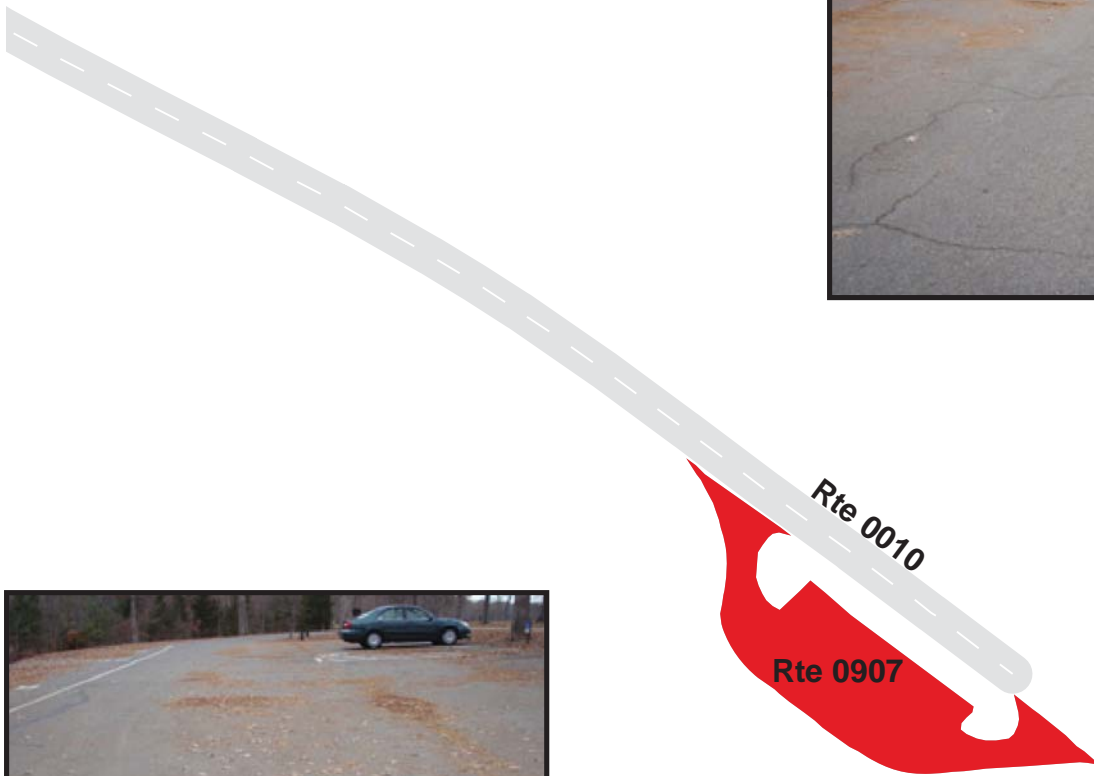
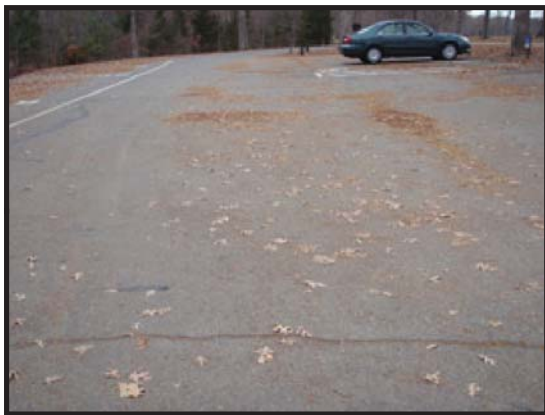
Route 0907

Route Number	Public / NonPublic	Date Visited		Area (sq ft)	Lane Miles *	Surface Type
0907	PUBLIC	12/9/2008		9,601	0.17	AS
Culverts	Drop Inlets	Gates	Fire Hydrants	Curb & Gutter	Curb	PCR
0	0	0	0	NO CURB AND GUTTER	NO CURB	GOOD/90

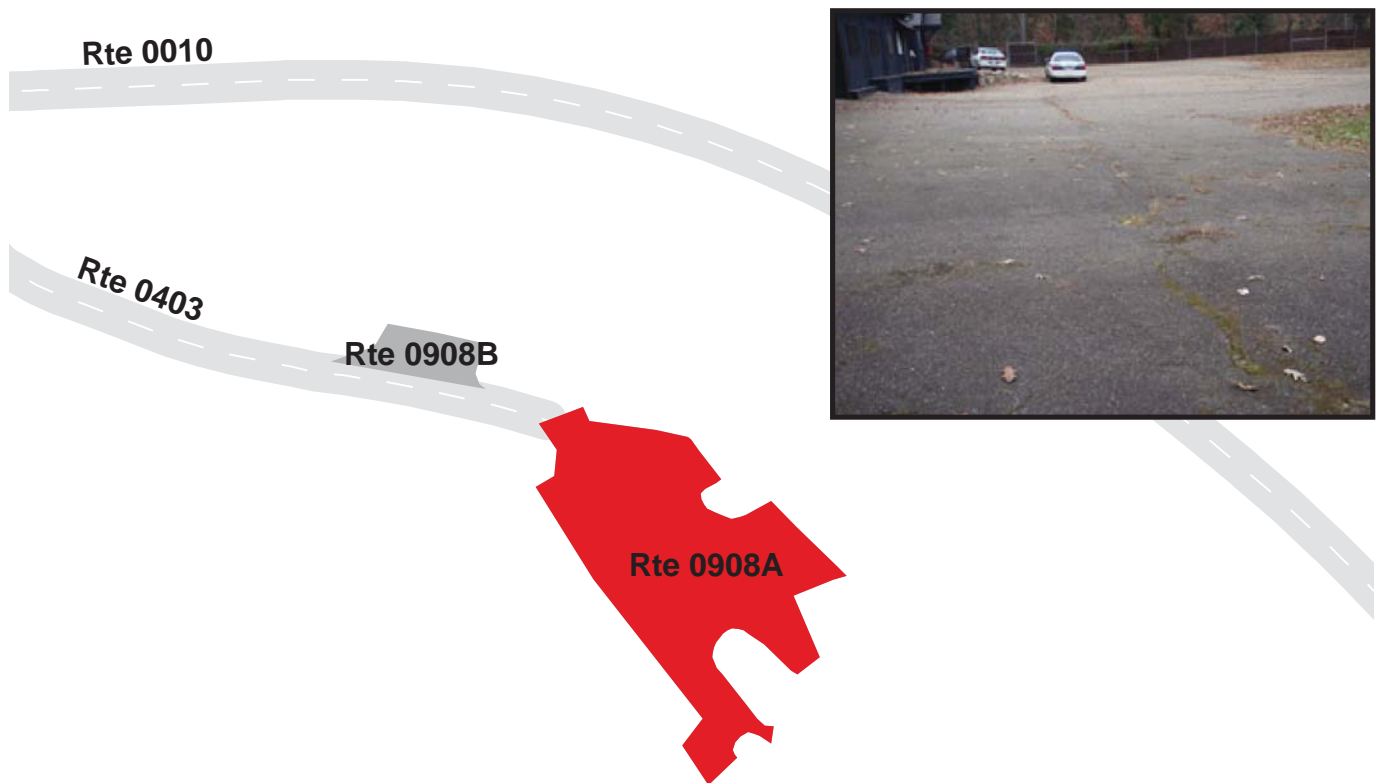
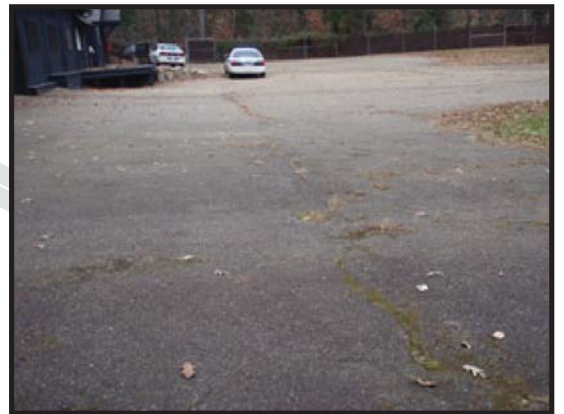
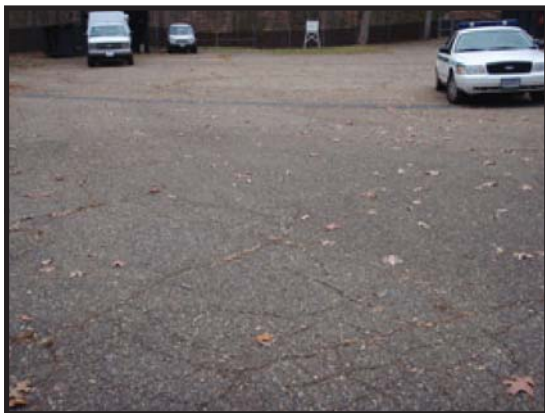
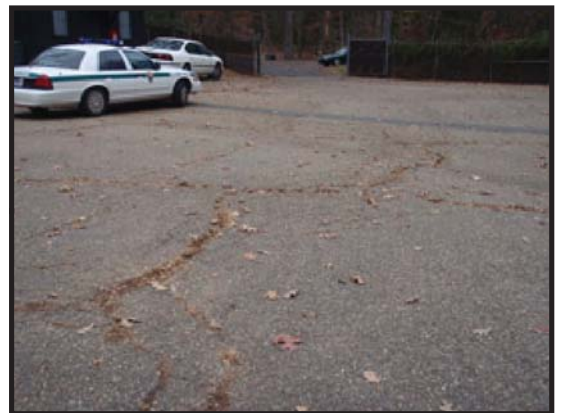
Route 0908A

Route Number	Public / NonPublic	Date Visited		Area (sq ft)	Lane Miles *	Surface Type
0908A	NONPUBLIC	12/9/2008		11,500	0.20	AS
Culverts	Drop Inlets	Gates	Fire Hydrants	Curb & Gutter	Curb	PCR
0	0	1	0	NO CURB AND GUTTER	NO CURB	POOR/45

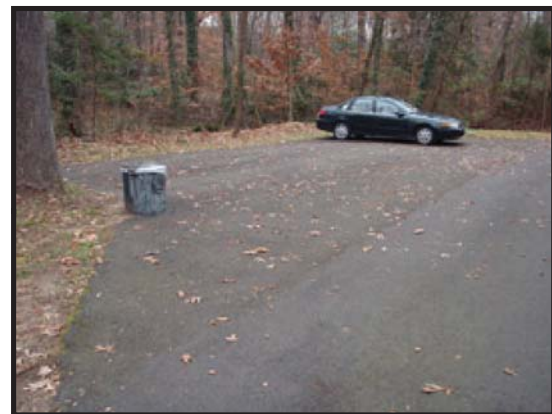
Route 0908B

Route Number	Public / NonPublic	Date Visited		Area (sq ft)	Lane Miles *	Surface Type
0908B	PUBLIC	12/9/2008		1,231	0.02	AS
Culverts	Drop Inlets	Gates	Fire Hydrants	Curb & Gutter	Curb	PCR
0	0	0	0	NO CURB AND GUTTER	NO CURB	GOOD/90

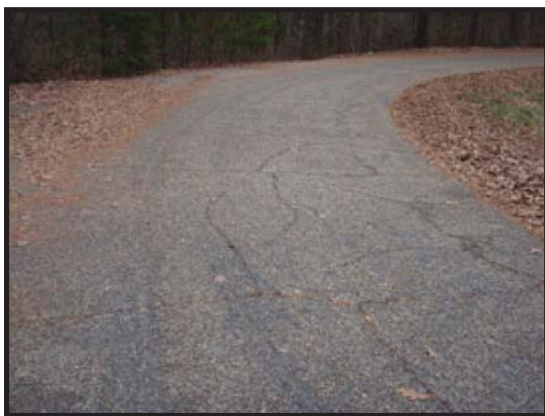
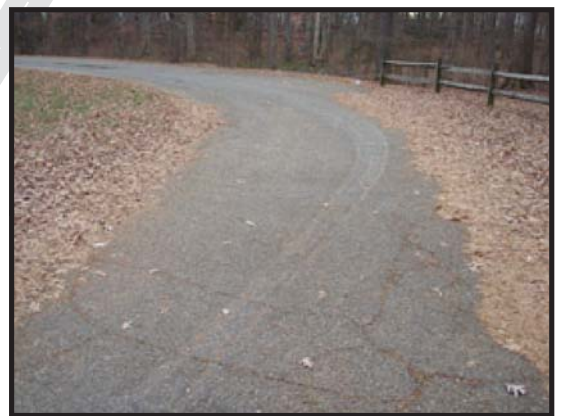
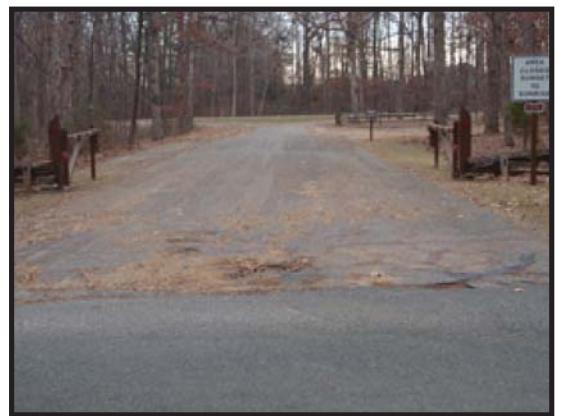
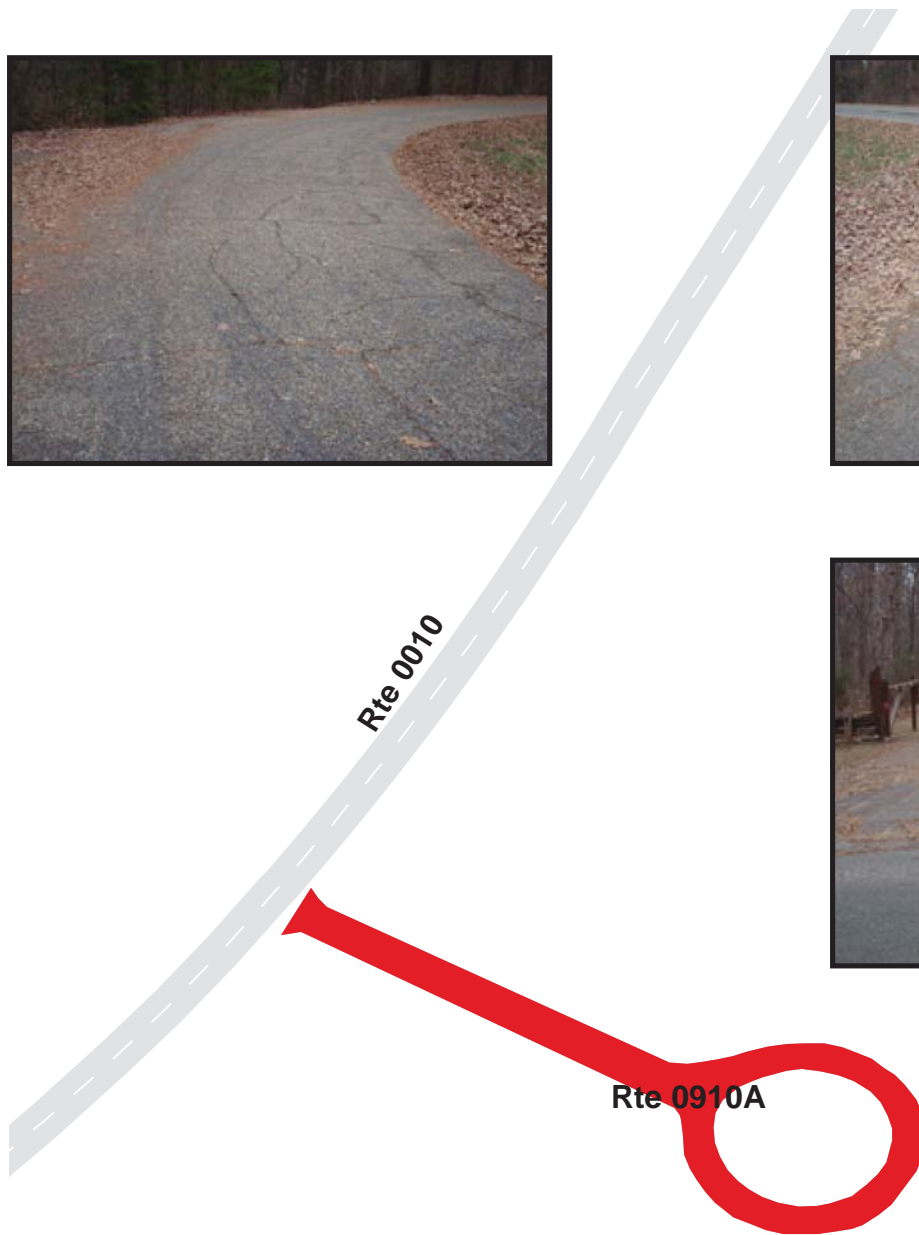
Route Number	Public / NonPublic	Date Visited		Area (sq ft)	Lane Miles *	Surface Type
0910A	PUBLIC	12/9/2008		14,263	0.25	AS
Culverts	Drop Inlets	Gates	Fire Hydrants	Curb & Gutter	Curb	PCR
1	1	1	0	NO CURB AND GUTTER	NO CURB	FAIR/73

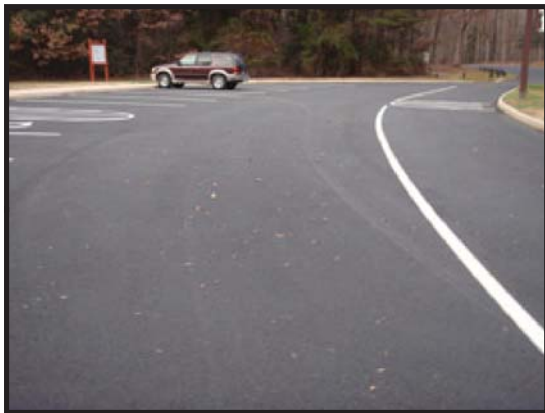
Route 0912

Route Number	Public / NonPublic	Date Visited		Area (sq ft)	Lane Miles *	Surface Type
0912	PUBLIC	12/9/2008		7,776	0.13	AS
Culverts	Drop Inlets	Gates	Fire Hydrants	Curb & Gutter	Curb	PCR
0	2	0	0	NO CURB AND GUTTER	CONCRETE CURB	EXCELLENT/97

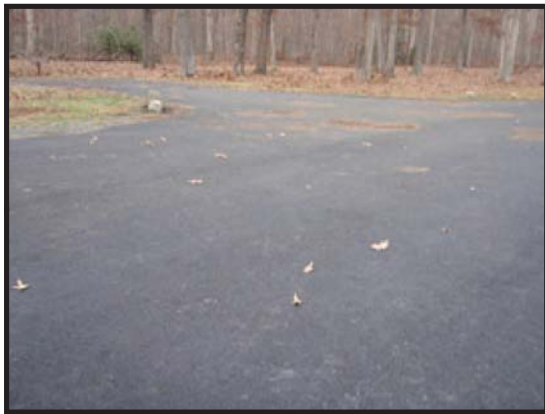
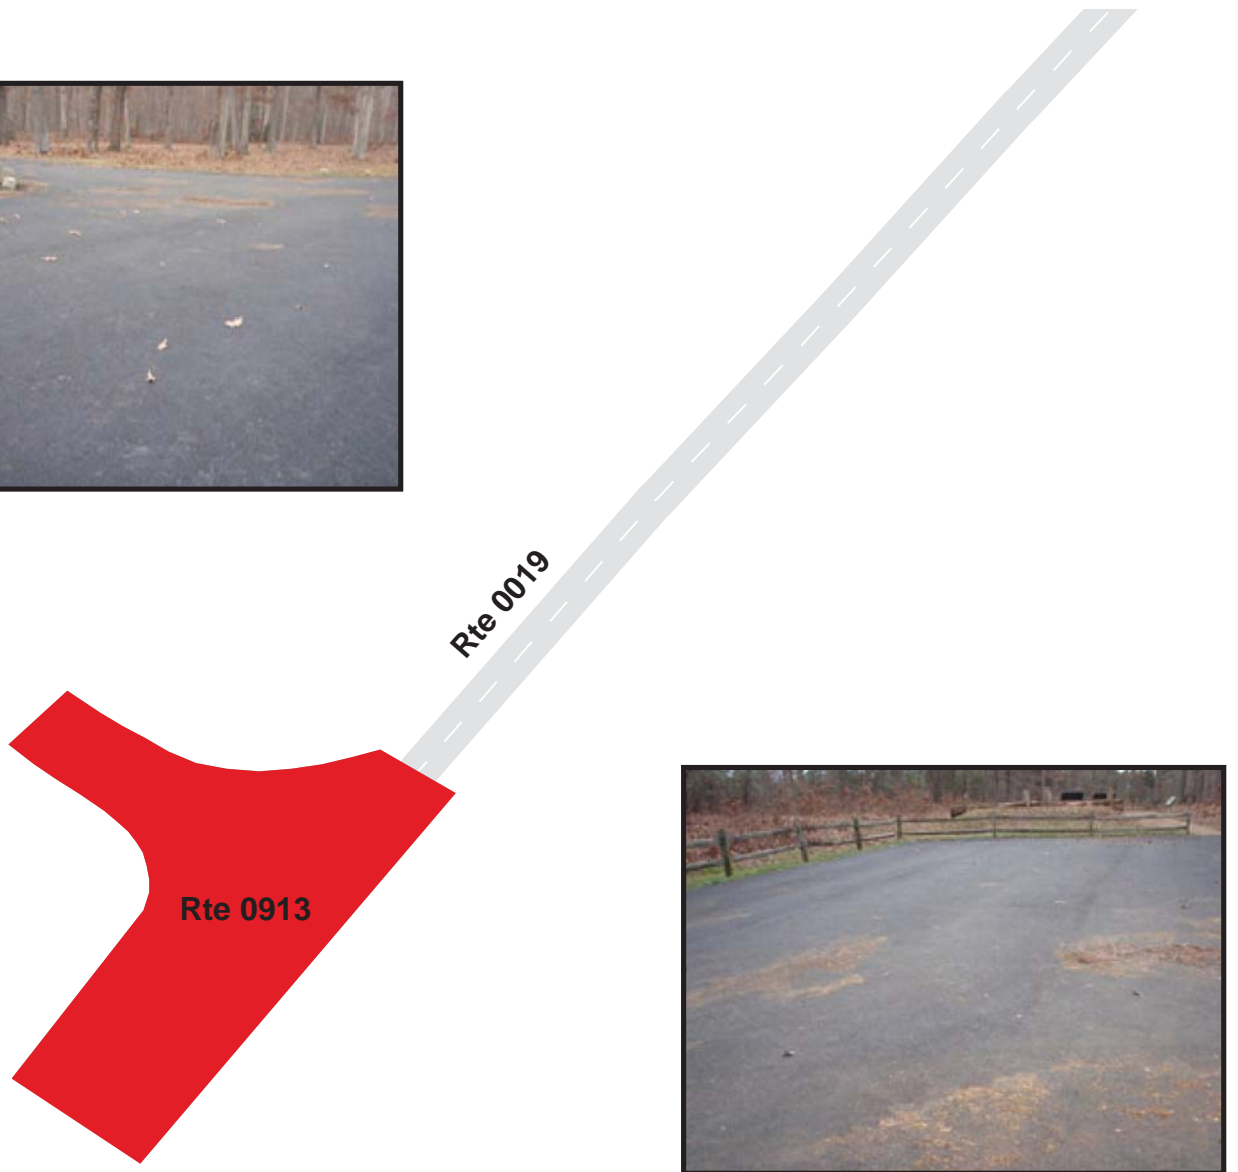
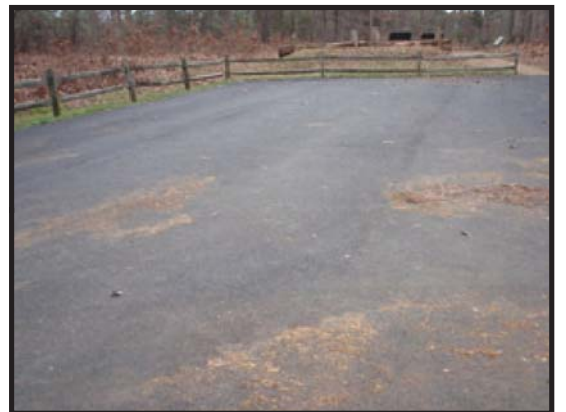
Route 0913

Route Number	Public / NonPublic	Date Visited		Area (sq ft)	Lane Miles *	Surface Type
0913	PUBLIC	12/9/2008		3,494	0.06	AS
Culverts	Drop Inlets	Gates	Fire Hydrants	Curb & Gutter	Curb	PCR
0	0	0	0	NO CURB AND GUTTER	NO CURB	EXCELLENT/97

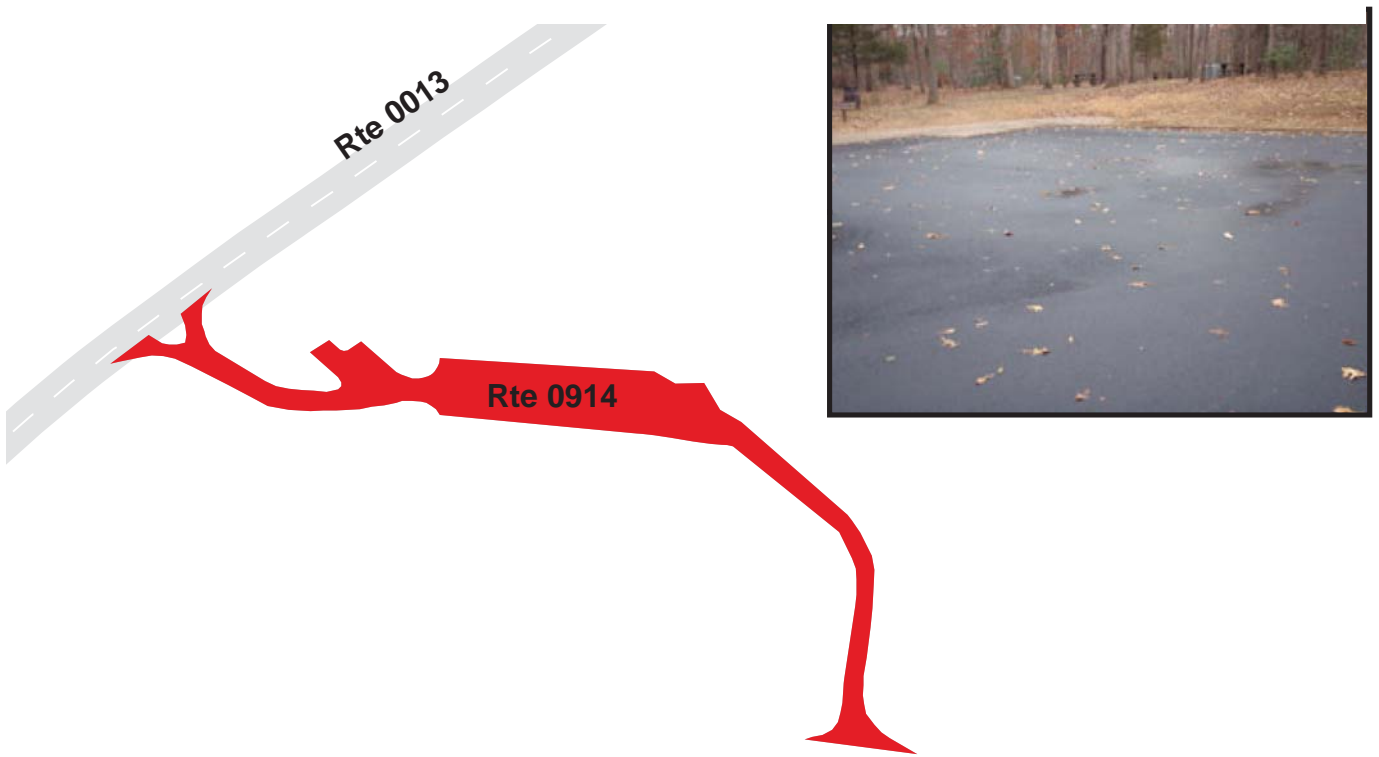
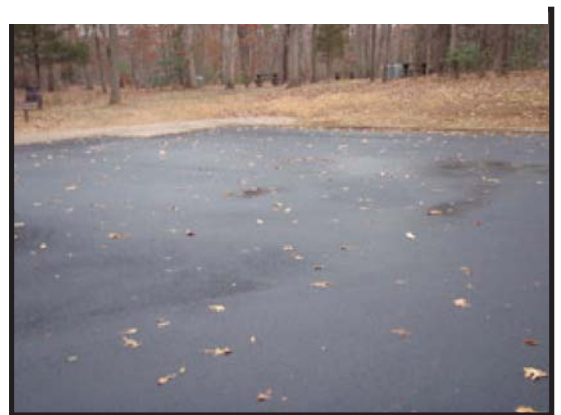
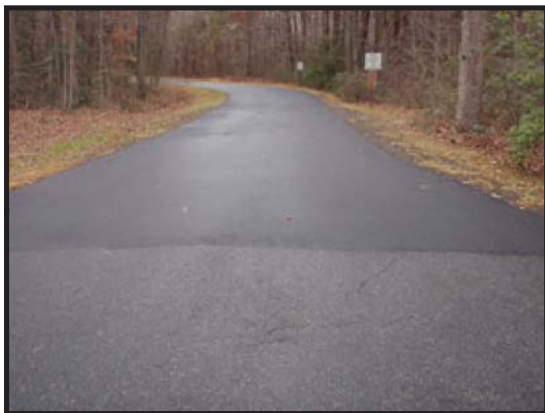
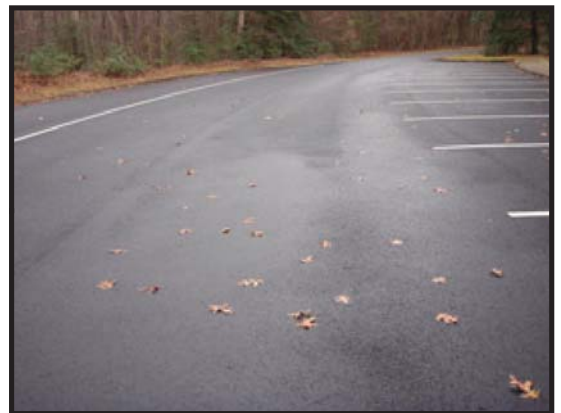
Route 0914

Route Number	Public / NonPublic	Date Visited		Area (sq ft)	Lane Miles *	Surface Type
0914	PUBLIC	12/10/2008		34,566	0.60	AS
Culverts	Drop Inlets	Gates	Fire Hydrants	Curb & Gutter	Curb	PCR
1	2	0	1	NO CURB AND GUTTER	CONCRETE CURB	EXCELLENT/97

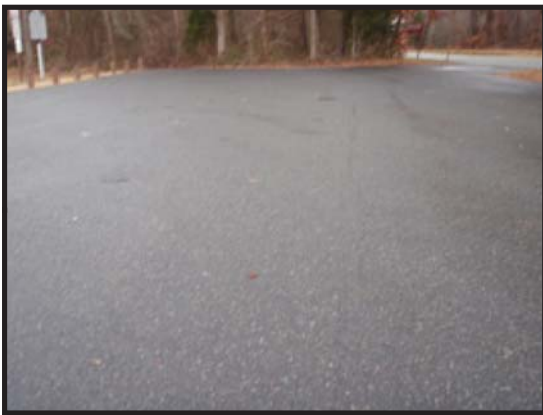
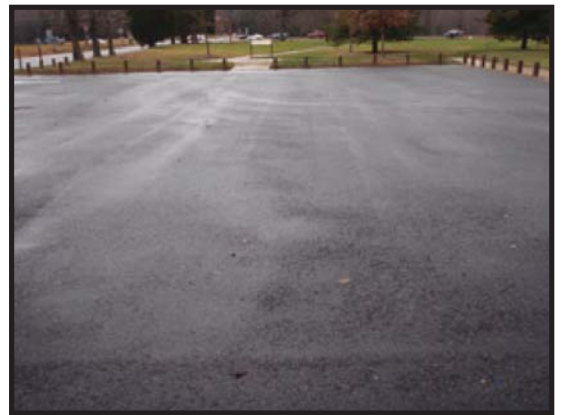
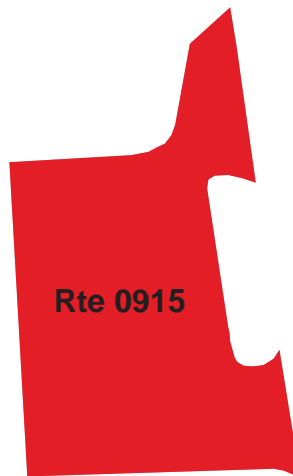
Route 0915

Route Number	Public / NonPublic	Date Visited		Area (sq ft)	Lane Miles *	Surface Type
0915	PUBLIC	12/10/2008		6,659	0.12	AS
Culverts	Drop Inlets	Gates	Fire Hydrants	Curb & Gutter	Curb	PCR
2	0	0	0	NO CURB AND GUTTER	NO CURB	EXCELLENT/97

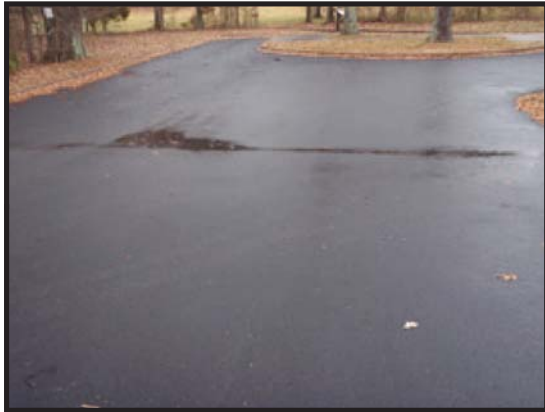
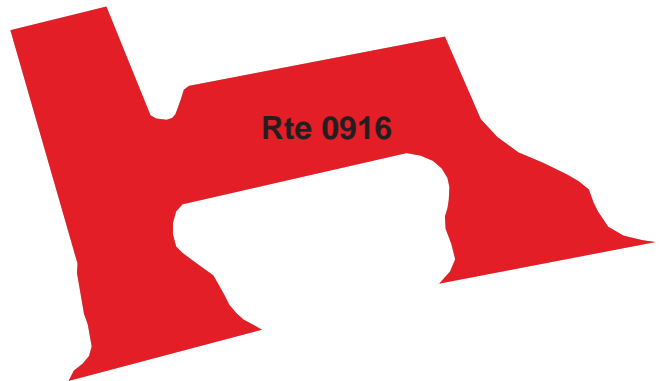
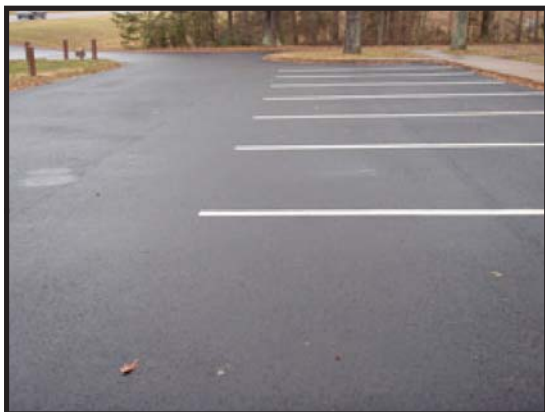
Route 0916

Route Number	Public / NonPublic	Date Visited		Area (sq ft)	Lane Miles *	Surface Type
0916	PUBLIC	12/10/2008		13,471	0.23	AS
Culverts	Drop Inlets	Gates	Fire Hydrants	Curb & Gutter	Curb	PCR
2	0	0	0	NO CURB AND GUTTER	CONCRETE CURB	EXCELLENT/97

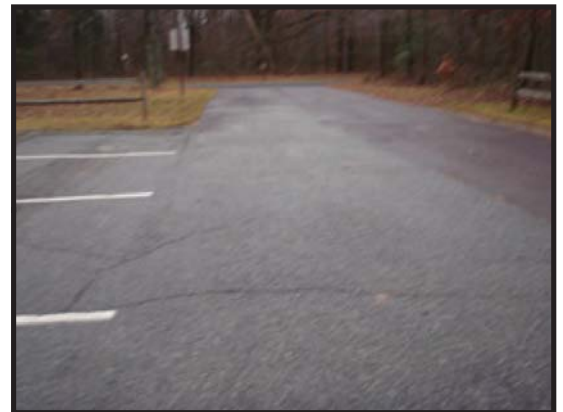
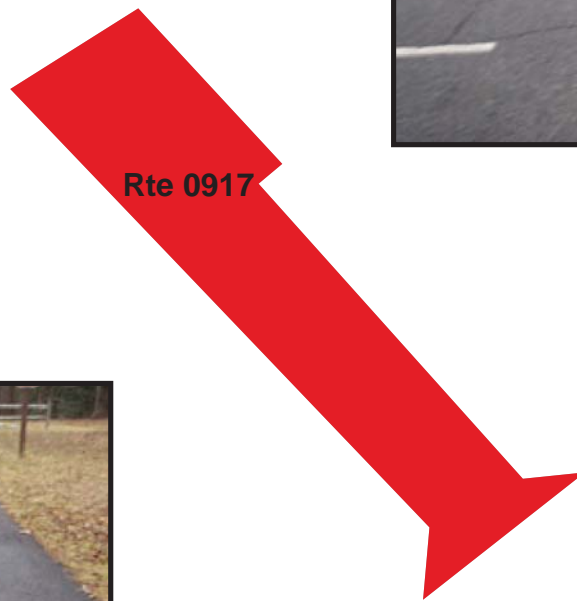
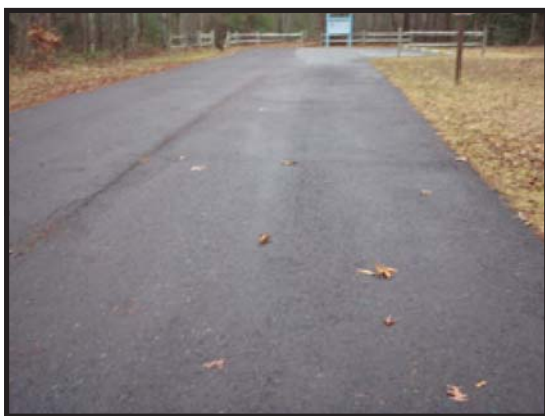
Route 0917

Route Number	Public / NonPublic	Date Visited		Area (sq ft)	Lane Miles *	Surface Type
0917	PUBLIC	12/10/2008		4,063	0.07	AS
Culverts	Drop Inlets	Gates	Fire Hydrants	Curb & Gutter	Curb	PCR
1	0	0	0	NO CURB AND GUTTER	NO CURB	FAIR/73

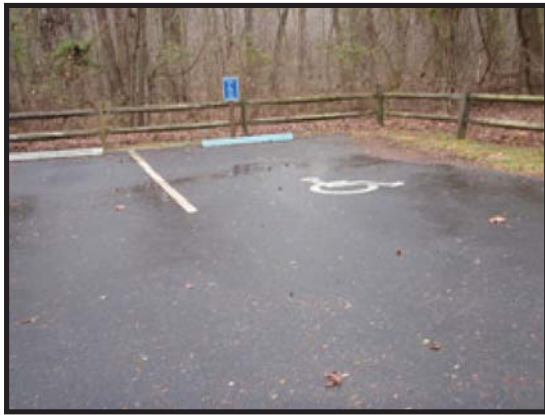
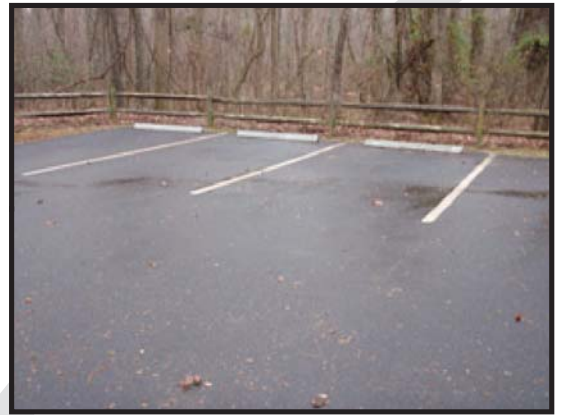
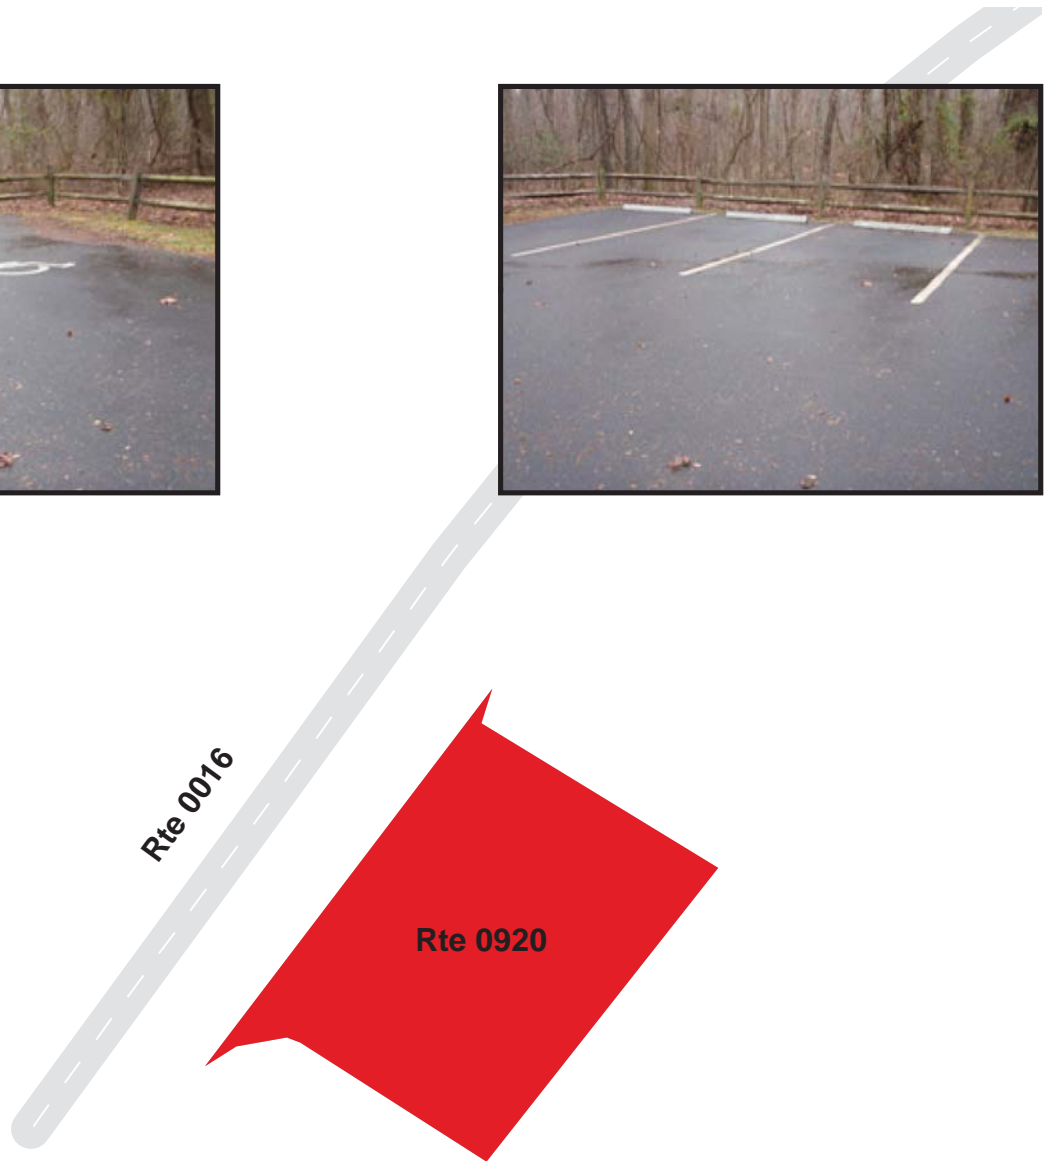
Route 0920

Route Number	Public / NonPublic	Date Visited		Area (sq ft)	Lane Miles *	Surface Type
0920	PUBLIC	12/10/2008		1,491	0.03	AS
Culverts	Drop Inlets	Gates	Fire Hydrants	Curb & Gutter	Curb	PCR
0	0	0	0	NO CURB AND GUTTER	NO CURB	EXCELLENT/97

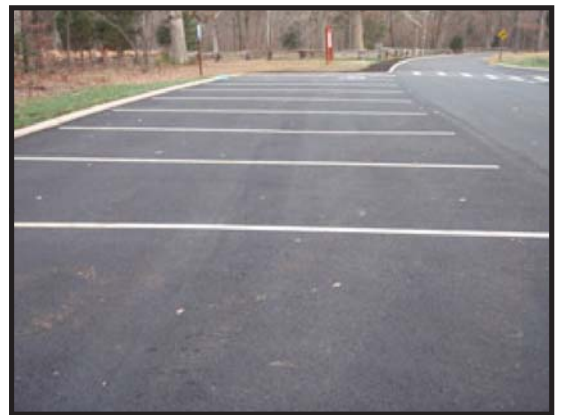
Route 0921BZ

Route Number	Public / NonPublic	Date Visited		Area (sq ft)	Lane Miles *	Surface Type
0921BZ	PUBLIC	12/9/2008		3,474	0.06	AS
Culverts	Drop Inlets	Gates	Fire Hydrants	Curb & Gutter	Curb	PCR
0	0	0	0	NO CURB AND GUTTER	CONCRETE CURB	EXCELLENT/97

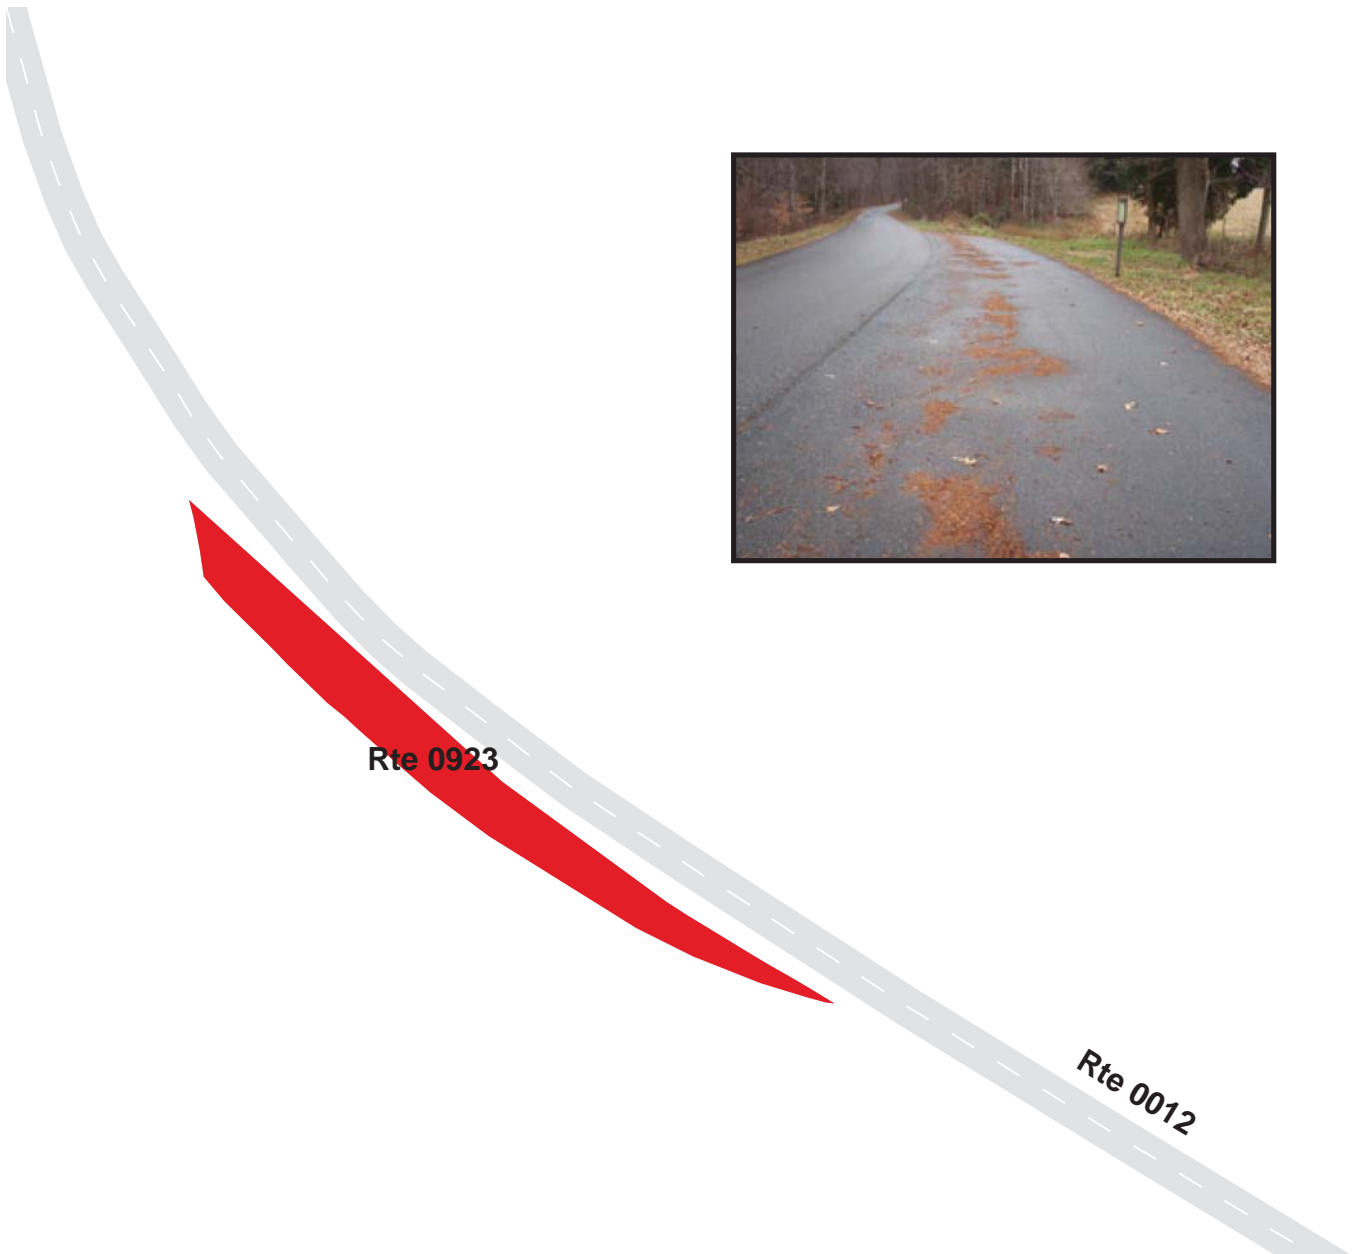
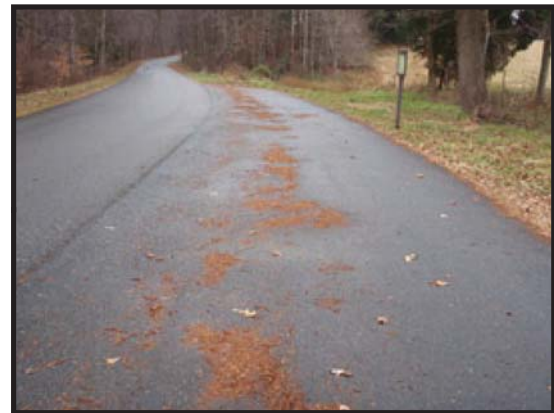
Route 0923

Route Number	Public / NonPublic	Date Visited		Area (sq ft)	Lane Miles *	Surface Type
0923	PUBLIC	12/10/2008		1,521	0.03	AS
Culverts	Drop Inlets	Gates	Fire Hydrants	Curb & Gutter	Curb	PCR
0	0	0	0	NO CURB AND GUTTER	NO CURB	GOOD/90

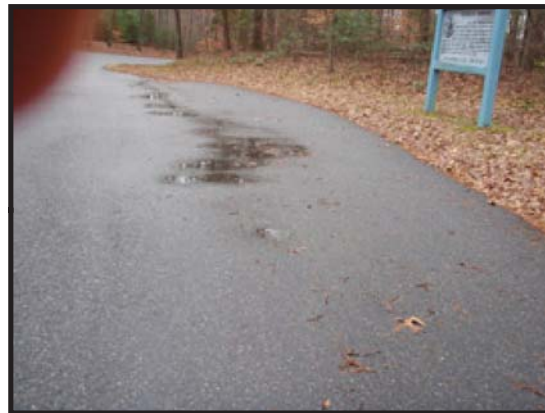
Route 0924

Route Number	Public / NonPublic	Date Visited		Area (sq ft)	Lane Miles *	Surface Type
0924	PUBLIC	12/10/2008		818	0.01	AS
Culverts	Drop Inlets	Gates	Fire Hydrants	Curb & Gutter	Curb	PCR
0	0	0	0	NO CURB AND GUTTER	NO CURB	GOOD/90

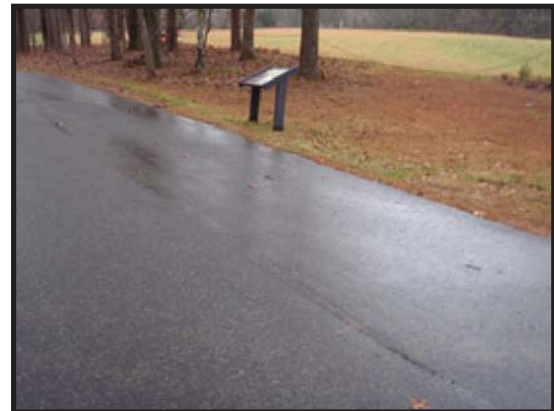
Route 0925

Route Number	Public / NonPublic	Date Visited		Area (sq ft)	Lane Miles *	Surface Type
0925	PUBLIC	12/10/2008		663	0.01	AS
Culverts	Drop Inlets	Gates	Fire Hydrants	Curb & Gutter	Curb	PCR
0	0	0	0	NO CURB AND GUTTER	NO CURB	GOOD/90

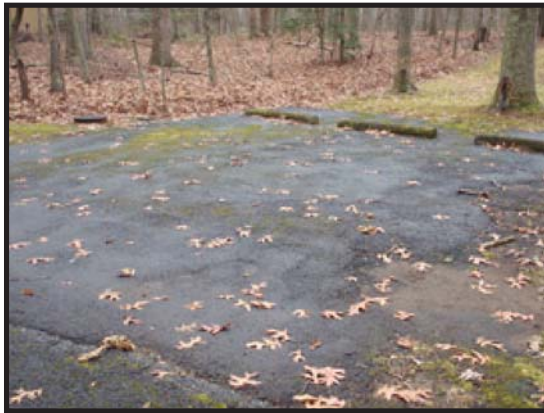
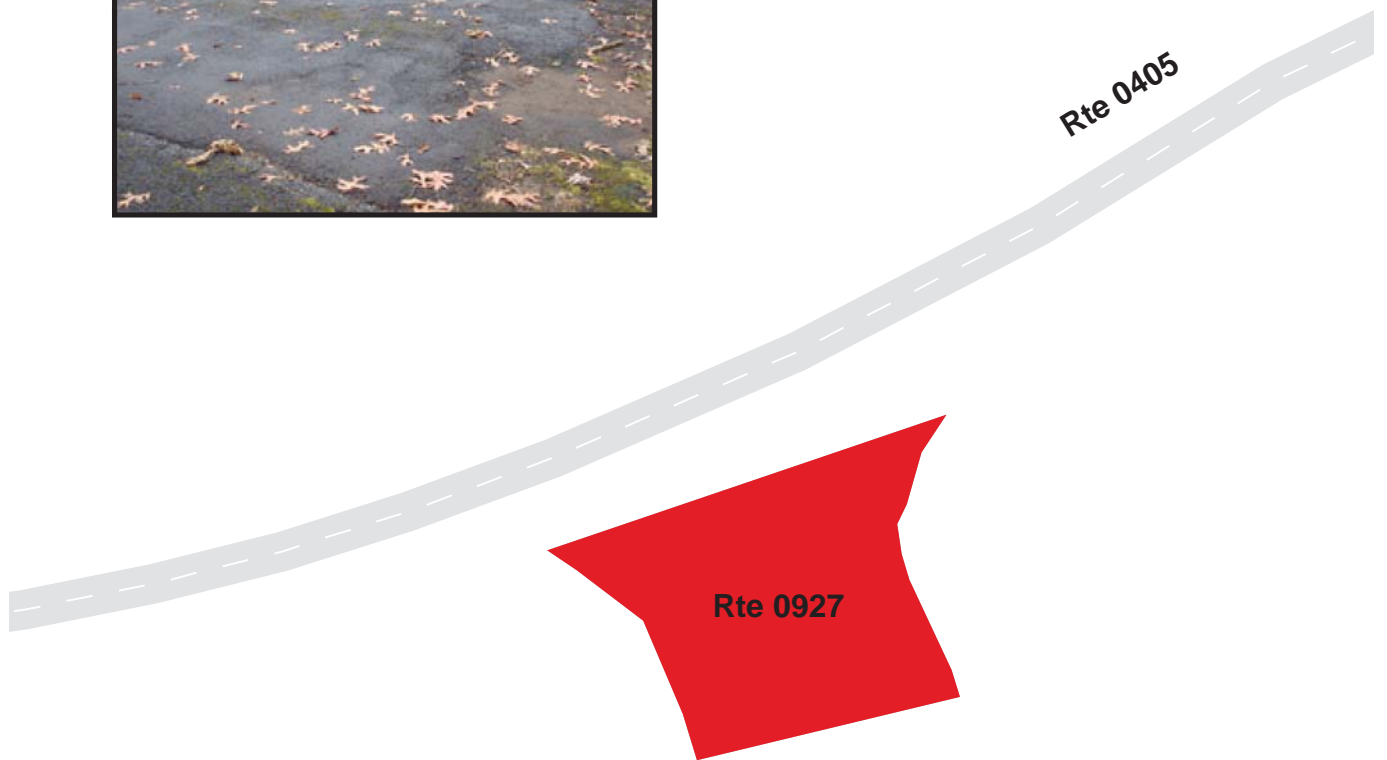
Route 0927

Route Number	Public / NonPublic	Date Visited		Area (sq ft)	Lane Miles *	Surface Type
0927	PUBLIC	12/10/2008		826	0.01	AS
Culverts	Drop Inlets	Gates	Fire Hydrants	Curb & Gutter	Curb	PCR
0	0	0	0	NO CURB AND GUTTER	NO CURB	POOR/45
