**The Road Inventory
of
Fredericksburg and Spotsylvania
National Military Park
FRSP – 4370
Cycle 4**

**Prepared By:
Federal Highway Administration
Road Inventory Program
Cycle 4**

Fredericksburg and Spotsylvania National Military Park in Virginia

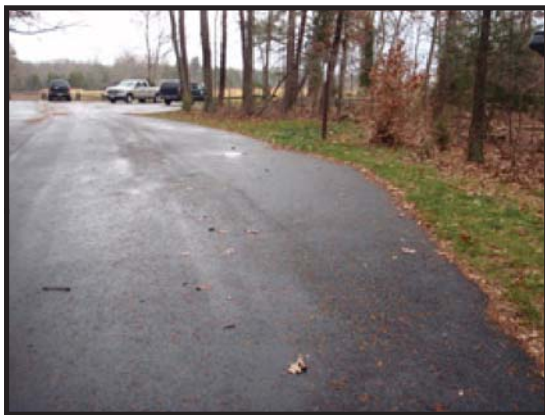
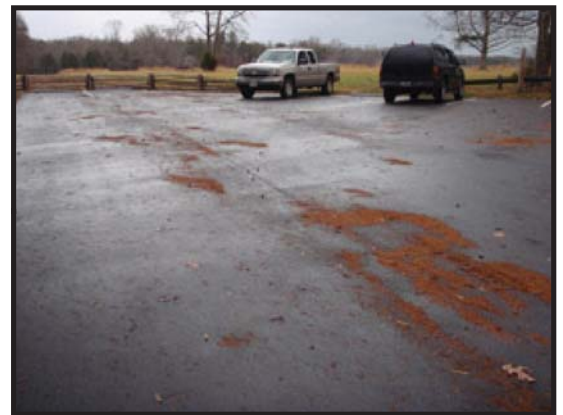
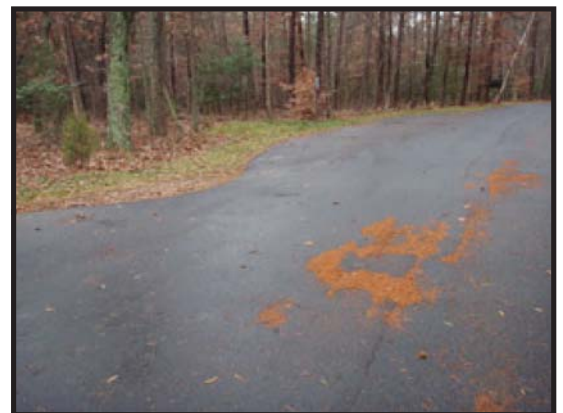
Route 0929

Route Number	Public / NonPublic	Date Visited		Area (sq ft)	Lane Miles *	Surface Type
0929	PUBLIC	12/10/2008		7,306	0.13	AS
Culverts	Drop Inlets	Gates	Fire Hydrants	Curb & Gutter	Curb	PCR
0	0	0	0	NO CURB AND GUTTER	NO CURB	EXCELLENT/97

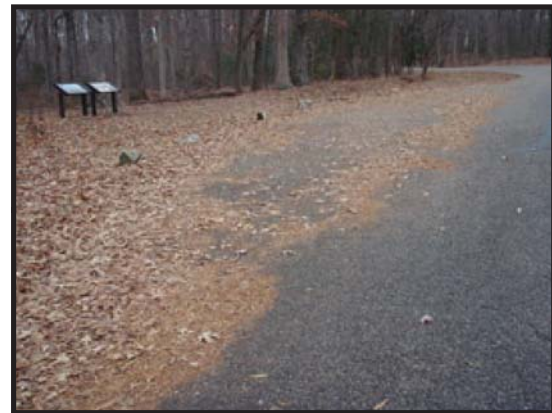
Route 0931

Route Number	Public / NonPublic	Date Visited		Area (sq ft)	Lane Miles *	Surface Type
0931	PUBLIC	12/9/2008		1,630	0.03	AS
Culverts	Drop Inlets	Gates	Fire Hydrants	Curb & Gutter	Curb	PCR
0	0	0	0	NO CURB AND GUTTER	NO CURB	GOOD/90

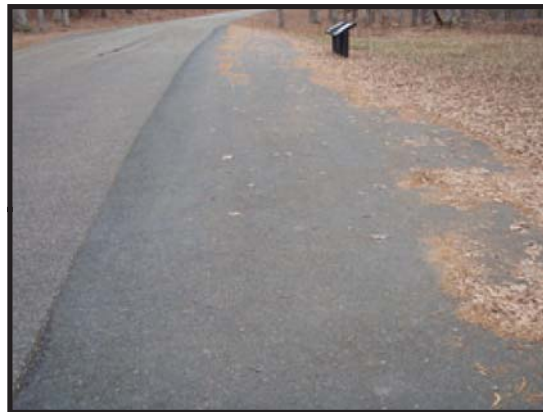
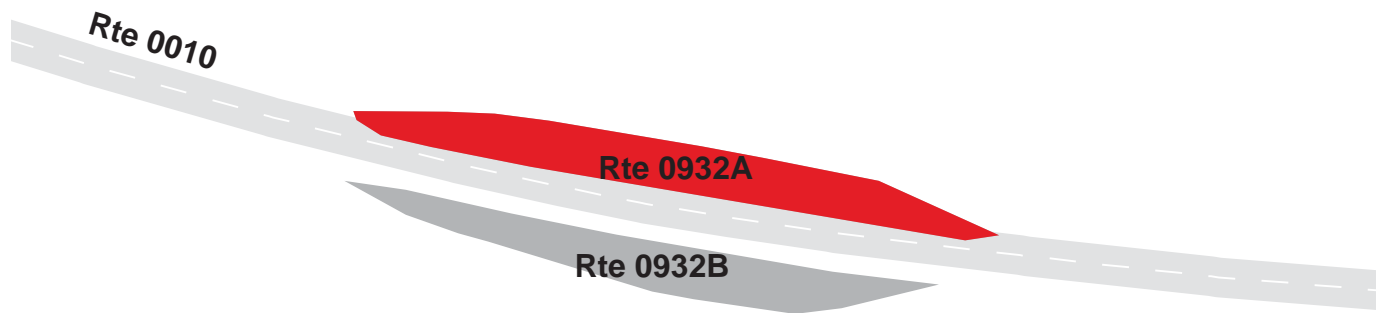
Route 0932A

Route Number	Public / NonPublic	Date Visited		Area (sq ft)	Lane Miles *	Surface Type
0932A	PUBLIC	12/9/2008		2,484	0.04	AS
Culverts	Drop Inlets	Gates	Fire Hydrants	Curb & Gutter	Curb	PCR
0	0	0	0	NO CURB AND GUTTER	NO CURB	GOOD/90

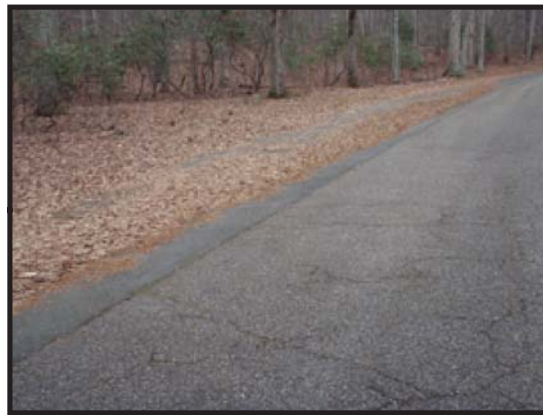
Route 0932B

Route Number	Public / NonPublic	Date Visited		Area (sq ft)	Lane Miles *	Surface Type
0932B	PUBLIC	12/10/2008		1,981	0.03	AS
Culverts	Drop Inlets	Gates	Fire Hydrants	Curb & Gutter	Curb	PCR
0	0	0	0	NO CURB AND GUTTER	NO CURB	GOOD/90

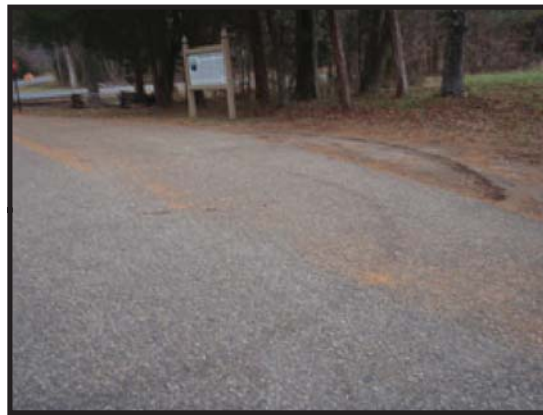
Route 0933

Route Number	Public / NonPublic	Date Visited		Area (sq ft)	Lane Miles *	Surface Type
0933	PUBLIC	12/9/2008		951	0.02	AS
Culverts	Drop Inlets	Gates	Fire Hydrants	Curb & Gutter	Curb	PCR
0	0	0	0	NO CURB AND GUTTER	NO CURB	GOOD/90

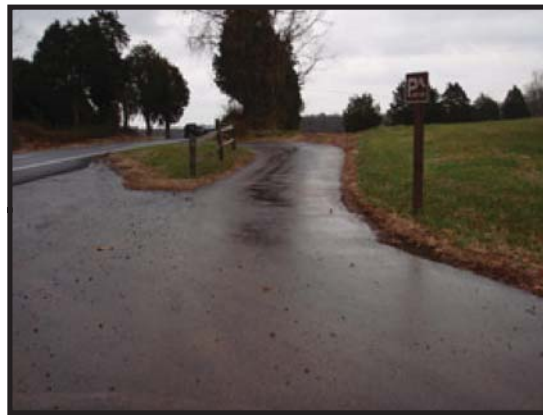
Route Number	Public / NonPublic	Date Visited		Area (sq ft)	Lane Miles *	Surface Type
0935	PUBLIC	12/10/2008		809	0.01	AS
Culverts	Drop Inlets	Gates	Fire Hydrants	Curb & Gutter	Curb	PCR
0	0	0	0	NO CURB AND GUTTER	NO CURB	GOOD/90

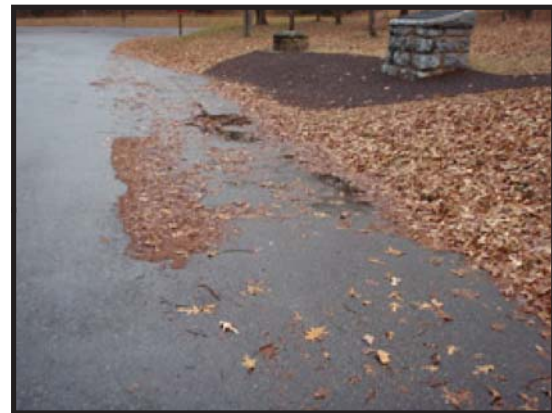
Route 0936

Route Number	Public / NonPublic	Date Visited		Area (sq ft)	Lane Miles *	Surface Type
0936	PUBLIC	12/9/2008		814	0.01	AS
Culverts	Drop Inlets	Gates	Fire Hydrants	Curb & Gutter	Curb	PCR
0	0	0	0	NO CURB AND GUTTER	NO CURB	GOOD/90

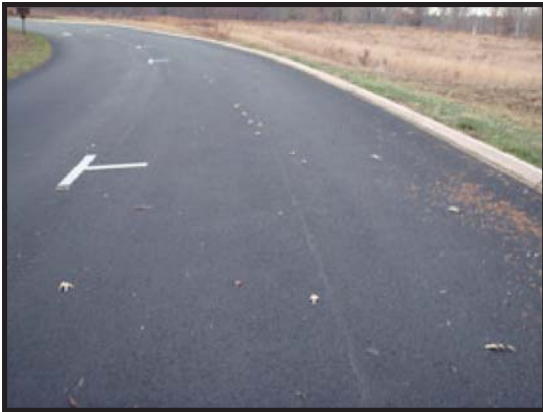
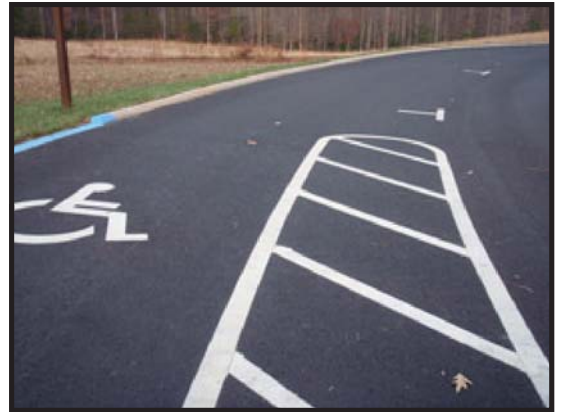
Route 0937

ADJACENT TO ROUTE 0022 (BURNSIDE DRIVE) AND ROUTE 0020 (GORDON DRIVE)

Route Number	Public / NonPublic	Date Visited		Area (sq ft)	Lane Miles *	Surface Type
0937	PUBLIC	12/9/2008		10,122	0.17	AS
Culverts	Drop Inlets	Gates	Fire Hydrants	Curb & Gutter	Curb	PCR
0	0	0	0	NO CURB AND GUTTER	CONCRETE CURB	EXCELLENT/97

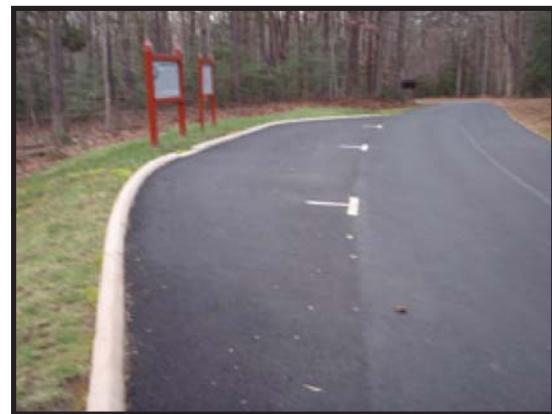
Route 0938

Route Number	Public / NonPublic	Date Visited		Area (sq ft)	Lane Miles *	Surface Type
0938	PUBLIC	12/9/2008		965	0.02	AS
Culverts	Drop Inlets	Gates	Fire Hydrants	Curb & Gutter	Curb	PCR
0	0	0	0	NO CURB AND GUTTER	CONCRETE CURB	EXCELLENT/97

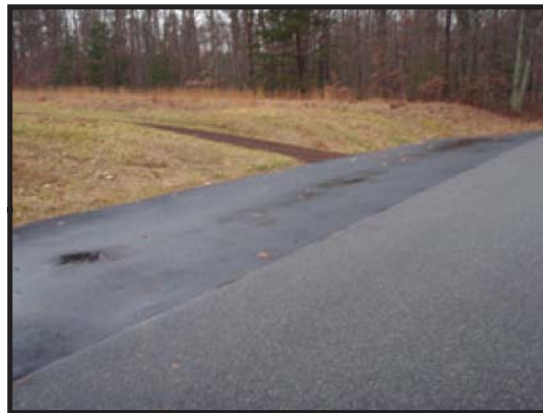
Route 0939

Route Number	Public / NonPublic	Date Visited		Area (sq ft)	Lane Miles *	Surface Type
0939	PUBLIC	12/9/2008		1,182	0.02	AS
Culverts	Drop Inlets	Gates	Fire Hydrants	Curb & Gutter	Curb	PCR
0	0	0	0	NO CURB AND GUTTER	NO CURB	EXCELLENT/97

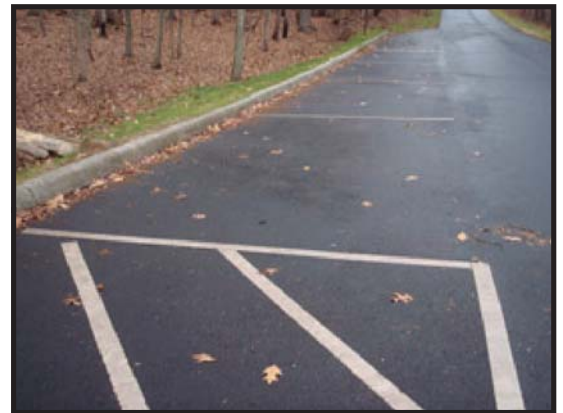
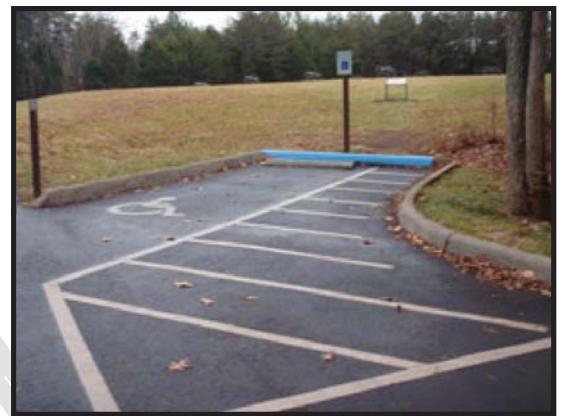
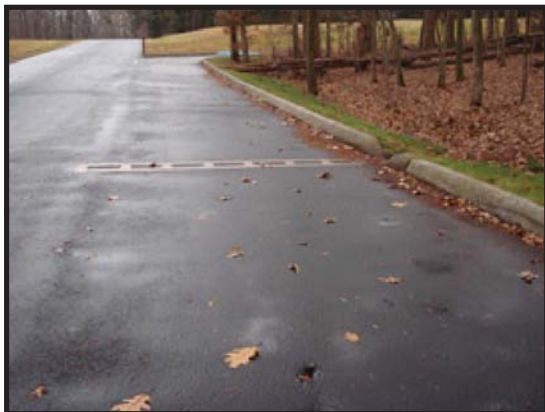
Route 0940

Route Number	Public / NonPublic	Date Visited		Area (sq ft)	Lane Miles *	Surface Type
0940	PUBLIC	12/10/2008		3,194	0.06	AS
Culverts	Drop Inlets	Gates	Fire Hydrants	Curb & Gutter	Curb	PCR
0	0	0	0	NO CURB AND GUTTER	CONCRETE CURB	EXCELLENT/97

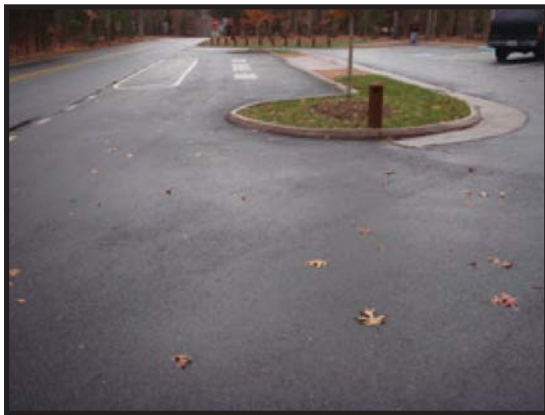
Route 0941

Route Number	Public / NonPublic	Date Visited		Area (sq ft)	Lane Miles *	Surface Type
0941	PUBLIC	12/10/2008		6,860	0.12	AS
Culverts	Drop Inlets	Gates	Fire Hydrants	Curb & Gutter	Curb	PCR
0	0	0	0	CONCRETE CURB AND GUTTER	CONCRETE CURB	EXCELLENT/97

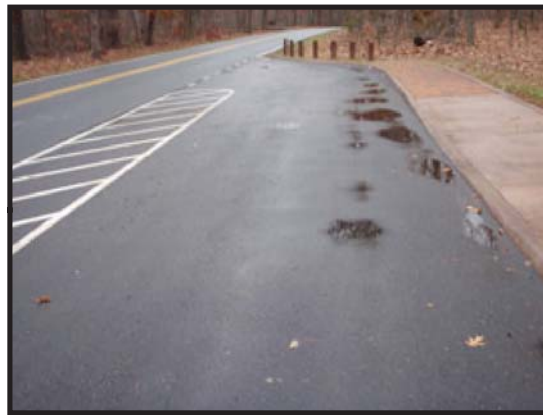
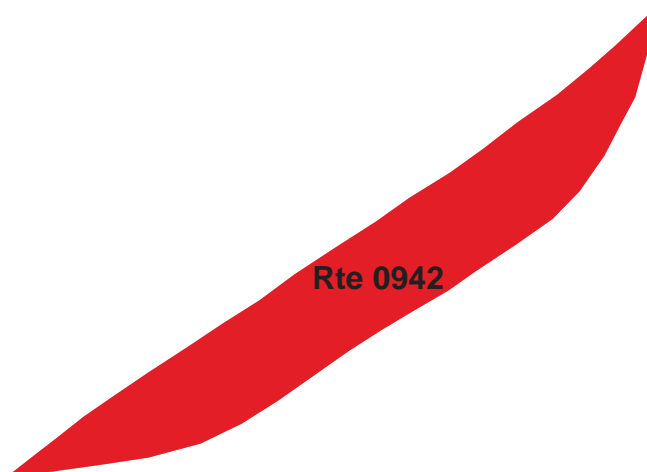
Route 0942

Route Number	Public / NonPublic	Date Visited		Area (sq ft)	Lane Miles *	Surface Type
0942	PUBLIC	12/10/2008		2,035	0.04	AS
Culverts	Drop Inlets	Gates	Fire Hydrants	Curb & Gutter	Curb	PCR
0	0	0	0	NO CURB AND GUTTER	CONCRETE CURB	EXCELLENT/97

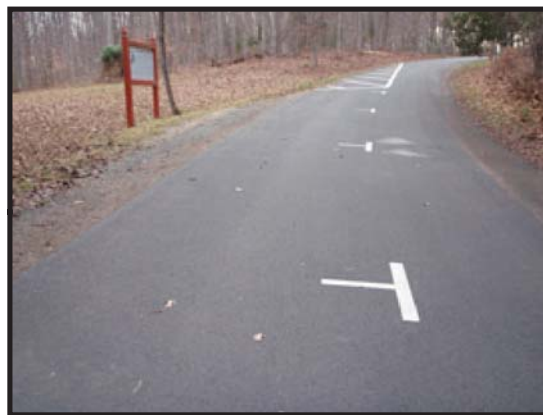
Route 0944

Route Number	Public / NonPublic	Date Visited		Area (sq ft)	Lane Miles *	Surface Type
0944	PUBLIC	12/9/2008		2,425	0.04	AS
Culverts	Drop Inlets	Gates	Fire Hydrants	Curb & Gutter	Curb	PCR
0	0	0	0	NO CURB AND GUTTER	NO CURB	EXCELLENT/97

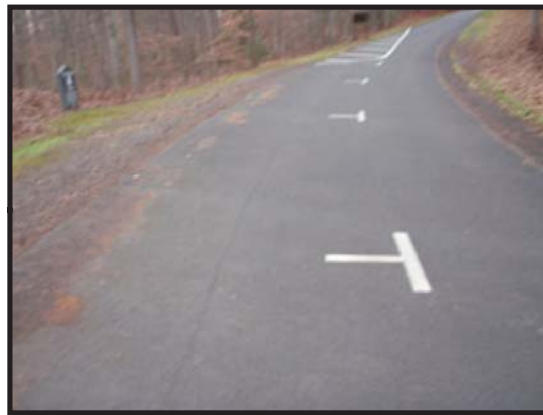
Route 0945

ADJACENT TO ROUTE 0022 (BURNSIDE DRIVE)

Route Number	Public / NonPublic	Date Visited		Area (sq ft)	Lane Miles *	Surface Type
0945	PUBLIC	12/9/2008		2,511	0.04	AS
Culverts	Drop Inlets	Gates	Fire Hydrants	Curb & Gutter	Curb	PCR
0	0	0	0	NO CURB AND GUTTER	NO CURB	EXCELLENT/97

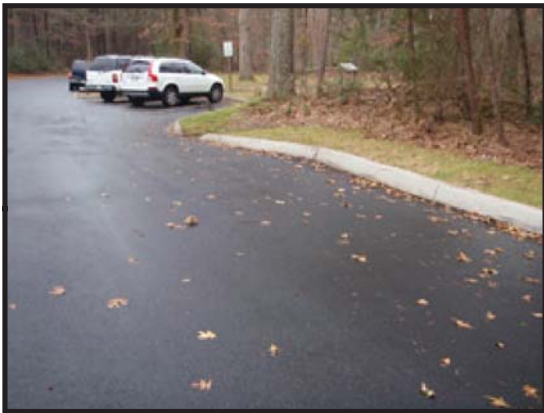
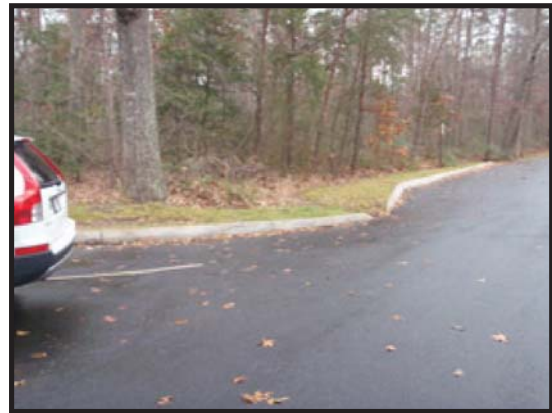
Route 0946

Route Number	Public / NonPublic	Date Visited		Area (sq ft)	Lane Miles *	Surface Type
0946	PUBLIC	12/10/2008		1,824	0.03	AS
Culverts	Drop Inlets	Gates	Fire Hydrants	Curb & Gutter	Curb	PCR
0	1	0	0	NO CURB AND GUTTER	CONCRETE CURB	EXCELLENT/97

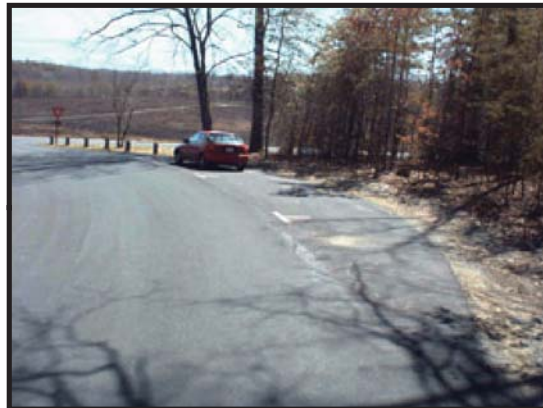
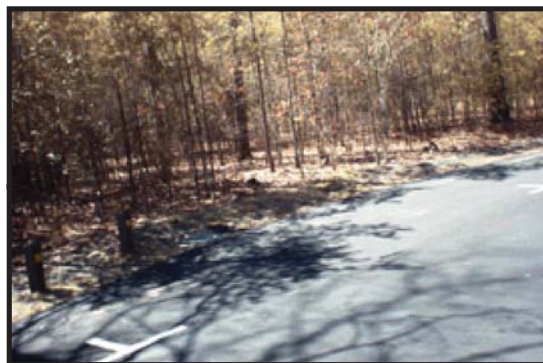
Route 0947

NOTE: GPS DATA WAS NOT COLLECTED IN CYCLE-4 FOR THIS ROUTE.
