**The Road Inventory
of
Gettysburg National Military Park
GETT – 4400
Cycle 4**

**Prepared By:
Federal Highway Administration
Road Inventory Program
Cycle 4**

Gettysburg National Military Park in Pennsylvania

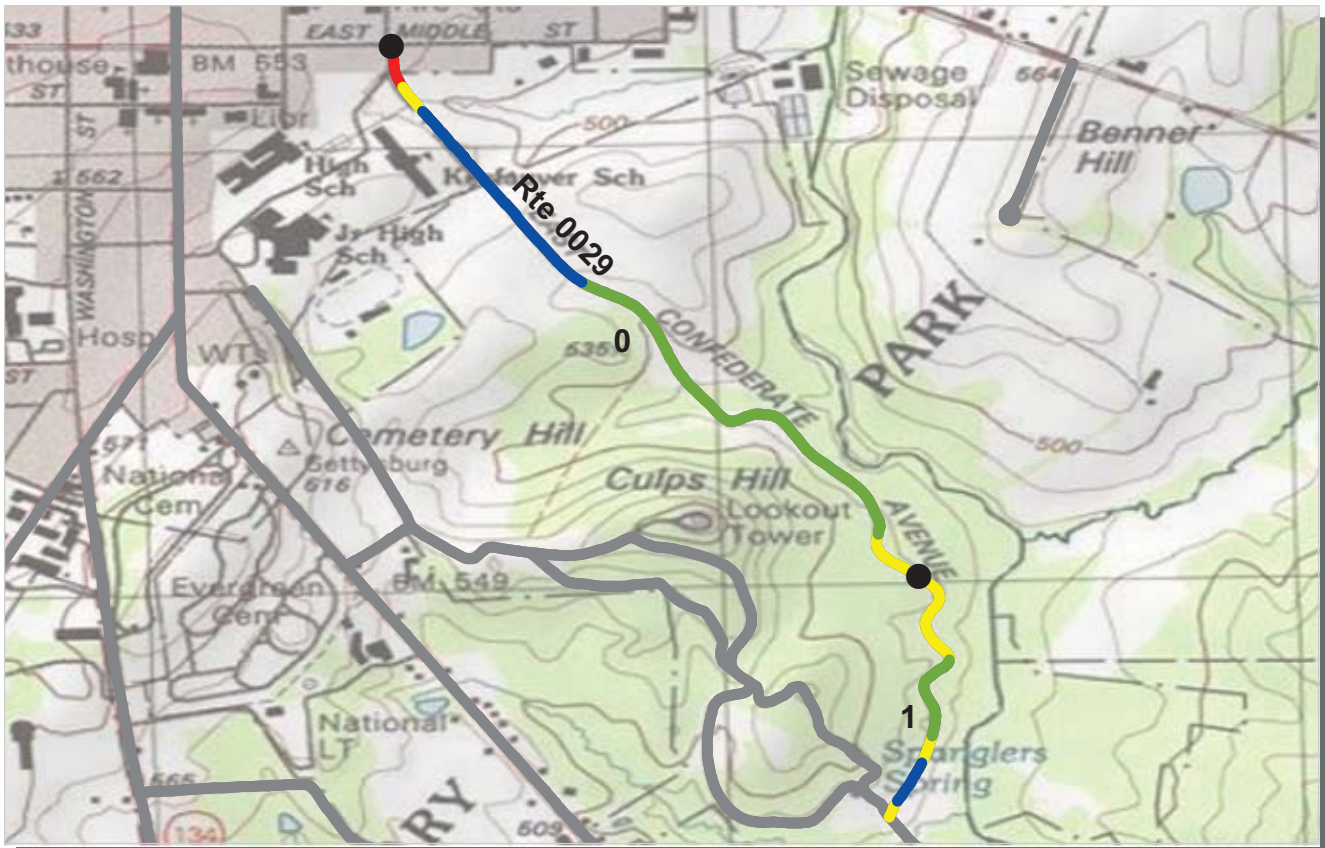
ROUTE: 0028 HOWARD AVENUE

Section Number	0				
Section Length (mi)	0.96				
Traffic	Traffic data may be found at www.efl.fhwa.dot.gov Click on PROGRAMS / NPS Traffic Data (Note: Not all parks have traffic data)				
Cross Section Information					
Number of Lanes	2				
Paved Width (ft)	20				
Lane Width (ft)	16				
Shoulder Width Right (ft)	NC				
Shoulder Width Left (ft)	NC				
Roadway Condition Information					
SCR (Surface Condition Rating)	39				
PCR (Pavement Condition Rating)	56				
Distress Index Values					
Alligator Cracking Index	84				
Longitudinal Cracking Index	72				
Transverse Cracking Index	83				
Patching Index	100				
Rutting Index	94				
Roughness Condition Index (RCI)	95

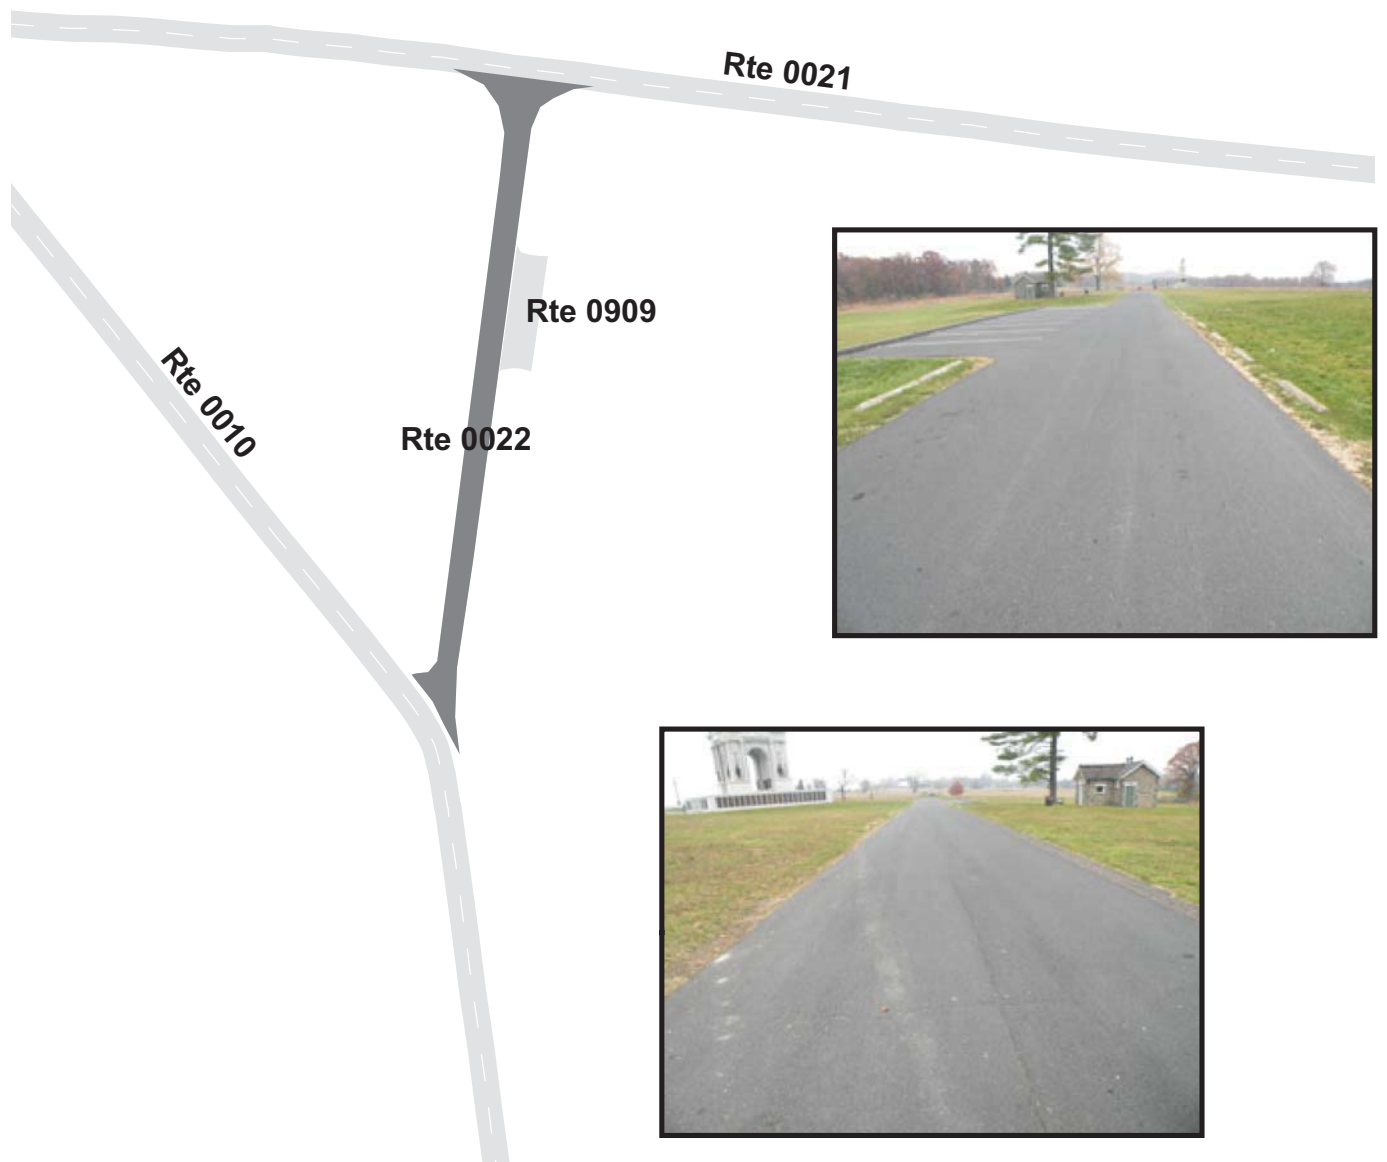
Route 0022

Route Number	Public / NonPublic	Date Visited		Area (sq ft)	Lane Miles *	Surface Type
0022	PUBLIC	11/4/2008		10,003	0.17	AS
Culverts	Drop Inlets	Gates	Fire Hydrants	Curb & Gutter	Curb	PCR
1	0	0	0	NO CURB AND GUTTER	NO CURB	GOOD/90

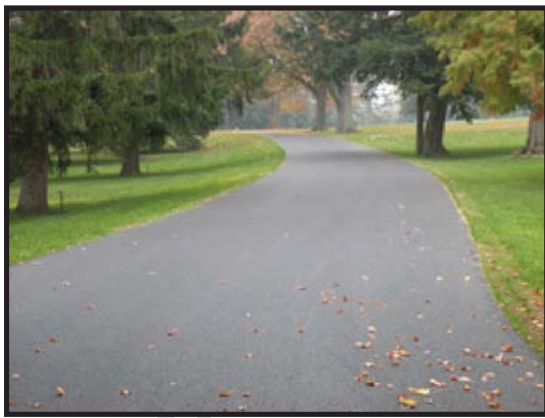
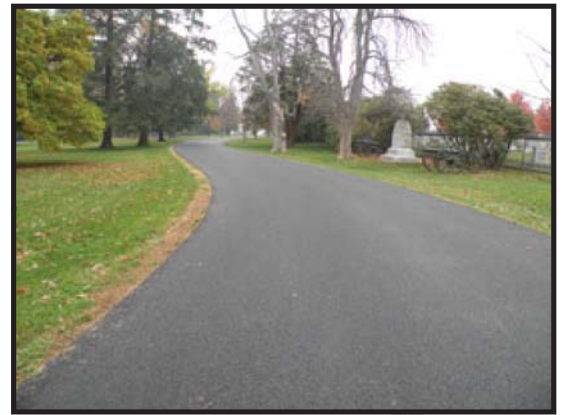
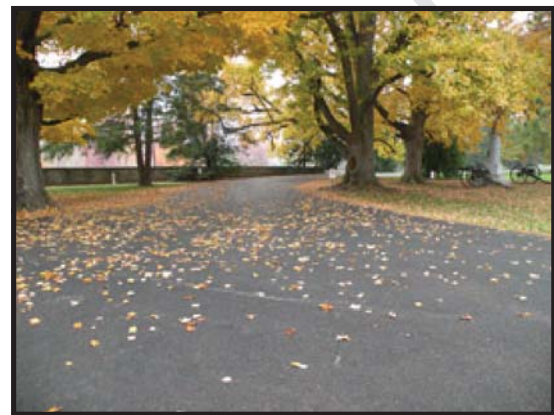
Route 0037

Route Number	Public / NonPublic	Date Visited		Area (sq ft)	Lane Miles *	Surface Type
0037	PUBLIC	11/4/2008		65,388	1.13	AS
Culverts	Drop Inlets	Gates	Fire Hydrants	Curb & Gutter	Curb	PCR
0	1	2	0	NO CURB AND GUTTER	CONCRETE CURB	EXCELLENT/97

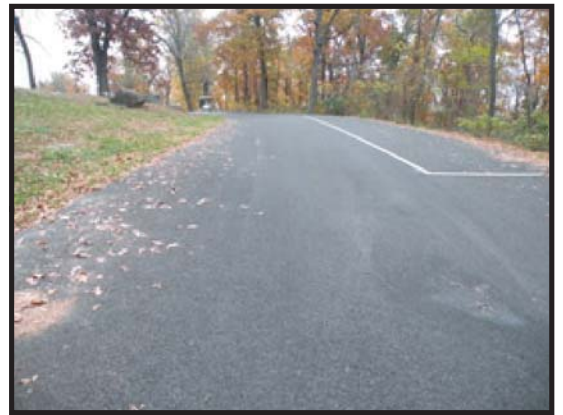
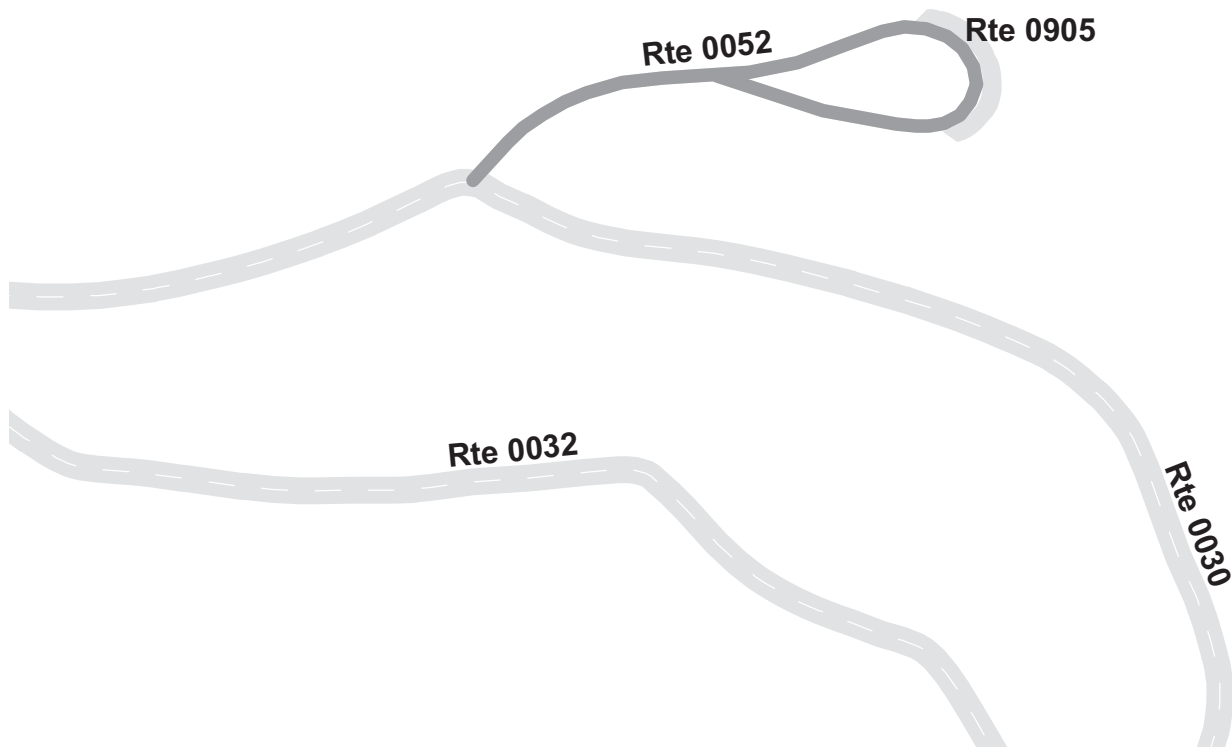
Route 0052

Route Number	Public / NonPublic	Date Visited		Area (sq ft)	Lane Miles *	Surface Type
0052	PUBLIC	11/4/2008		18,945	0.33	AS
Culverts	Drop Inlets	Gates	Fire Hydrants	Curb & Gutter	Curb	PCR
0	1	0	0	NO CURB AND GUTTER	NO CURB	EXCELLENT/97

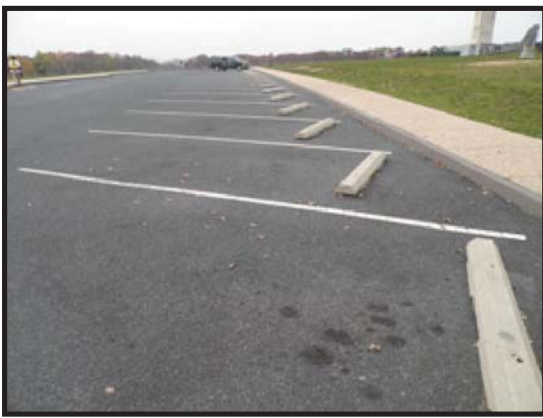
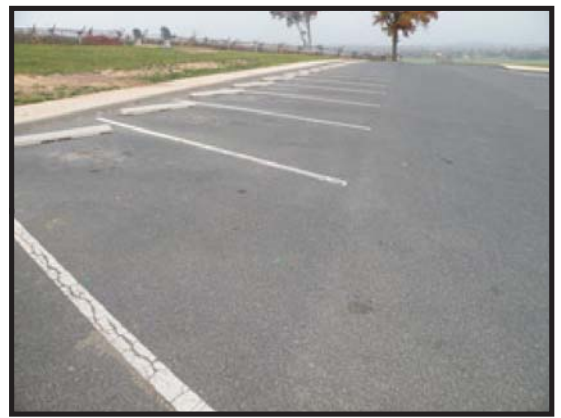
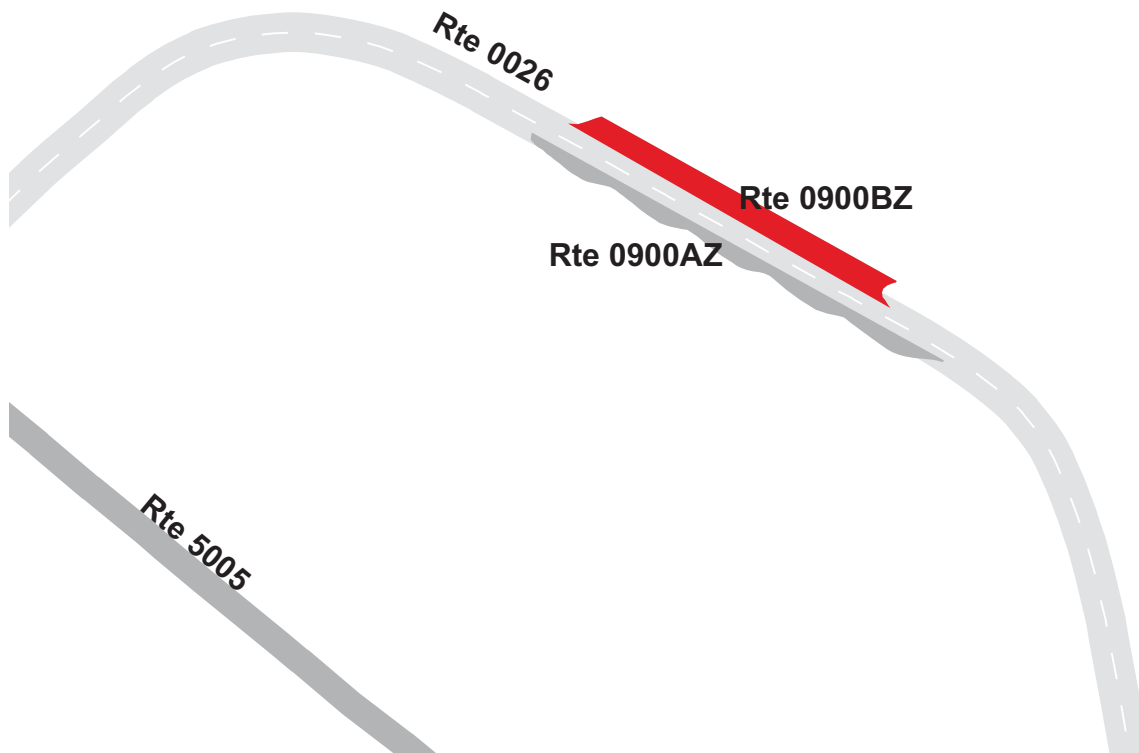
Route 0900BZ

Route Number	Public / NonPublic	Date Visited		Area (sq ft)	Lane Miles *	Surface Type
0900BZ	PUBLIC	11/4/2008		5,168	0.09	AS
Culverts	Drop Inlets	Gates	Fire Hydrants	Curb & Gutter	Curb	PCR
0	0	0	0	NO CURB AND GUTTER	CONCRETE CURB	EXCELLENT/97

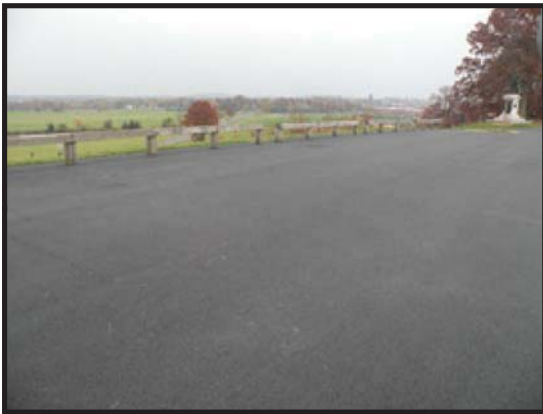
Route 0901

Route Number	Public / NonPublic	Date Visited		Area (sq ft)	Lane Miles *	Surface Type
0901	PUBLIC	11/4/2008		2,440	0.04	AS
Culverts	Drop Inlets	Gates	Fire Hydrants	Curb & Gutter	Curb	PCR
0	0	0	0	NO CURB AND GUTTER	NO CURB	EXCELLENT/97

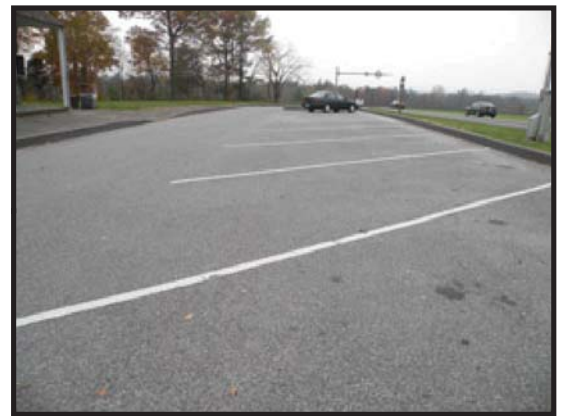
Route 0902

Route Number	Public / NonPublic	Date Visited		Area (sq ft)	Lane Miles *	Surface Type
0902	PUBLIC	11/4/2008		6,695	0.12	AS
Culverts	Drop Inlets	Gates	Fire Hydrants	Curb & Gutter	Curb	PCR
0	0	0	0	NO CURB AND GUTTER	CONCRETE CURB	GOOD/90

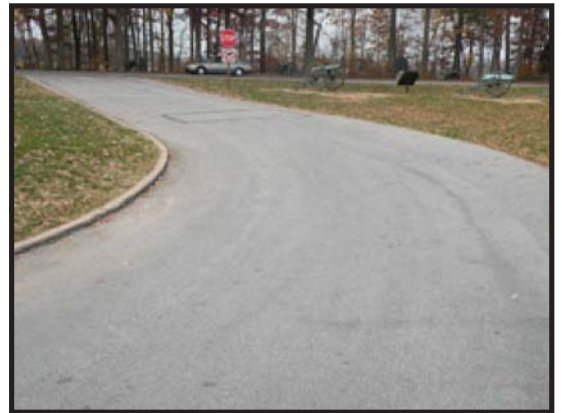
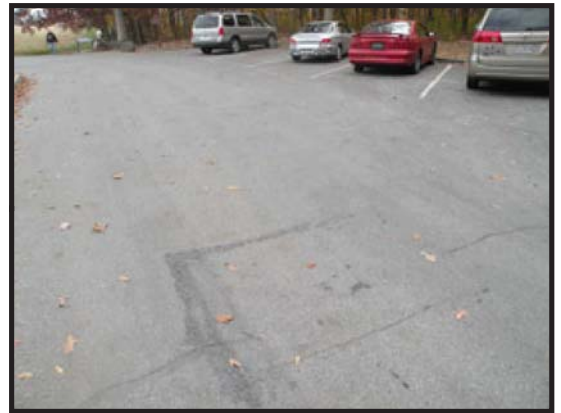
Route 0908

Route Number	Public / NonPublic	Date Visited		Area (sq ft)	Lane Miles *	Surface Type
0908	PUBLIC	11/4/2008		7,755	0.13	AS
Culverts	Drop Inlets	Gates	Fire Hydrants	Curb & Gutter	Curb	PCR
0	1	0	0	NO CURB AND GUTTER	CONCRETE CURB	FAIR/73

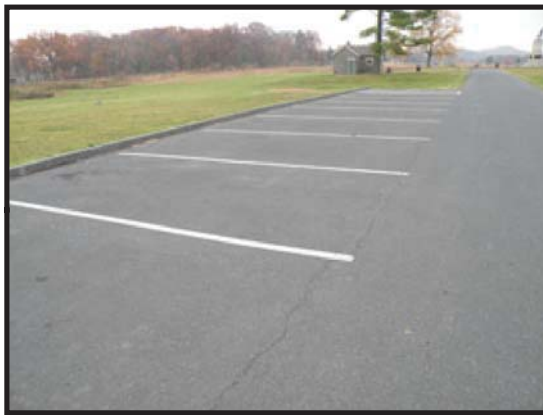
Route 0909

Route Number	Public / NonPublic	Date Visited		Area (sq ft)	Lane Miles *	Surface Type
0909	PUBLIC	11/4/2008		2,100	0.04	AS
Culverts	Drop Inlets	Gates	Fire Hydrants	Curb & Gutter	Curb	PCR
0	0	0	0	NO CURB AND GUTTER	CONCRETE CURB	GOOD/90

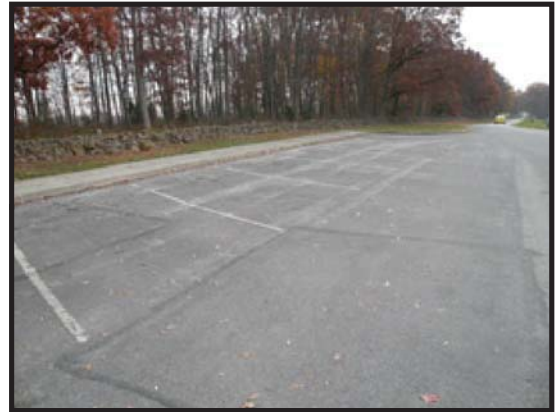
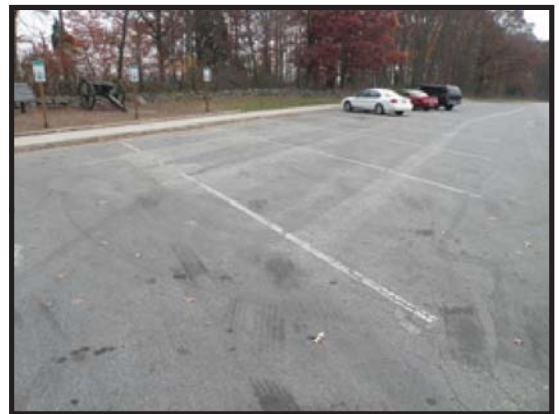
Route 0912

Route Number	Public / NonPublic	Date Visited		Area (sq ft)	Lane Miles *	Surface Type
0912	PUBLIC	11/4/2008		7,593	0.13	AS
Culverts	Drop Inlets	Gates	Fire Hydrants	Curb & Gutter	Curb	PCR
0	0	0	0	NO CURB AND GUTTER	CONCRETE CURB	GOOD/90

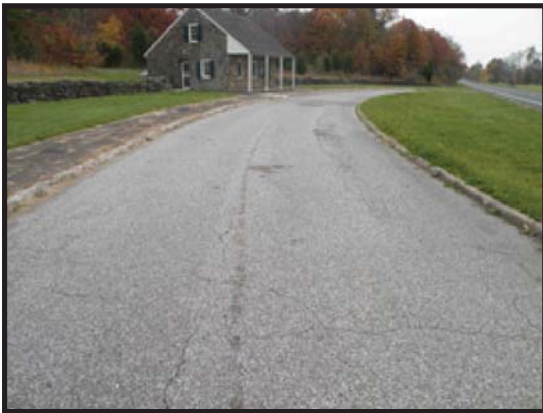
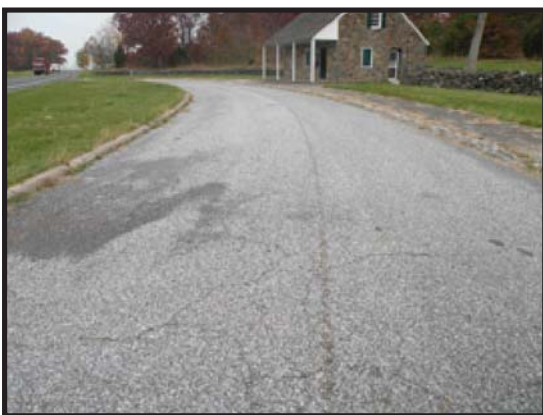
Route 0913

Route Number	Public / NonPublic	Date Visited		Area (sq ft)	Lane Miles *	Surface Type
0913	PUBLIC	11/4/2008		5,567	0.10	AS
Culverts	Drop Inlets	Gates	Fire Hydrants	Curb & Gutter	Curb	PCR
0	0	0	0	NO CURB AND GUTTER	CONCRETE CURB	FAIR/73

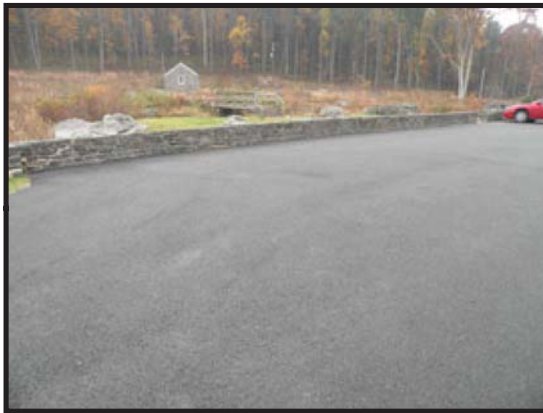
Route Number	Public / NonPublic	Date Visited		Area (sq ft)	Lane Miles *	Surface Type
0914AZ	PUBLIC	11/4/2008		1,493	0.03	AS
Culverts	Drop Inlets	Gates	Fire Hydrants	Curb & Gutter	Curb	PCR
0	0	0	0	NO CURB AND GUTTER	NO CURB	EXCELLENT/97

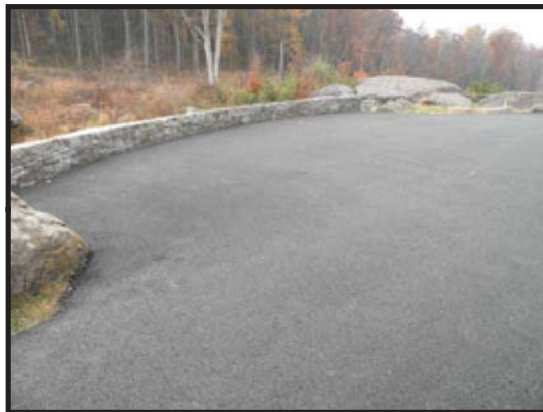
Route Number	Public / NonPublic	Date Visited		Area (sq ft)	Lane Miles *	Surface Type
0914BZ	PUBLIC	11/4/2008		989	0.02	AS
Culverts	Drop Inlets	Gates	Fire Hydrants	Curb & Gutter	Curb	PCR
0	0	0	0	NO CURB AND GUTTER	NO CURB	EXCELLENT/97

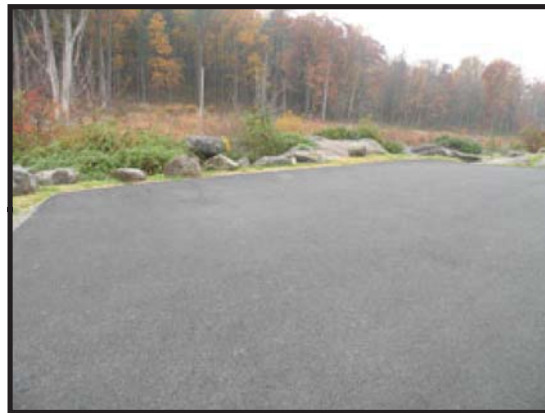
Route Number	Public / NonPublic	Date Visited		Area (sq ft)	Lane Miles *	Surface Type
0914CZ	PUBLIC	11/4/2008		813	0.01	AS
Culverts	Drop Inlets	Gates	Fire Hydrants	Curb & Gutter	Curb	PCR
0	0	0	0	NO CURB AND GUTTER	NO CURB	EXCELLENT/97

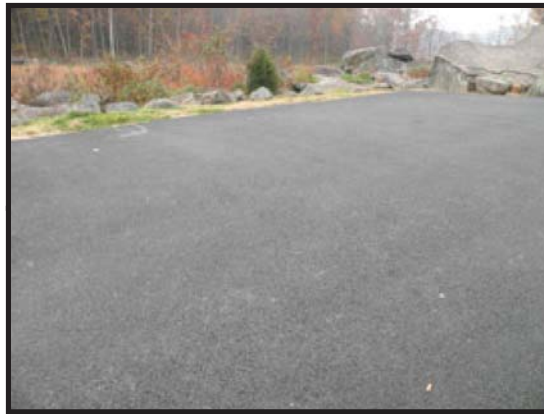
Route Number	Public / NonPublic	Date Visited		Area (sq ft)	Lane Miles *	Surface Type
0914DZ	PUBLIC	11/4/2008		828	0.01	AS
Culverts	Drop Inlets	Gates	Fire Hydrants	Curb & Gutter	Curb	PCR
0	0	0	0	NO CURB AND GUTTER	NO CURB	EXCELLENT/97

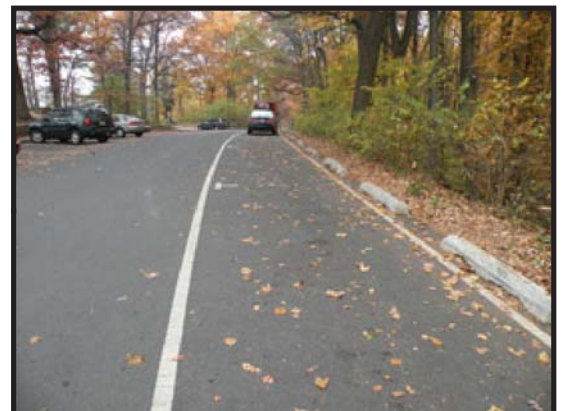
Route Number	Public / NonPublic	Date Visited		Area (sq ft)	Lane Miles *	Surface Type
0915AZ	PUBLIC	11/4/2008		2,940	0.05	AS
Culverts	Drop Inlets	Gates	Fire Hydrants	Curb & Gutter	Curb	PCR
0	0	0	0	NO CURB AND GUTTER	NO CURB	EXCELLENT/97

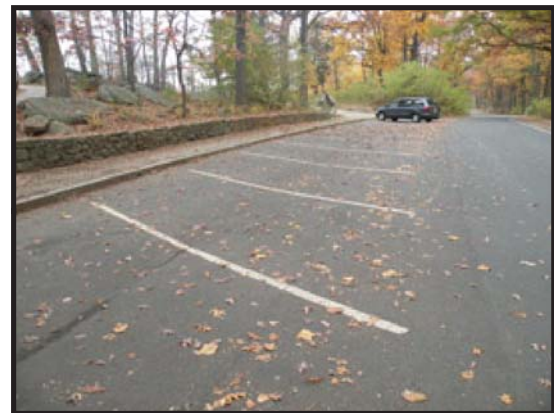
Route Number	Public / NonPublic	Date Visited		Area (sq ft)	Lane Miles *	Surface Type
0915BZ	PUBLIC	11/4/2008		5,224	0.09	AS
Culverts	Drop Inlets	Gates	Fire Hydrants	Curb & Gutter	Curb	PCR
0	1	0	0	NO CURB AND GUTTER	STONE CURB	EXCELLENT/97

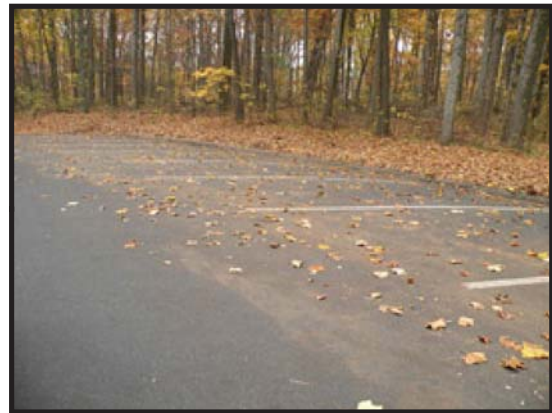
Route Number	Public / NonPublic	Date Visited		Area (sq ft)	Lane Miles *	Surface Type
0916	PUBLIC	11/4/2008		4,730	0.08	AS
Culverts	Drop Inlets	Gates	Fire Hydrants	Curb & Gutter	Curb	PCR
0	0	0	0	NO CURB AND GUTTER	STONE CURB	GOOD/90

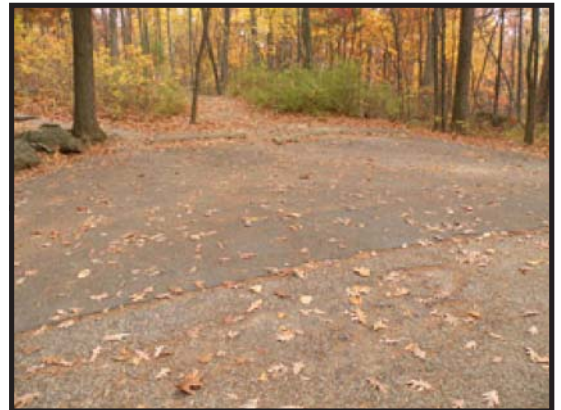
Route Number	Public / NonPublic	Date Visited		Area (sq ft)	Lane Miles *	Surface Type
0917	PUBLIC	11/4/2008		1,708	0.03	AS
Culverts	Drop Inlets	Gates	Fire Hydrants	Curb & Gutter	Curb	PCR
0	0	0	0	NO CURB AND GUTTER	NO CURB	FAIR/73

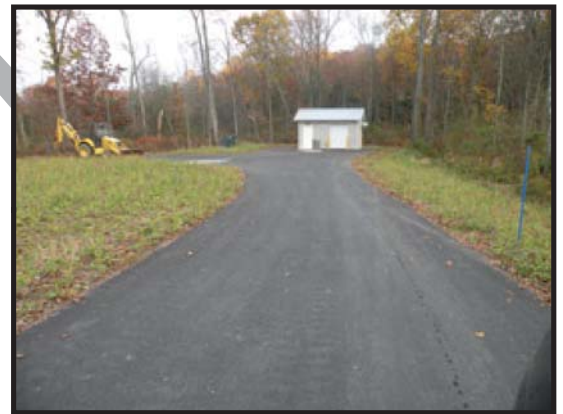
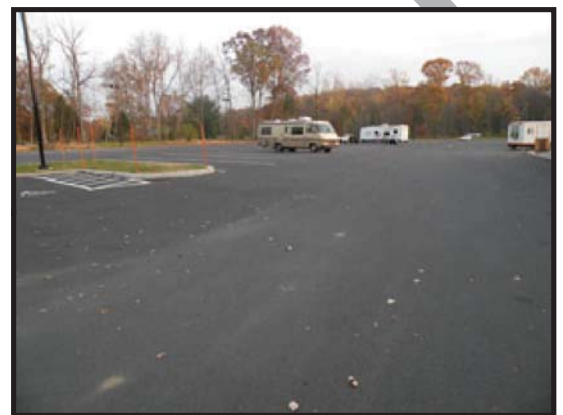
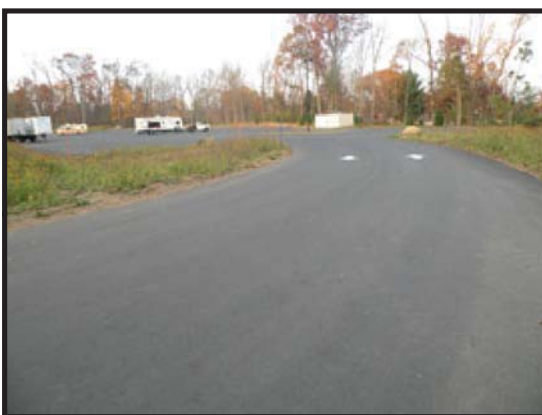
Route Number	Public / NonPublic	Date Visited		Area (sq ft)	Lane Miles *	Surface Type
0920	PUBLIC	11/3/2008		100,997	1.74	AS
Culverts	Drop Inlets	Gates	Fire Hydrants	Curb & Gutter	Curb	PCR
0	0	0	0	NO CURB AND GUTTER	ASPHALT CURB	EXCELLENT/97

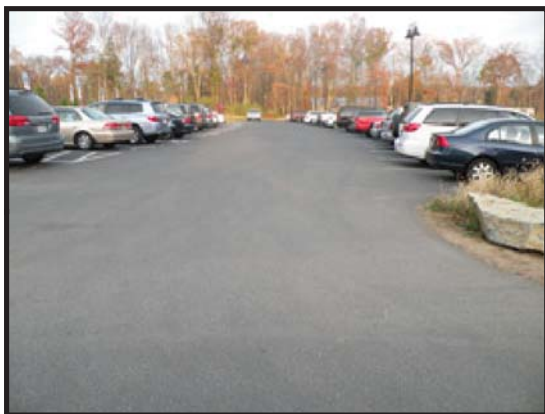
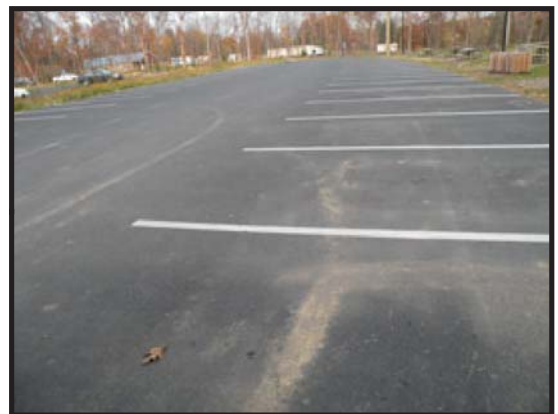
Route Number	Public / NonPublic	Date Visited		Area (sq ft)	Lane Miles *	Surface Type
0921	PUBLIC	11/3/2008		97,889	1.69	AS
Culverts	Drop Inlets	Gates	Fire Hydrants	Curb & Gutter	Curb	PCR
0	0	0	0	NO CURB AND GUTTER	CONCRETE CURB	EXCELLENT/97

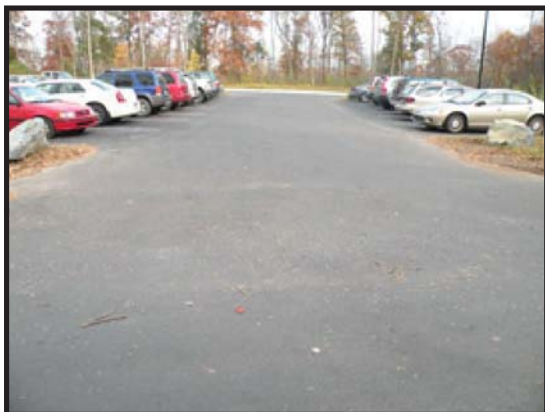
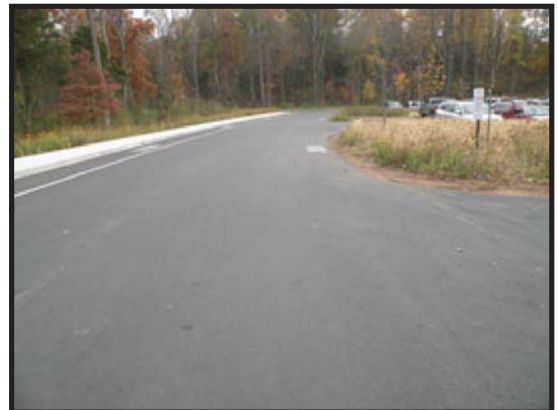
Route Number	Public / NonPublic	Date Visited		Area (sq ft)	Lane Miles *	Surface Type
0922	PUBLIC	11/3/2008		45,004	0.78	AS
Culverts	Drop Inlets	Gates	Fire Hydrants	Curb & Gutter	Curb	PCR
0	4	0	1	NO CURB AND GUTTER	CONCRETE CURB	EXCELLENT/97

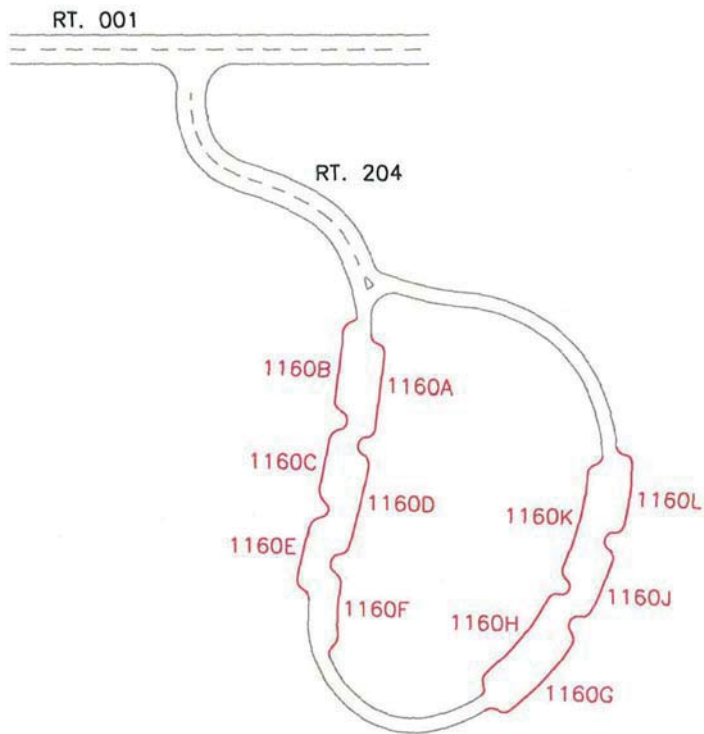
Figure 3: Parking with access route 204 and multiple parking areas (1160 A-L). Currently, this parking area is 12 routes and 12 assets (one 1100 asset and 11 1300 assets).
