**The Road Inventory
of
Glen Canyon National Recreation Area
GLCA – 1440
Cycle 4**

**Prepared By:
Federal Highway Administration
Road Inventory Program
Cycle 4**

Glen Canyon National Recreation Area in Utah and Arizona

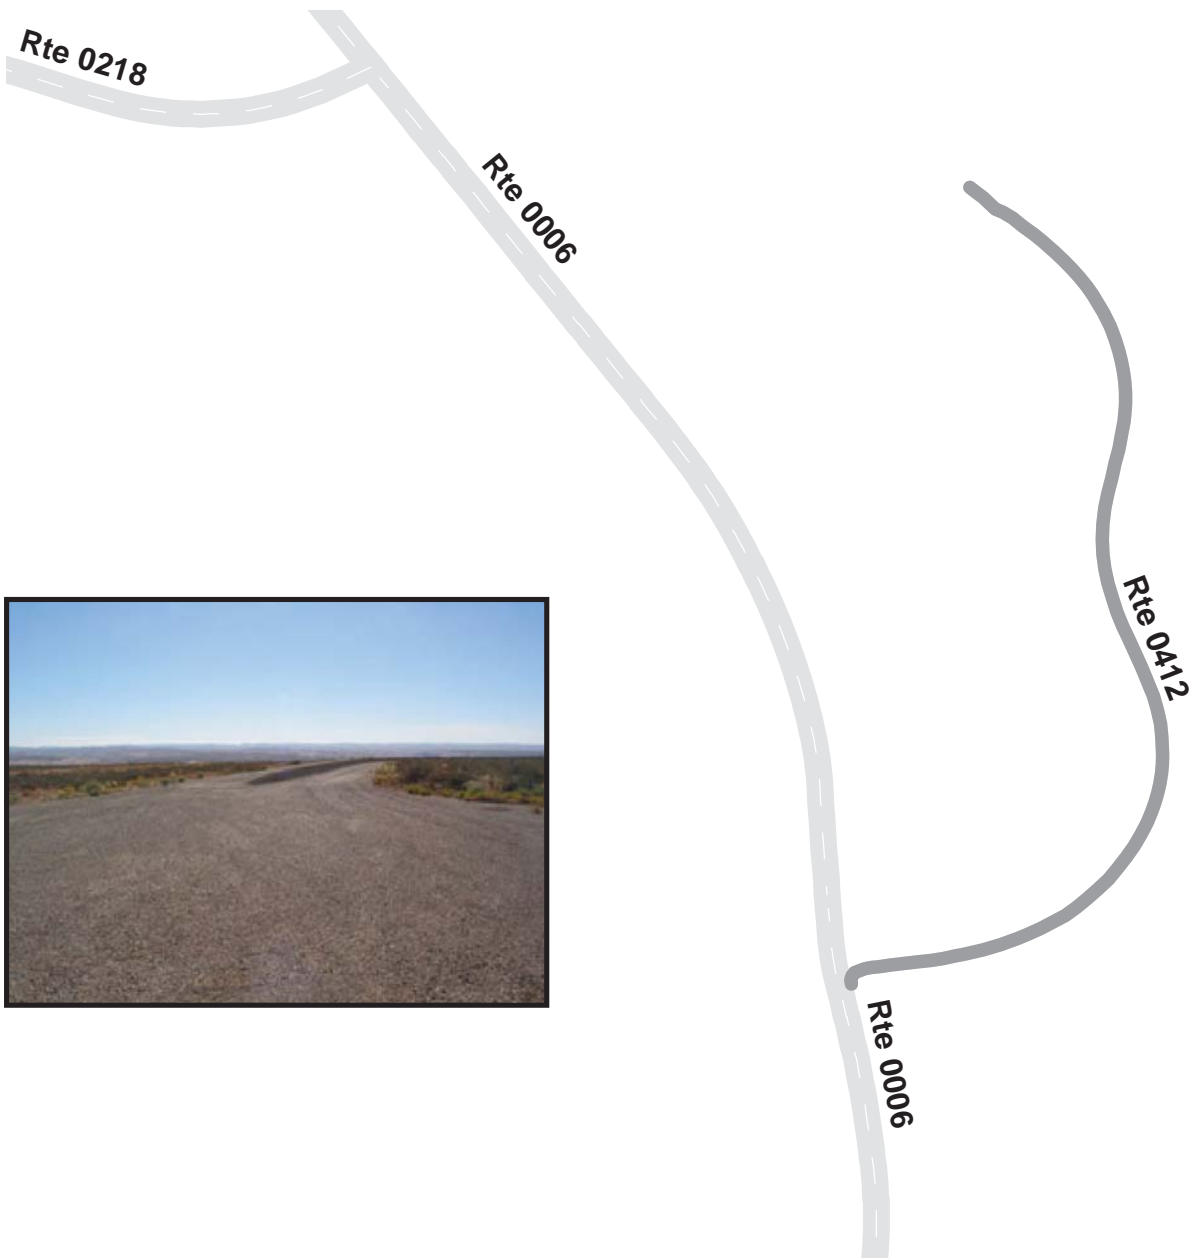
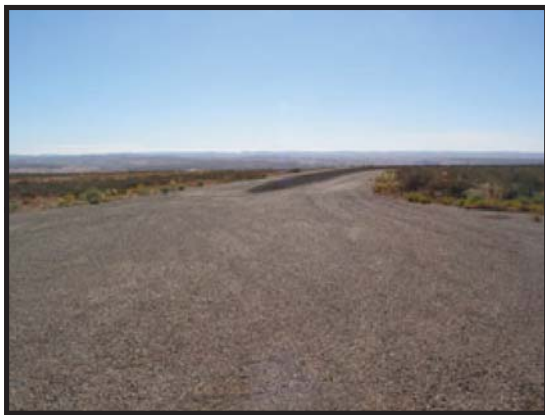
Route 0412

Route Number	Public / NonPublic	Date Visited		Area (sq ft)	Lane Miles *	Surface Type
0412	PUBLIC	9/17/2007		71,074	1.22	AS
Culverts	Drop Inlets	Gates	Fire Hydrants	Curb & Gutter	Curb	PCR
0	0	0	0	NO CURB AND GUTTER	NO CURB	POOR/45

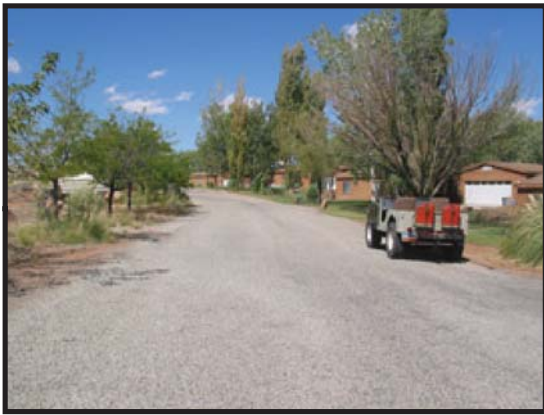
Route 0420

Route Number	Public / NonPublic	Date Visited		Area (sq ft)	Lane Miles *	Surface Type
0420	NONPUBLIC	9/17/2007		11,642	0.20	AS
Culverts	Drop Inlets	Gates	Fire Hydrants	Curb & Gutter	Curb	PCR
0	0	0	1	NO CURB AND GUTTER	NO CURB	POOR/45

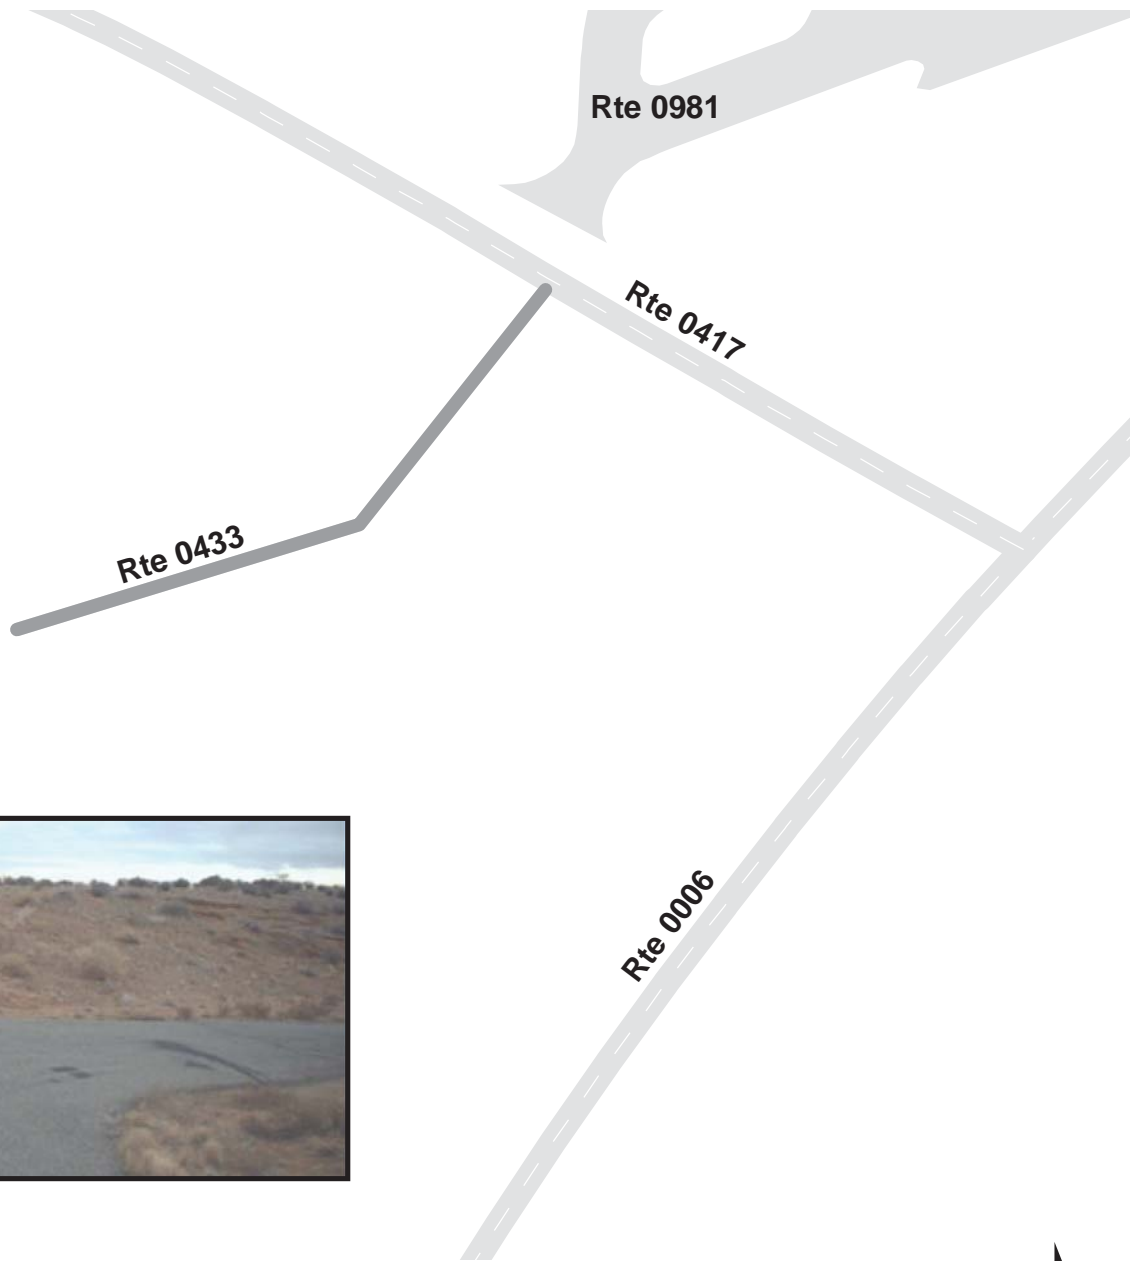
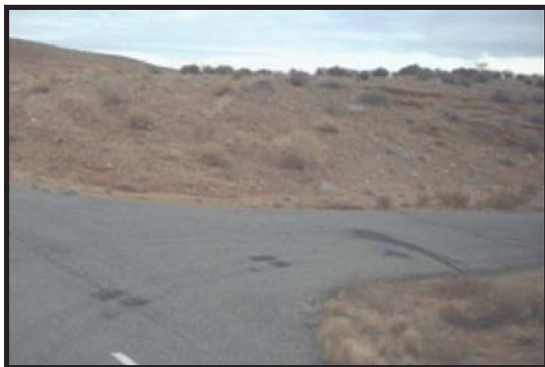
Route 0433

Route Number	Public / NonPublic	Date Visited		Area (sq ft)	Lane Miles *	Surface Type
0433	PUBLIC	12/6/2007		6,320	0.11	AS
Culverts	Drop Inlets	Gates	Fire Hydrants	Curb & Gutter	Curb	PCR
0	0	0	0	NO CURB AND GUTTER	NO CURB	FAIR/73

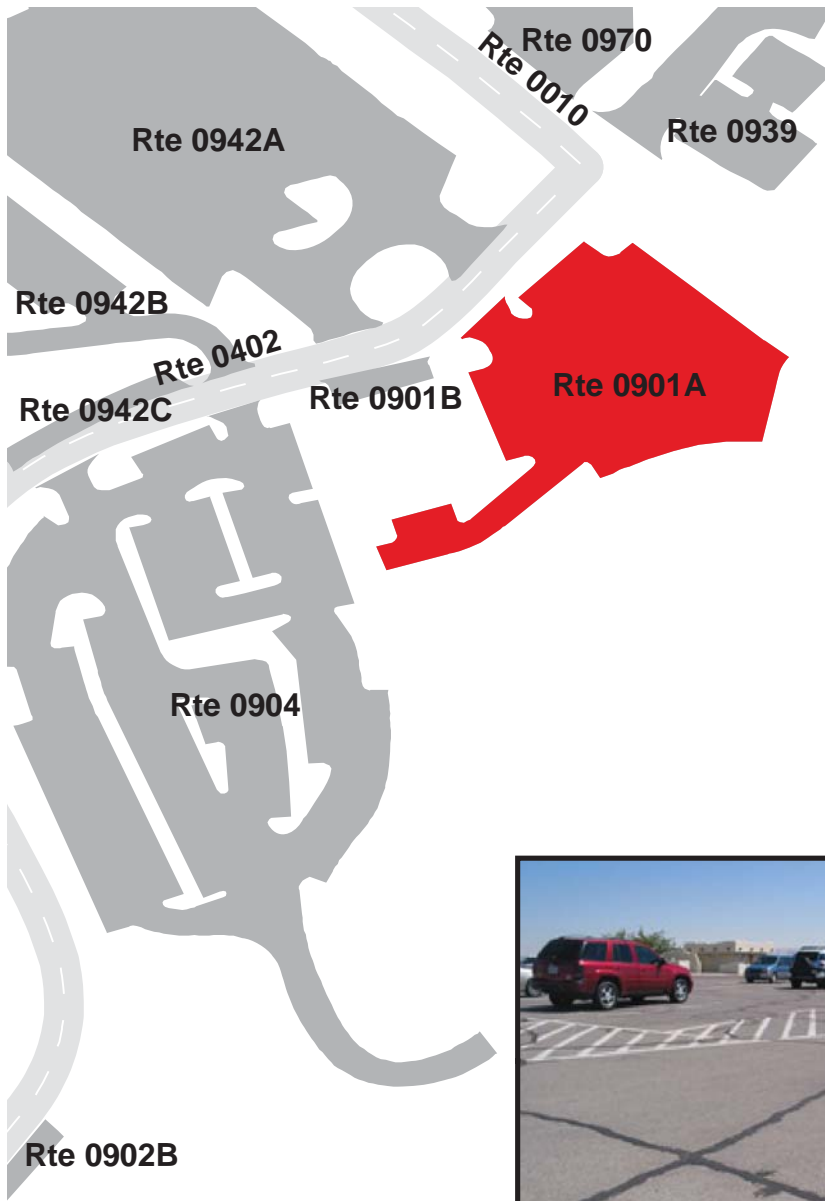
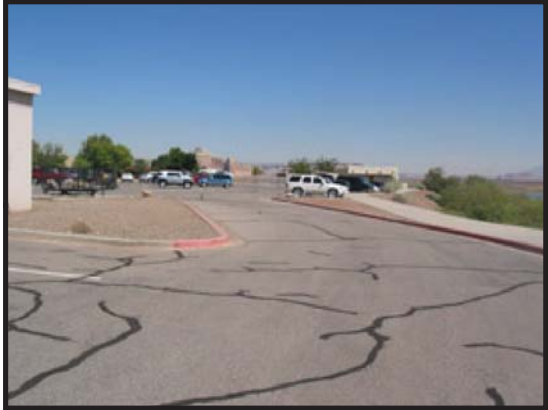
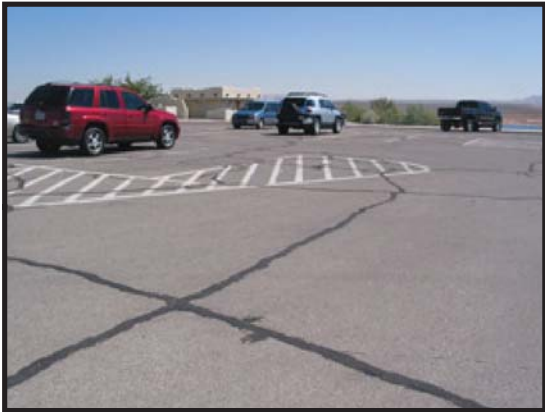
Route Number	Public / NonPublic	Date Visited		Area (sq ft)	Lane Miles *	Surface Type
0901A	PUBLIC	9/18/2007		40,459	0.70	AS
Culverts	Drop Inlets	Gates	Fire Hydrants	Curb & Gutter	Curb	PCR
0	2	0	0	CONCRETE CURB AND GUTTER	CONCRETE CURB	FAIR/73

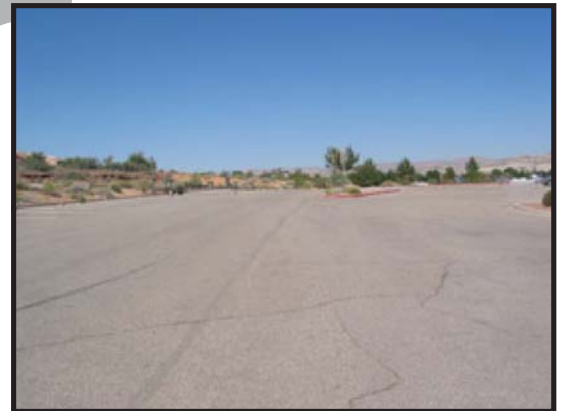
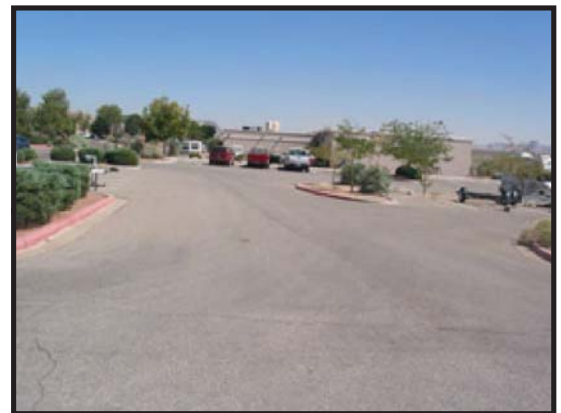
Route Number	Public / NonPublic	Date Visited		Area (sq ft)	Lane Miles *	Surface Type
0904	PUBLIC	9/18/2007		97,764	1.68	AS
Culverts	Drop Inlets	Gates	Fire Hydrants	Curb & Gutter	Curb	PCR
0	2	0	1	CONCRETE CURB AND GUTTER	CONCRETE CURB	GOOD/90

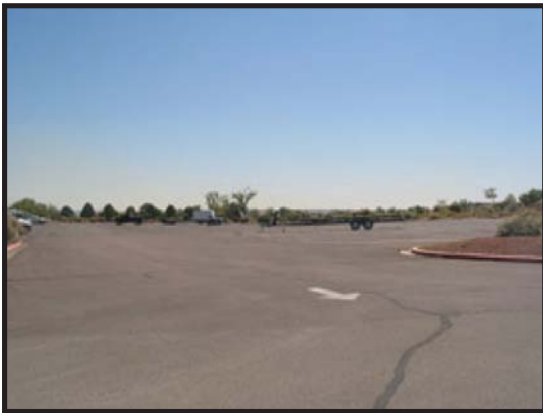
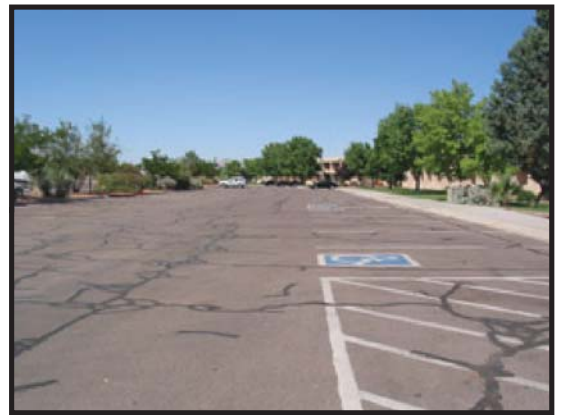
Route 0905

Route Number	Public / NonPublic	Date Visited		Area (sq ft)	Lane Miles *	Surface Type
0905	PUBLIC	9/18/2007		236,264	4.07	AS
Culverts	Drop Inlets	Gates	Fire Hydrants	Curb & Gutter	Curb	PCR
1	3	0	4	CONCRETE CURB AND GUTTER	CONCRETE CURB	FAIR/73

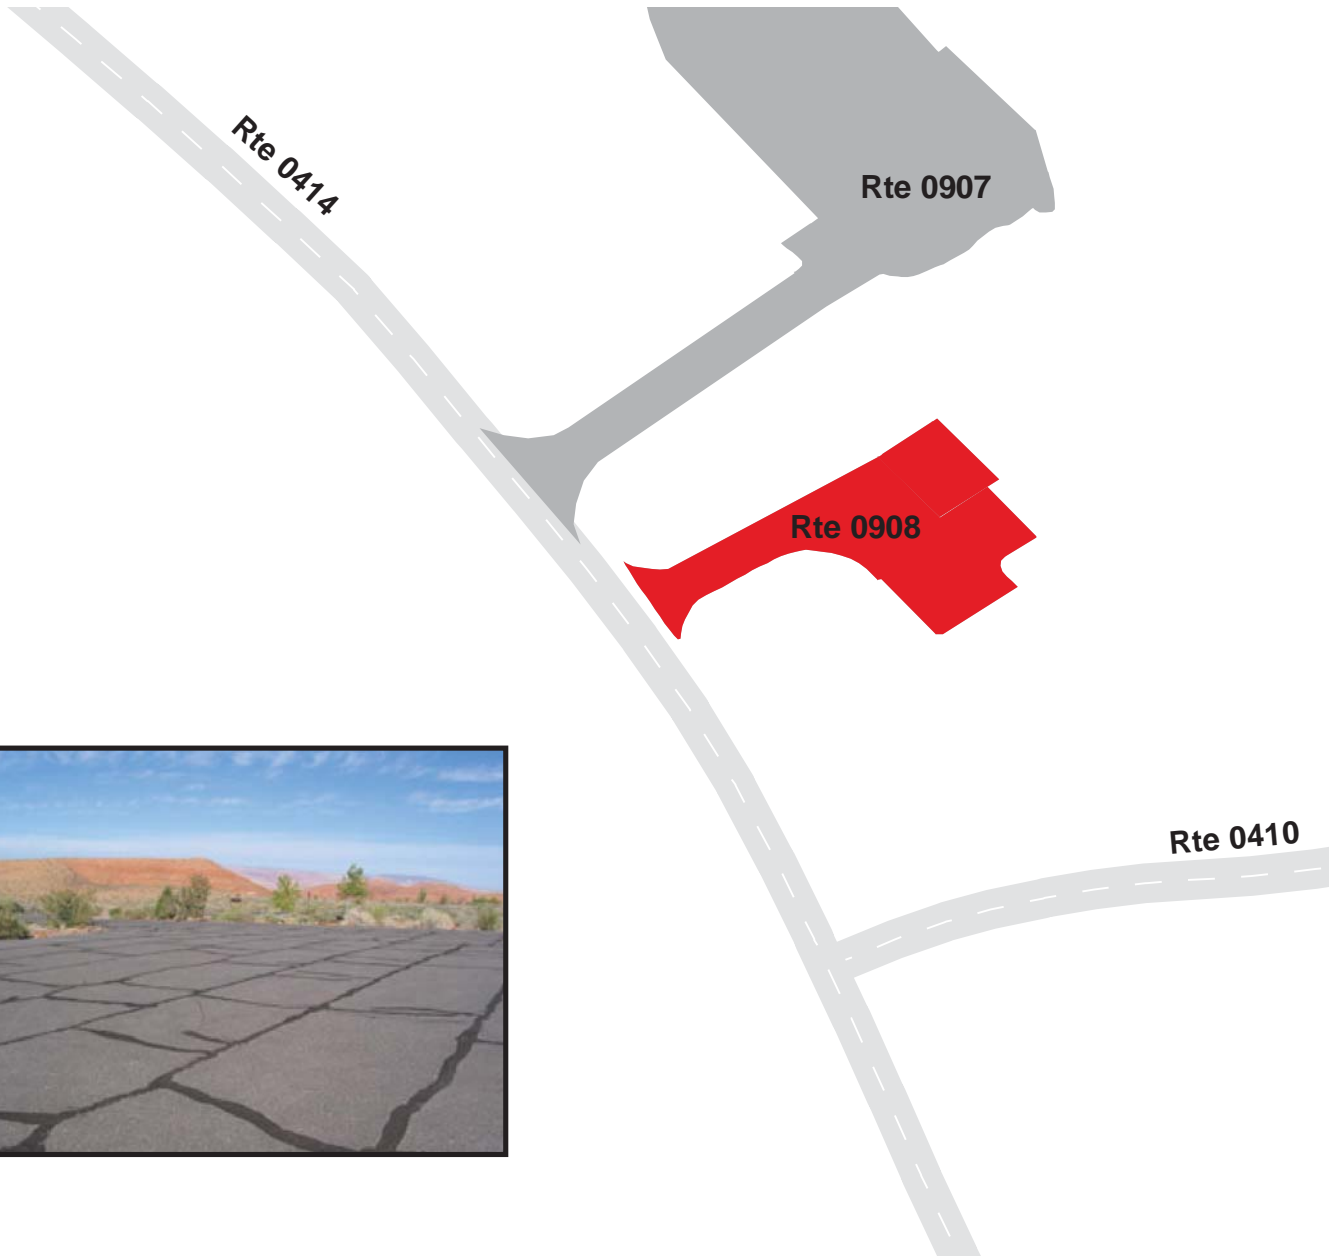
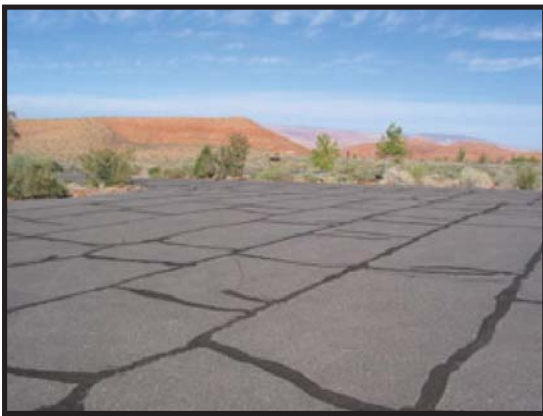
Route Number	Public / NonPublic	Date Visited		Area (sq ft)	Lane Miles *	Surface Type
0908	NONPUBLIC	9/20/2007		11,264	0.19	AS
Culverts	Drop Inlets	Gates	Fire Hydrants	Curb & Gutter	Curb	PCR
0	0	0	0	CONCRETE CURB AND GUTTER	CONCRETE CURB	POOR/45

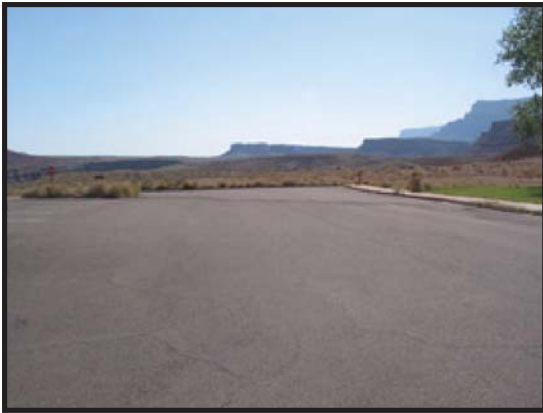
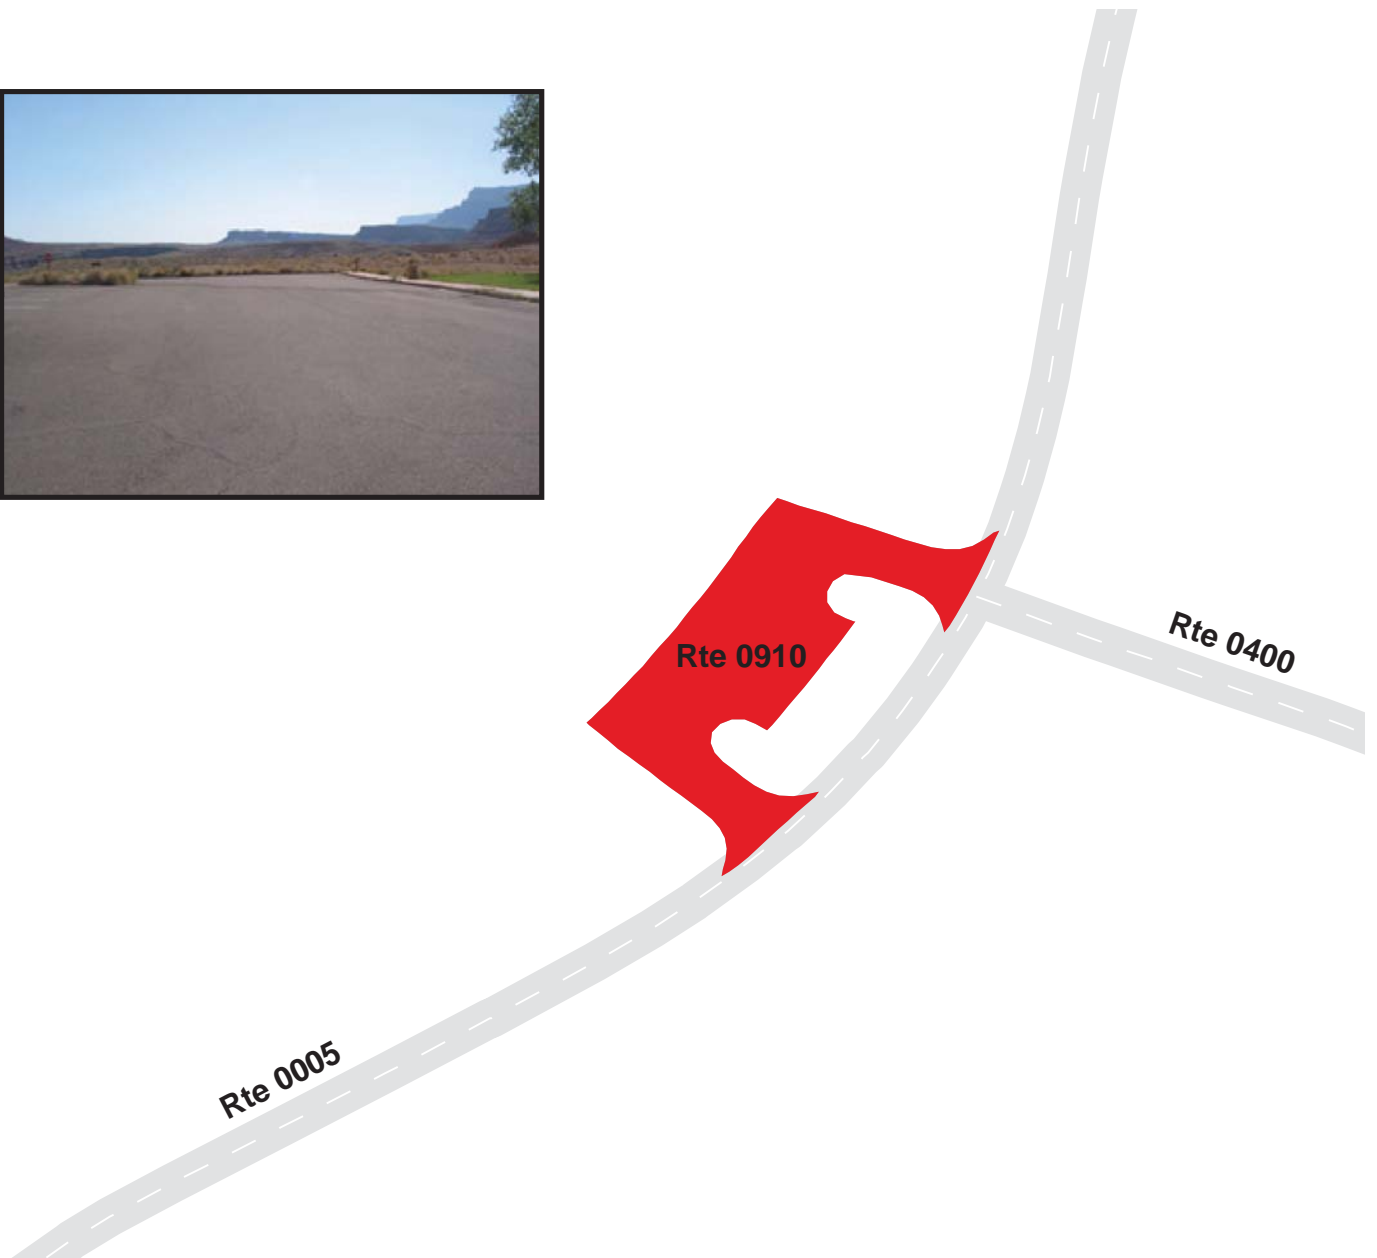
Route Number	Public / NonPublic	Date Visited		Area (sq ft)	Lane Miles *	Surface Type
0910	PUBLIC	9/17/2007		10,796	0.19	AS
Culverts	Drop Inlets	Gates	Fire Hydrants	Curb & Gutter	Curb	PCR
0	0	0	0	CONCRETE CURB AND GUTTER	CONCRETE CURB	GOOD/90

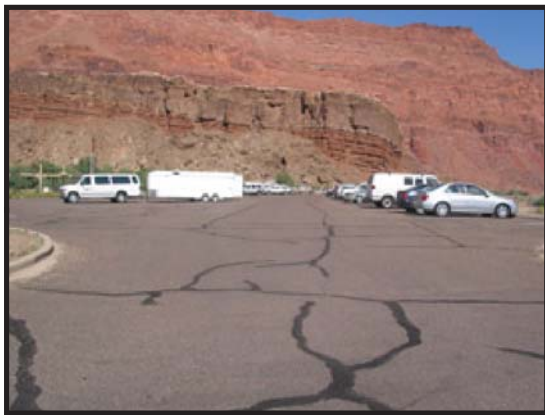
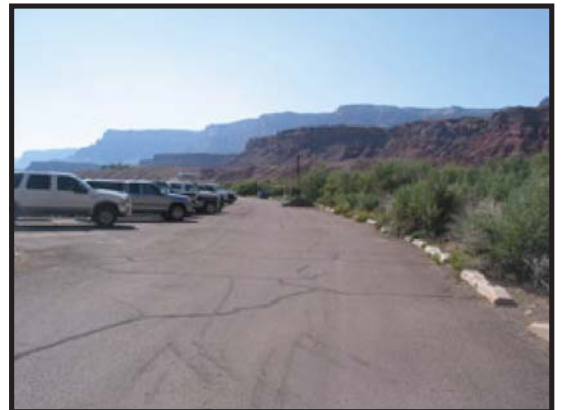
Route Number	Public / NonPublic	Date Visited		Area (sq ft)	Lane Miles *	Surface Type
0911	PUBLIC	9/17/2007		78,189	1.35	AS
Culverts	Drop Inlets	Gates	Fire Hydrants	Curb & Gutter	Curb	PCR
0	0	0	0	CONCRETE CURB AND GUTTER	CONCRETE CURB	FAIR/73

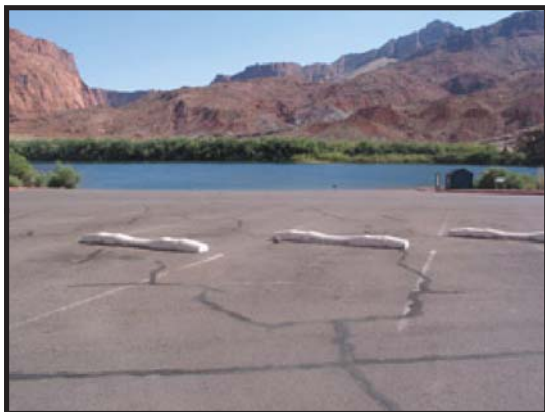
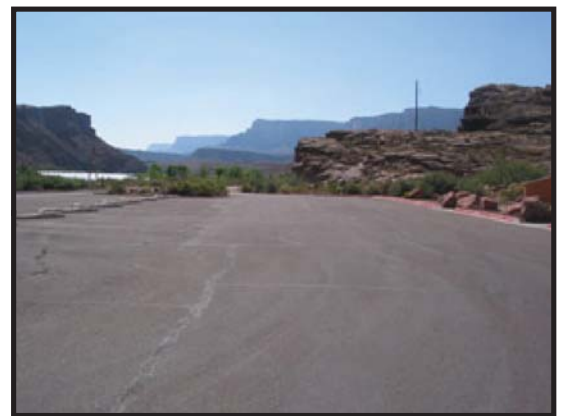
Route Number	Public / NonPublic	Date Visited		Area (sq ft)	Lane Miles *	Surface Type
0913	PUBLIC	9/17/2007		40,943	0.71	AS
Culverts	Drop Inlets	Gates	Fire Hydrants	Curb & Gutter	Curb	PCR
0	0	0	0	ASPHALT CURB AND GUTTER	ASPHALT CURB	FAIR/73

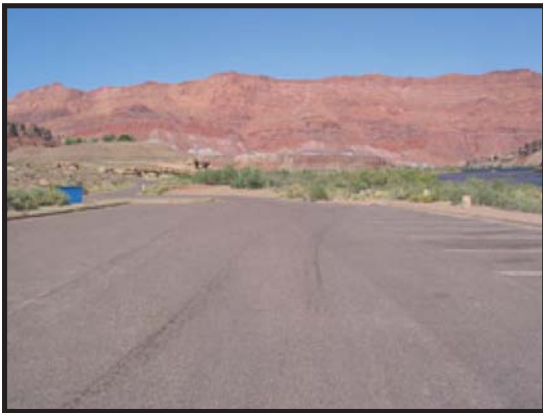
Route Number	Public / NonPublic	Date Visited		Area (sq ft)	Lane Miles *	Surface Type
0915	PUBLIC	9/17/2007		11,932	0.21	AS
Culverts	Drop Inlets	Gates	Fire Hydrants	Curb & Gutter	Curb	PCR
0	1	0	0	CONCRETE CURB AND GUTTER	CONCRETE CURB	FAIR/73

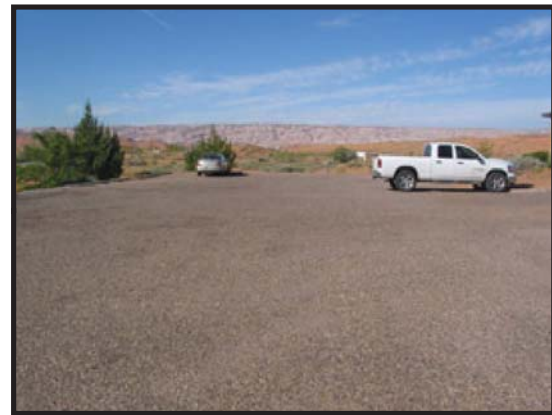
Route Number	Public / NonPublic	Date Visited		Area (sq ft)	Lane Miles *	Surface Type
0916A	PUBLIC	9/20/2007		11,267	0.19	AS
Culverts	Drop Inlets	Gates	Fire Hydrants	Curb & Gutter	Curb	PCR
0	0	0	0	NO CURB AND GUTTER	CONCRETE CURB	POOR/45

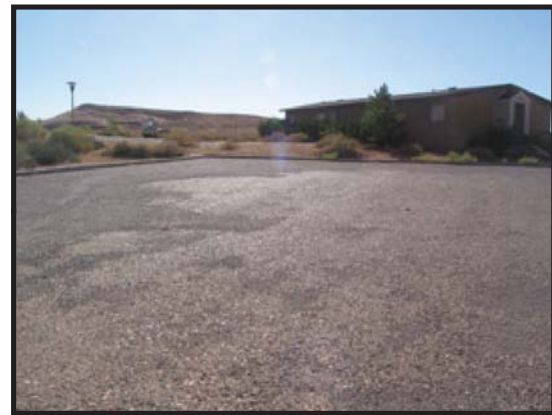
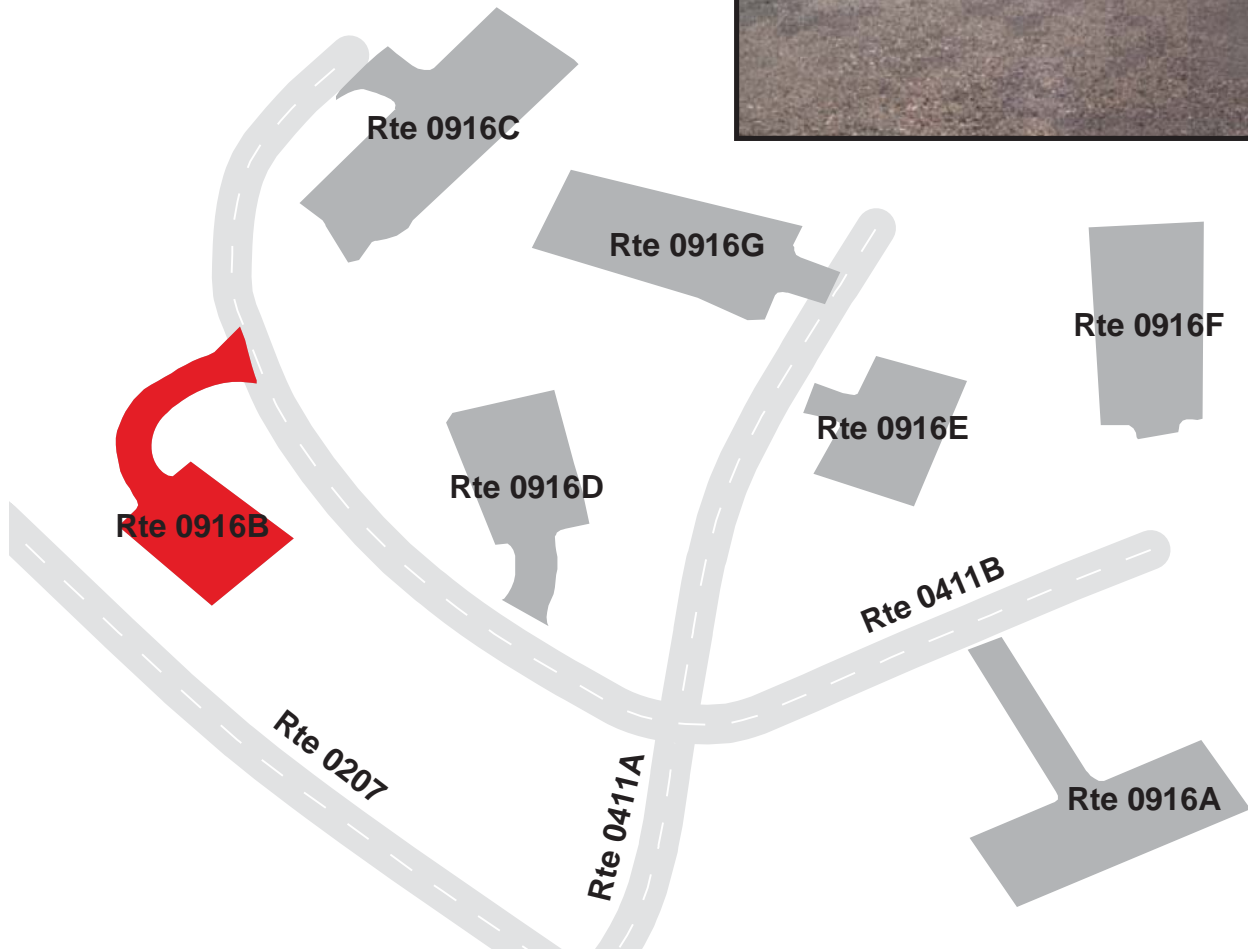
Route Number	Public / NonPublic	Date Visited		Area (sq ft)	Lane Miles *	Surface Type
0916B	PUBLIC	9/20/2007		8,210	0.14	AS
Culverts	Drop Inlets	Gates	Fire Hydrants	Curb & Gutter	Curb	PCR
0	0	0	0	NO CURB AND GUTTER	CONCRETE CURB	POOR/45

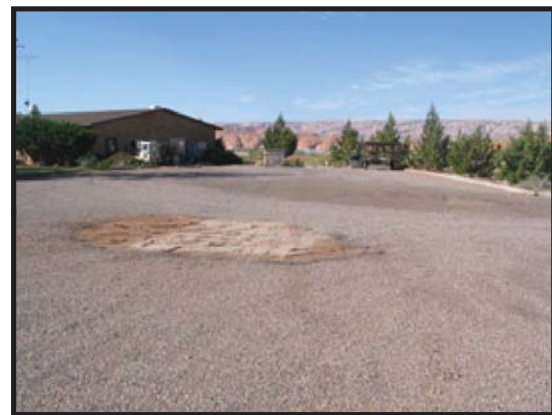
Route Number	Public / NonPublic	Date Visited		Area (sq ft)	Lane Miles *	Surface Type
0916C	PUBLIC	9/20/2007		12,130	0.21	AS
Culverts	Drop Inlets	Gates	Fire Hydrants	Curb & Gutter	Curb	PCR
0	0	0	0	NO CURB AND GUTTER	CONCRETE CURB	POOR/45

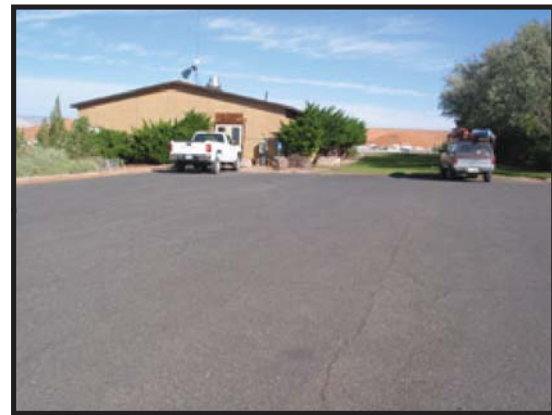
Route Number	Public / NonPublic	Date Visited		Area (sq ft)	Lane Miles *	Surface Type
0916D	PUBLIC	9/20/2007		7,404	0.13	AS
Culverts	Drop Inlets	Gates	Fire Hydrants	Curb & Gutter	Curb	PCR
0	0	0	0	NO CURB AND GUTTER	CONCRETE CURB	GOOD/90

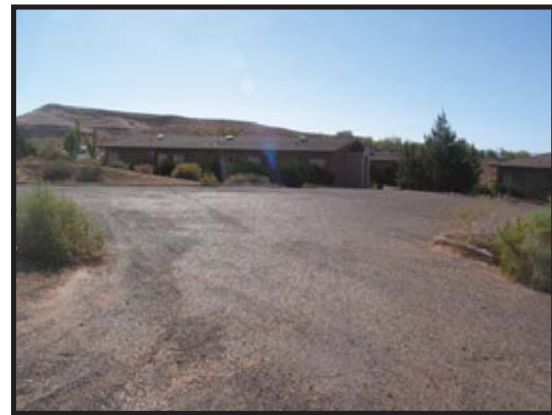
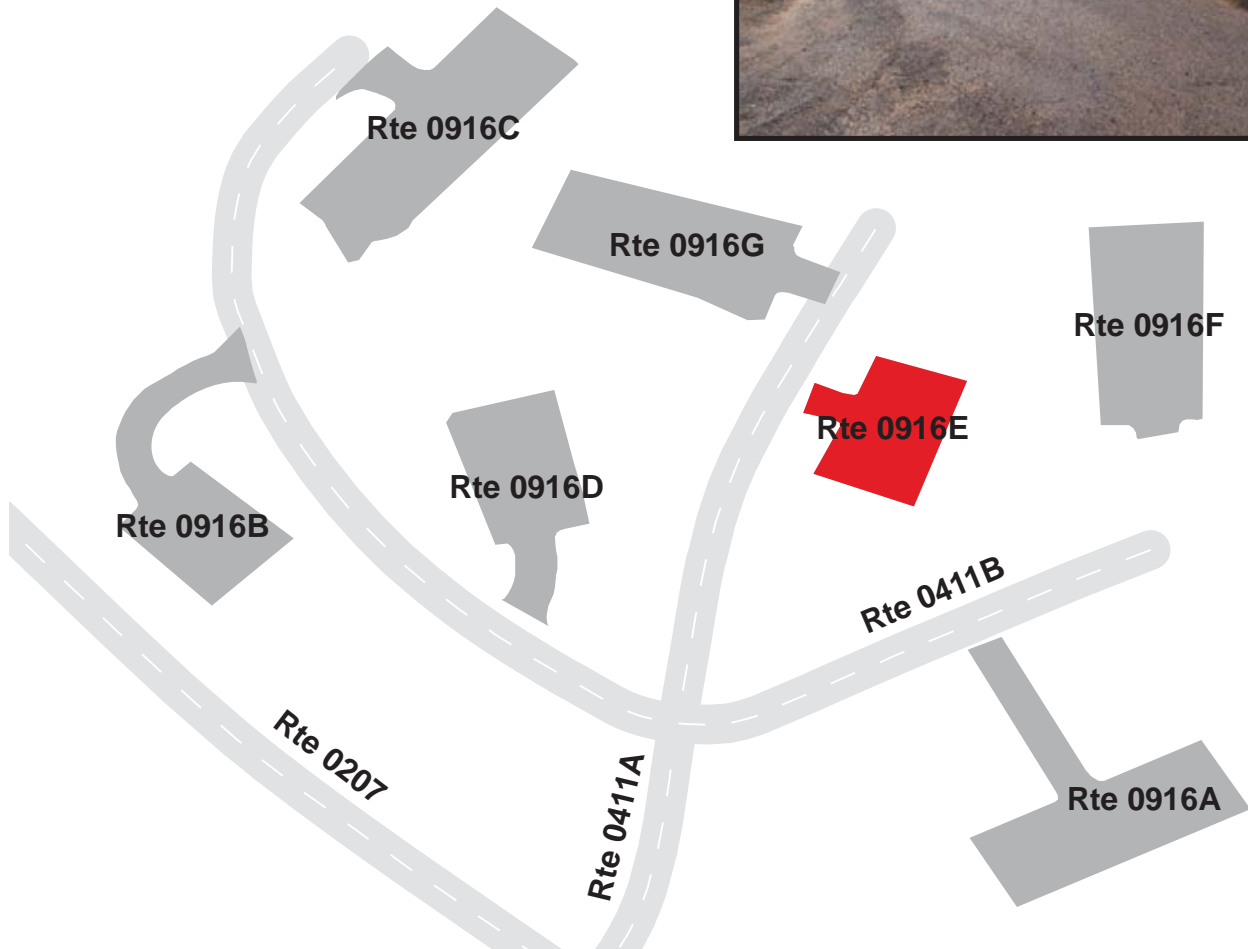
Route Number	Public / NonPublic	Date Visited		Area (sq ft)	Lane Miles *	Surface Type
0916E	PUBLIC	9/20/2007		5,992	0.10	AS
Culverts	Drop Inlets	Gates	Fire Hydrants	Curb & Gutter	Curb	PCR
0	0	0	0	NO CURB AND GUTTER	CONCRETE CURB	POOR/45

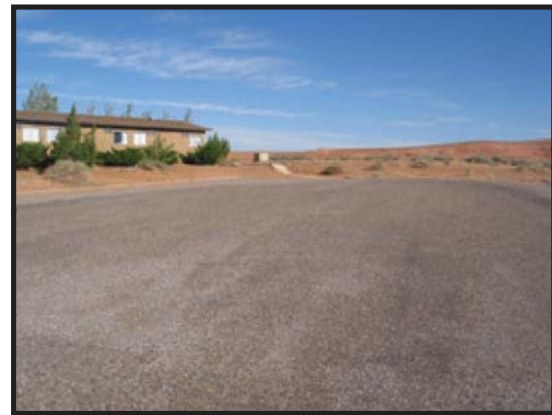
Route Number	Public / NonPublic	Date Visited		Area (sq ft)	Lane Miles *	Surface Type
0916F	PUBLIC	9/20/2007		9,138	0.16	AS
Culverts	Drop Inlets	Gates	Fire Hydrants	Curb & Gutter	Curb	PCR
0	0	0	0	NO CURB AND GUTTER	CONCRETE CURB	FAIR/73

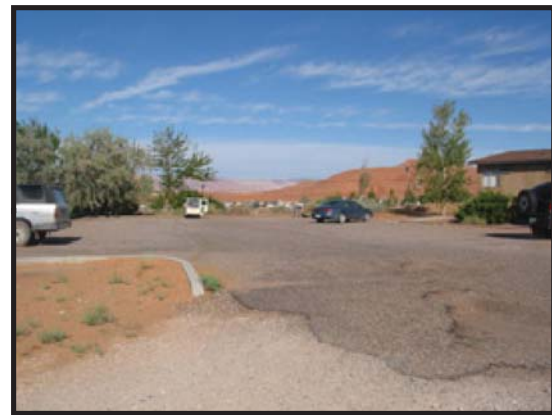
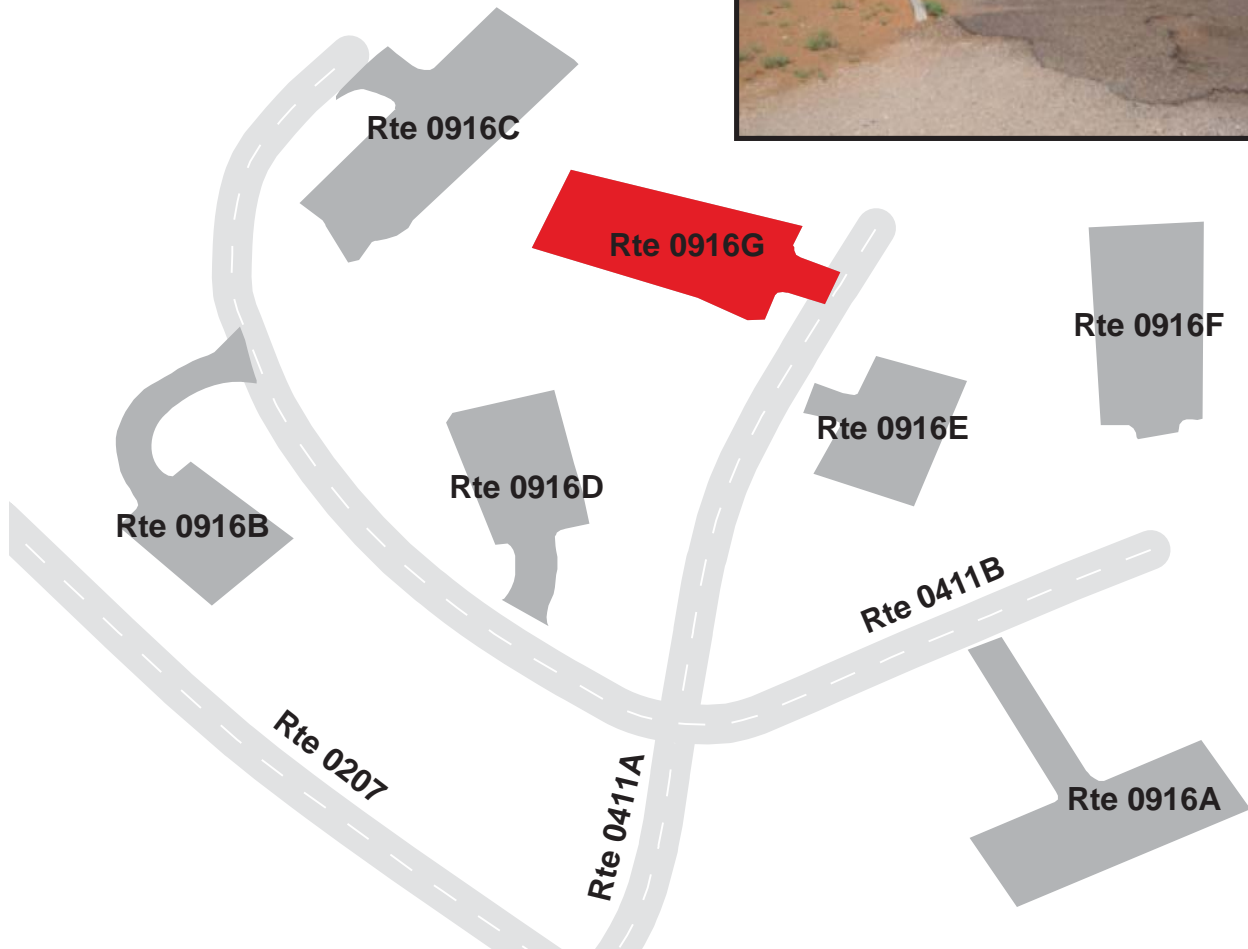
Route Number	Public / NonPublic	Date Visited		Area (sq ft)	Lane Miles *	Surface Type
0916G	PUBLIC	9/20/2007		10,087	0.17	AS
Culverts	Drop Inlets	Gates	Fire Hydrants	Curb & Gutter	Curb	PCR
0	0	0	0	NO CURB AND GUTTER	CONCRETE CURB	FAIR/73

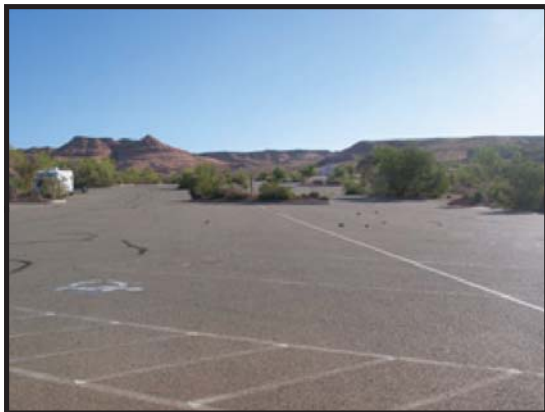
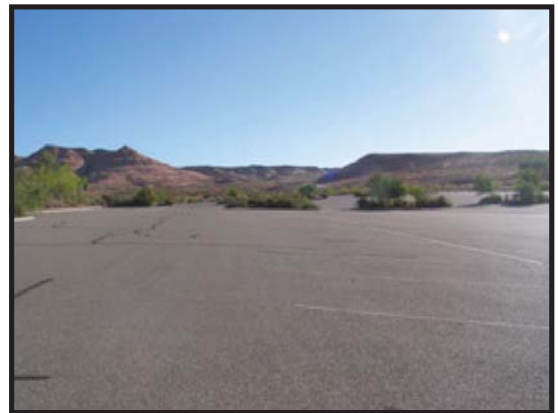
Route Number	Public / NonPublic	Date Visited		Area (sq ft)	Lane Miles *	Surface Type
0918	PUBLIC	9/20/2007		288,845	4.97	AS
Culverts	Drop Inlets	Gates	Fire Hydrants	Curb & Gutter	Curb	PCR
0	0	0	0	CONCRETE CURB AND GUTTER	CONCRETE CURB	FAIR/73

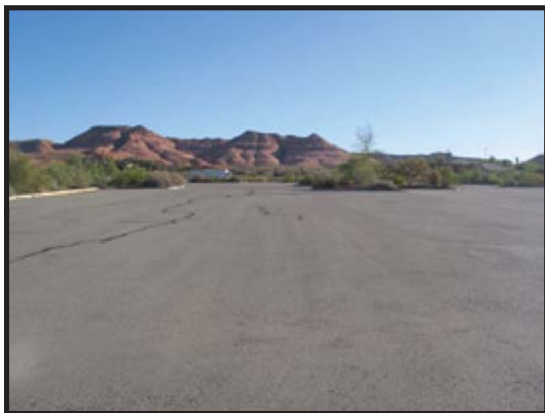
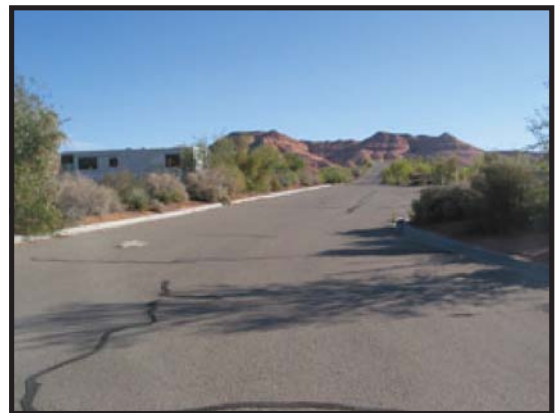
Route Number	Public / NonPublic	Date Visited		Area (sq ft)	Lane Miles *	Surface Type
0919	PUBLIC	9/20/2007		144,409	2.49	AS
Culverts	Drop Inlets	Gates	Fire Hydrants	Curb & Gutter	Curb	PCR
0	2	0	0	CONCRETE CURB AND GUTTER	CONCRETE CURB	GOOD/90

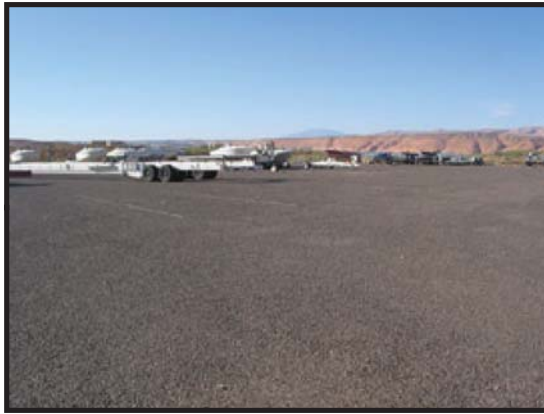
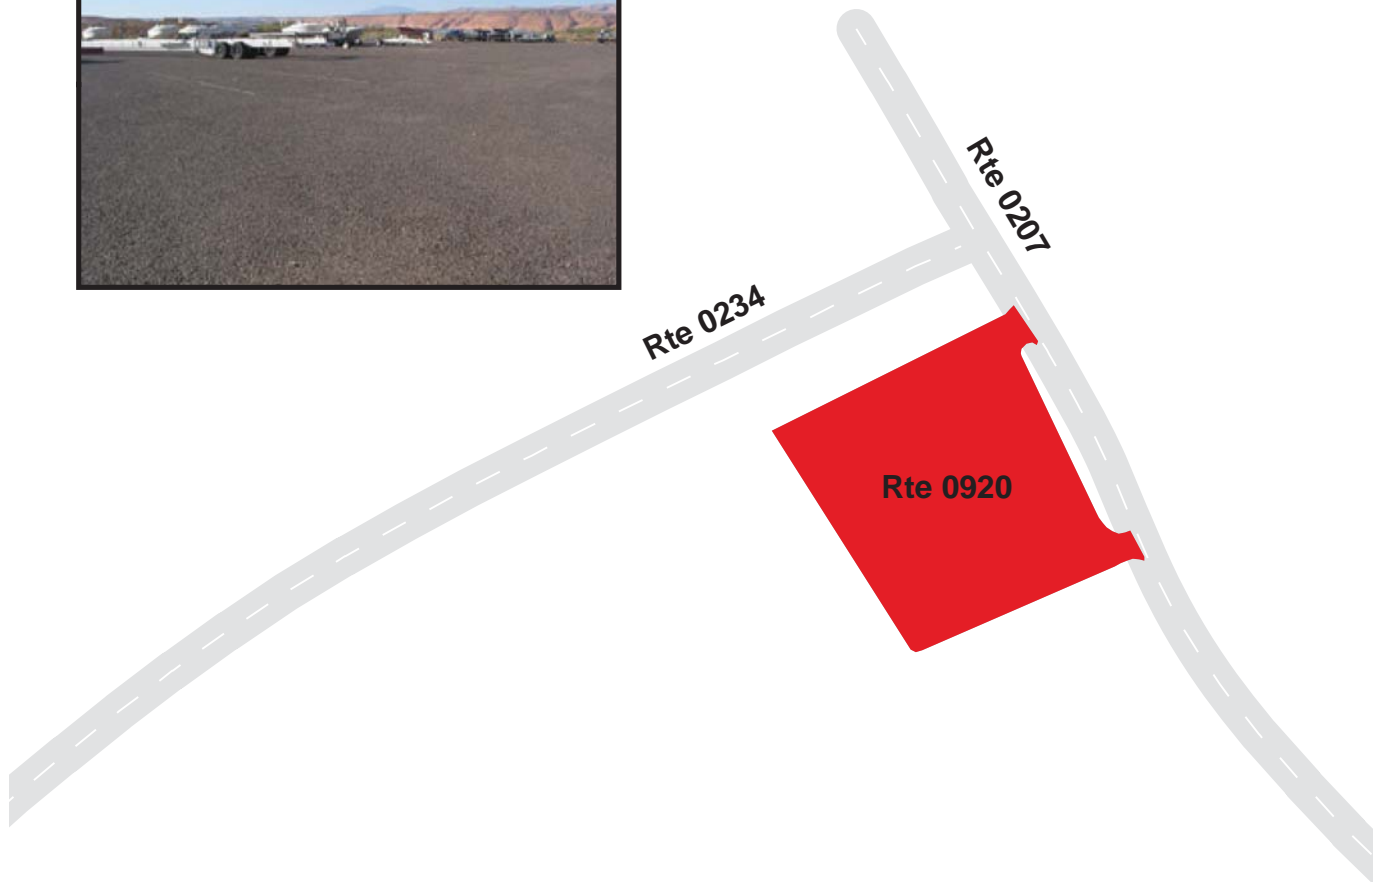
Route Number	Public / NonPublic	Date Visited		Area (sq ft)	Lane Miles *	Surface Type
0920	PUBLIC	9/20/2007		40,478	0.70	AS
Culverts	Drop Inlets	Gates	Fire Hydrants	Curb & Gutter	Curb	PCR
0	0	0	0	NO CURB AND GUTTER	NO CURB	POOR/45

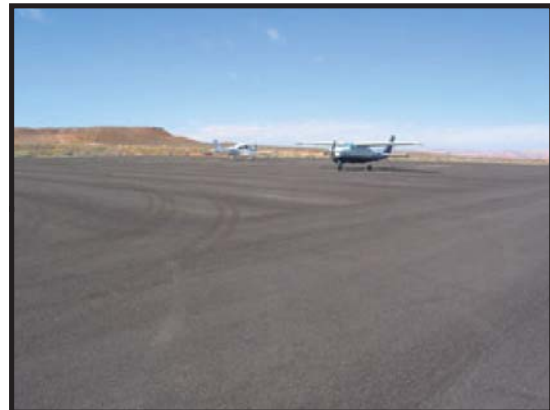
Route Number	Public / NonPublic	Date Visited		Area (sq ft)	Lane Miles *	Surface Type
0922	PUBLIC	9/20/2007		82,442	1.42	AS
Culverts	Drop Inlets	Gates	Fire Hydrants	Curb & Gutter	Curb	PCR
0	0	0	0	NO CURB AND GUTTER	NO CURB	GOOD/90

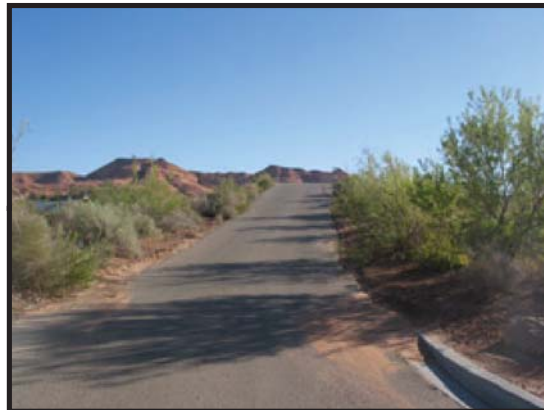
Route Number	Public / NonPublic	Date Visited		Area (sq ft)	Lane Miles *	Surface Type
0923	PUBLIC	9/20/2007		9,583	0.17	AS
Culverts	Drop Inlets	Gates	Fire Hydrants	Curb & Gutter	Curb	PCR
0	0	0	0	NO CURB AND GUTTER	CONCRETE CURB	GOOD/90

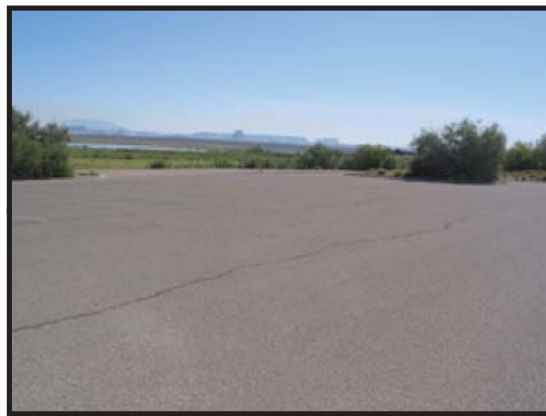
Route Number	Public / NonPublic	Date Visited		Area (sq ft)	Lane Miles *	Surface Type
0926	PUBLIC	9/18/2007		40,918	0.71	AS
Culverts	Drop Inlets	Gates	Fire Hydrants	Curb & Gutter	Curb	PCR
0	2	0	0	CONCRETE CURB AND GUTTER	CONCRETE CURB	FAIR/73

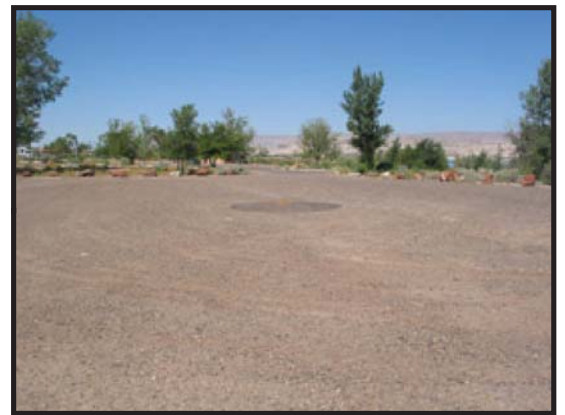
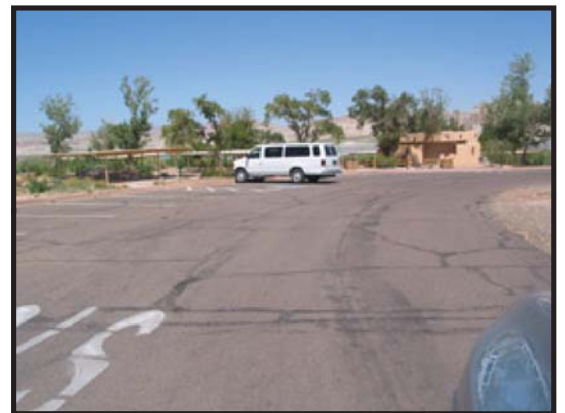
Route Number	Public / NonPublic	Date Visited		Area (sq ft)	Lane Miles *	Surface Type
0927	PUBLIC	9/18/2007		61,281	1.06	AS
Culverts	Drop Inlets	Gates	Fire Hydrants	Curb & Gutter	Curb	PCR
0	1	0	1	CONCRETE CURB AND GUTTER	CONCRETE CURB	POOR/45

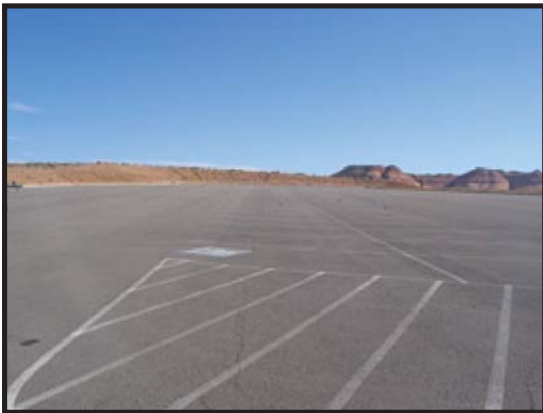
Route Number	Public / NonPublic	Date Visited		Area (sq ft)	Lane Miles *	Surface Type
0932	PUBLIC	9/20/2007		53,037	0.91	AS
Culverts	Drop Inlets	Gates	Fire Hydrants	Curb & Gutter	Curb	PCR
0	1	0	0	CONCRETE CURB AND GUTTER	CONCRETE CURB	GOOD/90
