**The Road Inventory
of
Glen Canyon National Recreation Area
GLCA – 1440
Cycle 4**

**Prepared By:
Federal Highway Administration
Road Inventory Program
Cycle 4**

Glen Canyon National Recreation Area in Utah and Arizona

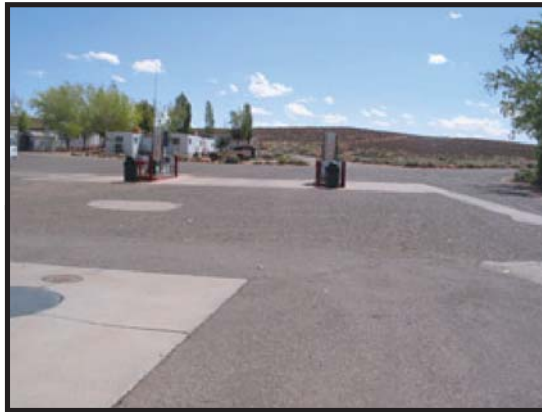
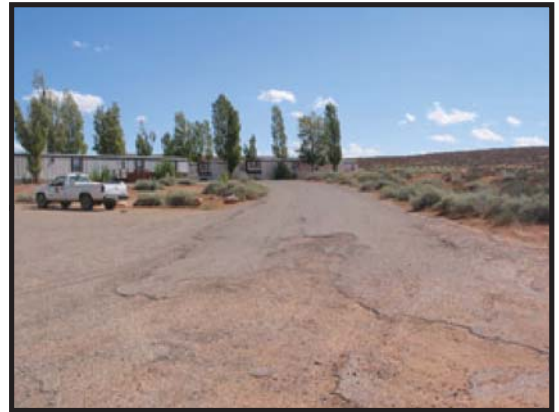
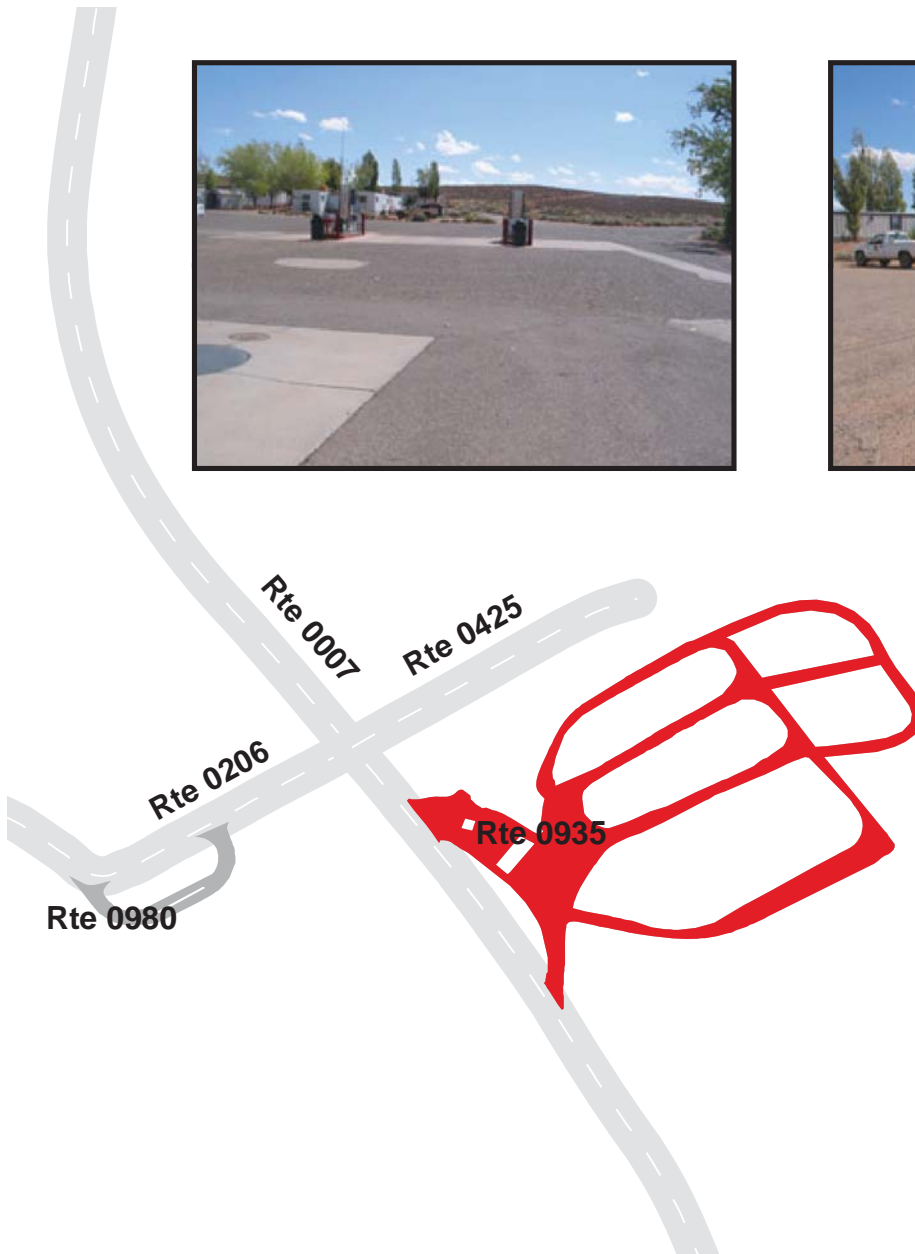
Route Number	Public / NonPublic	Date Visited		Area (sq ft)	Lane Miles *	Surface Type
0935	PUBLIC	9/20/2007		98,946	1.70	AS
Culverts	Drop Inlets	Gates	Fire Hydrants	Curb & Gutter	Curb	PCR
0	0	0	1	NO CURB AND GUTTER	NO CURB	POOR/45

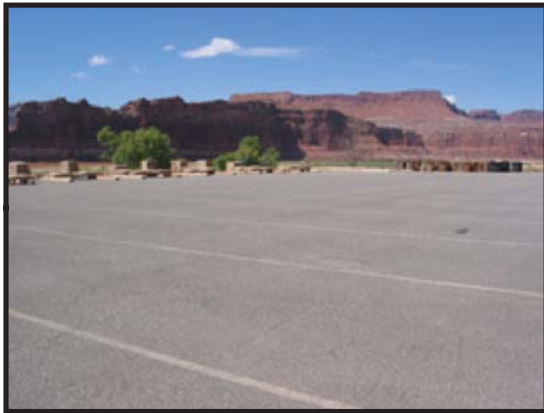
Route Number	Public / NonPublic	Date Visited		Area (sq ft)	Lane Miles *	Surface Type
0937	PUBLIC	9/20/2007		21,643	0.37	AS
Culverts	Drop Inlets	Gates	Fire Hydrants	Curb & Gutter	Curb	PCR
0	0	0	0	NO CURB AND GUTTER	NO CURB	GOOD/90

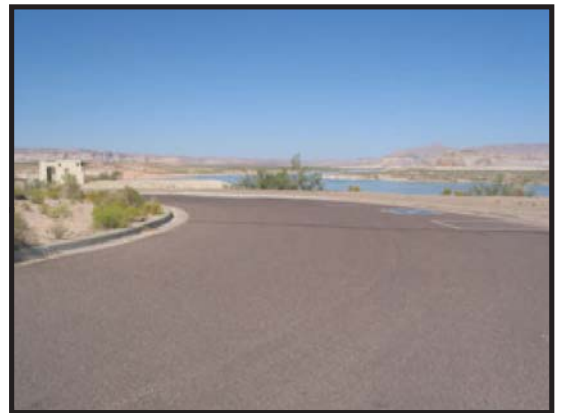
Route Number	Public / NonPublic	Date Visited		Area (sq ft)	Lane Miles *	Surface Type
0940	PUBLIC	9/18/2007		15,327	0.26	AS
Culverts	Drop Inlets	Gates	Fire Hydrants	Curb & Gutter	Curb	PCR
0	1	0	0	CONCRETE CURB AND GUTTER	CONCRETE CURB	GOOD/90

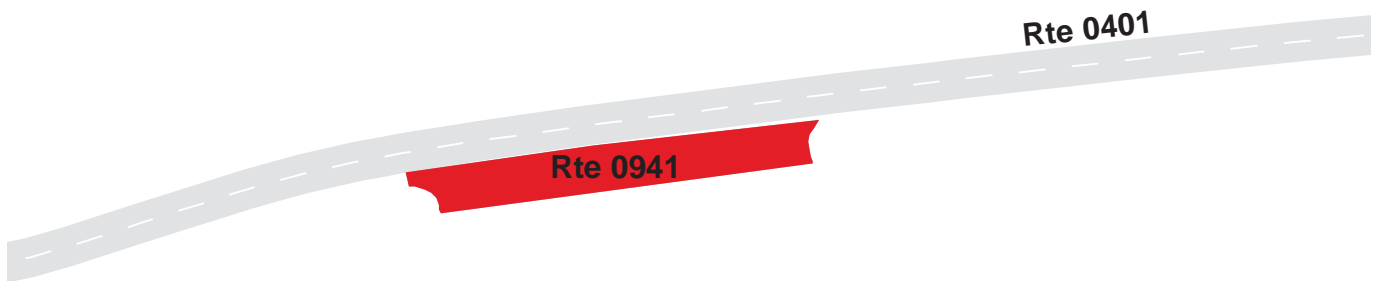
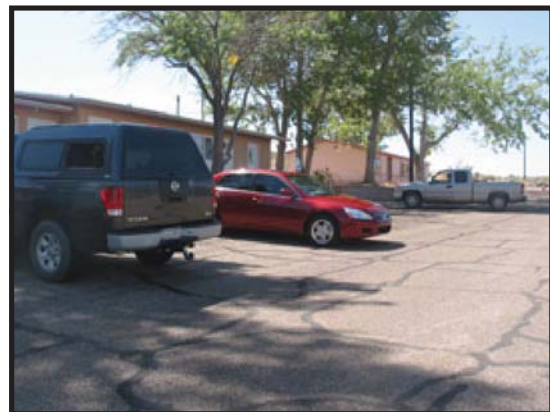
Route Number	Public / NonPublic	Date Visited		Area (sq ft)	Lane Miles *	Surface Type
0941	NONPUBLIC	9/18/2007		4,485	0.08	AS
Culverts	Drop Inlets	Gates	Fire Hydrants	Curb & Gutter	Curb	PCR
0	0	0	0	CONCRETE CURB AND GUTTER	CONCRETE CURB	FAIR/73

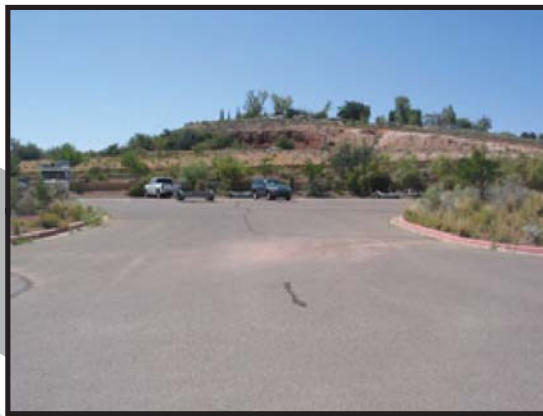
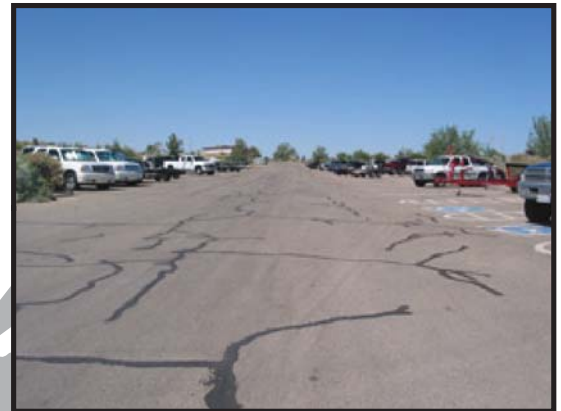
Route Number	Public / NonPublic	Date Visited		Area (sq ft)	Lane Miles *	Surface Type
0942A	PUBLIC	9/18/2007		181,186	3.12	AS
Culverts	Drop Inlets	Gates	Fire Hydrants	Curb & Gutter	Curb	PCR
0	0	0	1	CONCRETE CURB AND GUTTER	CONCRETE CURB	FAIR/73

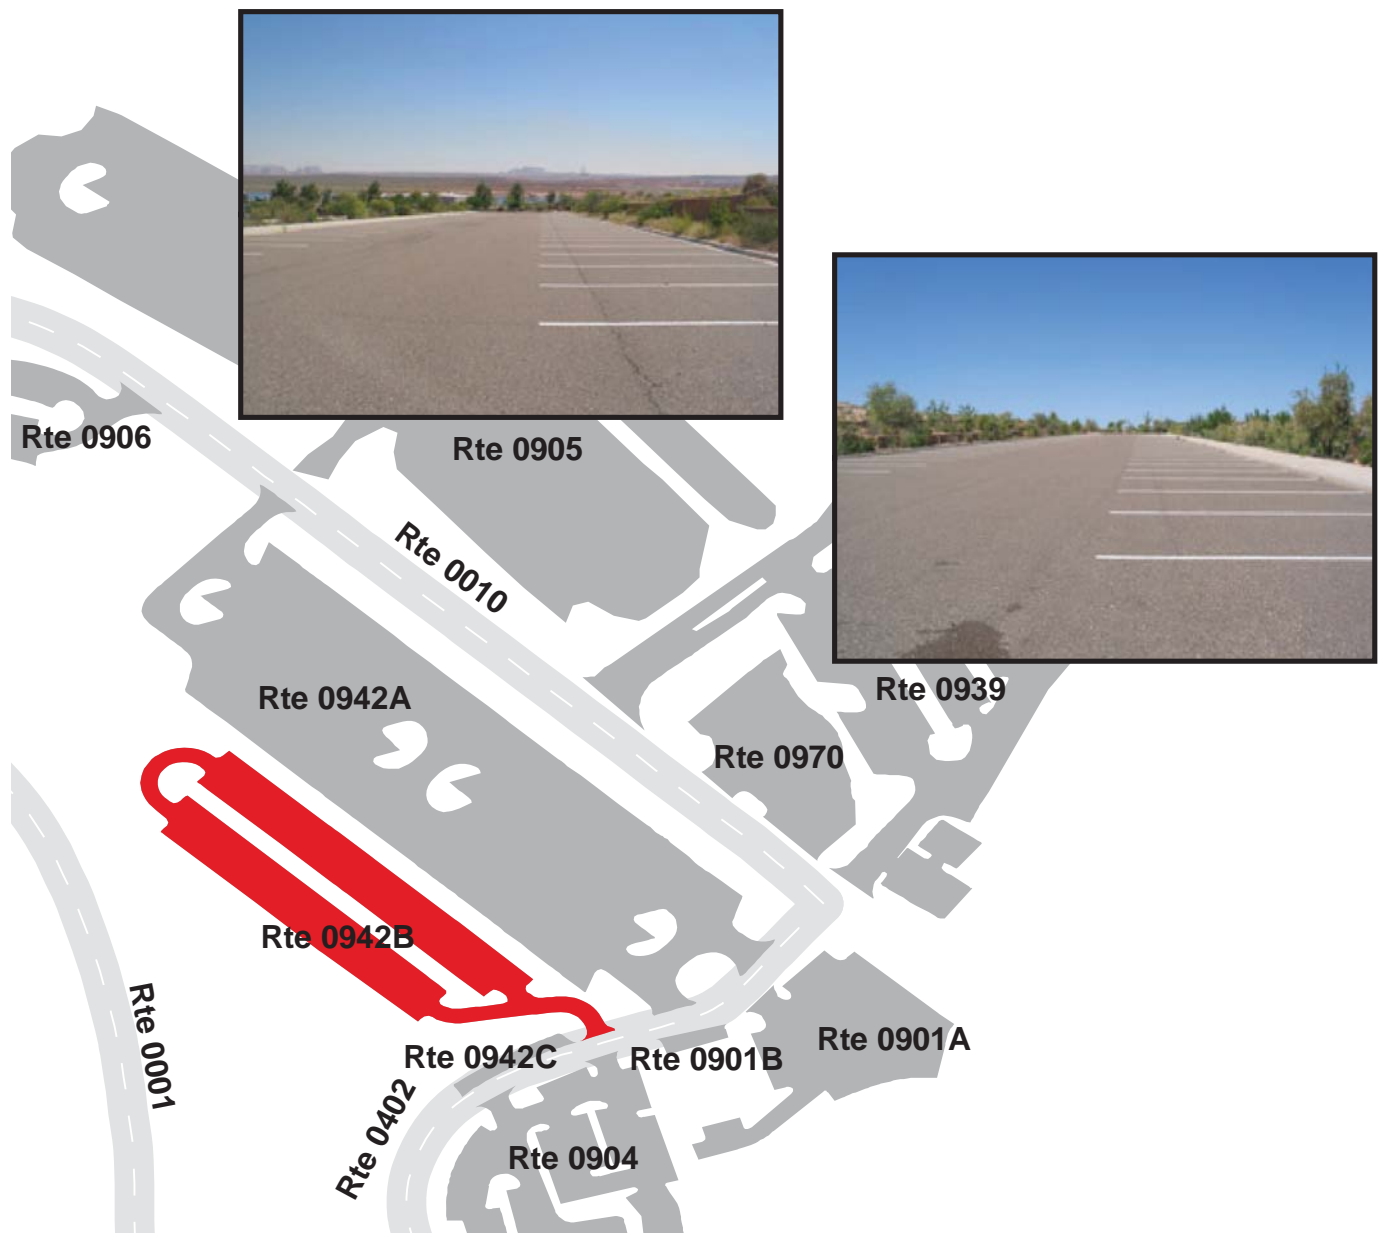
Route 0942B

Route Number	Public / NonPublic	Date Visited		Area (sq ft)	Lane Miles *	Surface Type
0942B	PUBLIC	9/18/2007		63,520	1.09	AS
Culverts	Drop Inlets	Gates	Fire Hydrants	Curb & Gutter	Curb	PCR
0	2	0	0	CONCRETE CURB AND GUTTER	CONCRETE CURB	GOOD/90

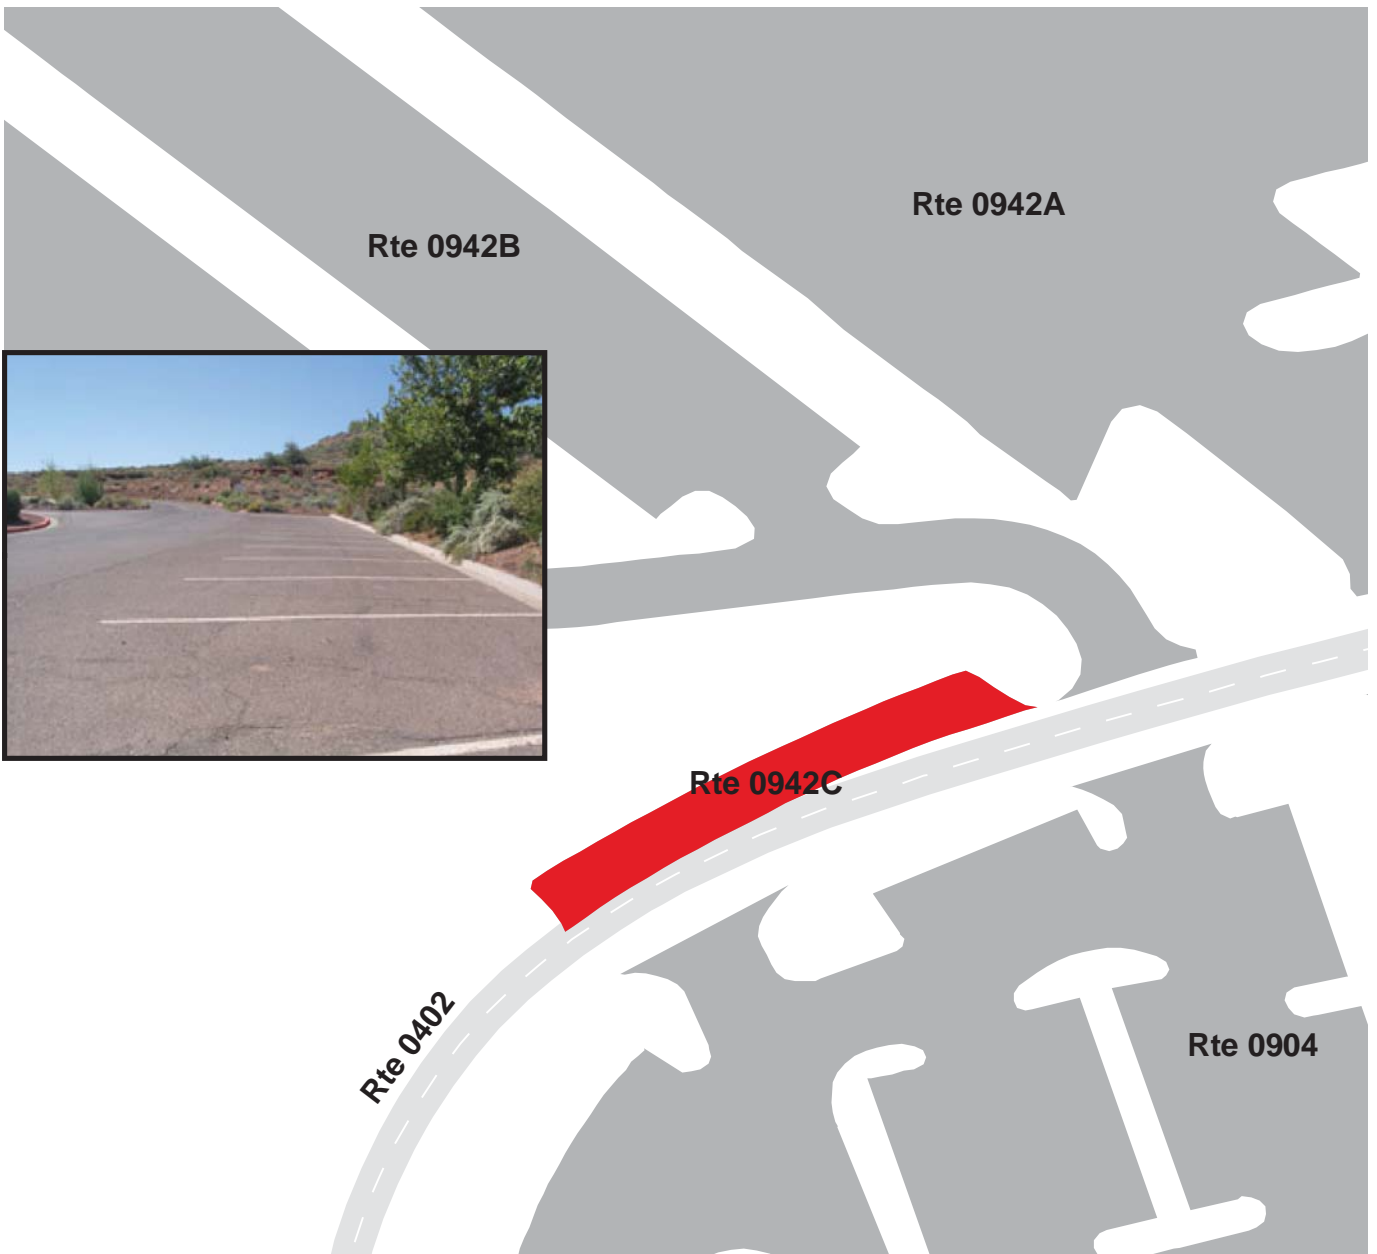
Route 0942C

Route Number	Public / NonPublic	Date Visited		Area (sq ft)	Lane Miles *	Surface Type
0942C	PUBLIC	9/18/2007		2,889	0.05	AS
Culverts	Drop Inlets	Gates	Fire Hydrants	Curb & Gutter	Curb	PCR
0	0	0	0	CONCRETE CURB AND GUTTER	CONCRETE CURB	FAIR/73

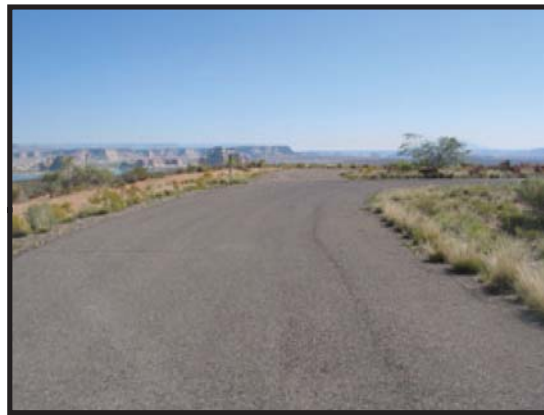
Route 0943

Route Number	Public / NonPublic	Date Visited		Area (sq ft)	Lane Miles *	Surface Type
0943	PUBLIC	9/17/2007		4,092	0.07	AS
Culverts	Drop Inlets	Gates	Fire Hydrants	Curb & Gutter	Curb	PCR
0	0	0	0	NO CURB AND GUTTER	NO CURB	GOOD/90

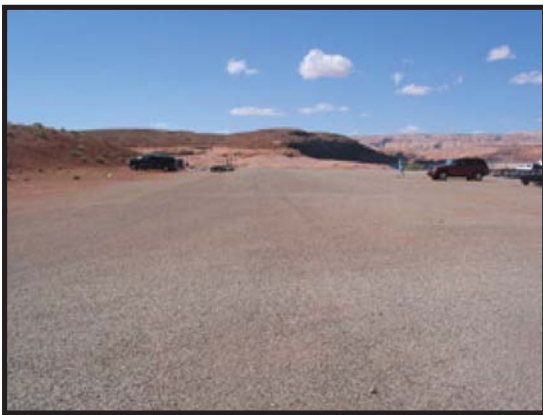
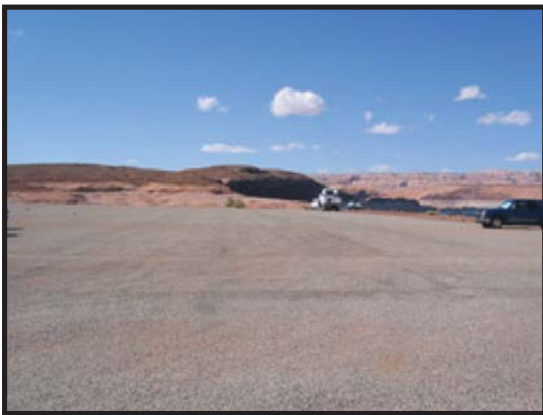
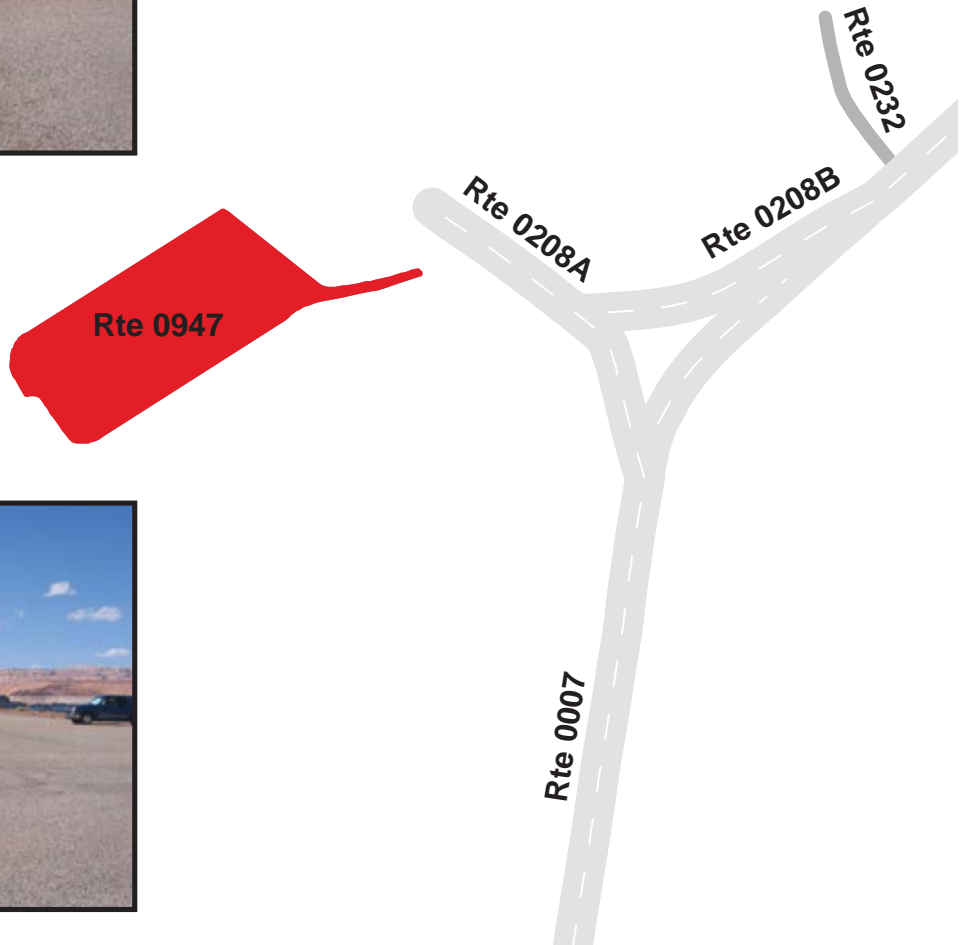
Route 0947

Route Number	Public / NonPublic	Date Visited		Area (sq ft)	Lane Miles *	Surface Type
0947	PUBLIC	9/20/2007		86,102	1.48	AS
Culverts	Drop Inlets	Gates	Fire Hydrants	Curb & Gutter	Curb	PCR
0	0	0	0	NO CURB AND GUTTER	NO CURB	POOR/45

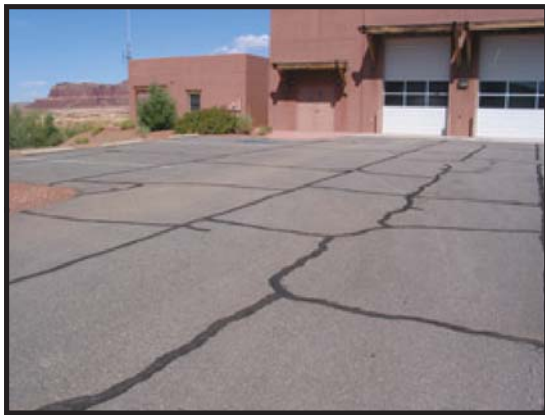
Route 0954

Route Number	Public / NonPublic	Date Visited		Area (sq ft)	Lane Miles *	Surface Type
0954	NONPUBLIC	9/20/2007		6,514	0.11	AS
Culverts	Drop Inlets	Gates	Fire Hydrants	Curb & Gutter	Curb	PCR
0	0	0	0	NO CURB AND GUTTER	NO CURB	POOR/45

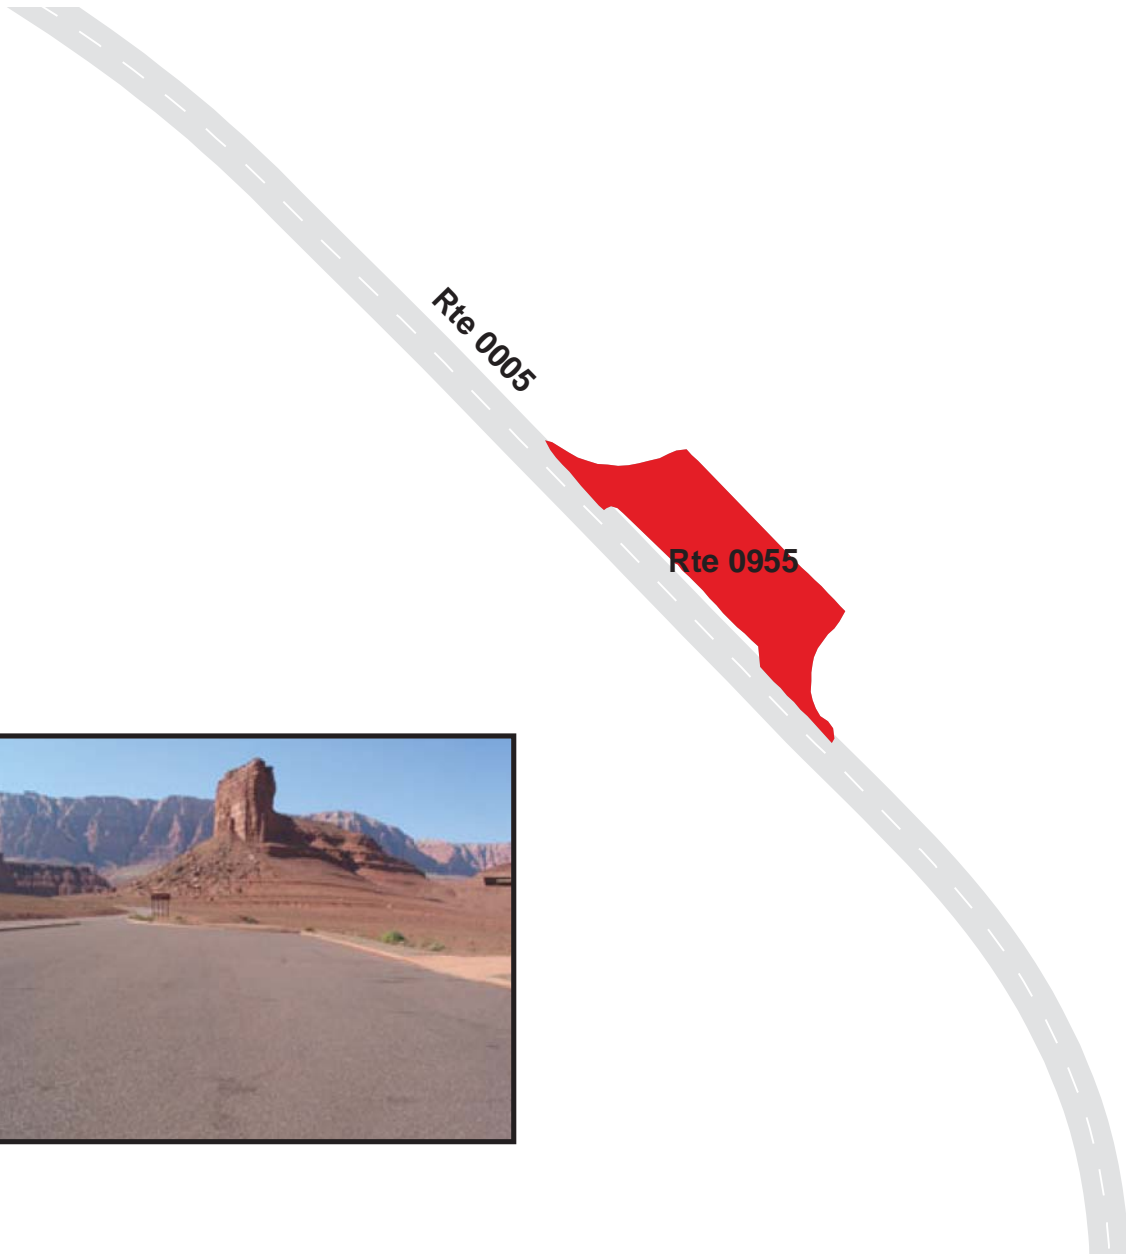
Route 0955

Route Number	Public / NonPublic	Date Visited		Area (sq ft)	Lane Miles *	Surface Type
0955	PUBLIC	9/17/2007		9,517	0.16	AS
Culverts	Drop Inlets	Gates	Fire Hydrants	Curb & Gutter	Curb	PCR
0	1	0	0	CONCRETE CURB AND GUTTER	CONCRETE CURB	GOOD/90

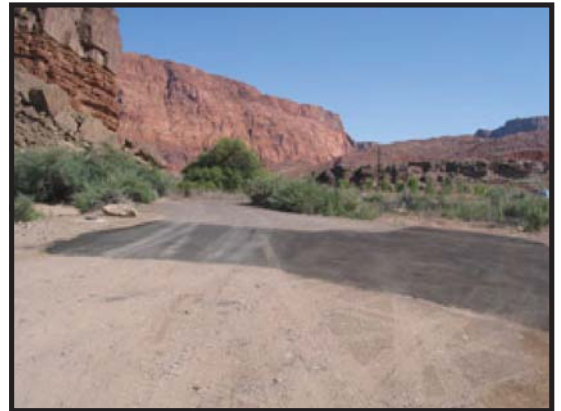
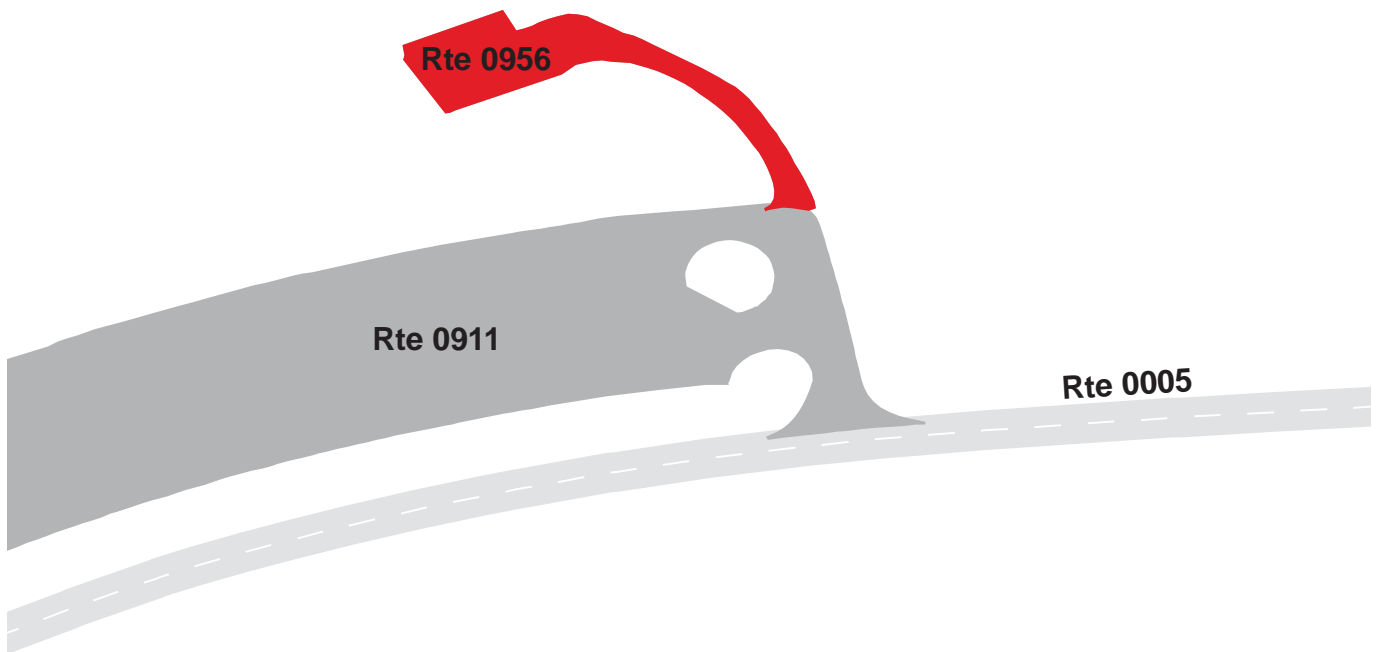
Route 0956

Route Number	Public / NonPublic	Date Visited		Area (sq ft)	Lane Miles *	Surface Type
0956	NONPUBLIC	9/17/2007		7,575	0.13	AS
Culverts	Drop Inlets	Gates	Fire Hydrants	Curb & Gutter	Curb	PCR
0	0	0	0	NO CURB AND GUTTER	NO CURB	EXCELLENT/97

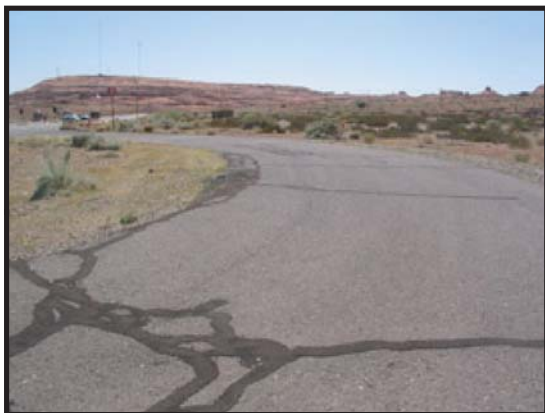
Route 0957A

Route Number	Public / NonPublic	Date Visited		Area (sq ft)	Lane Miles *	Surface Type
0957A	PUBLIC	9/18/2007		4,190	0.07	AS
Culverts	Drop Inlets	Gates	Fire Hydrants	Curb & Gutter	Curb	PCR
0	0	0	0	NO CURB AND GUTTER	NO CURB	FAIR/73

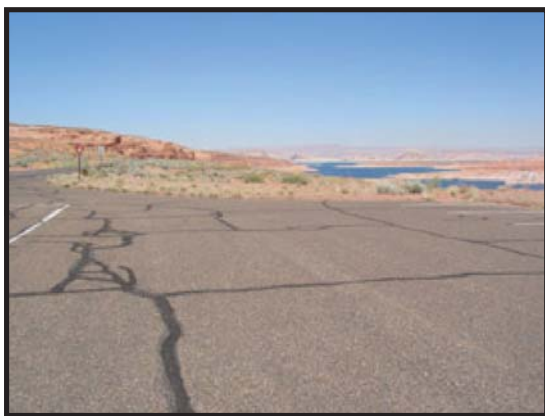
Route 0957B

Route Number	Public / NonPublic	Date Visited		Area (sq ft)	Lane Miles *	Surface Type
0957B	PUBLIC	9/18/2007		6,431	0.11	AS
Culverts	Drop Inlets	Gates	Fire Hydrants	Curb & Gutter	Curb	PCR
0	1	0	0	CONCRETE CURB AND GUTTER	CONCRETE CURB	FAIR/73

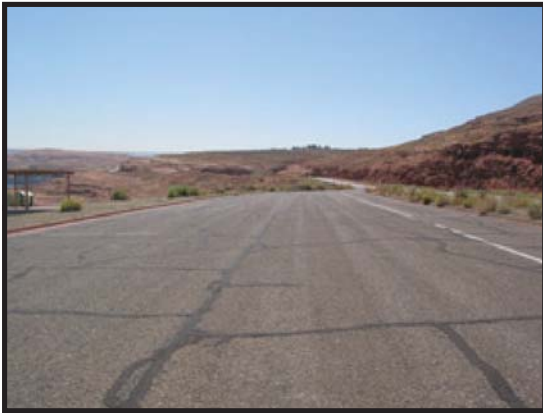
Route 0958

Route Number	Public / NonPublic	Date Visited		Area (sq ft)	Lane Miles *	Surface Type
0958	PUBLIC	9/18/2007		17,496	0.30	AS
Culverts	Drop Inlets	Gates	Fire Hydrants	Curb & Gutter	Curb	PCR
0	1	0	0	CONCRETE CURB AND GUTTER	CONCRETE CURB	FAIR/73

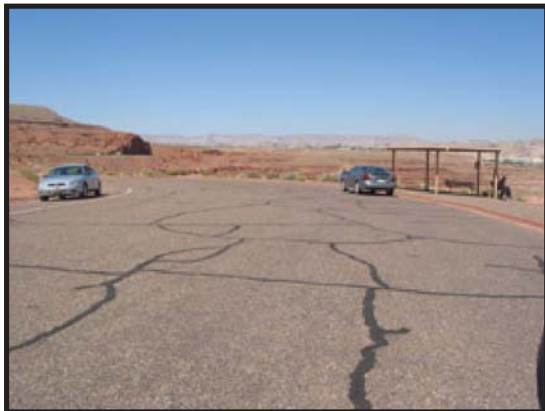
Route 0959

Route Number	Public / NonPublic	Date Visited		Area (sq ft)	Lane Miles *	Surface Type
0959	PUBLIC	9/18/2007		33,645	0.58	AS
Culverts	Drop Inlets	Gates	Fire Hydrants	Curb & Gutter	Curb	PCR
0	1	0	0	CONCRETE CURB AND GUTTER	CONCRETE CURB	FAIR/73

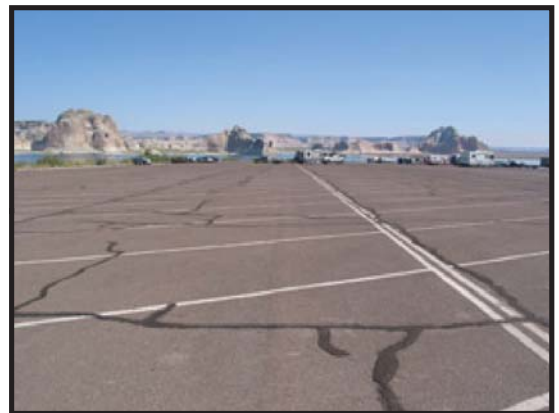
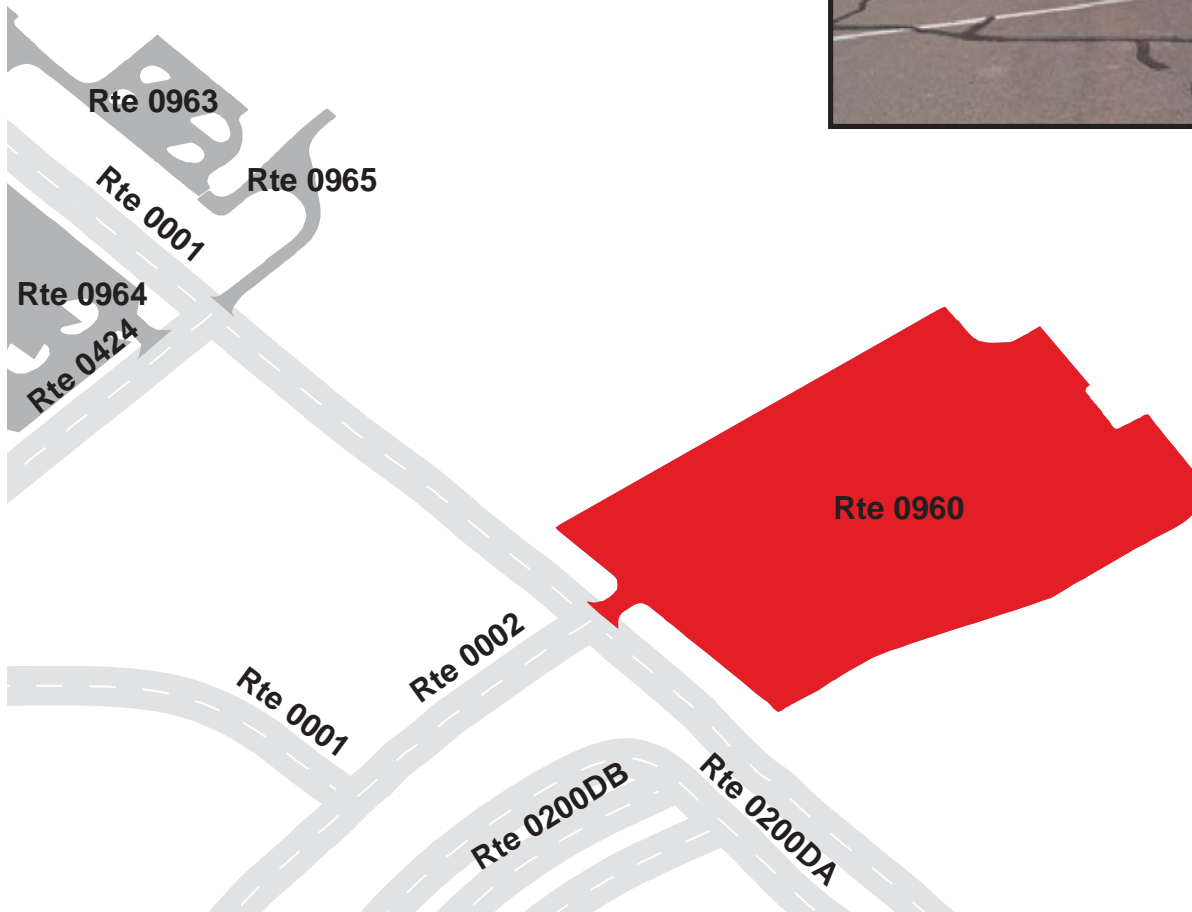
Route 0960

Route Number	Public / NonPublic	Date Visited		Area (sq ft)	Lane Miles *	Surface Type
0960	PUBLIC	9/18/2007		477,618	8.22	AS
Culverts	Drop Inlets	Gates	Fire Hydrants	Curb & Gutter	Curb	PCR
0	0	0	0	CONCRETE CURB AND GUTTER	CONCRETE CURB	FAIR/73

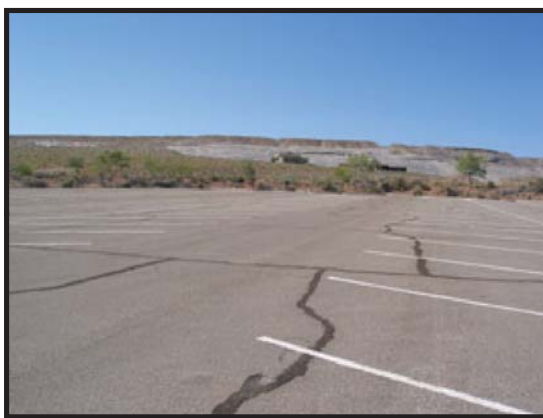
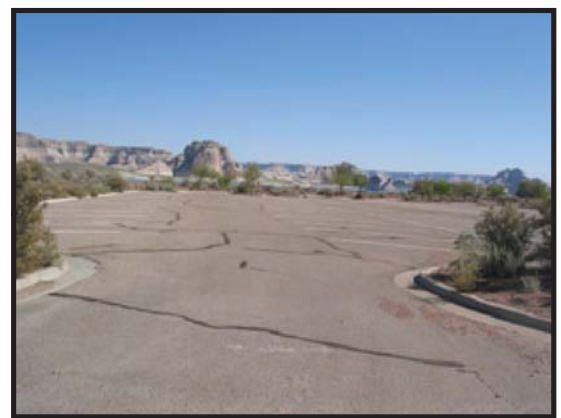
Route Number	Public / NonPublic	Date Visited		Area (sq ft)	Lane Miles *	Surface Type
0962	PUBLIC	9/18/2007		280,921	4.84	AS
Culverts	Drop Inlets	Gates	Fire Hydrants	Curb & Gutter	Curb	PCR
0	3	0	0	CONCRETE CURB AND GUTTER	CONCRETE CURB	FAIR/73

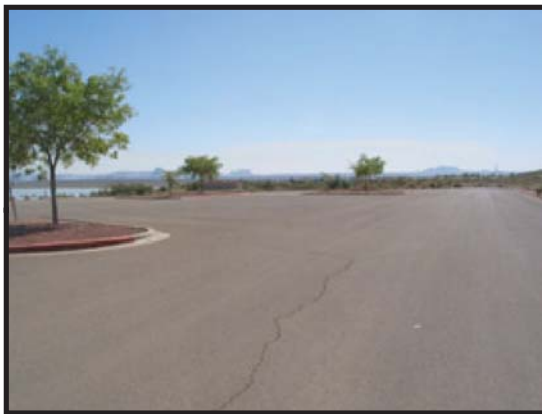
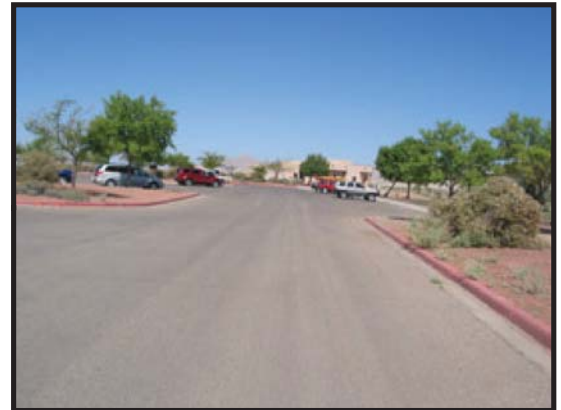
Route 0963

Route Number	Public / NonPublic	Date Visited		Area (sq ft)	Lane Miles *	Surface Type
0963	PUBLIC	9/18/2007		78,767	1.36	AS
Culverts	Drop Inlets	Gates	Fire Hydrants	Curb & Gutter	Curb	PCR
0	2	0	1	CONCRETE CURB AND GUTTER	CONCRETE CURB	FAIR/73

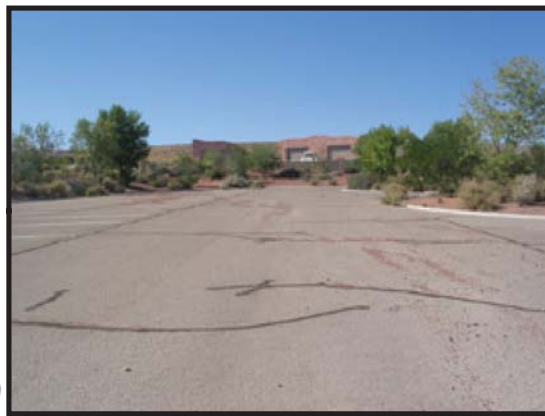
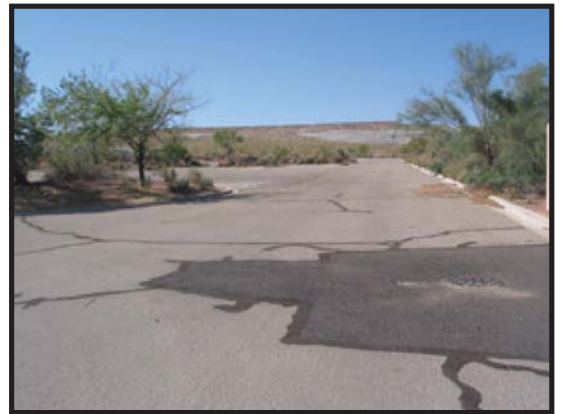
Route 0964

Route Number	Public / NonPublic	Date Visited		Area (sq ft)	Lane Miles *	Surface Type
0964	PUBLIC	9/18/2007		441,034	7.59	AS
Culverts	Drop Inlets	Gates	Fire Hydrants	Curb & Gutter	Curb	PCR
1	6	0	0	CONCRETE CURB AND GUTTER	CONCRETE CURB	FAIR/73

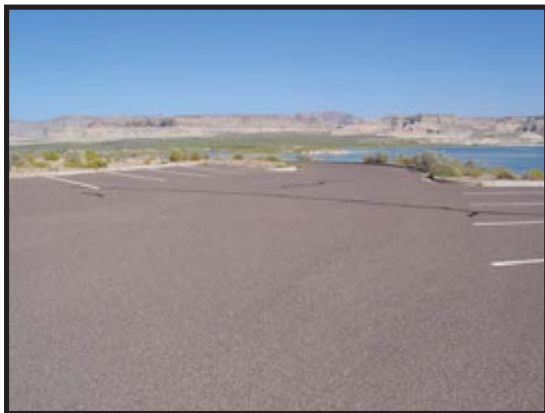
Route Number	Public / NonPublic	Date Visited		Area (sq ft)	Lane Miles *	Surface Type
0966	PUBLIC	9/18/2007		23,540	0.41	AS
Culverts	Drop Inlets	Gates	Fire Hydrants	Curb & Gutter	Curb	PCR
0	0	0	0	CONCRETE CURB AND GUTTER	CONCRETE CURB	GOOD/90

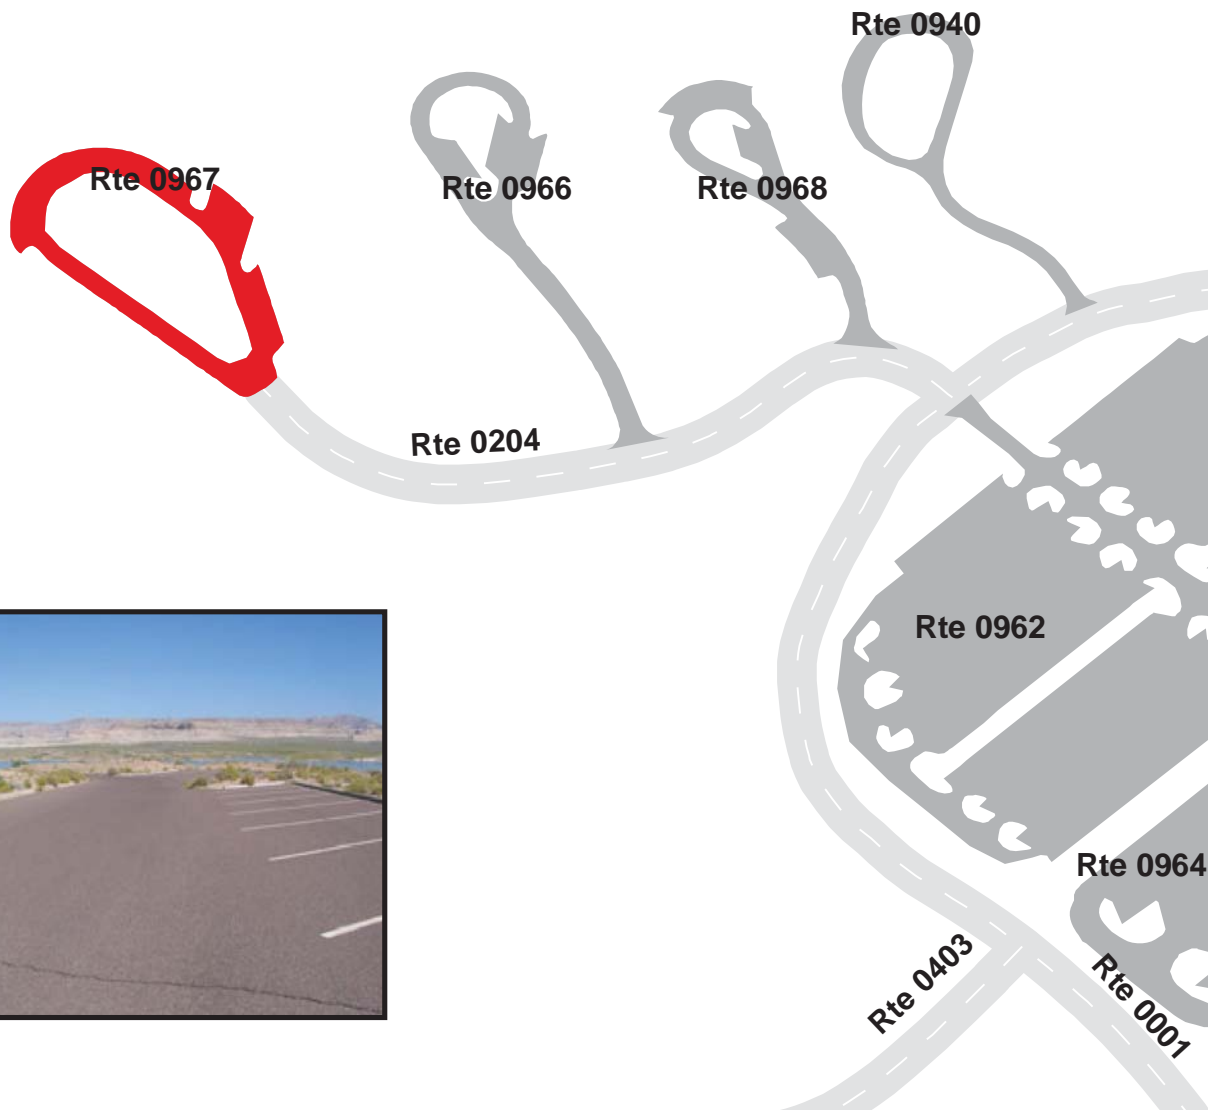
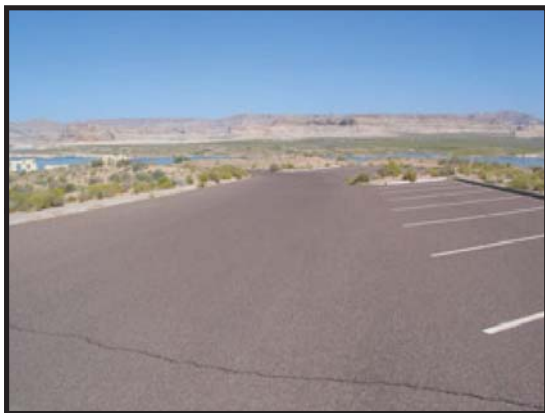
Route 0967

Route Number	Public / NonPublic	Date Visited		Area (sq ft)	Lane Miles *	Surface Type
0967	PUBLIC	9/18/2007		28,081	0.48	AS
Culverts	Drop Inlets	Gates	Fire Hydrants	Curb & Gutter	Curb	PCR
0	1	0	0	CONCRETE CURB AND GUTTER	CONCRETE CURB	GOOD/90

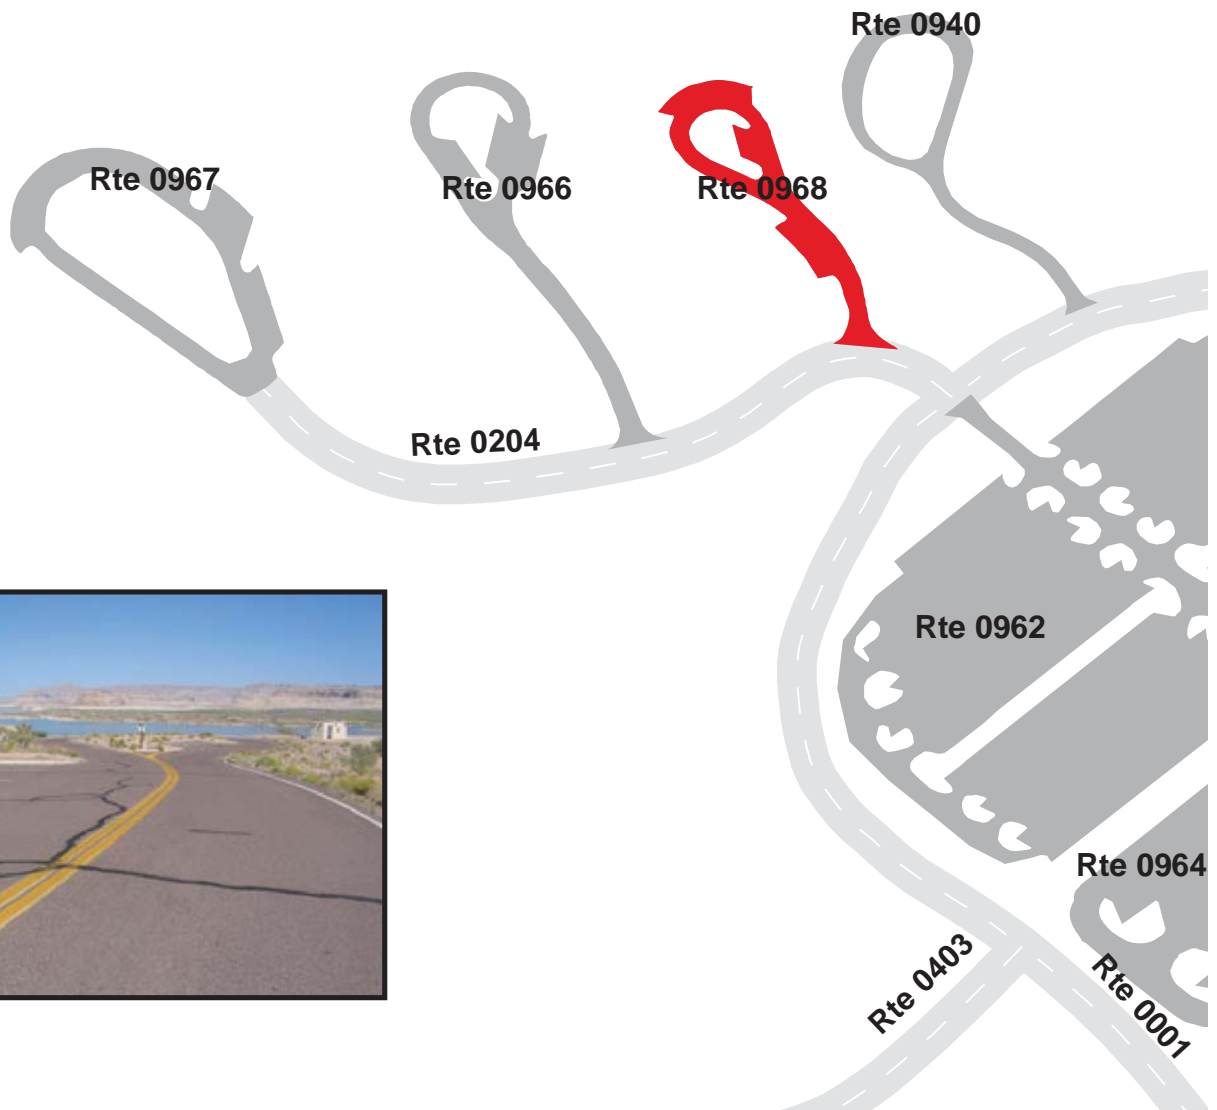
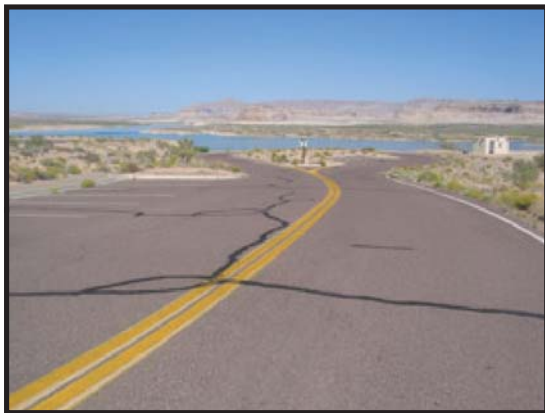
Route 0968

Route Number	Public / NonPublic	Date Visited		Area (sq ft)	Lane Miles *	Surface Type
0968	PUBLIC	9/18/2007		18,961	0.33	AS
Culverts	Drop Inlets	Gates	Fire Hydrants	Curb & Gutter	Curb	PCR
0	0	0	0	CONCRETE CURB AND GUTTER	CONCRETE CURB	GOOD/90

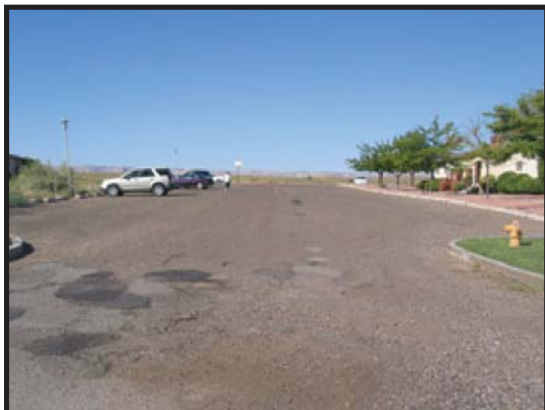
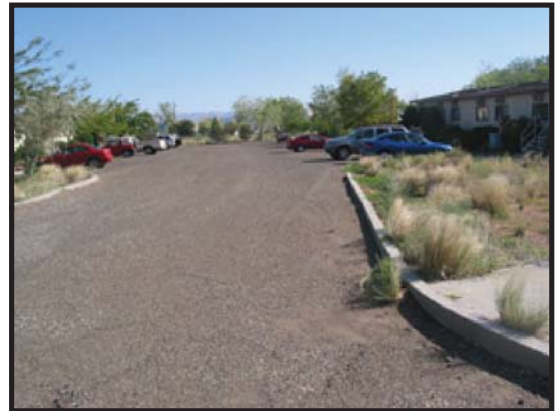
Route 0969A

Route Number	Public / NonPublic	Date Visited		Area (sq ft)	Lane Miles *	Surface Type
0969A	PUBLIC	9/18/2007		88,209	1.52	AS
Culverts	Drop Inlets	Gates	Fire Hydrants	Curb & Gutter	Curb	PCR
0	0	0	3	NO CURB AND GUTTER	CONCRETE CURB	POOR/45

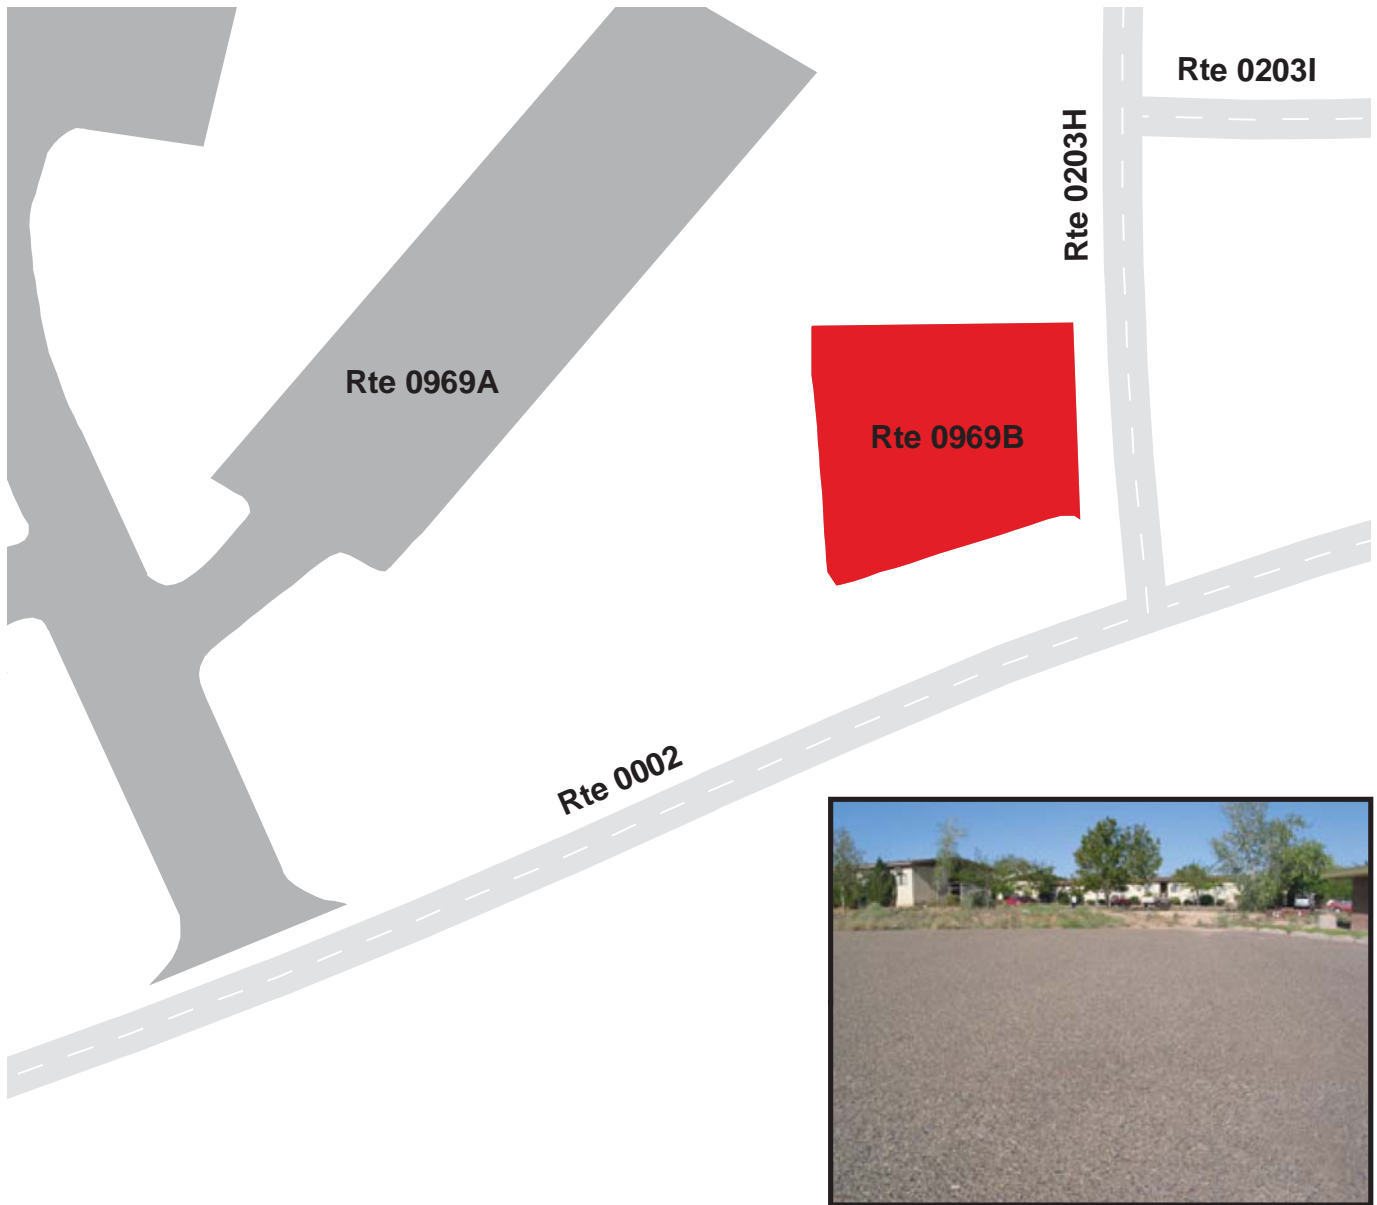
Route 0969B

Route Number	Public / NonPublic	Date Visited		Area (sq ft)	Lane Miles *	Surface Type
0969B	PUBLIC	9/18/2007		7,332	0.13	AS
Culverts	Drop Inlets	Gates	Fire Hydrants	Curb & Gutter	Curb	PCR
0	0	0	0	NO CURB AND GUTTER	NO CURB	FAIR/73

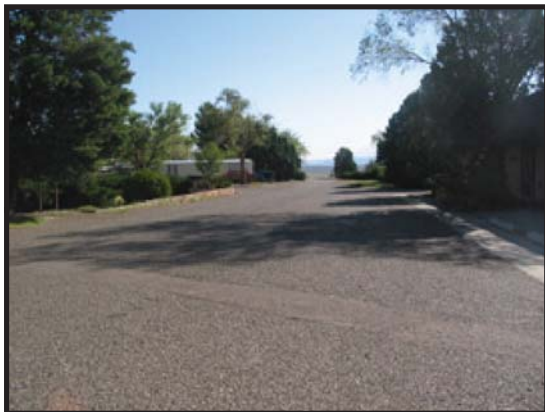
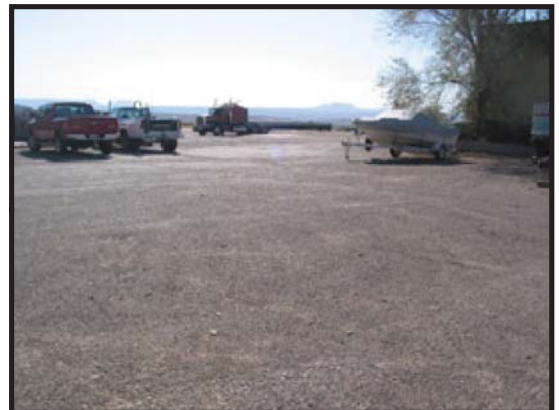
Route 0969C

Route Number	Public / NonPublic	Date Visited		Area (sq ft)	Lane Miles *	Surface Type
0969C	PUBLIC	9/18/2007		23,967	0.41	AS
Culverts	Drop Inlets	Gates	Fire Hydrants	Curb & Gutter	Curb	PCR
0	0	0	0	NO CURB AND GUTTER	NO CURB	POOR/45

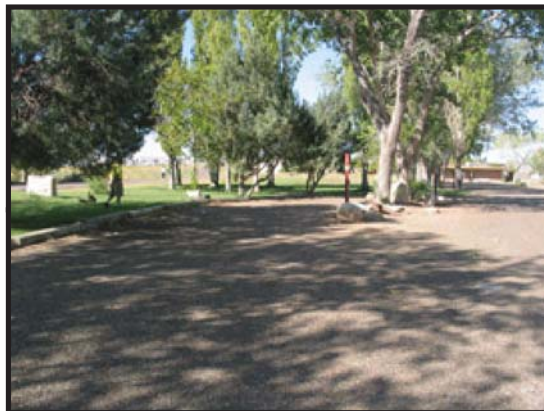
Route 0969D

Route Number	Public / NonPublic	Date Visited		Area (sq ft)	Lane Miles *	Surface Type
0969D	PUBLIC	9/18/2007		2,072	0.04	AS
Culverts	Drop Inlets	Gates	Fire Hydrants	Curb & Gutter	Curb	PCR
0	0	0	1	NO CURB AND GUTTER	NO CURB	POOR/45
