**The Road Inventory
of
Glen Canyon National Recreation Area
GLCA – 1440
Cycle 4**

**Prepared By:
Federal Highway Administration
Road Inventory Program
Cycle 4**

Glen Canyon National Recreation Area in Utah and Arizona

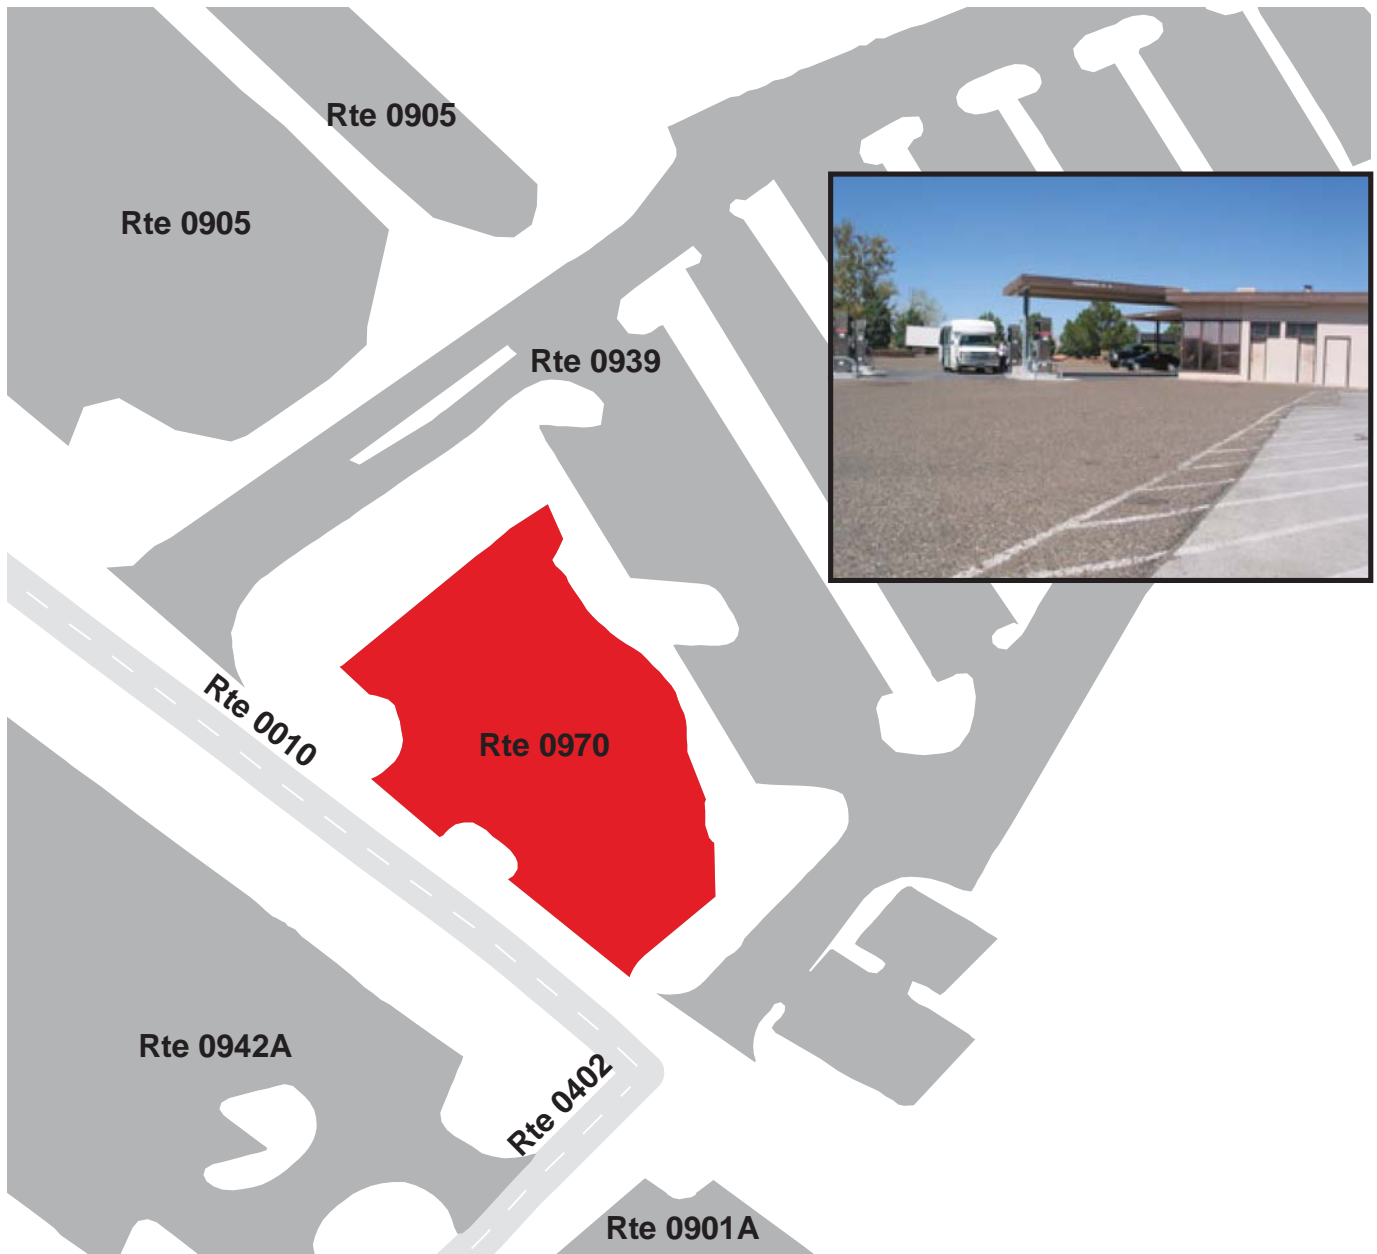
Route 0970

Route Number	Public / NonPublic	Date Visited		Area (sq ft)	Lane Miles *	Surface Type
0970	PUBLIC	9/18/2007		32,835	0.57	AS
Culverts	Drop Inlets	Gates	Fire Hydrants	Curb & Gutter	Curb	PCR
0	0	0	0	NO CURB AND GUTTER	NO CURB	FAIR/73

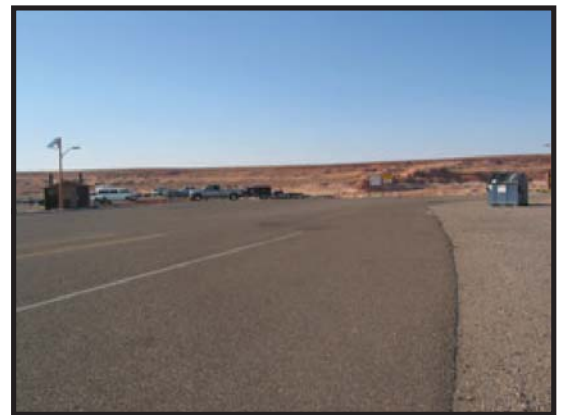
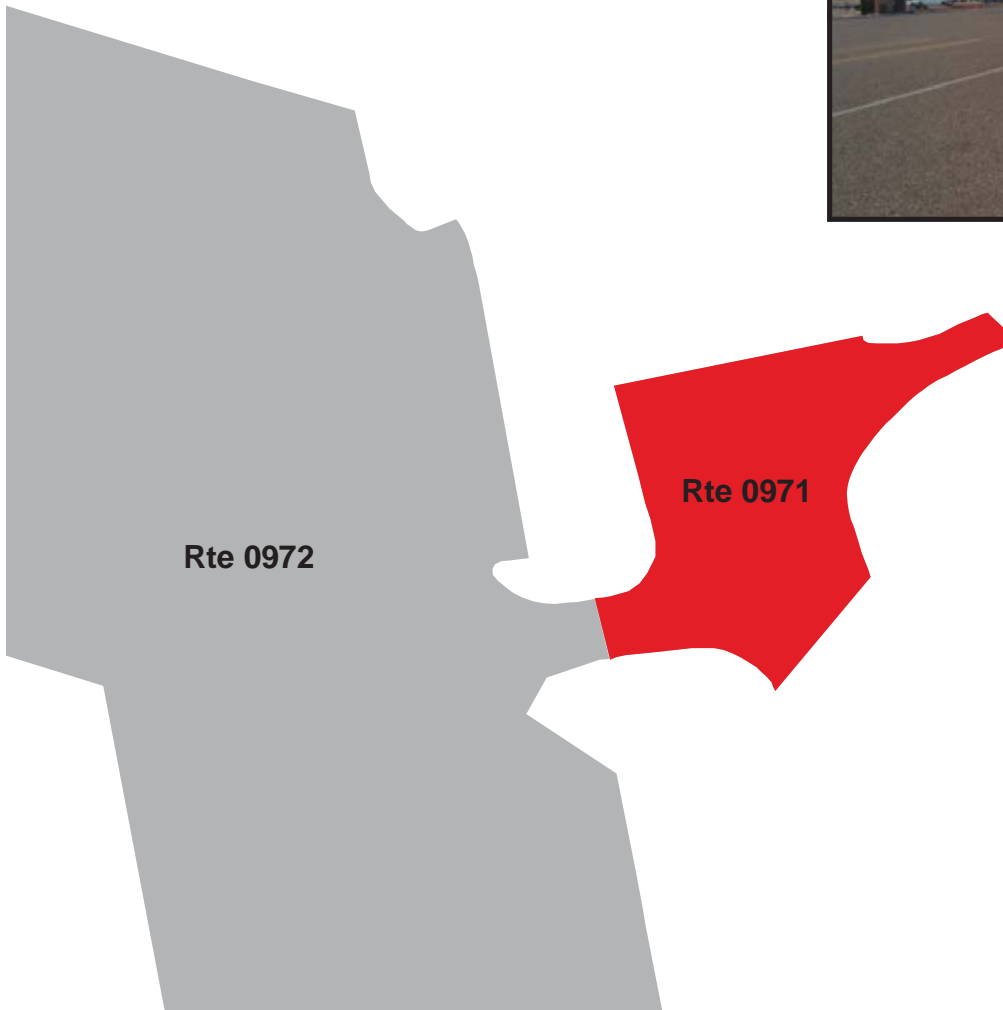
Route 0971

Route Number	Public / NonPublic	Date Visited		Area (sq ft)	Lane Miles *	Surface Type
0971	PUBLIC	9/17/2007		19,546	0.34	AS
Culverts	Drop Inlets	Gates	Fire Hydrants	Curb & Gutter	Curb	PCR
0	0	0	0	CONCRETE CURB AND GUTTER	CONCRETE CURB	GOOD/90

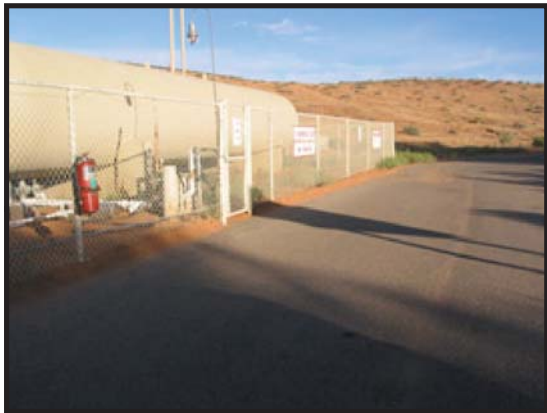
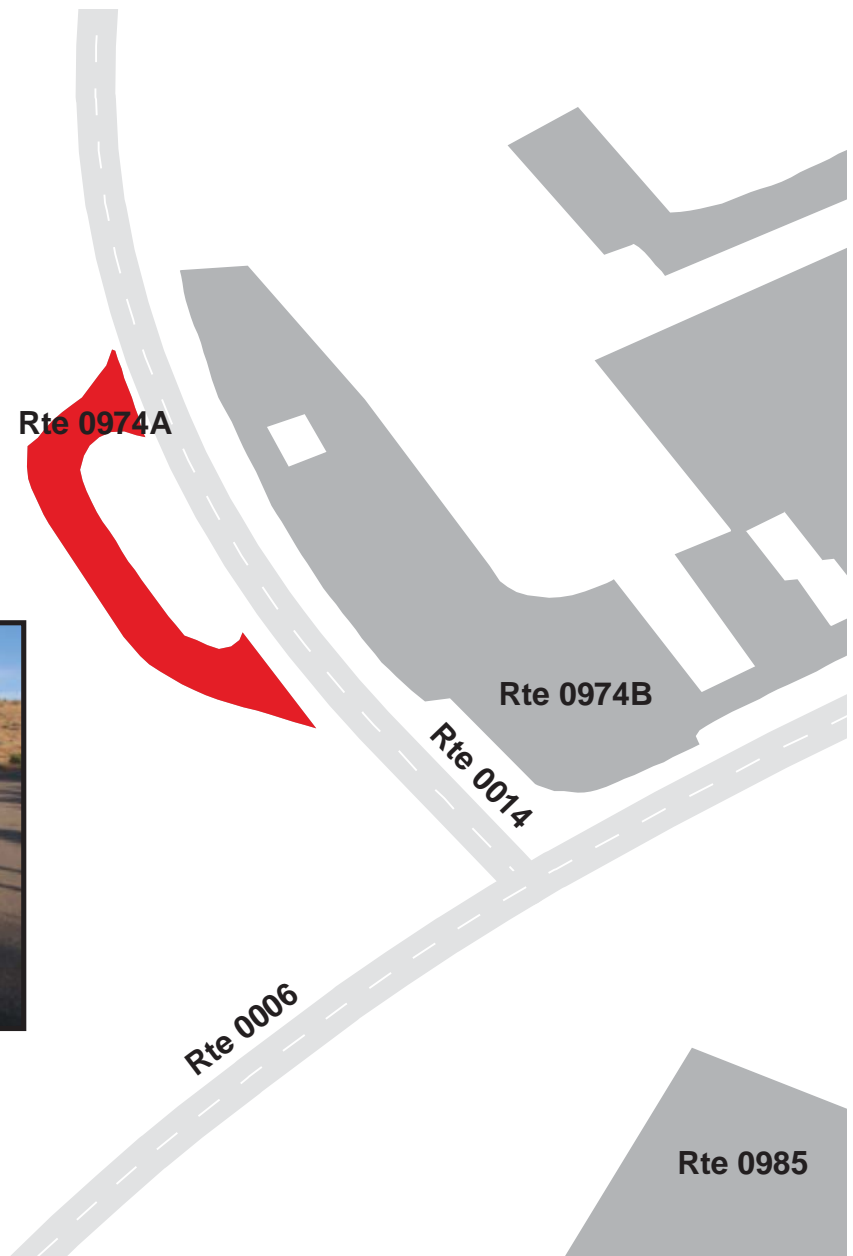
Route 0974A

Route Number	Public / NonPublic	Date Visited		Area (sq ft)	Lane Miles *	Surface Type
0974A	PUBLIC	9/20/2007		4,390	0.08	AS
Culverts	Drop Inlets	Gates	Fire Hydrants	Curb & Gutter	Curb	PCR
1	0	0	0	NO CURB AND GUTTER	NO CURB	FAIR/73

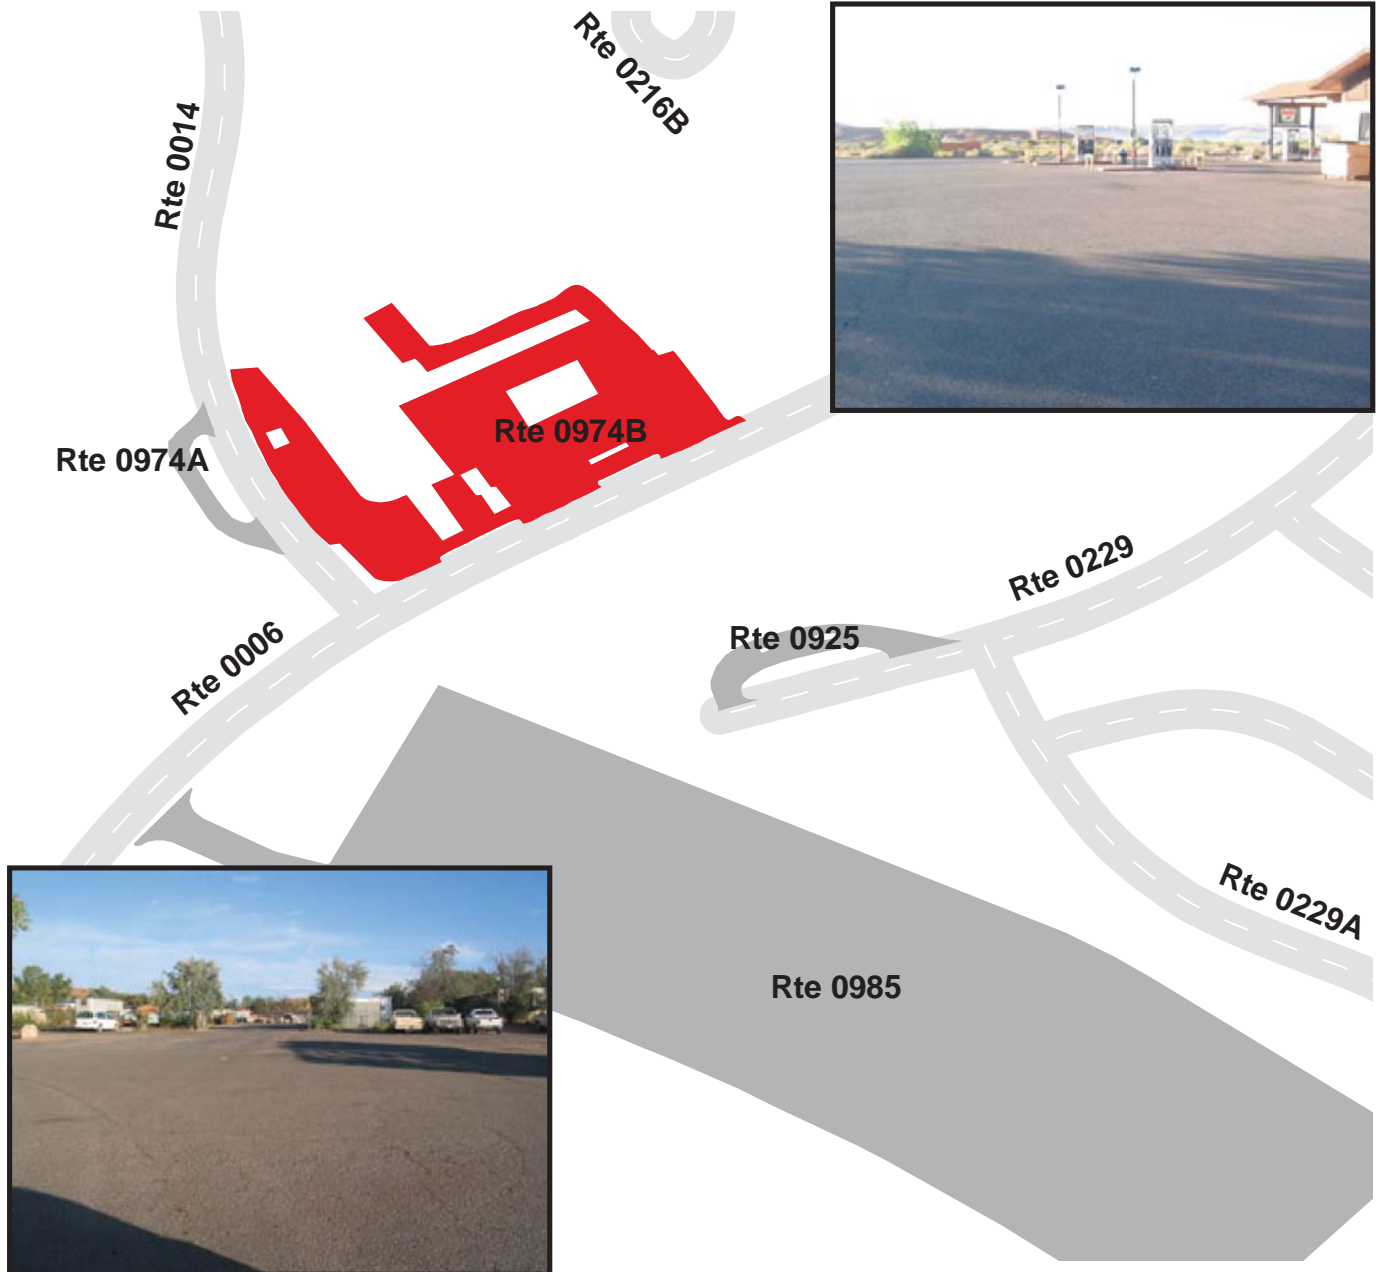
Route 0974B

Route Number	Public / NonPublic	Date Visited		Area (sq ft)	Lane Miles *	Surface Type
0974B	PUBLIC	9/20/2007		66,692	1.15	AS
Culverts	Drop Inlets	Gates	Fire Hydrants	Curb & Gutter	Curb	PCR
0	0	0	1	CONCRETE CURB AND GUTTER	CONCRETE CURB	POOR/45

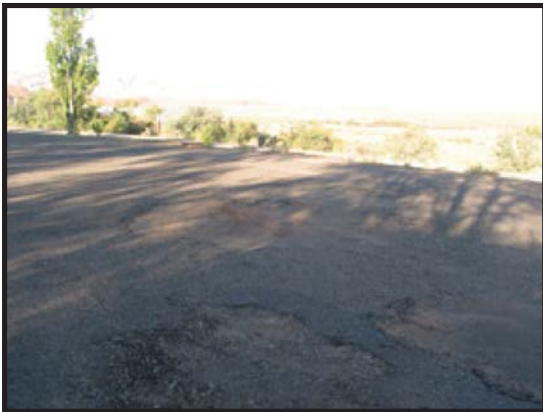
Route 0976A

Route Number	Public / NonPublic	Date Visited		Area (sq ft)	Lane Miles *	Surface Type
0976A	PUBLIC	9/20/2007		2,835	0.05	AS
Culverts	Drop Inlets	Gates	Fire Hydrants	Curb & Gutter	Curb	PCR
0	0	0	0	CONCRETE CURB AND GUTTER	CONCRETE CURB	POOR/45

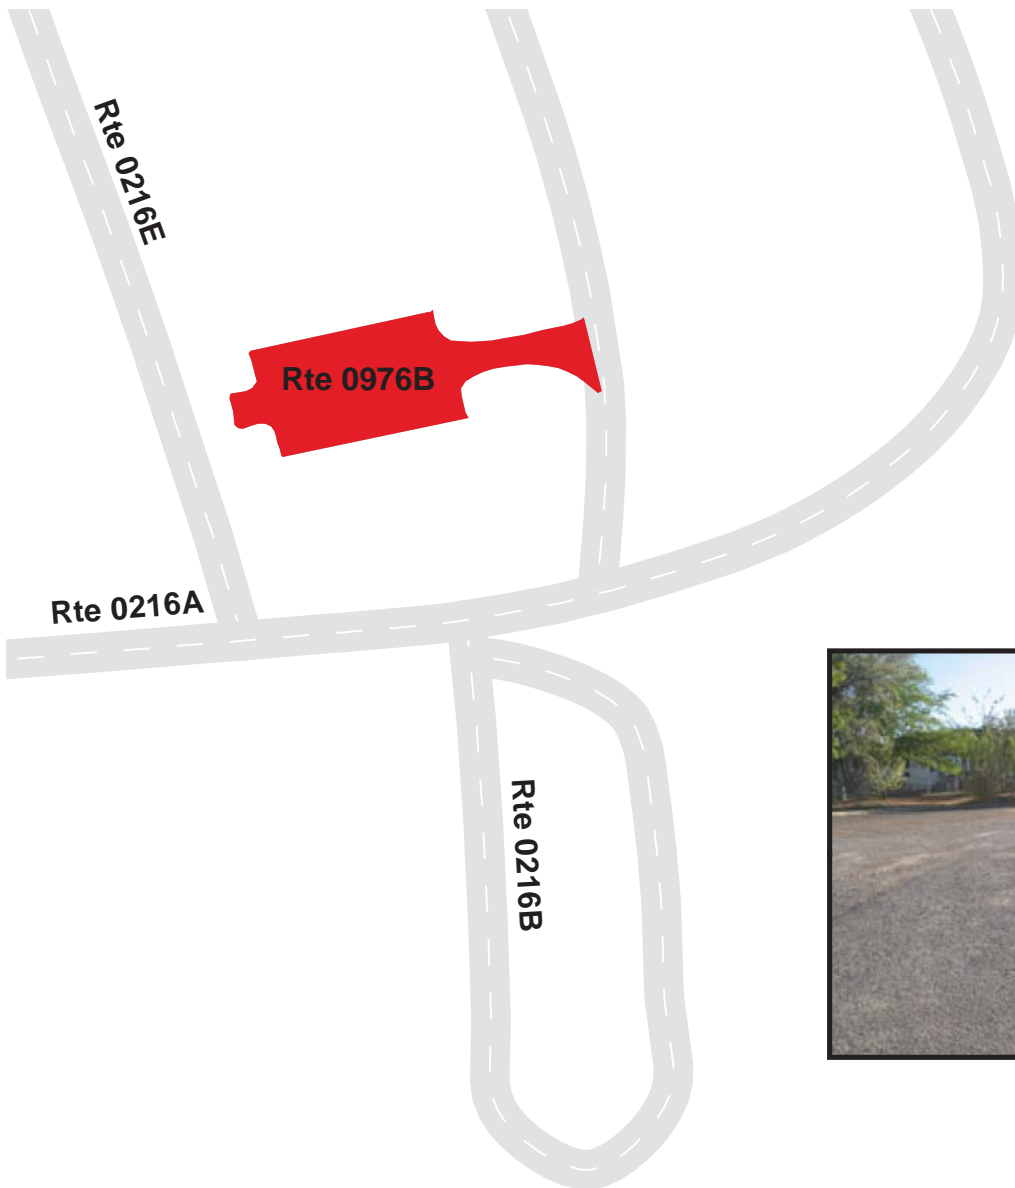
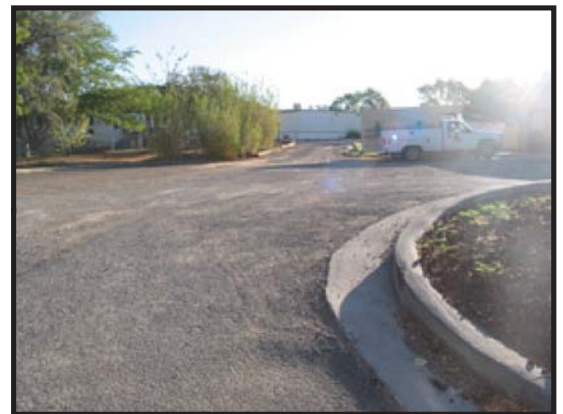
Route 0976B

Route Number	Public / NonPublic	Date Visited		Area (sq ft)	Lane Miles *	Surface Type
0976B	NONPUBLIC	9/20/2007		6,889	0.12	AS
Culverts	Drop Inlets	Gates	Fire Hydrants	Curb & Gutter	Curb	PCR
0	0	0	0	CONCRETE CURB AND GUTTER	CONCRETE CURB	POOR/45

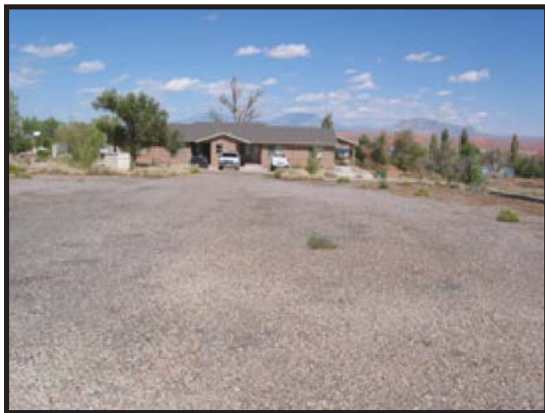
Route 0977

Route Number	Public / NonPublic	Date Visited		Area (sq ft)	Lane Miles *	Surface Type
0977	NONPUBLIC	9/17/2007		10,278	0.18	AS
Culverts	Drop Inlets	Gates	Fire Hydrants	Curb & Gutter	Curb	PCR
0	0	0	0	NO CURB AND GUTTER	CONCRETE CURB	POOR/45

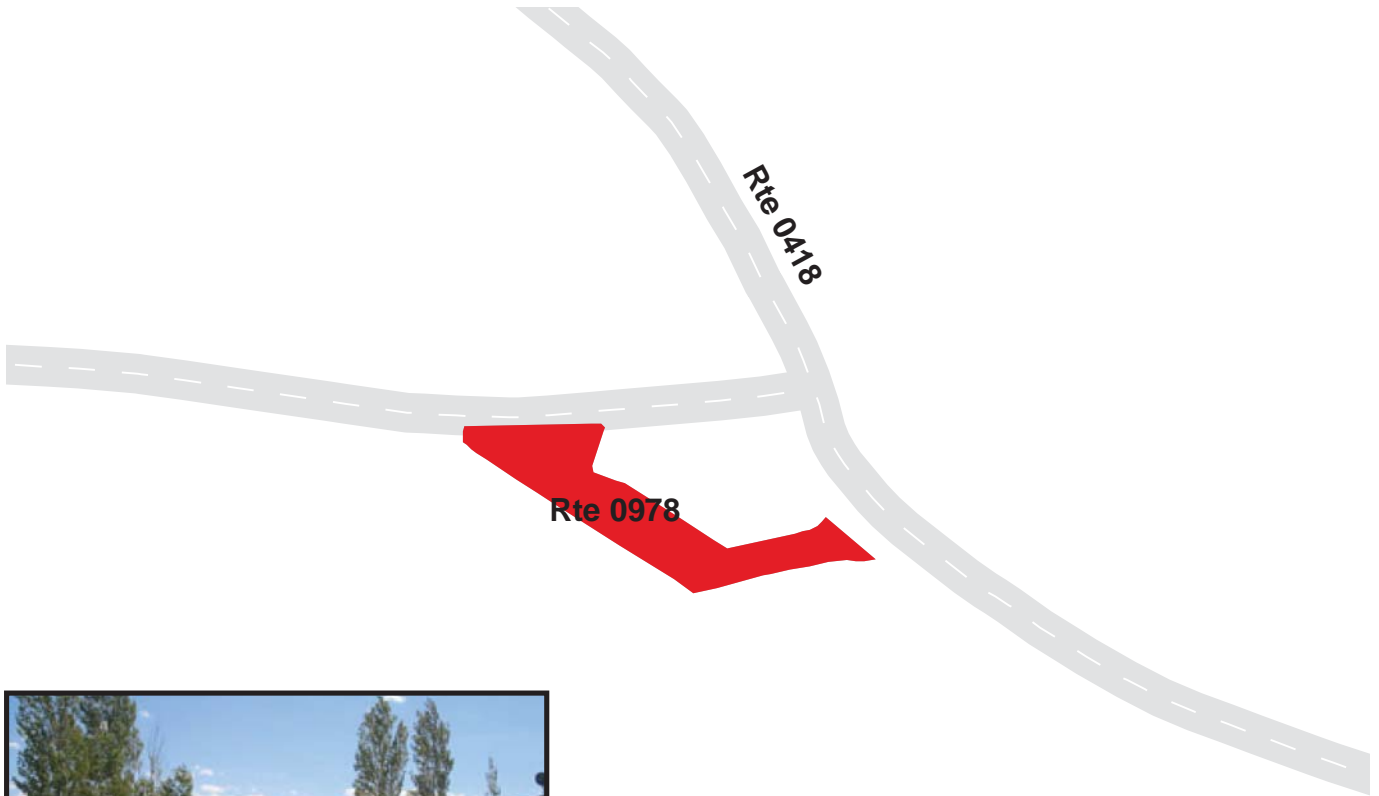
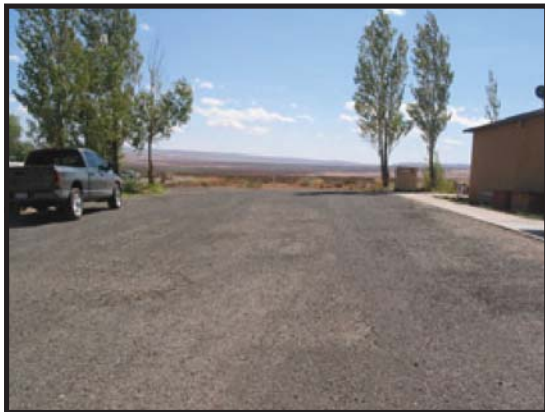
Route 0978

Route Number	Public / NonPublic	Date Visited		Area (sq ft)	Lane Miles *	Surface Type
0978	NONPUBLIC	9/20/2007		7,991	0.14	AS
Culverts	Drop Inlets	Gates	Fire Hydrants	Curb & Gutter	Curb	PCR
0	0	0	0	NO CURB AND GUTTER	NO CURB	POOR/45

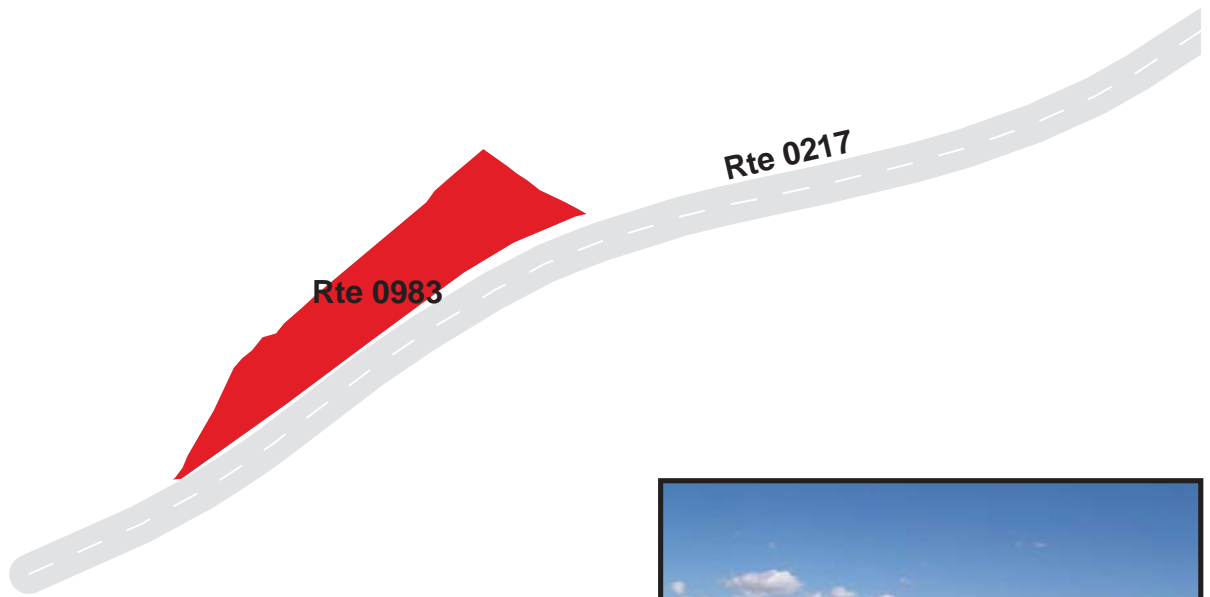
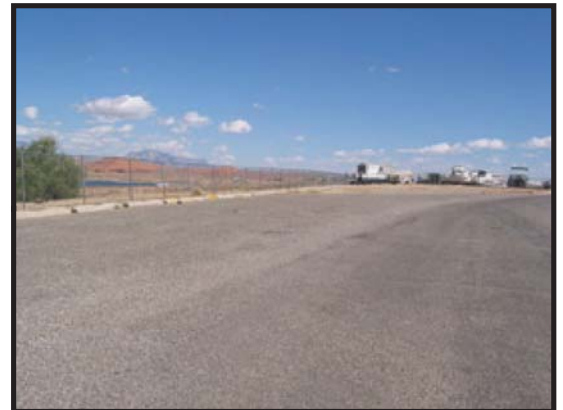
Route 0983

Route Number	Public / NonPublic	Date Visited		Area (sq ft)	Lane Miles *	Surface Type
0983	PUBLIC	9/20/2007		4,745	0.08	AS
Culverts	Drop Inlets	Gates	Fire Hydrants	Curb & Gutter	Curb	PCR
0	0	0	0	NO CURB AND GUTTER	NO CURB	FAIR/73

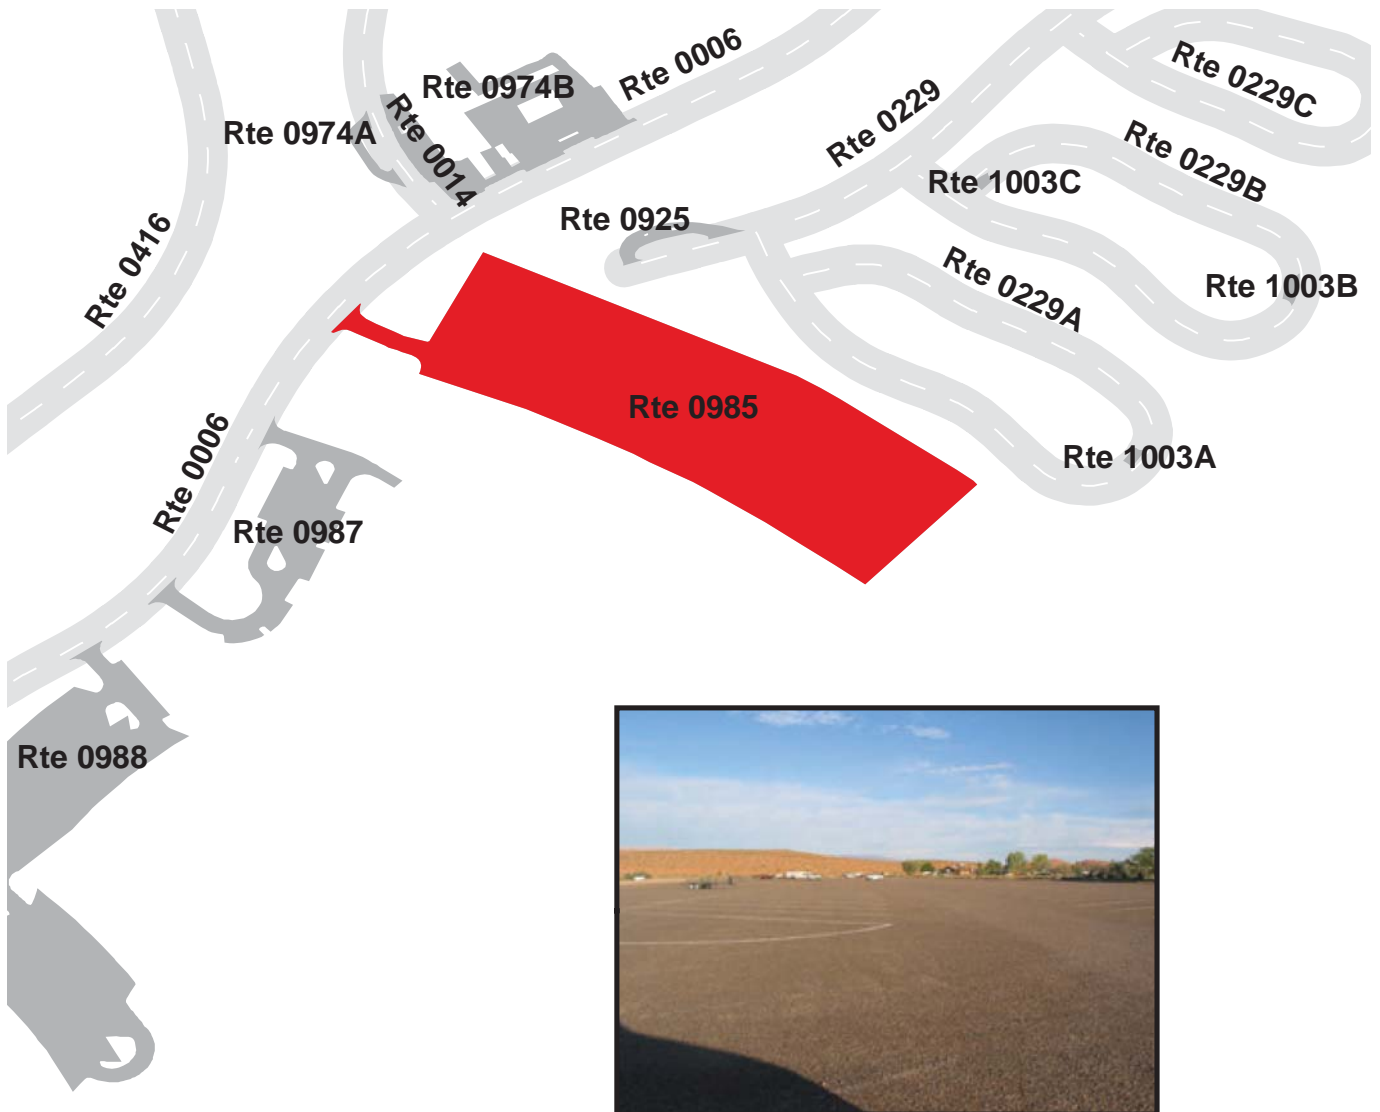
Route 0985

Route Number	Public / NonPublic	Date Visited		Area (sq ft)	Lane Miles *	Surface Type
0985	PUBLIC	9/20/2007		342,940	5.91	AS
Culverts	Drop Inlets	Gates	Fire Hydrants	Curb & Gutter	Curb	PCR
0	0	0	1	CONCRETE CURB AND GUTTER	CONCRETE CURB	FAIR/73

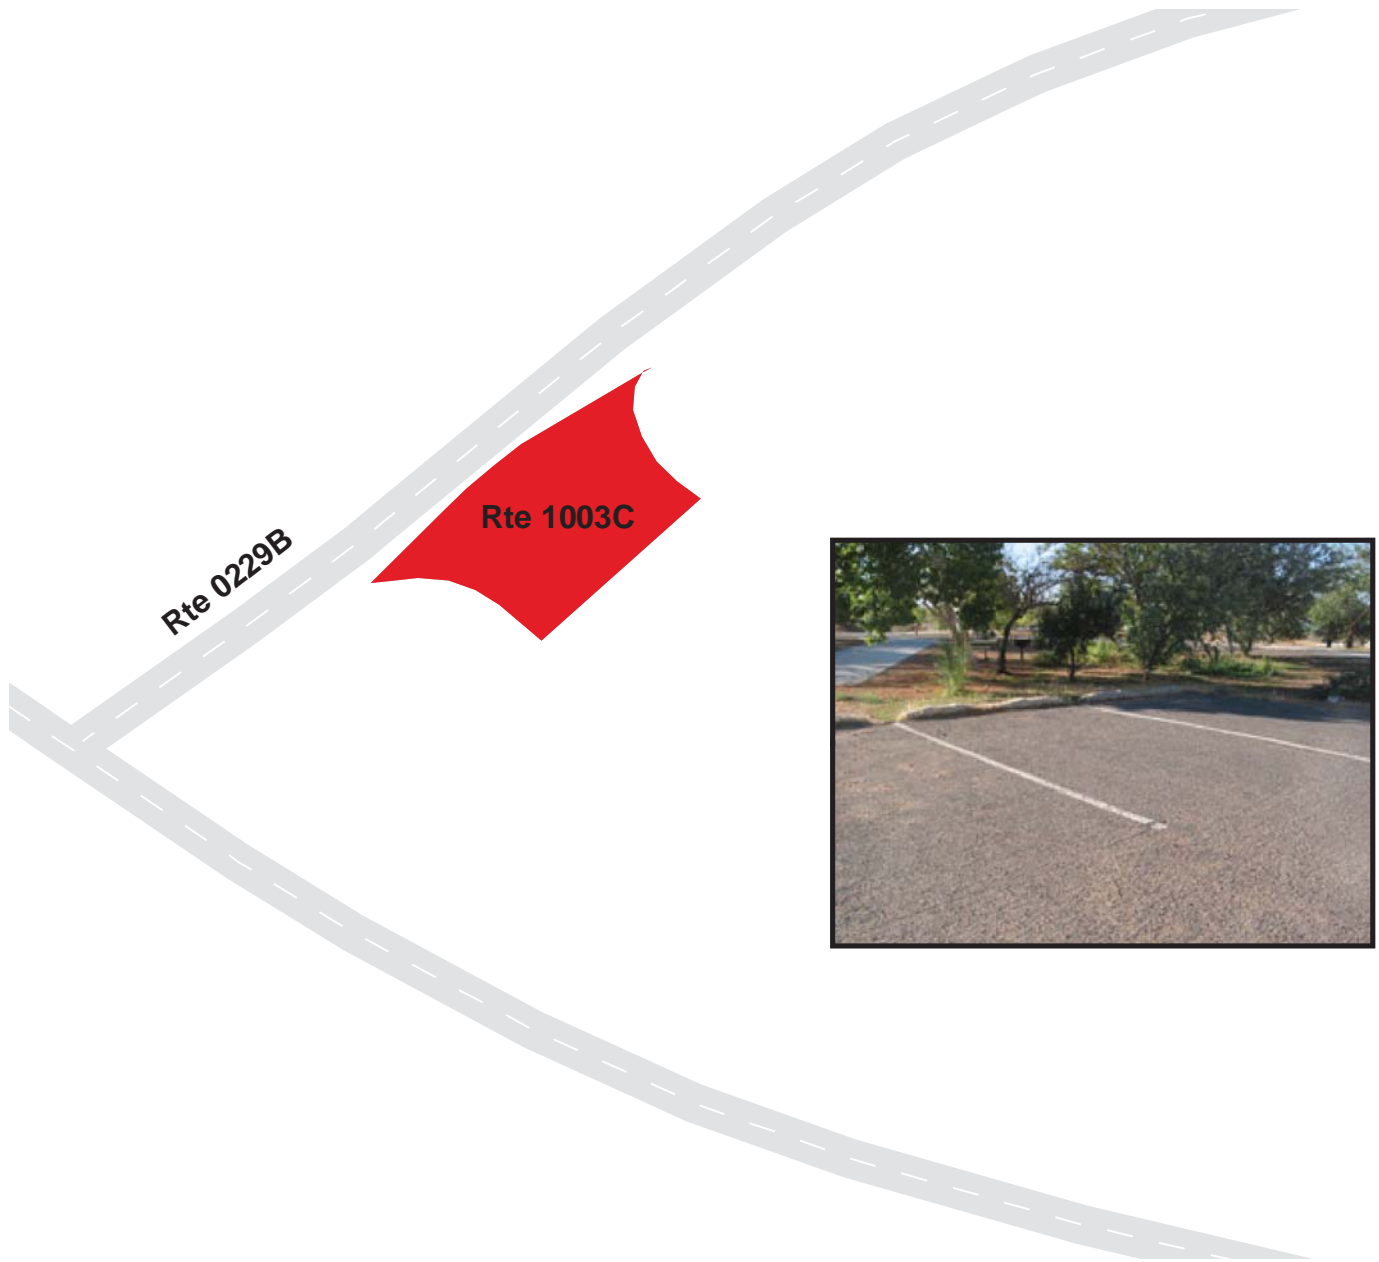
Route Number	Public / NonPublic	Date Visited		Area (sq ft)	Lane Miles *	Surface Type
1003C	PUBLIC	9/20/2007		799	0.01	AS
Culverts	Drop Inlets	Gates	Fire Hydrants	Curb & Gutter	Curb	PCR
0	0	0	0	NO CURB AND GUTTER	CONCRETE CURB	EXCELLENT/97

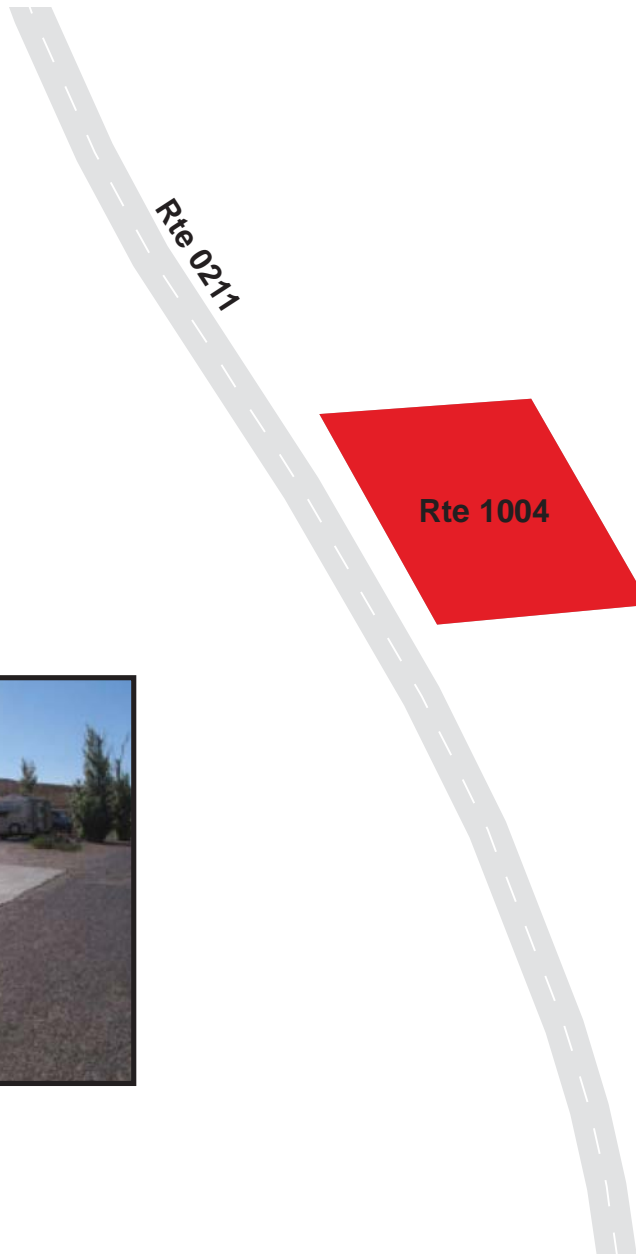
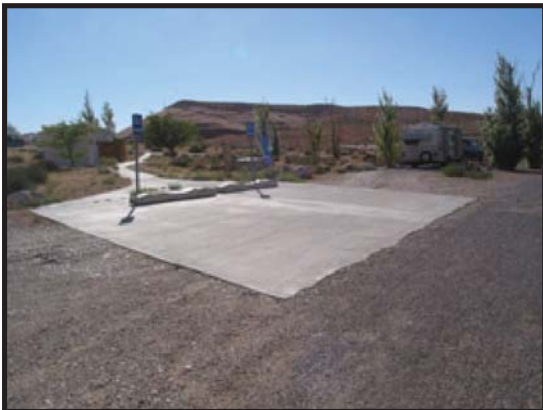
Route Number	Public / NonPublic	Date Visited		Area (sq ft)	Lane Miles *	Surface Type
1004	PUBLIC	9/20/2007		731	0.01	CO
Culverts	Drop Inlets	Gates	Fire Hydrants	Curb & Gutter	Curb	PCR
0	0	0	0	NO CURB AND GUTTER	NO CURB	GOOD/90
