**The Road Inventory
of
Great Basin National Park
GRBA – 8420
Cycle 4**

**Prepared By:
Federal Highway Administration
Road Inventory Program
Cycle 4**

Great Basin National Park in Nevada

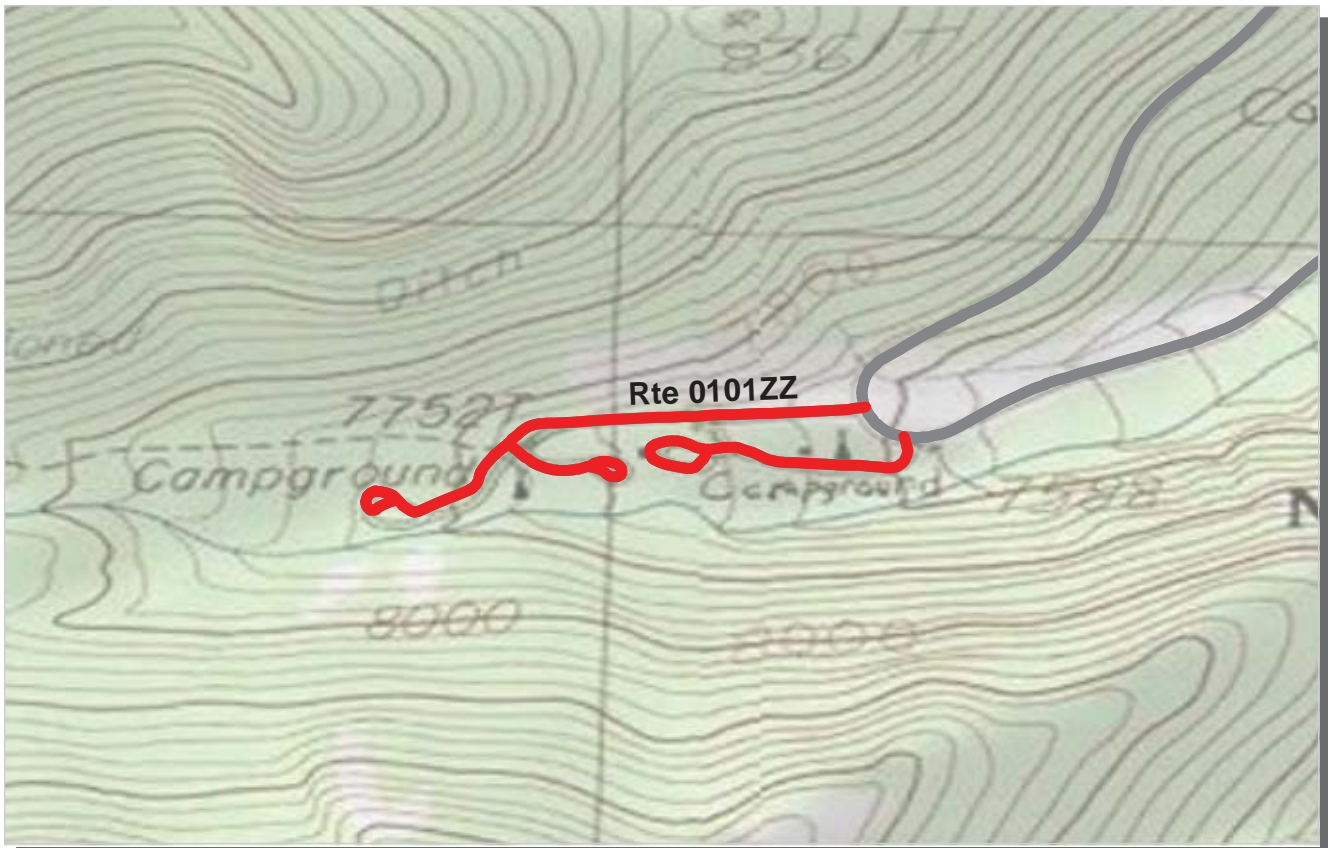
ROUTE: 0100 WHEELER PEAK SCENIC DRIVE

PCR Poor ■ Fair ■ Good ■ Excellent ■ No Data ■
 (<=60) (61 - 84) (85 - 94) (95 - 100)

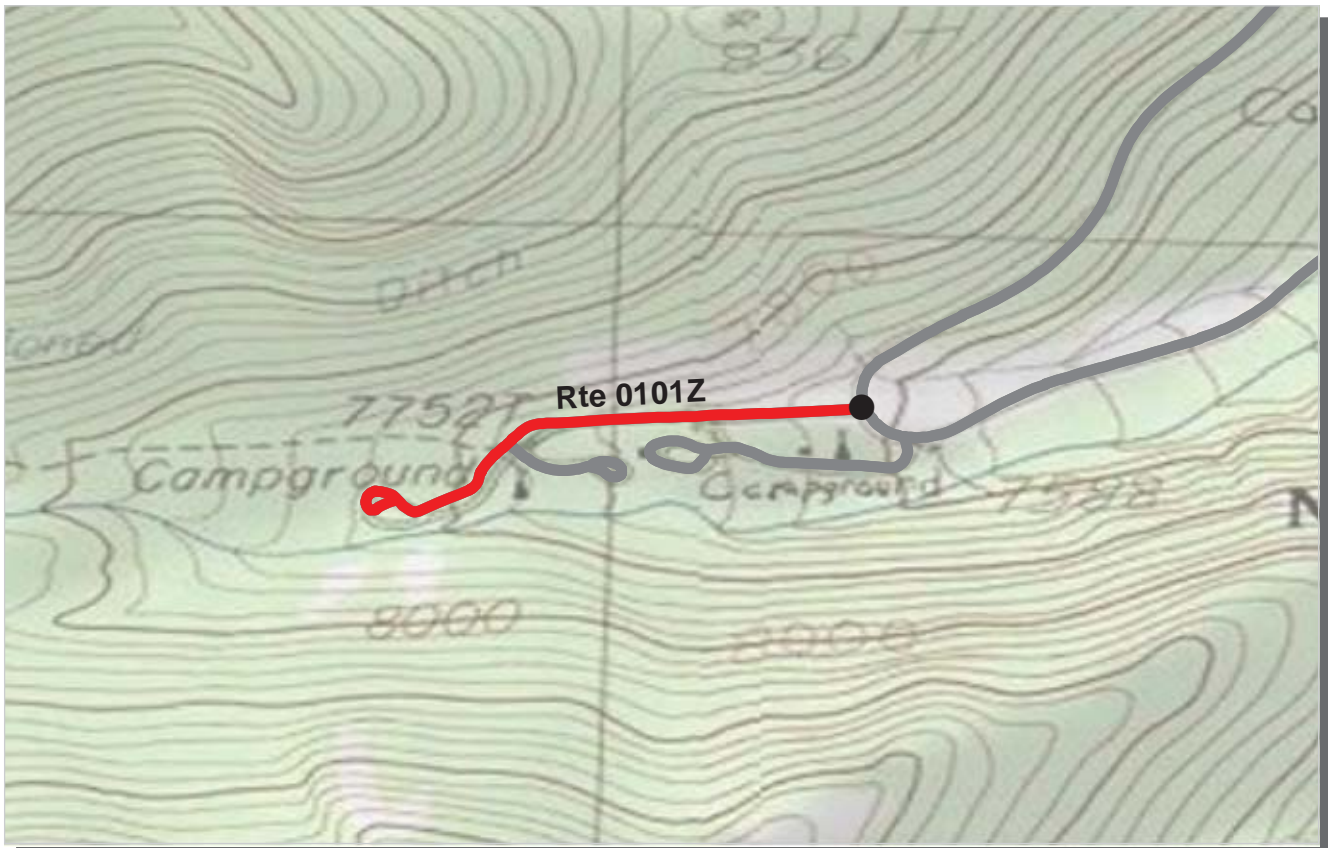
ROUTE: 0101Z UPPER LEHMAN CREEK CAMPGROUND ACCESS ROAD

<i>Section Number</i>	0				
<i>Section Length (mi)</i>	0.47				
<i>Traffic</i>	Traffic data may be found at www.efl.fhwa.dot.gov Click on PROGRAMS / NPS Traffic Data (Note: Not all parks have traffic data)				
<i>Cross Section Information</i>					
Number of Lanes	2				
Paved Width (ft)	15				
Lane Width (ft)	8				
Shoulder Width Right (ft)	NC				
Shoulder Width Left (ft)	NC				
<i>Roadway Condition Information</i>					
SCR (Surface Condition Rating)	32				
PCR (Pavement Condition Rating)	32				
<i>Distress Index Values</i>					
Alligator Cracking Index	87				
Longitudinal Cracking Index	93				
Transverse Cracking Index	94				
Patching Index	100				
Rutting Index	53				
Roughness Condition Index (RCI)	32

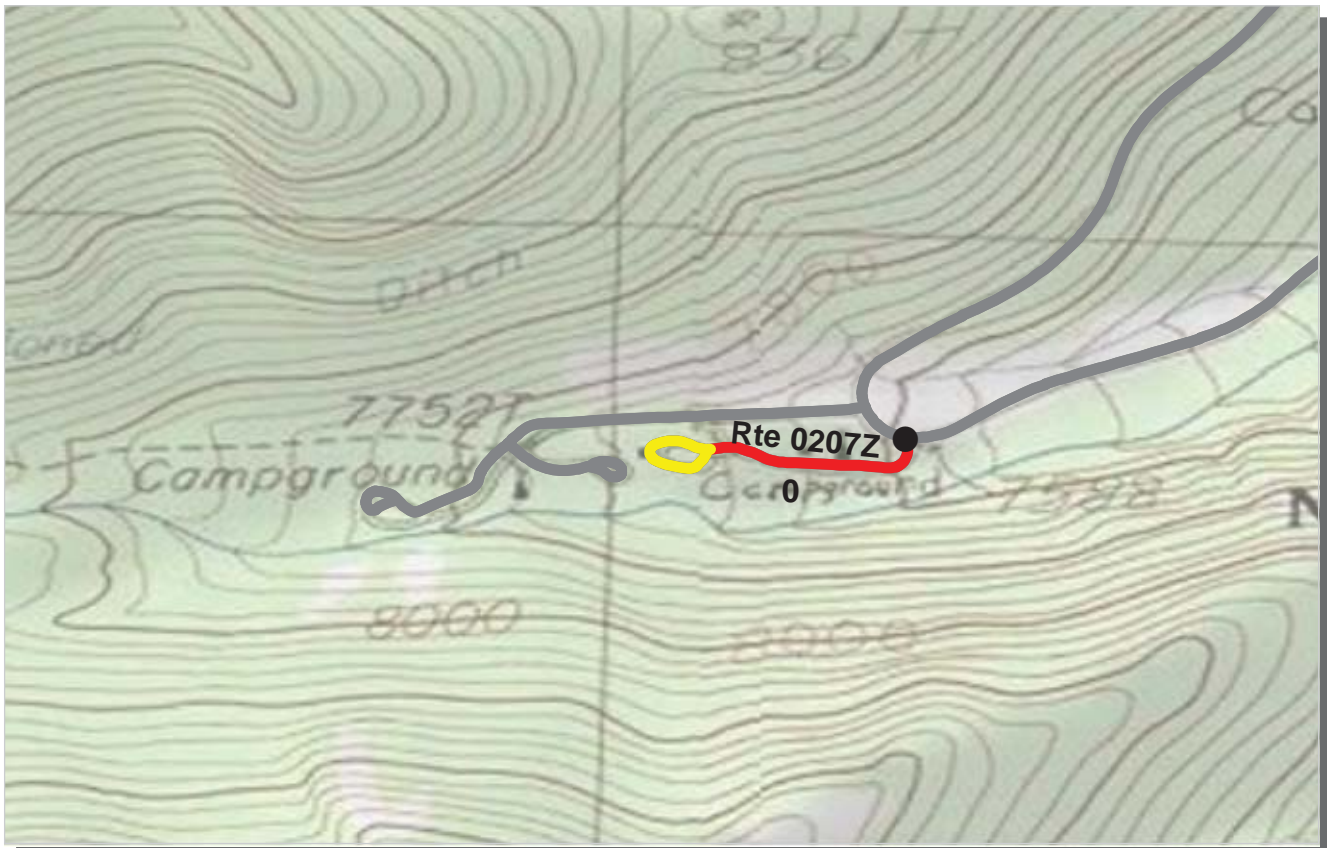
ROUTE: 0207Z UPPER LEHMAN CREEK LOWER CAMPGROUND ROAD

<i>Section Number</i>	0				
<i>Section Length (mi)</i>	0.29				
<i>Traffic</i> AADT SADT ADT Date	Traffic data may be found at www.efl.fhwa.dot.gov Click on PROGRAMS / NPS Traffic Data (Note: Not all parks have traffic data)				
<i>Cross Section Information</i> Number of Lanes Paved Width (ft) Lane Width (ft) Shoulder Width Right (ft) Shoulder Width Left (ft)	2 14 9 NC NC				
<i>Roadway Condition Information</i> SCR (Surface Condition Rating) PCR (Pavement Condition Rating)	50 50				
<i>Distress Index Values</i> Alligator Cracking Index Longitudinal Cracking Index Transverse Cracking Index Patching Index Rutting Index Roughness Condition Index (RCI)	92 95 95 100 68 27

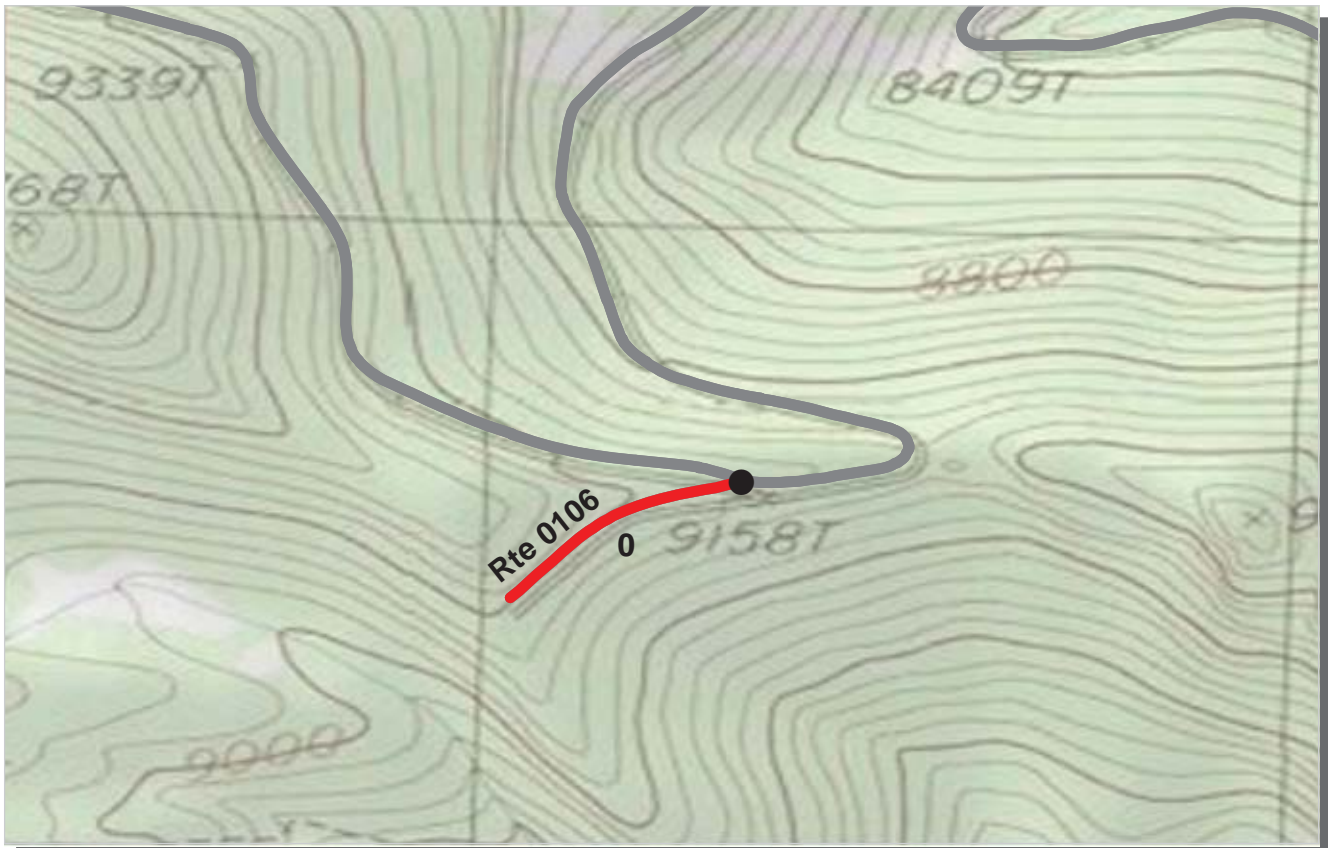
ROUTE: 0106 MATHER OVERLOOK

Section Number	0				
Section Length (mi)	0.22				
Traffic	Traffic data may be found at www.efl.fhwa.dot.gov Click on PROGRAMS / NPS Traffic Data (Note: Not all parks have traffic data)				
Cross Section Information					
Number of Lanes	2				
Paved Width (ft)	26				
Lane Width (ft)	13				
Shoulder Width Right (ft)	NC				
Shoulder Width Left (ft)	NC				
Roadway Condition Information					
SCR (Surface Condition Rating)	43				
PCR (Pavement Condition Rating)	47				
Distress Index Values					
Alligator Cracking Index	100				
Longitudinal Cracking Index	99				
Transverse Cracking Index	99				
Patching Index	100				
Rutting Index	45				
Roughness Condition Index (RCI)	49

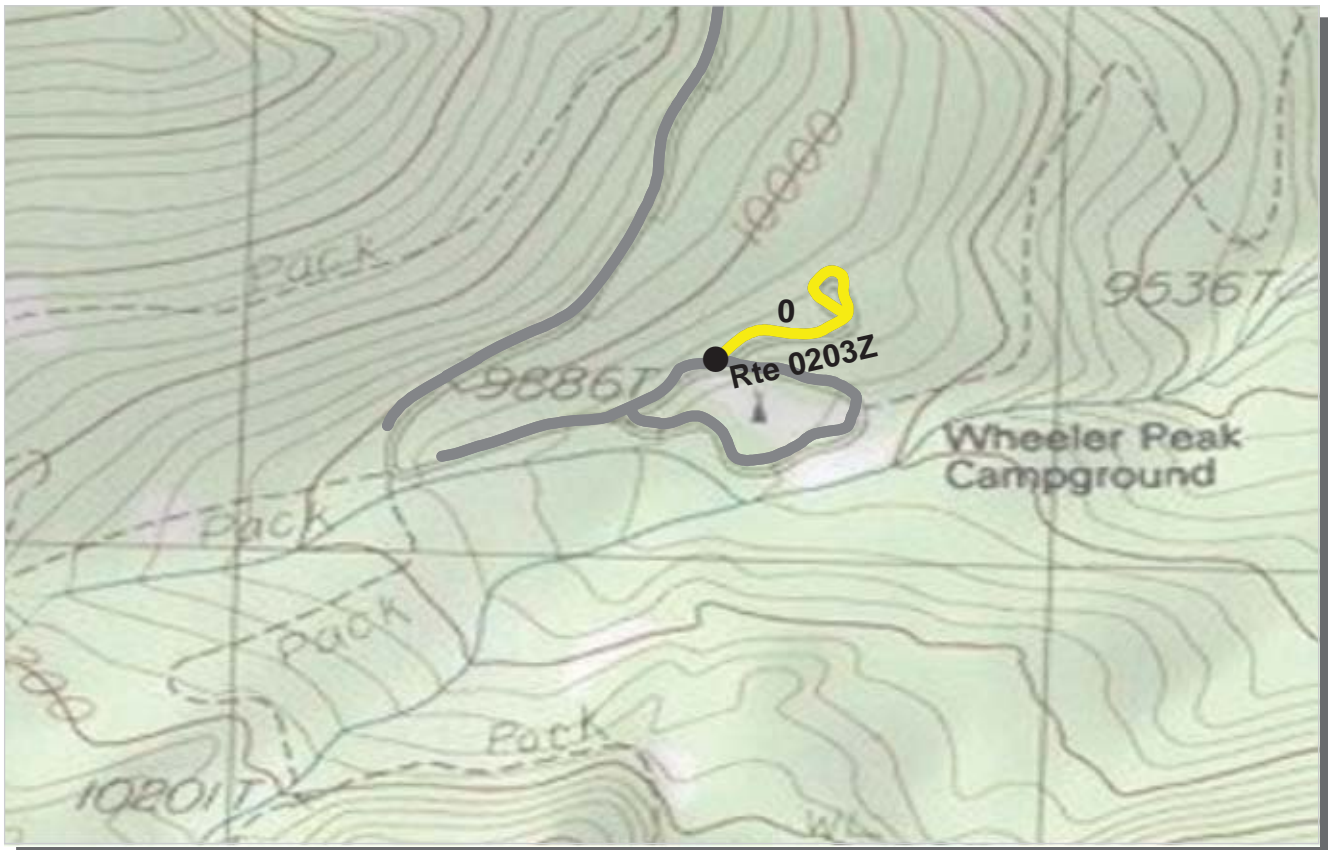
ROUTE: 0203Z WHEELER PEAK UPPER CAMPGROUND ROAD

Section Number	0				
Section Length (mi)	0.23				
Traffic	Traffic data may be found at www.efl.fhwa.dot.gov Click on PROGRAMS / NPS Traffic Data (Note: Not all parks have traffic data)				
Cross Section Information					
Number of Lanes	2				
Paved Width (ft)	14				
Lane Width (ft)	12				
Shoulder Width Right (ft)	NC				
Shoulder Width Left (ft)	NC				
Roadway Condition Information					
SCR (Surface Condition Rating)	78				
PCR (Pavement Condition Rating)	78				
Distress Index Values					
Alligator Cracking Index	100				
Longitudinal Cracking Index	100				
Transverse Cracking Index	100				
Patching Index	100				
Rutting Index	78				
Roughness Condition Index (RCI)	NC

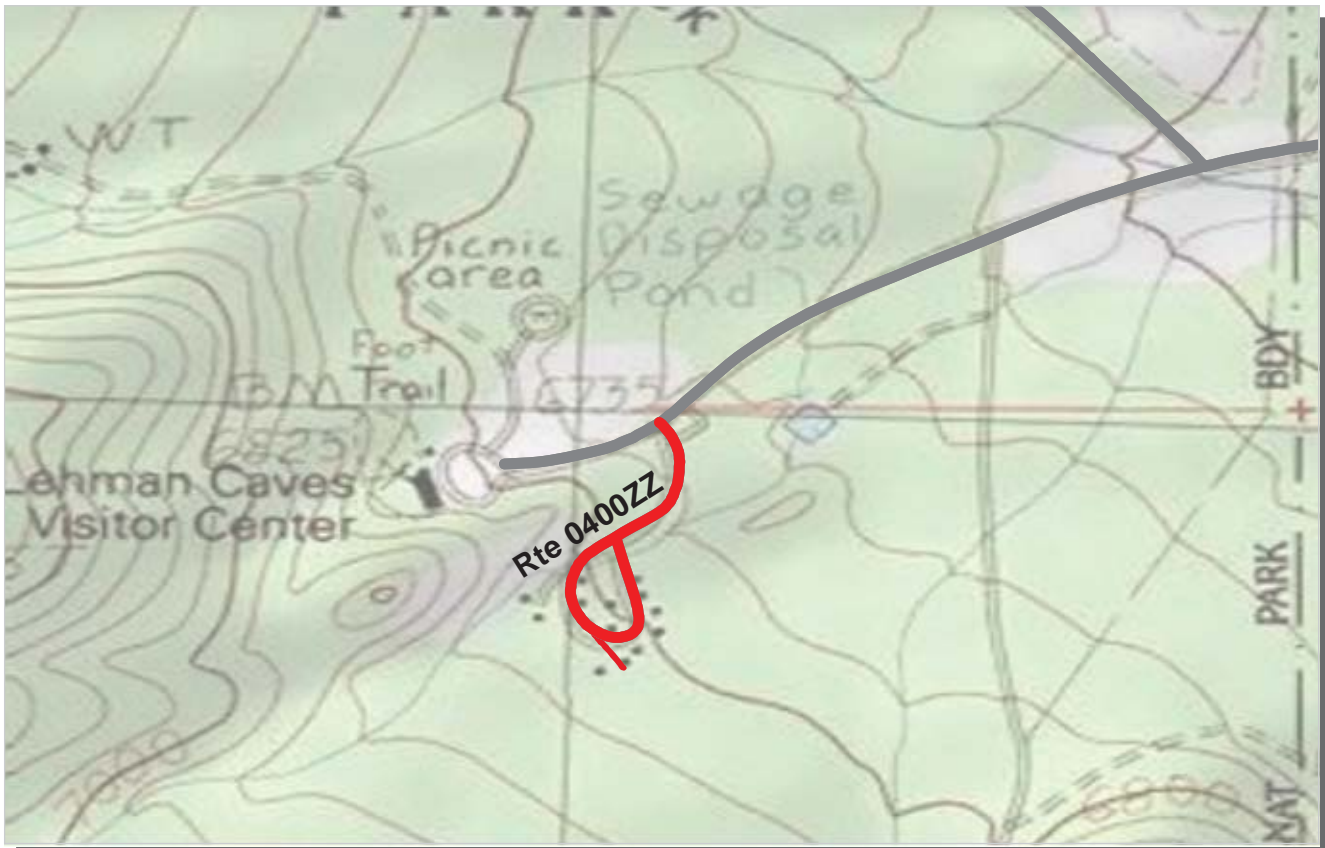
ROUTE: 0209 LOWER LEHMAN CREEK CAMPGROUND LOOP

PCR	Poor	Fair	Good	Excellent	No Data
	(≤60)	(61 - 84)	(85 - 94)	(95 - 100)

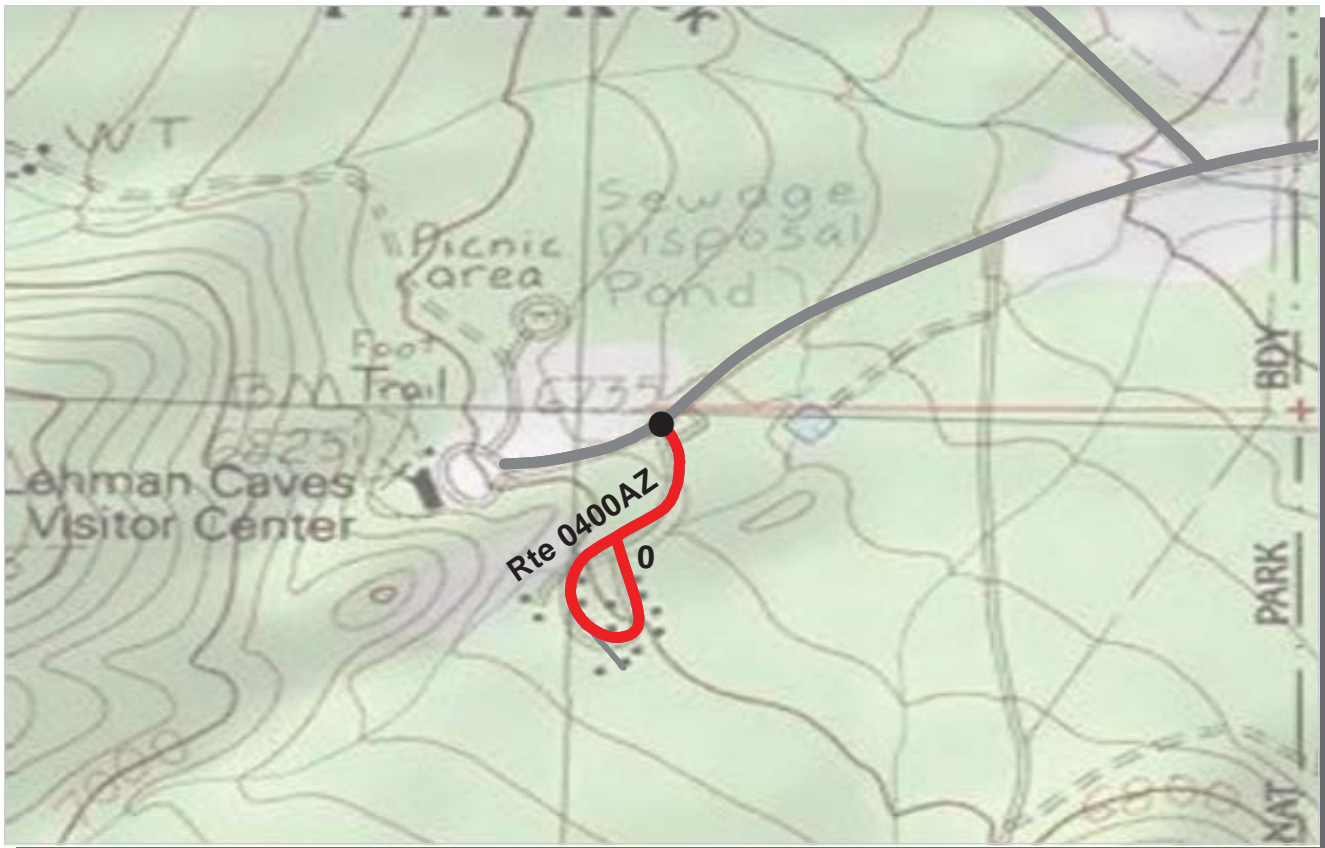
ROUTE: 0400AZ RESIDENTIAL / MAINTENANCE ROAD

Section Number	0				
Section Length (mi)	0.37				
Traffic	Traffic data may be found at www.efl.fhwa.dot.gov Click on PROGRAMS / NPS Traffic Data (Note: Not all parks have traffic data)				
Cross Section Information					
Number of Lanes	2				
Paved Width (ft)	19				
Lane Width (ft)	9				
Shoulder Width Right (ft)	NC				
Shoulder Width Left (ft)	NC				
Roadway Condition Information					
SCR (Surface Condition Rating)	43				
PCR (Pavement Condition Rating)	45				
Distress Index Values					
Alligator Cracking Index	100				
Longitudinal Cracking Index	98				
Transverse Cracking Index	96				
Patching Index	100				
Rutting Index	49				
Roughness Condition Index (RCI)	56

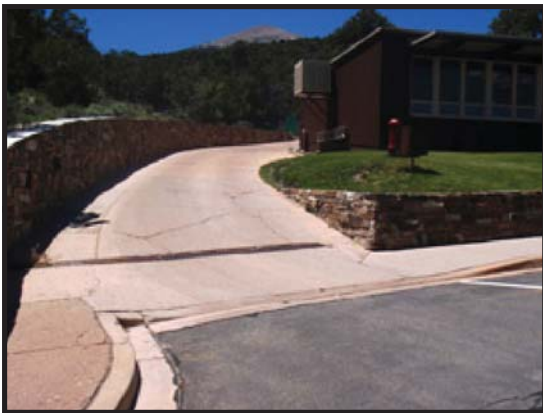
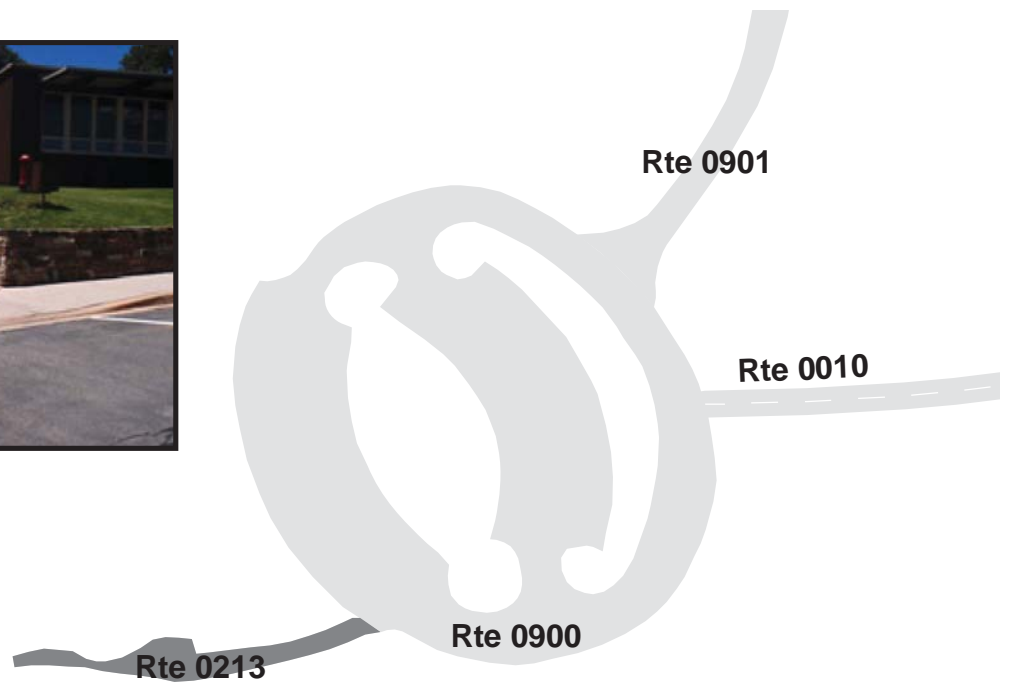
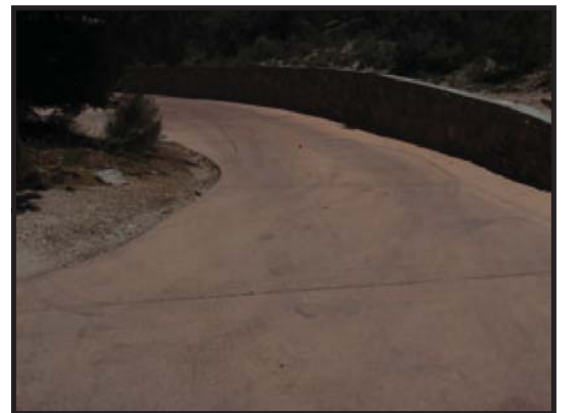
Route Number	Public / NonPublic	Date Visited		Area (sq ft)	Lane Miles *	Surface Type
0213	NONPUBLIC	7/13/2009		2,820	0.05	CO
Culverts	Drop Inlets	Gates	Fire Hydrants	Curb & Gutter	Curb	PCR
0	1	0	1	NO CURB AND GUTTER	CONCRETE CURB	FAIR/73

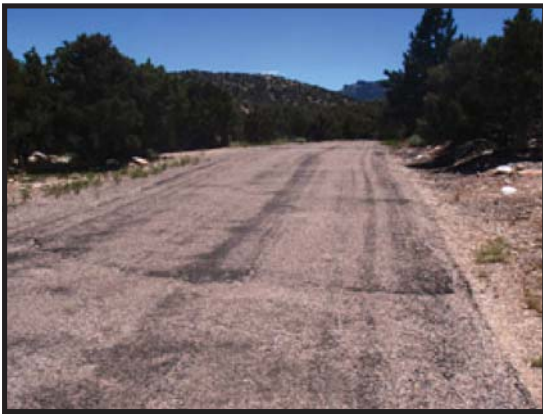
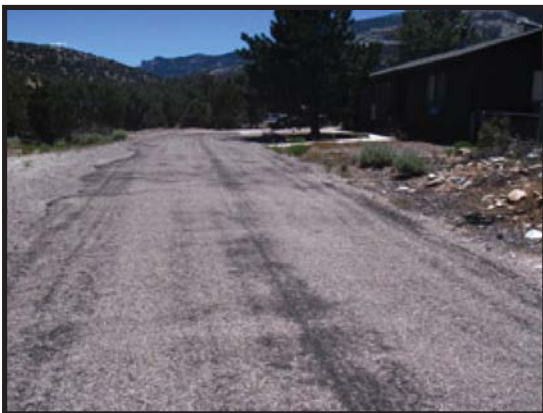
Route Number	Public / NonPublic	Date Visited		Area (sq ft)	Lane Miles *	Surface Type
0400BZ	NONPUBLIC	7/13/2009		3,451	0.06	AS
Culverts	Drop Inlets	Gates	Fire Hydrants	Curb & Gutter	Curb	PCR
0	0	0	1	NO CURB AND GUTTER	ASPHALT CURB	POOR/45

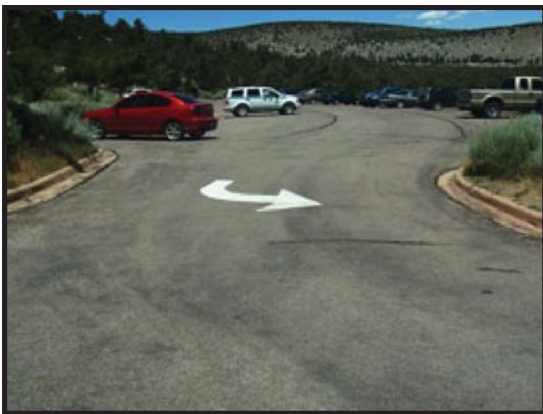
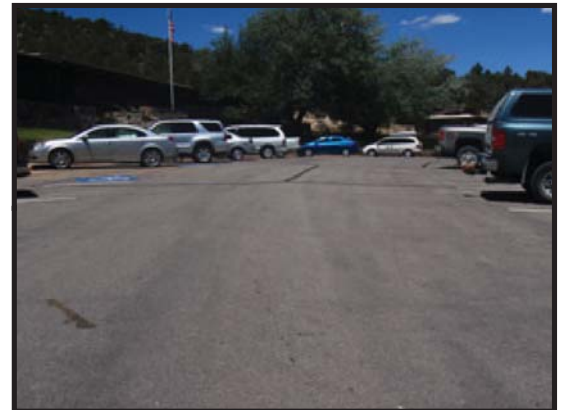
Route Number	Public / NonPublic	Date Visited		Area (sq ft)	Lane Miles *	Surface Type
0900	PUBLIC	7/13/2009		43,362	0.75	AS
Culverts	Drop Inlets	Gates	Fire Hydrants	Curb & Gutter	Curb	PCR
0	3	0	0	CONCRETE CURB AND GUTTER	NO CURB	FAIR/73

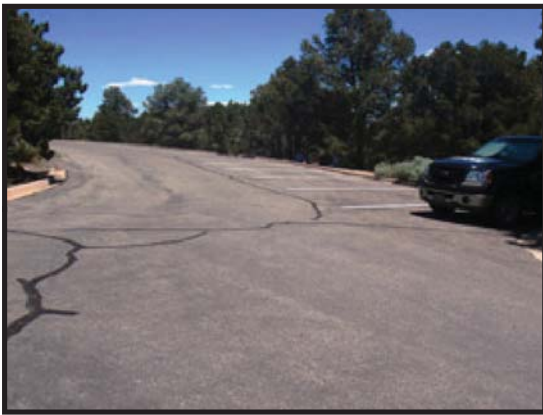
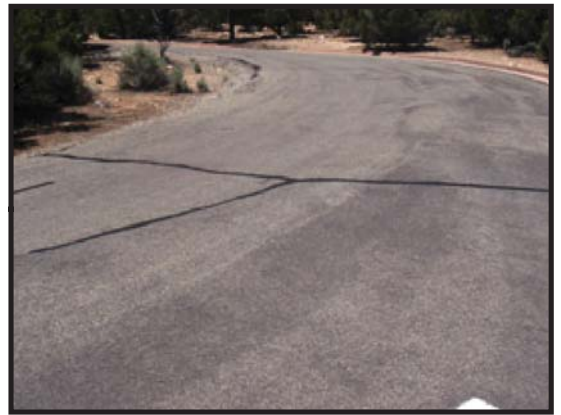
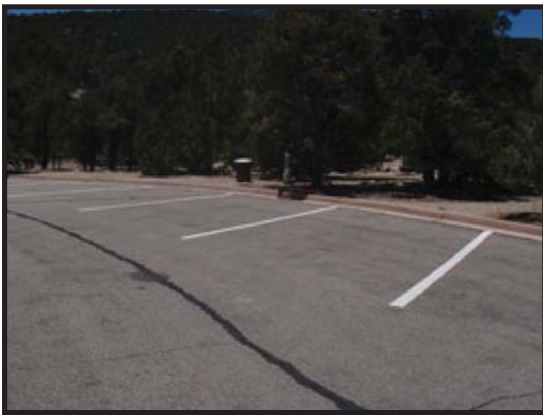
Route 0901

Route Number	Public / NonPublic	Date Visited		Area (sq ft)	Lane Miles *	Surface Type
0901	PUBLIC	7/13/2009		30,439	0.52	AS
Culverts	Drop Inlets	Gates	Fire Hydrants	Curb & Gutter	Curb	PCR
0	0	0	0	CONCRETE CURB AND GUTTER	NO CURB	FAIR/73

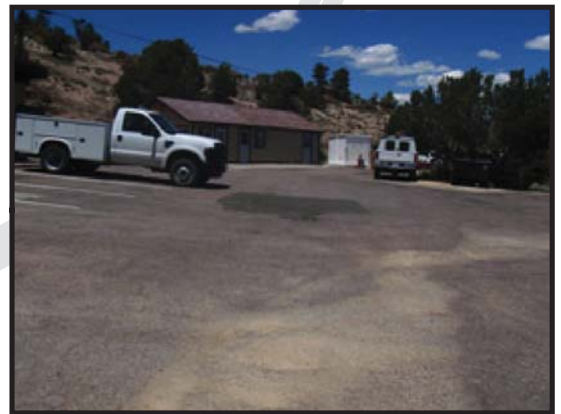
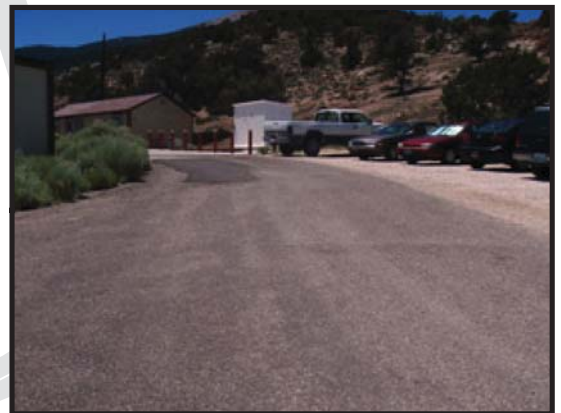
Route 0902

Route Number	Public / NonPublic	Date Visited		Area (sq ft)	Lane Miles *	Surface Type
0902	NONPUBLIC	7/13/2009		15,155	0.26	AS
Culverts	Drop Inlets	Gates	Fire Hydrants	Curb & Gutter	Curb	PCR
0	0	0	0	NO CURB AND GUTTER	CONCRETE CURB	FAIR/73

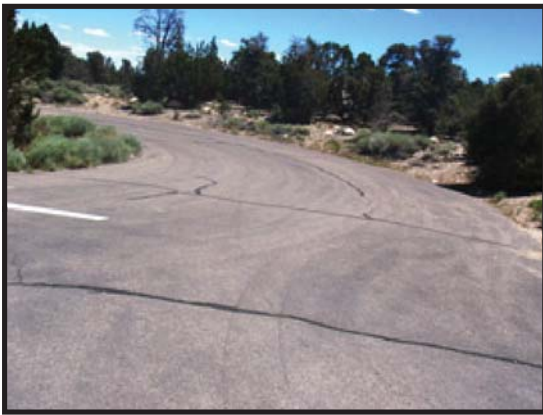
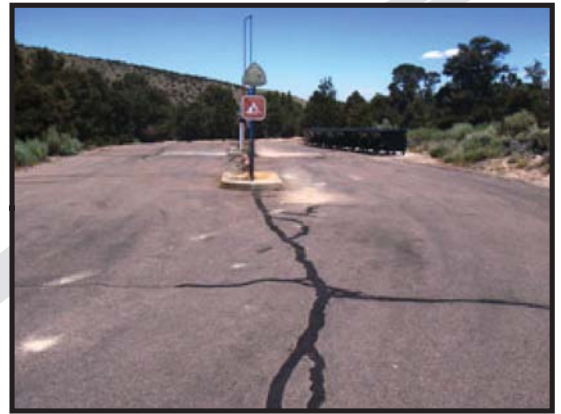
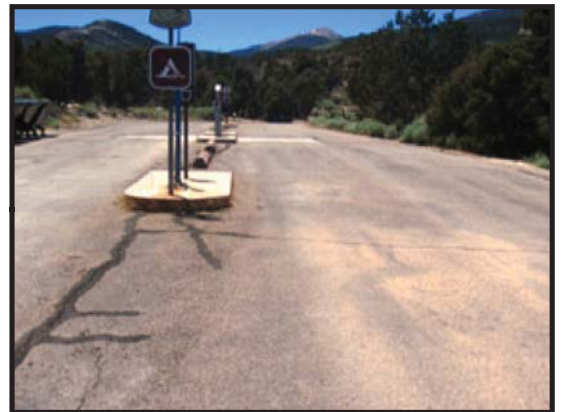
Route 0903

Route Number	Public / NonPublic	Date Visited		Area (sq ft)	Lane Miles *	Surface Type
0903	PUBLIC	7/13/2009		12,326	0.21	AS
Culverts	Drop Inlets	Gates	Fire Hydrants	Curb & Gutter	Curb	PCR
0	0	0	0	NO CURB AND GUTTER	CONCRETE CURB	FAIR/73

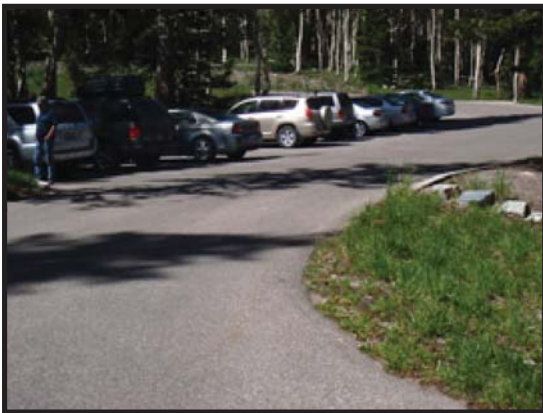
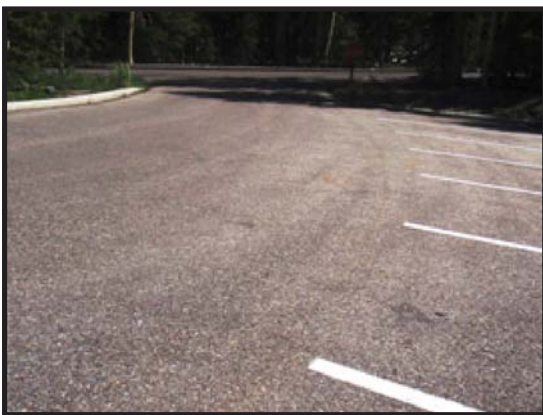
Route 0904

Route Number	Public / NonPublic	Date Visited		Area (sq ft)	Lane Miles *	Surface Type
0904	PUBLIC	7/13/2009		31,407	0.54	AS
Culverts	Drop Inlets	Gates	Fire Hydrants	Curb & Gutter	Curb	PCR
0	1	0	0	NO CURB AND GUTTER	ASPHALT & CONCRETE CURB	GOOD/90

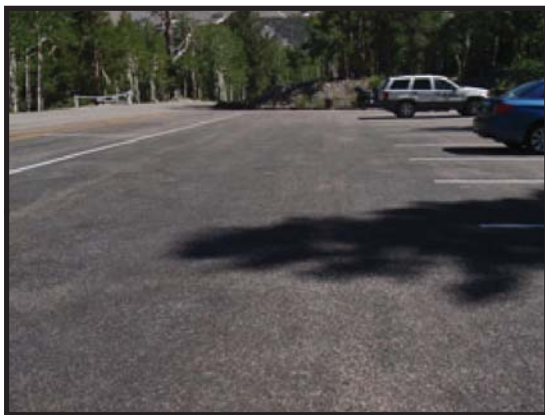
Route 0905

Route Number	Public / NonPublic	Date Visited		Area (sq ft)	Lane Miles *	Surface Type
0905	PUBLIC	7/13/2009		8,723	0.15	AS
Culverts	Drop Inlets	Gates	Fire Hydrants	Curb & Gutter	Curb	PCR
0	0	0	0	NO CURB AND GUTTER	ASPHALT CURB	GOOD/90

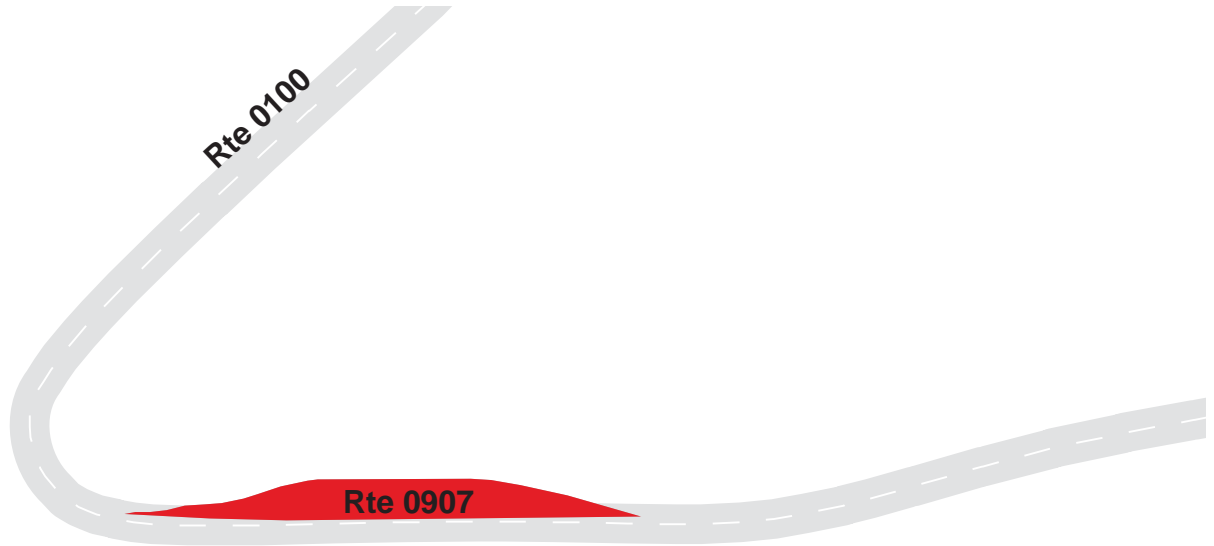
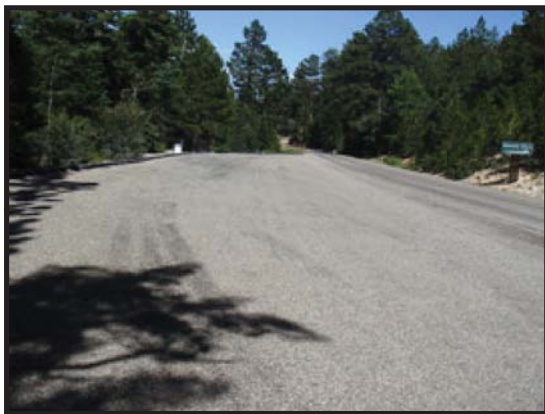
Route 0907

Route Number	Public / NonPublic	Date Visited		Area (sq ft)	Lane Miles *	Surface Type
0907	PUBLIC	7/13/2009		8,810	0.15	AS
Culverts	Drop Inlets	Gates	Fire Hydrants	Curb & Gutter	Curb	PCR
0	0	0	0	NO CURB AND GUTTER	ASPHALT CURB	FAIR/73

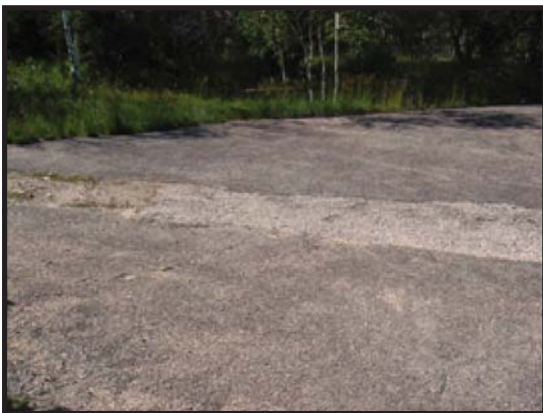
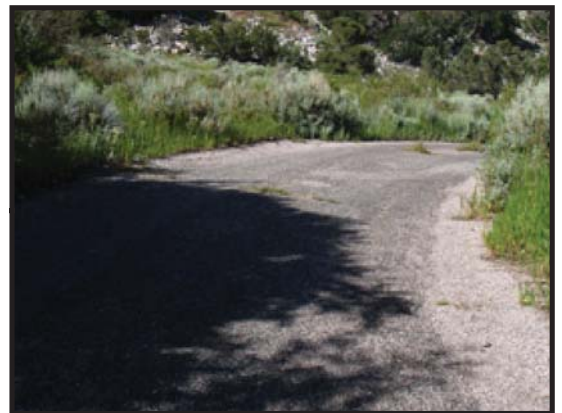
Route Number	Public / NonPublic	Date Visited		Area (sq ft)	Lane Miles *	Surface Type
0908Z	PUBLIC	7/13/2009		3,102	0.05	AS
Culverts	Drop Inlets	Gates	Fire Hydrants	Curb & Gutter	Curb	PCR
0	0	0	0	NO CURB AND GUTTER	NO CURB	POOR/45

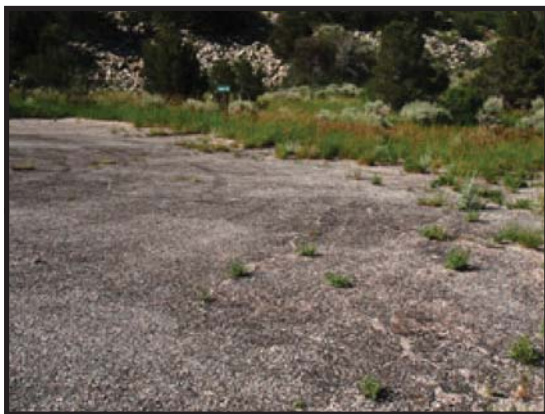
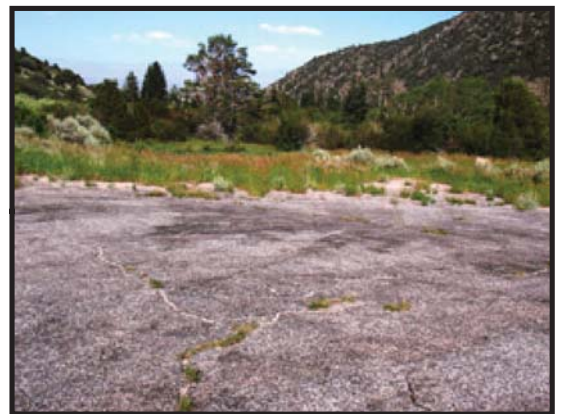
Route 0909Z

Route Number	Public / NonPublic	Date Visited		Area (sq ft)	Lane Miles *	Surface Type
0909Z	PUBLIC	7/13/2009		2,991	0.05	AS
Culverts	Drop Inlets	Gates	Fire Hydrants	Curb & Gutter	Curb	PCR
0	0	0	0	NO CURB AND GUTTER	NO CURB	POOR/45

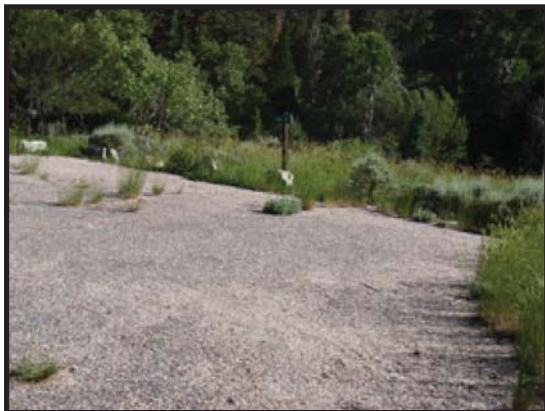
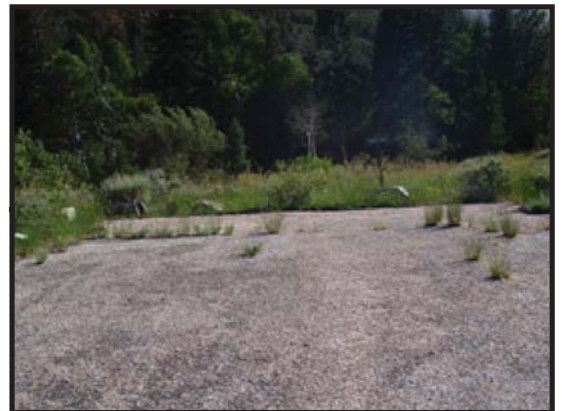
Route 0910Z

Route Number	Public / NonPublic	Date Visited		Area (sq ft)	Lane Miles *	Surface Type
0910Z	PUBLIC	7/13/2009		1,253	0.02	AS
Culverts	Drop Inlets	Gates	Fire Hydrants	Curb & Gutter	Curb	PCR
0	0	0	0	NO CURB AND GUTTER	NO CURB	POOR/45

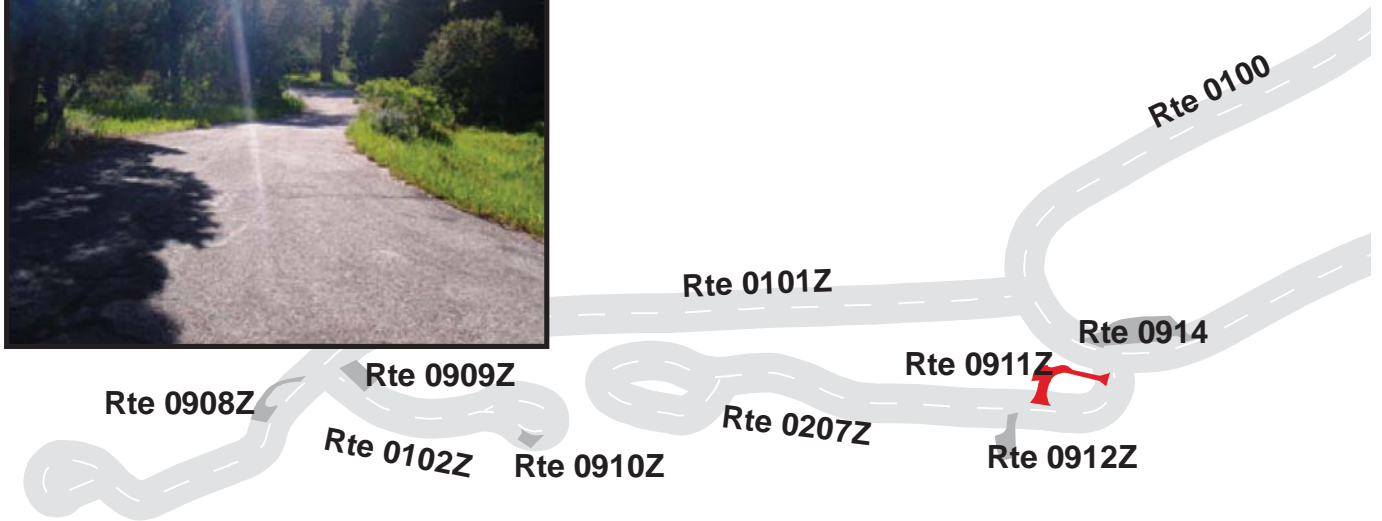
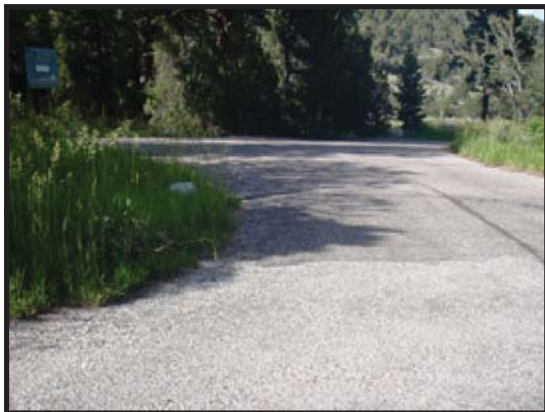
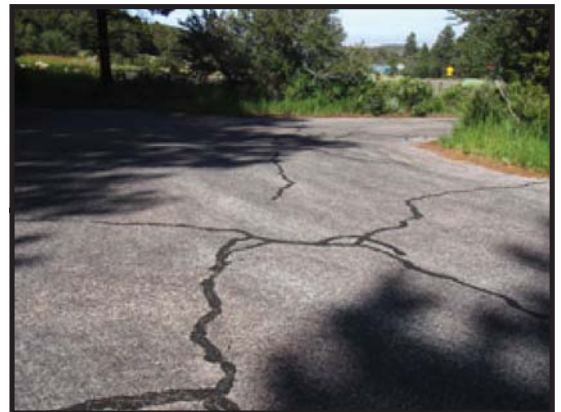
Route 0911Z

Route Number	Public / NonPublic	Date Visited		Area (sq ft)	Lane Miles *	Surface Type
0911Z	PUBLIC	7/13/2009		4,934	0.09	AS
Culverts	Drop Inlets	Gates	Fire Hydrants	Curb & Gutter	Curb	PCR
0	0	0	0	NO CURB AND GUTTER	NO CURB	FAIR/73

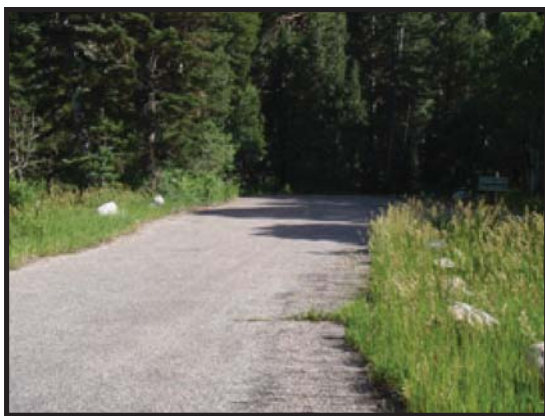
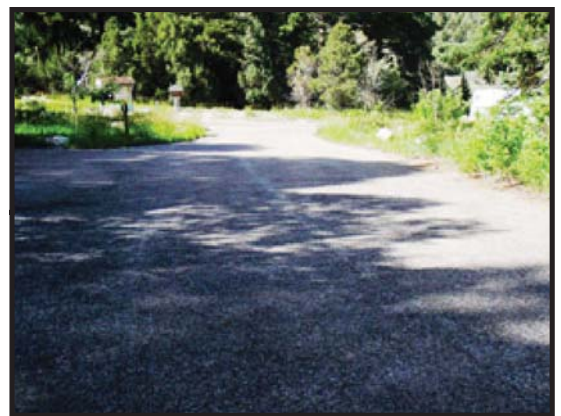
Route 0912Z

Route Number	Public / NonPublic	Date Visited		Area (sq ft)	Lane Miles *	Surface Type
0912Z	PUBLIC	7/13/2009		3,613	0.06	AS
Culverts	Drop Inlets	Gates	Fire Hydrants	Curb & Gutter	Curb	PCR
0	0	0	0	NO CURB AND GUTTER	NO CURB	POOR/45

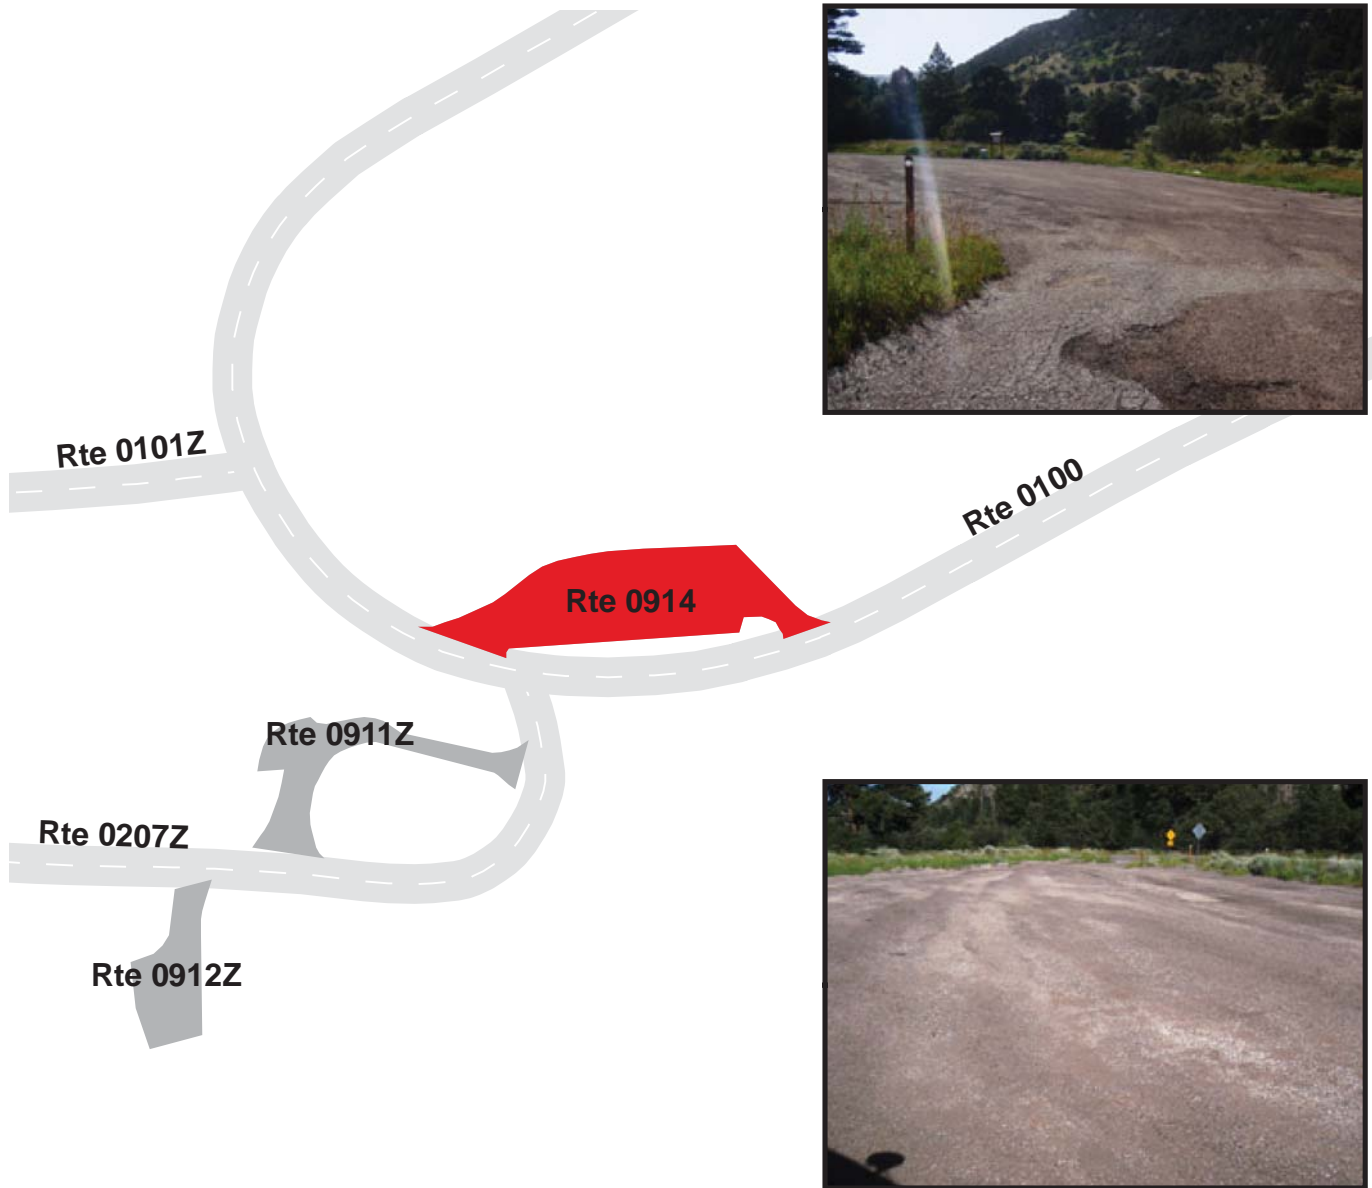
Route 0914

Route Number	Public / NonPublic	Date Visited		Area (sq ft)	Lane Miles *	Surface Type
0914	PUBLIC	7/13/2009		11,459	0.20	AS
Culverts	Drop Inlets	Gates	Fire Hydrants	Curb & Gutter	Curb	PCR
0	0	0	0	NO CURB AND GUTTER	NO CURB	POOR/45
