**The Road Inventory  
of  
Grand Teton National Park  
GRTE – 1460  
Cycle 4**

**Prepared By:  
Federal Highway Administration  
Road Inventory Program  
Cycle 4**

# Grand Teton National Park in Wyoming

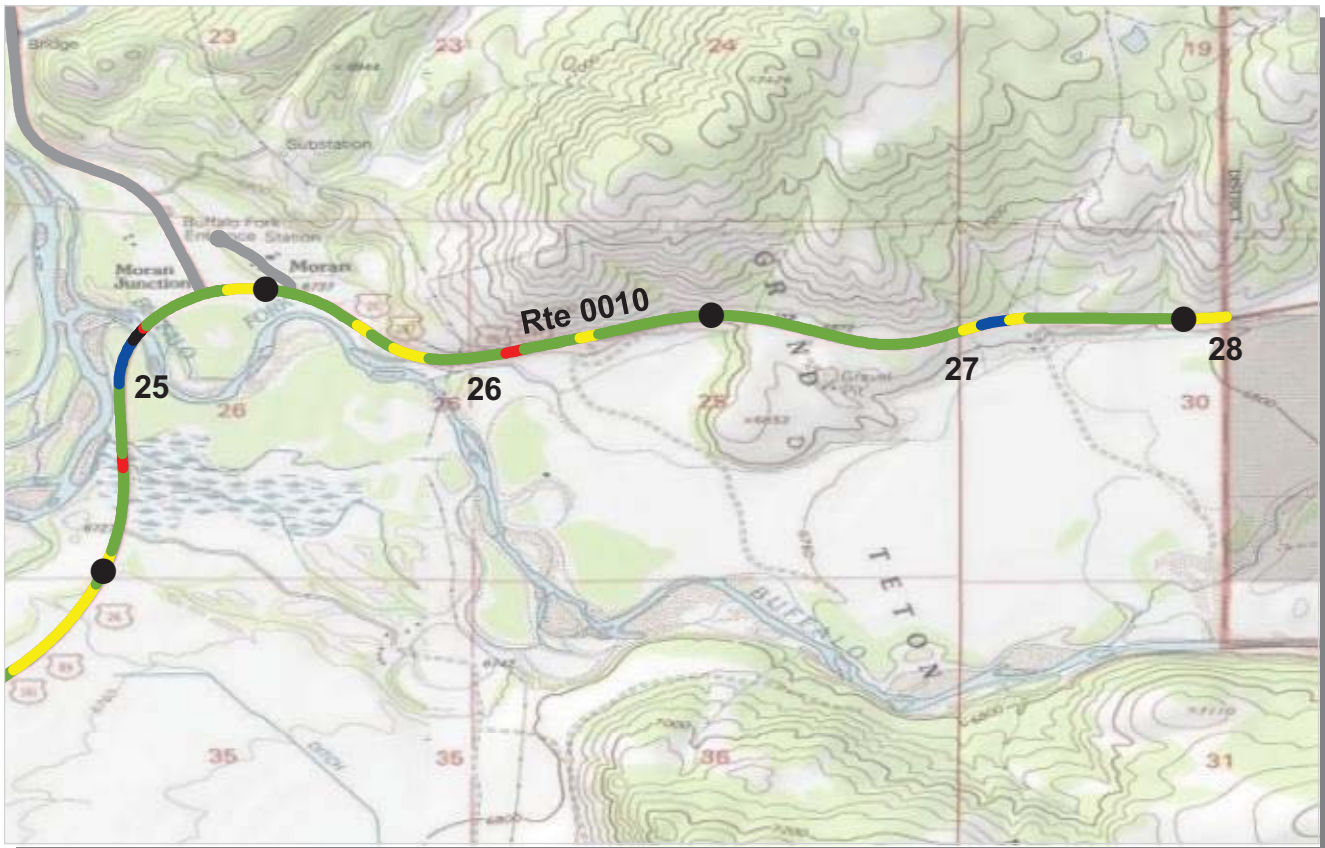
**ROUTE: 0010 NORTH-SOUTH HIGHWAY**

Section Number	20	21	22	23	24
Section Length (mi)	1.00	1.00	1.00	1.00	1.00
<b>Traffic</b>	Traffic data may be found at <a href="http://www.efl.fhwa.dot.gov">www.efl.fhwa.dot.gov</a> Click on PROGRAMS / NPS Traffic Data (Note: Not all parks have traffic data)				
<b>Cross Section Information</b>					
Number of Lanes	2	2	2	2	2
Paved Width (ft)	35	31	32	31	32
Lane Width (ft)	11	12	12	12	12
Shoulder Width Right (ft)	NC	NC	NC	NC	NC
Shoulder Width Left (ft)	NC	NC	NC	NC	NC
<b>Roadway Condition Information</b>					
SCR (Surface Condition Rating)	65	77	78	72	74
PCR (Pavement Condition Rating)	78	82	84	80	81
<b>Distress Index Values</b>					
Alligator Cracking Index	100	100	100	100	100
Longitudinal Cracking Index	97	100	100	100	99
Transverse Cracking Index	98	98	99	99	99
Patching Index	100	100	100	100	100
Rutting Index	70	79	79	73	76
Roughness Condition Index (RCI)	99	100	99	100	100

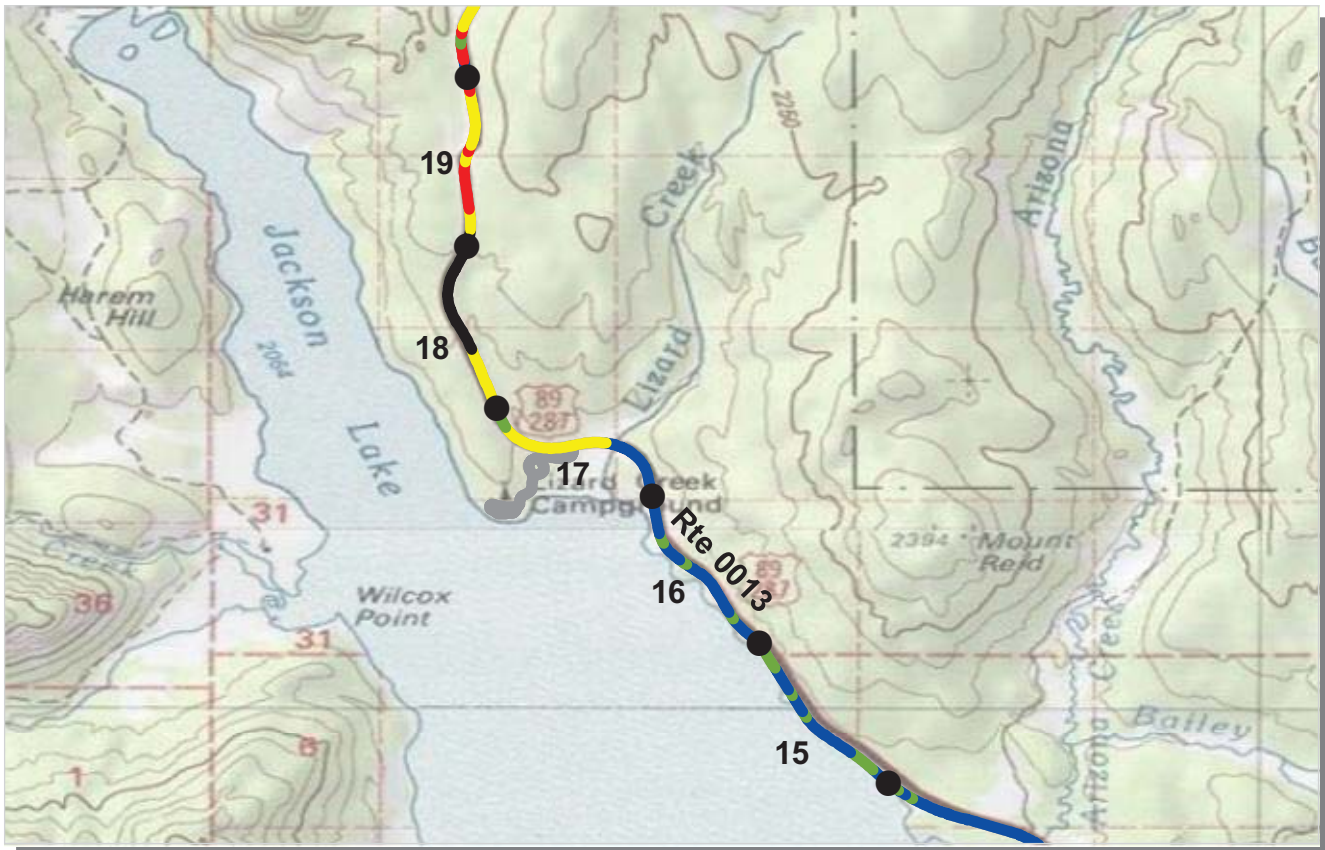
**ROUTE: 0013 NORTH PARK ROAD**

Section Number	10	11	12	13	14
Section Length (mi)	1.00	1.00	1.00	1.00	1.00
<b>Traffic</b>	Traffic data may be found at <a href="http://www.efl.fhwa.dot.gov">www.efl.fhwa.dot.gov</a> Click on PROGRAMS / NPS Traffic Data (Note: Not all parks have traffic data)				
<b>Cross Section Information</b>					
Number of Lanes	2	2	2	2	2
Paved Width (ft)	32	29	29	30	29
Lane Width (ft)	12	12	11	11	11
Shoulder Width Right (ft)	NC	NC	NC	NC	NC
Shoulder Width Left (ft)	NC	NC	NC	NC	NC
<b>Roadway Condition Information</b>					
SCR (Surface Condition Rating)	75	86	94	95	95
PCR (Pavement Condition Rating)	80	87	96	97	97
<b>Distress Index Values</b>					
Alligator Cracking Index	100	100	100	100	100
Longitudinal Cracking Index	99	100	100	100	100
Transverse Cracking Index	98	100	100	100	99
Patching Index	100	100	100	100	100
Rutting Index	78	86	94	96	96
Roughness Condition Index (RCI)	86	90	100	100	100

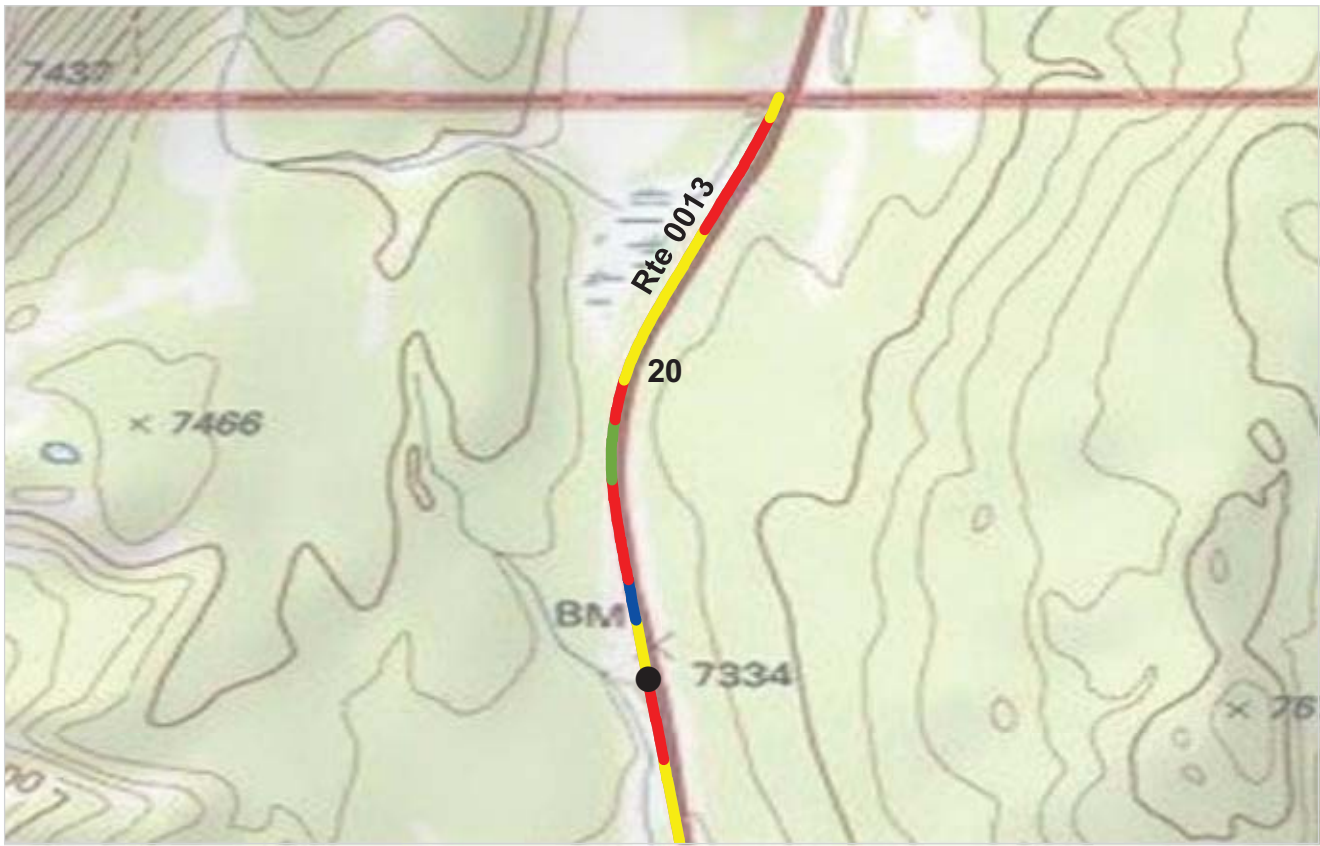
**ROUTE: 0013 NORTH PARK ROAD**

Section Number	15	16	17	18	19
Section Length (mi)	1.00	1.00	1.00	1.00	1.00
<b>Traffic</b>	Traffic data may be found at <a href="http://www.efl.fhwa.dot.gov">www.efl.fhwa.dot.gov</a> Click on PROGRAMS / NPS Traffic Data (Note: Not all parks have traffic data)				
<b>Cross Section Information</b>					
Number of Lanes	2	2	2	2	2
Paved Width (ft)	29	29	28	28	27
Lane Width (ft)	11	11	10	10	10
Shoulder Width Right (ft)	NC	NC	NC	NC	NC
Shoulder Width Left (ft)	NC	NC	NC	NC	NC
<b>Roadway Condition Information</b>					
SCR (Surface Condition Rating)	95	94	79	67	53
PCR (Pavement Condition Rating)	95	96	82	72	59
<b>Distress Index Values</b>					
Alligator Cracking Index	100	100	100	100	94
Longitudinal Cracking Index	100	100	99	98	97
Transverse Cracking Index	100	100	99	99	98
Patching Index	100	100	100	99	99
Rutting Index	95	95	81	70	65
Roughness Condition Index (RCI)	97	98	87	86	67

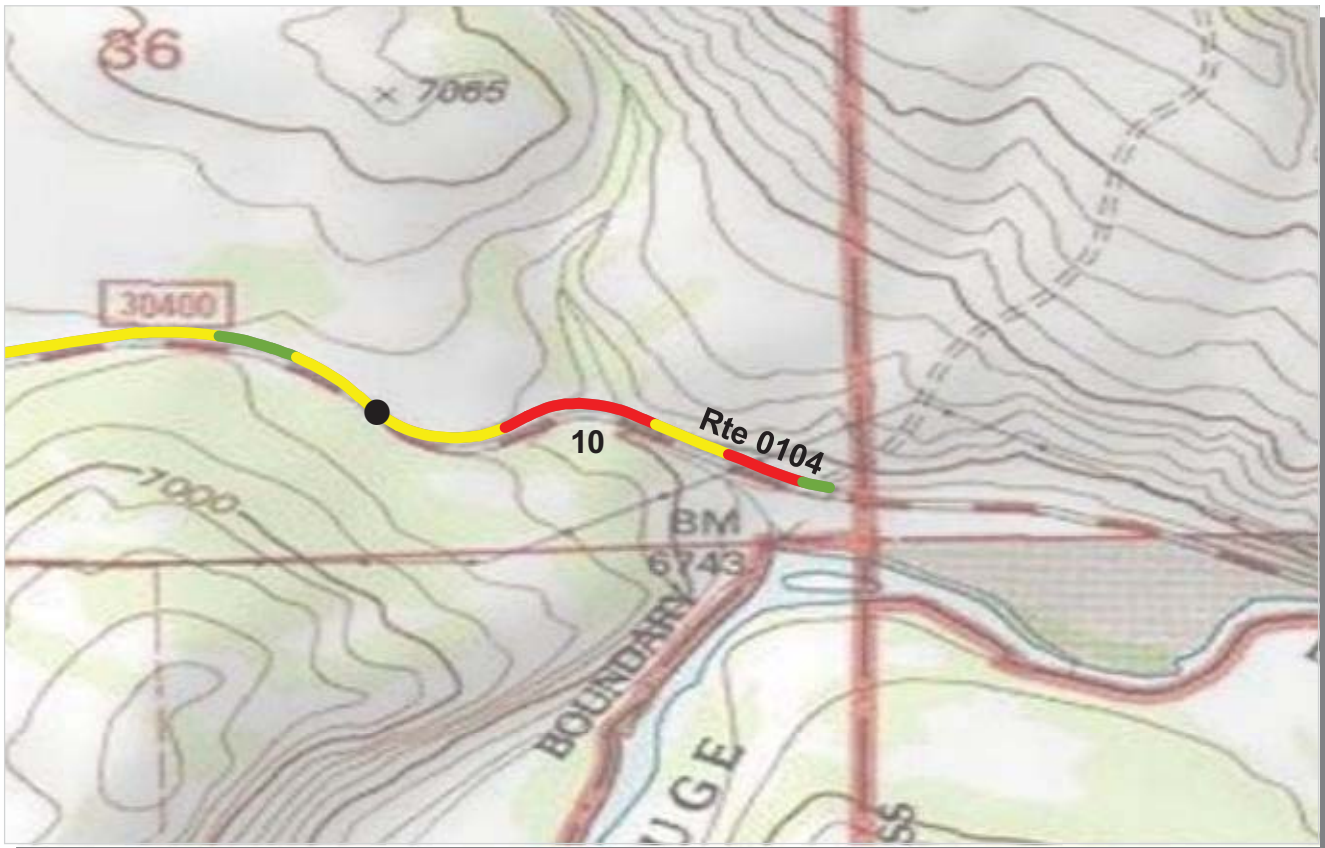
**ROUTE: 0104 GROS VENTRE ROAD**

<i>Section Number</i>	5	6	7	8	9
<i>Section Length (mi)</i>	1.00	1.00	1.00	1.00	1.00
<i>Traffic</i>	Traffic data may be found at <a href="http://www.efl.fhwa.dot.gov">www.efl.fhwa.dot.gov</a> Click on PROGRAMS / NPS Traffic Data (Note: Not all parks have traffic data)				
<i>Cross Section Information</i>					
Number of Lanes	2	2	2	2	2
Paved Width (ft)	22	22	22	21	19
Lane Width (ft)	10	10	9	10	10
Shoulder Width Right (ft)	NC	NC	NC	NC	NC
Shoulder Width Left (ft)	NC	NC	NC	NC	NC
<i>Roadway Condition Information</i>					
SCR (Surface Condition Rating)	61	65	67	68	69
PCR (Pavement Condition Rating)	72	78	75	67	72
<i>Distress Index Values</i>					
Alligator Cracking Index	100	100	100	100	100
Longitudinal Cracking Index	97	98	98	98	99
Transverse Cracking Index	90	92	94	97	97
Patching Index	100	100	100	100	100
Rutting Index	74	76	75	73	74
Roughness Condition Index (RCI)	89	98	87	66	77

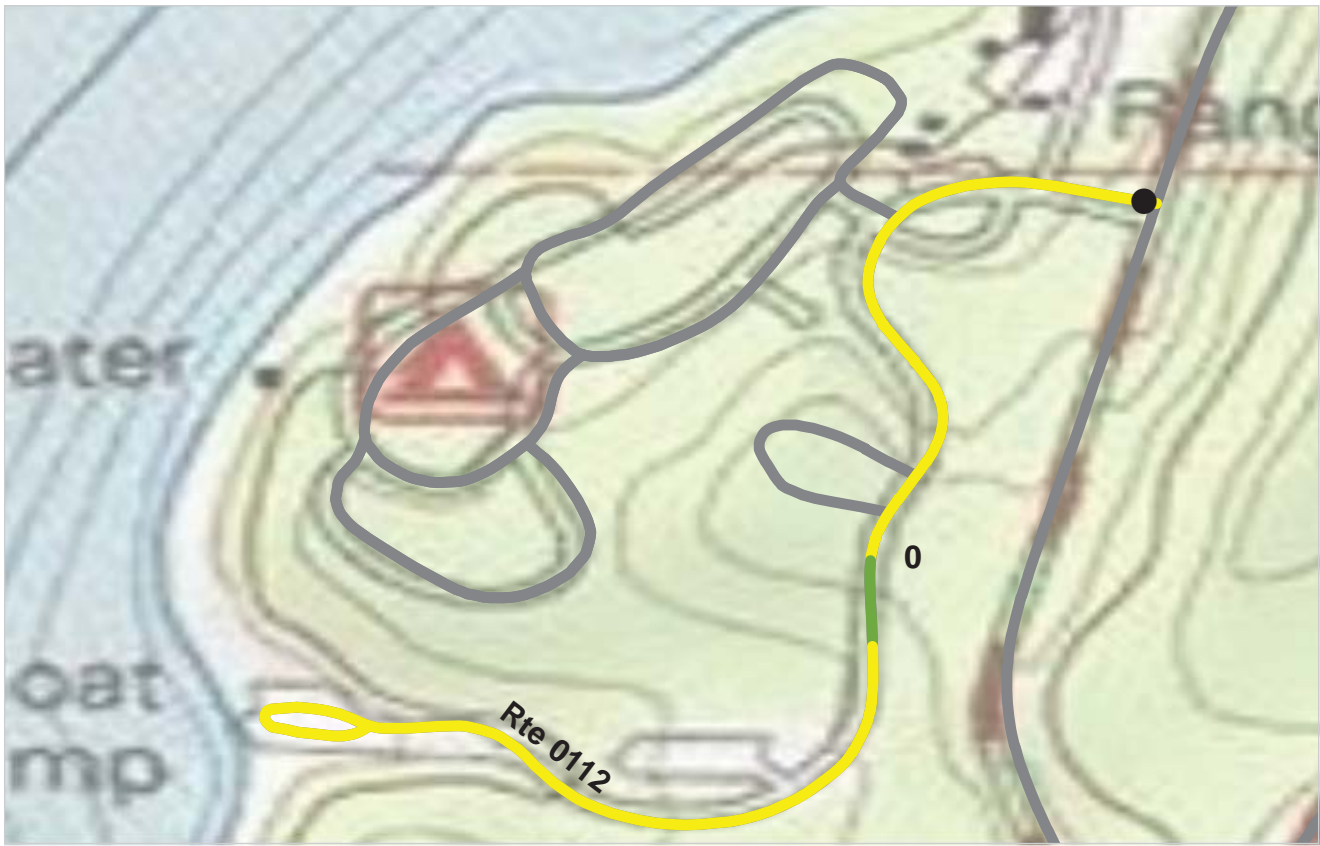
**ROUTE: 0111 SIGNAL MOUNTAIN SUMMIT ROAD**

Section Number	0	1	2	3	4
Section Length (mi)	1.00	1.00	1.00	1.00	0.76
<b>Traffic</b>	Traffic data may be found at <a href="http://www.efl.fhwa.dot.gov">www.efl.fhwa.dot.gov</a> Click on PROGRAMS / NPS Traffic Data (Note: Not all parks have traffic data)				
<b>Cross Section Information</b>					
Number of Lanes	2	2	2	2	2
Paved Width (ft)	18	19	19	19	18
Lane Width (ft)	9	9	9	10	9
Shoulder Width Right (ft)	NC	NC	NC	NC	NC
Shoulder Width Left (ft)	NC	NC	NC	NC	NC
<b>Roadway Condition Information</b>					
SCR (Surface Condition Rating)	31	64	95	94	97
PCR (Pavement Condition Rating)	33	60	86	85	87
<b>Distress Index Values</b>					
Alligator Cracking Index	93	98	100	100	100
Longitudinal Cracking Index	97	99	100	100	100
Transverse Cracking Index	99	100	100	100	100
Patching Index	100	98	100	100	100
Rutting Index	37	69	95	94	97
Roughness Condition Index (RCI)	38	55	72	69	62

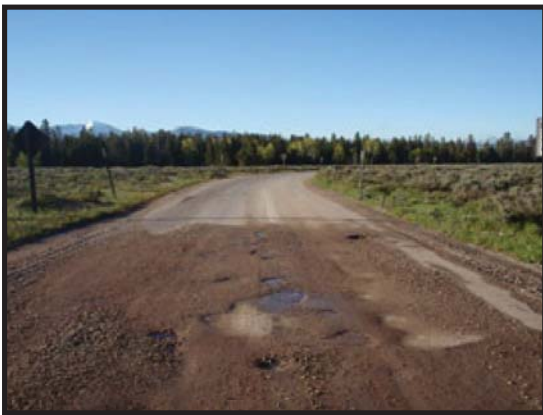
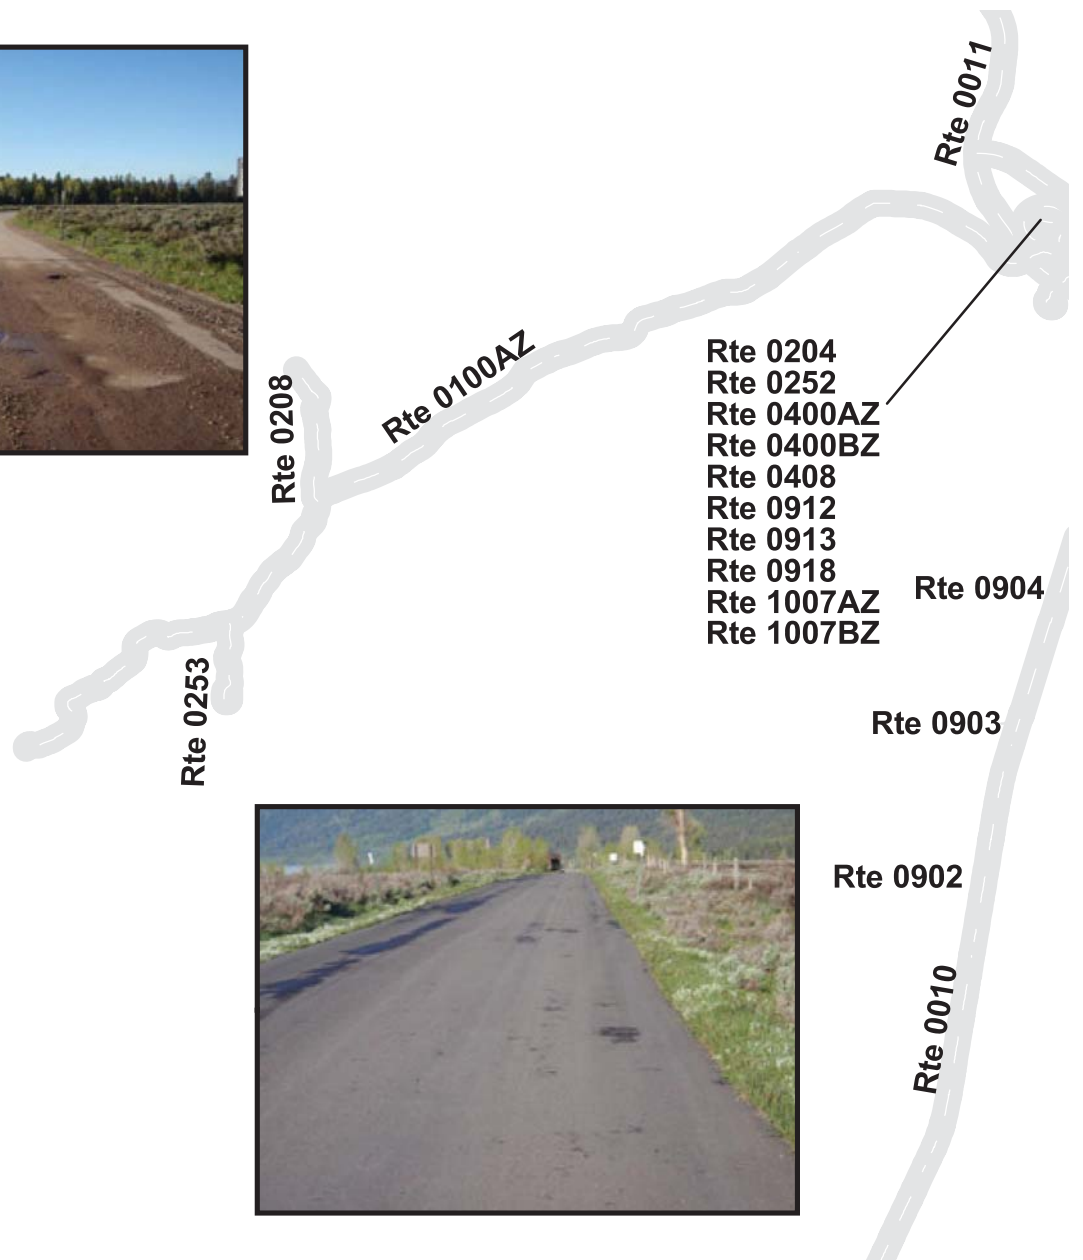
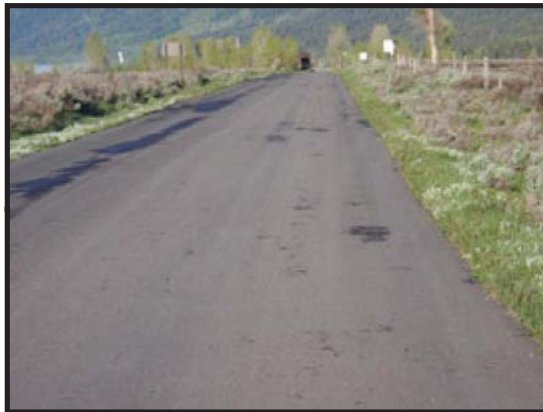
Rte 0100BZ  
 Rte 1021

Route Number	Public / NonPublic	Date Visited		Area (sq ft)	Lane Miles *	Surface Type
0100BZ	PUBLIC	6/13/2008		100,383	1.73	AS
Culverts	Drop Inlets	Gates	Fire Hydrants	Curb & Gutter	Curb	PCR
0	0	0	0	NO CURB AND GUTTER	NO CURB	FAIR/73

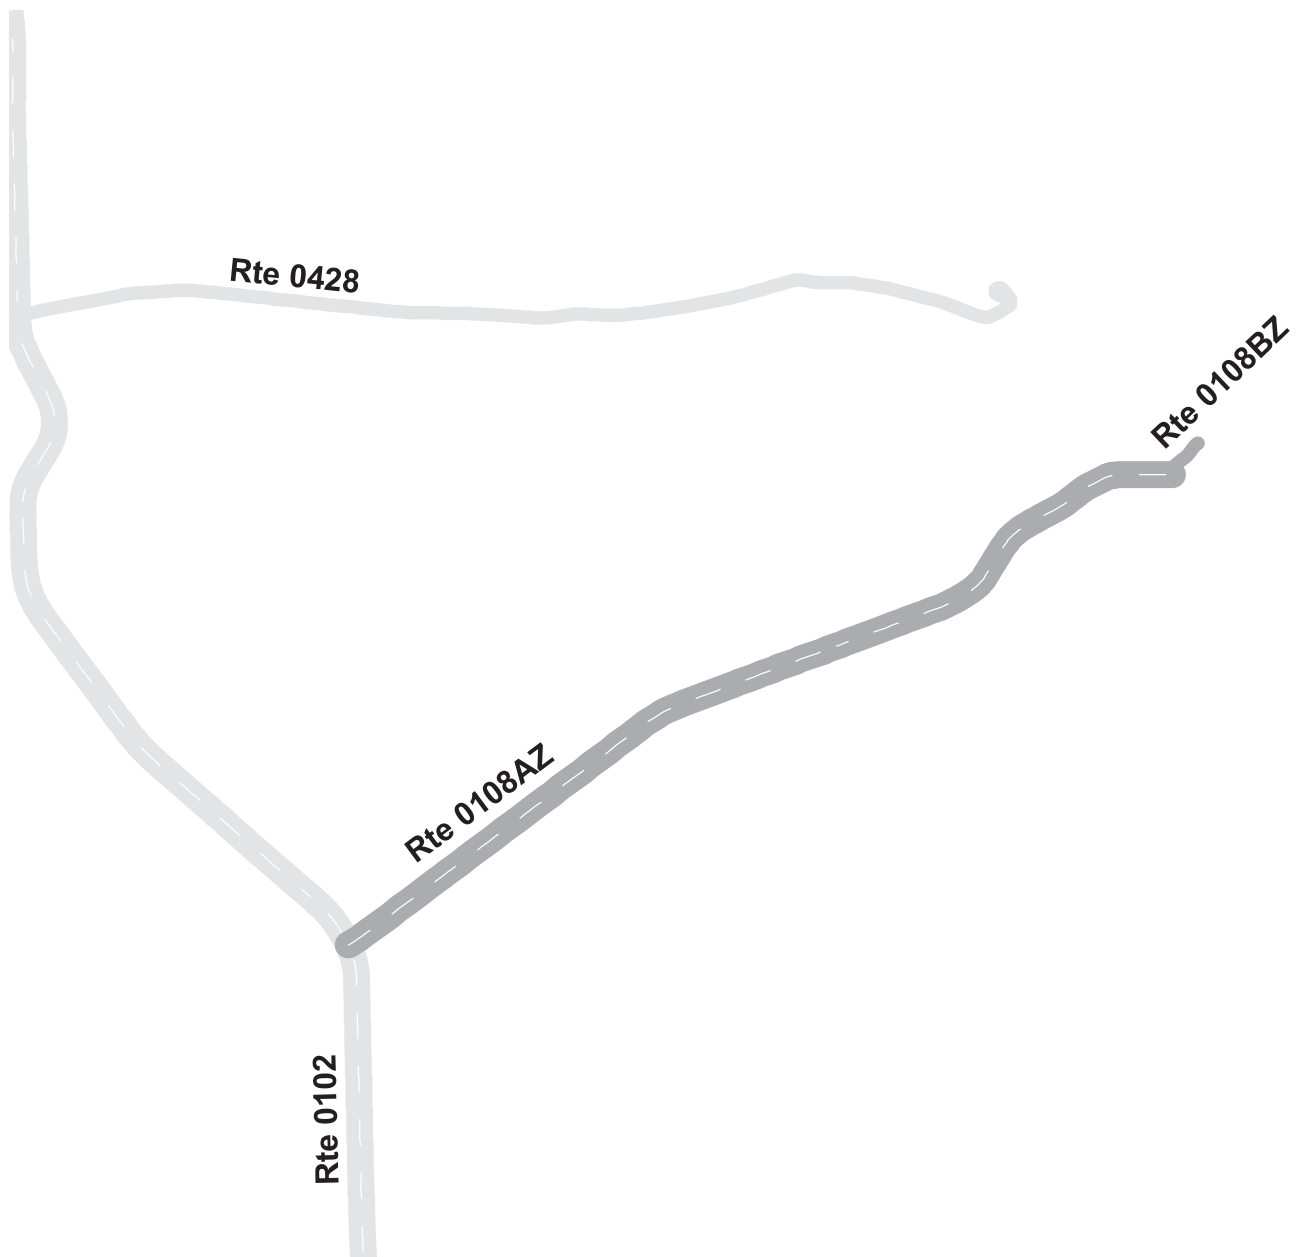
## Route 0108ZZ

Route Number	Public / NonPublic	Date Visited		Area (sq ft)	Lane Miles *	Surface Type
0108ZZ	PUBLIC	8/18/2008		7,318	2.75	AS
Culverts	Drop Inlets	Gates	Fire Hydrants	Curb & Gutter	Curb	PCR
0	0	0	0	N/A	N/A	SUMMARY/56.86

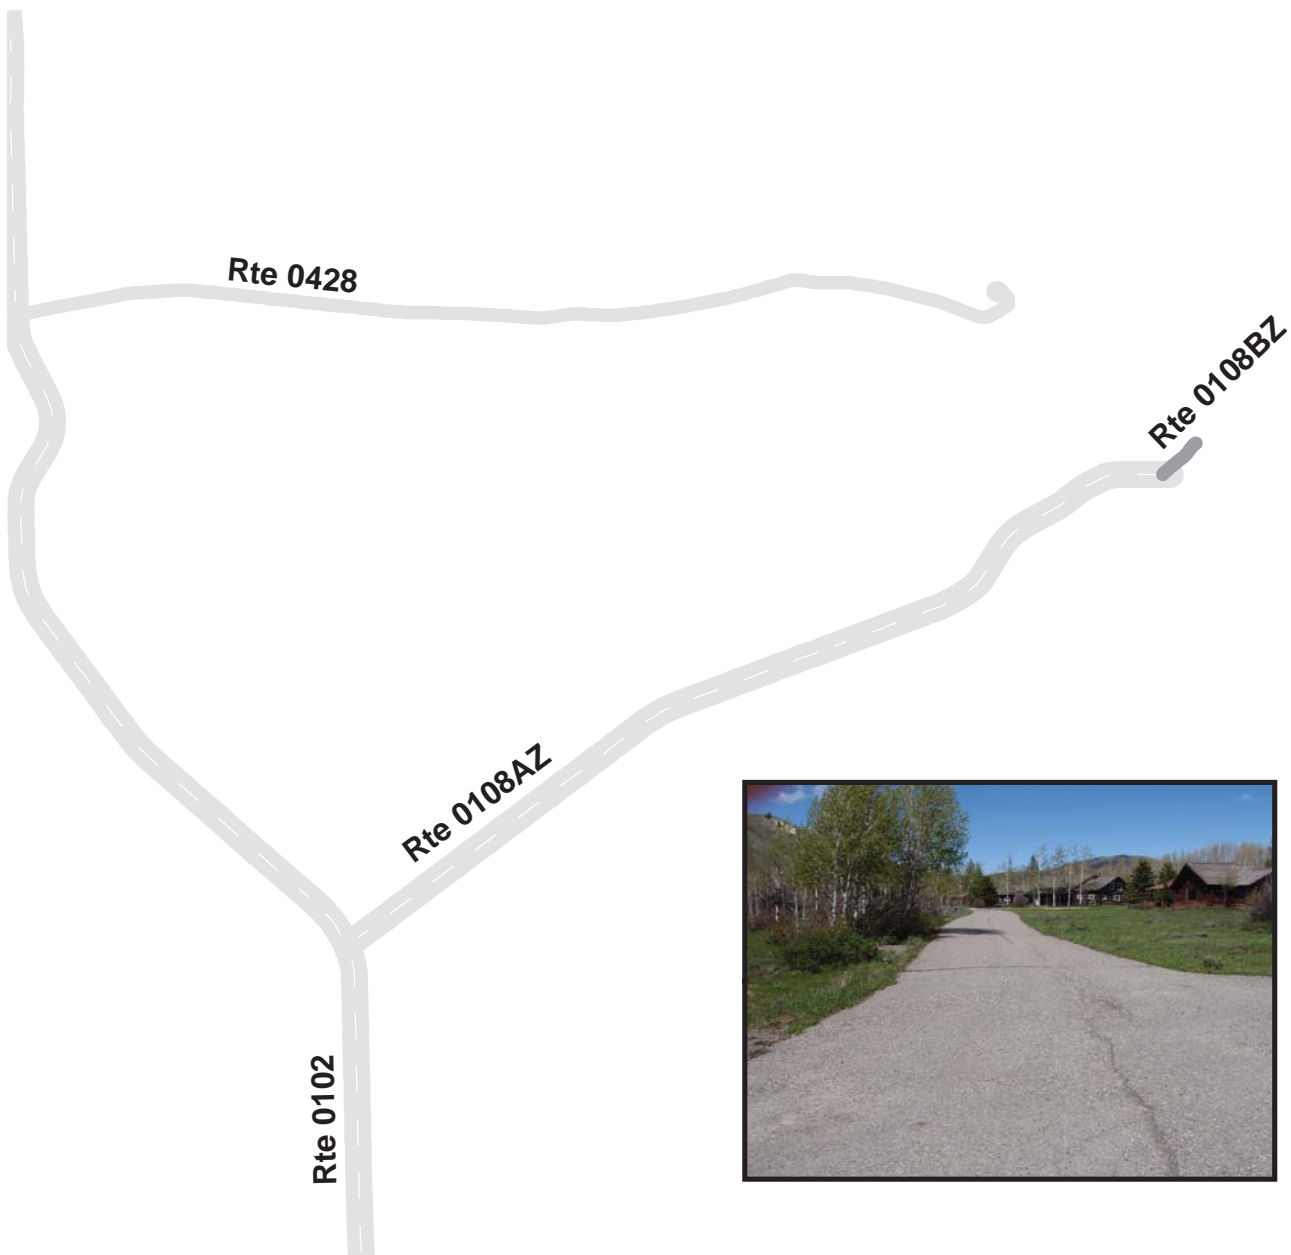
## Route 0108BZ

Route Number	Public / NonPublic	Date Visited		Area (sq ft)	Lane Miles *	Surface Type
0108BZ	PUBLIC	6/10/2008		7,318	0.13	AS
Culverts	Drop Inlets	Gates	Fire Hydrants	Curb & Gutter	Curb	PCR
0	0	0	0	NO CURB AND GUTTER	NO CURB	FAIR/73

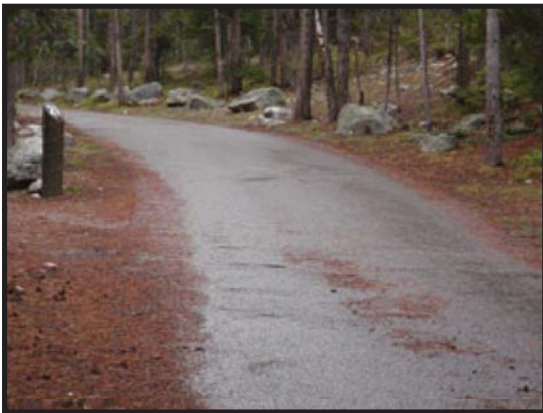
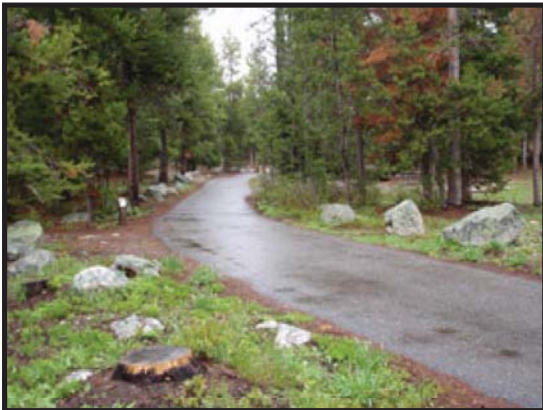
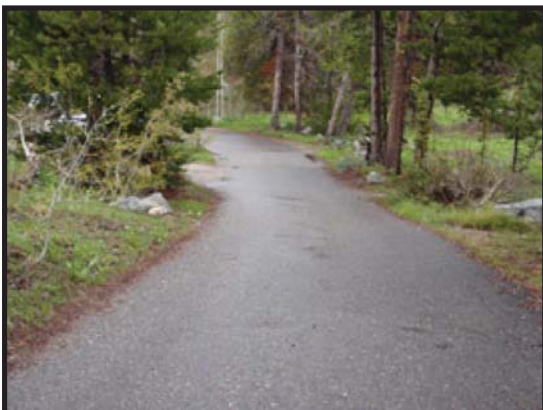
## Route 0205

Route Number	Public / NonPublic	Date Visited		Area (sq ft)	Lane Miles *	Surface Type
0205	PUBLIC	6/11/2008		49,685	0.86	AS
Culverts	Drop Inlets	Gates	Fire Hydrants	Curb & Gutter	Curb	PCR
0	0	0	0	NO CURB AND GUTTER	NO CURB	FAIR/73

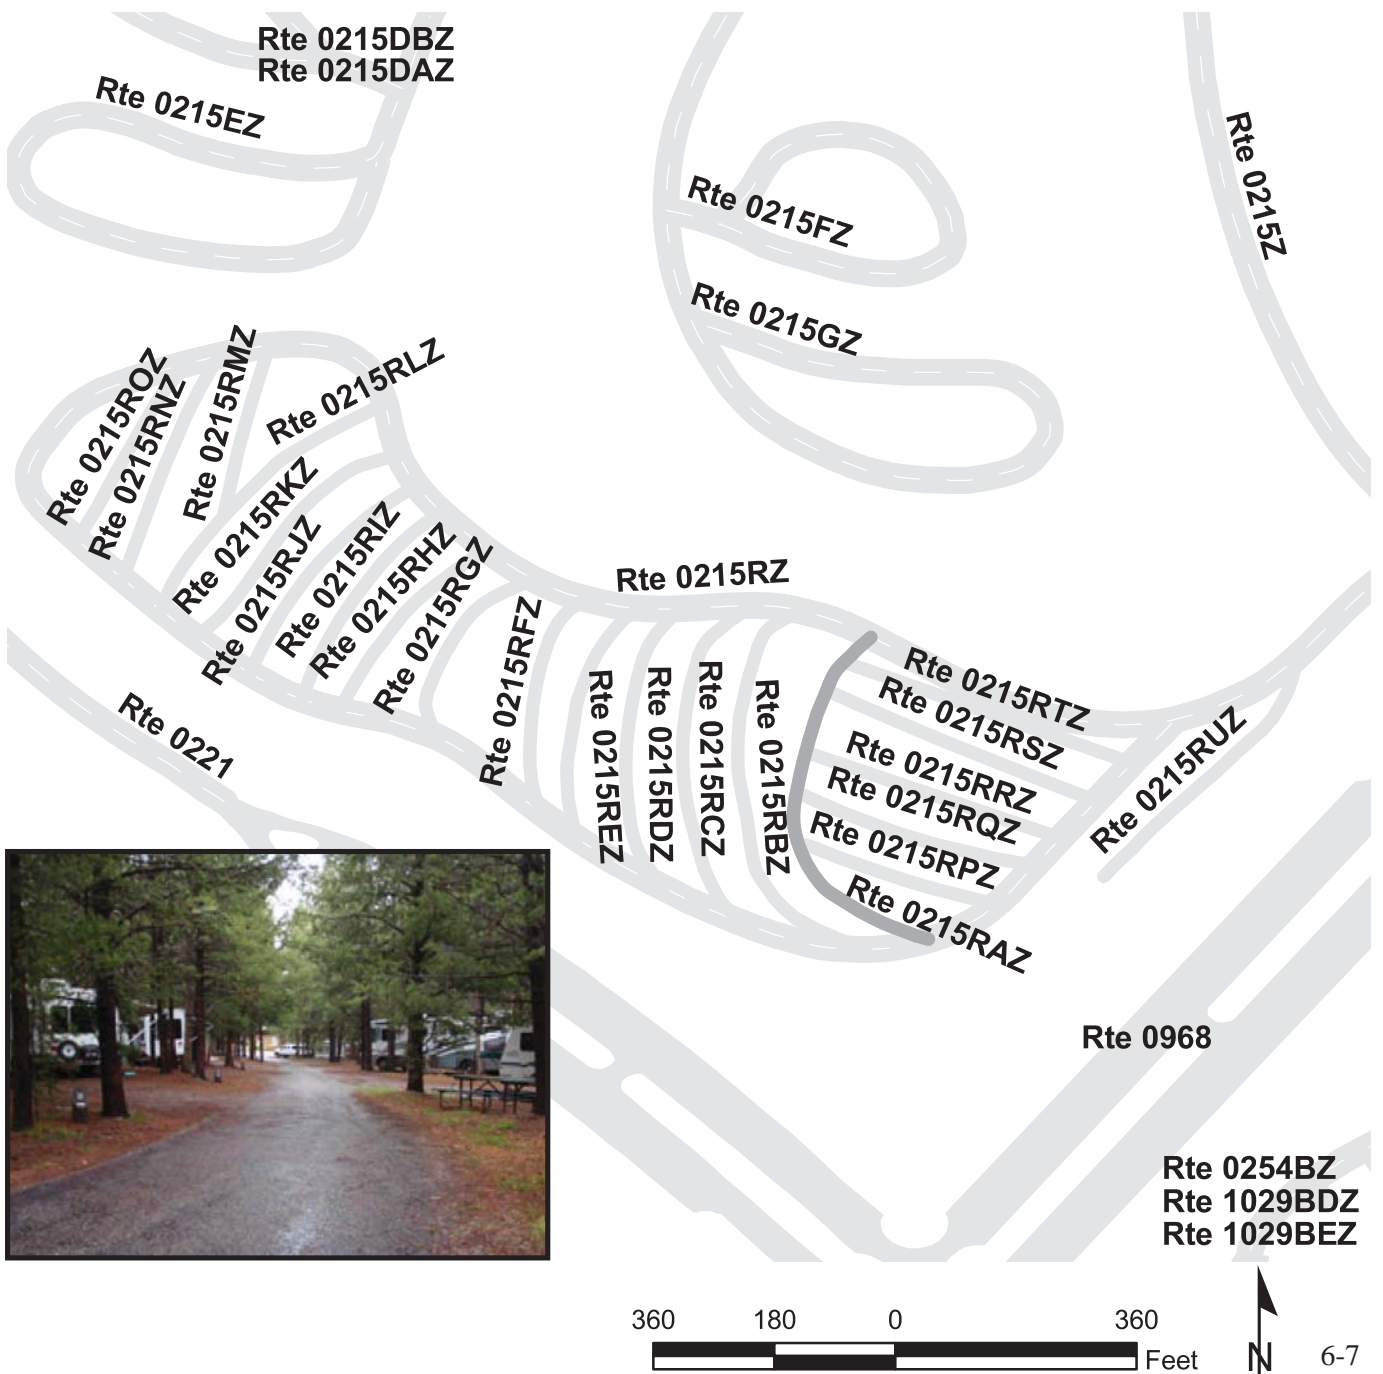
Route Number	Public / NonPublic	Date Visited		Area (sq ft)	Lane Miles *	Surface Type
0215RAZ	PUBLIC	6/13/2008		10,181	0.18	AS
Culverts	Drop Inlets	Gates	Fire Hydrants	Curb & Gutter	Curb	PCR
0	0	0	0	NO CURB AND GUTTER	NO CURB	POOR/45

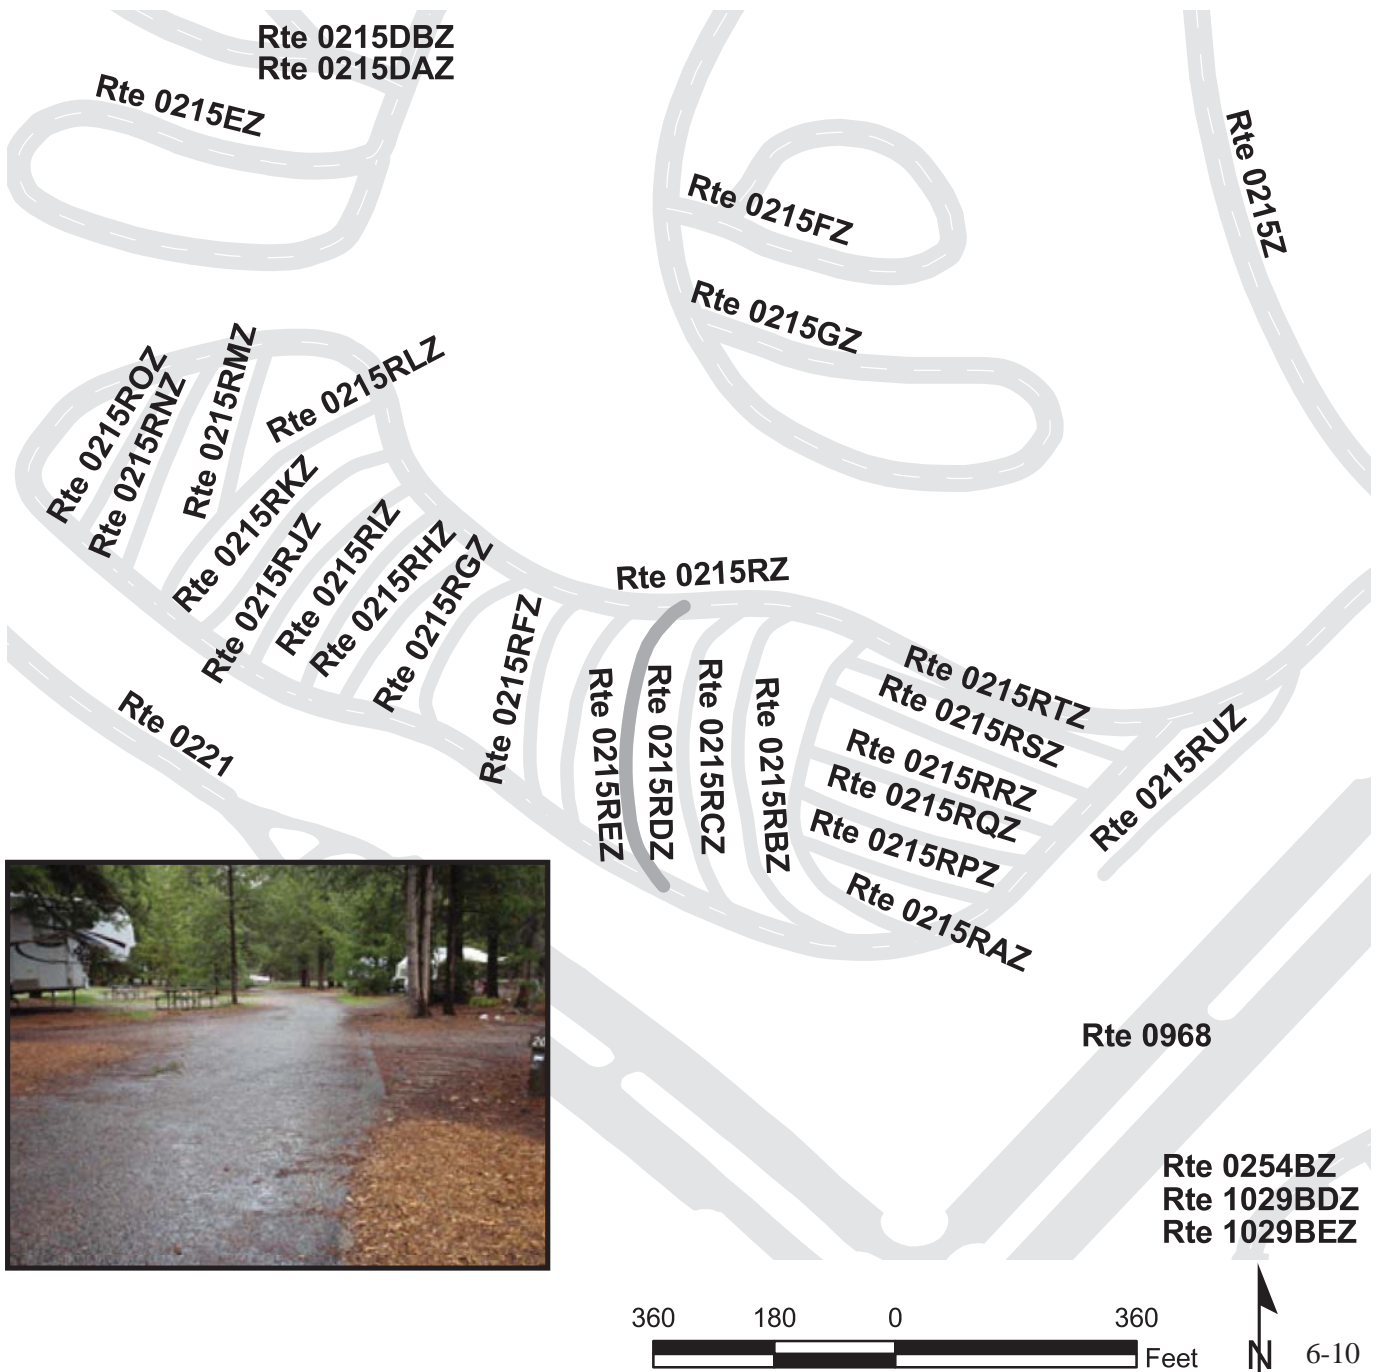
Route Number	Public / NonPublic	Date Visited		Area (sq ft)	Lane Miles *	Surface Type
0215RDZ	PUBLIC	6/13/2008		8,343	0.14	AS
Culverts	Drop Inlets	Gates	Fire Hydrants	Curb & Gutter	Curb	PCR
0	0	0	0	NO CURB AND GUTTER	NO CURB	POOR/45

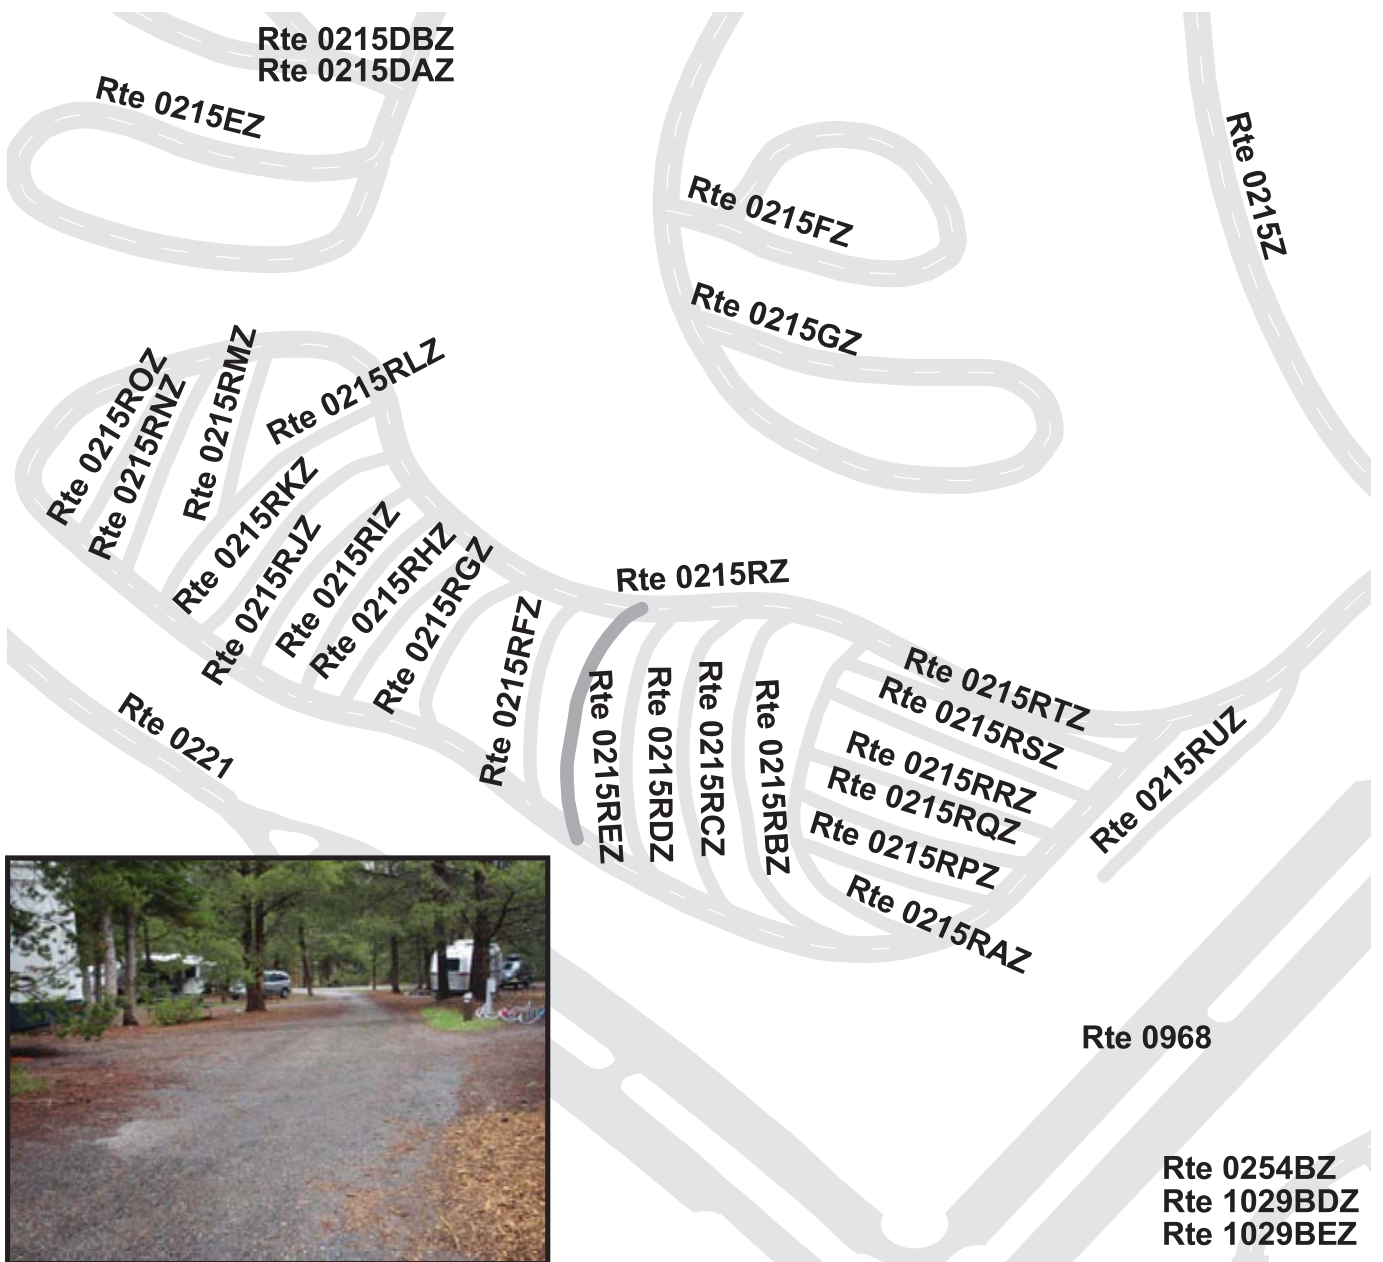
Route Number	Public / NonPublic	Date Visited		Area (sq ft)	Lane Miles *	Surface Type
0215REZ	PUBLIC	6/13/2008		6,920	0.12	AS
Culverts	Drop Inlets	Gates	Fire Hydrants	Curb & Gutter	Curb	PCR
0	0	0	0	NO CURB AND GUTTER	NO CURB	POOR/45

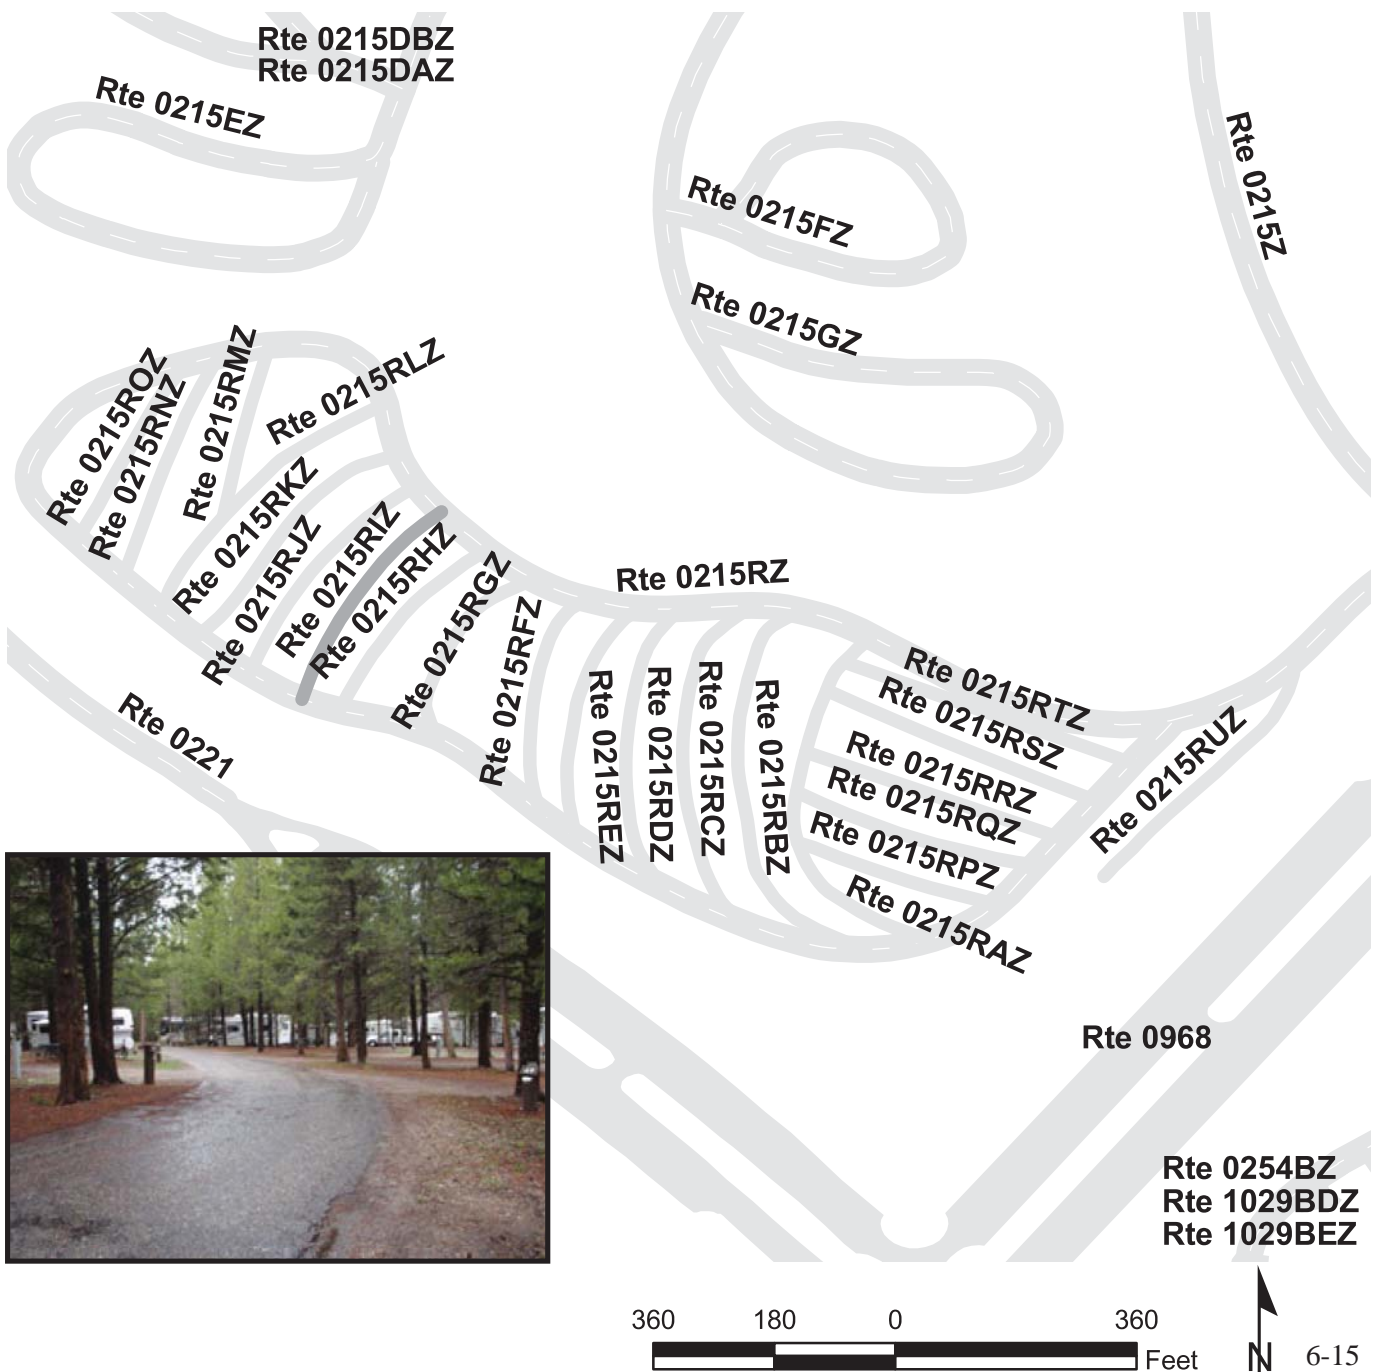
Route Number	Public / NonPublic	Date Visited		Area (sq ft)	Lane Miles *	Surface Type
0215RIZ	PUBLIC	6/13/2008		6,115	0.11	AS
Culverts	Drop Inlets	Gates	Fire Hydrants	Curb & Gutter	Curb	PCR
0	0	0	0	NO CURB AND GUTTER	NO CURB	POOR/45

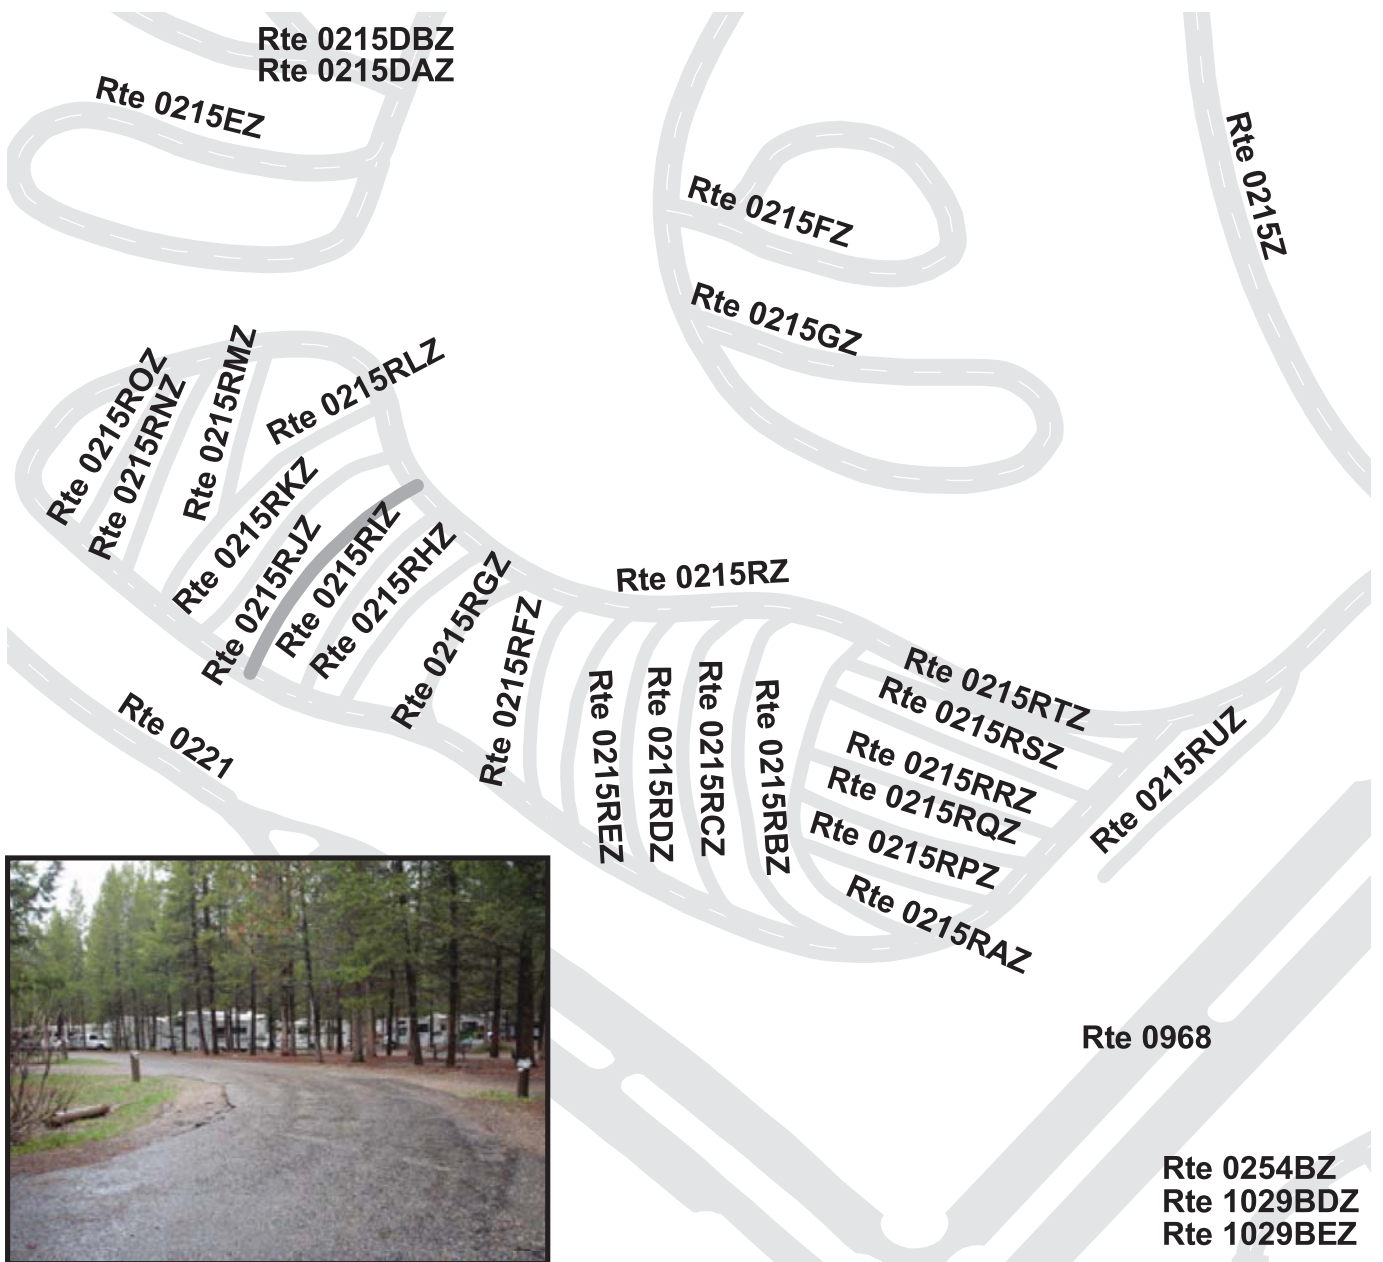
Route Number	Public / NonPublic	Date Visited		Area (sq ft)	Lane Miles *	Surface Type
0215RJZ	PUBLIC	6/13/2008		6,421	0.11	AS
Culverts	Drop Inlets	Gates	Fire Hydrants	Curb & Gutter	Curb	PCR
0	0	0	0	NO CURB AND GUTTER	NO CURB	POOR/45
