**The Road Inventory  
of  
Grand Teton National Park  
GRTE – 1460  
Cycle 4**

**Prepared By:  
Federal Highway Administration  
Road Inventory Program  
Cycle 4**

# Grand Teton National Park in Wyoming

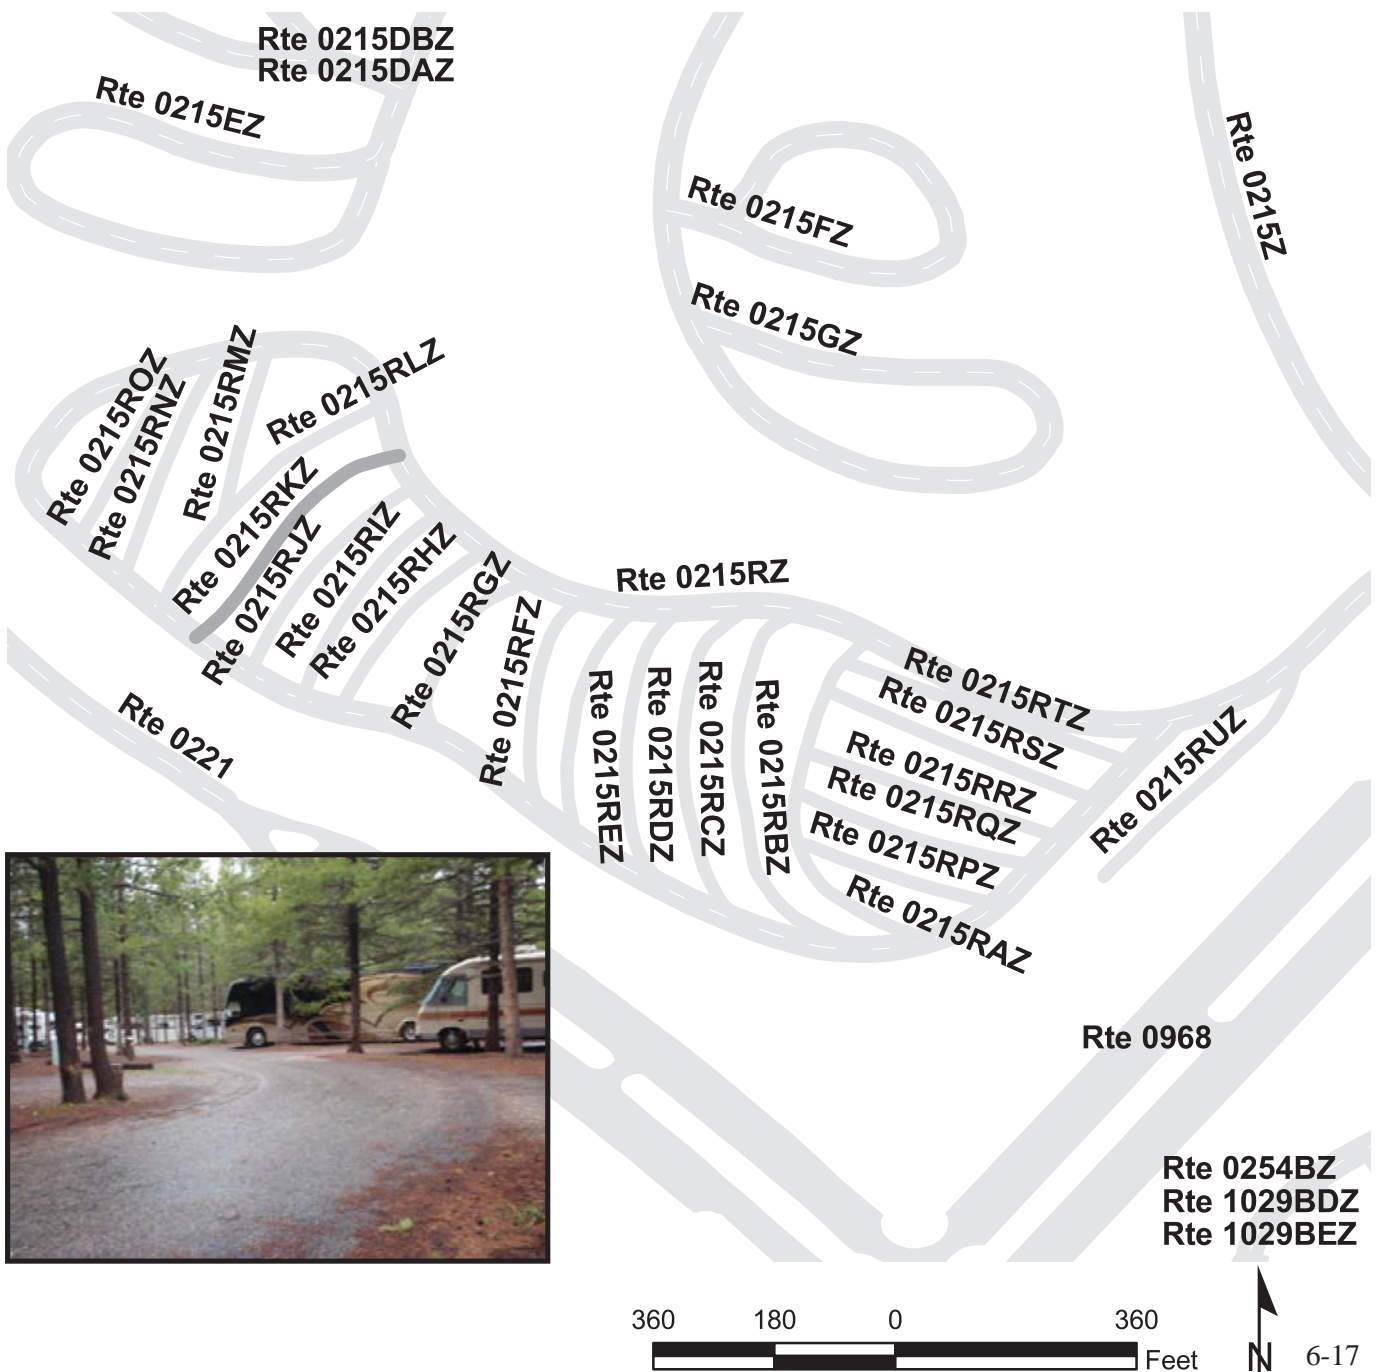
Route Number	Public / NonPublic	Date Visited		Area (sq ft)	Lane Miles *	Surface Type
0215RKZ	PUBLIC	6/13/2008		6,812	0.12	AS
Culverts	Drop Inlets	Gates	Fire Hydrants	Curb & Gutter	Curb	PCR
0	0	0	0	NO CURB AND GUTTER	NO CURB	POOR/45

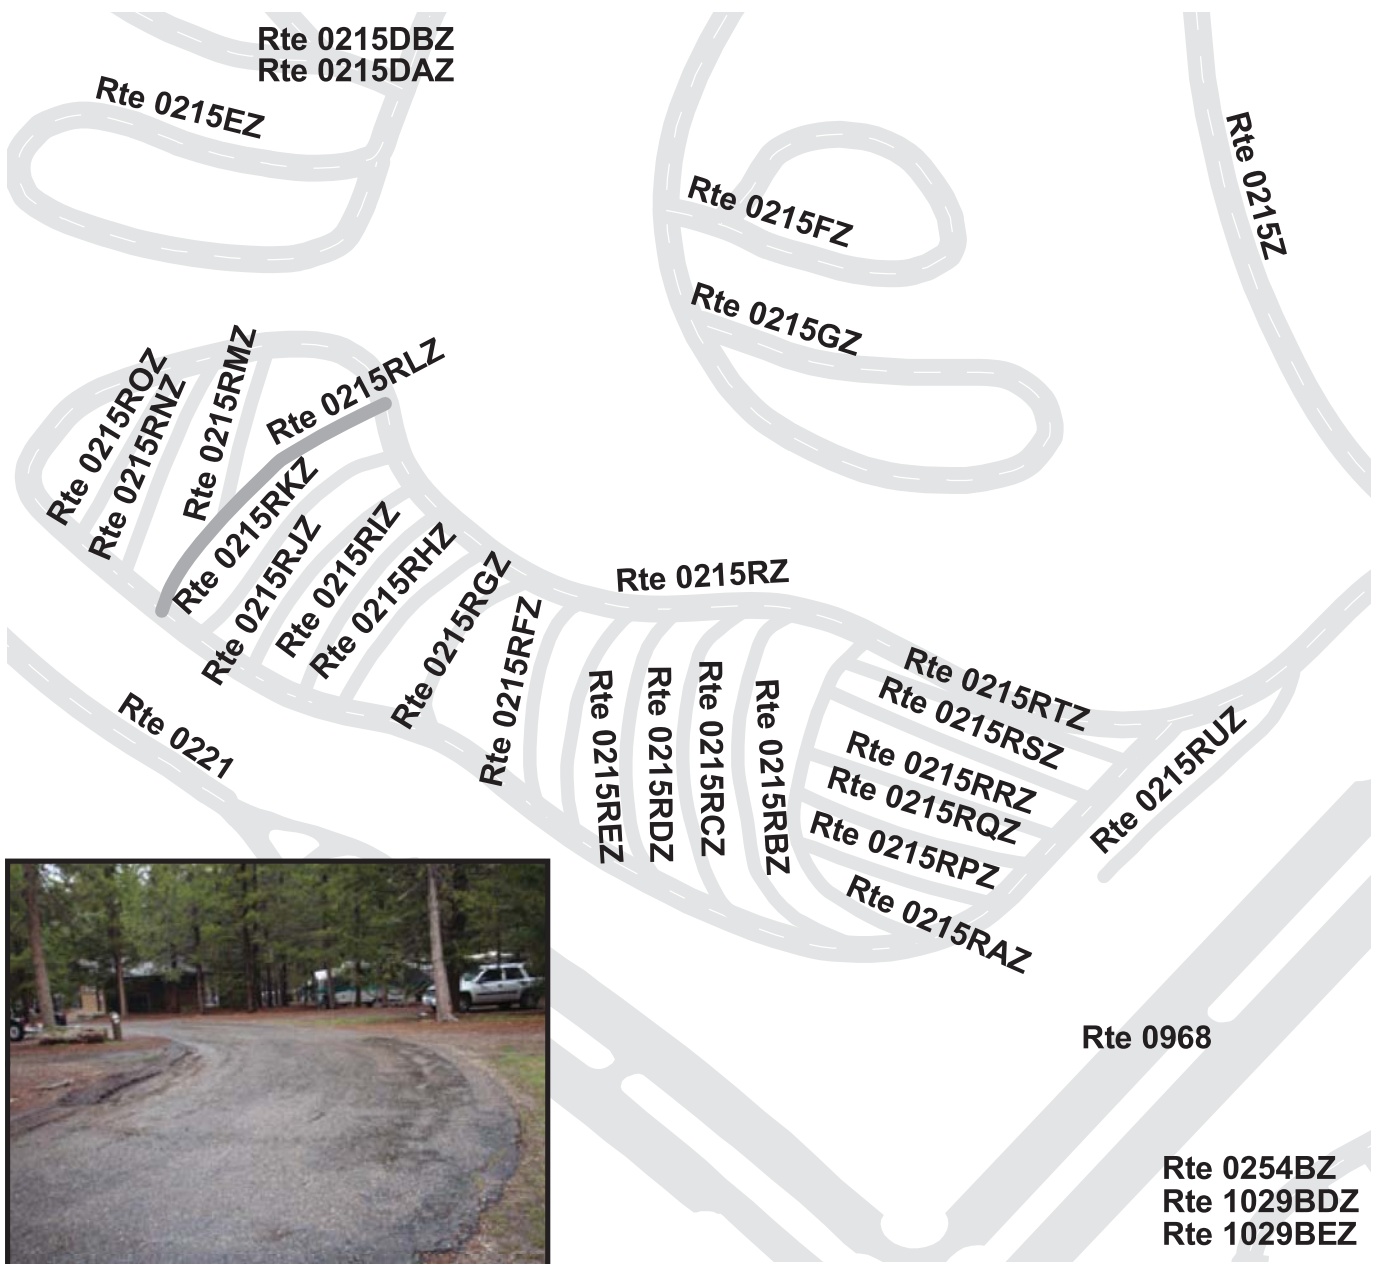
Route Number	Public / NonPublic	Date Visited		Area (sq ft)	Lane Miles *	Surface Type
0215RLZ	PUBLIC	6/13/2008		7,623	0.13	AS
Culverts	Drop Inlets	Gates	Fire Hydrants	Curb & Gutter	Curb	PCR
0	0	0	0	NO CURB AND GUTTER	NO CURB	POOR/45

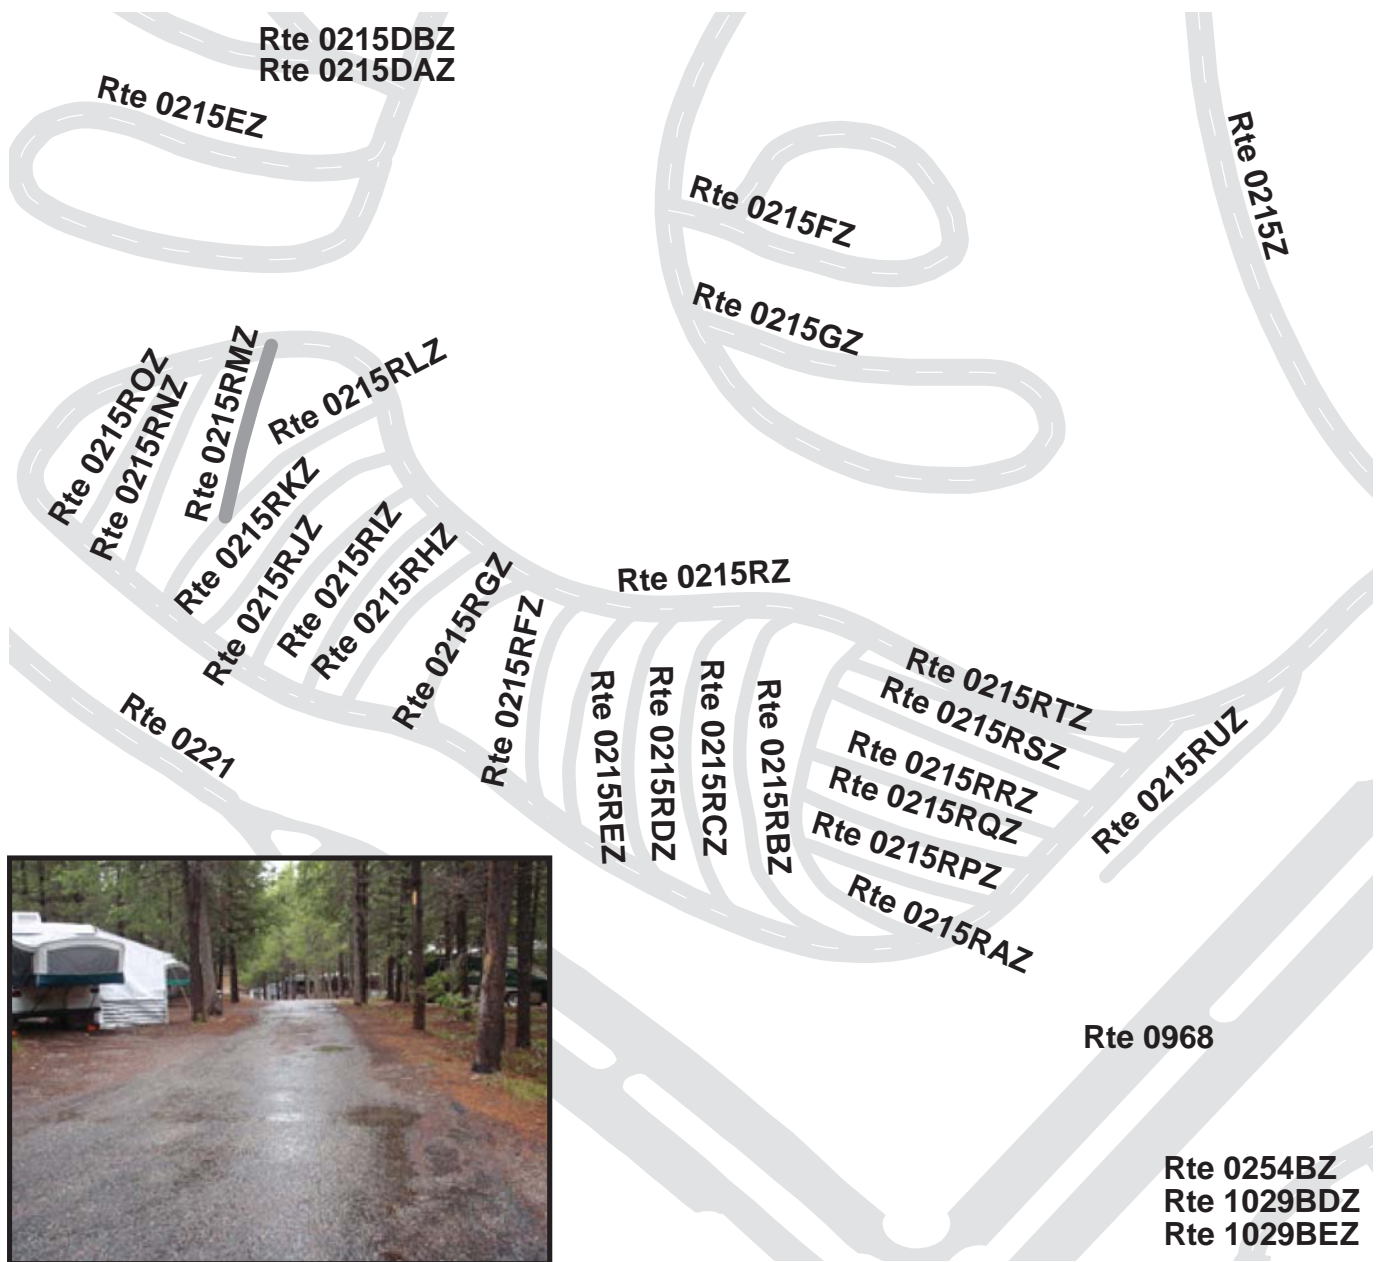
Route Number	Public / NonPublic	Date Visited		Area (sq ft)	Lane Miles *	Surface Type
0215RMZ	PUBLIC	6/13/2008		4,955	0.09	AS
Culverts	Drop Inlets	Gates	Fire Hydrants	Curb & Gutter	Curb	PCR
0	0	0	0	NO CURB AND GUTTER	NO CURB	POOR/45

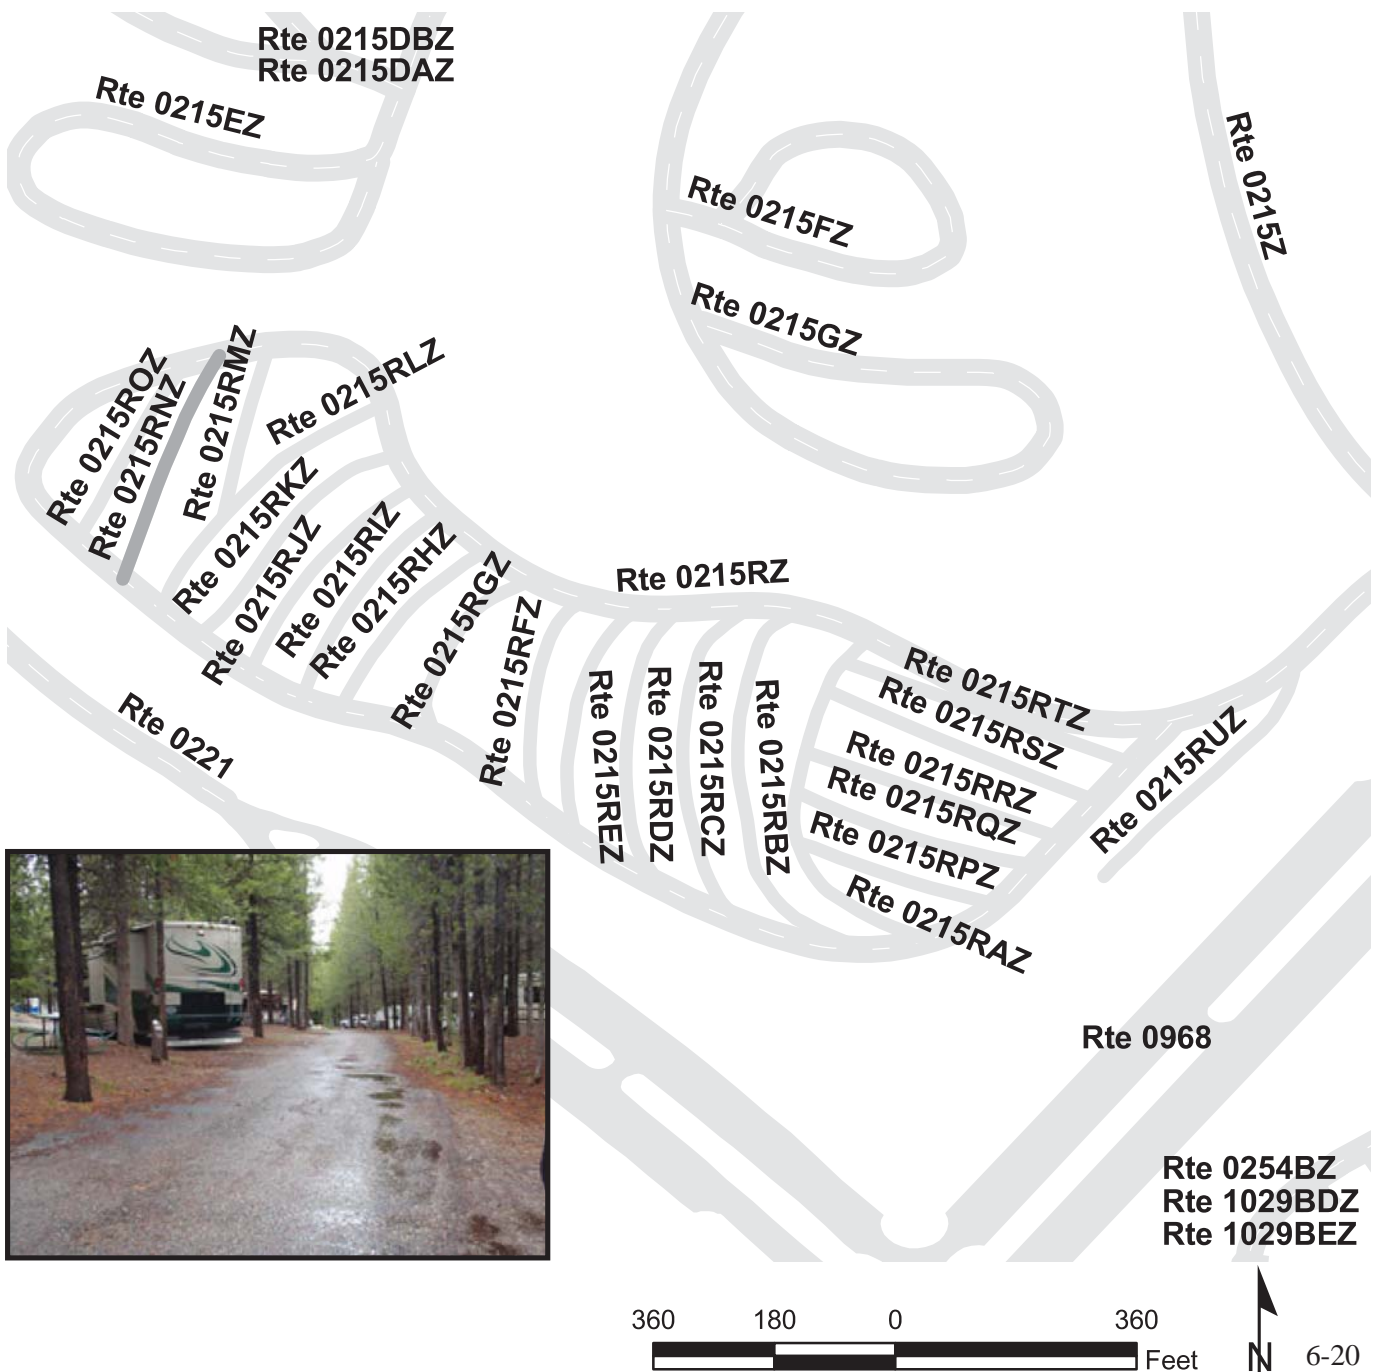
Route Number	Public / NonPublic	Date Visited		Area (sq ft)	Lane Miles *	Surface Type
0215RNZ	PUBLIC	6/13/2008		6,636	0.11	AS
Culverts	Drop Inlets	Gates	Fire Hydrants	Curb & Gutter	Curb	PCR
0	0	0	0	NO CURB AND GUTTER	NO CURB	POOR/45

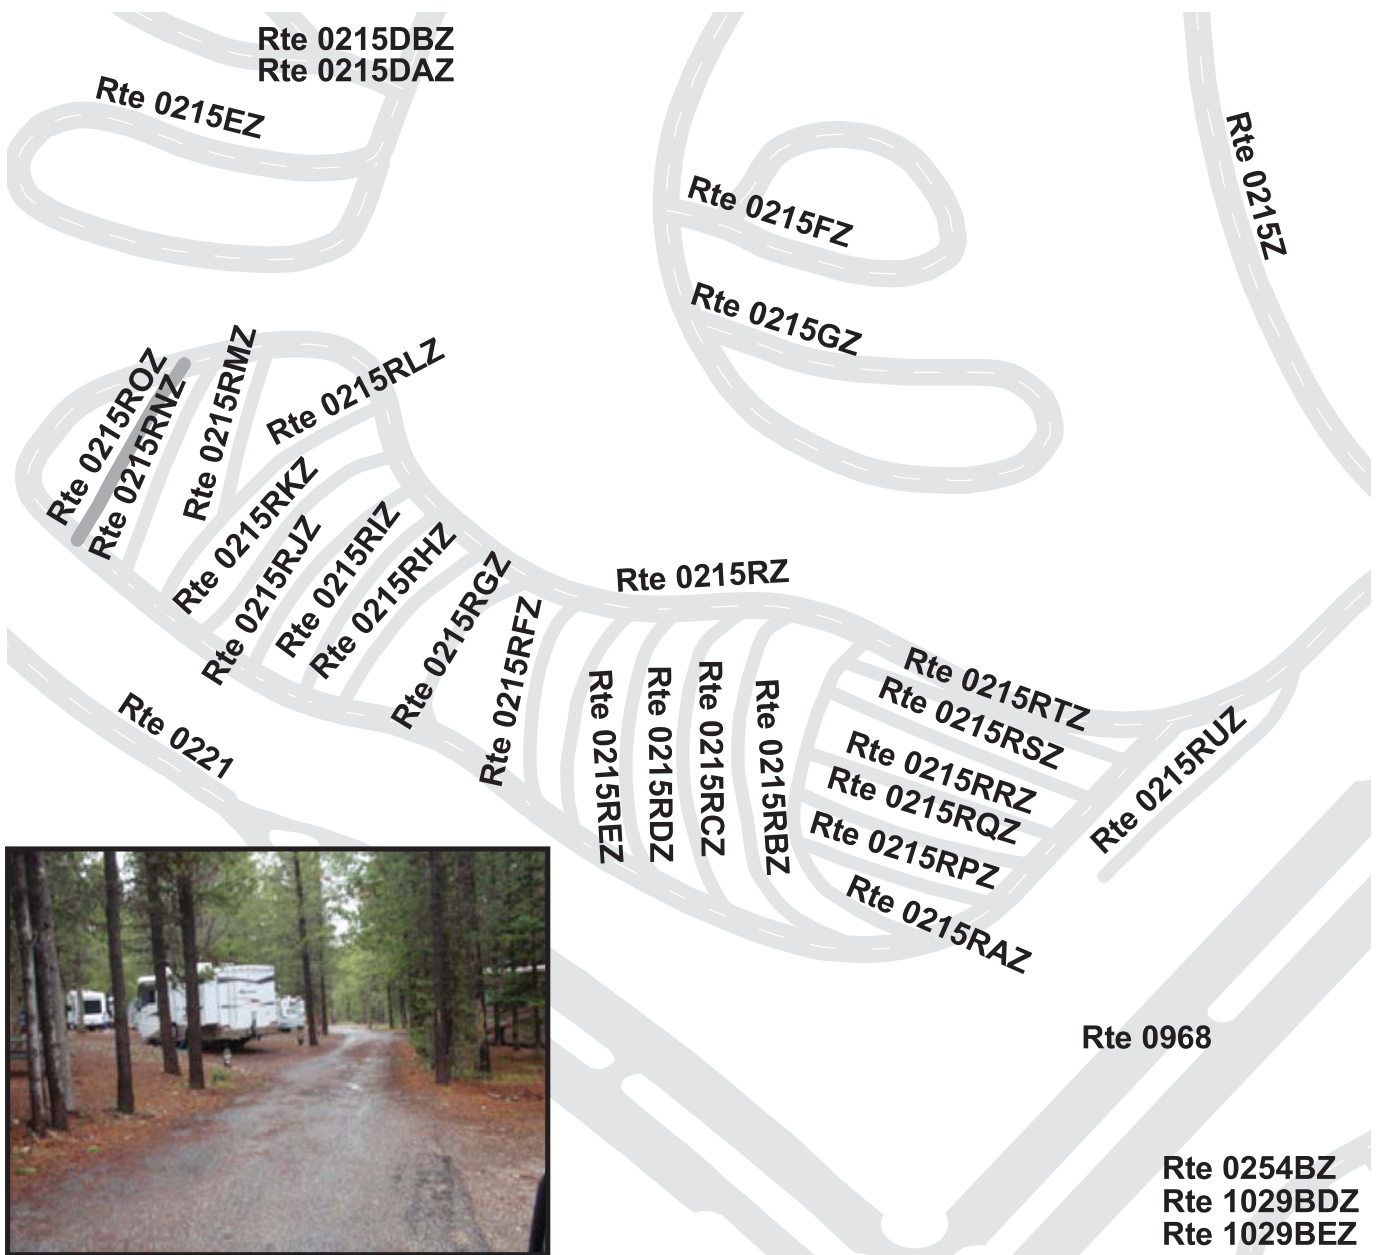
Route Number	Public / NonPublic	Date Visited		Area (sq ft)	Lane Miles *	Surface Type
0215ROZ	PUBLIC	6/13/2008		5,441	0.09	AS
Culverts	Drop Inlets	Gates	Fire Hydrants	Curb & Gutter	Curb	PCR
0	0	0	0	NO CURB AND GUTTER	NO CURB	POOR/45

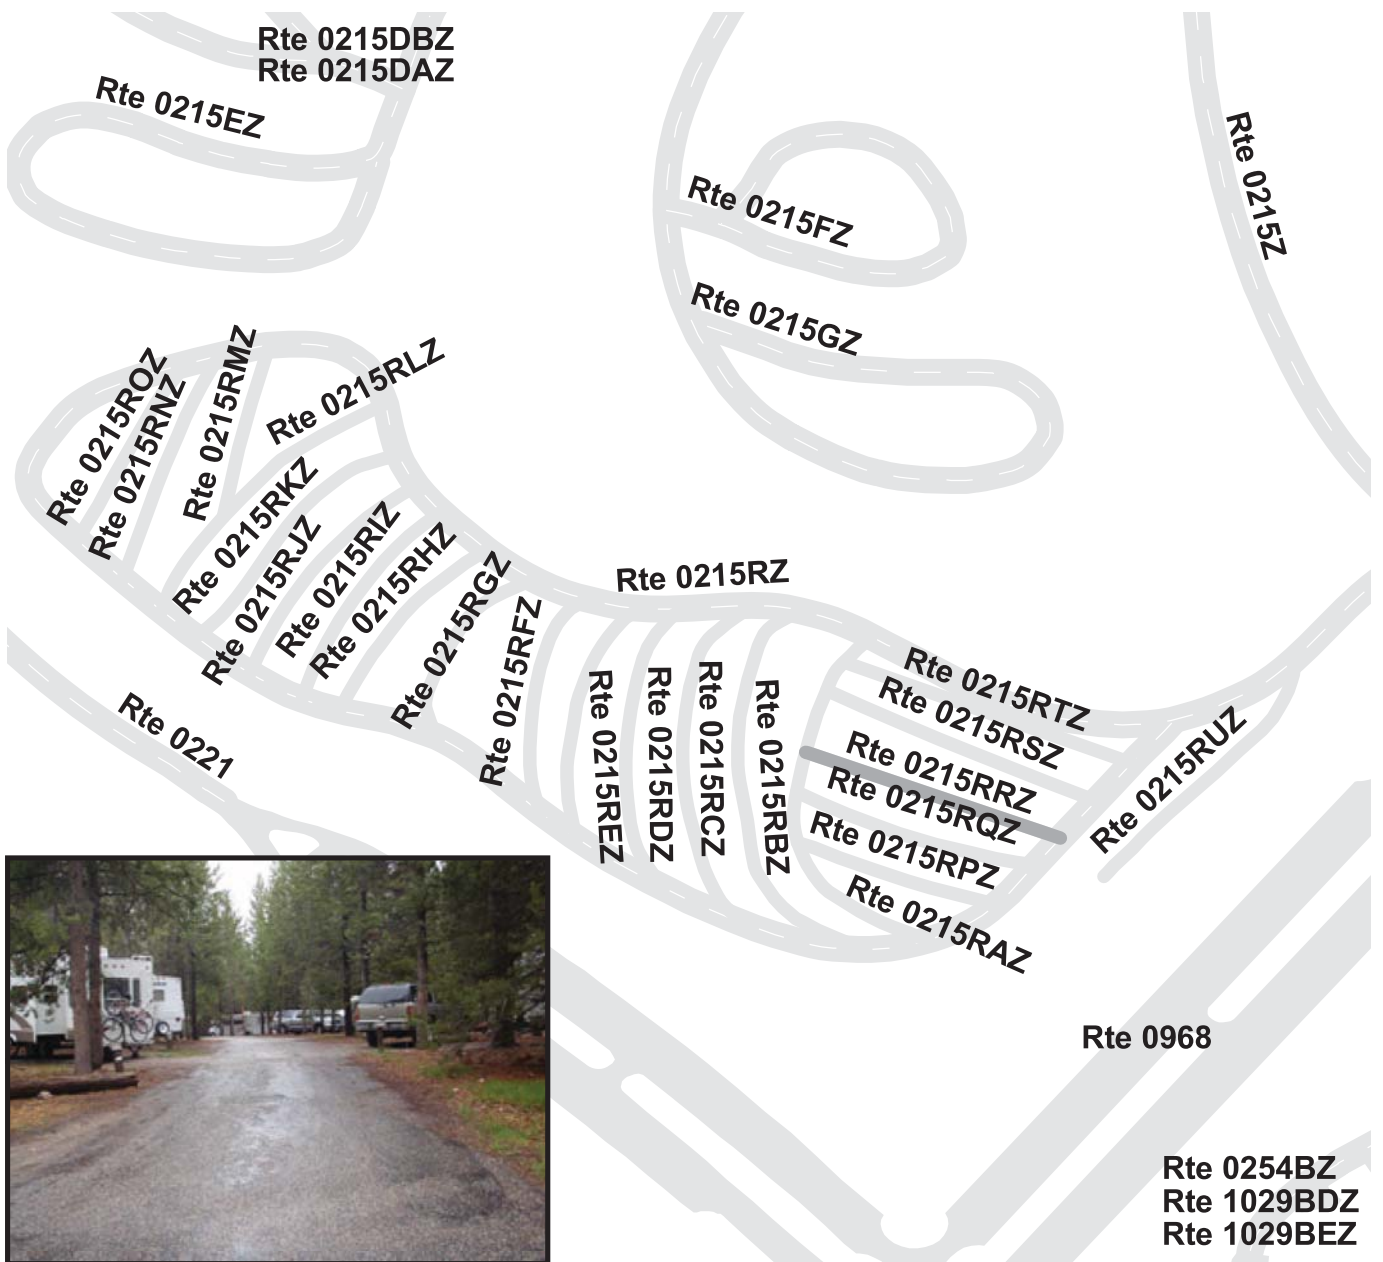
Route Number	Public / NonPublic	Date Visited		Area (sq ft)	Lane Miles *	Surface Type
0215RRZ	PUBLIC	6/13/2008		5,757	0.10	AS
Culverts	Drop Inlets	Gates	Fire Hydrants	Curb & Gutter	Curb	PCR
0	0	0	0	NO CURB AND GUTTER	NO CURB	POOR/45

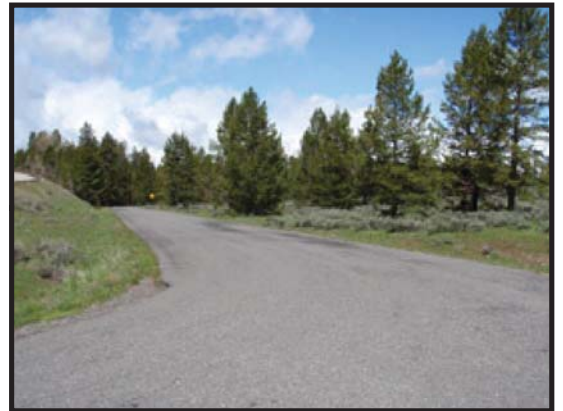
Route Number	Public / NonPublic	Date Visited		Area (sq ft)	Lane Miles *	Surface Type
0217AZ	PUBLIC	6/11/2008		24,224	0.42	AS
Culverts	Drop Inlets	Gates	Fire Hydrants	Curb & Gutter	Curb	PCR
0	0	0	0	NO CURB AND GUTTER	NO CURB	FAIR/73

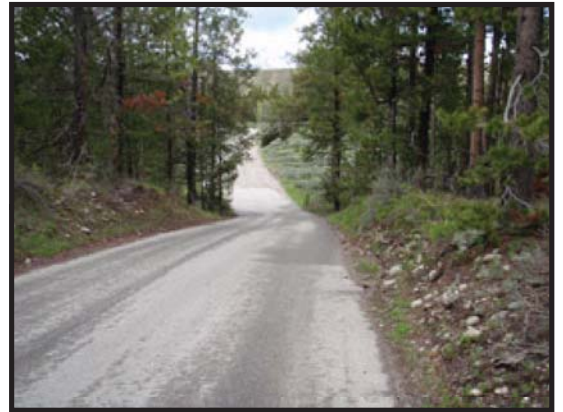
Rte 0217BZ

Route Number	Public / NonPublic	Date Visited		Area (sq ft)	Lane Miles *	Surface Type
0217BZ	PUBLIC	6/11/2008		4,202	0.07	AS
Culverts	Drop Inlets	Gates	Fire Hydrants	Curb & Gutter	Curb	PCR
0	0	0	0	NO CURB AND GUTTER	NO CURB	FAIR/73

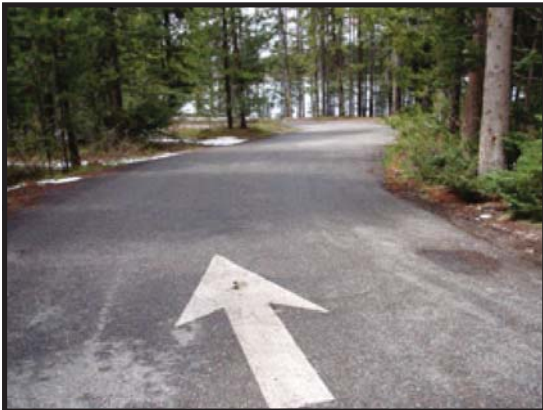
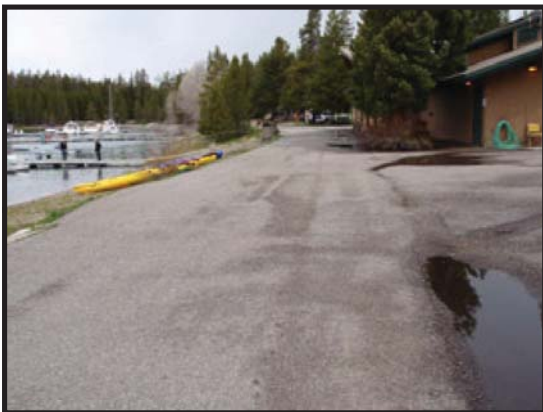
Route Number	Public / NonPublic	Date Visited		Area (sq ft)	Lane Miles *	Surface Type
0235	PUBLIC	6/13/2008		26,722	0.46	AS
Culverts	Drop Inlets	Gates	Fire Hydrants	Curb & Gutter	Curb	PCR
0	0	1	0	NO CURB AND GUTTER	NO CURB	FAIR/73

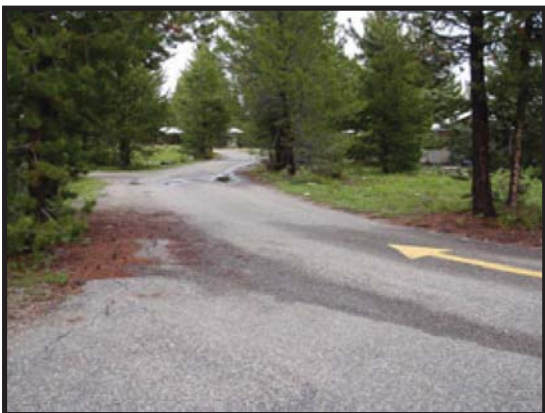
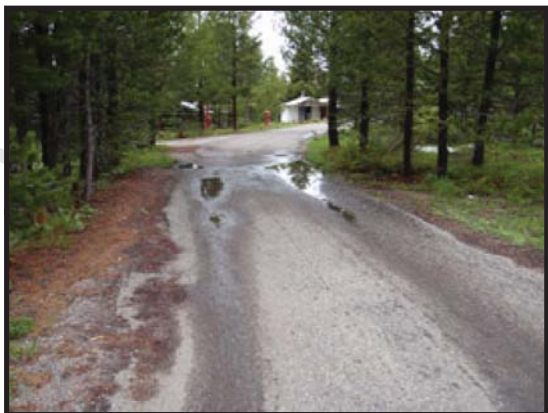
Route Number	Public / NonPublic	Date Visited		Area (sq ft)	Lane Miles *	Surface Type
0255CZ	PUBLIC	6/12/2008		15,878	0.27	AS
Culverts	Drop Inlets	Gates	Fire Hydrants	Curb & Gutter	Curb	PCR
0	0	0	5	NO CURB AND GUTTER	NO CURB	FAIR/73

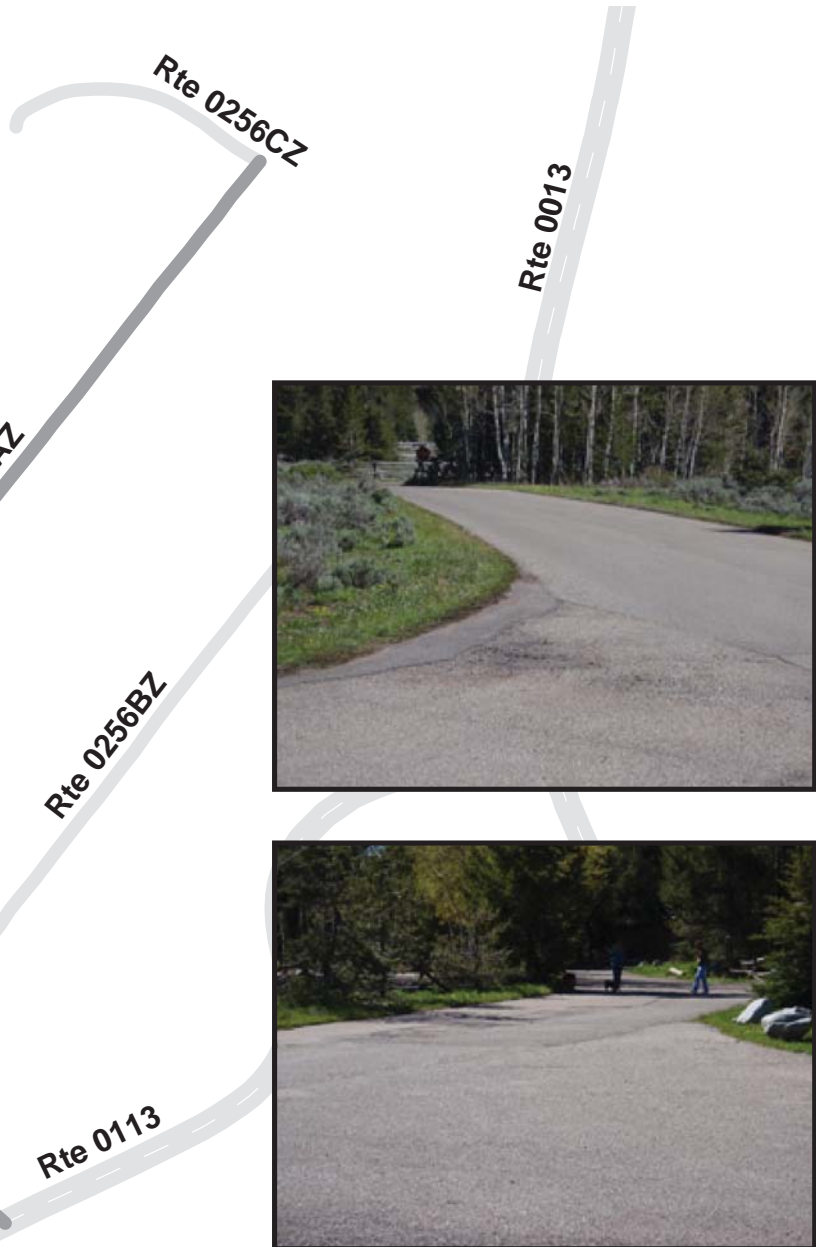
Route Number	Public / NonPublic	Date Visited		Area (sq ft)	Lane Miles *	Surface Type
0256AZ	NONPUBLIC	6/13/2008		34,493	0.59	AS
Culverts	Drop Inlets	Gates	Fire Hydrants	Curb & Gutter	Curb	PCR
0	0	0	1	CONCRETE CURB AND GUTTER	CONCRETE CURB	POOR/45

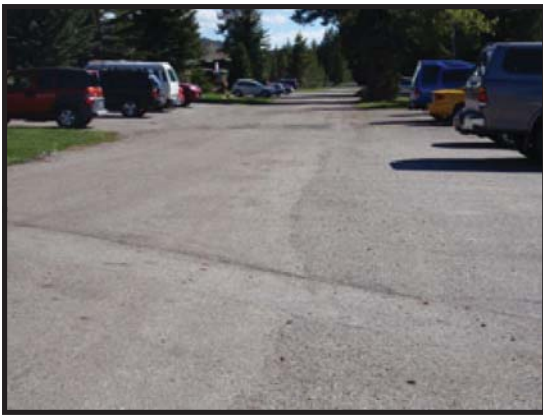
Route Number	Public / NonPublic	Date Visited		Area (sq ft)	Lane Miles *	Surface Type
0256BZ	NONPUBLIC	6/13/2008		17,613	0.30	AS
Culverts	Drop Inlets	Gates	Fire Hydrants	Curb & Gutter	Curb	PCR
0	0	0	0	CONCRETE CURB AND GUTTER	CONCRETE CURB	POOR/45

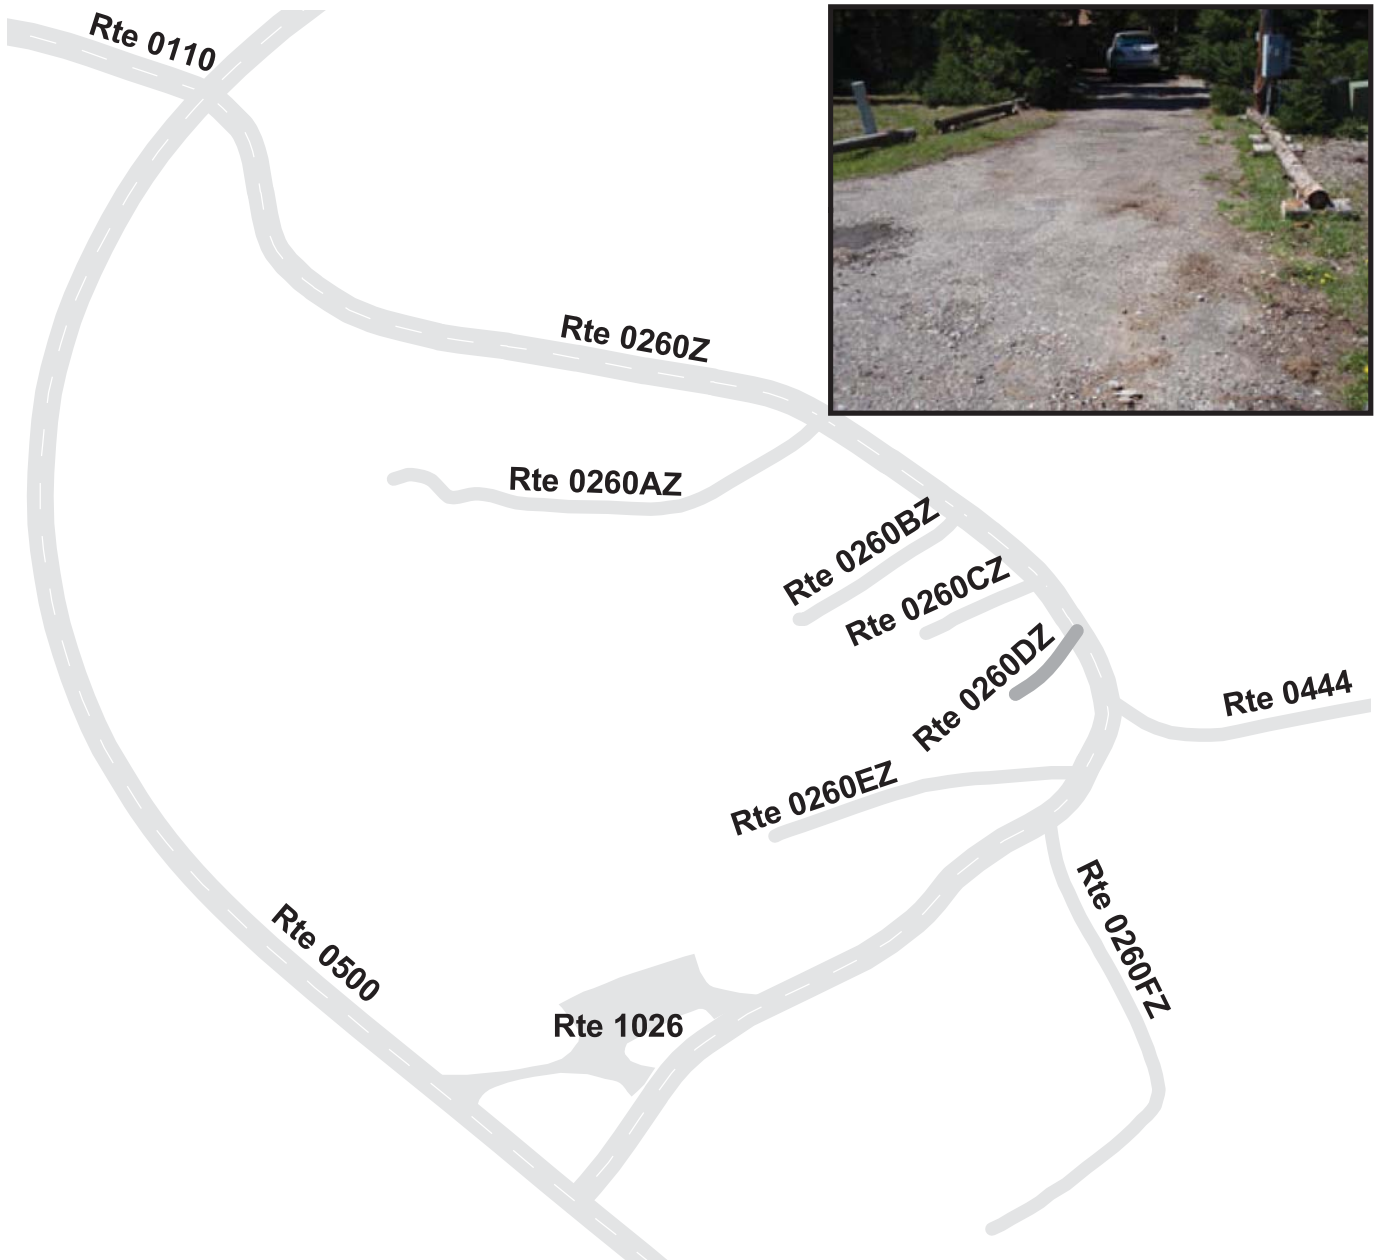
Route Number	Public / NonPublic	Date Visited		Area (sq ft)	Lane Miles *	Surface Type
0260DZ	PUBLIC	6/13/2008		963	0.02	AS
Culverts	Drop Inlets	Gates	Fire Hydrants	Curb & Gutter	Curb	PCR
0	0	0	0	NO CURB AND GUTTER	NO CURB	POOR/45

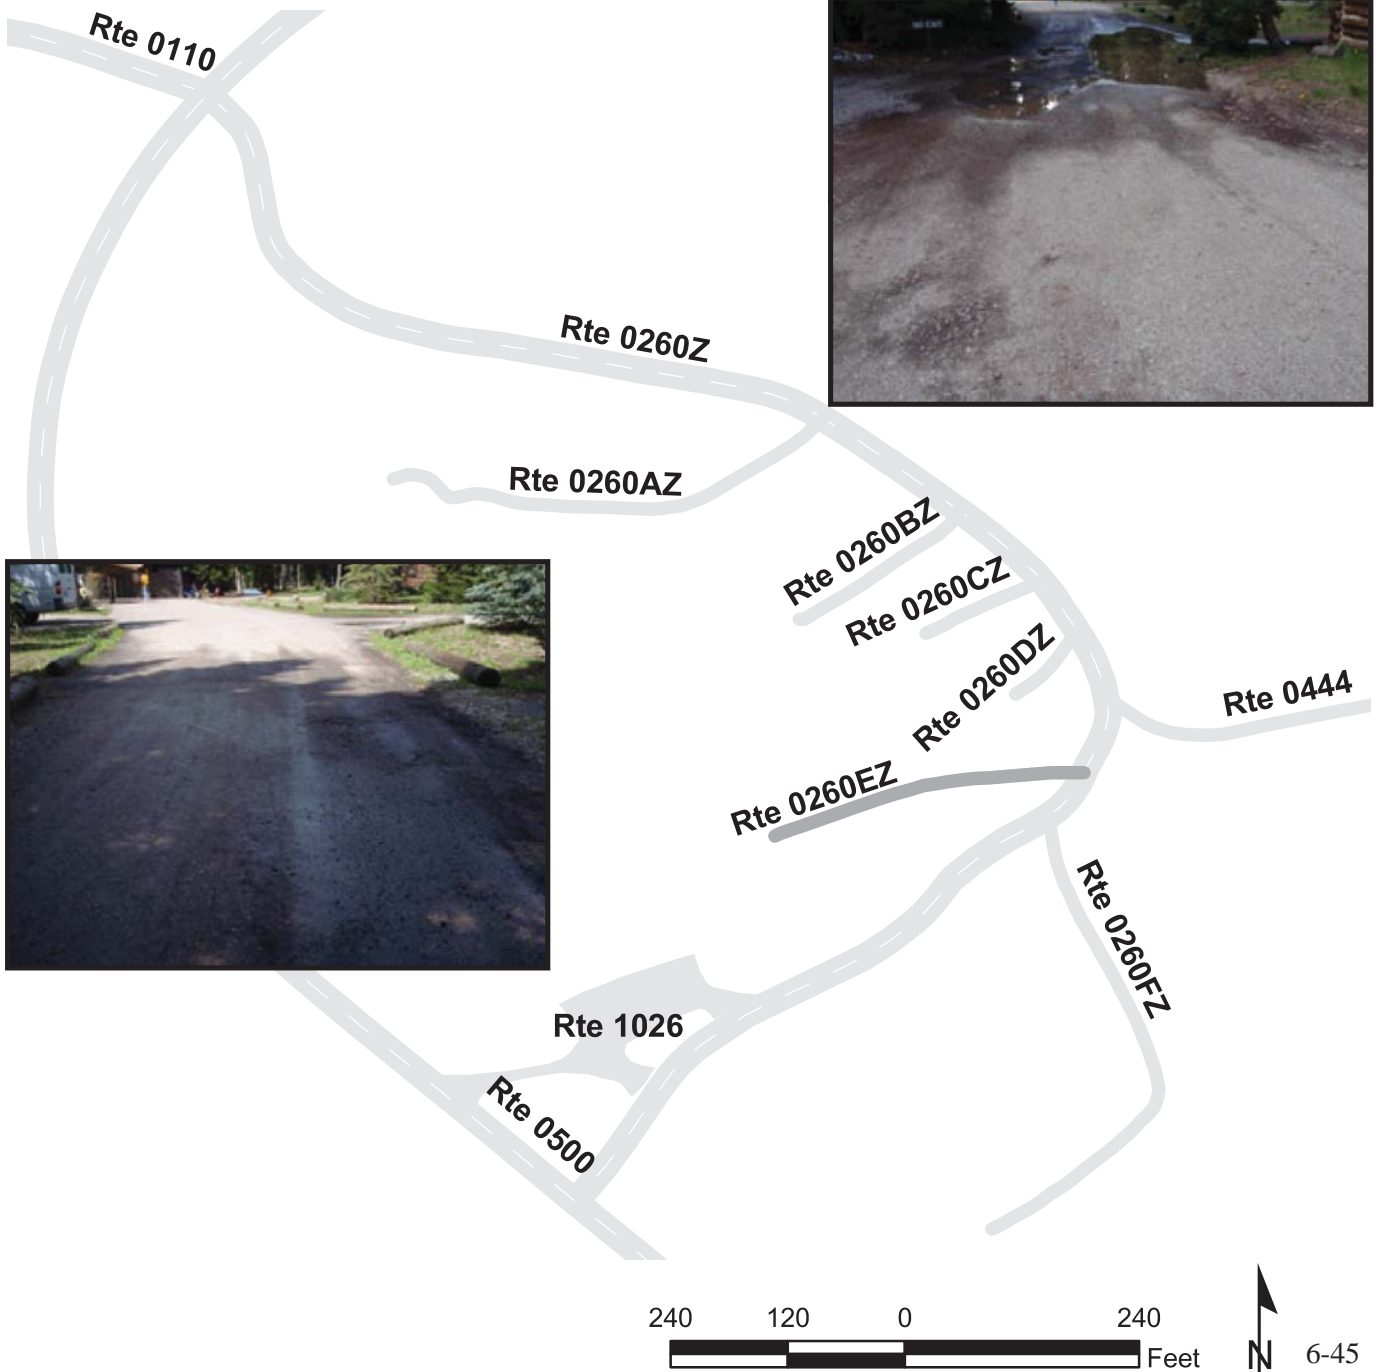
Route Number	Public / NonPublic	Date Visited		Area (sq ft)	Lane Miles *	Surface Type
0260EZ	PUBLIC	6/13/2008		3,144	0.05	AS
Culverts	Drop Inlets	Gates	Fire Hydrants	Curb & Gutter	Curb	PCR
0	0	0	0	NO CURB AND GUTTER	NO CURB	FAIR/73

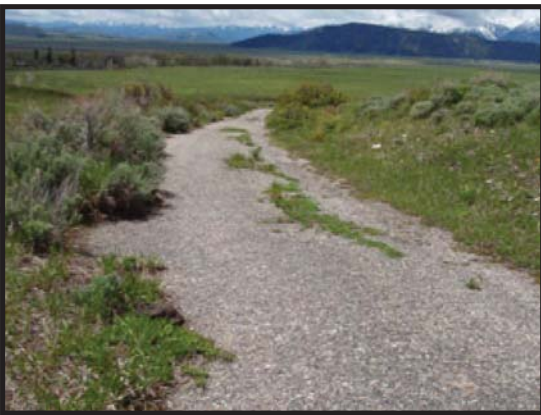
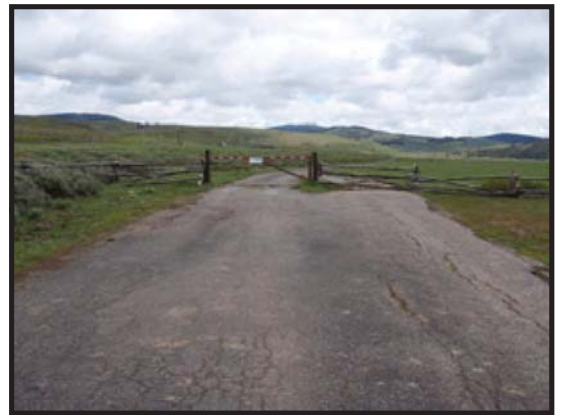
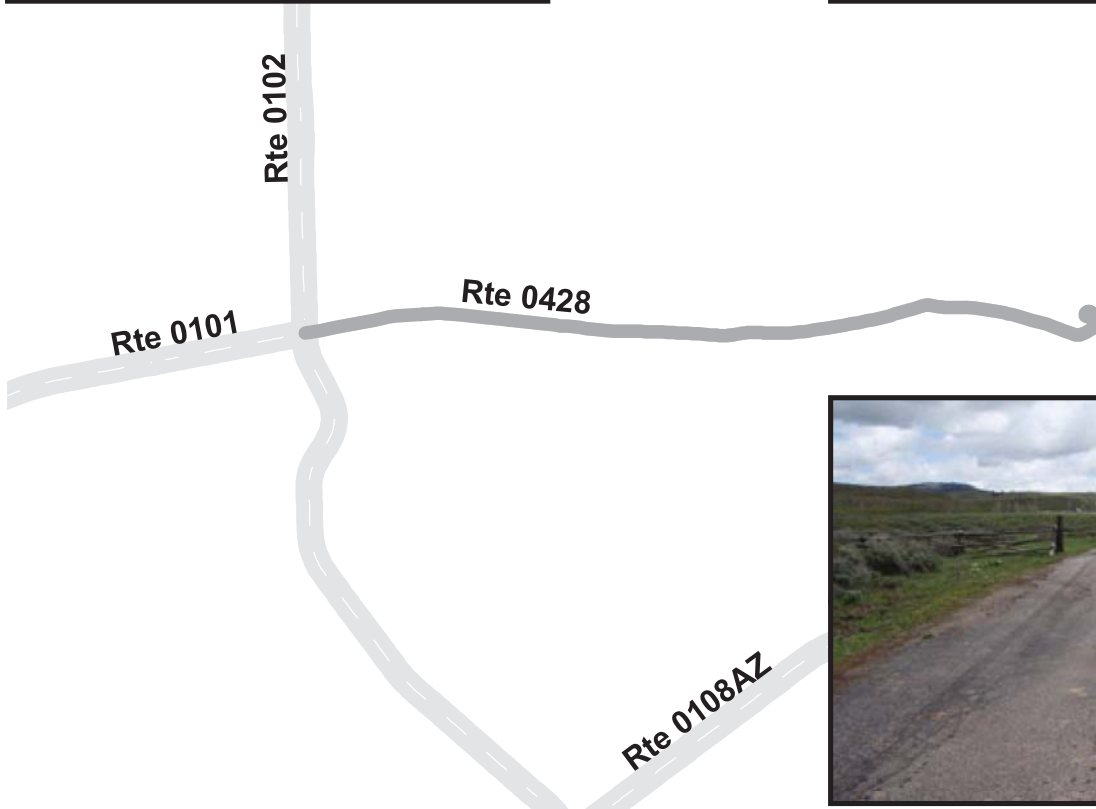
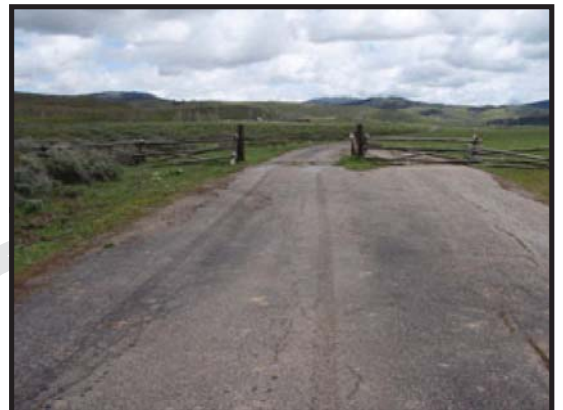
Route Number	Public / NonPublic	Date Visited		Area (sq ft)	Lane Miles *	Surface Type
0428	PUBLIC	6/12/2008		107,499	1.85	AS
Culverts	Drop Inlets	Gates	Fire Hydrants	Curb & Gutter	Curb	PCR
0	0	0	0	NO CURB AND GUTTER	NO CURB	POOR/45

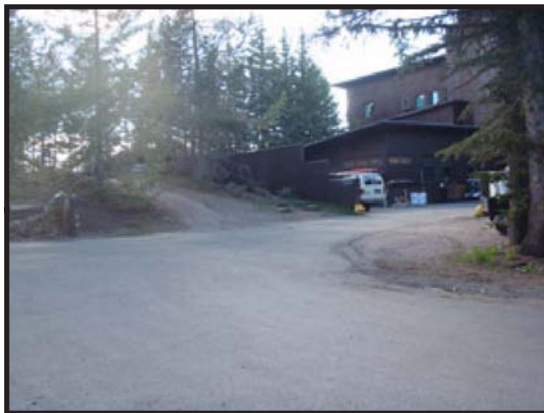
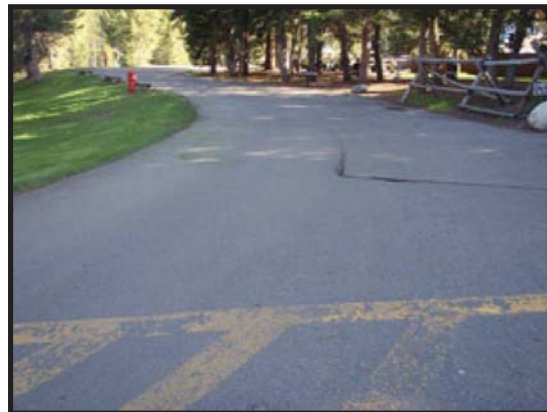
Route Number	Public / NonPublic	Date Visited		Area (sq ft)	Lane Miles *	Surface Type
0441	NONPUBLIC	6/13/2008		11,609	0.20	AS
Culverts	Drop Inlets	Gates	Fire Hydrants	Curb & Gutter	Curb	PCR
0	0	0	0	NO CURB AND GUTTER	NO CURB	FAIR/73

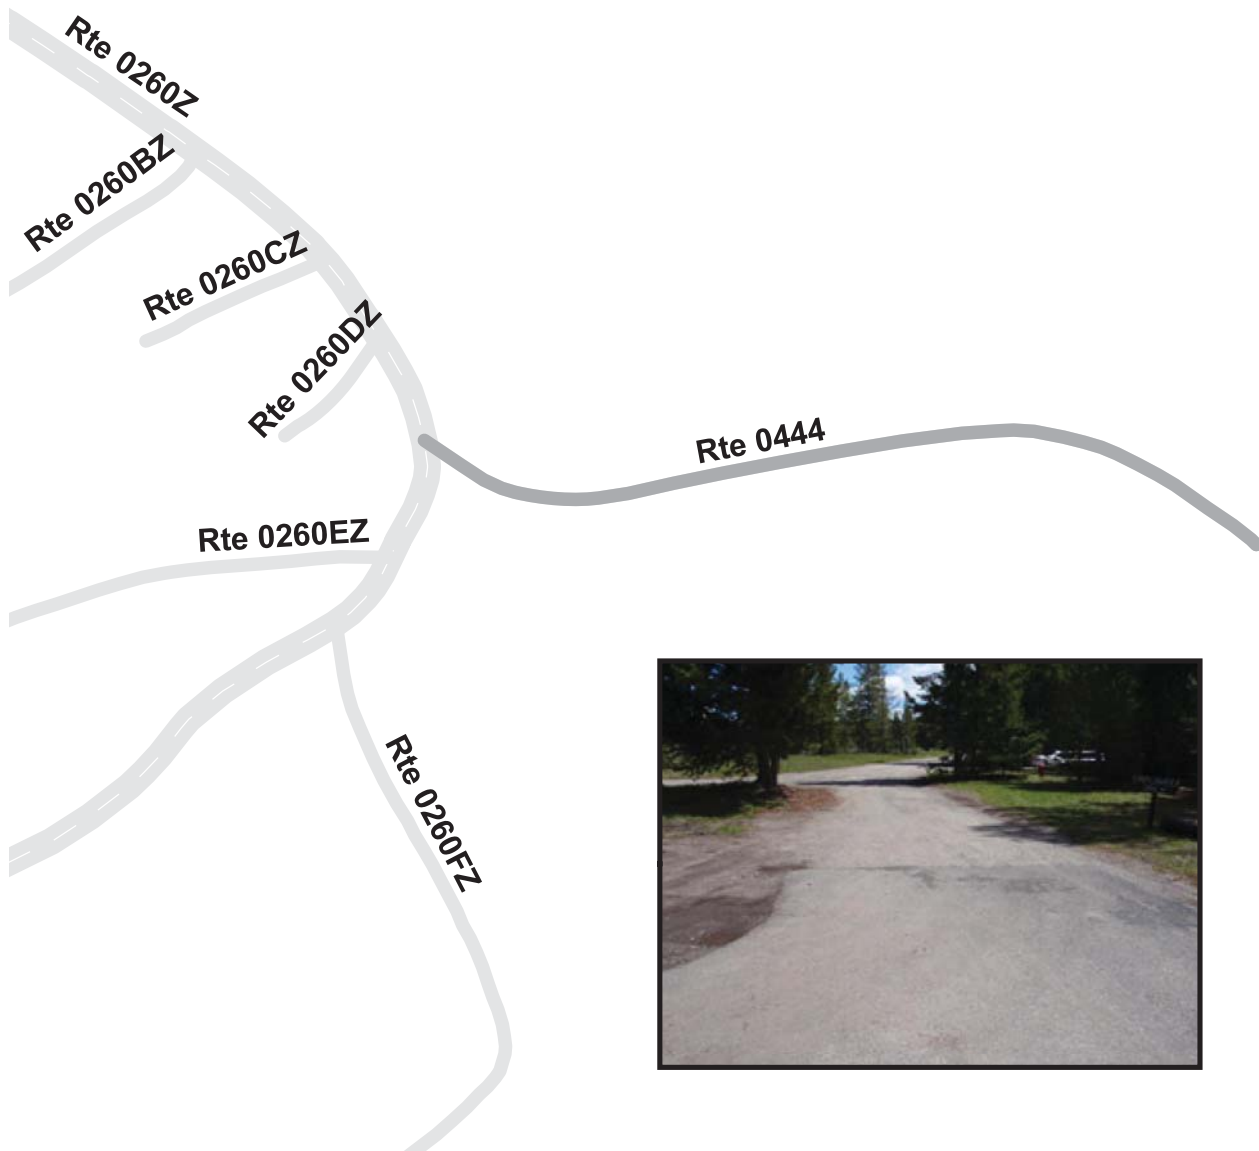
Route Number	Public / NonPublic	Date Visited		Area (sq ft)	Lane Miles *	Surface Type
0444	PUBLIC	6/13/2008		5,329	0.09	AS
Culverts	Drop Inlets	Gates	Fire Hydrants	Curb & Gutter	Curb	PCR
0	0	0	0	NO CURB AND GUTTER	NO CURB	FAIR/73

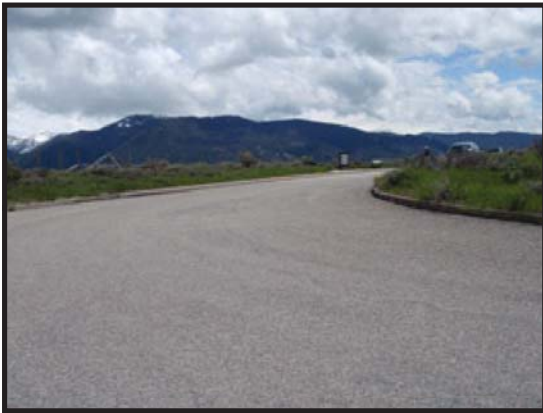
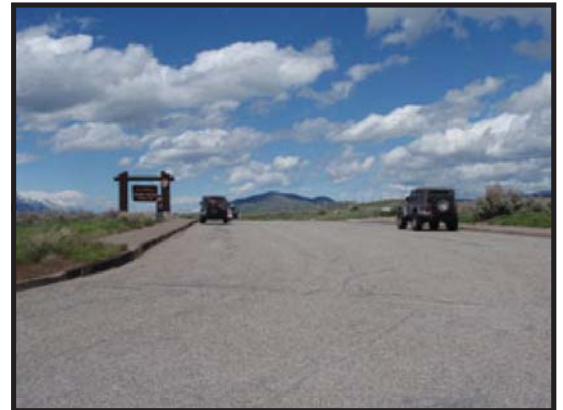
Route Number	Public / NonPublic	Date Visited		Area (sq ft)	Lane Miles *	Surface Type
0900	PUBLIC	6/10/2008		23,826	0.41	AS
Culverts	Drop Inlets	Gates	Fire Hydrants	Curb & Gutter	Curb	PCR
0	0	0	0	NO CURB AND GUTTER	CONCRETE CURB	GOOD/90

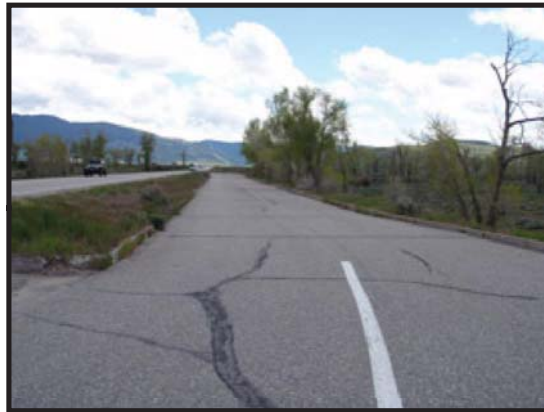
Route Number	Public / NonPublic	Date Visited		Area (sq ft)	Lane Miles *	Surface Type
0901	PUBLIC	6/10/2008		17,045	0.29	AS
Culverts	Drop Inlets	Gates	Fire Hydrants	Curb & Gutter	Curb	PCR
0	0	0	0	NO CURB AND GUTTER	CONCRETE CURB	FAIR/73

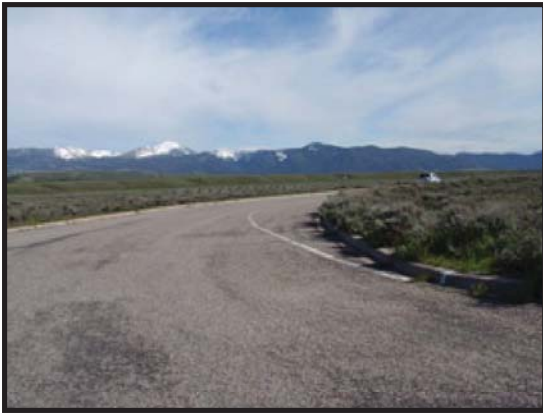
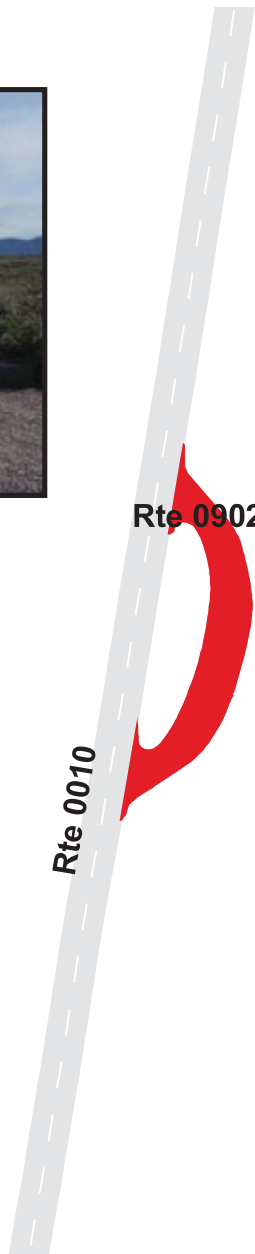
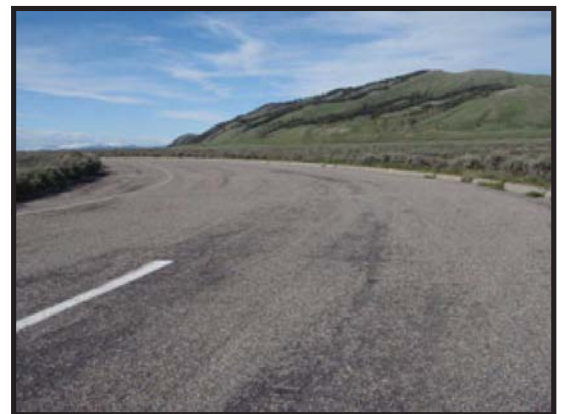
Route Number	Public / NonPublic	Date Visited		Area (sq ft)	Lane Miles *	Surface Type
0902	PUBLIC	6/10/2008		20,528	0.35	AS
Culverts	Drop Inlets	Gates	Fire Hydrants	Curb & Gutter	Curb	PCR
0	0	0	0	CONCRETE CURB AND GUTTER	CONCRETE CURB	FAIR/73
