**The Road Inventory  
of  
Grand Teton National Park  
GRTE – 1460  
Cycle 4**

**Prepared By:  
Federal Highway Administration  
Road Inventory Program  
Cycle 4**

# Grand Teton National Park in Wyoming

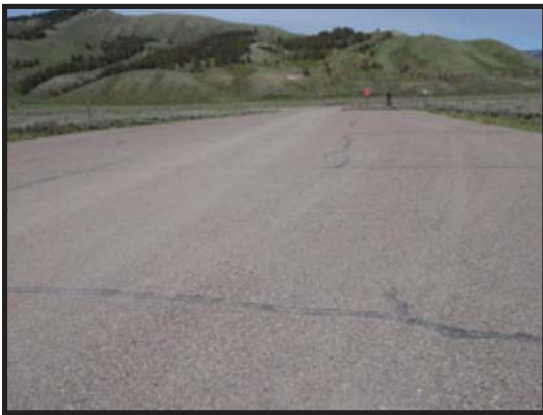
Route Number	Public / NonPublic	Date Visited		Area (sq ft)	Lane Miles *	Surface Type
0903	PUBLIC	6/10/2008		16,993	0.29	AS
Culverts	Drop Inlets	Gates	Fire Hydrants	Curb & Gutter	Curb	PCR
0	0	0	0	NO CURB AND GUTTER	NO CURB	FAIR/73

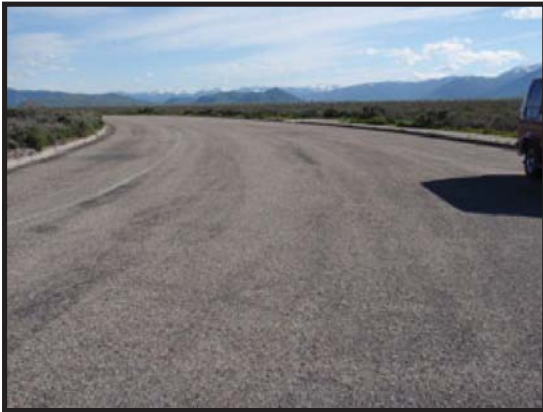
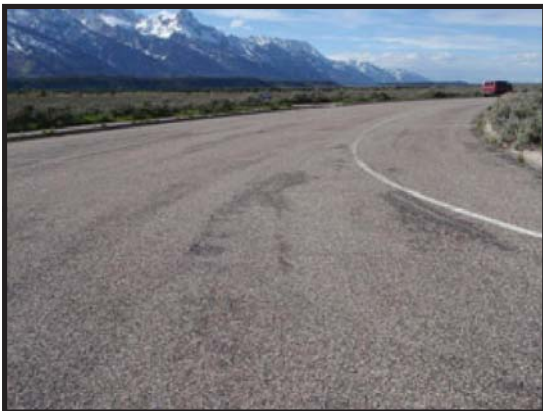
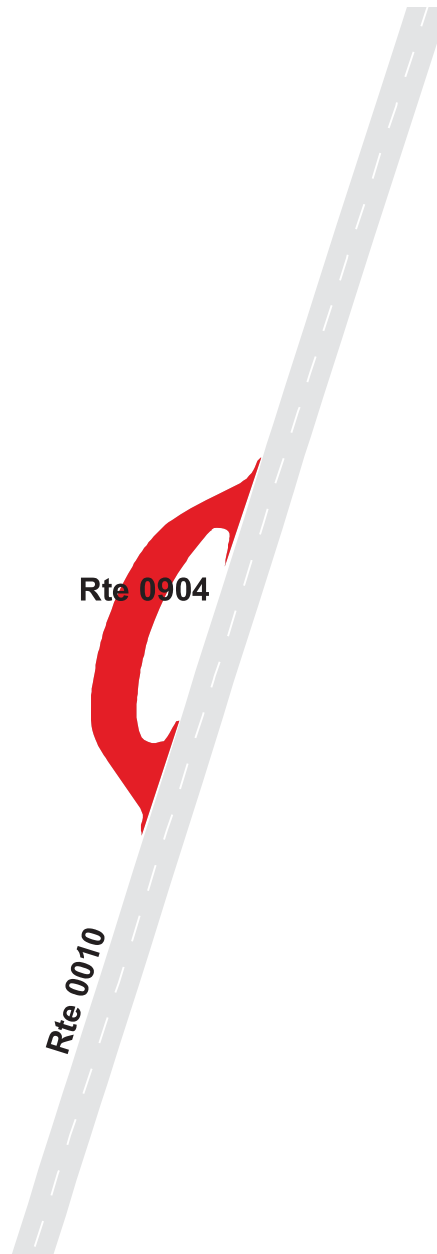
Route Number	Public / NonPublic	Date Visited		Area (sq ft)	Lane Miles *	Surface Type
0904	PUBLIC	6/10/2008		20,731	0.36	AS
Culverts	Drop Inlets	Gates	Fire Hydrants	Curb & Gutter	Curb	PCR
0	0	0	0	CONCRETE CURB AND GUTTER	CONCRETE CURB	POOR/45

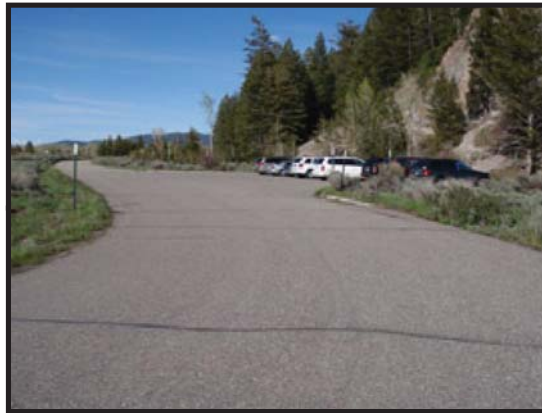
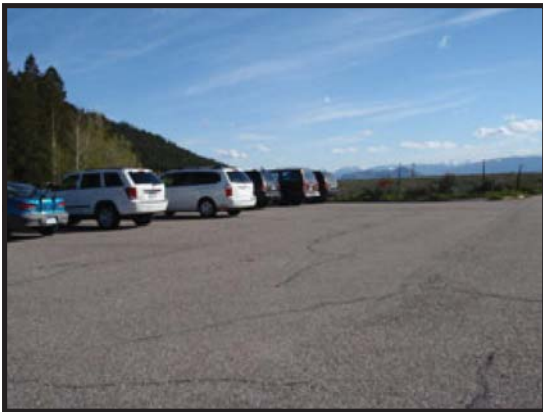
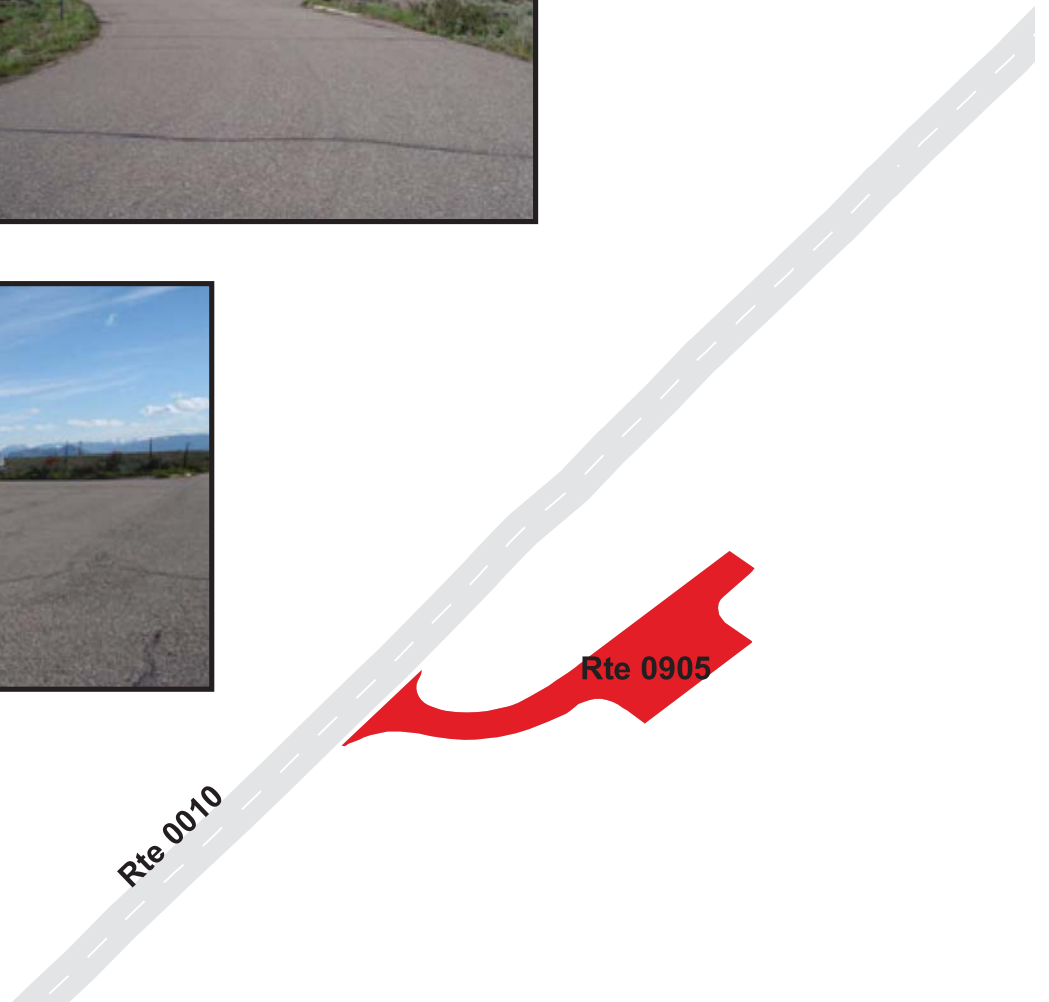
Route Number	Public / NonPublic	Date Visited		Area (sq ft)	Lane Miles *	Surface Type
0905	PUBLIC	6/10/2008		14,628	0.25	AS
Culverts	Drop Inlets	Gates	Fire Hydrants	Curb & Gutter	Curb	PCR
0	0	0	0	CONCRETE CURB AND GUTTER	CONCRETE CURB	FAIR/73

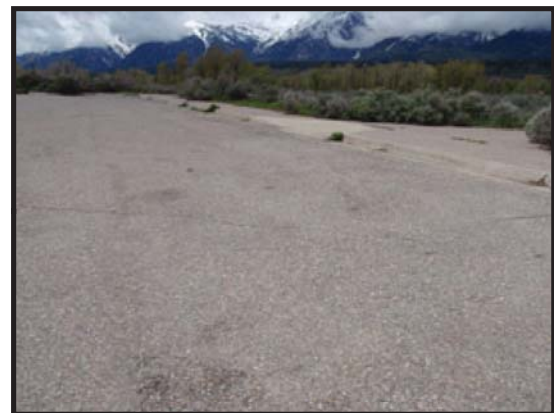
Route Number	Public / NonPublic	Date Visited		Area (sq ft)	Lane Miles *	Surface Type
0906AZ	PUBLIC	6/10/2008		2,361	0.04	AS
Culverts	Drop Inlets	Gates	Fire Hydrants	Curb & Gutter	Curb	PCR
0	0	0	0	CONCRETE CURB AND GUTTER	CONCRETE CURB	GOOD/90

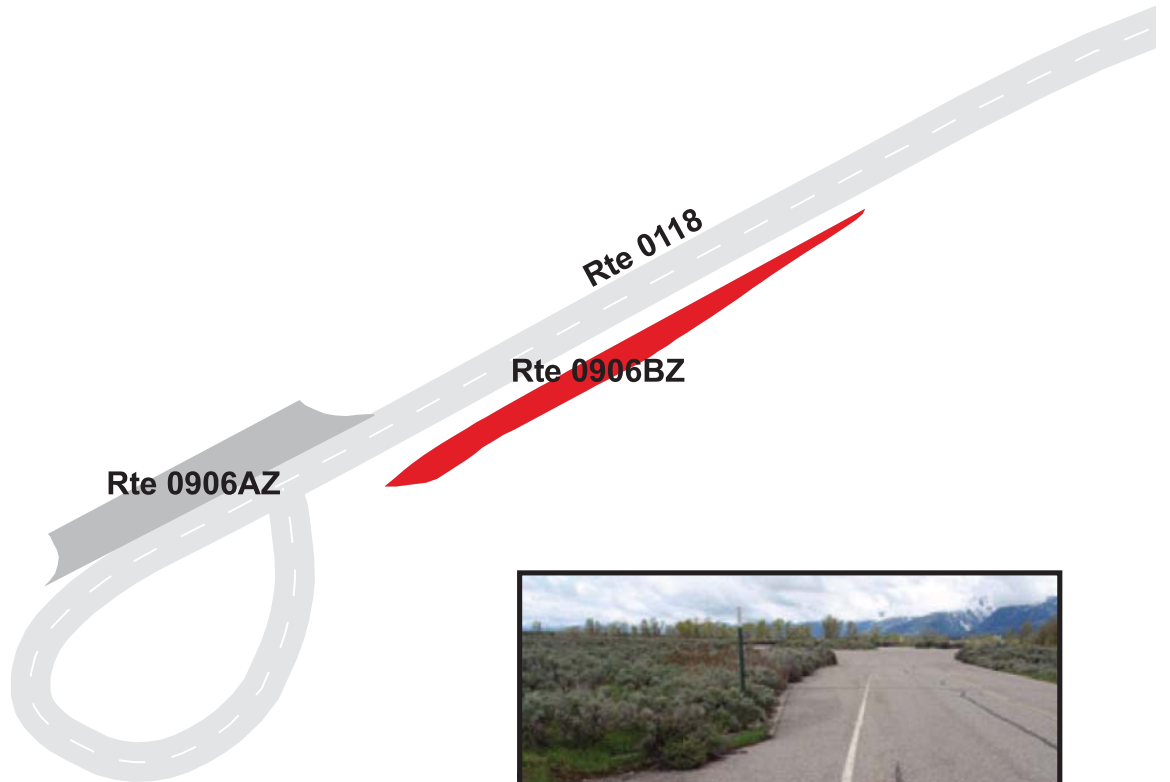
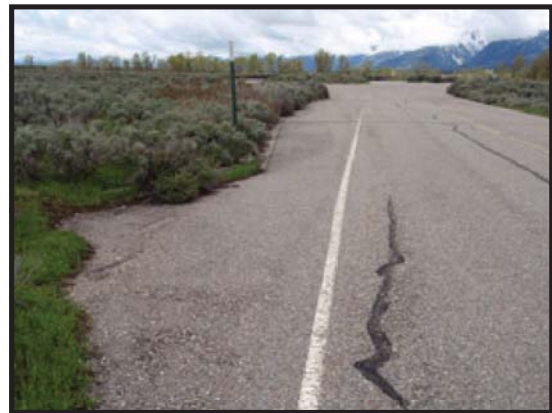
**GRAND TETON NATIONAL PARK**  
**Route 0906BZ**  
 BLACKTAIL PONDS OVERLOOK PARKING B  
 ADJACENT TO ROUTE 0118

Route Number	Public / NonPublic	Date Visited		Area (sq ft)	Lane Miles *	Surface Type
0906BZ	PUBLIC	6/10/2008		1,797	0.03	AS
Culverts	Drop Inlets	Gates	Fire Hydrants	Curb & Gutter	Curb	PCR
0	0	0	0	CONCRETE CURB AND GUTTER	CONCRETE CURB	GOOD/90

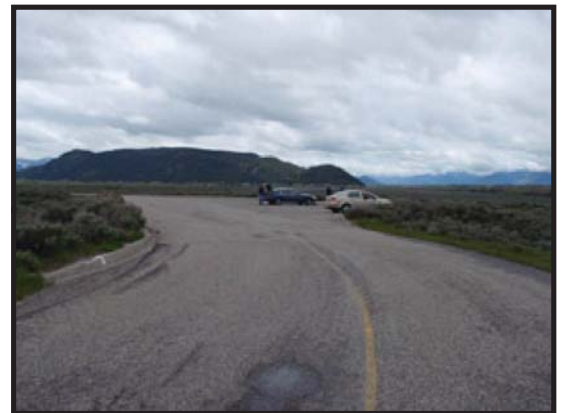
Route Number	Public / NonPublic	Date Visited		Area (sq ft)	Lane Miles *	Surface Type
0907	PUBLIC	6/10/2008		25,216	0.43	AS
Culverts	Drop Inlets	Gates	Fire Hydrants	Curb & Gutter	Curb	PCR
0	0	0	0	CONCRETE CURB AND GUTTER	CONCRETE CURB	FAIR/73

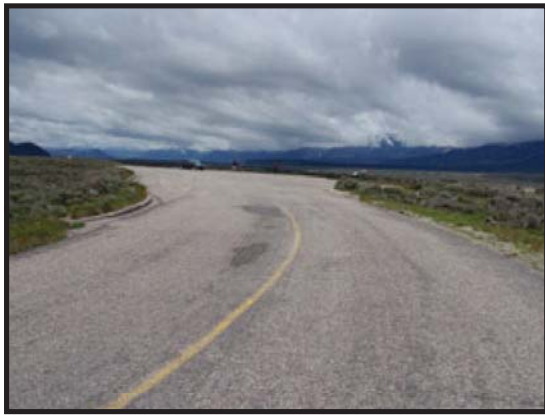
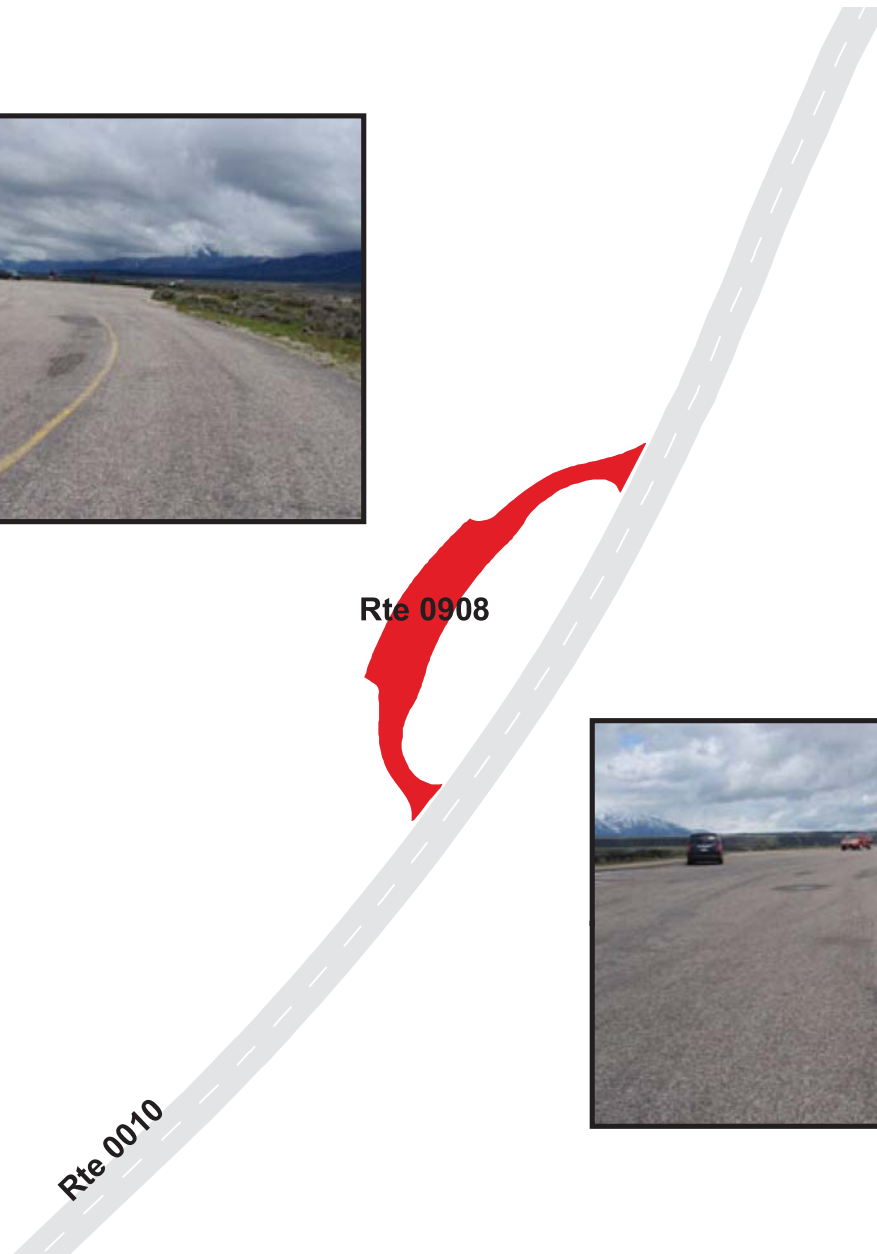
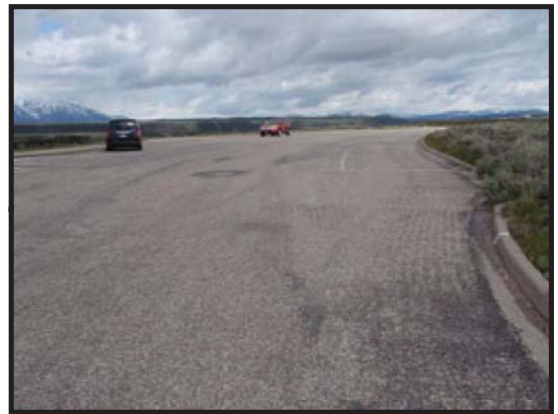
Route Number	Public / NonPublic	Date Visited		Area (sq ft)	Lane Miles *	Surface Type
0908	PUBLIC	6/10/2008		26,718	0.46	AS
Culverts	Drop Inlets	Gates	Fire Hydrants	Curb & Gutter	Curb	PCR
0	0	0	0	CONCRETE CURB AND GUTTER	CONCRETE CURB	FAIR/73

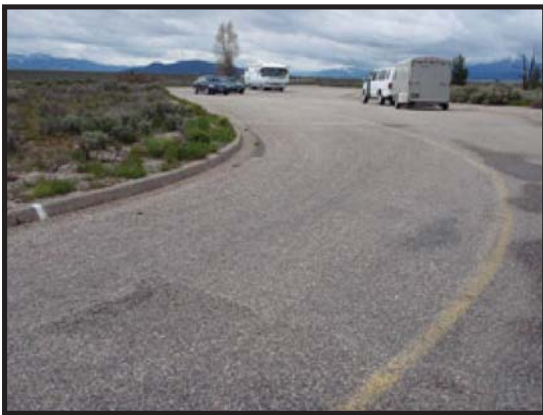
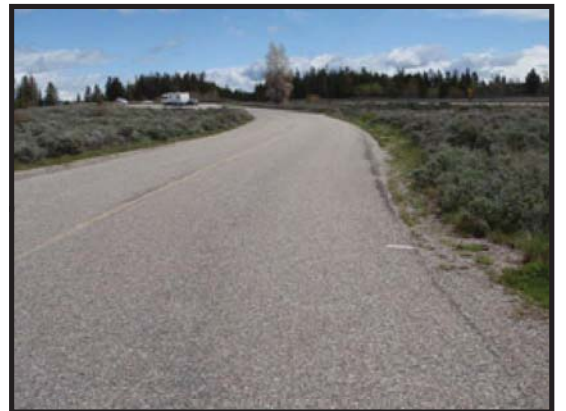
Route Number	Public / NonPublic	Date Visited		Area (sq ft)	Lane Miles *	Surface Type
0909	PUBLIC	6/10/2008		54,514	0.94	AS
Culverts	Drop Inlets	Gates	Fire Hydrants	Curb & Gutter	Curb	PCR
0	0	0	0	CONCRETE CURB AND GUTTER	CONCRETE CURB	FAIR/73

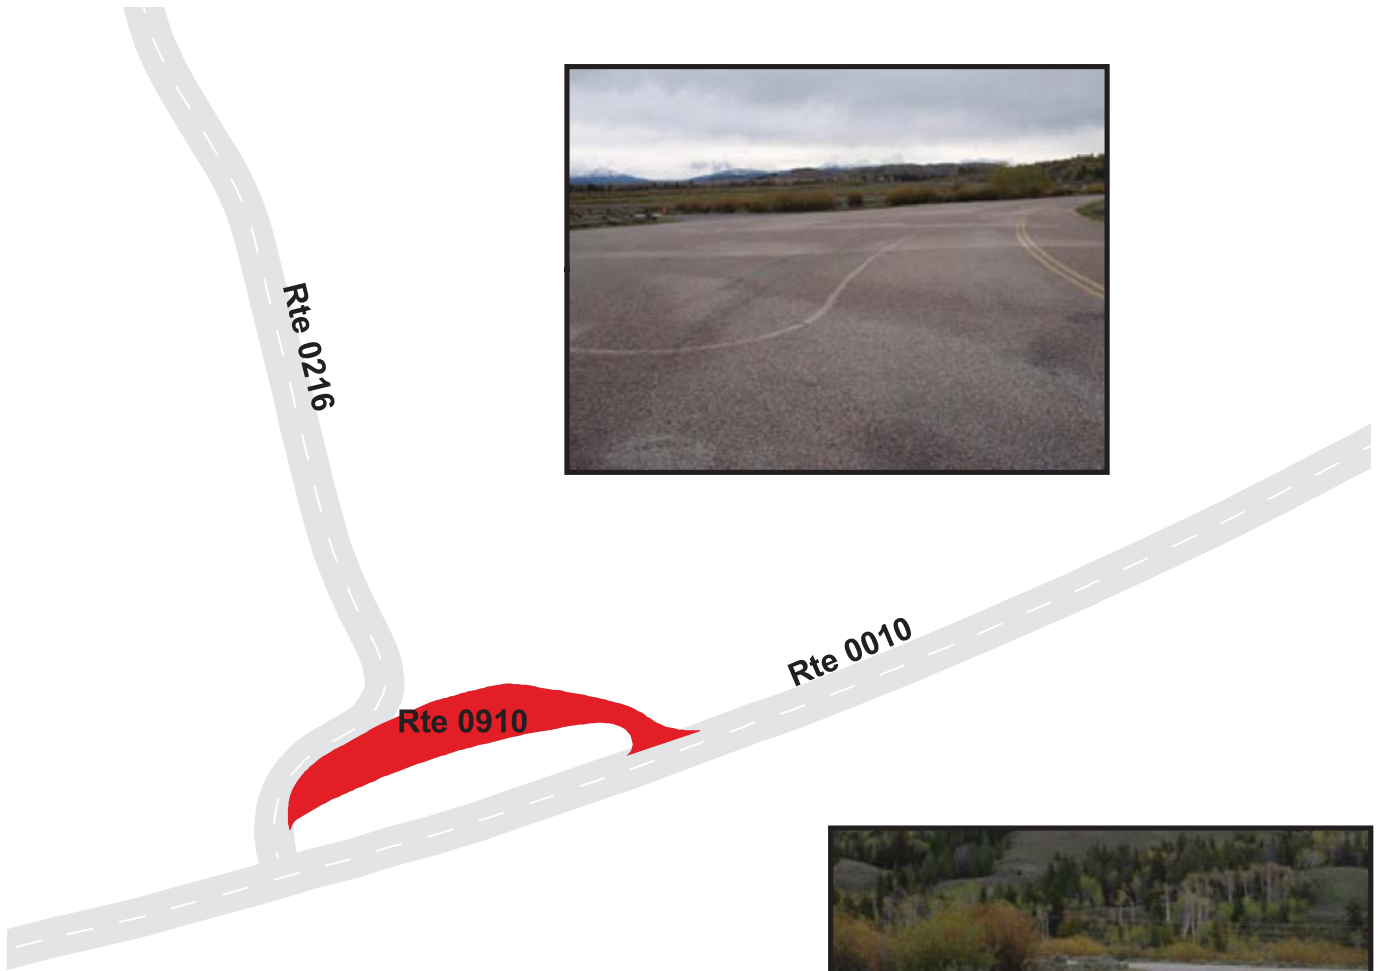
Route Number	Public / NonPublic	Date Visited		Area (sq ft)	Lane Miles *	Surface Type
0910	PUBLIC	6/10/2008		34,320	0.59	AS
Culverts	Drop Inlets	Gates	Fire Hydrants	Curb & Gutter	Curb	PCR
0	0	0	0	NO CURB AND GUTTER	NO CURB	FAIR/73

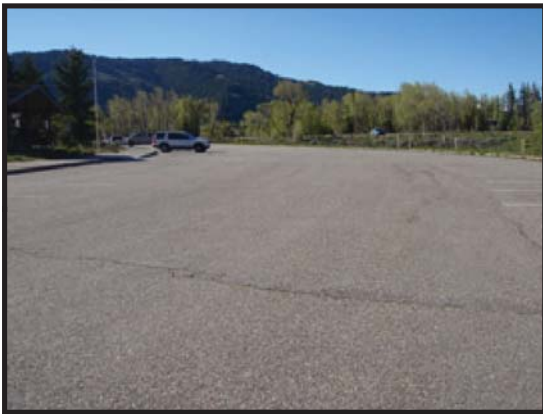
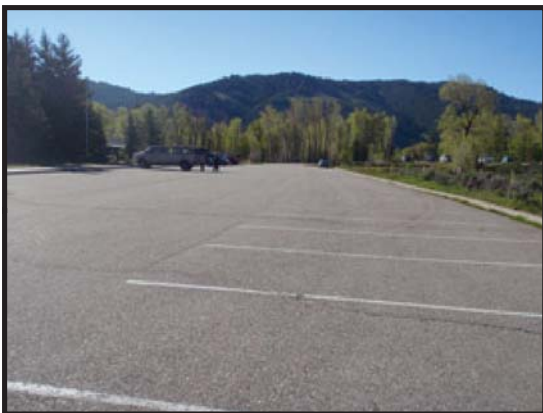
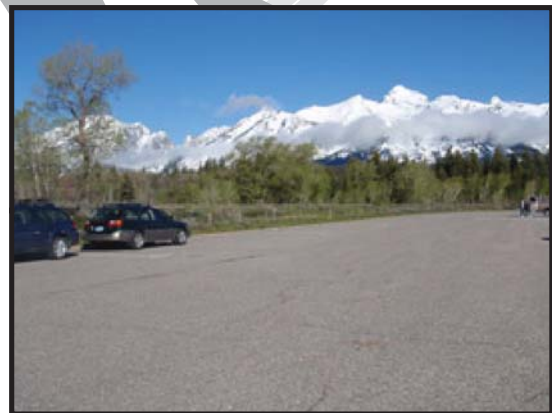
Route Number	Public / NonPublic	Date Visited		Area (sq ft)	Lane Miles *	Surface Type
0912	PUBLIC	6/13/2008		47,557	0.82	AS
Culverts	Drop Inlets	Gates	Fire Hydrants	Curb & Gutter	Curb	PCR
0	0	0	1	CONCRETE CURB AND GUTTER	CONCRETE CURB	FAIR/73

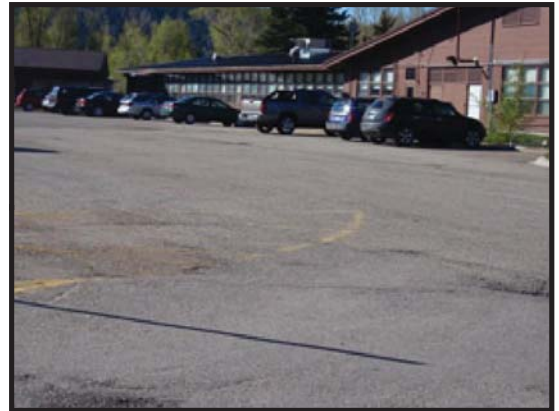
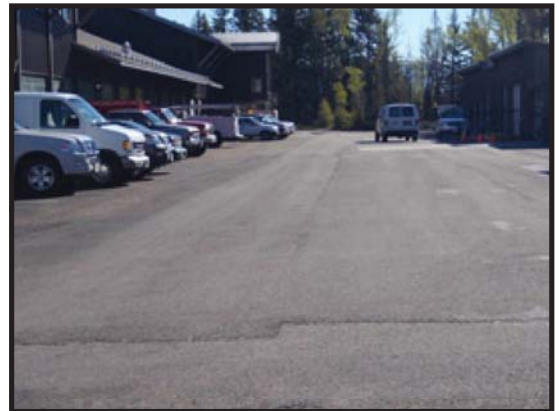
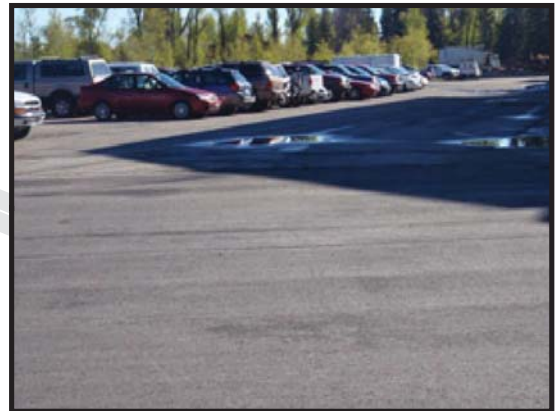
Route Number	Public / NonPublic	Date Visited		Area (sq ft)	Lane Miles *	Surface Type
0913	NONPUBLIC	6/13/2008		129,959	2.24	AS
Culverts	Drop Inlets	Gates	Fire Hydrants	Curb & Gutter	Curb	PCR
0	0	0	2	NO CURB AND GUTTER	CONCRETE CURB	FAIR/73

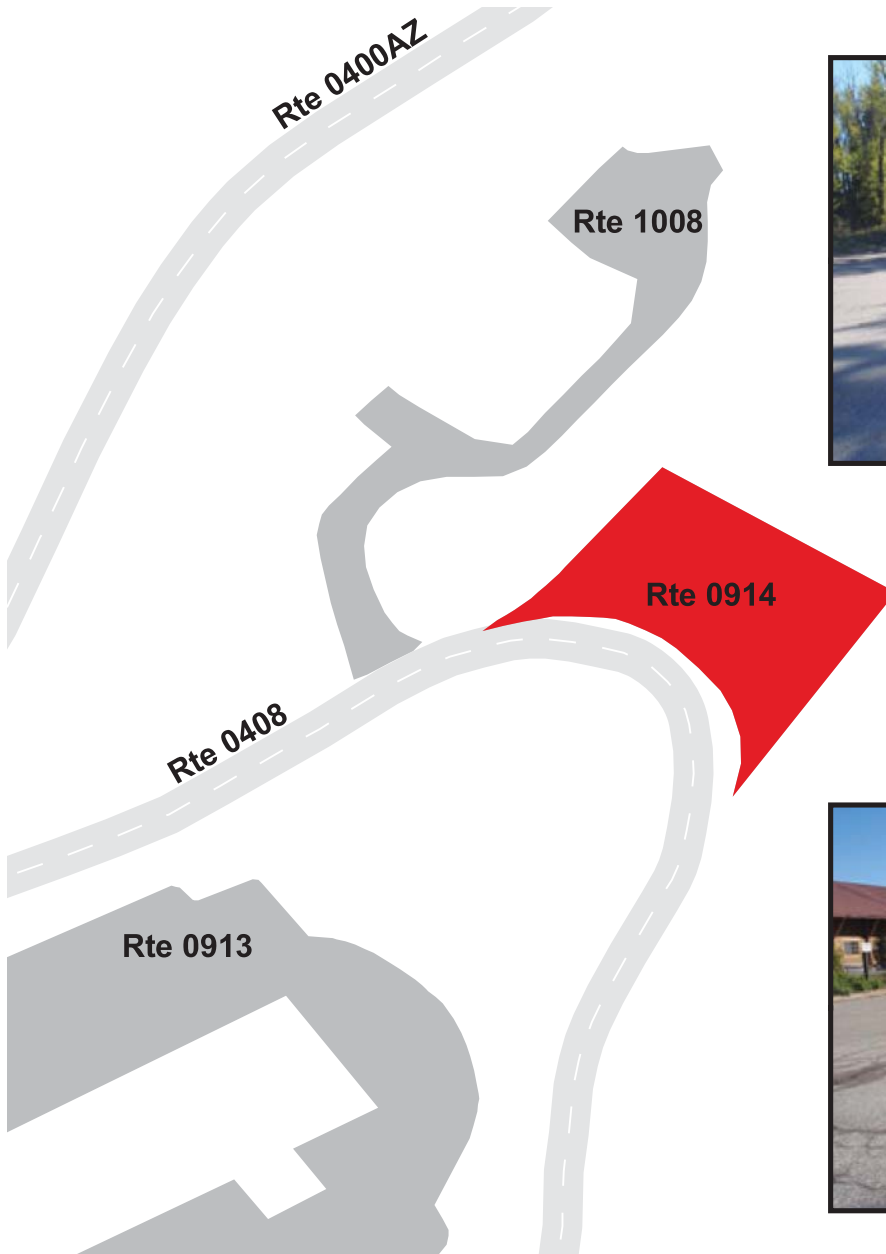
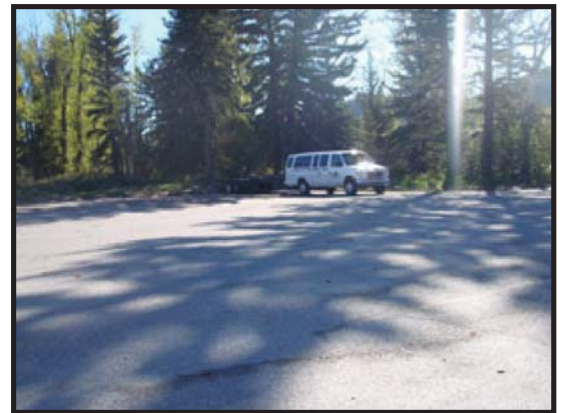
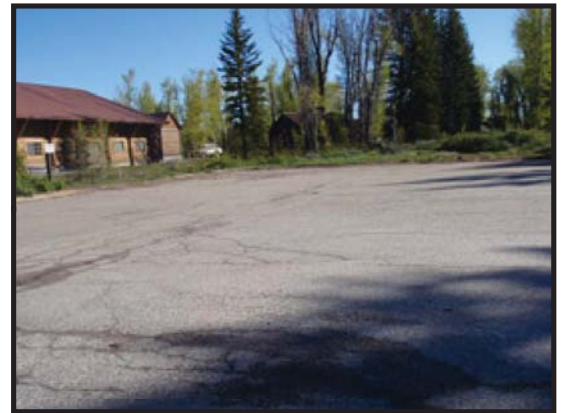
Route Number	Public / NonPublic	Date Visited		Area (sq ft)	Lane Miles *	Surface Type
0914	NONPUBLIC	6/13/2008		11,028	0.19	AS
Culverts	Drop Inlets	Gates	Fire Hydrants	Curb & Gutter	Curb	PCR
0	0	0	0	NO CURB AND GUTTER	WOOD CURB	POOR/45

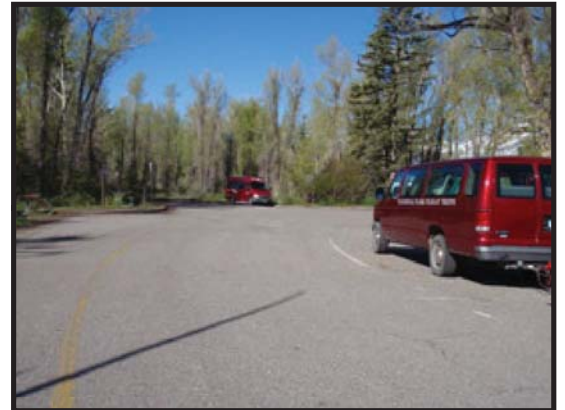
Route Number	Public / NonPublic	Date Visited		Area (sq ft)	Lane Miles *	Surface Type
0915AZ	PUBLIC	6/13/2008		14,915	0.26	AS
Culverts	Drop Inlets	Gates	Fire Hydrants	Curb & Gutter	Curb	PCR
0	0	0	0	CONCRETE CURB AND GUTTER	CONCRETE CURB	FAIR/73

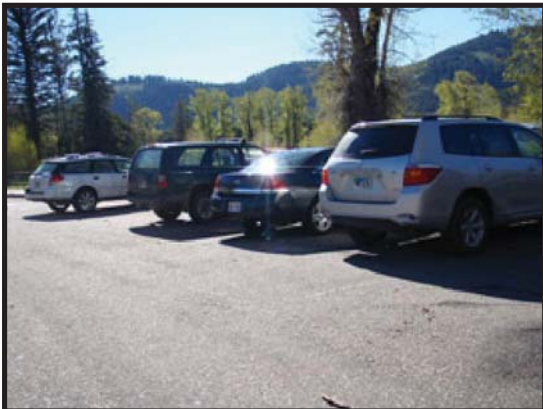
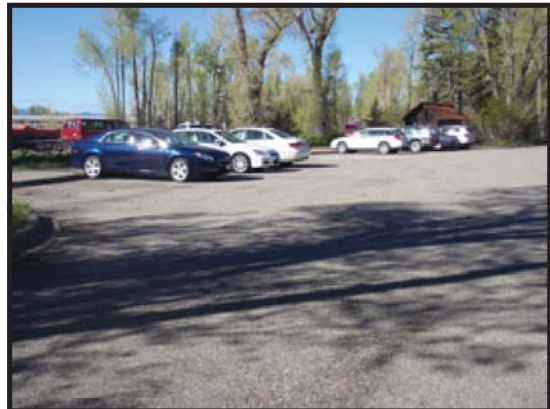
Route Number	Public / NonPublic	Date Visited		Area (sq ft)	Lane Miles *	Surface Type
0915BZ	PUBLIC	6/13/2008		2,728	0.05	AS
Culverts	Drop Inlets	Gates	Fire Hydrants	Curb & Gutter	Curb	PCR
0	0	0	0	CONCRETE CURB AND GUTTER	CONCRETE CURB	FAIR/73

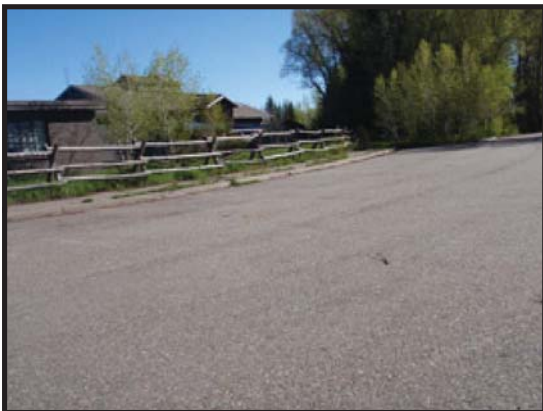
**GRAND TETON NATIONAL PARK**  
**Route 0915CZ**  
MOOSE OVERFLOW PARKING C  
ADJACENT TO ROUTE 0408 AT MP 0.10 ON RIGHT

Route Number	Public / NonPublic	Date Visited		Area (sq ft)	Lane Miles *	Surface Type
0915CZ	PUBLIC	6/13/2008		3,523	0.06	AS
Culverts	Drop Inlets	Gates	Fire Hydrants	Curb & Gutter	Curb	PCR
0	0	0	0	CONCRETE CURB AND GUTTER	CONCRETE CURB	FAIR/73

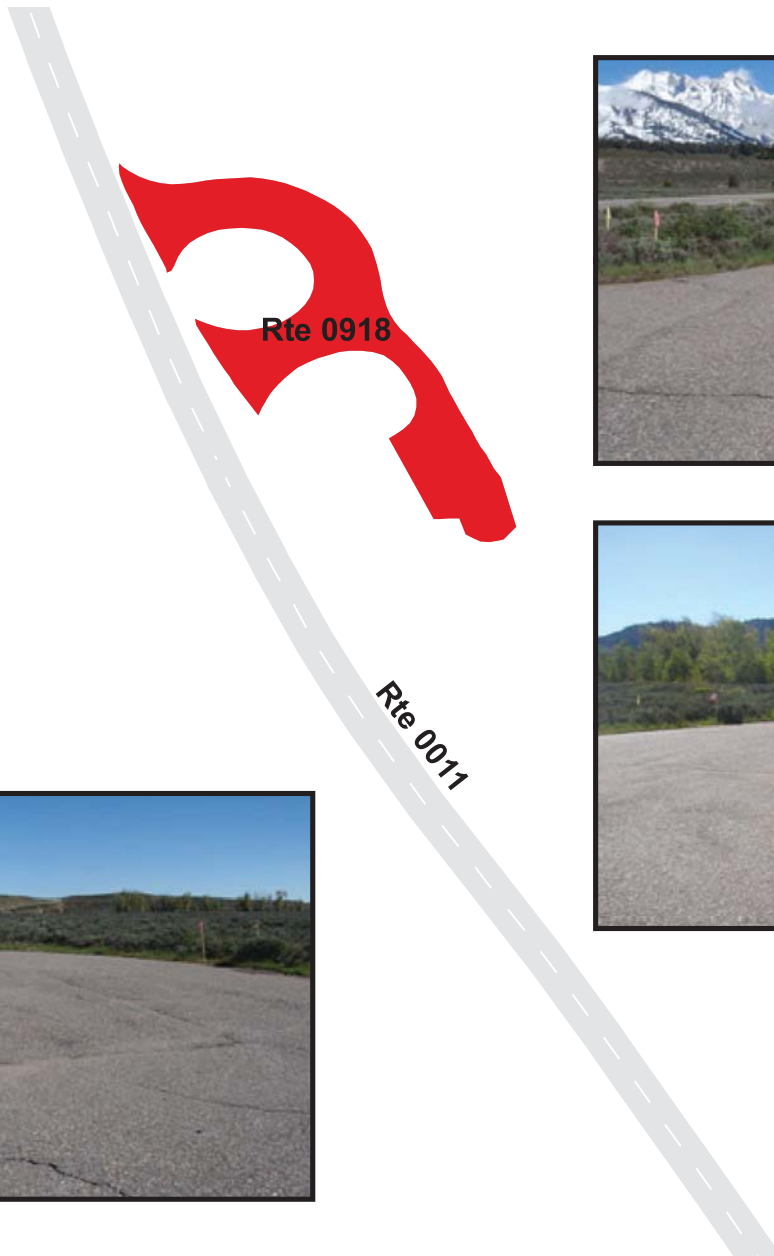
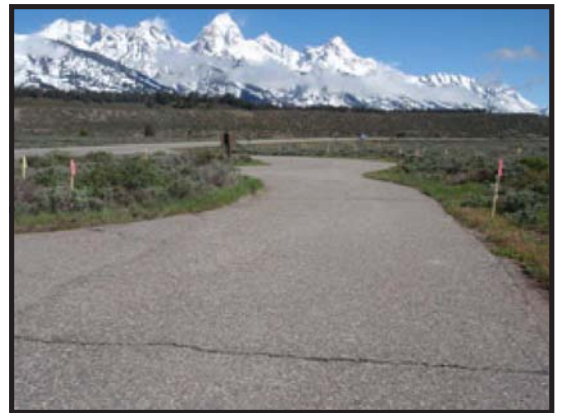
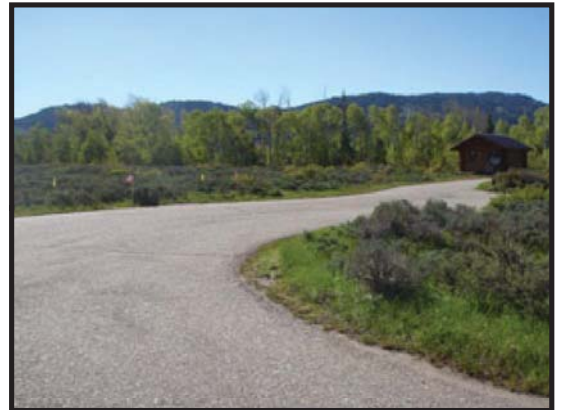
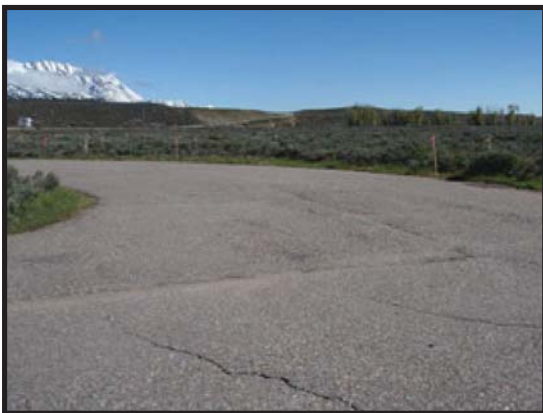
Route Number	Public / NonPublic	Date Visited		Area (sq ft)	Lane Miles *	Surface Type
0918	PUBLIC	6/13/2008		9,770	0.17	AS
Culverts	Drop Inlets	Gates	Fire Hydrants	Curb & Gutter	Curb	PCR
0	0	0	0	NO CURB AND GUTTER	NO CURB	FAIR/73

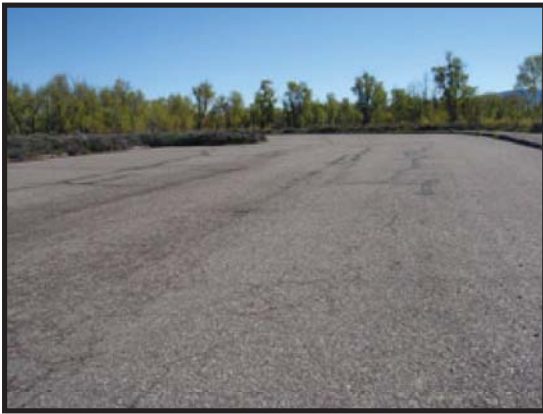
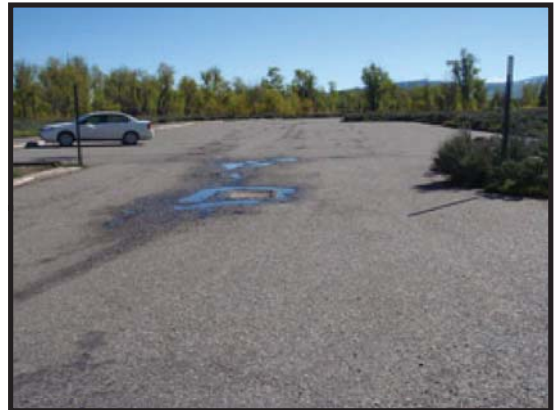
Route Number	Public / NonPublic	Date Visited		Area (sq ft)	Lane Miles *	Surface Type
0919	PUBLIC	6/13/2008		33,134	0.57	AS
Culverts	Drop Inlets	Gates	Fire Hydrants	Curb & Gutter	Curb	PCR
0	2	0	0	NO CURB AND GUTTER	WOOD CURB	POOR/45

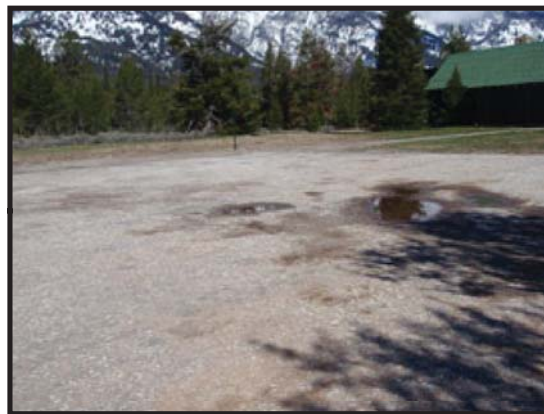
Route Number	Public / NonPublic	Date Visited		Area (sq ft)	Lane Miles *	Surface Type
0921	NONPUBLIC	6/13/2008		6,600	0.11	AS
Culverts	Drop Inlets	Gates	Fire Hydrants	Curb & Gutter	Curb	PCR
0	0	0	0	NO CURB AND GUTTER	NO CURB	POOR/45

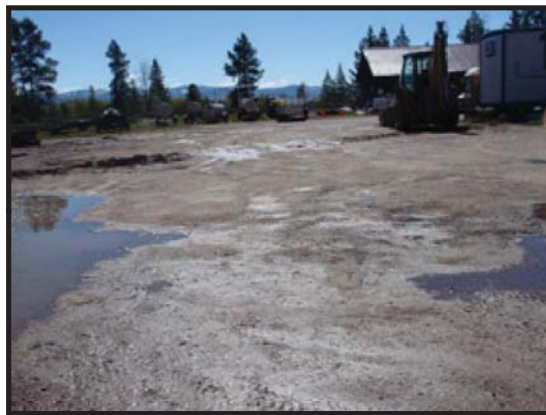
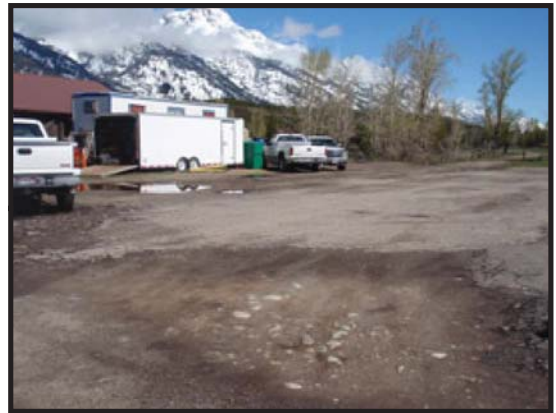
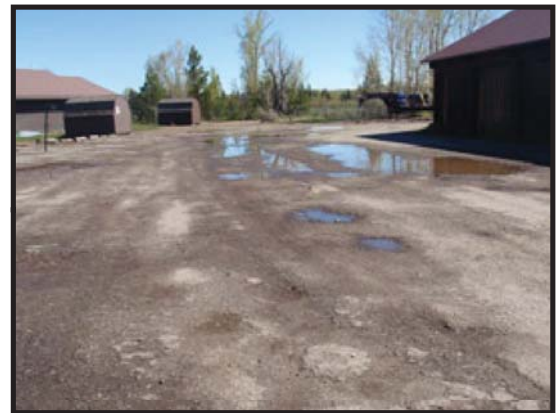
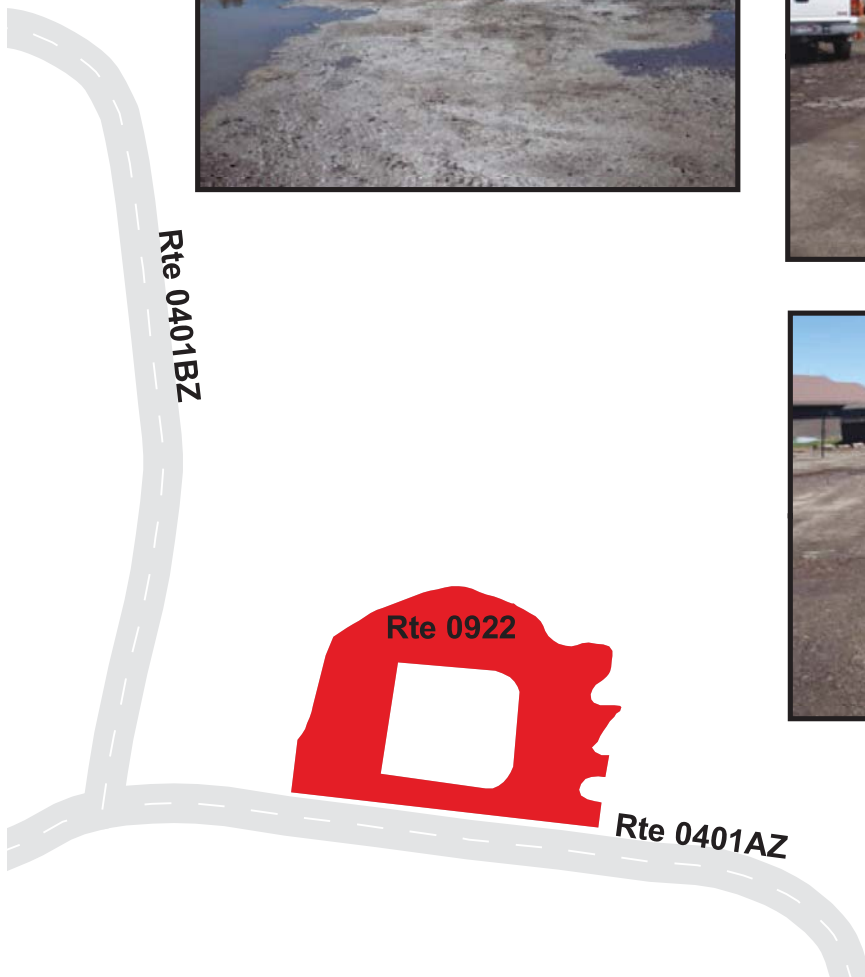
Route Number	Public / NonPublic	Date Visited		Area (sq ft)	Lane Miles *	Surface Type
0922	NONPUBLIC	6/13/2008		19,167	0.33	AS
Culverts	Drop Inlets	Gates	Fire Hydrants	Curb & Gutter	Curb	PCR
0	0	0	0	NO CURB AND GUTTER	NO CURB	POOR/45

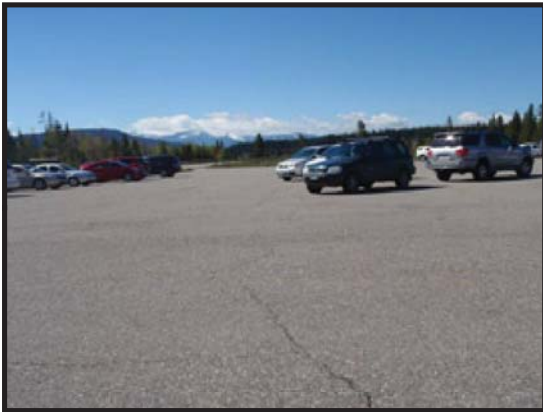
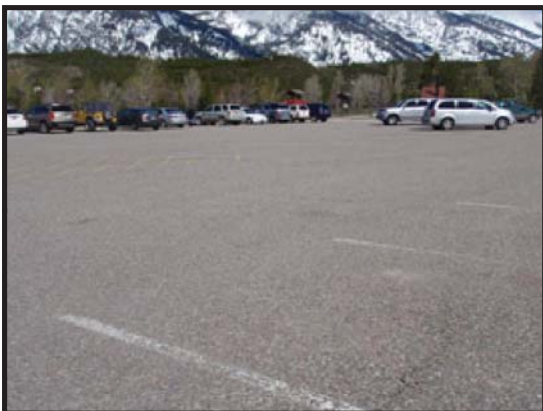
Route Number	Public / NonPublic	Date Visited		Area (sq ft)	Lane Miles *	Surface Type
0923	PUBLIC	6/13/2008		37,665	0.65	AS
Culverts	Drop Inlets	Gates	Fire Hydrants	Curb & Gutter	Curb	PCR
0	0	0	0	CONCRETE CURB AND GUTTER	CONCRETE CURB	GOOD/90

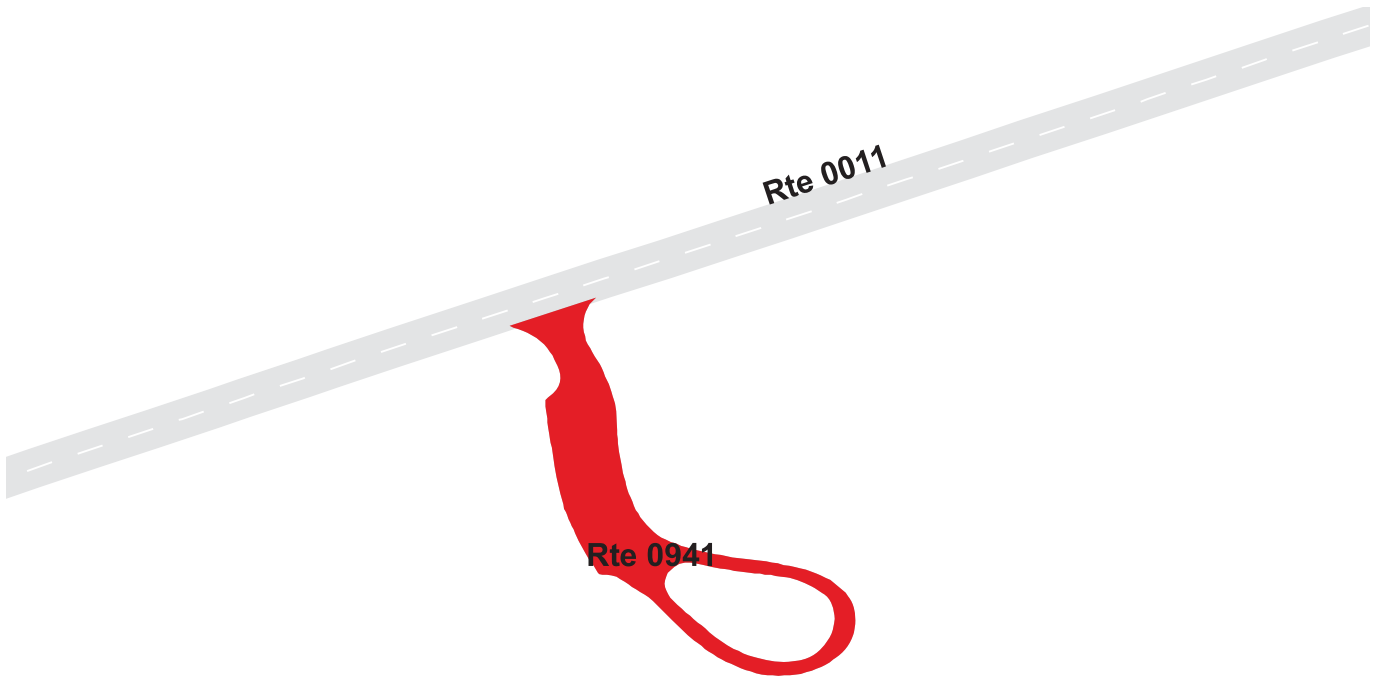
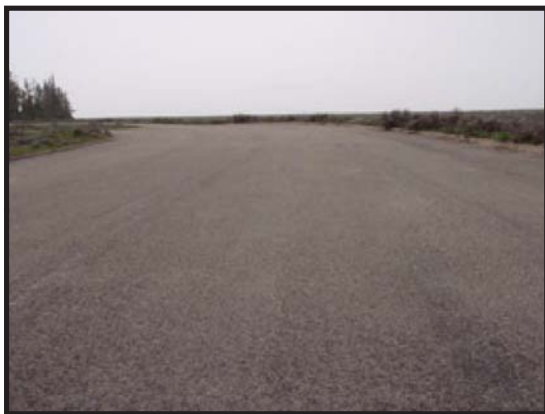
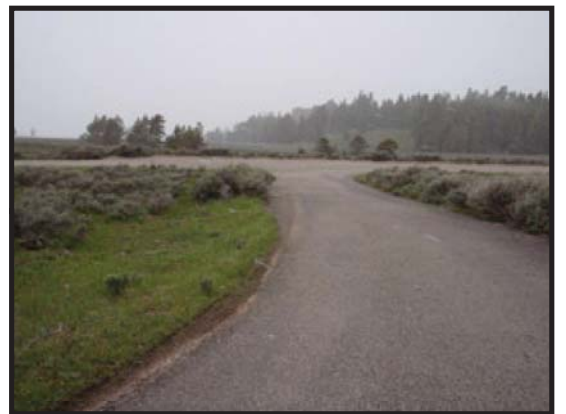
Route Number	Public / NonPublic	Date Visited		Area (sq ft)	Lane Miles *	Surface Type
0941	PUBLIC	6/11/2008		21,475	0.37	AS
Culverts	Drop Inlets	Gates	Fire Hydrants	Curb & Gutter	Curb	PCR
0	0	0	0	CONCRETE CURB AND GUTTER	ASPHALT & CONCRETE	FAIR/73

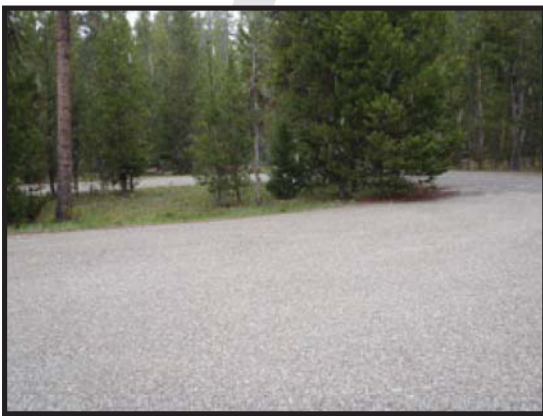
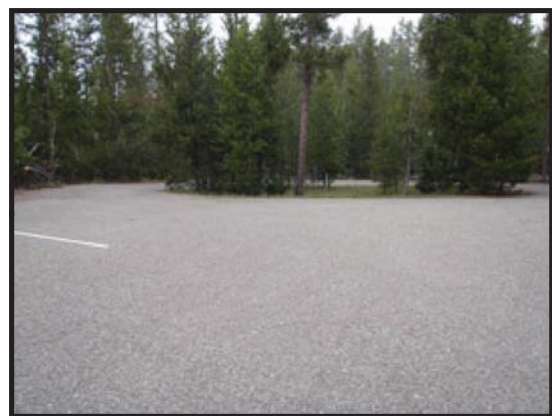
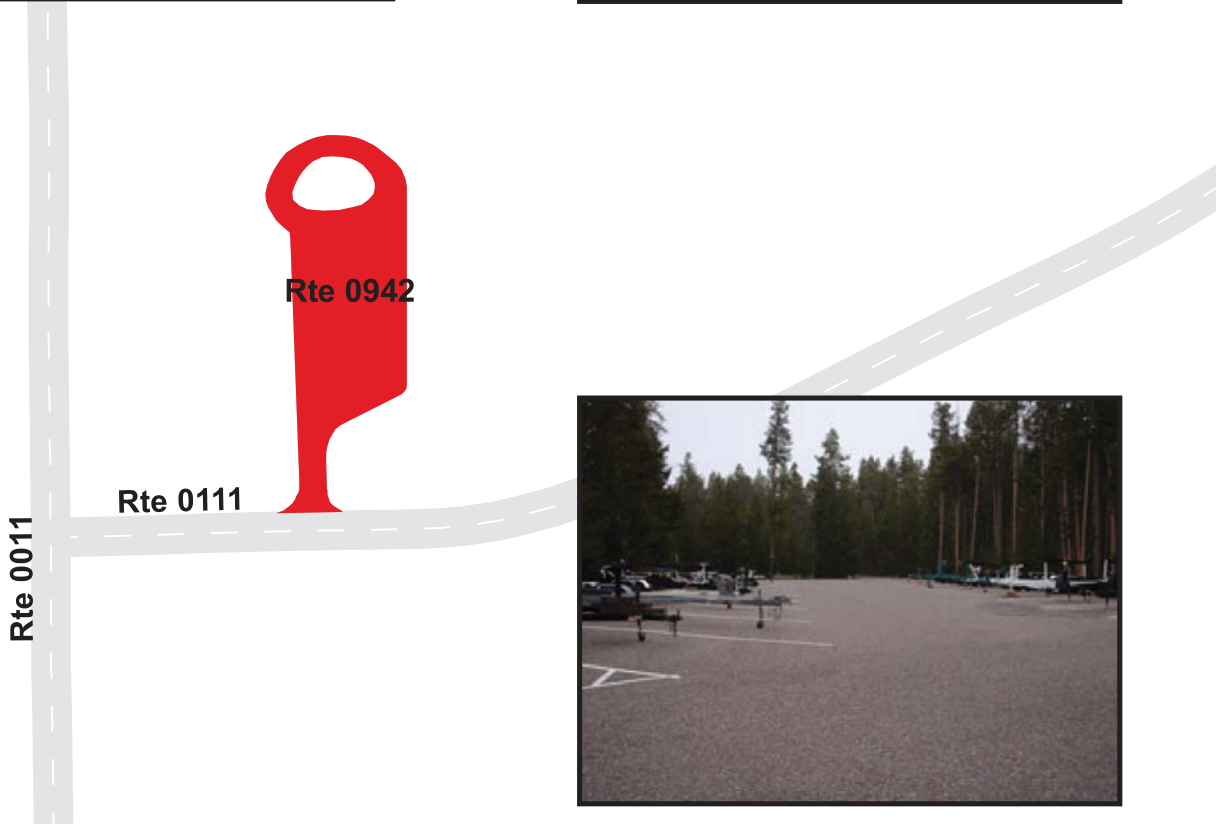
## Route 0942

Route Number	Public / NonPublic	Date Visited		Area (sq ft)	Lane Miles *	Surface Type
0942	PUBLIC	6/11/2008		20,375	0.35	AS
Culverts	Drop Inlets	Gates	Fire Hydrants	Curb & Gutter	Curb	PCR
0	0	0	0	NO CURB AND GUTTER	NO CURB	FAIR/73

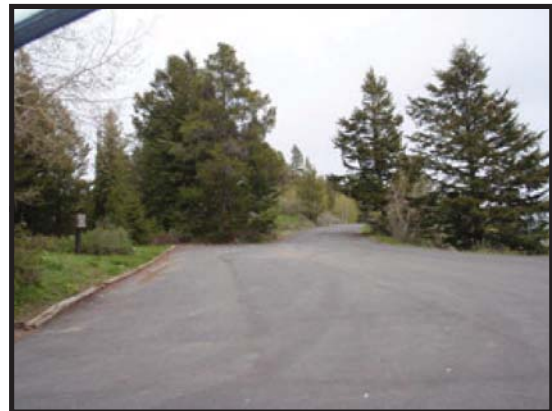
## Route 0943

Route Number	Public / NonPublic	Date Visited		Area (sq ft)	Lane Miles *	Surface Type
0943	PUBLIC	6/11/2008		1,534	0.03	AS
Culverts	Drop Inlets	Gates	Fire Hydrants	Curb & Gutter	Curb	PCR
0	0	0	0	NO CURB AND GUTTER	WOOD CURB	FAIR/73

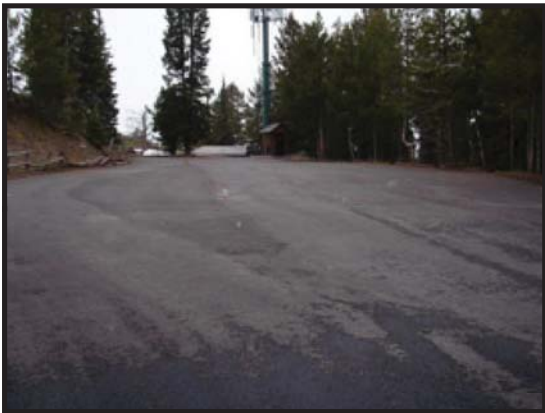
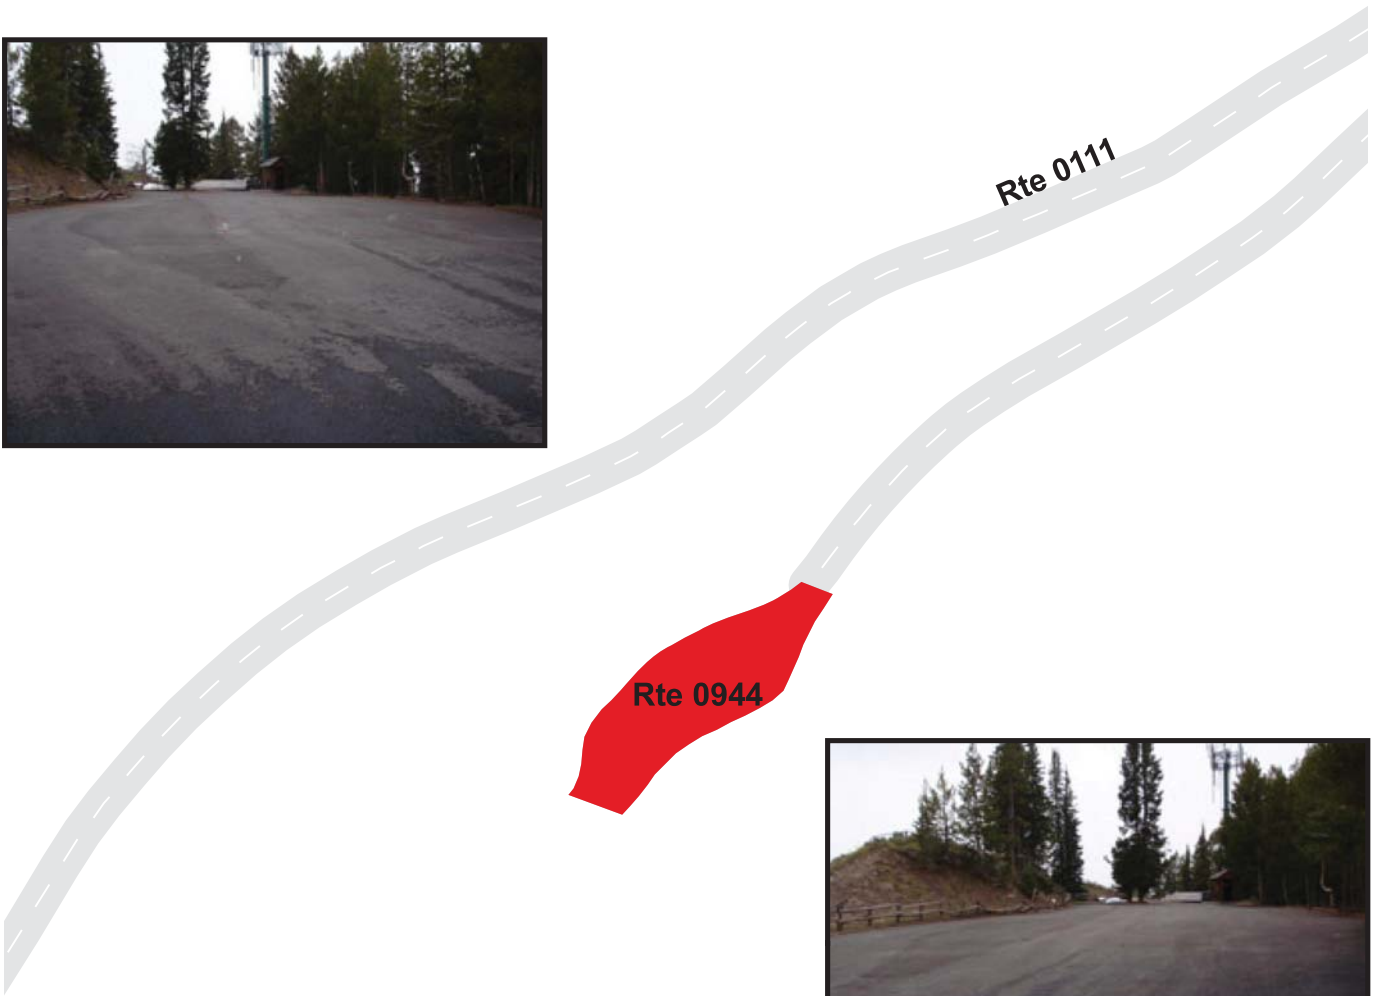
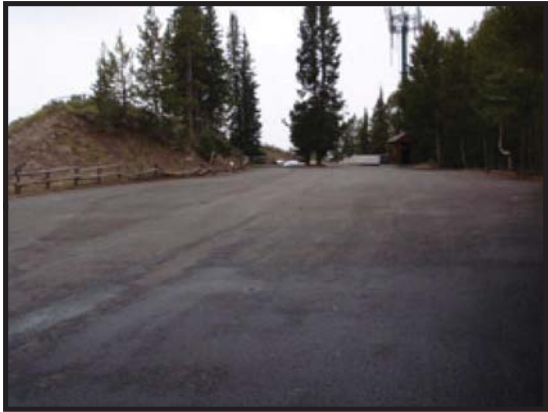
## Route 0944

Route Number	Public / NonPublic	Date Visited		Area (sq ft)	Lane Miles *	Surface Type
0944	PUBLIC	6/11/2008		9,760	0.17	AS
Culverts	Drop Inlets	Gates	Fire Hydrants	Curb & Gutter	Curb	PCR
0	0	0	0	NO CURB AND GUTTER	WOOD CURB	GOOD/90
