**The Road Inventory  
of  
Grand Teton National Park  
GRTE – 1460  
Cycle 4**

**Prepared By:  
Federal Highway Administration  
Road Inventory Program  
Cycle 4**

# Grand Teton National Park in Wyoming

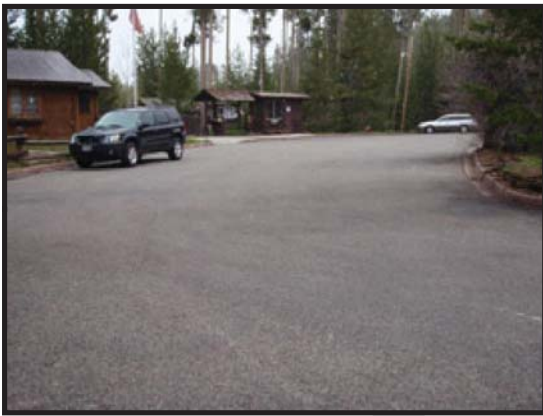
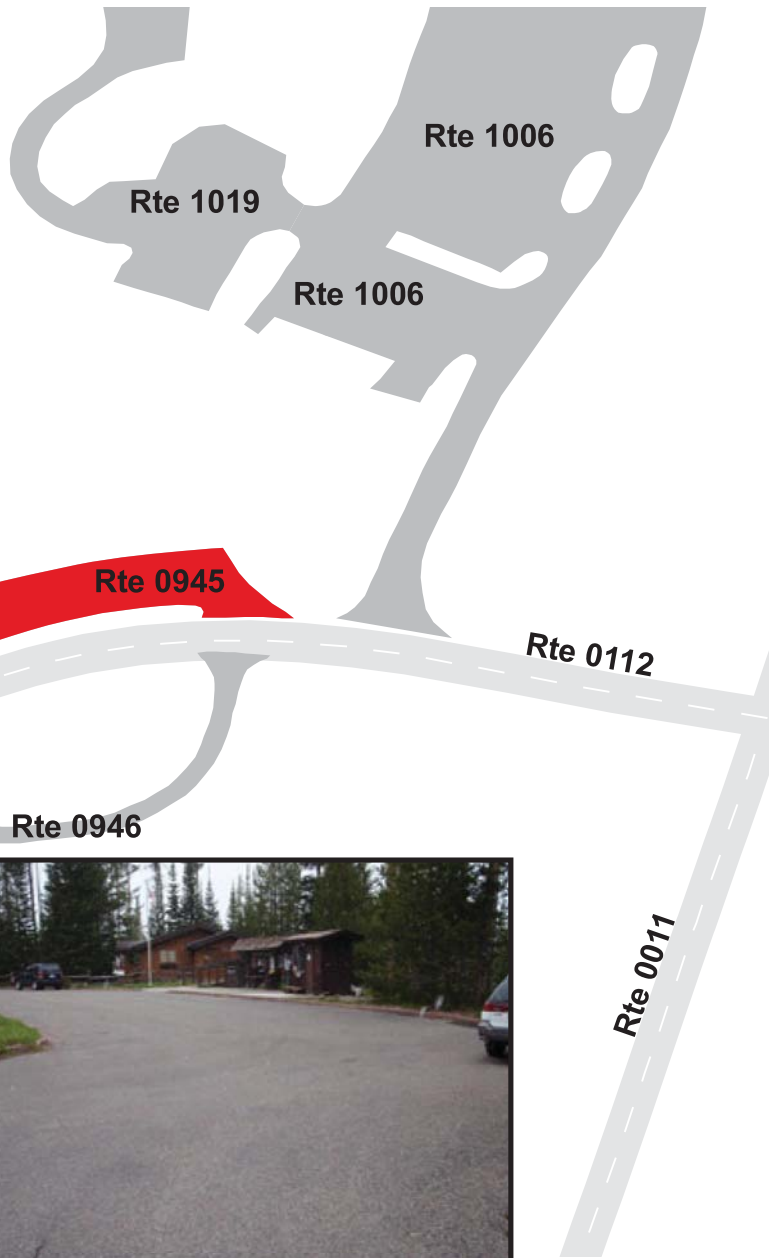
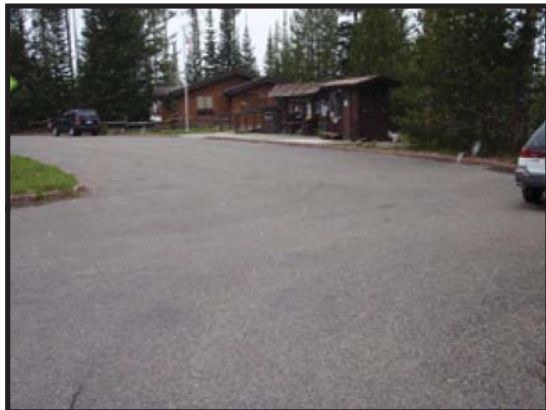
## Route 0945

Route Number	Public / NonPublic	Date Visited		Area (sq ft)	Lane Miles *	Surface Type
0945	NONPUBLIC	6/11/2008		7,158	0.12	AS
Culverts	Drop Inlets	Gates	Fire Hydrants	Curb & Gutter	Curb	PCR
0	0	0	1	CONCRETE CURB AND GUTTER	ASPHALT CURB	FAIR/73

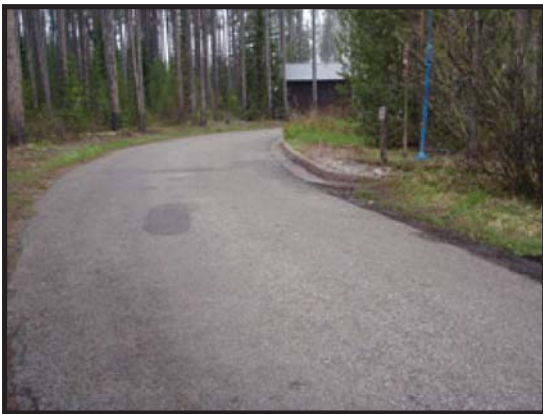
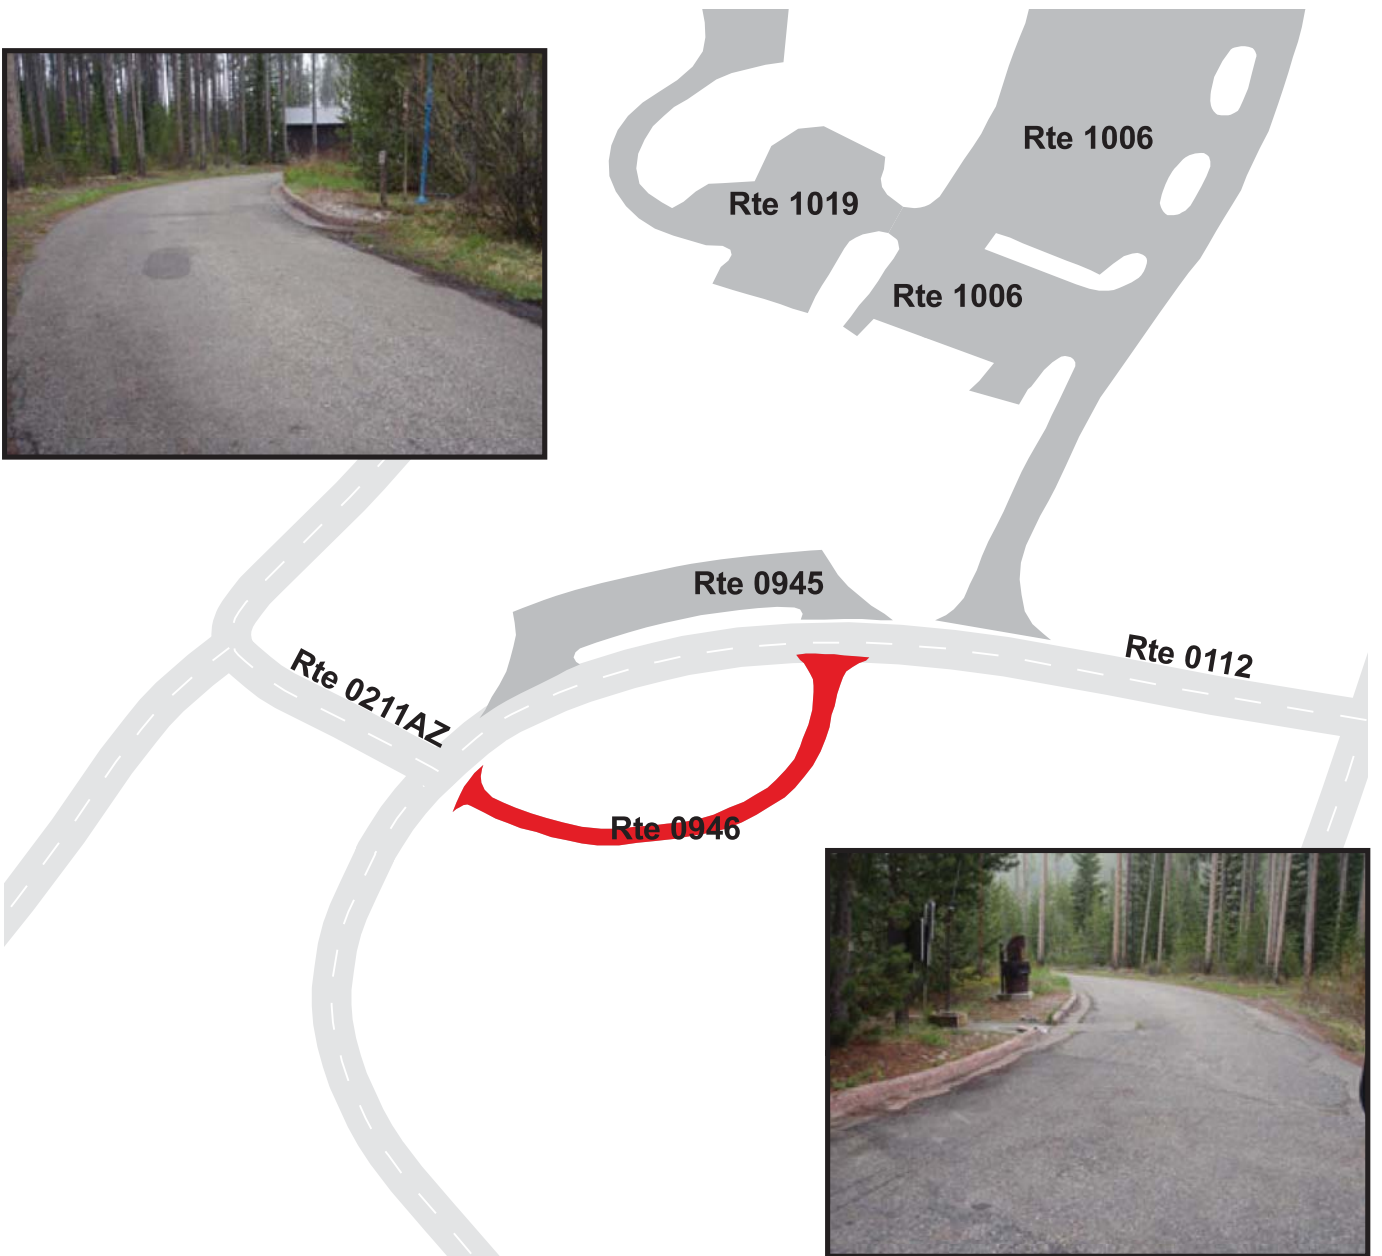
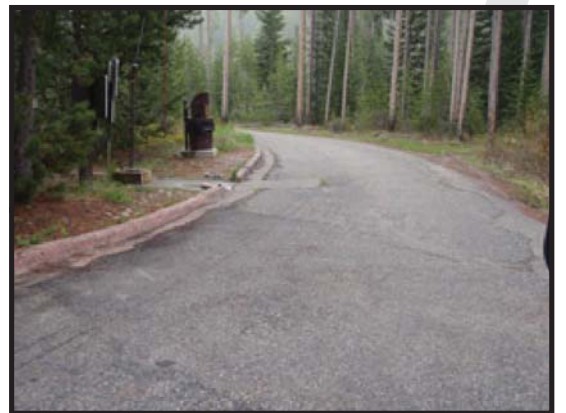
## Route 0946

Route Number	Public / NonPublic	Date Visited		Area (sq ft)	Lane Miles *	Surface Type
0946	PUBLIC	6/11/2008		3,250	0.06	AS
Culverts	Drop Inlets	Gates	Fire Hydrants	Curb & Gutter	Curb	PCR
0	0	0	0	CONCRETE CURB AND GUTTER	ASPHALT CURB	FAIR/73

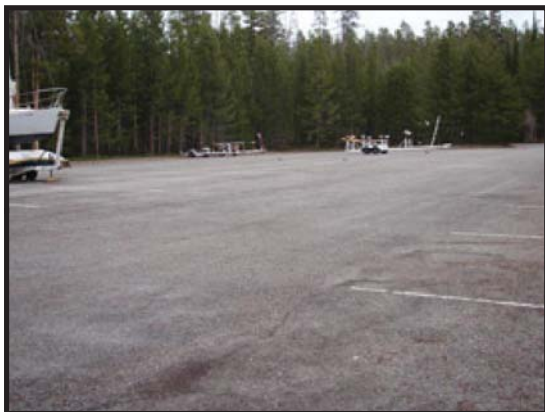
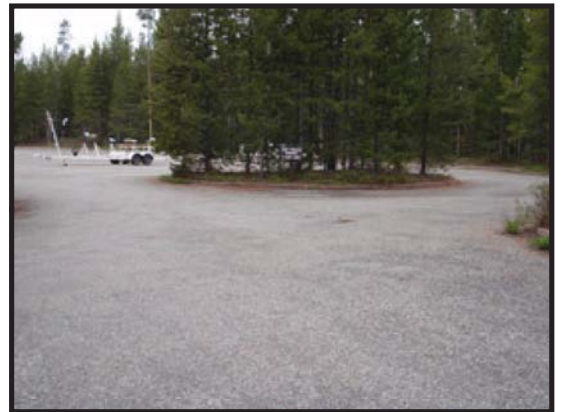
## Route 0947

Route Number	Public / NonPublic	Date Visited		Area (sq ft)	Lane Miles *	Surface Type
0947	PUBLIC	6/11/2008		37,347	0.64	AS
Culverts	Drop Inlets	Gates	Fire Hydrants	Curb & Gutter	Curb	PCR
0	2	0	0	CONCRETE CURB AND GUTTER	ASPHALT CURB	FAIR/73

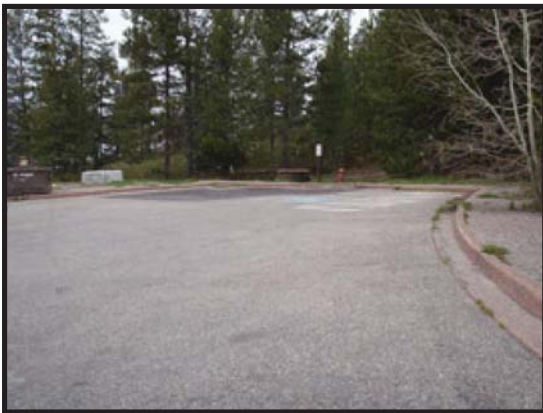
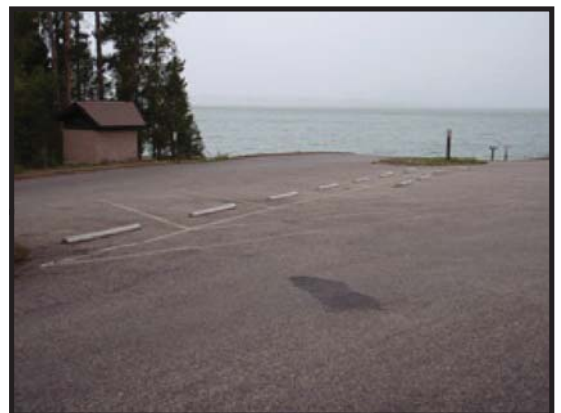
## Route 0948AZ

Route Number	Public / NonPublic	Date Visited		Area (sq ft)	Lane Miles *	Surface Type
0948AZ	PUBLIC	6/11/2008		3,923	0.07	AS
Culverts	Drop Inlets	Gates	Fire Hydrants	Curb & Gutter	Curb	PCR
0	0	0	0	CONCRETE CURB AND GUTTER	ASPHALT CURB	FAIR/73

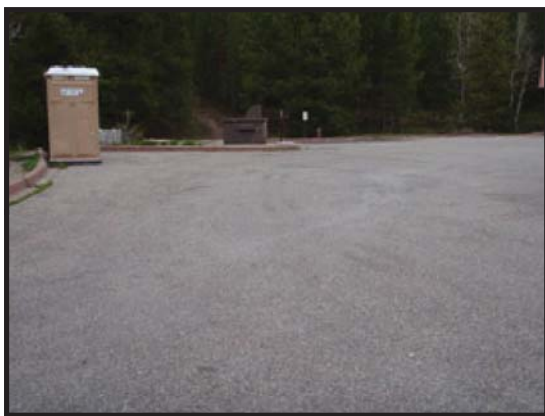
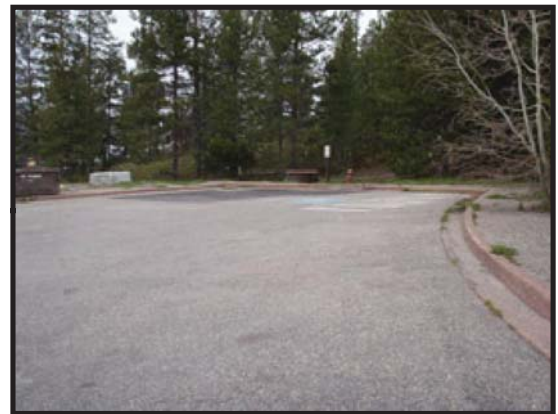
## Route 0948BZ

Route Number	Public / NonPublic	Date Visited		Area (sq ft)	Lane Miles *	Surface Type
0948BZ	PUBLIC	6/11/2008		5,440	0.09	AS
Culverts	Drop Inlets	Gates	Fire Hydrants	Curb & Gutter	Curb	PCR
0	0	0	1	CONCRETE CURB AND GUTTER	ASPHALT CURB	FAIR/73

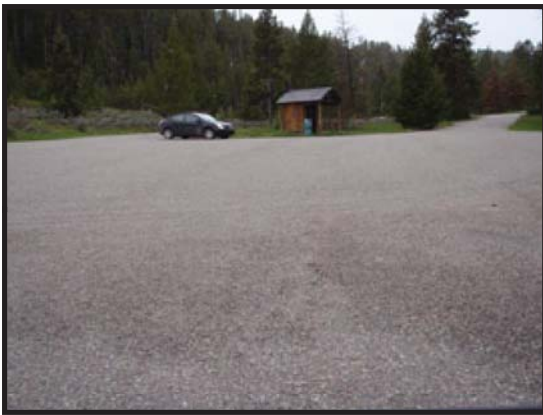
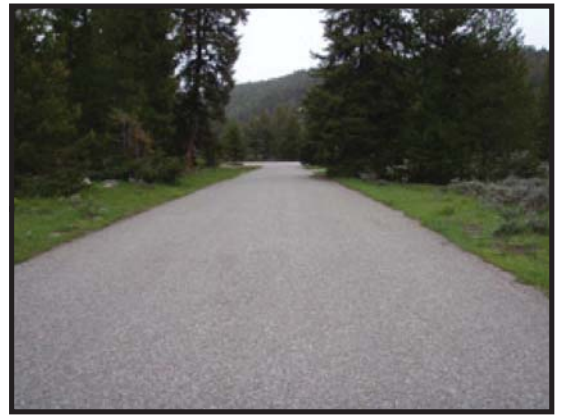
## Route 0949

Route Number	Public / NonPublic	Date Visited		Area (sq ft)	Lane Miles *	Surface Type
0949	PUBLIC	6/11/2008		28,177	0.49	AS
Culverts	Drop Inlets	Gates	Fire Hydrants	Curb & Gutter	Curb	PCR
0	0	0	0	NO CURB AND GUTTER	NO CURB	FAIR/73

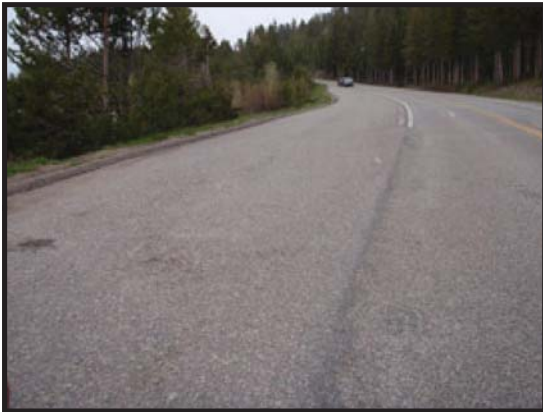
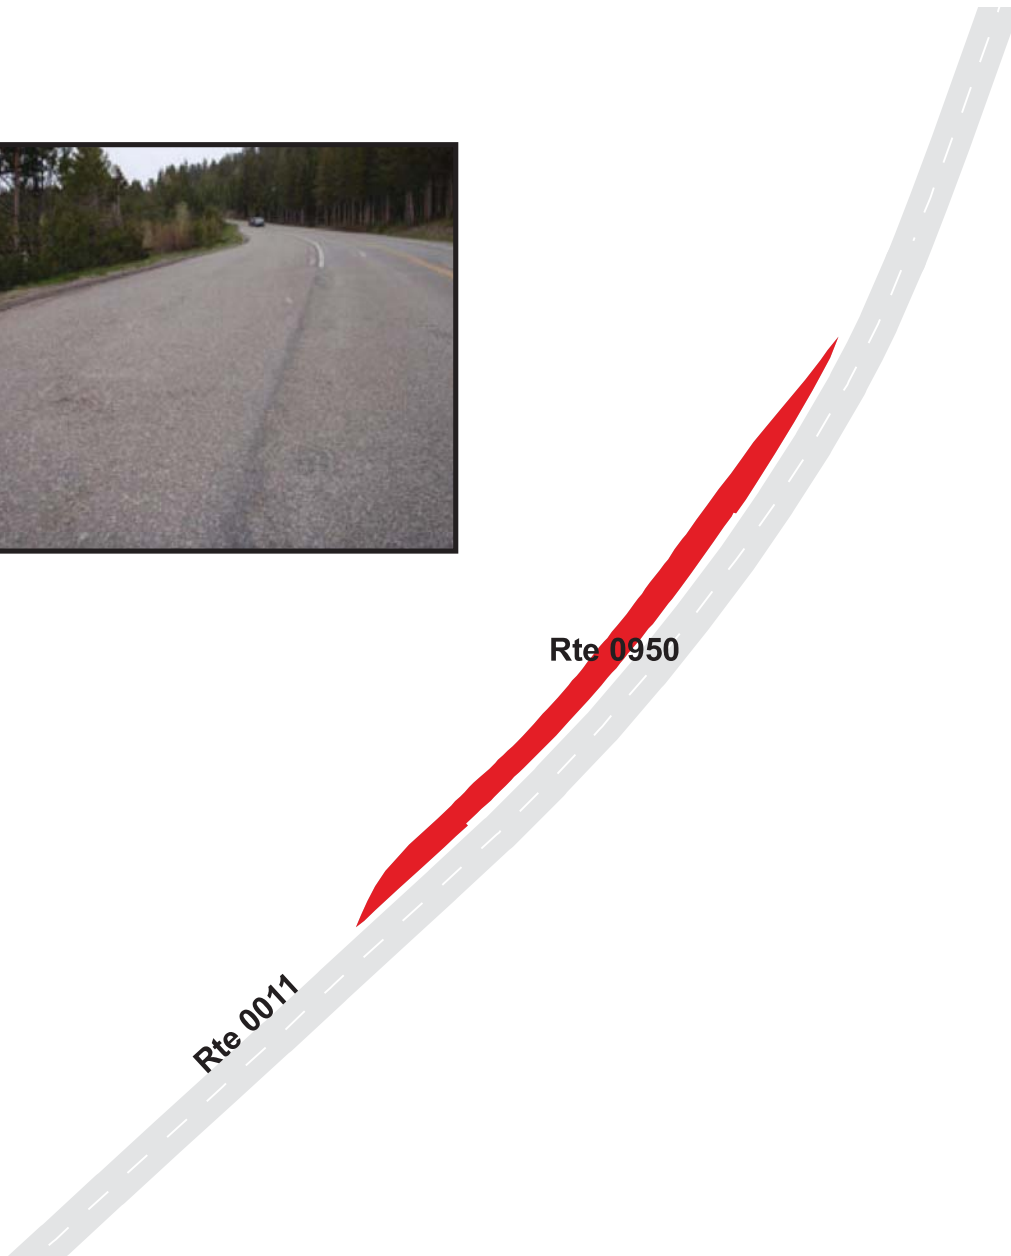
## Route 0950

Route Number	Public / NonPublic	Date Visited		Area (sq ft)	Lane Miles *	Surface Type
0950	PUBLIC	6/11/2008		8,142	0.14	AS
Culverts	Drop Inlets	Gates	Fire Hydrants	Curb & Gutter	Curb	PCR
0	0	0	0	NO CURB AND GUTTER	ASPHALT CURB	GOOD/90

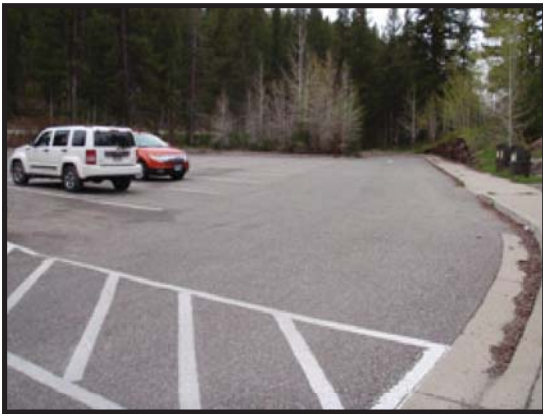
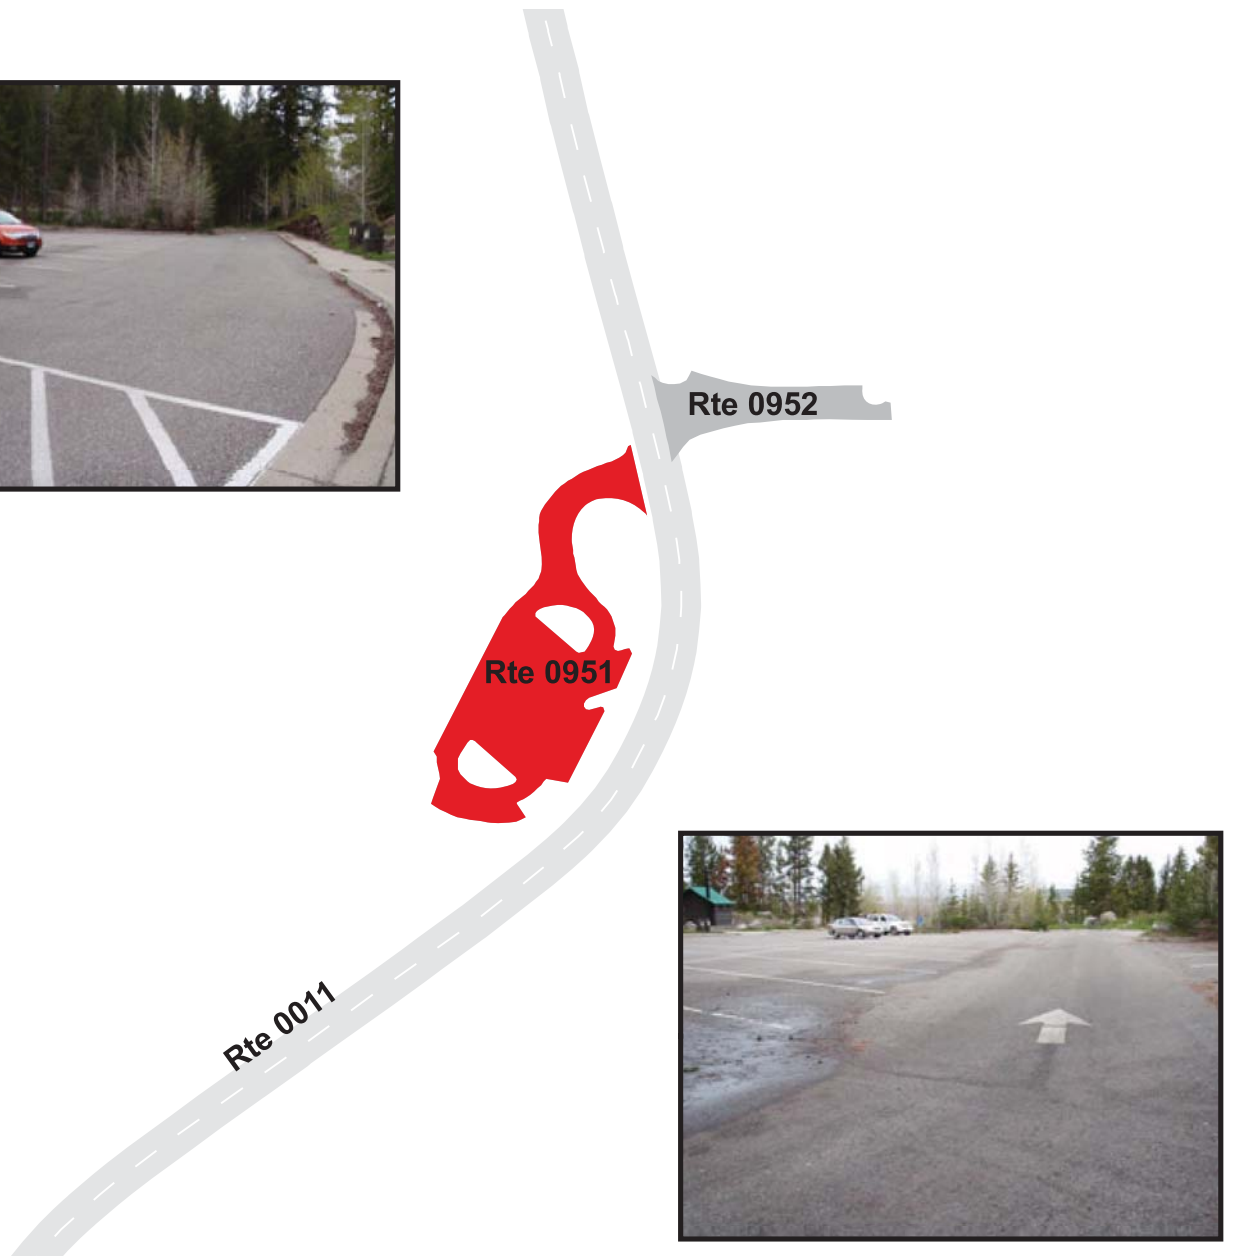
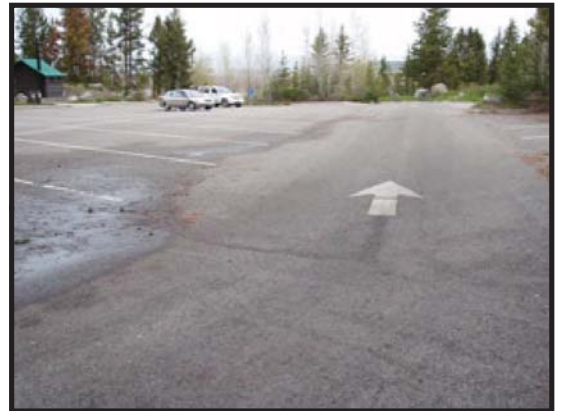
## Route 0951

Route Number	Public / NonPublic	Date Visited		Area (sq ft)	Lane Miles *	Surface Type
0951	PUBLIC	6/11/2008		31,284	0.54	AS
Culverts	Drop Inlets	Gates	Fire Hydrants	Curb & Gutter	Curb	PCR
0	0	0	0	CONCRETE CURB AND GUTTER	CONCRETE CURB	GOOD/90

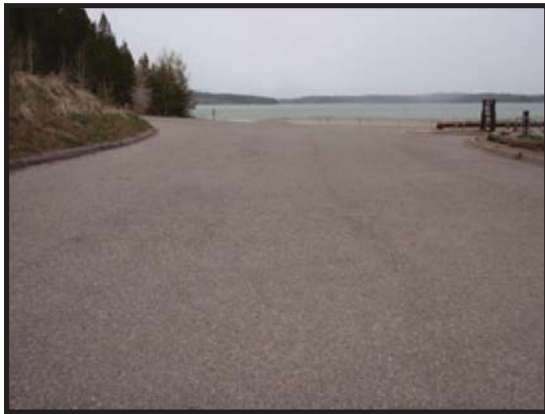
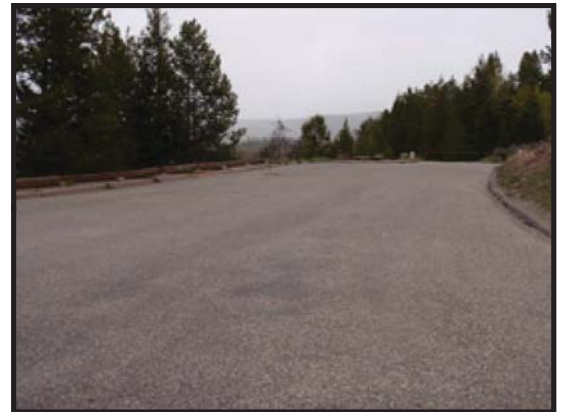
## Route 0952

Route Number	Public / NonPublic	Date Visited		Area (sq ft)	Lane Miles *	Surface Type
0952	PUBLIC	6/11/2008		9,322	0.16	AS
Culverts	Drop Inlets	Gates	Fire Hydrants	Curb & Gutter	Curb	PCR
0	1	1	0	CONCRETE CURB AND GUTTER	ASPHALT & CONCRETE	GOOD/90

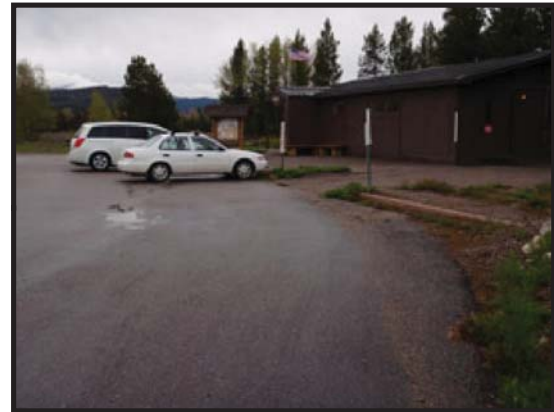
Route Number	Public / NonPublic	Date Visited		Area (sq ft)	Lane Miles *	Surface Type
0953AZ	PUBLIC	6/10/2008		2,401	0.04	AS
Culverts	Drop Inlets	Gates	Fire Hydrants	Curb & Gutter	Curb	PCR
0	0	0	0	NO CURB AND GUTTER	ASPHALT CURB	GOOD/90

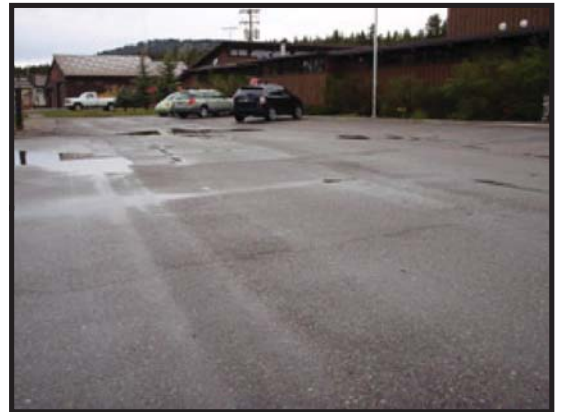
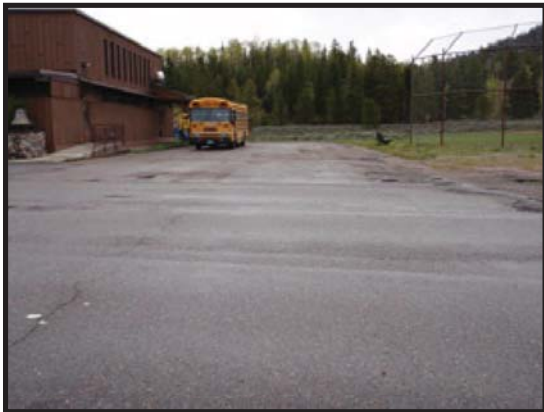
## Route 0953BZ

Route Number	Public / NonPublic	Date Visited		Area (sq ft)	Lane Miles *	Surface Type
0953BZ	PUBLIC	6/10/2008		10,479	0.18	AS
Culverts	Drop Inlets	Gates	Fire Hydrants	Curb & Gutter	Curb	PCR
0	0	0	0	NO CURB AND GUTTER	NO CURB	POOR/45

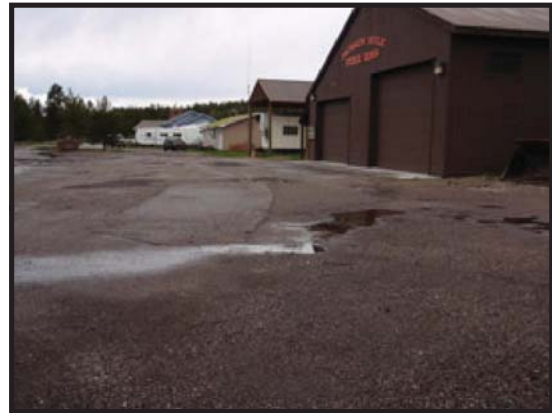
## Route 0953CZ

Route Number	Public / NonPublic	Date Visited		Area (sq ft)	Lane Miles *	Surface Type
0953CZ	PUBLIC	6/10/2008		8,269	0.14	AS
Culverts	Drop Inlets	Gates	Fire Hydrants	Curb & Gutter	Curb	PCR
0	0	0	0	NO CURB AND GUTTER	NO CURB	POOR/45

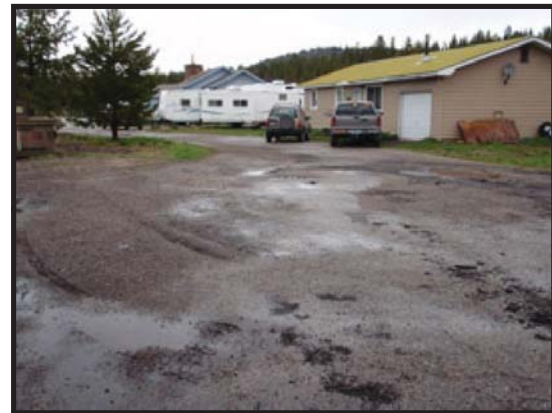
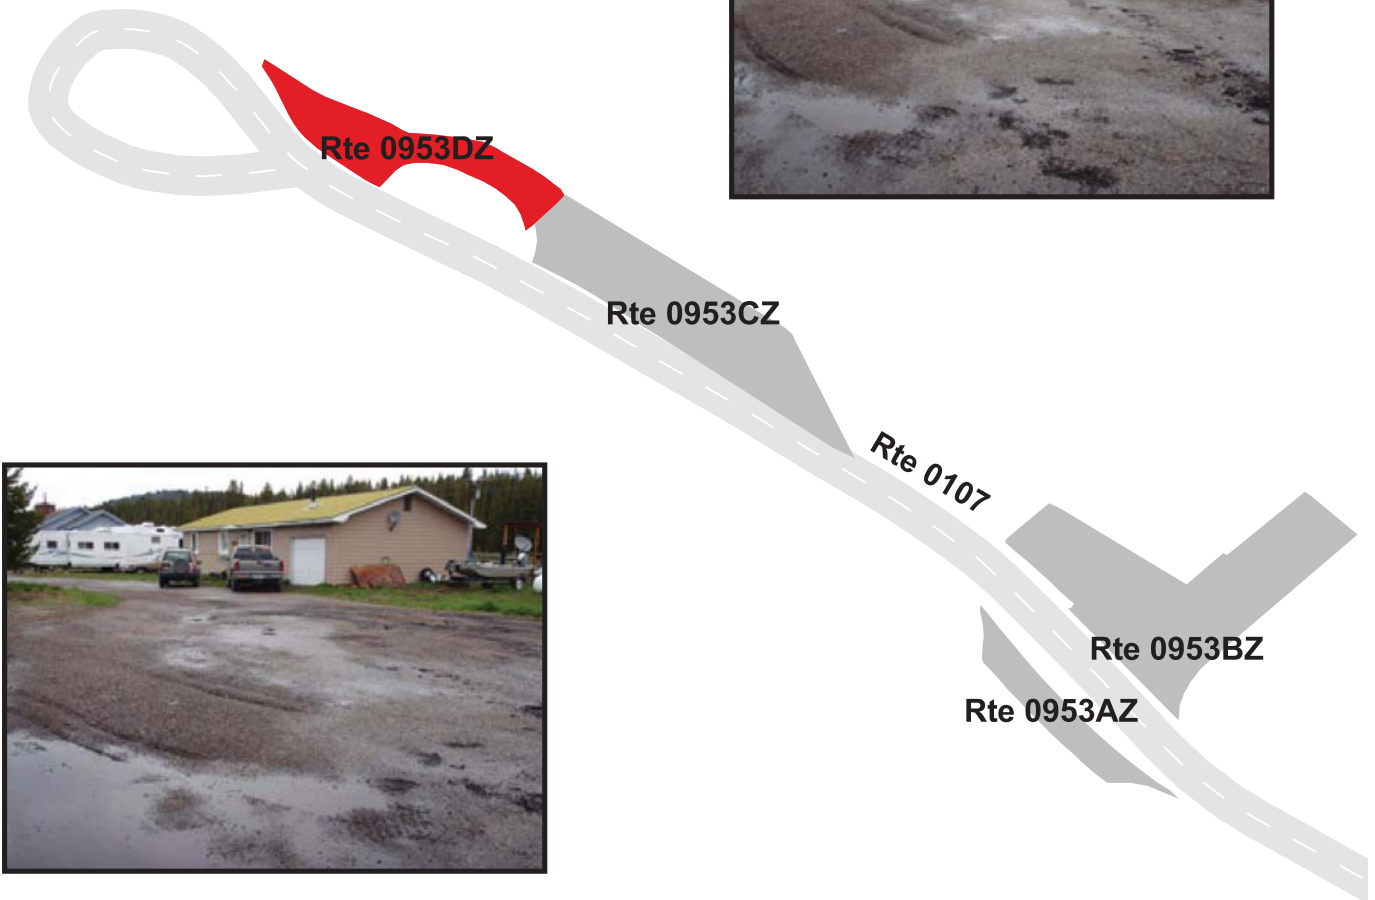
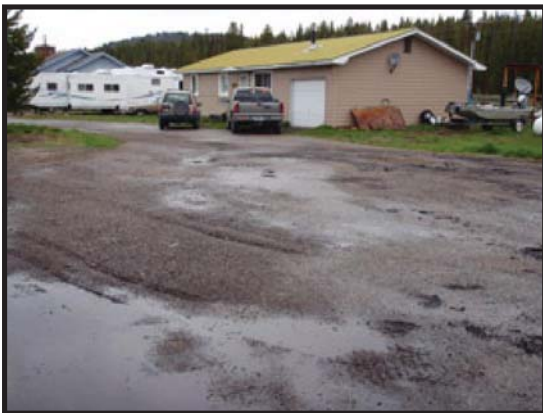
## Route 0953DZ

Route Number	Public / NonPublic	Date Visited		Area (sq ft)	Lane Miles *	Surface Type
0953DZ	PUBLIC	6/10/2008		4,478	0.08	AS
Culverts	Drop Inlets	Gates	Fire Hydrants	Curb & Gutter	Curb	PCR
0	0	0	0	NO CURB AND GUTTER	NO CURB	POOR/45

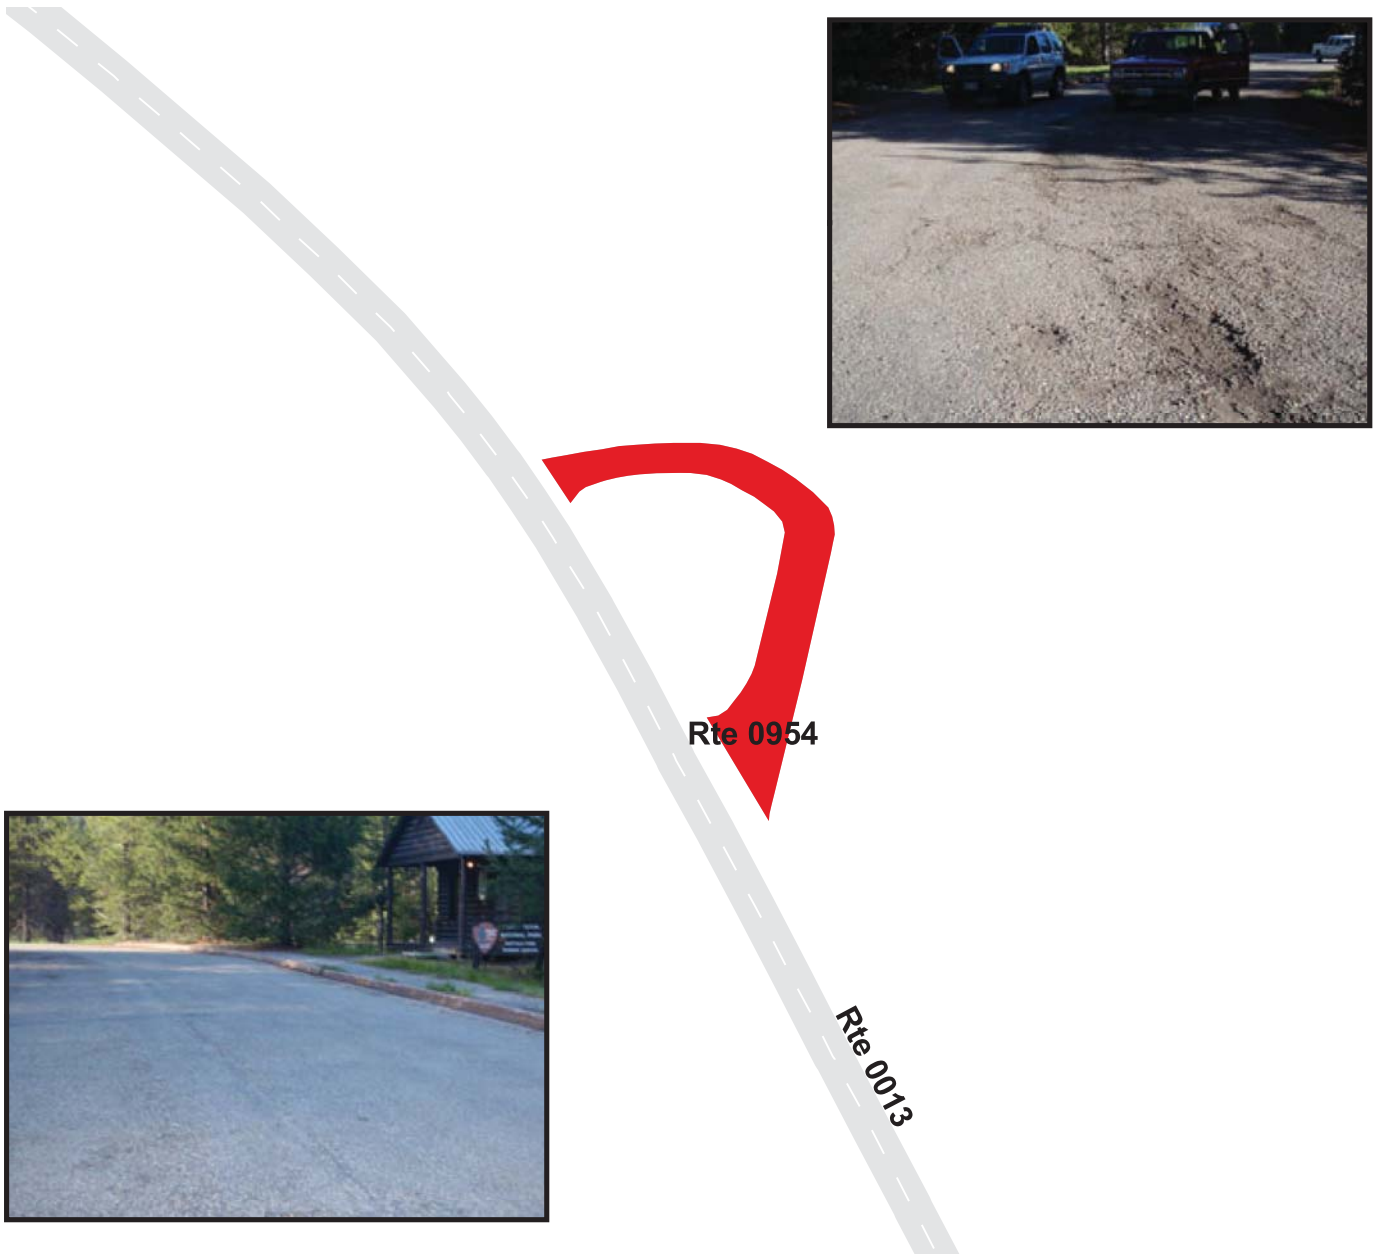
## Route 0954

Route Number	Public / NonPublic	Date Visited		Area (sq ft)	Lane Miles *	Surface Type
0954	PUBLIC	6/13/2008		7,615	0.13	AS
Culverts	Drop Inlets	Gates	Fire Hydrants	Curb & Gutter	Curb	PCR
0	0	0	0	CONCRETE CURB AND GUTTER	CONCRETE CURB	POOR/45

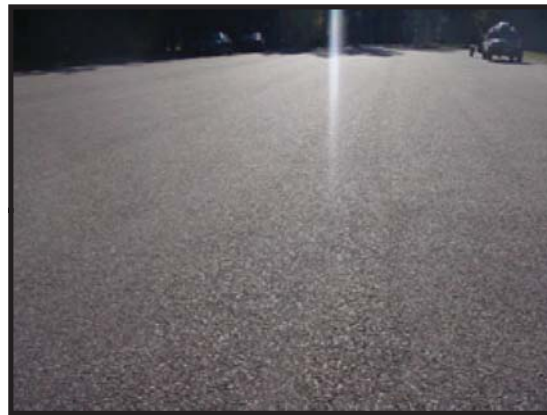
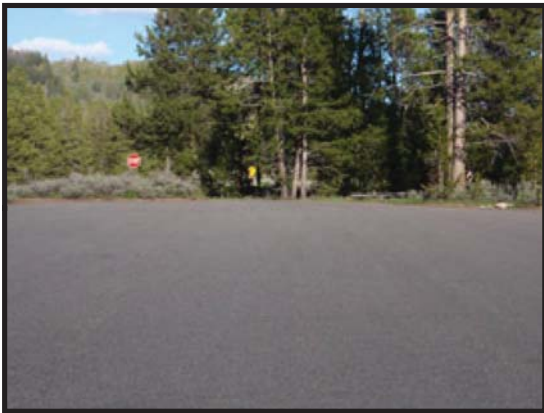
Route Number	Public / NonPublic	Date Visited		Area (sq ft)	Lane Miles *	Surface Type
0955	PUBLIC	6/13/2008		24,314	0.42	AS
Culverts	Drop Inlets	Gates	Fire Hydrants	Curb & Gutter	Curb	PCR
0	1	0	0	NO CURB AND GUTTER	CONCRETE CURB	FAIR/73

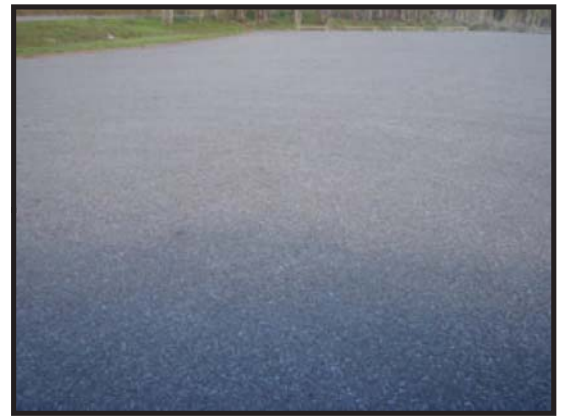
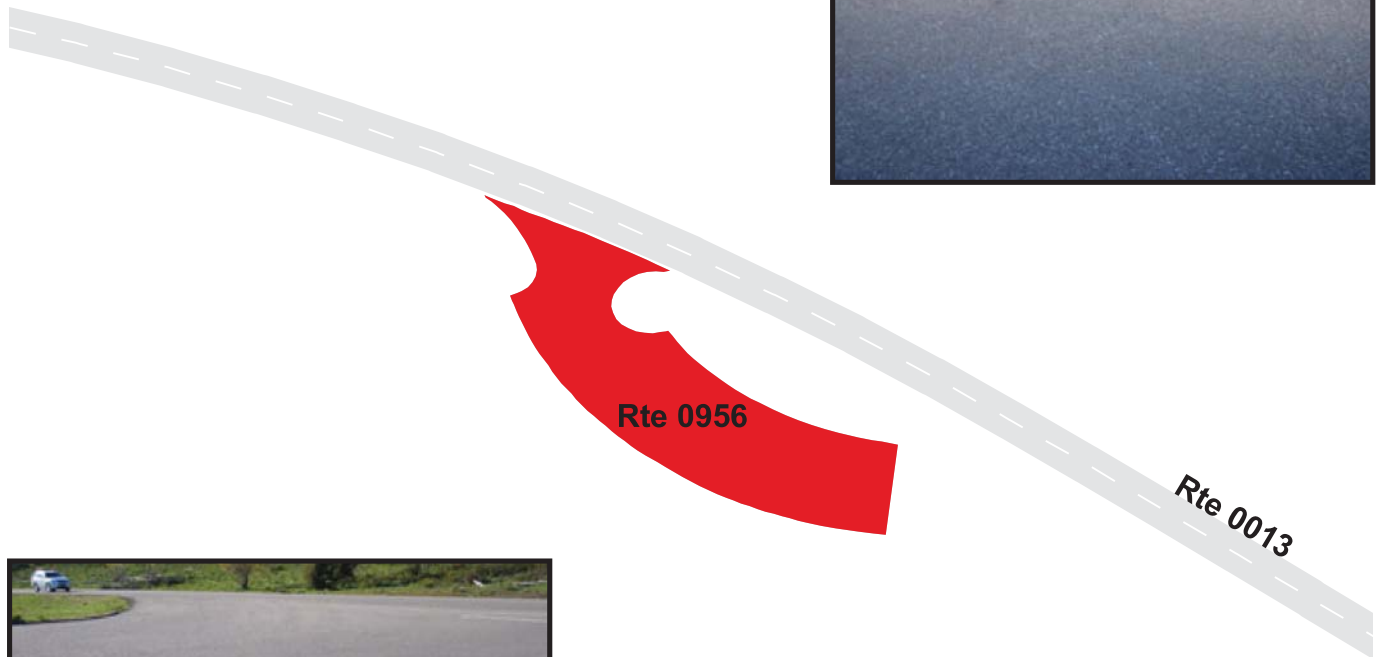
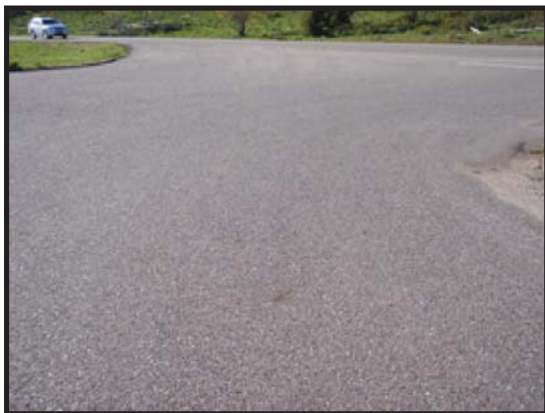
## Route 0956

Route Number	Public / NonPublic	Date Visited		Area (sq ft)	Lane Miles *	Surface Type
0956	PUBLIC	6/13/2008		18,563	0.32	AS
Culverts	Drop Inlets	Gates	Fire Hydrants	Curb & Gutter	Curb	PCR
0	1	0	0	NO CURB AND GUTTER	ASPHALT CURB	GOOD/90

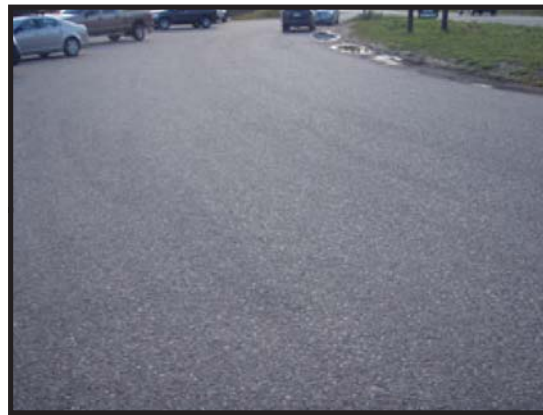
## Route 0957

Route Number	Public / NonPublic	Date Visited		Area (sq ft)	Lane Miles *	Surface Type
0957	PUBLIC	6/13/2008		11,279	0.19	AS
Culverts	Drop Inlets	Gates	Fire Hydrants	Curb & Gutter	Curb	PCR
2	0	0	0	NO CURB AND GUTTER	ASPHALT CURB	FAIR/73

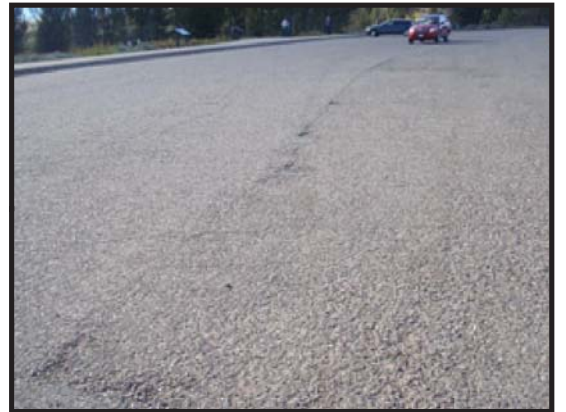
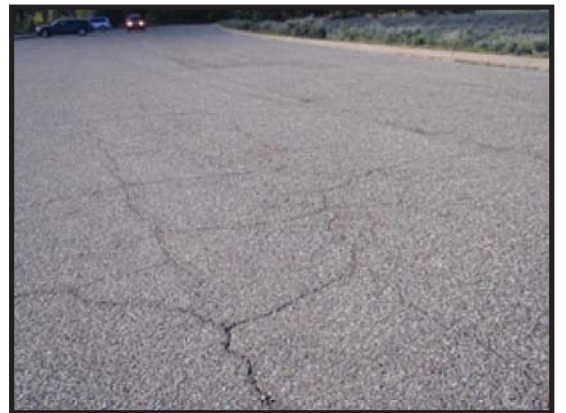
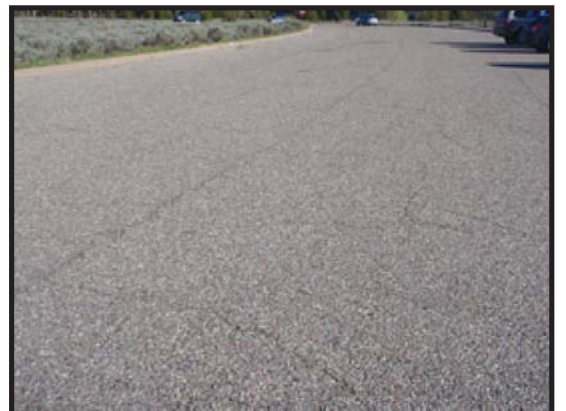
Route Number	Public / NonPublic	Date Visited		Area (sq ft)	Lane Miles *	Surface Type
0959	PUBLIC	6/13/2008		28,501	0.49	AS
Culverts	Drop Inlets	Gates	Fire Hydrants	Curb & Gutter	Curb	PCR
0	1	0	0	CONCRETE CURB AND GUTTER	CONCRETE CURB	FAIR/73

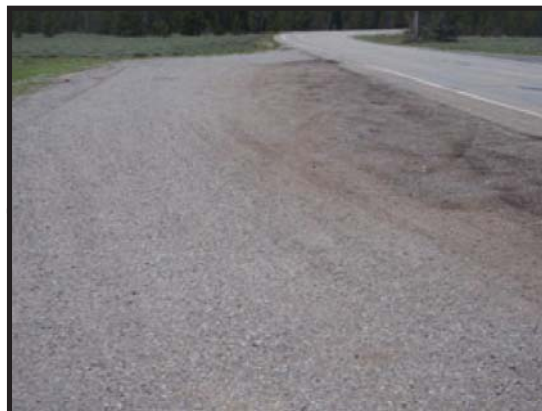
## Route 0963

Route Number	Public / NonPublic	Date Visited		Area (sq ft)	Lane Miles *	Surface Type
0963	PUBLIC	6/13/2008		2,337	0.04	AS
Culverts	Drop Inlets	Gates	Fire Hydrants	Curb & Gutter	Curb	PCR
0	0	0	0	NO CURB AND GUTTER	NO CURB	POOR/45

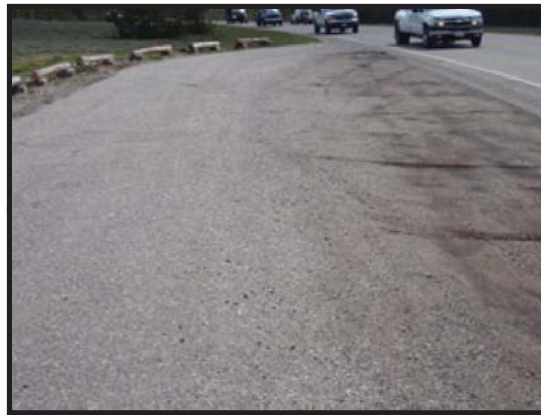
## Route 0964

Route Number	Public / NonPublic	Date Visited		Area (sq ft)	Lane Miles *	Surface Type
0964	PUBLIC	6/13/2008		2,596	0.05	AS
Culverts	Drop Inlets	Gates	Fire Hydrants	Curb & Gutter	Curb	PCR
0	0	0	0	NO CURB AND GUTTER	NO CURB	POOR/45

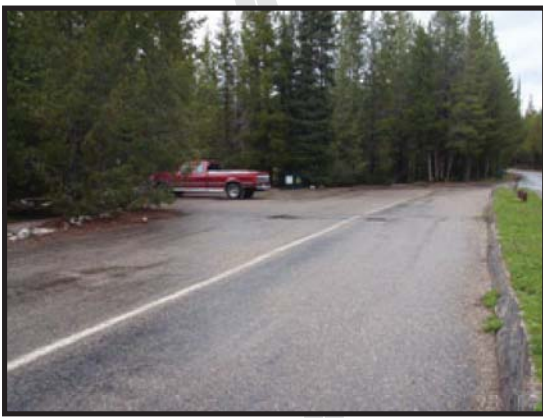
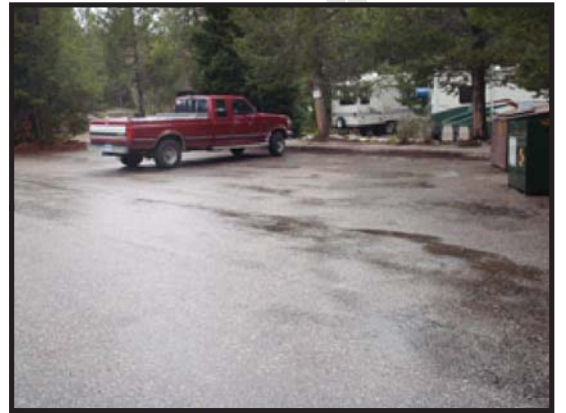
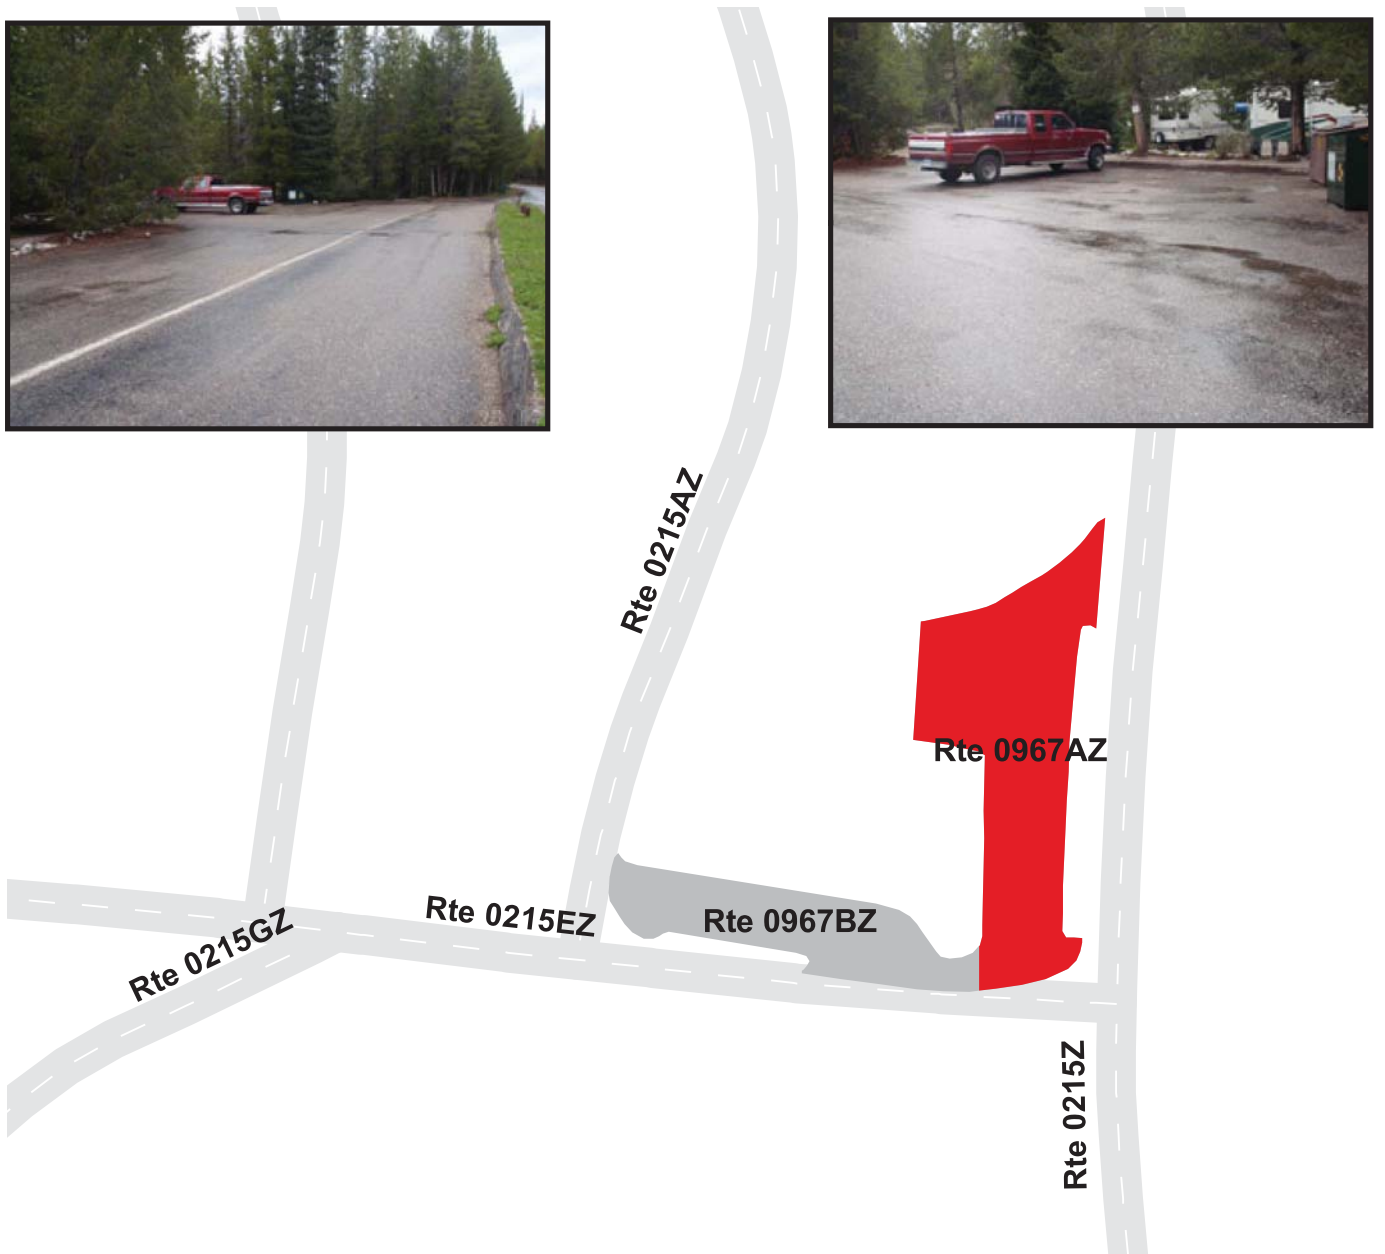
Route Number	Public / NonPublic	Date Visited		Area (sq ft)	Lane Miles *	Surface Type
0967AZ	PUBLIC	6/13/2008		8,245	0.14	AS
Culverts	Drop Inlets	Gates	Fire Hydrants	Curb & Gutter	Curb	PCR
0	0	0	0	NO CURB AND GUTTER	WOOD CURB	POOR/45

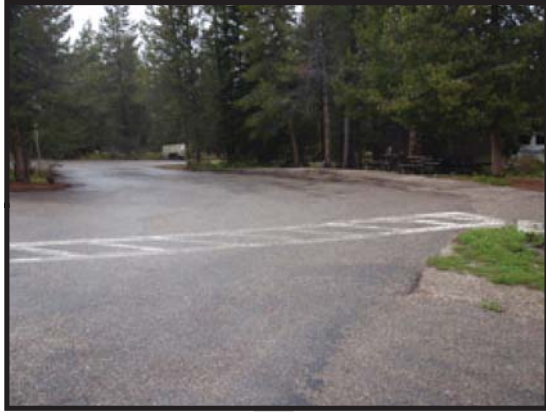
## Route 0967BZ

Route Number	Public / NonPublic	Date Visited		Area (sq ft)	Lane Miles *	Surface Type
0967BZ	PUBLIC	6/13/2008		4,234	0.07	AS
Culverts	Drop Inlets	Gates	Fire Hydrants	Curb & Gutter	Curb	PCR
0	0	0	0	NO CURB AND GUTTER	WOOD CURB	POOR/45

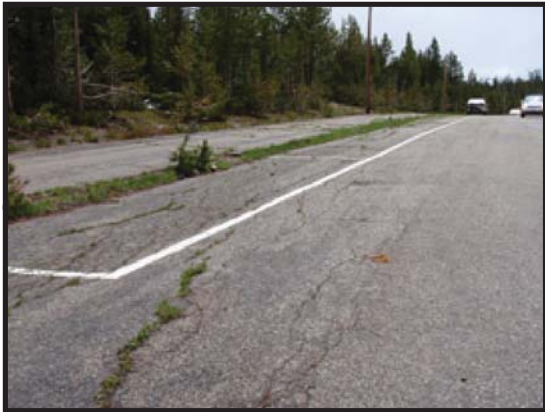
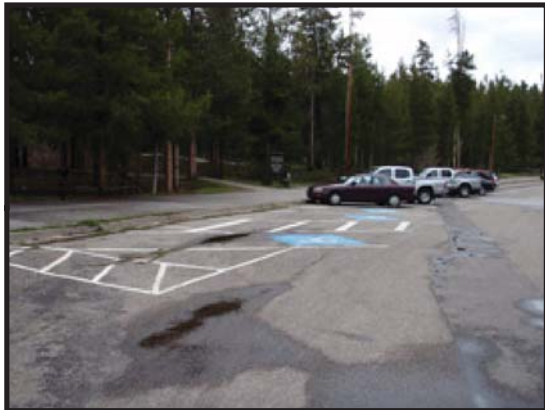
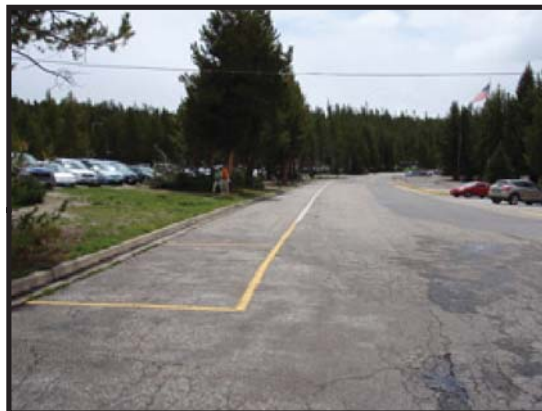
## Route 0968

Route Number	Public / NonPublic	Date Visited		Area (sq ft)	Lane Miles *	Surface Type
0968	PUBLIC	6/12/2008		314,742	5.42	AS
Culverts	Drop Inlets	Gates	Fire Hydrants	Curb & Gutter	Curb	PCR
0	0	0	0	CONCRETE CURB AND GUTTER	CONCRETE CURB	POOR/45

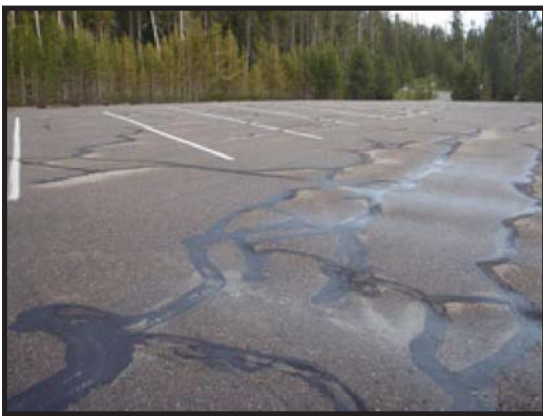
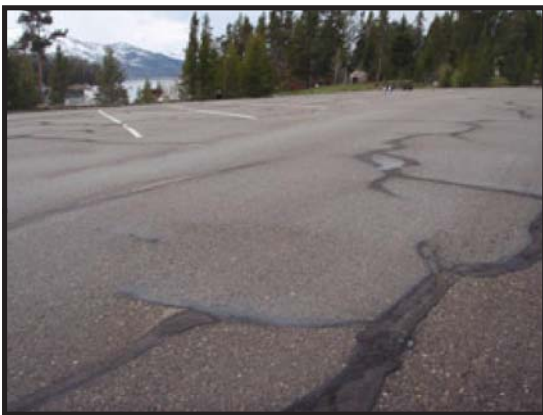
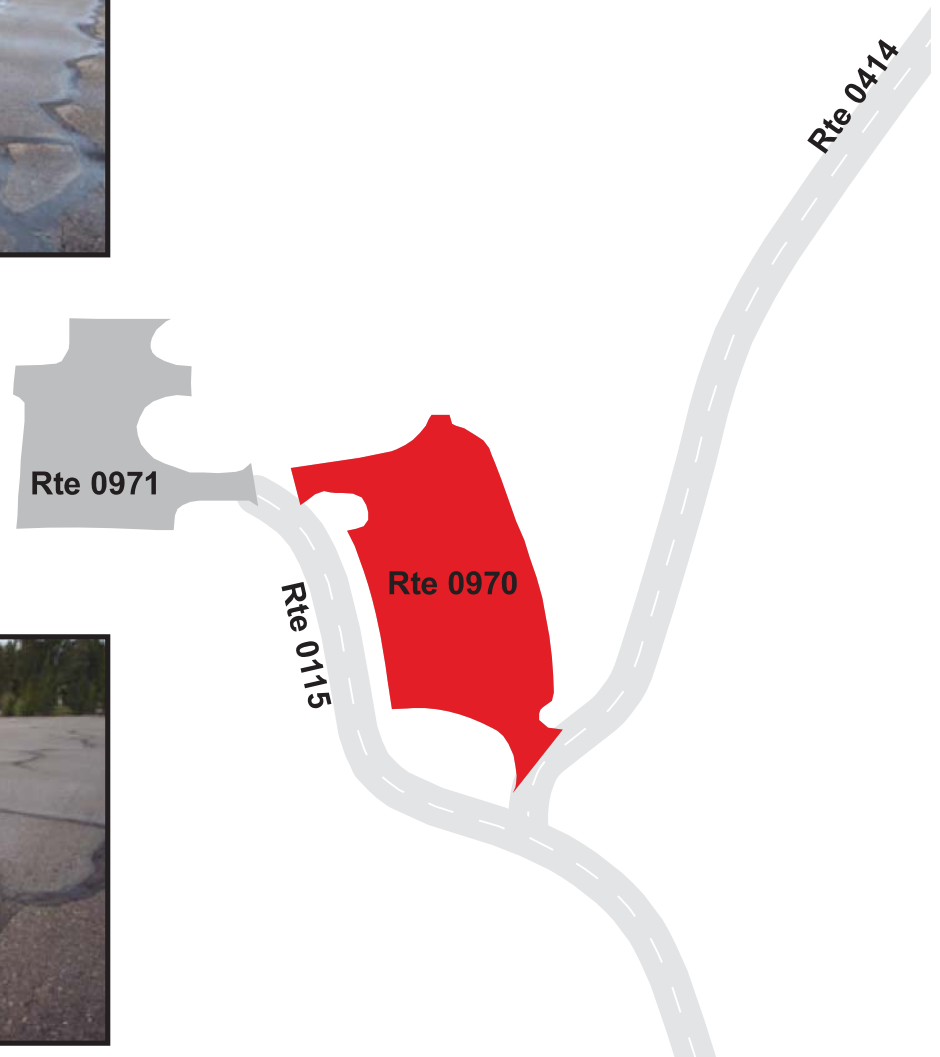
Route Number	Public / NonPublic	Date Visited		Area (sq ft)	Lane Miles *	Surface Type
0970	PUBLIC	6/12/2008		38,863	0.67	AS
Culverts	Drop Inlets	Gates	Fire Hydrants	Curb & Gutter	Curb	PCR
0	0	0	0	NO CURB AND GUTTER	NO CURB	FAIR/73
