**The Road Inventory  
of  
Grand Teton National Park  
GRTE – 1460  
Cycle 4**

**Prepared By:  
Federal Highway Administration  
Road Inventory Program  
Cycle 4**

# Grand Teton National Park in Wyoming

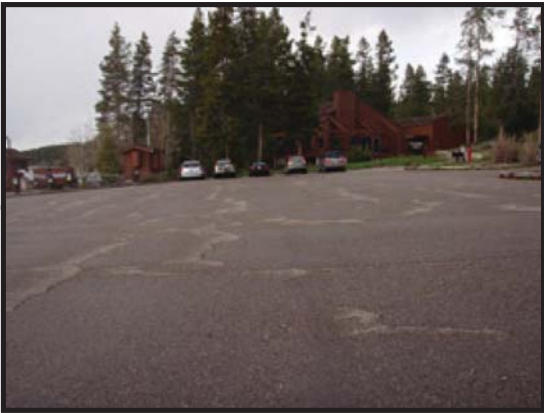
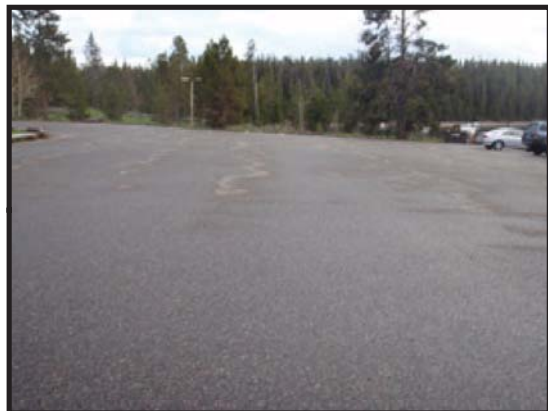
## Route 0971

Route Number	Public / NonPublic	Date Visited		Area (sq ft)	Lane Miles *	Surface Type
0971	PUBLIC	6/12/2008		24,420	0.42	AS
Culverts	Drop Inlets	Gates	Fire Hydrants	Curb & Gutter	Curb	PCR
0	0	0	0	NO CURB AND GUTTER	ASPHALT CURB	FAIR/73

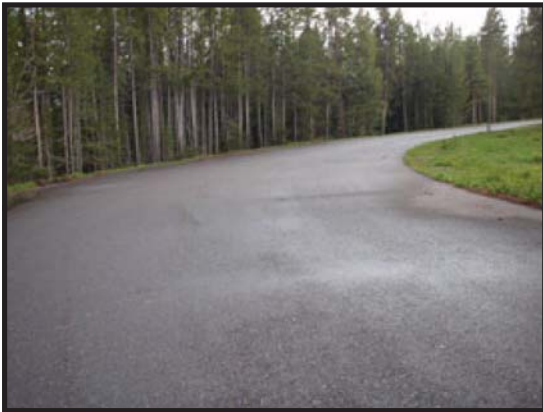
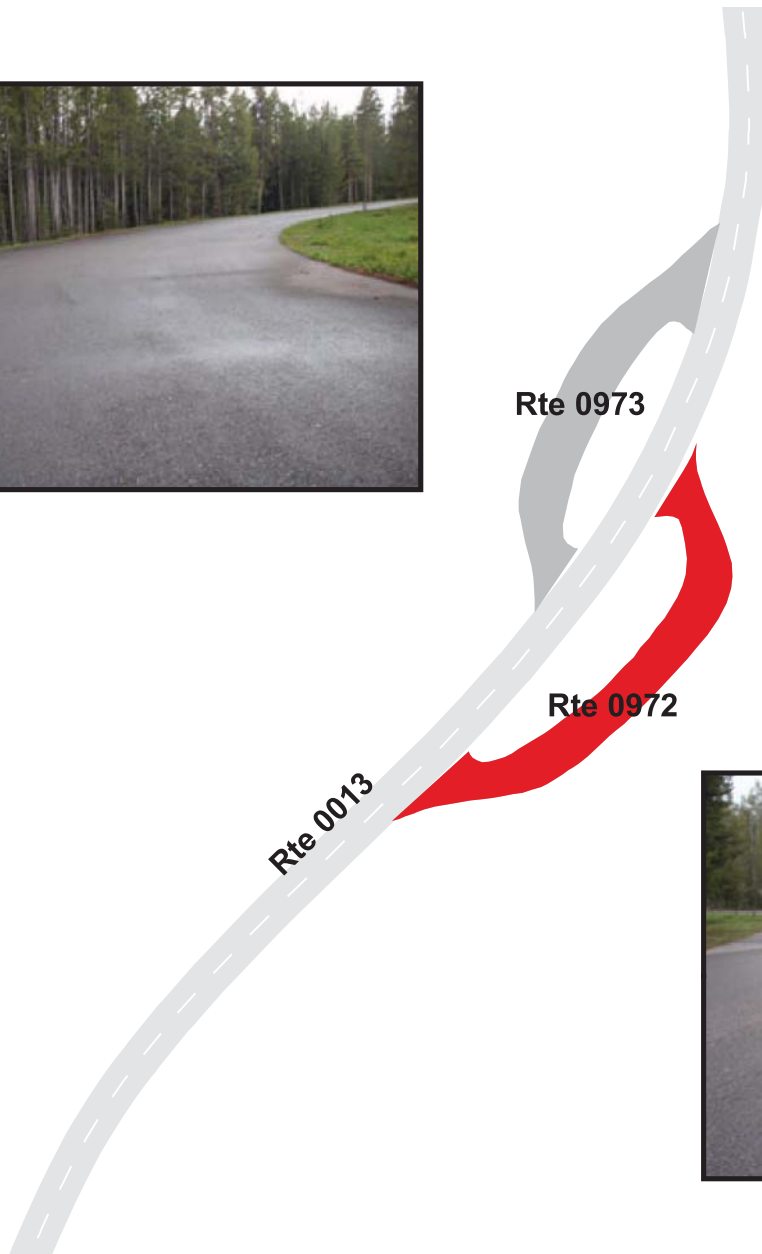
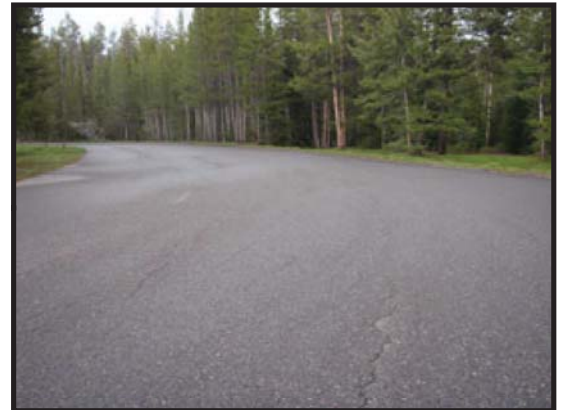
## Route 0972

Route Number	Public / NonPublic	Date Visited		Area (sq ft)	Lane Miles *	Surface Type
0972	PUBLIC	6/12/2008		17,957	0.31	AS
Culverts	Drop Inlets	Gates	Fire Hydrants	Curb & Gutter	Curb	PCR
0	0	0	0	NO CURB AND GUTTER	NO CURB	GOOD/90

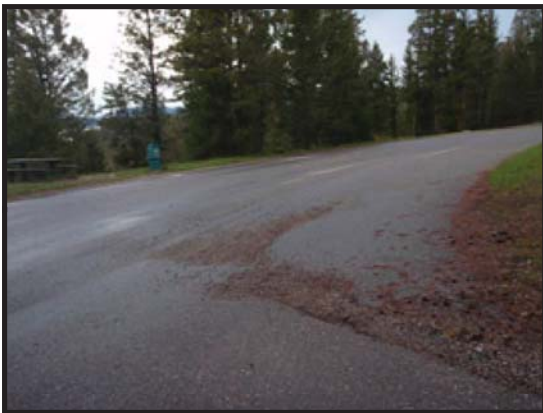
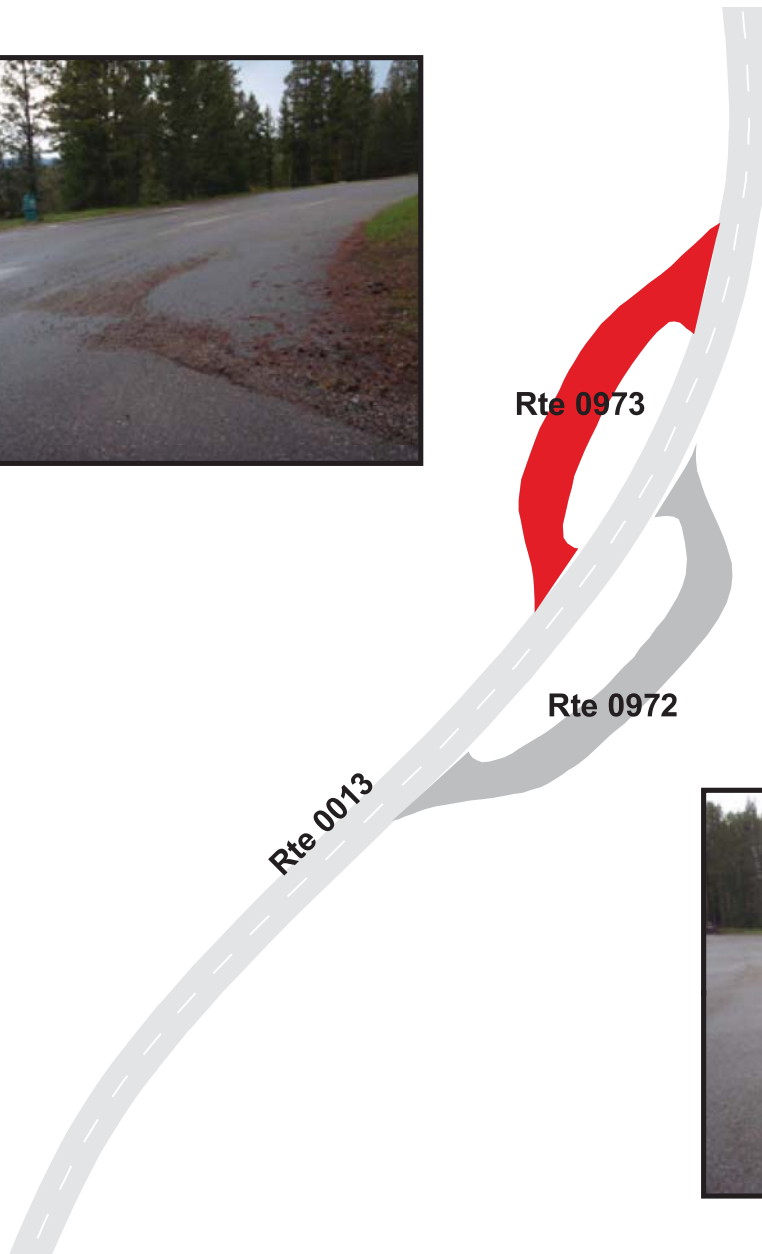
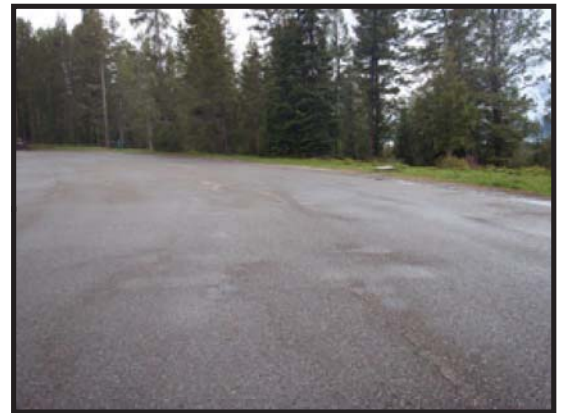
## Route 0973

Route Number	Public / NonPublic	Date Visited		Area (sq ft)	Lane Miles *	Surface Type
0973	PUBLIC	6/12/2008		16,395	0.28	AS
Culverts	Drop Inlets	Gates	Fire Hydrants	Curb & Gutter	Curb	PCR
0	0	0	0	NO CURB AND GUTTER	NO CURB	GOOD/90

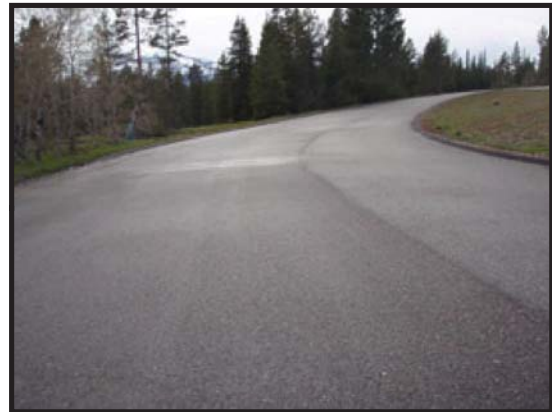
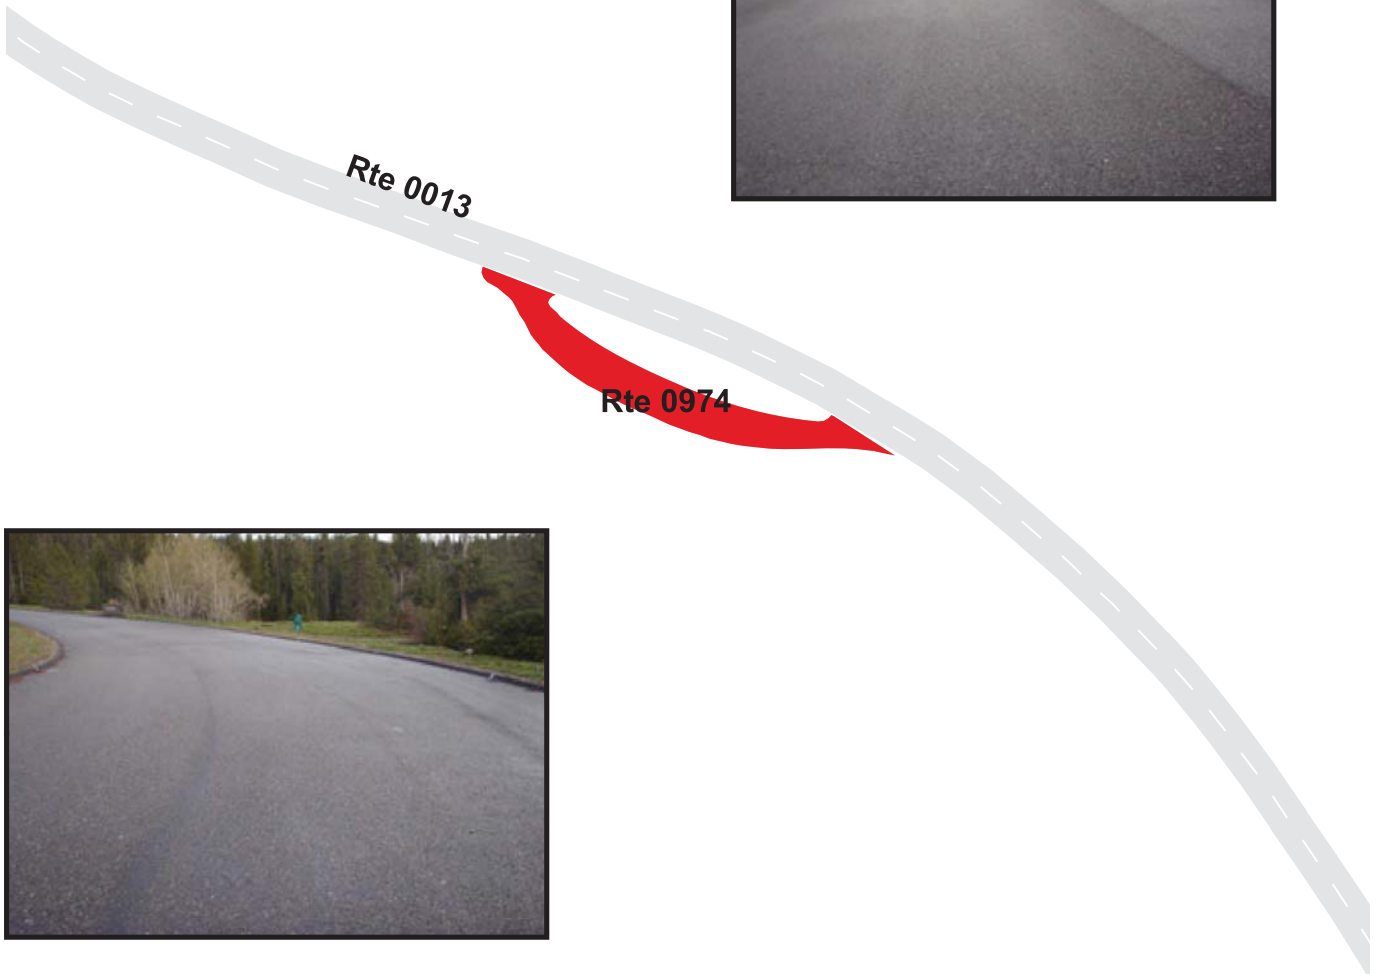
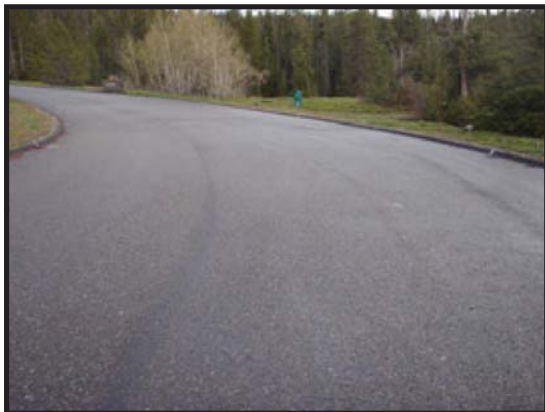
Route Number	Public / NonPublic	Date Visited		Area (sq ft)	Lane Miles *	Surface Type
0974	PUBLIC	6/12/2008		11,580	0.20	AS
Culverts	Drop Inlets	Gates	Fire Hydrants	Curb & Gutter	Curb	PCR
0	0	0	0	NO CURB AND GUTTER	ASPHALT CURB	GOOD/90

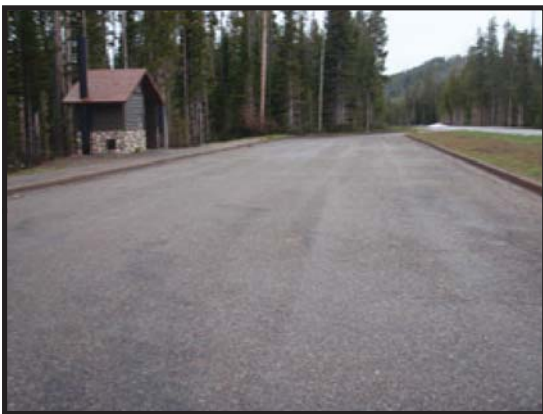
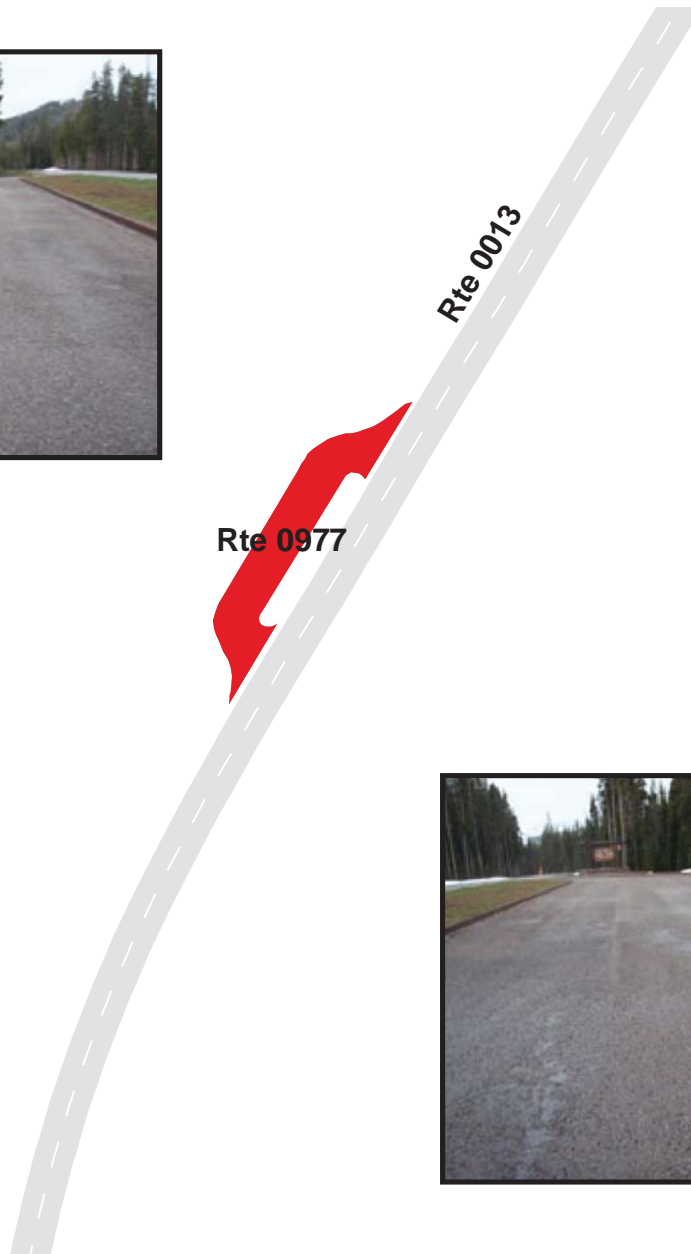
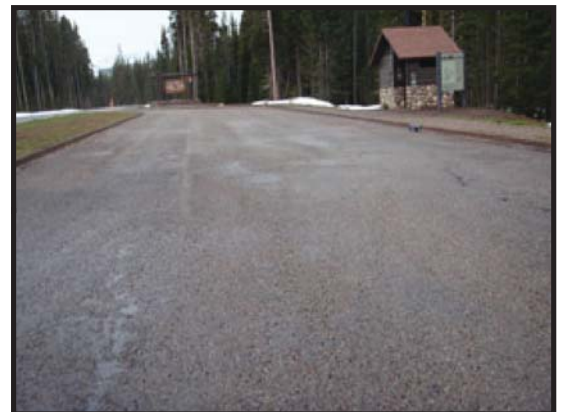
## Route 0977

Route Number	Public / NonPublic	Date Visited		Area (sq ft)	Lane Miles *	Surface Type
0977	PUBLIC	6/12/2008		9,061	0.16	AS
Culverts	Drop Inlets	Gates	Fire Hydrants	Curb & Gutter	Curb	PCR
0	0	0	0	NO CURB AND GUTTER	CONCRETE CURB	FAIR/73

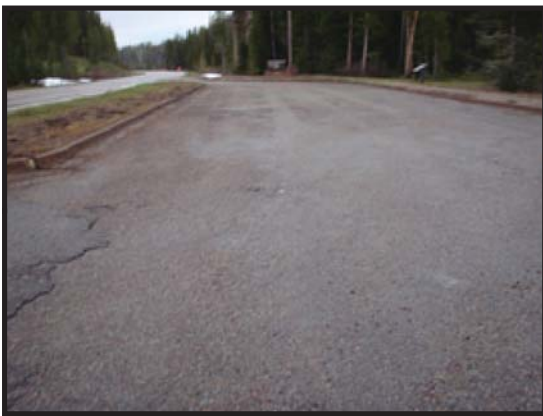
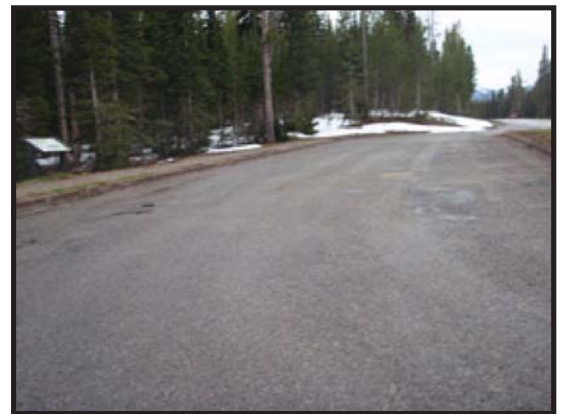
## Route 0978

Route Number	Public / NonPublic	Date Visited		Area (sq ft)	Lane Miles *	Surface Type
0978	PUBLIC	6/12/2008		6,943	0.12	AS
Culverts	Drop Inlets	Gates	Fire Hydrants	Curb & Gutter	Curb	PCR
0	0	0	0	CONCRETE CURB AND GUTTER	CONCRETE CURB	POOR/45

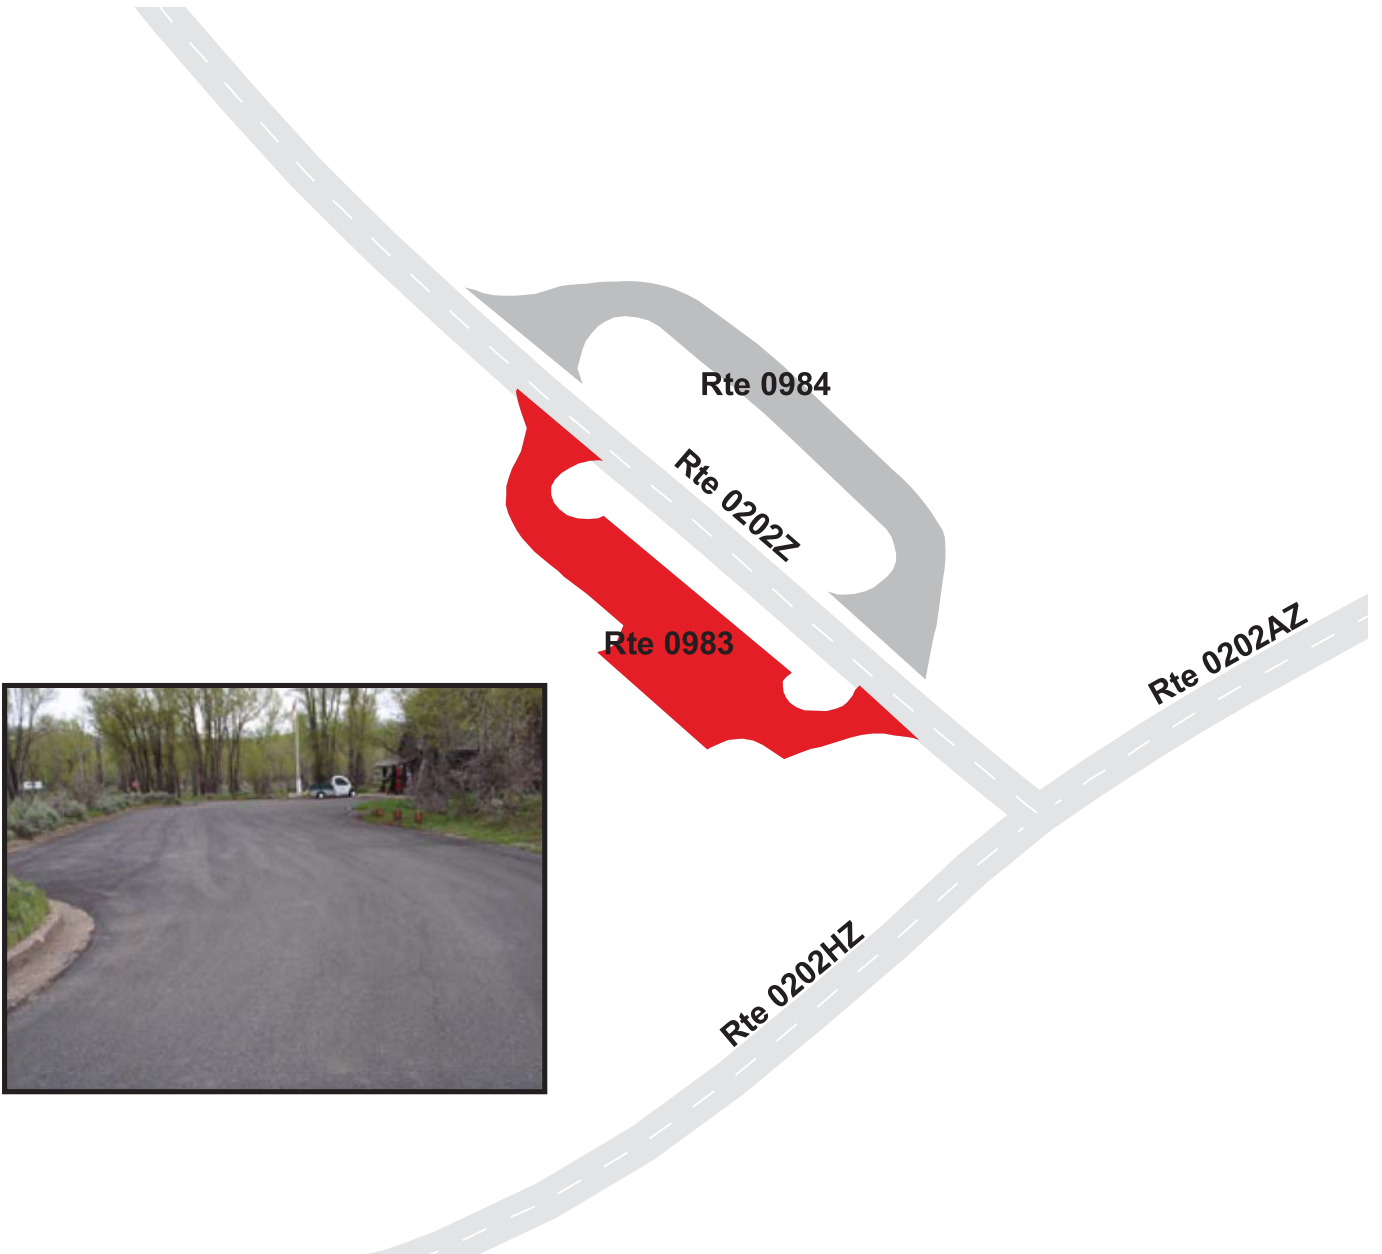
**GRAND TETON NATIONAL PARK**  
**Route 0983**  
 GROS VENTRE RANGER STATION PARKING  
 FROM ROUTE 0202ZZ  
 TO ROUTE 0202ZZ

Route Number	Public / NonPublic	Date Visited		Area (sq ft)	Lane Miles *	Surface Type
0983	NONPUBLIC	6/10/2008		9,187	0.16	AS
Culverts	Drop Inlets	Gates	Fire Hydrants	Curb & Gutter	Curb	PCR
0	0	0	0	CONCRETE CURB AND GUTTER	CONCRETE CURB	GOOD/90

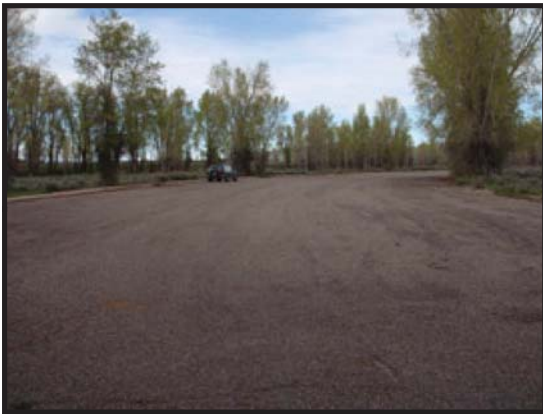
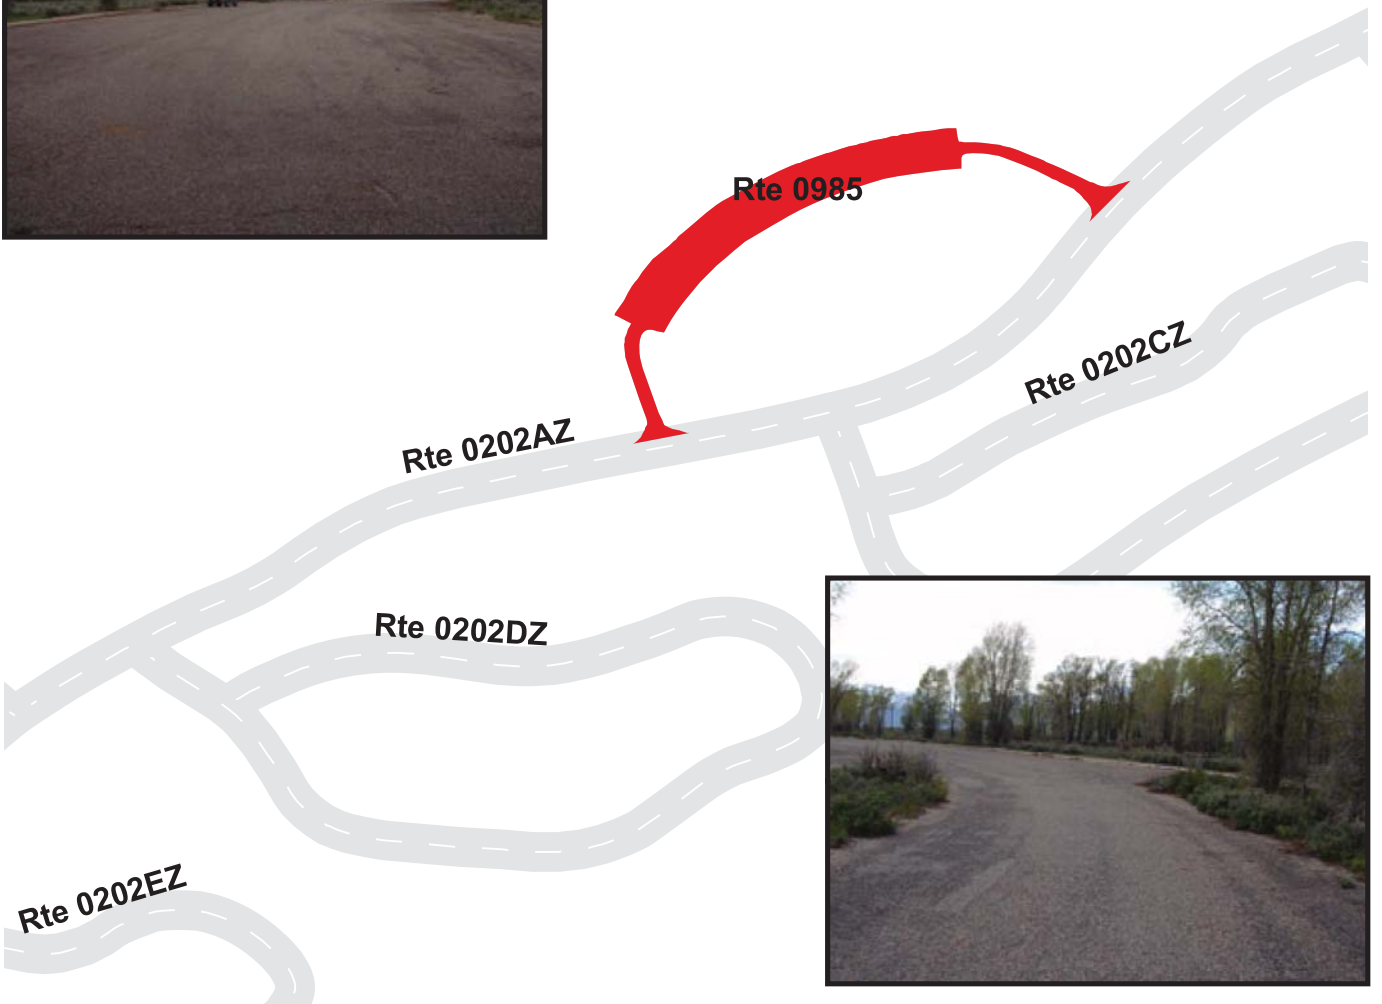
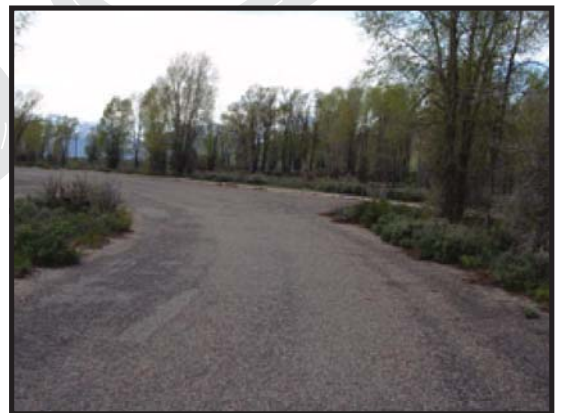
## Route 0985

Route Number	Public / NonPublic	Date Visited		Area (sq ft)	Lane Miles *	Surface Type
0985	PUBLIC	6/10/2008		40,797	0.70	AS
Culverts	Drop Inlets	Gates	Fire Hydrants	Curb & Gutter	Curb	PCR
0	0	0	0	NO CURB AND GUTTER	WOOD CURB	FAIR/73

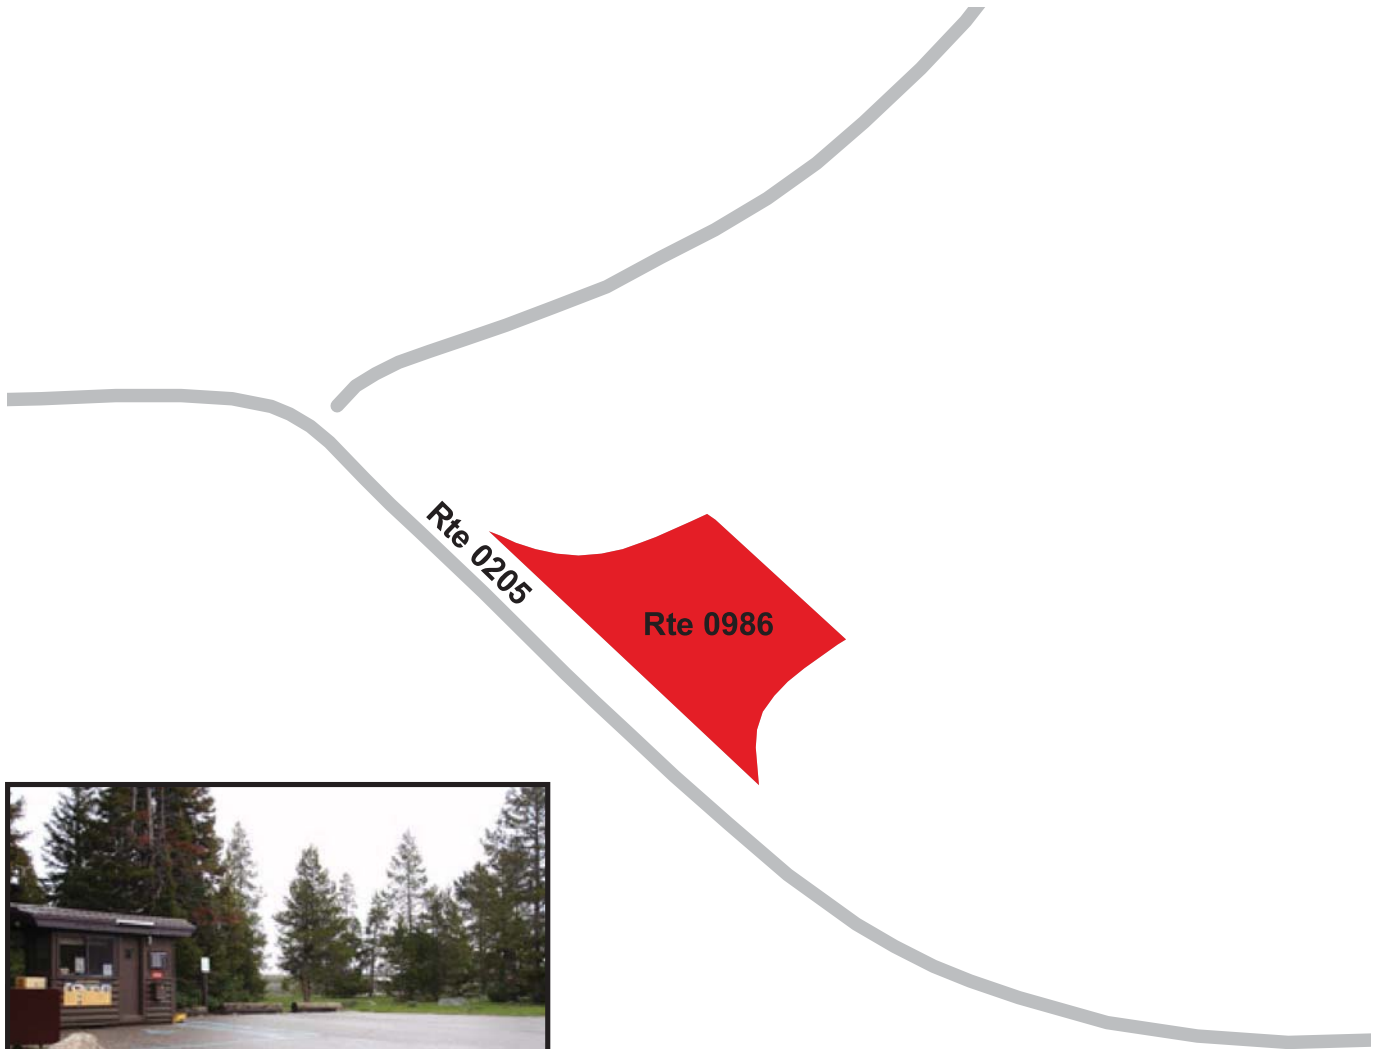
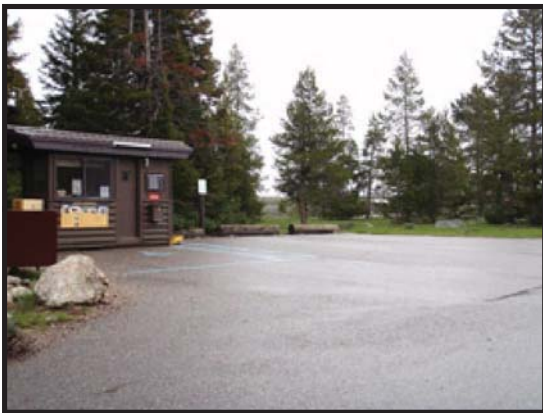
## Route 0986

Route Number	Public / NonPublic	Date Visited		Area (sq ft)	Lane Miles *	Surface Type
0986	PUBLIC	6/11/2008		2,000	0.03	AS
Culverts	Drop Inlets	Gates	Fire Hydrants	Curb & Gutter	Curb	PCR
0	0	0	0	NO CURB AND GUTTER	NO CURB	GOOD/90

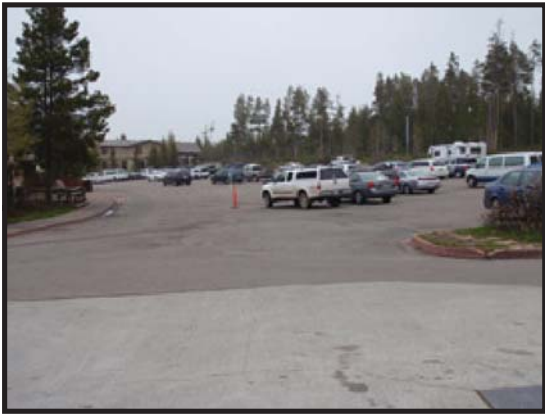
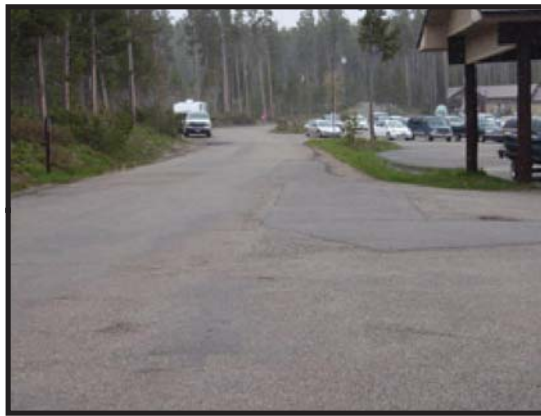
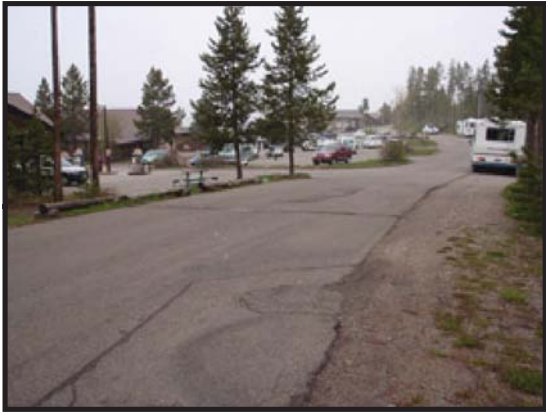
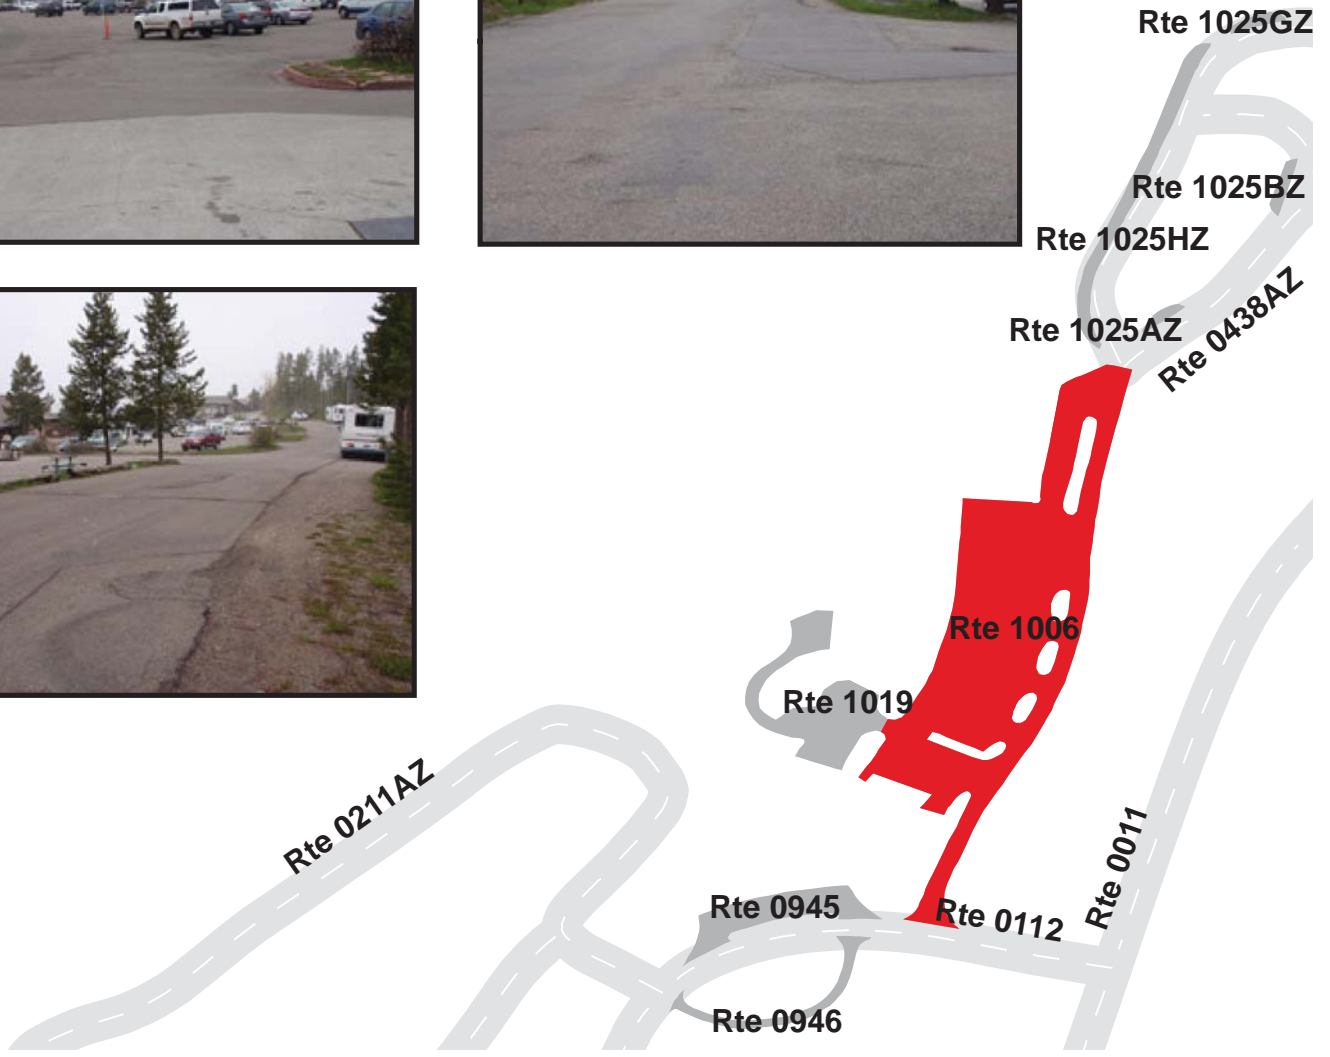
## Route 1006

Route Number	Public / NonPublic	Date Visited		Area (sq ft)	Lane Miles *	Surface Type
1006	PUBLIC	6/11/2008		72,905	1.26	AS
Culverts	Drop Inlets	Gates	Fire Hydrants	Curb & Gutter	Curb	PCR
0	0	0	0	CONCRETE CURB AND GUTTER	ASPHALT CURB	FAIR/73

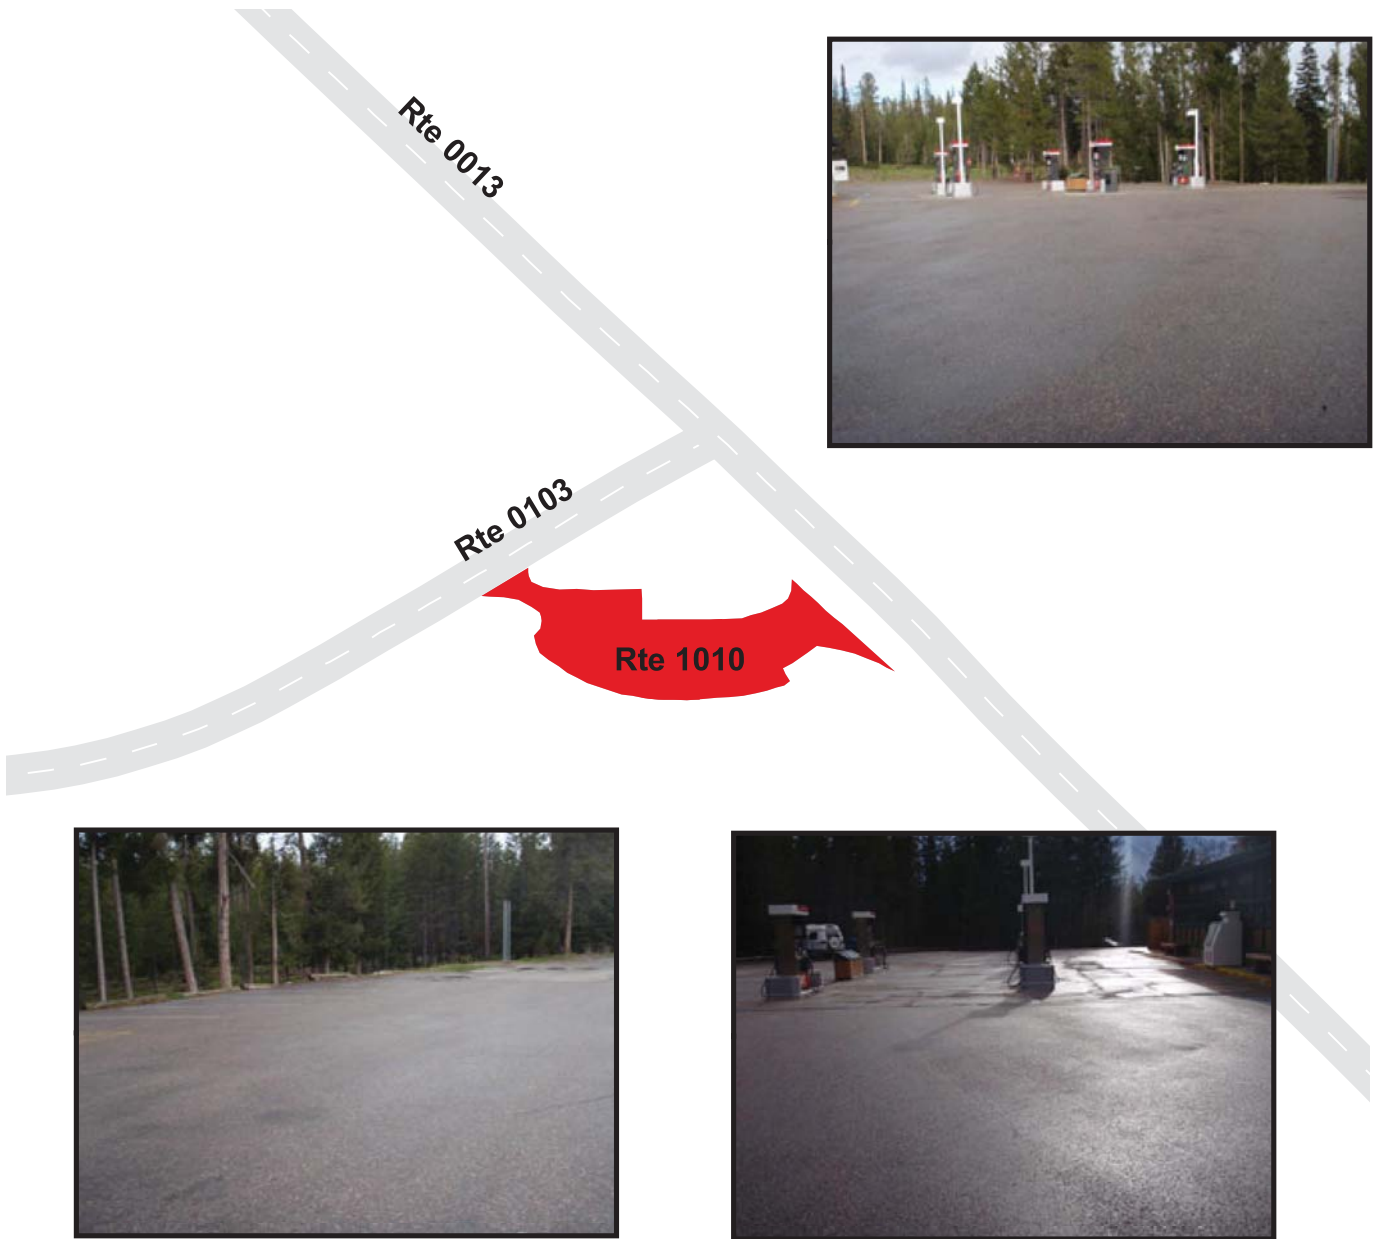
## Route 1010

Route Number	Public / NonPublic	Date Visited		Area (sq ft)	Lane Miles *	Surface Type
1010	PUBLIC	6/12/2008		28,494	0.49	AS
Culverts	Drop Inlets	Gates	Fire Hydrants	Curb & Gutter	Curb	PCR
0	0	0	0	NO CURB AND GUTTER	NO CURB	FAIR/73

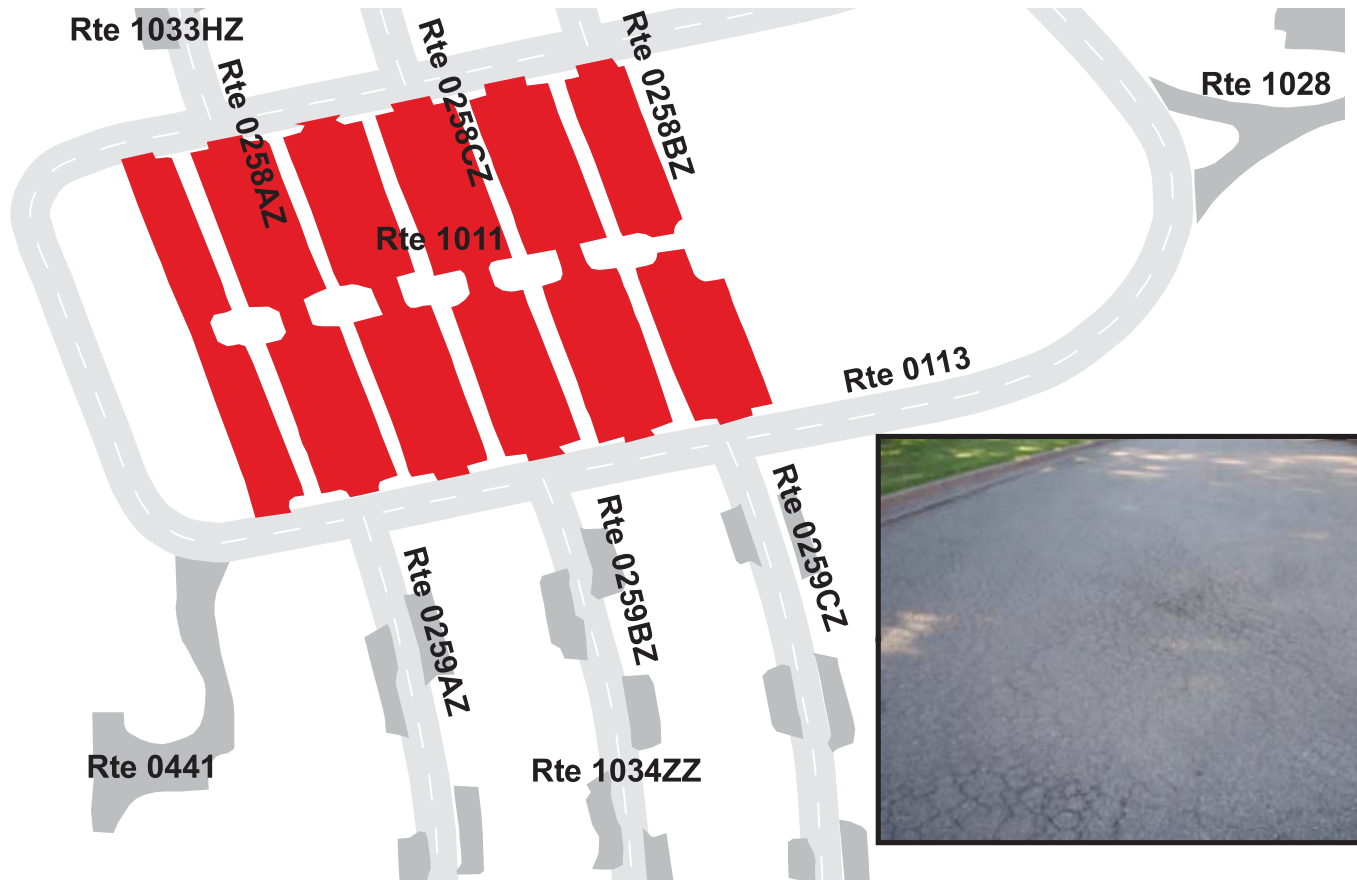
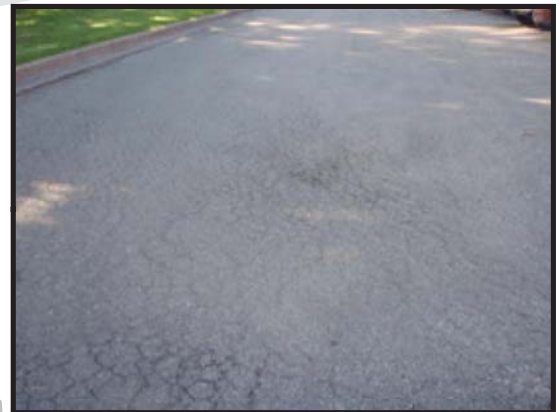
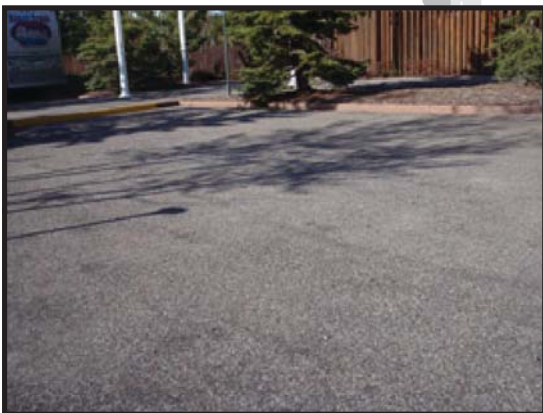
## Route 1011

Route Number	Public / NonPublic	Date Visited		Area (sq ft)	Lane Miles *	Surface Type
1011	PUBLIC	6/13/2008		109,914	1.89	AS
Culverts	Drop Inlets	Gates	Fire Hydrants	Curb & Gutter	Curb	PCR
0	1	0	0	CONCRETE CURB AND GUTTER	CONCRETE CURB	FAIR/73

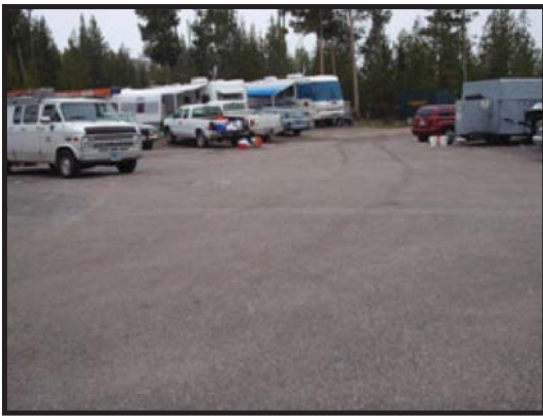
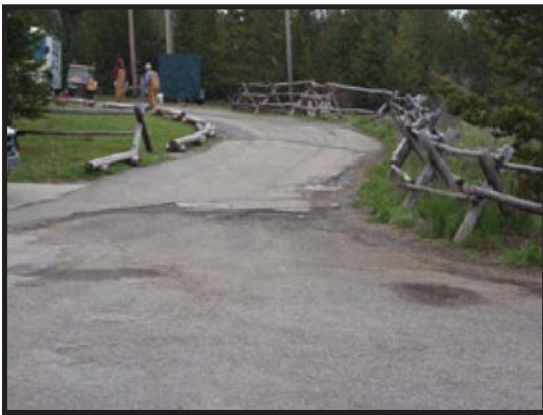
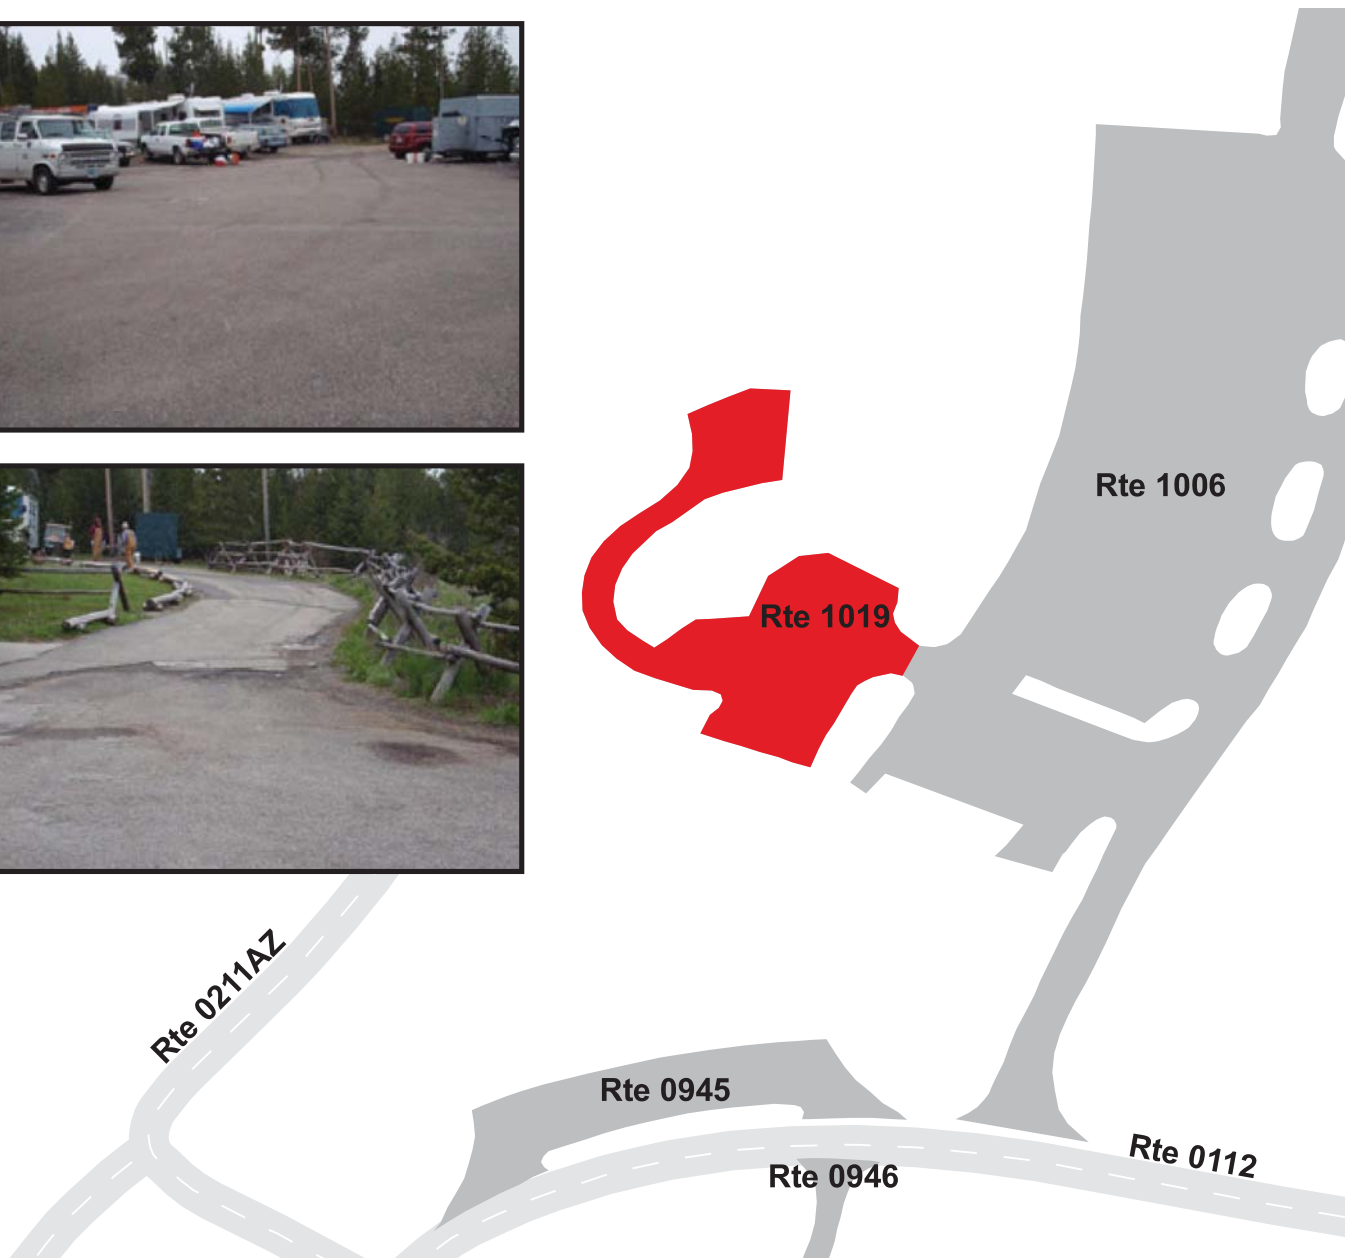
## Route 1019

Route Number	Public / NonPublic	Date Visited		Area (sq ft)	Lane Miles *	Surface Type
1019	PUBLIC	6/11/2008		12,038	0.21	AS
Culverts	Drop Inlets	Gates	Fire Hydrants	Curb & Gutter	Curb	PCR
0	1	1	1	NO CURB AND GUTTER	NO CURB	FAIR/73

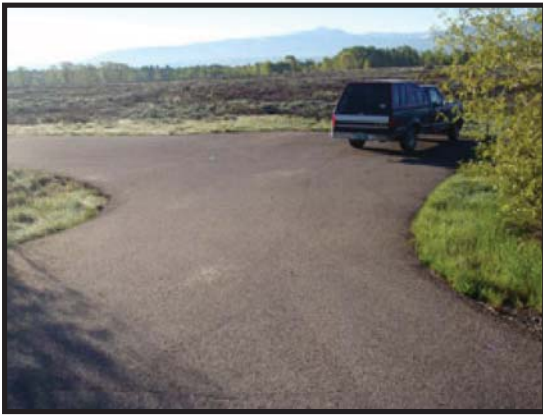
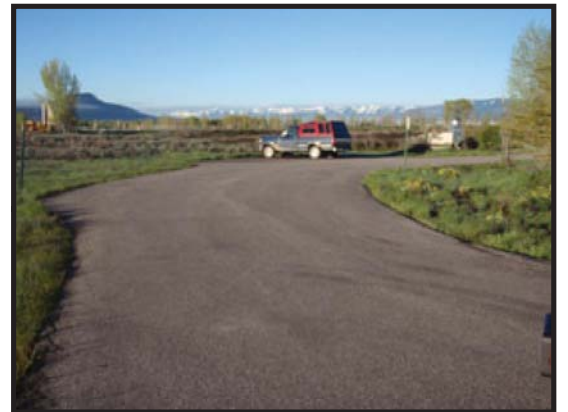
**GRAND TETON NATIONAL PARK**  
**Route 1021**  
 GRANITE ENTRANCE STATION PARKING  
 ADJACENT TO ROUTE 0100ZZ ON RIGHT

Route Number	Public / NonPublic	Date Visited		Area (sq ft)	Lane Miles *	Surface Type
1021	PUBLIC	6/13/2008		4,303	0.07	AS
Culverts	Drop Inlets	Gates	Fire Hydrants	Curb & Gutter	Curb	PCR
0	0	0	0	NO CURB AND GUTTER	NO CURB	FAIR/73

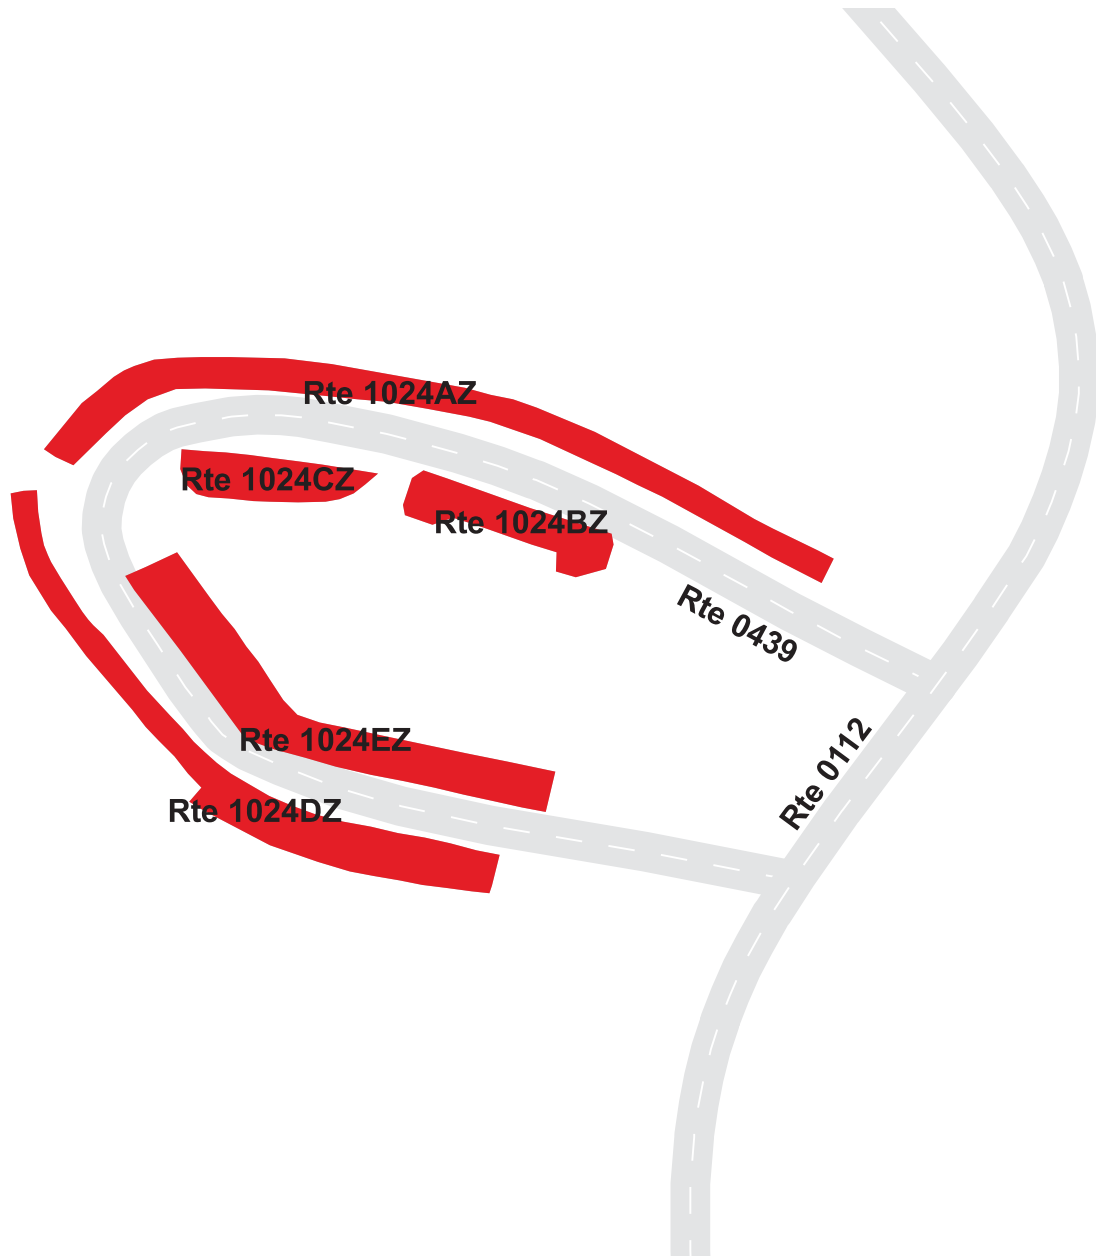
## Route 1024ZZ

Route Number	Public / NonPublic	Date Visited		Area (sq ft)	Lane Miles *	Surface Type
1024ZZ	PUBLIC	6/11/2008		13,123	0.23	AS
Culverts	Drop Inlets	Gates	Fire Hydrants	Curb & Gutter	Curb	PCR
0	1	0	3	CONCRETE CURB AND GUTTER	CONCRETE CURB	SUMMARY/81.95
