**The Road Inventory  
of  
Grand Teton National Park  
GRTE – 1460  
Cycle 4**

**Prepared By:  
Federal Highway Administration  
Road Inventory Program  
Cycle 4**

# Grand Teton National Park in Wyoming

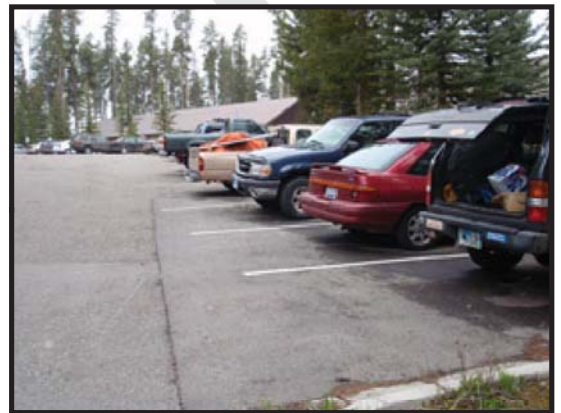
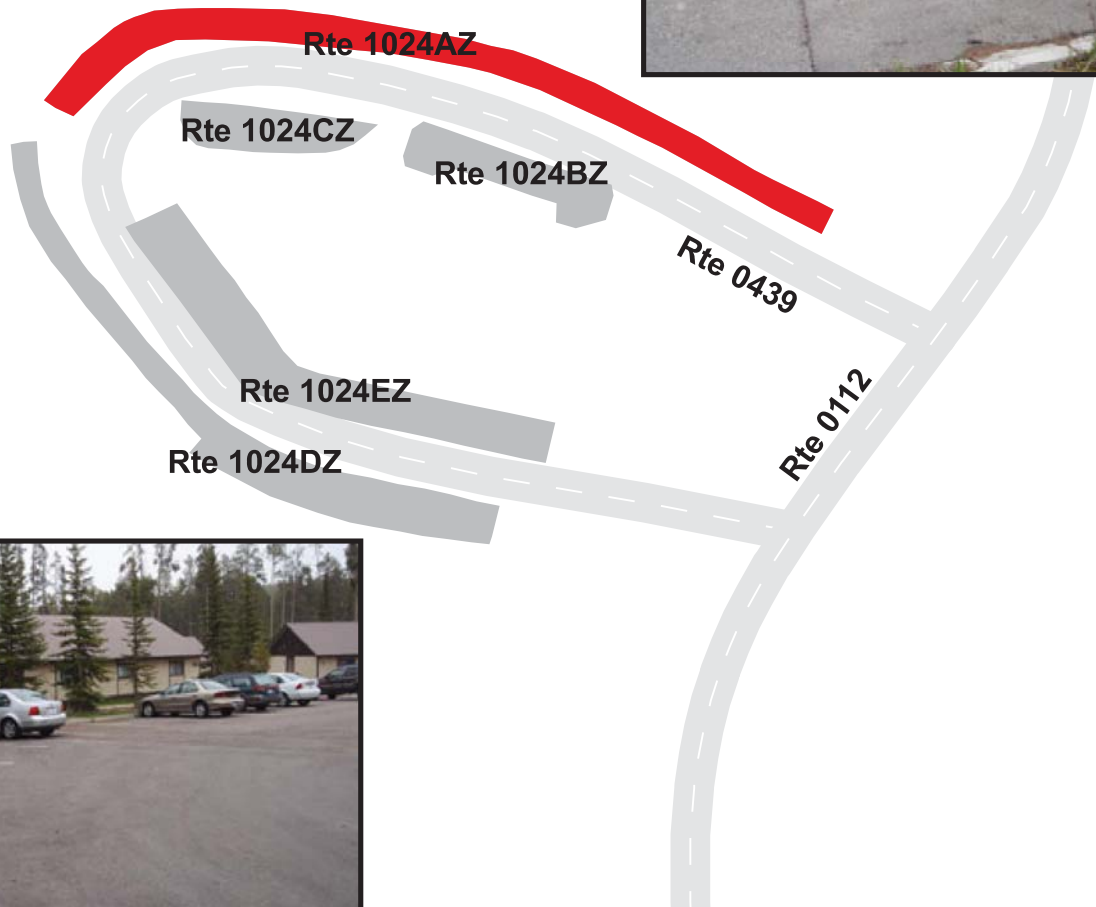
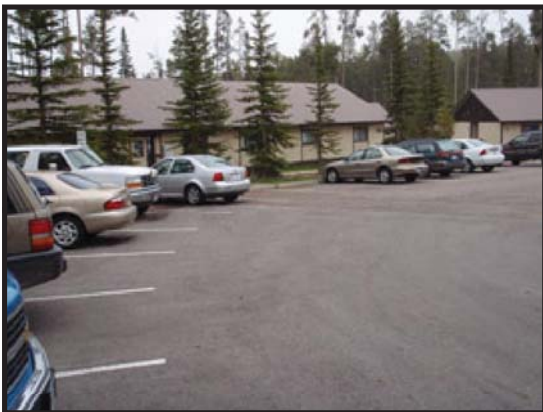
## Route 1024AZ

Route Number	Public / NonPublic	Date Visited		Area (sq ft)	Lane Miles *	Surface Type
1024AZ	PUBLIC	6/11/2008		3,810	0.07	AS
Culverts	Drop Inlets	Gates	Fire Hydrants	Curb & Gutter	Curb	PCR
0	0	0	1	CONCRETE CURB AND GUTTER	CONCRETE CURB	FAIR/73

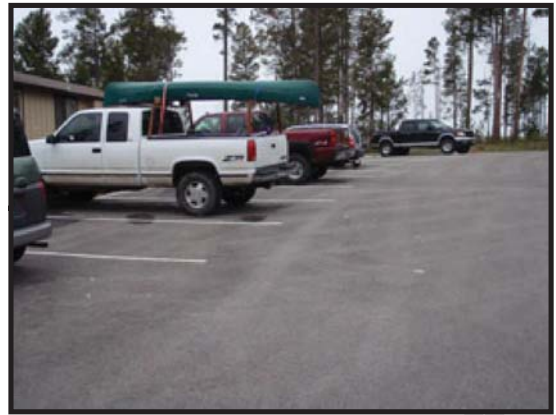
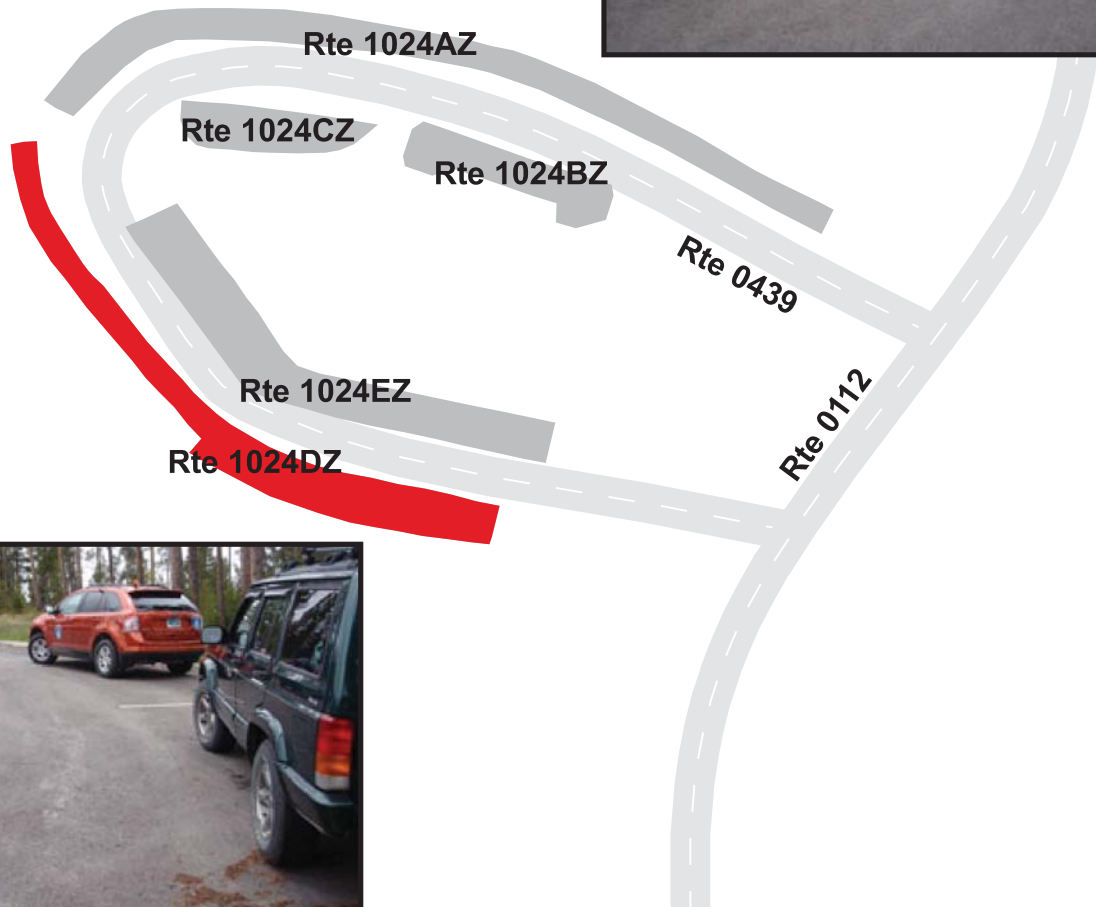
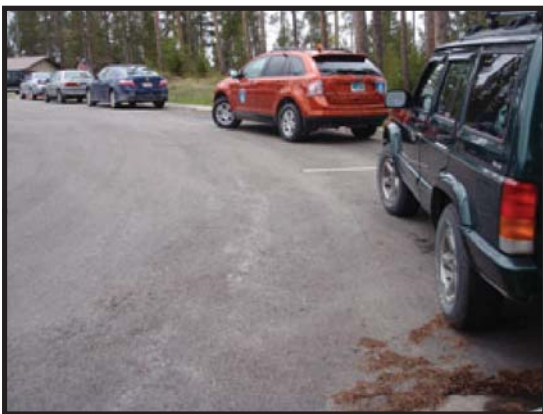
# GRAND TETON NATIONAL PARK

Route Number	Public / NonPublic	Date Visited		Area (sq ft)	Lane Miles *	Surface Type
1024DZ	PUBLIC	6/11/2008		3,433	0.06	AS
Culverts	Drop Inlets	Gates	Fire Hydrants	Curb & Gutter	Curb	PCR
0	0	0	2	CONCRETE CURB AND GUTTER	CONCRETE CURB	GOOD/90

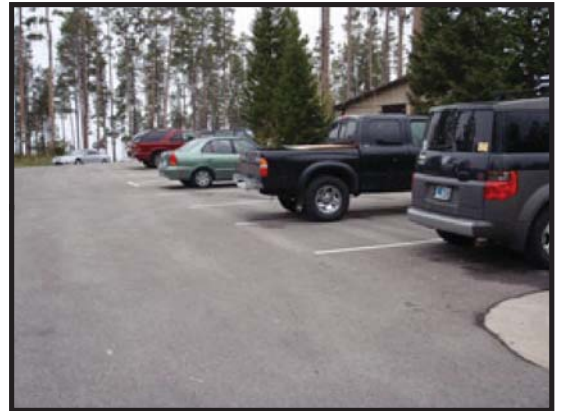
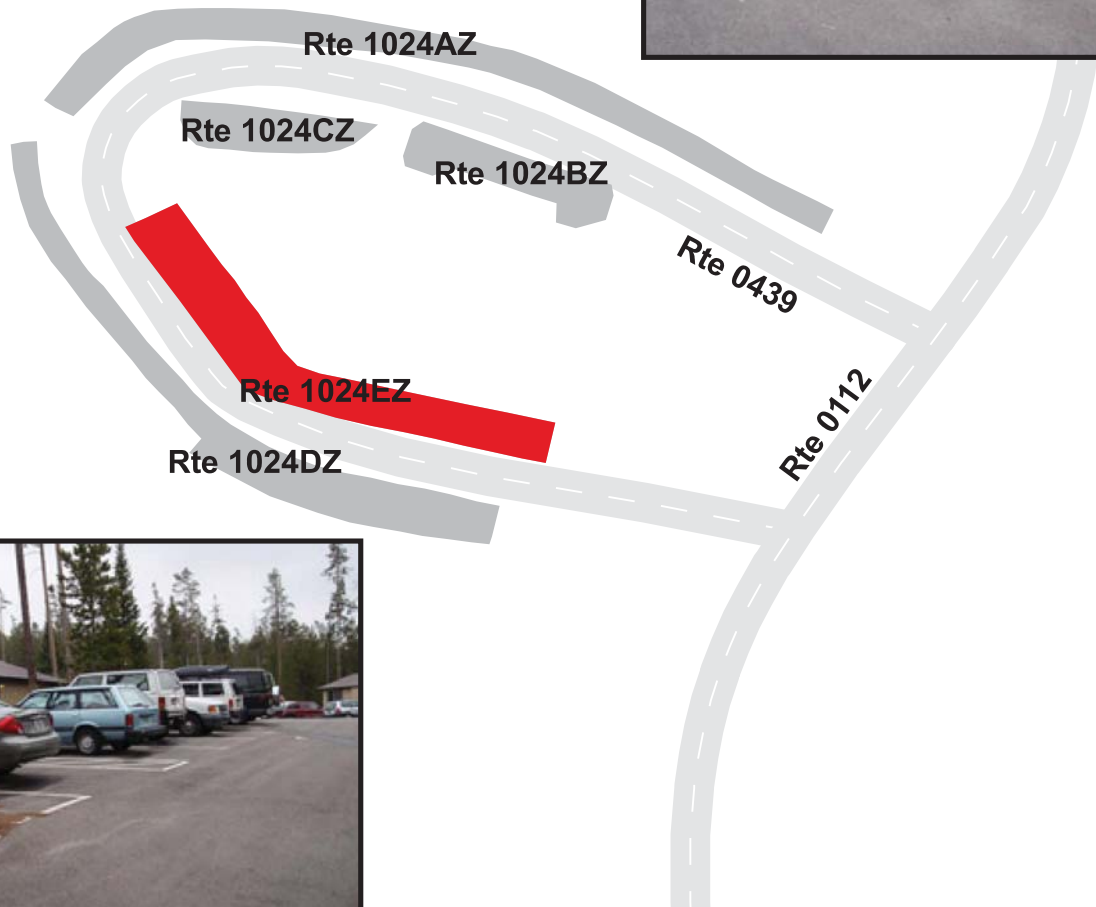
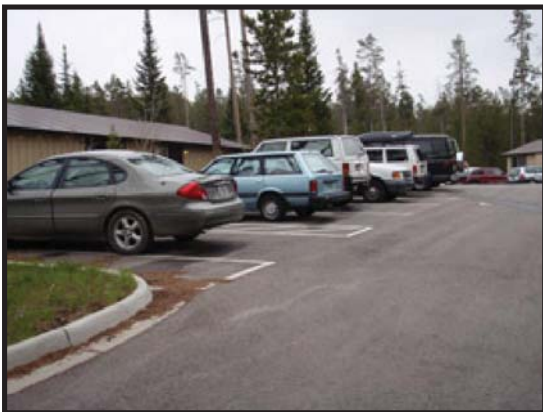
# GRAND TETON NATIONAL PARK

Route Number	Public / NonPublic	Date Visited		Area (sq ft)	Lane Miles *	Surface Type
1024EZ	PUBLIC	6/11/2008		3,473	0.06	AS
Culverts	Drop Inlets	Gates	Fire Hydrants	Curb & Gutter	Curb	PCR
0	1	0	0	CONCRETE CURB AND GUTTER	CONCRETE CURB	GOOD/90

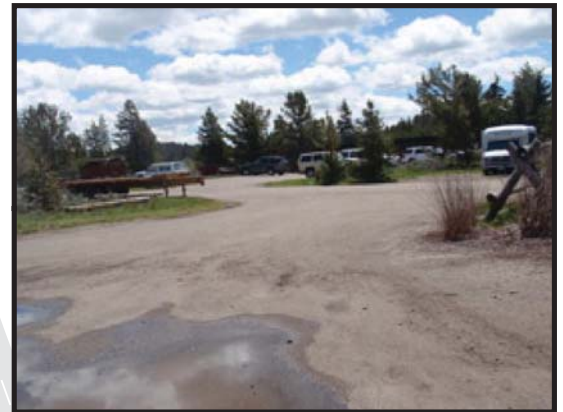
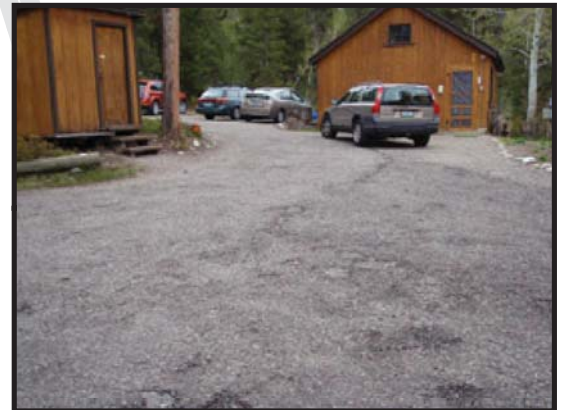
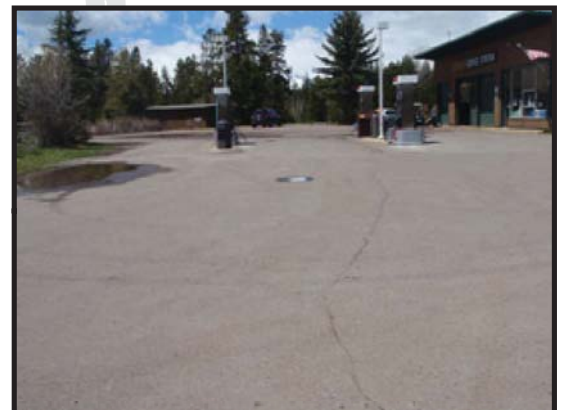
Route Number	Public / NonPublic	Date Visited		Area (sq ft)	Lane Miles *	Surface Type
1028	PUBLIC	6/13/2008		49,065	0.85	AS
Culverts	Drop Inlets	Gates	Fire Hydrants	Curb & Gutter	Curb	PCR
0	0	0	0	NO CURB AND GUTTER	CONCRETE CURB	POOR/45

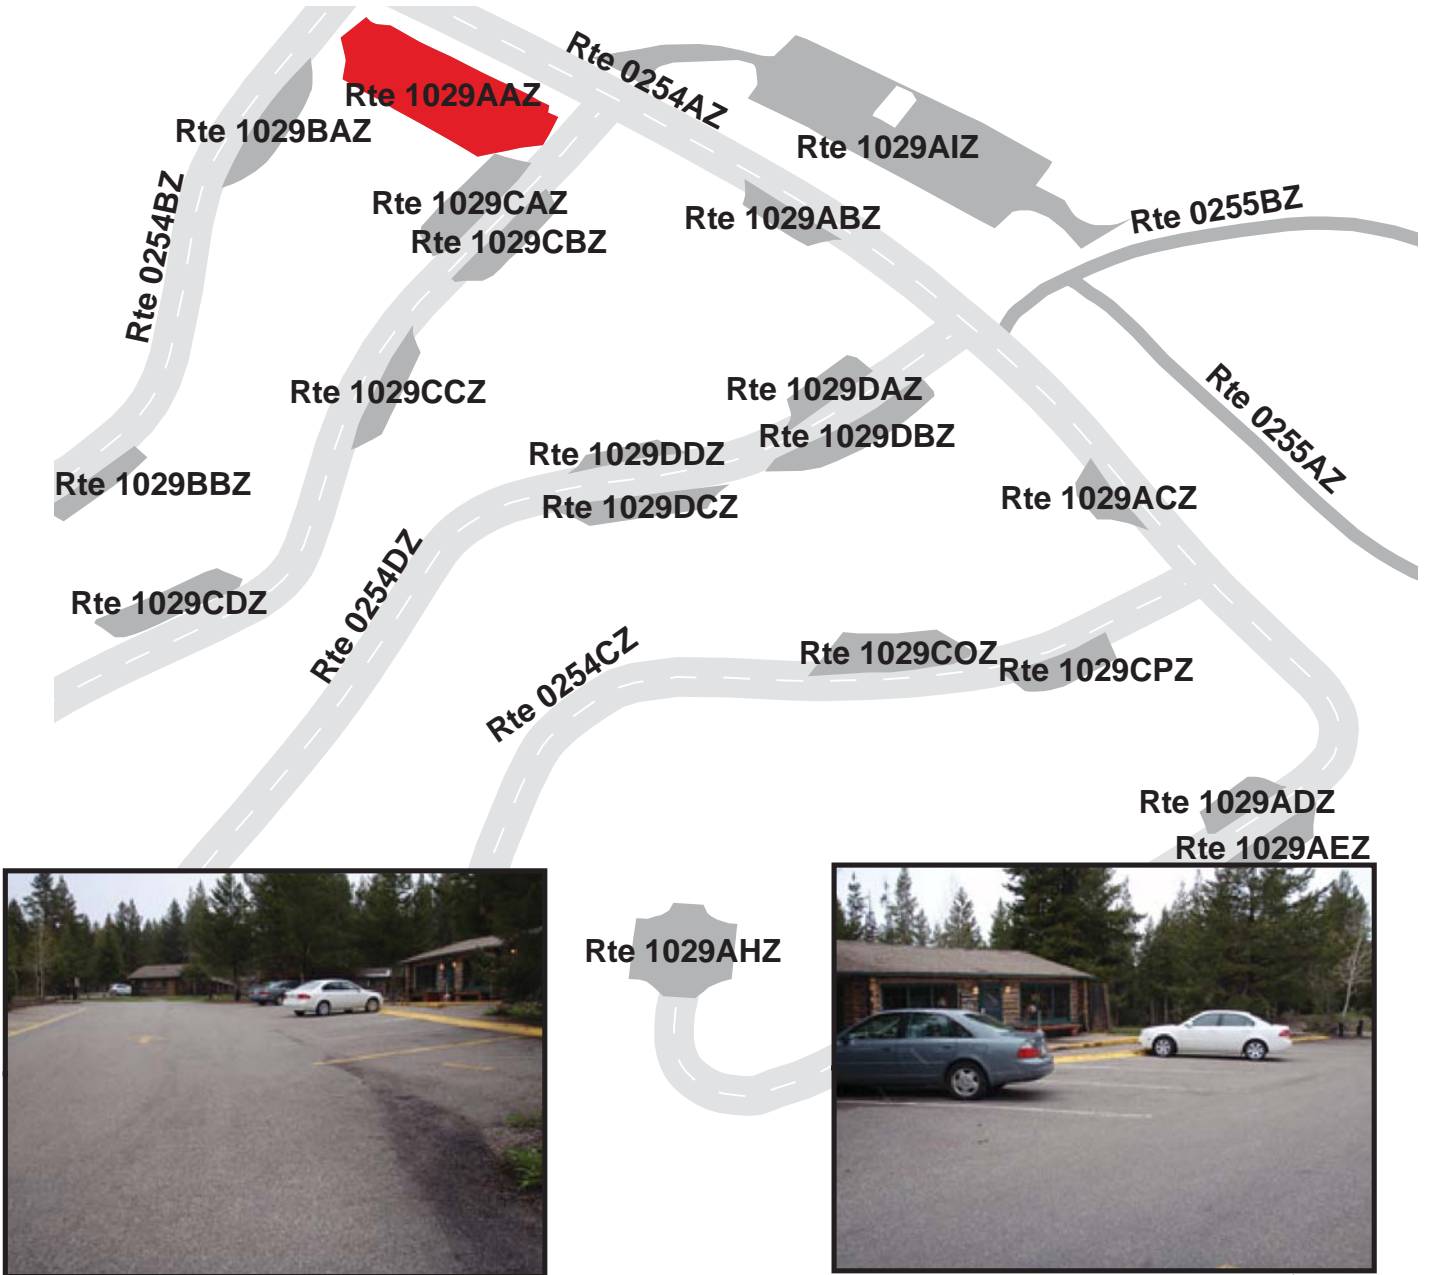
Route Number	Public / NonPublic	Date Visited		Area (sq ft)	Lane Miles *	Surface Type
1029AAZ	PUBLIC	6/13/2008		6,413	0.11	AS
Culverts	Drop Inlets	Gates	Fire Hydrants	Curb & Gutter	Curb	PCR
0	0	0	0	NO CURB AND GUTTER	WOOD CURB	POOR/45

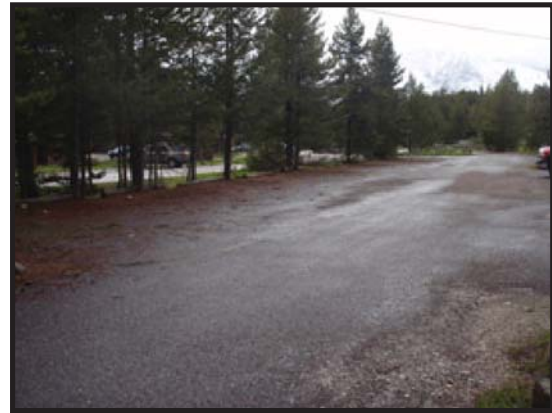
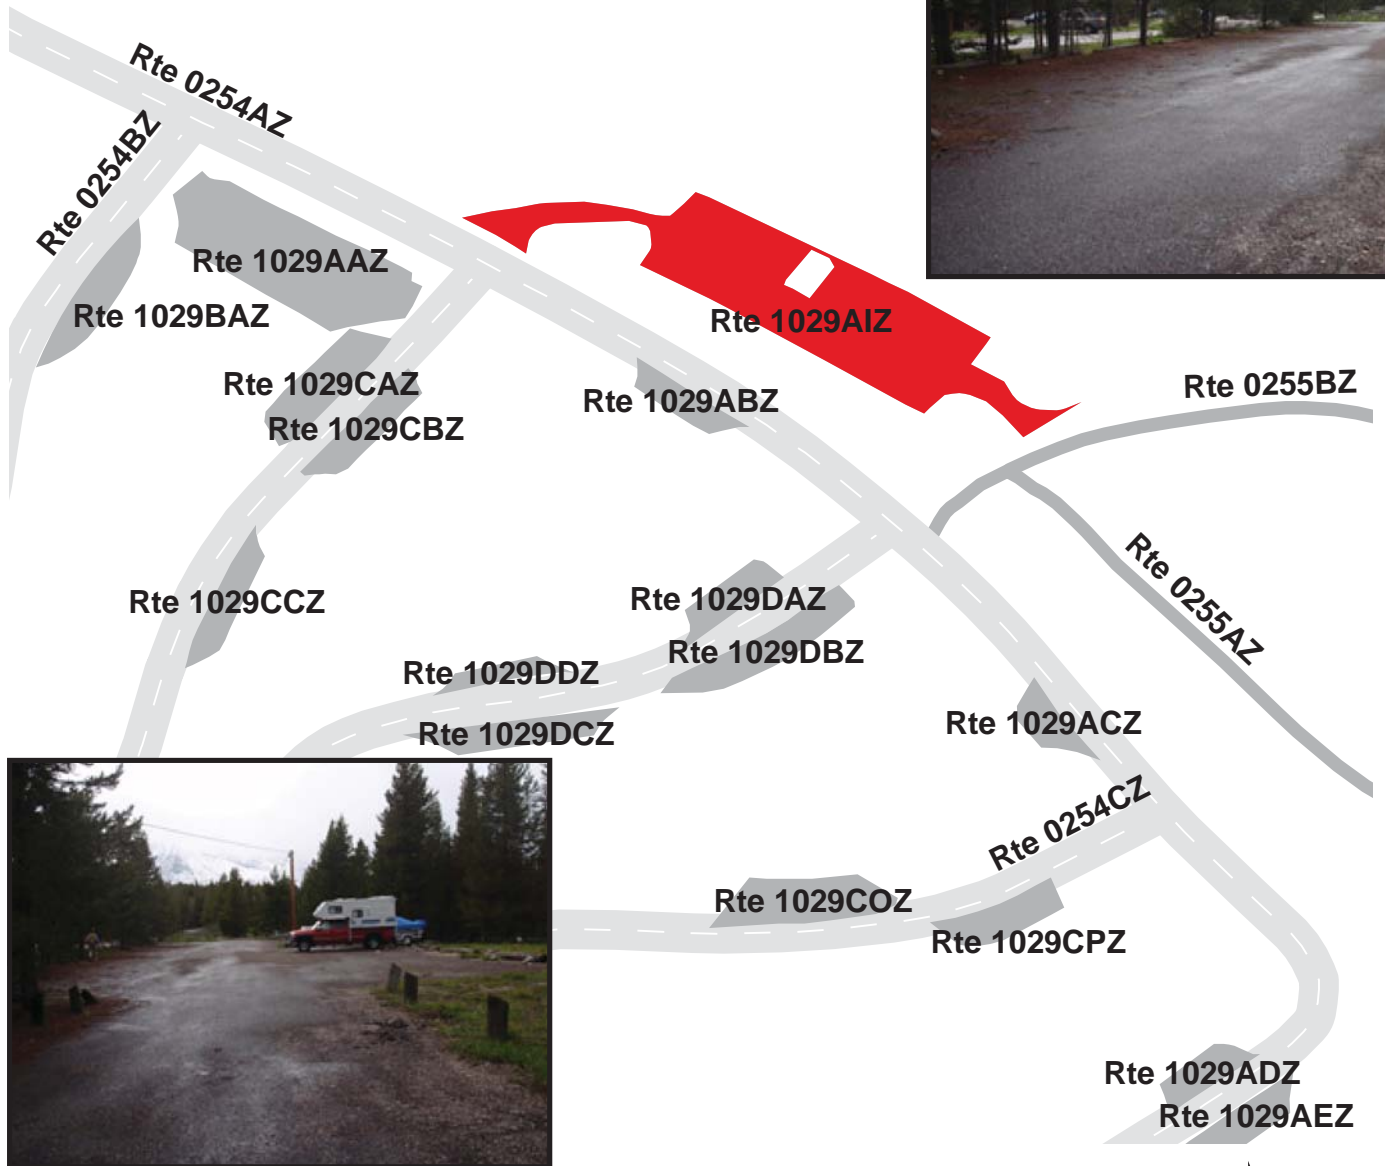
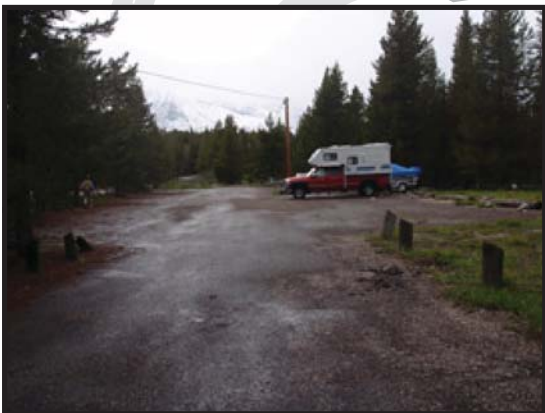
Route Number	Public / NonPublic	Date Visited		Area (sq ft)	Lane Miles *	Surface Type
1029AIZ	PUBLIC	6/13/2008		12,059	0.21	AS
Culverts	Drop Inlets	Gates	Fire Hydrants	Curb & Gutter	Curb	PCR
0	0	0	0	NO CURB AND GUTTER	NO CURB	POOR/45

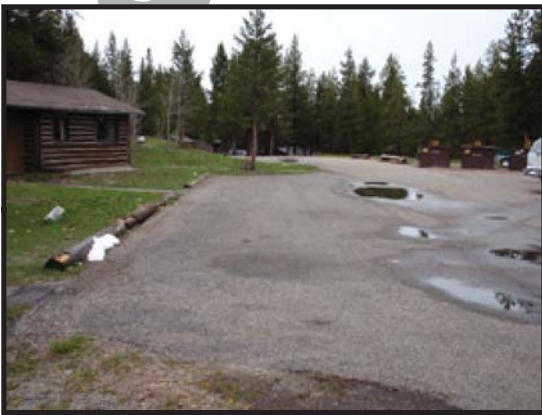
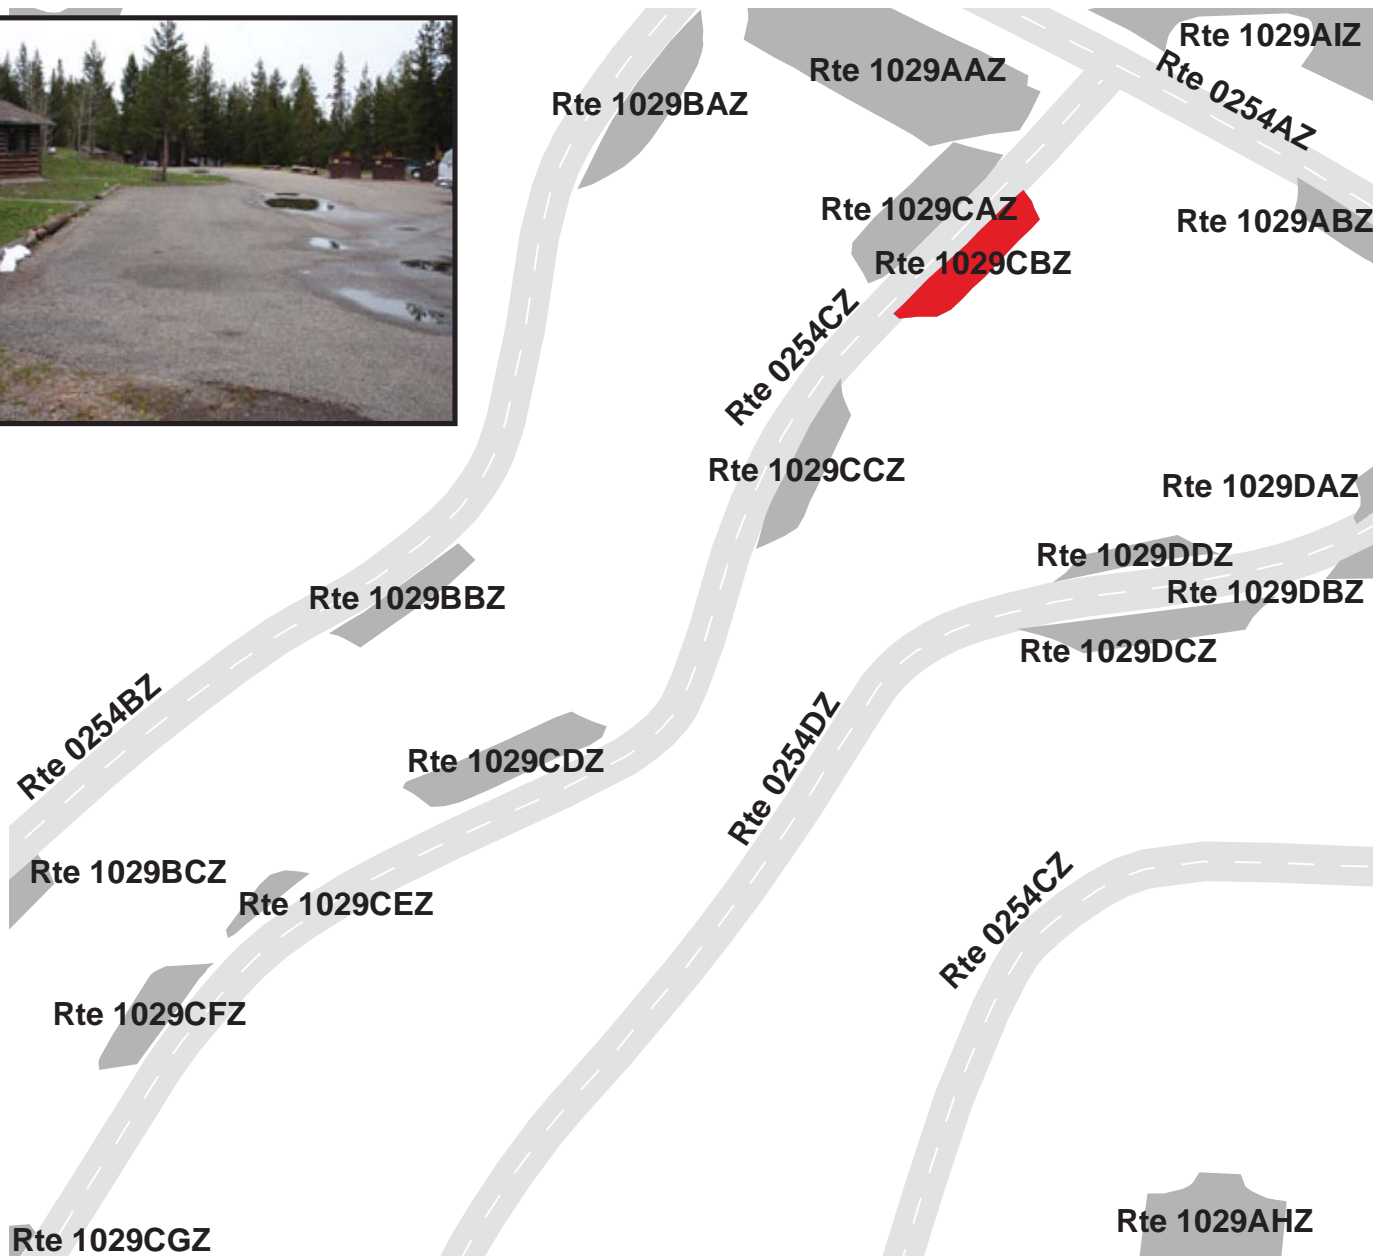
Route Number	Public / NonPublic	Date Visited		Area (sq ft)	Lane Miles *	Surface Type
1029CBZ	PUBLIC	6/13/2008		1,317	0.02	AS
Culverts	Drop Inlets	Gates	Fire Hydrants	Curb & Gutter	Curb	PCR
0	0	0	0	NO CURB AND GUTTER	NO CURB	FAIR/73

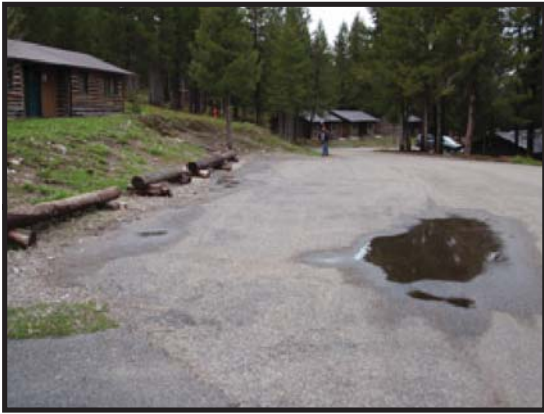
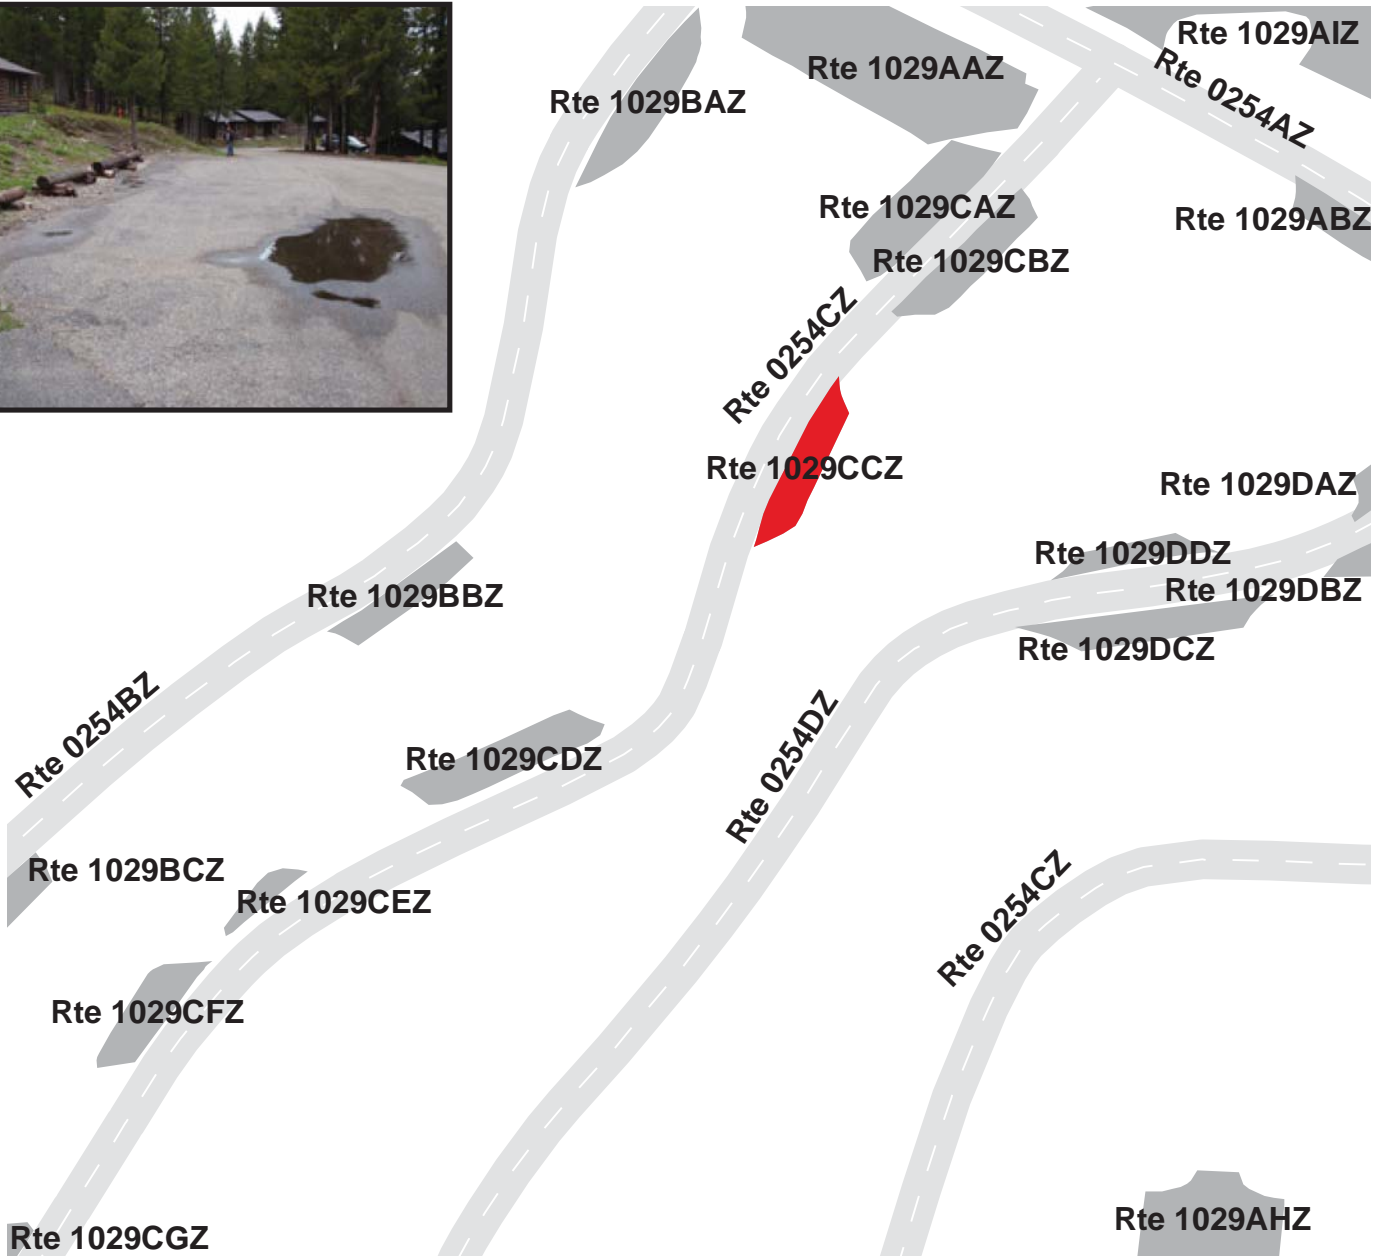
## Route 1029CCZ

Route Number	Public / NonPublic	Date Visited		Area (sq ft)	Lane Miles *	Surface Type
1029CCZ	PUBLIC	6/13/2008		1,193	0.02	AS
Culverts	Drop Inlets	Gates	Fire Hydrants	Curb & Gutter	Curb	PCR
0	0	0	0	NO CURB AND GUTTER	NO CURB	FAIR/73

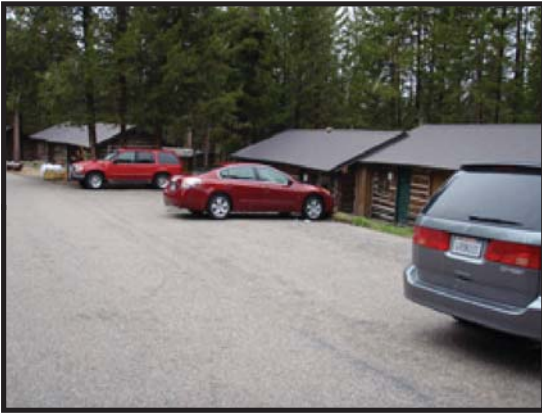
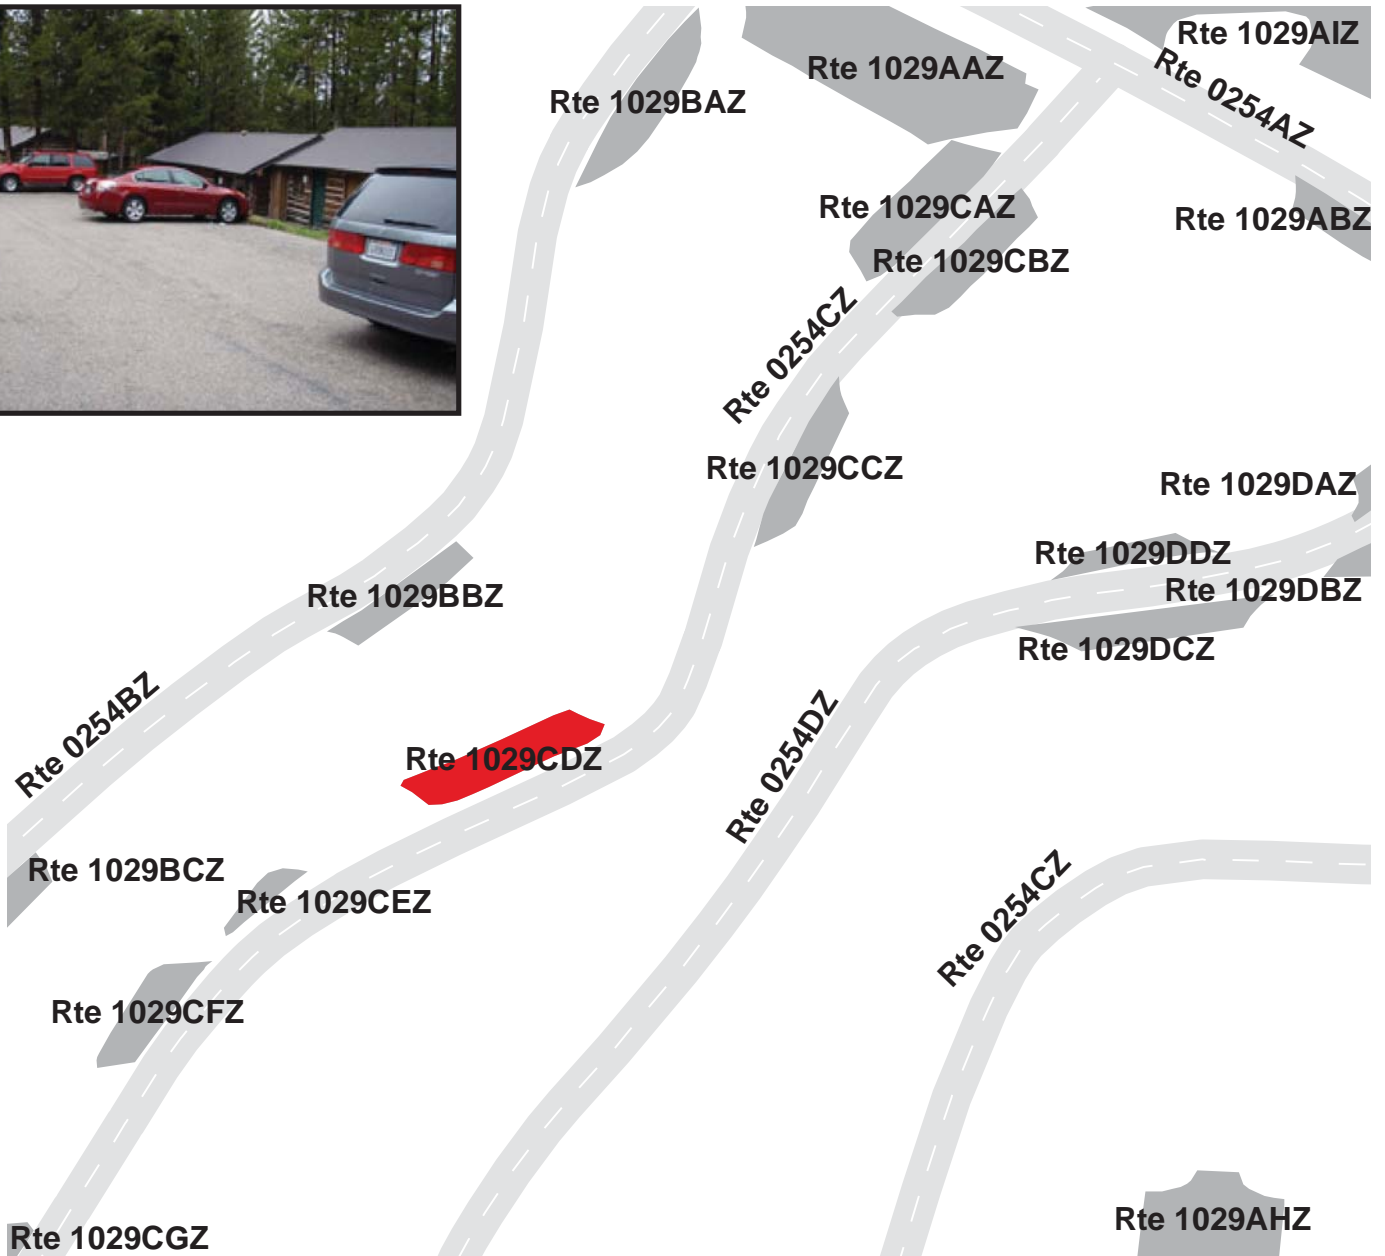
## Route 1029CDZ

Route Number	Public / NonPublic	Date Visited		Area (sq ft)	Lane Miles *	Surface Type
1029CDZ	PUBLIC	6/13/2008		1,618	0.03	AS
Culverts	Drop Inlets	Gates	Fire Hydrants	Curb & Gutter	Curb	PCR
0	0	0	0	NO CURB AND GUTTER	NO CURB	FAIR/73

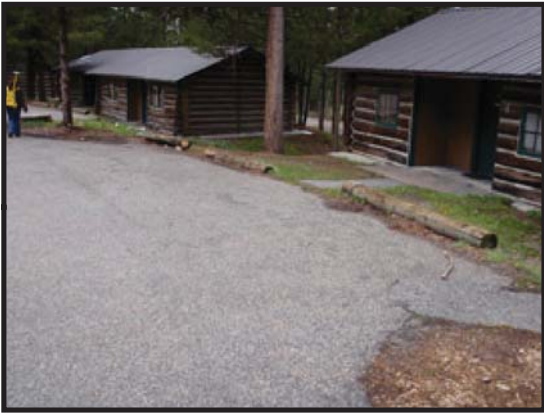
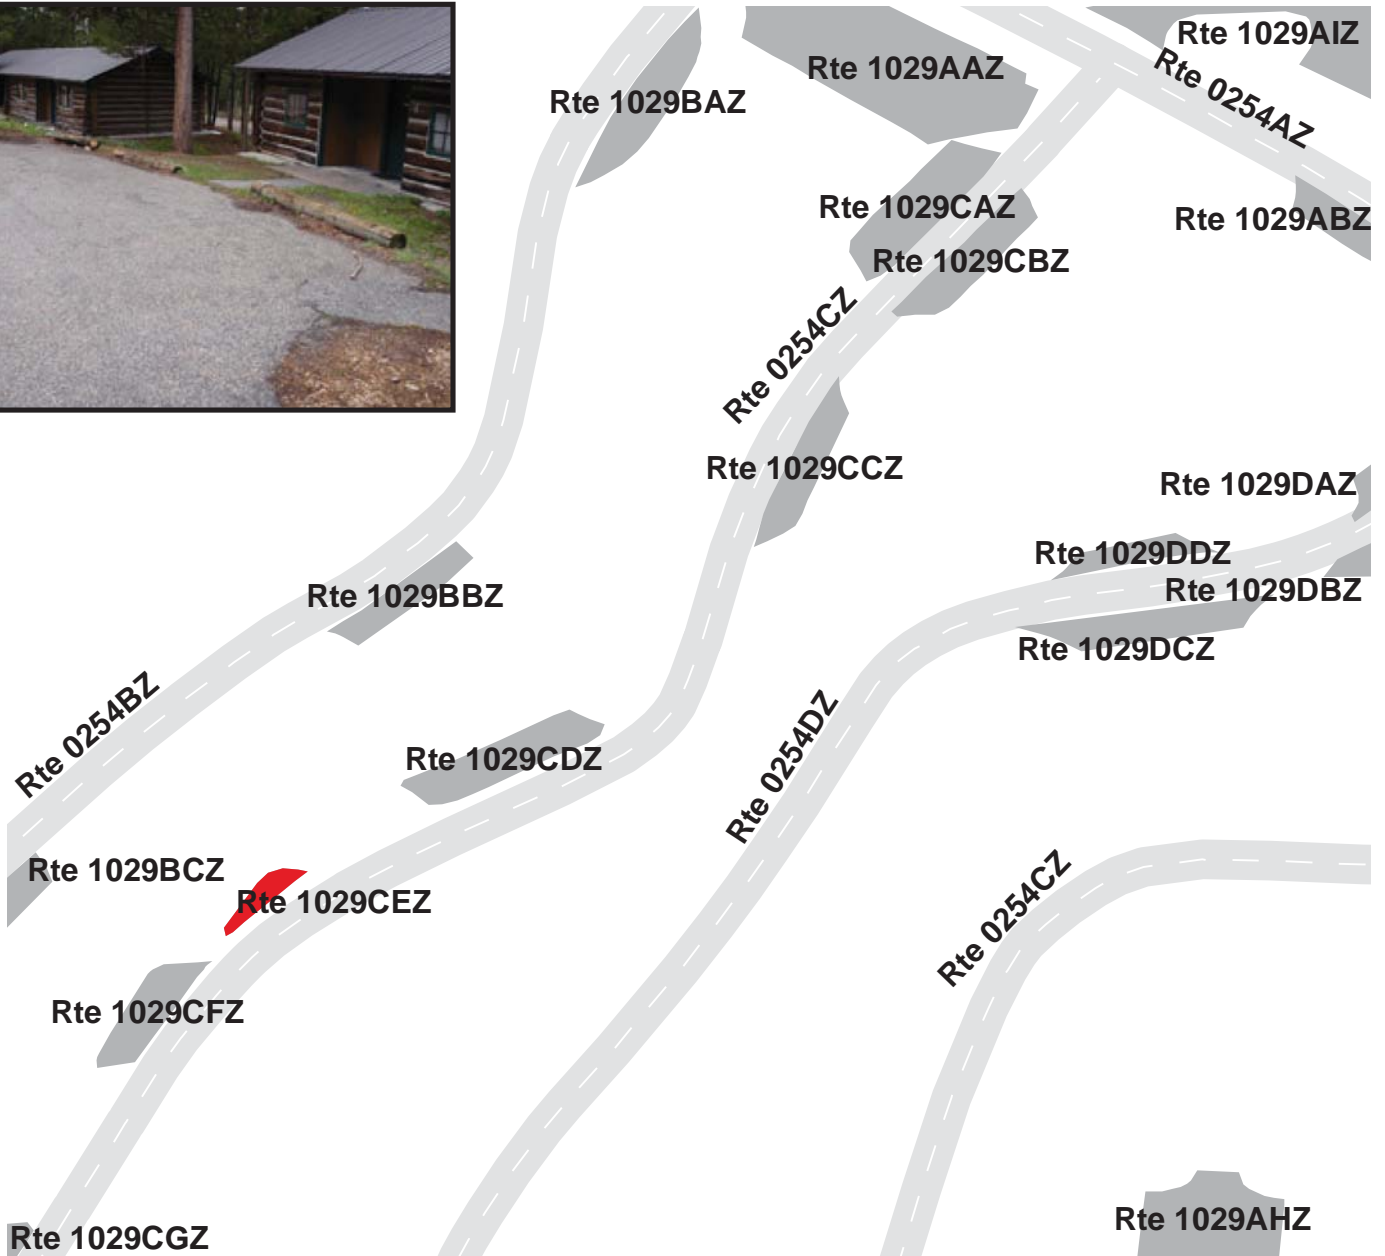
## Route 1029CEZ

Route Number	Public / NonPublic	Date Visited		Area (sq ft)	Lane Miles *	Surface Type
1029CEZ	PUBLIC	6/13/2008		375	0.01	AS
Culverts	Drop Inlets	Gates	Fire Hydrants	Curb & Gutter	Curb	PCR
0	0	0	0	NO CURB AND GUTTER	NO CURB	FAIR/73

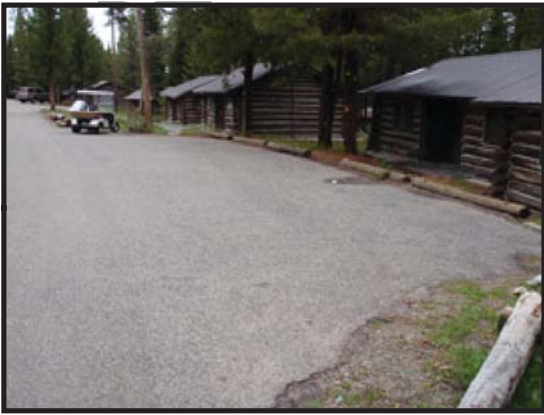
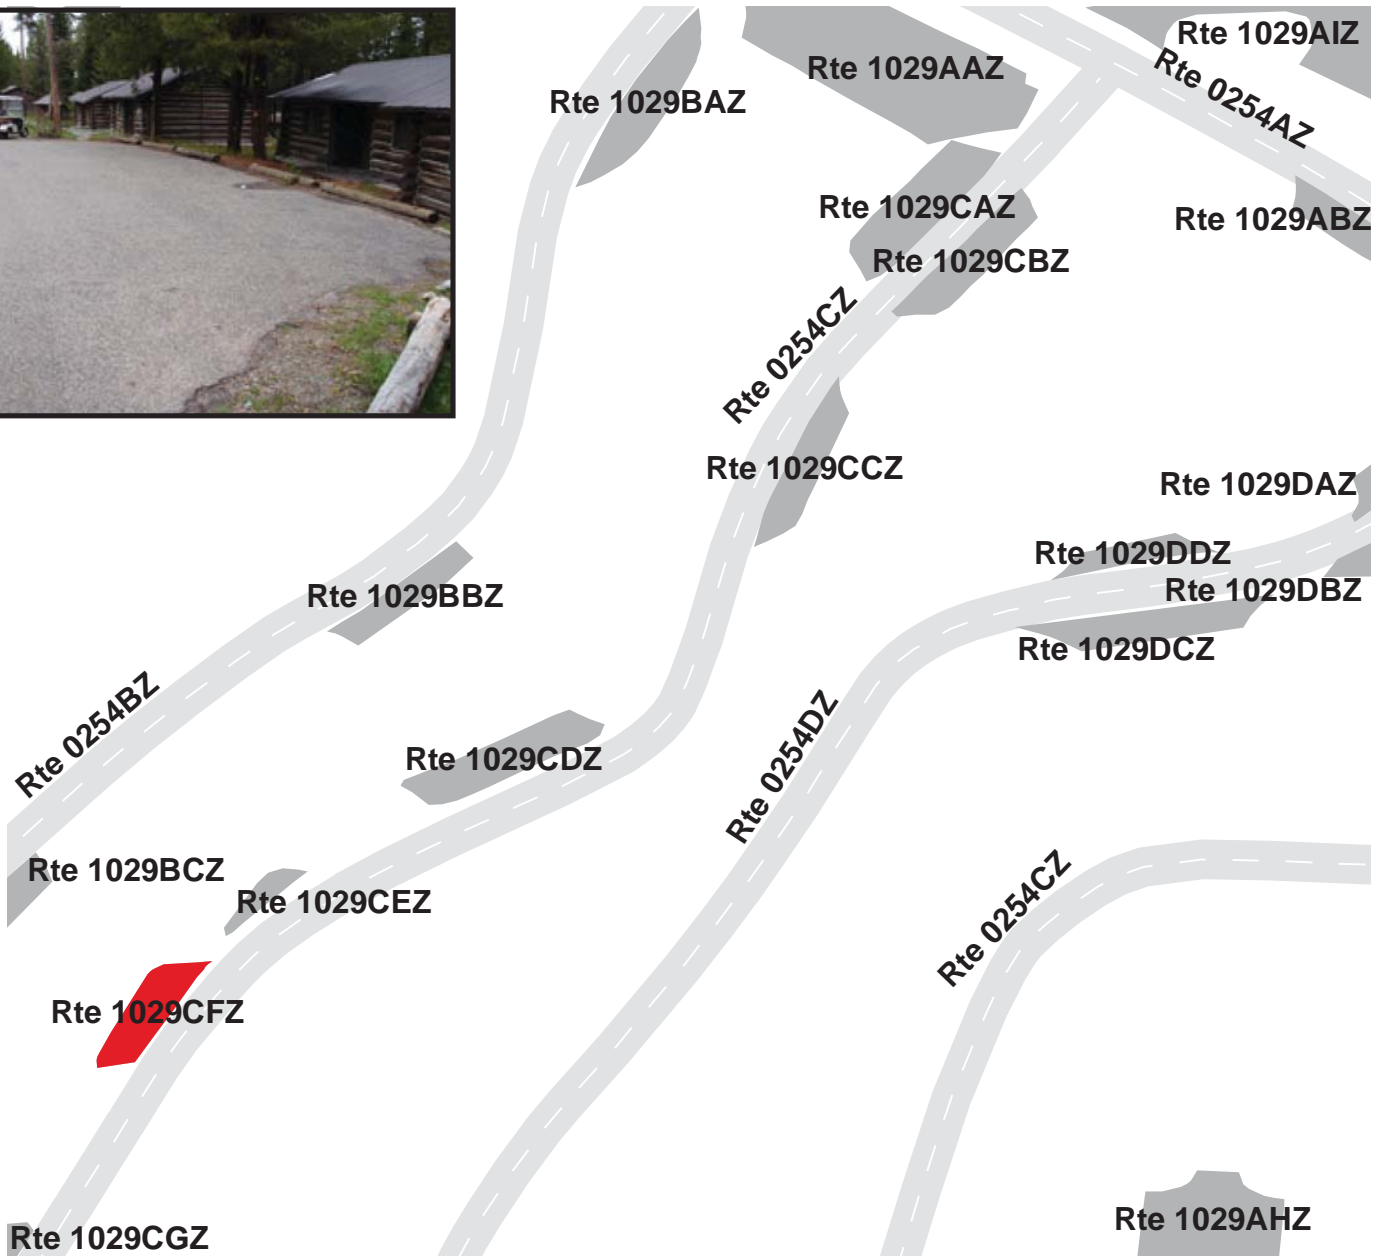
## Route 1029CFZ

Route Number	Public / NonPublic	Date Visited		Area (sq ft)	Lane Miles *	Surface Type
1029CFZ	PUBLIC	6/13/2008		1,097	0.02	AS
Culverts	Drop Inlets	Gates	Fire Hydrants	Curb & Gutter	Curb	PCR
0	0	0	0	NO CURB AND GUTTER	NO CURB	FAIR/73

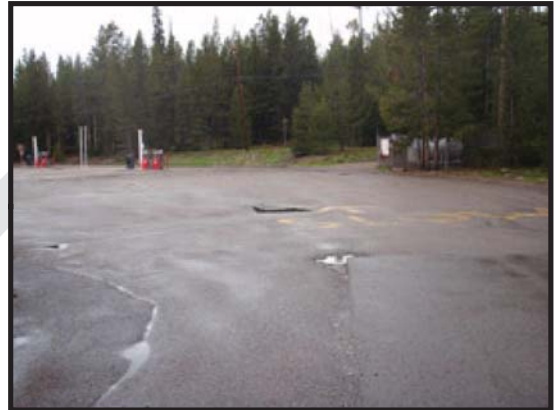
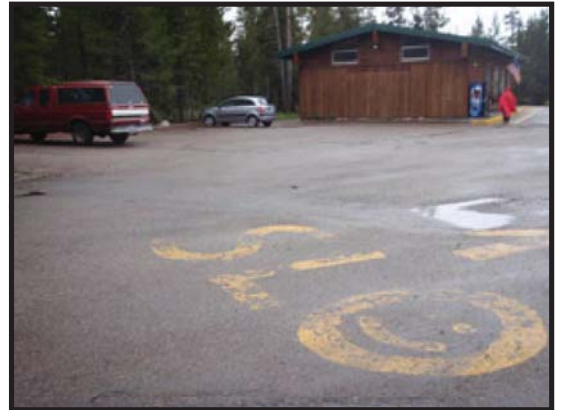
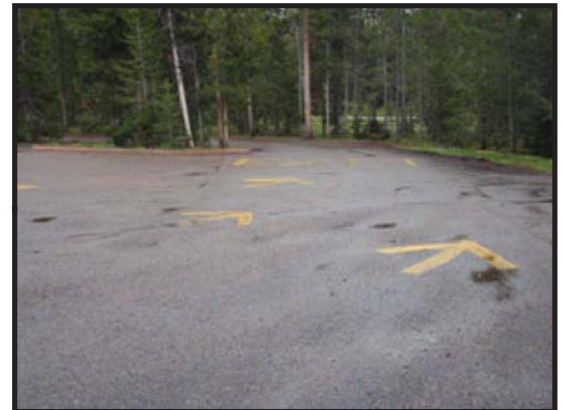
## Route 1030

Route Number	Public / NonPublic	Date Visited		Area (sq ft)	Lane Miles *	Surface Type
1030	PUBLIC	6/12/2008		68,984	1.19	AS
Culverts	Drop Inlets	Gates	Fire Hydrants	Curb & Gutter	Curb	PCR
0	0	0	1	NO CURB AND GUTTER	NO CURB	FAIR/73

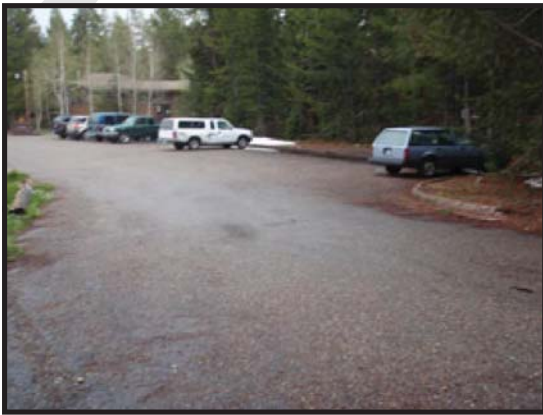
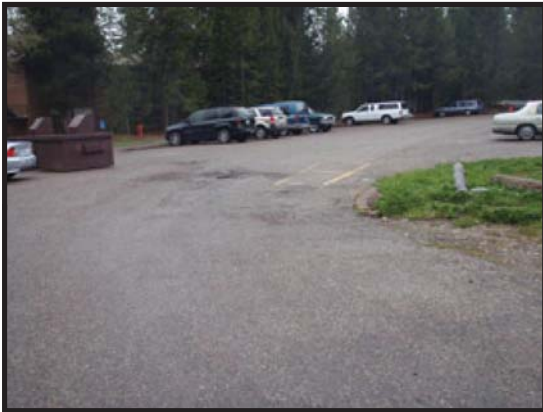
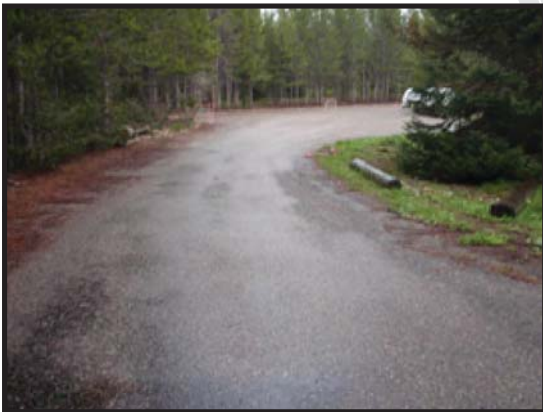
**GRAND TETON NATIONAL PARK**  
**Route 1031**  
**COLTER BAY CONCESSION EMPLOYEE PARKING**  
**FROM ROUTE 0415ZZ**  
**TO PARKING**

Route Number	Public / NonPublic	Date Visited		Area (sq ft)	Lane Miles *	Surface Type
1031	PUBLIC	6/12/2008		28,041	0.48	AS
Culverts	Drop Inlets	Gates	Fire Hydrants	Curb & Gutter	Curb	PCR
0	0	0	1	CONCRETE CURB AND GUTTER	ASPHALT CURB	FAIR/73

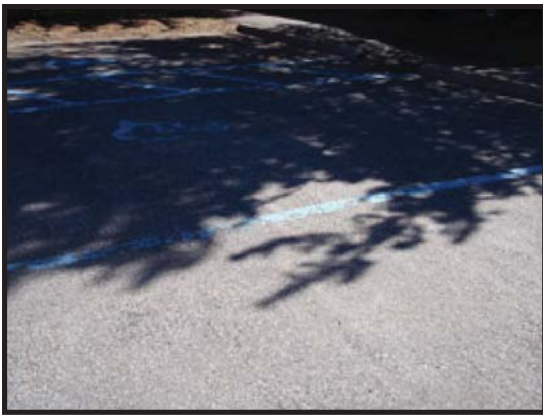
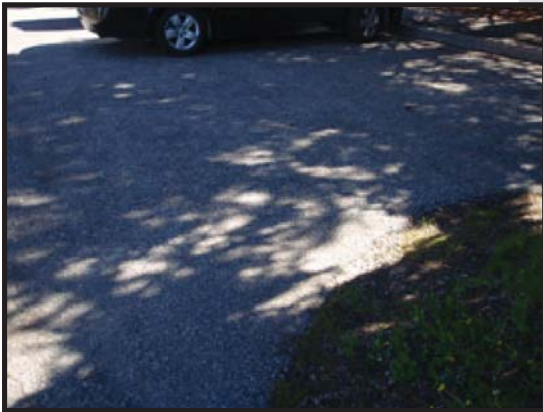
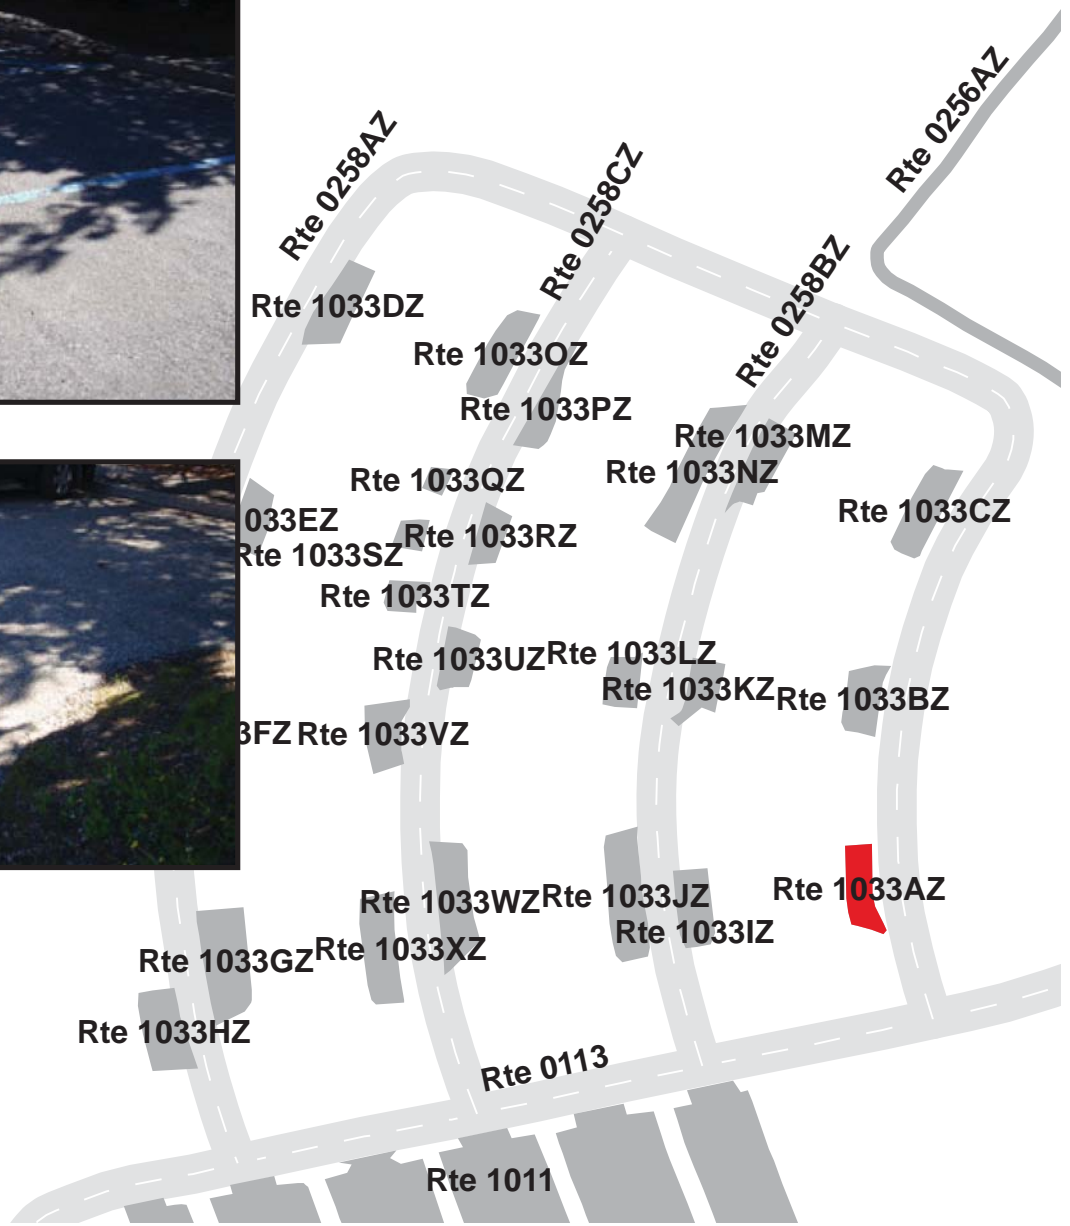
## Route 1033AZ

Route Number	Public / NonPublic	Date Visited		Area (sq ft)	Lane Miles *	Surface Type
1033AZ	PUBLIC	6/13/2008		1,114	0.02	AS
Culverts	Drop Inlets	Gates	Fire Hydrants	Curb & Gutter	Curb	PCR
0	0	0	0	CONCRETE CURB AND GUTTER	CONCRETE CURB	POOR/45
