**The Road Inventory  
of  
Grand Teton National Park  
GRTE – 1460  
Cycle 4**

**Prepared By:  
Federal Highway Administration  
Road Inventory Program  
Cycle 4**

# Grand Teton National Park in Wyoming

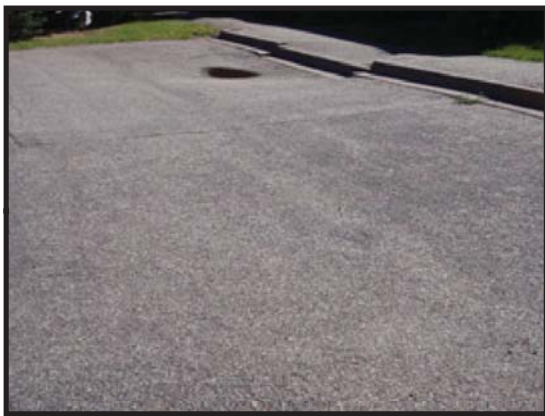
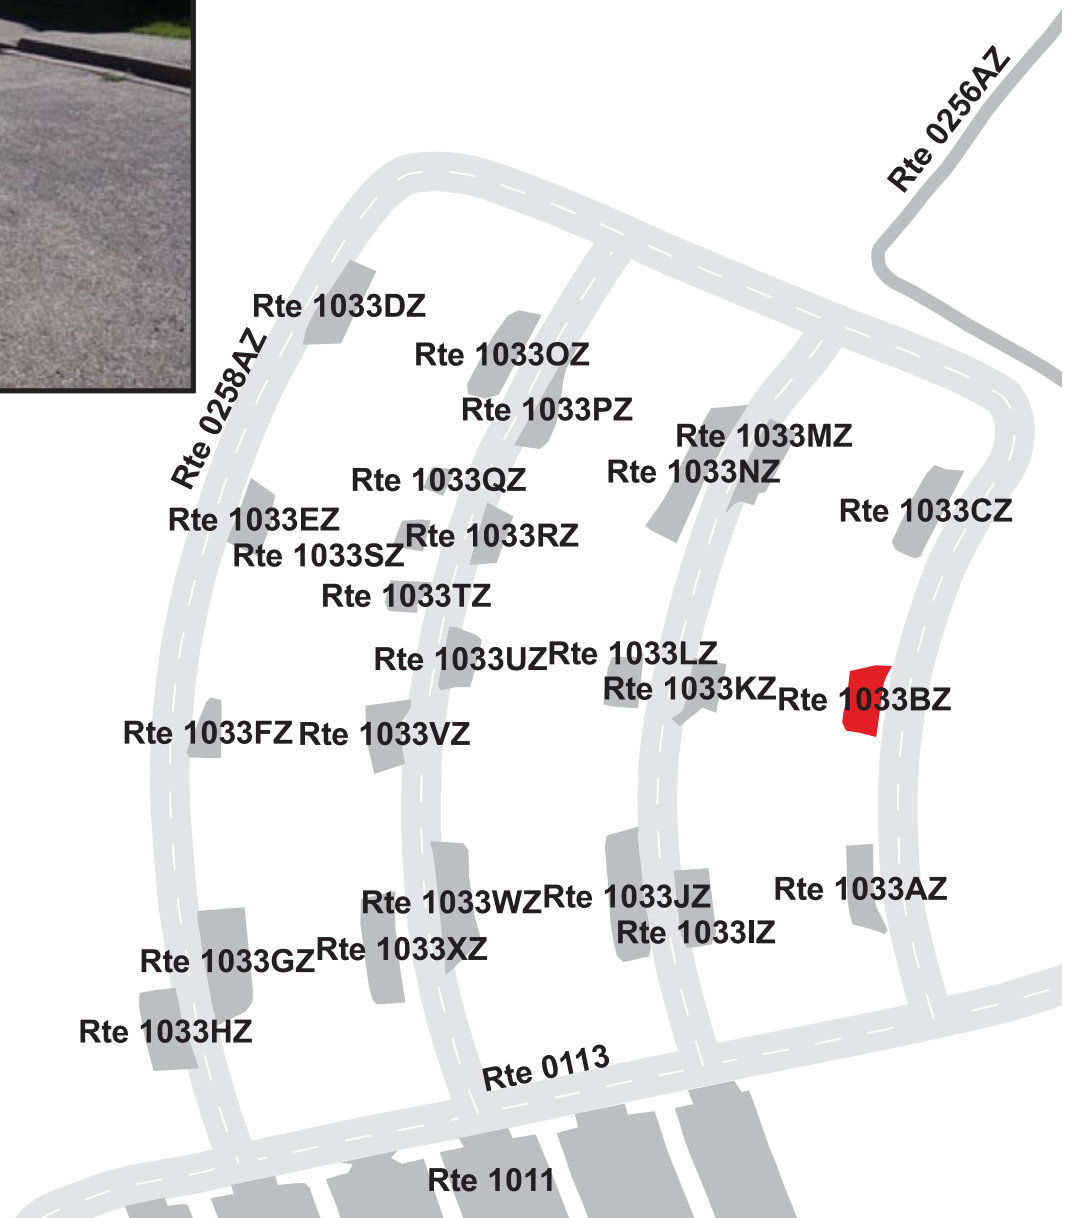
## Route 1033BZ

Route Number	Public / NonPublic	Date Visited		Area (sq ft)	Lane Miles *	Surface Type
1033BZ	PUBLIC	6/13/2008		1,121	0.02	AS
Culverts	Drop Inlets	Gates	Fire Hydrants	Curb & Gutter	Curb	PCR
0	0	0	0	CONCRETE CURB AND GUTTER	CONCRETE CURB	POOR/45

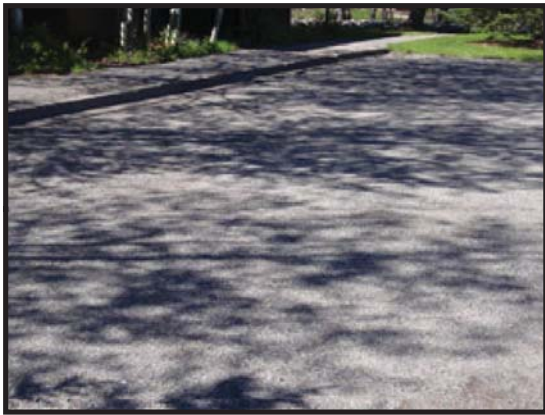
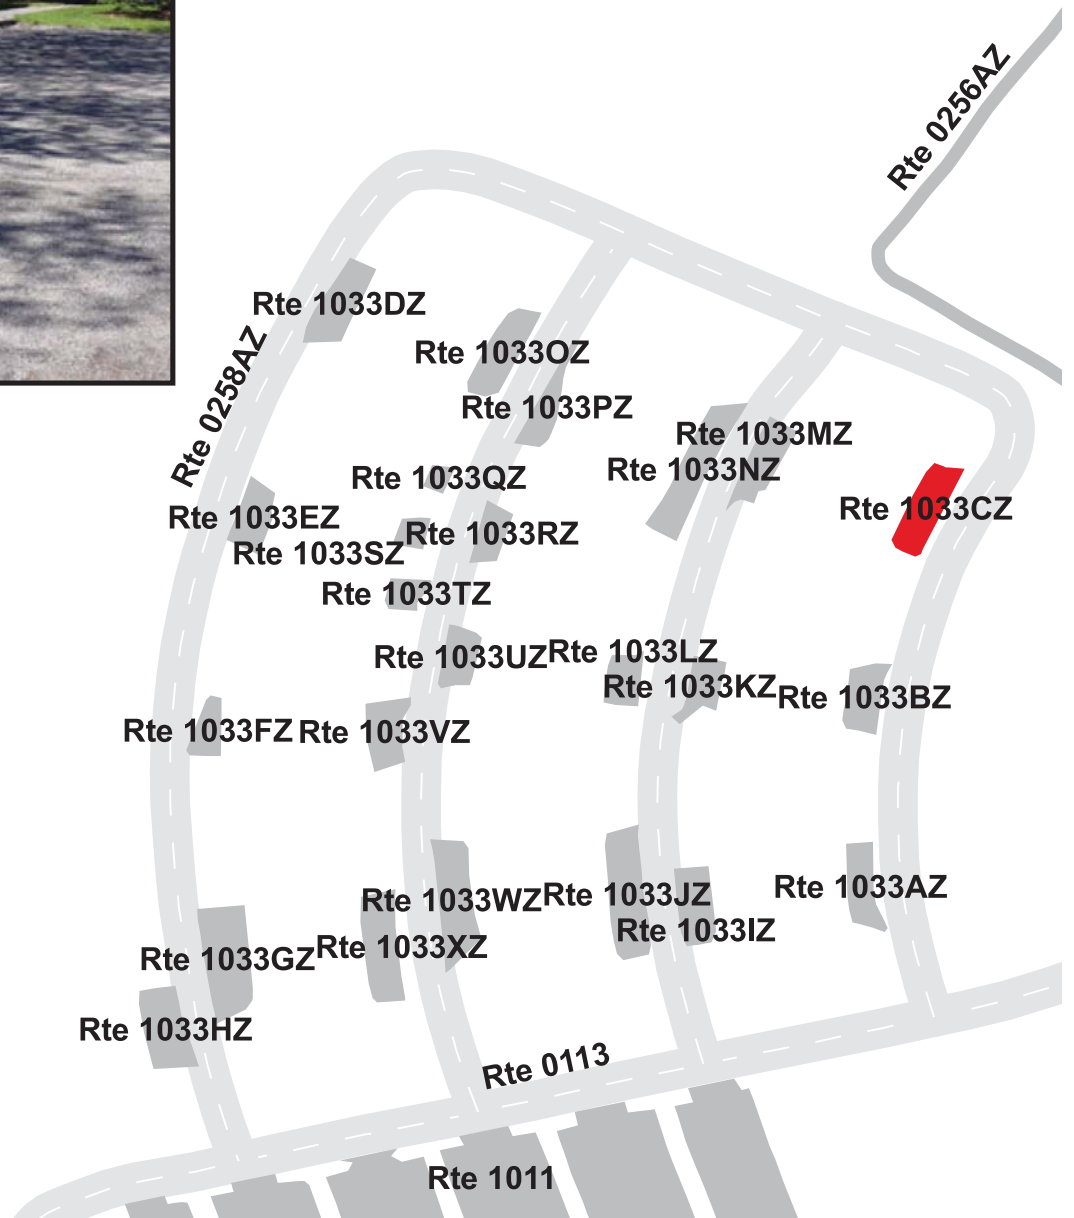
## Route 1033CZ

Route Number	Public / NonPublic	Date Visited		Area (sq ft)	Lane Miles *	Surface Type
1033CZ	PUBLIC	6/13/2008		1,477	0.03	AS
Culverts	Drop Inlets	Gates	Fire Hydrants	Curb & Gutter	Curb	PCR
0	0	0	0	CONCRETE CURB AND GUTTER	CONCRETE CURB	POOR/45

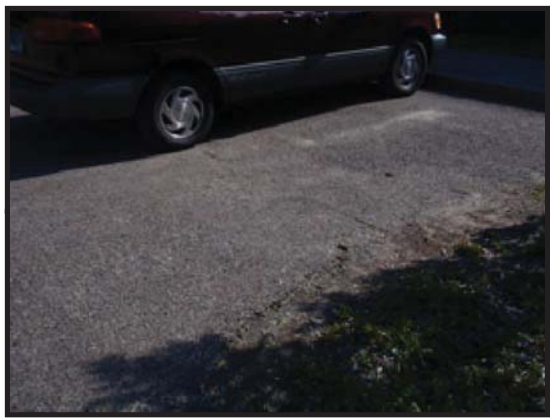
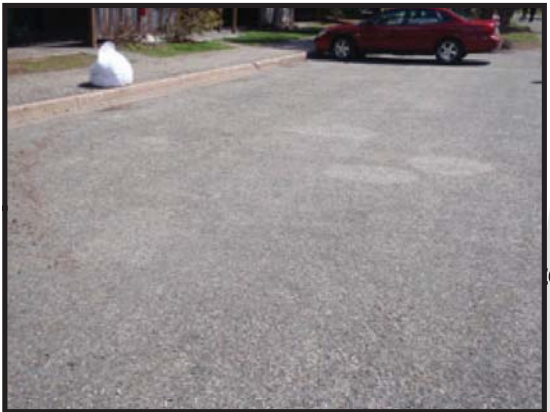
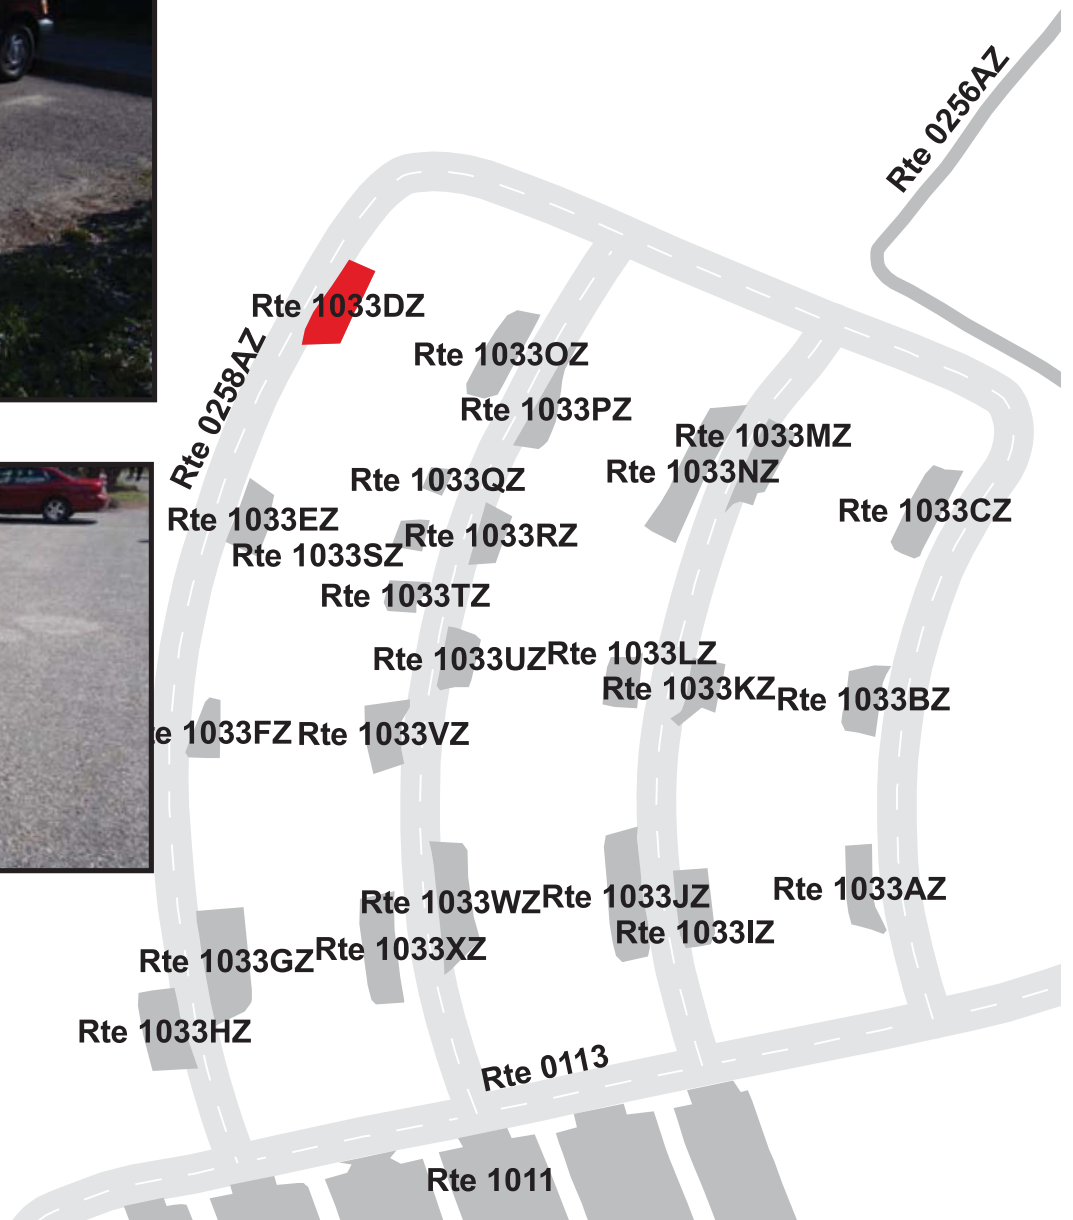
## Route 1033DZ

Route Number	Public / NonPublic	Date Visited		Area (sq ft)	Lane Miles *	Surface Type
1033DZ	PUBLIC	6/13/2008		1,454	0.03	AS
Culverts	Drop Inlets	Gates	Fire Hydrants	Curb & Gutter	Curb	PCR
0	1	0	0	CONCRETE CURB AND GUTTER	CONCRETE CURB	POOR/45

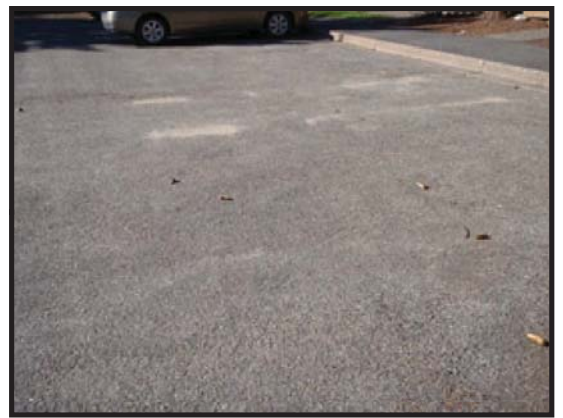
Route Number	Public / NonPublic	Date Visited		Area (sq ft)	Lane Miles *	Surface Type
1034NZ	PUBLIC	6/13/2008		1,976	0.03	AS
Culverts	Drop Inlets	Gates	Fire Hydrants	Curb & Gutter	Curb	PCR
0	0	0	0	CONCRETE CURB AND GUTTER	CONCRETE CURB	POOR/45

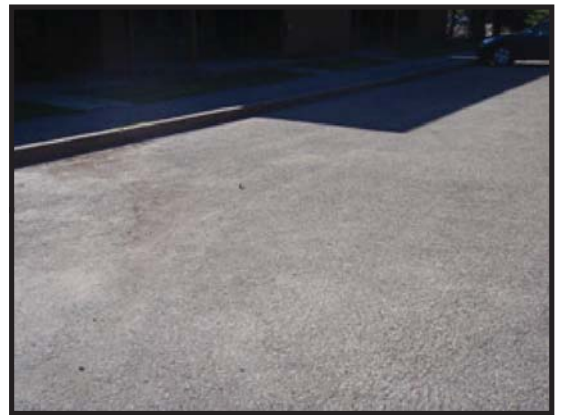
## Route 1034OZ

Route Number	Public / NonPublic	Date Visited		Area (sq ft)	Lane Miles *	Surface Type
1034OZ	PUBLIC	6/13/2008		1,484	0.03	AS
Culverts	Drop Inlets	Gates	Fire Hydrants	Curb & Gutter	Curb	PCR
0	0	0	0	CONCRETE CURB AND GUTTER	CONCRETE CURB	POOR/45

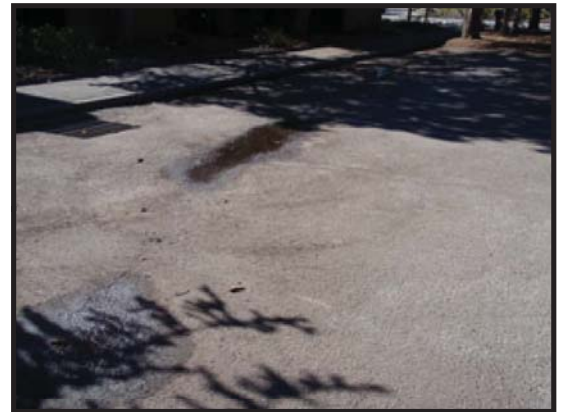
## Route 1034PZ

Route Number	Public / NonPublic	Date Visited		Area (sq ft)	Lane Miles *	Surface Type
1034PZ	PUBLIC	6/13/2008		951	0.02	AS
Culverts	Drop Inlets	Gates	Fire Hydrants	Curb & Gutter	Curb	PCR
0	1	0	0	CONCRETE CURB AND GUTTER	CONCRETE CURB	POOR/45

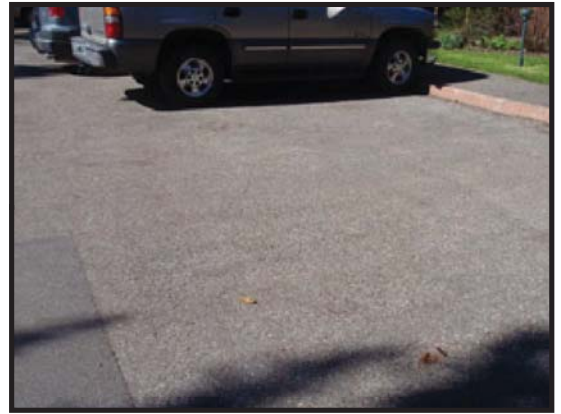
## Route 1034QZ

Route Number	Public / NonPublic	Date Visited		Area (sq ft)	Lane Miles *	Surface Type
1034QZ	PUBLIC	6/13/2008		1,233	0.02	AS
Culverts	Drop Inlets	Gates	Fire Hydrants	Curb & Gutter	Curb	PCR
0	0	0	0	CONCRETE CURB AND GUTTER	CONCRETE CURB	POOR/45

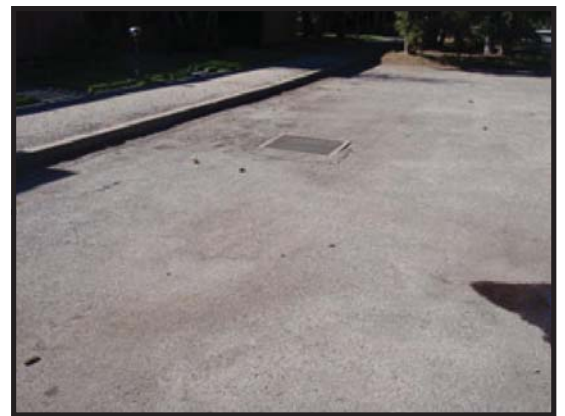
## Route 1034RZ

Route Number	Public / NonPublic	Date Visited		Area (sq ft)	Lane Miles *	Surface Type
1034RZ	PUBLIC	6/13/2008		1,422	0.02	AS
Culverts	Drop Inlets	Gates	Fire Hydrants	Curb & Gutter	Curb	PCR
0	1	0	0	CONCRETE CURB AND GUTTER	CONCRETE CURB	POOR/45

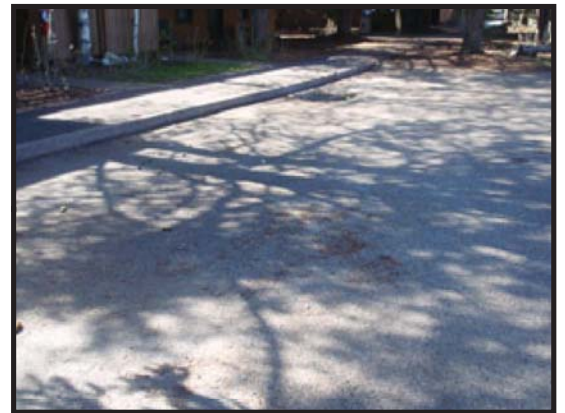
Route Number	Public / NonPublic	Date Visited		Area (sq ft)	Lane Miles *	Surface Type
1034TZ	PUBLIC	6/13/2008		754	0.01	AS
Culverts	Drop Inlets	Gates	Fire Hydrants	Curb & Gutter	Curb	PCR
0	1	0	0	CONCRETE CURB AND GUTTER	CONCRETE CURB	POOR/45

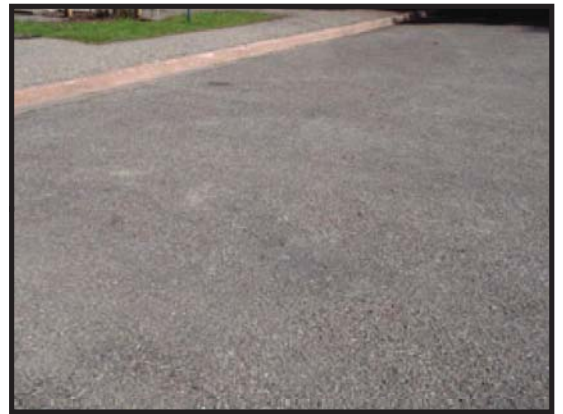
Route Number	Public / NonPublic	Date Visited		Area (sq ft)	Lane Miles *	Surface Type
1034WZ	PUBLIC	6/13/2008		828	0.01	AS
Culverts	Drop Inlets	Gates	Fire Hydrants	Curb & Gutter	Curb	PCR
0	0	0	0	CONCRETE CURB AND GUTTER	CONCRETE CURB	POOR/45

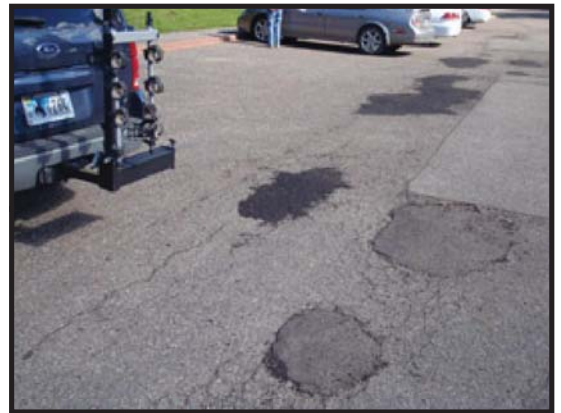
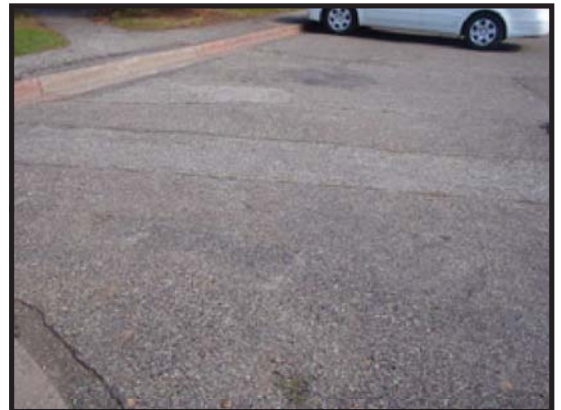
## Route 1034XZ

Route Number	Public / NonPublic	Date Visited		Area (sq ft)	Lane Miles *	Surface Type
1034XZ	PUBLIC	6/13/2008		4,116	0.07	AS
Culverts	Drop Inlets	Gates	Fire Hydrants	Curb & Gutter	Curb	PCR
0	0	0	0	CONCRETE CURB AND GUTTER	CONCRETE CURB	POOR/45

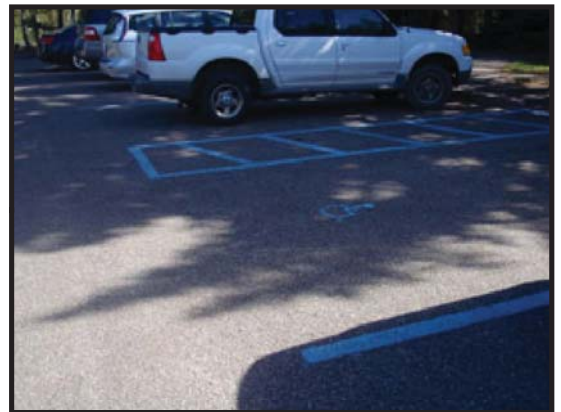
## Route 1034YZ

Route Number	Public / NonPublic	Date Visited		Area (sq ft)	Lane Miles *	Surface Type
1034YZ	PUBLIC	6/13/2008		3,343	0.06	AS
Culverts	Drop Inlets	Gates	Fire Hydrants	Curb & Gutter	Curb	PCR
0	0	0	0	CONCRETE CURB AND GUTTER	CONCRETE CURB	POOR/45
