**The Road Inventory
of
Haleakala National Park
HALE – 8290
Cycle 4**

**Prepared By:
Federal Highway Administration
Road Inventory Program
Cycle 4**

Haleakala National Park in Hawaii

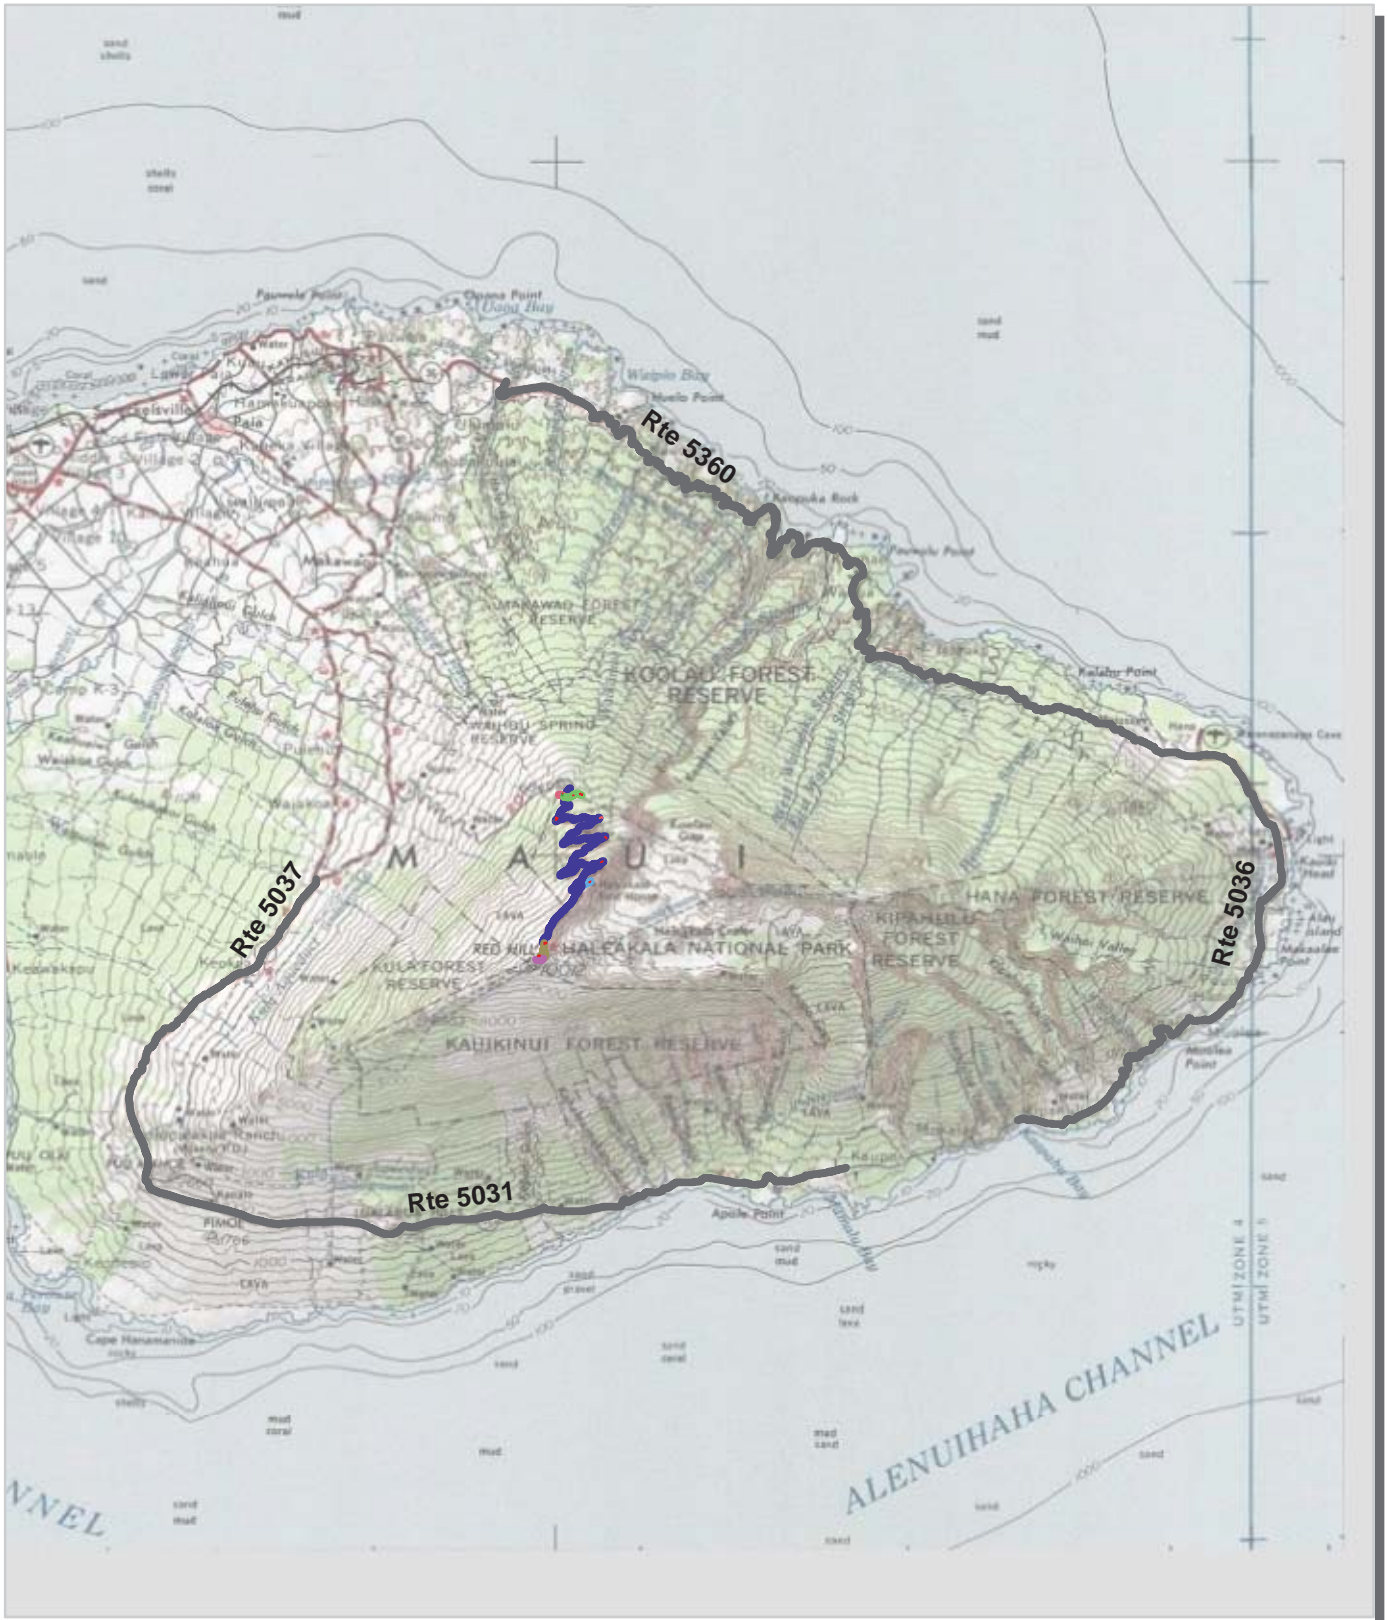
Haleakala National Park Route Location Map Area 1

Unique colors used to differentiate routes

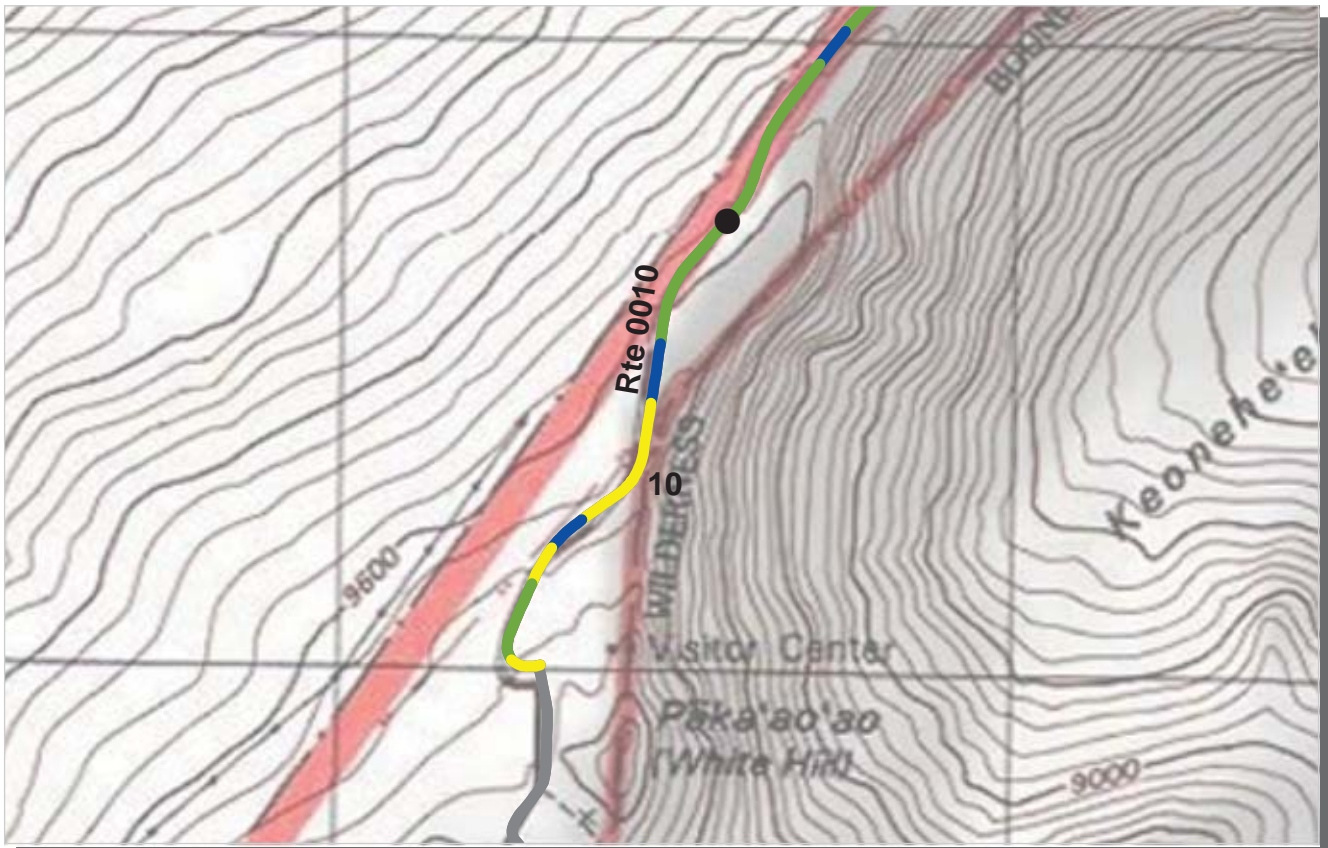
ROUTE: 0010 HALEAKALA PARK ROAD

PCR Poor ■ Fair ■ Good ■ Excellent ■ No Data ■
 (<=60) (61 - 84) (85 - 94) (95 - 100)

* If the PCR rating is not available for a section, the SCR rating will be displayed. See appendix for definitions and formulas.
