**The Road Inventory  
of  
Indiana Dunes National Lakeshore  
INDU – 6300  
Cycle 4**

**Prepared By:  
Federal Highway Administration  
Road Inventory Program  
Cycle 4**

# Indiana Dunes National Lakeshore in Indiana

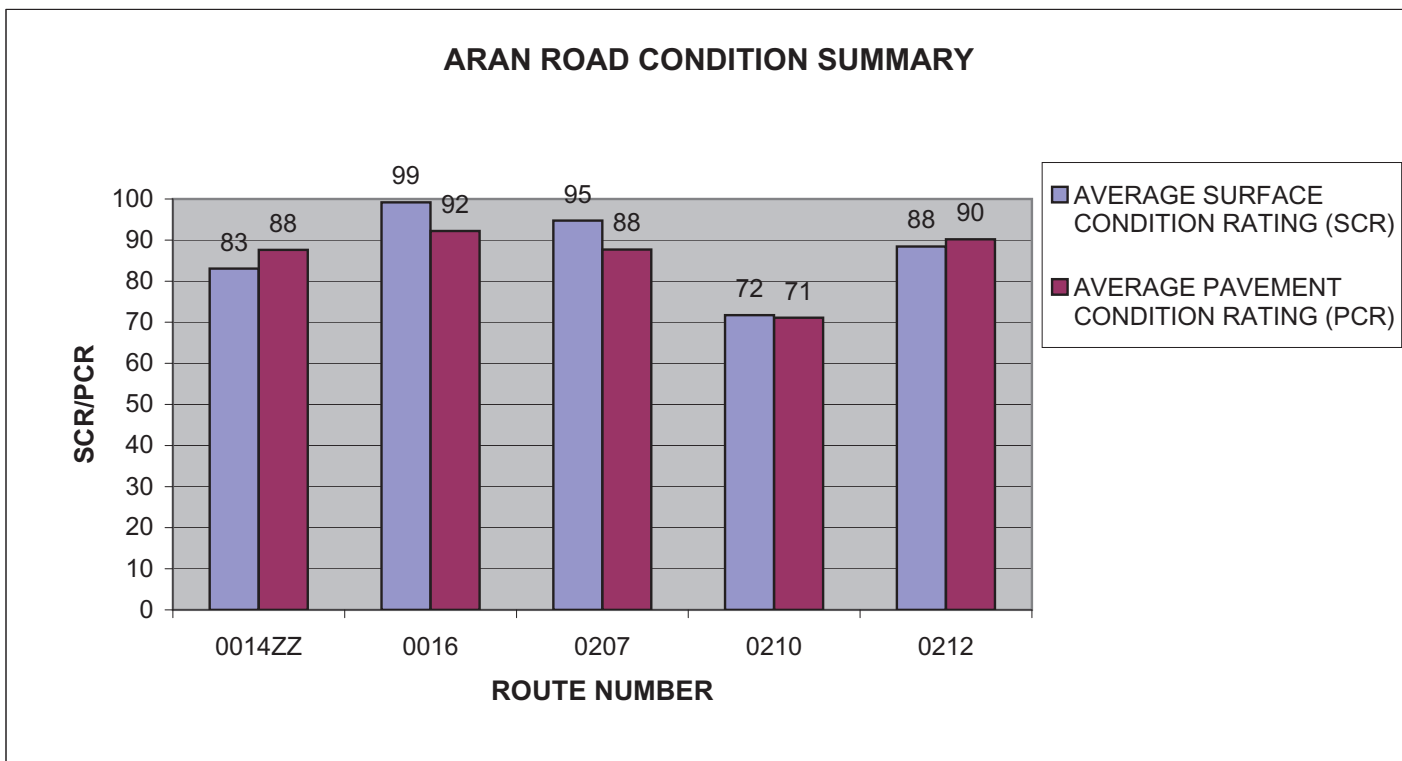
# INDU: ARAN ROAD CONDITION SUMMARY

ROUTE NUMBER	ROUTE NAME	FUNCT CLASS	ROUTE LENGTH	SURFACE TYPE	AVERAGE SURFACE CONDITION RATING (SCR)	AVERAGE PAVEMENT CONDITION RATING (PCR)
0014ZZ	WEST BEACH ACCESS ROADS	1	1.55	ASPHALT	83	88
0016	PORTAGE LAKEFRONT ENTRANCE ROAD	1	0.70	ASPHALT	99	92
0207	GOOD FELLOW CAMP ROAD IDELC	2	0.44	ASPHALT	95	88
0210	CENTRAL AVENUE	2	0.92	ASPHALT	72	71
0212	KEMIL ROAD (300 EAST ROAD)	2	0.81	ASPHALT	88	90

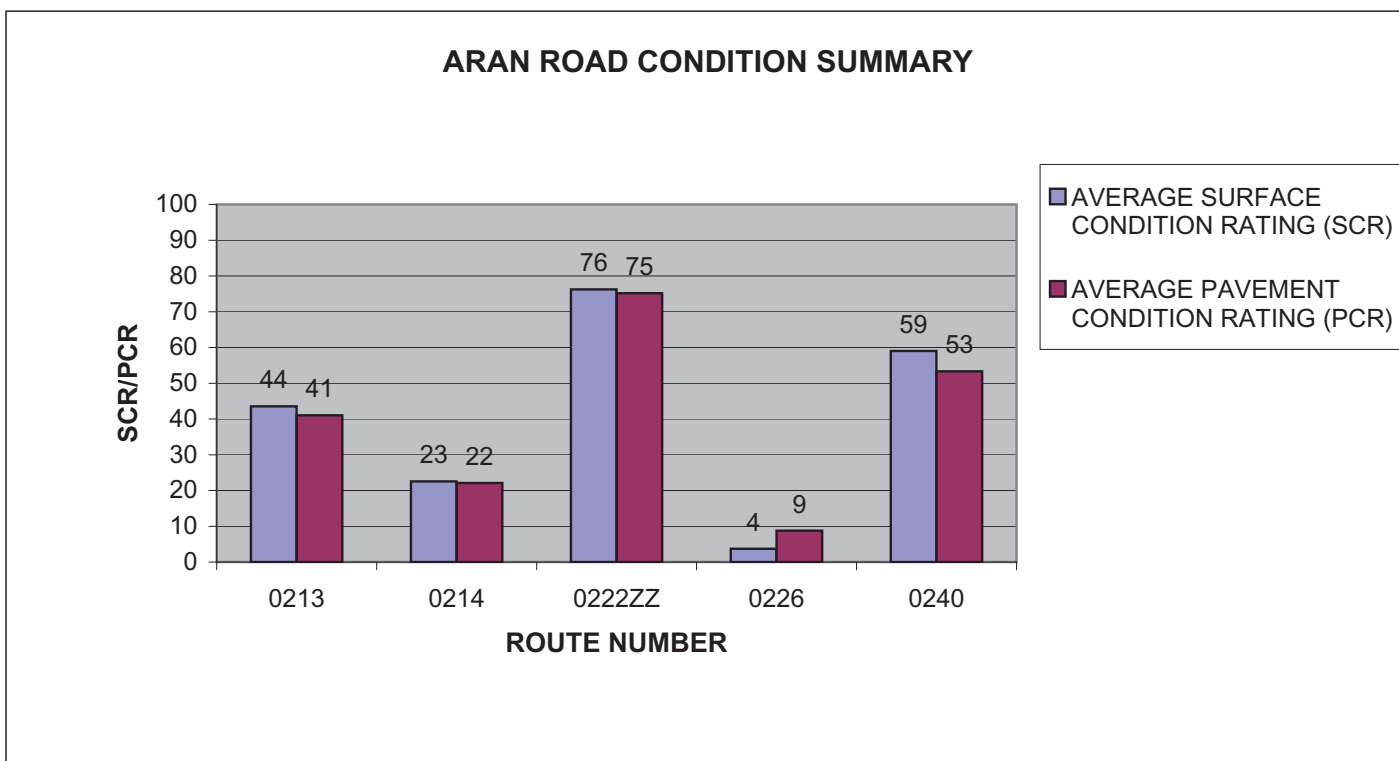
# INDU: ARAN ROAD CONDITION SUMMARY

ROUTE NUMBER	ROUTE NAME	FUNCT CLASS	ROUTE LENGTH	SURFACE TYPE	AVERAGE SURFACE CONDITION RATING (SCR)	AVERAGE PAVEMENT CONDITION RATING (PCR)
0213	FURNESSVILLE ROAD (1500 NORTH ROAD)	2	1.55	ASPHALT	44	41
0214	TEALE ROAD	2	0.37	ASPHALT	23	22
0222ZZ	DUNEWOOD CAMPGROUND ACCESS ROADS	3	1.35	ASPHALT	76	75
0226	SOUTH STATE PARK ROAD (1500 NORTH ROAD)	2	0.99	ASPHALT	4	9
0240	WAHL FARM ACCESS ROAD	3	0.12	ASPHALT	59	53

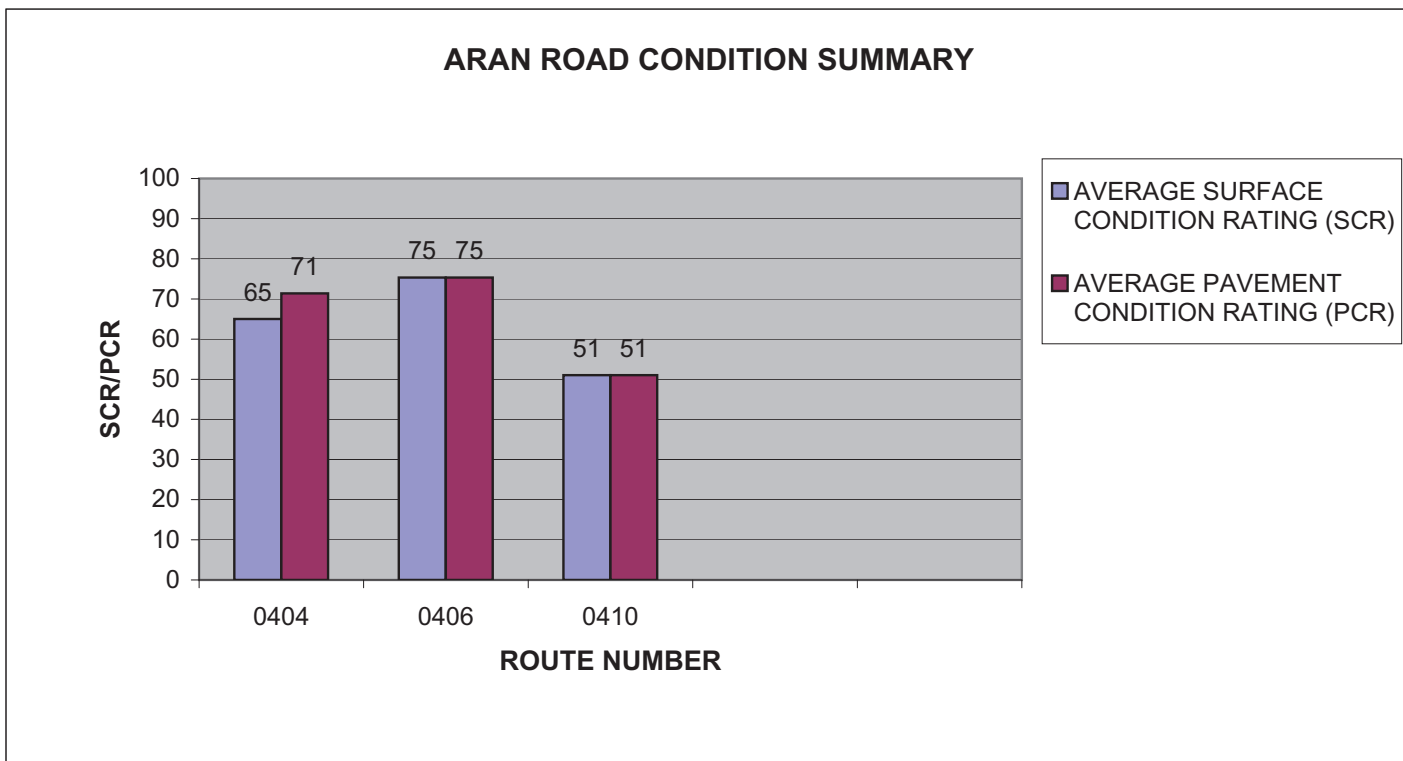
# INDU: ARAN ROAD CONDITION SUMMARY

ROUTE NUMBER	ROUTE NAME	FUNCT CLASS	ROUTE LENGTH	SURFACE TYPE	AVERAGE SURFACE CONDITION RATING (SCR)	AVERAGE PAVEMENT CONDITION RATING (PCR)
0404	WEST BEACH SERVICE ACCESS ROAD	4	0.32	ASPHALT	65	71
0406	WEST BEACH SERVICE ROAD	4	0.12	ASPHALT	75	75
0410	DUNEWOOD SERVICE ROAD	5	0.1	ASPHALT	51	51

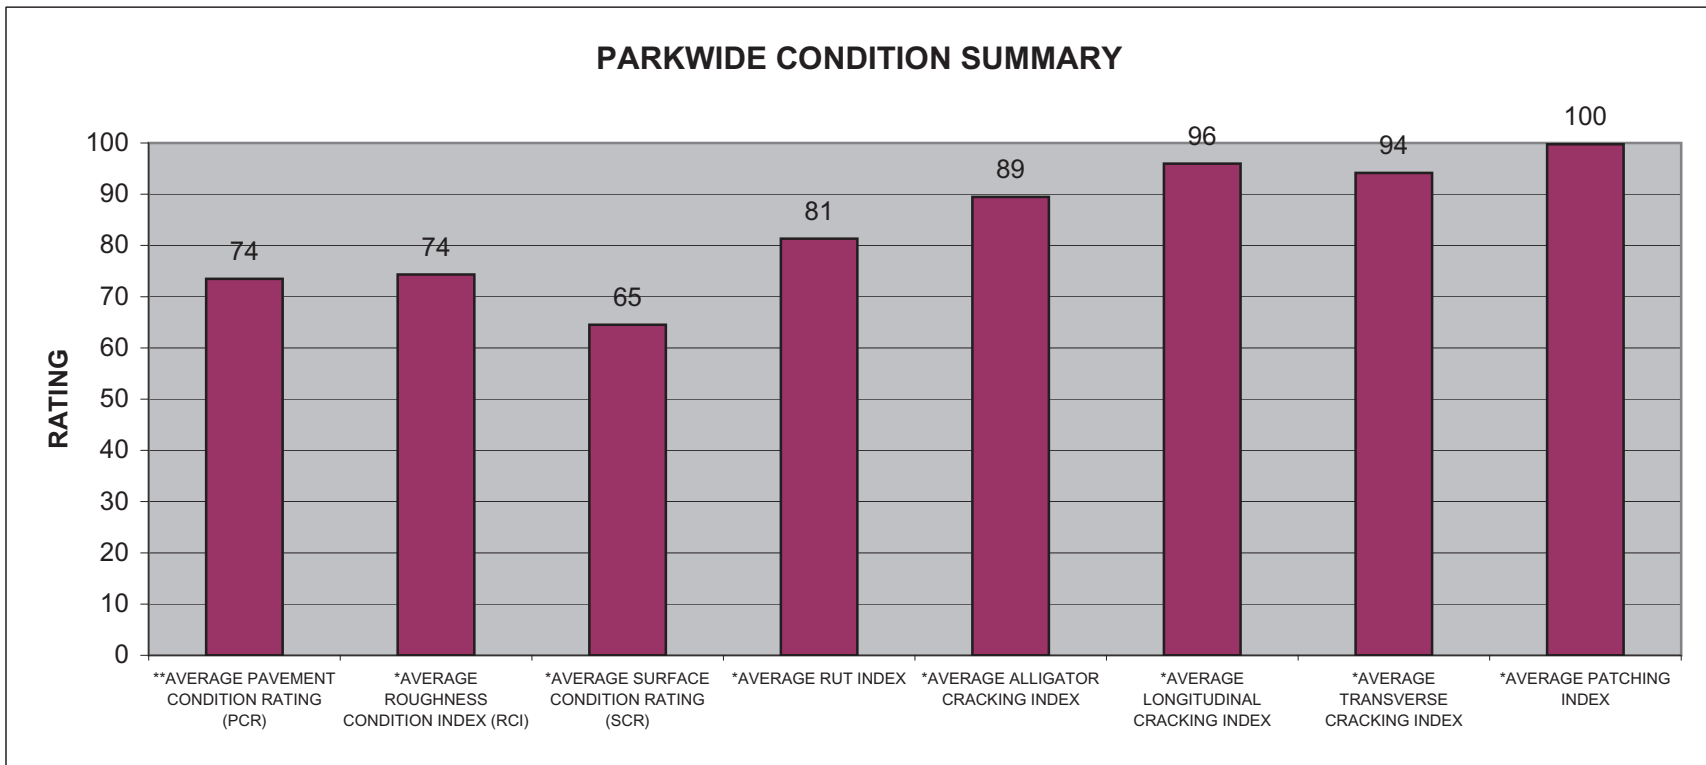
# INDU: PARKWIDE CONDITION SUMMARY

**AVERAGE PAVEMENT CONDITION RATING (PCR)	*AVERAGE ROUGHNESS CONDITION INDEX (RCI)	*AVERAGE SURFACE CONDITION RATING (SCR)	*AVERAGE RUT INDEX	*AVERAGE ALLIGATOR CRACKING INDEX	*AVERAGE LONGITUDINAL CRACKING INDEX	*AVERAGE TRANSVERSE CRACKING INDEX	*AVERAGE PATCHING INDEX
74	74	65	81	89	96	94	100

\*\* PCR Index is based on all ARAN-driven roads, parking areas, and manually rated routes.

\* Index values are based on ARAN-driven roads only.

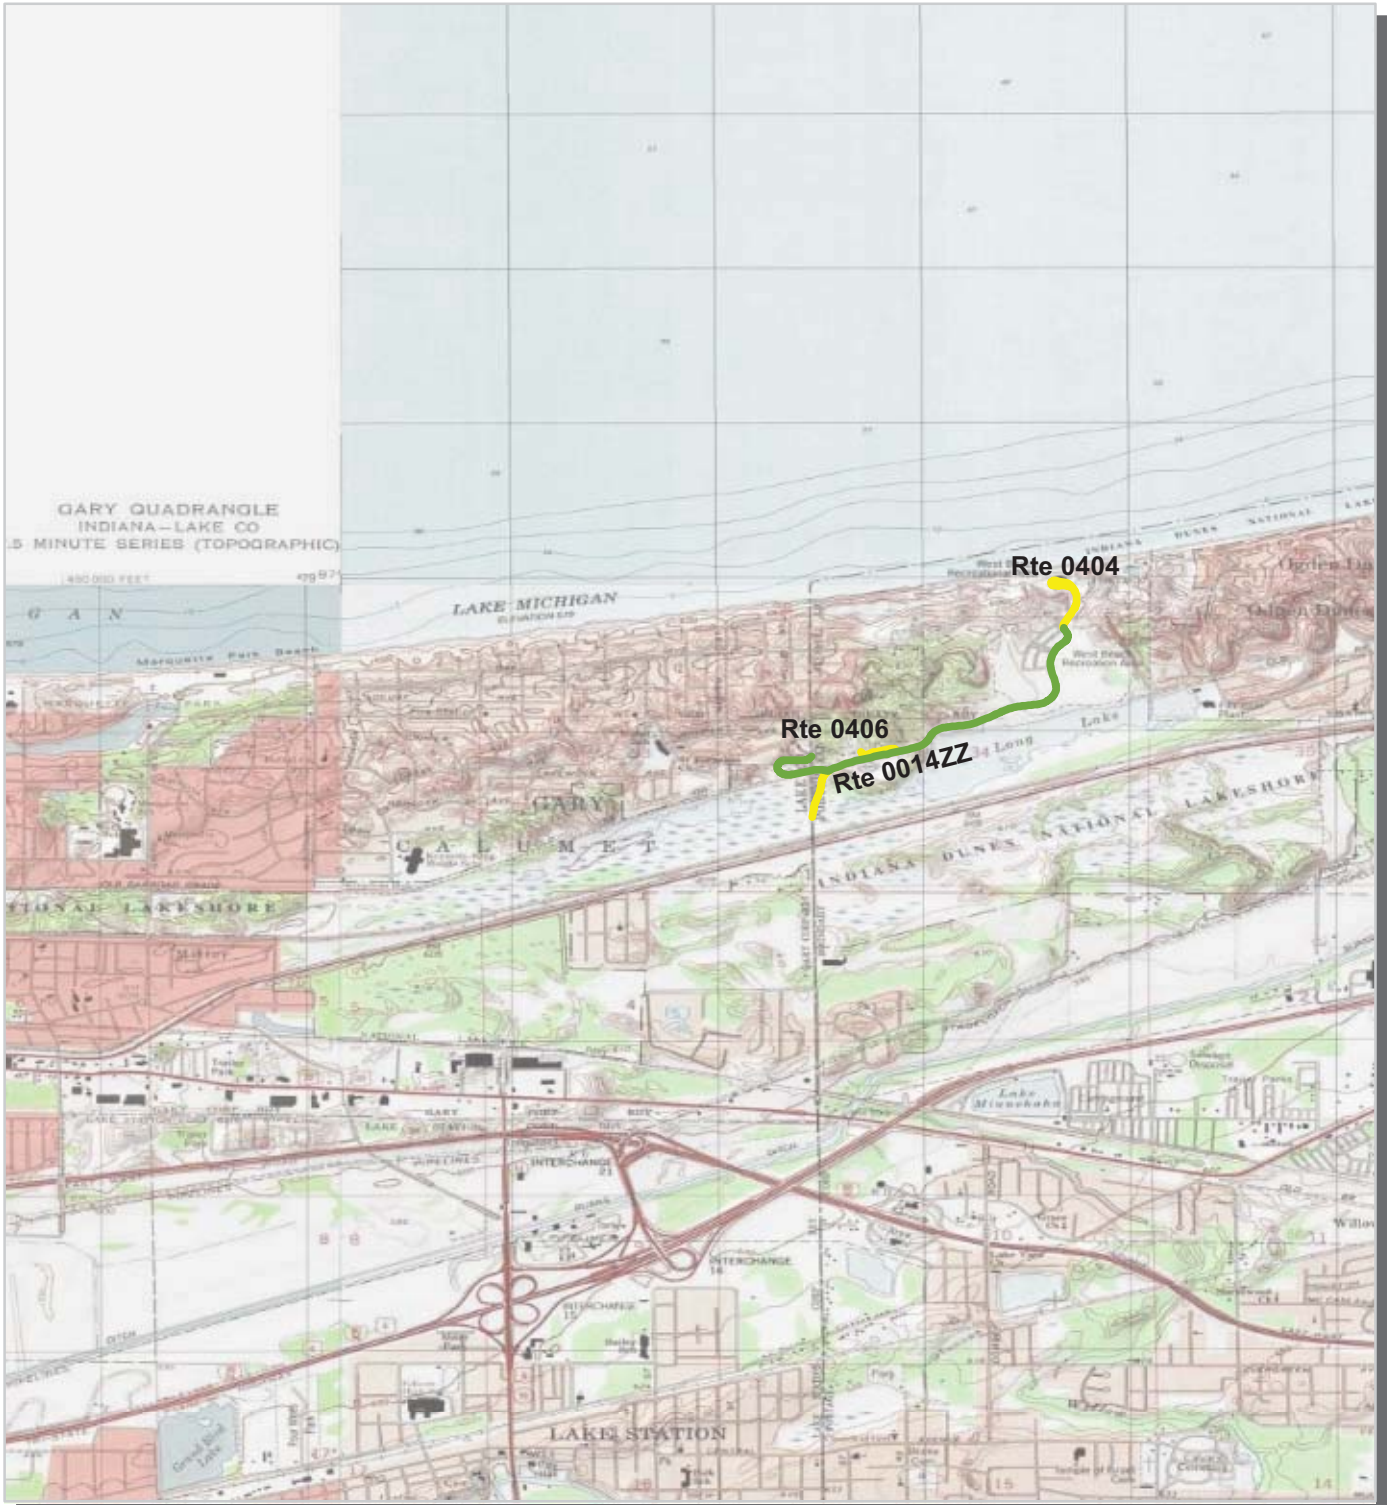
# Indiana Dunes National Lakeshore Route Condition Map PCR - Mile by Mile Area 1

PCR	Poor	Fair	Good	Excellent	No Data
	(≤60)	(61 - 84)	(85 - 94)	(95 - 100)

\* If the PCR rating is not available for a section, the SCR rating will be displayed. See appendix for definitions and formulas.

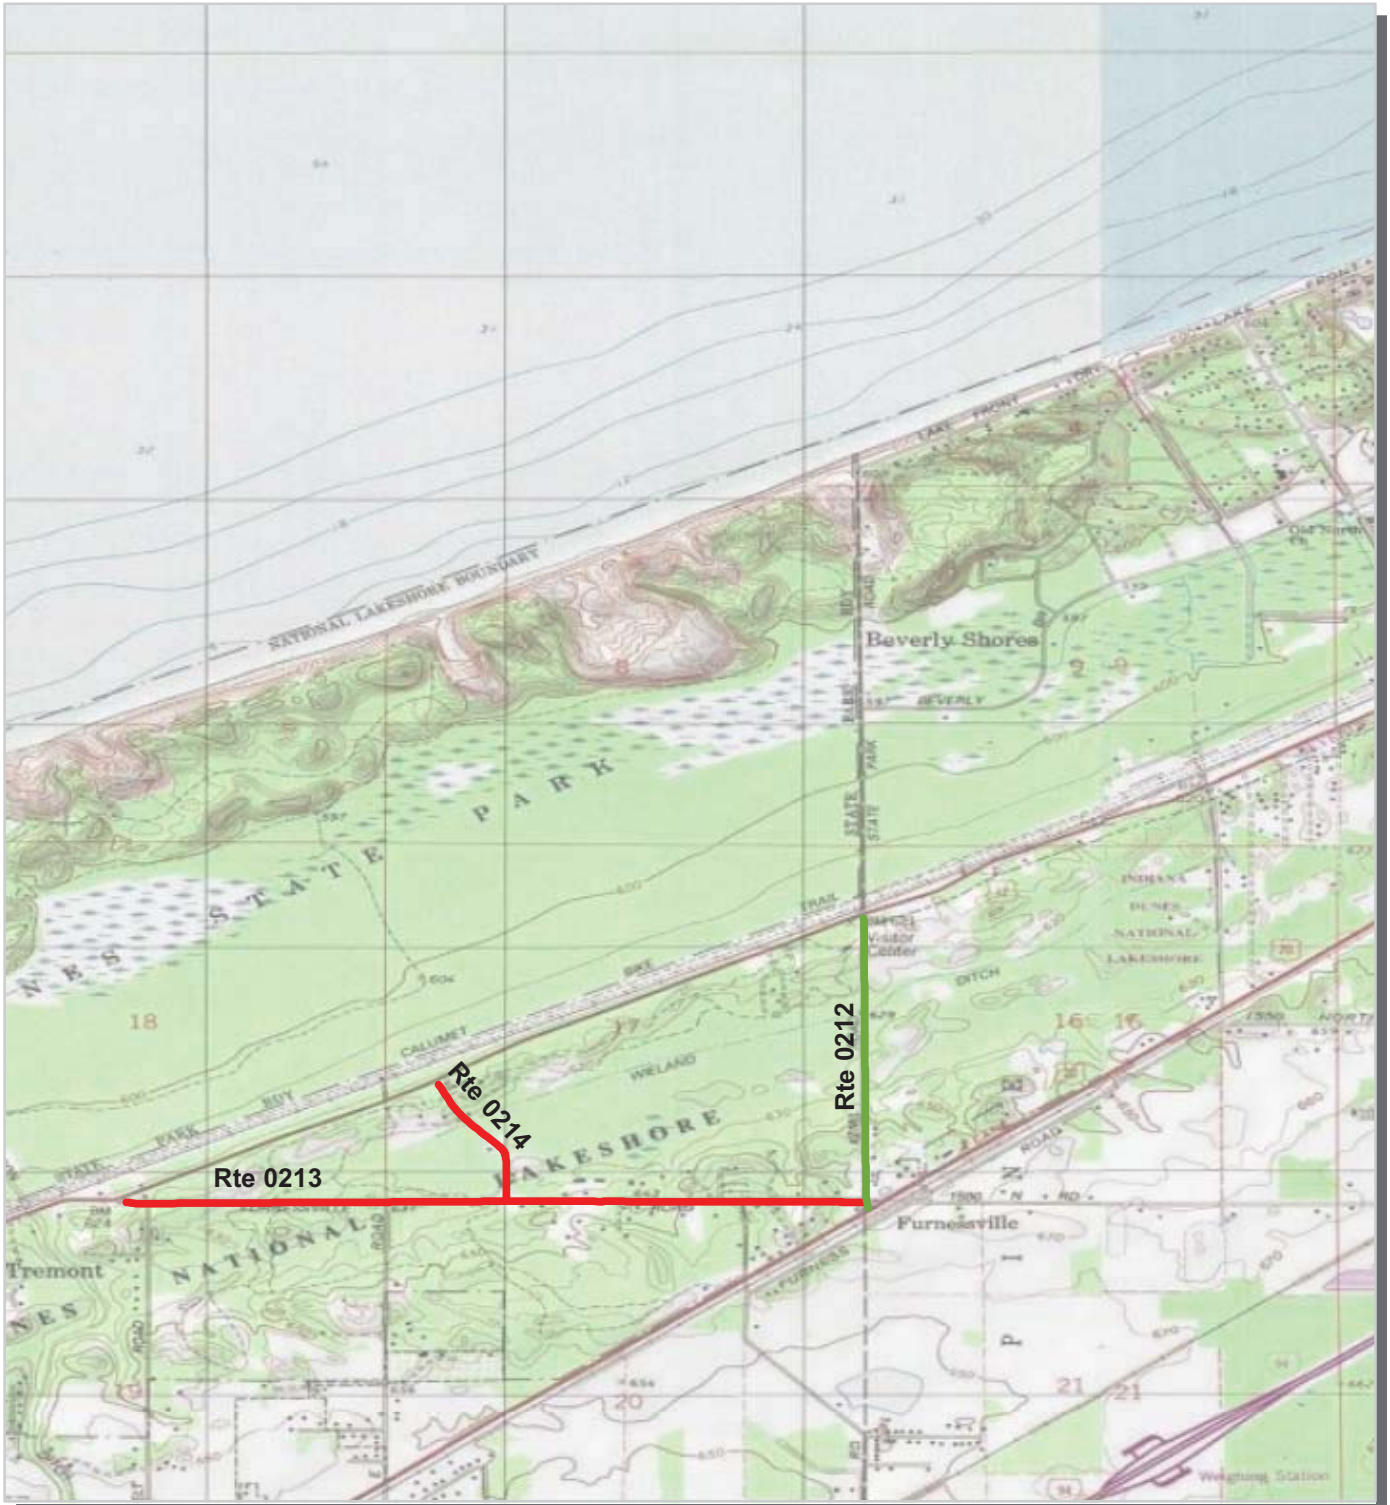
# Indiana Dunes National Lakeshore Route Condition Map PCR - Mile by Mile Area 3

PCR	Poor (≤60)	<span style="display: inline-block; width: 15px; height: 15px; background-color: red; border: 1px solid black;"></span>	Fair (61 - 84)	<span style="display: inline-block; width: 15px; height: 15px; background-color: yellow; border: 1px solid black;"></span>	Good (85 - 94)	<span style="display: inline-block; width: 15px; height: 15px; background-color: green; border: 1px solid black;"></span>	Excellent (95 - 100)	<span style="display: inline-block; width: 15px; height: 15px; background-color: blue; border: 1px solid black;"></span>	No Data	<span style="display: inline-block; width: 15px; height: 15px; background-color: black; border: 1px solid black;"></span>
-----	---------------	---	-------------------	--	-------------------	---	-------------------------	--	---------	---

\* If the PCR rating is not available for a section, the SCR rating will be displayed. See appendix for definitions and formulas.

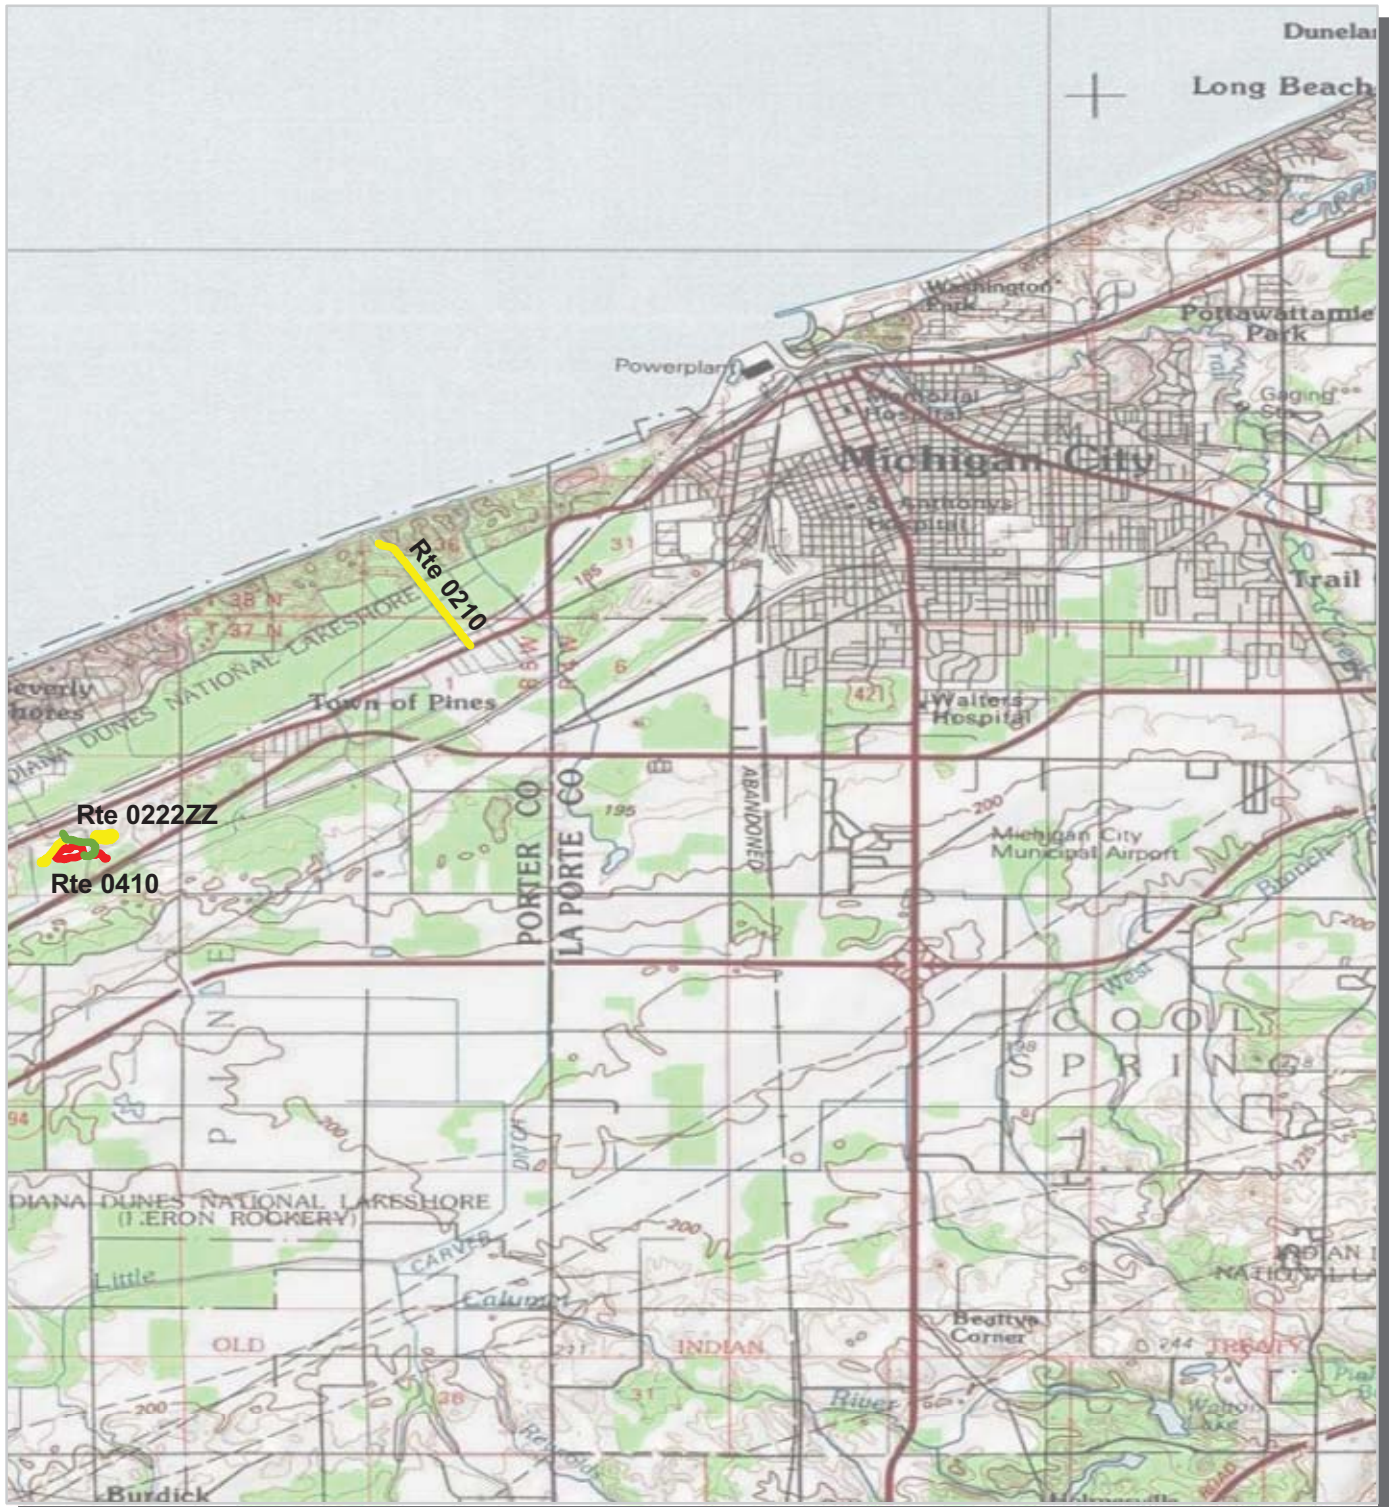
# Indiana Dunes National Lakeshore Route Condition Map PCR - Mile by Mile Area 4

PCR	Poor	Fair	Good	Excellent	No Data
	( $\leq 60$ )	(61 - 84)	(85 - 94)	(95 - 100)

\* If the PCR rating is not available for a section, the SCR rating will be displayed. See appendix for definitions and formulas.
