**The Road Inventory
of
John D. Rockefeller, Jr. Memorial Parkway
JODR – 1467
Cycle 4**

**Prepared By:
Federal Highway Administration
Road Inventory Program
Cycle 4**

John D. Rockefeller, Jr. Memorial Parkway in Wyoming

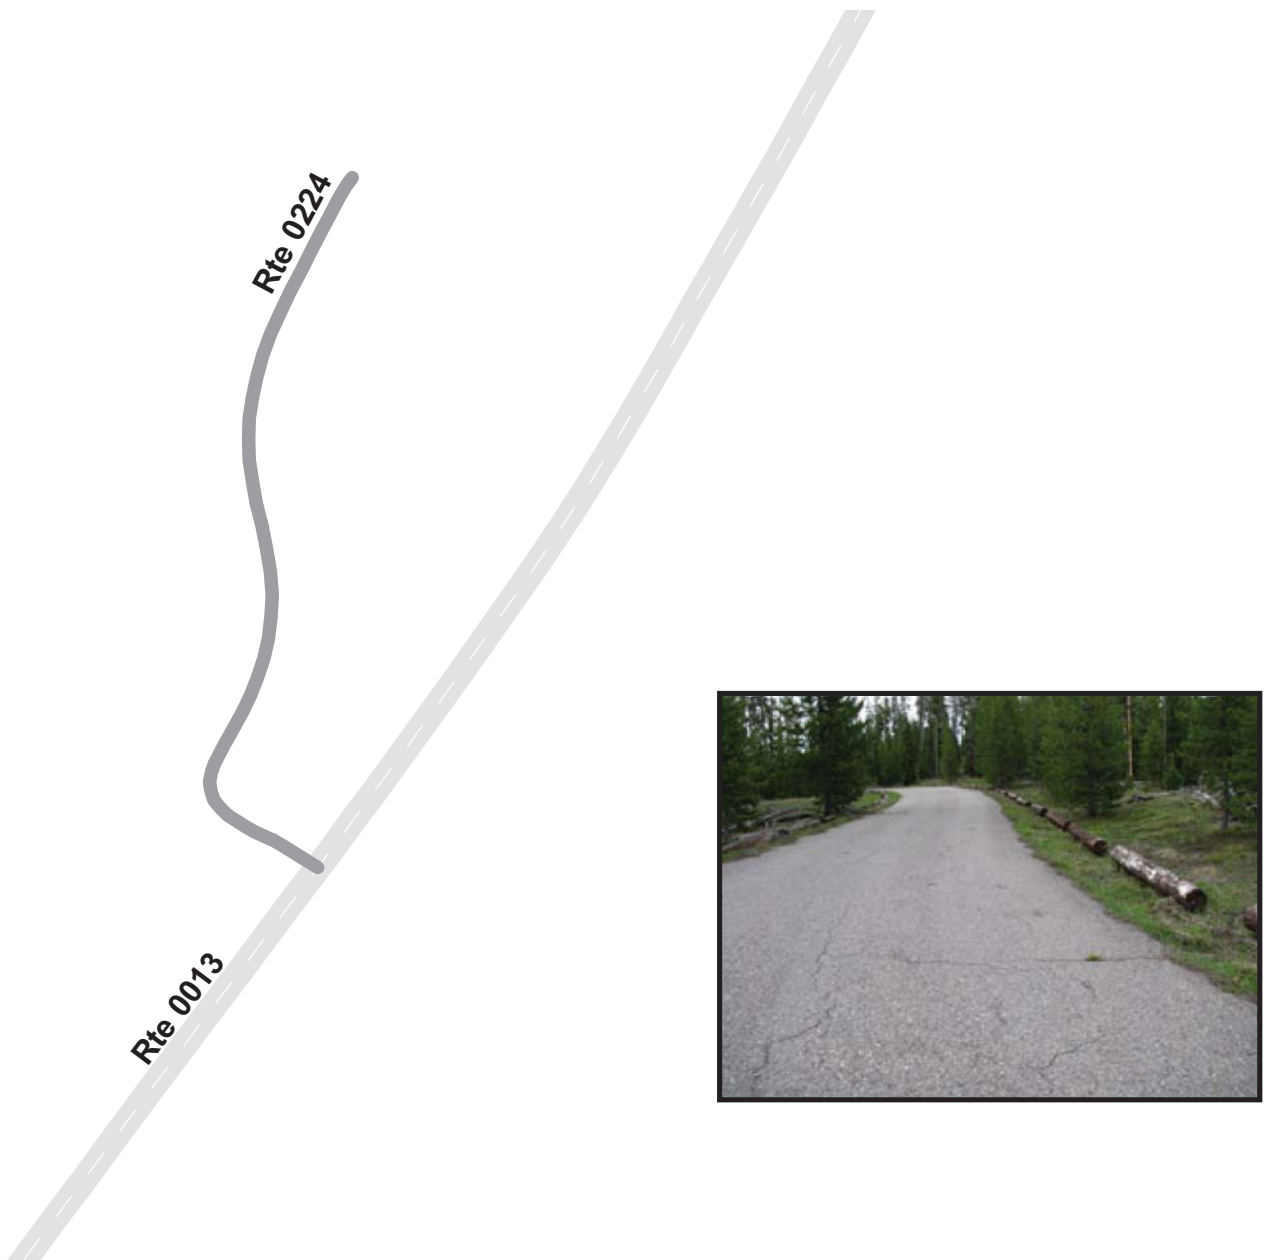
Route Number	Public / NonPublic	Date Visited		Area (sq ft)	Lane Miles *	Surface Type
0224	PUBLIC	6/9/2008		11,666	0.20	AS
Culverts	Drop Inlets	Gates	Fire Hydrants	Curb & Gutter	Curb	PCR
0	0	0	0	NO CURB AND GUTTER	NO CURB	POOR/45

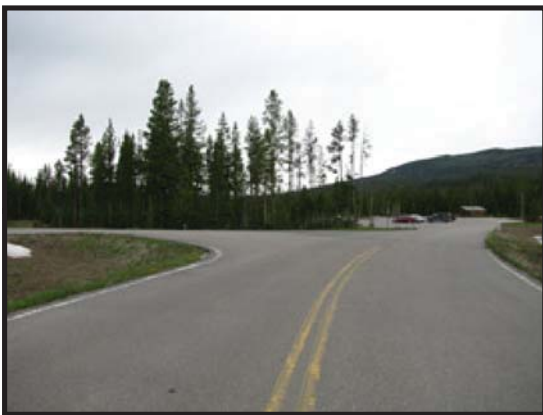
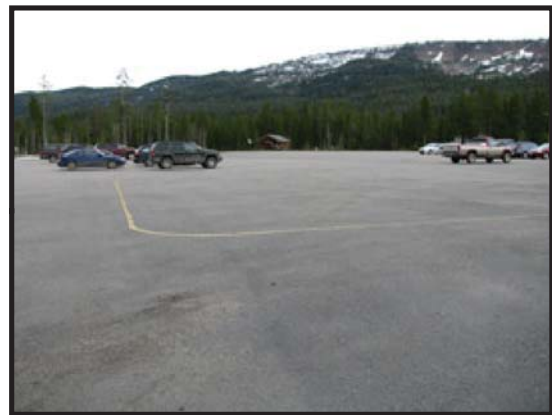
Route Number	Public / NonPublic	Date Visited		Area (sq ft)	Lane Miles *	Surface Type
0979	PUBLIC	6/9/2008		112,147	1.93	AS
Culverts	Drop Inlets	Gates	Fire Hydrants	Curb & Gutter	Curb	PCR
1	0	0	1	CONCRETE CURB AND GUTTER	CONCRETE CURB	GOOD/90

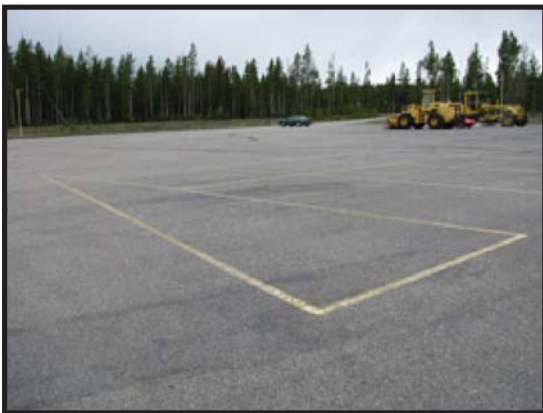
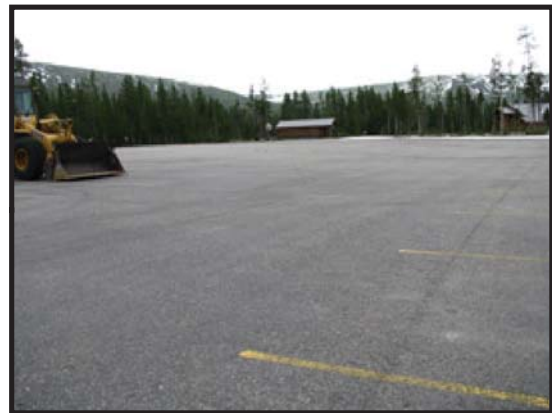
Route 0980

Route Number	Public / NonPublic	Date Visited		Area (sq ft)	Lane Miles *	Surface Type
0980	PUBLIC	6/9/2008		77,904	1.34	AS
Culverts	Drop Inlets	Gates	Fire Hydrants	Curb & Gutter	Curb	PCR
0	0	0	0	NO CURB AND GUTTER	NO CURB	FAIR/73

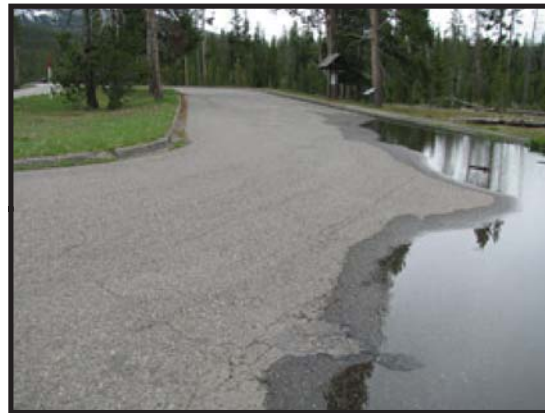
Route 0981

Route Number	Public / NonPublic	Date Visited		Area (sq ft)	Lane Miles *	Surface Type
0981	PUBLIC	6/9/2008		10,464	0.18	AS
Culverts	Drop Inlets	Gates	Fire Hydrants	Curb & Gutter	Curb	PCR
0	0	0	0	CONCRETE CURB AND GUTTER	CONCRETE CURB	FAIR/73

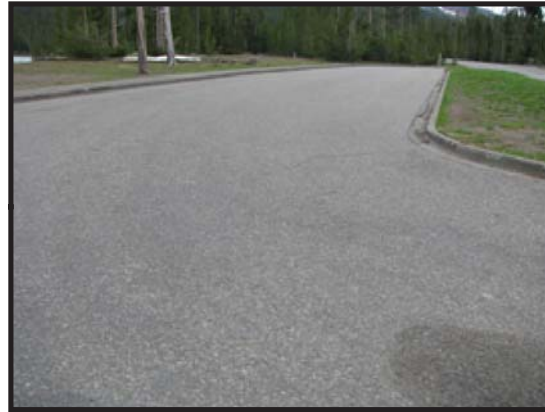
Route 0982

Route Number	Public / NonPublic	Date Visited		Area (sq ft)	Lane Miles *	Surface Type
0982	PUBLIC	6/9/2008		10,821	0.19	AS
Culverts	Drop Inlets	Gates	Fire Hydrants	Curb & Gutter	Curb	PCR
0	0	0	0	CONCRETE CURB AND GUTTER	CONCRETE CURB	FAIR/73

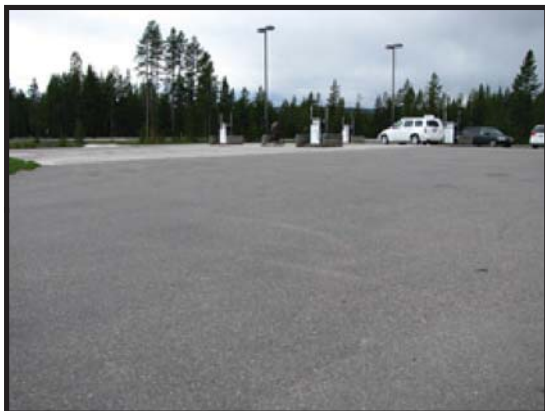
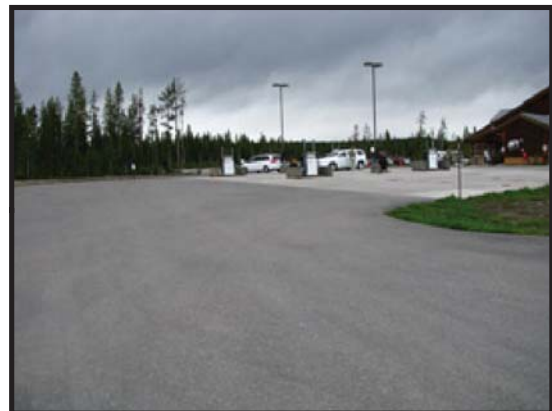
Route 1018

Route Number	Public / NonPublic	Date Visited		Area (sq ft)	Lane Miles *	Surface Type
1018	PUBLIC	6/9/2008		25,575	0.44	AS
Culverts	Drop Inlets	Gates	Fire Hydrants	Curb & Gutter	Curb	PCR
0	0	0	0	NO CURB AND GUTTER	NO CURB	GOOD/90
