**The Road Inventory
of
Joshua Tree National Park
JOTR – 8330
Cycle 4**

**Prepared By:
Federal Highway Administration
Road Inventory Program
Cycle 4**

Joshua Tree National Park in California

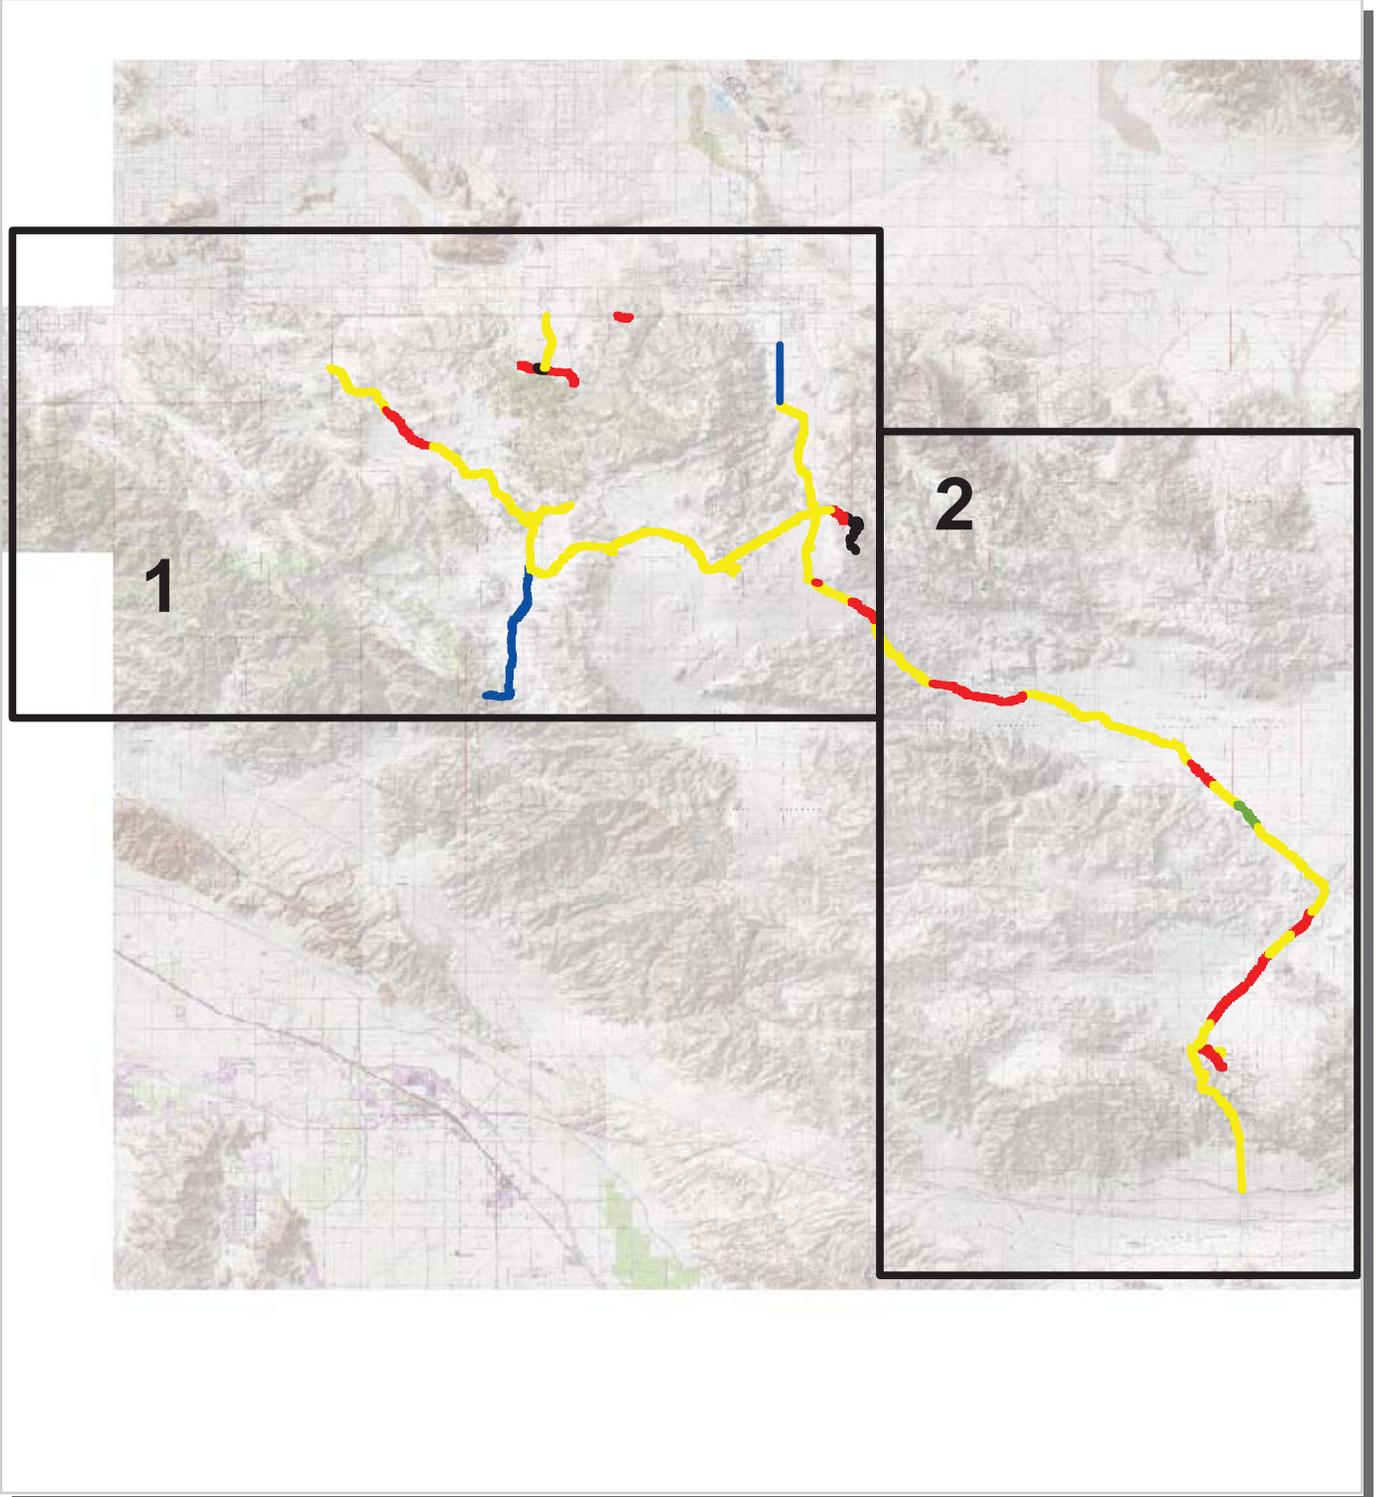
**Joshua Tree National Park
Route Condition Map
PCR - Mile by Mile
Key Map**

PCR	Poor

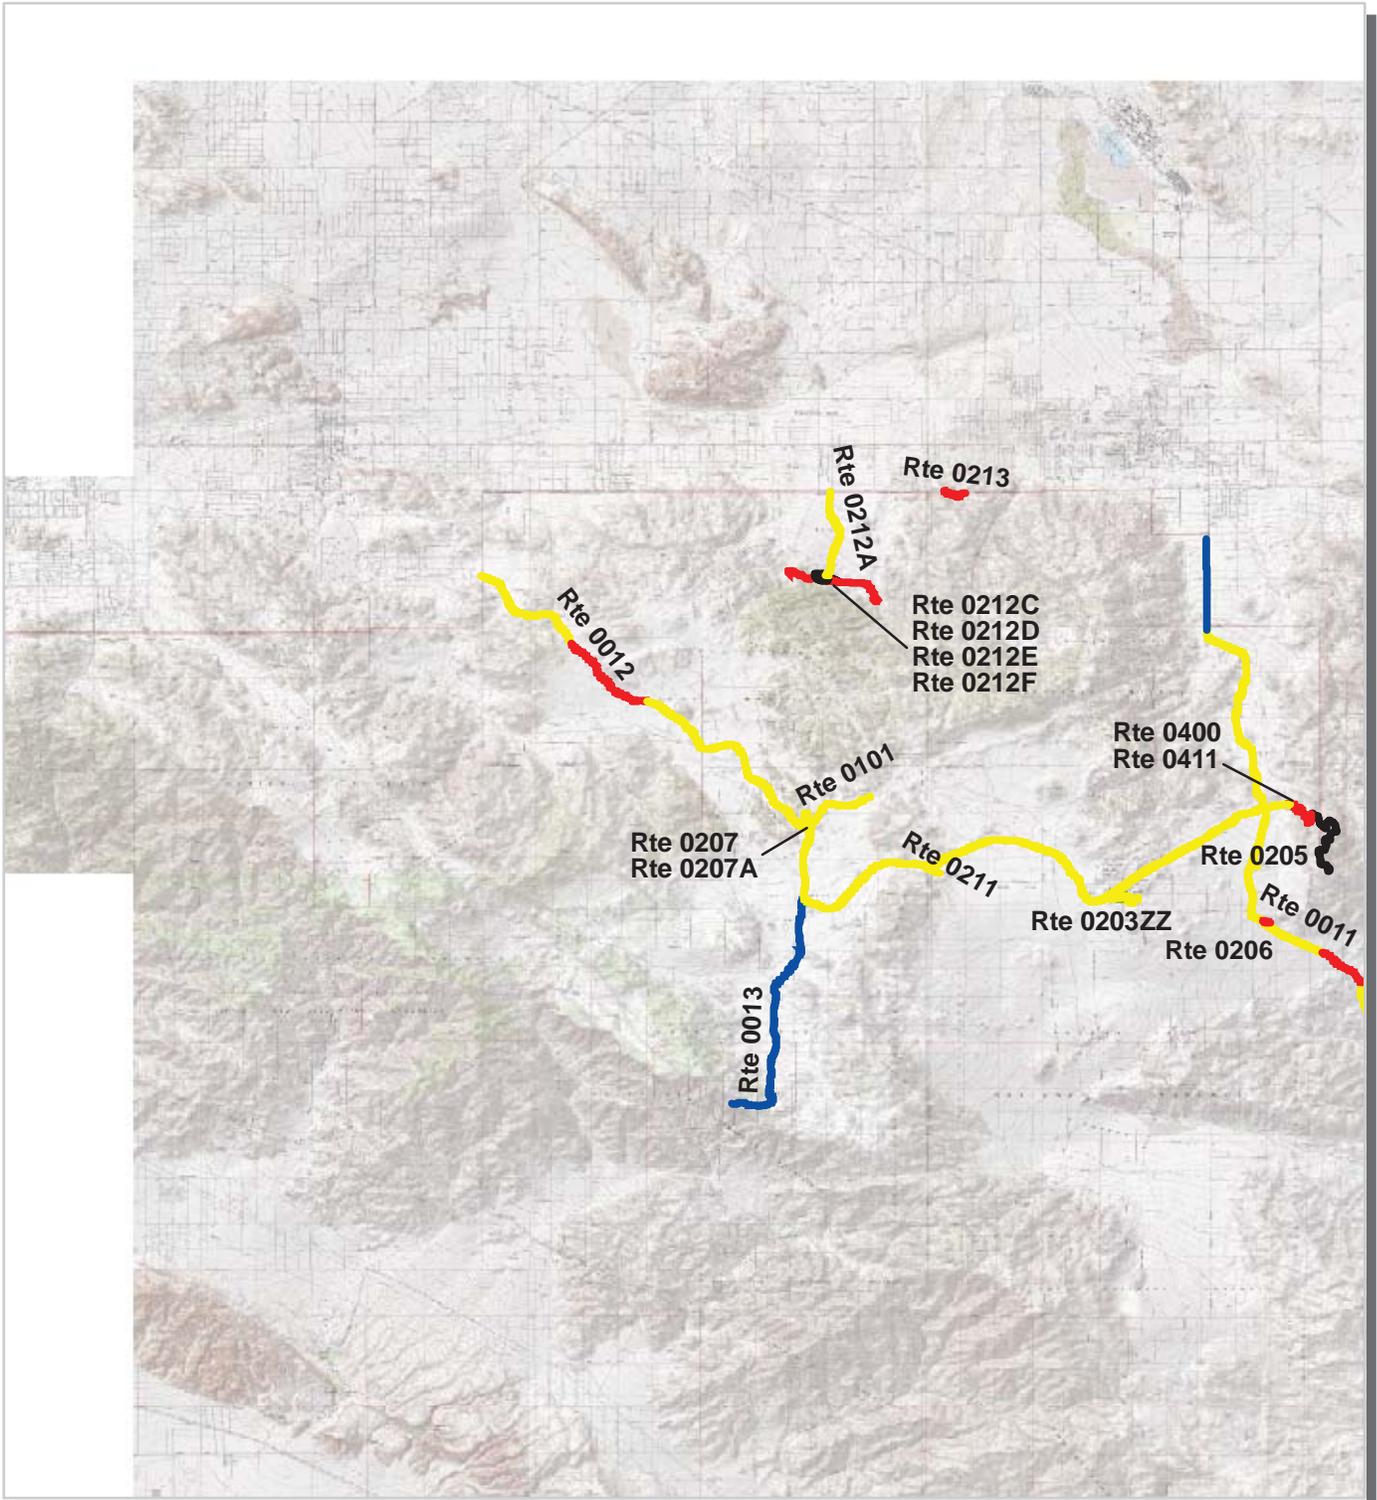
Joshua Tree National Park Route Condition Map PCR - Mile by Mile Area 1

PCR	Poor	Fair	Good	Excellent	No Data
	(≤60)	(61 - 84)	(85 - 94)	(95 - 100)

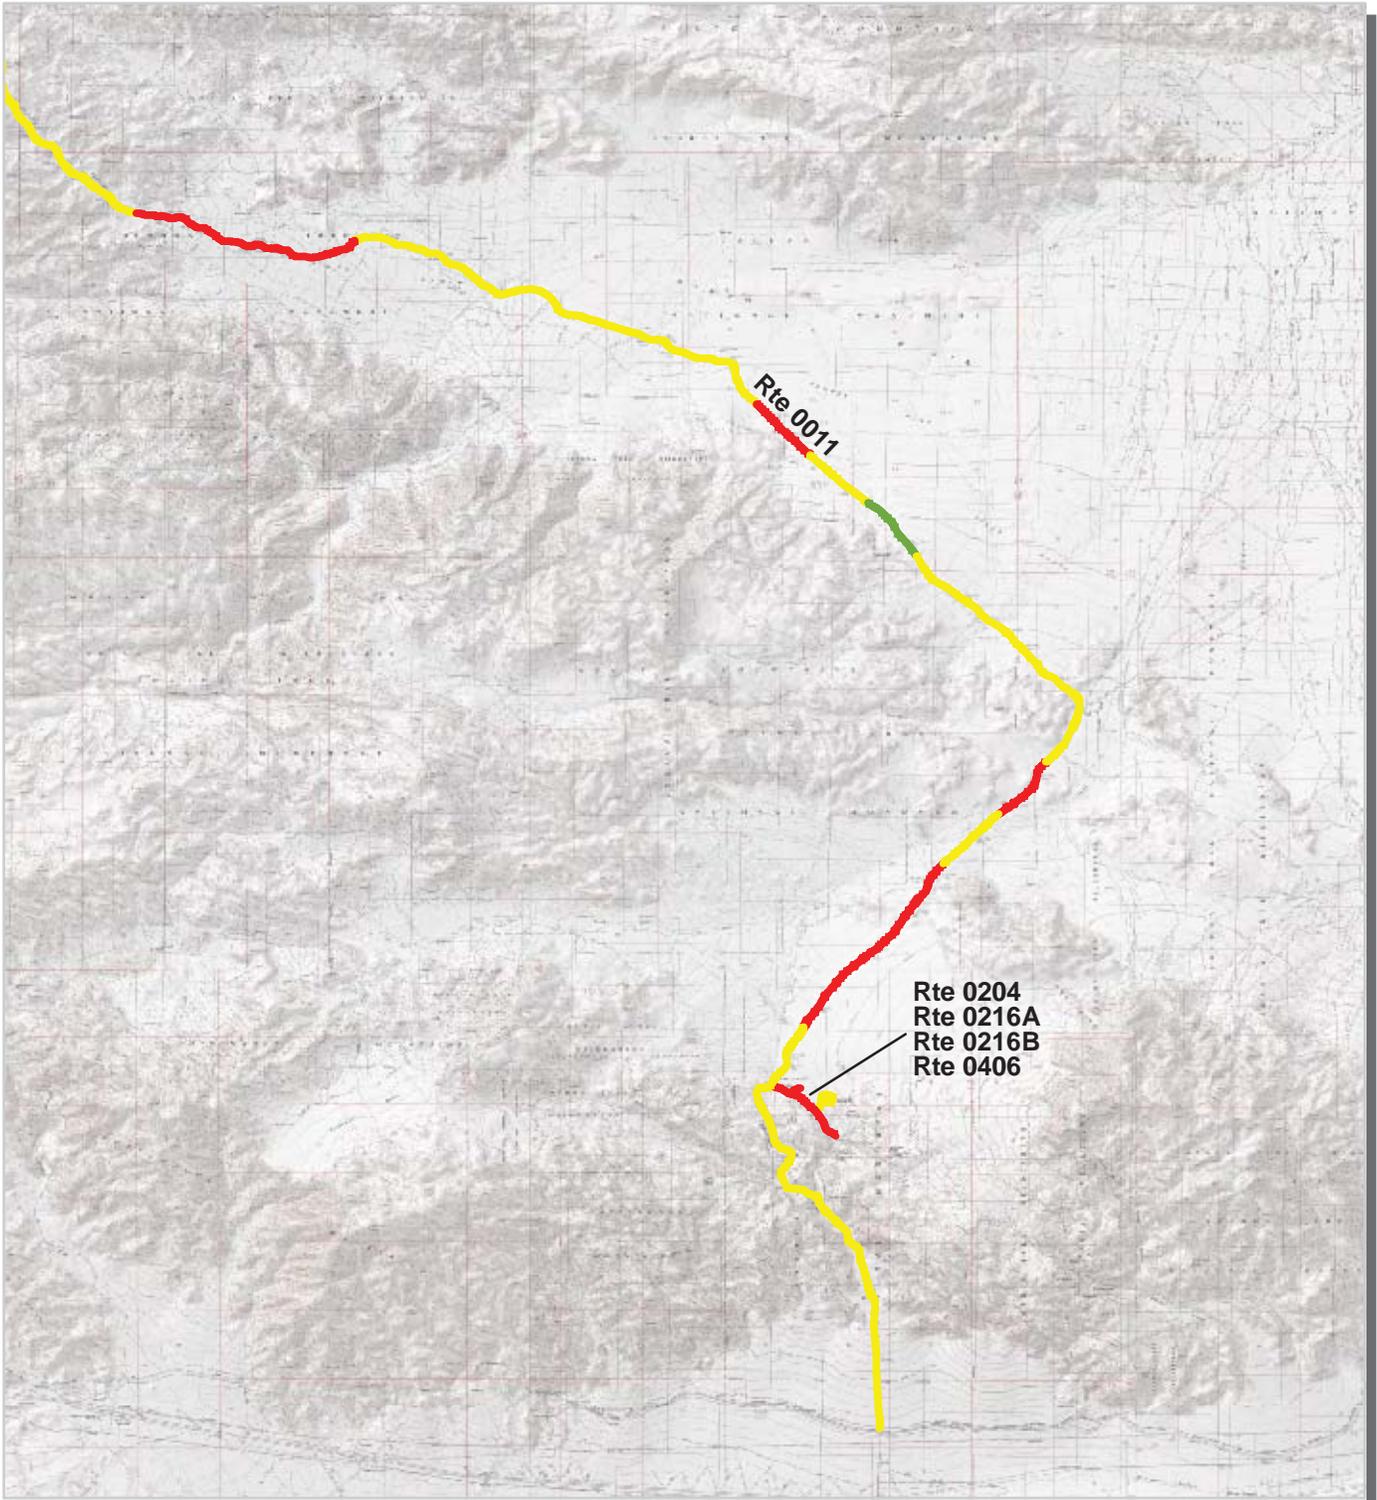
**Joshua Tree National Park
Route Condition Map
PCR - Mile by Mile
Area 2**

PCR	Poor		Fair		Good		Excellent		No Data	
	(≤60)		(61 - 84)	(85 - 94)	(95 - 100)

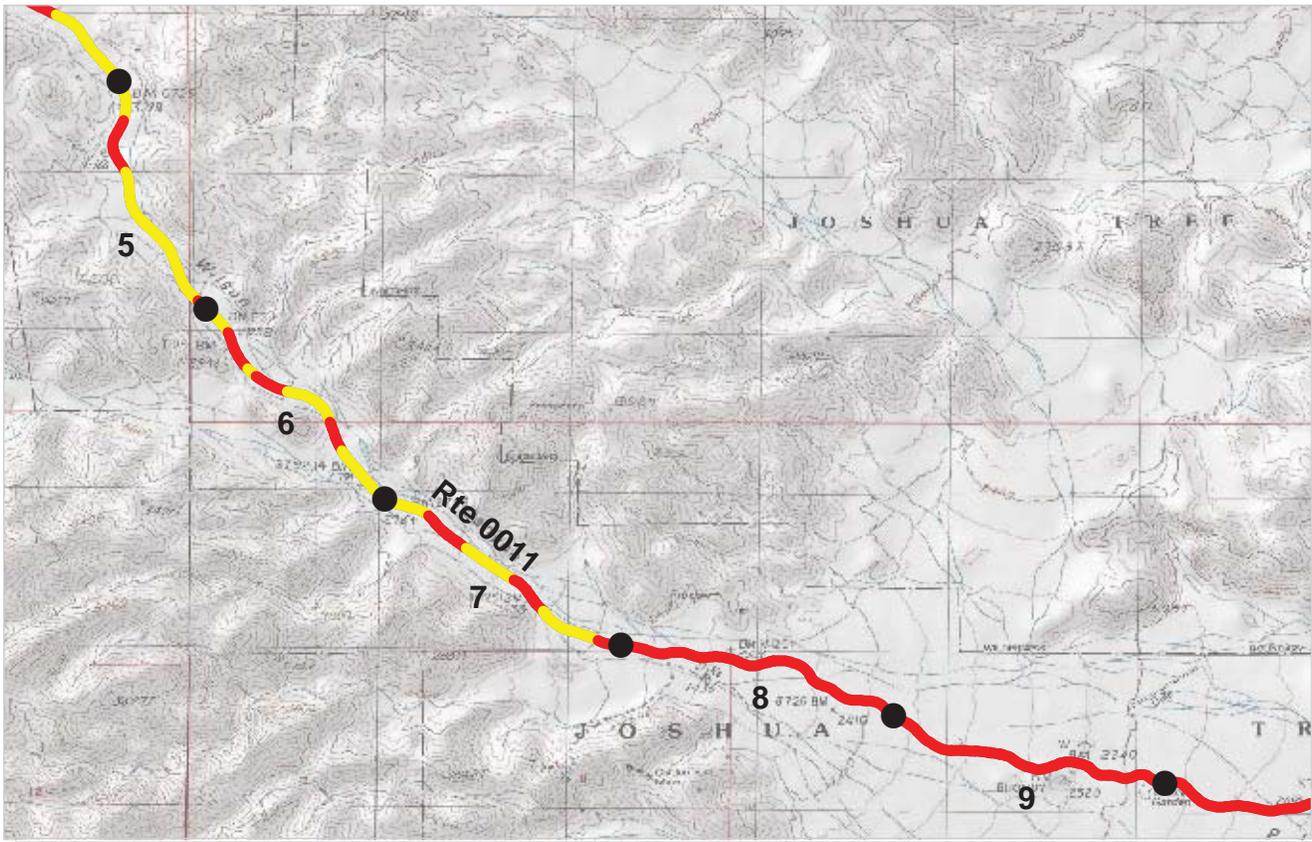
ROUTE: 0011 PINTO BASIN ROAD

Section Number	0	1	2	3	4
Section Length (mi)	1.00	1.00	1.00	1.00	1.00
Traffic	Traffic data may be found at www.efl.fhwa.dot.gov Click on PROGRAMS / NPS Traffic Data (Note: Not all parks have traffic data)				
Cross Section Information					
Number of Lanes	2	2	2	2	2
Paved Width (ft)	24	22	24	25	24
Lane Width (ft)	12	11	12	13	12
Shoulder Width Right (ft)**	0	0	0	0	0
Shoulder Width Left (ft)**	0	0	0	0	0
Roadway Condition Information					
SCR (Surface Condition Rating)	51	51	51	47	49
PCR (Pavement Condition Rating)	65	65	64	61	60
Distress Index Values					
Alligator Cracking Index	100	100	100	100	100
Longitudinal Cracking Index	95	97	96	95	96
Transverse Cracking Index	90	91	90	89	89
Patching Index	100	100	100	100	100
Rutting Index	66	64	65	63	63
Roughness Condition Index (RCI)	87	85	83	81	78

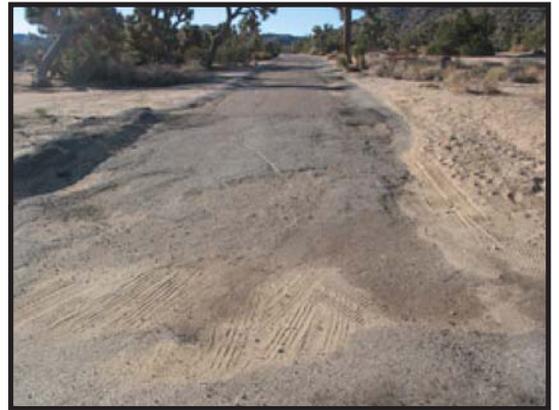
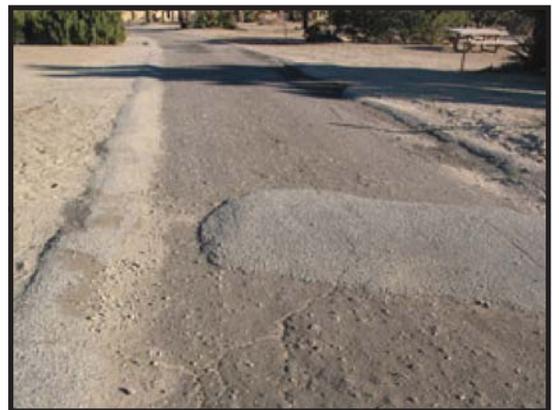
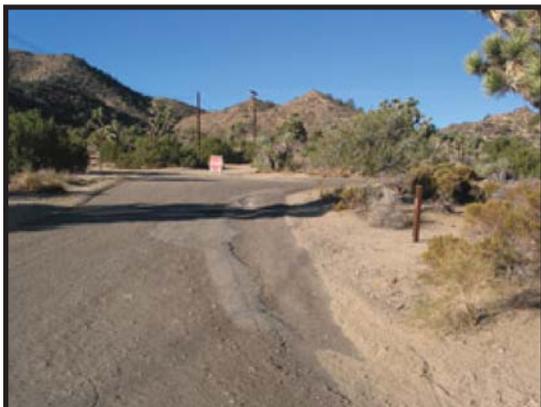
Route Number	Public / NonPublic	Date Visited		Area (sq ft)	Lane Miles *	Surface Type
0214	PUBLIC	11/15/2007		15,650	0.27	AS
Culverts	Drop Inlets	Gates	Fire Hydrants	Curb & Gutter	Curb	PCR
0	0	3	0	NO CURB AND GUTTER	ASPHALT CURB	POOR/45

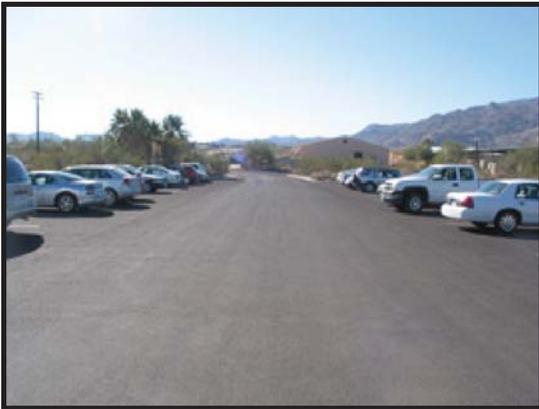
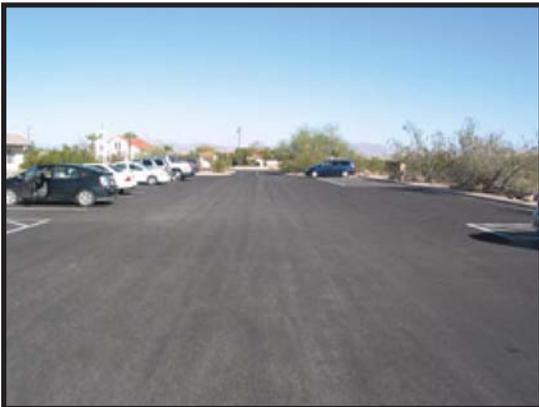
Route Number	Public / NonPublic	Date Visited		Area (sq ft)	Lane Miles *	Surface Type
0900	PUBLIC	11/13/2007		47,306	0.82	AS
Culverts	Drop Inlets	Gates	Fire Hydrants	Curb & Gutter	Curb	PCR
0	0	1	2	CONCRETE CURB AND GUTTER	CONCRETE CURB	GOOD/90

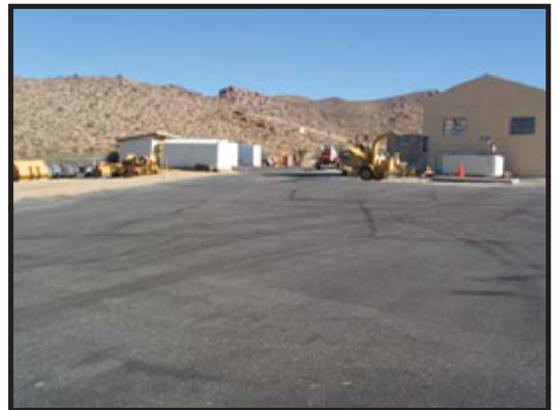
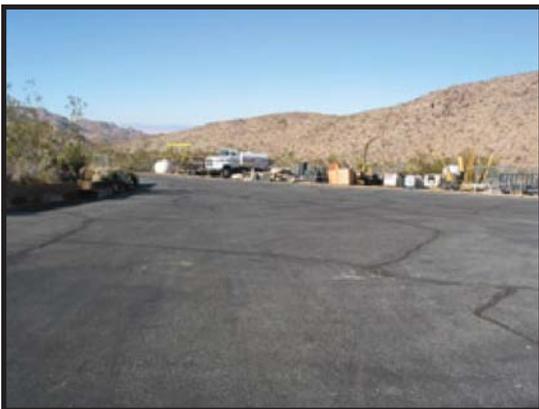
Route 0901

Route Number	Public / NonPublic	Date Visited		Area (sq ft)	Lane Miles *	Surface Type
0901	NONPUBLIC	11/14/2007		42,870	0.74	AS
Culverts	Drop Inlets	Gates	Fire Hydrants	Curb & Gutter	Curb	PCR
0	0	0	0	NO CURB AND GUTTER	NO CURB	FAIR/73

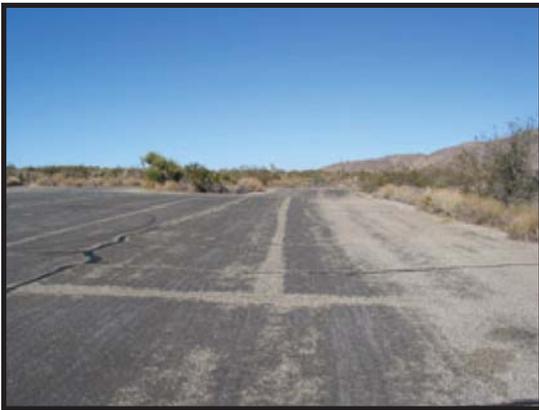
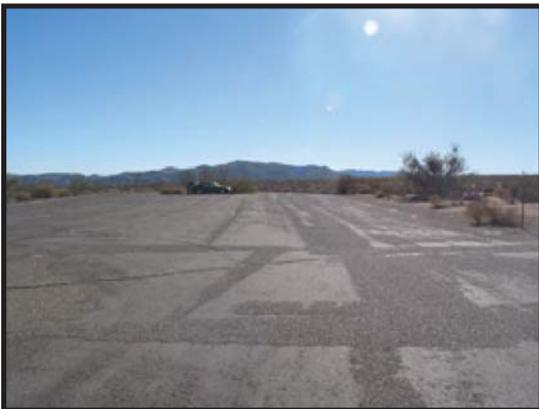
Route 0902

Route Number	Public / NonPublic	Date Visited		Area (sq ft)	Lane Miles *	Surface Type
0902	PUBLIC	11/14/2007		23,550	0.41	AS
Culverts	Drop Inlets	Gates	Fire Hydrants	Curb & Gutter	Curb	PCR
0	0	0	0	NO CURB AND GUTTER	NO CURB	POOR/45

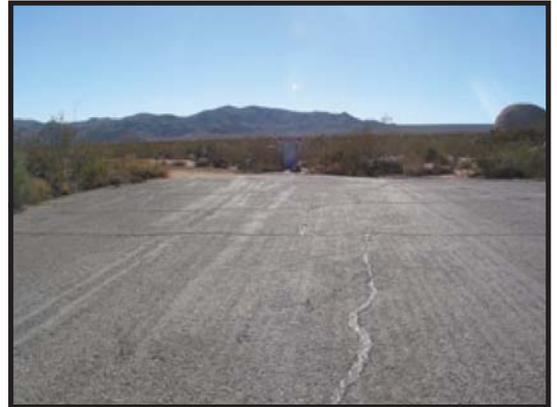
Route 0903

Route Number	Public / NonPublic	Date Visited		Area (sq ft)	Lane Miles *	Surface Type
0903	PUBLIC	11/14/2007		6,264	0.11	AS
Culverts	Drop Inlets	Gates	Fire Hydrants	Curb & Gutter	Curb	PCR
0	0	0	0	NO CURB AND GUTTER	NO CURB	POOR/45

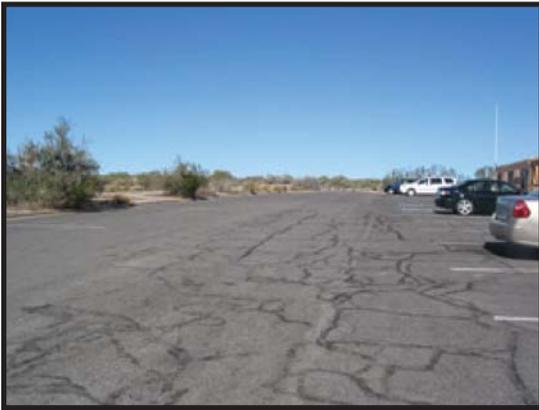
Route 0904

Route Number	Public / NonPublic	Date Visited		Area (sq ft)	Lane Miles *	Surface Type
0904	PUBLIC	11/14/2007		18,482	0.32	AS
Culverts	Drop Inlets	Gates	Fire Hydrants	Curb & Gutter	Curb	PCR
0	0	0	0	NO CURB AND GUTTER	CONCRETE CURB	FAIR/73

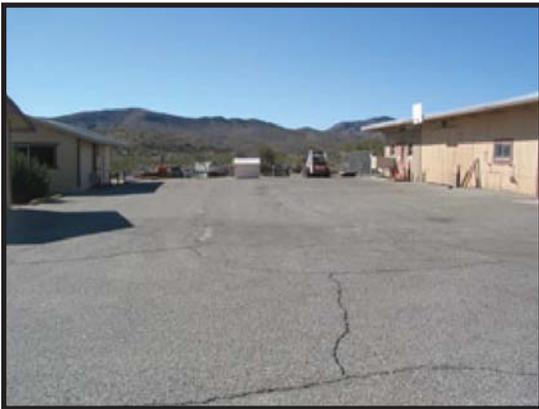
Route 0905

Route Number	Public / NonPublic	Date Visited		Area (sq ft)	Lane Miles *	Surface Type
0905	NONPUBLIC	11/14/2007		9,628	0.17	AS
Culverts	Drop Inlets	Gates	Fire Hydrants	Curb & Gutter	Curb	PCR
0	0	0	0	NO CURB AND GUTTER	NO CURB	FAIR/73

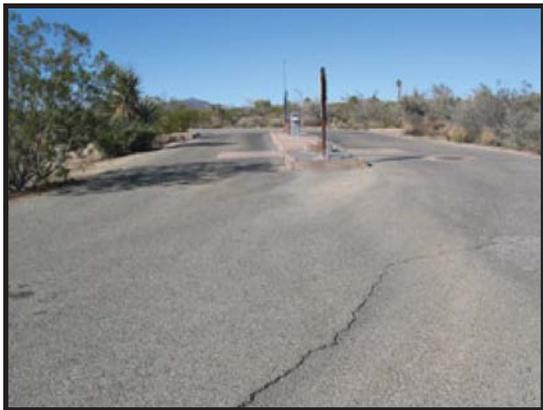
Route 0906

Route Number	Public / NonPublic	Date Visited		Area (sq ft)	Lane Miles *	Surface Type
0906	PUBLIC	11/14/2007		8,762	0.15	AS
Culverts	Drop Inlets	Gates	Fire Hydrants	Curb & Gutter	Curb	PCR
0	0	0	0	NO CURB AND GUTTER	CONCRETE CURB	GOOD/90

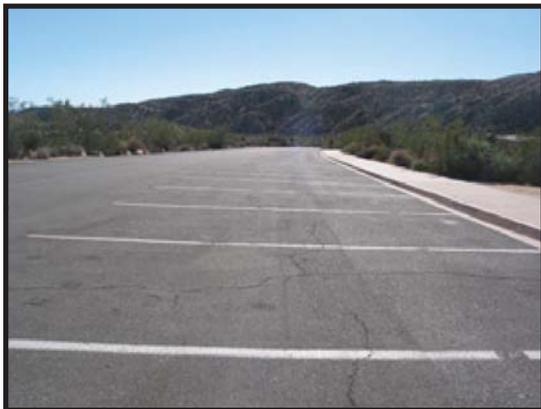
Route 0907A

Route Number	Public / NonPublic	Date Visited		Area (sq ft)	Lane Miles *	Surface Type
0907A	PUBLIC	11/14/2007		8,020	0.14	AS
Culverts	Drop Inlets	Gates	Fire Hydrants	Curb & Gutter	Curb	PCR
0	0	0	0	NO CURB AND GUTTER	CONCRETE CURB	FAIR/73

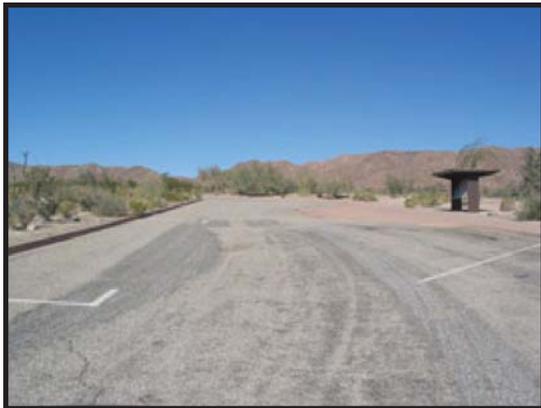
Route Number	Public / NonPublic	Date Visited		Area (sq ft)	Lane Miles *	Surface Type
0909	PUBLIC	11/14/2007		11,498	0.20	AS
Culverts	Drop Inlets	Gates	Fire Hydrants	Curb & Gutter	Curb	PCR
0	0	0	0	CONCRETE CURB AND GUTTER	NO CURB	FAIR/73

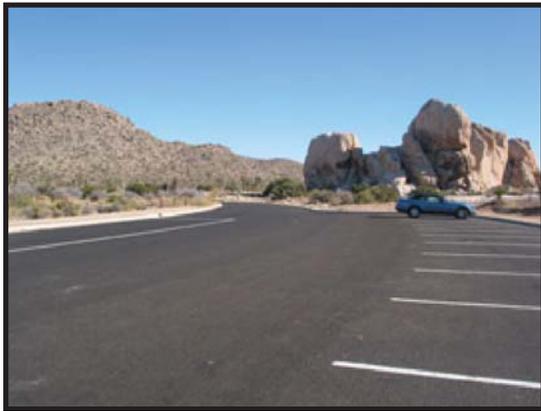
Route 0911

Route Number	Public / NonPublic	Date Visited		Area (sq ft)	Lane Miles *	Surface Type
0911	PUBLIC	11/14/2007		10,598	0.18	AS
Culverts	Drop Inlets	Gates	Fire Hydrants	Curb & Gutter	Curb	PCR
0	0	0	0	NO CURB AND GUTTER	CONCRETE CURB	EXCELLENT/97

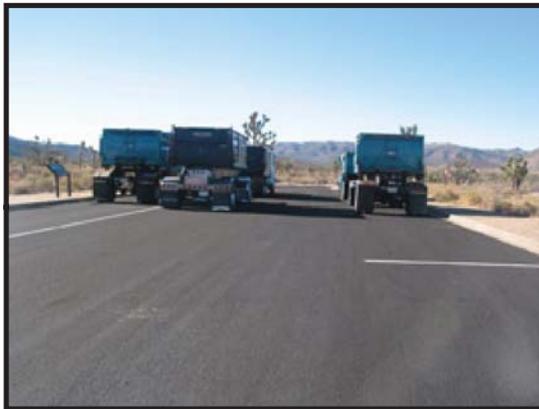
JOSHUA TREE NATIONAL PARK
Route 0912
 RYAN MOUNTAIN TRAILHEAD PARKING
 FROM ROUTE 0012 AT MP 14.78
 TO ROUTE 0012 AT MP 14.91

Route Number	Public / NonPublic	Date Visited		Area (sq ft)	Lane Miles *	Surface Type
0912	PUBLIC	11/14/2007		26,772	0.46	AS
Culverts	Drop Inlets	Gates	Fire Hydrants	Curb & Gutter	Curb	PCR
0	0	0	0	CONCRETE CURB AND GUTTER	NO CURB	EXCELLENT/97

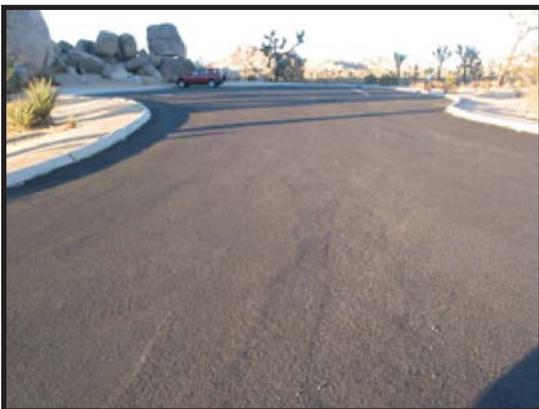
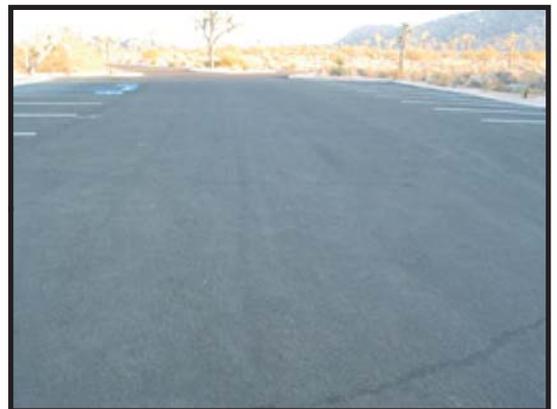
Route 0913

Route Number	Public / NonPublic	Date Visited		Area (sq ft)	Lane Miles *	Surface Type
0913	PUBLIC	11/13/2007		41,645	0.72	AS
Culverts	Drop Inlets	Gates	Fire Hydrants	Curb & Gutter	Curb	PCR
0	0	0	0	CONCRETE CURB AND GUTTER	NO CURB	EXCELLENT/97

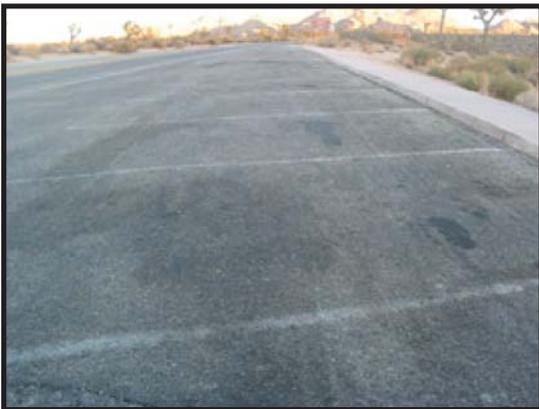
JOSHUA TREE NATIONAL PARK
Route 0914
 WEST ENTRANCE STATION
 ADJACENT TO ROUTE 0012 AT MP 27.45 ON LEFT

Route Number	Public / NonPublic	Date Visited		Area (sq ft)	Lane Miles *	Surface Type
0914	PUBLIC	11/13/2007		10,012	0.17	AS
Culverts	Drop Inlets	Gates	Fire Hydrants	Curb & Gutter	Curb	PCR
0	0	0	0	NO CURB AND GUTTER	CONCRETE CURB	FAIR/73

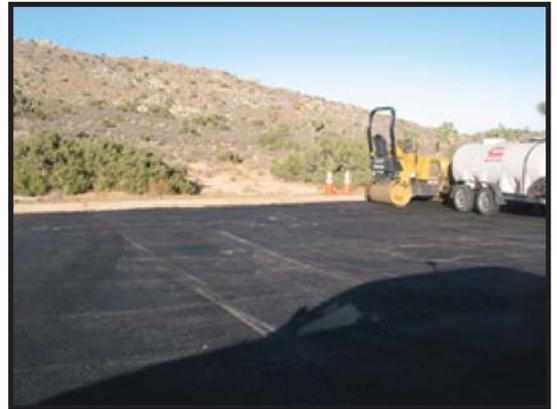
Route 0915A

Route Number	Public / NonPublic	Date Visited		Area (sq ft)	Lane Miles *	Surface Type
0915A	PUBLIC	11/13/2007		1,651	0.03	AS
Culverts	Drop Inlets	Gates	Fire Hydrants	Curb & Gutter	Curb	PCR
0	0	0	0	NO CURB AND GUTTER	CONCRETE CURB	EXCELLENT/97

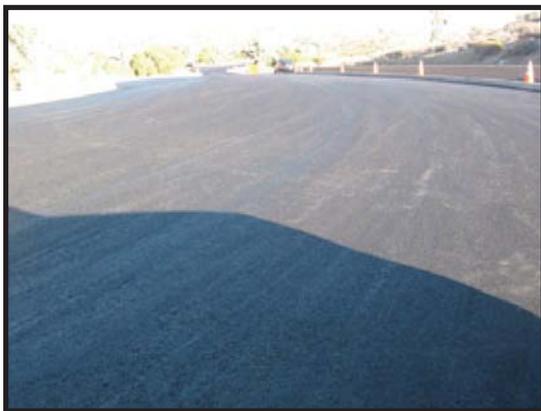
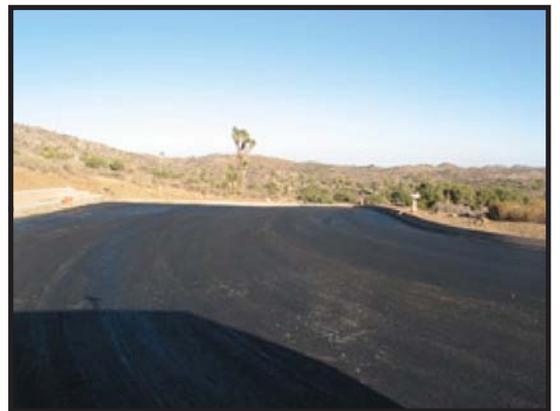
Route Number	Public / NonPublic	Date Visited		Area (sq ft)	Lane Miles *	Surface Type
0915B	PUBLIC	11/13/2007		21,015	0.36	AS
Culverts	Drop Inlets	Gates	Fire Hydrants	Curb & Gutter	Curb	PCR
0	0	0	0	NO CURB AND GUTTER	CONCRETE CURB	EXCELLENT/97

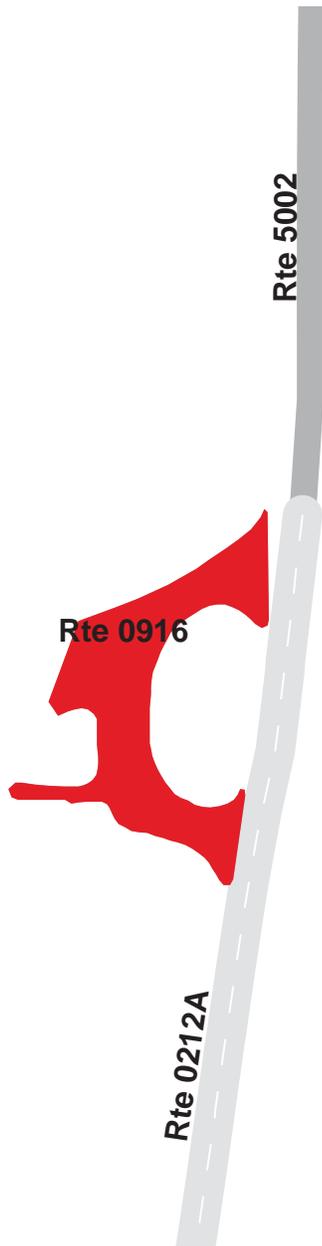
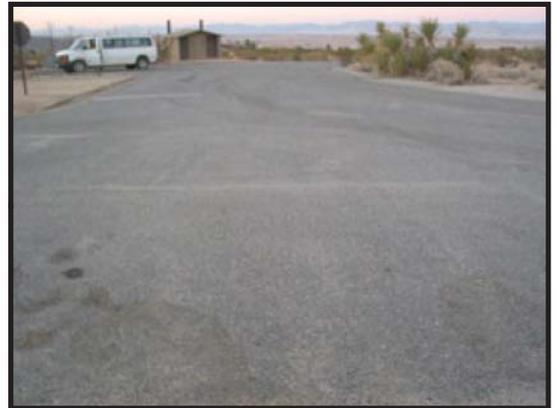
Route 0916

Route Number	Public / NonPublic	Date Visited		Area (sq ft)	Lane Miles *	Surface Type
0916	PUBLIC	11/13/2007		11,610	0.20	AS
Culverts	Drop Inlets	Gates	Fire Hydrants	Curb & Gutter	Curb	PCR
0	0	0	0	CONCRETE CURB AND GUTTER	CONCRETE CURB	FAIR/73

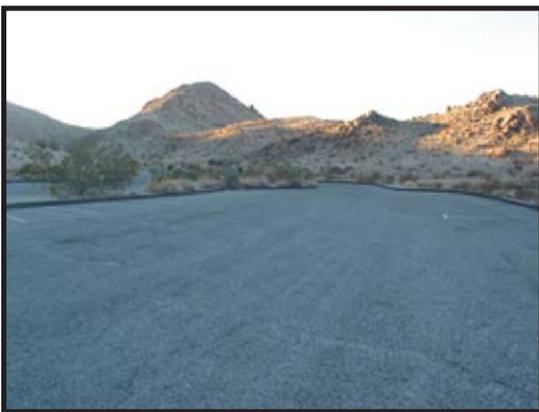
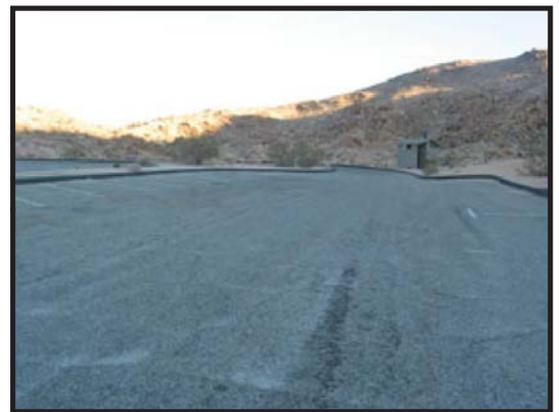
Route 0917

Route Number	Public / NonPublic	Date Visited		Area (sq ft)	Lane Miles *	Surface Type
0917	PUBLIC	11/14/2007		23,473	0.40	AS
Culverts	Drop Inlets	Gates	Fire Hydrants	Curb & Gutter	Curb	PCR
0	0	0	0	NO CURB AND GUTTER	ASPHALT CURB	FAIR/73

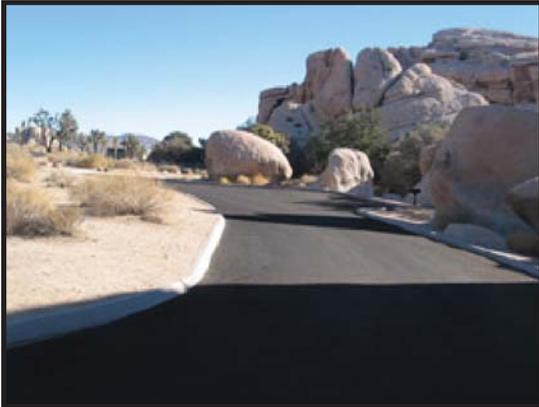
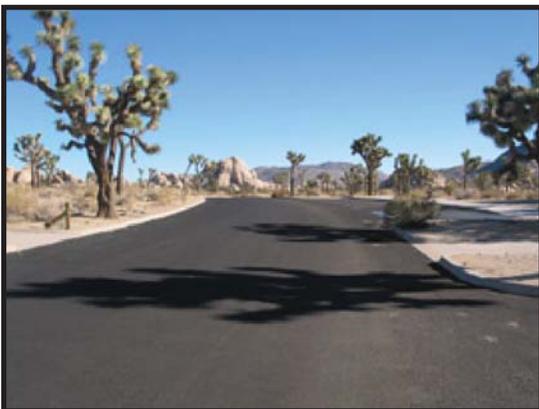
JOSHUA TREE NATIONAL PARK
Route 0918
 HIDDEN VALLEY PICNIC PARKING
 ADJACENT TO ROUTE 0012 AT MP 18.64 ON LEFT

Route Number	Public / NonPublic	Date Visited		Area (sq ft)	Lane Miles *	Surface Type
0918	PUBLIC	11/14/2007		101,480	1.75	AS
Culverts	Drop Inlets	Gates	Fire Hydrants	Curb & Gutter	Curb	PCR
0	0	0	0	NO CURB AND GUTTER	CONCRETE CURB	EXCELLENT/97

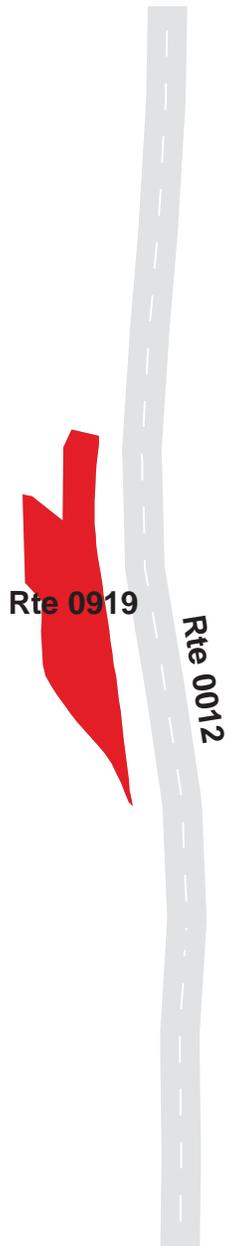
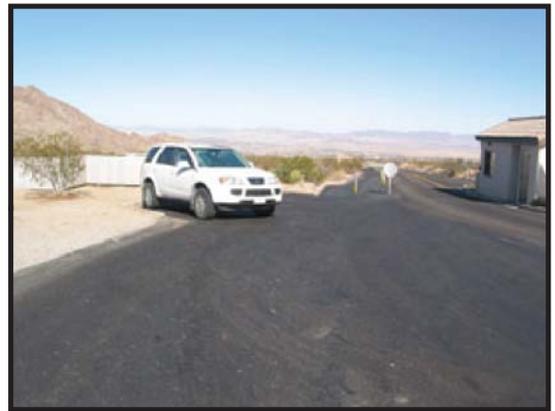
Route 0919

Route Number	Public / NonPublic	Date Visited		Area (sq ft)	Lane Miles *	Surface Type
0919	PUBLIC	11/14/2007		3,061	0.05	AS
Culverts	Drop Inlets	Gates	Fire Hydrants	Curb & Gutter	Curb	PCR
0	0	0	0	NO CURB AND GUTTER	CONCRETE CURB	GOOD/90

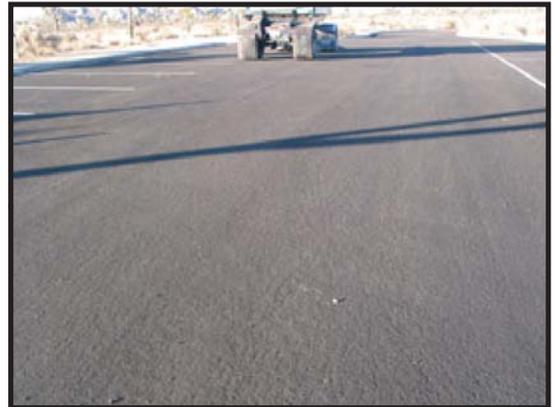
Route 0920

Route Number	Public / NonPublic	Date Visited		Area (sq ft)	Lane Miles *	Surface Type
0920	PUBLIC	11/13/2007		13,734	0.24	AS
Culverts	Drop Inlets	Gates	Fire Hydrants	Curb & Gutter	Curb	PCR
0	0	0	0	NO CURB AND GUTTER	CONCRETE CURB	EXCELLENT/97

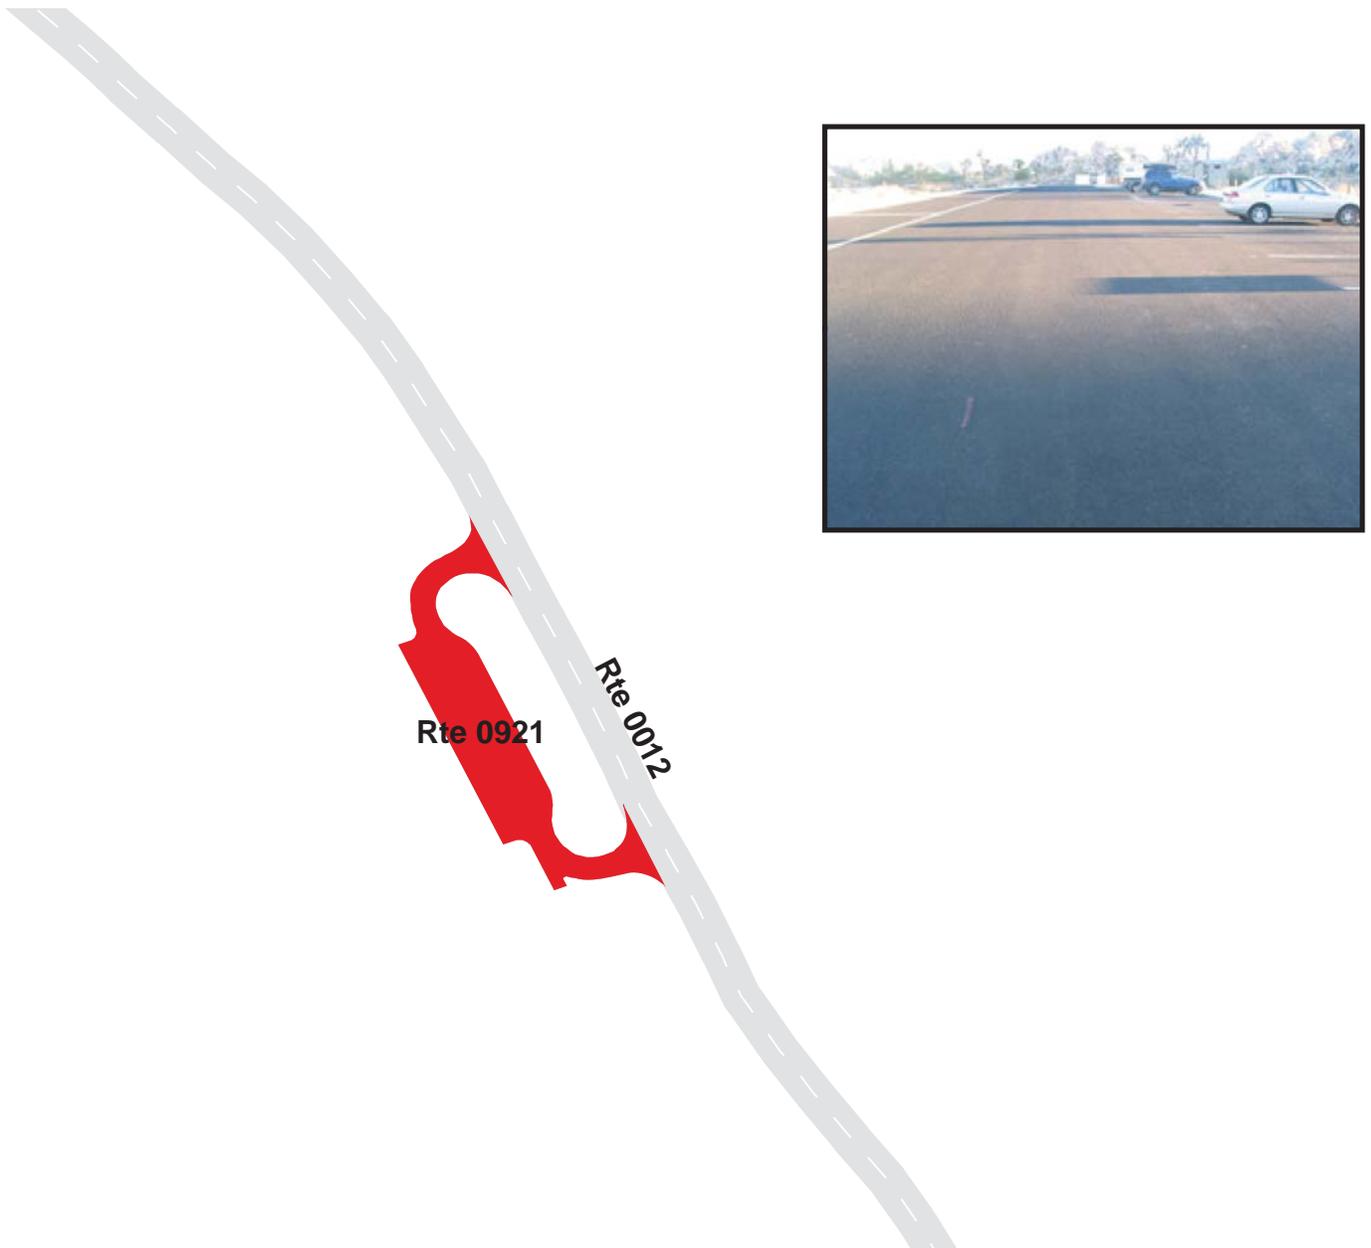
Route 0921

Route Number	Public / NonPublic	Date Visited		Area (sq ft)	Lane Miles *	Surface Type
0921	PUBLIC	11/13/2007		18,048	0.31	AS
Culverts	Drop Inlets	Gates	Fire Hydrants	Curb & Gutter	Curb	PCR
0	0	0	0	NO CURB AND GUTTER	CONCRETE CURB	EXCELLENT/97

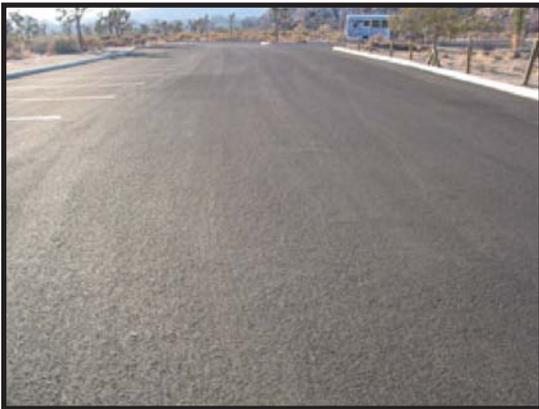
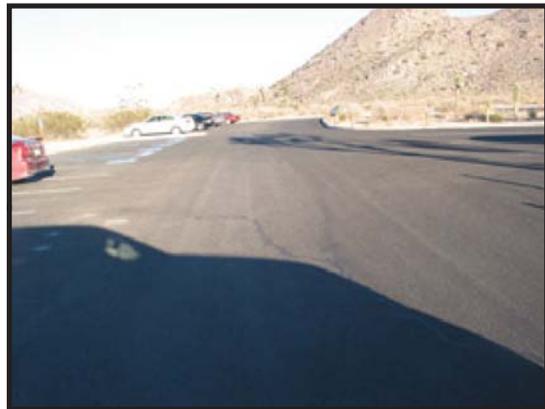
Route Number	Public / NonPublic	Date Visited		Area (sq ft)	Lane Miles *	Surface Type
0923	PUBLIC	11/13/2007		40,579	0.70	AS
Culverts	Drop Inlets	Gates	Fire Hydrants	Curb & Gutter	Curb	PCR
0	0	0	0	NO CURB AND GUTTER	CONCRETE CURB	EXCELLENT/97

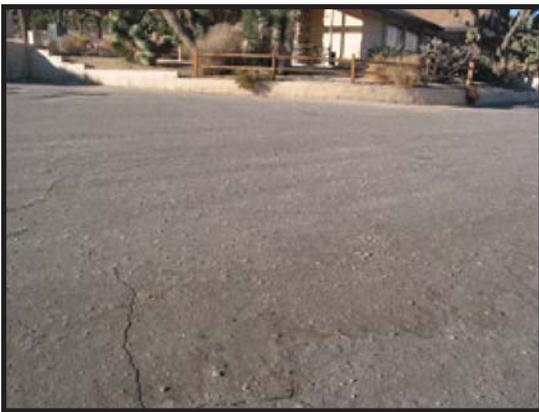
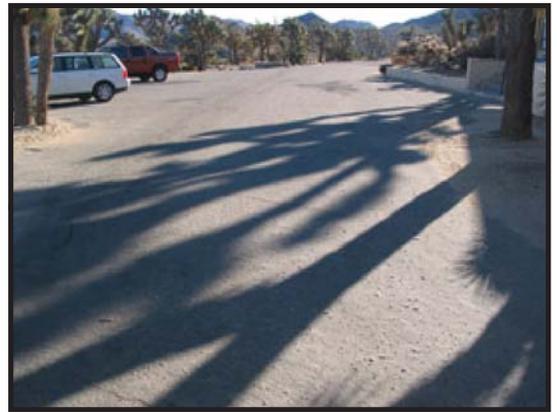
Route Number	Public / NonPublic	Date Visited		Area (sq ft)	Lane Miles *	Surface Type
0926	PUBLIC	11/15/2007		20,830	0.36	AS
Culverts	Drop Inlets	Gates	Fire Hydrants	Curb & Gutter	Curb	PCR
0	0	0	0	NO CURB AND GUTTER	NO CURB	POOR/45

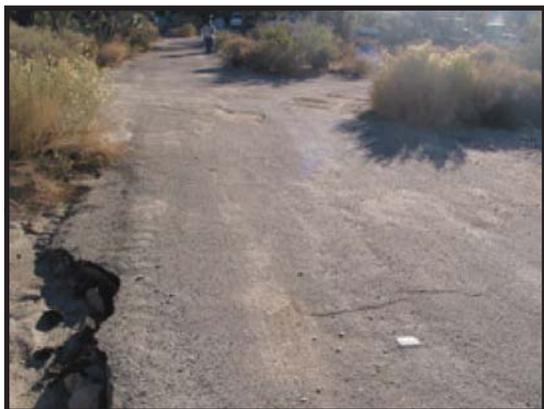
JOSHUA TREE NATIONAL PARK
Route 0952
LOST HORSE RANGER STATION PARKING
FROM ROUTE 0102
TO PARKING

Route Number	Public / NonPublic	Date Visited		Area (sq ft)	Lane Miles *	Surface Type
0952	PUBLIC	11/13/2007		17,124	0.30	AS
Culverts	Drop Inlets	Gates	Fire Hydrants	Curb & Gutter	Curb	PCR
0	0	0	0	NO CURB AND GUTTER	NO CURB	POOR/45

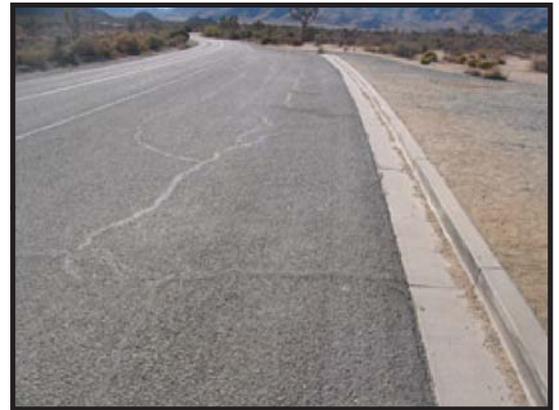
Route 0957

Route Number	Public / NonPublic	Date Visited		Area (sq ft)	Lane Miles *	Surface Type
0957	PUBLIC	11/13/2007		4,150	0.07	AS
Culverts	Drop Inlets	Gates	Fire Hydrants	Curb & Gutter	Curb	PCR
0	0	0	0	CONCRETE CURB AND GUTTER	CONCRETE CURB	FAIR/73

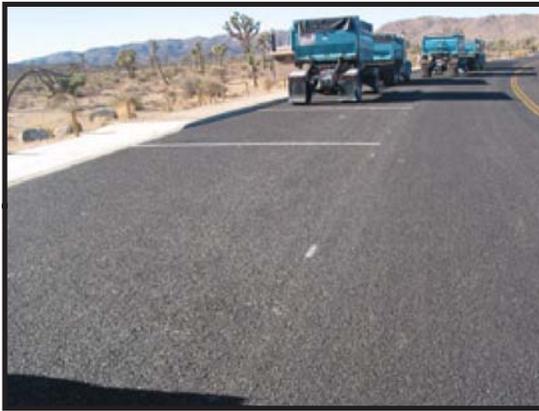
Route 0958

Route Number	Public / NonPublic	Date Visited		Area (sq ft)	Lane Miles *	Surface Type
0958	PUBLIC	11/13/2007		6,268	0.11	AS
Culverts	Drop Inlets	Gates	Fire Hydrants	Curb & Gutter	Curb	PCR
0	0	0	0	NO CURB AND GUTTER	CONCRETE CURB	EXCELLENT/97

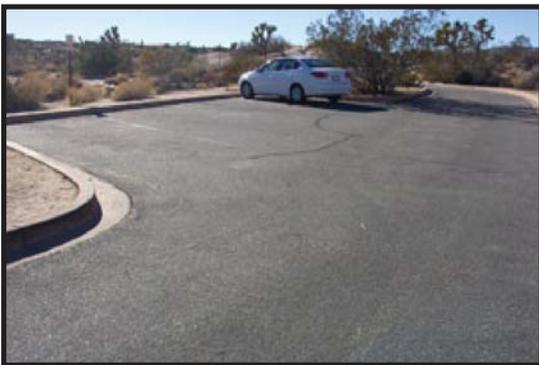
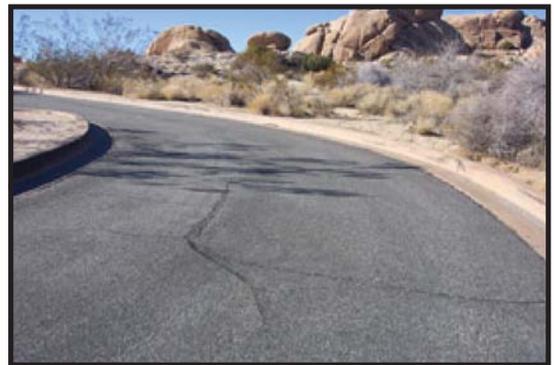
Route Number	Public / NonPublic	Date Visited		Area (sq ft)	Lane Miles *	Surface Type
0960AZ	PUBLIC	11/13/2007		4,340	0.08	AS
Culverts	Drop Inlets	Gates	Fire Hydrants	Curb & Gutter	Curb	PCR
0	0	0	0	CONCRETE CURB AND GUTTER	CONCRETE CURB	GOOD/90

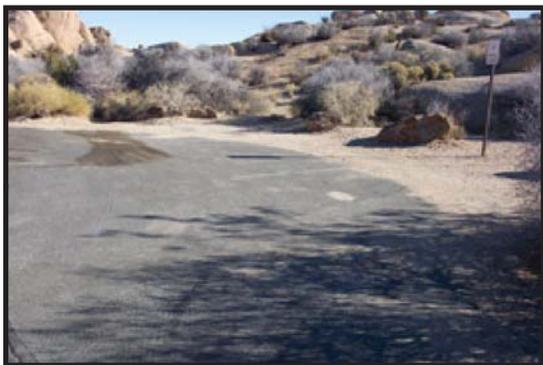
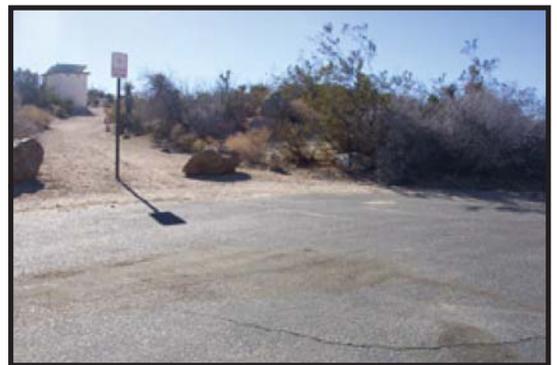
Route 0960BZ

Route Number	Public / NonPublic	Date Visited		Area (sq ft)	Lane Miles *	Surface Type
0960BZ	PUBLIC	1/13/2007		1,018	0.02	AS
Culverts	Drop Inlets	Gates	Fire Hydrants	Curb & Gutter	Curb	PCR
0	0	0	0	NO CURB AND GUTTER	NO CURB	FAIR/73

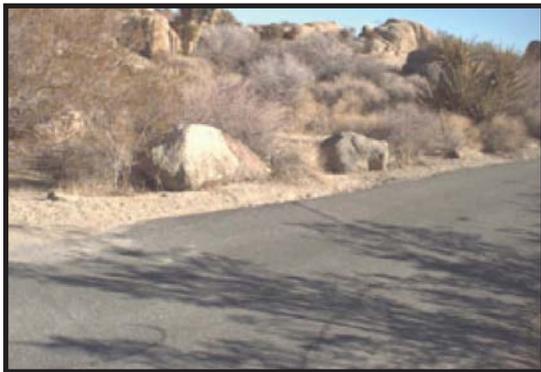
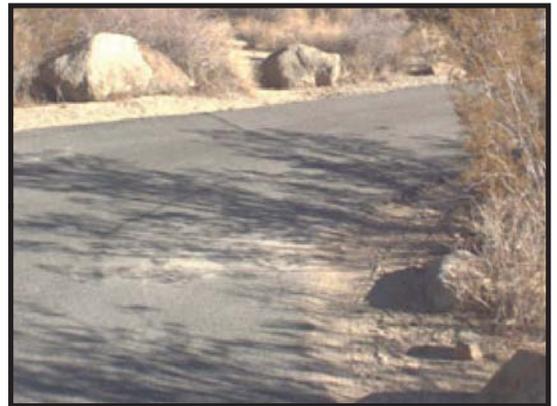
Route 0960CZ

Route Number	Public / NonPublic	Date Visited		Area (sq ft)	Lane Miles *	Surface Type
0960CZ	PUBLIC	1/13/2008		4,197	0.07	AS
Culverts	Drop Inlets	Gates	Fire Hydrants	Curb & Gutter	Curb	PCR
0	0	0	0	NO CURB AND GUTTER	NO CURB	FAIR/73

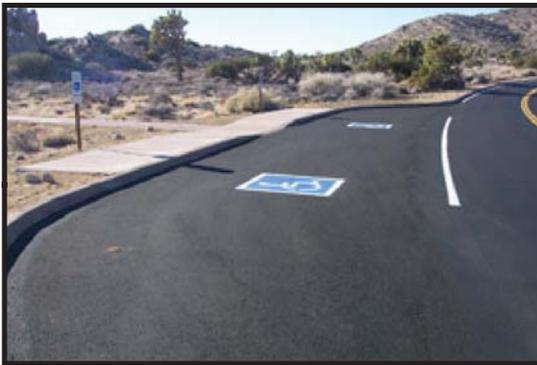
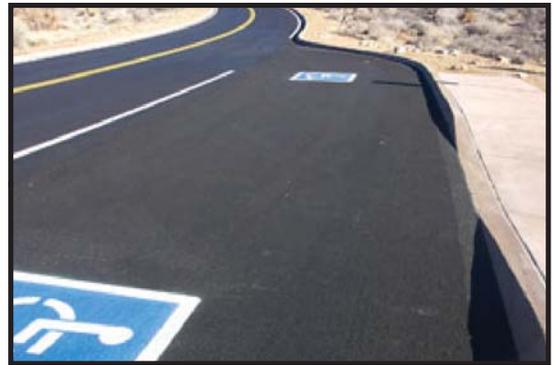
Route 0961

Route Number	Public / NonPublic	Date Visited		Area (sq ft)	Lane Miles *	Surface Type
0961	PUBLIC	1/10/2008		1,337	0.02	AS
Culverts	Drop Inlets	Gates	Fire Hydrants	Curb & Gutter	Curb	PCR
0	0	0	0	NO CURB AND GUTTER	CONCRETE CURB	EXCELLENT/97

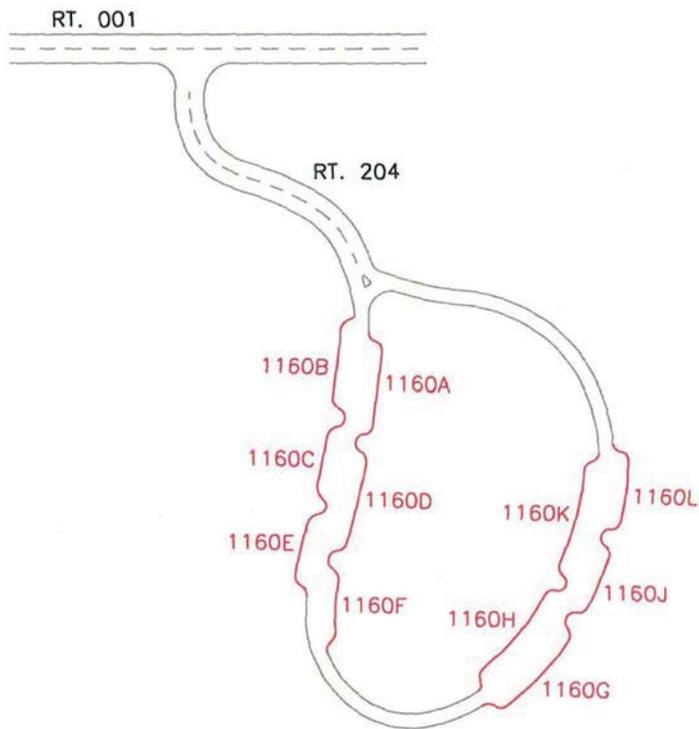
Figure 3: Parking with access route 204 and multiple parking areas (1160 A-L). Currently, this parking area is 12 routes and 12 assets (one 1100 asset and 11 1300 assets).
