**The Road Inventory
of
Lava Beds National Monument
LABE – 8410
Cycle 4**

**Prepared By:
Federal Highway Administration
Road Inventory Program
Cycle 4**

Lava Beds National Monument in California

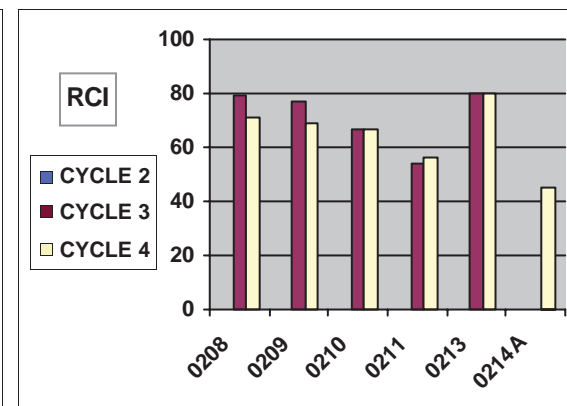
LABE : CYCLE 2 vs CYCLE 3 vs CYCLE 4 CONDITION COMPARISONS

ROUTE NUMBER	PAVED MILES	FROM MILEPOST	TO MILEPOST	PAVEMENT CONDITION RATING (PCR)				SURFACE CONDITION RATING (SCR)				ROUGHNESS CONDITION INDEX (RCI)				COMMENT
				CYCLE 2	CYCLE 3	CYCLE 4	PERCENT CHANGE	CYCLE 2	CYCLE 3	CYCLE 4	PERCENT CHANGE	CYCLE 2	CYCLE 3	CYCLE 4	PERCENT CHANGE	
0208	1.10	0.00	1.10	N/A	61	59	-3%	N/A	51	52	+2%	N/A	79	71	-10%	
0209	0.21	0.00	0.21	N/A	55	52	-5%	N/A	46	46	0%	N/A	77	69	-10%	
0210	1.98	0.00	1.98	N/A	55	57	+4%	N/A	48	51	+6%	N/A	67	67	0%	
0211	0.44	0.00	0.44	N/A	54	57	+6%	N/A	55	56	+2%	N/A	54	56	+4%	
0213	0.64	0.00	0.64	N/A	54	60	+11%	N/A	38	48	+26%	N/A	80	80	0%	
0214A	0.23	0.00	0.23	N/A	N/A	33	N/A	N/A	N/A	32	N/A	N/A	N/A	45	N/A	New ARAN route in Cycle 4.

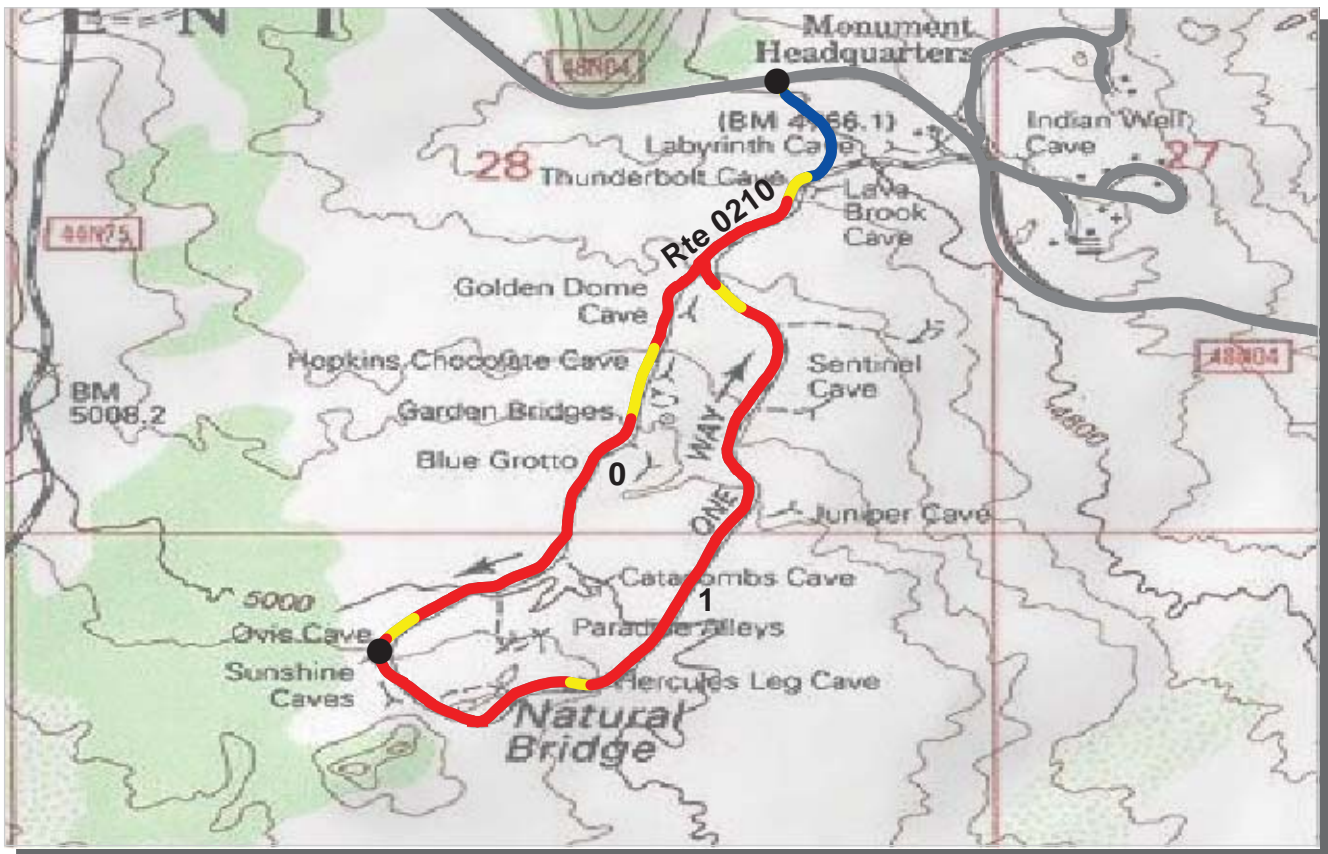
ROUTE: 0209 VALENTINE CAVE ROAD

PCR Poor ■ Fair ■ Good ■ Excellent ■ No Data ■
 (≤60) (61 - 84) (85 - 94) (95 - 100)

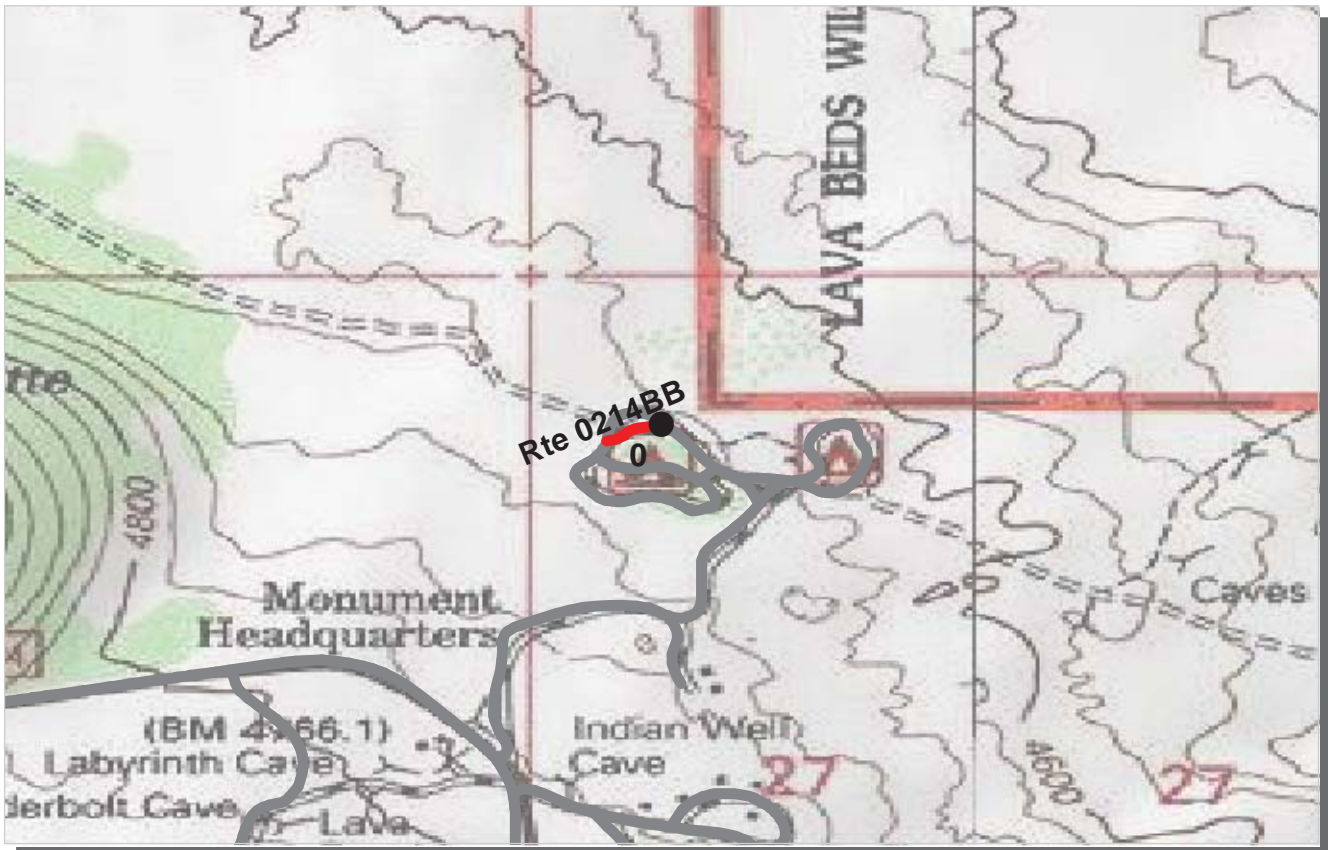
ROUTE: 0214BA CAMPGROUND LOOP B ROAD A

PCR	Poor	Fair	Good	Excellent	No Data
	(≤60)	(61 - 84)	(85 - 94)	(95 - 100)

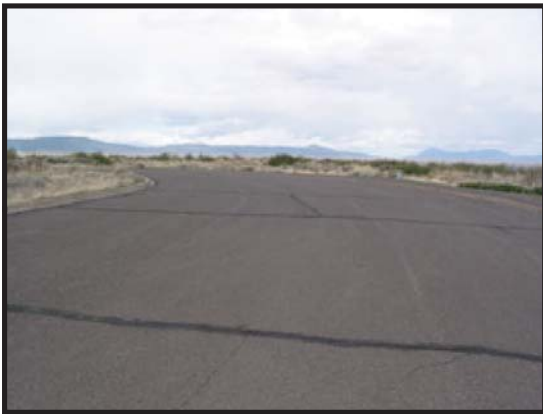
Route Number	Public / NonPublic	Date Visited		Area (sq ft)	Lane Miles *	Surface Type
0900	PUBLIC	4/17/2007		6,406	0.11	AS
Culverts	Drop Inlets	Gates	Fire Hydrants	Curb & Gutter	Curb	PCR
0	1	0	0	CONCRETE CURB AND GUTTER	NO CURB	FAIR/73

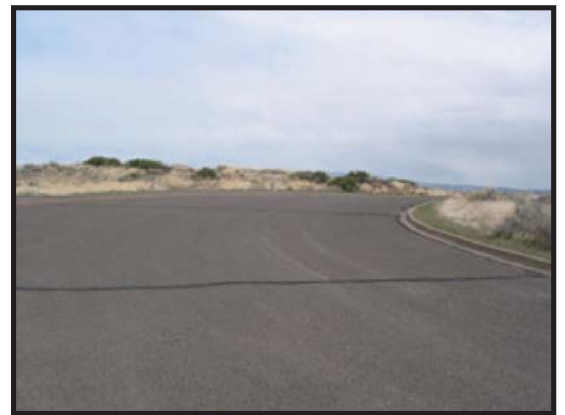
Route 0901

Route Number	Public / NonPublic	Date Visited		Area (sq ft)	Lane Miles *	Surface Type
0901	PUBLIC	4/17/2007		8,084	0.14	AS
Culverts	Drop Inlets	Gates	Fire Hydrants	Curb & Gutter	Curb	PCR
0	1	0	0	CONCRETE CURB AND GUTTER	NO CURB	POOR/45

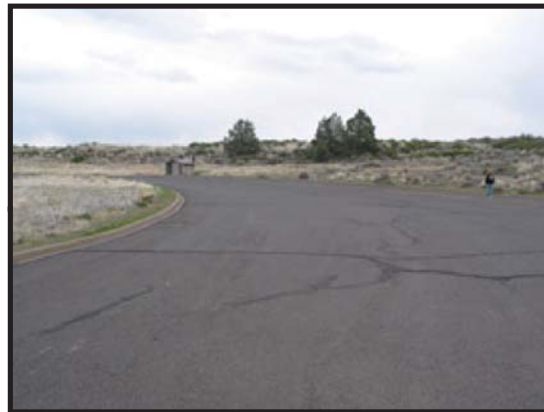
Route 0902

Route Number	Public / NonPublic	Date Visited		Area (sq ft)	Lane Miles *	Surface Type
0902	PUBLIC	4/17/2007		34,647	0.60	AS
Culverts	Drop Inlets	Gates	Fire Hydrants	Curb & Gutter	Curb	PCR
0	1	0	0	CONCRETE CURB AND GUTTER	NO CURB	POOR/45

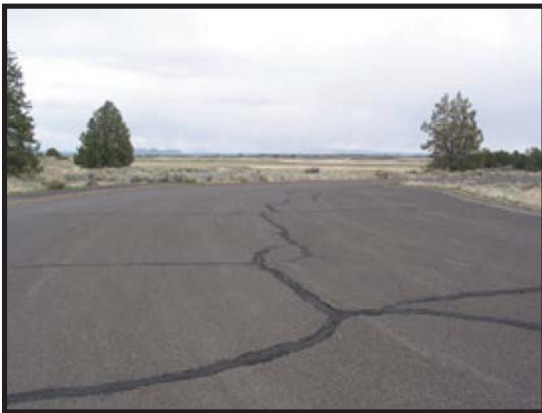
Route 0903

Route Number	Public / NonPublic	Date Visited		Area (sq ft)	Lane Miles *	Surface Type
0903	PUBLIC	4/17/2007		19,019	0.33	AS
Culverts	Drop Inlets	Gates	Fire Hydrants	Curb & Gutter	Curb	PCR
0	1	0	0	CONCRETE CURB AND GUTTER	NO CURB	POOR/45

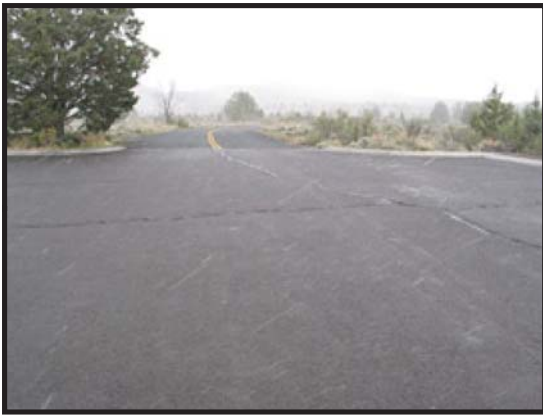
Route 0906

Route Number	Public / NonPublic	Date Visited		Area (sq ft)	Lane Miles *	Surface Type
0906	PUBLIC	4/17/2007		5,431	0.09	AS
Culverts	Drop Inlets	Gates	Fire Hydrants	Curb & Gutter	Curb	PCR
0	1	0	0	CONCRETE CURB AND GUTTER	NO CURB	FAIR/73

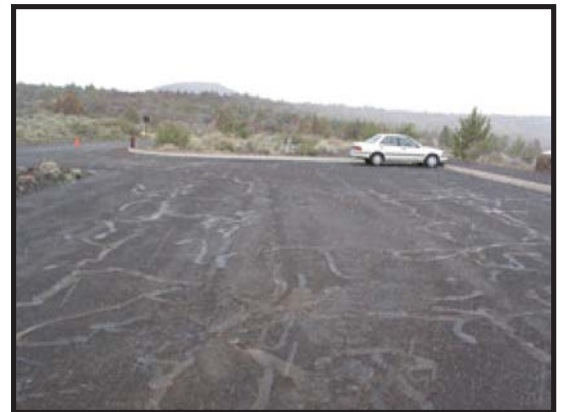
Route 0913

Route Number	Public / NonPublic	Date Visited		Area (sq ft)	Lane Miles *	Surface Type
0913	PUBLIC	4/17/2007		6,088	0.11	AS
Culverts	Drop Inlets	Gates	Fire Hydrants	Curb & Gutter	Curb	PCR
0	1	0	0	CONCRETE CURB AND GUTTER	NO CURB	FAIR/73

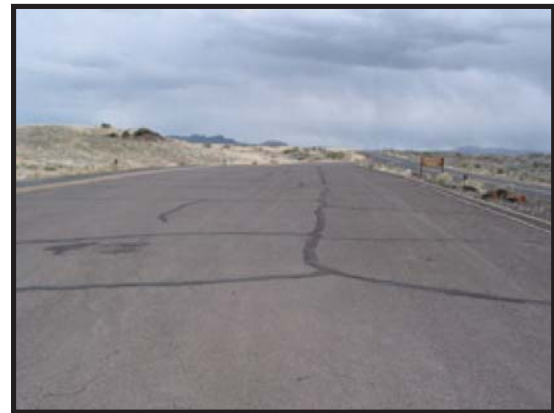
Route 0917

Route Number	Public / NonPublic	Date Visited		Area (sq ft)	Lane Miles *	Surface Type
0917	PUBLIC	4/17/2007		18,326	0.32	AS
Culverts	Drop Inlets	Gates	Fire Hydrants	Curb & Gutter	Curb	PCR
0	0	0	0	CONCRETE CURB AND GUTTER	NO CURB	POOR/45
