**The Road Inventory
of
Lake Meredith National Recreation Area
LAMR – 7540
Cycle 4**

**Prepared By:
Federal Highway Administration
Road Inventory Program
Cycle 4**

Lake Meredith National Recreation Area in Texas

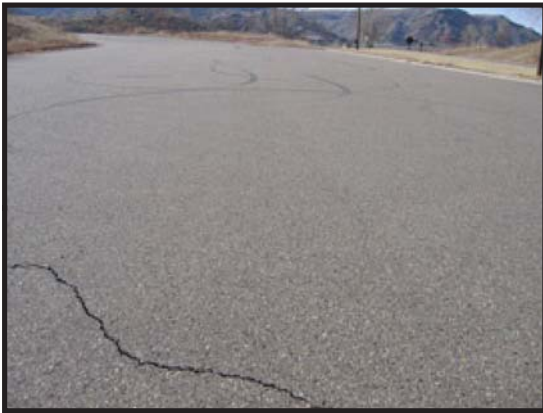
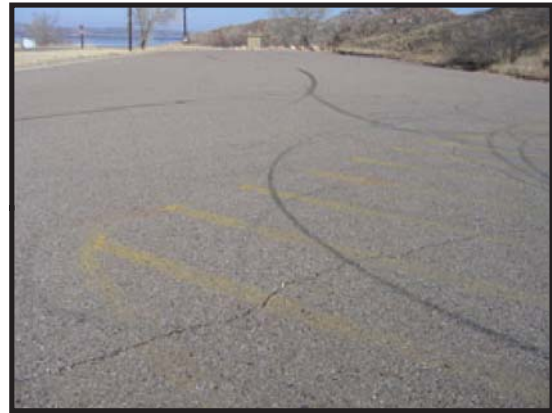
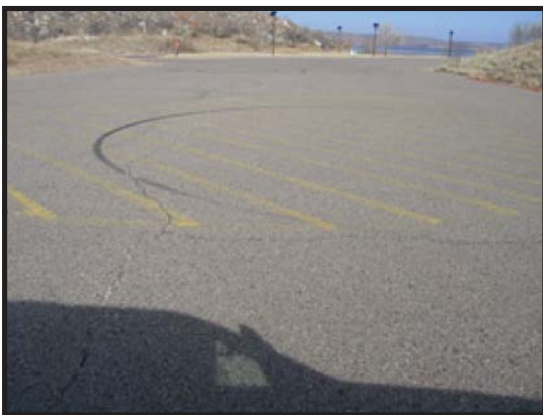
Route 0900B

Route Number	Public / NonPublic	Date Visited		Area (sq ft)	Lane Miles *	Surface Type
0900B	PUBLIC	1/23/2008		57,218	0.99	AS
Culverts	Drop Inlets	Gates	Fire Hydrants	Curb & Gutter	Curb	PCR
0	1	0	0	CONCRETE CURB AND GUTTER	CONCRETE CURB	FAIR/73

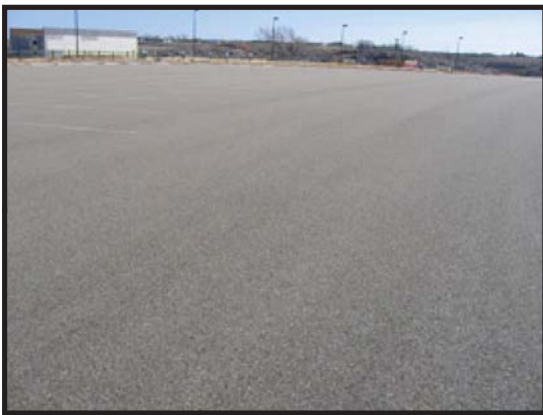
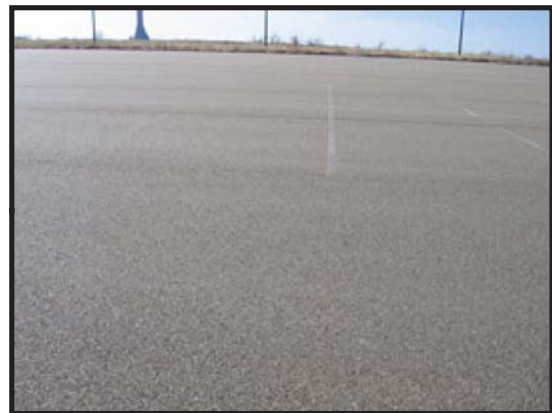
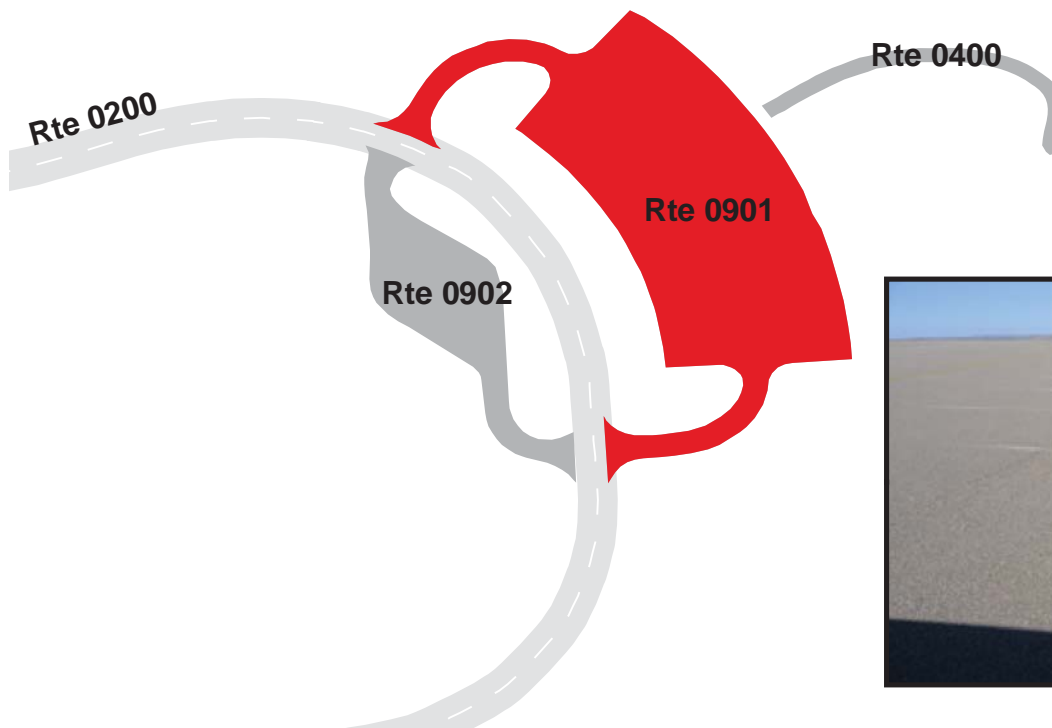
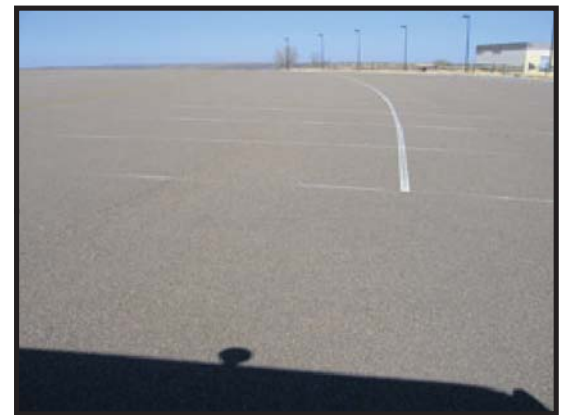
Route 0901

Route Number	Public / NonPublic	Date Visited		Area (sq ft)	Lane Miles *	Surface Type
0901	PUBLIC	1/23/2008		94,092	1.62	AS
Culverts	Drop Inlets	Gates	Fire Hydrants	Curb & Gutter	Curb	PCR
0	2	0	0	CONCRETE CURB AND GUTTER	CONCRETE CURB	GOOD/90

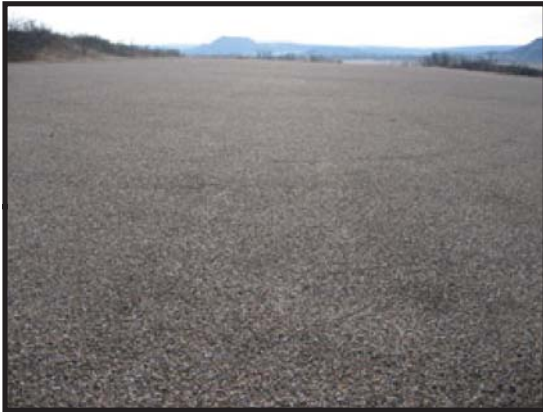
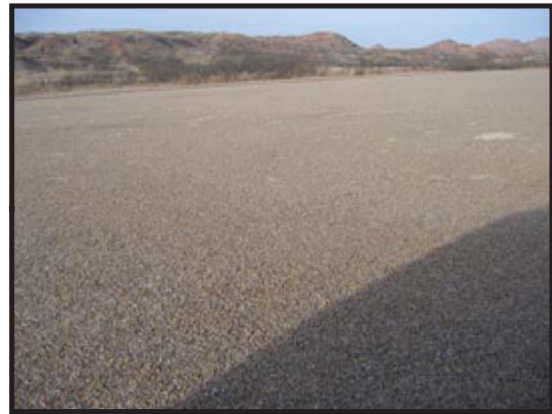
Route 0907

Route Number	Public / NonPublic	Date Visited		Area (sq ft)	Lane Miles *	Surface Type
0907	PUBLIC	1/24/2008		82,765	1.43	AS
Culverts	Drop Inlets	Gates	Fire Hydrants	Curb & Gutter	Curb	PCR
0	0	0	0	CONCRETE CURB AND GUTTER	CONCRETE CURB	POOR/45

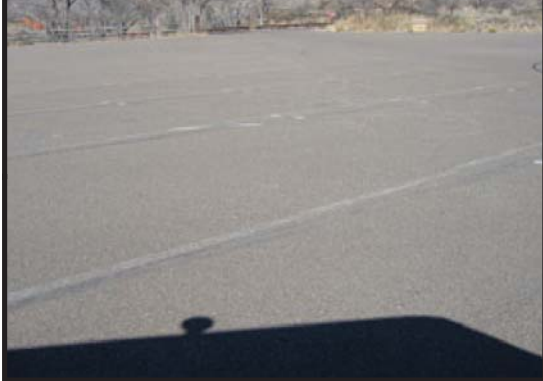
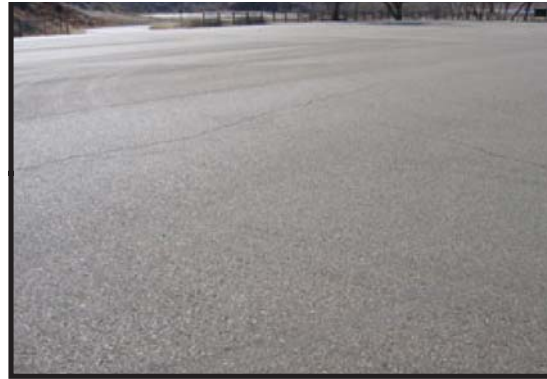
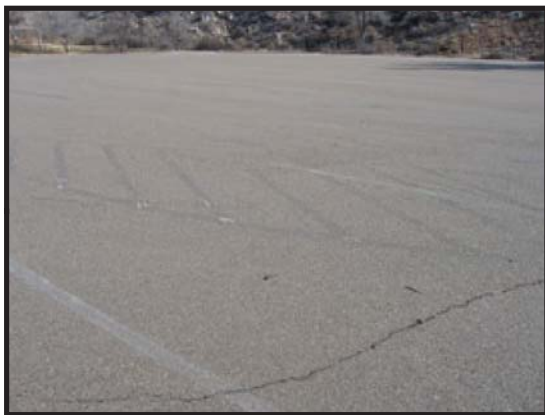
Route Number	Public / NonPublic	Date Visited		Area (sq ft)	Lane Miles *	Surface Type
0908	PUBLIC	1/23/2008		62,373	1.07	AS
Culverts	Drop Inlets	Gates	Fire Hydrants	Curb & Gutter	Curb	PCR
0	0	0	0	NO CURB AND GUTTER	NO CURB	GOOD/90

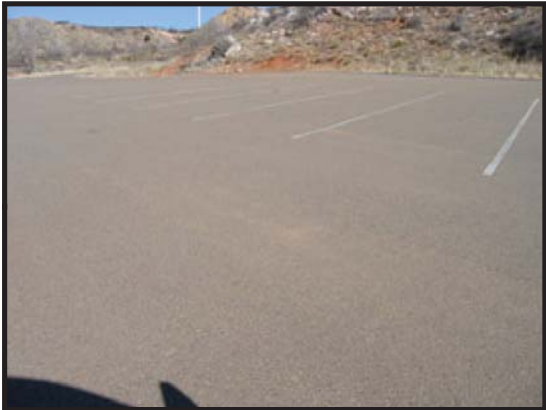
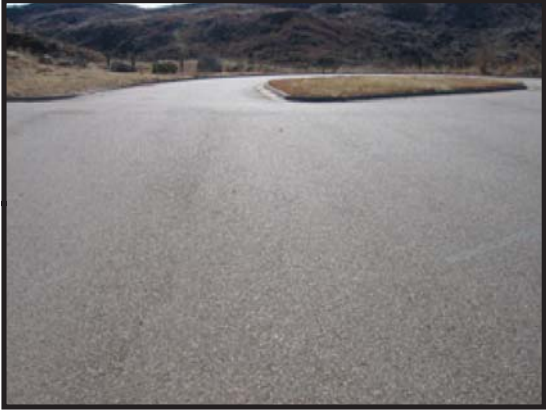
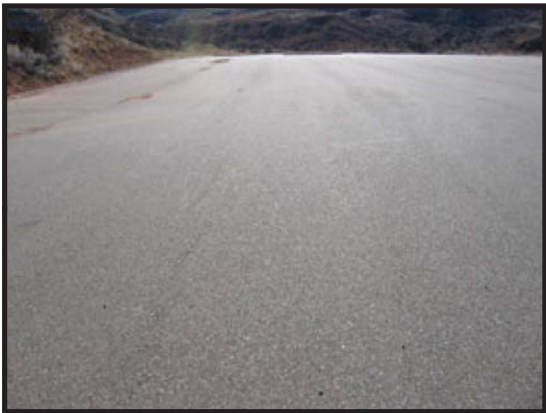
Route 0909

Route Number	Public / NonPublic	Date Visited		Area (sq ft)	Lane Miles *	Surface Type
0909	PUBLIC	1/23/2008		53,022	0.91	AS
Culverts	Drop Inlets	Gates	Fire Hydrants	Curb & Gutter	Curb	PCR
2	2	0	0	CONCRETE CURB AND GUTTER	CONCRETE CURB	GOOD/90

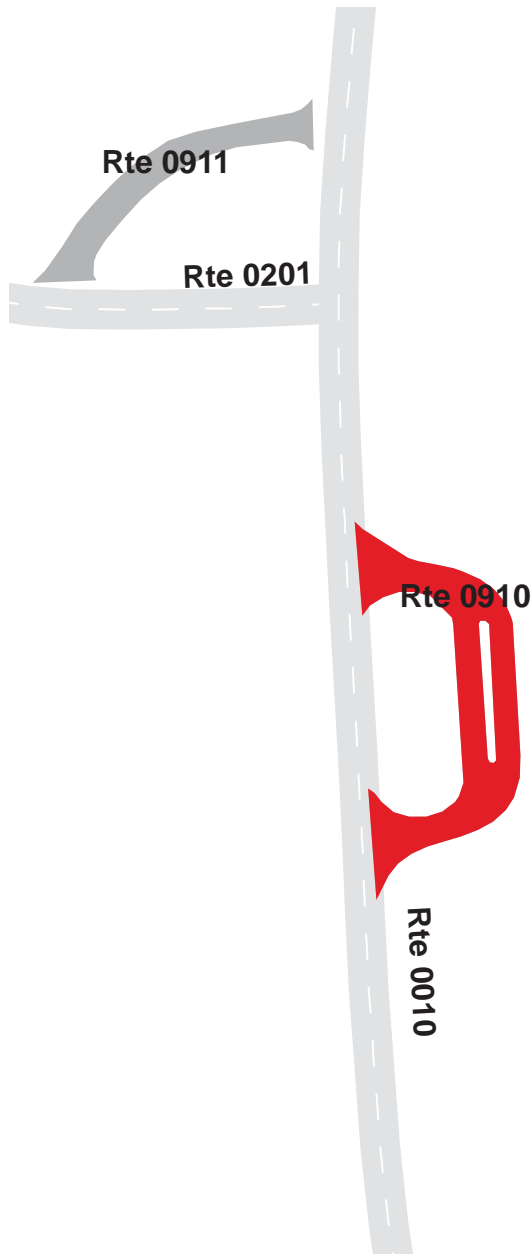
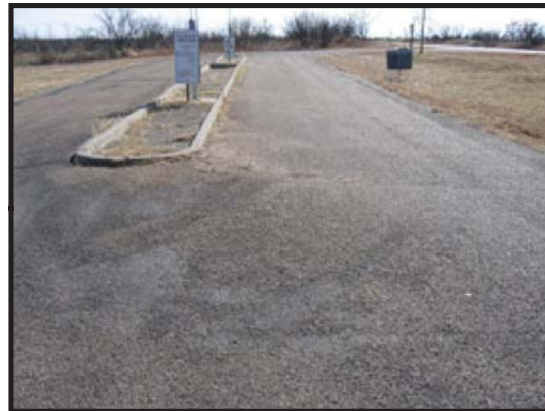
Route 0910

Route Number	Public / NonPublic	Date Visited		Area (sq ft)	Lane Miles *	Surface Type
0910	PUBLIC	1/23/2008		7,993	0.14	AS
Culverts	Drop Inlets	Gates	Fire Hydrants	Curb & Gutter	Curb	PCR
0	0	0	0	NO CURB AND GUTTER	NO CURB	FAIR/73

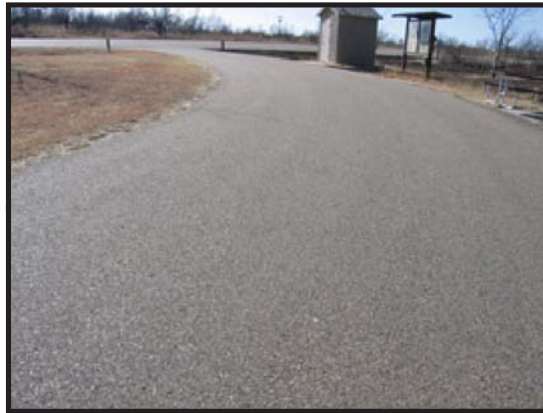
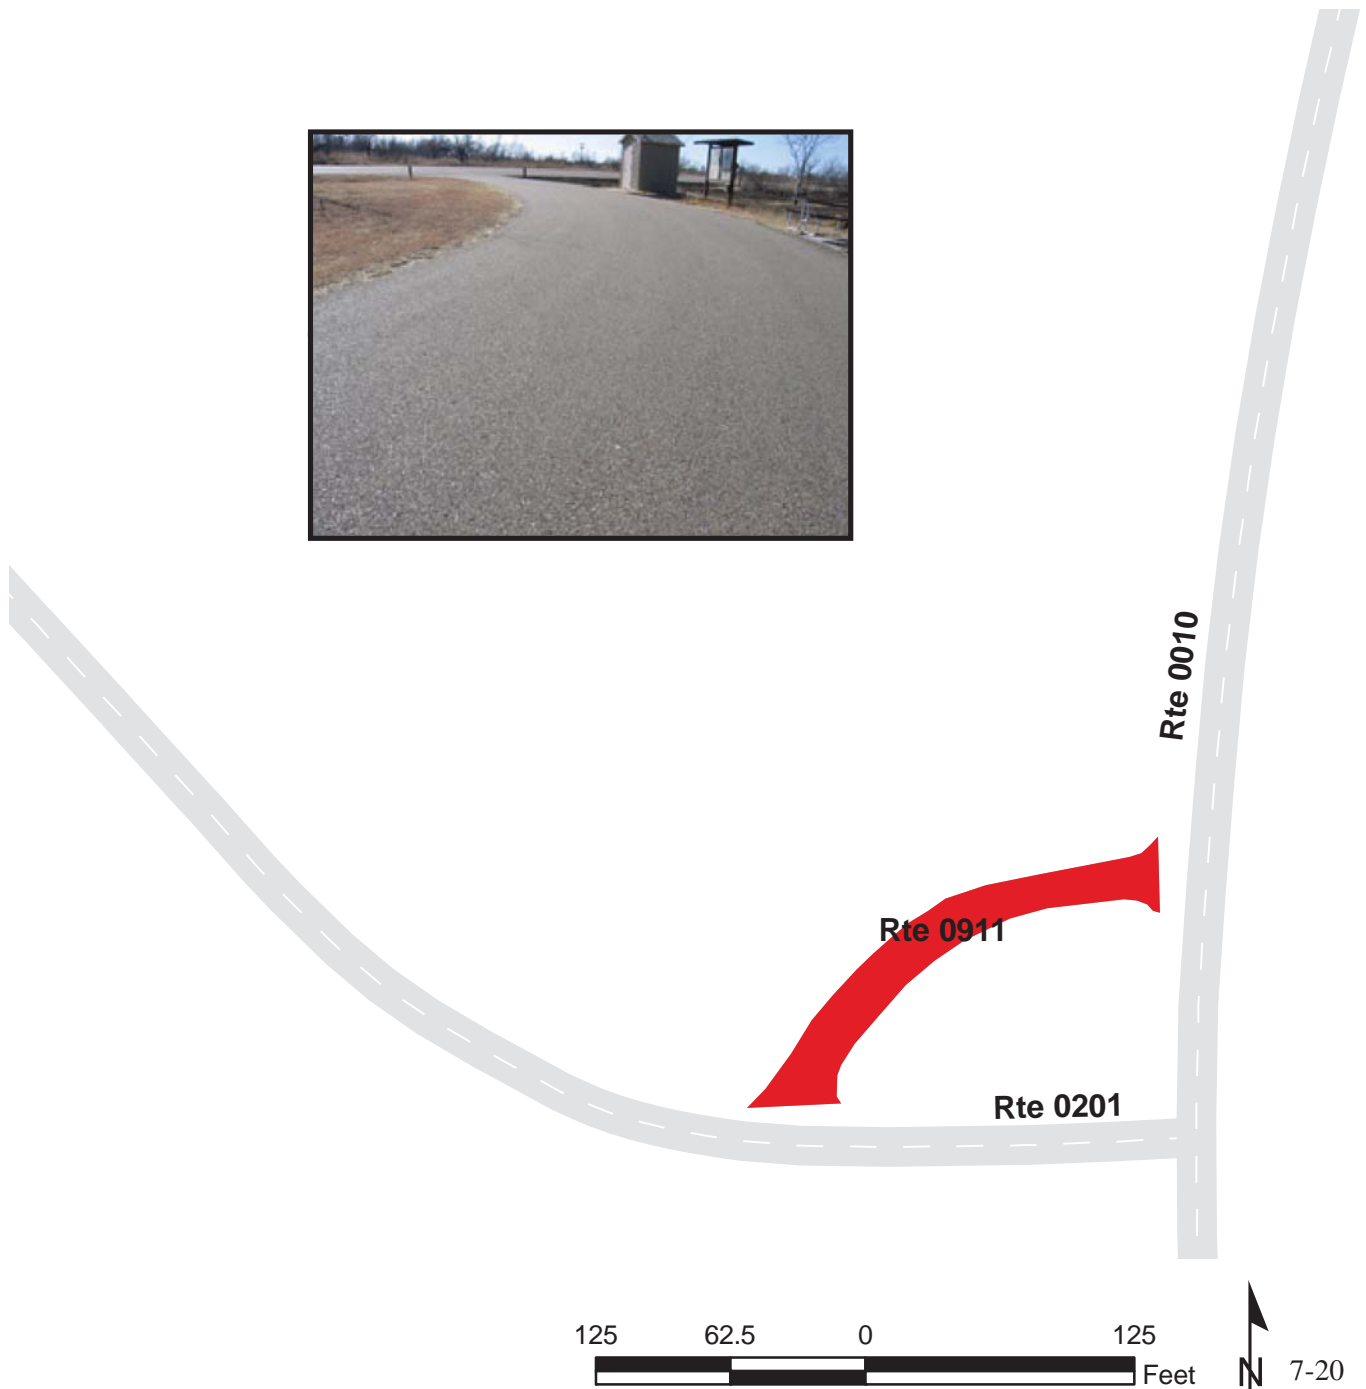
Route 0911

Route Number	Public / NonPublic	Date Visited		Area (sq ft)	Lane Miles *	Surface Type
0911	PUBLIC	1/23/2008		3,682	0.06	AS
Culverts	Drop Inlets	Gates	Fire Hydrants	Curb & Gutter	Curb	PCR
2	0	0	0	NO CURB AND GUTTER	NO CURB	GOOD/90

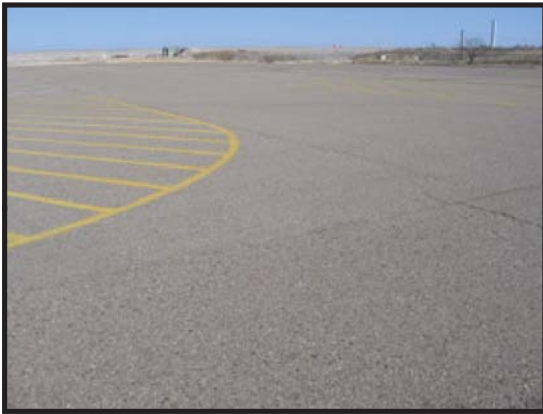
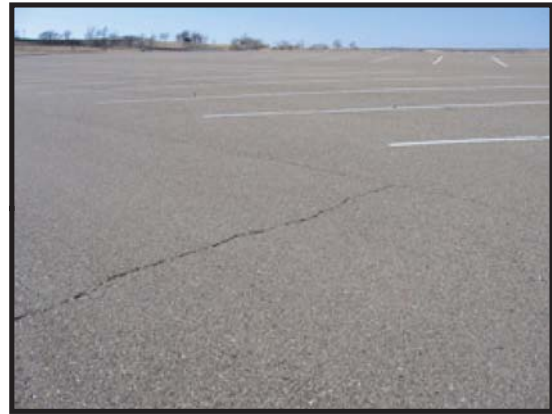
Route 0912

Route Number	Public / NonPublic	Date Visited		Area (sq ft)	Lane Miles *	Surface Type
0912	PUBLIC	1/23/2008		139,699	2.41	AS
Culverts	Drop Inlets	Gates	Fire Hydrants	Curb & Gutter	Curb	PCR
0	0	0	0	CONCRETE CURB AND GUTTER	CONCRETE CURB	GOOD/90

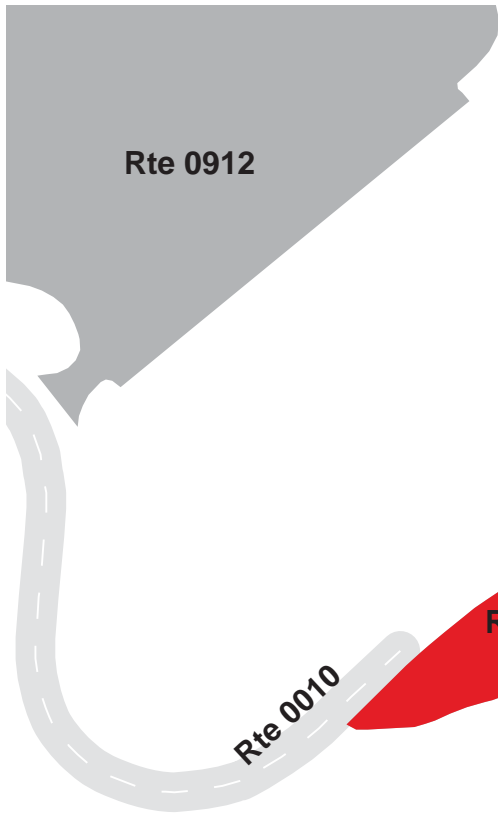
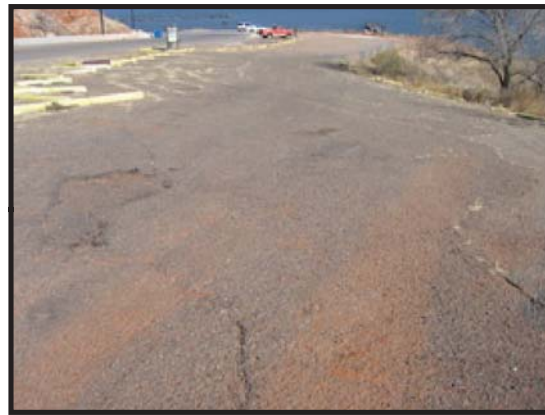
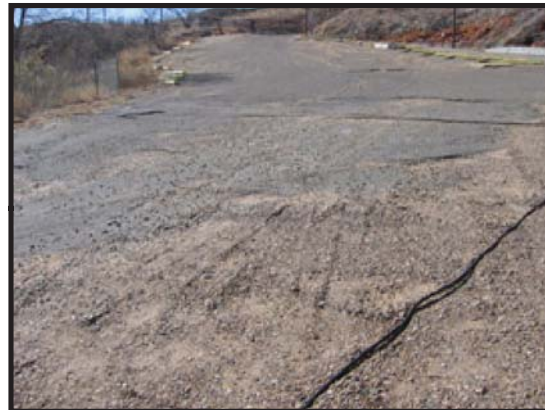
Route 0913

Route Number	Public / NonPublic	Date Visited		Area (sq ft)	Lane Miles *	Surface Type
0913	PUBLIC	1/23/2008		19,918	0.34	AS
Culverts	Drop Inlets	Gates	Fire Hydrants	Curb & Gutter	Curb	PCR
0	0	0	0	NO CURB AND GUTTER	NO CURB	POOR/45

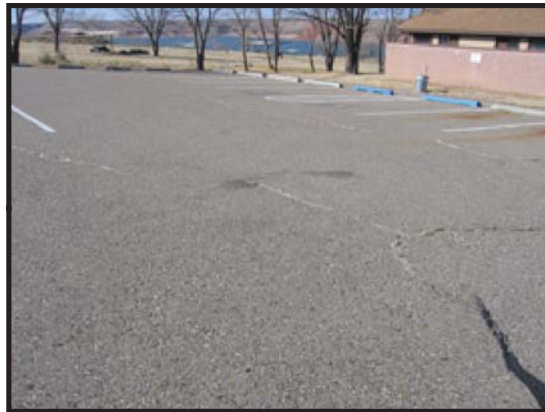
Route 0914

Route Number	Public / NonPublic	Date Visited		Area (sq ft)	Lane Miles *	Surface Type
0914	PUBLIC	1/23/2008		6,639	0.11	AS
Culverts	Drop Inlets	Gates	Fire Hydrants	Curb & Gutter	Curb	PCR
0	0	0	0	NO CURB AND GUTTER	NO CURB	FAIR/73

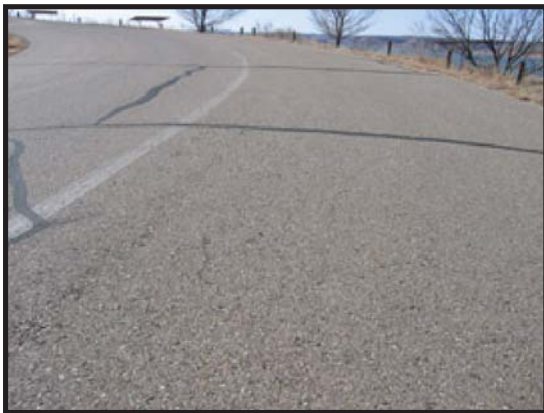
Route 0915A

Route Number	Public / NonPublic	Date Visited		Area (sq ft)	Lane Miles *	Surface Type
0915A	PUBLIC	1/23/2008		3,093	0.05	AS
Culverts	Drop Inlets	Gates	Fire Hydrants	Curb & Gutter	Curb	PCR
0	0	0	0	NO CURB AND GUTTER	NO CURB	FAIR/73

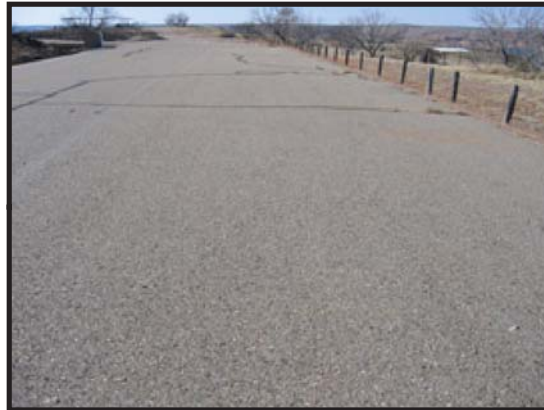
Route 0915B

Route Number	Public / NonPublic	Date Visited		Area (sq ft)	Lane Miles *	Surface Type
0915B	PUBLIC	1/23/2008		3,575	0.06	AS
Culverts	Drop Inlets	Gates	Fire Hydrants	Curb & Gutter	Curb	PCR
0	0	0	0	NO CURB AND GUTTER	NO CURB	FAIR/73

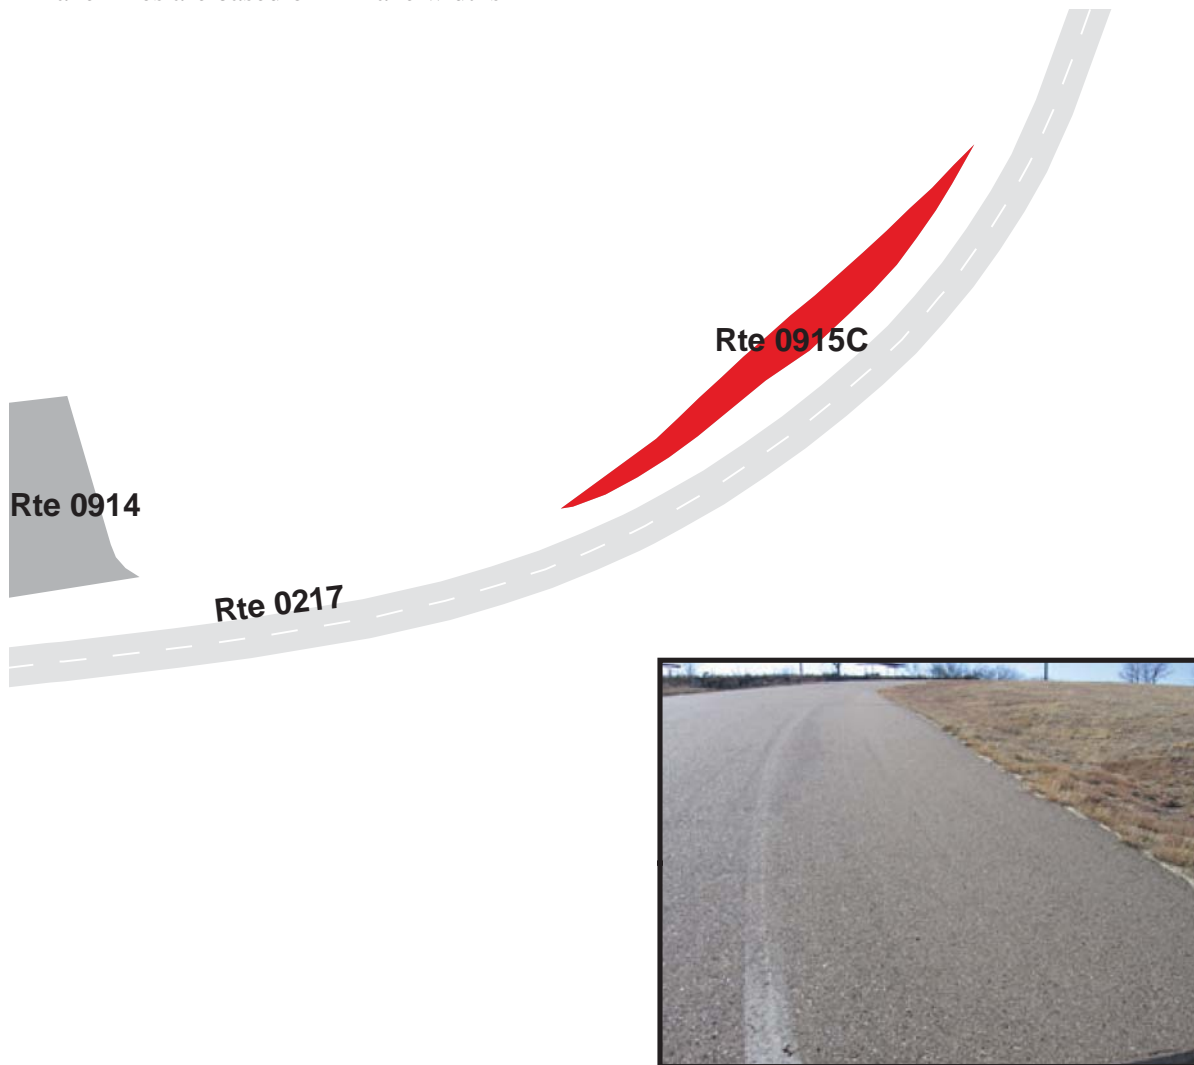
Route 0915C

Route Number	Public / NonPublic	Date Visited		Area (sq ft)	Lane Miles *	Surface Type
0915C	PUBLIC	1/23/2008		1,173	0.02	AS
Culverts	Drop Inlets	Gates	Fire Hydrants	Curb & Gutter	Curb	PCR
0	0	0	0	NO CURB AND GUTTER	NO CURB	FAIR/73

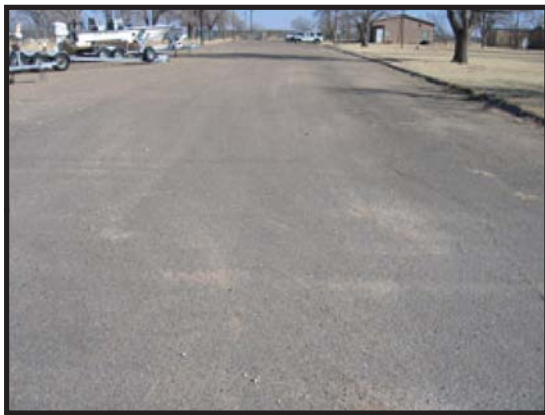
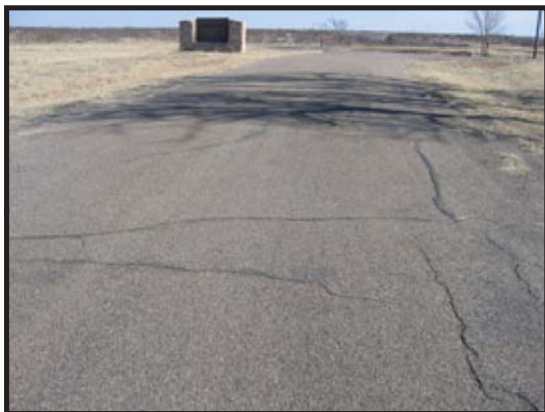
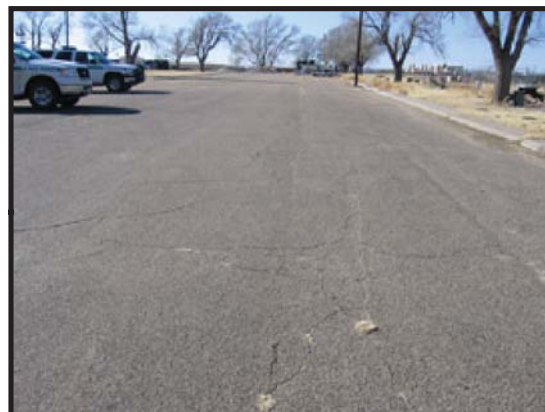
Route 0916

Route Number	Public / NonPublic	Date Visited		Area (sq ft)	Lane Miles *	Surface Type
0916	NONPUBLIC	1/23/2008		32,594	0.56	AS
Culverts	Drop Inlets	Gates	Fire Hydrants	Curb & Gutter	Curb	PCR
0	0	1	0	CONCRETE CURB AND GUTTER	CONCRETE CURB	POOR/45

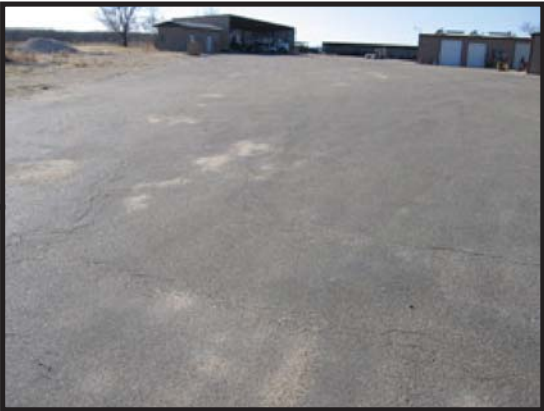
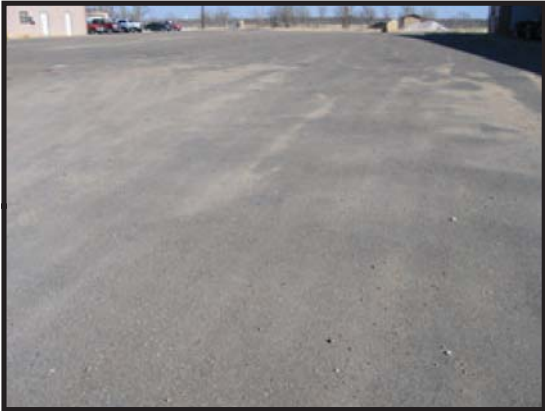
Route 0917

Route Number	Public / NonPublic	Date Visited		Area (sq ft)	Lane Miles *	Surface Type
0917	NONPUBLIC	1/23/2008		41,106	0.71	AS
Culverts	Drop Inlets	Gates	Fire Hydrants	Curb & Gutter	Curb	PCR
0	0	1	0	NO CURB AND GUTTER	NO CURB	POOR/45

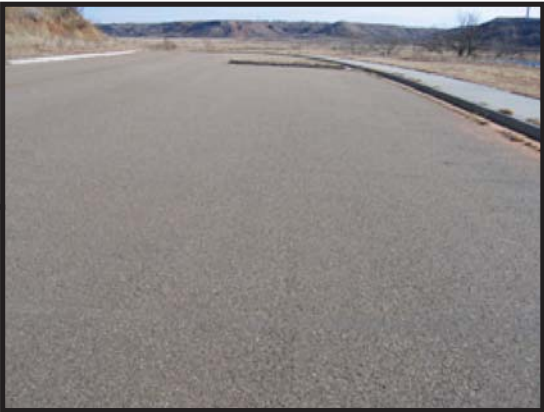
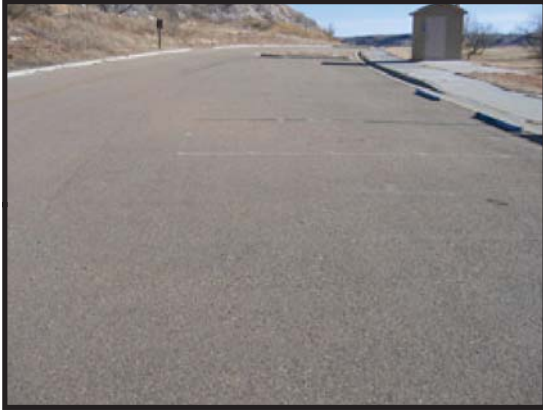
Route 0918A

Route Number	Public / NonPublic	Date Visited		Area (sq ft)	Lane Miles *	Surface Type
0918A	PUBLIC	1/23/2008		11,872	0.20	AS
Culverts	Drop Inlets	Gates	Fire Hydrants	Curb & Gutter	Curb	PCR
0	0	0	0	CONCRETE CURB AND GUTTER	CONCRETE CURB	FAIR/73

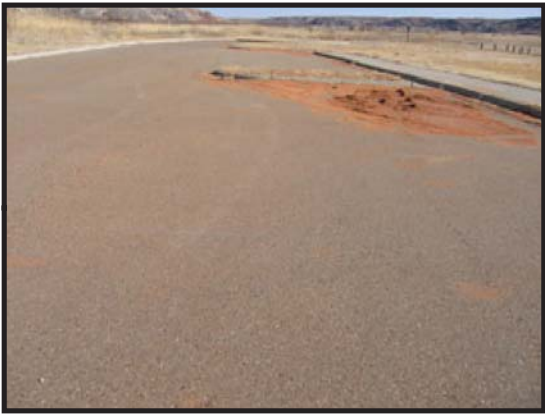
Route 0918B

Route Number	Public / NonPublic	Date Visited		Area (sq ft)	Lane Miles *	Surface Type
0918B	PUBLIC	1/23/2008		3,205	0.06	AS
Culverts	Drop Inlets	Gates	Fire Hydrants	Curb & Gutter	Curb	PCR
0	0	0	0	CONCRETE CURB AND GUTTER	CONCRETE CURB	FAIR/73

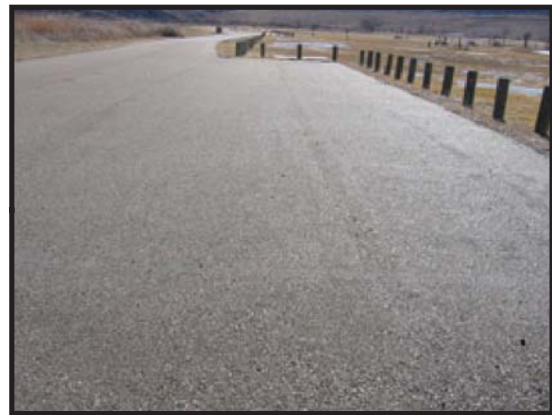
Route 0918C

Route Number	Public / NonPublic	Date Visited		Area (sq ft)	Lane Miles *	Surface Type
0918C	PUBLIC	1/23/2008		2,145	0.04	AS
Culverts	Drop Inlets	Gates	Fire Hydrants	Curb & Gutter	Curb	PCR
0	0	0	0	NO CURB AND GUTTER	NO CURB	FAIR/73

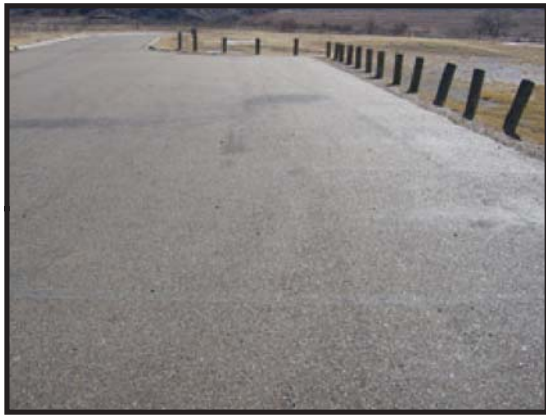
Route 0918D

Route Number	Public / NonPublic	Date Visited		Area (sq ft)	Lane Miles *	Surface Type
0918D	PUBLIC	1/23/2008		1,859	0.03	AS
Culverts	Drop Inlets	Gates	Fire Hydrants	Curb & Gutter	Curb	PCR
0	0	0	0	NO CURB AND GUTTER	NO CURB	FAIR/73

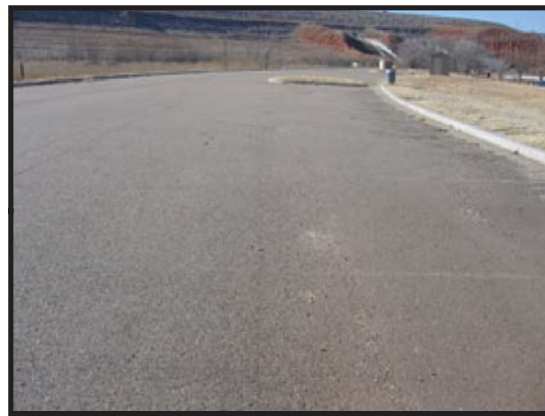
Route 0918E

Route Number	Public / NonPublic	Date Visited		Area (sq ft)	Lane Miles *	Surface Type
0918E	PUBLIC	1/23/2008		12,790	0.22	AS
Culverts	Drop Inlets	Gates	Fire Hydrants	Curb & Gutter	Curb	PCR
0	0	0	0	CONCRETE CURB AND GUTTER	CONCRETE CURB	FAIR/73

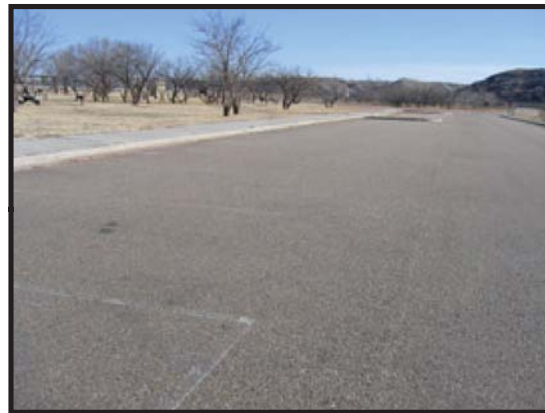
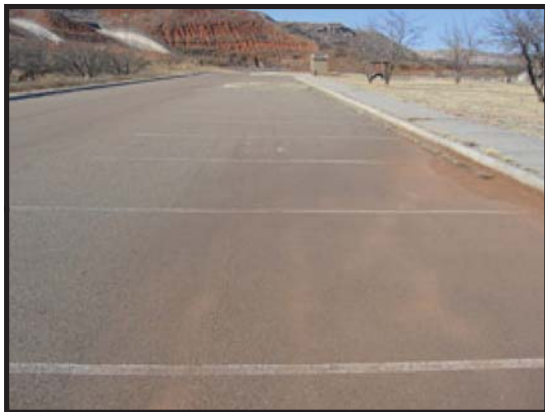
Route 0918F

Route Number	Public / NonPublic	Date Visited		Area (sq ft)	Lane Miles *	Surface Type
0918F	PUBLIC	1/23/2008		6,381	0.11	AS
Culverts	Drop Inlets	Gates	Fire Hydrants	Curb & Gutter	Curb	PCR
0	0	0	0	CONCRETE CURB AND GUTTER	CONCRETE CURB	GOOD/90

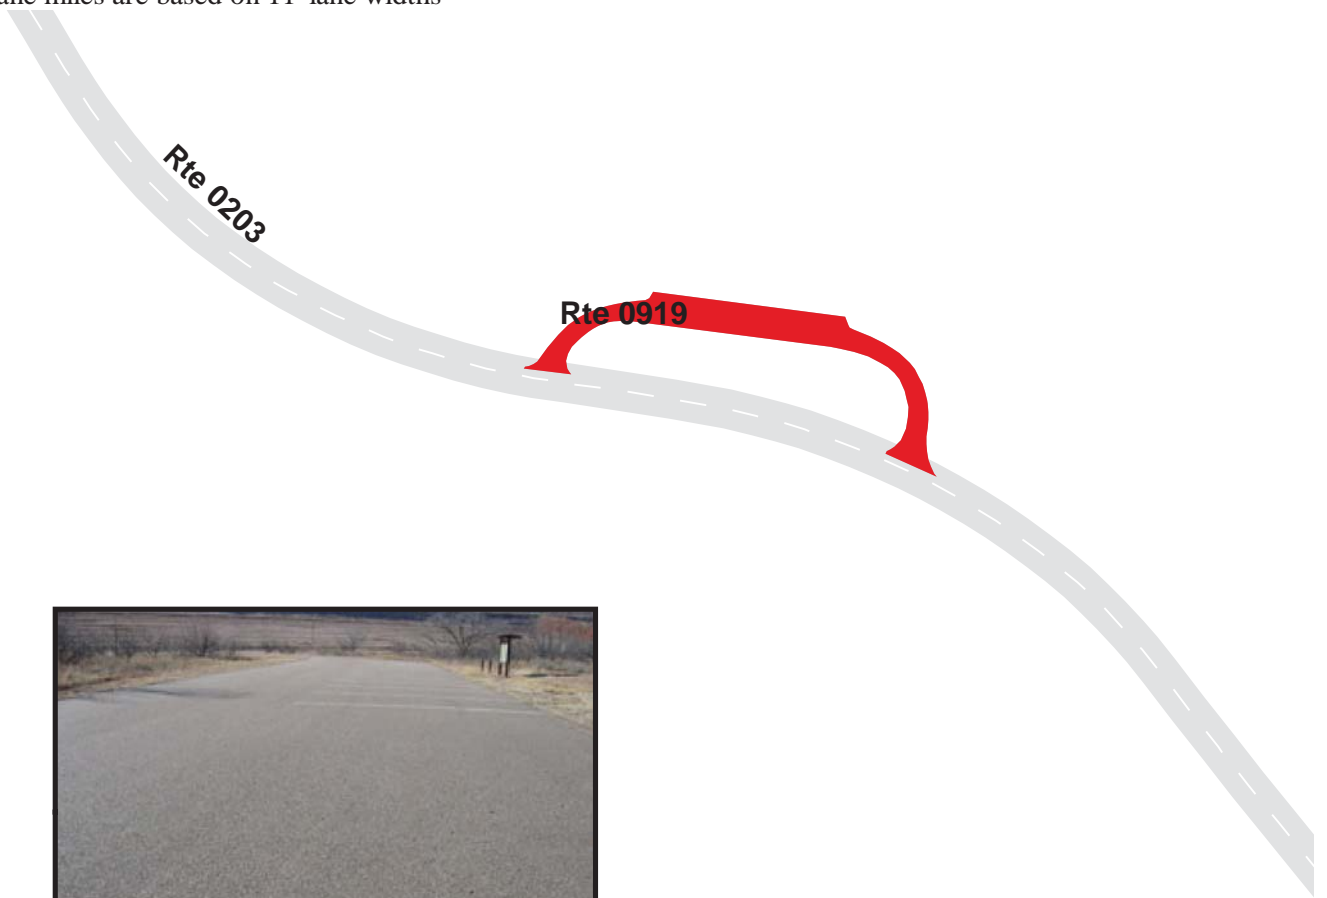
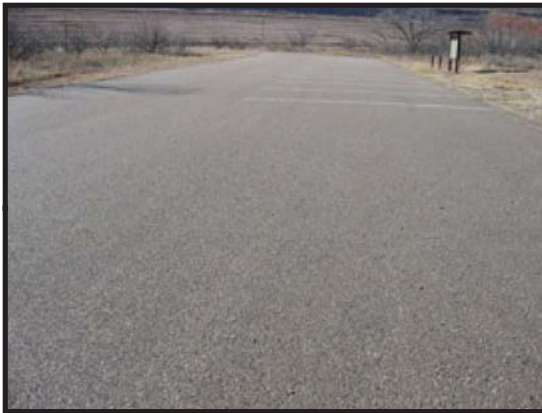
Route 0919

Route Number	Public / NonPublic	Date Visited		Area (sq ft)	Lane Miles *	Surface Type
0919	PUBLIC	1/23/2008		14,177	0.24	AS
Culverts	Drop Inlets	Gates	Fire Hydrants	Curb & Gutter	Curb	PCR
0	0	0	0	NO CURB AND GUTTER	NO CURB	GOOD/90

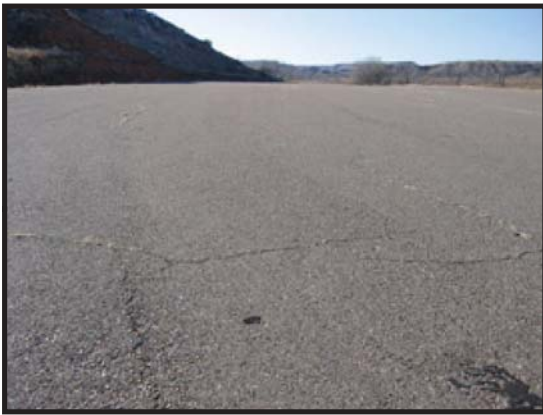
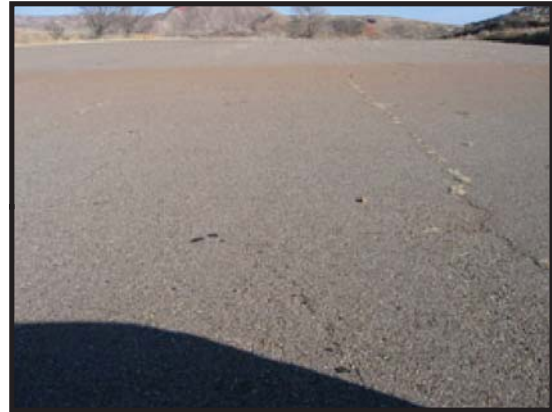
Route 0920

Route Number	Public / NonPublic	Date Visited		Area (sq ft)	Lane Miles *	Surface Type
0920	PUBLIC	1/23/2008		41,368	0.71	AS
Culverts	Drop Inlets	Gates	Fire Hydrants	Curb & Gutter	Curb	PCR
0	0	0	0	NO CURB AND GUTTER	NO CURB	POOR/45

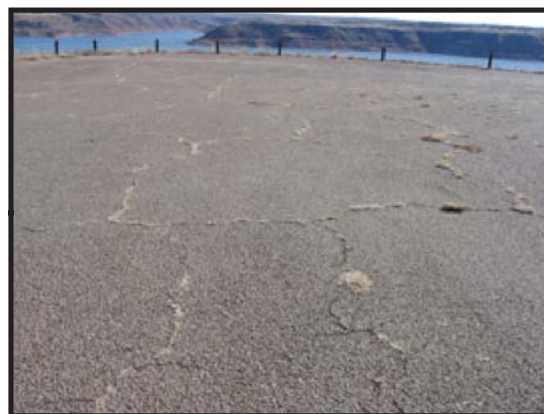
Route 0921

Route Number	Public / NonPublic	Date Visited		Area (sq ft)	Lane Miles *	Surface Type
0921	PUBLIC	1/23/2008		8,877	0.15	AS
Culverts	Drop Inlets	Gates	Fire Hydrants	Curb & Gutter	Curb	PCR
0	0	0	0	NO CURB AND GUTTER	NO CURB	POOR/45

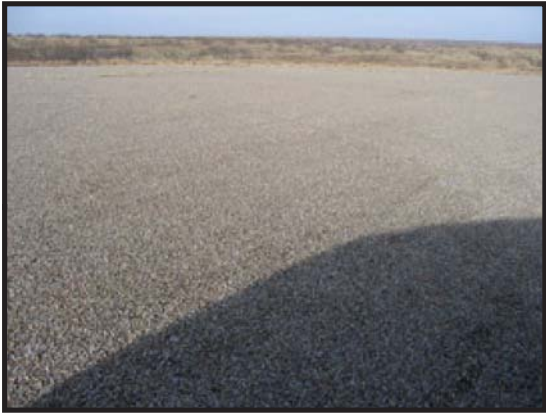
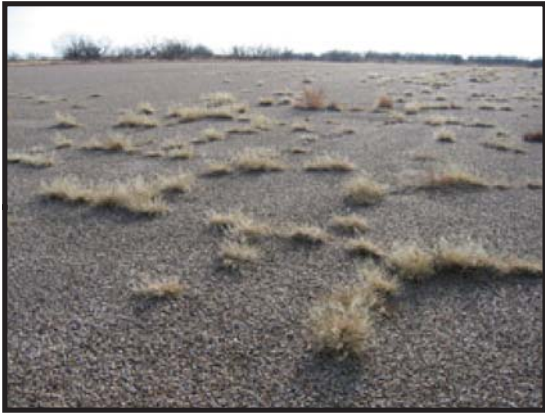
Route 0922

Route Number	Public / NonPublic	Date Visited		Area (sq ft)	Lane Miles *	Surface Type
0922	PUBLIC	1/24/2008		87,545	1.51	AS
Culverts	Drop Inlets	Gates	Fire Hydrants	Curb & Gutter	Curb	PCR
0	0	0	0	NO CURB AND GUTTER	NO CURB	POOR/45

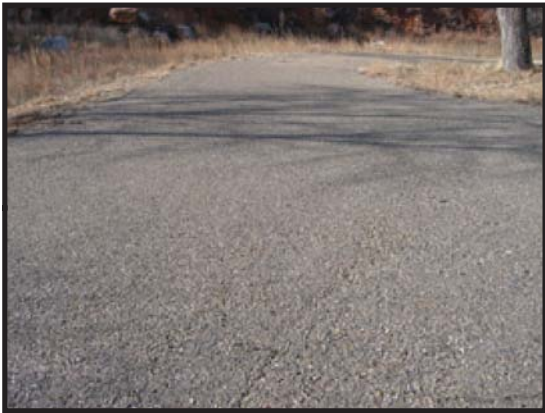
Route 0924

Route Number	Public / NonPublic	Date Visited		Area (sq ft)	Lane Miles *	Surface Type
0924	PUBLIC	1/24/2008		1,069	0.02	AS
Culverts	Drop Inlets	Gates	Fire Hydrants	Curb & Gutter	Curb	PCR
0	0	0	0	NO CURB AND GUTTER	NO CURB	POOR/45

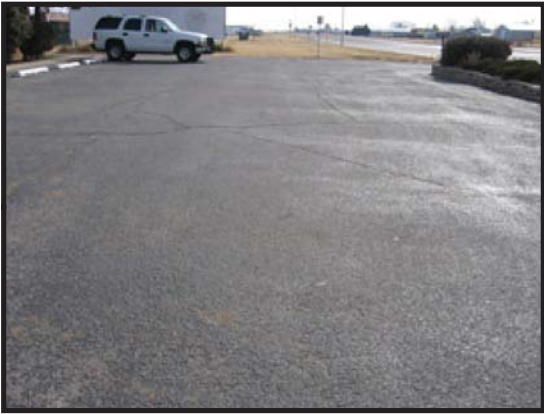
Route Number	Public / NonPublic	Date Visited		Area (sq ft)	Lane Miles *	Surface Type
0925	PUBLIC	1/23/2008		7,856	0.14	AS
Culverts	Drop Inlets	Gates	Fire Hydrants	Curb & Gutter	Curb	PCR
0	0	0	0	NO CURB AND GUTTER	NO CURB	POOR/45

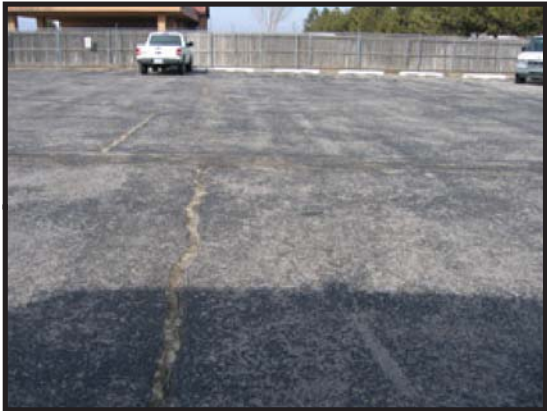
Route 0926

Route Number	Public / NonPublic	Date Visited		Area (sq ft)	Lane Miles *	Surface Type
0926	NONPUBLIC	1/23/2008		12,960	0.22	AS
Culverts	Drop Inlets	Gates	Fire Hydrants	Curb & Gutter	Curb	PCR
0	0	2	0	NO CURB AND GUTTER	NO CURB	POOR/45

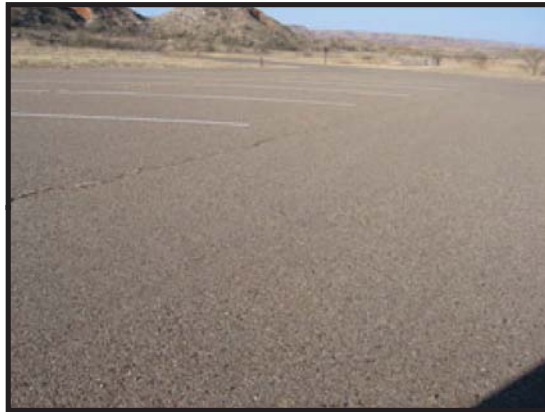
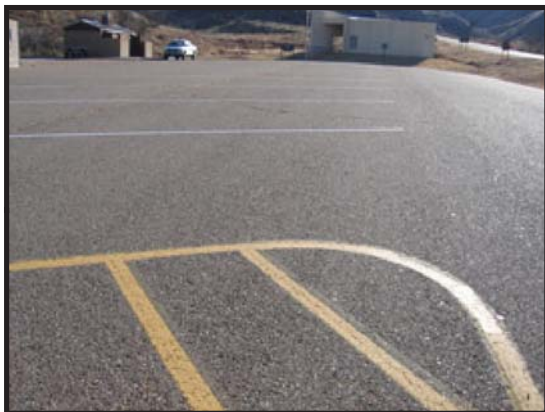
Route 0928

Route Number	Public / NonPublic	Date Visited		Area (sq ft)	Lane Miles *	Surface Type
0928	PUBLIC	1/23/2008		24,277	0.42	AS
Culverts	Drop Inlets	Gates	Fire Hydrants	Curb & Gutter	Curb	PCR
0	0	0	0	CONCRETE CURB AND GUTTER	CONCRETE CURB	FAIR/73

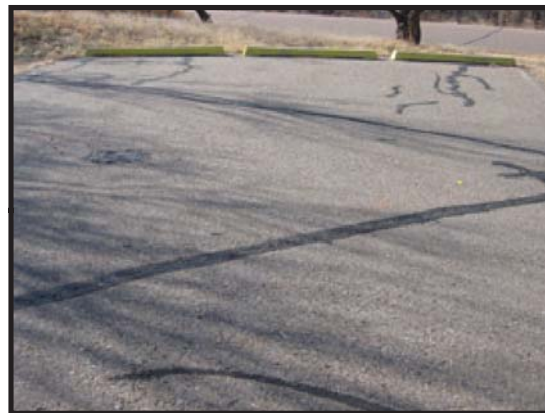
Route 0929A

Route Number	Public / NonPublic	Date Visited		Area (sq ft)	Lane Miles *	Surface Type
0929A	PUBLIC	1/23/2008		1,180	0.02	AS
Culverts	Drop Inlets	Gates	Fire Hydrants	Curb & Gutter	Curb	PCR
0	0	0	0	NO CURB AND GUTTER	NO CURB	FAIR/73

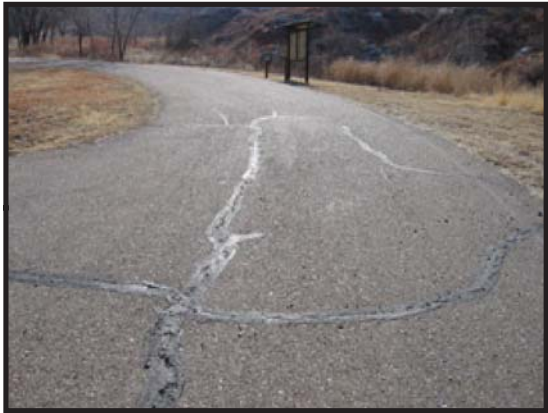
Route Number	Public / NonPublic	Date Visited		Area (sq ft)	Lane Miles *	Surface Type
0930	PUBLIC	1/23/2008		3,913	0.07	AS
Culverts	Drop Inlets	Gates	Fire Hydrants	Curb & Gutter	Curb	PCR
1	0	0	0	NO CURB AND GUTTER	NO CURB	FAIR/73

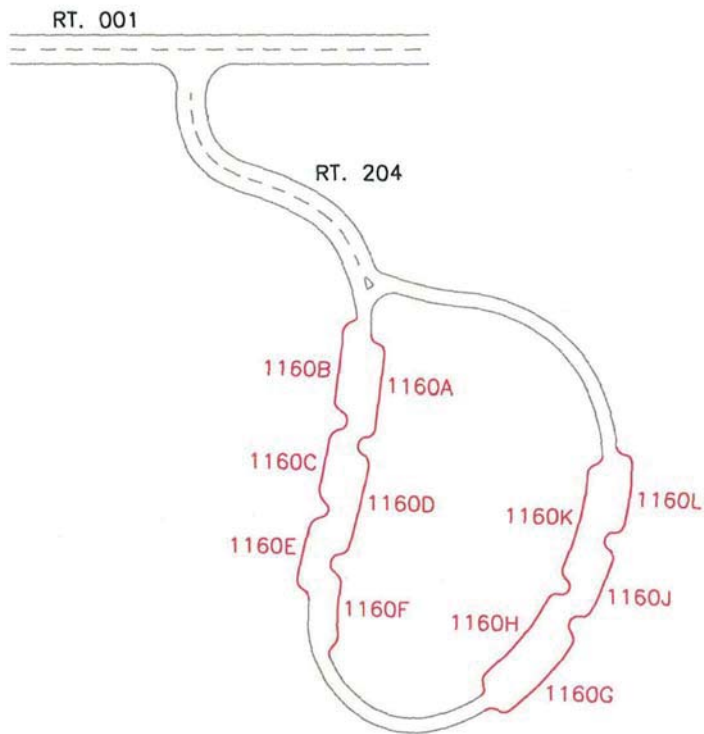
Figure 3: Parking with access route 204 and multiple parking areas (1160 A-L). Currently, this parking area is 12 routes and 12 assets (one 1100 asset and 11 1300 assets).

Discrete parking areas may be combined into a single asset where they service the same facility or resource and are within walking distance of each other. These combined areas should be maintained as one asset. There are many instances where small (5-10 space), discrete parking areas have been separated into individual assets even though they provide parking for the same area or facility. These may be combined into a single asset. Figures 3 and 4 shows examples of combining parking areas.

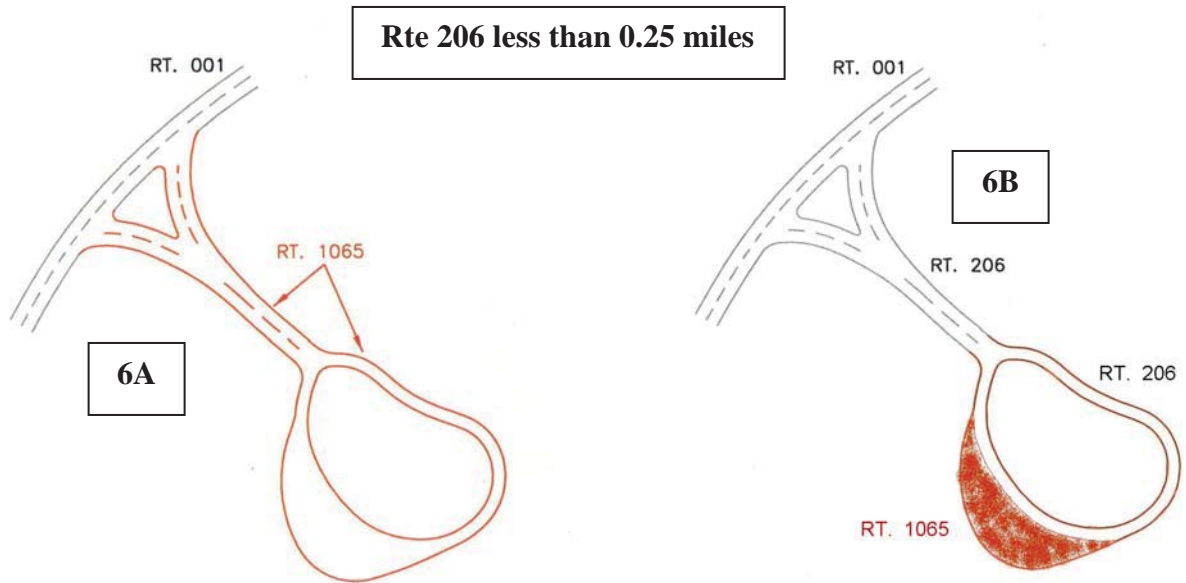
Figure 6: Since the access route is less than .25 miles in length and the only use of the access is to the parking, one route for both the access and the parking area can be established.

Where the primary purpose of a road is to provide access to a parking area, and that road segment is less than 0.25 miles in length, the access road should be considered part of the parking area. See Figures 8. Where a road continues on past a parking area to another facility or destination, even if it is less than 0.25 miles to the initial parking area, the road and parking area may not be combined.
