**The Road Inventory
of
Lake Roosevelt National Recreation Area
LARO – 9260
Cycle 4**

**Prepared By:
Federal Highway Administration
Road Inventory Program
Cycle 4**

Lake Roosevelt National Recreation Area in Washington

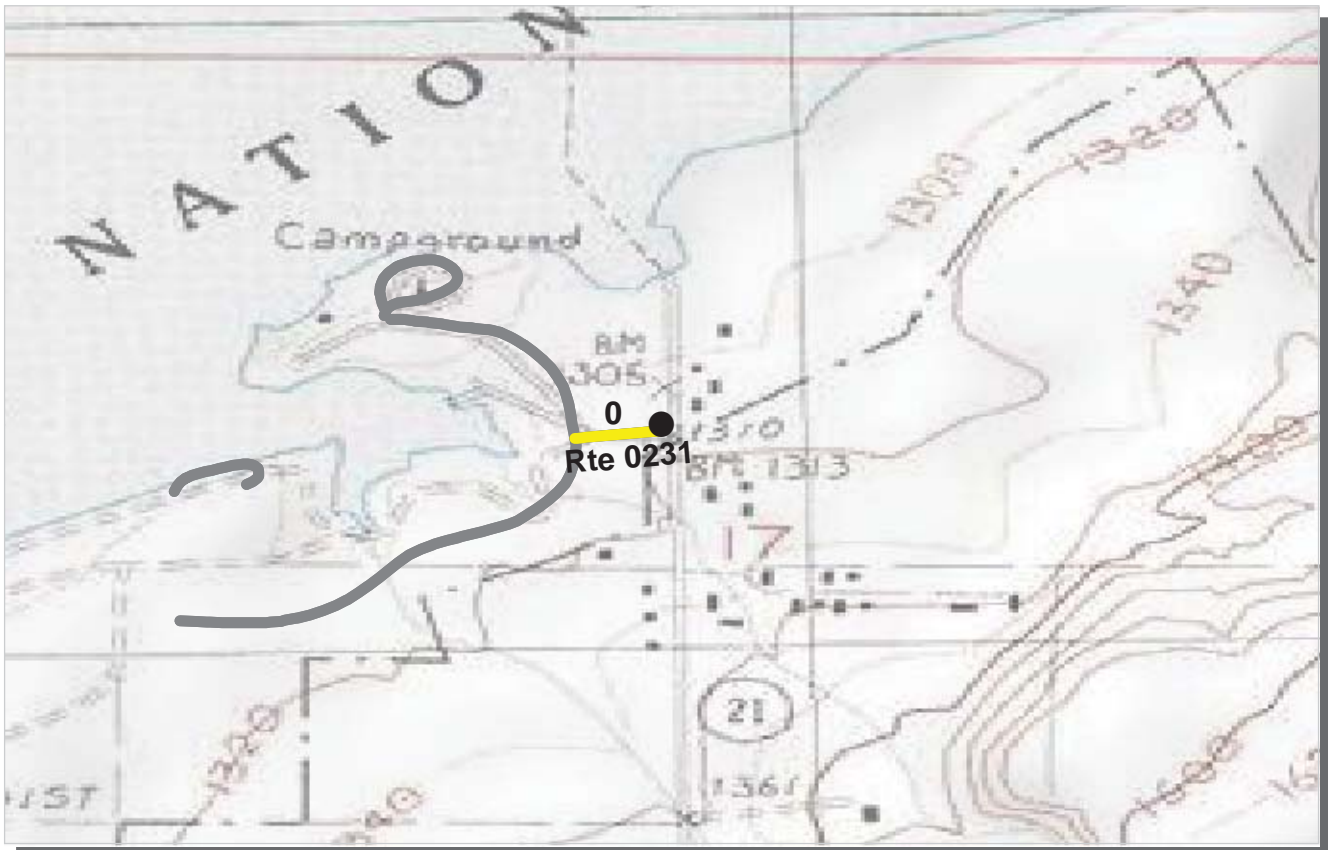
ROUTE: 0227 DAISY BOAT LAUNCH ACCESS ROAD

** Shoulder widths are measured from video at 0.50 mile intervals along route tangents. Visibility of actual shoulders in video images may affect accuracy of measured shoulder widths.

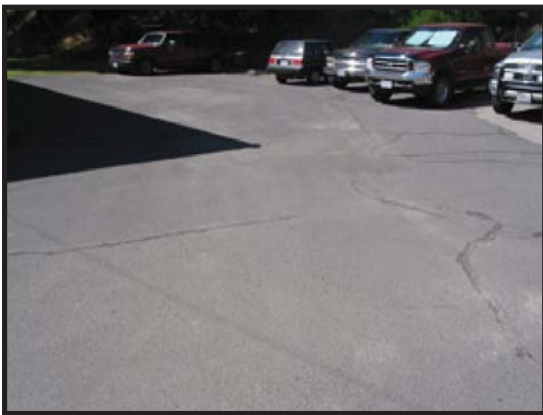
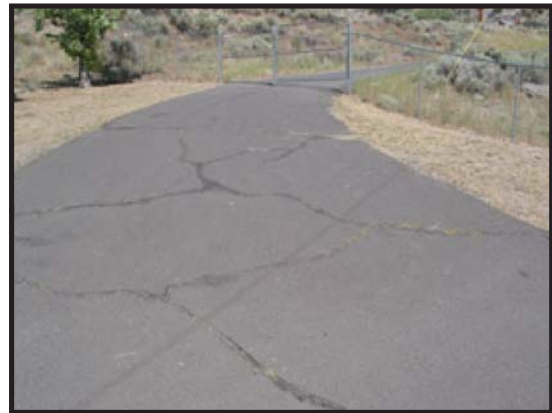
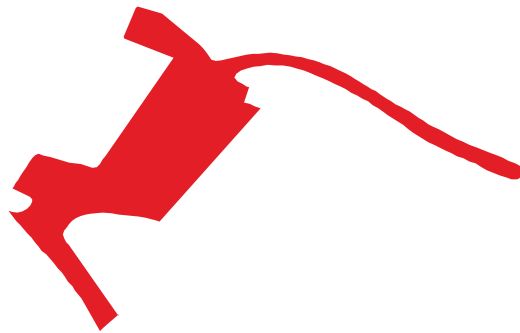
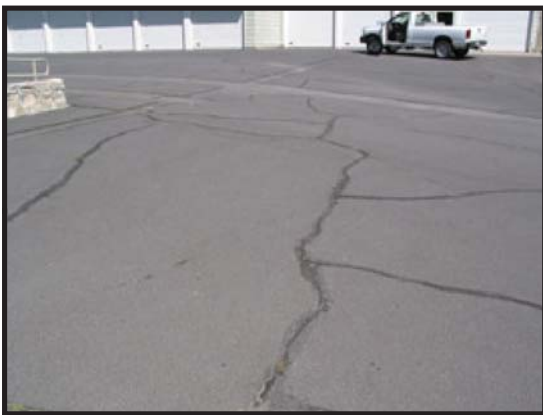
Route Number	Public / NonPublic	Date Visited	Area (sq ft)	Lane Miles *	Surface Type
0900	PUBLIC	7/10/2006	25,722	0.44	AS
Culverts	Drop Inlets	Gates	Curb & Gutter	Curb	PCR
0	2	3	NO CURB AND GUTTER	CONCRETE CURB	POOR/45

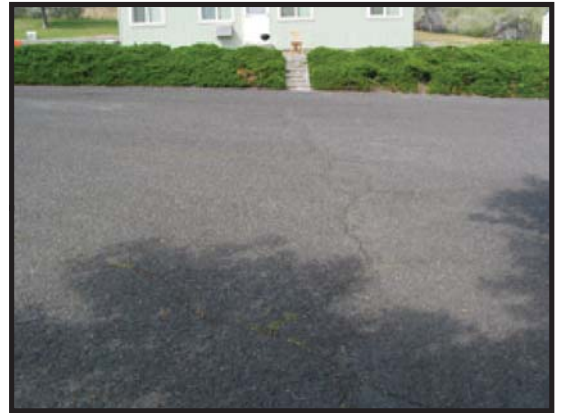
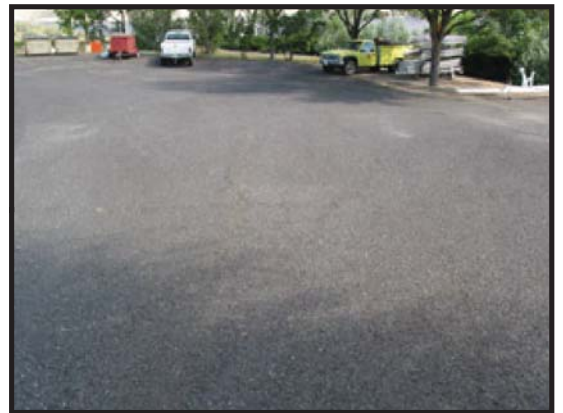
Route Number	Public / NonPublic	Date Visited	Area (sq ft)	Lane Miles *	Surface Type
0901	NONPUBLIC	7/10/2006	8,712	0.15	AS
Culverts	Drop Inlets	Gates	Curb & Gutter	Curb	PCR
0	1	0	NO CURB AND GUTTER	NO CURB	FAIR/73

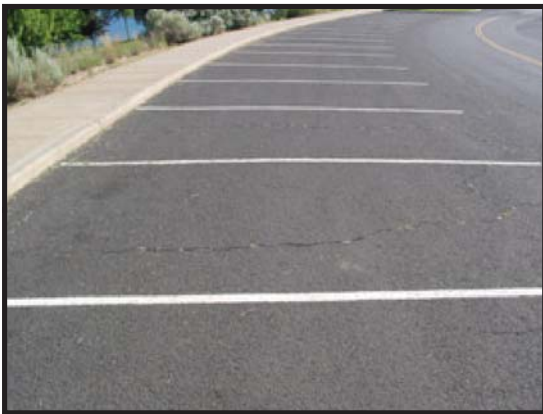
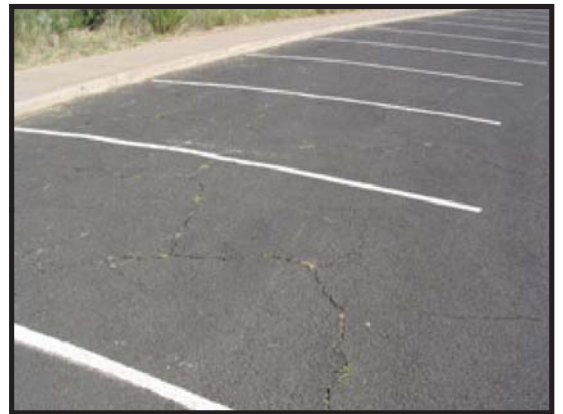
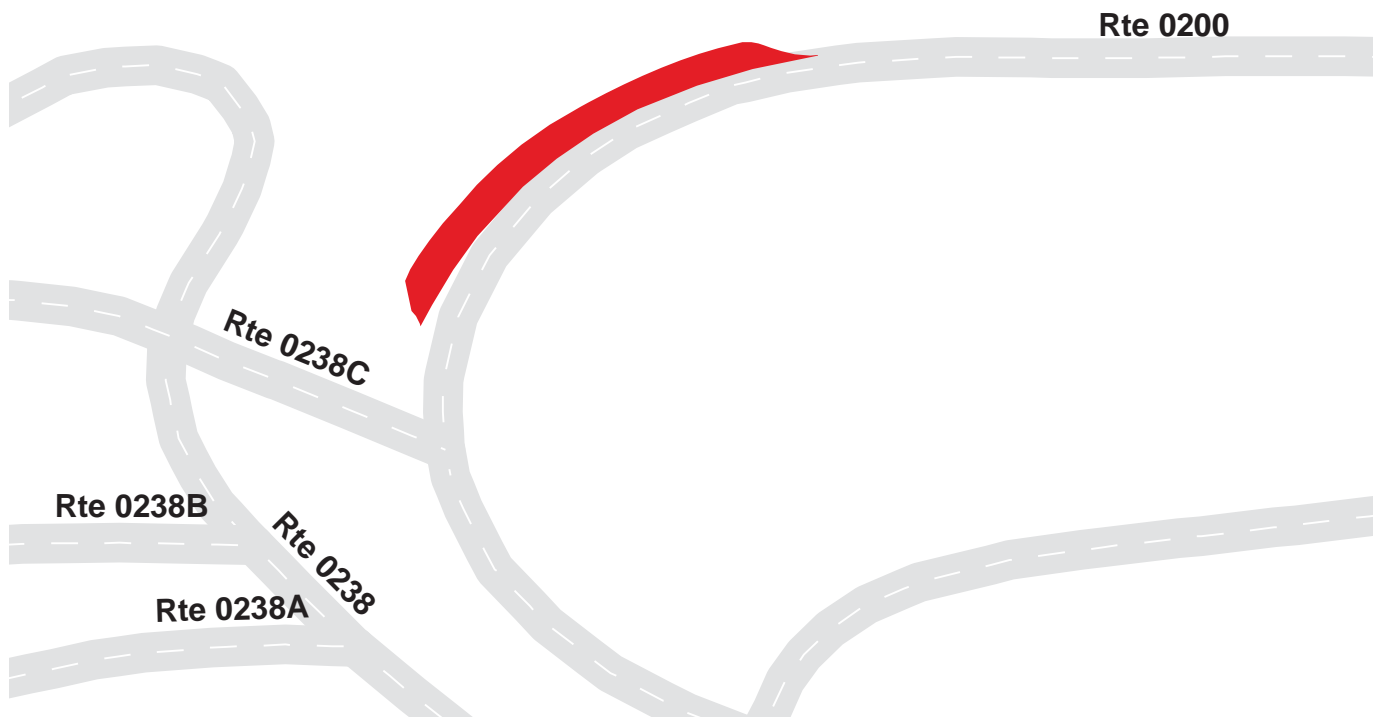
Route Number	Public / NonPublic	Date Visited	Area (sq ft)	Lane Miles *	Surface Type
0902AZ	PUBLIC	7/10/2006	6,402	0.11	AS
Culverts	Drop Inlets	Gates	Curb & Gutter	Curb	PCR
0	0	0	NO CURB AND GUTTER	CONCRETE CURB	POOR/45

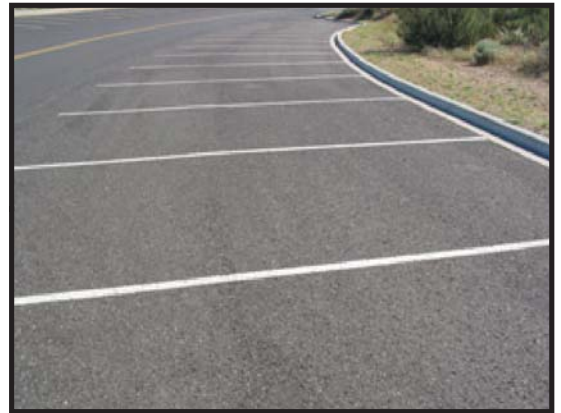
Route Number	Public / NonPublic	Date Visited	Area (sq ft)	Lane Miles *	Surface Type
0902BZ	PUBLIC	7/10/2006	4,615	0.08	AS
Culverts	Drop Inlets	Gates	Curb & Gutter	Curb	PCR
0	0	0	CONCRETE CURB AND GUTTER	NO CURB	GOOD/90

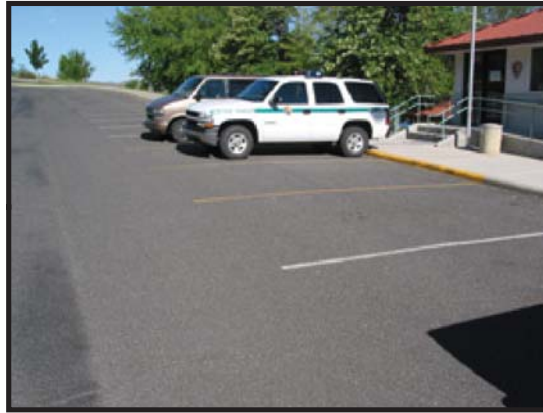
Route Number	Public / NonPublic	Date Visited	Area (sq ft)	Lane Miles *	Surface Type
0902CZ	PUBLIC	7/10/2006	5,000	0.09	AS
Culverts	Drop Inlets	Gates	Curb & Gutter	Curb	PCR
0	0	0	NO CURB AND GUTTER	CONCRETE CURB	FAIR/73

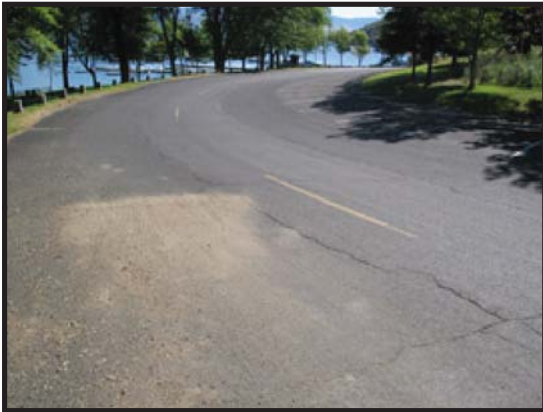
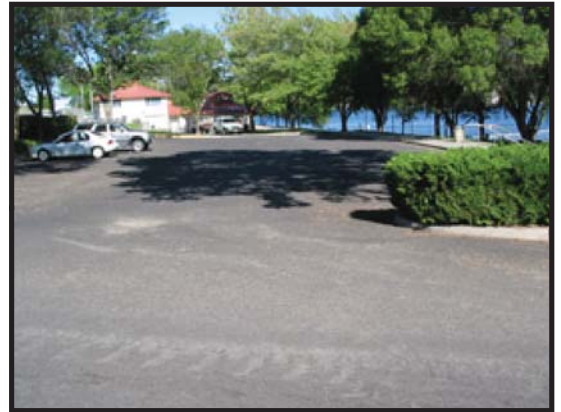
Route Number	Public / NonPublic	Date Visited	Area (sq ft)	Lane Miles *	Surface Type
0902EZ	PUBLIC	7/10/2006	29,188	0.50	AS
Culverts	Drop Inlets	Gates	Curb & Gutter	Curb	PCR
0	0	0	NO CURB AND GUTTER	CONCRETE CURB	POOR/45

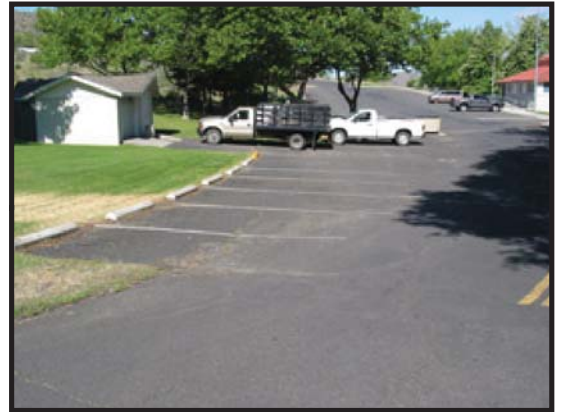
Route Number	Public / NonPublic	Date Visited	Area (sq ft)	Lane Miles *	Surface Type
0902FZ	PUBLIC	7/10/2006	2,629	0.05	AS
Culverts	Drop Inlets	Gates	Curb & Gutter	Curb	PCR
0	0	0	NO CURB AND GUTTER	NO CURB	POOR/45

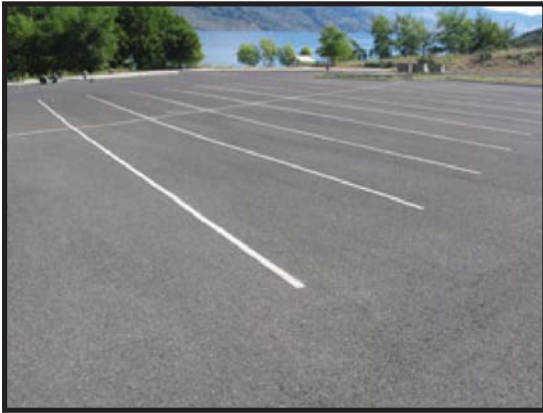
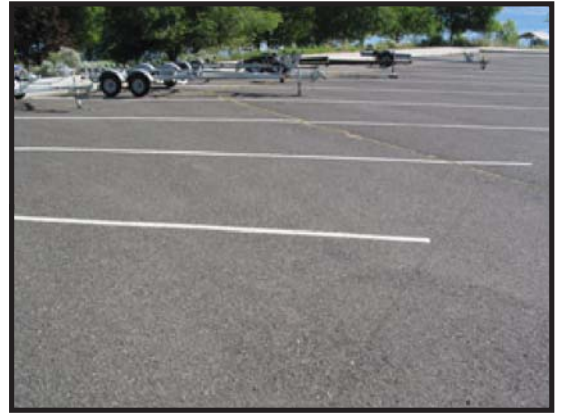
Route Number	Public / NonPublic	Date Visited	Area (sq ft)	Lane Miles *	Surface Type
0902G	PUBLIC	7/10/2006	39,388	0.68	AS
Culverts	Drop Inlets	Gates	Curb & Gutter	Curb	PCR
0	1	0	CONCRETE CURB AND GUTTER	NO CURB	FAIR/73

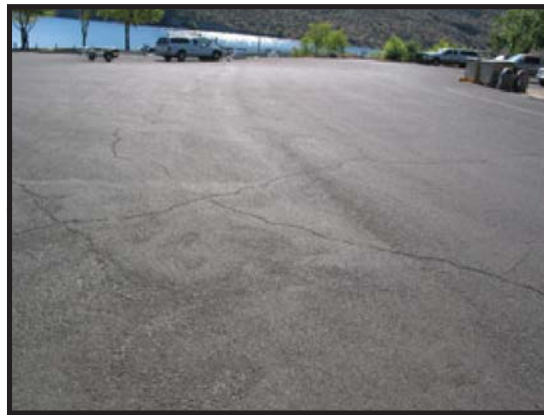
Route Number	Public / NonPublic	Date Visited	Area (sq ft)	Lane Miles *	Surface Type
0902H	PUBLIC	7/10/2006	27,342	0.47	AS
Culverts	Drop Inlets	Gates	Curb & Gutter	Curb	PCR
0	0	0	NO CURB AND GUTTER	CONCRETE CURB	POOR/45

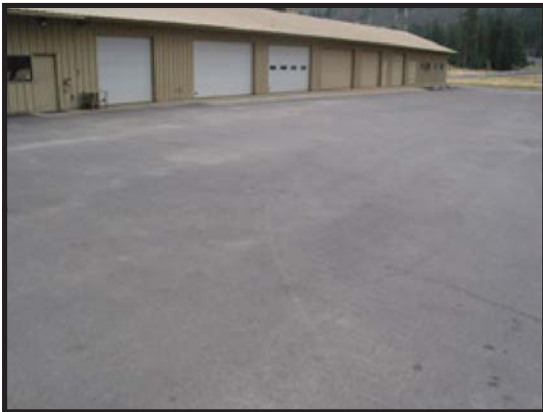
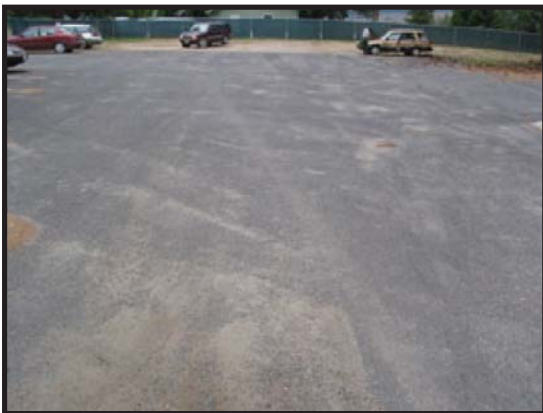
Route Number	Public / NonPublic	Date Visited	Area (sq ft)	Lane Miles *	Surface Type
0905	PUBLIC	7/12/2006	32,635	0.56	AS
Culverts	Drop Inlets	Gates	Curb & Gutter	Curb	PCR
0	0	2	NO CURB AND GUTTER	NO CURB	FAIR/73

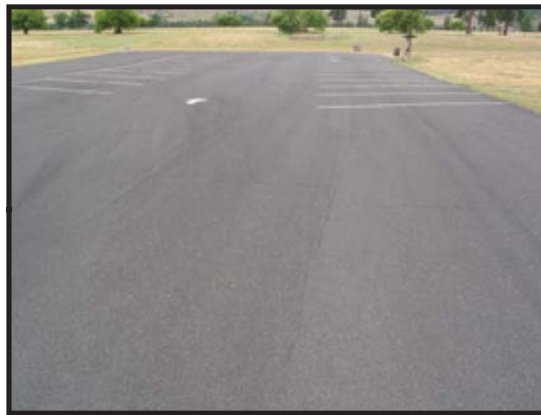
Route Number	Public / NonPublic	Date Visited	Area (sq ft)	Lane Miles *	Surface Type
0906	PUBLIC	7/12/2006	19,864	0.34	AS
Culverts	Drop Inlets	Gates	Curb & Gutter	Curb	PCR
0	0	0	NO CURB AND GUTTER	NO CURB	FAIR/73

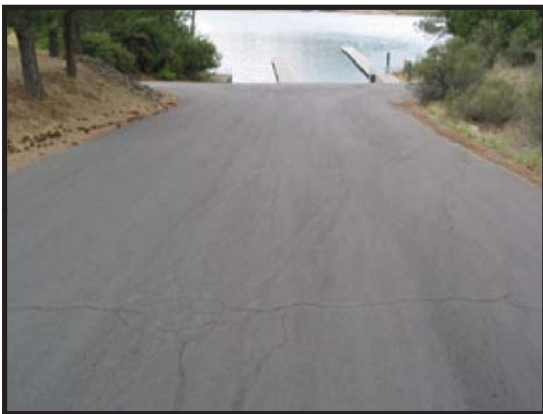
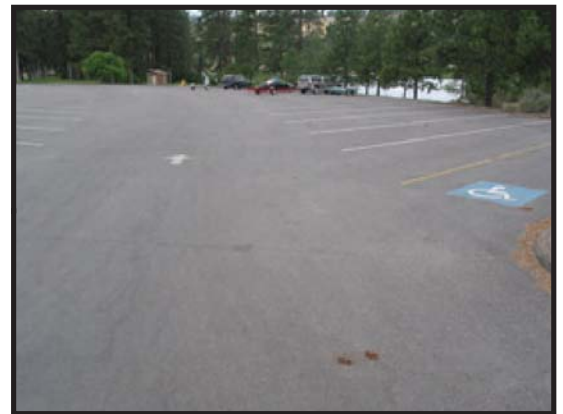
Route Number	Public / NonPublic	Date Visited	Area (sq ft)	Lane Miles *	Surface Type
0907	PUBLIC	7/12/2006	105,524	1.82	AS
Culverts	Drop Inlets	Gates	Curb & Gutter	Curb	PCR
0	2	0	NO CURB AND GUTTER	ASPHALT CURB	FAIR/73

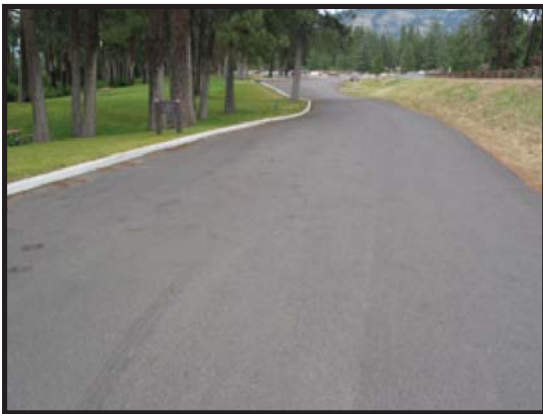
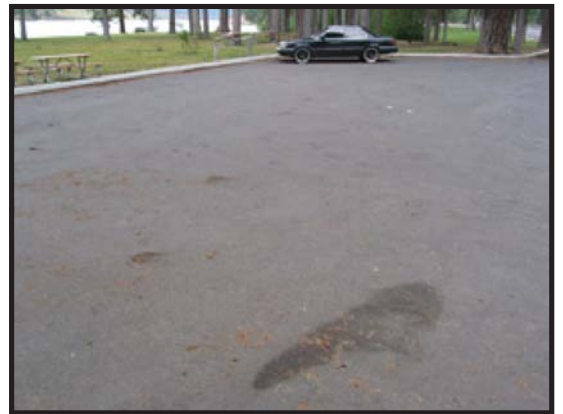
Route Number	Public / NonPublic	Date Visited	Area (sq ft)	Lane Miles *	Surface Type
0908	PUBLIC	7/12/2006	28,180	0.49	AS
Culverts	Drop Inlets	Gates	Curb & Gutter	Curb	PCR
0	0	0	NO CURB AND GUTTER	CONCRETE CURB	GOOD/90

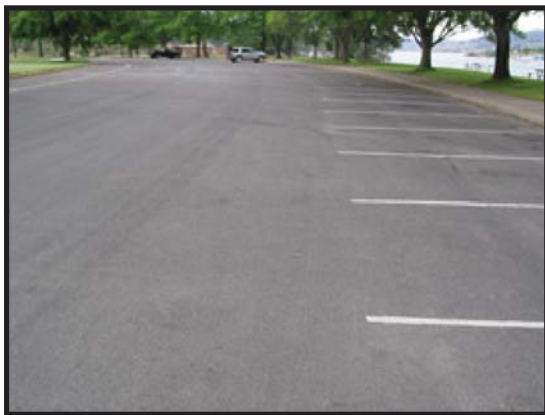
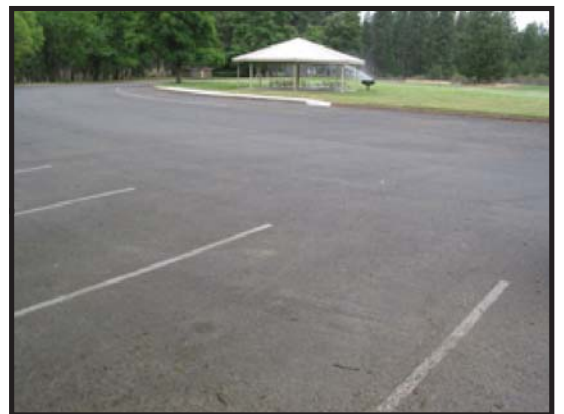
Route Number	Public / NonPublic	Date Visited	Area (sq ft)	Lane Miles *	Surface Type
0909BZ	PUBLIC	7/12/2006	23,877	0.41	AS
Culverts	Drop Inlets	Gates	Curb & Gutter	Curb	PCR
0	1	0	CONCRETE CURB AND GUTTER	NO CURB	GOOD/90

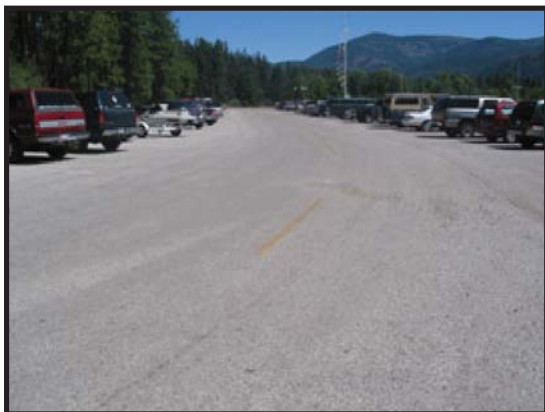
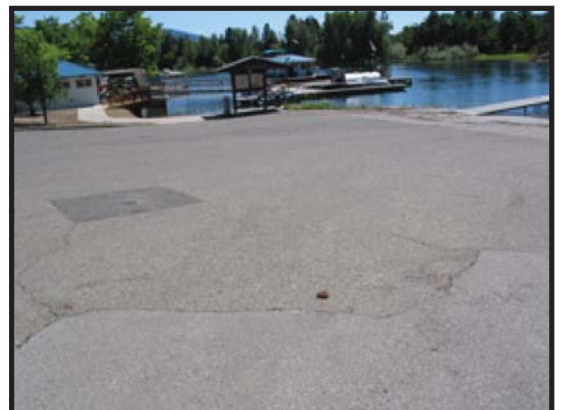
Route Number	Public / NonPublic	Date Visited	Area (sq ft)	Lane Miles *	Surface Type
0911A	PUBLIC	7/11/2006	79,165	1.36	AS
Culverts	Drop Inlets	Gates	Curb & Gutter	Curb	PCR
0	3	0	CONCRETE CURB AND GUTTER	CONCRETE CURB	FAIR/73

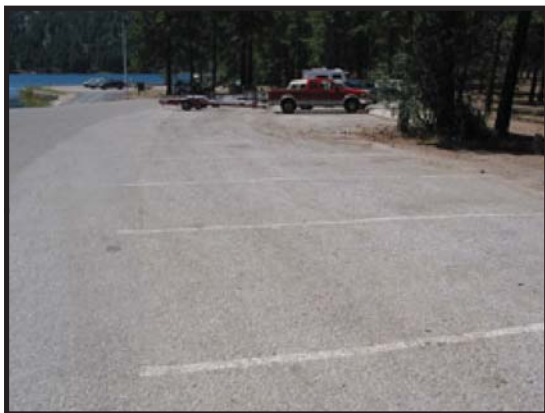
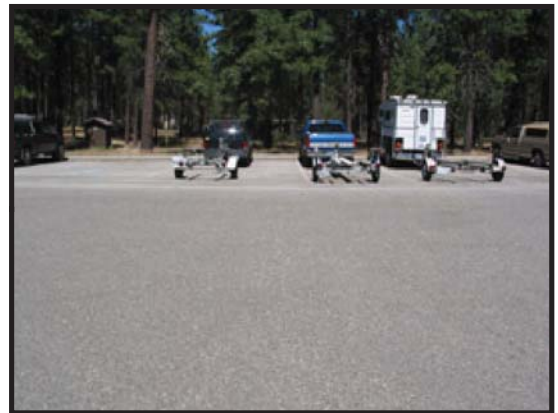
Route Number	Public / NonPublic	Date Visited	Area (sq ft)	Lane Miles *	Surface Type
0911B	PUBLIC	7/11/2006	9,759	0.17	AS
Culverts	Drop Inlets	Gates	Curb & Gutter	Curb	PCR
0	1	0	NO CURB AND GUTTER	CONCRETE CURB	FAIR/73

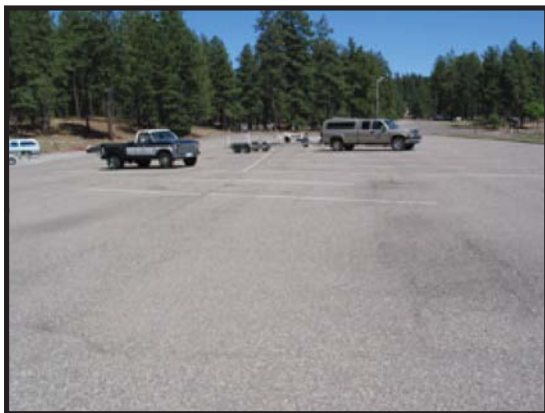
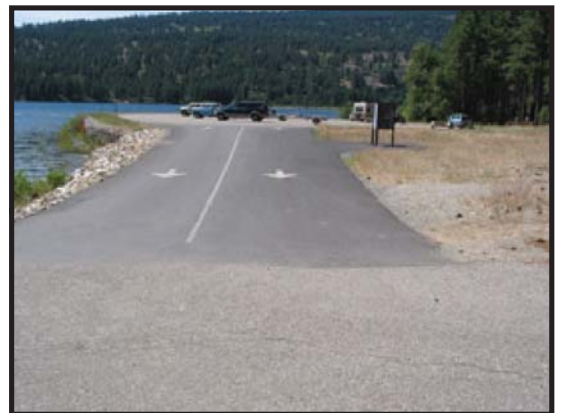
Route Number	Public / NonPublic	Date Visited	Area (sq ft)	Lane Miles *	Surface Type
0911C	PUBLIC	7/11/2006	42,108	0.73	AS
Culverts	Drop Inlets	Gates	Curb & Gutter	Curb	PCR
0	0	0	NO CURB AND GUTTER	CONCRETE CURB	GOOD/90

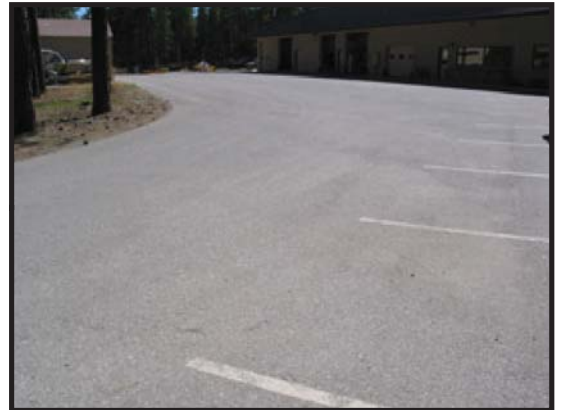
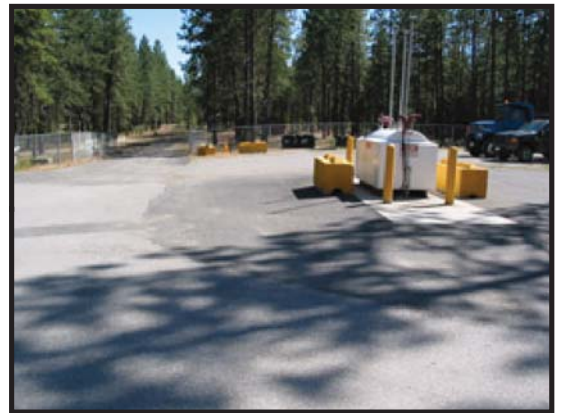
Route Number	Public / NonPublic	Date Visited	Area (sq ft)	Lane Miles *	Surface Type
0913AZ	NONPUBLIC	7/11/2006	37,982	0.65	AS
Culverts	Drop Inlets	Gates	Curb & Gutter	Curb	PCR
0	4	2	NO CURB AND GUTTER	NO CURB	GOOD/90

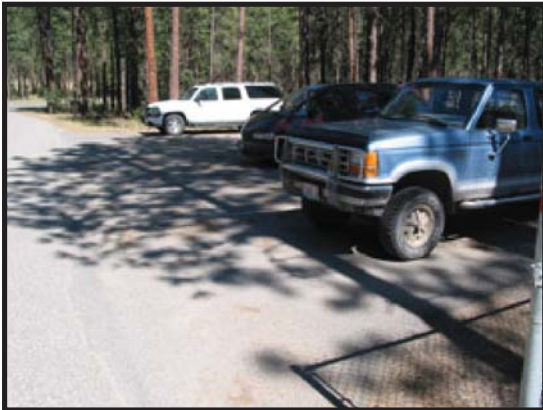
Route Number	Public / NonPublic	Date Visited	Area (sq ft)	Lane Miles *	Surface Type
0913CZ	NONPUBLIC	7/11/2006	1,713	0.03	AS
Culverts	Drop Inlets	Gates	Curb & Gutter	Curb	PCR
0	0	0	NO CURB AND GUTTER	NO CURB	GOOD/90

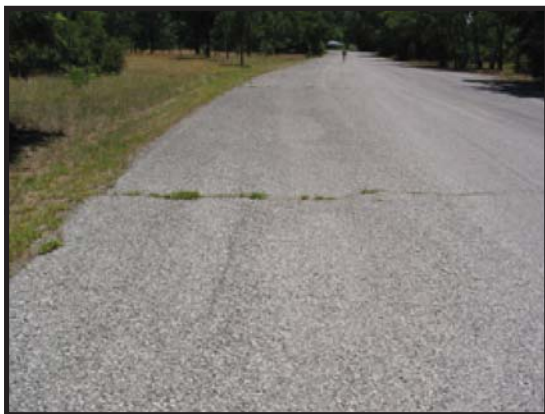
Route Number	Public / NonPublic	Date Visited	Area (sq ft)	Lane Miles *	Surface Type
0914AZ	PUBLIC	7/11/2006	10,761	0.19	AS
Culverts	Drop Inlets	Gates	Curb & Gutter	Curb	PCR
0	0	0	NO CURB AND GUTTER	NO CURB	FAIR/73

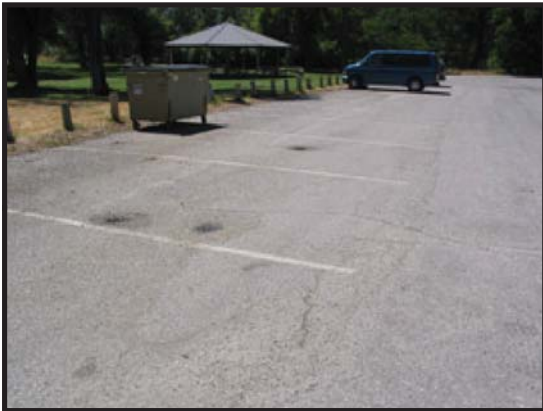
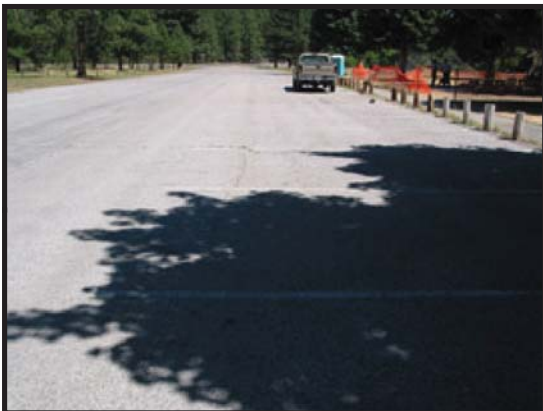
Route Number	Public / NonPublic	Date Visited	Area (sq ft)	Lane Miles *	Surface Type
0914BZ	PUBLIC	7/11/2006	14,152	0.24	AS
Culverts	Drop Inlets	Gates	Curb & Gutter	Curb	PCR
0	0	0	NO CURB AND GUTTER	NO CURB	FAIR/73

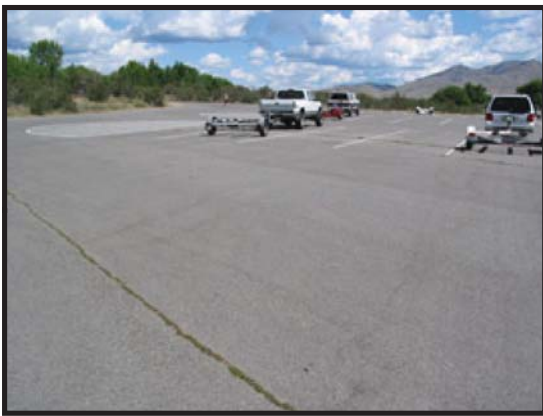
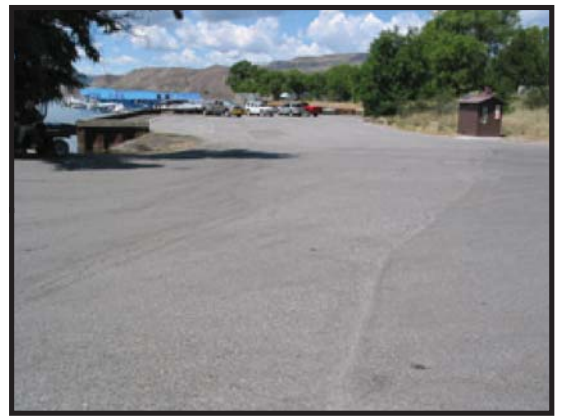
Route Number	Public / NonPublic	Date Visited	Area (sq ft)	Lane Miles *	Surface Type
0915	PUBLIC	7/10/2006	116,887	2.01	AS
Culverts	Drop Inlets	Gates	Curb & Gutter	Curb	PCR
0	0	0	NO CURB AND GUTTER	ASPHALT AND CONCRETE CURB	FAIR/73

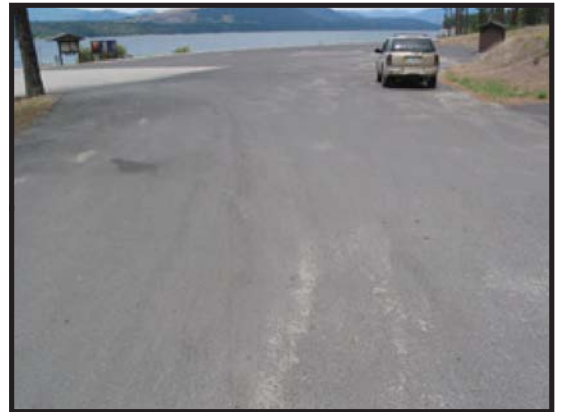
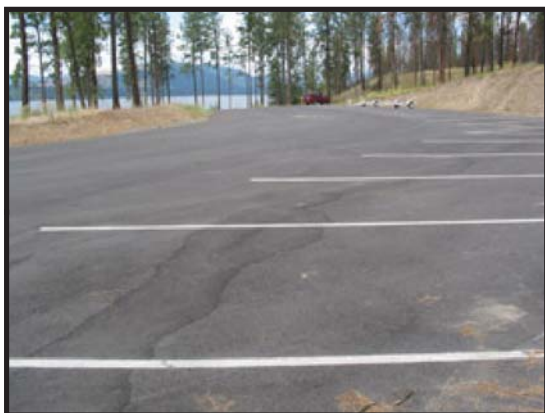
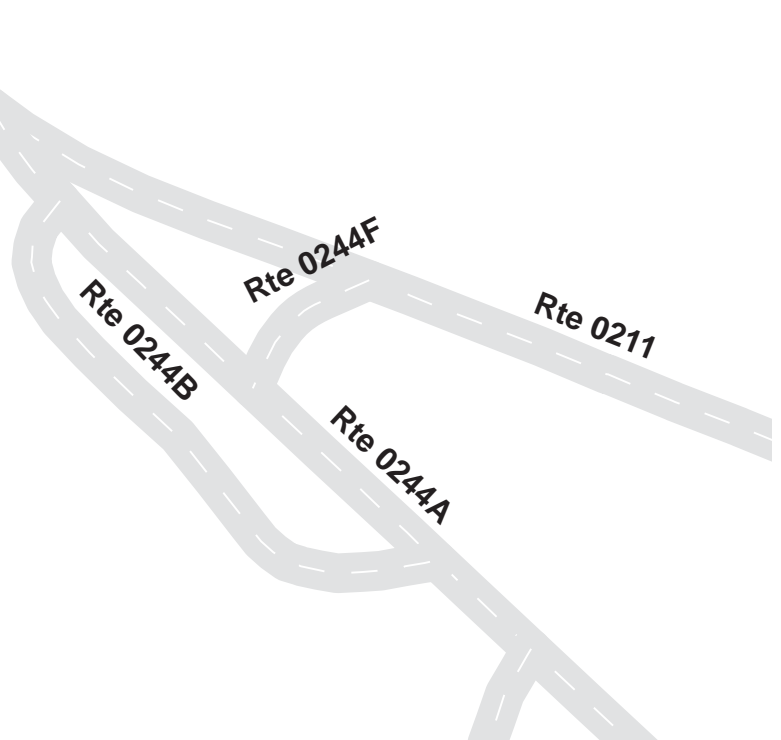
Route Number	Public / NonPublic	Date Visited	Area (sq ft)	Lane Miles *	Surface Type
0917	PUBLIC	7/12/2006	47,206	0.81	AS
Culverts	Drop Inlets	Gates	Curb & Gutter	Curb	PCR
0	0	0	NO CURB AND GUTTER	CONCRETE CURB	EXCELLENT/97

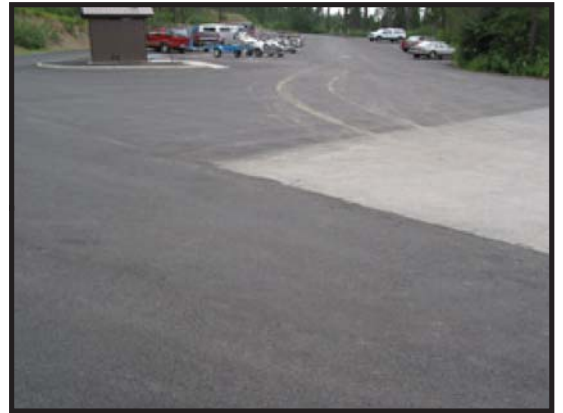
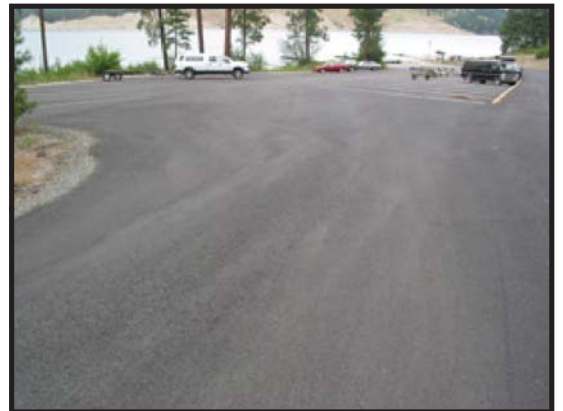
Route Number	Public / NonPublic	Date Visited	Area (sq ft)	Lane Miles *	Surface Type
0918A	PUBLIC	7/12/2006	30,028	0.52	AS
Culverts	Drop Inlets	Gates	Curb & Gutter	Curb	PCR
0	0	0	NO CURB AND GUTTER	CONCRETE CURB	EXCELLENT/97

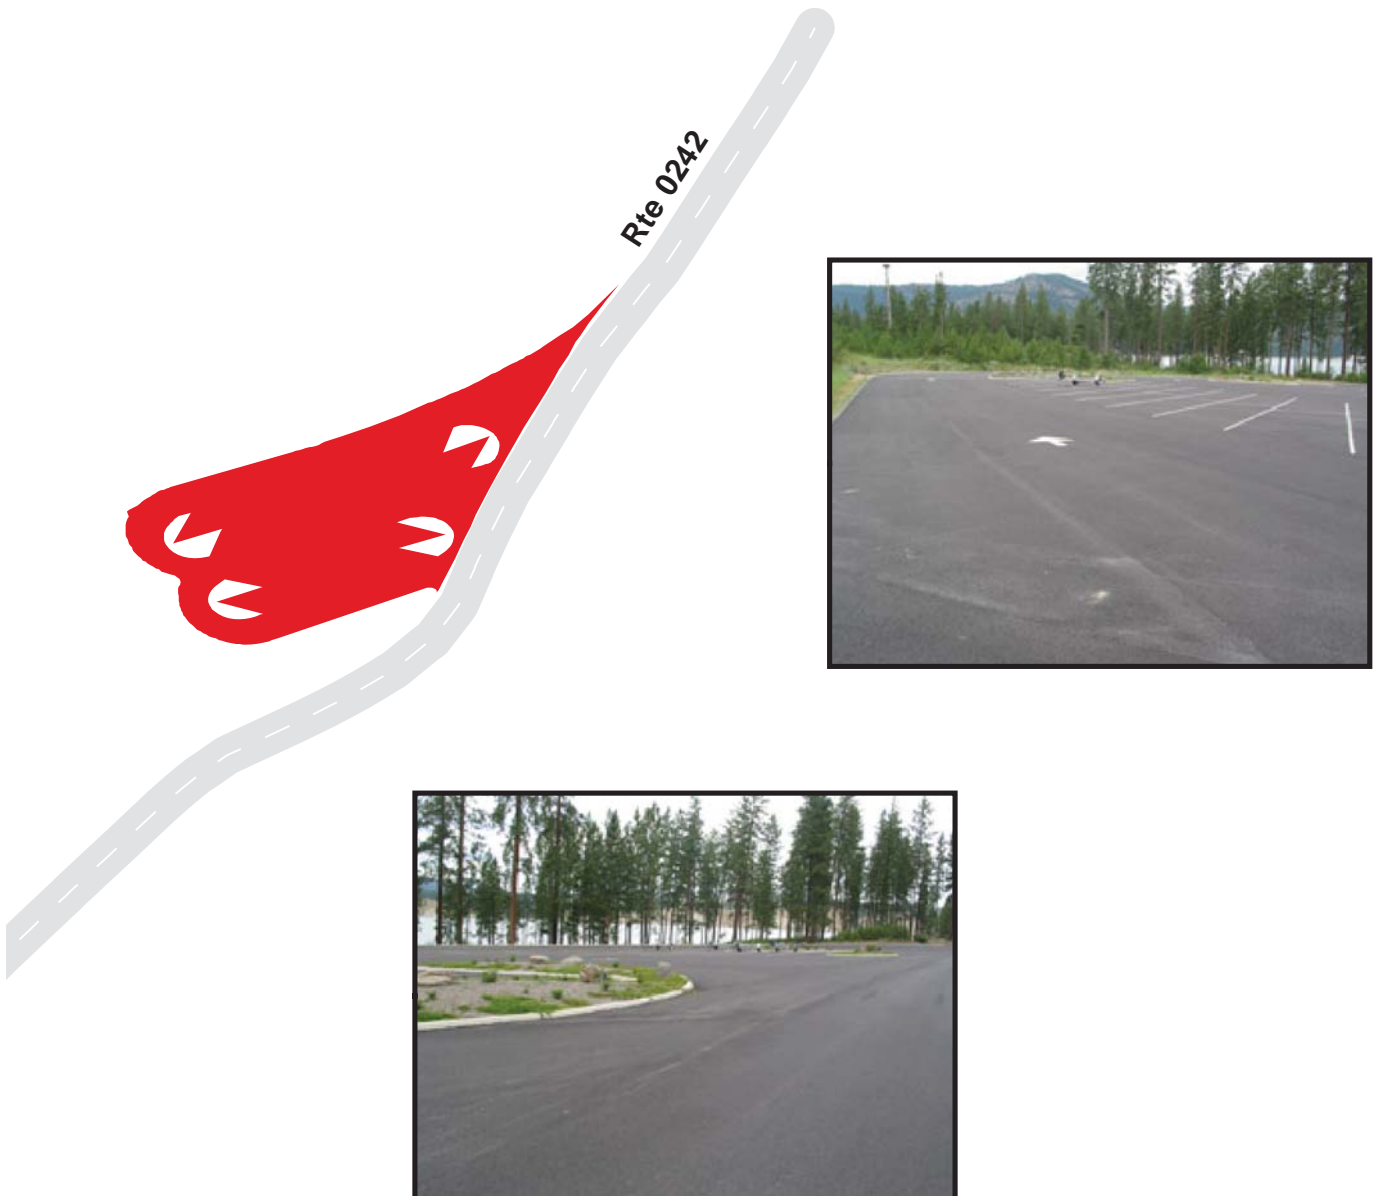
Route Number	Public / NonPublic	Date Visited	Area (sq ft)	Lane Miles *	Surface Type
0918B	PUBLIC	7/12/2006	69,644	1.20	AS
Culverts	Drop Inlets	Gates	Curb & Gutter	Curb	PCR
0	0	0	NO CURB AND GUTTER	CONCRETE CURB	EXCELLENT/97

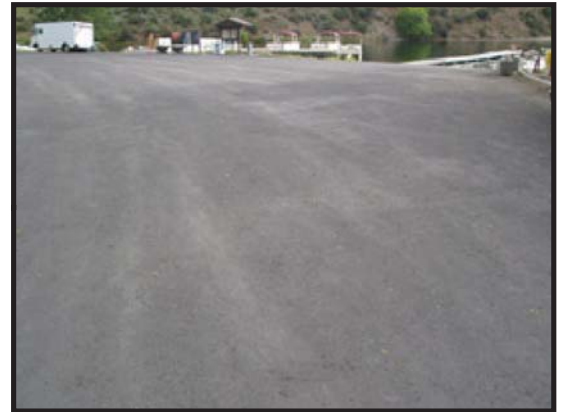
Route Number	Public / NonPublic	Date Visited	Area (sq ft)	Lane Miles *	Surface Type
0919	PUBLIC	7/12/2006	17,521	0.30	AS
Culverts	Drop Inlets	Gates	Curb & Gutter	Curb	PCR
0	0	0	NO CURB AND GUTTER	CONCRETE CURB	GOOD/90

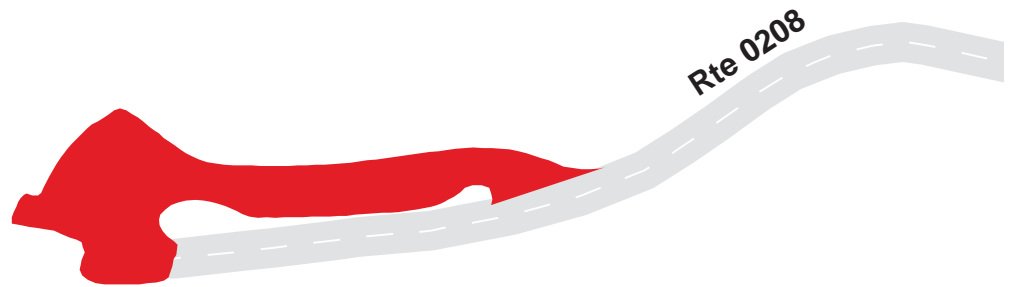
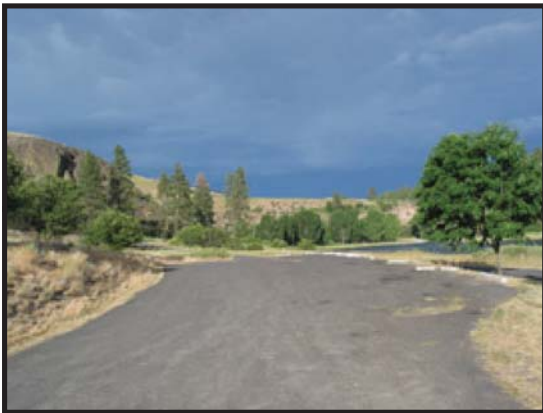
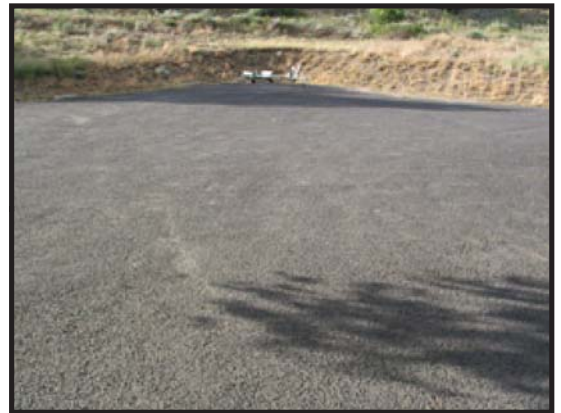
Route Number	Public / NonPublic	Date Visited	Area (sq ft)	Lane Miles *	Surface Type
0920	PUBLIC	7/12/2006	18,516	0.32	AS
Culverts	Drop Inlets	Gates	Curb & Gutter	Curb	PCR
0	0	0	NO CURB AND GUTTER	NO CURB	POOR/45

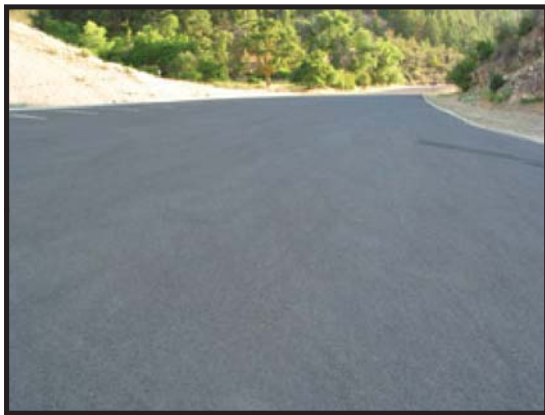
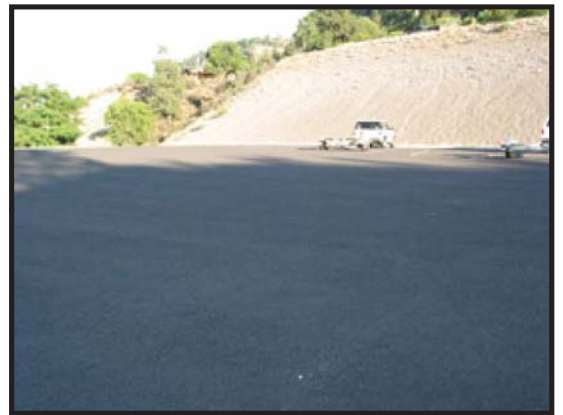
Route Number	Public / NonPublic	Date Visited	Area (sq ft)	Lane Miles *	Surface Type
0921	PUBLIC	7/12/2006	50,402	0.87	AS
Culverts	Drop Inlets	Gates	Curb & Gutter	Curb	PCR
0	0	0	NO CURB AND GUTTER	CONCRETE CURB	GOOD/90

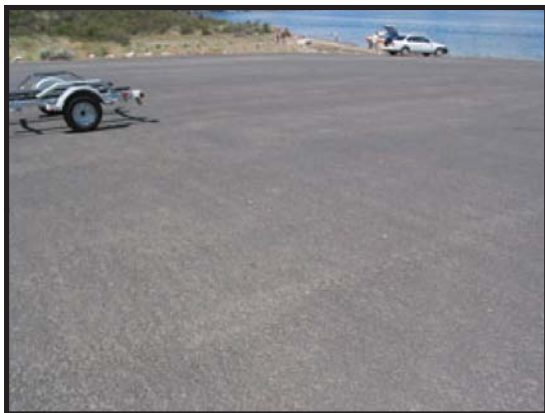
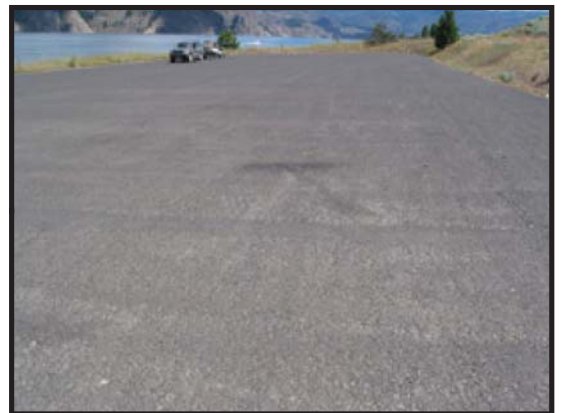
Route Number	Public / NonPublic	Date Visited	Area (sq ft)	Lane Miles *	Surface Type
0922	PUBLIC	7/10/2006	47,754	0.82	AS
Culverts	Drop Inlets	Gates	Curb & Gutter	Curb	PCR
2	0	0	NO CURB AND GUTTER	NO CURB	GOOD/90

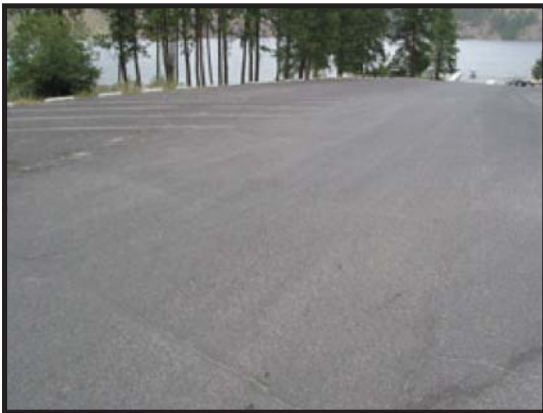
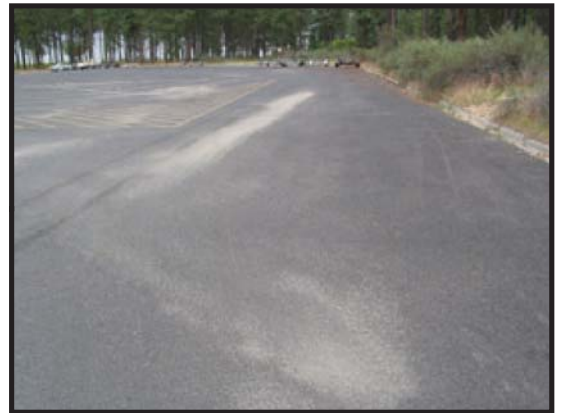
Route Number	Public / NonPublic	Date Visited	Area (sq ft)	Lane Miles *	Surface Type
0923	PUBLIC	7/12/2006	81,765	1.41	AS
Culverts	Drop Inlets	Gates	Curb & Gutter	Curb	PCR
0	0	0	CONCRETE CURB AND GUTTER	NO CURB	FAIR/73

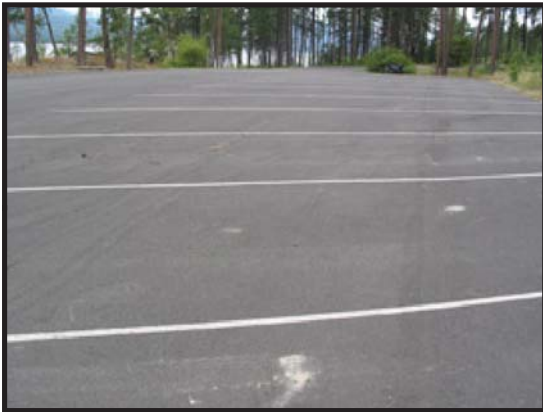
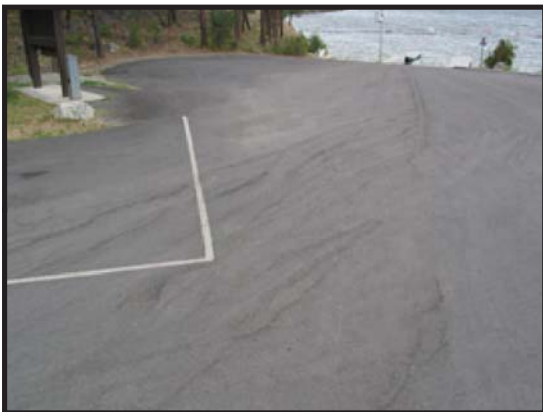
Route Number	Public / NonPublic	Date Visited	Area (sq ft)	Lane Miles *	Surface Type
0926	PUBLIC	7/12/2006	24,745	0.43	AS
Culverts	Drop Inlets	Gates	Curb & Gutter	Curb	PCR
0	0	0	NO CURB AND GUTTER	CONCRETE CURB	EXCELLENT/97

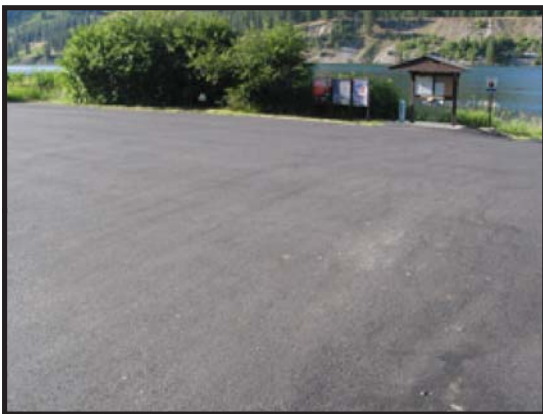
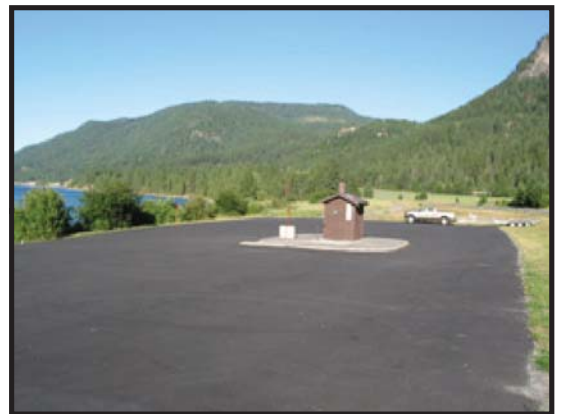
Route Number	Public / NonPublic	Date Visited	Area (sq ft)	Lane Miles *	Surface Type
0927	PUBLIC	7/11/2006	22,284	0.38	AS
Culverts	Drop Inlets	Gates	Curb & Gutter	Curb	PCR
0	0	0	NO CURB AND GUTTER	CONCRETE CURB	EXCELLENT/97

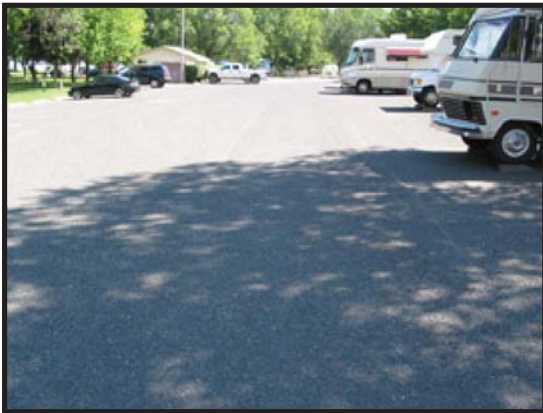
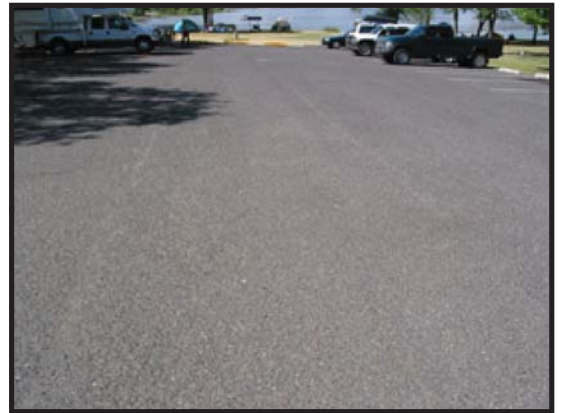
Route Number	Public / NonPublic	Date Visited	Area (sq ft)	Lane Miles *	Surface Type
0928	PUBLIC	7/10/2006	33,766	0.58	AS
Culverts	Drop Inlets	Gates	Curb & Gutter	Curb	PCR
0	0	0	NO CURB AND GUTTER	NO CURB	FAIR/73

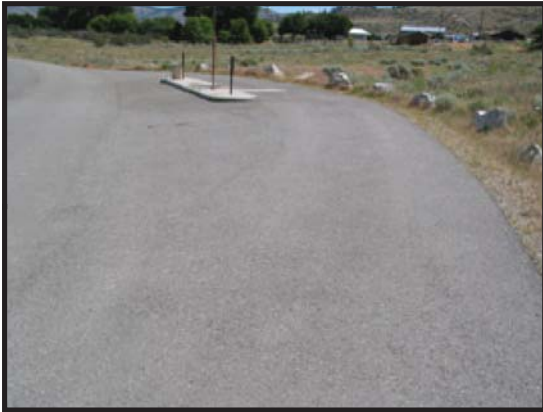
Route Number	Public / NonPublic	Date Visited	Area (sq ft)	Lane Miles *	Surface Type
0931	PUBLIC	7/10/2006	2,867	0.05	AS
Culverts	Drop Inlets	Gates	Curb & Gutter	Curb	PCR
0	0	0	NO CURB AND GUTTER	CONCRETE CURB	GOOD/90

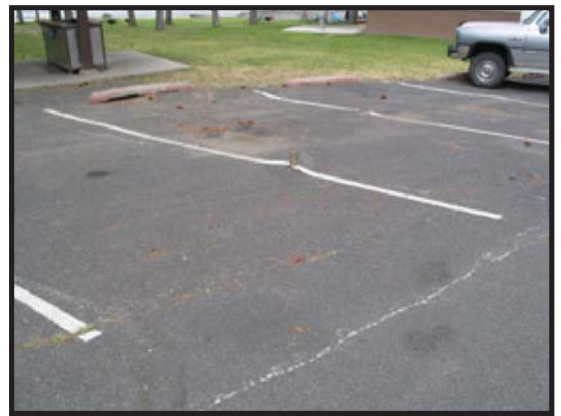
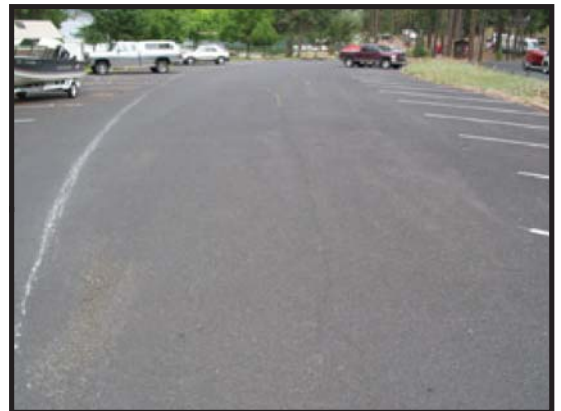
Route Number	Public / NonPublic	Date Visited	Area (sq ft)	Lane Miles *	Surface Type
0932	PUBLIC	7/12/2006	17,229	0.30	AS
Culverts	Drop Inlets	Gates	Curb & Gutter	Curb	PCR
0	0	0	NO CURB AND GUTTER	NO CURB	FAIR/73

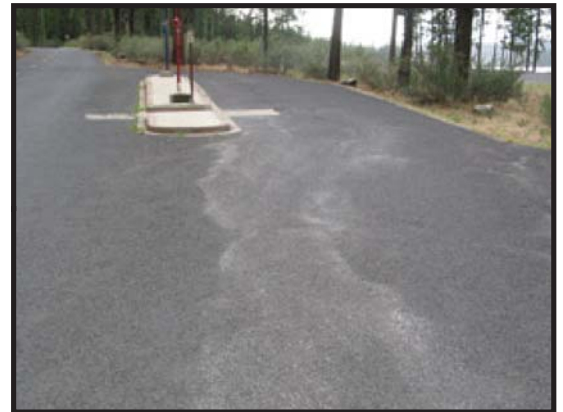
Route Number	Public / NonPublic	Date Visited	Area (sq ft)	Lane Miles *	Surface Type
0933	PUBLIC	7/12/2006	2,078	0.04	AS
Culverts	Drop Inlets	Gates	Curb & Gutter	Curb	PCR
0	0	0	CONCRETE CURB AND GUTTER	NO CURB	GOOD/90

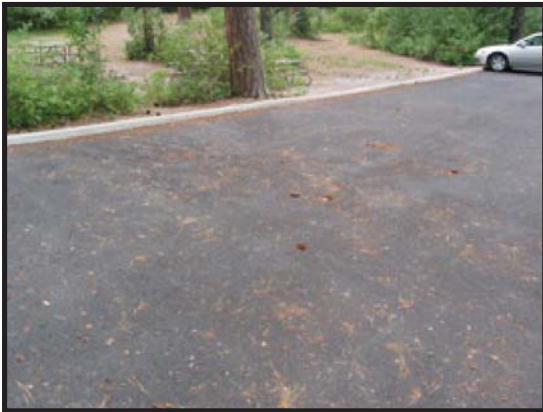
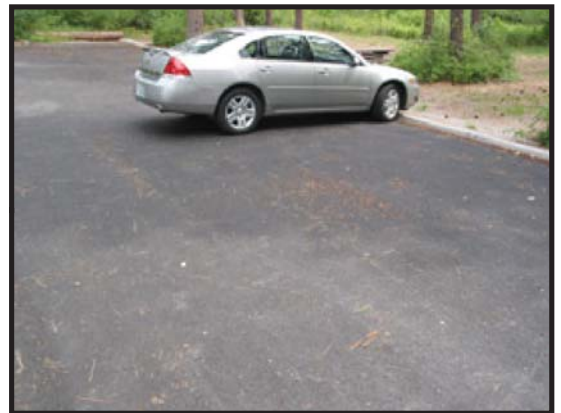
Route Number	Public / NonPublic	Date Visited	Area (sq ft)	Lane Miles *	Surface Type
0934AZ	PUBLIC	7/12/2006	2,064	0.04	AS
Culverts	Drop Inlets	Gates	Curb & Gutter	Curb	PCR
0	0	0	NO CURB AND GUTTER	CONCRETE CURB	EXCELLENT/97

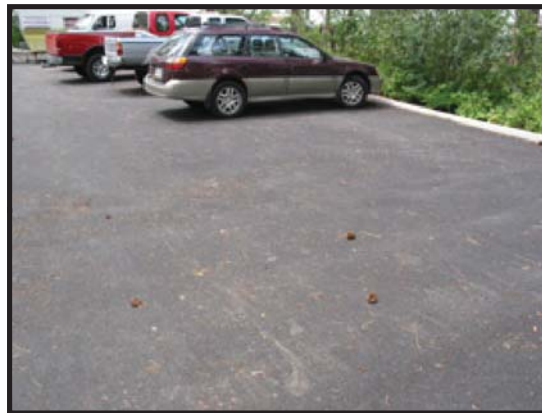
Route Number	Public / NonPublic	Date Visited	Area (sq ft)	Lane Miles *	Surface Type
0934BZ	PUBLIC	7/12/2006	3,352	0.06	AS
Culverts	Drop Inlets	Gates	Curb & Gutter	Curb	PCR
0	0	0	NO CURB AND GUTTER	CONCRETE CURB	EXCELLENT/97

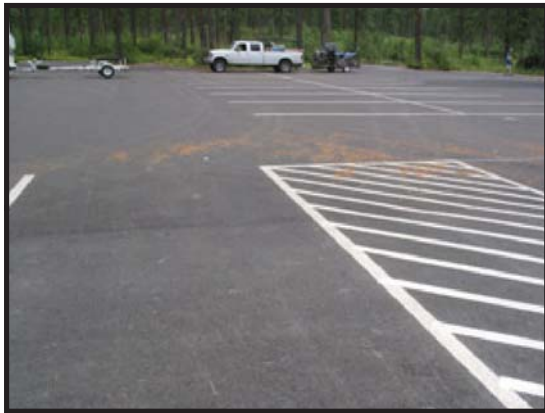
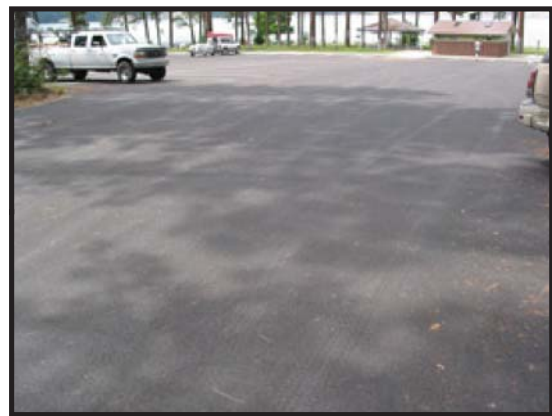
Route Number	Public / NonPublic	Date Visited	Area (sq ft)	Lane Miles *	Surface Type
0935	PUBLIC	7/12/2006	24,964	0.43	AS
Culverts	Drop Inlets	Gates	Curb & Gutter	Curb	PCR
0	0	0	NO CURB AND GUTTER	CONCRETE CURB	EXCELLENT/97
