**The Road Inventory
of
Lake Roosevelt National Recreation Area
LARO – 9260
Cycle 4**

**Prepared By:
Federal Highway Administration
Road Inventory Program
Cycle 4**

Lake Roosevelt National Recreation Area in Washington

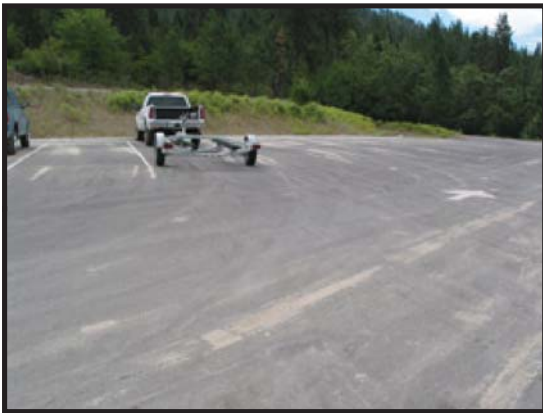
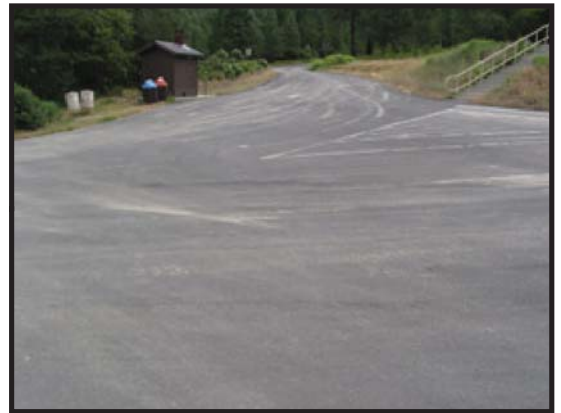
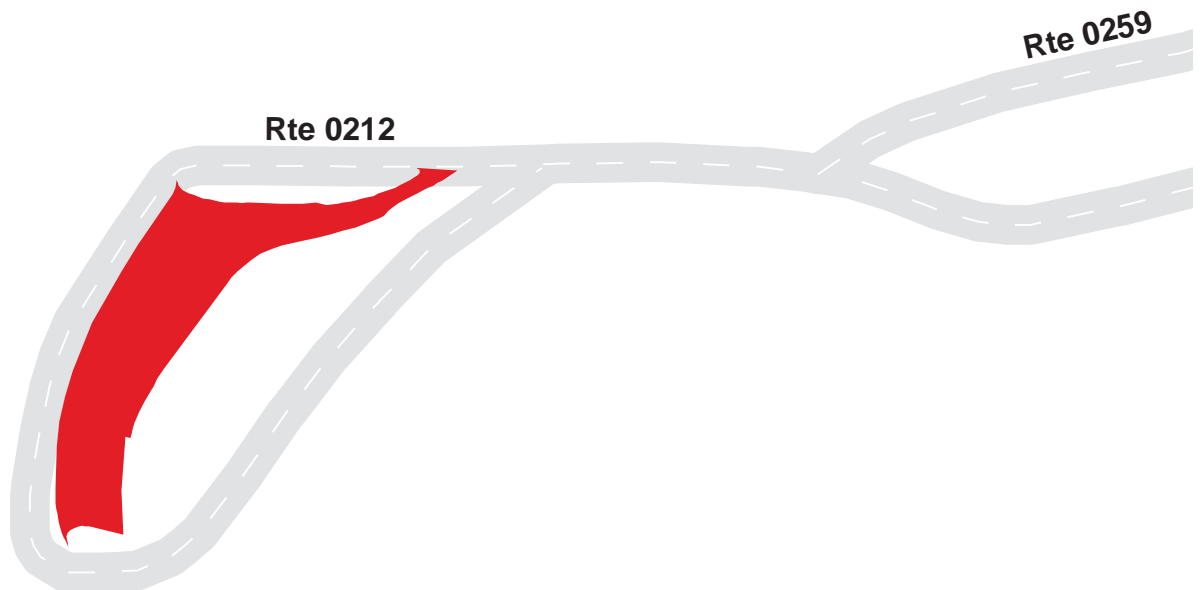
Route 0937BZ

Route Number	Public / NonPublic	Date Visited	Area (sq ft)	Lane Miles *	Surface Type
0937BZ	PUBLIC	7/12/2006	7,108	0.12	AS
Culverts	Drop Inlets	Gates	Curb & Gutter	Curb	PCR
0	0	0	NO CURB AND GUTTER	CONCRETE CURB	EXCELLENT/97

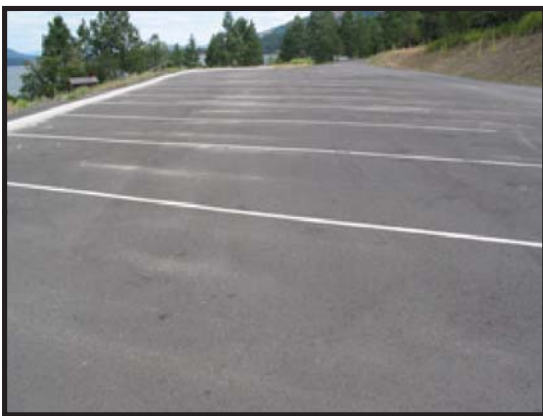
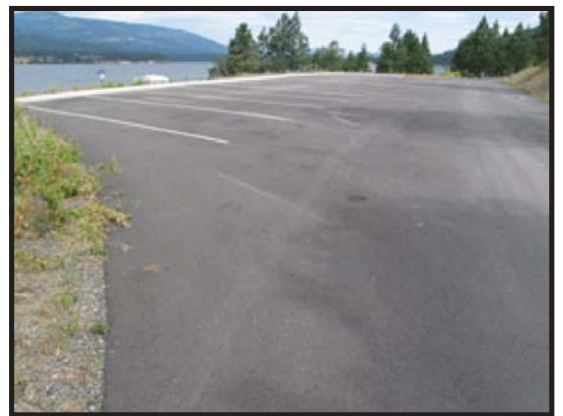
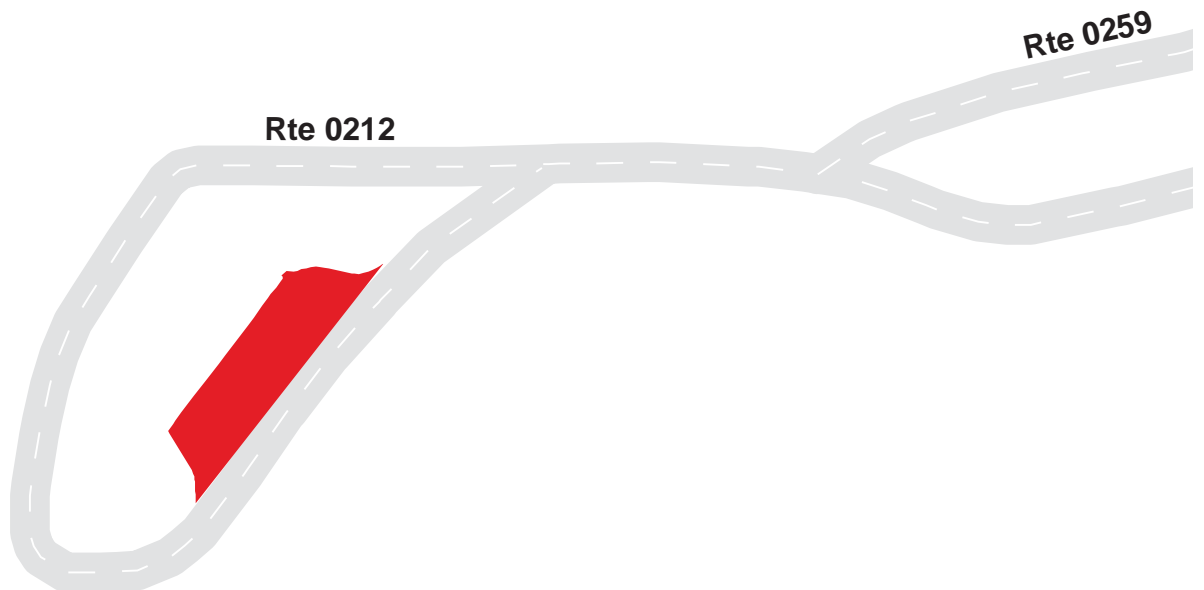
Route 0938

Route Number	Public / NonPublic	Date Visited	Area (sq ft)	Lane Miles *	Surface Type
0938	PUBLIC	7/12/2006	51,221	0.88	AS
Culverts	Drop Inlets	Gates	Curb & Gutter	Curb	PCR
0	0	0	NO CURB AND GUTTER	NO CURB	GOOD/90

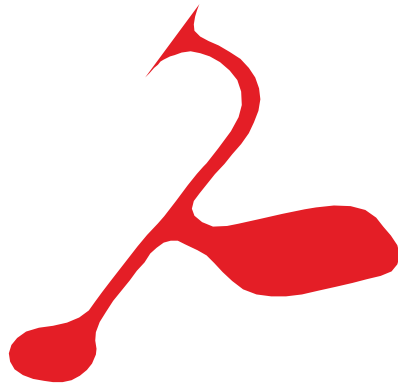
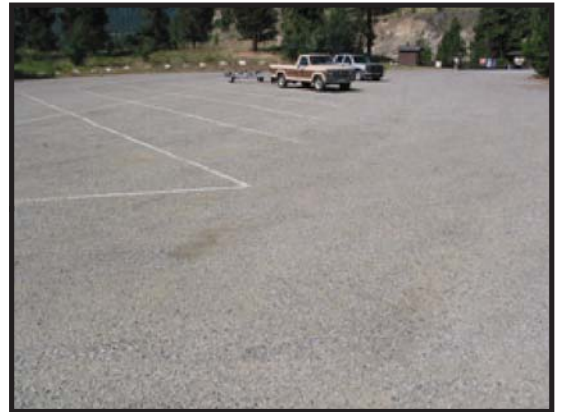
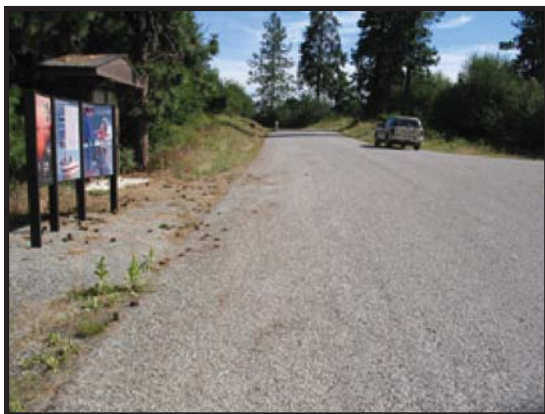
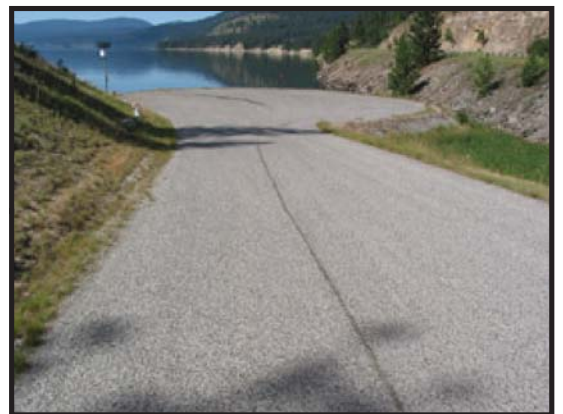
Route 0940

Route Number	Public / NonPublic	Date Visited	Area (sq ft)	Lane Miles *	Surface Type
0940	PUBLIC	7/11/2006	41,695	0.72	AS
Culverts	Drop Inlets	Gates	Curb & Gutter	Curb	PCR
0	0	0	NO CURB AND GUTTER	NO CURB	EXCELLENT/97

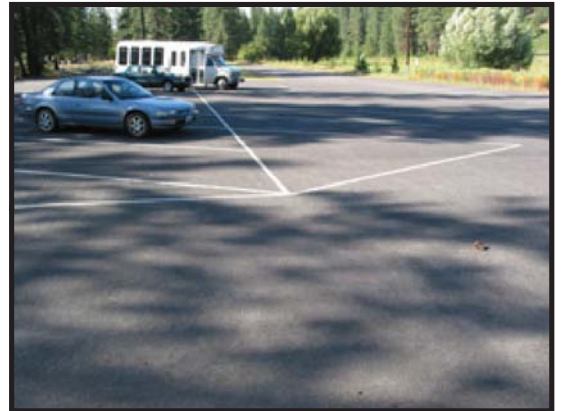
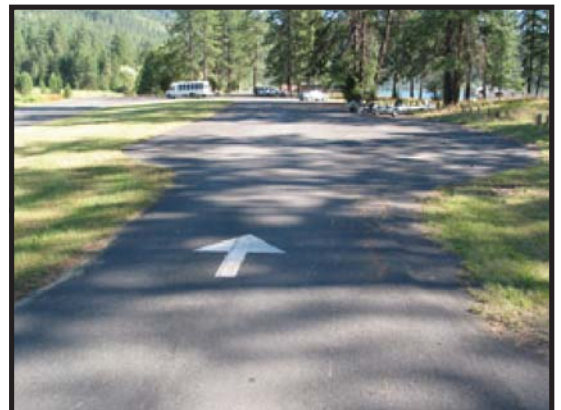
Route 0941

Route Number	Public / NonPublic	Date Visited	Area (sq ft)	Lane Miles *	Surface Type
0941	PUBLIC	7/11/2006	24,584	0.42	AS
Culverts	Drop Inlets	Gates	Curb & Gutter	Curb	PCR
0	0	0	NO CURB AND GUTTER	CONCRETE CURB	EXCELLENT/97

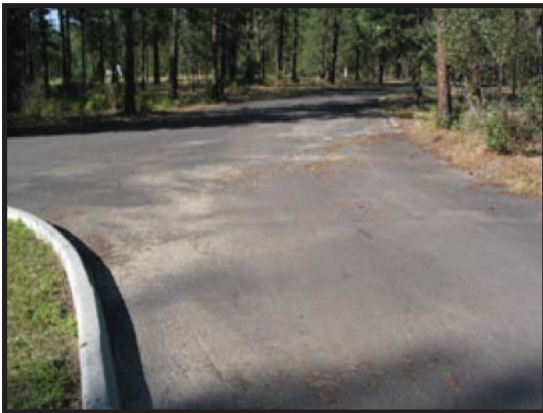
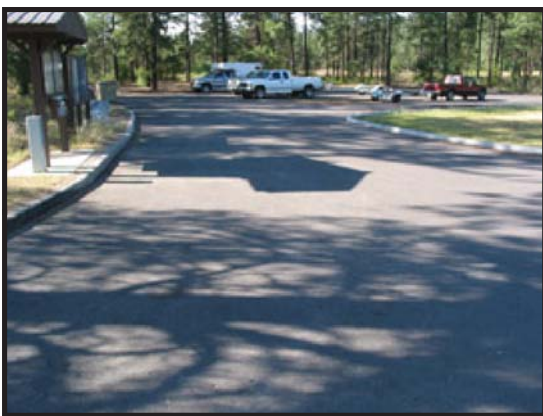
Route 0942

Route Number	Public / NonPublic	Date Visited	Area (sq ft)	Lane Miles *	Surface Type
0942	PUBLIC	7/11/2006	17,720	0.31	AS
Culverts	Drop Inlets	Gates	Curb & Gutter	Curb	PCR
0	0	0	NO CURB AND GUTTER	CONCRETE CURB	EXCELLENT/97

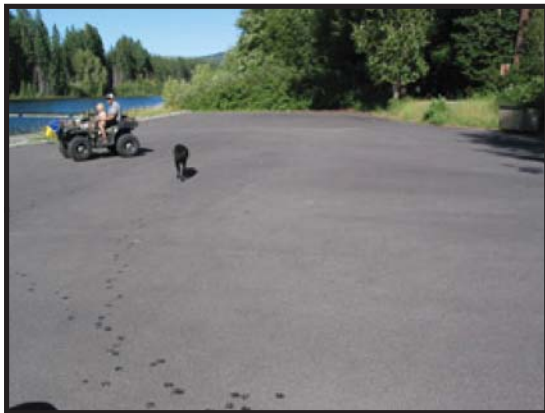
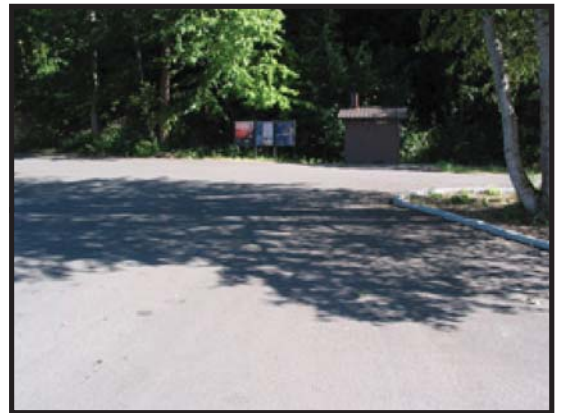
Route 0944

Route Number	Public / NonPublic	Date Visited	Area (sq ft)	Lane Miles *	Surface Type
0944	PUBLIC	7/11/2006	16,074	0.28	AS
Culverts	Drop Inlets	Gates	Curb & Gutter	Curb	PCR
0	0	0	NO CURB AND GUTTER	CONCRETE CURB	EXCELLENT/97

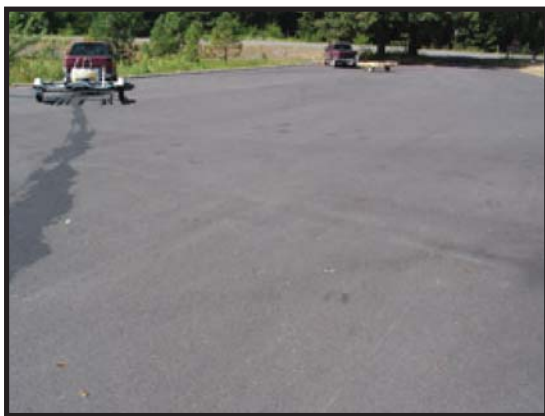
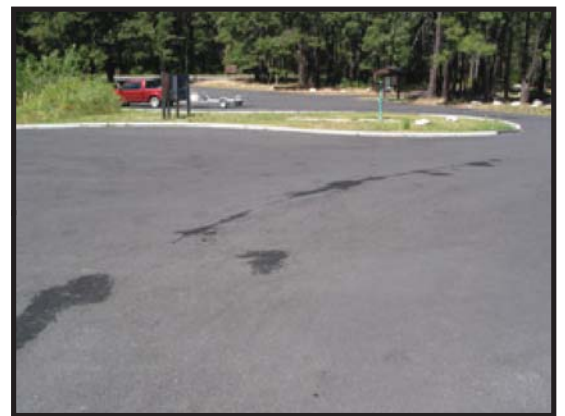
Route 0947

Route Number	Public / NonPublic	Date Visited	Area (sq ft)	Lane Miles *	Surface Type
0947	PUBLIC	7/12/2006	56,450	0.97	AS
Culverts	Drop Inlets	Gates	Curb & Gutter	Curb	PCR
0	0	0	NO CURB AND GUTTER	CONCRETE CURB	GOOD/90

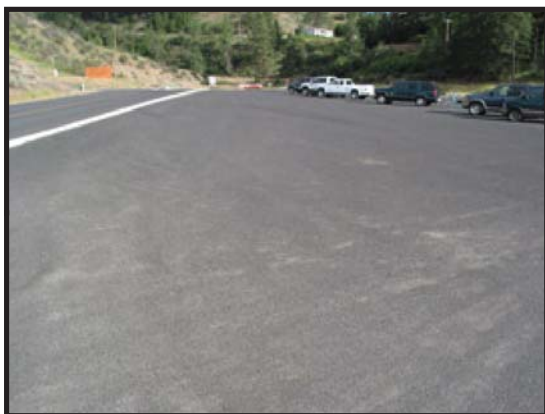
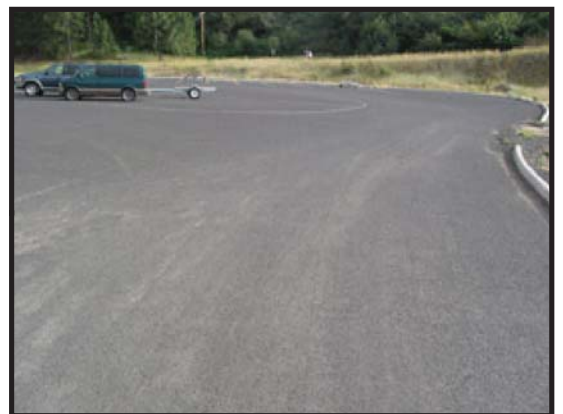
Route 0949

Route Number	Public / NonPublic	Date Visited	Area (sq ft)	Lane Miles *	Surface Type
0949	PUBLIC	7/12/2006	2,272	0.04	AS
Culverts	Drop Inlets	Gates	Curb & Gutter	Curb	PCR
0	0	0	NO CURB AND GUTTER	CONCRETE CURB	GOOD/90

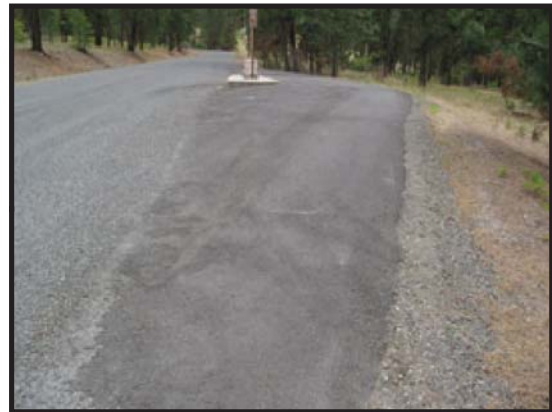
Route 0950

Route Number	Public / NonPublic	Date Visited	Area (sq ft)	Lane Miles *	Surface Type
0950	PUBLIC	7/11/2006	3,110	0.05	AS
Culverts	Drop Inlets	Gates	Curb & Gutter	Curb	PCR
0	0	0	NO CURB AND GUTTER	CONCRETE CURB	GOOD/90

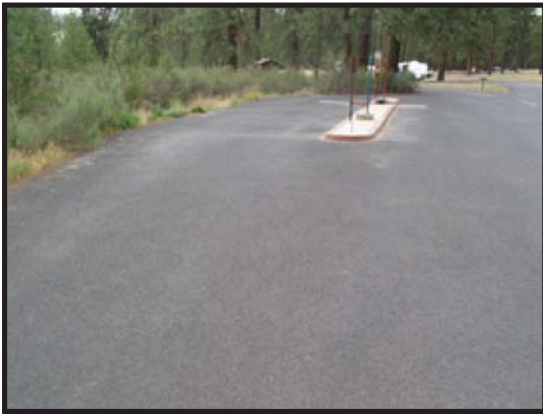
Route 0955

Route Number	Public / NonPublic	Date Visited	Area (sq ft)	Lane Miles *	Surface Type
0955	PUBLIC	7/12/2006	3,322	0.06	AS
Culverts	Drop Inlets	Gates	Curb & Gutter	Curb	PCR
0	0	0	NO CURB AND GUTTER	CONCRETE CURB	EXCELLENT/97

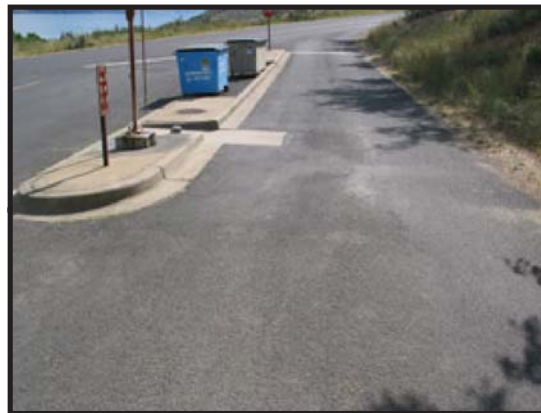
Route 0959

Route Number	Public / NonPublic	Date Visited	Area (sq ft)	Lane Miles *	Surface Type
0959	PUBLIC	7/12/2006	4,993	0.09	AS
Culverts	Drop Inlets	Gates	Curb & Gutter	Curb	PCR
0	0	0	NO CURB AND GUTTER	NO CURB	EXCELLENT/97

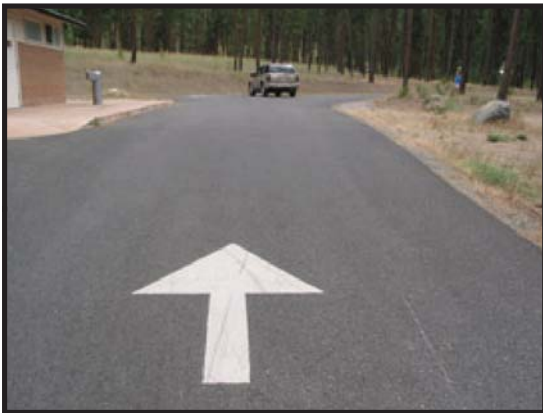
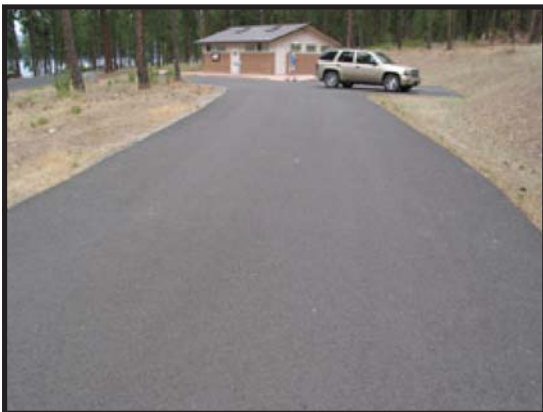
Route 0961

Route Number	Public / NonPublic	Date Visited	Area (sq ft)	Lane Miles *	Surface Type
0961	PUBLIC	7/11/2006	2,464	0.04	AS
Culverts	Drop Inlets	Gates	Curb & Gutter	Curb	PCR
0	0	0	NO CURB AND GUTTER	CONCRETE CURB	GOOD/90

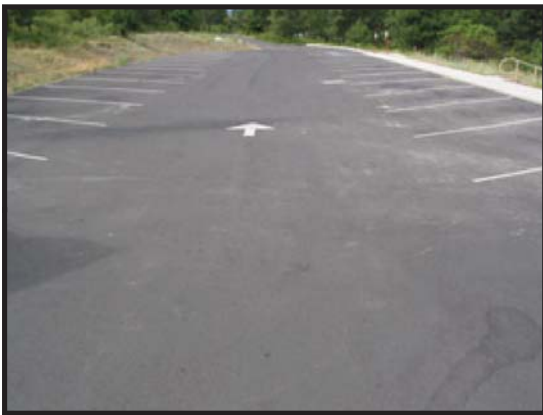
Route 0962BZ

Route Number	Public / NonPublic	Date Visited	Area (sq ft)	Lane Miles *	Surface Type
0962BZ	PUBLIC	7/12/2006	10,676	0.18	AS
Culverts	Drop Inlets	Gates	Curb & Gutter	Curb	PCR
0	0	0	NO CURB AND GUTTER	CONCRETE CURB	EXCELLENT/97

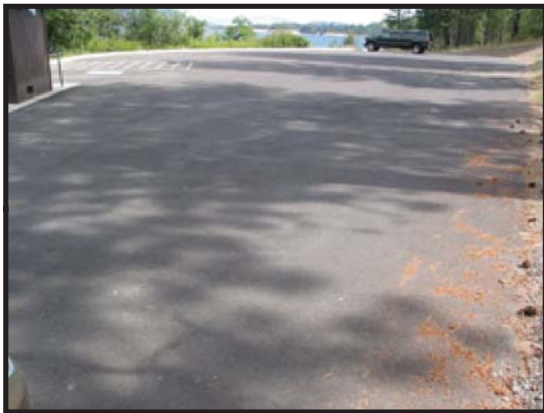
Route 0963

Route Number	Public / NonPublic	Date Visited	Area (sq ft)	Lane Miles *	Surface Type
0963	NONPUBLIC	7/12/2006	18,163	0.31	AS
Culverts	Drop Inlets	Gates	Curb & Gutter	Curb	PCR
0	0	0	NO CURB AND GUTTER	NO CURB	EXCELLENT/97
