**The Road Inventory
of
Mammoth Cave National Park
MACA – 5530
Cycle 4**

**Prepared By:
Federal Highway Administration
Road Inventory Program
Cycle 4**

Mammoth Cave National Park in Kentucky

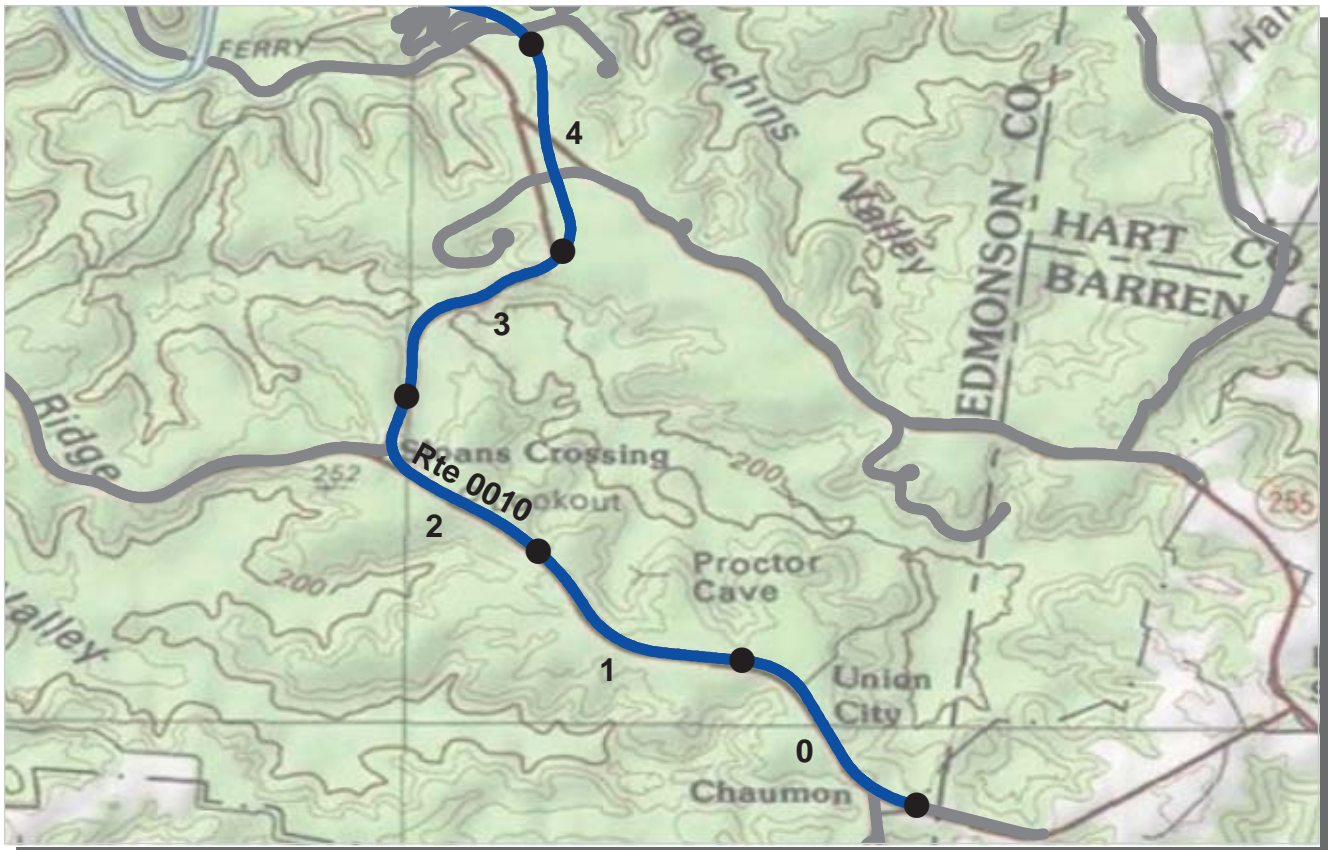
Section Number	0	1	2	3	4
Section Length (mi)	1.00	1.00	1.00	1.00	1.00
Traffic	Traffic data may be found at www.efl.fhwa.dot.gov Click on PROGRAMS / NPS Traffic Data (Note: Not all parks have traffic data)				
Cross Section Information					
Number of Lanes	2	2	2	2	2
Paved Width (ft)	26	21	25	23	21
Lane Width (ft)	11	10	10	10	9
Shoulder Width Right (ft)	NC	NC	NC	NC	NC
Shoulder Width Left (ft)	NC	NC	NC	NC	NC
Roadway Condition Information					
SCR (Surface Condition Rating)	100	100	100	99	100
PCR (Pavement Condition Rating)	100	100	100	99	100
Distress Index Values					
Alligator Cracking Index	100	100	100	100	100
Longitudinal Cracking Index	100	100	100	100	100
Transverse Cracking Index	100	100	100	100	100
Patching Index	100	100	100	100	100
Rutting Index	100	100	100	100	100
Roughness Condition Index (RCI)	100	100	100	100	99

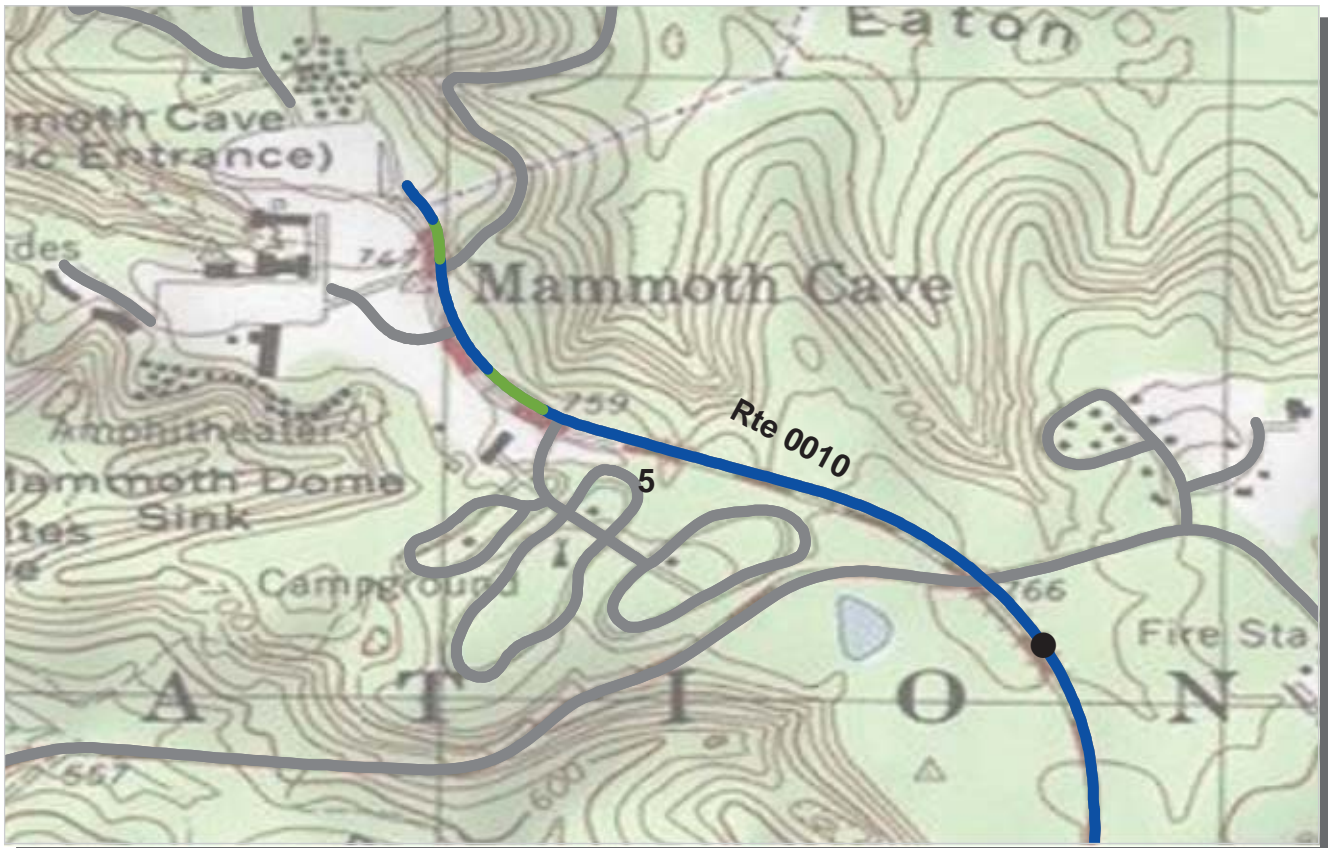
ROUTE: 0010 MAMMOTH CAVE PARKWAY

Section Number	5				
Section Length (mi)	0.74				
Traffic	Traffic data may be found at www.efl.fhwa.dot.gov Click on PROGRAMS / NPS Traffic Data (Note: Not all parks have traffic data)				
Cross Section Information					
Number of Lanes	2				
Paved Width (ft)	27				
Lane Width (ft)	11				
Shoulder Width Right (ft)	NC				
Shoulder Width Left (ft)	NC				
Roadway Condition Information					
SCR (Surface Condition Rating)	100				
PCR (Pavement Condition Rating)	99				
Distress Index Values					
Alligator Cracking Index	100				
Longitudinal Cracking Index	100				
Transverse Cracking Index	100				
Patching Index	100				
Rutting Index	100				
Roughness Condition Index (RCI)	97

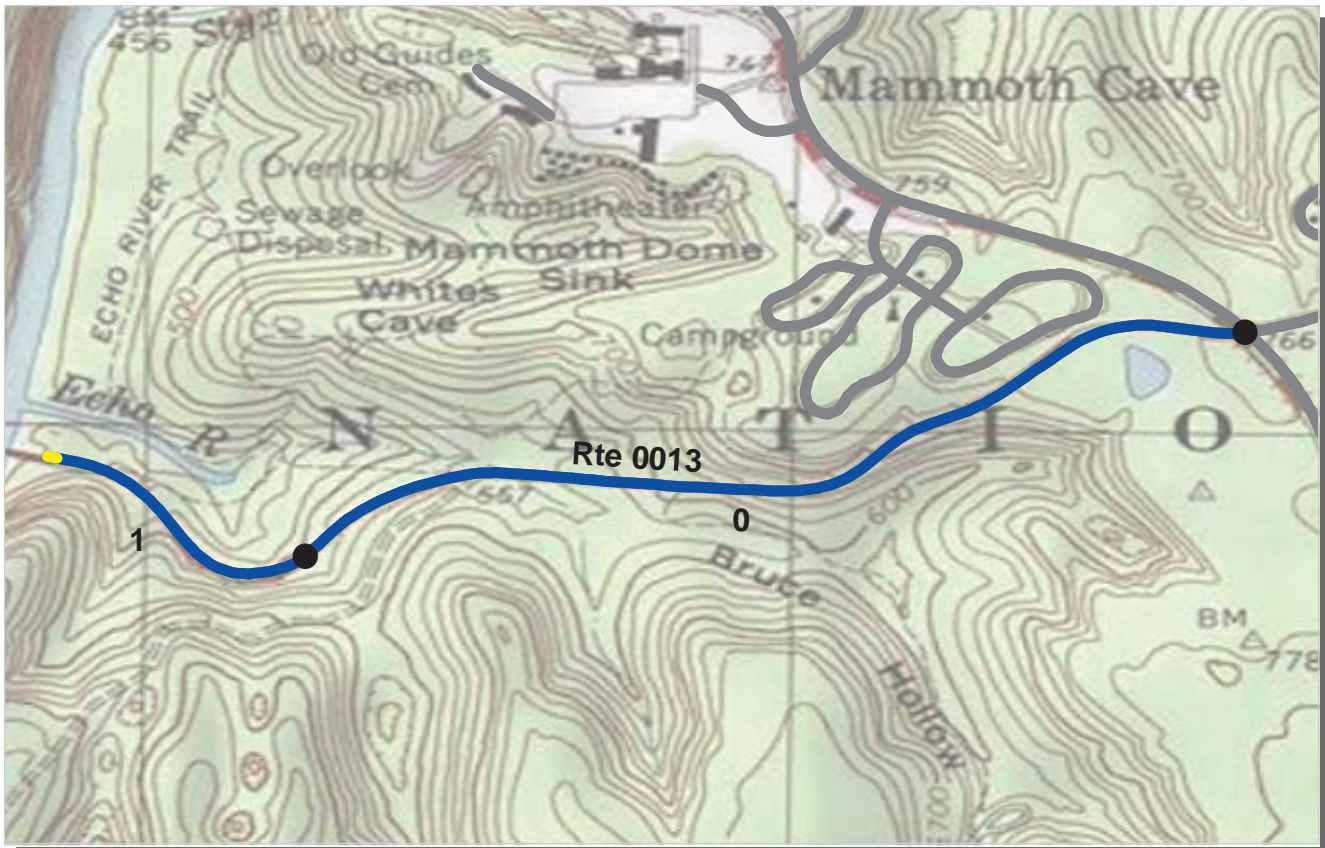
ROUTE: 0012 HOTEL ENTRANCE ROAD

Section Number	0				
Section Length (mi)	0.12				
Traffic	Traffic data may be found at www.efl.fhwa.dot.gov Click on PROGRAMS / NPS Traffic Data (Note: Not all parks have traffic data)				
Cross Section Information					
Number of Lanes	2				
Paved Width (ft)	20				
Lane Width (ft)	9				
Shoulder Width Right (ft)	NC				
Shoulder Width Left (ft)	NC				
Roadway Condition Information					
SCR (Surface Condition Rating)	94				
PCR (Pavement Condition Rating)	85				
Distress Index Values					
Alligator Cracking Index	100				
Longitudinal Cracking Index	100				
Transverse Cracking Index	100				
Patching Index	100				
Rutting Index	94				
Roughness Condition Index (RCI)	70

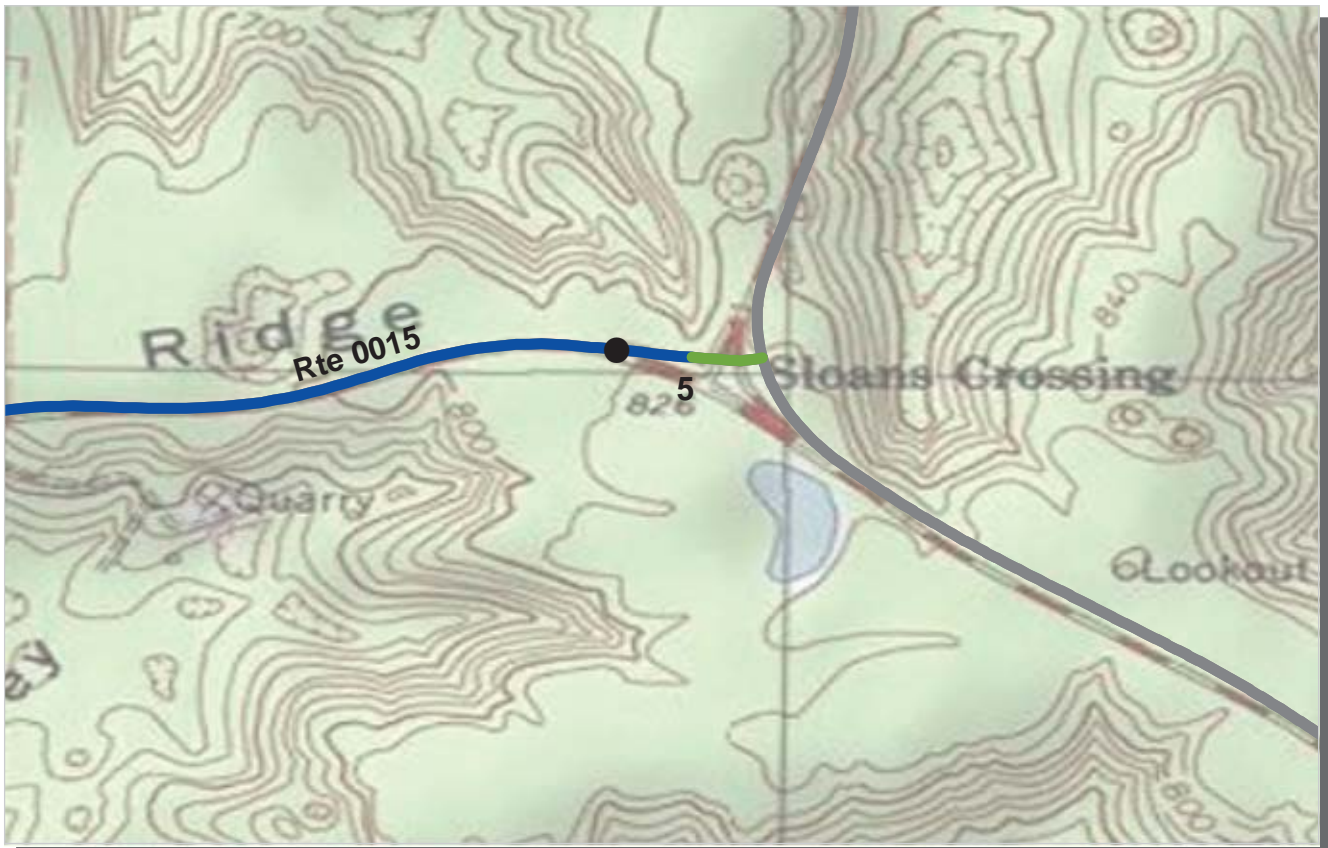
ROUTE: 0015 BROWNSVILLE ROAD

Section Number	5				
Section Length (mi)	0.10				
Traffic	Traffic data may be found at www.efl.fhwa.dot.gov Click on PROGRAMS / NPS Traffic Data (Note: Not all parks have traffic data)				
Cross Section Information					
Number of Lanes	2				
Paved Width (ft)	27				
Lane Width (ft)	11				
Shoulder Width Right (ft)	NC				
Shoulder Width Left (ft)	NC				
Roadway Condition Information					
SCR (Surface Condition Rating)	95				
PCR (Pavement Condition Rating)	95				
Distress Index Values					
Alligator Cracking Index	100				
Longitudinal Cracking Index	100				
Transverse Cracking Index	100				
Patching Index	100				
Rutting Index	95				
Roughness Condition Index (RCI)	100

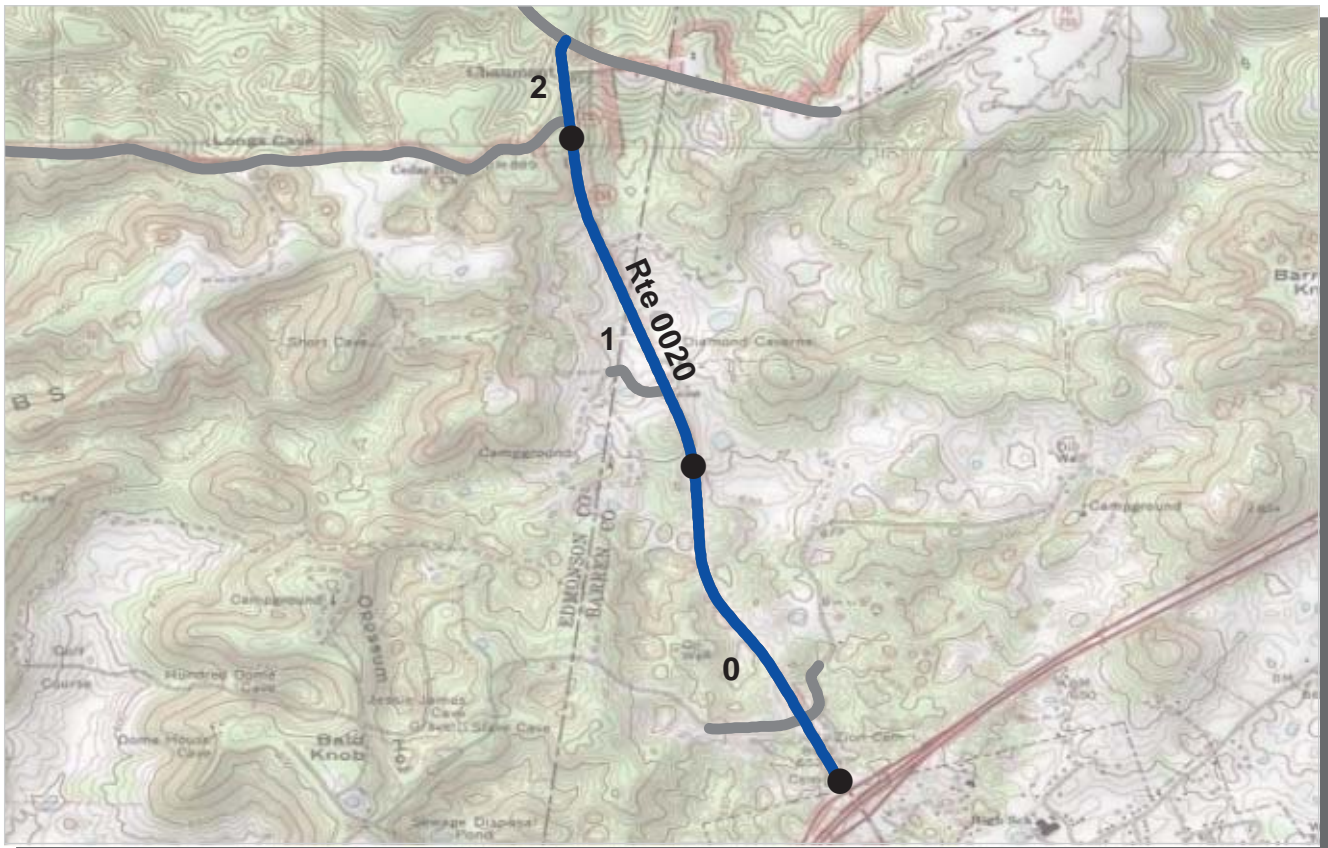
ROUTE: 0016 CAVE CITY ROAD

Section Number	0	1	2		
Section Length (mi)	1.00	1.00	0.28		
Traffic	Traffic data may be found at www.efl.fhwa.dot.gov Click on PROGRAMS / NPS Traffic Data (Note: Not all parks have traffic data)				
Cross Section Information					
Number of Lanes	2	2	2		
Paved Width (ft)	24	25	26		
Lane Width (ft)	10	10	11		
Shoulder Width Right (ft)	NC	NC	NC		
Shoulder Width Left (ft)	NC	NC	NC		
Roadway Condition Information					
SCR (Surface Condition Rating)	99	100	99		
PCR (Pavement Condition Rating)	99	100	98		
Distress Index Values					
Alligator Cracking Index	100	100	100		
Longitudinal Cracking Index	100	100	100		
Transverse Cracking Index	100	100	100		
Patching Index	100	100	100		
Rutting Index	99	100	99		
Roughness Condition Index (RCI)	100	99	97

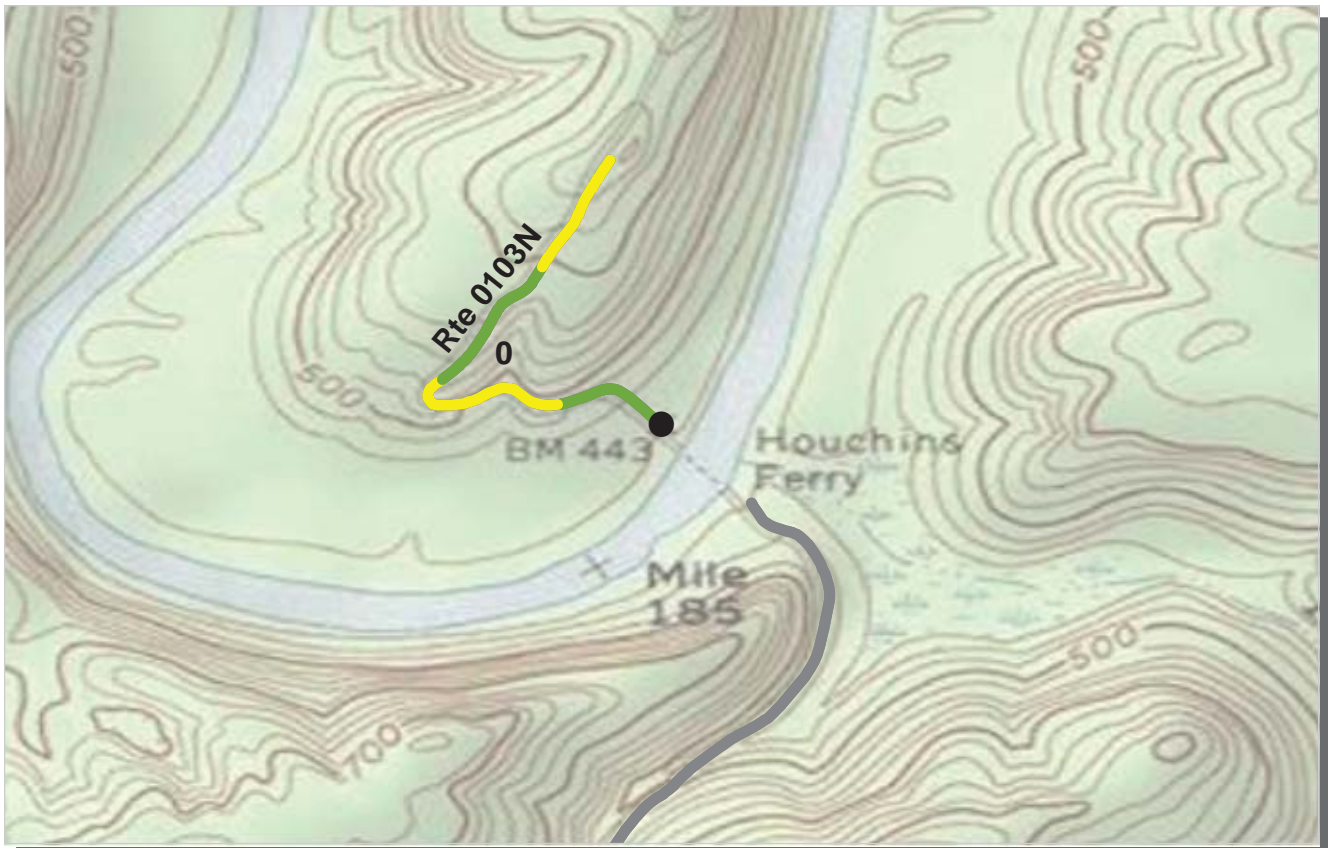
ROUTE: 0103 HOUCHINS FERRY ROAD SOUTH

Section Number	0				
Section Length (mi)	0.50				
Traffic	Traffic data may be found at www.efl.fhwa.dot.gov Click on PROGRAMS / NPS Traffic Data (Note: Not all parks have traffic data)				
Cross Section Information					
Number of Lanes	2				
Paved Width (ft)	16				
Lane Width (ft)	9				
Shoulder Width Right (ft)	NC				
Shoulder Width Left (ft)	NC				
Roadway Condition Information					
SCR (Surface Condition Rating)	92				
PCR (Pavement Condition Rating)	83				
Distress Index Values					
Alligator Cracking Index	99				
Longitudinal Cracking Index	98				
Transverse Cracking Index	100				
Patching Index	100				
Rutting Index	95				
Roughness Condition Index (RCI)	63

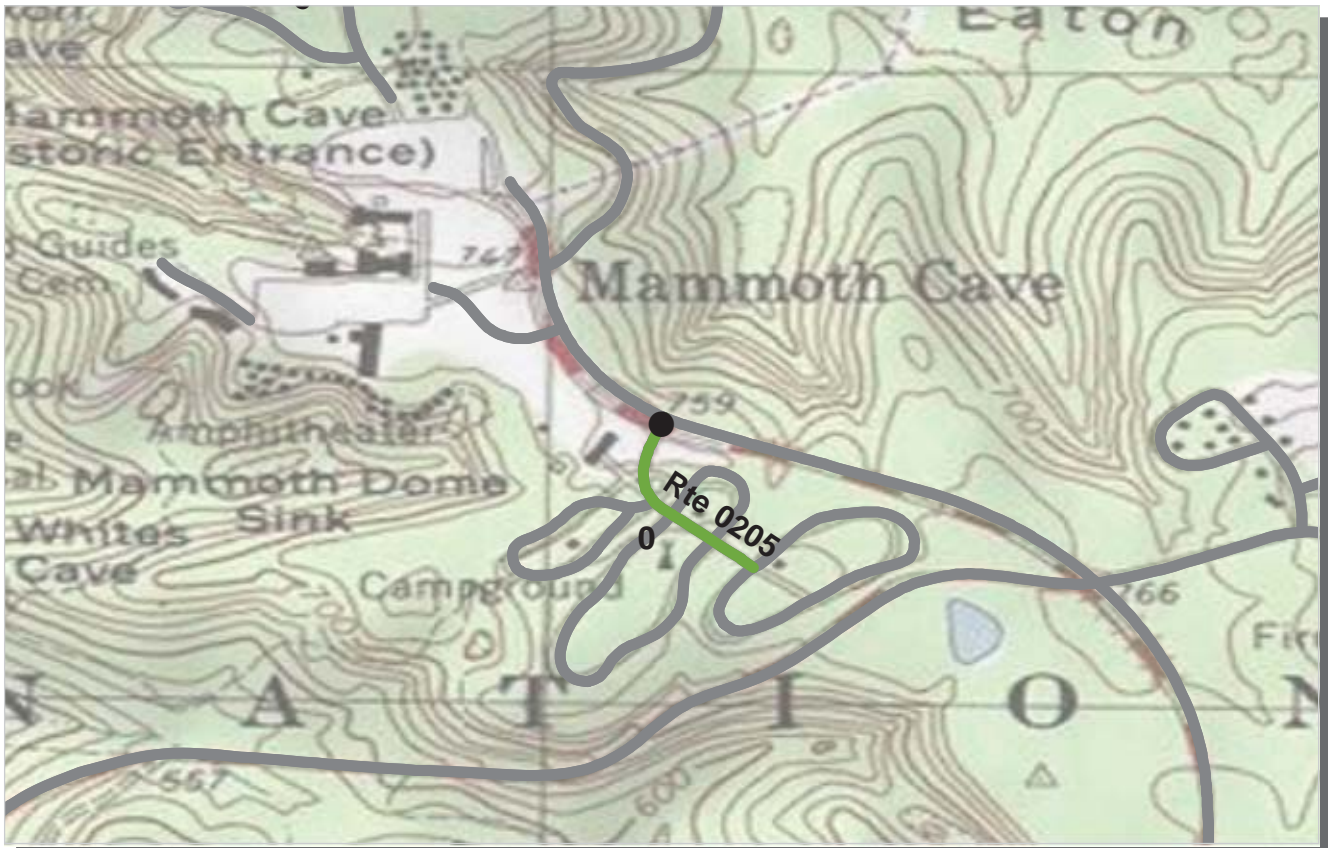
ROUTE: 0203 VISITOR CENTER PICNIC SHELTER ROAD

Section Number	0				
Section Length (mi)	0.18				
Traffic	Traffic data may be found at www.efl.fhwa.dot.gov Click on PROGRAMS / NPS Traffic Data (Note: Not all parks have traffic data)				
Cross Section Information					
Number of Lanes	2				
Paved Width (ft)	25				
Lane Width (ft)	10				
Shoulder Width Right (ft)	NC				
Shoulder Width Left (ft)	NC				
Roadway Condition Information					
SCR (Surface Condition Rating)	87				
PCR (Pavement Condition Rating)	88				
Distress Index Values					
Alligator Cracking Index	99				
Longitudinal Cracking Index	94				
Transverse Cracking Index	98				
Patching Index	100				
Rutting Index	95				
Roughness Condition Index (RCI)	92

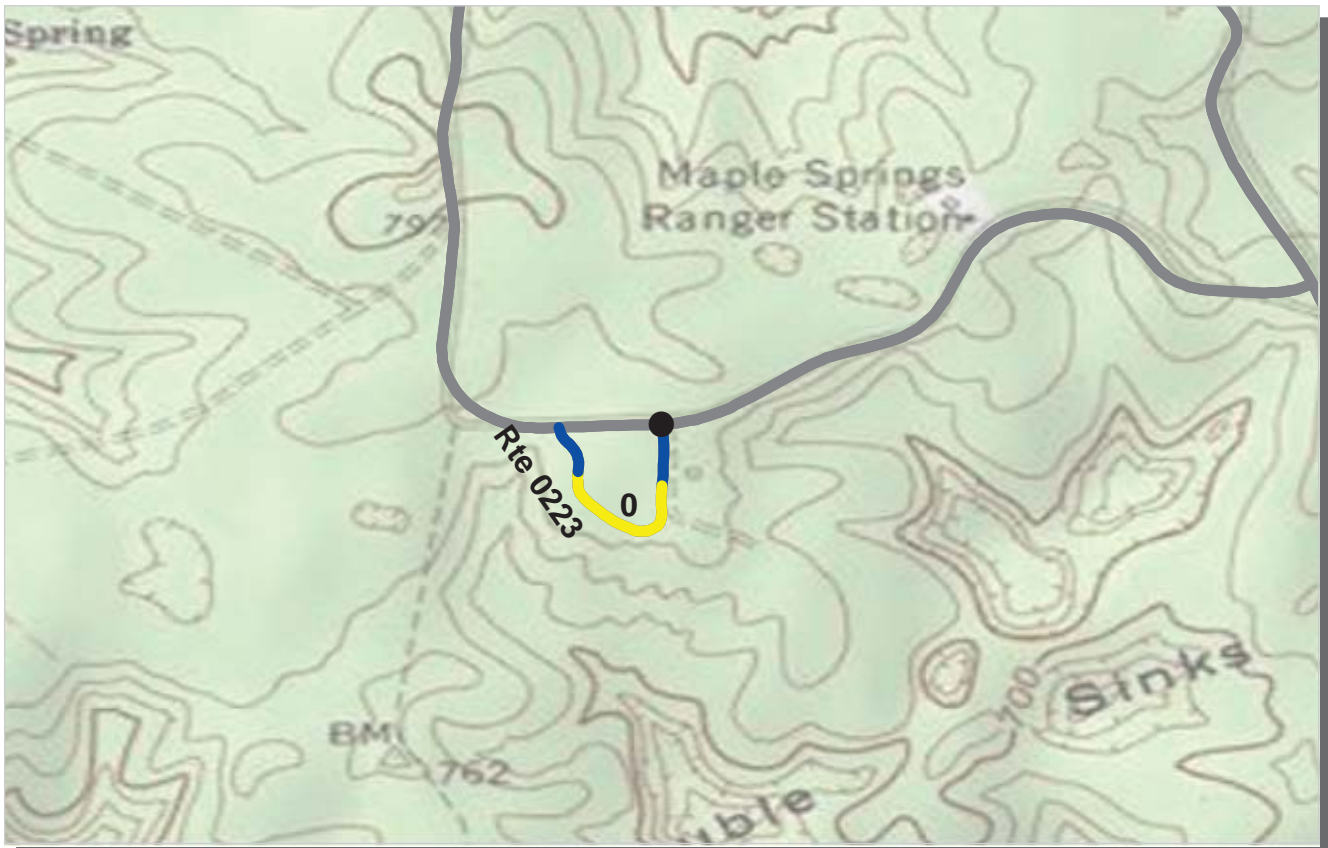
ROUTE: 0205 HQ CAMPGROUND ACCESS ROAD

Section Number	0				
Section Length (mi)	0.25				
Traffic	Traffic data may be found at www.efl.fhwa.dot.gov Click on PROGRAMS / NPS Traffic Data (Note: Not all parks have traffic data)				
Cross Section Information					
Number of Lanes	1				
Paved Width (ft)	12				
Lane Width (ft)	12				
Shoulder Width Right (ft)	NC				
Shoulder Width Left (ft)	NC				
Roadway Condition Information					
SCR (Surface Condition Rating)	99				
PCR (Pavement Condition Rating)	87				
Distress Index Values					
Alligator Cracking Index	100				
Longitudinal Cracking Index	100				
Transverse Cracking Index	100				
Patching Index	100				
Rutting Index	99				
Roughness Condition Index (RCI)	41

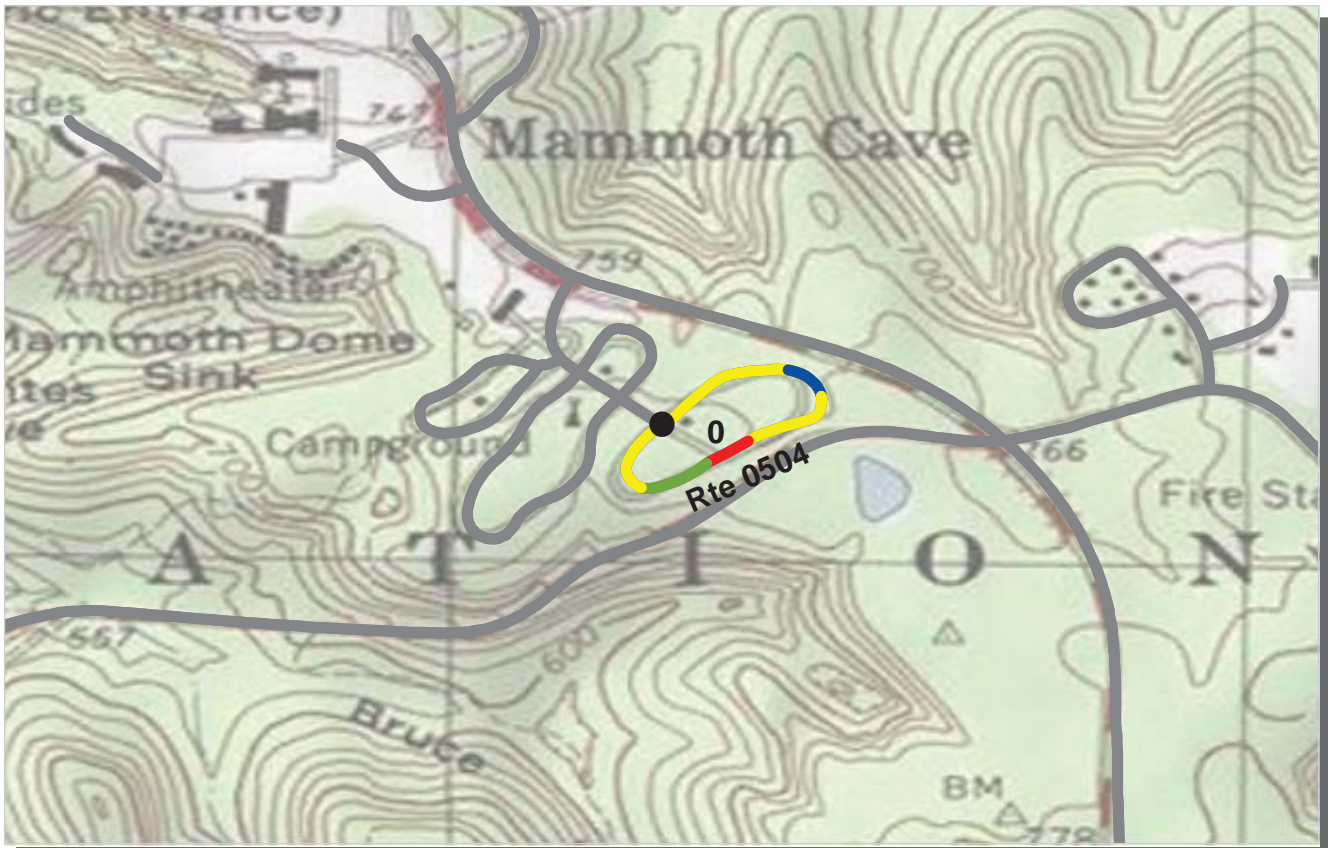
ROUTE: 0503 VISITOR CENTER CAMPGROUND LOOP C

Section Number	0				
Section Length (mi)	0.38				
Traffic	Traffic data may be found at www.efl.fhwa.dot.gov Click on PROGRAMS / NPS Traffic Data (Note: Not all parks have traffic data)				
Cross Section Information					
Number of Lanes	1				
Paved Width (ft)	12				
Lane Width (ft)	12				
Shoulder Width Right (ft)	NC				
Shoulder Width Left (ft)	NC				
Roadway Condition Information					
SCR (Surface Condition Rating)	86				
PCR (Pavement Condition Rating)	83				
Distress Index Values					
Alligator Cracking Index	99				
Longitudinal Cracking Index	95				
Transverse Cracking Index	97				
Patching Index	100				
Rutting Index	94				
Roughness Condition Index (RCI)	80

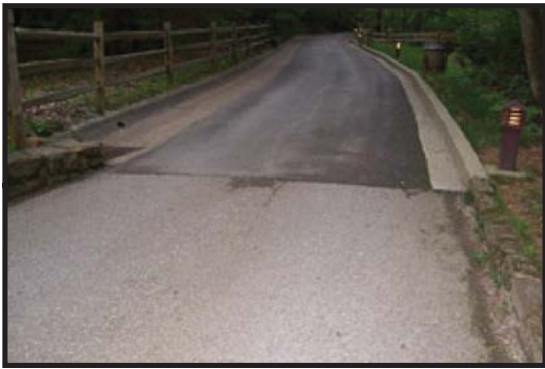
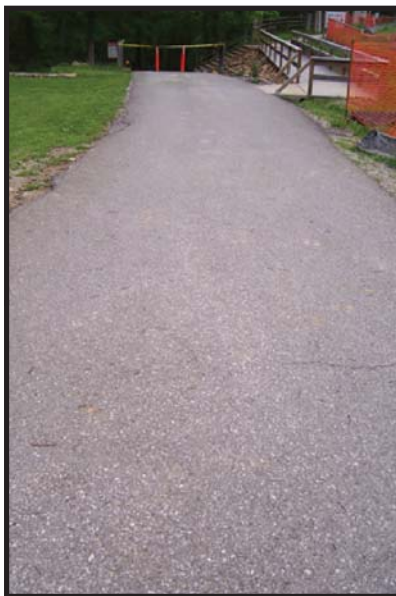
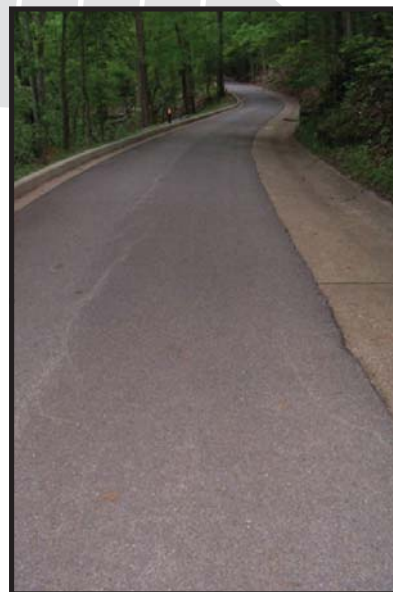
Route Number	Public / NonPublic	Date Visited		Area (sq ft)	Lane Miles *	Surface Type
0407	PUBLIC	5/5/2009		9,293	0.16	AS
Culverts	Drop Inlets	Gates	Fire Hydrants	Curb & Gutter	Curb	PCR
1	10	0	0	CONCRETE CURB AND GUTTER	NO CURB	GOOD/90

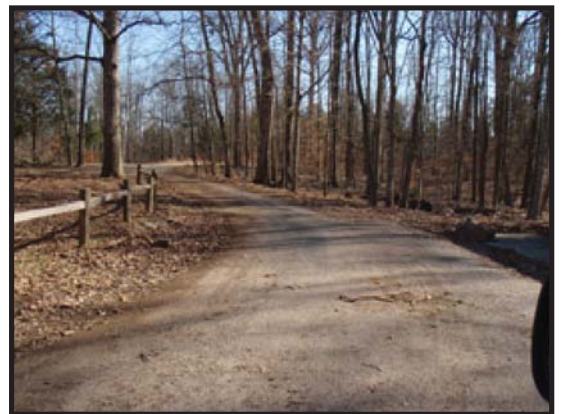
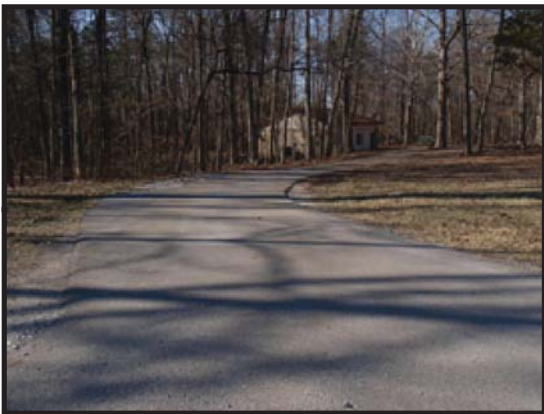
Route Number	Public / NonPublic	Date Visited		Area (sq ft)	Lane Miles *	Surface Type
0434	PUBLIC	3/4/2009		3,379	0.06	AS
Culverts	Drop Inlets	Gates	Fire Hydrants	Curb & Gutter	Curb	PCR
0	0	0	0	NO CURB AND GUTTER	NO CURB	POOR/45

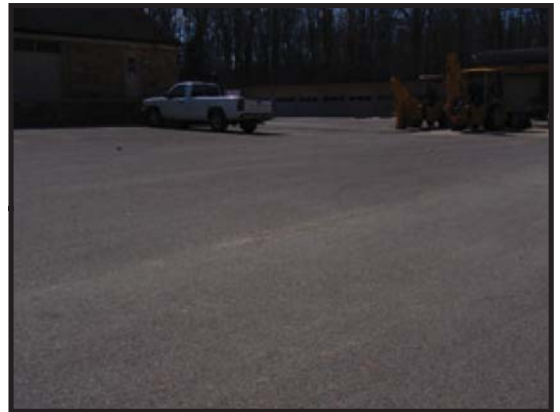
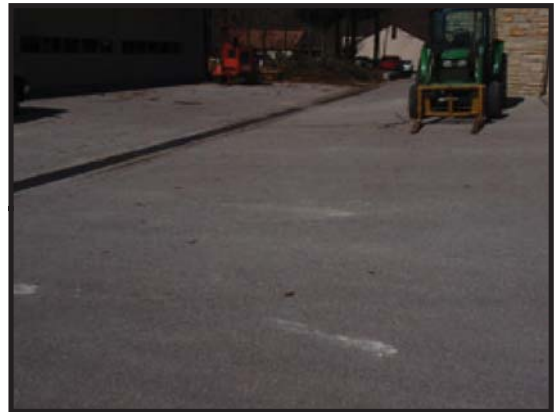
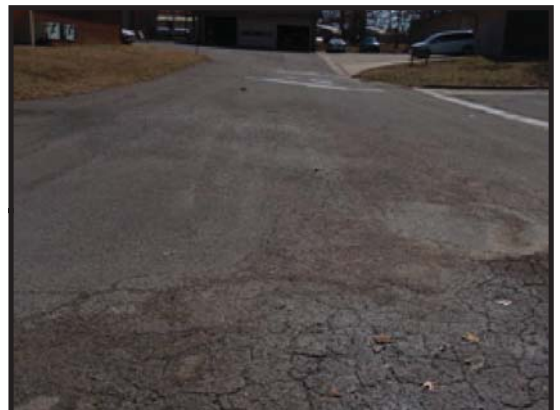
Route Number	Public / NonPublic	Date Visited		Area (sq ft)	Lane Miles *	Surface Type
0902A	NONPUBLIC	3/4/2009		43,786	0.75	AS
Culverts	Drop Inlets	Gates	Fire Hydrants	Curb & Gutter	Curb	PCR
0	2	0	0	NO CURB AND GUTTER	NO CURB	FAIR/73

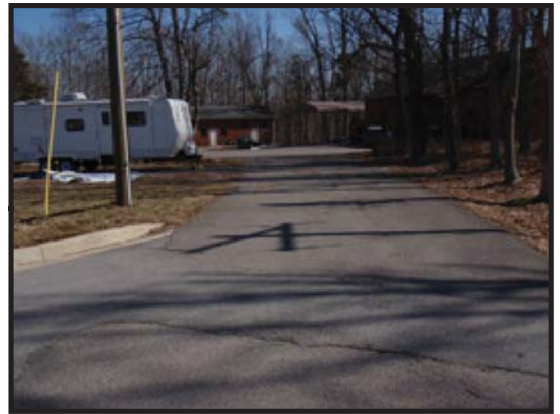
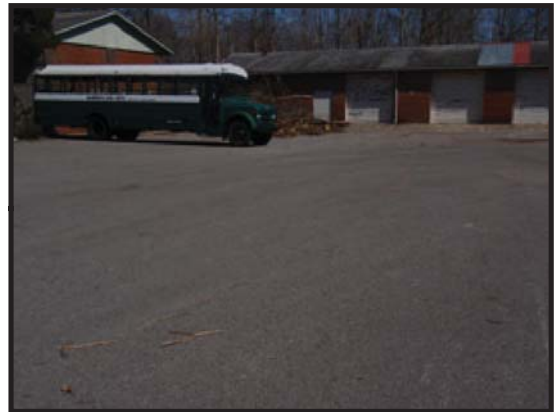
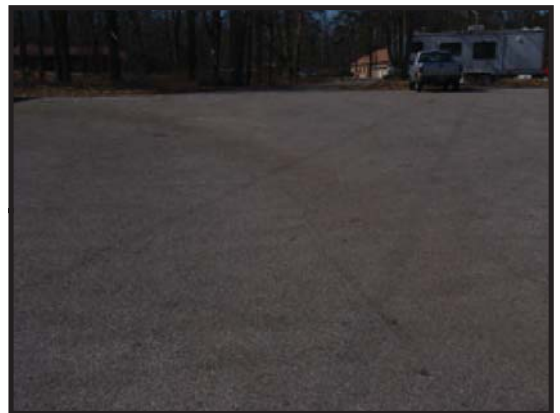
Route 0902B

Route Number	Public / NonPublic	Date Visited		Area (sq ft)	Lane Miles *	Surface Type
0902B	NONPUBLIC	3/4/2009		16,224	0.28	AS
Culverts	Drop Inlets	Gates	Fire Hydrants	Curb & Gutter	Curb	PCR
1	0	1	1	NO CURB AND GUTTER	NO CURB	FAIR/73

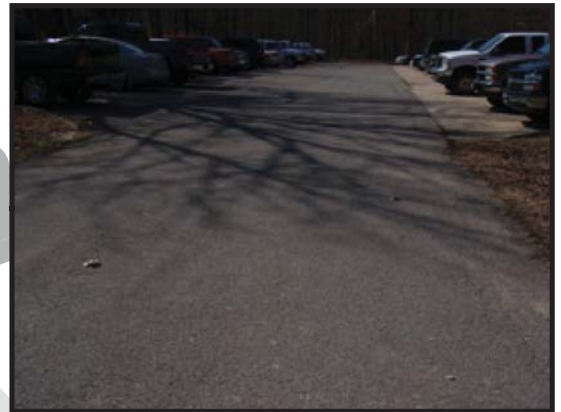
Route Number	Public / NonPublic	Date Visited		Area (sq ft)	Lane Miles *	Surface Type
0903AZ	NONPUBLIC	3/4/2009		9,974	0.17	AS
Culverts	Drop Inlets	Gates	Fire Hydrants	Curb & Gutter	Curb	PCR
0	0	0	0	NO CURB AND GUTTER	CONCRETE CURB	FAIR/73

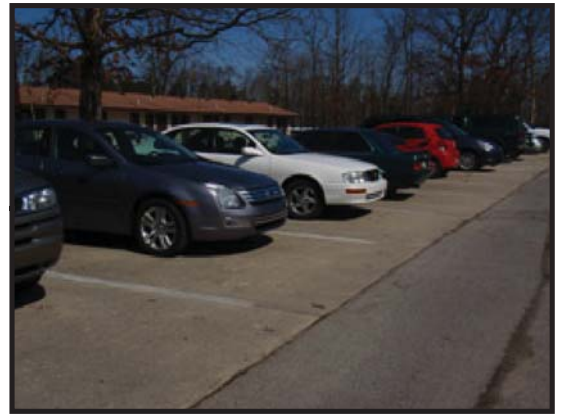
Route Number	Public / NonPublic	Date Visited		Area (sq ft)	Lane Miles *	Surface Type
0903BZ	NONPUBLIC	3/4/2009		3,827	0.07	CO
Culverts	Drop Inlets	Gates	Fire Hydrants	Curb & Gutter	Curb	PCR
0	0	0	0	NO CURB AND GUTTER	CONCRETE CURB	GOOD/90

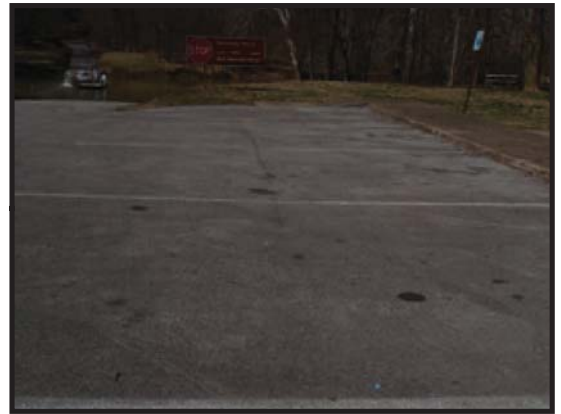
Route Number	Public / NonPublic	Date Visited		Area (sq ft)	Lane Miles *	Surface Type
0904A	PUBLIC	3/4/2009		1,602	0.03	AS
Culverts	Drop Inlets	Gates	Fire Hydrants	Curb & Gutter	Curb	PCR
0	0	0	0	NO CURB AND GUTTER	CONCRETE CURB	FAIR/73

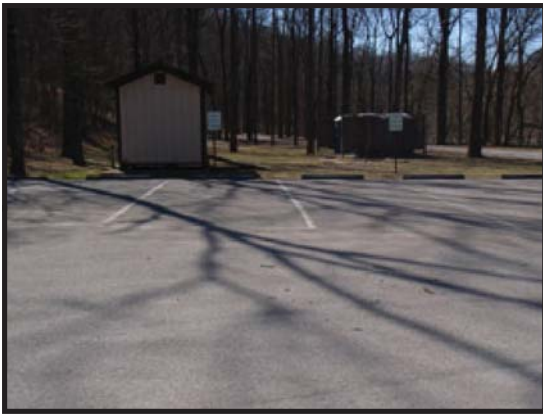
Route Number	Public / NonPublic	Date Visited		Area (sq ft)	Lane Miles *	Surface Type
0904B	PUBLIC	3/4/2009		3,164	0.05	AS
Culverts	Drop Inlets	Gates	Fire Hydrants	Curb & Gutter	Curb	PCR
0	0	0	0	NO CURB AND GUTTER	ASPHALT CURB	GOOD/90

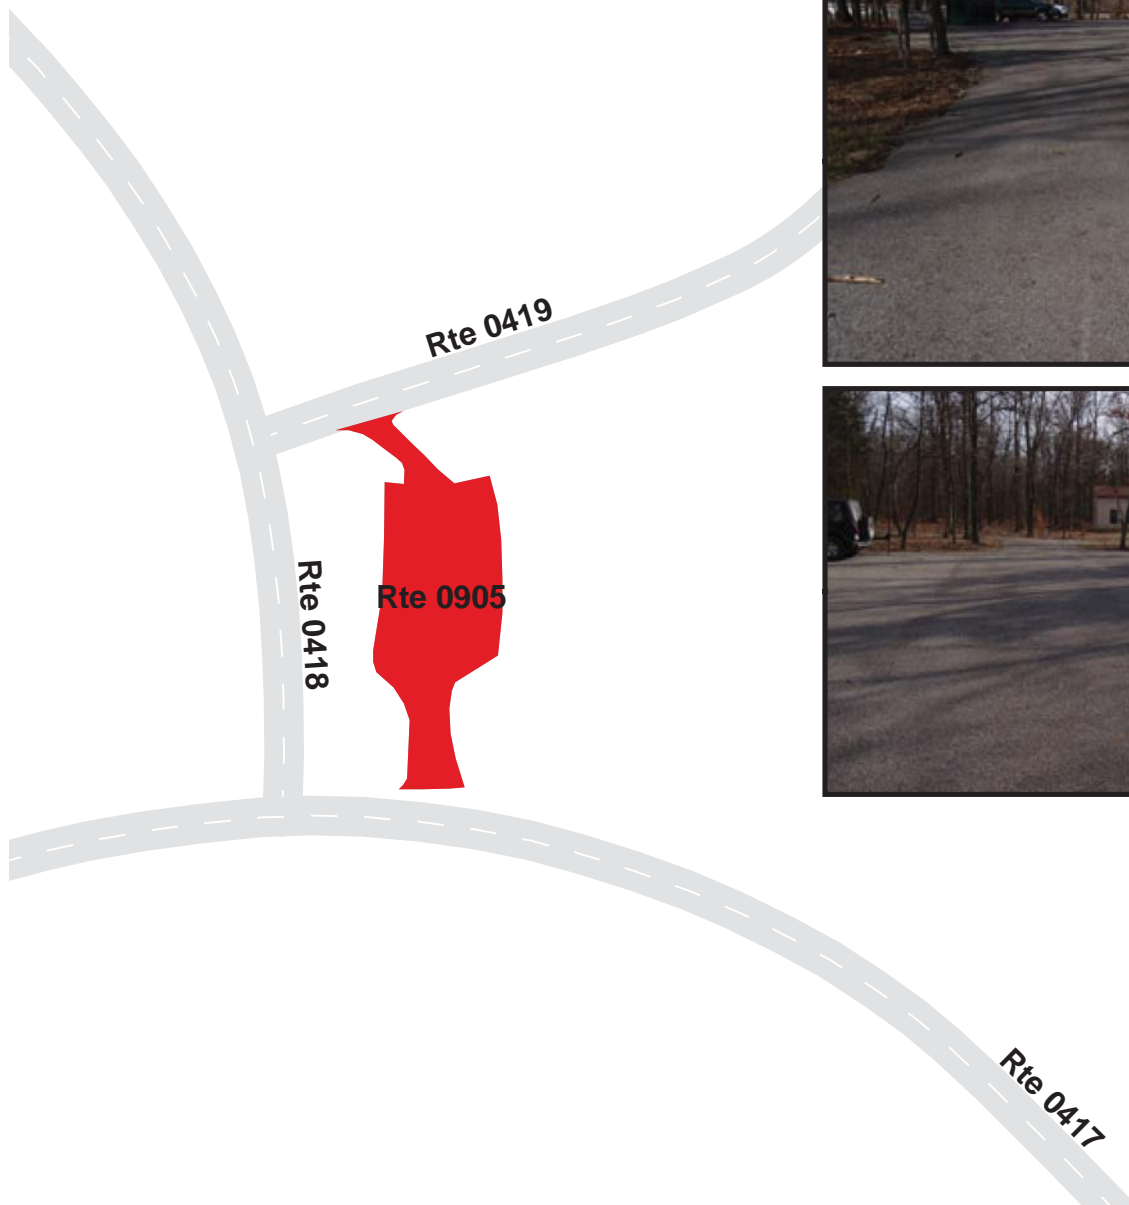
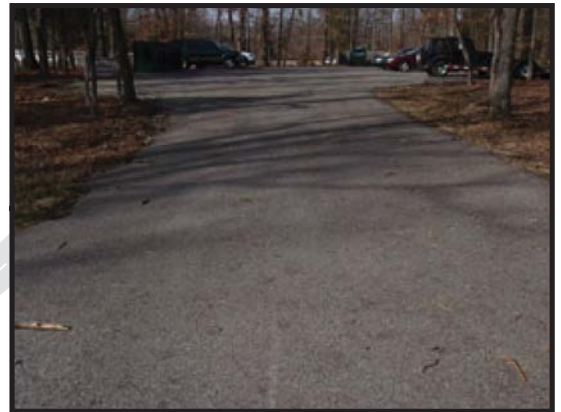
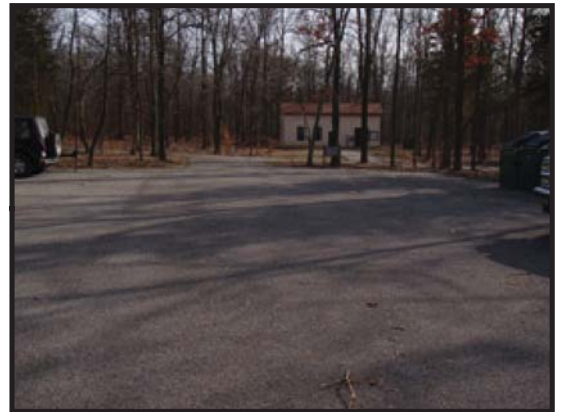
Route Number	Public / NonPublic	Date Visited		Area (sq ft)	Lane Miles *	Surface Type
0905	NONPUBLIC	3/3/2009		8,238	0.14	AS
Culverts	Drop Inlets	Gates	Fire Hydrants	Curb & Gutter	Curb	PCR
2	0	0	0	NO CURB AND GUTTER	NO CURB	GOOD/90

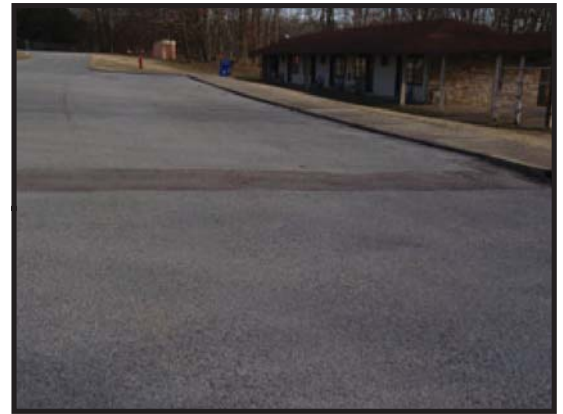
MAMMOTH CAVE NATIONAL PARK
Route 0906A
 SUNSET LODGE PARKING A
 ADJACENT TO ROUTE 0430 (SUNSET LODGE ROAD)

Route Number	Public / NonPublic	Date Visited		Area (sq ft)	Lane Miles *	Surface Type
0906A	PUBLIC	3/4/2009		2,376	0.04	AS
Culverts	Drop Inlets	Gates	Fire Hydrants	Curb & Gutter	Curb	PCR
0	1	0	1	NO CURB AND GUTTER	CONCRETE CURB	FAIR/73

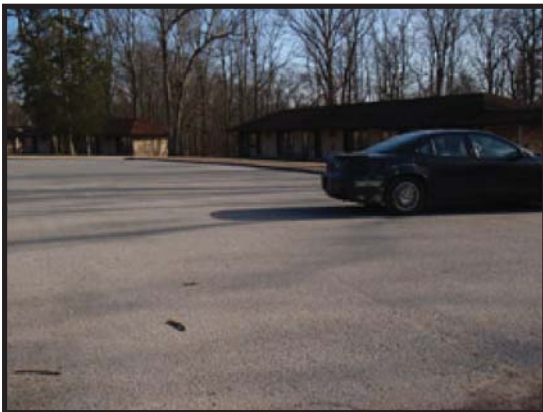
MAMMOTH CAVE NATIONAL PARK
Route 0906B
 SUNSET LODGE PARKING B
 ADJACENT TO ROUTE 0430 (SUNSET LODGE ROAD)

Route Number	Public / NonPublic	Date Visited		Area (sq ft)	Lane Miles *	Surface Type
0906B	PUBLIC	3/4/2009		2,647	0.05	AS
Culverts	Drop Inlets	Gates	Fire Hydrants	Curb & Gutter	Curb	PCR
0	2	0	1	NO CURB AND GUTTER	CONCRETE CURB	FAIR/73

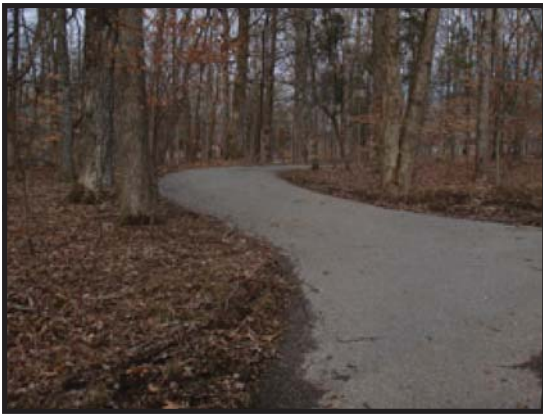
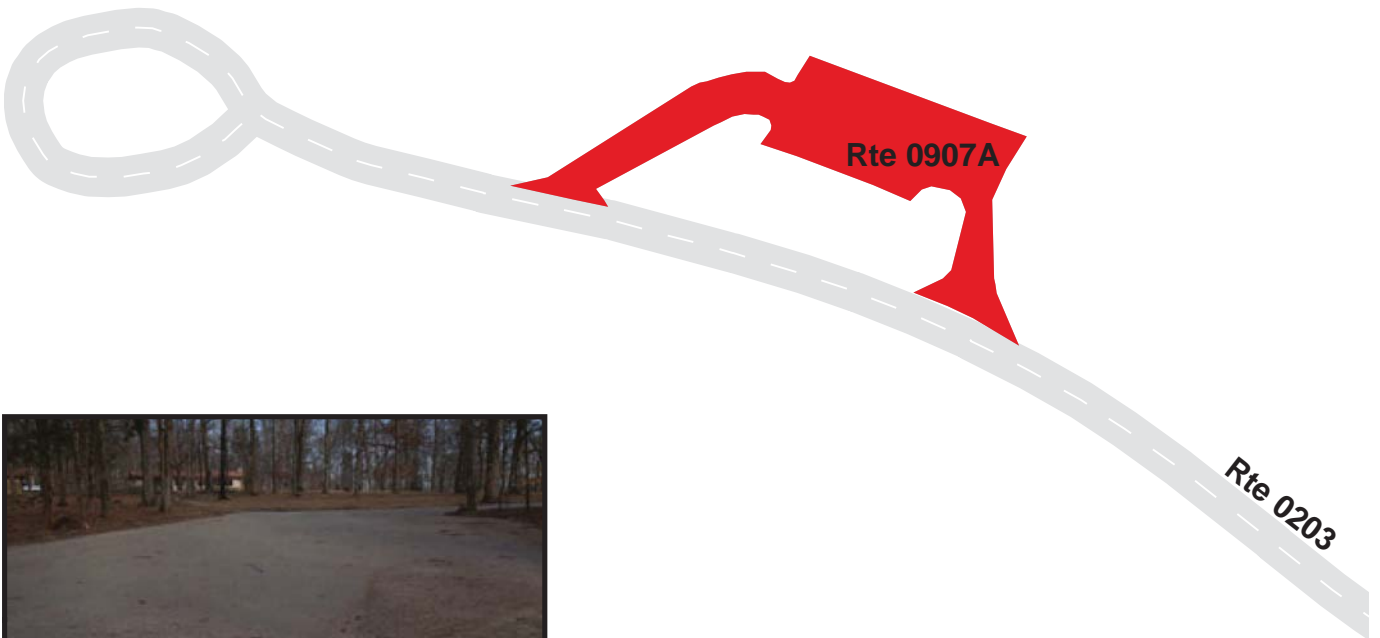
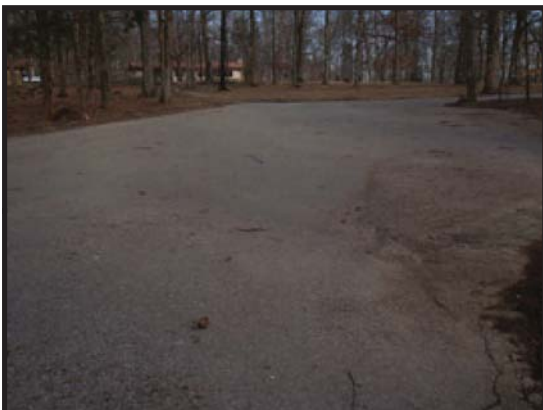
Route Number	Public / NonPublic	Date Visited		Area (sq ft)	Lane Miles *	Surface Type
0907A	PUBLIC	3/4/2009		7,779	0.13	AS
Culverts	Drop Inlets	Gates	Fire Hydrants	Curb & Gutter	Curb	PCR
0	0	0	0	NO CURB AND GUTTER	STONE CURB	FAIR/73

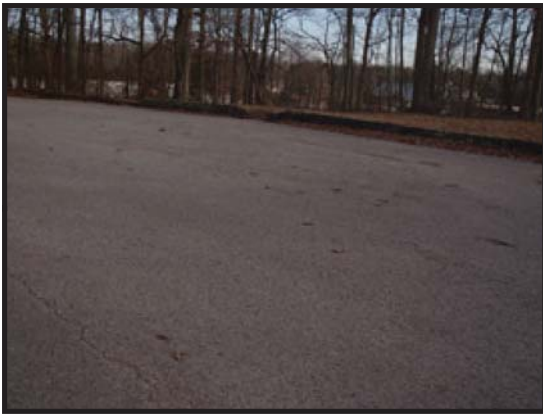
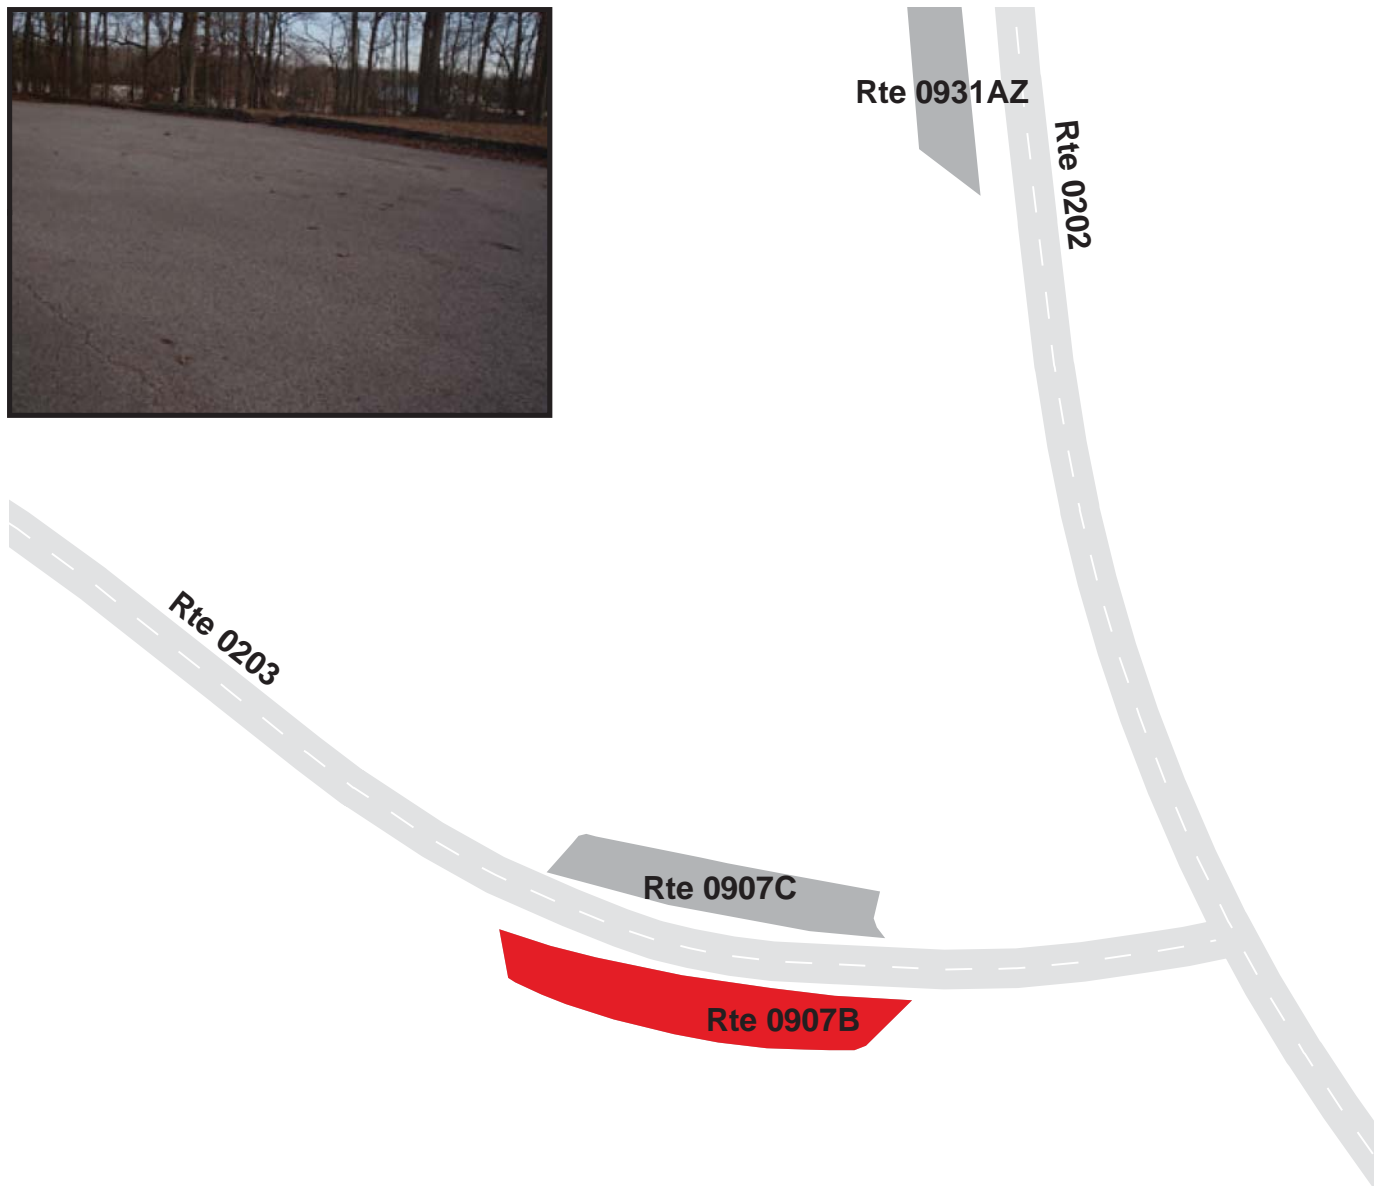
Route Number	Public / NonPublic	Date Visited		Area (sq ft)	Lane Miles *	Surface Type
0907B	PUBLIC	3/4/2009		2,322	0.04	AS
Culverts	Drop Inlets	Gates	Fire Hydrants	Curb & Gutter	Curb	PCR
0	0	0	0	NO CURB AND GUTTER	NO CURB	FAIR/73

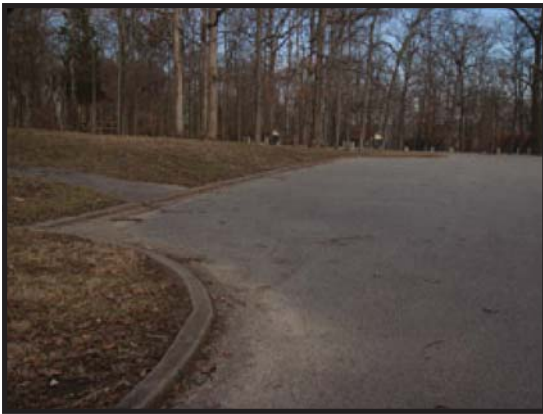
Route Number	Public / NonPublic	Date Visited		Area (sq ft)	Lane Miles *	Surface Type
0907C	PUBLIC	3/4/2009		1,706	0.03	AS
Culverts	Drop Inlets	Gates	Fire Hydrants	Curb & Gutter	Curb	PCR
0	0	0	0	NO CURB AND GUTTER	CONCRETE CURB	FAIR/73

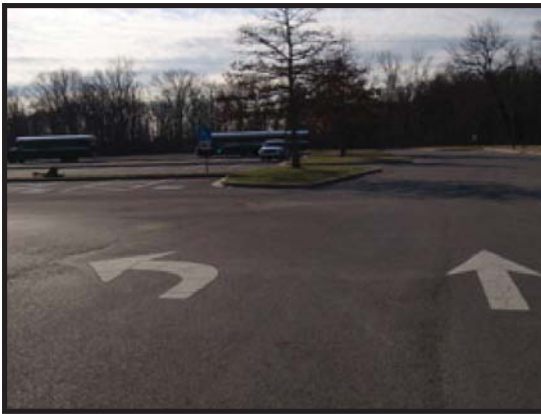
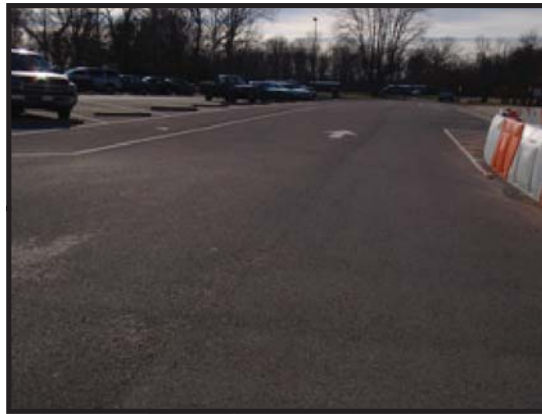
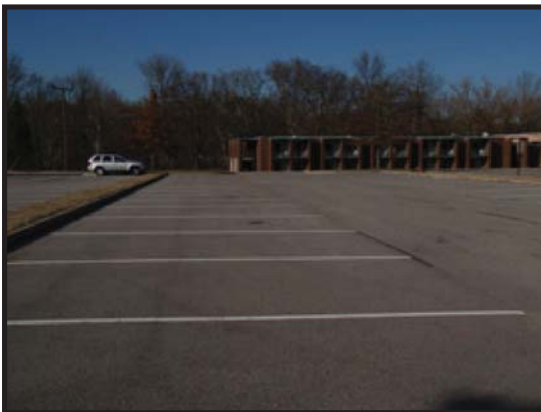
Route Number	Public / NonPublic	Date Visited		Area (sq ft)	Lane Miles *	Surface Type
0908	PUBLIC	3/4/2009		122,969	2.12	AS
Culverts	Drop Inlets	Gates	Fire Hydrants	Curb & Gutter	Curb	PCR
0	4	0	2	CONCRETE CURB AND GUTTER	CONCRETE CURB	FAIR/73
